ARCHITECTURAL/HISTORIC INVENTORY FORM

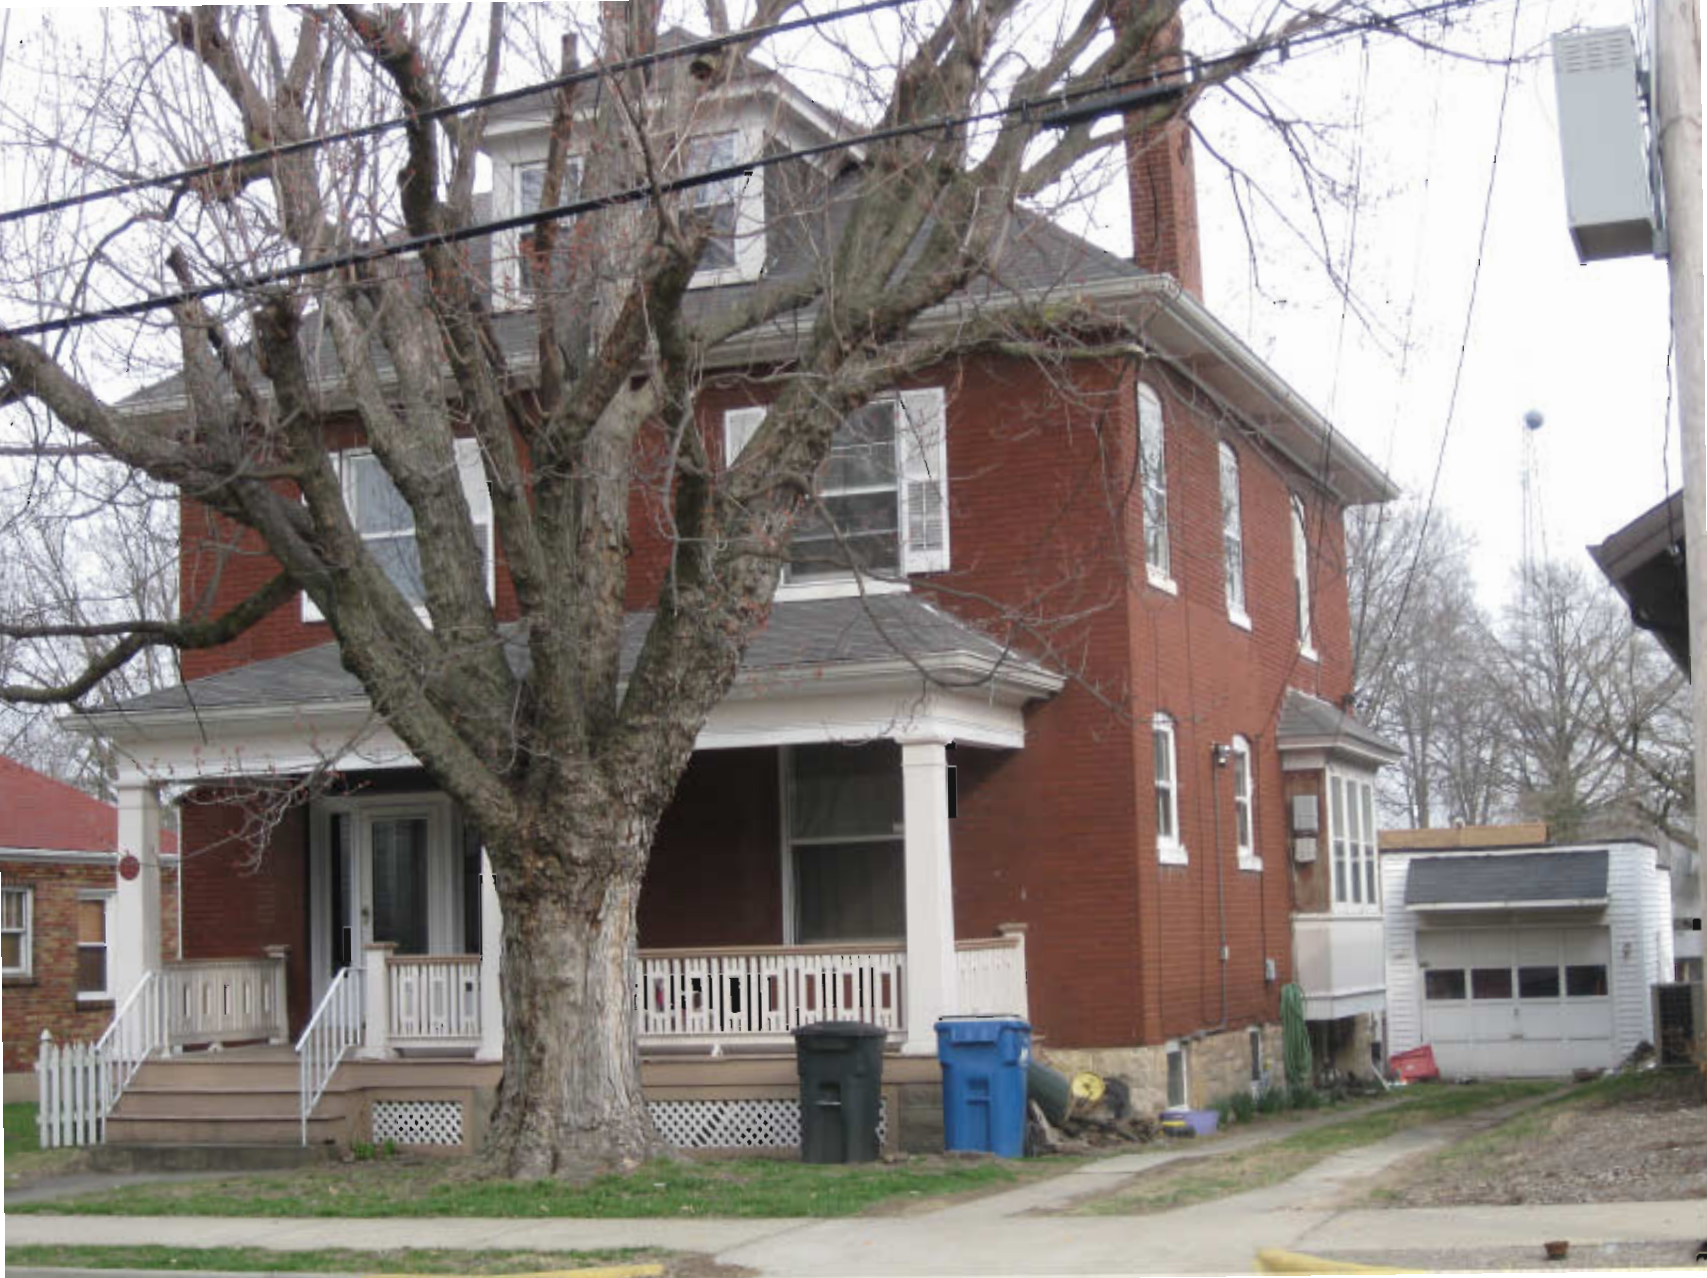
This 2.5-story, hipped roof, brick house appears at first to be a Four Square house since it is two bays wide on the facade, but it is much deeper than two bays on each side. There is a nearly full-width hipped roof porch spanning the facade with a simple entablature treatment and three evenly spaced, slightly tapered square columns that extend to the wood porch floor. There are limestone piers under the porch floor with lattice work between the piers. The wood steps at the north end of the porch facade lead up to the entry door and the unusual porch railings span the columns and terminate at a boxed newel post to define the entry to the porch. It is difficult to tell whether the balustrades are historic or not given the unusual geometric design. The facade has a large 1/1 wood sashed window in each bay on both levels of the south bay and on the second floor of the north bay above the entry. The entry door is framed by single-light sidelights and a single-light transom. The door itself is obscured by the storm door, but appears to be a rectangular light wood door. The house has a hipped dormer with three 1/1 sashed windows on the facade and dormers on the north side and rear elevations that each have paired 1/1 sash windows. There is a shallow boxed, one story bay with a hipped roof and three 1/1 sashed windows on the south elevation. There is a simple interior brick chimney abutting the north dormer and another, larger interior brick chimney on the south side, both with simple banded brick caps. The soffits of the house and dormers are enclosed, now clad with vinyl siding, but this appears to simply cover a similar wood treatment. The facade windows have flat headed openings but the other windows are segmental arched brick openings, all with soldier course brick lintels and stone sills. The windows are 1/1 wood sashed windows. The foundation is coursed, rusticated limestone and the basement windows are 2-light awning windows. Aluminum storm windows have been added and the wood louvered false shutters on the second floor facade windows do not appear to be historic. The 1917 fire insurance map showed a two-story, full width porch on the back of the house, but the 1929 and 1947 maps show the central, two story enclosed section and a two story porch on the north side of this central section, as it appears currently. There are two rear entry doors from this northeast corner porch, one leading into the main house has a transom while the one into the centered brick first floor extension does not, possibly verifying that the center brick section was added shortly after construction. The second floor is a frame, enclosed room that extends across the brick central extension as well as the corner porch. The porch retains the original wood porch floor and original wood railing on the north side, but the second floor porch with its shed roof was probably originally a sleeping porch that has been enclosed more recently with vinyl siding and 6/6 vinyl windows.

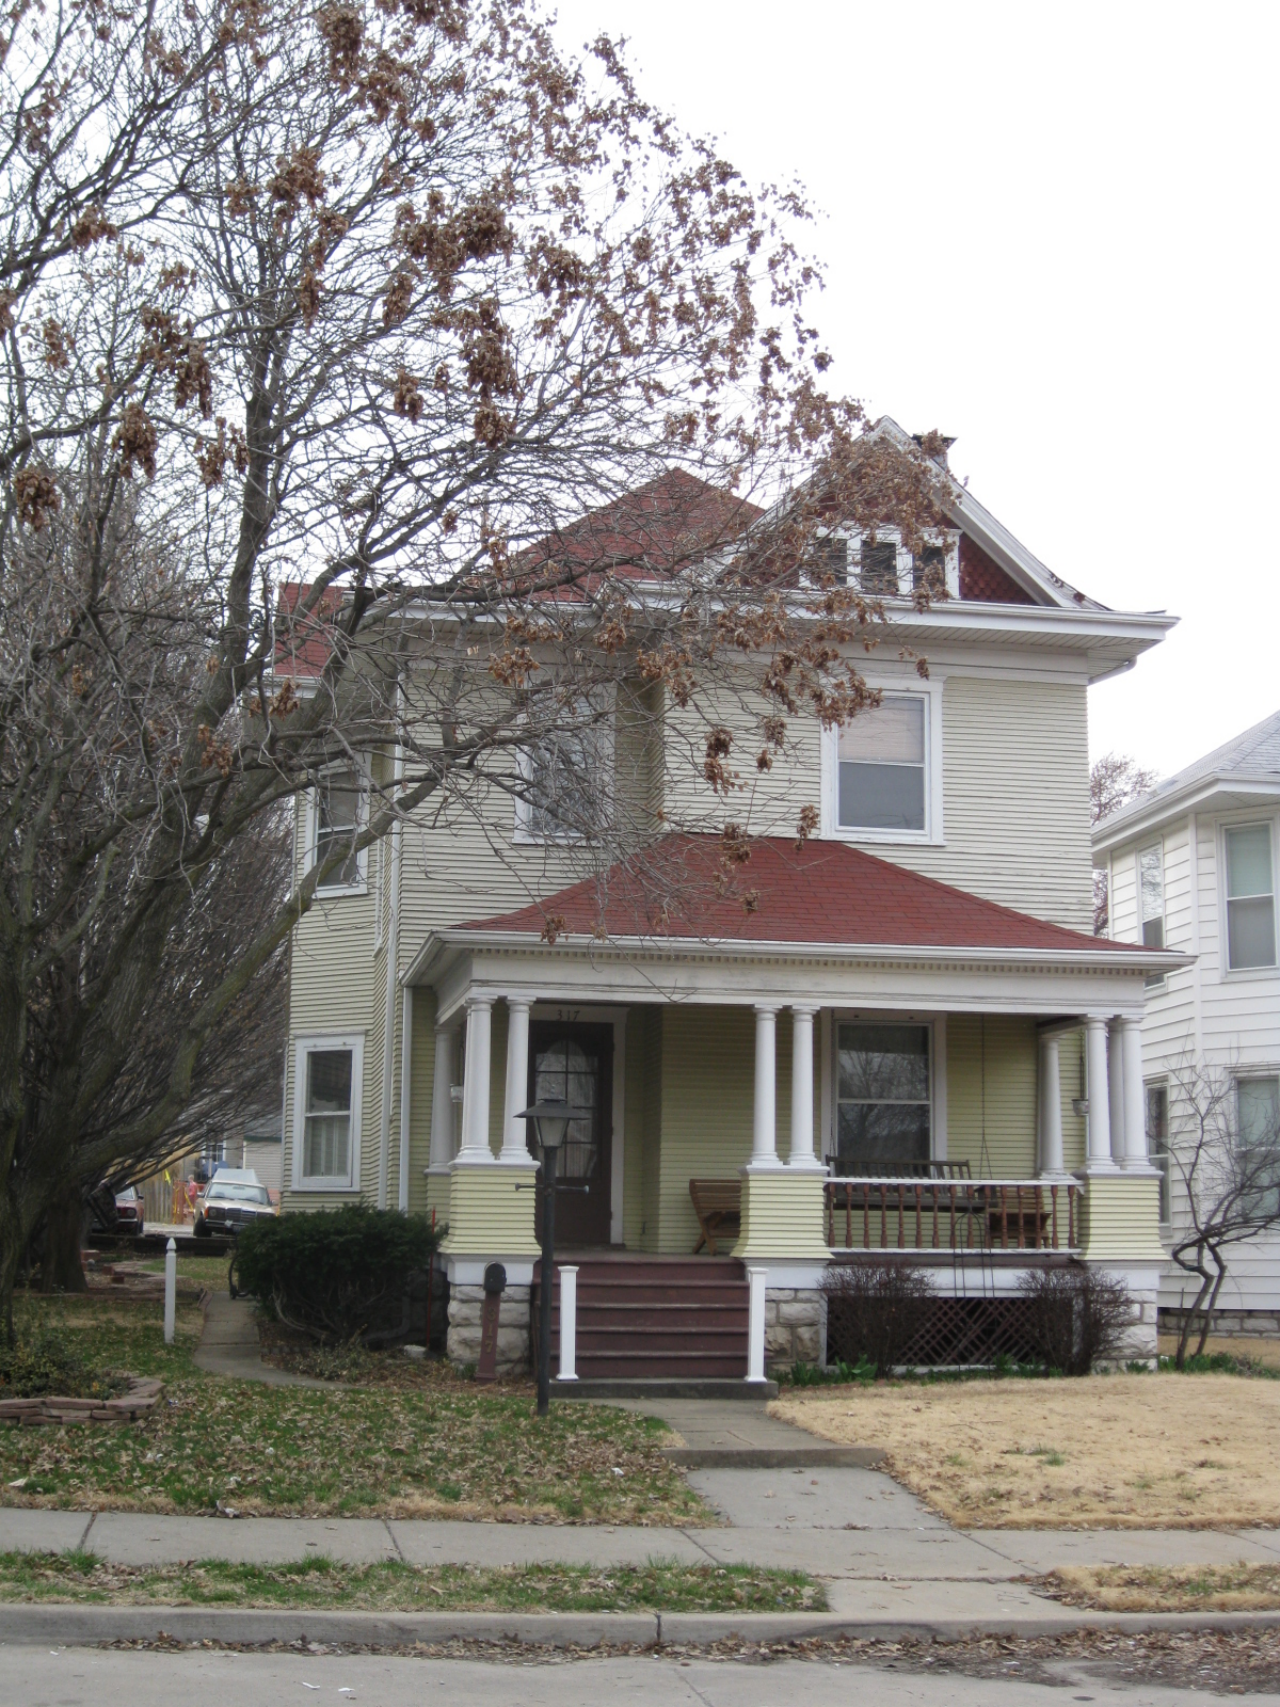
This large, two story, hipped roof, frame building has Colonial Revival detailing concentrated on the full width front porch, although the pedimented gable end with its shingle siding of the slightly projecting cross gabled bay on the north two-thirds of the facade is also a common element on early Colonial Revival houses. The roof has wide, enclosed eaves, now clad with vinyl, but the house retains its original clapboard siding with mitered corners. The windows also show some Colonial Revival influence; most are 1/1 wood sashed windows with crowned cap lintels. The pedimented gable end has a tripartite wood framed window with three single light windows. There is a 1/1 wood sashed window in each of the two bay facade openings, both levels, except for the entry, which has an oval light wood door. The full width porch has a hipped roof with an entablature and dentil course under the eaves. There are paired Doric columns at the corners and off-center to define the entry bay as well as single Doric pilasters against the house, all resting on clapboard clad plinth blocks. Directly below, there are rusticated stone piers. The porch floor is wood as are the steps. It has spindle balusters on the rails that appear original. There is another cross gabled bay on the south elevation, also with the same shingle siding pediment and tripartite window, but this bay is canted, with 1/1 wood sashed windows on each facet. There are incised, curved brackets under the corners of the eaves where the bay is cutaway. On the rear, the one story porch appears to be a later addition surrounding the original porch given the shed roof extension below the original hipped porch roof. The one story porch is shown as much smaller on the fire insurance map. There are two chimneys, one metal (nonhistoric) and one brick, both along the north elevation. There is a 3/1 window on the south elevation, east end and it is unclear whether this is original or a later replacement.

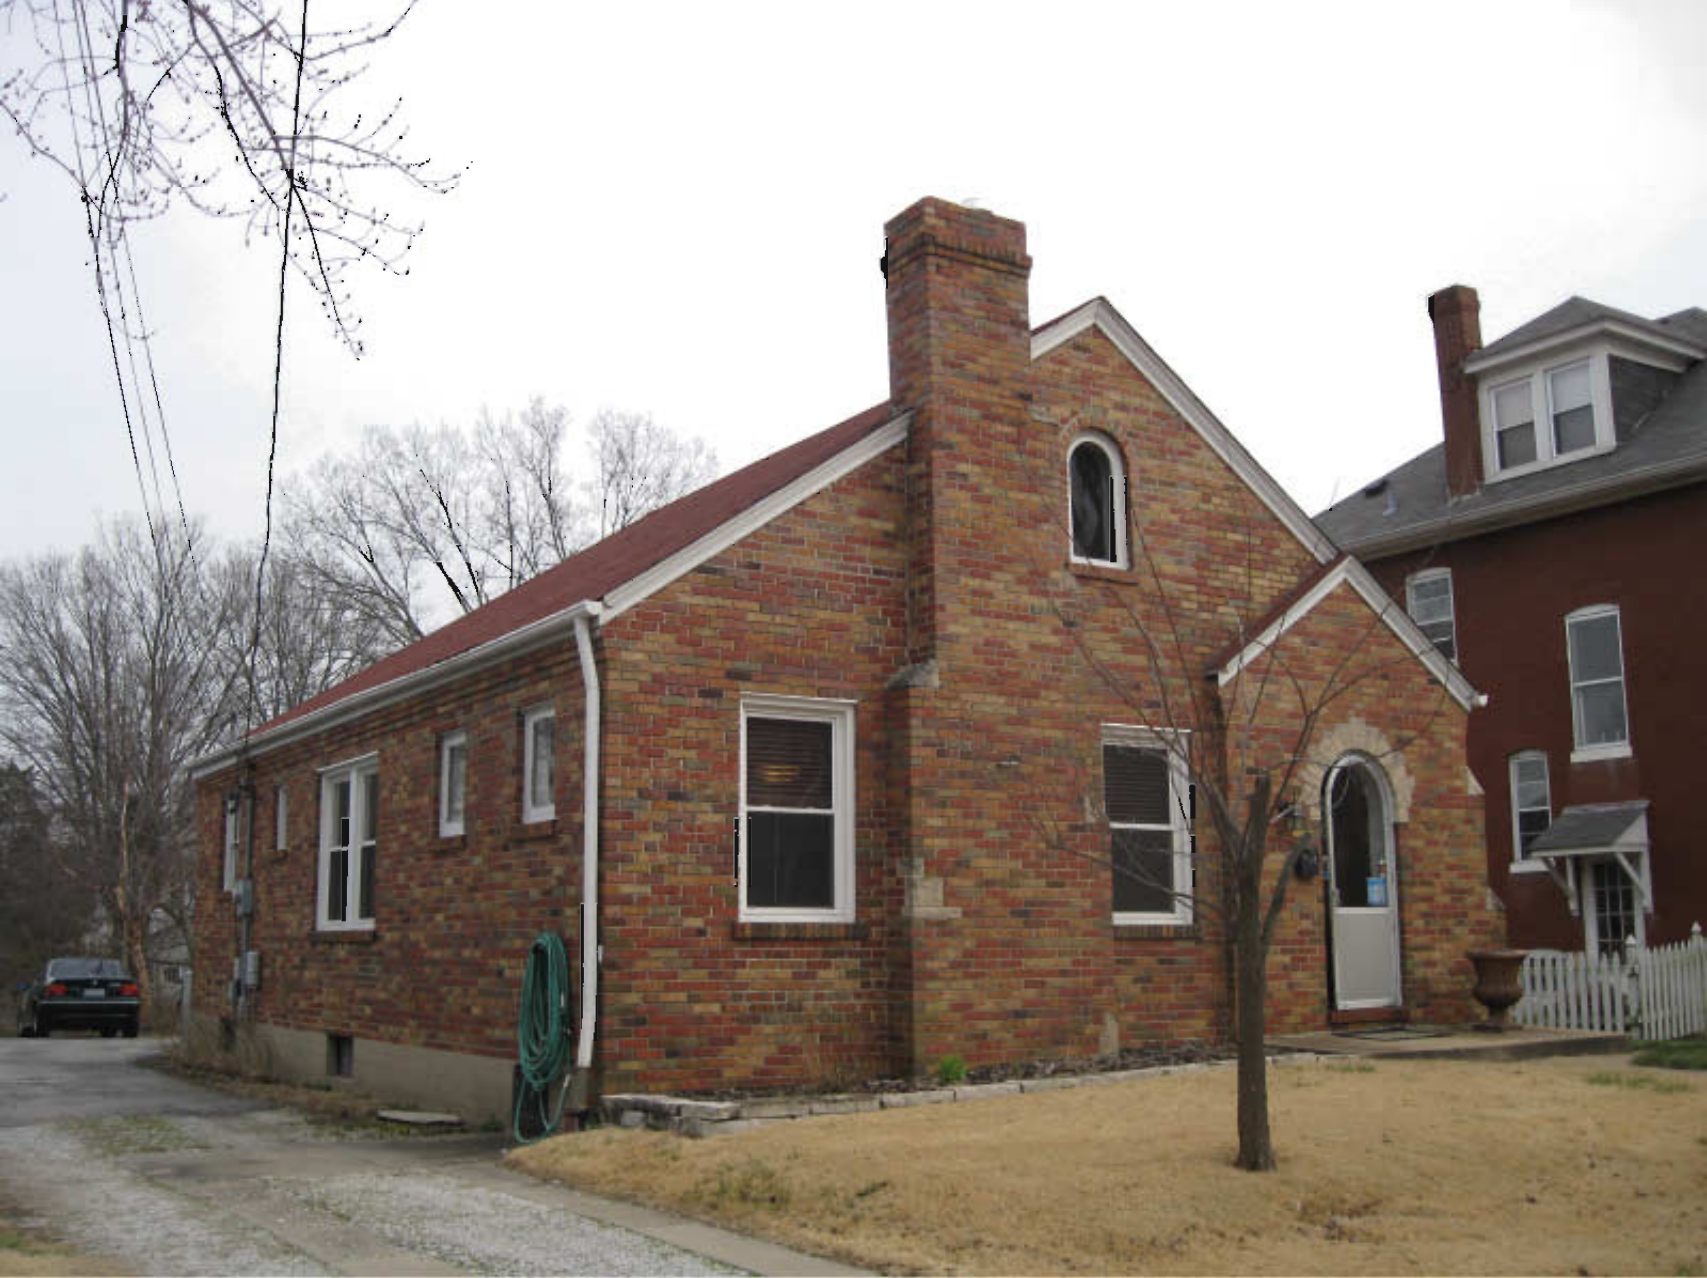
This one story, multicolored brick, gable end house is a simple Tudor Revival design, noted for its multicolored brick with rusticated limestone accents, the round arched attic window with its diamond pattern leaded glass, the round arched front door with its rusticated stone arched lintel, the tiered, exterior end wall chimney on the facade and the wing wall on the south facade corner that steps down with stone ledges. The facade is divided into three bays with 1/1 replacement windows in the two windows that flank the large end wall chimney and the entry door with its very shallow concrete stoop in the south bay. The entrance bay projects slightly from the remainder of the facade and is gabled. The side elevations have a tiered brick detail at the eaves. Near the facade, on the north elevation there are two diamond patterned leaded glass casement windows and another one near the facade of the south elevation. On the north elevation behind the leaded glass windows are paired 1/1 replacement sashed windows and behind this window unit is a small 3-vertical light fixed window that appears original as does the 3/1 wood sashed window at the rear of the elevation. On the rear, the roof is actually a hipped roof with a hipped dormer with a 3/1 wood sashed window. The shed roofed porch on the rear is obscured by the latticework on the east and north sides but it appears to retain its original concrete stoop. The scored concrete foundation is visible on all elevations except the facade. Even though it is likely that the 1/1 replacement sashes probably replaced 3/1 windows since some are still extant, the basic Tudor Revival features and the distinctive diamond patterned leaded glass windows are still intact and as such this is a contributing building in the historic district.

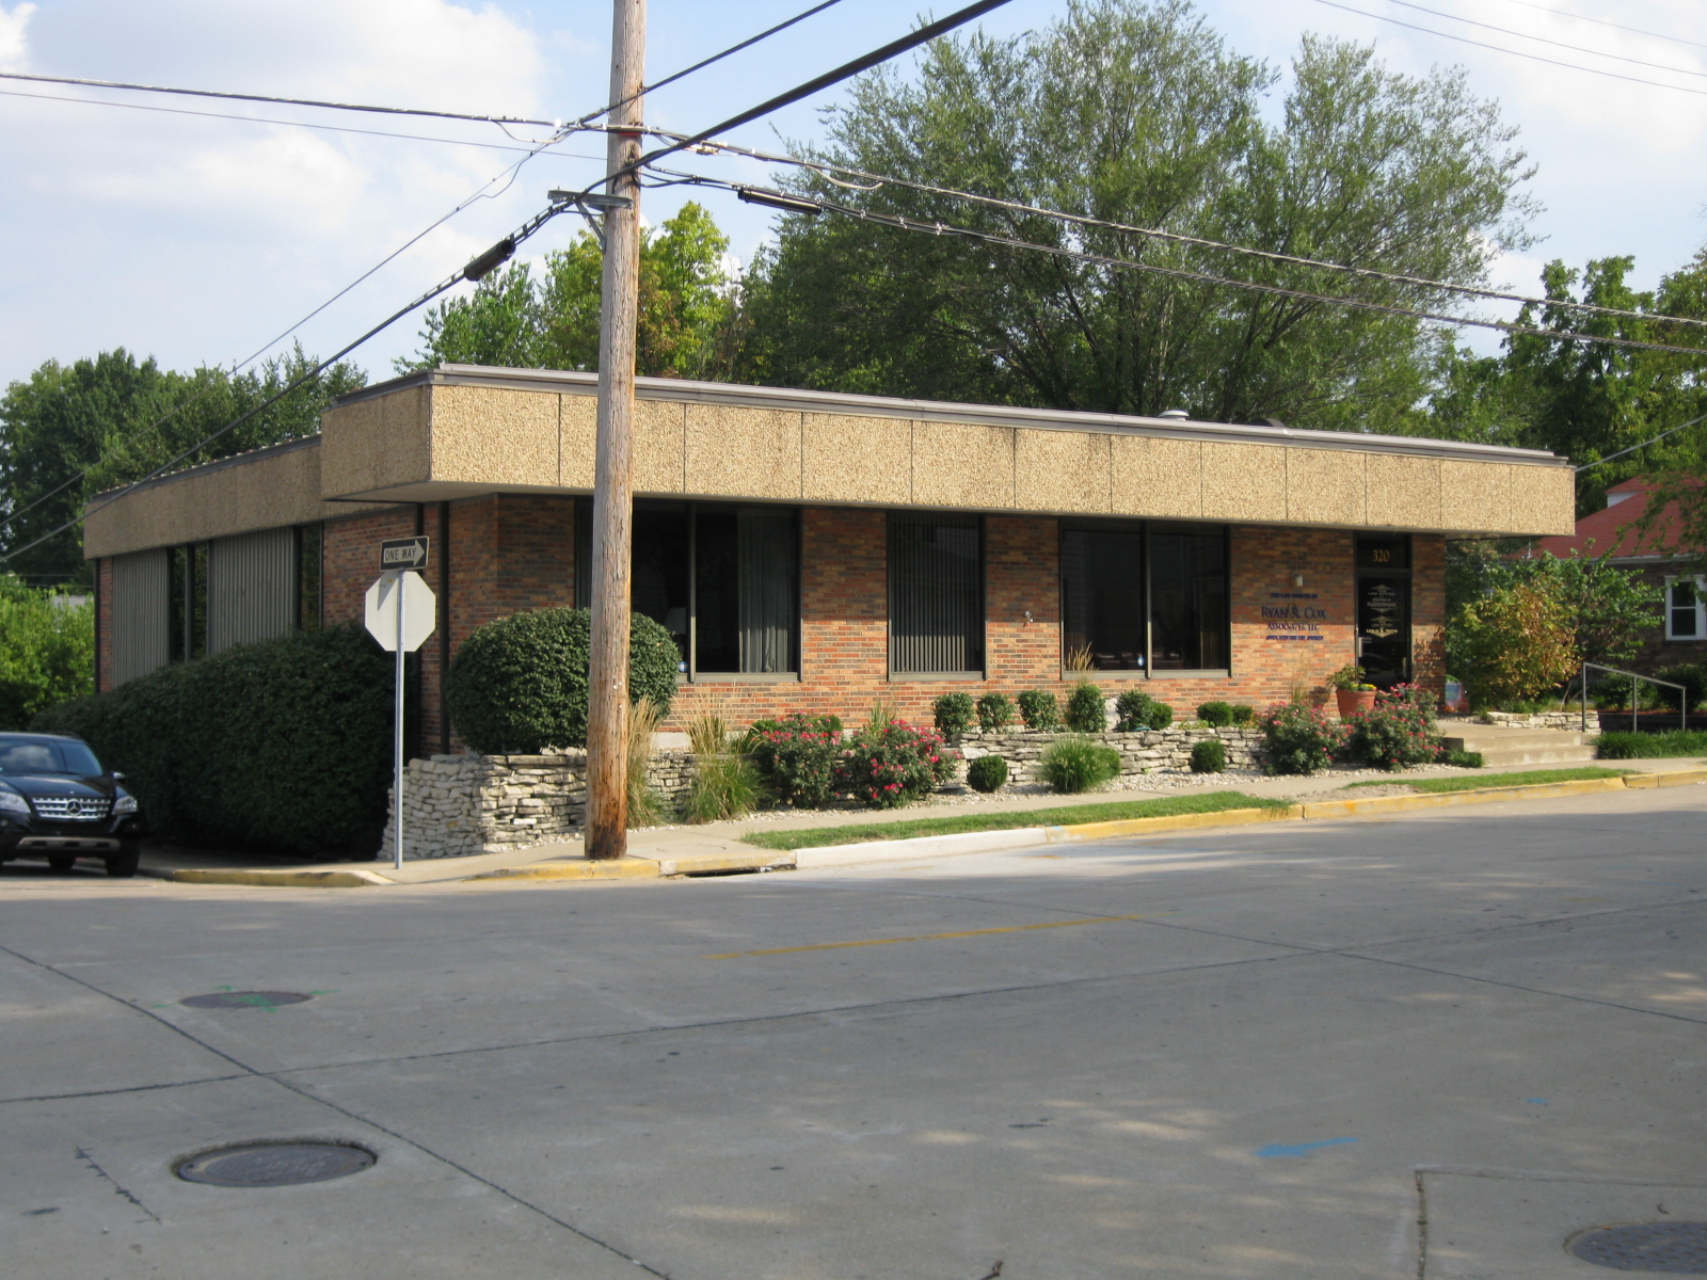
This flat roofed, modern office building has a projecting band of aggregate veneer panels at the top of the building that overhang on the side elevations and form a projecting canopy across the facade. The facade walls are multicolored brick, with anodized aluminum, smoked plate glass windows in three of the four bay facade. The anodized aluminum, smoked glass door and transom are located in the south bay with a concrete stoop to the public sidewalk. On the sides the brick walls only wrap from the facade with vertical board siding and slender smoked glass plate glass windows on the rear two thirds. The stacked stone flower beds surrounding the facade appear to be later alterations.

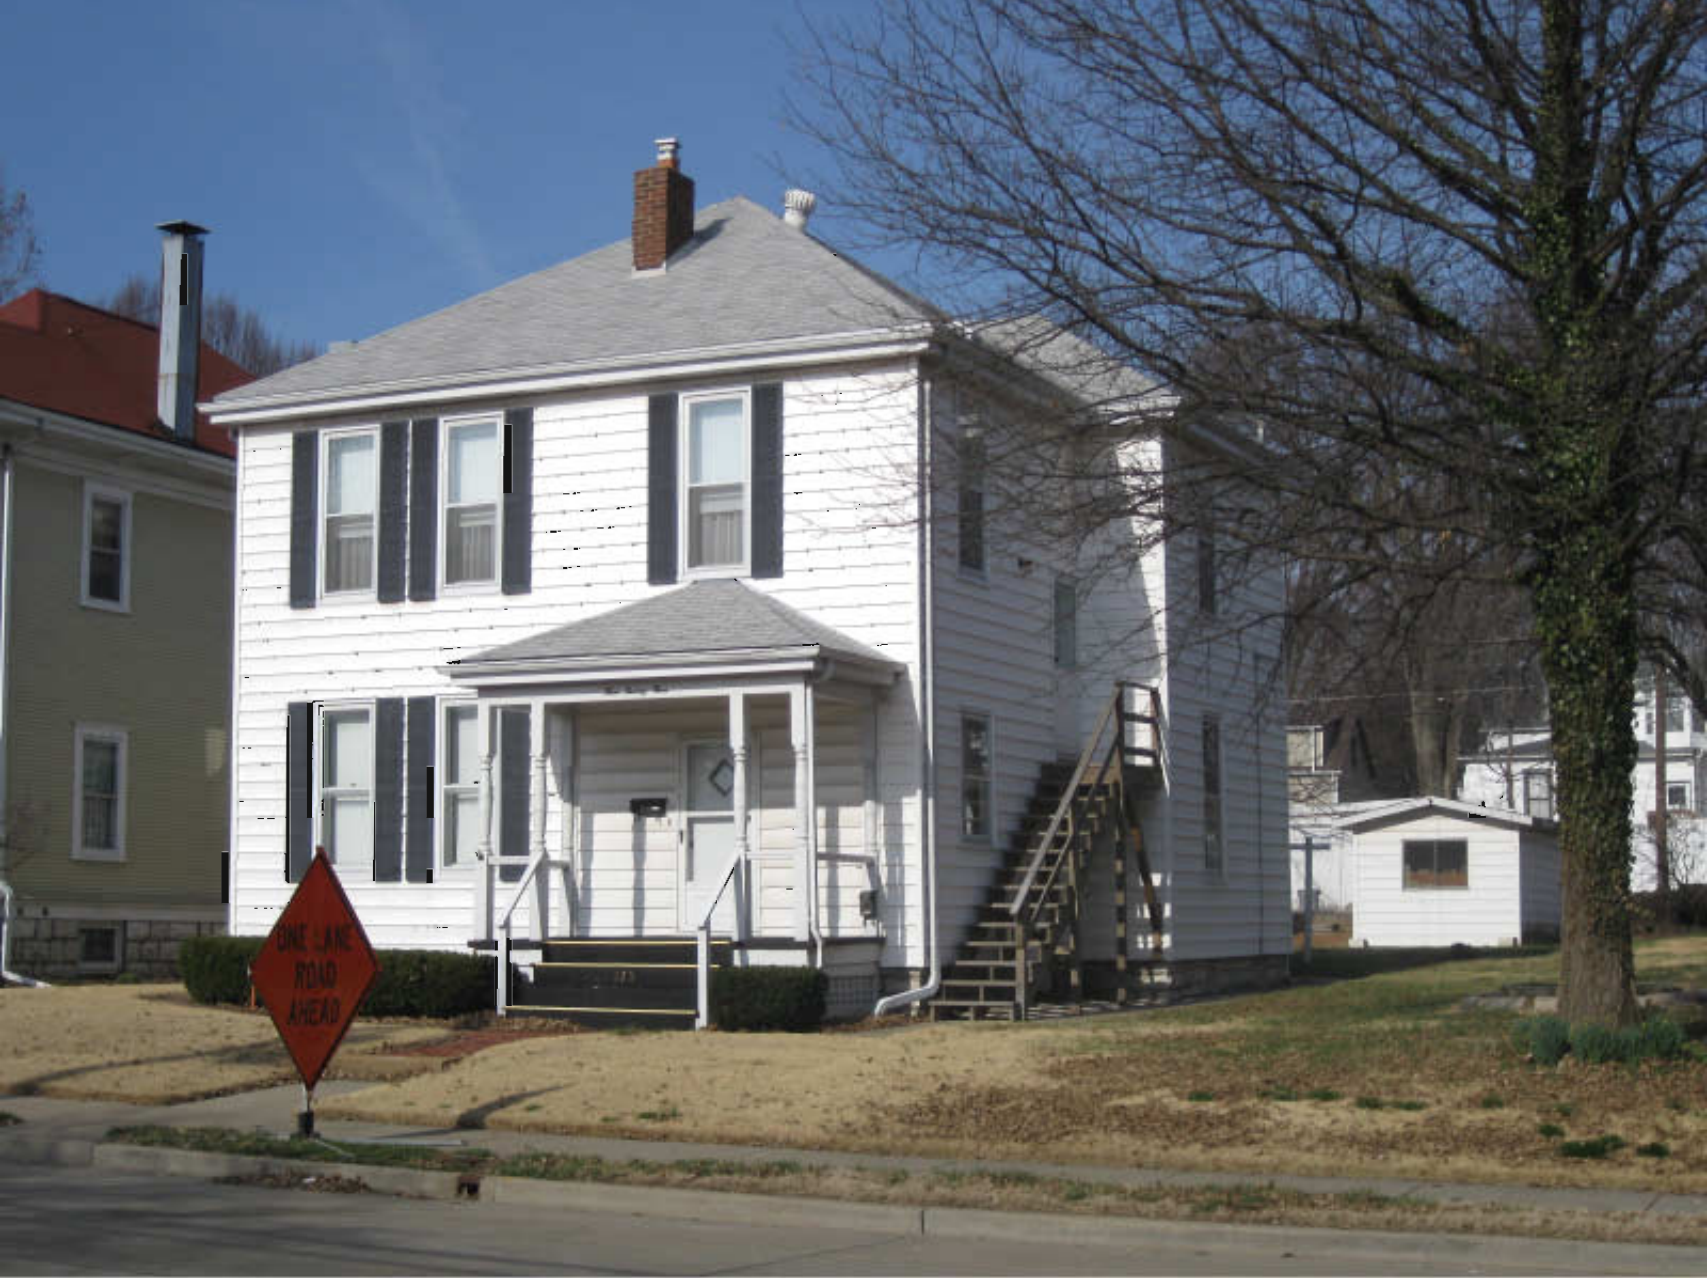
This two story residence has been converted into apartments. It is a hipped roof building that has been clad in wide vinyl siding that covers the original window trim, but it retains its original 1/1 wood sashed windows and elements of the original front porch, which is shown on the 1909-1947 Sanborn maps. The facade is divided into two principal bays, with two windows on each level of the south half of the facade and one on the second floor of the north half, above a hipped roof porch. The porch retains the original turned porch posts, one against the house at each corner of the porch, and paired at the front corners. The original railings remain along each side although the balusters are missing. The wood porch floor and steps remain, but are currently covered with carpet. There is wood latticework below the porch floor. The front door has been replaced with a slat door with a diamond shaped light. A cross hipped wing projects slightly on the north elevation at the rear, which is part of an addition completed between 1917 and 1929 across the back of the house. On the south elevation there is a two story canted bay with a hipped roof, which originally marked the rear of the house (before the rear addition). On the rear there is a central, partial width, hipped roof porch with square posts, and the porch rests on a concrete foundation. The house has a coursed, rusticated limestone foundation. There is an interior brick chimney on the front facet of the roof. A nonhistoric exterior straight flight stairs extends up the north elevation to a doorway (added for an apartment). Because the siding does not mirror the original siding in width and obscures the historic window trim, this is currently identified as noncontributing to the historic district, but because it retains the original windows and some important original porch elements, it could be contributing if the siding were removed or at least replaced with a more historically appropriate width siding that did not cover historic trim.

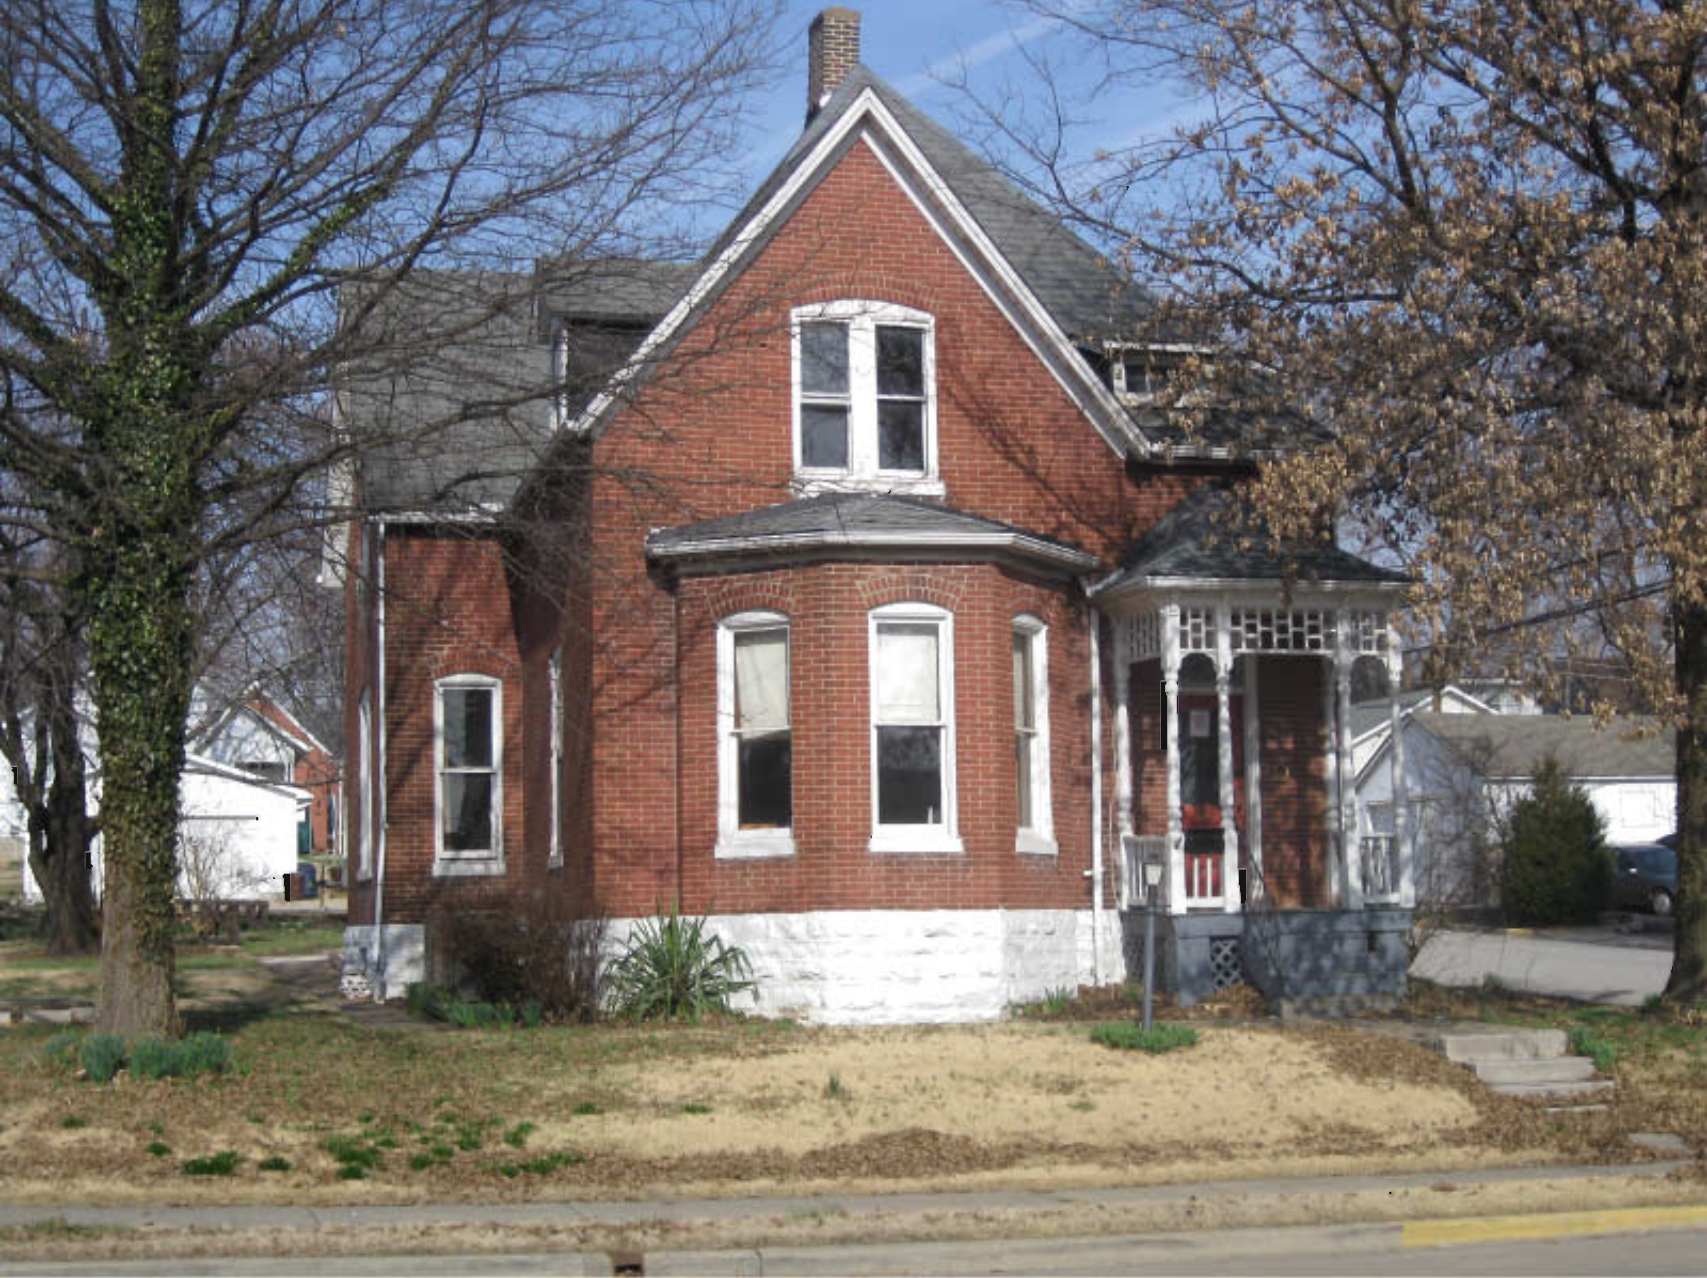
north elevation there is another dormer, gabled, but it appears to be a new alteration and it has an oddly proportioned new window (only in the lower half of the dormer). The rear elevation is spanned by another cross gabled wing that has two 1/1 sashed windows on each level. The cross gabled, 1.5 story bay on the south elevation has paired 1/1 windows with incised lintels matching those on the north elevation. There is a brick interior chimney near the peak of the hipped roof. Windows on the entire house have segmental arches of two rows of brick and stone sills. The sashes have been replaced with 1/1 windows. The brick on the facade is laid in a running bond pattern and other walls are a 5-course common bond. The eaves have been clad with aluminum or vinyl. Since the windows are being replaced with nonmatching windows in some cases, this building is probably no longer individually eligible for listing on the National Register although it still retains enough historic integrity to be a contributing building in the historic district.

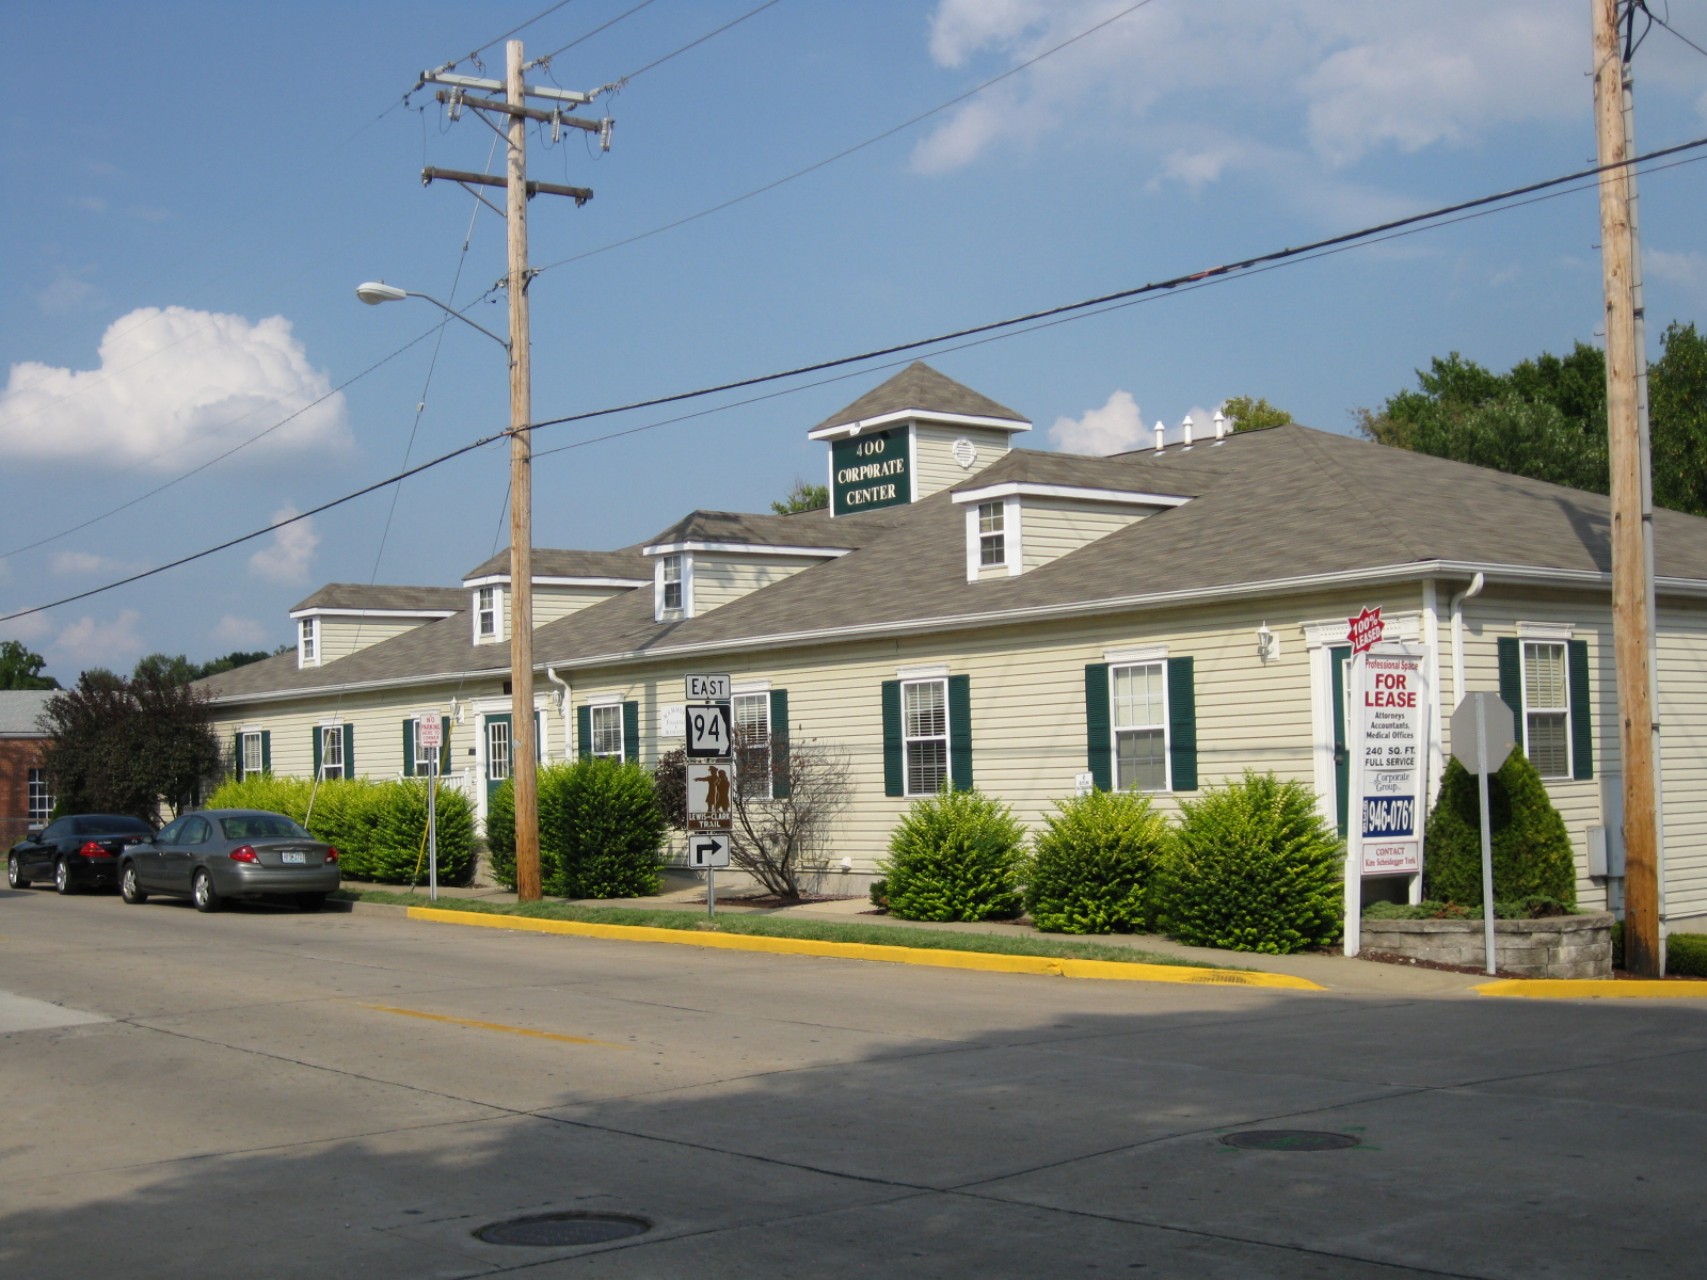
Built in 1997, this one story frame building with vinyl siding has a hipped roof with a pyramidal roofed cupola and four hipped dormers on the facade. The building facade is divided into ten bays with a simple entablature and pilaster strip surround on the two doorways on the west facade. There are paired doors five bays from the left and there is a single door at the south end, with simple pilasters and entablature surrounds. In front of the doors are simple low concrete stoops. The other bays have 6/6 vinyl windows with shutters and entablature-like lintels. The foundation is poured concrete. Since the building is not historic, it is noncontributing to the historic district.

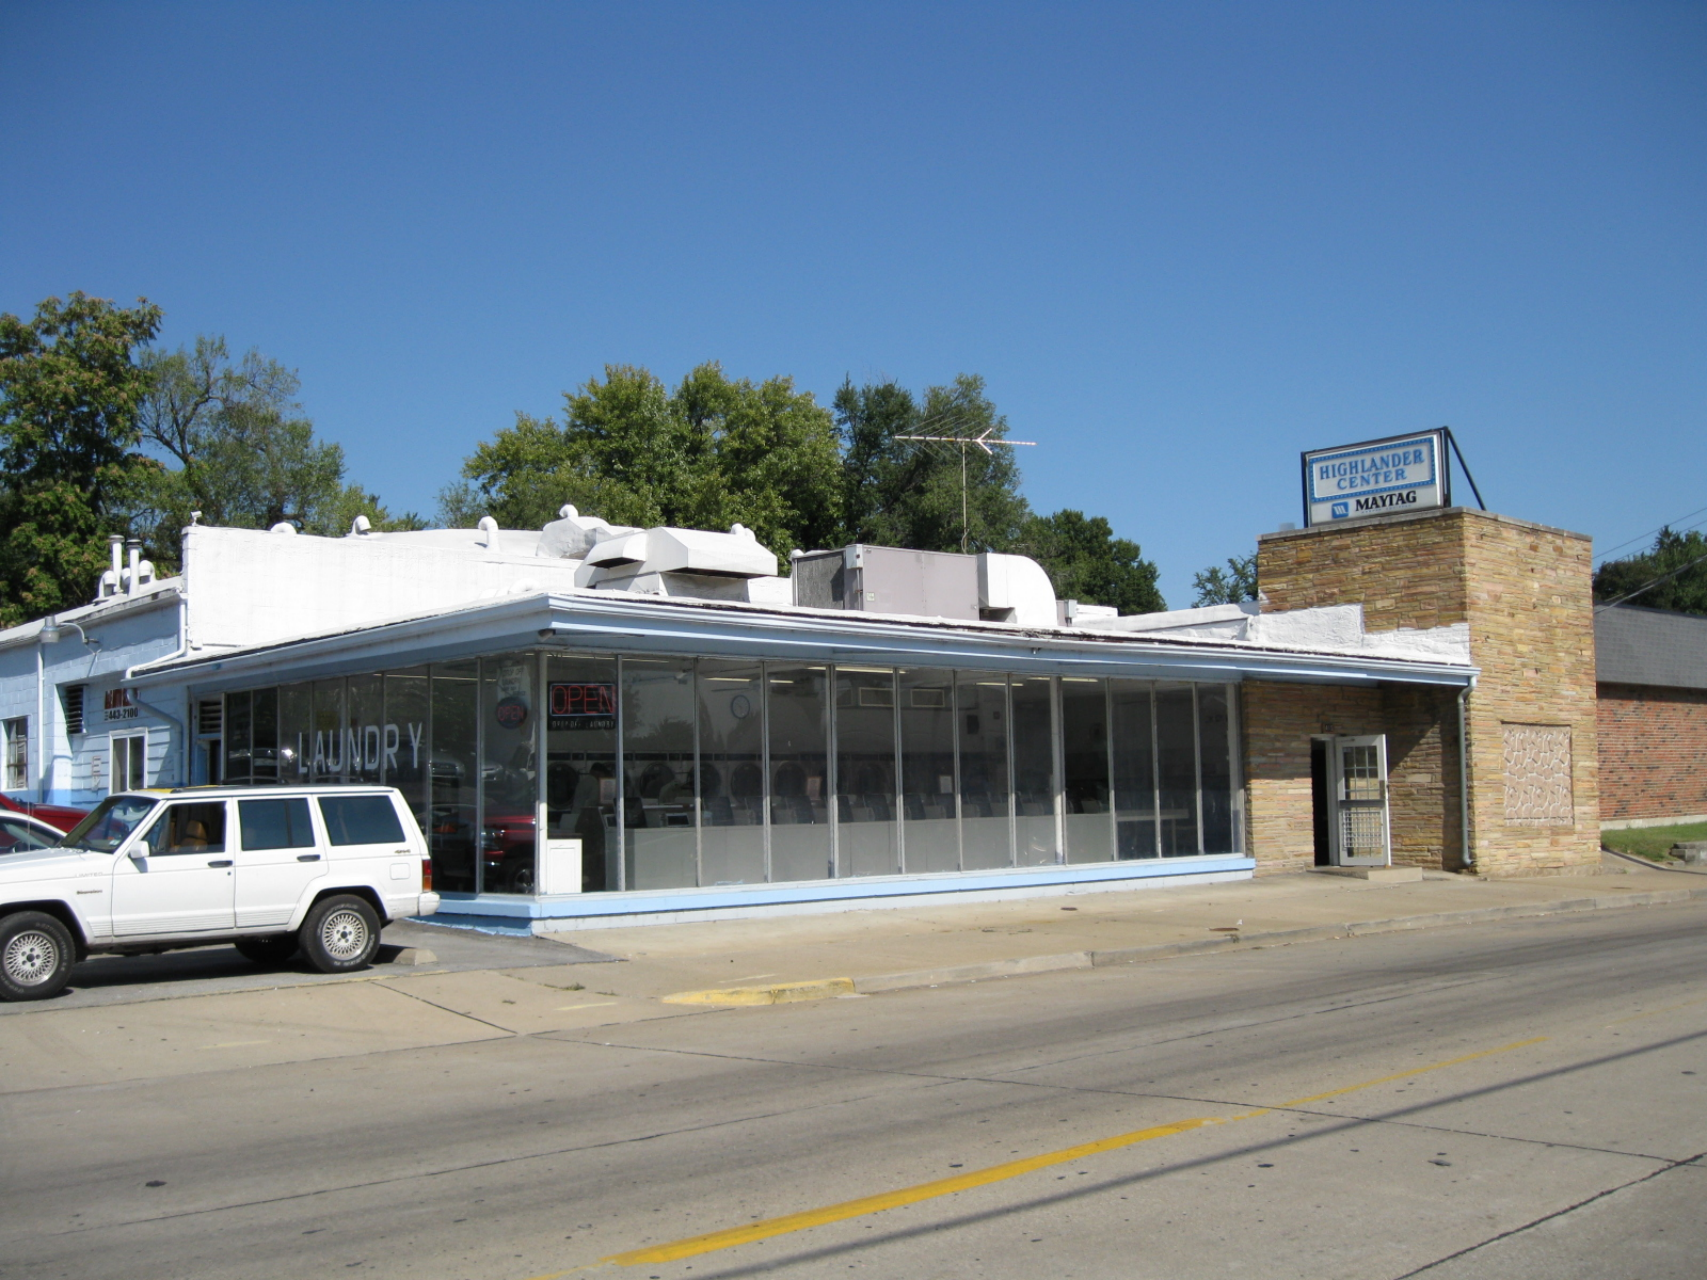
Built between 1948 and 1950, Schumpe Motors building is a mid-century Modern automotive dealership building. Most of the building is the actual automotive garage, housed in a barrel vault roofed section that actually has a false parapet of concrete block that is coated with stucco. The walls of this section of the building, which spans the rear two thirds of the entire complex, are made of concrete block that has been painted. There were originally two large overhead garage door entries on the south elevation, near each end, but the front one has been infilled with wide siding and a small two light window. Between these windows are four 9-light industrial steel windows. Just north of the south overhead door is a man door which appears to be a replacement half light door with multipaned glass. Across the facade is a low profile, flat roofed display showroom. The flat roof cantilevers out on both the south and east elevation to form a deep canopy over the plate glass window walls that extend across the south elevation (from the concrete block section to the front corner) and across most of the facade, except for the entry area at the north end. The display windows extend to a very low-height kickplate designed deliberately to better serve to show off automobiles. The actual display windows have been replaced with narrower framed sections of aluminum framed display glass (since originally they would have used plate glass as wide as possible to show the automobiles). Near the north end, under the canopy is a permastone wall with the entry door, a full light door, but this appears to be a replacement door given the multipaned appearance of this door, which is not in keeping with the Modern design of the building. At the north end of the facade there is a tall, tower-like permastone section that projects out to align with the outer edge of the canopy and is wide enough that it has a large plate glass window opening (currently covered over). The permastone mimics rock faced ashlar limestone laid in thin strips, a technique popular in the post-war era. While the building has some cosmetic alterations, it is relatively intact and even the showroom inside appears to retain much of its original character. Given the relative importance of automobile dealerships and the scarcity of representative examples from the mid-century dealership designs, this building is not only a contributing building in the historic district but it might also be individually eligible to the National Register if the large plate glass display windows were restored.
