ARCHITECTURAL/HISTORIC INVENTORY FORM

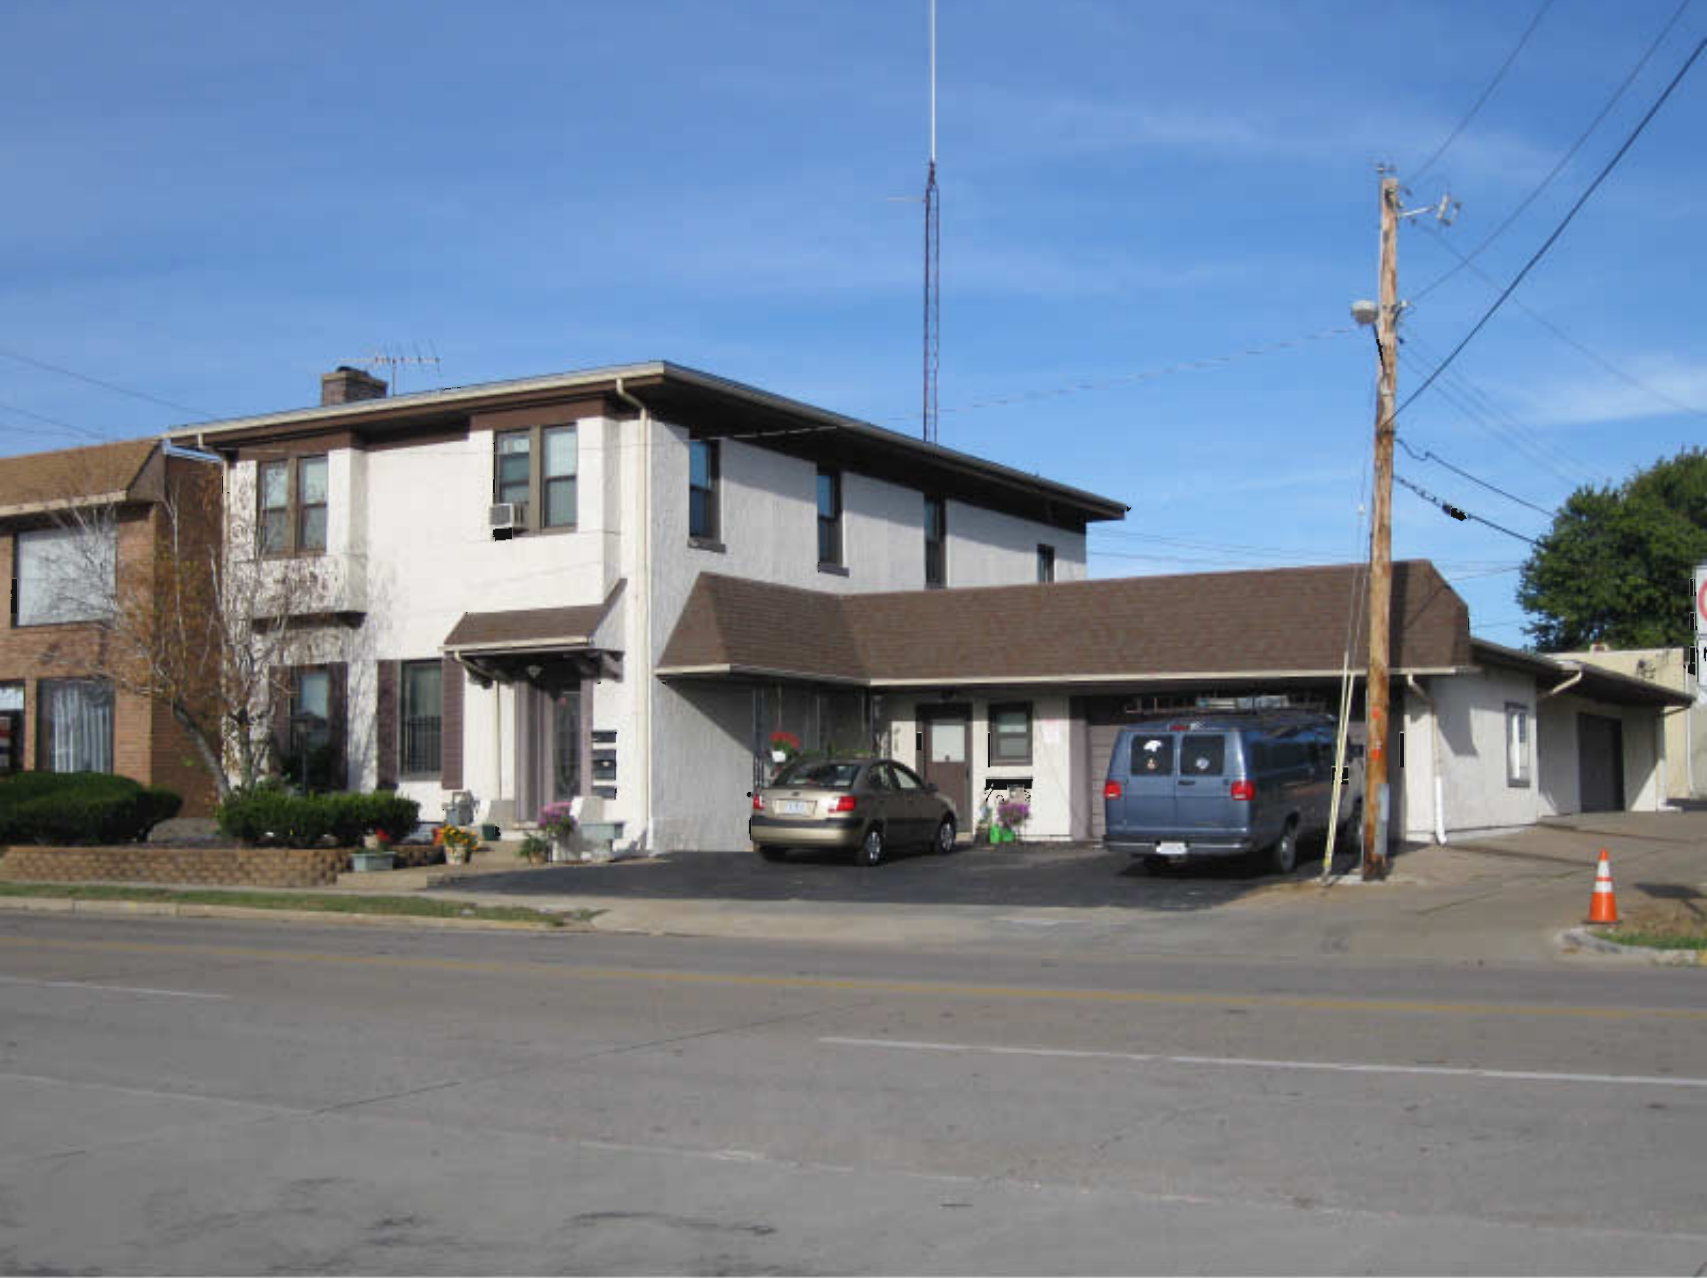
This two story, heavily textured stucco house has a flat roof with wide eaves. The facade is divided into three bays with boxed oriel windows in the outer two bays on the second floor that have paired sashed windows and small brackets underneath. On the first floor, the south and center bays have sashed windows while the north bay has a shed roof supported by two pairs of curved brackets over the doorway. Curved stucco knee walls and a series of concrete steps lead up to the front door. On the north side of the house, a large garage has been built with a false mansard facing Fifth, obscuring the flat roof visible in front of an end gabled roof facing Jefferson on this corner lot. On both elevations there is a two-car garage door. There is a small sashed window and a half-light door to the south side of the garage door on the Fifth Street elevation. It appears that the end gabled roof peaking above the flat roof represents an older detached garage but it has since been incorporated and wrapped with a much larger, flat roofed garage. The house is difficult to date, but appears to have at least been remodeled in the early twentieth century to reflect Prairie School stylistic details (stucco, boxed bays, wide eaves, bracketed roof over the entry), but other characteristic details (window and door patterns) have been modified again in recent years and the large commercial size garage dominates the facade. Unless the addition can be dated to the period of significance of the historic district, this building is noncontributing to the historic district.

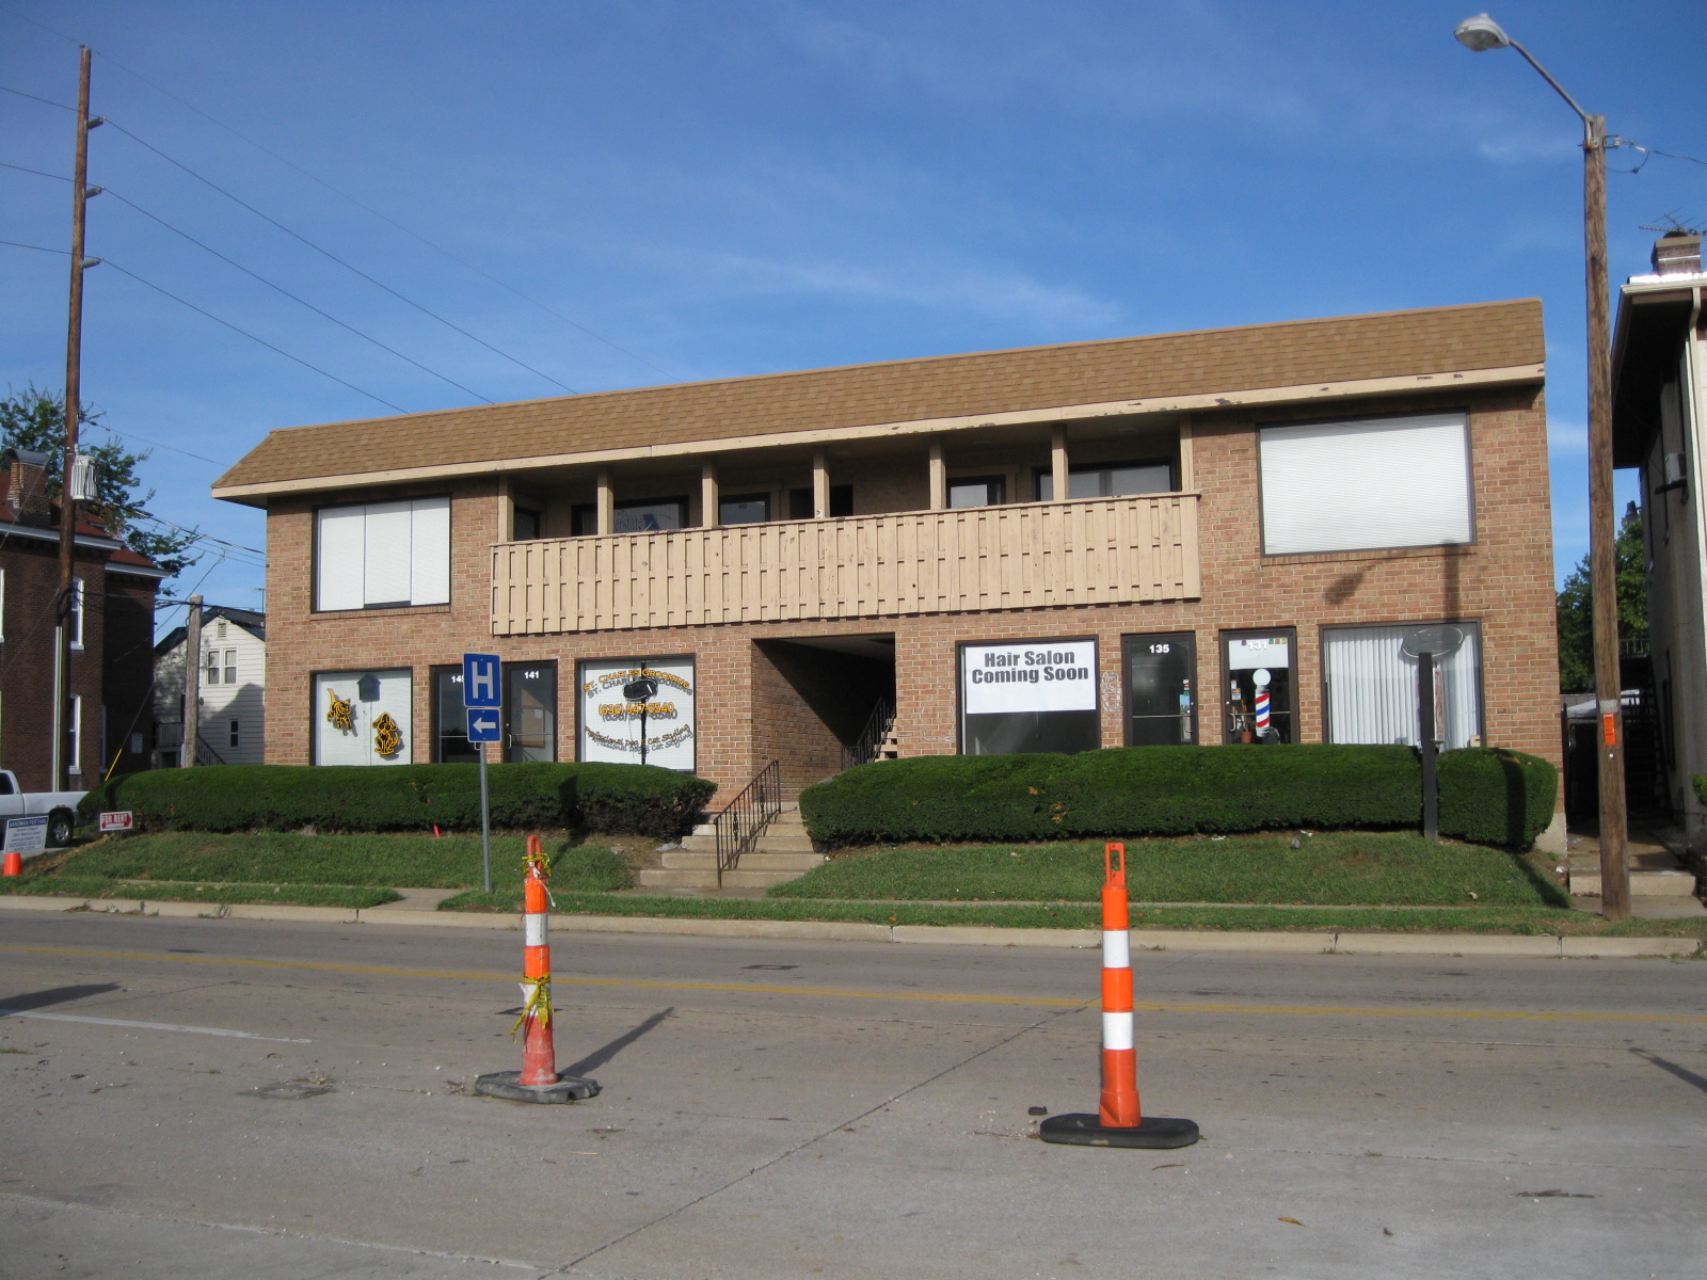
This two story, flat roofed building has light toned, multicolored brick walls and a false mansard on the two street elevations (east and south). The facade is divided into seven bays, with the second bay from each end having a pair of full light entrance doors. The other bays have plate glass display windows except for the center bay which is a pass-through to the back of the property and the internal, exterior staircase to the second floor. The upper floor has a balcony spanning the five central bays with plate glass windows in the outer two bays. The recessed area behind the balcony has additional plate glass windows and full light entrance doors. The south end of the building is highlighted by a pair of tall, round arched friezes with stucco panels. The rear has a shed roof with wrought iron posts spanning the first floor and four 9-pane, half light doors directly below the four 1/1 sashed windows on the second floor.

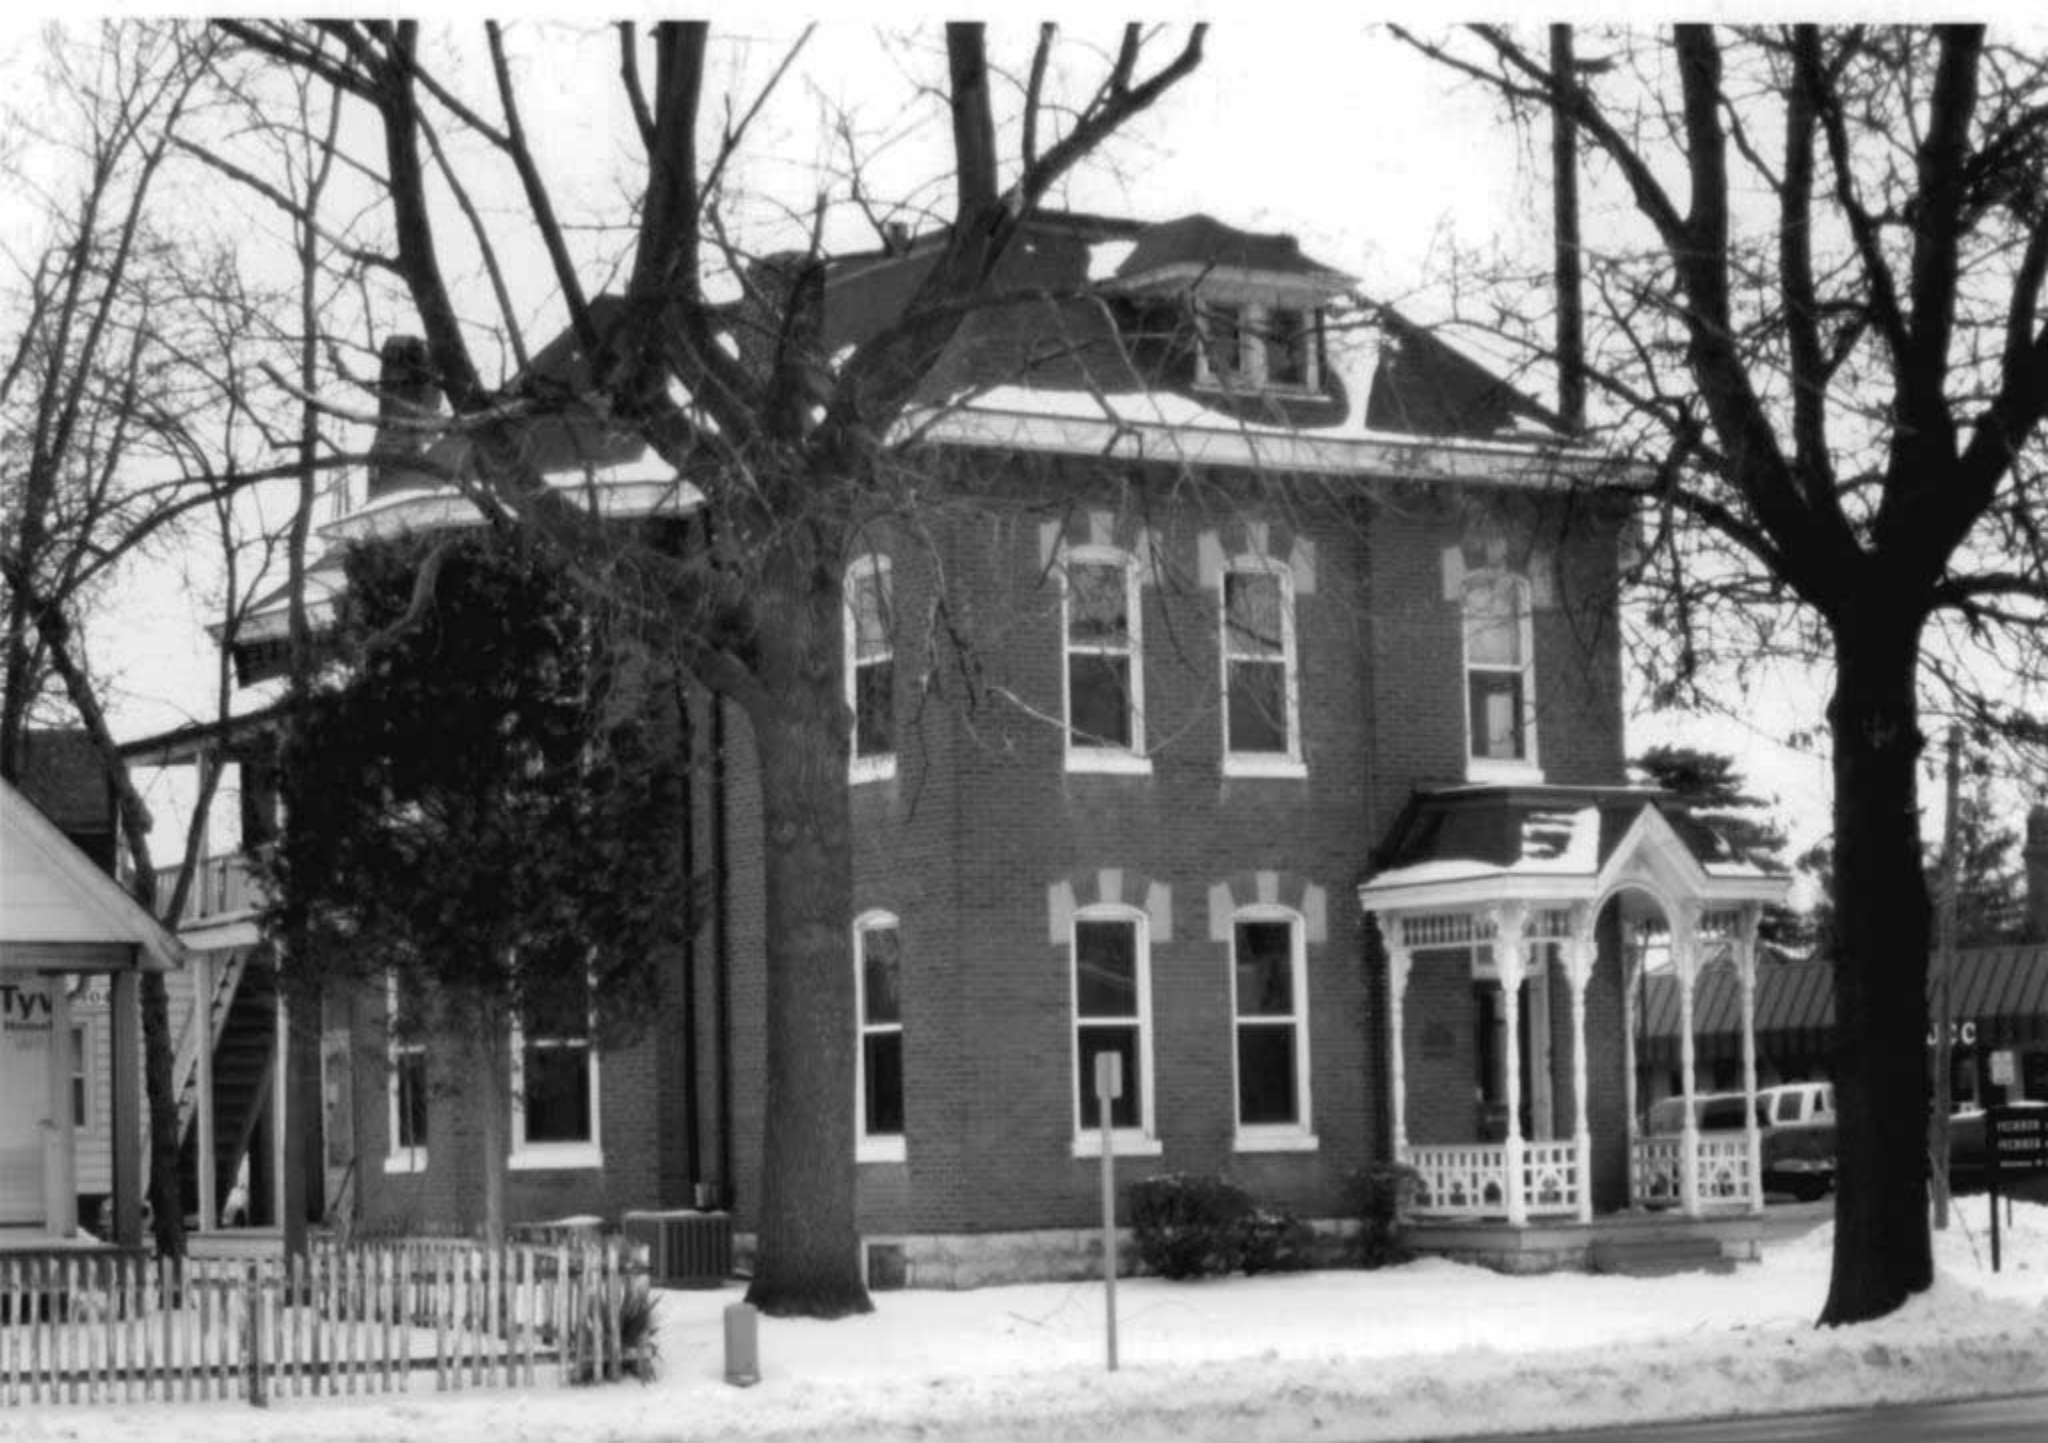
This two story, red brick house has running bond laid on the main facade but a five-course common bond on the other elevations. The hipped roof, asymmetrical plan house has a canted two story wing on the middle of the south elevation and a hipped roof, two story projecting wing on the middle of the north elevation. There are four internal chimneys, all of which have been lowered. There are hipped dormers on the front and rear; the front dormer has a two light window while the rear dormer has a 1/1 sashed window. Under the eaves, there is a brick crenellated course. The windows appear to be segmental topped 1/1 sashes (2/2 on the rear) with flat headed storms added within the segmental arched openings. The windows on the three bay facade have large, decorative hood molds (flush with the walls), alternating brick with limestone. The entry bay projects slightly on the north end of the facade and has an elaborate spindlework, mansard roofed porch. There is a gable over the round arched opening centered above the porch entry steps. There are spooled spandrels under the wide eaves of the porch and scrollwork brackets under the eaves and under the spandrels at the turned porch posts. The porch railing consists of a geometric design and the wood porch floor rests on a rusticated limestone foundation. The front door is a half-glazed, two panel wood door with a single-light transom. The foundation is coursed, rusticated limestone with the basement windows topped by brick segmental arches. On the south side, behind the canted bay, is a two story, shed roof porch with wood porch floors and a wood balustrade on the second floor as well as a straight flight staircase leading to the upper level. Porch posts are chamfered.

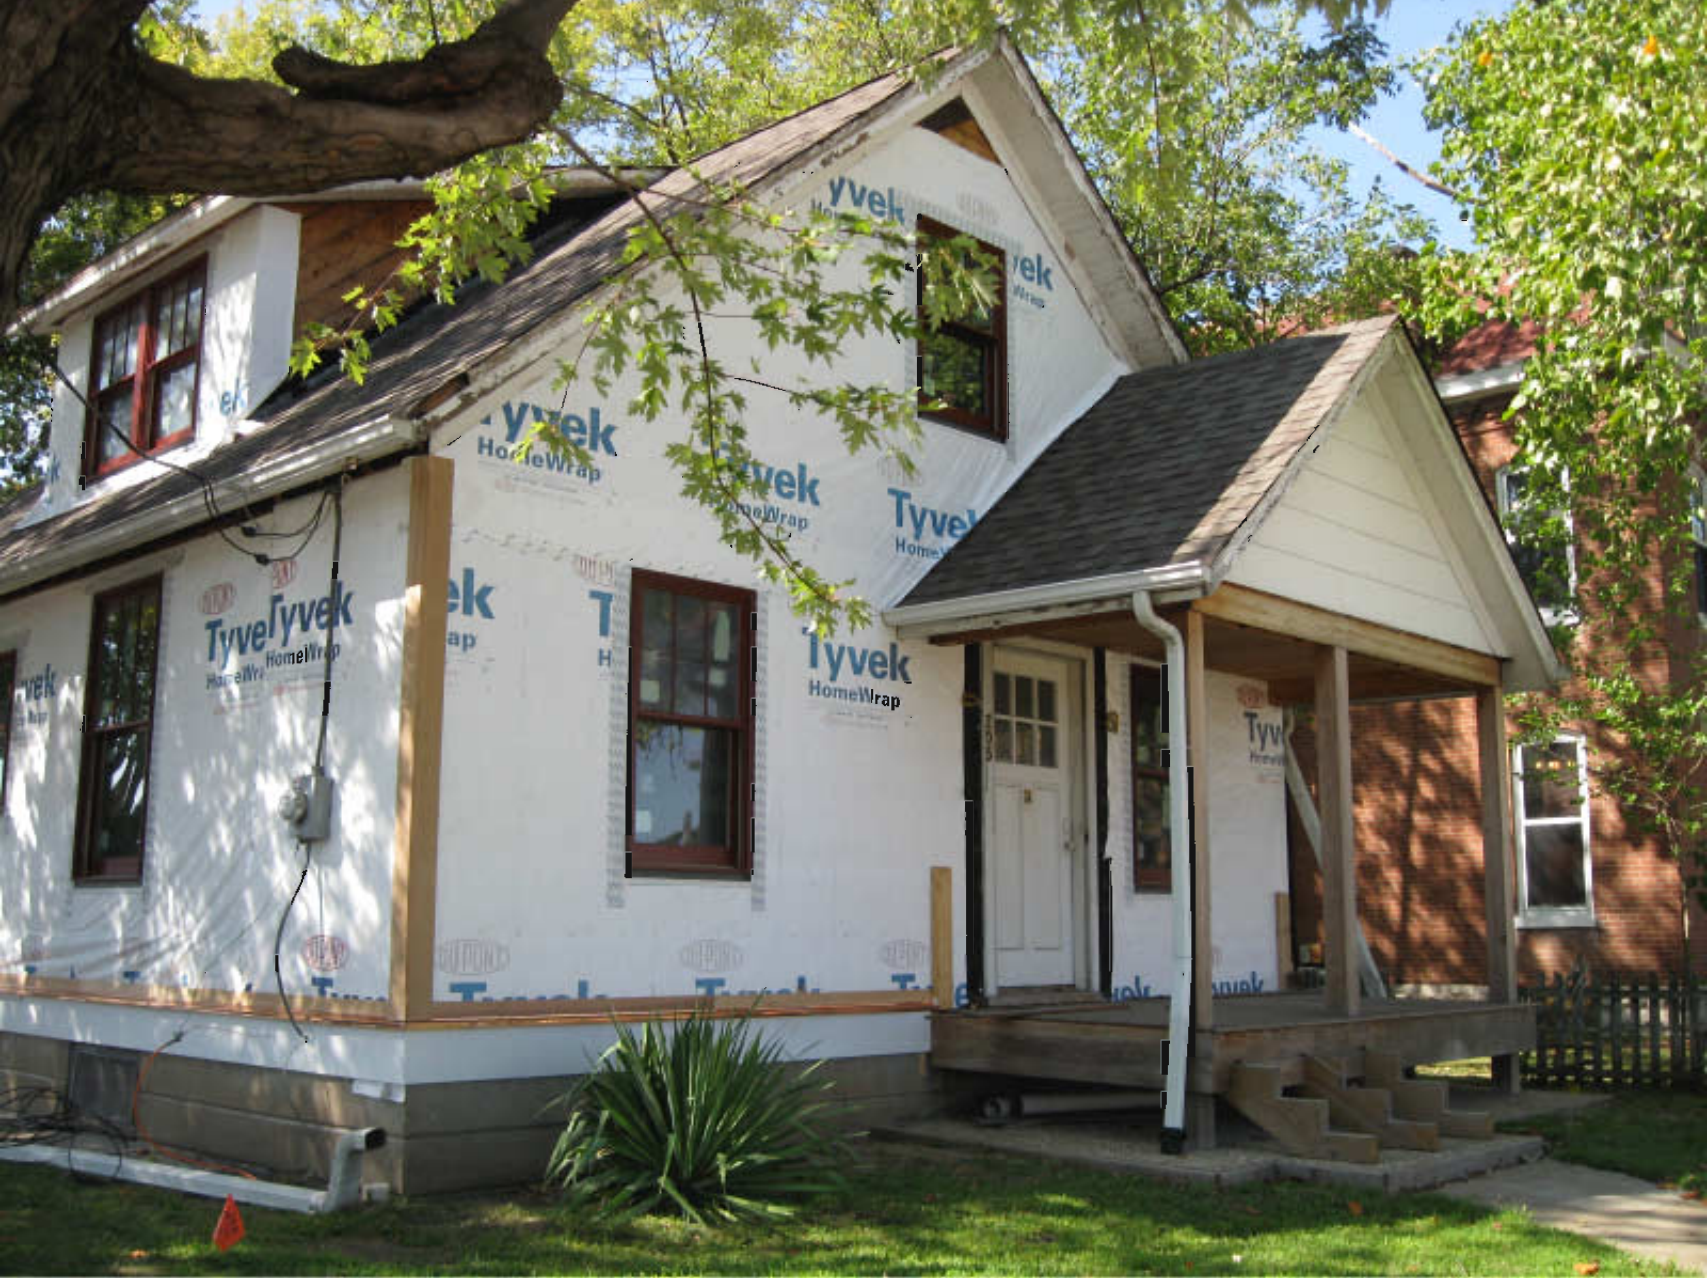
This 1.5 story frame bungalow has an end gabled roof with sashed windows on either side of the front door and another sashed window above. The north window and door are positioned in the north half of the facade under the one story, gabled roof porch. The porch roof retains its original bead board underside on the wide eaves (as does the main roof), but the porch posts and wood porch floor boards and framing have been replaced. There is a shed roofed dormer facing toward each side elevation with paired sashed windows. The house windows are replacement 3/1 sashes, although the 2007 photo shows that the house had 6/6 sashed windows previously (along with asbestos shingle siding), but the house retains its original Craftsman door, a tall two panel door with a 6-light rectangular light at the top of the door. The asbestos shingle siding has been removed from the house, and it was probably a replacement material since it was not popular until the late 1940s. The house is currently under renovation, possibly to restore an original Craftsman appearance but there is no known documentation of these original details (window patterns, porch details, and siding) and without these, the house cannot be considered contributing to the historic district. It retains its original scored concrete foundation and 3-light basement windows.

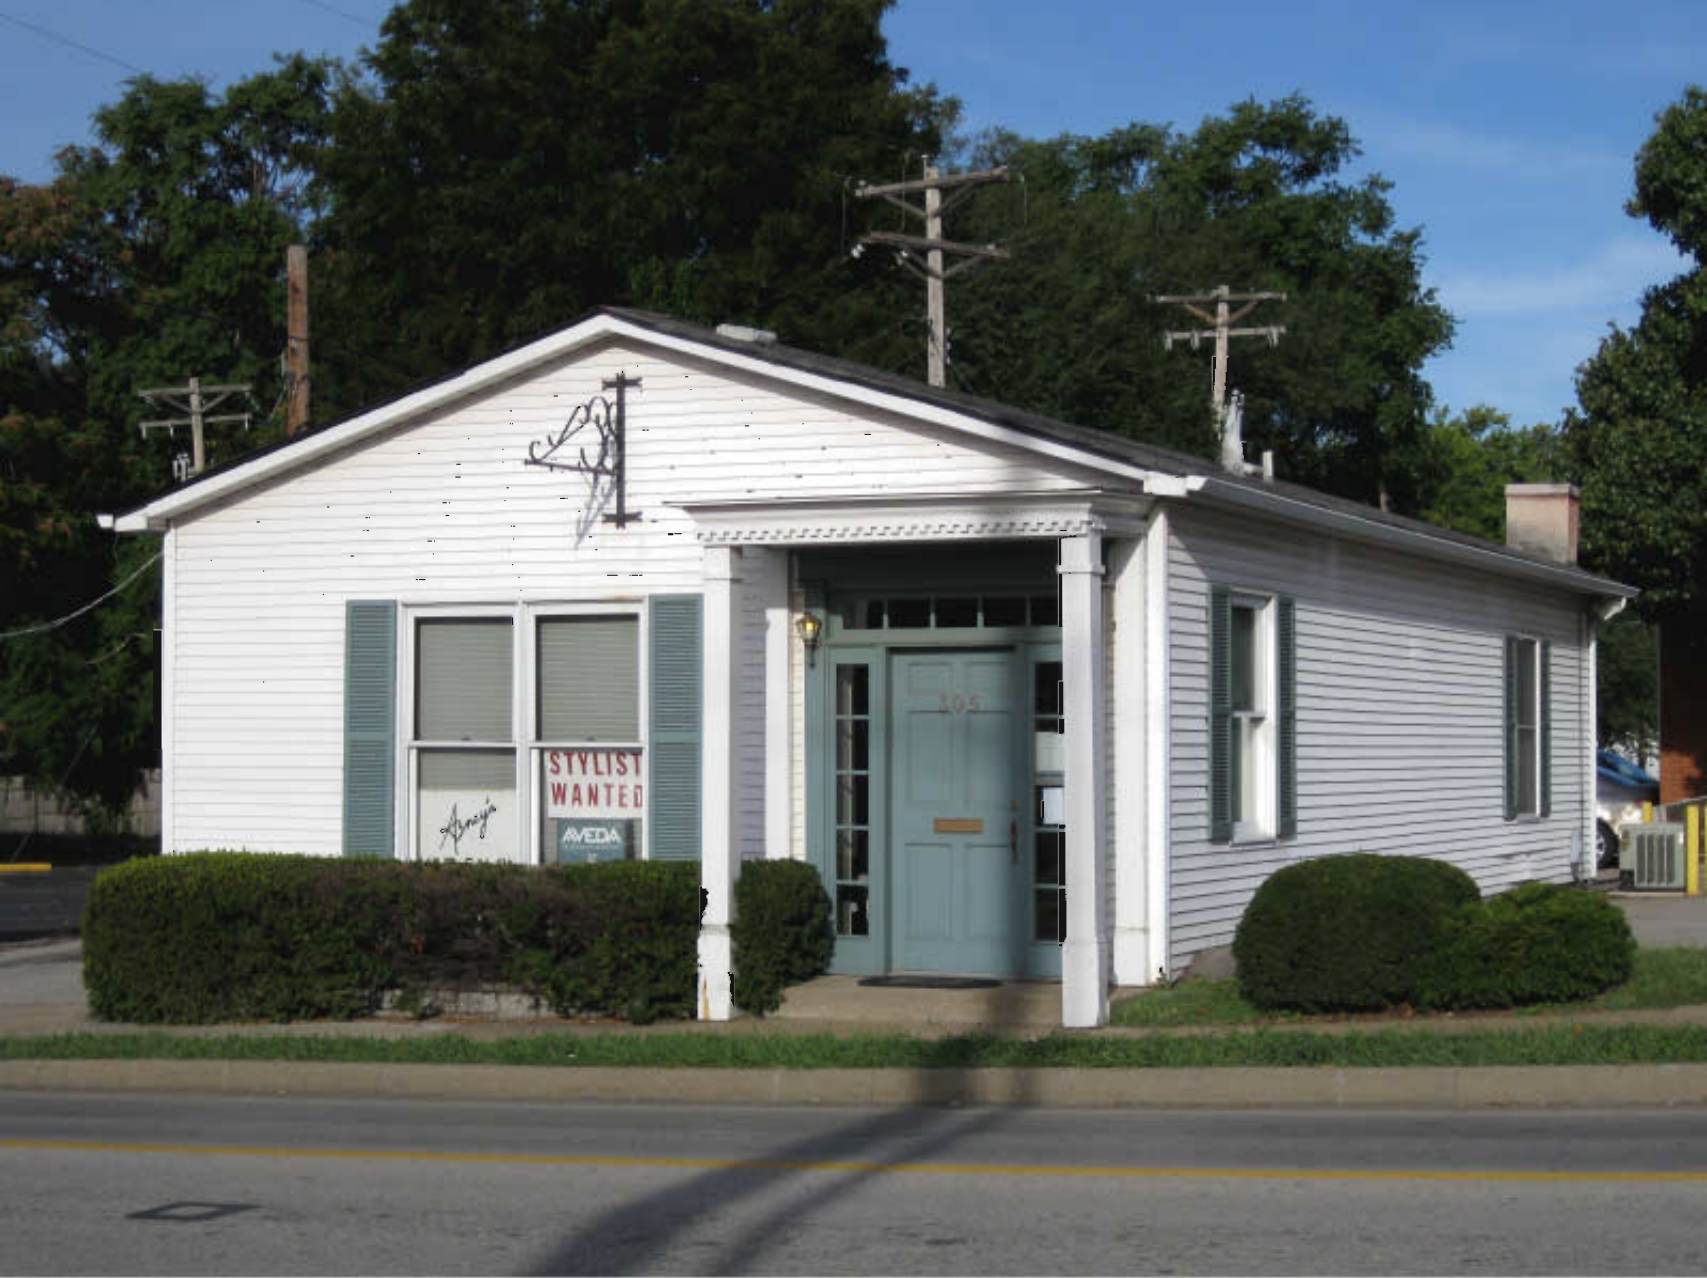
This one-story, end gabled building is divided into two bays on the facade with paired 1/1 wood sashed windows on the south side of the facade and a small portico on the north side. The portico has a flat roof with an entablature with dentils supported by squared columns resting on simple plinths. These corner columns extend to a concrete slab at grade and fluted pilasters flanking the doorway visually support the entablature with a crown cap and dentil course over the door. There are five-light sidelights and a five-light transom surrounding the six panel wood door. On each side of the house there are two 1/1 sashed windows. The windows appear original, but the shutters appear to be vinyl replacements, although appropriate to the Colonial Revival stylistic details on the house. The original siding has been covered with vinyl siding. Some of the details on the portico appear to be more modern materials and it is difficult to determine whether it is a more recent, or an original feature of the building which was originally used as a photo studio even though the features are that of a house. Without further documentation about what original features are still intact on the exterior, the building is identified as noncontributing.

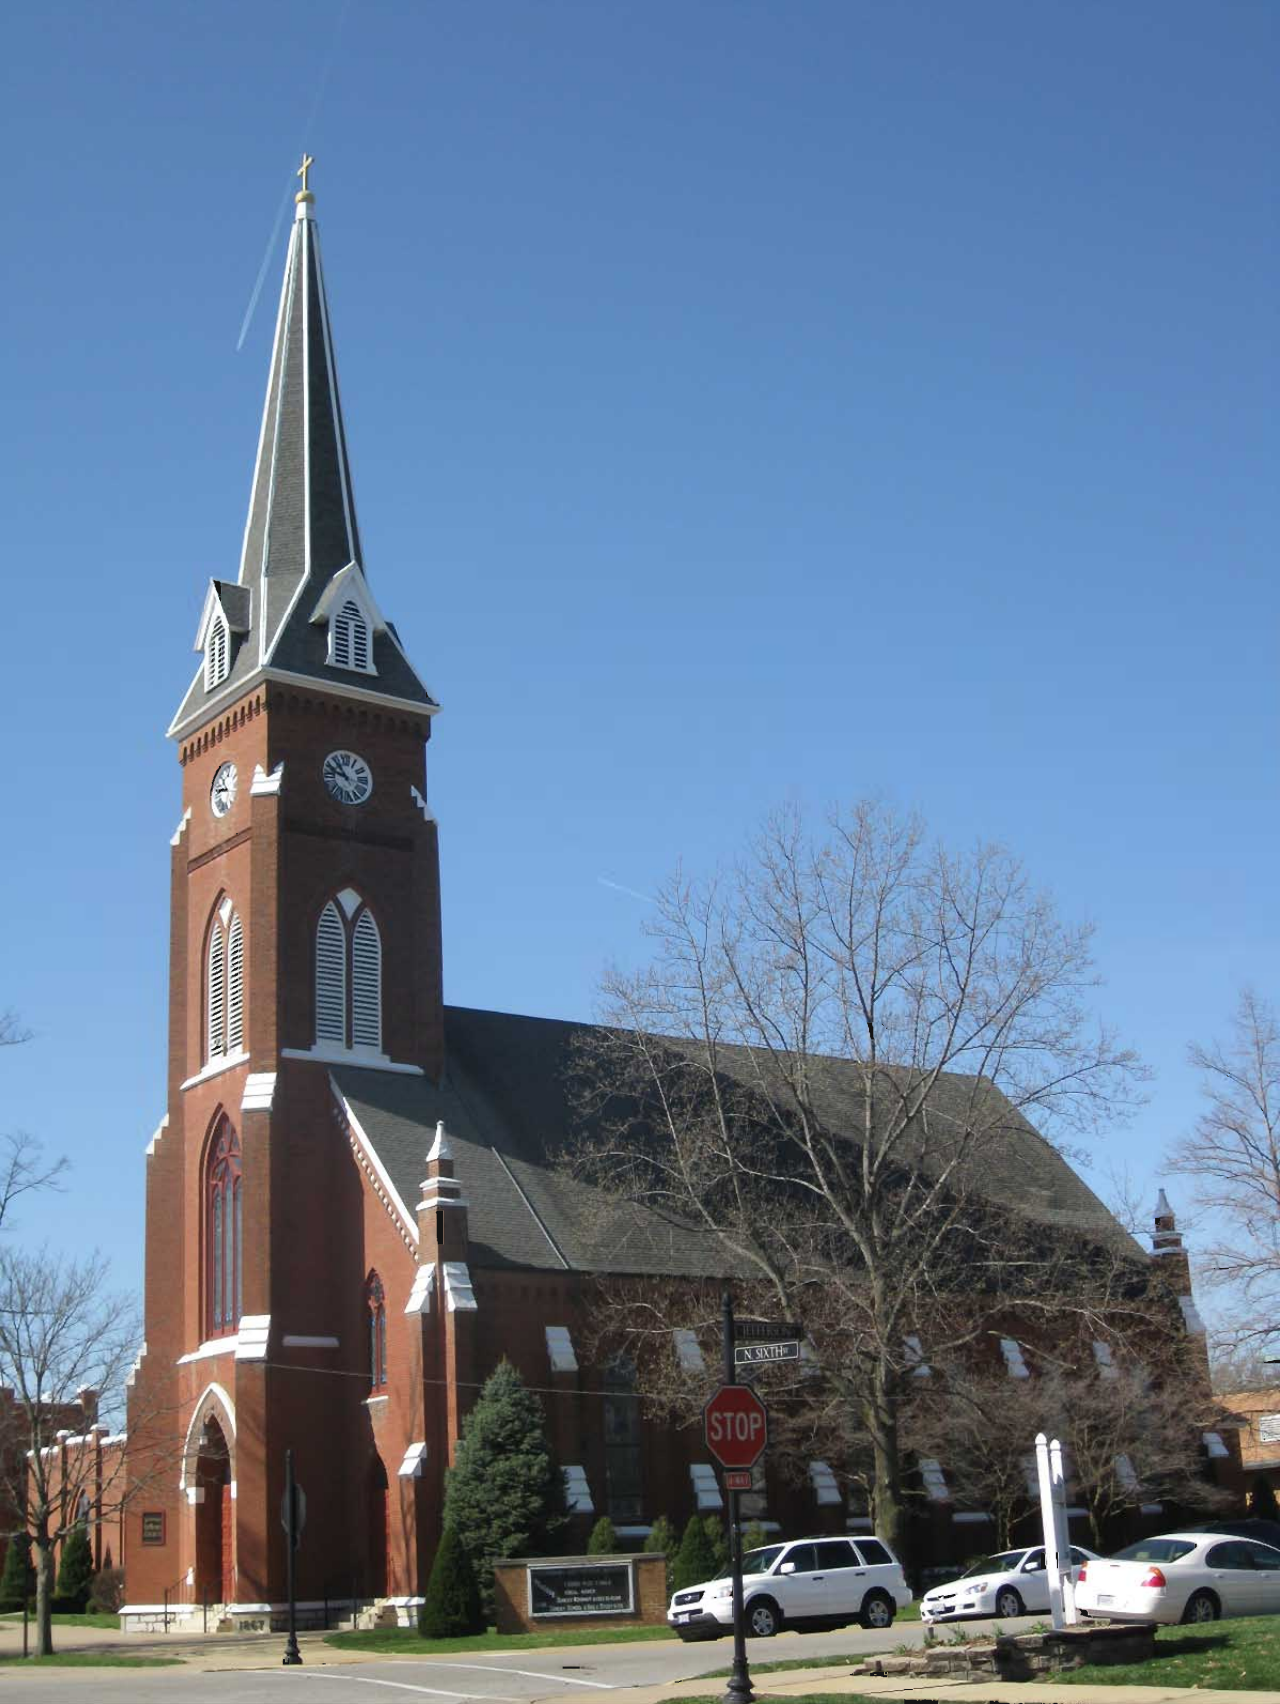
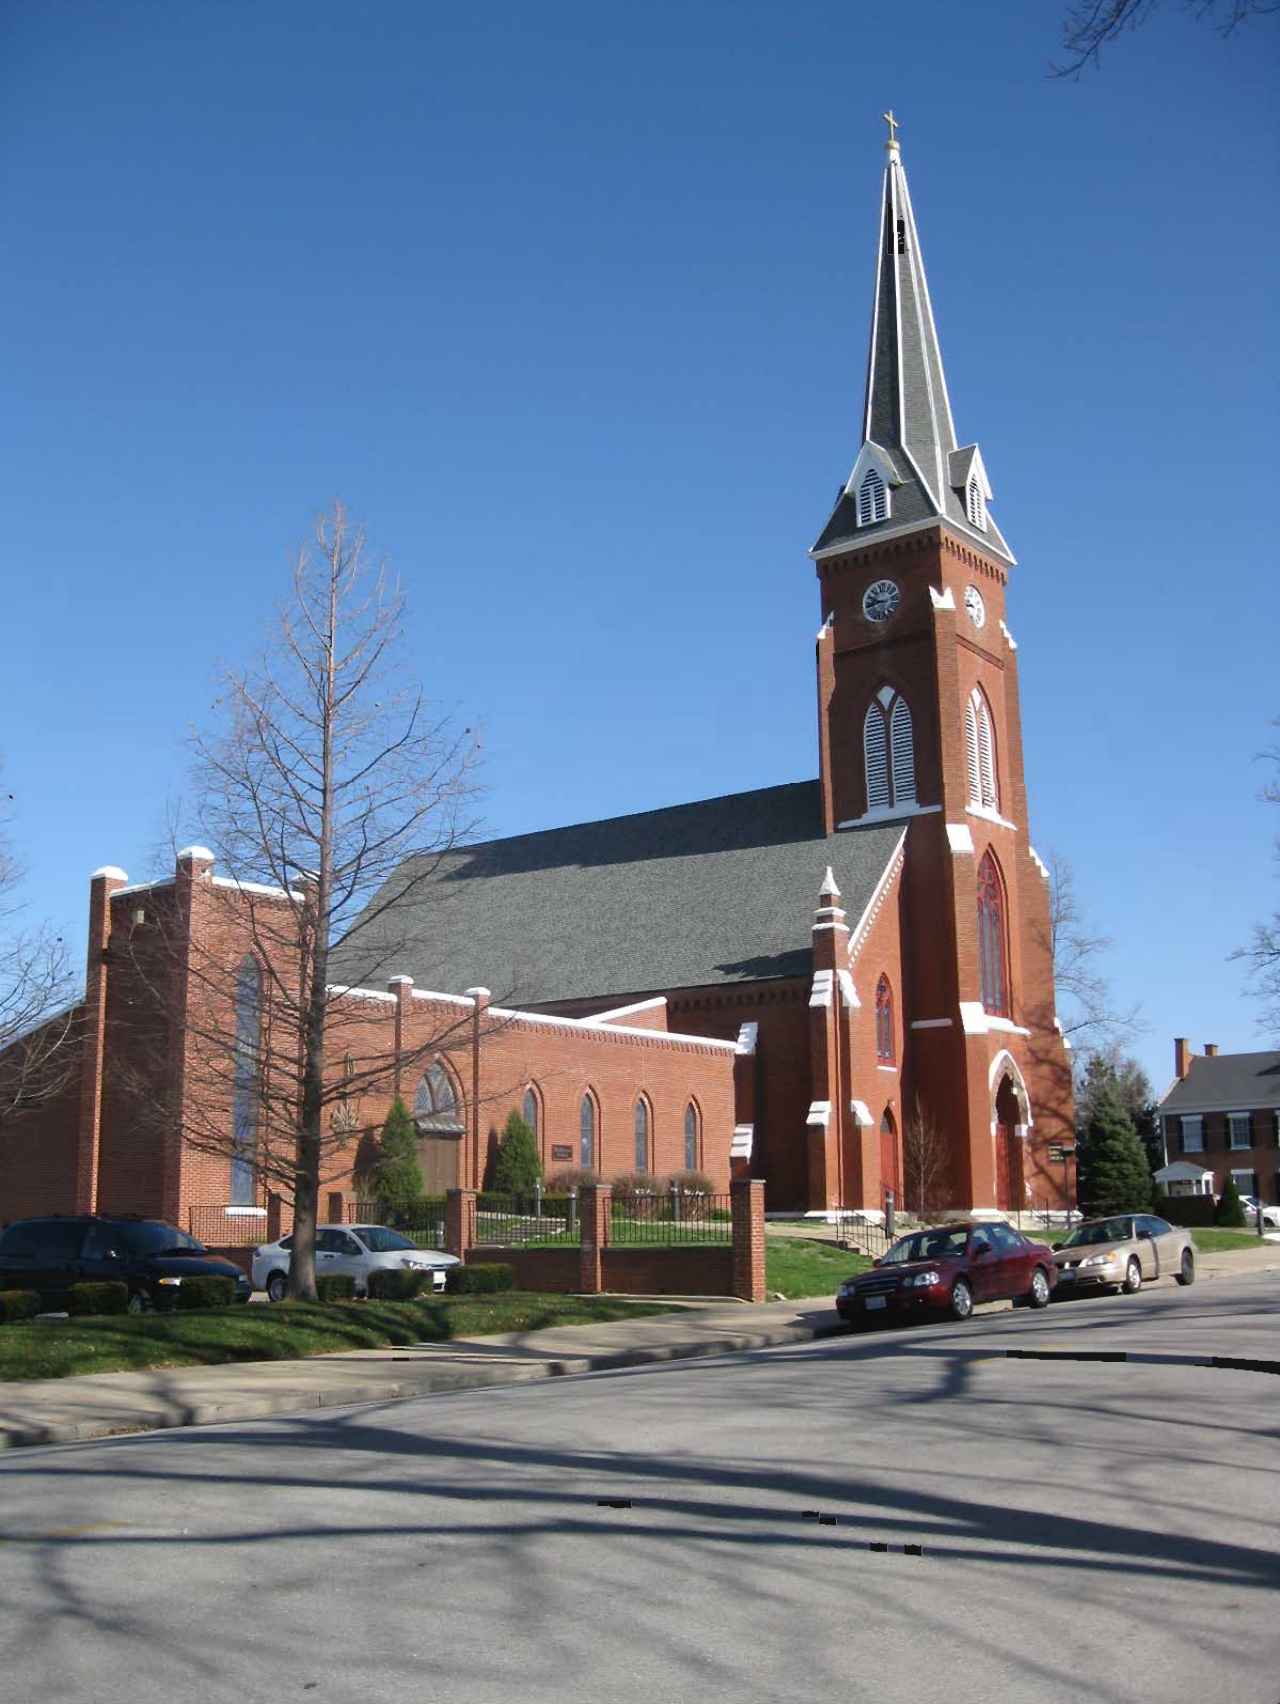
This red brick, Gothic Revival church was built in 1867 and it has a symmetrical three bay facade facing Sixth Street that has tiered buttresses that flank at an angle the projecting central entry bay and tier up to visually support the steeple. The base of the church is surrounded by the rusticated limestone foundation with the sloped dressed limestone course separating the raised foundation from the red brick walls of the church. The dressed limestone course of the foundation as well as the other limestone details on the building have been painted, including the capstones on the tiered ledges on the buttresses, stone defining the entry arch, the pilaster capitals on the main entry, the window sills, and the pyramidal finial details on each corner of the facade. The main entry has a Gothic arch opening with pilaster-like strips flanking the doorway that have flattened capital-like details at the base of the brick arched opening which in turn is capped by a limestone ledge to highlight the Gothic arch. The oversized doorway has paired six panel wood doors with a stained glass transom above. Simple limestone waterfall steps with iron railings descend from the door. Above the entry is a large Gothic arched tracery stained glass window and above this window, piercing through the end gabled roof, is the belfry in the square base of the steeple, which has an additional tier of the angled buttresses at each corner above the roofline. Spanning out to the buttresses, there are continuous limestone sills on the tracery window as well as the belfry openings, which are Gothic arched openings with paired Gothic arched vents. Above the belfry openings is a soldier course of brick framed with projecting brick to separate this level from the round clock face and at the top of the square tower is a crenellated cornice. The 8-sided steeple flares out at the square base and has gabled attic dormers with trefoil arched, louvered vent openings. There is a cross at the top of the steeple. Each side of the bell tower and steeple are treated the same. The facets of the steeple are highlighted with painted divisions between the asphalt roof sections.

Flanking the entry bay, there are secondary doorways, also with Gothic arched openings and stained glass transoms above paired five panel wood doors. These too have limestone waterfall stairs. Above each of these flanking entries, a half-flight up, there is a Gothic arched tracery stained glass window. At each corner of the facade there are tiered buttresses to the east and to the side that extend up to a square brick finial-like detail that has stone courses separating the three tiers and a pyramidal stone cap. The roofline on the facade is highlighted by a brick dentil-like course with the recesses either painted brick or painted stone.

On the north street elevation, there is a brick crenellated cornice, and the wall is divided by seven brick buttresses into six bays of stained glass lancet windows. On the rear of the sanctuary, there are similar corner buttresses with the finial-like treatments and a large 1.5 story high apse that has clipped corners and roof. Above, there are two small, Gothic arched, louvered vents. On the north side of the apse is a one story, hipped roof, rear entry which has two lancet windows with two louvered basement windows facing west and a Gothic arched, four-panel wood door with a set of concrete steps with pipe rails facing north.

Built in 1978, the Lutheran Center is a one story brick wing that was added to the south side of the church. It has a parapet across the front facing Sixth Street, with brick crenellated course under the painted concrete parapet cap. This portion of the facade is divided into eight bays with the north five bays containing a lancet window with a painted concrete sill. The sixth bay is defined by the brick pilasters which project through the parapet and has a large Gothic arched doorway with a tracery transom over the paired entry doors (which have a small shed-roofed metal awning). The next bay is blank, without an opening the south bay has a slightly projecting square tower that extends 1.5 stories, with a tall lancet window on the facade. The south elevation has a pitched parapet extending down from the corner tower to the rear where there is a recessed corner entry. The rear, west elevation also has a sloped parapet, sloping downhill away from the church to this same recessed corner entry. The roof of this addition is not strictly flat, since it steeply slopes away from the church as well as the corner tower, but most of the roof is hidden behind the parapets.

Although the addition, which was fitted between the two buttresses at either end of the south elevation of the church, impacts the historic integrity of the 1867 church building, it was designed with matching brick and utilized Gothic Revival detailing to help it blend with the historic church. Since it is much lower in height, recessed back from the church facade and meets the Secretary of the Interior's criterion for additions (being distinct but compatible), the church is still identified as a contributing building in the historic district. The original church building still dominates the skylight of the neighborhood and is clearly distinguished from the additions and surrounding buildings.

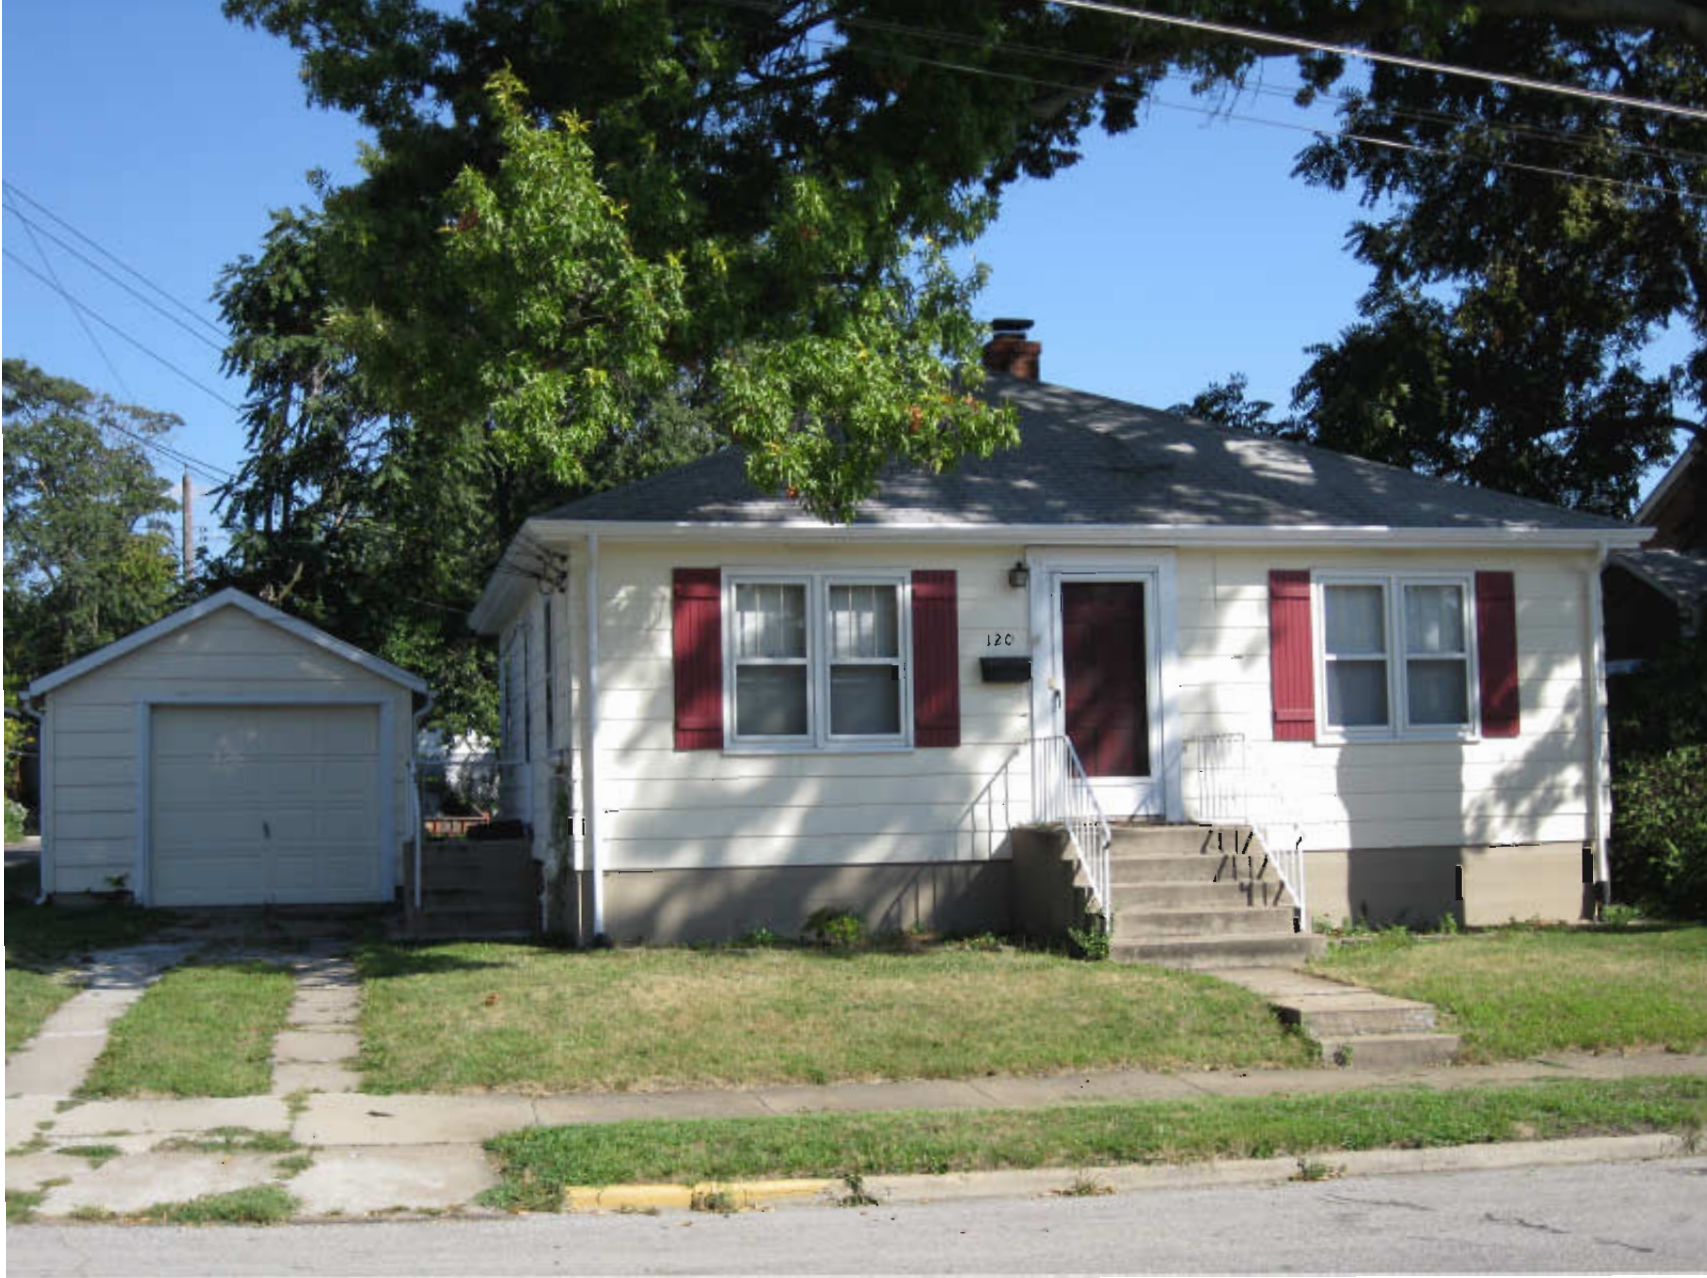
This frame, one-car, end gabled garage retains its original asbestos shingle siding. It has a poured concrete foundation and a small two-light window on the east elevation facing the rear of the property. The only visible alteration is the replacement metal paneled overhead door. It appears it was built with the house, around 1952-1955 since it utilizes the same siding.

This one-story, frame, pyramidal house retains its original asbestos shingle siding. It has a poured concrete foundation and asphalt shingle roofing. The facade is divided into three bays with wood batten shutters flanking the paired 3 over 1 wood sashed windows that are on either side of the central entry. The entry door is a six panel door with a simple lintel. It retains the original concrete stoop with flanking metal railings. On the north side elevation there are two 3 over 1 wood sashed windows on either side of the side doorway, which has a 3-light, wood paneled door and concrete stoop with the original pipe railing. Centered on the rear slope is a brick chimney that retains its original corbel cap, but it has had a newer metal cap added to the flue vent. The house has had aluminum combination storm windows and doors added, as well as a turbine vent, but otherwise appears unaltered.
