ARCHITECTURAL/HISTORIC INVENTORY FORM

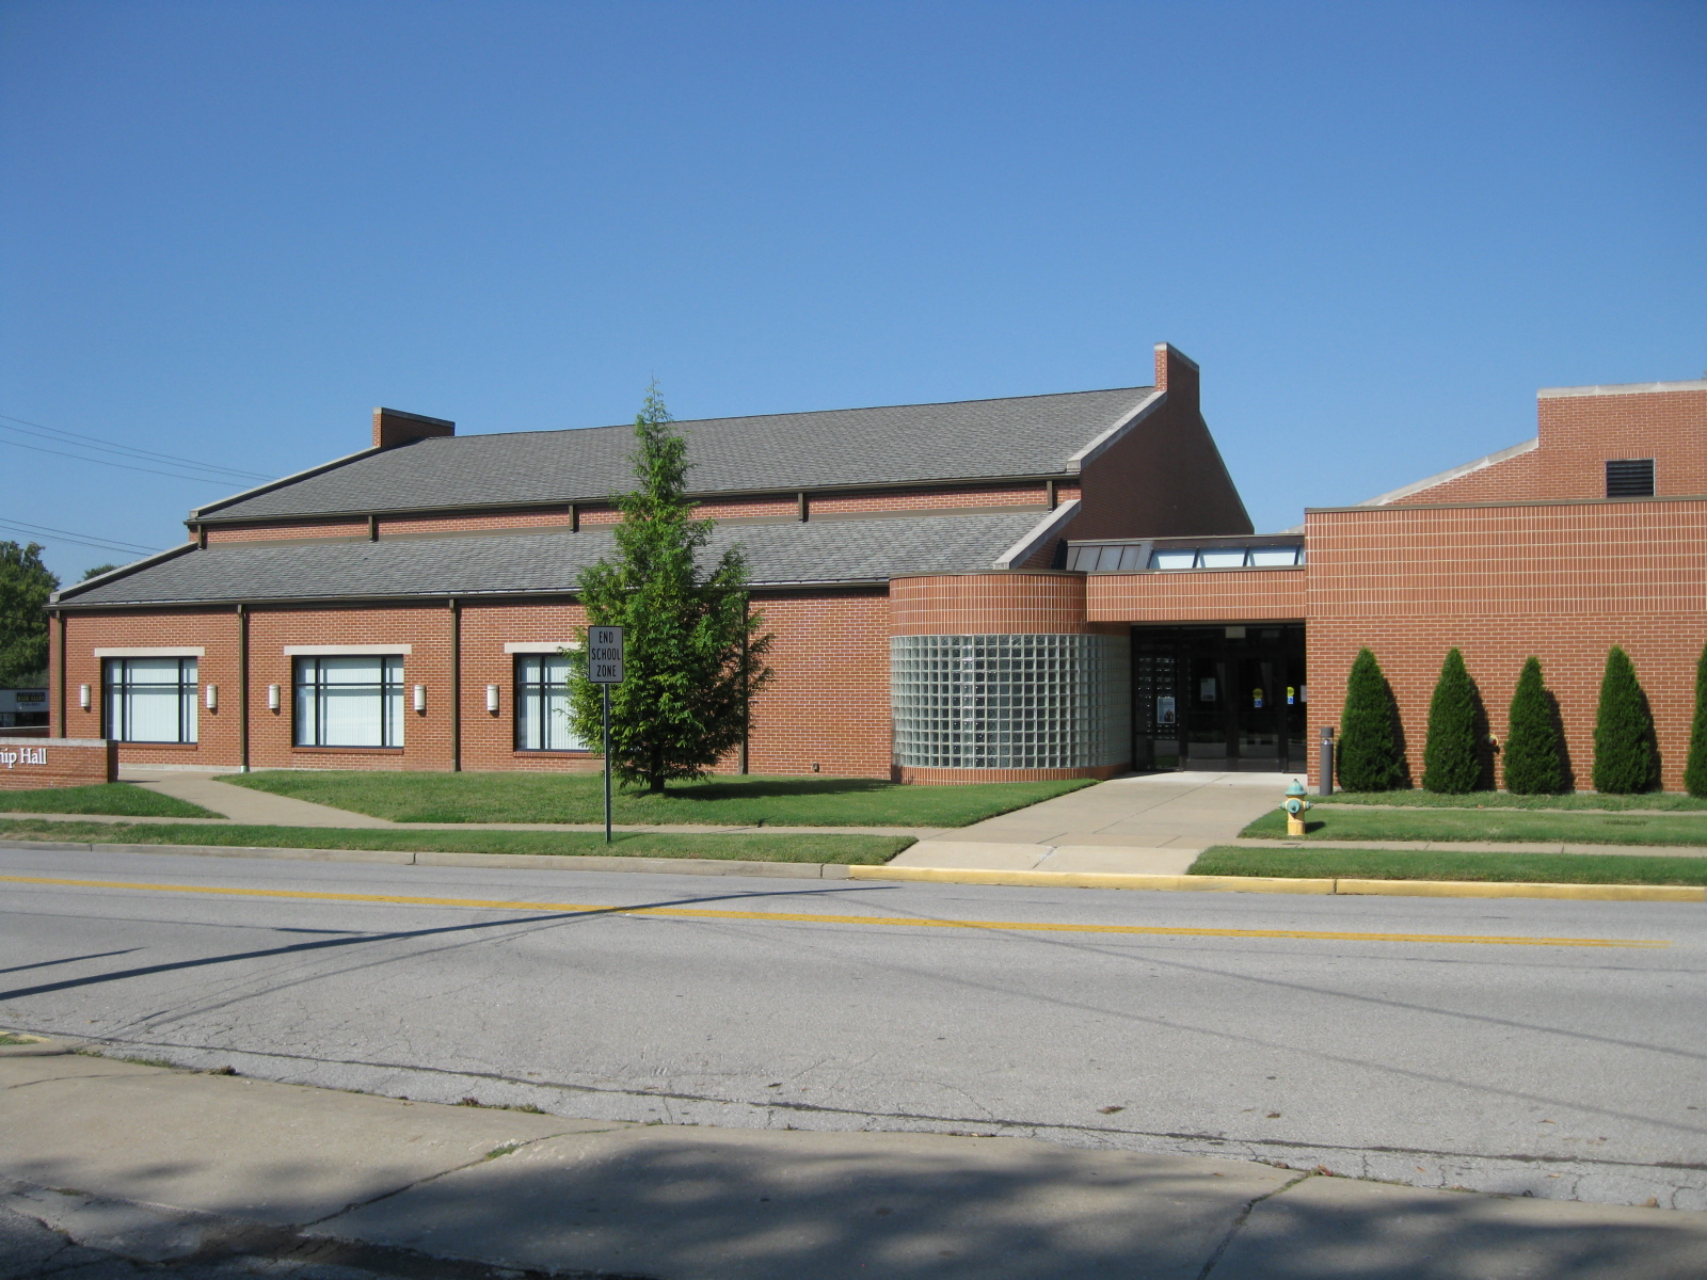
This is a 1998 red brick building with parapets at the gable ends with rectangular parapet extensions to emulate the broad central or paired chimneys of old Adams style houses. The wide end gable of this 1.5 story building faces First Capitol Drive, where the main entrance to the building is located, although it is addressed as 203 S. Sixth. Over what appears to be the main entry, with its vertical slit windows, is a massive round arched transom-like window. In reality the doors flank this central bay with simple paired doors with a flat stone lintel. On the east side there is a one story shed roofed extension with three bays of plate glass windows divided like transomed Chicago style windows. Along the alley (west elevation) there is a parapeted, flat roofed, one story bay. There is a hyphen with a deeply recessed entry behind this section of the building, with a projected rounded bay to its south. The hyphen connects to another gabled wing with similar parapeted gabled ends, but this wing is smaller and the gable ridge runs perpendicular to the main wing to the south. Its north elevation has two pairs of flat stone lintel window openings, each with a transomed fixed glass window. On the Sixth Street elevation of this wing is a one story, flat roofed, parapeted brick, rounded corner wing that utilized a stacked brick to detail the blank wall. Since this was built outside the period of significance for the district it is identified as a noncontributing building.

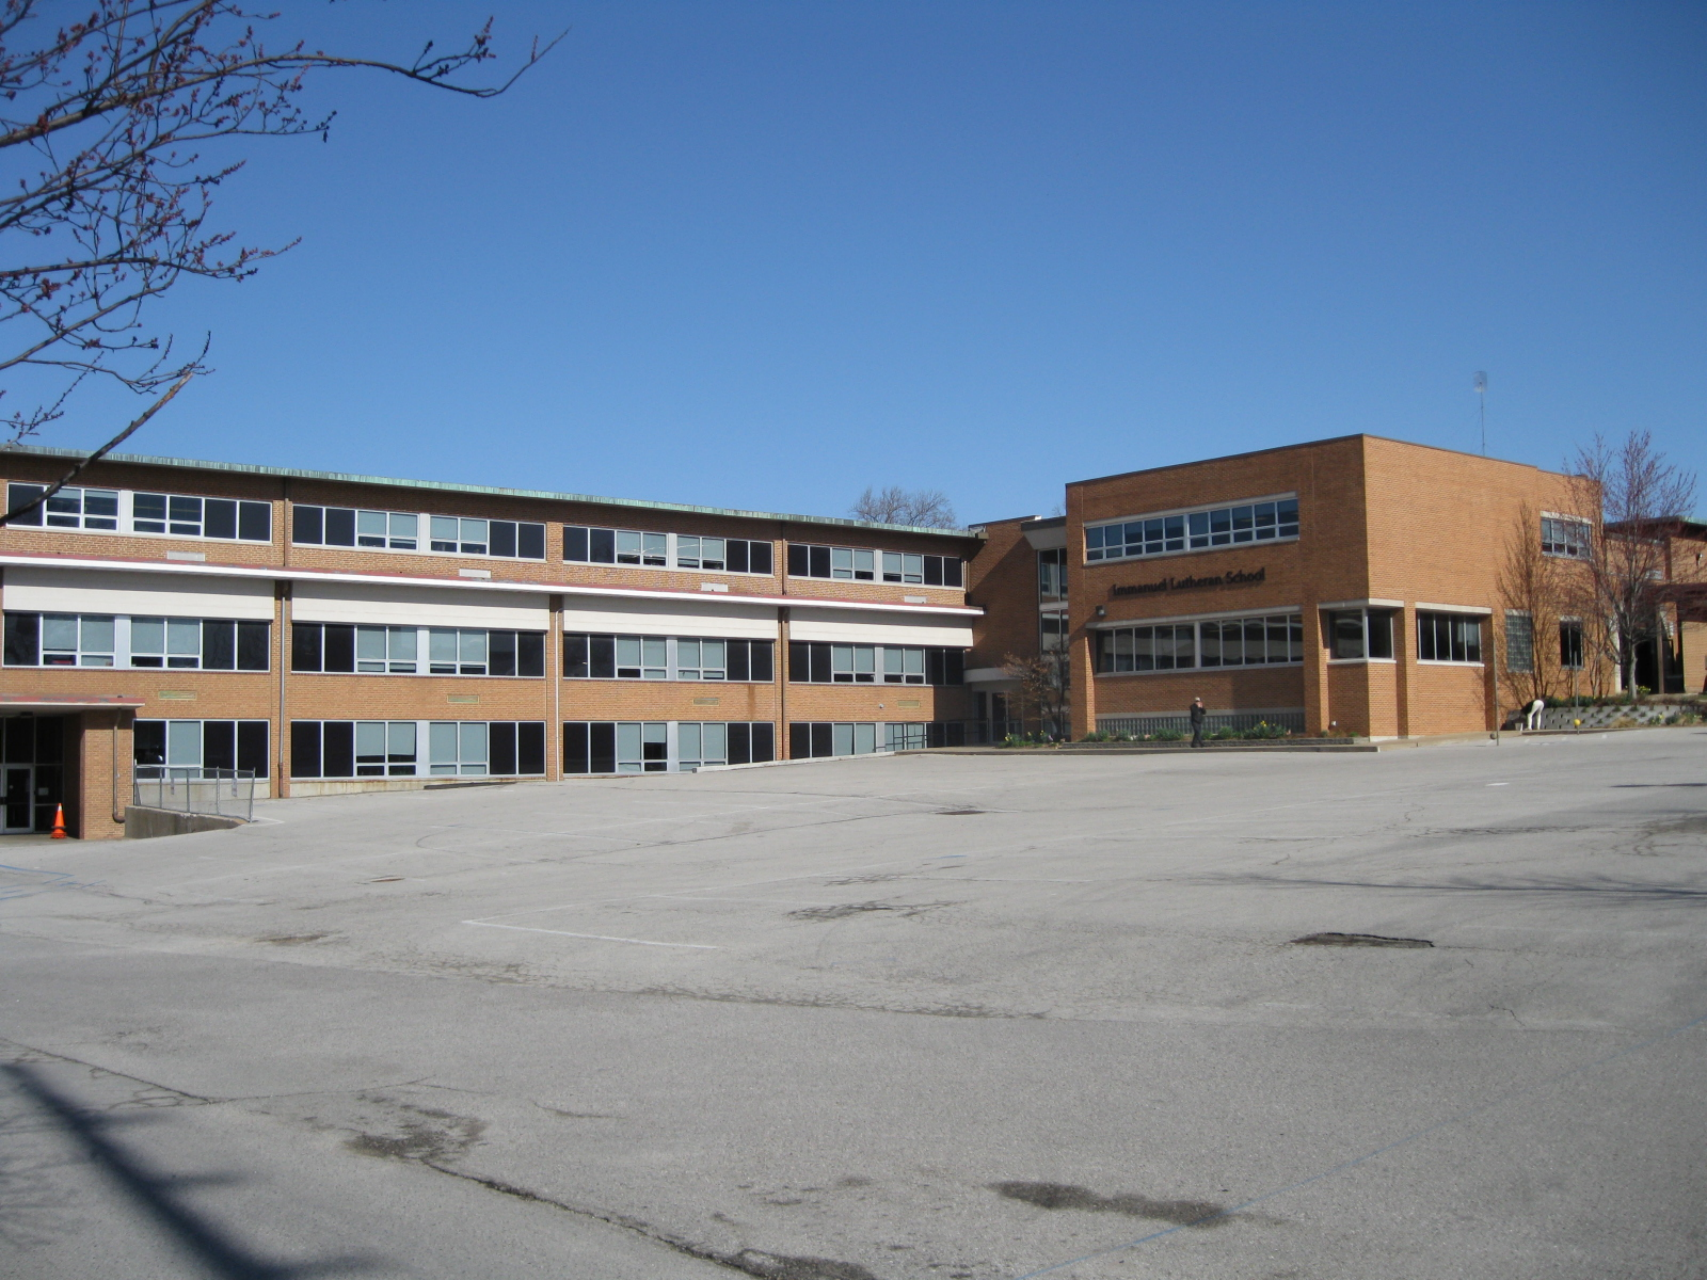
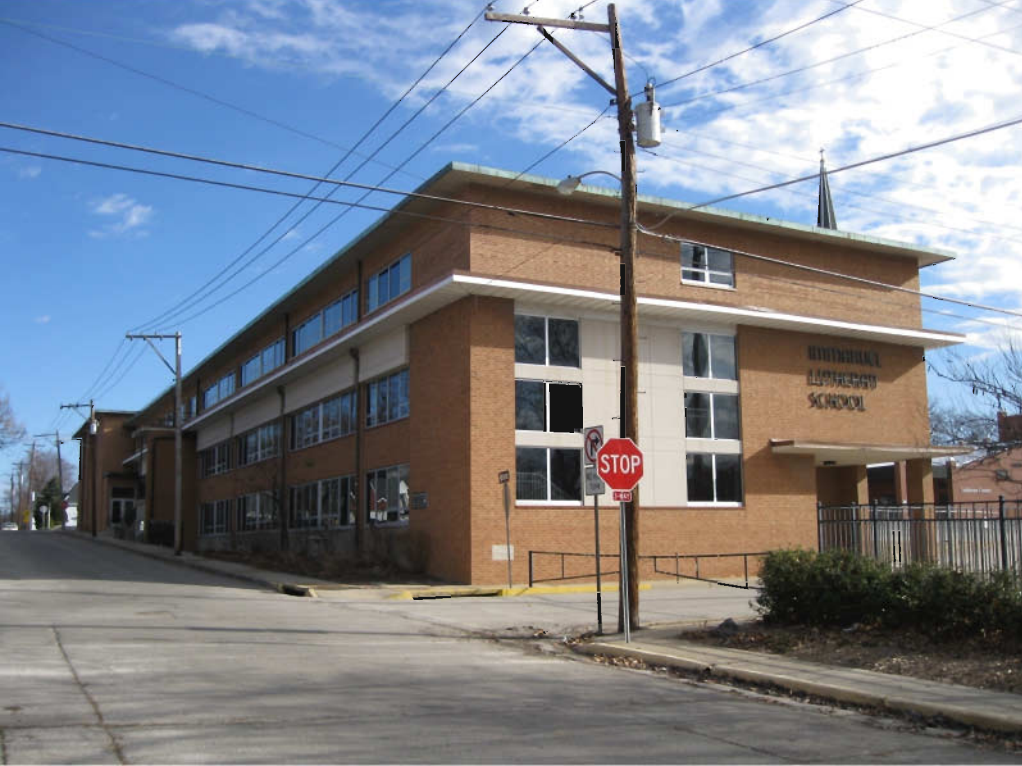
The classroom and gymnasium create an L-shaped plan and at the interior corner there are what appear to be some other additions, but research has yet to date these additions. At the southeast corner of this rectangular addition is a tall two-story, orange brick building that has similar aluminum windows on the second floor in partial width bands on the east and south elevations. On the first floor, these windows are recessed slightly under concrete lintel bands and separated by projecting brick piers. Given its styling it appears to be a more recent addition that blends well with the classroom and gymnasium.

Although the gymnasium is not yet 50 years old, the classroom building is the prominent element in the design and it retains its integrity from its period of construction and as such the complex is identified as a contributing building in the historic district. There appears to be few alterations to the exterior of the classroom or gymnasium and even the aluminum windows appear to be the originals.

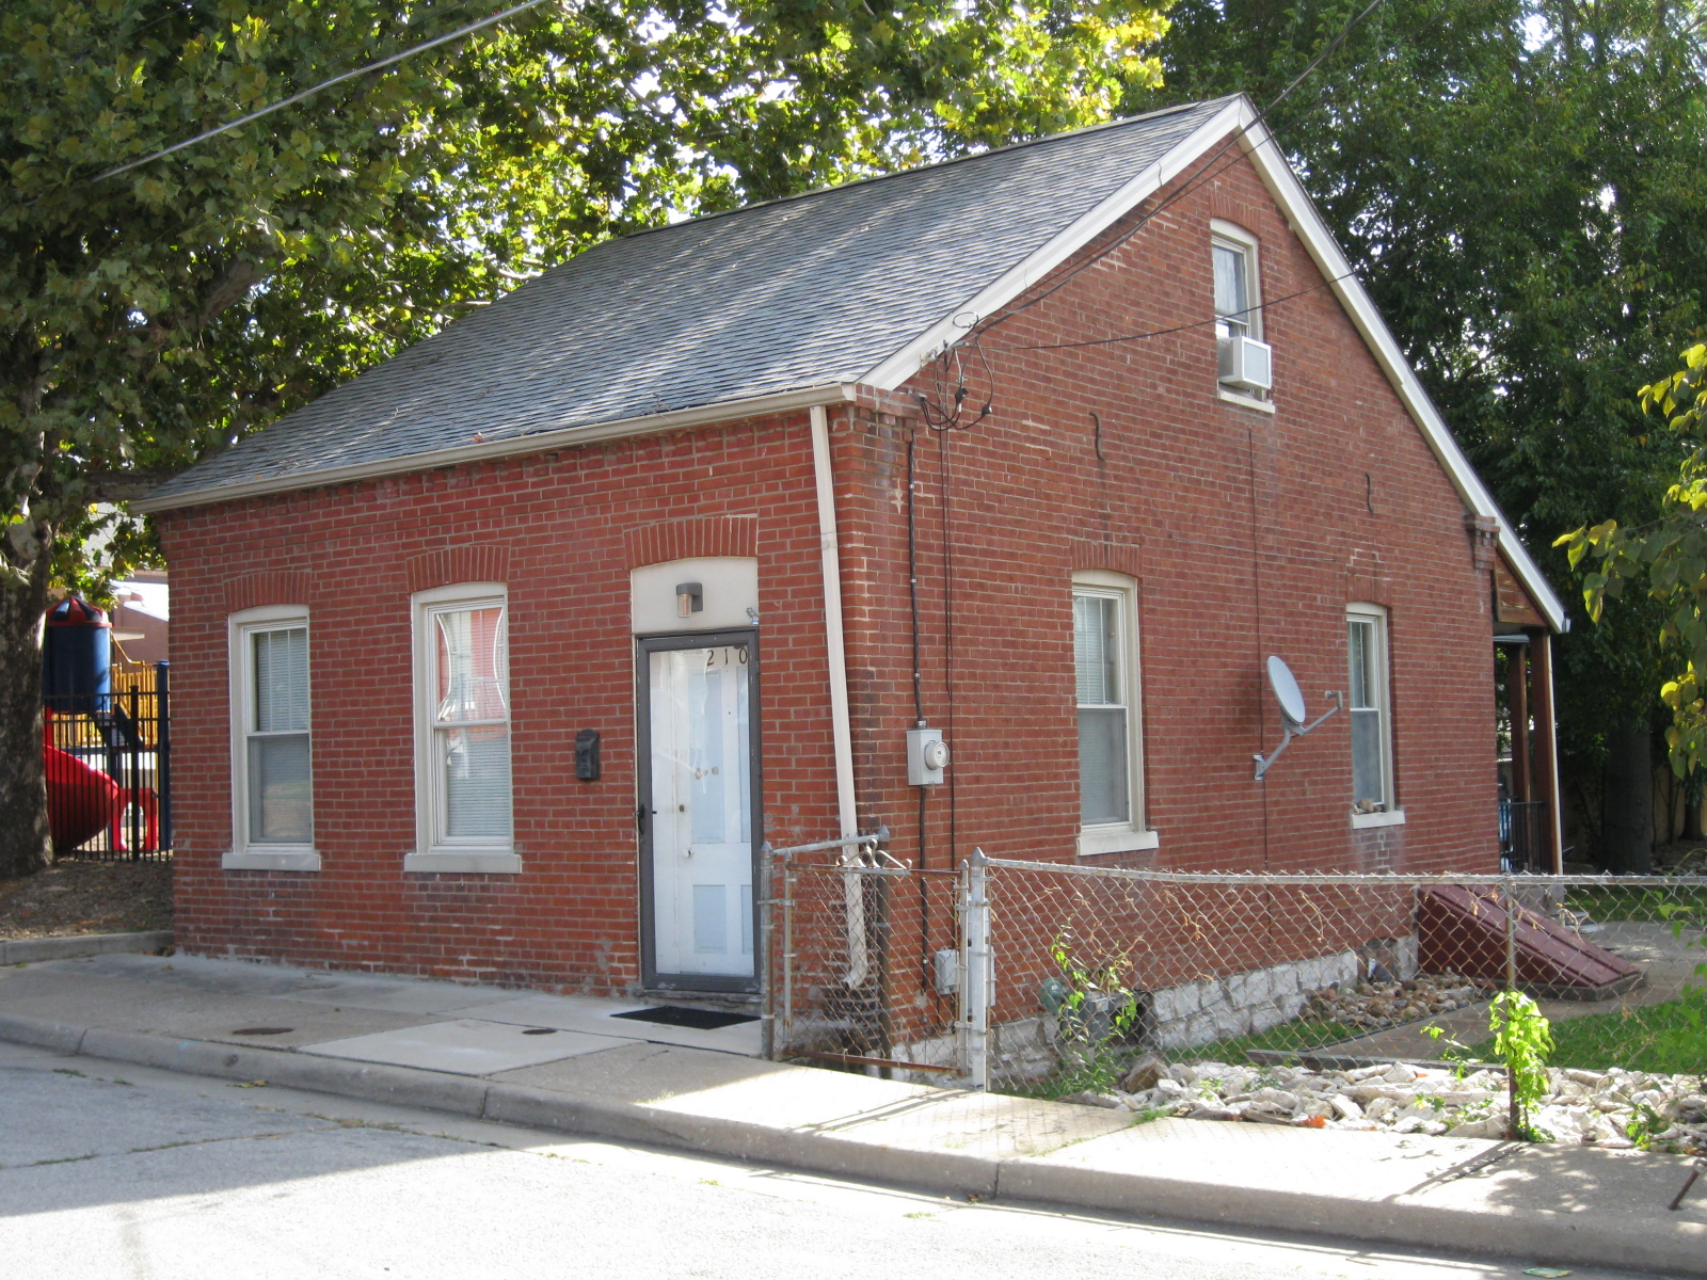
This 1.5 story, red brick, side gabled house is divided in three bays on the facade with a brick corbelled, dentil course under the soffit and gutter on the facade. The windows are segmental brick arched openings with flat headed, three over one wood sashed windows that are now covered with combination storm windows. In the south bay on the facade there is a segmental arched entry opening with a transomed doorway. The door is an historic four-panel wood door, covered by a full light storm door. The transom above the door is boarded in. On the south side elevation, the coursed, limestone foundation is visible and there is a trap door to the basement. There are also symmetrically positioned windows, two on the first floor and a smaller window on the second floor, all three over one windows. On the rear, there is a cross-gabled wing, and a portion of that roof, as well as an extension of the main roof, cover the L-shaped porch nestled on the south side of this wing. It appears to have replacement wooden posts and metal railings, but the original corbelling at the rear wall of the main wing is still intact, extending around the corner onto the south elevation. The small section between the facade and the public sidewalk is now concrete, level with the sidewalk.
