**NATIONAL REGISTER OF HISTORIC PLACES
INVENTORY -- NOMINATION FORM**

United States Post Office at Carrollton

101 N. Folger Street

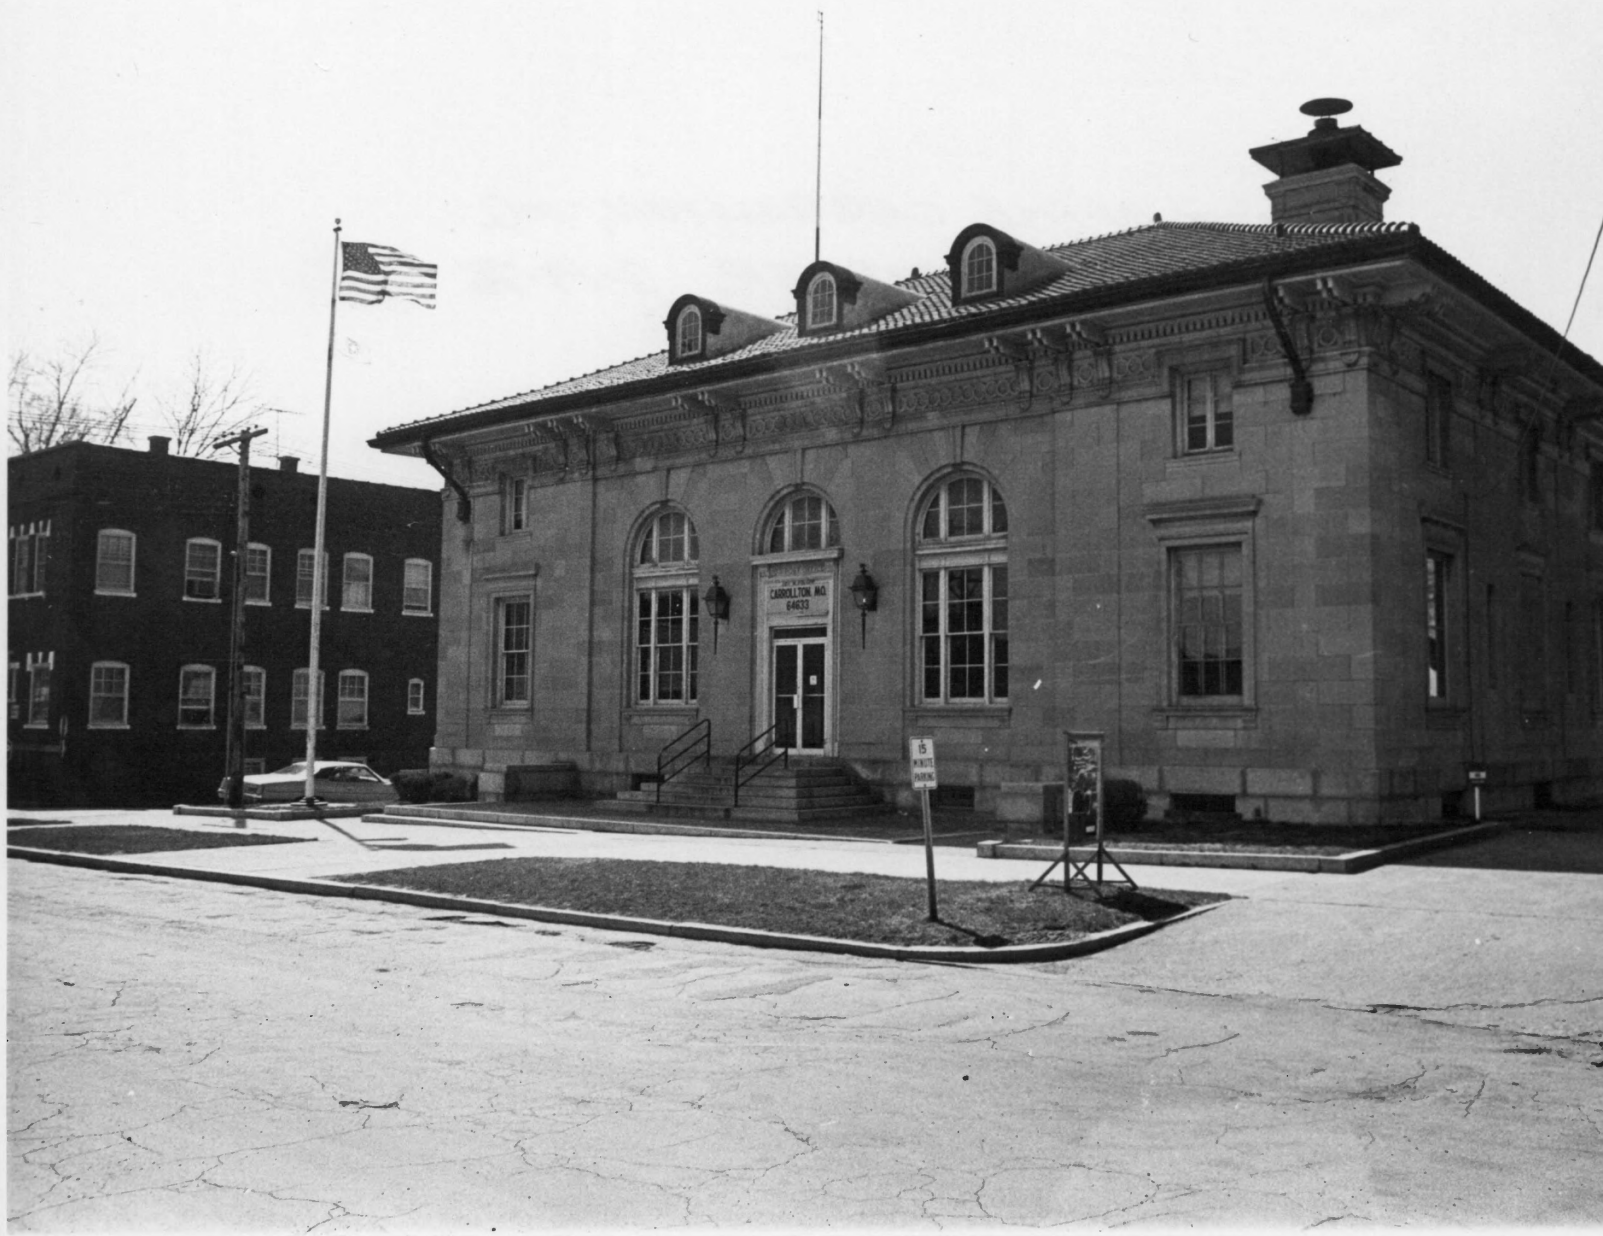
UNITED STATES POST OFFICE AT CARROLLTON
Carrollton, Missouri
Randy L. Cottier, Photographer, March 19,
1976 Neg. Loc.: Office of Hist. Pres.
PO Box 176, Jefferson City MO 65101
From northeast to southwest. Photo No. 1

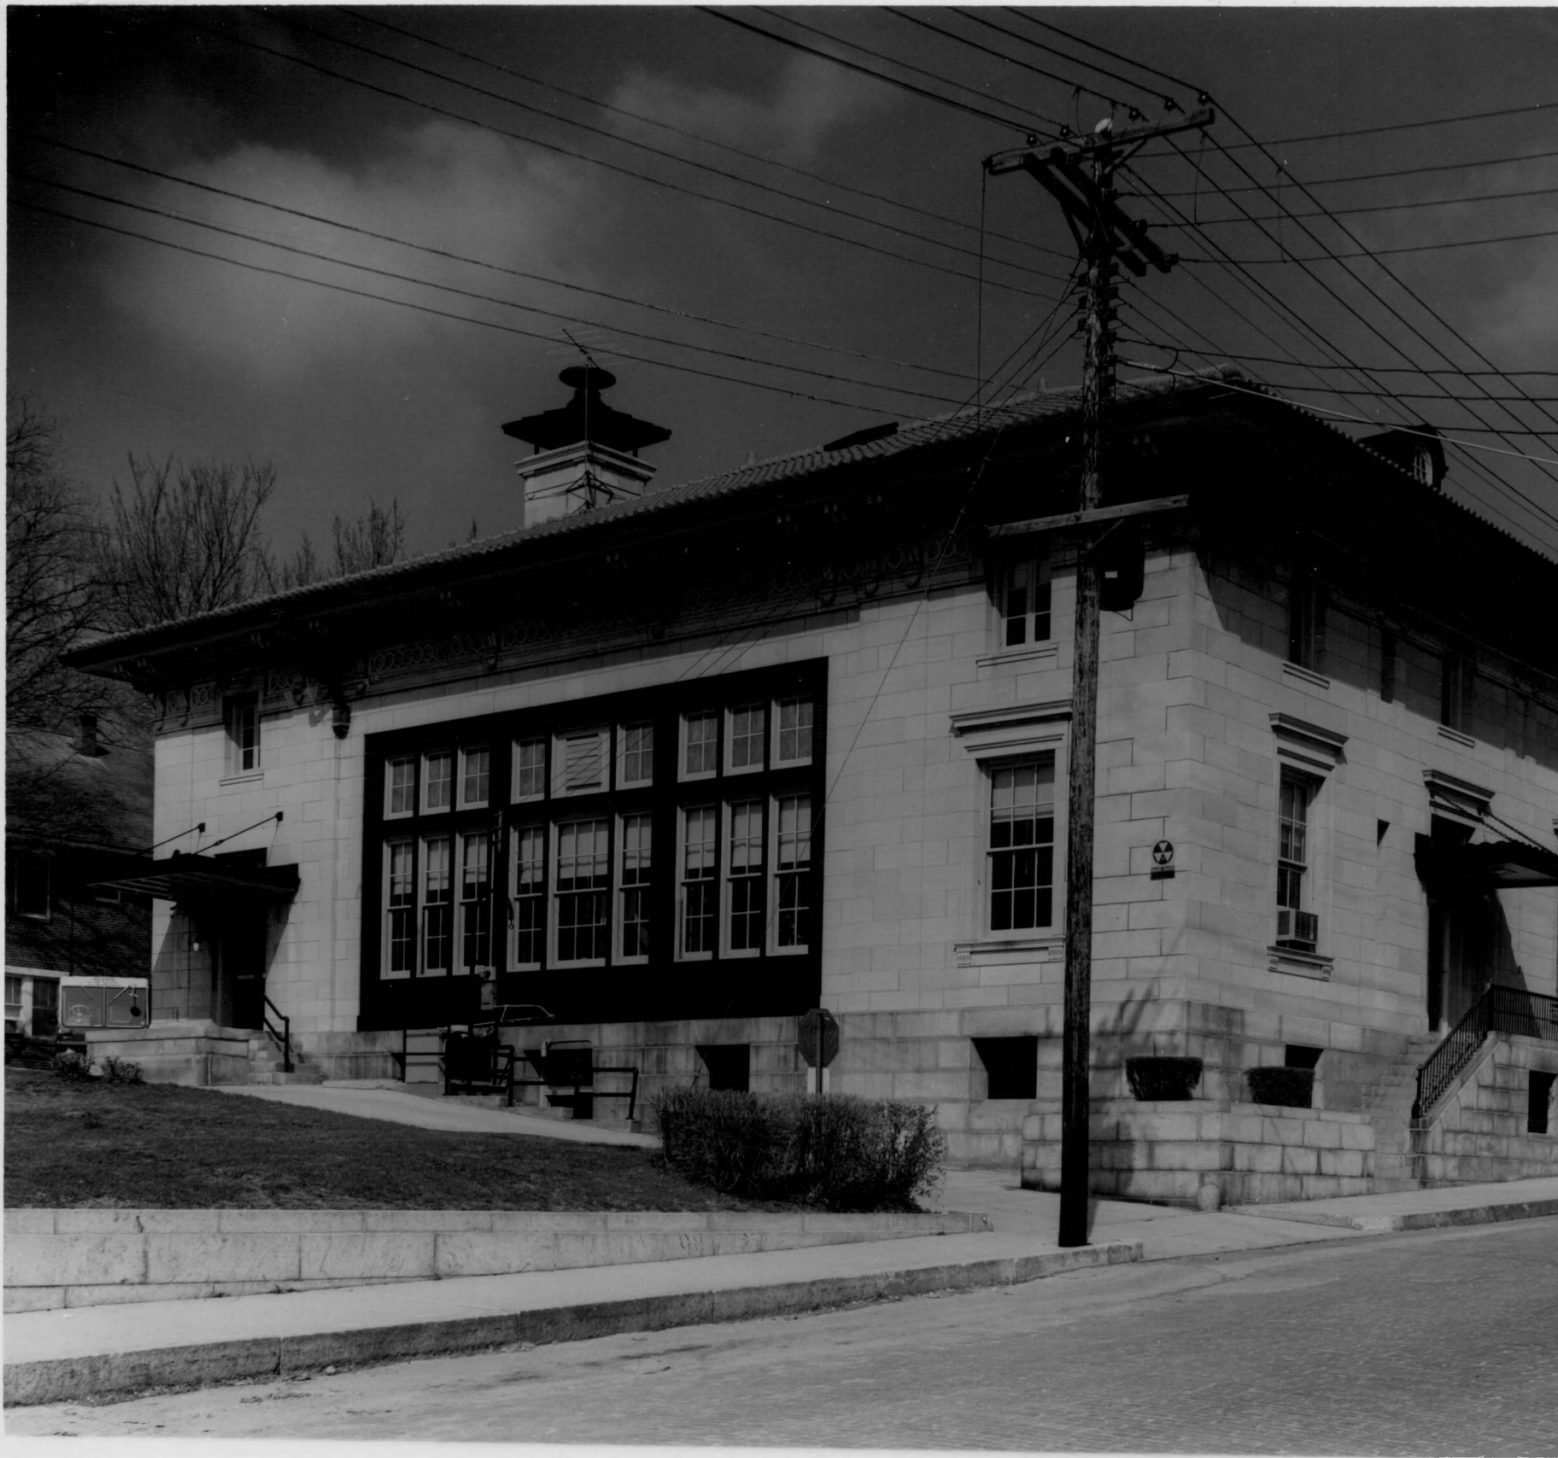
Photo No. 2. From southwest to northeast

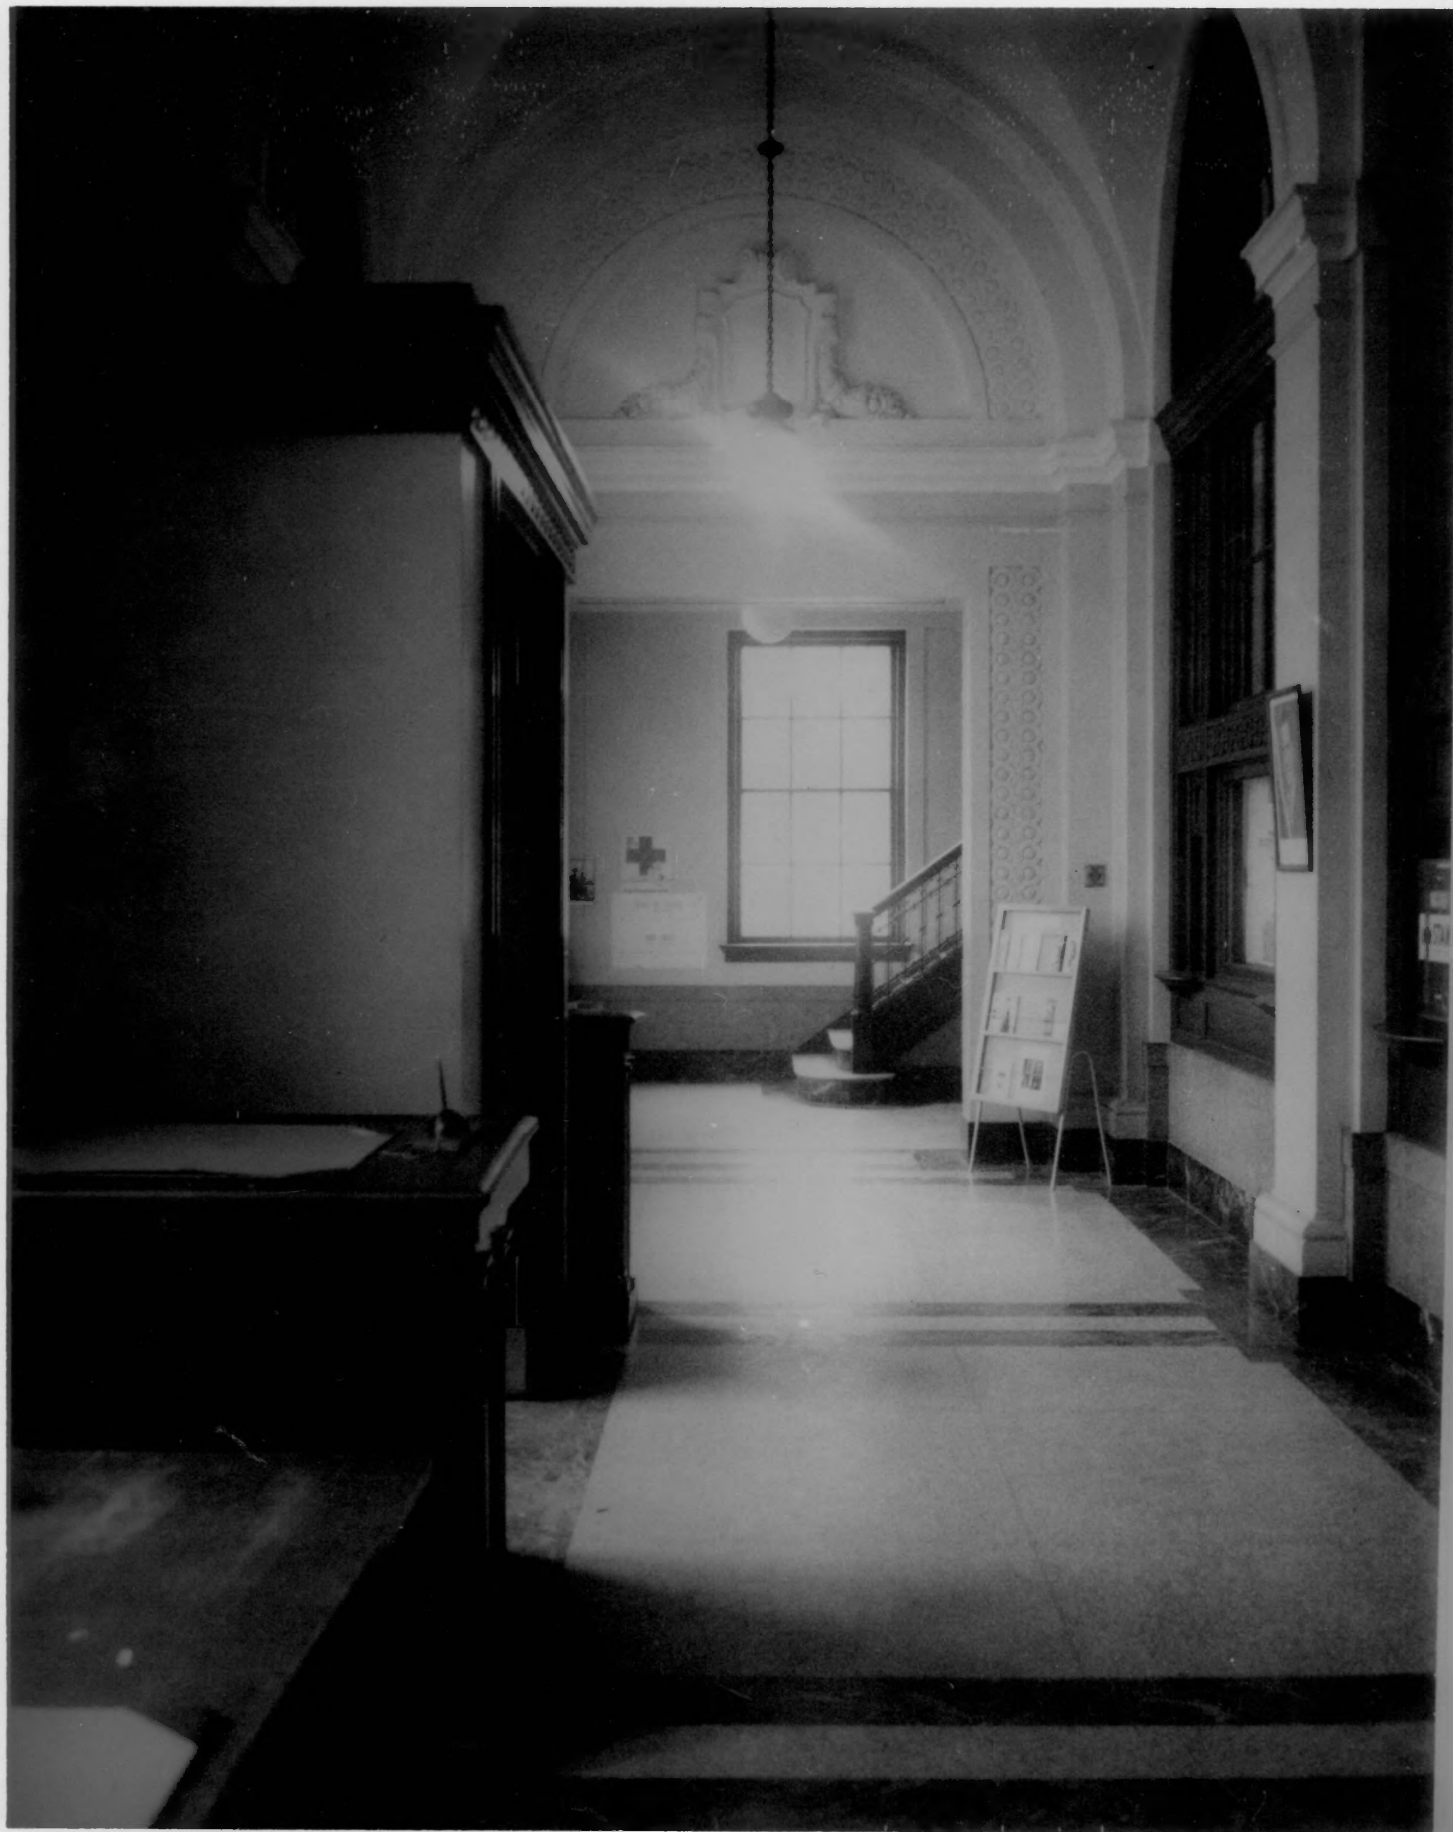
Photo No 3

Photo No. 3: Interior view from the north to
the south showing the main public lobby,
including the entrance at left, groin
vaulted ceiling and stairway.

Groin vaulted ceilings are found in the main public lobby only. These ceilings and the sidewalls were originally painted to imitate Caen stone. The vaulted ceilings and ceilings throughout are now finished with painted smooth plaster. The sidewalls of the public lobbies are finished with paint applied to the regular coursed smooth stone, with a Verona marble wainscot. Toilet rooms in the basement have painted plastered walls and ceilings, with marble wainscot and marble bordered floors.
