National Register of Historic Places
Inventory—Nomination Form

historic Wallace House

street & number 230 Harwood Avenue not for publication

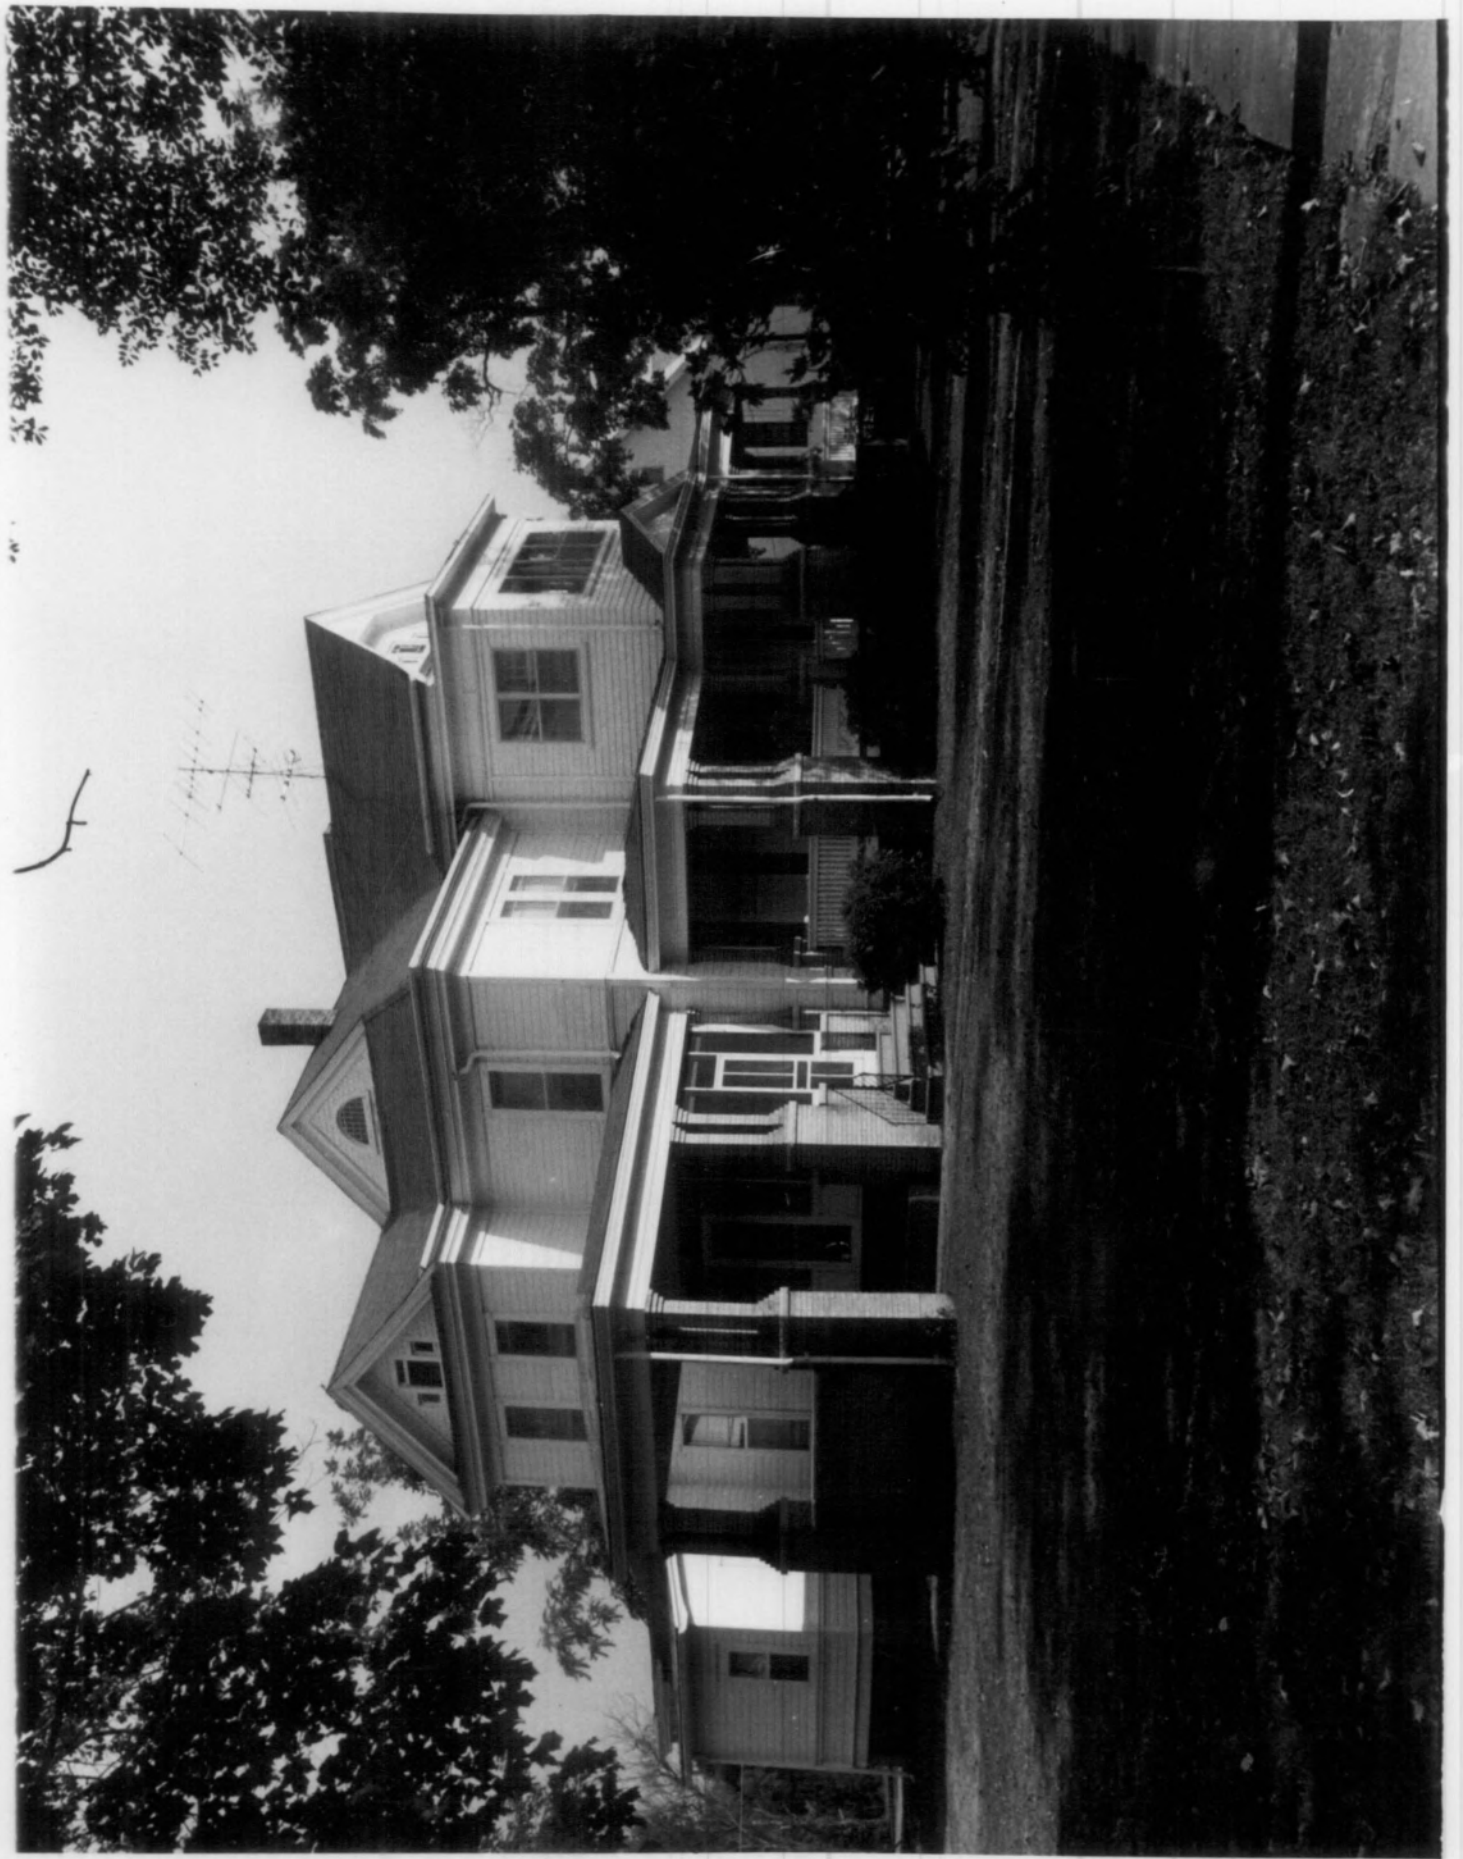
#2 of 14

View of north and west facade

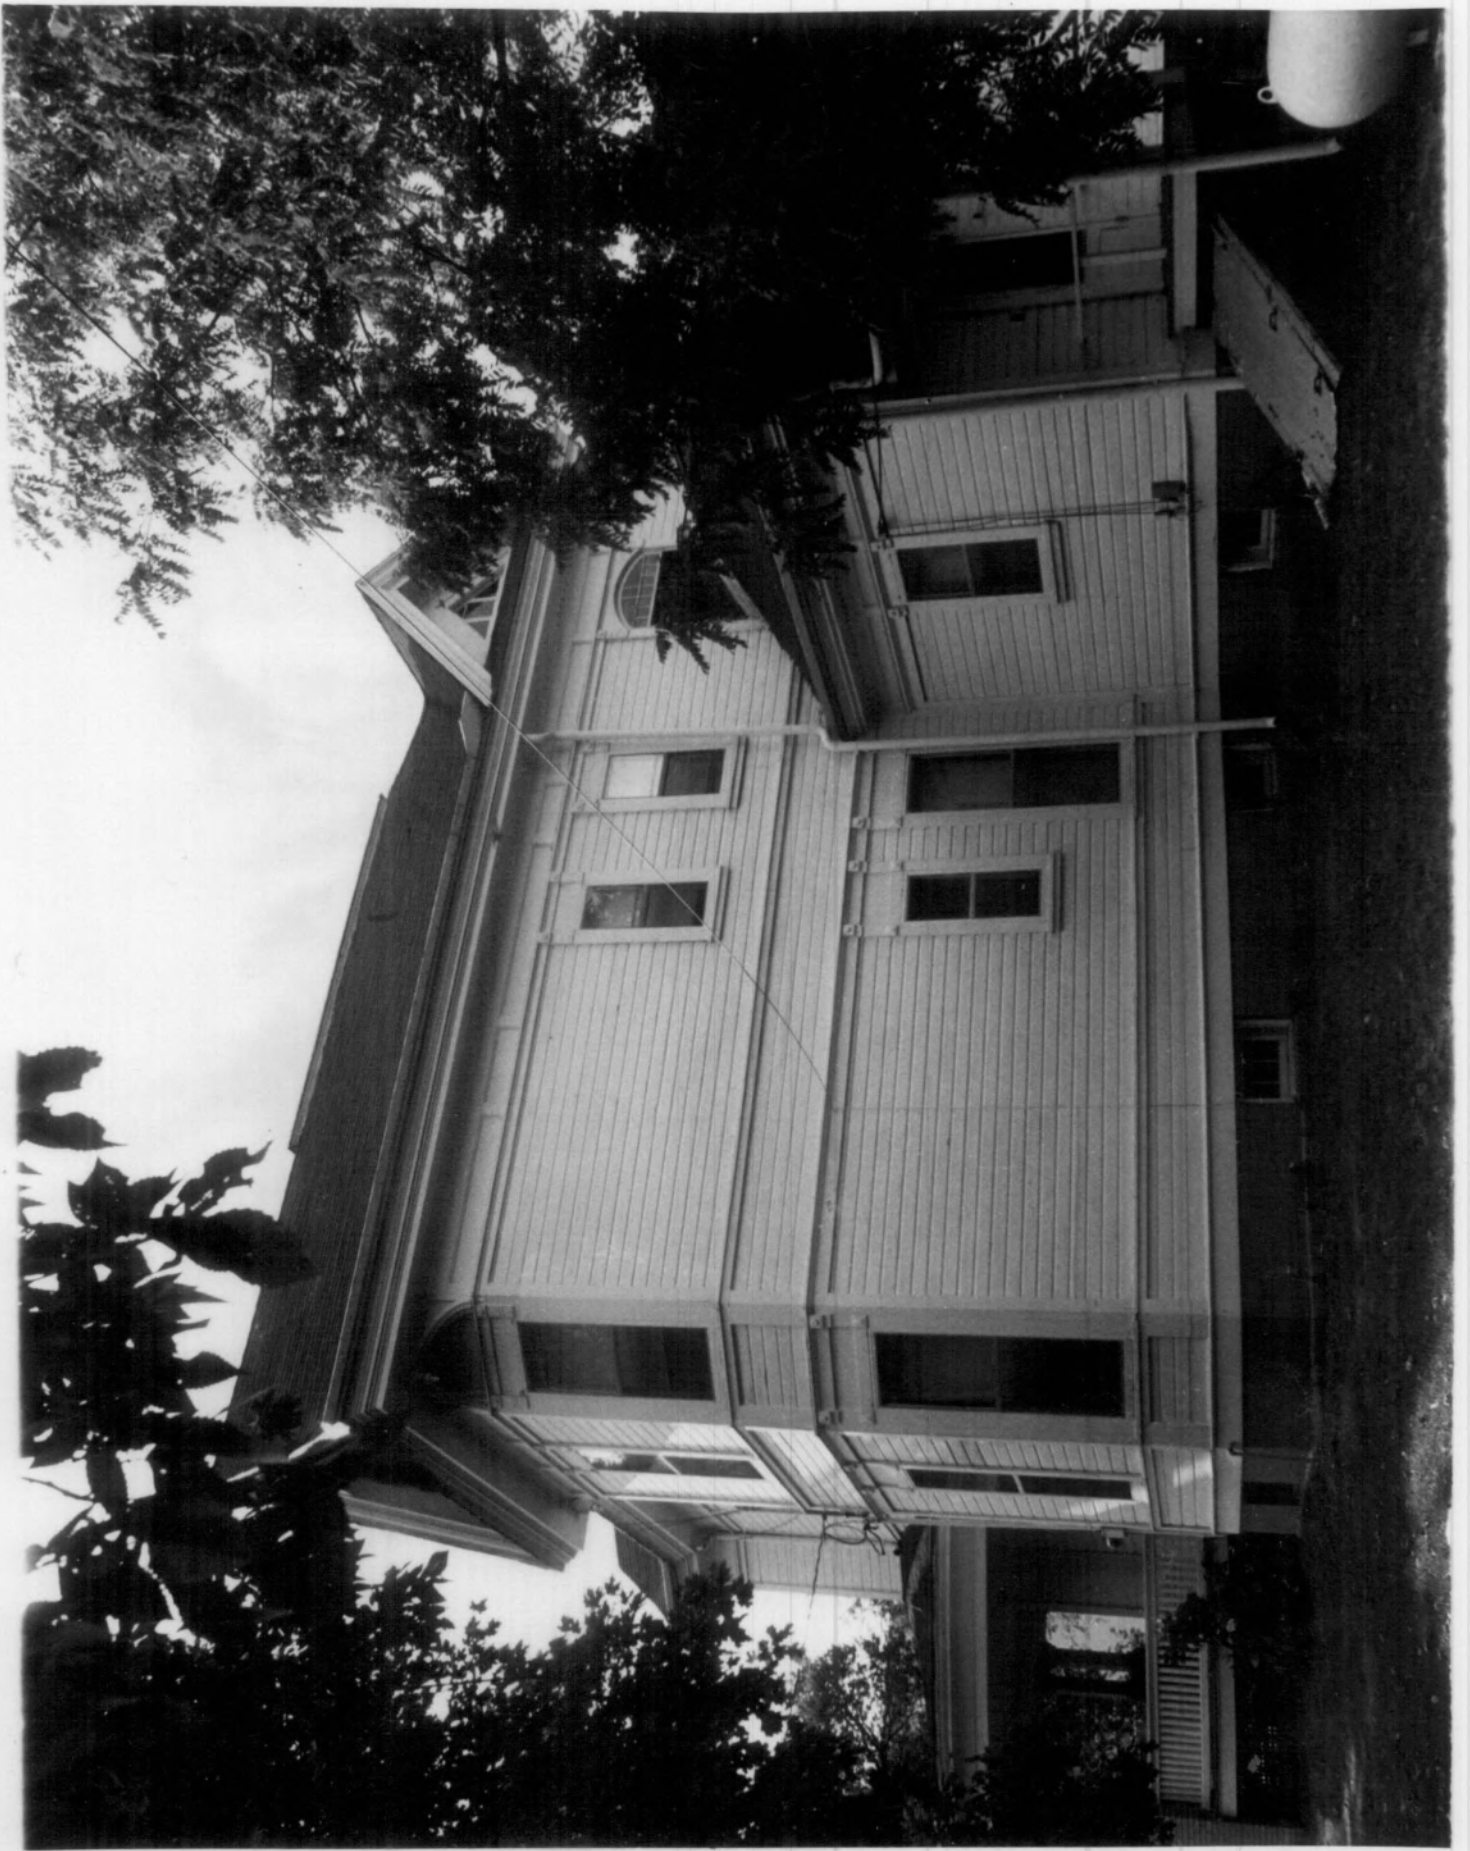
#9 of 14

Missouri Heritage Trust
P. O. Box 895
Jefferson City, MO 65102
View of east facade

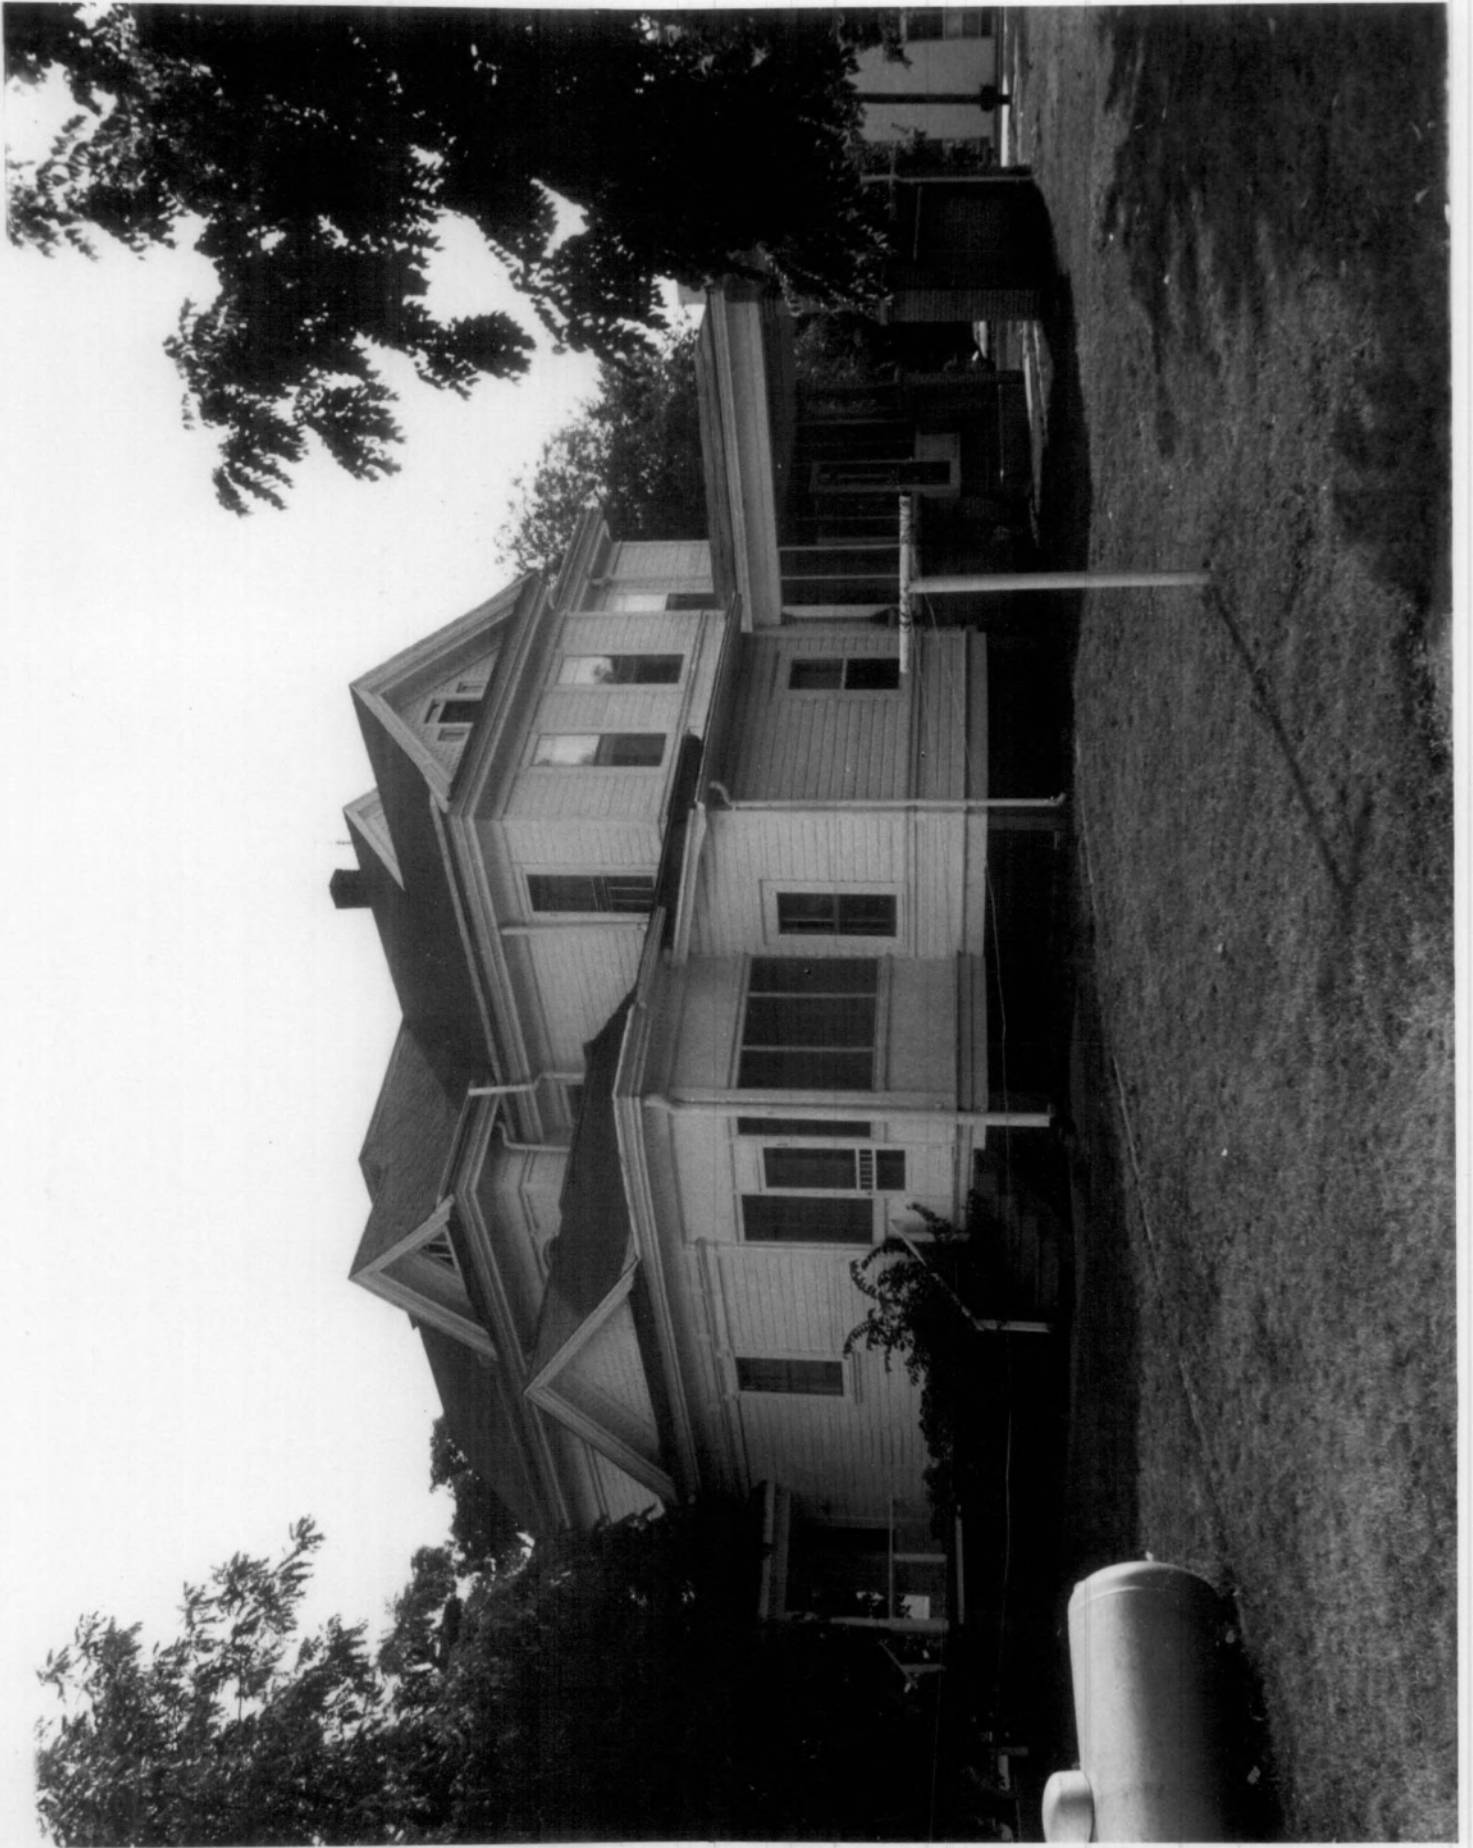
#10 of 14

Missouri Heritage Trust
P.O. Box 895
Jefferson City, MO 65102
View of east and north facade

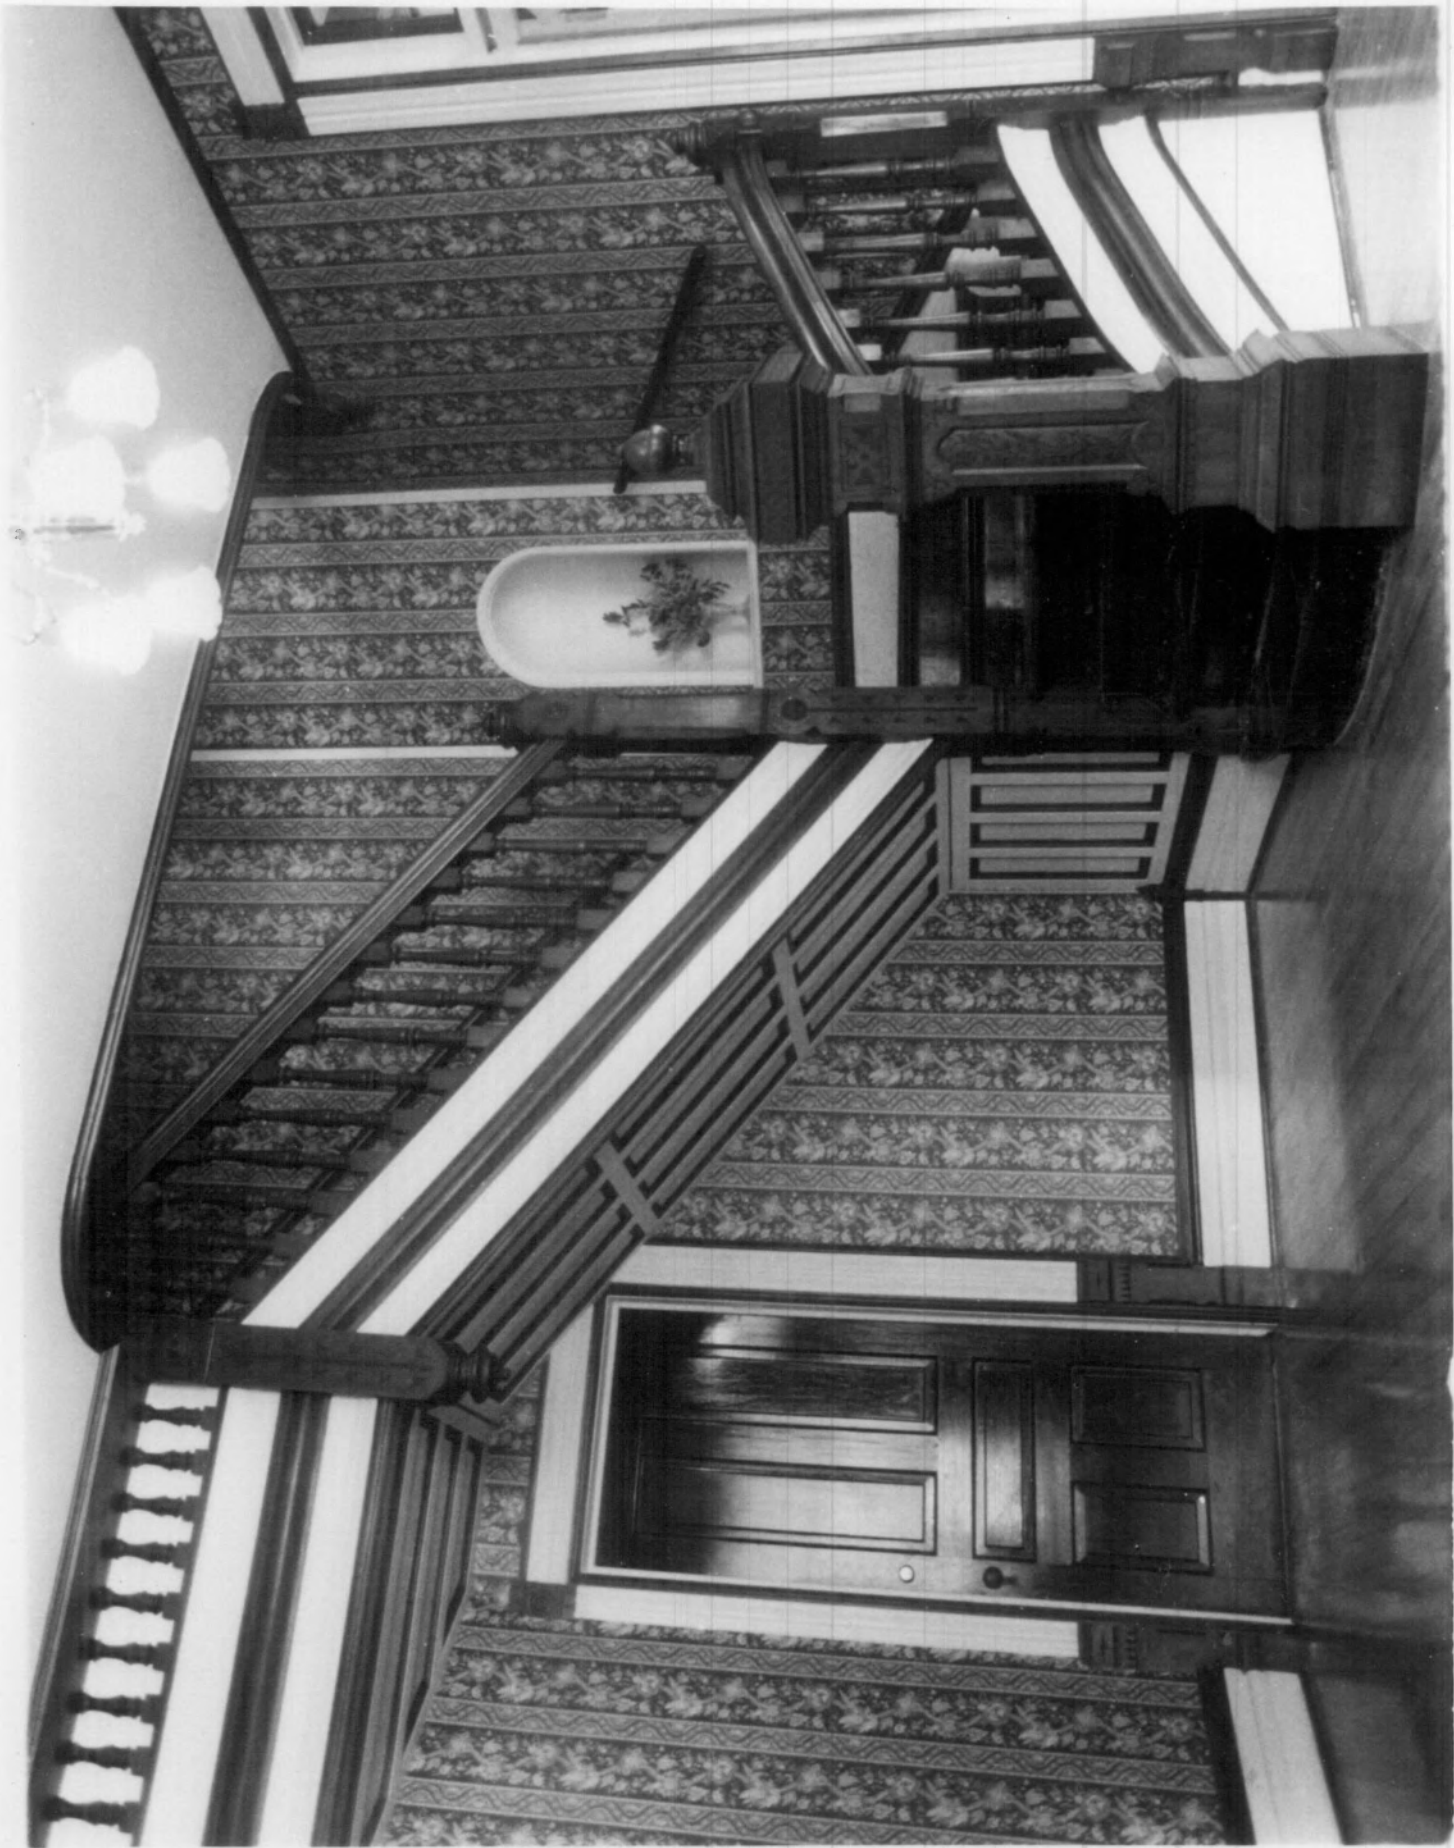
12 of 14

Missouri Heritage Trust
P. O. Box 895
Jefferson City, MO 65102
View of stair hall from
entrance

The entrance was in the middle of the west front and included a double set of 2 leaf doors, creating a small vestibule with a small window seat to the north. You entered the stair hall which featured a large newell post with machine-carved sunflower motif. A short flight of steps at an angle against the south wall, turned and ran up along the east wall and again turned to reach the second floor against the north wall. Folding doors could be used to close off the music room on the north or the parlor with its corner fireplace on the south. The hall, parlor and music room apparently had plaster ceiling cornices and medallions. The plaster cornice work remains only in the vestibule and window seat area of the front hall.

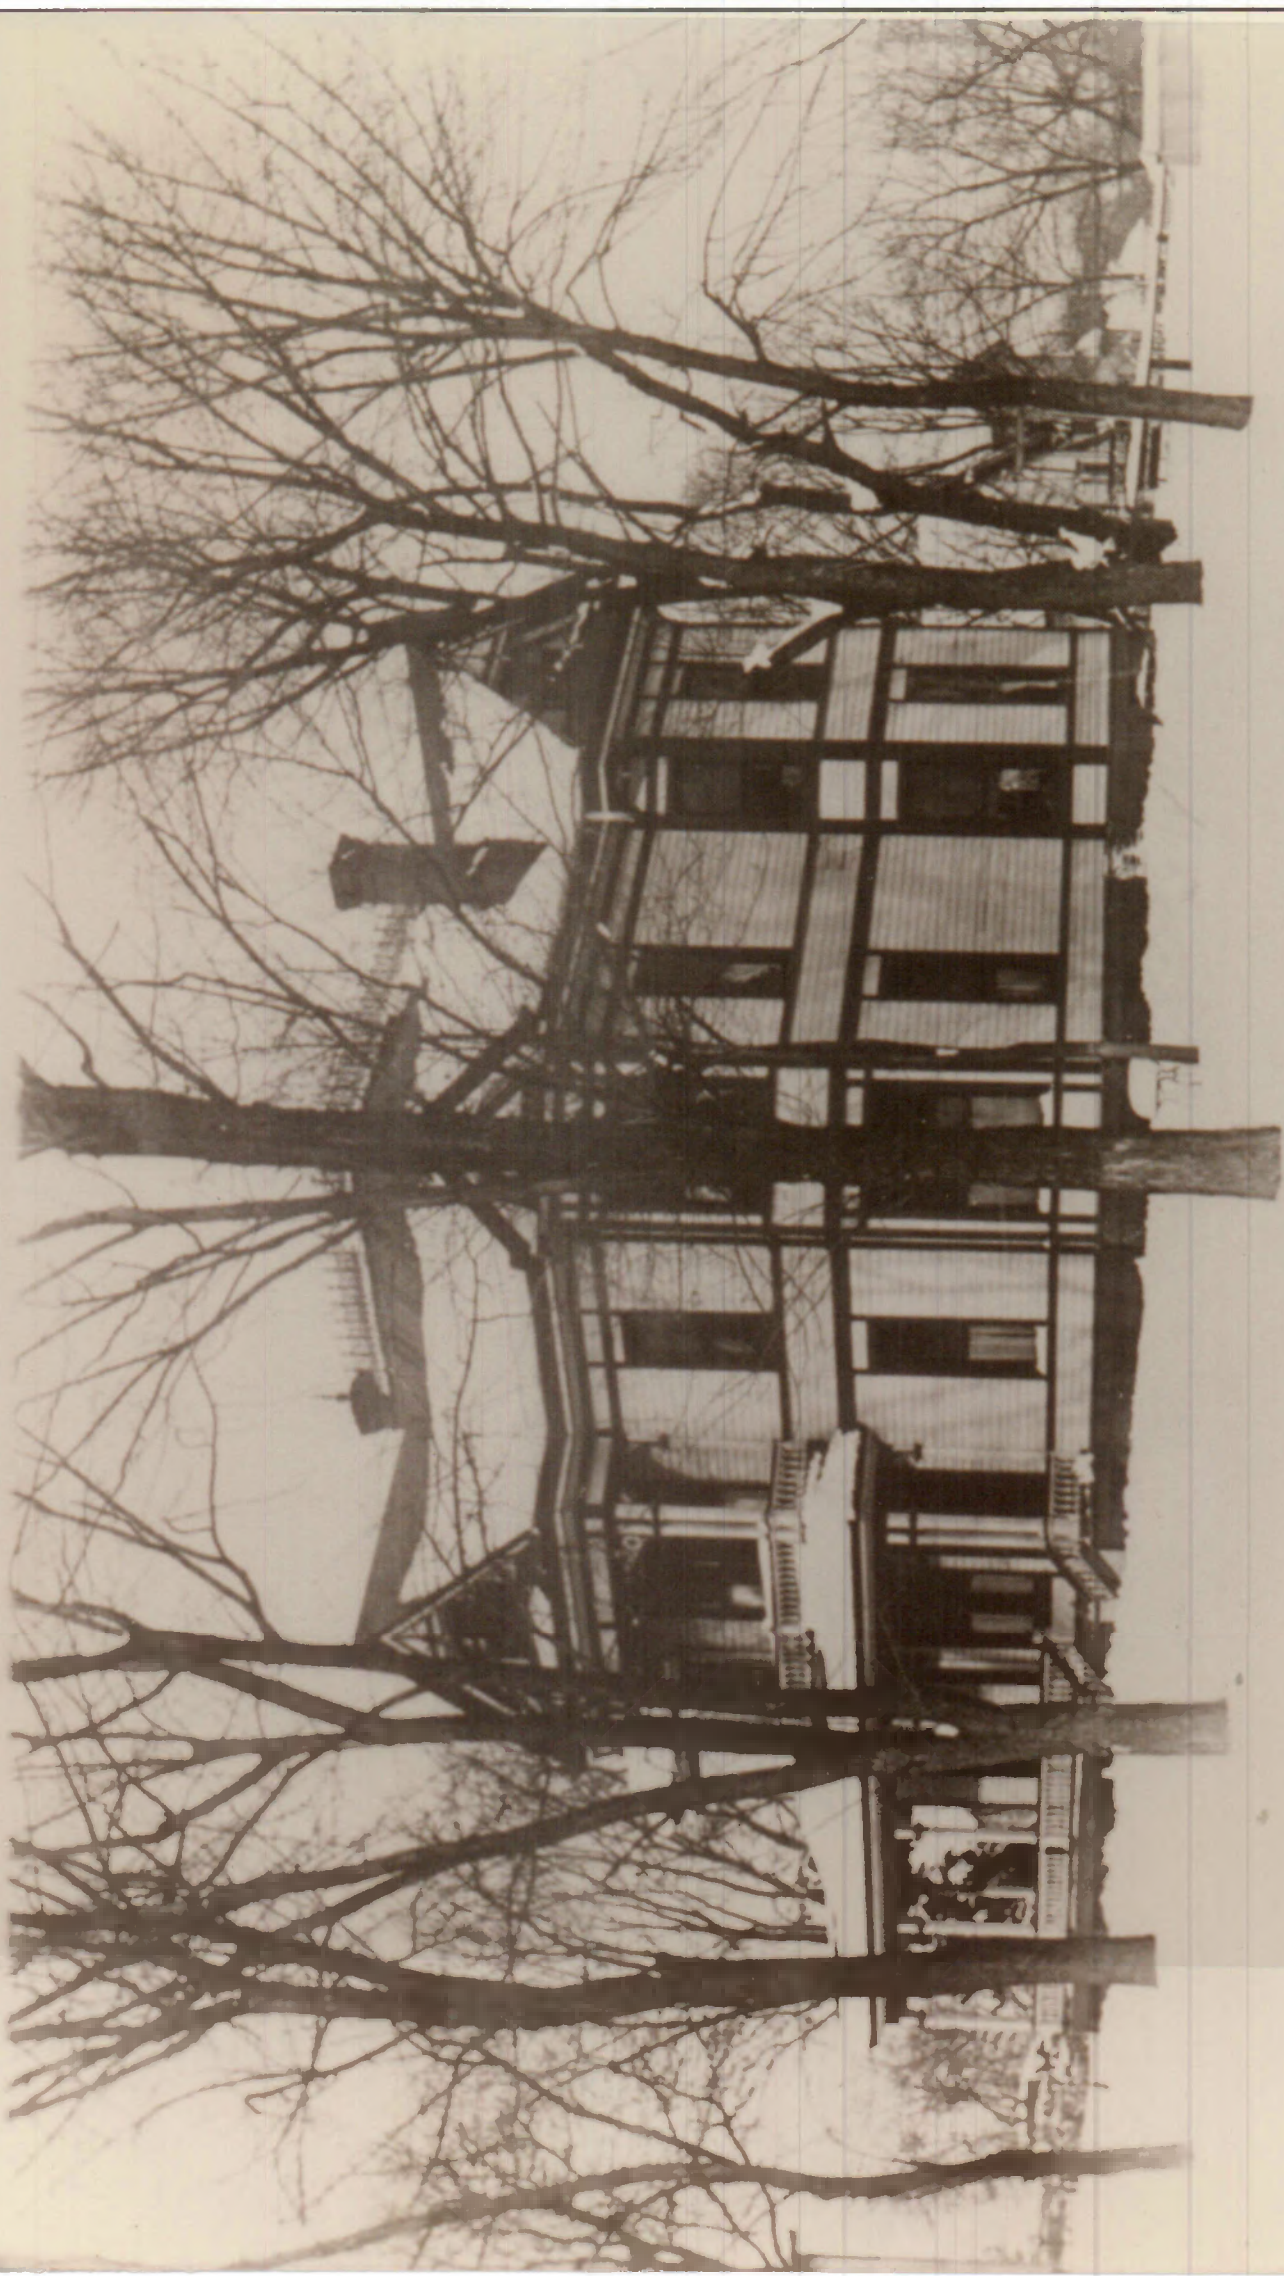
Wallace House
230 Harwood Ave.
Lebanon, MO
Laclede Co.

Photograph:
Original exterior

The Wallace House was constructed in 1876-1877 by Washington Irving Wallace as one of the first high-styled homes to be built between the old town of Lebanon and the new settlement area along the tracks of the St. Louis-San Francisco Railroad. This 16 room, Eastlake "Stick" style building had an irregular floor plan and irregular roof line. Predominant features were decorated gables, a corner bay window, a porch with squared columns and cut-out brackets on the northern 2/3 of the ground floor and a small open porch with similar detail over the main entrance under a projecting gable. Major stylistic element was achieved by creating patterns in the facade by the use of trim boards vertically and horizontally to create rectangular panels. Machined decorative blocks were used at edges of windows and the direction of the siding was reversed to enhance this patterning. Machined molding and trim was used to build out the cornice of the roof and projecting gables. Patterned shingles were used in the gables and Queen Ann sash (large single clear glass light surrounded by small colored glass lights) were used. Dark brown trim, a light tan body color and red sash were typical of this rich patterned exterior of this period. The steep pitch of the main roof is broken by several different gables and two corbelled brick chimneys on the west and south side. Iron cresting decorated the flat area of the truncated hip of the main roof structure.
