# Dutchtown South Community Corporation Dutchtown South Neighborhood Survey

Lynn Josse and NiNi Harris  
8/5/2010

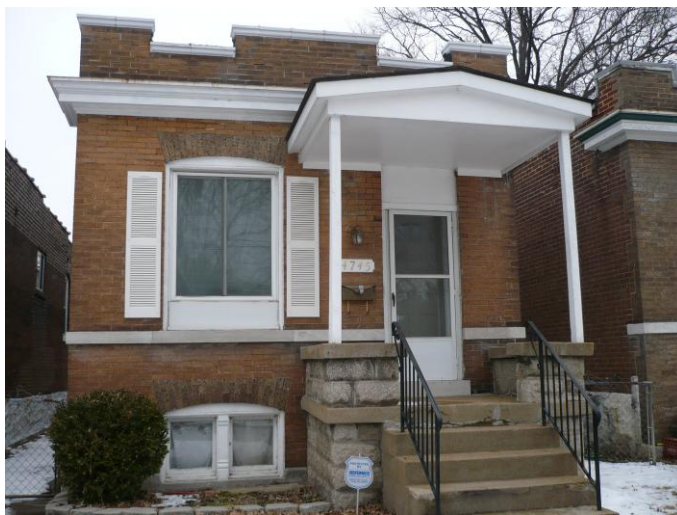
A cast stone stoop at the right bay is sheltered by a replacement gable roof. The front door is a replacement, its transom covered. At the left bay, a wide segmental arched window opening bears a replacement window. Above a metal cornice, the parapet wall has a center step and end blocks.

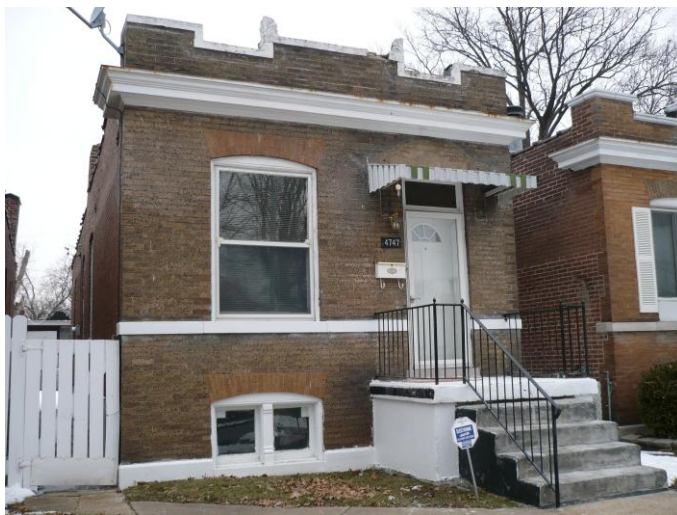
A concrete stoop at the right bay is sheltered by a metal awning. The front door is a replacement, its transom still open. At the left bay, a wide segmental arched window opening bears an original 1/1 wood window. Above a metal cornice, the parapet wall has a center step and end blocks.

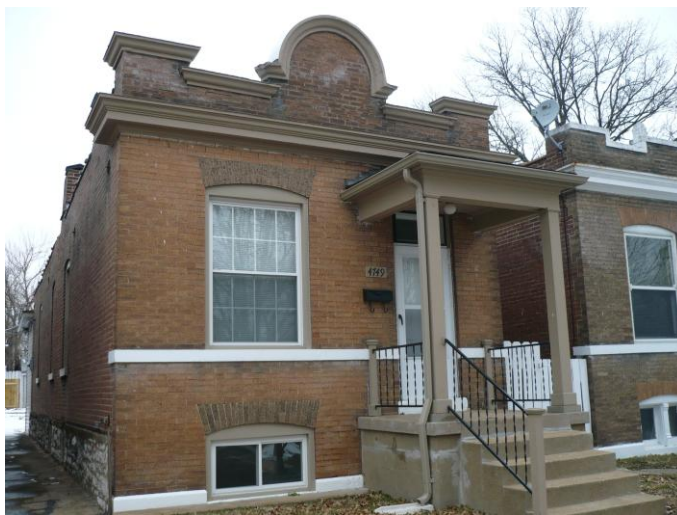
A concrete porch base at the right bay bear a replacement hipped roof. The front door is a replacement, its transom still open. At the left bay, a wide segmental arched window opening bears a replacement window. Above a metal cornice, the parapet wall has a center arch and end blocks.

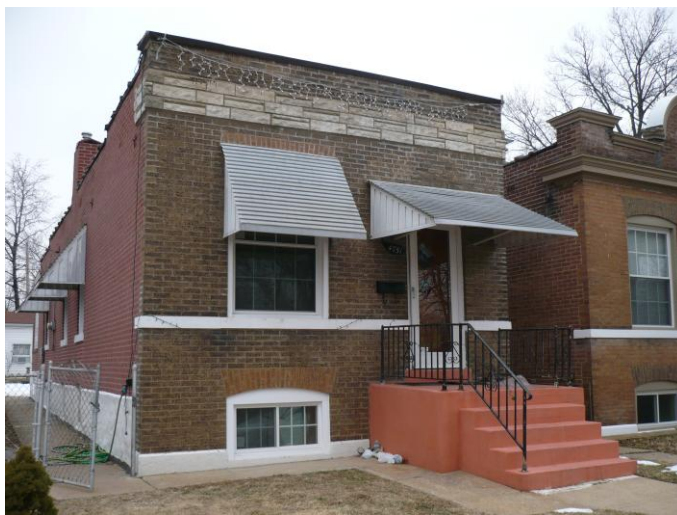
A concrete stoop at the right bay is sheltered by a metal awning. The front door is a replacement. At the left bay, a wide window opening bears a replacement window. The metal cornice was removed, and the area covered with imitation stone veneer.

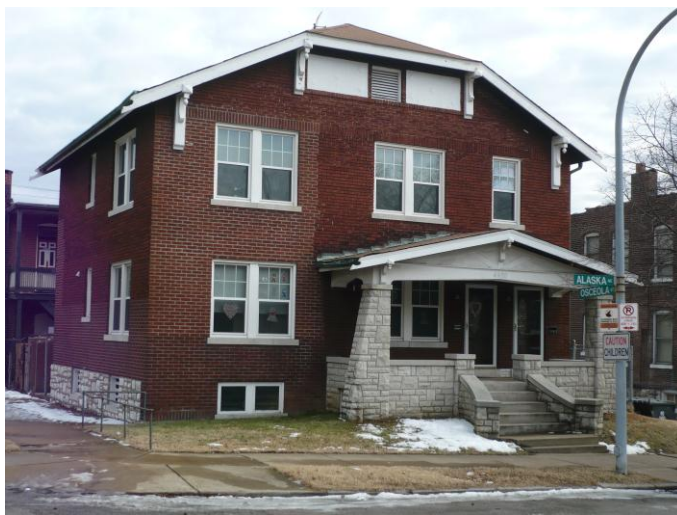
This unusually side two-family building has a limestone porch at the right two bays. Its gabled roof is supported on two battered limestone piers and has three brackets supporting the eaves. At the right side of the porch are two replacement doors; a single window is above. At the center bay (the left side of the porch) and the left bay are pairs of replacement windows. The front eaves are supported on four brackets, and between the top two brackets, the clipped gable end is stuccoed.

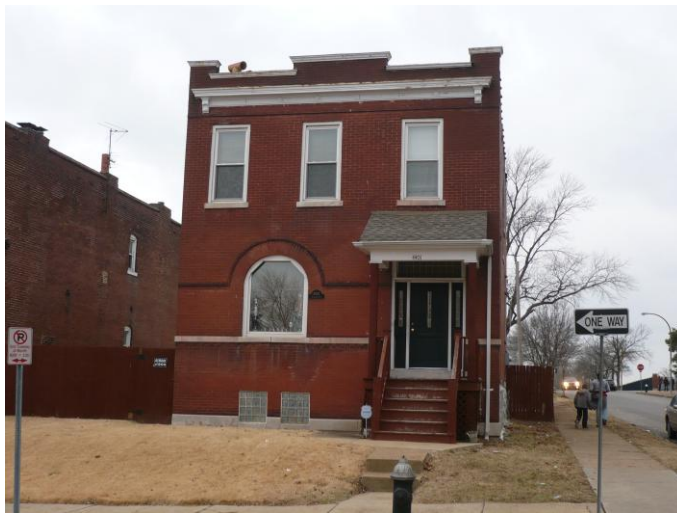
This two-story building was constructed as flats. It appears to have been converted to single family use: at the right bay's shed-roofed porch, the front doors have been replaced with a new door between new sidelights. At the first story's right bay, a wide round-arched window opening has been fitted with a fixed pane window. At the second story, three 1/1 windows are also replacements.

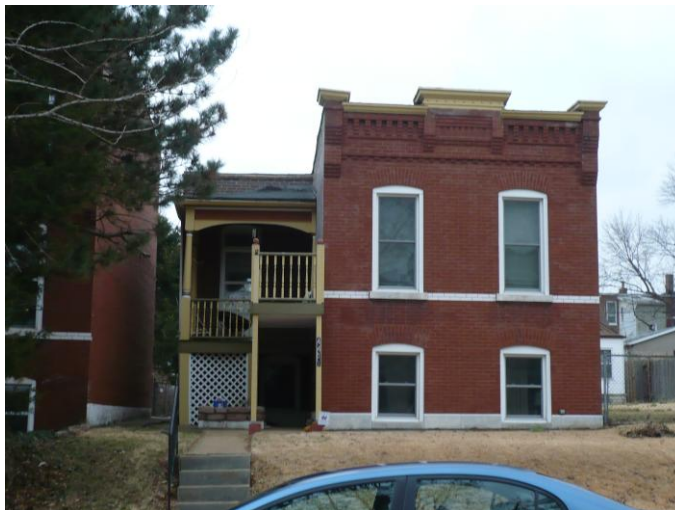
Atop a high basement, this single story house has a two-bay front facing Alaska. The 1908 Sanborn map shows this as a single family house. Two bays face the street at the right side; each has a replacement window in a segmental arched opening, the brick mold now wrapped. Tall basement windows at the foundation are treated similarly. Above a corbelled brick cornice, the parapet wall has end blocks and a center step with metal coping. To the left, a recessed bay includes doors at both the first story and basement level. Both are original. The frame porch is extended forward to the façade and is compatible with the historic character of the house.

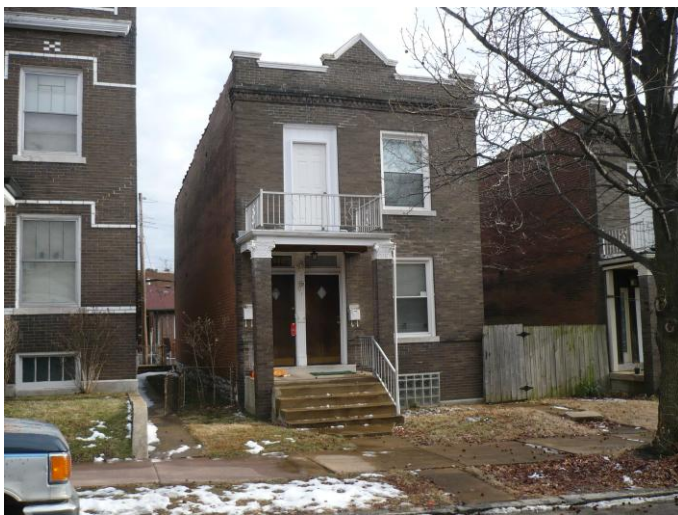
Brick porch is at the left bay, with two replacement doors under transoms. The balcony door above is new and its surround filled in with infill paneling. At the right bay, the two windows are replacements Above a corbelled brick cornice the parapet wall has end blocks and a peaked center step with metal coping.

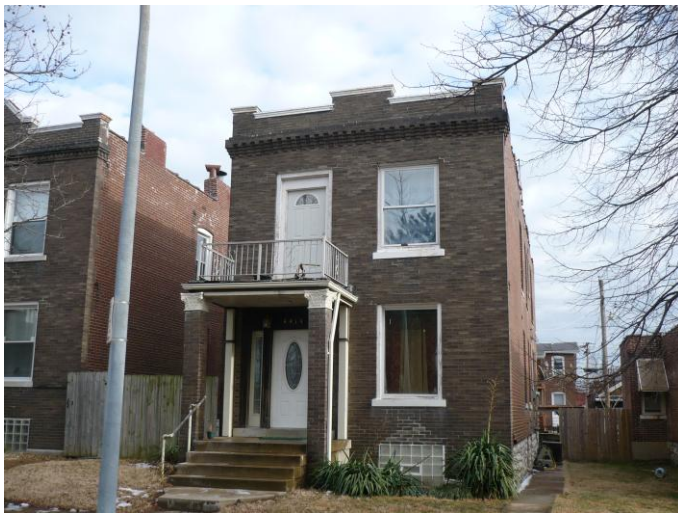
Brick porch is at the left bay, with a replacement door centered in a new surround (the Sanborn map of 1951 shows this as flats). The balcony door above is new and its surround filled in with infill paneling. At the right bay, the two windows are replacements. Above a corbelled brick cornice the parapet wall has end blocks and a center step with metal coping.

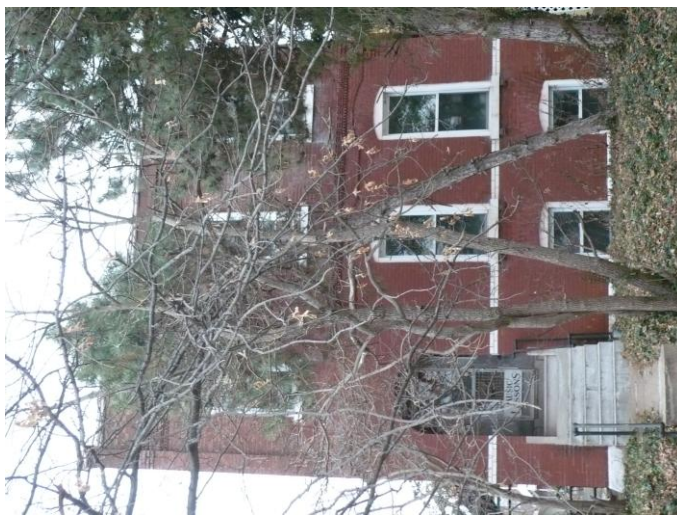
The second story of this two-story building was added sometime after 1908. The entrance is at a round-arched opening at the left bay. The two high basement windows, two first story windows, and the three second story windows are in segmental arched openings and are replacements. There is a pressed brick label course over the first story openings. Molded brick courses separate the first and second stories. The corbelled brick cornice includes end blocks which descend down the outer edges of the second story as raised pilasters.

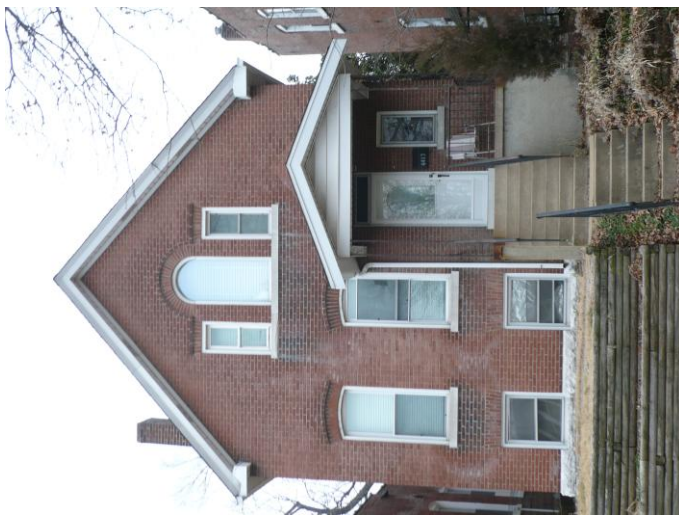
This is a 1 1/2 story front gabled red brick house on a high raised basement. A gabled porch is at the right bay; its base is concrete, with replacement metal railings and uprights. The front door is a replacement (although its transom and the side art glass window appear original. Other façade windows appear to be replacements (two at the basement, two in segmental arched openings at the first floor's left bays, and a modified Palladian arrangement in the gable end). The front gable end is open and has eave returns. This house seems to correspond with the building permit for 4419 Alaska (which does not exist).

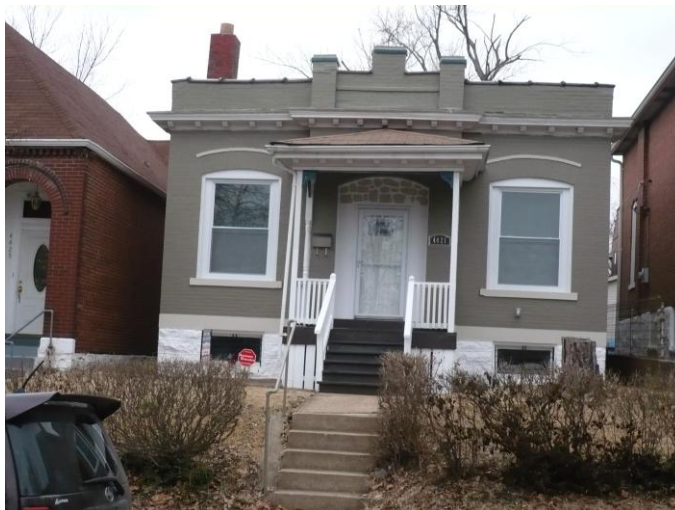
This single story house has a painted brick façade over a coursed limestone foundation level. At the center bay, a hipped porch has a frame base and replacement wood supports. The front door is centered under a wide segmental arch; the door is a replacement and the sidelight and transom areas are covered over. To either side, a replacement vinyl 1/1 is in a wide segmental arched opening. A modest bracketed cornice is over the first story. At the center bay, the parapet wall projects slightly with a center step and end blocks. Clay tile coping.

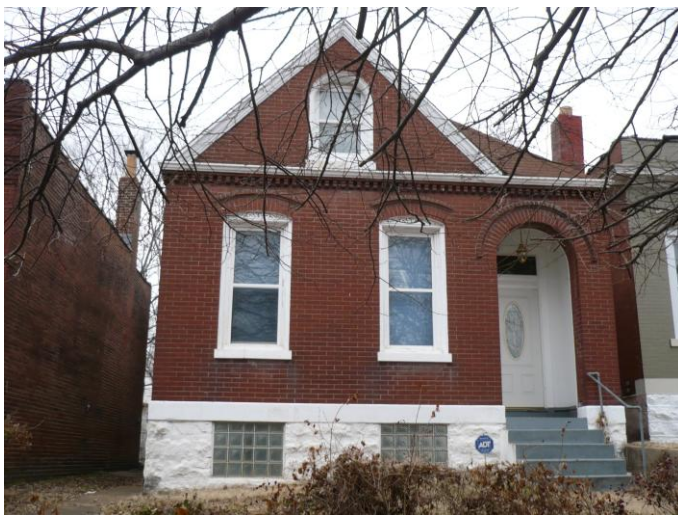
This single story house has a three bay red brick façade over a painted coursed limestone foundation. The front door (a replacement) and transom are recessed behind a round-arched opening at the right bay. The two left bays have segmental arched window openings which retain ornamental wood eyebrows. Above these two bays is a low cross gable from the main hipped roof. Its round-arched window opening is fitted with a square head window. The rear of the house has a side gabled roof. Basement windows at the façade are filled in with glass block.

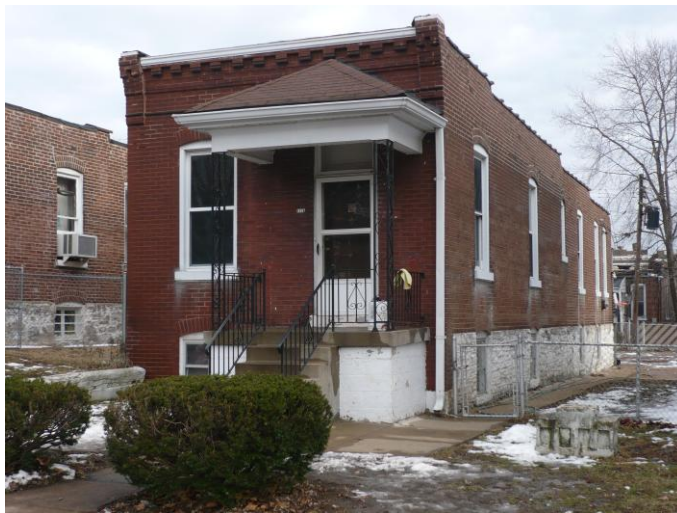
This narrow house has a replacement window at the left side of the façade and a replacement door at the right. The front porch has a concrete base and metal uprights but retains the original hipped porch roof. Corbelled brick parapet wall has metal coping.

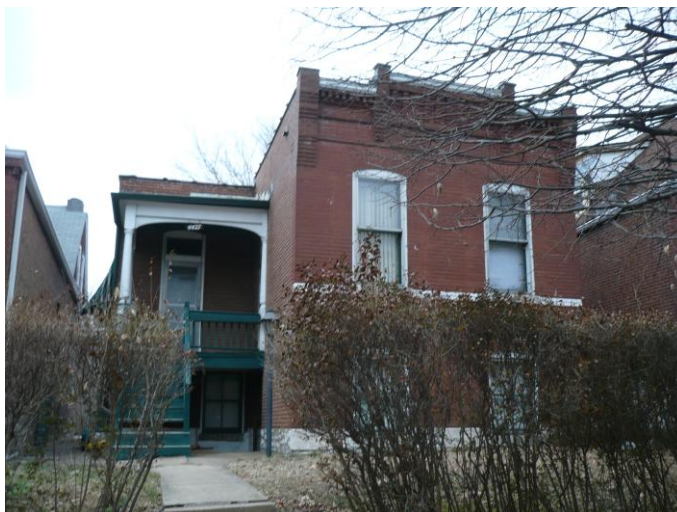
Atop a high basement, this single story house has a two-bay front facing Alaska. The 1908 Sanborn map shows this as a single family house. Two bays face the street at the right side; each has an original window in a segmental arched opening. Tall basement windows at the foundation are below. Above a corbelled brick cornice, the parapet wall has end blocks and a center step with metal coping. To the left, a recessed bay includes doors at both the first story and basement level. Both are original. The frame porch includes original or compatible elements.

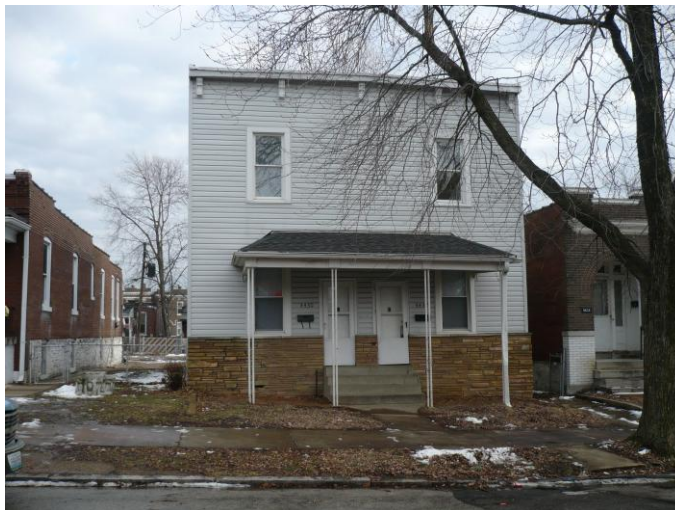
The façade of this frame multifamily building has a centered concrete steps leading up to the two front doors (non-historic); at the left and right bays a non-historic window is at each story. A wide hipped porch roof appears to date from the historic period; it is supported on four metal posts and there is no porch base. Five brackets at the cornice are from the historic period. Date found on building division certificate; permit not found.

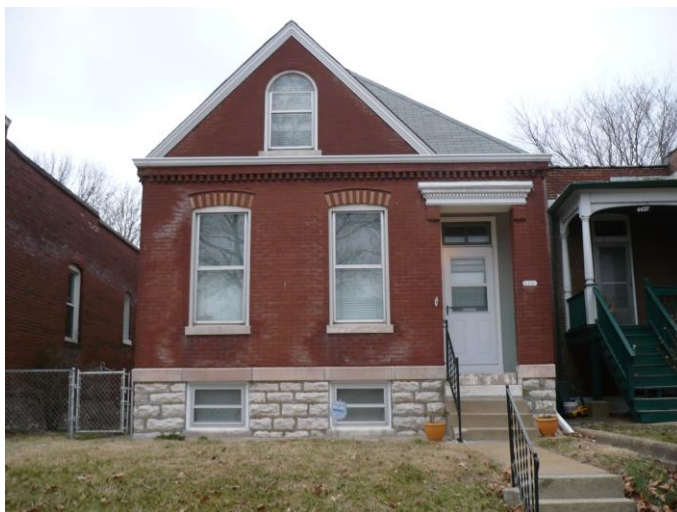
This single story house has a three bay red brick façade over a coursed limestone foundation. The front door (original) and transom are recessed behind an opening at the right bay. At either side, the entry has brick corbels which suggest a triglyph with guttae and which support a painted entablature. The two left bays have segmental arched window openings with alternating red and tan brick voussoirs. Above these two bays is a low cross gable from the main hipped roof with a round-arched window opening. The center section of the house has a side gabled roof. Façade windows all appear original. A brick addition permitted in 1923 is likely the rear.

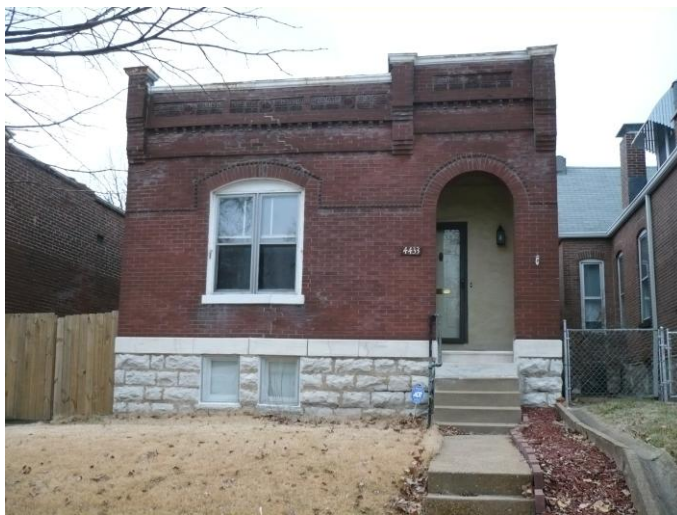
This two-bay red brick house has a round-arched entry at the right bay. It appears likely that this was one of many houses in the area which were built with two door-sized openings for future expansion; one is now covered and the other bears a replacement door. At the left bay, a wide segmental arched window opening bears an original 3/1 window. Below it at the coursed stone foundation level are two single-pane wood basement windows. Ornamental pressed brick composes a label course and corbels and panels at the parapet wall.

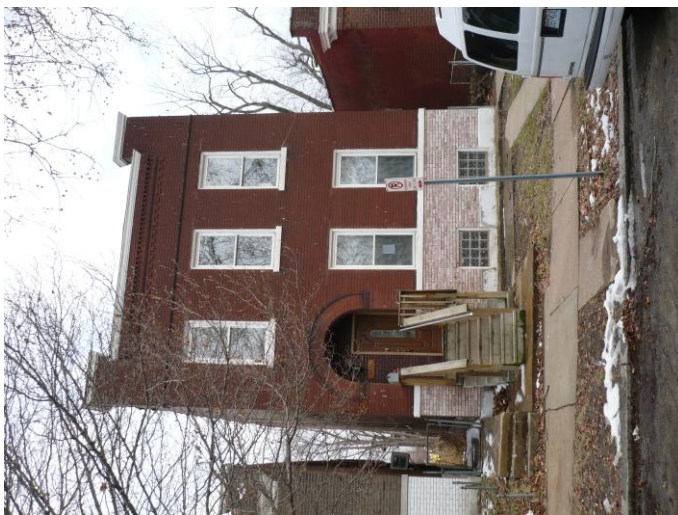
Permits indicate that this was constructed as a single family dwelling in 1908 (it does not appear on the Sanborn map of that year), but it is shown as flats in 1951. It is now converted back to single family use. The new front door is recessed behind a round-arched opening at the left bay. The other door opening and transoms are covered with imitation brick siding. The five façade windows are replacements. Metal coping.

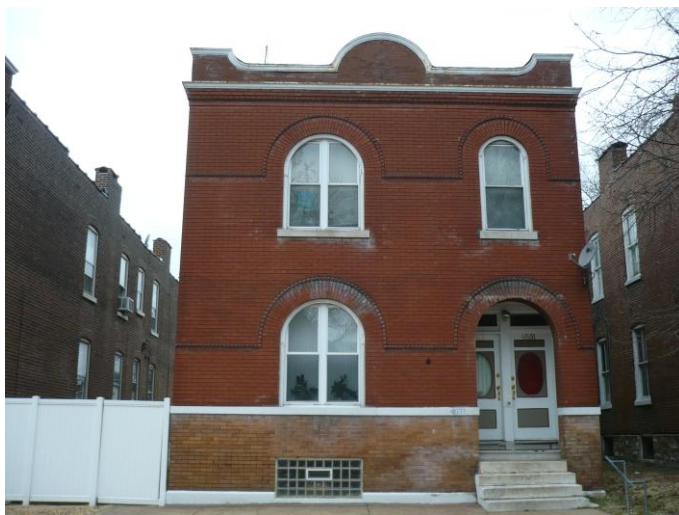
This building has a red brick façade (tan brick below the first story's limestone window sill course). There are two doors recessed behind a round-arched opening at the right bay. The doors and transoms are original. There is a round-arched window opening at the second story over the entry, and wider round-arched window openings at the left bay - all three are filled in with replacement windows. Molded brick traces label courses at both stories. The center step of the parapet wall is actually a round arch.

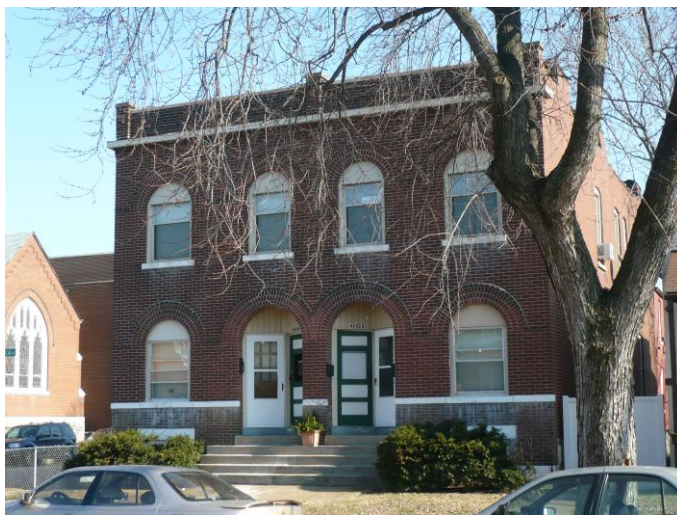
This two-story building has a symmetrical four-bay façade. At the second story there are four round-arched window openings; at the first story the same windows are at the outer bays, and two round-arched recessed porches are at the center bays. Three of the four doors are original. The fourth is a replacement, and the transom areas are covered with paneling. Windows are replacements, and the tops of the arches are covered over. Cornice and coping are wrapped with aluminum.

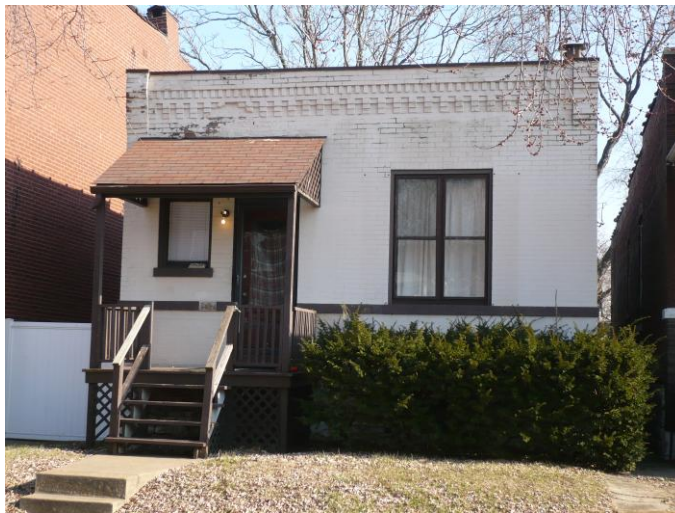
This single story house has a frame porch (not original) at the left bay. The front door and transom are original. At the right bay, the window is a replacement. Corbelled brick forms a cornice.

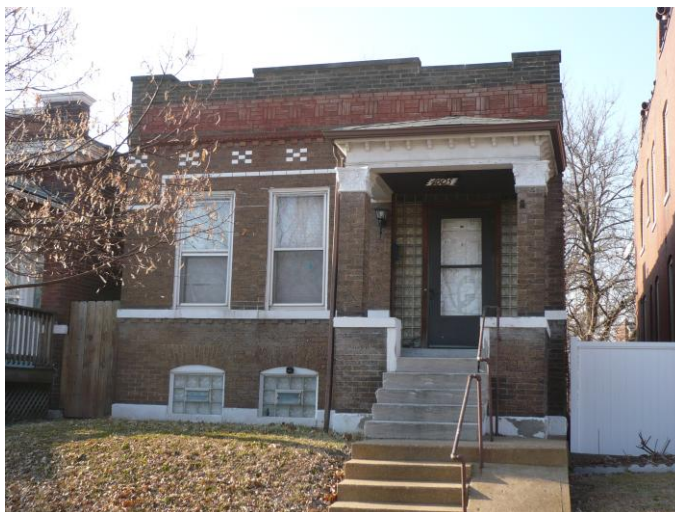
This single story house has a brick porch with a hipped roof at the right bay. The front door is a replacement and its sidelights are now glass block. To the left, two 1/1 windows are original. The cornice and parapet wall are rebuilt; the cornice strip is now parged, and the center and end steps of the parapet appear somewhat truncated.

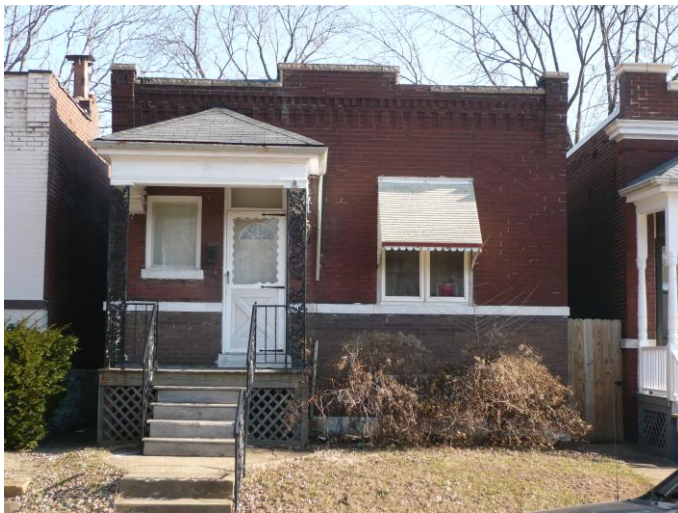
This single story house has a hipped porch at the left bay. The frame porch base and metal uprights are not original, but the roof appears to be. The front door and transom are replacements. At the right bay, the window is a replacement under a later awning. Corbelled brick forms a cornice.

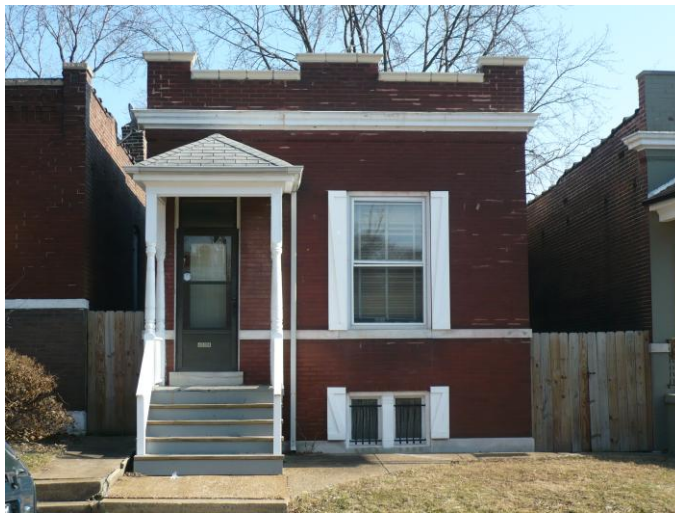
This narrow house has a two-bay façade. At the left bay, the front door and transom are original. The small frame porch has a hipped roof. At the right bay, the window is a replacement, although the basement windows below it appear original. The parapet wall has terra cotta coping.

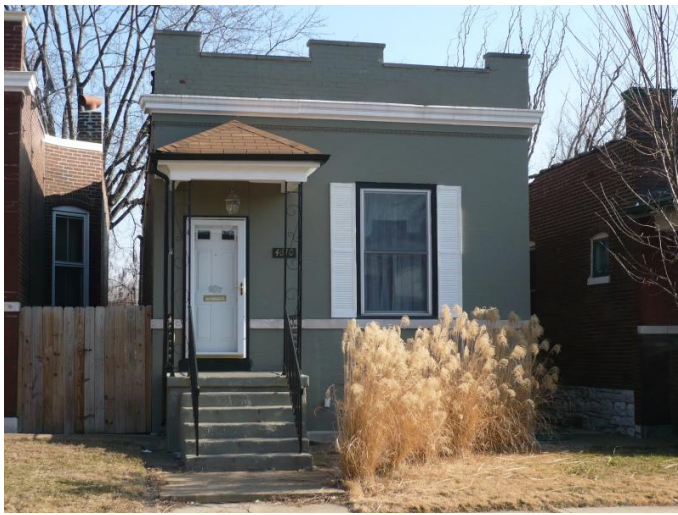
This narrow brick house has a two-bay façade. At the left bay, the front door is a replacement. The porch has a hipped roof (original) on metal supports and a concrete base. At the right bay, the window is a replacement, although the basement windows below it appear original.

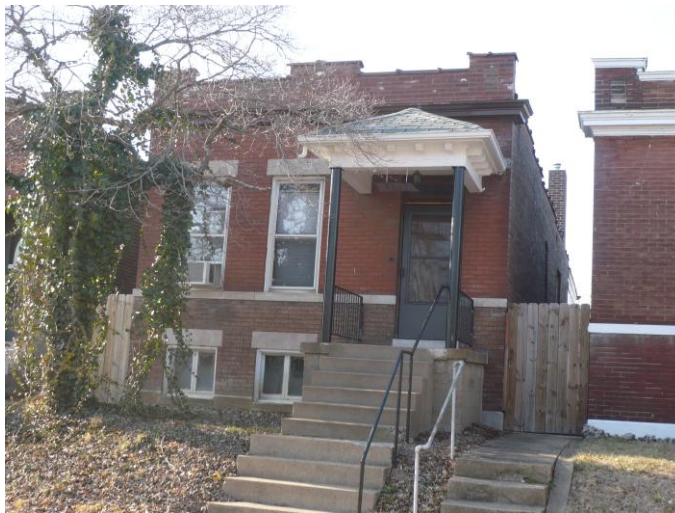
This single story house has a hipped porch at the right bay. Its original structure ha been replaced with an open concrete base and metal post supports. The front door is a replacement. Its transom appears original. To the left, under thick stone lintels, two 1/1 windows are original.

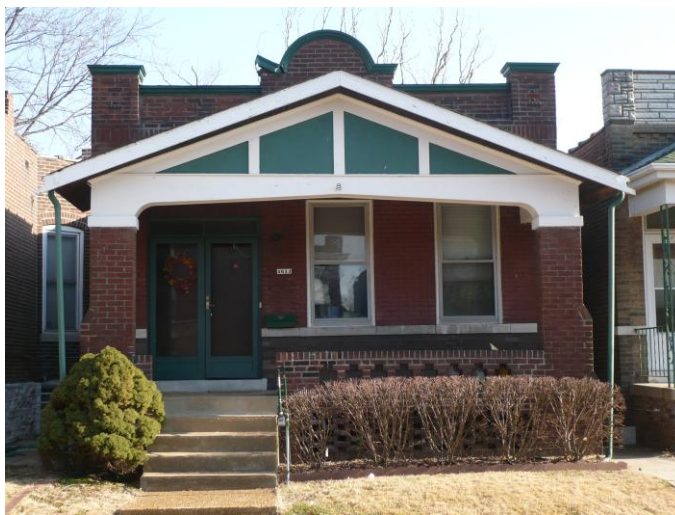
This shaped parapet house has an added full-width brick porch from the Craftsman era. Its roof is gabled, and the gable end retains stickwork and stucco. At the left bay, the original doors have been replaced by a set of double doors. The two windows to the right are original 1/1s. The parapet wall has a center arch and retains metal coping.

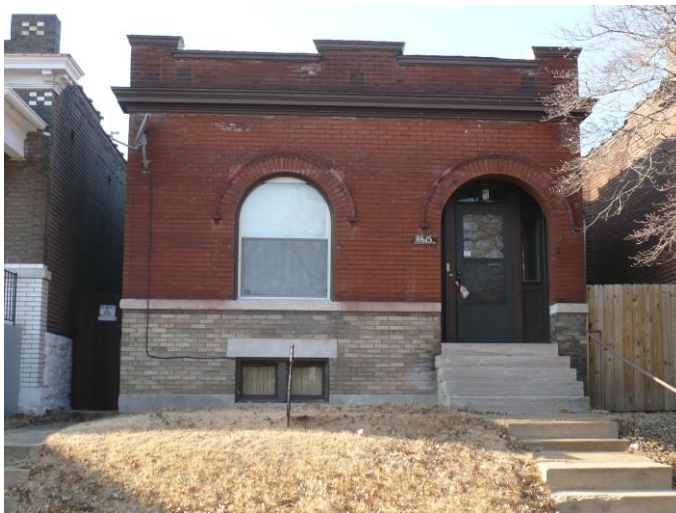
This single story house has a recessed porch with a round-arched entry at the right bay. The front door is a replacement, but sidelights and transom appear original. To the left, a wide round-arched window opening now bears a square-headed window. The parapet wall has metal coping. The basement window has a thick stone lintel.

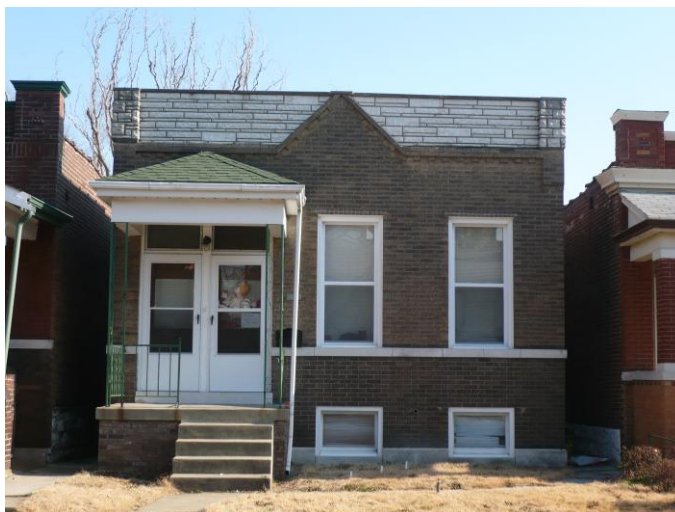
At the left bay of this single story brick house, a hipped porch retains its roof but the base has been replaced with concrete and the piers with trellis-style metal supports. The two front doors are original and retain their transoms. The two windows to the right, and the basement windows below them, are replacements. Most of the parapet wall has been covered with imitation stone veneer, except for a center peak in the brown brick façade. Two building permits in 1909 show this address, so the builder/arch. are uncertain.

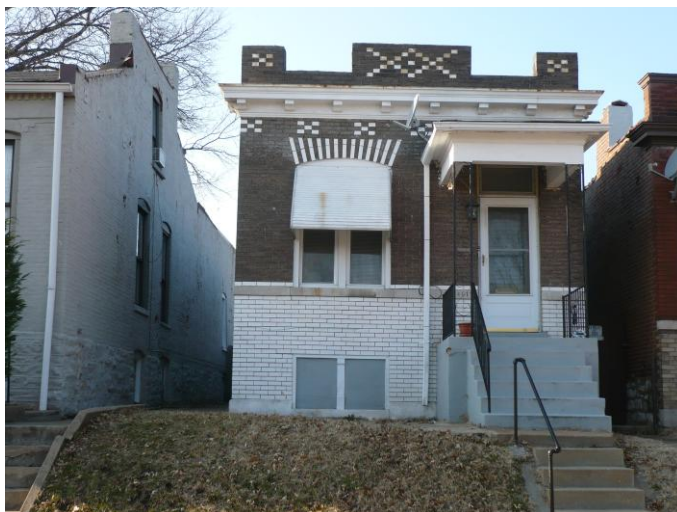
This sweet shotgun house shares many characteristics with other "bakery brick" houses of the larger neighborhood. The porch base at the right bay is now a concrete stoop with metal supports, but the hipped roof appears original. The door and transom are original. At the left bay, the wide segmental arched window opening is filled with replacement window(s) under a fiberglass awning.

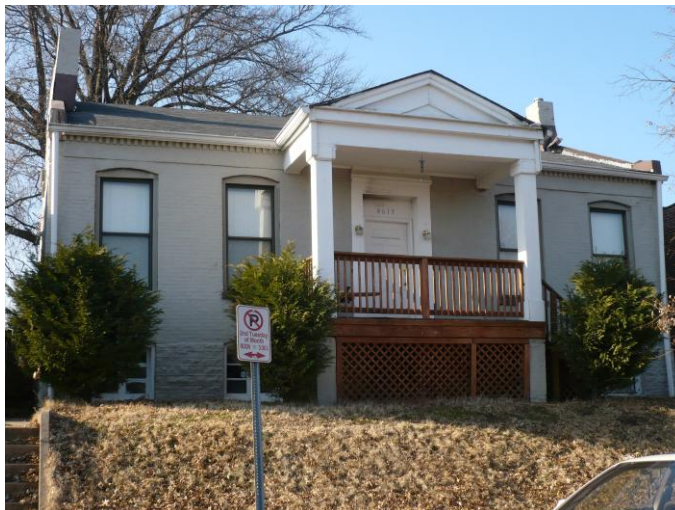
This side gabled brick house does not appear on the Hopkins map, but probably was built shortly afterwards. The façade retains a dentil cornice at the front eaves and Baltimore chimneys at either end. The pedimented front porch is centered at the 5-bay façade. To either side are two segmental arched window openings. The door and windows are replacements. A flounder rear addition (?) is on the 1908 Sanborn map.

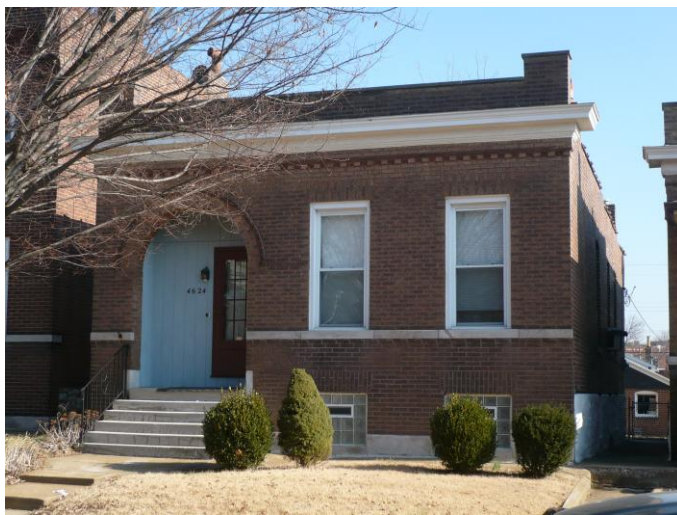
Behind a round-arched opening at the left bay, the original door is intact but the rest of the porch (including the second door/side window) is paneled over. The two windows to the right are replacement windows in square head openings. The coping is not original at the parapet wall, and the two basement windows at the façade are filled in with glass block.

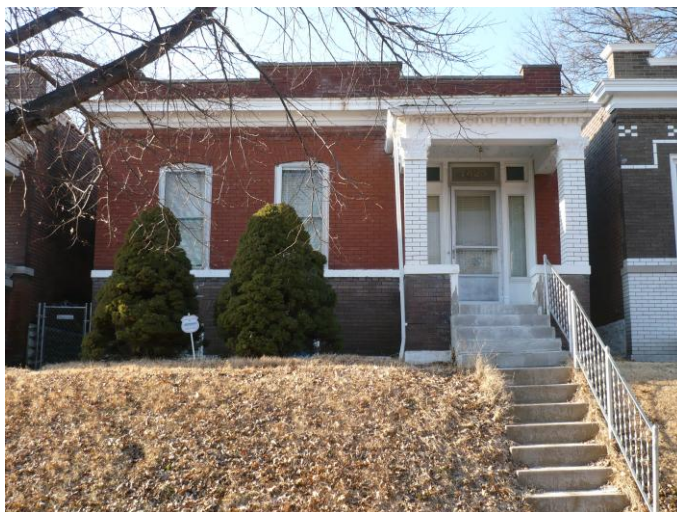
At the right bay of this single story house, the open brick porch has a hipped roof. The front door is original and retains original sidelights/transom. To the left are two original 1/1 windows. Below them, the basement windows are also original. Above a metal cornice, the parapet wall has end blocks and a center step with replacement coping.

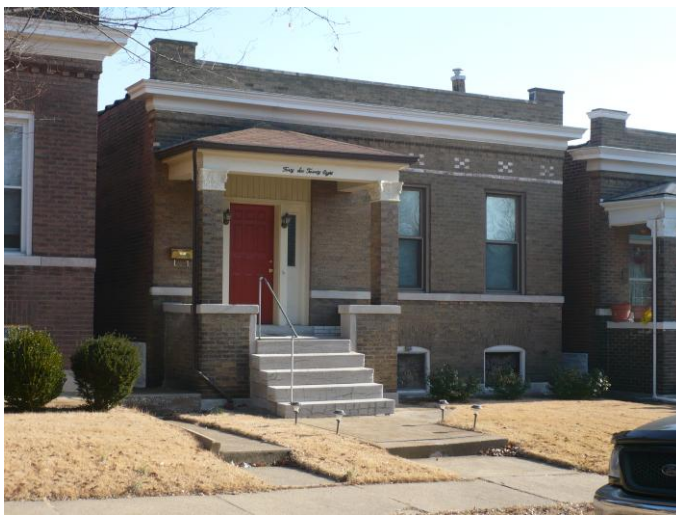
At the left bay of this single story house, a replacement front door is flanked by new sidelight panels. It is presumed that this configuration replaces an original two-door arrangement as in the house next door at 4630. The brick porch has squared Corinthian capitals and a hipped roof. The two windows to the right are replacement windows in square head openings. The coping is not original at the parapet wall. The two basement windows at the façade appear to be original.

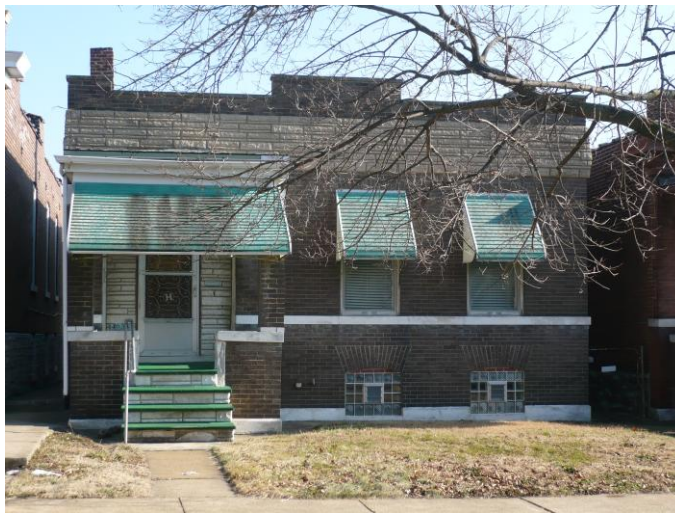
At the left bay of this single story house, a replacement front door is flanked by imitation stone veneer panels. Across the front of the brick porch and at both window to the right are large fiberglass awnings. The two windows to the right are original 1/1s. The coping is not original at the parapet wall. The cornice area is filled in with imitation stone veneer, presumably indicating the removal of a metal cornice.

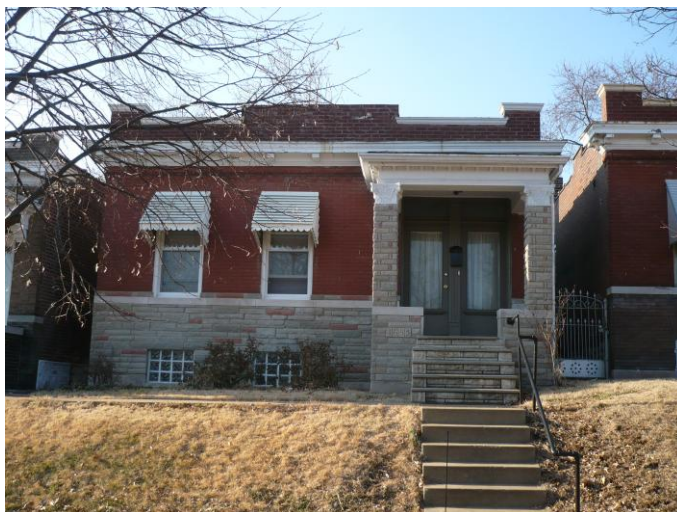
At the right bay of this single story house, the open brick porch has a hipped roof. The two front doors are original and retain original transoms. To the left are two replacement 1/1 windows. Below them, the basement windows are filled in with glass block. Above a metal cornice, the parapet wall has end blocks and a center step with original metal coping (except on the center step). Fiberglass awnings are at the two windows. The façade base and porch piers are clad in imitation stone veneer.

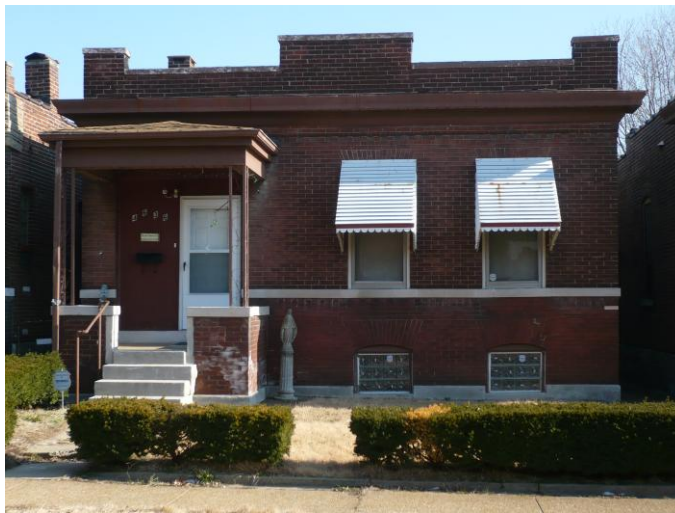
At the left bay of this single story house, a replacement front door at the right is next to a door-sized area of painted paneling or plywood, indicating the removal or covering of the second door. The brick porch base is intact but its piers have been replaced by metal posts supporting the hipped roof.. The two windows to the right are original 1/1s under metal awnings. The coping is not original at the parapet wall. Basement windows at the façade are now filled in with glass block.

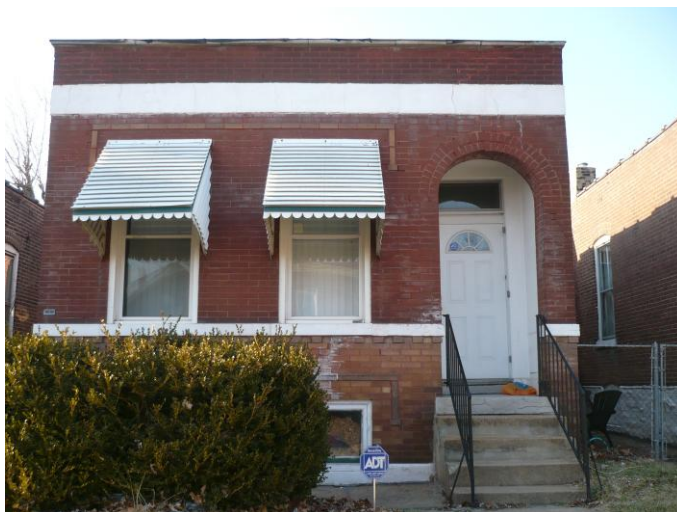
At the right bay of this single story house, a modern transomed front door is recessed behind a round-arched opening. To the left are two replacement 1/1 windows under metal awnings. Below them, the basement windows are original. At both the basement and first story, the two windows share a common raised brick label. Instead of a metal cornice, there is a parged strip, above which the altered parapet wall is now flat. At the rear el, left, a door opening is sided over.

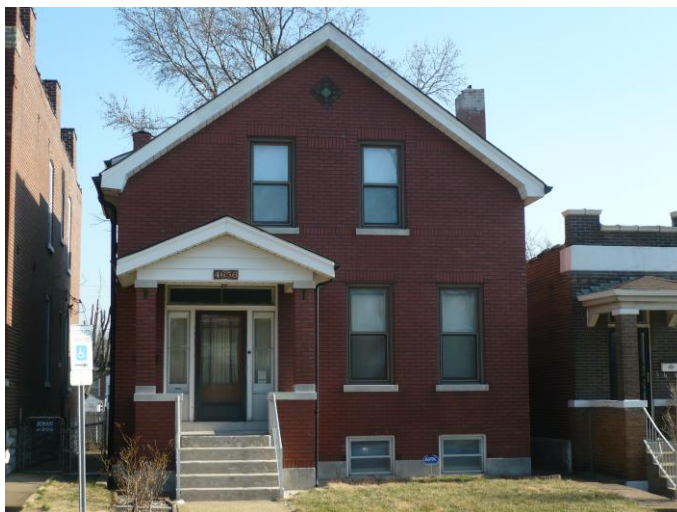
This front gabled house has a red brick façade. At the left bay is a gabled brick porch. The front door is original and is surrounded by sidelights and transom. Both the porch eaves and front gable eaves are aluminum soffitted. To the right of the porch the two windows are replacement 1/1s, as are the two second story windows. There is a small diamond-shaped green and brown tile pattern in the gable end.

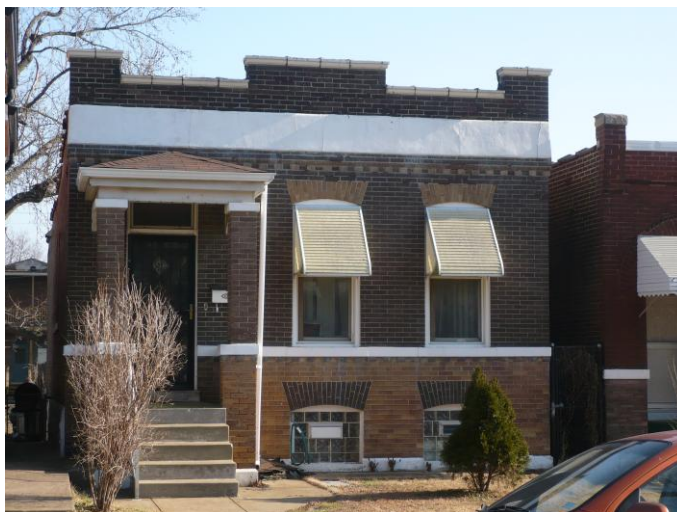
At the left bay of this single story house, the open brick porch has a hipped roof. The front door is a modern replacement but retains its transom. To the right are two replacement windows in segmental arched openings. They are shaded by fiberglass awnings. Below them, the basement windows are filled in with glass block. Above a parged cornice strip, the parapet wall has end blocks and a center step with original terra cotta coping. This is one of quite a few houses in the survey area to have contrasting brick colors at the base and upper façade, and to use the contrasting color brick for the flat-topped segmental arches at both sets of windows.

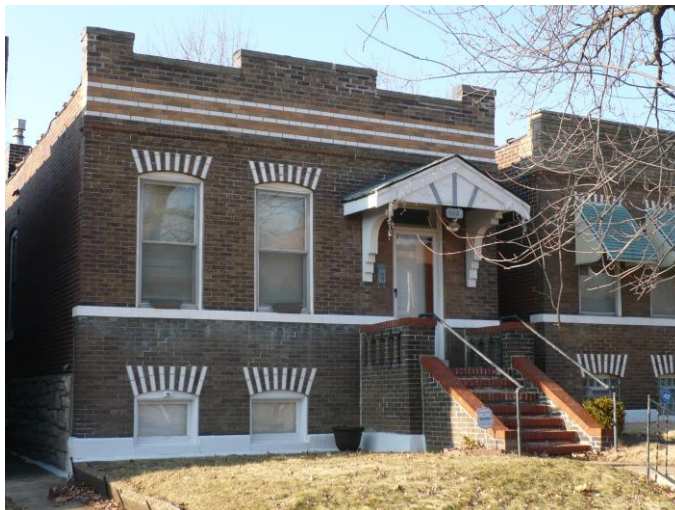
At the right bay of this single story house, the original doors and transom is at a brick-clad stoop. A gabled hood is supported on two brackets. To the left are two original 1/1 windows under fiberglass awnings. Below them, the basement windows are filled with glass block. If there was a cornice, it has been replaced by alternating courses of tan and enameled white brick. The front parapet wall has ends blocks and a center step.

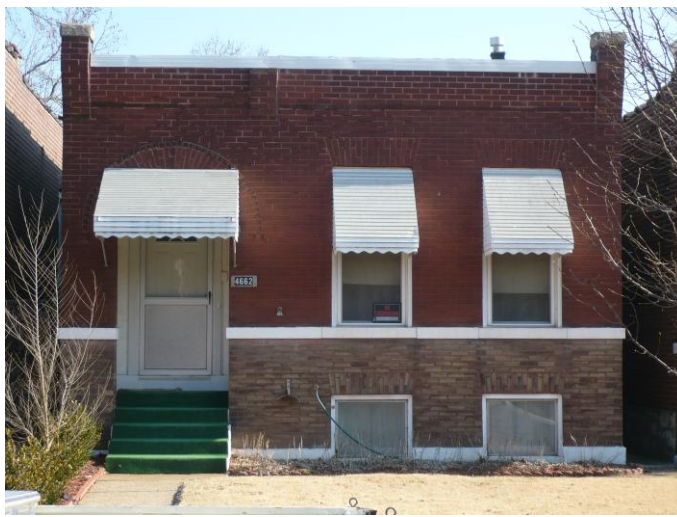
At the left bay of this single story house, the recessed porch has a round-arched opening, its arch outlined in pressed brick. The front door is a modern replacement. To the right are two replacement windows in square head openings with soldier/sailor and gauged brick flared voussoirs. Entry and windows are shaded by metal awnings. Below them, the basement windows are original. At the parapet wall, there were formerly blocks to either side of the entry bay and another at the right side of the façade; there would probably have been a step or peak centered over the two windows, as at the two houses to the south. The wall has been altered, rebuilt to retain only the two end blocks.

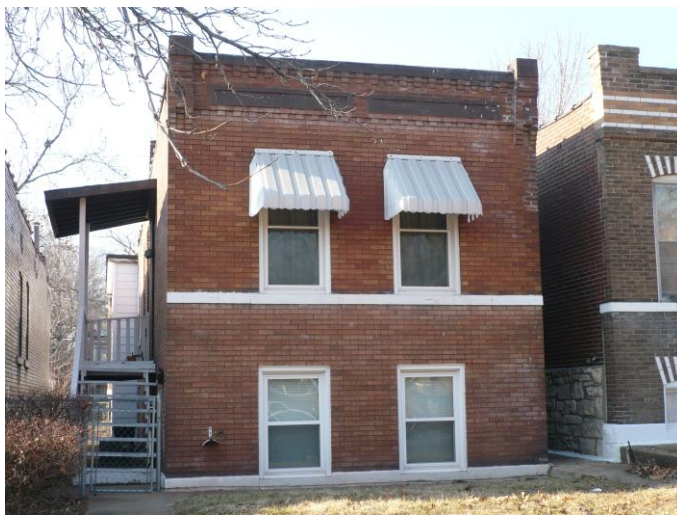
This house has much taller basement windows at the façade than its neighbors, although the overall height is about the same. The two 1/1 basement windows and the two first story windows above them are vinyl replacements. Metal awnings are over the upper windows. Corbelled brick is at the cornice level and the parapet, and supporting the parapet wall's slightly projecting end blocks. There is a newer frame porch at the left (south) side elevation.

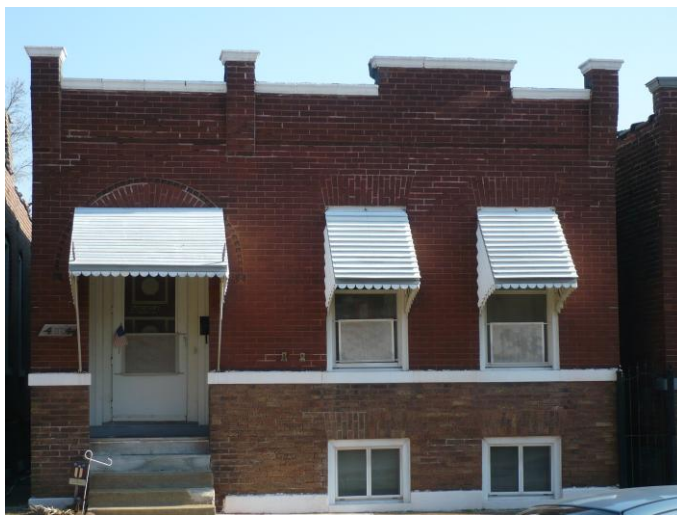
At the left bay of this single story house, the recessed porch has a round-arched opening, its arch outlined in pressed brick. The front door is a 1960s-era replacement with an original transom. To the right are two replacement windows in square head openings with soldier/sailor and gauged brick flared voussoirs. Entry and windows are shaded by metal awnings. Below them, the basement windows are also replacements. At the parapet wall, there are blocks to either side of the entry bay and another at the right side of the façade; a wider step is centered over the two windows. The three blocks project slightly on corbelled brick.

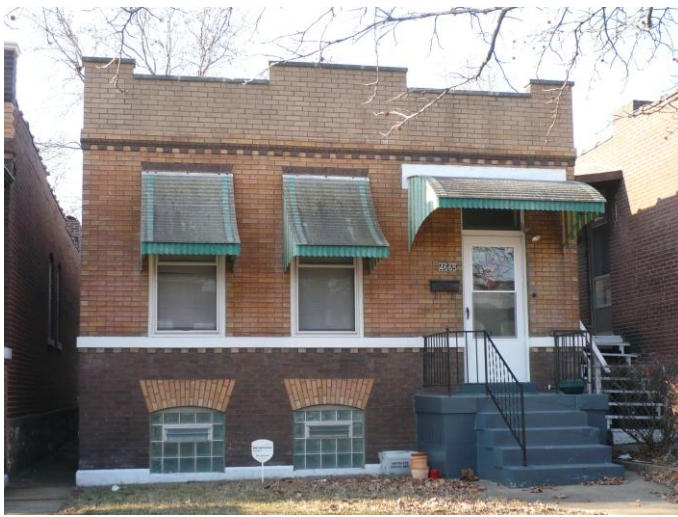
At the right bay of this single story house, the transomed front door (a replacement) is at a concrete stoop. To the left are two original 1/1 windows in segmental arched openings. Below them, the basement windows are now glass block. Fiberglass awnings are at the door and both windows. The rebuilt parapet wall is a light brick, and has a short center step and end blocks. This is one of quite a few houses in the survey area to have contrasting brick colors at the base and upper façade, and to use the contrasting color brick for the flat-topped segmental arches at both sets of windows.

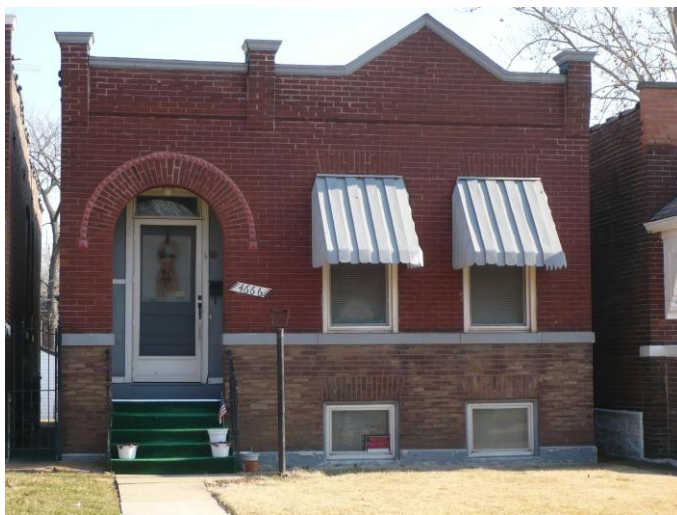
At the left bay of this single story house, the recessed porch has a round-arched opening, its arch outlined in pressed brick. The front door is original and retains its transom. To the right are two replacement windows in square head openings with soldier/sailor and gauged brick flared voussoirs. Both windows are shaded by metal awnings. Below them, the basement windows are original. At the parapet wall, there are blocks to either side of the entry bay and another at the right side of the façade; a wider medium pitched peak in the parapet wall is centered over the two windows. The three blocks project slightly on corbelled brick.

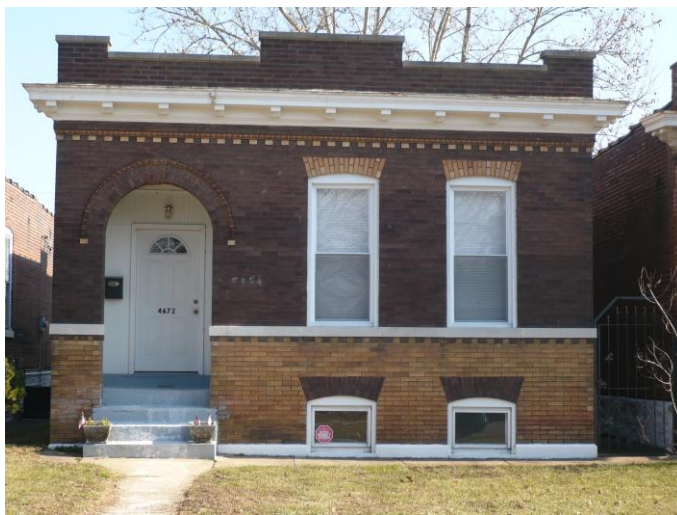
At the left bay of this single story house, a round-arched opening leads to a recessed front porch. The front door is modern, presumably replacing two original doors (as in the sister house just south). To the right are two replacement windows in segmental arched openings. Below them, the basement windows are replacements. Above a metal cornice, the parapet wall has end blocks and a center step. This is one of quite a few houses in the survey area to have contrasting brick colors at the base and upper façade, and to use the contrasting color brick for the flat-topped segmental arches at both sets of windows.
