# Dutchtown South Community Corporation Dutchtown South Neighborhood Survey

Lynn Josse and NiNi Harris  
8/5/2010

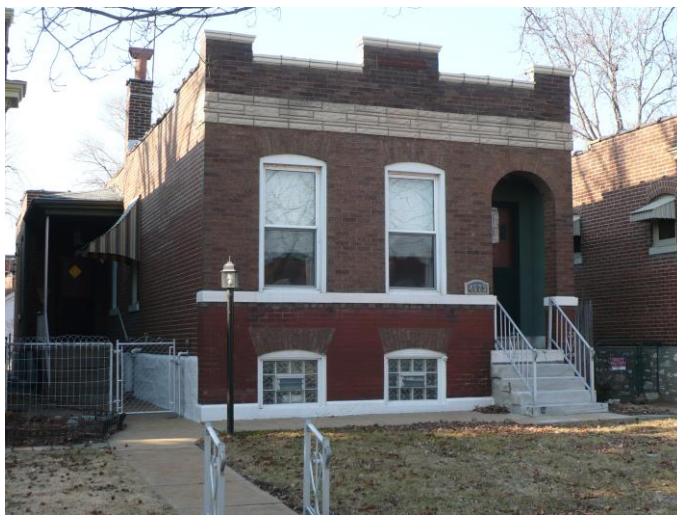
At the right bay of this single story house, a round-arched entry heralds a small recessed porch. The front door is a midcentury replacement and retains a transom light. To the left are two replacement 1/1 vinyl windows. The basement windows below them are filled in with glass block. And have light brown brick forming the segmental arches (with a flat extrados) Over a course of imitation stone veneer, the parapet wall retains terra cotta coping.

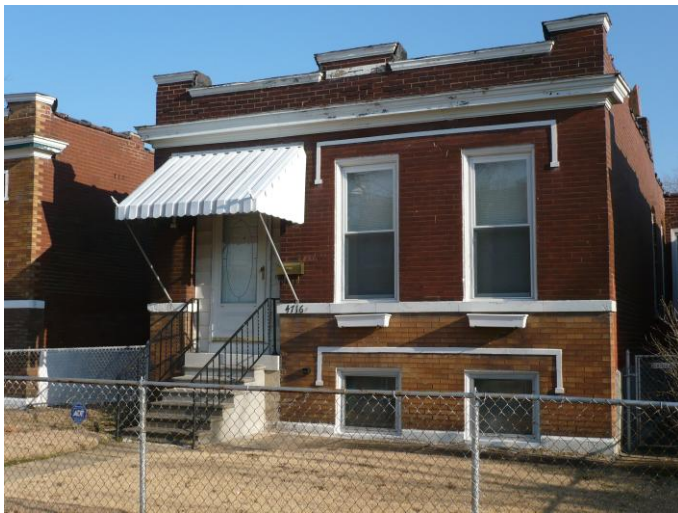
At a round-arched opening at the left bay is a replacement front door and siding (fronting what was a recessed porch). To the right are two new white 1/1 windows. Above a metal cornice, the parapet wall has end blocks and a center step with metal coping. Molded brick, now painted white, forms common labels at both the first story and basement windows. A metal awning covers the entry.

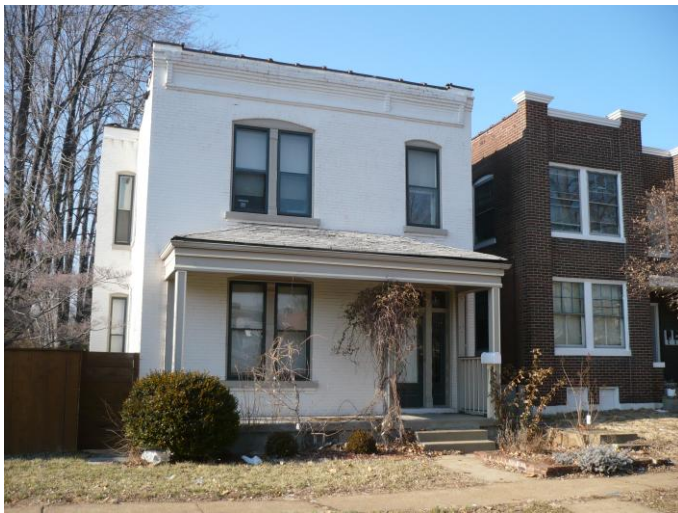
This two-story brick house has a full-width frame hipped porch. The porch roof and entablature appear historic (probably those shown on the 1908 Sanborn map), but the railing and posts (compatible wood) are contemporary, as is the concrete base. The front door is at the right bay. Door, sidelights, transoms and millwork are original. The two window openings at the left bay are for paired windows under a common segmental arch; the second story of the right bay has a single segmental arched opening. The windows themselves are replacements. The house has a simple corbelled cornice; vestigial end blocks are at either end. Parapet coping is clay tile.

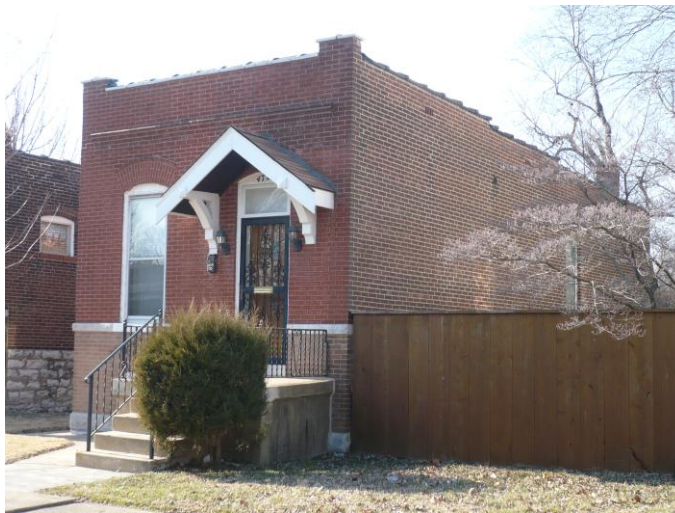
This narrow house has a two bay façade. The front door is at the right bay. The door itself is not original, but its transom is. It appears that the original porch was replaced during the historic period by a stoop (now a concrete replacement) and an open gable hood on two brackets. The window, left, is an original 1/1. Over a corbelled brick cornice, the front parapet wall retains terra cotta coping. The date is from a building division certificate.

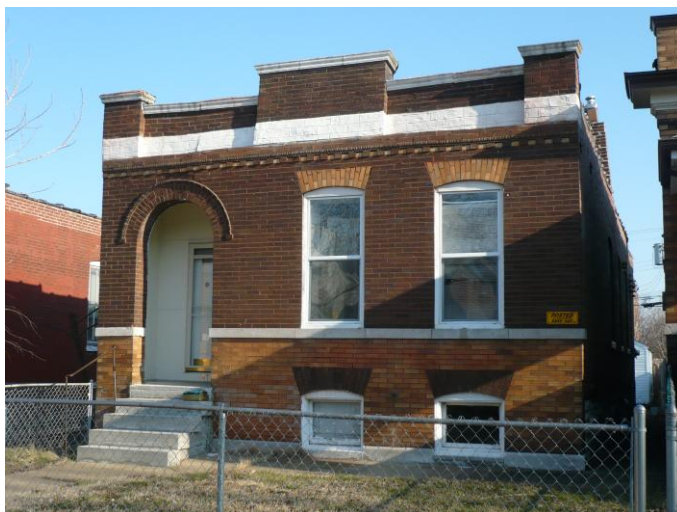
Behind a round-arched opening at the left bay, the replacement door is in a recessed entry. To the right are two white replacement 1/1 windows. Above a parged strip, the parapet wall has end blocks and a center step and metal coping. Voussoirs at the first story are in the brick color of the façade's base and vice-versa.

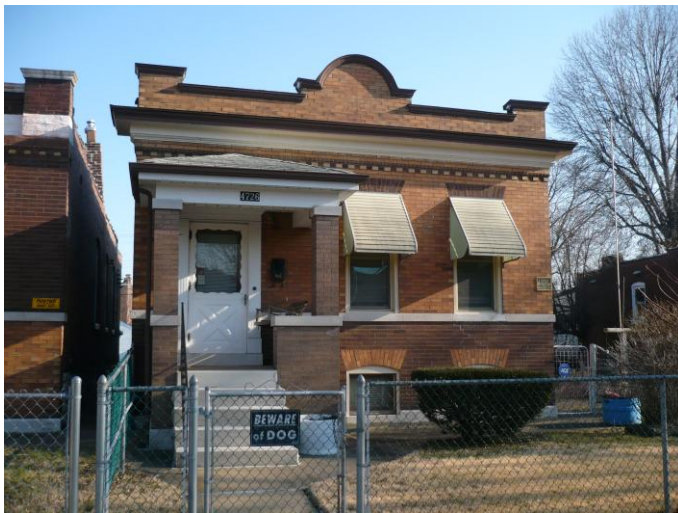
At the left bay, a hipped porch appears to be a historic addition; the front door (a replacement) is flush with the front wall but it appears that there was originally a recessed entry as at #4724. To the right are two replacement 1/1 windows partially concealed by fiberglass awnings. Above a metal cornice, the parapet wall has end blocks and a rounded center step, and metal coping. Voussoirs at the first story are in the brick color of the façade's base and vice-versa.

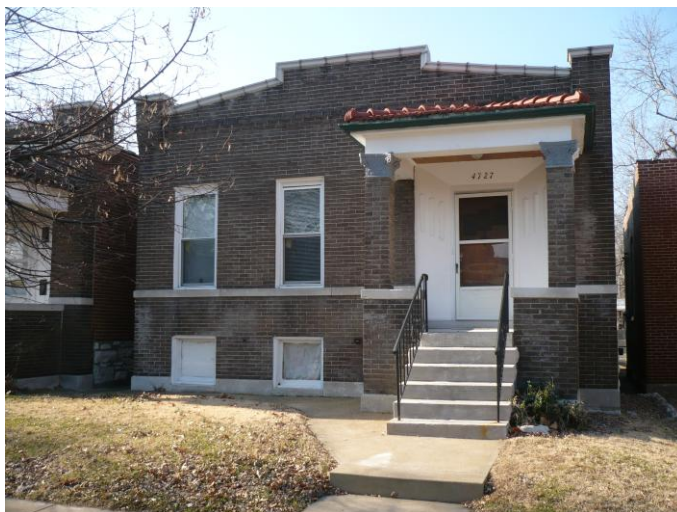
This single story house has a brick porch at the right bay. The porch has a hipped roof which retains its red French tile surface, and squared Corinthian capitals top the piers. The front door is a replacement (perhaps now historic) and the sidelights and transom have been paneled over. The two windows to the left are also replacements. The slightly peaked parapet wall has a center step and white terra cotta coping.

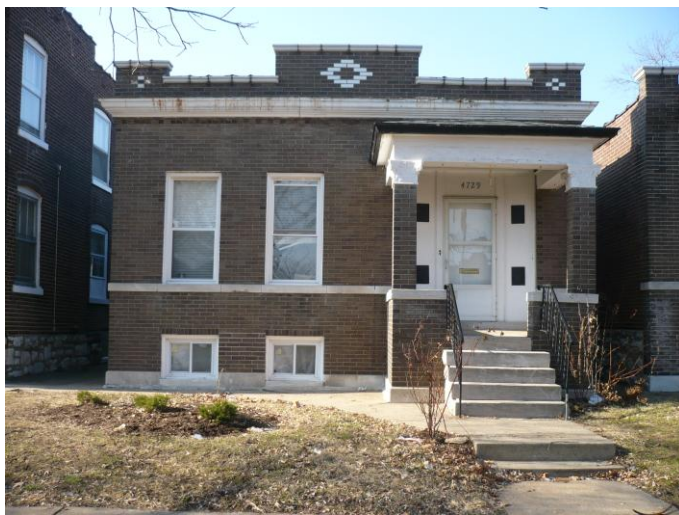
This single story house has a brick porch at the right bay. The porch has a hipped roof and squared Corinthian capitals. The front door is a replacement and the sidelights and transom have been paneled over. The two windows to the left are also replacements. The parapet wall has white terra cotta coping.

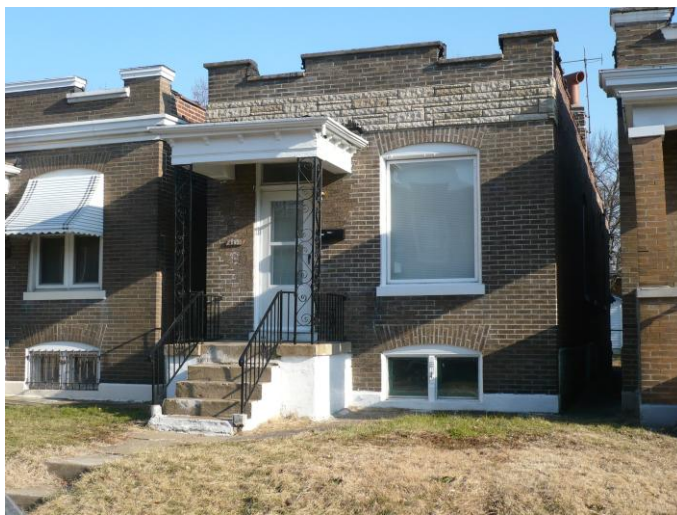
This narrow house is one of six in a row built from the same plans. At the left bay, the concrete porch base has metal uprights supporting what appears to be a historic-era hipped roof. The front door is a transomed replacement. At the right bay, a non-historic picture window is fit into a wide segmental arched opening. Above an imitation stone veneer strip (indicating the removal of a cornice), the front parapet wall has end blocks and a center step.

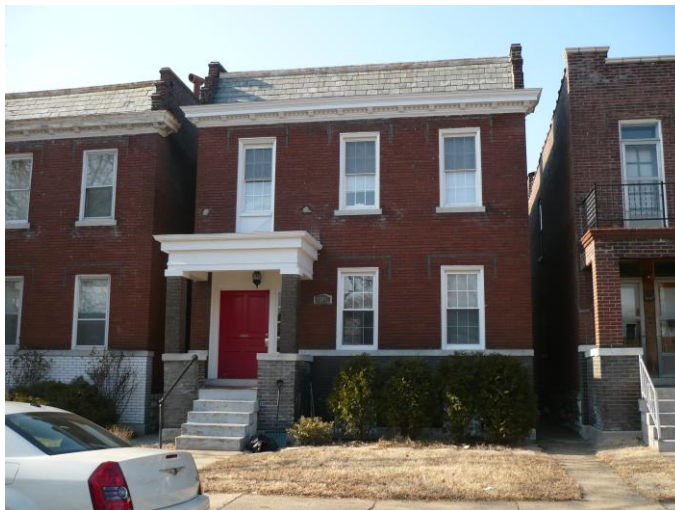
This former two family has been converted to single family use by replacing the two front doors with a single wide door in a new painted wood surround. The flat roof of the porch was a second story balcony, but the railing is removed and the door opening has been converted to a window. At the right bays, similar replacement windows are at both stories. Brown brick labels are over the windows and balcony door. Instead of a shaped parapet, this building has an intact false front roof, imitating a short mansard. The front roof retains six courses of slate tile and is held between two side parapet walls.

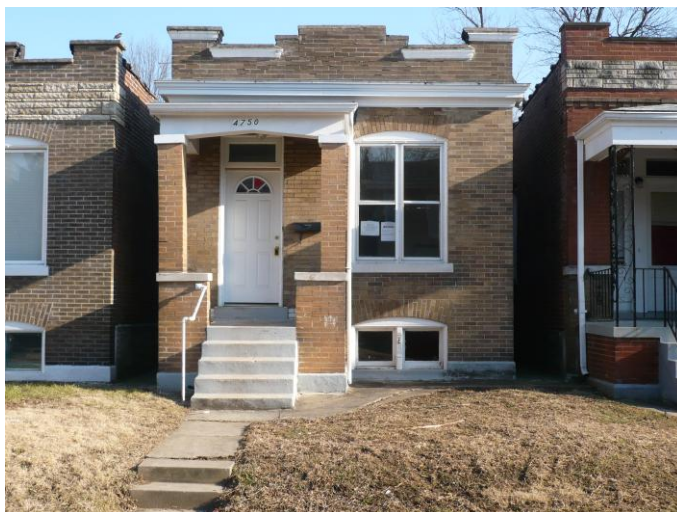
This narrow house is one of six in a row built from the same plans. This house has a brick porch at the left bay. The front door is a transomed replacement. At the right bay, a new pair of vinyl windows is fit into a wide segmental arched opening. Above a metal cornice, the front parapet wall has end blocks and a double stepped center.

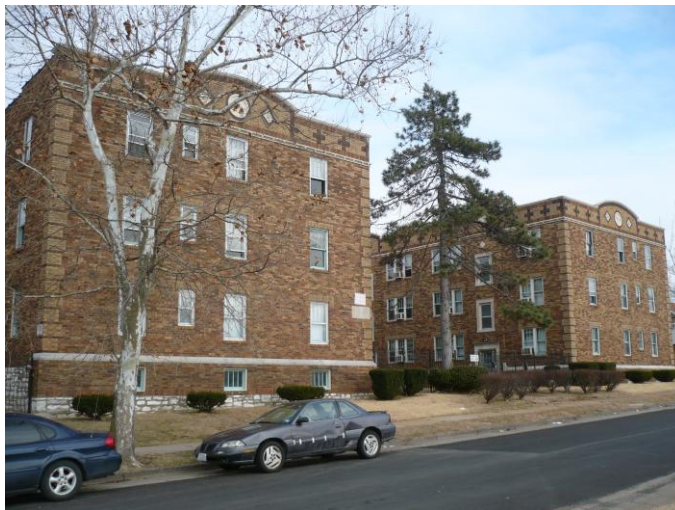
This is one of two large buff brick courtyard apartment buildings constructed in 1929. primary elevations face into the courtyard. Each of the seven entrances features a single 15-light door next to a 5-pane sidelight, and each entrance bay has two windows between stories above it, indicating walk-up stairwells. Each entrance bay is crowned by a rounded section of parapet wall with a terra cotta roundel; the entire parapet is set off by a terra cotta cornice and has brown and orange brick patterns below terra cotta coping. At the central south elevation facing into the courtyard, one entrance bay is centered, and another is separated from it on either side by triple 3/1 windows at each story. Facing into the courtyard on either side, two entrance bays on each side are separated by two sets of 3/1s; two sets are at the north end of these elevations and one at the south end. Brick quoins mark the edges of the front elevations at either side of the courtyard. At each story there are three wood sash 4/1 windows and a single small 1/1.

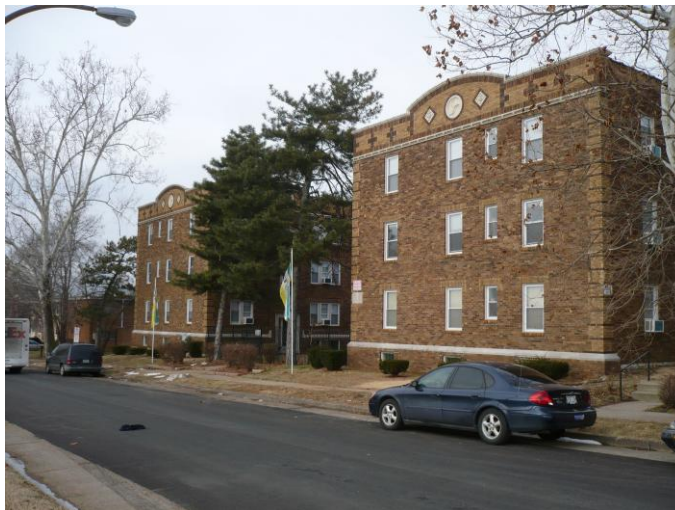
This is one of two large buff brick courtyard apartment buildings constructed in 1929. primary elevations face into the courtyard. Each of the seven entrances features a single 15-light door next to a 5-pane sidelight, and each entrance bay has two windows between stories above it, indicating walk-up stairwells. Each entrance bay is crowned by a rounded section of parapet wall with a terra cotta roundel; the entire parapet is set off by a terra cotta cornice and has brown and orange brick patterns below terra cotta coping. At the central south elevation facing into the courtyard, one entrance bay is centered, and another is separated from it on either side by triple 1/1 replacement windows at each story. Facing into the courtyard on either side, two entrance bays on each side are separated by two sets of triple replacement windows; two sets are at the north end of these elevations and one at the south end. Brick quoins mark the edges of the front elevations at either side of the courtyard. At each story there are three replacement 1/1 windows and a single small 1/1.

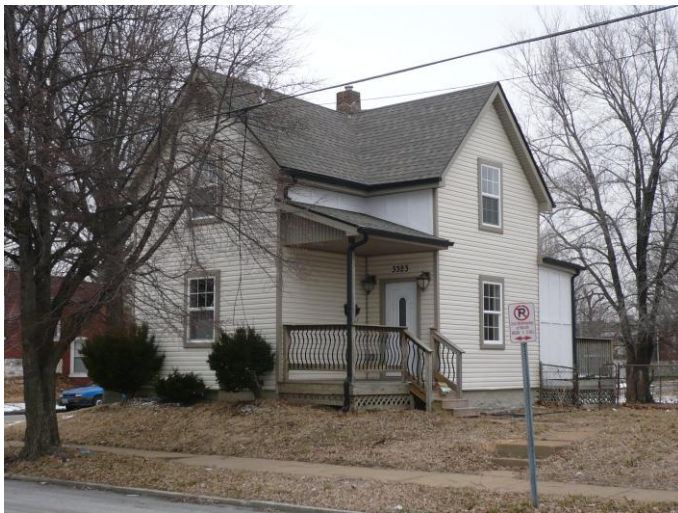
(Frame addition, 1917 to owner Bertha Beckerle.) This Gabled el house is unfortunately noncontributing at present due to the combination of non-original siding and replacement doors and windows. Window openings retain a sense of the original trim.

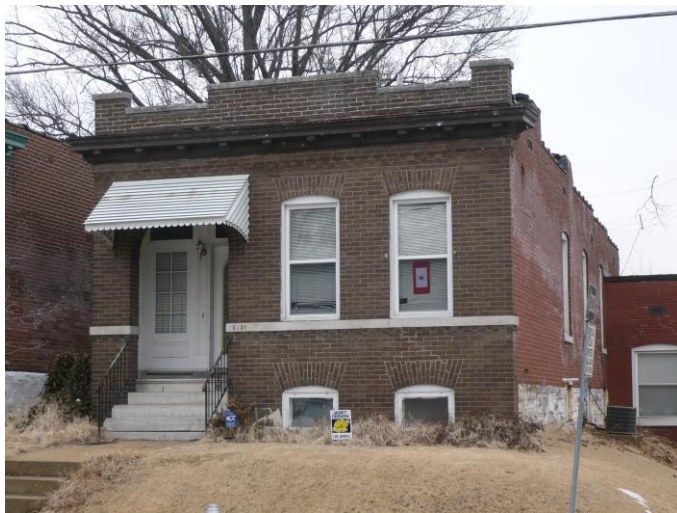
Behind the building on Delor, a red brick shop has a replacement door. The storefront is partially filled in,

At a recessed porch at the left bay, the replacement door is next to an original door-shaped side panel, both under original transoms. To the right are two replacement 1/1 windows. Above a metal cornice, the parapet wall has end blocks and a center step. There is a metal awning over the entrance.

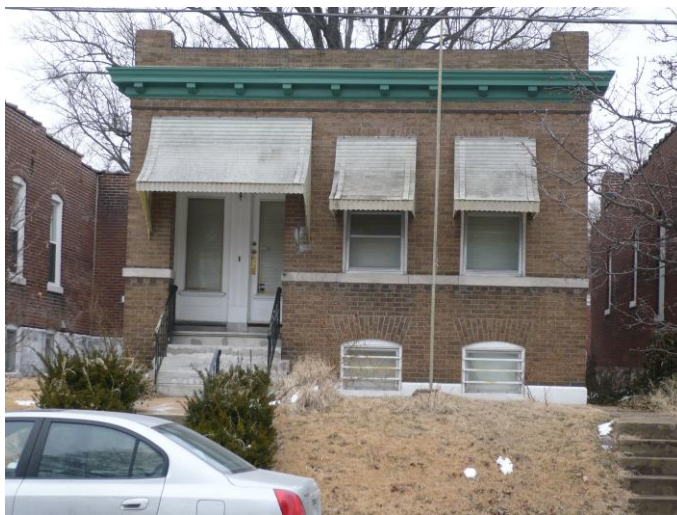
At a recessed porch at the left bay, the replacement door is next to an original door-shaped side panel, both under original transoms. To the right are two original 1/1 windows. Above a metal cornice, the parapet wall has end blocks. Fiberglass awnings are over the entrance and both windows.

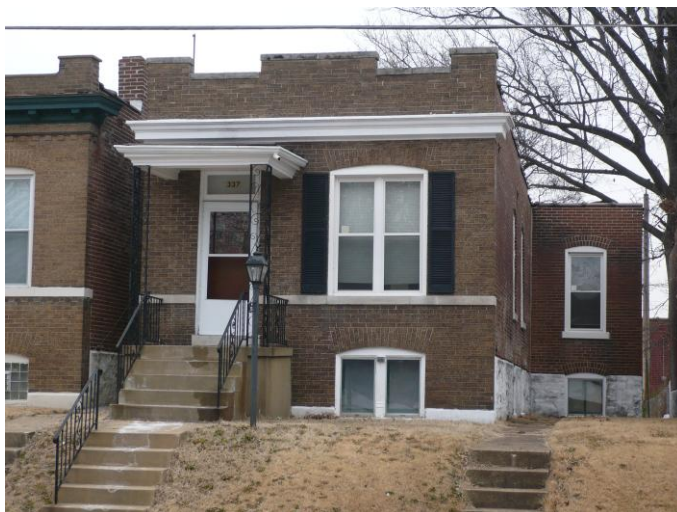
At the left bay, this house has a replacement door at a hipped porch with non-original concrete base and metal supports. The transom is original, as is the pair of basement windows at the right bay. Above the basement windows, the wide segmental arched window opening is filled with a pair of vinyl replacements. There is a rear el at the right side.

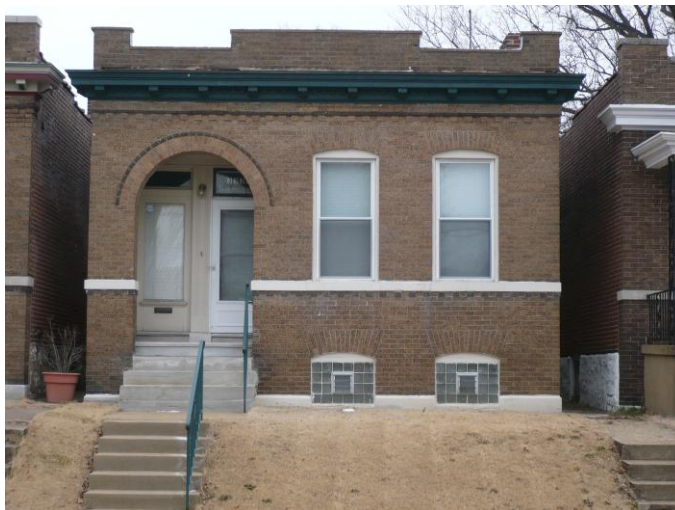
At a recessed porch at the left bay, the original door is next to an original door-shaped side window, both under original transoms. To the right are two replacement 1/1 windows. Above a metal cornice, the parapet wall has end blocks and a center step.

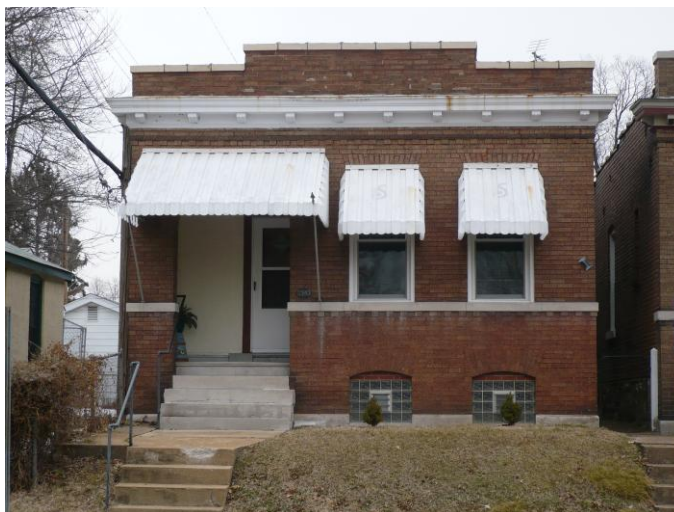
At a recessed porch at the left bay, a replacement porch is next to a covered-over side window. To the right are two replacement 1/1 windows. Above a metal cornice, the parapet wall has end a center step and white terra cotta coping. Metal awnings are over all three facade openings.

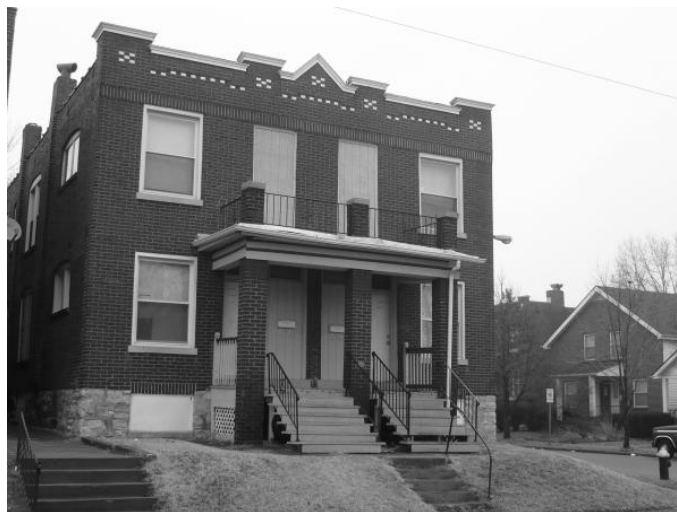
This is one of four four-family buildings in a row constructed from the same permit. All four have symmetrical brick facades and stone foundations. The porch is centered across two bays, with a pair of doors at both. The brick and frame porch's roof was designed as a second story balcony. The inner two doors at the first story and the balcony doors are sided over here, and the outer doors that remain are modern replacements. The 1/1 windows at the outer bays are also replacements. Soldier brick forms a full course over the second story doors and windows. The front parapet wall has a center peak. Its coping is metal.

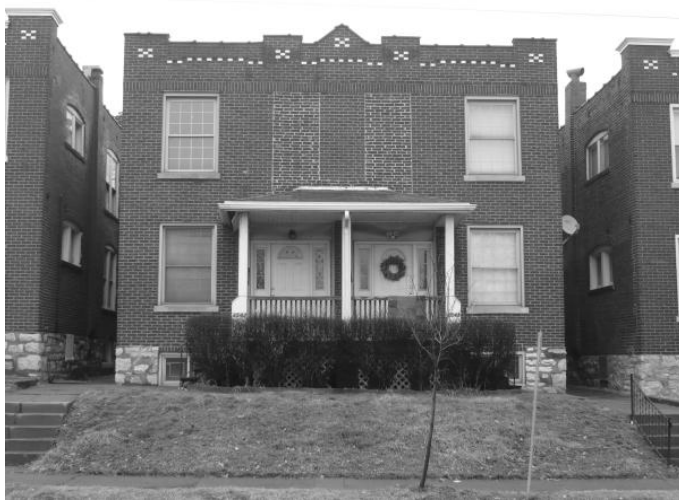
This is one of four four-family buildings in a row constructed from the same permit. All four have symmetrical brick facades and stone foundations. The porch is centered across two bays. The original brick and frame porch's roof was designed as a second story balcony, but the new frame porch has a hipped roof. The four front doors are replaced with two doors with sidelights, and the balcony doors are bricked in. The 1/1 windows at the outer bays are also replacements. Over the second story openings is a full soldier course. The front parapet wall has a center peak. Its metal coping has been replaced by clay tile.

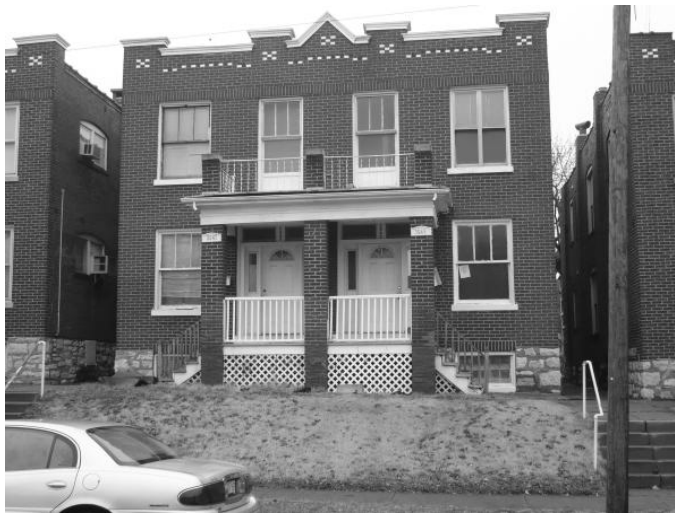
This is one of four four-family buildings in a row constructed from the same permit. All four have symmetrical brick facades and stone foundations. The porch is centered across two bays. The brick and frame porch's roof was designed as a second story balcony. The four original front doors have been replaced by two doors and their sidelights, although the original paired transoms are intact. The balcony's 3/1 Jefferson windows are also intact. The windows at the outer bays are original 3/1s.. Soldier brick forms a full course over the second story doors and windows. The front parapet wall has a center peak and metal coping.

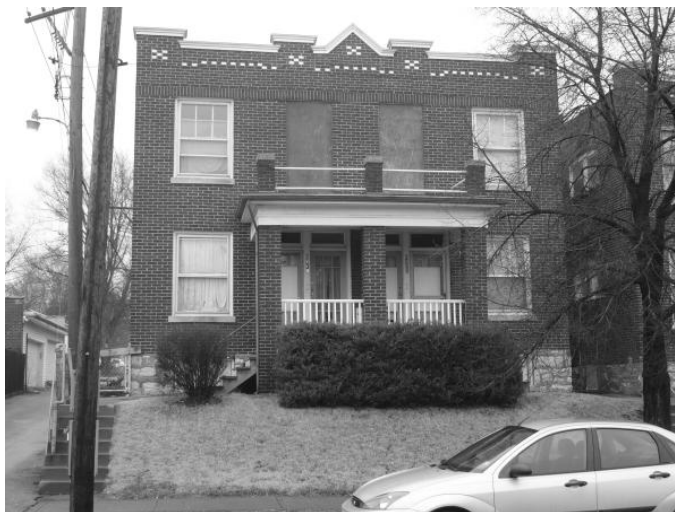
This is one of four four-family buildings in a row constructed from the same permit. All four have symmetrical brick facades and stone foundations. The porch is centered across two bays, with a pair of original transomed doors at both. The brick porch's roof was designed as a second story balcony. The balcony doors are now boarded up.. The wide 3/1 windows at the outer bays are original. Soldier brick forms a full course over the second story doors and windows. The front parapet wall has a center peak and metal coping.

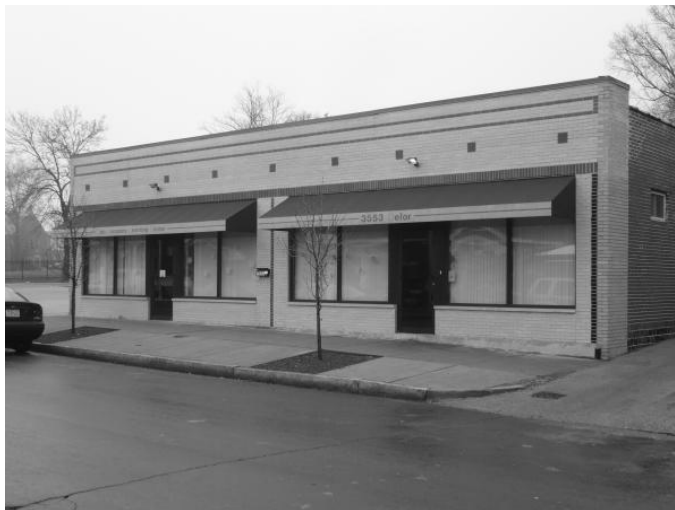
This single story commercial building has a buff brick façade and red brick sides. The storefront windows are replacements, symmetrically arranged around two new doors. Façade is divided into two storefronts, but the 1951 Sanborn map indicates that there were once three. Enameled green brick forms a rowlock course over the storefronts, 3-brick squares spaced across the façade, and a full-width panel just under the flat front parapet wall. The original building permit says it's for an alteration (1938), but this parcel is unbuilt on the 1938 Sanborn; Assessor's database confirms 1938 date of construction.

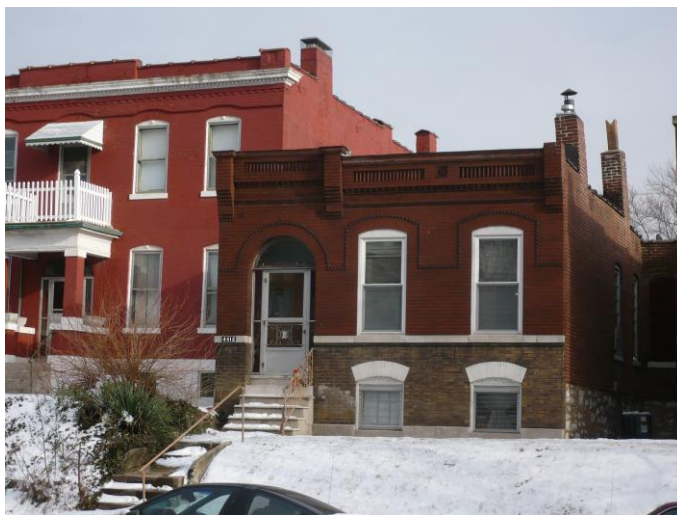
At the left bay of the façade, steps lead to a round-arched opening, now filled in with a storm door and windows. Behind it is the original door and side window. This entry bay is emphasized by corbelled blocks which define a section of the parapet wall which is higher than the rest. At the right bays the two segmental arched window openings now bear replacement vinyl 1/1 windows. A limestone sill course under the windows separates the light brown brick base from the red brick upper wall. The voussoirs at the two segmental arched basement window openings draw attention to themselves with white paint. There is a pressed brick label course over the entry and windows; the cornice features corbelled and pressed brick below metal coping.

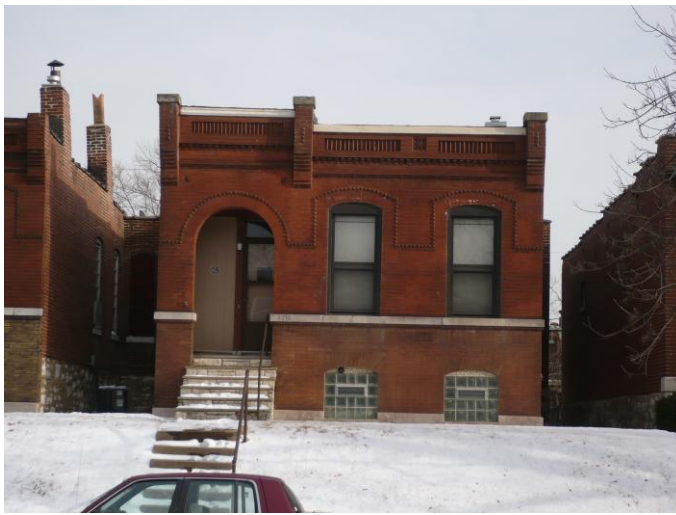
At the left bay of the façade, steps lead to a round-arched opening. Behind it is a replacement door (which retains its transom window), its original side window now covered. This entry bay is emphasized by corbelled blocks defining a section of the parapet wall which is higher than the rest. At the right bays the two segmental arched window openings now bear replacement 1/1 windows. A limestone sill course under the windows separates the base from the upper wall. There is a pressed brick label course over the entry and windows; the cornice features corbelled and pressed brick.

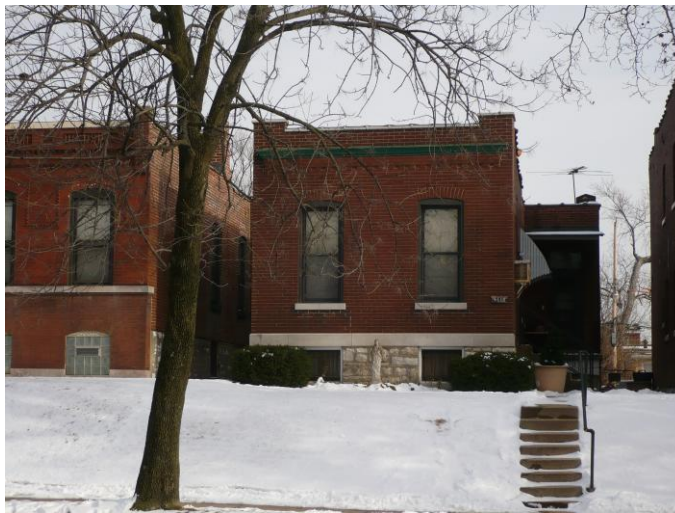
This L-shaped brick house is a fairly common type in the neighborhood. Its façade presents two replacement windows in segmental arched openings to the street. The front door is at the right elevation, and a second door faces the street in a short rear el at the right elevation. A thick limestone water table separates the limestone foundation from the front wall. A brick and metal cornice is below the front parapet wall, which has end blocks and clay tile coping.

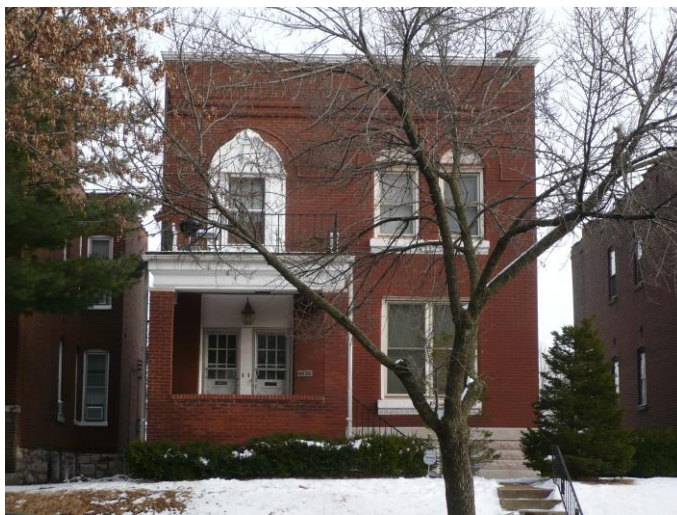
This two-story brick building has a lat-roofed porch at the left bay. Its roof is a balcony for the second story. The two front doors are under a covered transom area. At the balcony, a round arch in the brick contains an unusually curved wooden broken arched pediment over the balcony door. At the right bay's first story there is a wide window opening with a splayed soldier lintel which doesn't stop until the sill of the windows above. These two (replacement) 1/1s are set below stucco arched tympanums. Above a slight brick cornice, the parapet wall has metal coping.

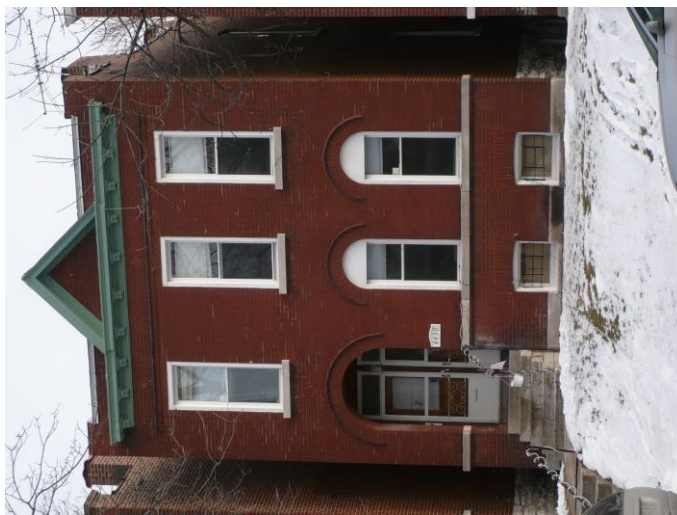
Behind a round-arched opening at the left bay, two original front doors are topped by transoms in a paneled entry. The two round-arched windows at the first story are replacements (the tympanum filled in with plywood or other covering), as are the three square headed windows at the second story. The metal cornice has a center peak which forms the center peak of the parapet wall.

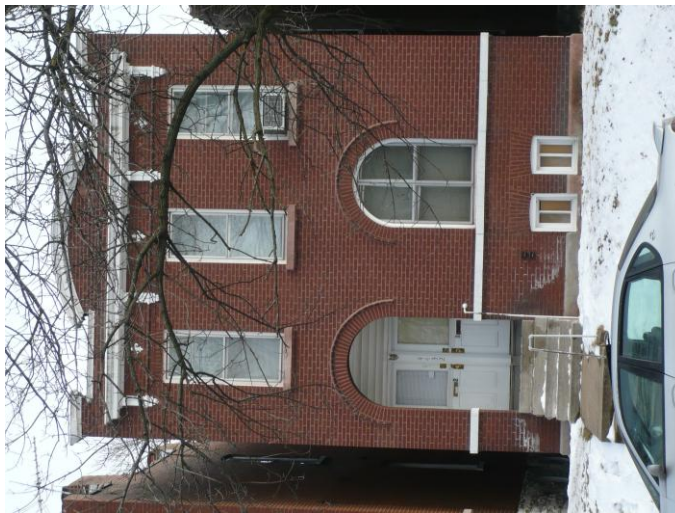
Behind a round-arched opening at the left bay, two original front doors are topped by a vinyl-sided area instead of transom windows. The wide round-arched window at the first story is a replacement, as are the three square headed windows at the second story. The metal cornice has four intrinsic brackets between which three metal fleur de lis dot the cornice. The parapet wall has metal coping, with end blocks and a rounded center step.

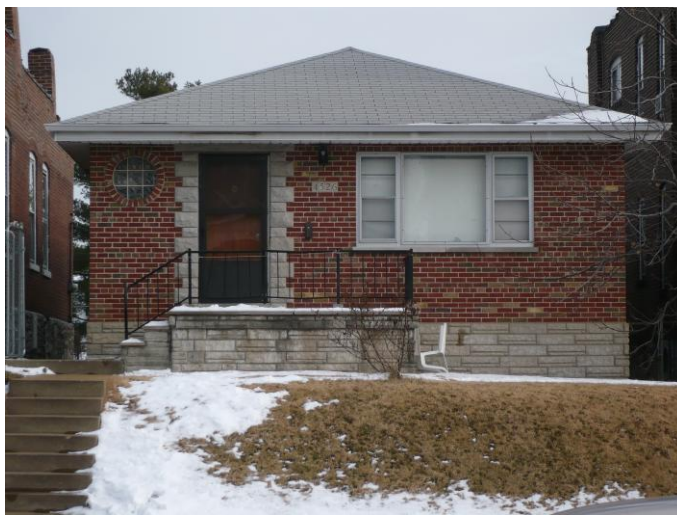
This simple Modern-era house has a brick exterior and imitation stone veneer at the foundation. At the left bay, an original round glass block window is to the left of the original front door. The 3-part window at the right is wide and horizontal, with 2/2 (horizontal pane) sash windows to either side of a square center fixed pane.

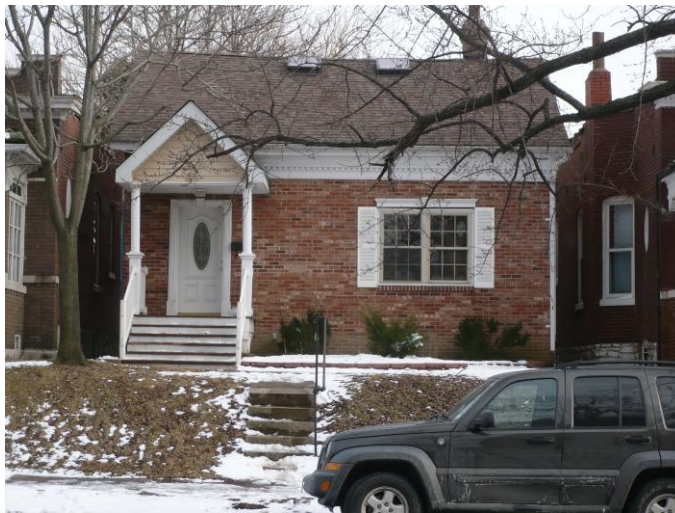
Although there is no real evidence of this at the façade, this appears to be a historic frame house which the city assessor's database dates to the 1860s, and which appears on Hopkins' Atlas and the 1909 Sanborn map. In 1951 the house still had a frame foundation.

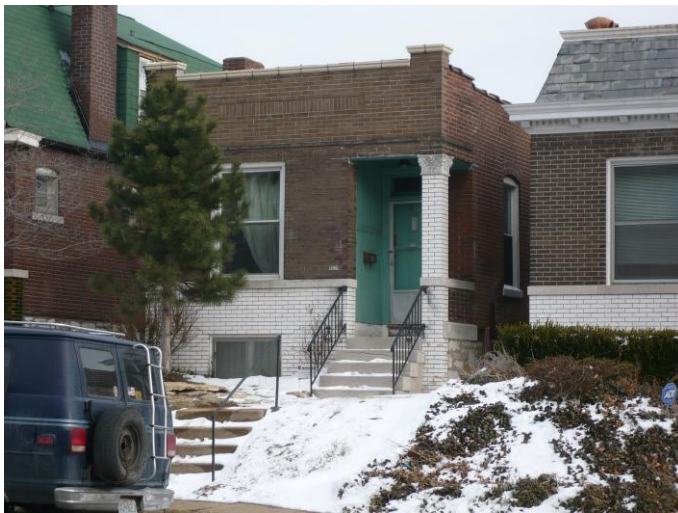
This narrow house has a corner porch, right, with a squared corner column of white enameled brick and Corinthian capital. Door and window (at left) are replacements. Terra cotta coping.

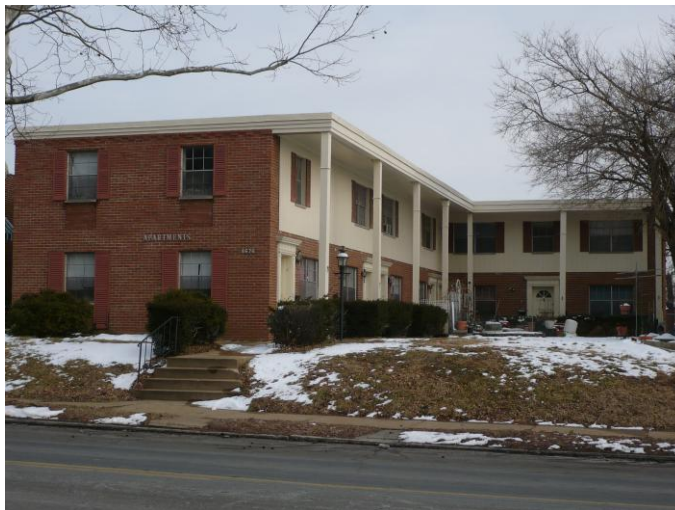
This apartment building has an L-shaped plan. The end facing the street is brick; the walls with the doors has a brick first story and sided second story. Replacement doors.

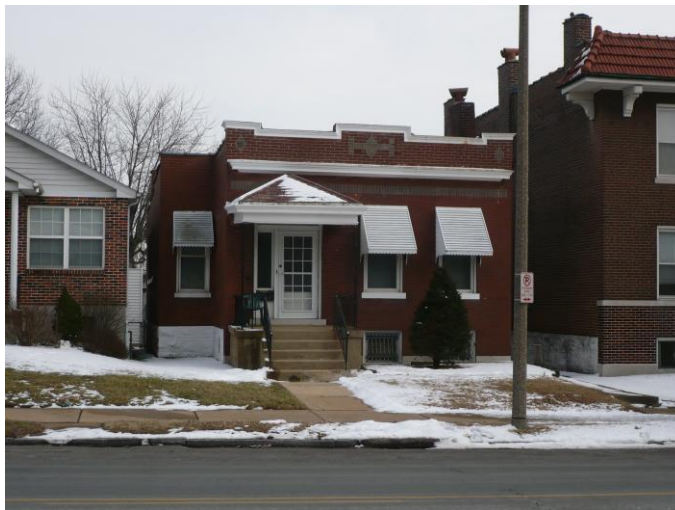
This single story house has a red brick facade with a brown brick soldier course below the metal cornice and a brown brick pattern at the center of the parapet. The front door and side window, left, appear original. The porch has a hipped roof; the concrete base and metal uprights are replacements. The two windows, right, are replacements under metal awnings. There is a rear el at the left elevation.

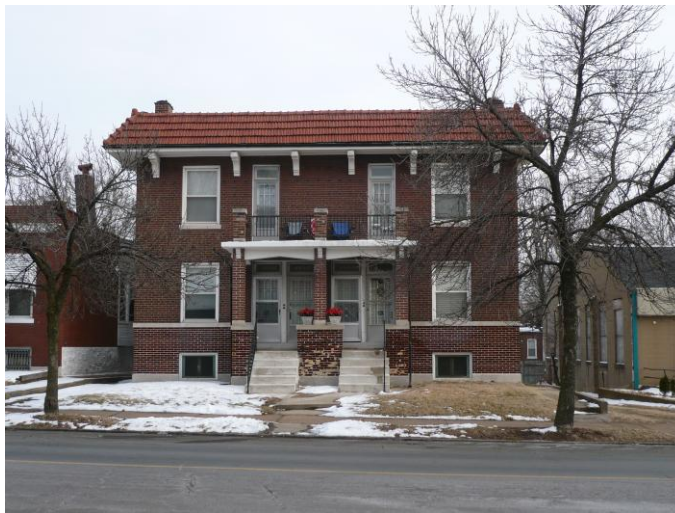
This four-family building has a symmetrical façade. Its base is enameled reddish-brown brick below a first story limestone sill course. Above this, the façade is red brick; at every 6th course the stretchers alternate with burnt headers. The brick porch is at the center two bays, topped by a second story balcony. The four front doors and the two balcony doors are 15-pane multilights with transoms. At the outer bays, the 1/1 façade windows are replacements. Instead of a front parapet wall, an applied roof is supported by 6 brackets and has 4 courses of French tile roofing.

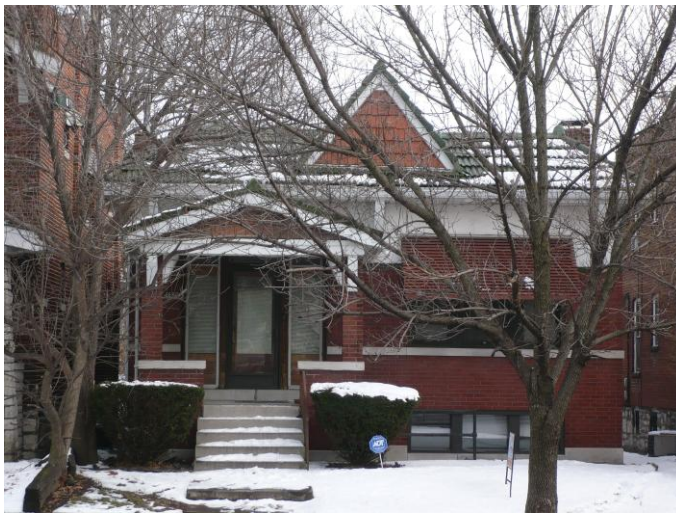
This two-bay house has a brick porch at the left bay; its roof is gabled. The front door is original, unpainted, and retains sidelights, transoms and original millwork. Above a lintel course the façade is stuccoed. A hipped pent roof with green ceramic tile and a tall center peak is supported on three brackets between end blocks. The windows, right, are replacements under an awning.

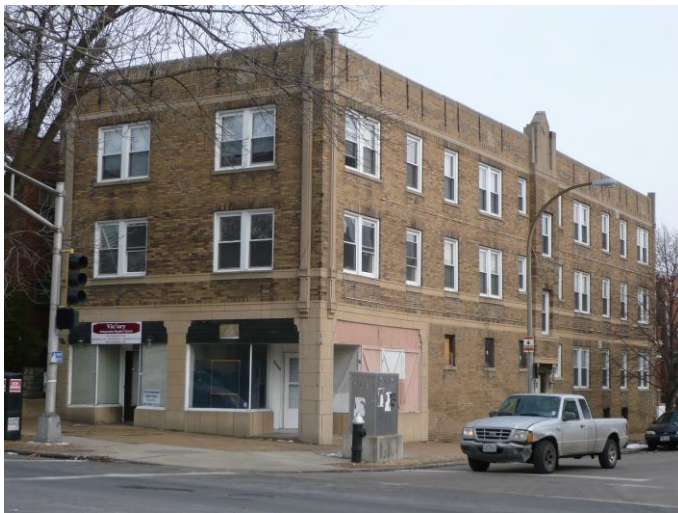
Two storefront face Grand; the longer elevation along the side street has a slightly projecting center bay with 5 bays to either side at the second and third story. Cast concrete frames the storefront openings. The right storefront is accessed by a corner entry behind a concrete column. Store window transoms are sided over with composition shingle. Apartment windows at the rear of the first floor and across the entire second and third floors are replacements. Art Deco detailing includes panels at the parapet.

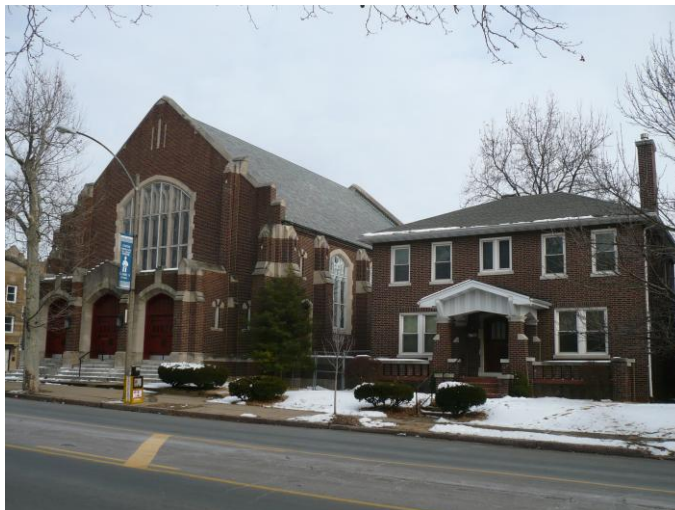
This parcel is presumably aka 4708 S. Grand, the parsonage that was historically connected with the house of worship next door. The original Tudor arched door is at the center bay in a stone surround. The front porch runs the full width of the house, but only its center bay is roofed (gabled roof). Other than a pair of leaded glass casements over the entrance, façade windows are replacements.

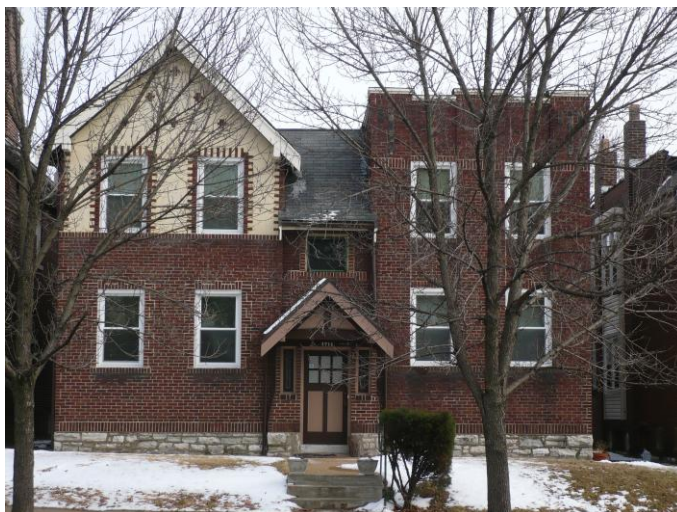
This is one of ten Romantic Revival-influenced walkup apartment buildings permitted together in 1923. They are notable for the variety designed into their asymmetric facades, no two of which are alike. Sanborn maps indicate they are tile construction with brick facing. This façade is primarily red brick. The front door in the center bay's projecting, gabled first story appears original, with a small narrow window to either side. The left bay is gabled, with a stucco face above the second story sill level. The right bay has a parapet wall. All 8 of the outer bay windows are replacements. The roof (behind the façade's various roof forms) is flat.

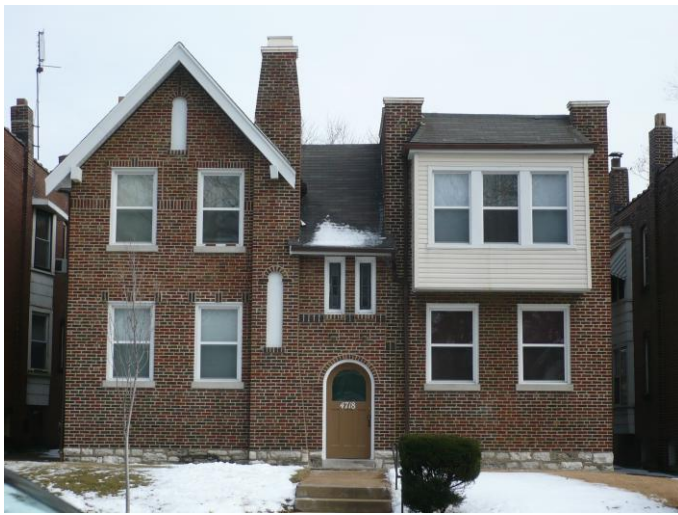
This four-family walkup building is one of several in a row built to the same approximate plan but with different façade treatments. The round-arched original door is centered. At both outer bays of the 1st story and the left bay of the 2nd are two replacement windows. At the right bay of the second story is a projecting vinyl-sided shed-roofed bay with 3 replacement windows. Over the left bay is a front gabled roof.

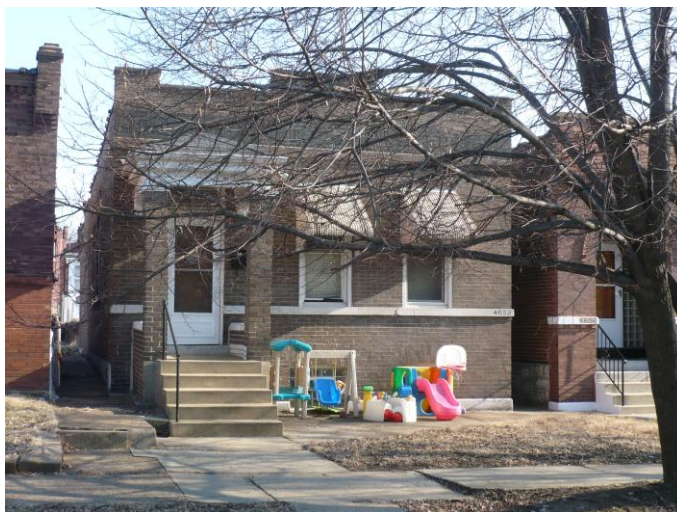
This single story brick house has a brick porch at the left bay. Full-height brick piers support a hipped roof. The front door is a replacement, but its transom appears original. To the right are two replacement windows under metal awnings. Instead of a cornice below the parapet wall, there is a panel of dark brick with a basketweave course across the center.

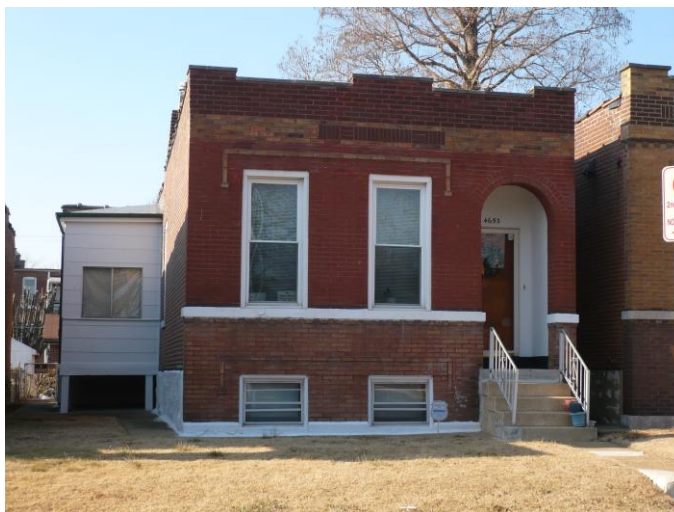
This single story brick house has a round-arched entry to the recessed porch at the right bay. The door and surrounding surfaces at the recessed porch are non-historic. To the left, two square-head window openings bear replacement windows. The basement windows below them are original. Windows at both stories have common raised brick labels. Below the parapet wall is a strip of tan brick with a red brick center panel.

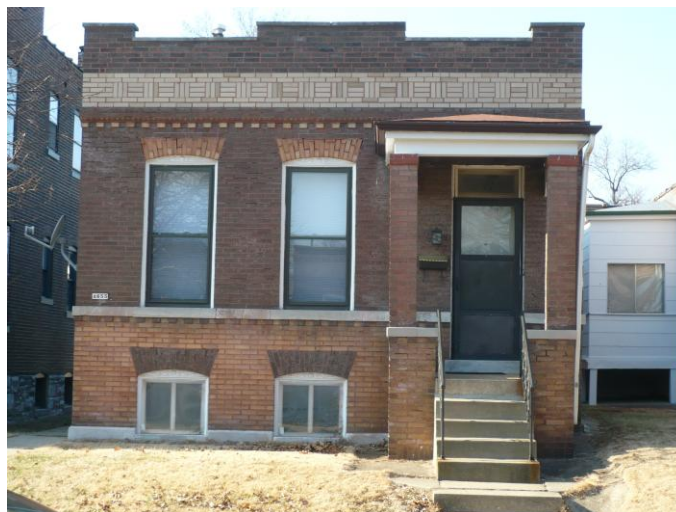
At the right bay of this single story house, the open brick porch has a hipped roof. The front door is a replacement but the transom is original. To the left are two original 1/1 windows in segmental arched openings. Below them, the basement windows are also original. Above seven courses of blond brick (the middle three arranged in a basketweave), the parapet wall has end blocks and a center step. This is one of quite a few houses in the survey area to have contrasting brick colors at the base and upper façade, and to use the contrasting color brick for the flat-topped segmental arches at both sets of windows.

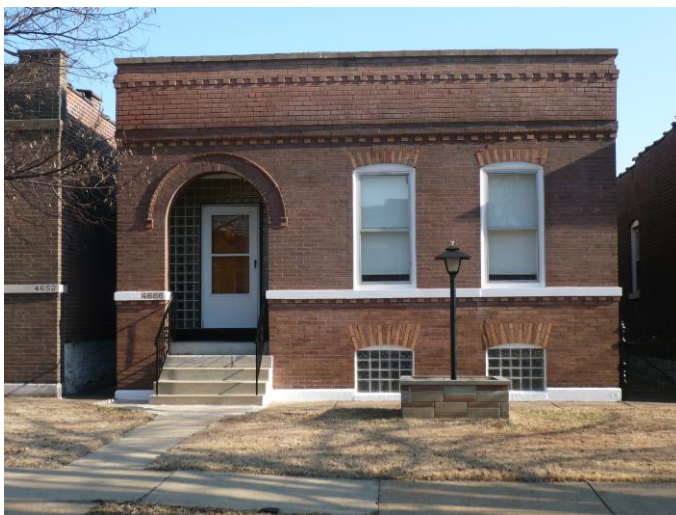
This single story brick house has a recessed porch at the left bay. Behind a round-arched opening, there is a single replacement front door. What would have been a second door opening and transom are now filled in with glass block. To the right are two original 1/1 windows in segmental arched openings. Below them, the basement windows are filled in with glass block. The parapet wall has been rebuilt and is now flat.

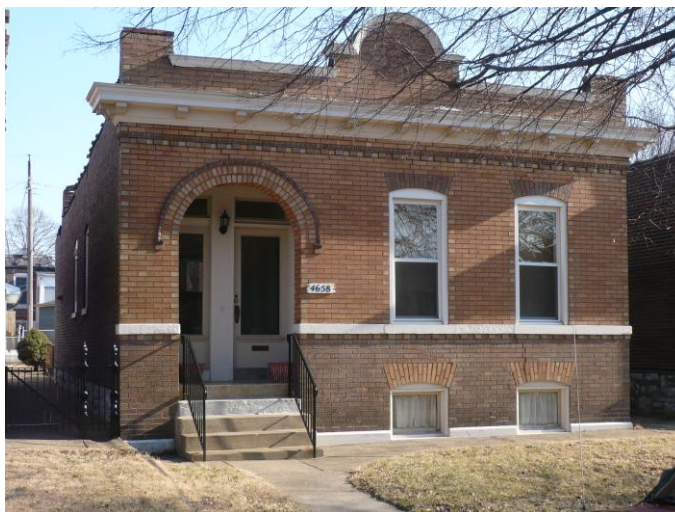
This single story brick house has a recessed porch at the left bay. Behind a round-arched opening, the two doors are original and have original transoms. To the right are two replacement 1/1 windows in segmental arched openings. Below them, the basement windows are original. This is one of quite a few houses in the survey area to have contrasting brick colors at the base and upper façade, and to use the contrasting color brick for the flat-topped segmental arches at both sets of windows. The parapet wall has a round center step.

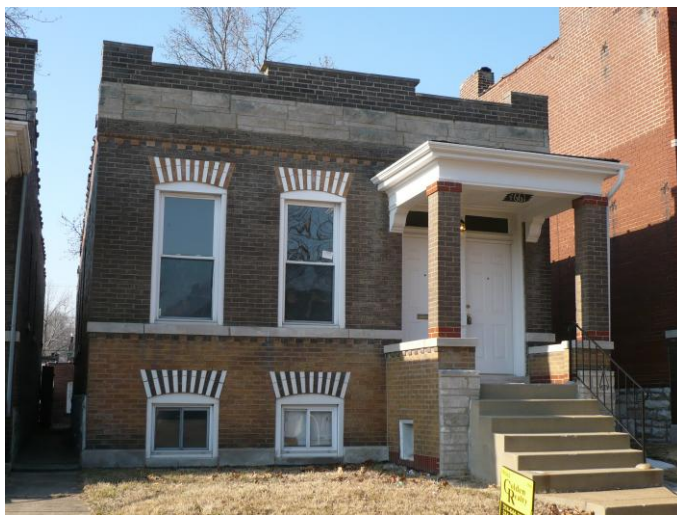
At the right bay of this single story house, two replacement doors are at a brick porch with a hipped roof. The two transoms appear original. To the left are two replacement windows. Below them, the basement windows are also replacements. If there was a cornice, it has been replaced by a strip of imitation stone veneer (also used at the front of the lower section of the porch). Flat-topped segmental arches at both stories' windows feature alternating white brick voussoirs and brick that contrasts with the façade (and matches the other half of the façade).
