# Dutchtown South Community Corporation Dutchtown South Neighborhood Survey

Lynn Josse and NiNi Harris  
8/5/2010

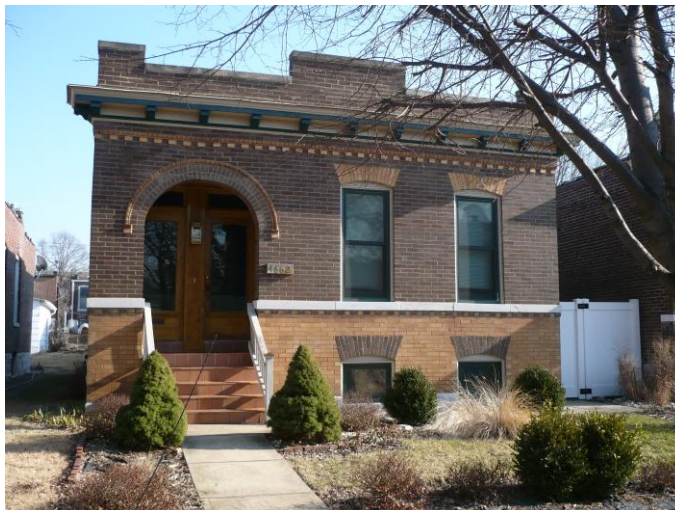
This single story brick house has a recessed porch at the left bay. Behind a round-arched opening, the two doors are original and have original transoms. To the right are two replacement 1/1 windows in segmental arched openings. Below them, the basement windows are also replacements. This is one of quite a few houses in the survey area to have contrasting brick colors at the base and upper façade, and to use the contrasting color brick for the flat-topped segmental arches at both sets of windows.

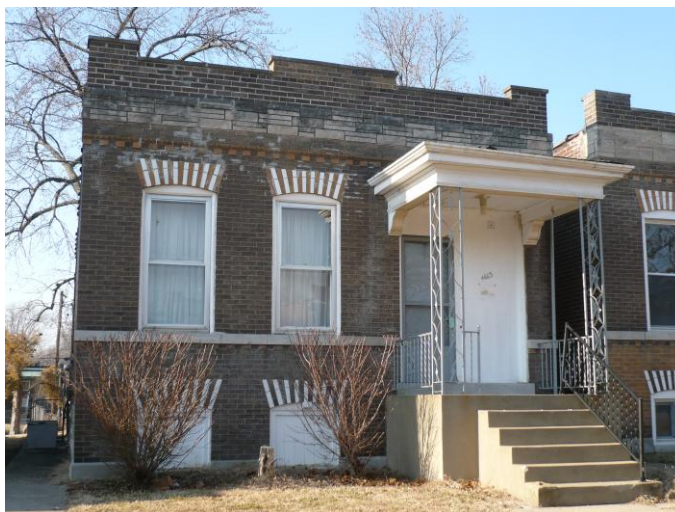
At the right bay of this single story house, a replacement door is at a replacement porch with a hipped roof. The second door opening is covered over with wood or paneling, as are both transoms. To the left are two original 1/1 windows. Below them, the basement windows are boarded over. If there was a cornice, it has been replaced by a strip of imitation stone veneer (also used at the front of the lower section of the porch. Flat-topped segmental arches at both stories' windows feature alternating white brick voussoirs (alternating with tan brick at the first story and light brown at the basement).

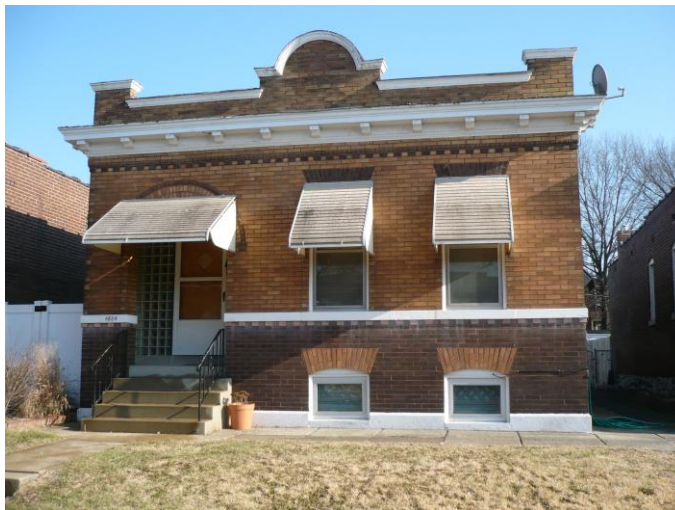
This single story brick house has a recessed porch at the left bay. Behind a round-arched opening, the front door is a replacement and the wall next to it is filled in with glass block. To the right are two original 1/1 windows in segmental arched openings. Below them, the basement windows are original. The entry and two windows are sheltered by added fiberglass awnings. This is one of quite a few houses in the survey area to have contrasting brick colors at the base and upper façade, and to use the contrasting color brick for the flat-topped segmental arches at both sets of windows. The parapet wall has a round center step.

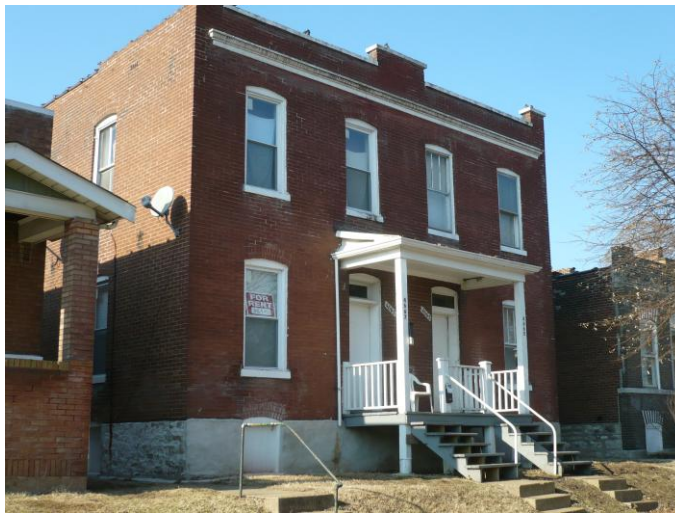
This two-story building has a four bay symmetrical façade. It is not a true four-flat building in the sense described in the property type report because there does not appear to be a separate exterior front door for each unit. The two doors are centered at the frame porch. The doors are modern replacements but the transoms appear original. The right two bays have 3/1 windows; the façade windows at the left two bays are new replacements. The porch's shed roof structure also appears original.

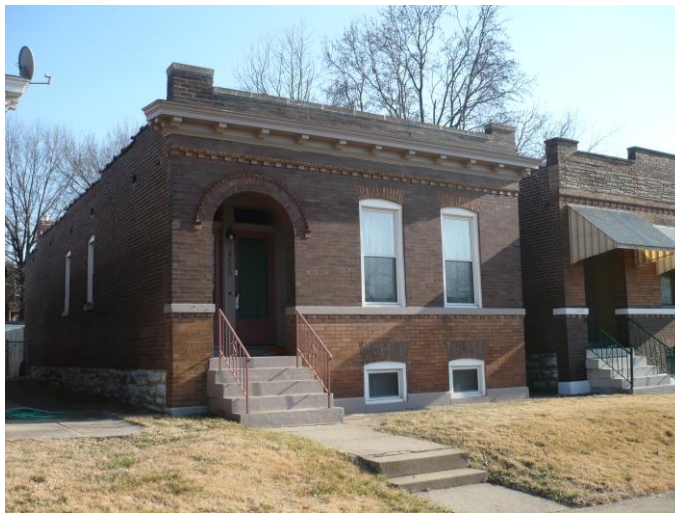
This single story brick house has a recessed porch at the left bay. Behind a round-arched opening, the two front doors and transoms are original. To the right are two replacement 1/1 windows in segmental arched openings. Below them, the basement windows are also replacements. This is one of quite a few houses in the survey area to have contrasting brick colors at the base and upper façade, and to use the contrasting color brick for the flat-topped segmental arches at both sets of windows.

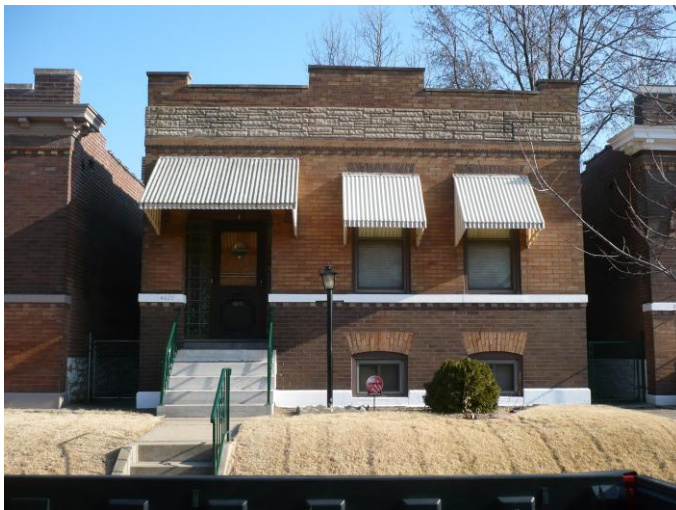
This single story brick house has a recessed porch at the left bay. Behind a round-arched opening, the front door is a replacement and the wall next to it is filled in with glass block. To the right are two replacement windows in segmental arched openings. Below them, the basement windows are also replacements. The entry and two windows are sheltered by added fiberglass awnings. This is one of quite a few houses in the survey area to have contrasting brick colors at the base and upper façade, and to use the contrasting color brick for the flat-topped segmental arches at both sets of windows. Instead of a metal cornice, this façade has a wide strip of imitation stone veneer across the façade.

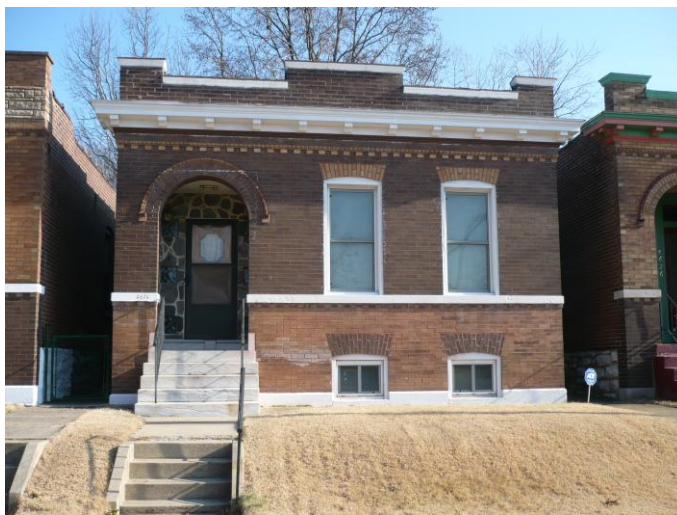
This single story brick house has a recessed porch at the left bay. Behind a round-arched opening, the front door is a centered replacement in a slab stone (or imitation) surround with large glass block lights. To the right are two replacement windows in segmental arched openings. Below them, the basement windows are also replacements. This is one of quite a few houses in the survey area to have contrasting brick colors at the base and upper façade, and to use the contrasting color brick for the flat-topped segmental arches at both sets of windows.

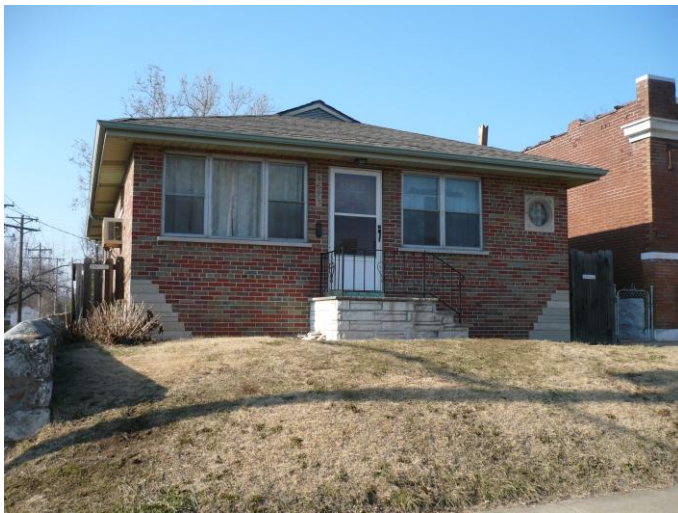
The front door (a replacement) is centered at the façade of this midcentury house. To the left is a triple set of aluminum windows; to the right is a pair of windows and a glass block roundel.

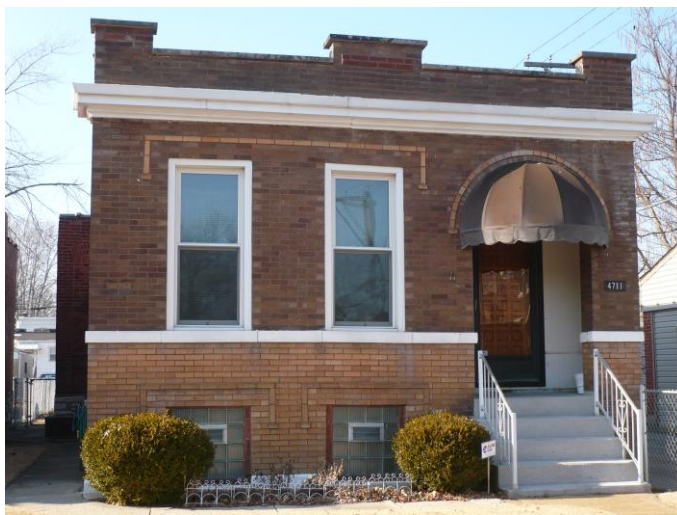
Behind a round-arched opening at the right bay, the replacement door is centered. To the left are two vinyl 1/1 windows. Above a metal cornice, the parapet wall has end blocks and a center step. The two windows share a common tan brick label; the two basement windows are filled in with glass block. There is a fabric awning at the entry.

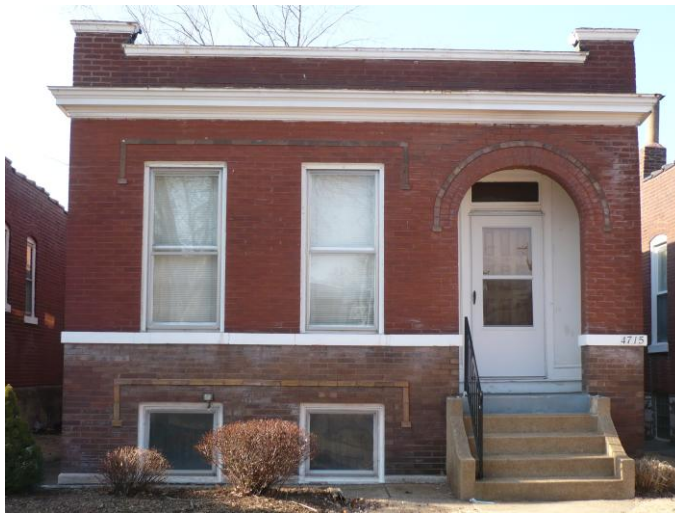
Behind a round-arched opening at the right bay, the replacement door is centered and retains a transom. To the left are two wood 1/1 windows. Above a metal cornice, the parapet wall has end blocks and retains original metal coping. The two windows share a common brown brick label.

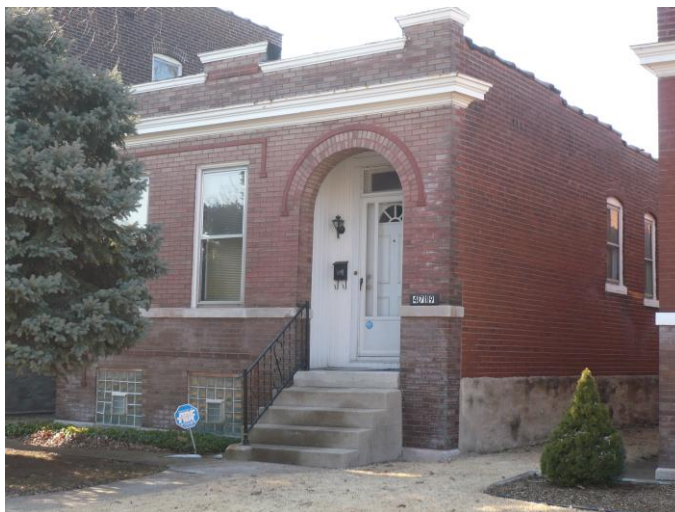
Behind a round-arched opening at the right bay, the replacement door is centered and retains a transom. To the left are two wood 1/1 windows. Above a metal cornice, the parapet wall has end blocks and center step, and retains original metal coping. The two windows share a common red brick label.

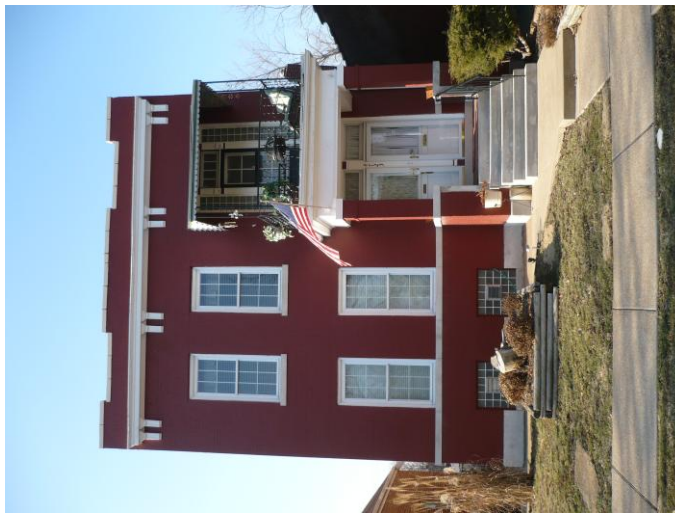
The first story of this 2-family building was permitted as a dwelling in 1910; the second story was added in 1914 by the same owner and builder. At the right bay, the two front doors and transoms appear original. The brick porch has a flat roof which doubles as a balcony; the balcony door and its transom and sidelights also appear to date to 1914. There is a metal awning over the balcony. At the right bays, the four façade windows are vinyl replacements. There is a metal cornice under the parapet wall.

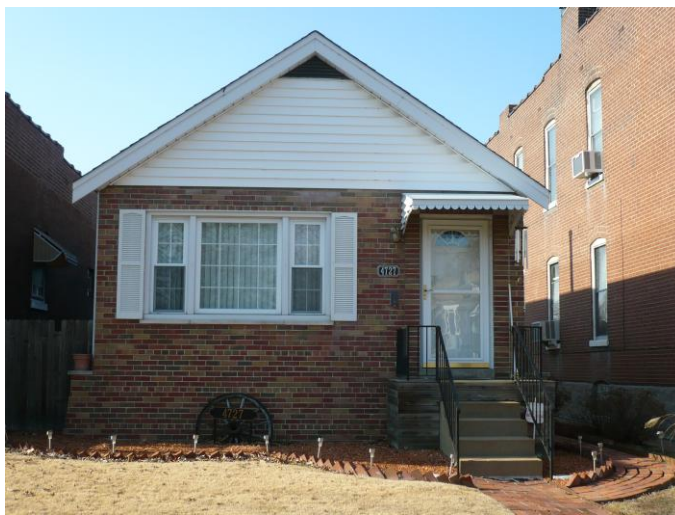
This front gabled house has a brick exterior; the gable end is filled in with modern horizontal siding. At the right bay, a new front door is at a concrete stoop and sheltered by a metal awning. At the left bay, original windows have been replaced.

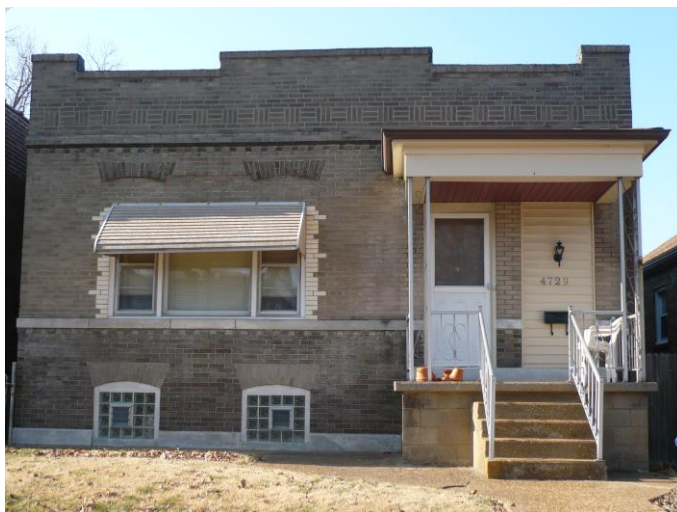
At the right bay, the replacement front door is to the right of a second door-sized opening, now covered with modern horizontal siding. The base and supports of the front porch have been replaced with concrete and metal, but the hipped roof is intact. To the left, the fenestration has been altered - the original arrangement of two windows in segmental arched openings has been reconfigured with the top part of the original openings bricked in, and a triple set of 1950s-60s windows inserted under a fiberglass awning. The parapet wall has end blocks and center step. The building is still considered contributing because the vast majority of its surface material is intact, as well as its form and its identity as one of a number of similar houses lining the same block.

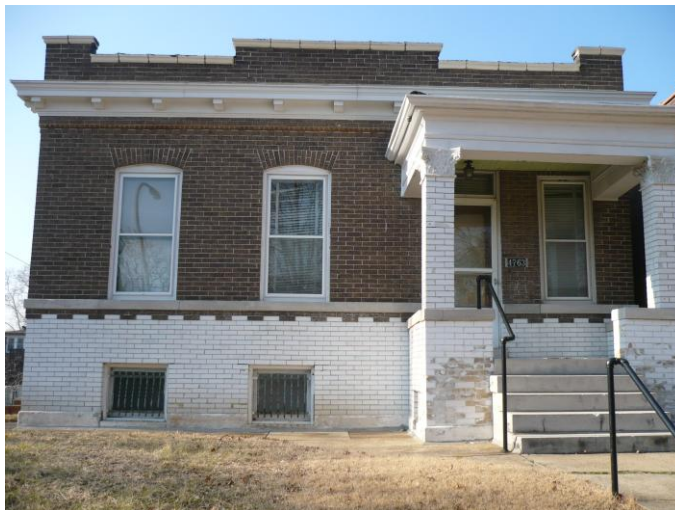
**Condition:** Good

At a hip-roofed white brick porch at the right bay, the original door is under an original transom, next to a 1/1 window. The porch's enameled white brick piers are topped by squared Corinthian capitals. To the left are two replacement 1/1 windows. Above a metal cornice, the parapet wall has end blocks and a center step, all with terra cotta coping.

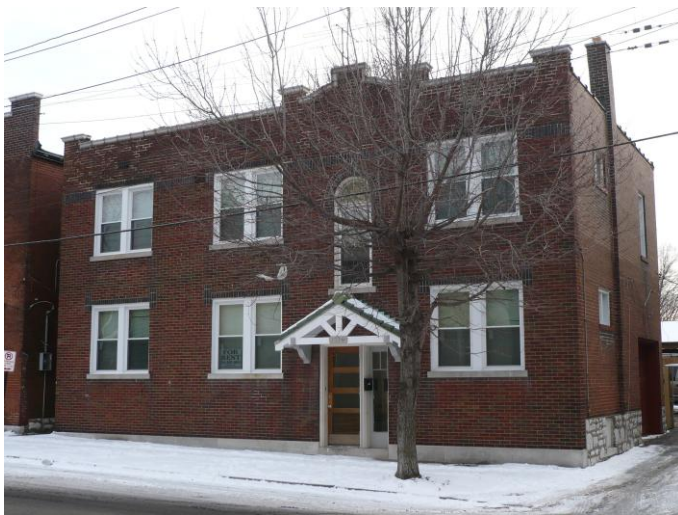
Condition: Good

This brick building has a four-bay façade. The replacement wood and glass door is at the third bay at grade under a gabled hood with an open truss and two knee brace brackets and green ceramic tile roofing. The sidelight, right, has two panes over one tall pane. Over the door between stories, the window has a round-arched art glass fan or transom. The entrance bay is also marked by an arch in the parapet wall with a step to either side. The other three bays have pairs of vinyl replacement windows at both stories. Sills are limestone. Dark brick (almost black) forms lintels and arch and a soldier course at the top of the second story windows.

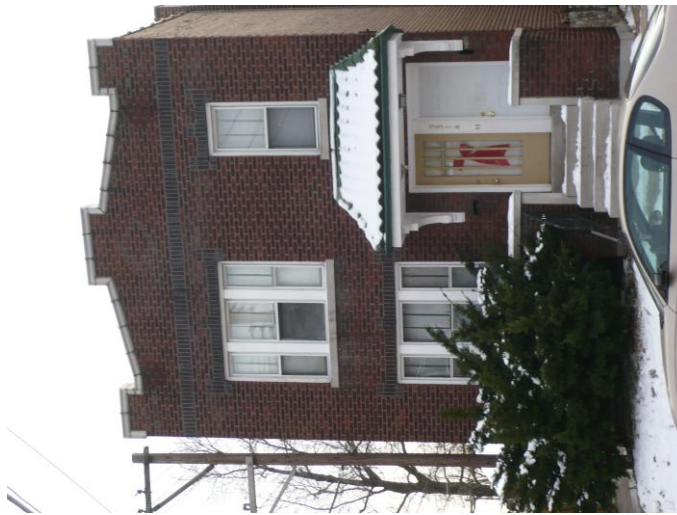
Condition: Good

This two family building has a brick stoop at the right bay. The two front doors - one original, one a new replacement - are sheltered by a bracketed hipped hood which retains its green ceramic tile surface. Above the front doors at the second story is a single 3/1 window. At both stories of the left bay, there is a 3/1 window flanked by 2/1s. The tapestry brick façade is highlighted by courses and labels composed of near-black brick. The parapet wall peaks to a center step and retains white terra cotta coping.

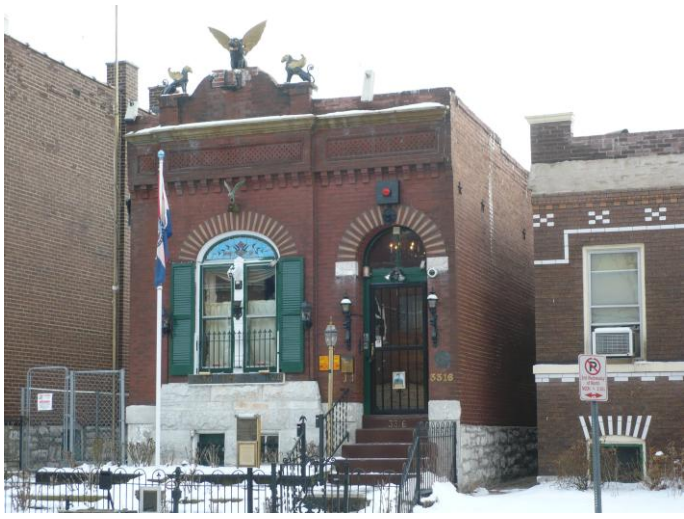
Condition: Good

This narrow single story house has a limestone foundation at the façade. The front door, transom and paneling are at the right bay behind a narrow round-arched opening. The window bay to the left projects about one with; the paired 1/1 windows are under an irregular (3-centered) arch an art glass transom. Both arches feature Roman brick voussoirs in alternating red and tan. The entry has stone imposts; the sides of the window are obscured by applied shutters. Molded brick corbels are under slightly projecting panels of square Celtic knot terra cotta/brick pieces, which are in turn below the metal cornice. The front parapet wall has a moderately rebuilt center arch over the projecting bay. Various griffons, birds, lamps, shutters, alarms and cameras are applied to the façade and parapet but do not detract significantly from the house's integrity. An informational sign dates the house to 1886 and offers information about the house's history. The 1896 date is from a building division certificate.

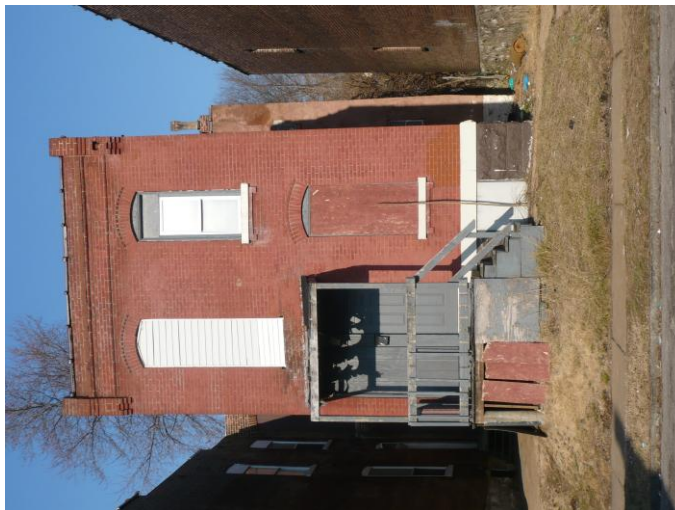
Condition: Good

This two-family building has a shed-roofed replacement frame porch at the left bay. It appears that the original porch had a flat roof as a second story balcony; the balcony door above it his now filled in with modern horizontal siding. The foundation at the façade is coursed rock-faced limestone. The right front door is a replacement; the left is paneled over. The three façade windows are boarded in segmental arched openings. The parapet wall has corbelled end blocks (somewhat truncated, it appears) and clay tile coping. The house appears to be vacant. A \$1200 addition was permitted in 1905; the building was listed as a dwelling on that permit. This building is shown as flats on the 1908 Sanborn map, but there are no permits for pre-1900 flats.

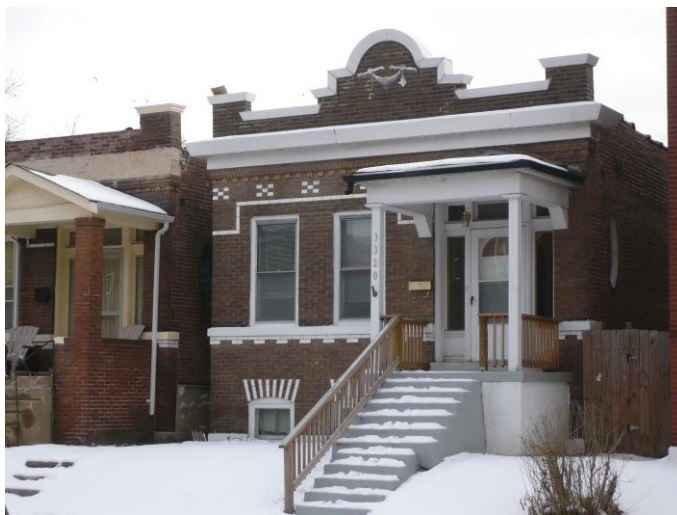
Condition: Good

At a hipped frame porch at the right bay, a replacement door is surrounded by original sidelights and transoms. To the left are two original 1/1 windows. The basement windows below them are also original. Aluminum wraps wood porch elements and the cornice. The center step of the parapet wall has a rounded center section.

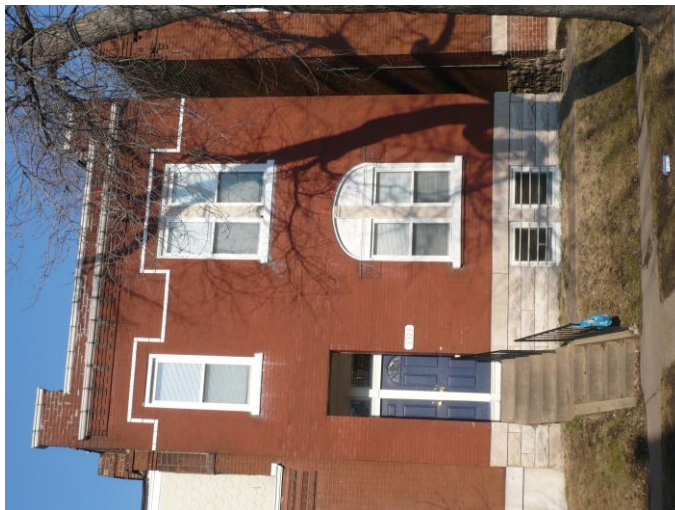
Condition: Good

This building was constructed as a single story house in the 19th century. It appears that the 2nd story was added in 1911 (builder and architect: A. Degenhardt). Above a rock-faced coursed limestone foundation, there is a recessed porch at the left bay. The two doors are replacements under original transoms. At the right bay, a three-centered arch tops a wide window opening. The windows within are replacements, the transoms covered. Decorative brick form handsome imposts. At the second story, the right bay window opening is as wide as the one below it. Both this and the left bay window are replacements. There is a corbelled brick and terra cotta cornice, and the parapet wall retains terra cotta coping.

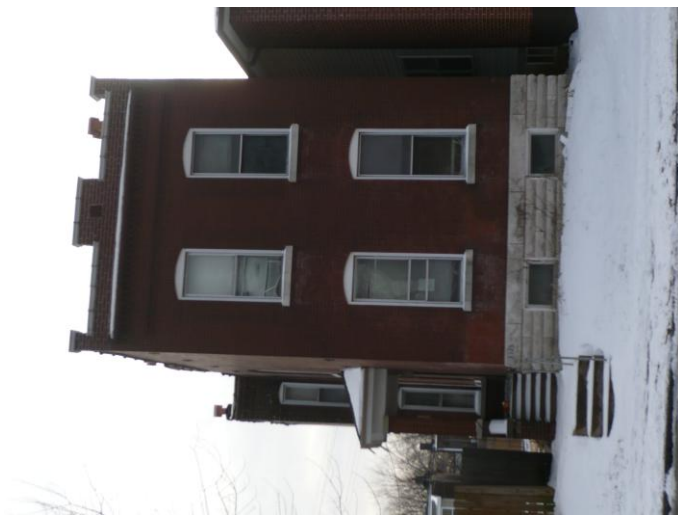
Condition: Good

This building is shown as flats on the 1908 Sanborn map. Above a coursed limestone foundation, the façade has two segmental arched window openings with stone sills at both stories. The windows are replacements. Above a corbelled brick cornice, it appears that the parapet wall was rebuilt during the historic period to have end blocks, a center step, and terra cotta coping. The front door at the left (east) side is a replacement at a brick porch with a hipped roof.

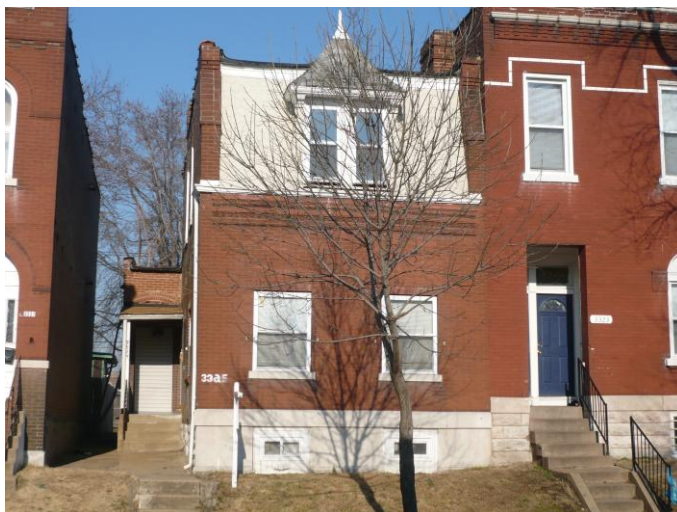
Condition: Good

This red brick house has a stone foundation (smooth at the façade). The red brick façade has two square-headed window openings with replacement windows. The small height of the window openings and the use of plain soldier lintels is not consistent with the style of the house, but the brickwork does not appear altered. The façade is crowned with corbelled molded brick courses including egg and dart and a course with beads. The scalloped slate roof is painted. The dormer has a flared pyramidal roof with a metal finial and front eaves supported on two wood corbels. The two small windows are replacements. The front door is at a narrow rear el, left, and is a replacement.

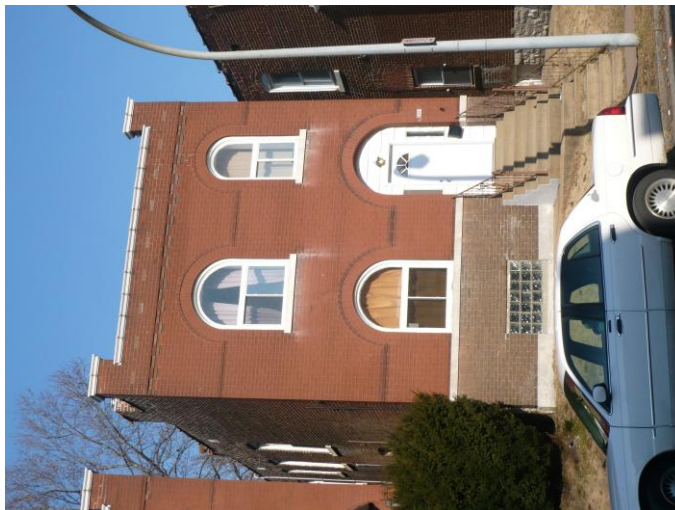
Condition: Good

This former two-family building is two stories and two façade bays, each with a round-arched opening for entry or window. The new front door is in what was once the opening to a recessed porch, right, with asbestos shingle filling in around it. At the left bay, both windows openings are wide. There are raised brick courses at the springing lines and following the arches of both stories of both stories. Façade windows are all replaced. The parapet wall is corbelled out very slightly and retains terra cotta coping.

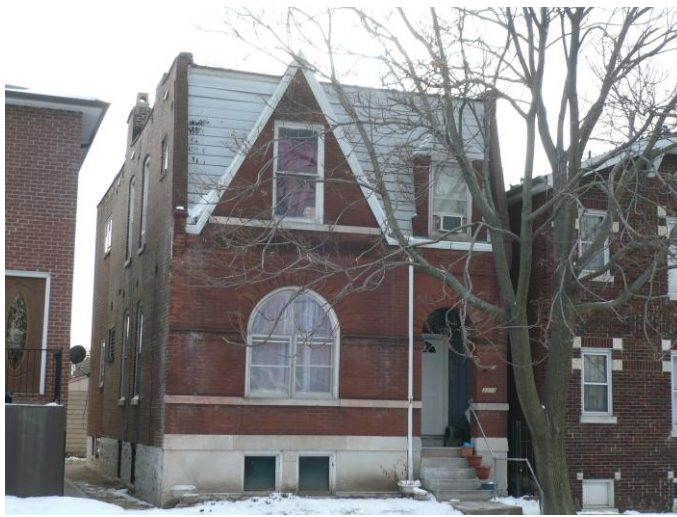
Condition: Good

This unusual house has a single story façade with a steep gable wall dormer at the left bay and a hipped dormer at the right in a near-vertical pseudo-mansard roof which is almost vertical. The "mansard" is steep enough to be sided with aluminum horizontal siding rather than roofing, and the side walls are brick. The front door (a modern replacement) is behind a round-arched entry at the right bay. The wide, round-arched window at the left bay appears to be an original 2/1 behind contemporary storm windows. The base of the façade is smooth limestone. Molded pressed brick is used for courses at the springing line of the first story and across the top of the first story. In the second story dormers, both 1/1 windows are original.

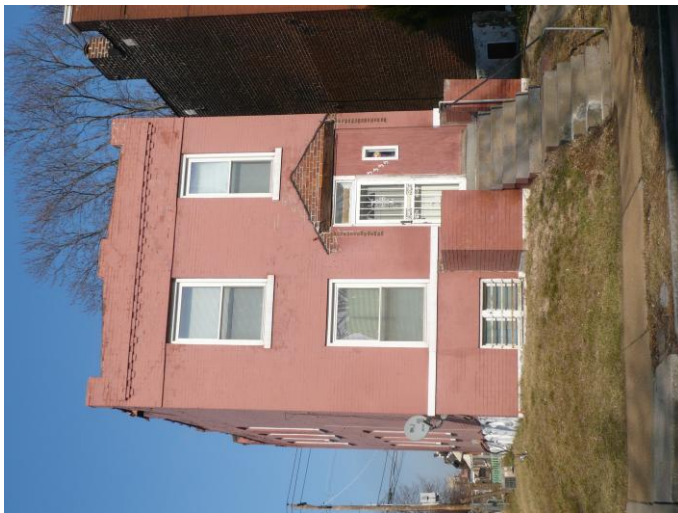
Condition: Good

This two-family building has two stories and two façade bays. The front porch at the right bay retains its brick base and knee walls, but the roof has been removed. One of the two original door openings bears a replacement, and the other is covered (for conversion to single family use). The three façade windows are square headed; at the left bay, both are wide. All three are modern replacements. The parapet wall is corbelled out very slightly; it slopes gently up to the center step. Original coping is missing.

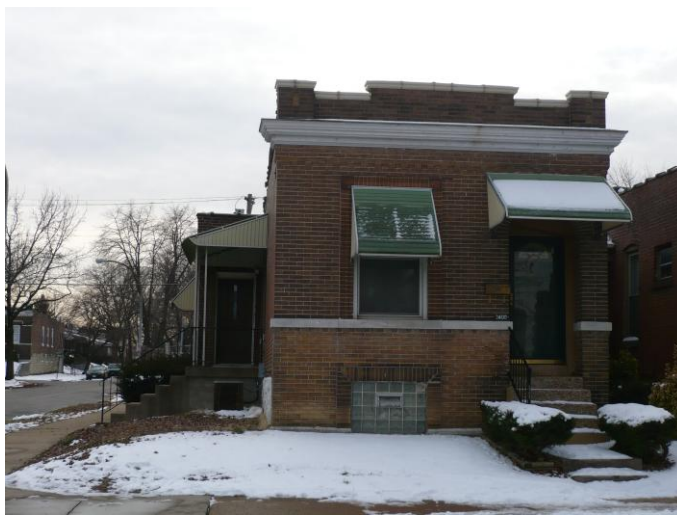
Condition: Excellent

The two-bay façade has a recessed front door at the right. The front door and the window, left, are replacements. Both openings are covered with fiberglass awnings. Over the metal cornice, the parapet wall has end blocks, a wide center step, and terra cotta coping. A small rear el at the left elevation includes another replacement door.

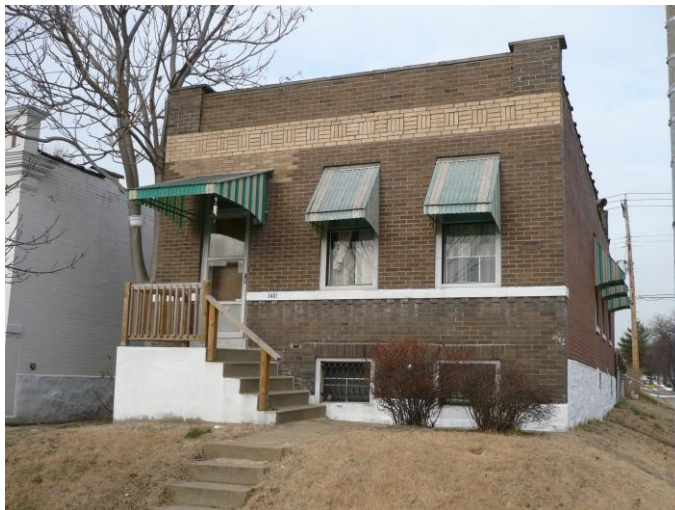
Condition: Good

This single family house has a replacement concrete stoop at the left bay. The front door (a replacement) and its transom are shaded by a fiberglass awning. To the right, the two 1/1 windows appear original. They too are under fiberglass awnings. Instead of an added cornice, the parapet wall is set off with seven courses of lighter brick (the middle three laid as a basketweave pattern).

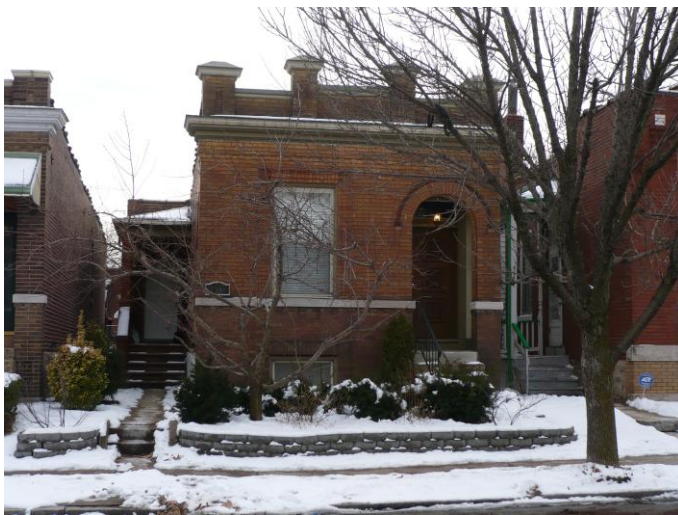
Condition: Excellent

The two-bay façade has a recessed front door at the right behind a round-arched opening. The front door and the window, left, are replacements. Over the metal cornice, the parapet wall has end blocks, a wide center step with blocks at either end, and metal coping. A small rear el at the left elevation includes another replacement door.

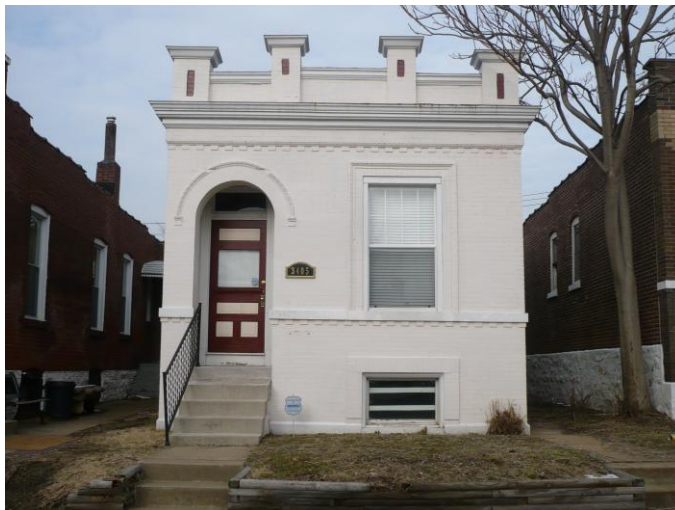
Condition: Good

The two-bay façade has a recessed front door at the left behind a round-arched opening. Both this door and that at the rear el are original and retain transoms. The wide window at the right side of the façade is a replacement. Over the metal cornice, the parapet wall has end blocks, a wide center step with blocks at either end, and metal coping.

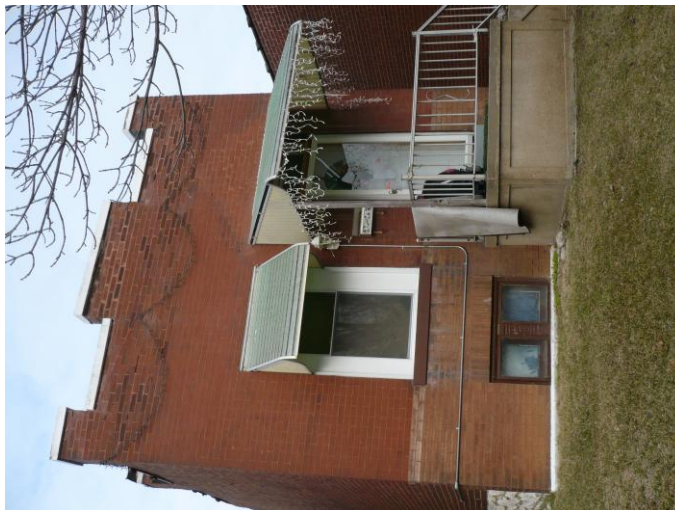
Condition: Good

The two-bay façade has a replacement front door (with original transom) at the right at a concrete stoop. The main window at the left is a much smaller replacement, the wide opening filled in to either side of it. Instead of a stone course at the sill (a common feature in this house type), there are two courses of lighter brick taking up the line of the stone windowsill. The basement windows below are original and retain their carved wood mullion. The parapet wall has been rebuilt. Fiberglass awnings shelter both the front door and window.

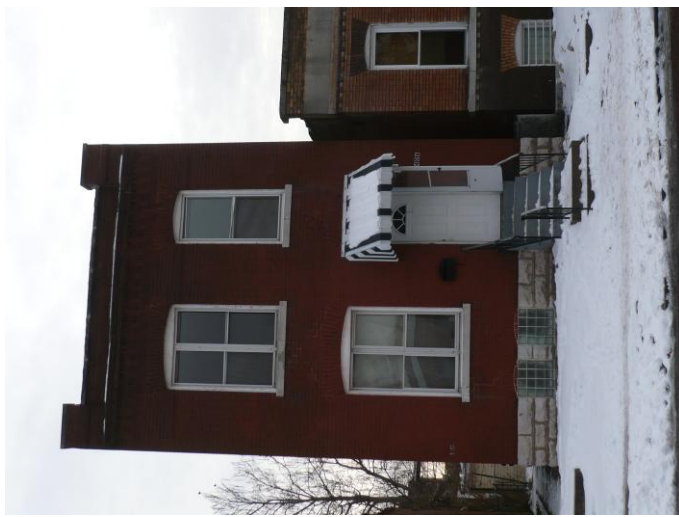
Condition: Good

This two-story house has a red brick façade atop a coursed rock-faced stone foundation. Steps at the right bay lead to a replacement front door topped by a metal awning. The windows - a single 1/1 at the second story over the entrance, and pairs in wide segmental arched openings at both stories of the left bay. Above a corbelled brick cornice, the parapet wall has end blocks.

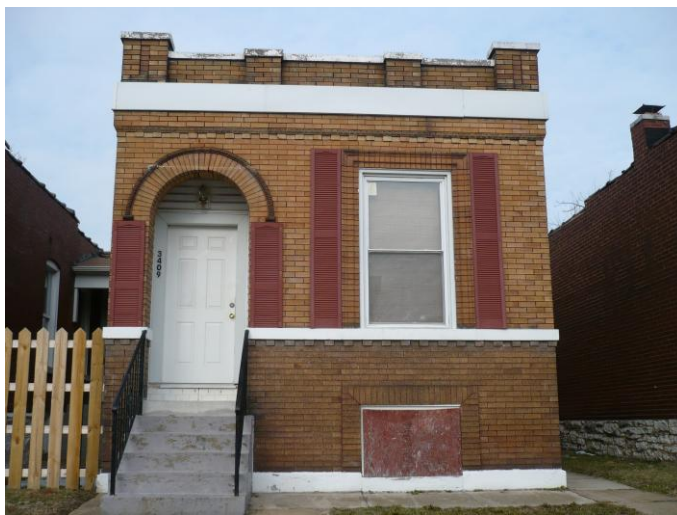
Condition: Good

The two-bay façade has a recessed front door at the left behind a round-arched opening. The front door and the window at the right side of the façade are replacements. The first floor and basement façade windows have brick surrounds. At the first floor, the narrow applied shutters are to either side of the brick surround. It appears a metal cornice has been removed and replaced by a strip of aluminum. The parapet wall has end blocks; the wide center step with blocks at either end has been sheared to be even with the parapet to either side. A small rear el includes another replacement door under a transom light.

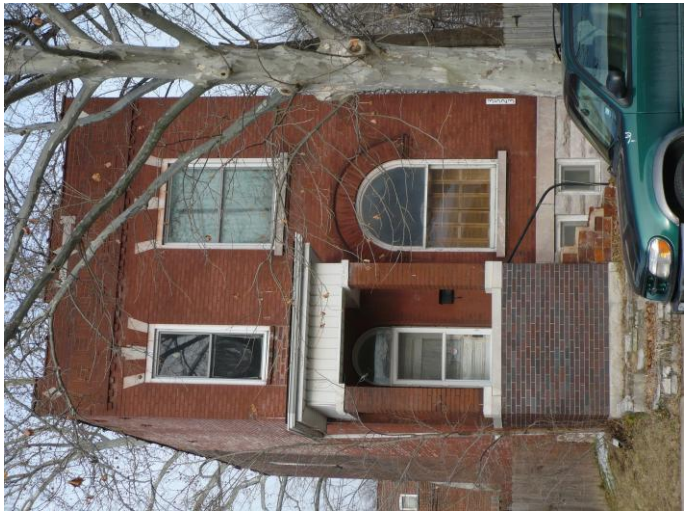
Photo date 2/11/2010

The original part of this two-family building was constructed before 1900. The second story was added in 1910 by builder Geo. Moeller for owner J. Heidenry. The base of the façade is coursed limestone. Two narrow basement windows (original) are below the right bay's wide windows: a round-arched 1/1 at the first floor (original) and at square head 1/1 at the second (replacement). The front porch at the left bay is also an addition, possibly from 1910 as well, and has a purply brown brick base with red piers. The frieze/cornice of the porch is clad with aluminum, and the rooftop balcony no longer serves its purpose. The front door and round-arched transom light are original, but the second story window is a replacement in what was a door opening (its bottom now bricked in). The two second story openings have stone keys and imposts at the flat arch lintels. The parapet wall includes stone lozenges and other insets. The first story's date is found on a building division certificate.

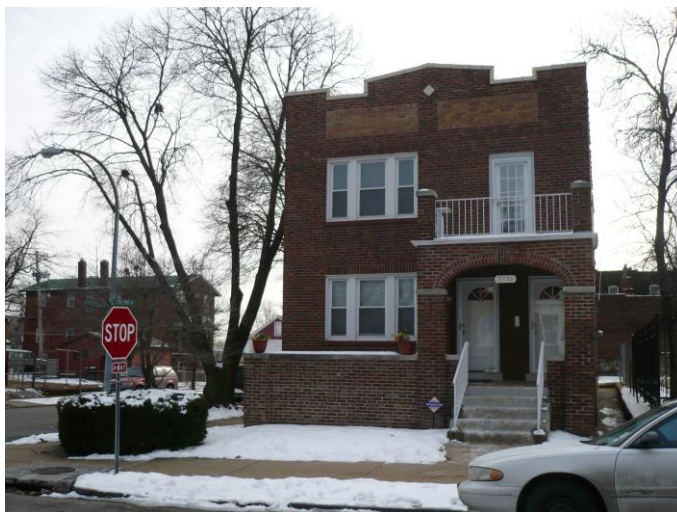
Photo date 2/11/2010

Condition: Good

This two-unit building has a full-width porch, but only the right bay is roofed. The two front doors at the right bay are replacements. The porch roof balcony door is also a replacement. At the left bay, triple sets of windows at both stories are new. Below the front parapet there are side by side panels of tan brick. The center step of the parapet has a terra cotta canted square and a center peak.

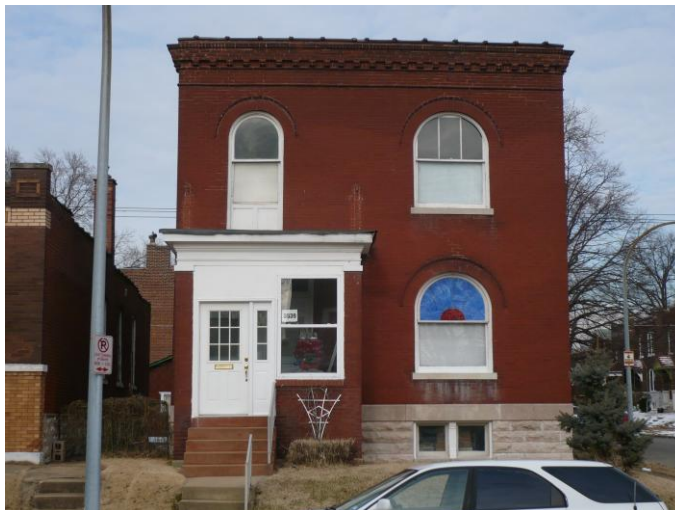
**Photo date** 2/11/2010

The date of this building is probably 1907, although the permit says 1911. Additional research can confirm this. The appearance of the façade marks the building as something of a throwback if the 1907 date is correct. The foundation is coursed limestone. The brick front porch, left, is an addition (not shown on the 1908 Sanborn map). The windows and doors which enclosed the porch are new. The two front doors and their transoms appear original. All three of the window openings (other than the two small basement windows) are round-arched. The right bay's windows are wide and have wood sashes: a round-arched 1/1 at the first story has a modern-looking art glass upper sash, and a square head 3/1 at the second story is apparently a historic-era replacement. At the left bay, the narrower round-arched window is floor-to ceiling and double hung, with paneling across the bottom of the lower sash. Above a bullnose course, the cornice uses pressed brick corbels; the parapet wall is flat with clay tile coping (an alteration).

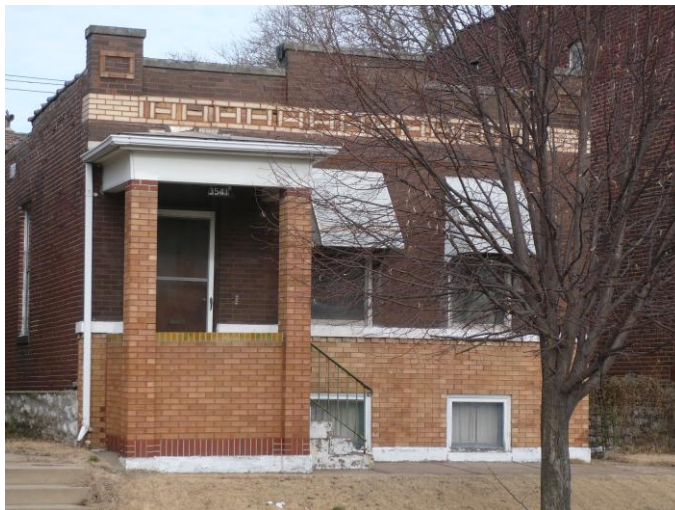
**Photo date** 2/11/2010

**Condition:** Good

The date of this building is probably 1907, although the permit says 1911. (Additional research can confirm this.) The hipped front porch at the left bay is the same tan brick as the base of the façade. The porch steps are at its right side rather than the front. The front door itself is a replacement but retains its transom window. To the right are two 3/1 wood sash windows. The basement windows below them also appear original. The two windows share a common label molding composed of a course of egg and dart brick. Instead of a metal cornice, there is a strip of blond brick with tan brick patterns, five courses wide. The two windows have metal awnings.

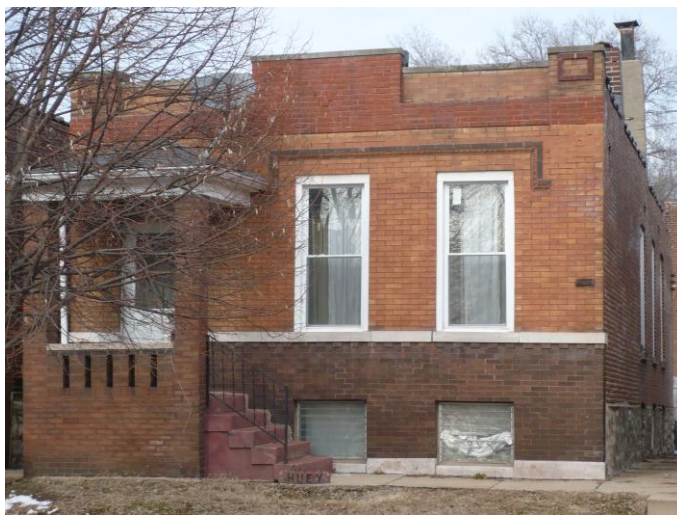
Photo date 2/11/2010

Condition: Good

The date of this building is probably 1907, although the permit says 1911. (Additional research can confirm this.) The hipped front porch at the left bay is the same brown brick as the base of the façade. The porch steps are at its right side rather than the front. The front door itself is original and retains its transom window. To the right, two replacement 1/1 windows share a common label molding composed of a course of egg and dart brick under one of raised brown brick. Instead of a metal cornice, there is a strip of red brick, five courses wide. Most of the parapet wall except for the end blocks and center step is slightly recessed from the red courses; the center step uses the same red brick.

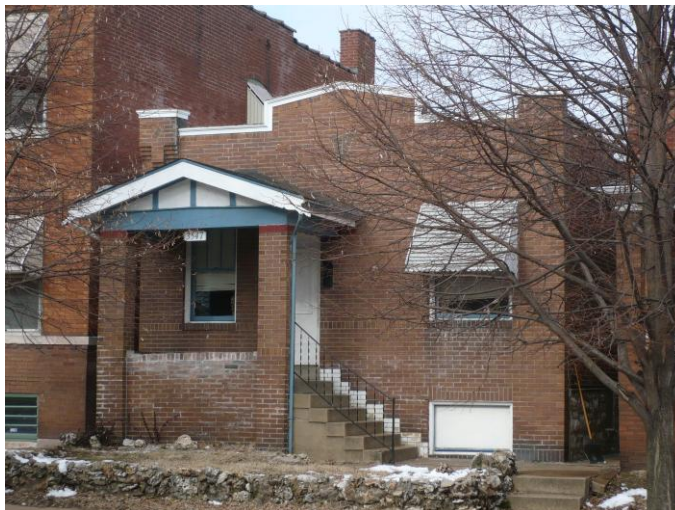
Photo date 2/11/2010

Condition: Good

This single story brick house has a gable-roofed. Brick front porch at the left bay. The porch steps are at its right side rather than the front. The gable end retains stucco and stickwork, and the vergeboards have notched and carved ends. The front door is a replacement. There is a 3/1 window to its left, also at the porch. To the right, a 4/1 window is under a metal awning. The basement window below it is boarded. The simple parapet wall has a peaked center step and corbelled end blocks.

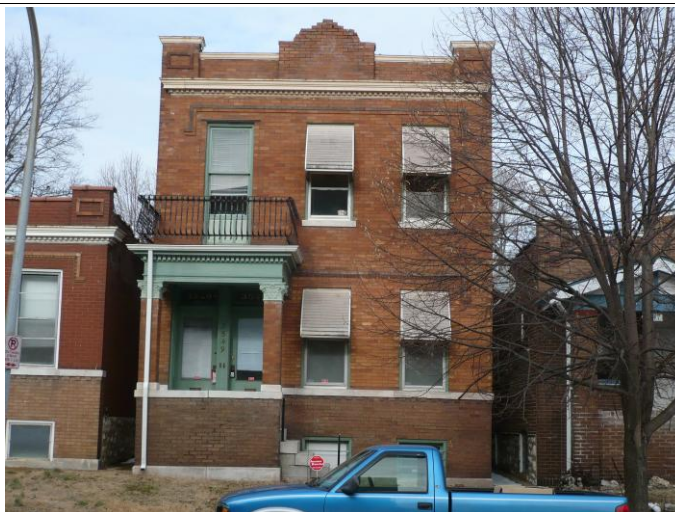
Photo date 2/11/2010

Condition: Good

The second story of this building was added in 1911; the original 1907 house would have looked very similar to the one next door at 3551. The front porch at the right bay has squared stylized capitals atop the two brick piers; the roof is a balcony for the second story unit. The porch steps are at its right side rather than the front. The two doors and their transoms date from the historic period. At the balcony above the Jefferson window is intact. At the right, the two windows at each story are replacements under fiberglass awnings. Common label molds are over the openings at each story; the first story's is ornamental pressed brick under a course of raised brick; at the second story it's two courses of raised brick. The center peak of the parapet wall (apparently one an arch with an applied metal garland) has no coping and is deteriorating. Metal coping is intact at the rest of the parapet.

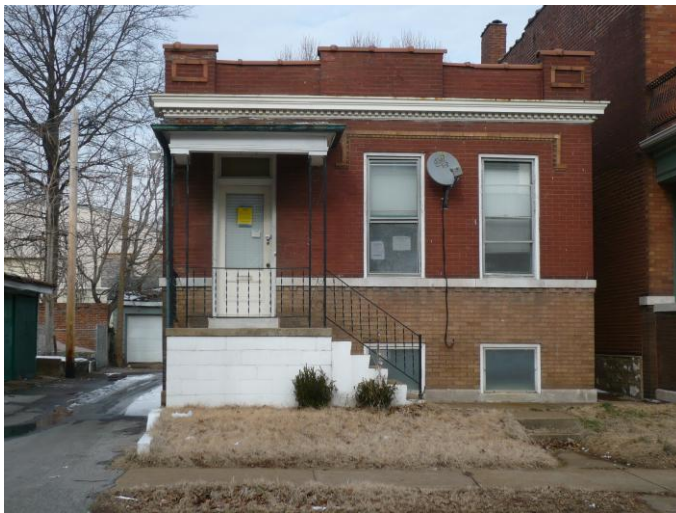
Photo date 2/11/2010

Condition: Good

The front porch at the right bay of this brick house has a replacement concrete block base and metal uprights supporting the hipped roof.. The porch steps are at its right side rather than the front. The door and transom are original. At the right, the two windows are original 1/1s. A common label molding over the windows is ornamental pressed brick under a course of raised brick. The parapet wall has clay tile coping.

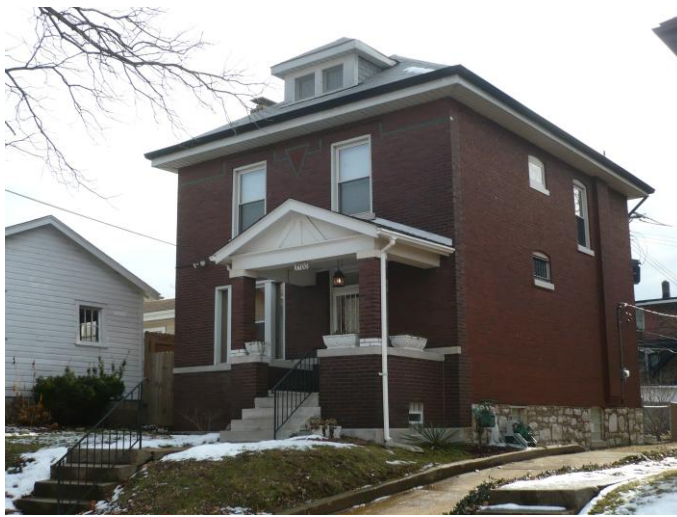
Photo date 1/14/2010

Condition: Good

This foursquare has gabled brick porch at the right bay. Its gable end retains stick and stucco work. Windows are replacements, including the narrow side windows flanking the first story left bay window. The front door, sidelight and transom are original. A limestone sill course separates the façade from the brick base. Green glazed brick forms a label course with center triangle over the second story windows. Main eaves and those at the low hipped dormer are soffitted.

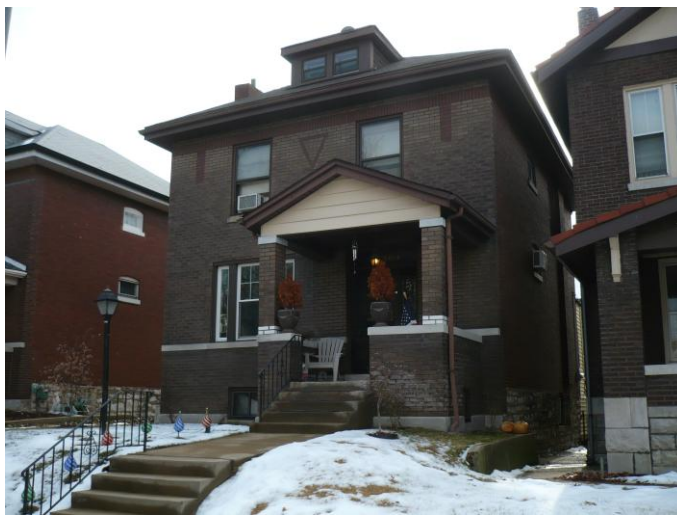
**Photo date** 1/14/2010

**Condition:** Good

This foursquare has gabled brick porch at the right bay. Its gable end is sided with modern horizontal siding.. First story windows are replacements, including the narrow side windows flanking the first story left bay window. The front door, sidelight and transom are original. A limestone sill course separates the façade from the brick base. Red soldier brick forms a lintel course and center triangle over the second story windows.

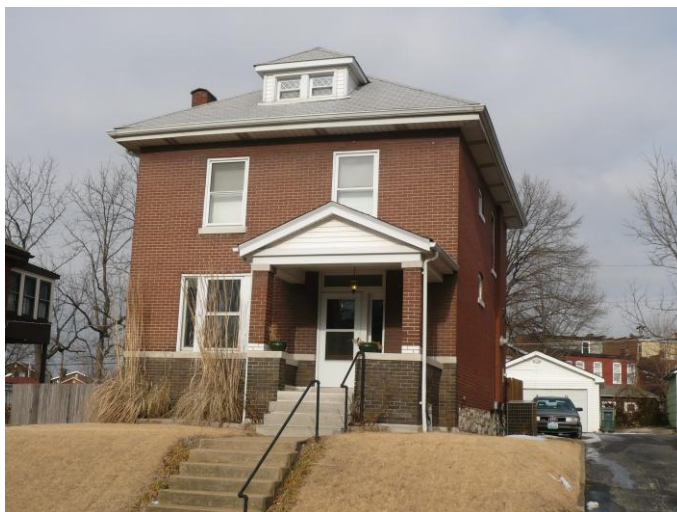
**Photo date** 1/14/2010

**Condition:** Good

This foursquare house has a gabled brick porch at the right bay. The door, sidelight and transom are original. At the left bay, there is a wide original 1/1 with narrow flanking casements. The two second story windows are original 1/1s. The windows in the hipped dormer are replacements.
