# Dutchtown South Community Corporation Dutchtown South Neighborhood Survey

Lynn Josse and NiNi Harris  
8/5/2010

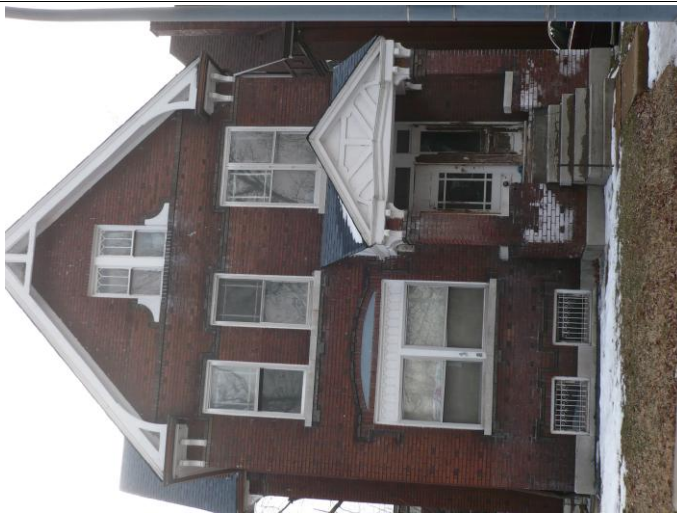
Photo date 1/14/2010

Condition: Good

This front-gabled foursquare has a gable-on-shed brick porch at the right bay. Its gable end retains unusually elaborate stick and stucco work. Original windows include four 9/1s at the second story (the kind with the large center pane with narrow panes around it). The front door, sidelight and transoms are original. At the first story of the left bay is a pair of 1/1s under a leaded glass transom, now painted. A segmental arched stucco panel is over this window set. Burnt headers alternate with stretchers at every 6th course on the façade. Raised brown brick forms a label course over the second story windows and a label at the first story.. A paired of smaller windows is in the open gable end. Bracketed eave returns support a shaped vergeboard, and a small king post truss is in the gable end.

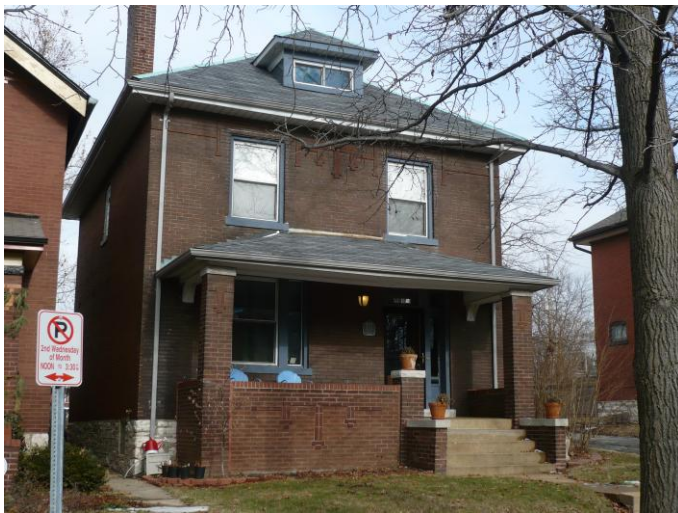
**Photo date** 1/14/2010

**Condition:** Good

This foursquare house has an almost full width hip-roof brick porch across its first story. The front door, sidelight and transom (right) are original. The window set to the left of the front door and the two windows at the second story are replacements. A contrasting brick label course is over the second story windows.

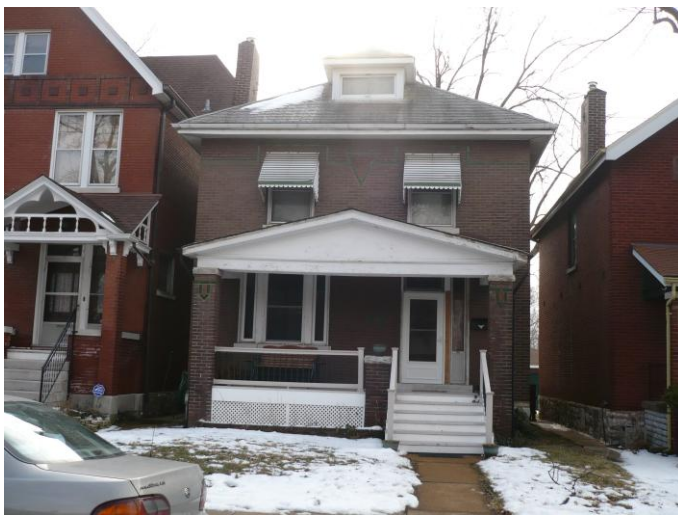
Photo date 1/14/2010

Condition: Good

This foursquare has a full-width gabled porch with brick piers and wood structure. The front door, sidelight and transom are original. The windows to the left of the door are replacements. The two 1/1 windows at the second story are original, but covered with metal awnings. Enameled green brick forms a label course with center triangle over the second story windows. The same material forms small chevrons at the top of the porch piers. Main eaves and those at the low hipped dormer are soffitted. The dormer window is a replacement.

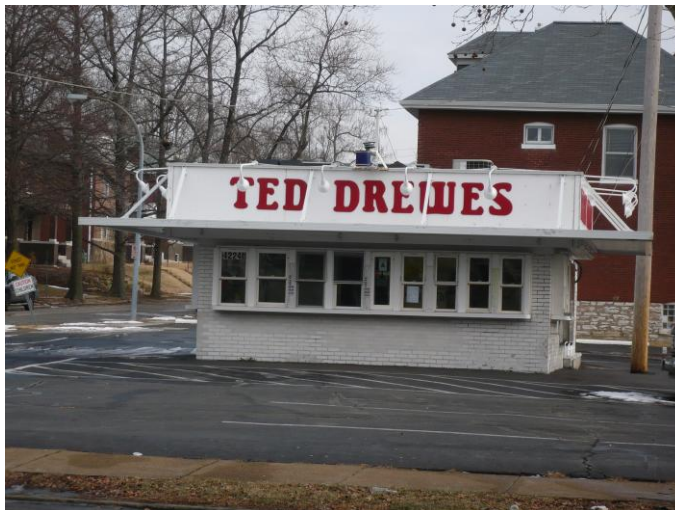
Photo date 1/14/2010

Condition: Good

This drive-up frozen custard stand is simply constructed of long concrete bricks, with service windows (replacements and wide overhanging eaves on three sides. The building is individually eligible for listing in the National Register of Historic Places.

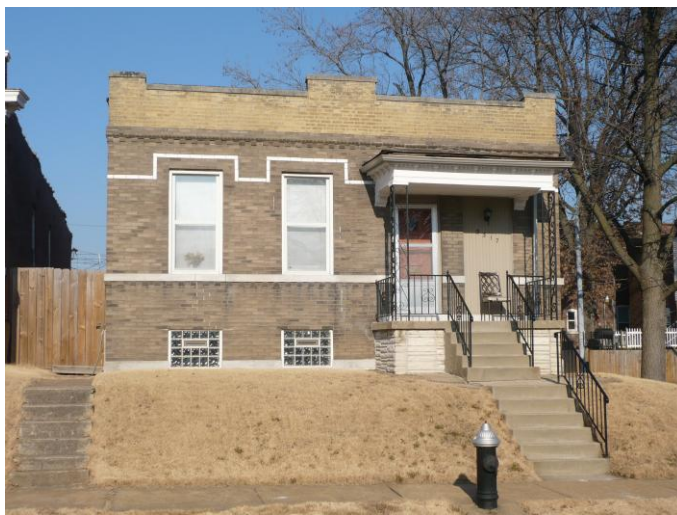
Photo date 2/3/2010

Condition: Good

At a hipped porch at the right bay, the replacement front door is next to a second door-sized opening, now covered with modern paneling. The porch retains the original hipped roof; its base is covered with imitation stone veneer and the uprights are metal. To the left are two replacement 1/1 windows. Instead of a metal cornice, the cornice area is parged. The parapet wall has end blocks and a center step.

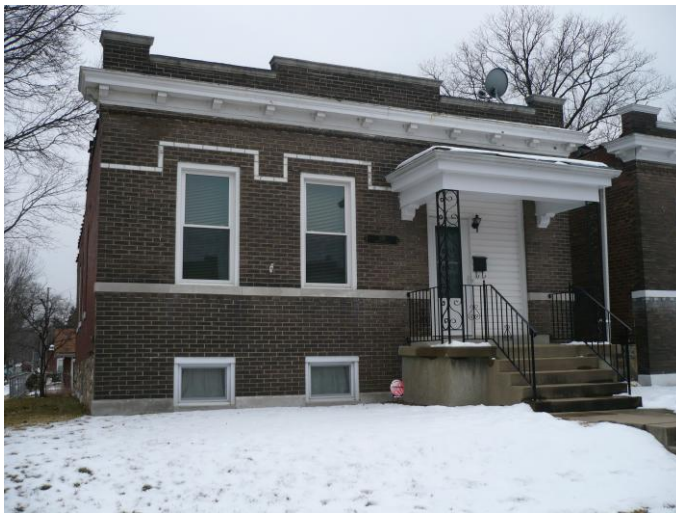
Photo date 2/12/2010

Condition: Good

At a hipped porch at the right bay, the replacement door is next to a vinyl-covered side panel. The porch retains the original hipped roof, but the base is poured concrete and the two supports are trellis-style metal. To the left are two vinyl 1/1 windows. Above a metal cornice, the parapet wall has end blocks and a center step.

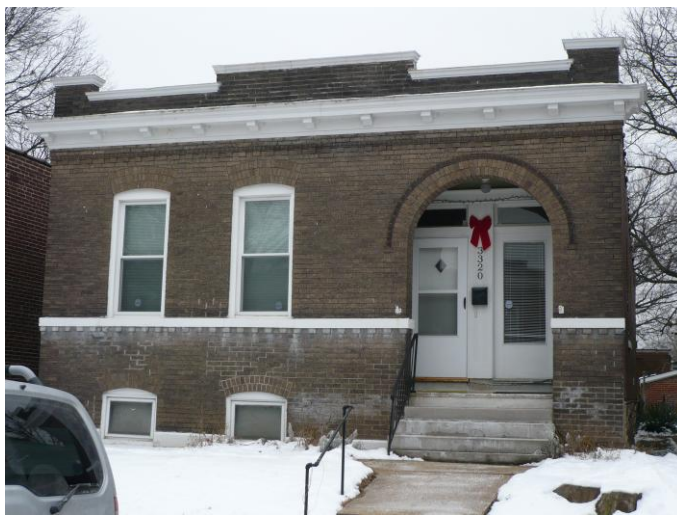
Photo date 2/12/2010

Condition: Good

Behind a round-arched opening at the right bay, the replacement door is next to an original door-sized side panel and window. Both are under original transom lights. \To the left are two vinyl 1/1 windows. Above a metal cornice, the parapet wall has end blocks and a center step, and retains original metal coping.

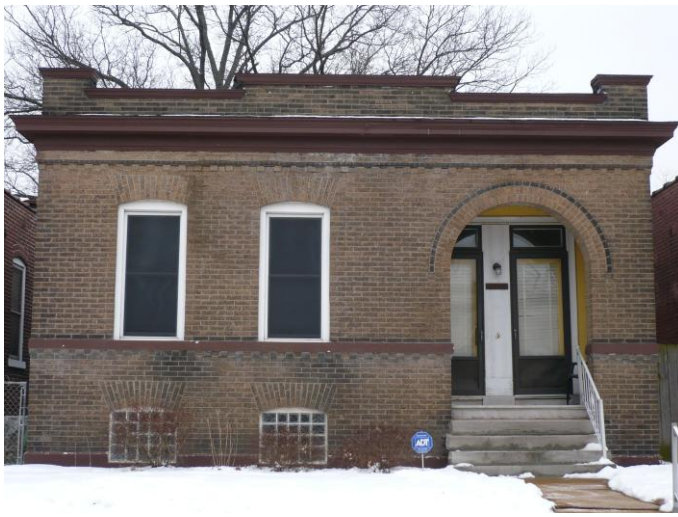
Photo date

Condition: Good

Behind a round-arched opening at the right bay, the original door is next to a matching original door-sized side panel and window. Both are under original transom lights. To the left are two replacement 1/1 windows. Above a metal cornice, the parapet wall has end blocks and a center step, and retains original metal coping.

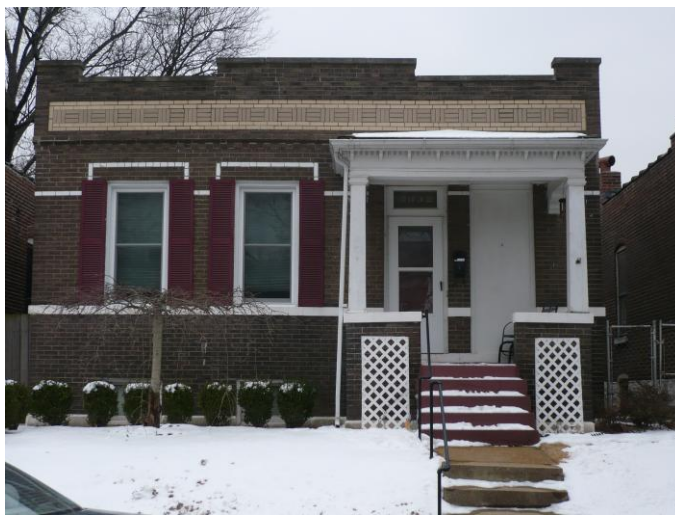
At a hipped porch at the right bay, the replacement front door (with original transom light) is next to a second door-sized opening, now covered with wood. The porch retains the original hipped roof, brick base, and tapered squared wood piers. To the left are two replacement 1/1 windows with added shutters. Instead of a metal cornice, the cornice area is a buff brickwork pattern across the facade. The parapet wall has end blocks and a center step.

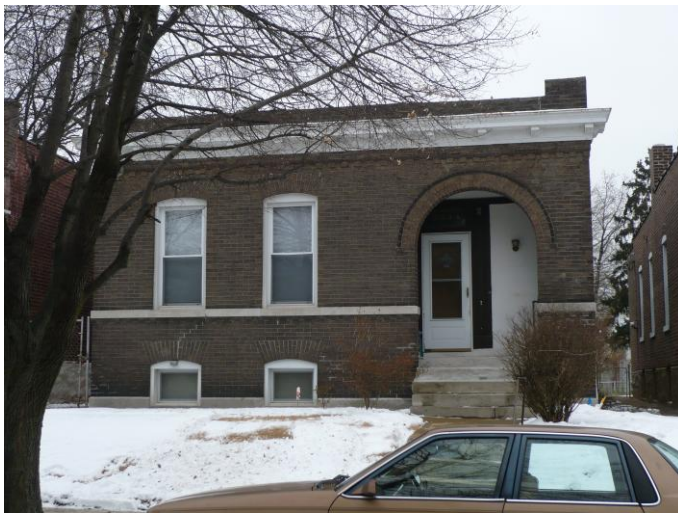
Behind a round-arched opening at the right bay, the replacement door (with original transom light) is next to a second door-sized opening, now covered with wood. To the left are two vinyl 1/1 windows. Above a metal cornice, the somewhat shortened parapet wall has end blocks.

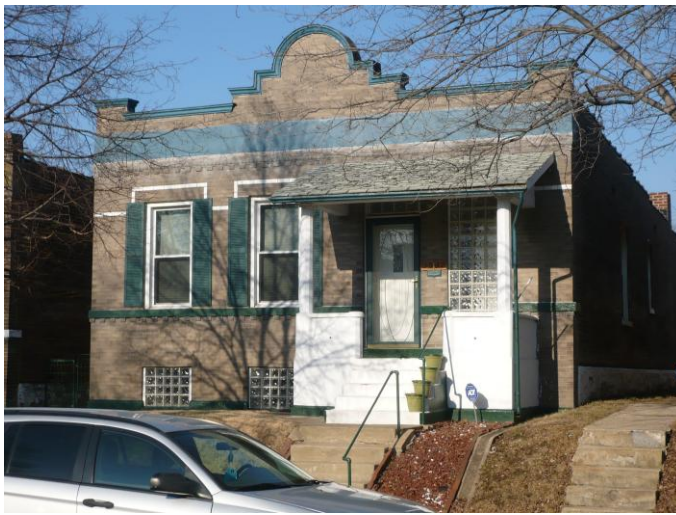
At a replacement porch at the right bay, the replacement front door is next to a door-sized glass block window (separated by a narrow expanse of brick wall). The porch has a shed roof. To the left are two replacement 1/1 windows. Instead of a metal cornice, the cornice area is parged with concrete. The parapet wall has end blocks and a rounded center step, with metal coping.

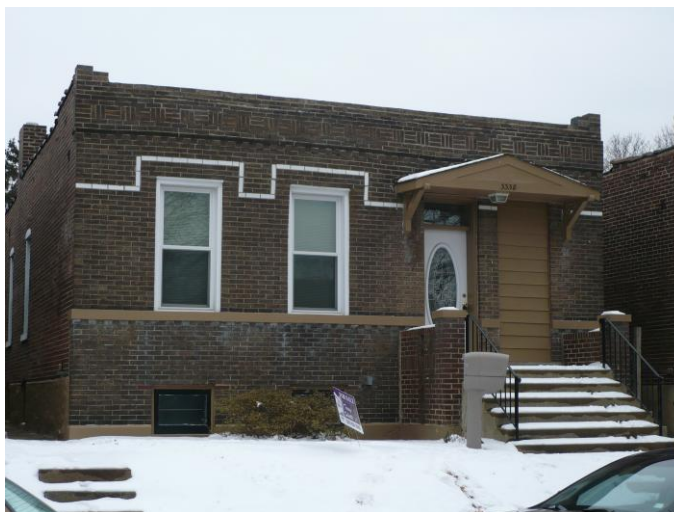
Condition: Fair

At the right bay, the replacement front door (with original transom light) is next to a second door-sized opening, now filled in with modern horizontal siding. Instead of a porch, a brick-walled stoop is sheltered by a Craftsman-era gabled hood on two knee brace brackets. To the left are two replacement 1/1 windows. Instead of a metal cornice, the cornice area is a brickwork pattern across the façade (in the same brick). The parapet and upper façade are slightly bulging, and much of the parapet wall has been removed, leaving only vestigial end blocks.

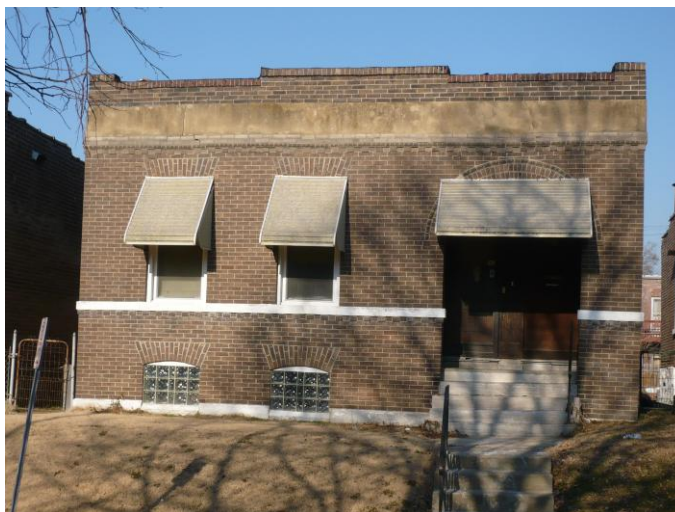
At the right bay behind a round arched opening, the replacement front door is next to a second door-sized opening, now paneled over. To the left are two replacement 1/1 windows. Instead of a metal cornice, the cornice area is parged with concrete. The parapet wall's end blocks and center step have been reduced to a single course, and the coping is now brick. Fiberglass awnings are over all three façade openings.

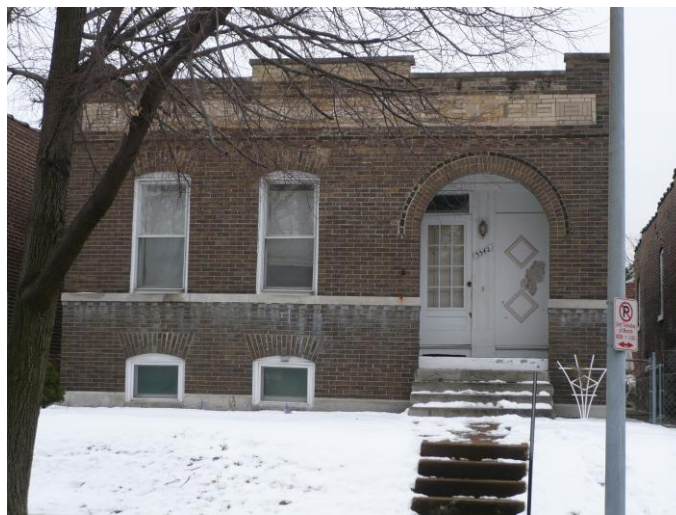
Behind a round-arched opening at the right bay, the replacement door (with original transom light) is next to a second door-sized opening, now covered with wood. To the left are two original 1/1 windows over two original basement windows. Above a brickwork cornice, the parapet wall has end blocks and a center step.

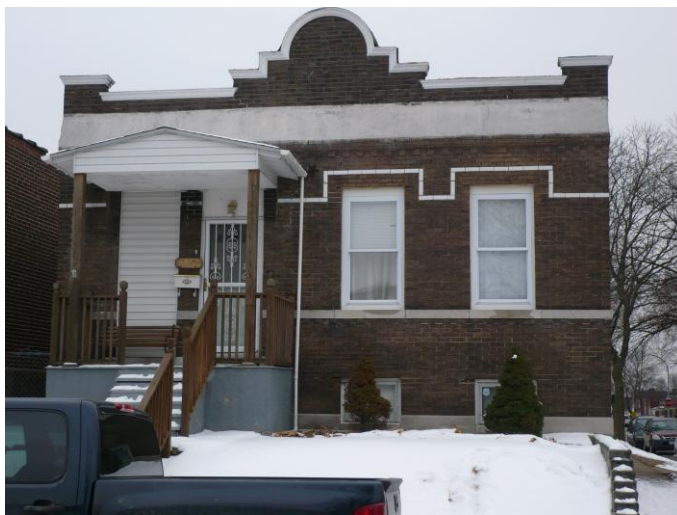
at the left bay, a replacement front door (with original transom light) is next to a second door-sized opening, now covered with modern horizontal siding. The porch is rebuilt, with a concrete base, wood uprights, and a shallow gable roof. To the right are two replacement 1/1 windows. Instead of a metal cornice, the cornice area is parged. The parapet wall has end blocks and a rounded center step with metal coping.

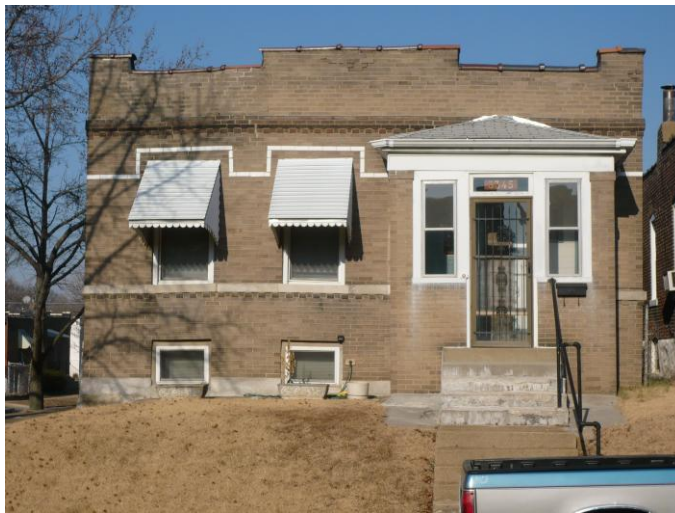
Condition: Fair

At the right bay, the hipped brick porch has been enclosed with windows and a storm door. It appears that, like its neighbors, this house original had two door openings next to each other. To the left are two replacement 1/1 windows. Instead of a metal cornice, there is a slight brick cornice.

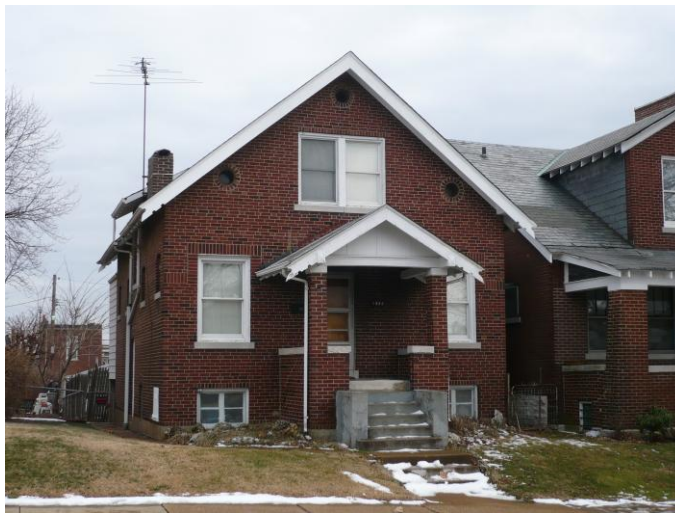
This front gabled house evokes the Craftsman style with its notched vergeboards at the porch and main eaves and the low shed dormer at the side elevation. Eaves at the main roof and porch have rounded projecting rafter tails. The brick front porch is centered, and the door is a replacement. The windows to either side of the porch and the pair in the gable end are replacements. The house has three unusual round vents under the gable eaves.

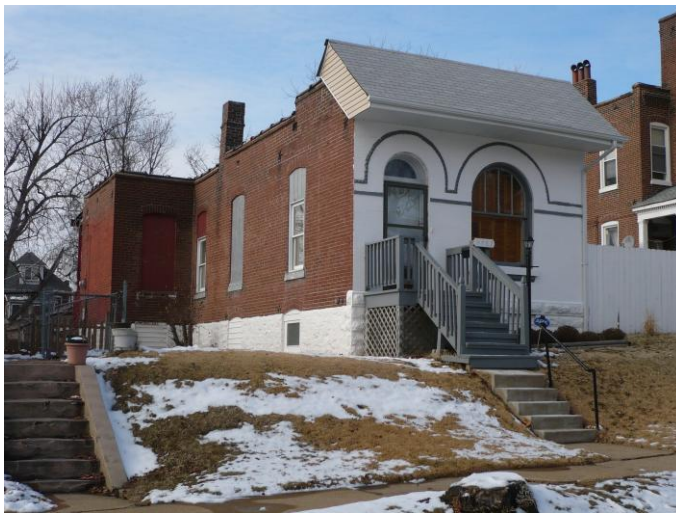
This single story brick house has two round-arched openings at the façade. At the left is a front door (a replacement) at a frame deck-style stoop. To the right, a wide round-arched window appears to be a historic 4/1 - not original, but certainly unusual. Courses tracing the arches and at the springing point are picked out in contrasting paint. A vinyl and composition shingled mansard-style roof has eaves that project beyond the façade. There is a small rear el (boarded ) at the left (south) elevation.

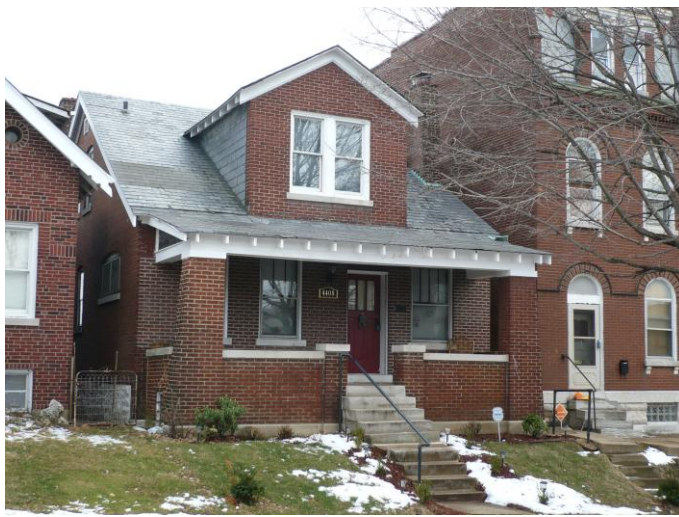
This side-gabled bungalow retains its slate roof. The full-width brick porch has a shed roof supported by 2 battered brick piers. The front door and three windows at the first story are original (two 3/s at the left side of the façade and a 4/1 to the right of the front door). At the hipped dormer there is a pair of replacement windows.

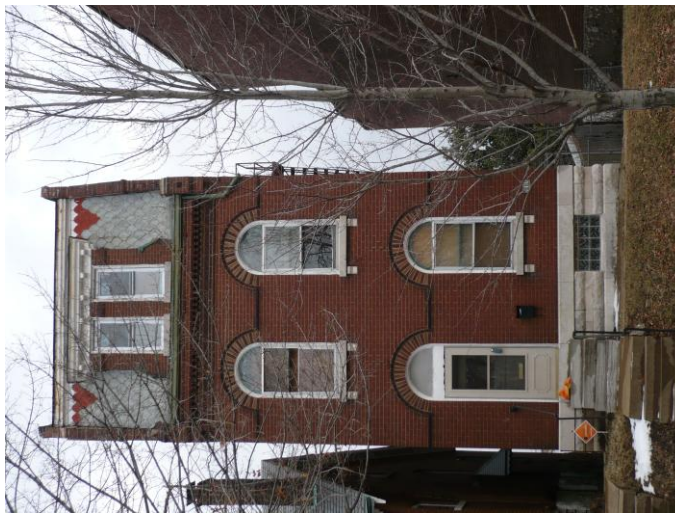
This building is shown as flats on the 1908 Sanborn map. The four façade openings are round-arched; at the first story the front door, left, has an arched transom. The window to its right and both at the second story retain 1/1 arched wood windows. Molded brick label courses at both stories. Molded and corbelled brick cornice is below a slate mansard roof which has a two-window dormer with its own bracketed cornice. The foundation at the façade is coursed limestone.

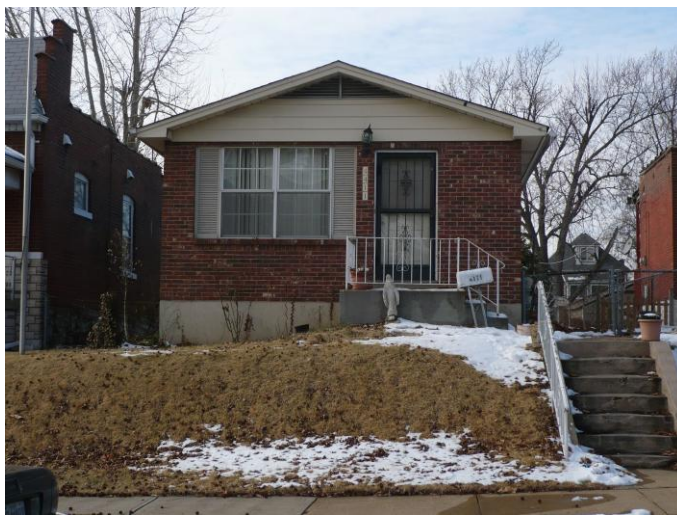
This front gabled house has a front door at a concrete stoop, right; the window set at the left is a replacement. This building replaced a frame house that was still here in 1951. The 1979 date is from the City Assessor's database.

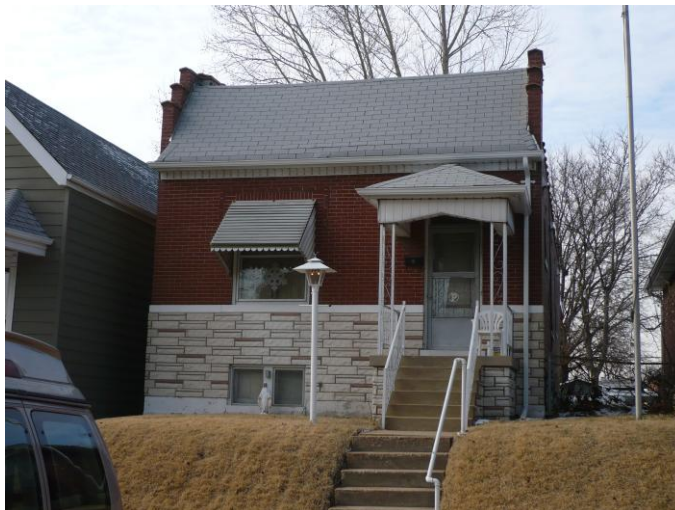
This two-bay single story house has a red brick façade, the lower half of which is covered with imitation stone veneer. The door and transom window at the right bay are original, but the hipped porch's veneered base and metal uprights are midcentury replacements. To the left is an original 1/1 window under a metal awning. A tall shingled false front roof slopes toward the façade between two stepped side parapet walls.

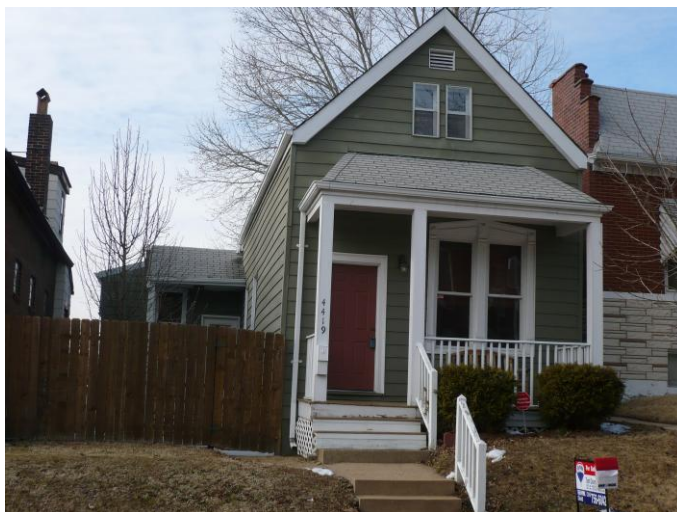
This frame house has a full-width frame porch with a hipped roof. The first floor window pair is a replacement, but retains ornate millwork surround. Attic casements appear original, and front door trim, while wrapped, is of the appropriate dimensions. There is a rear el at the left (south) elevation. This house retains integrity because its important character-defining features are intact (millwork, some windows) and because its form is completely intact. The date is almost certainly 1893; three 1.5 frame houses were built on this side of the block that year.

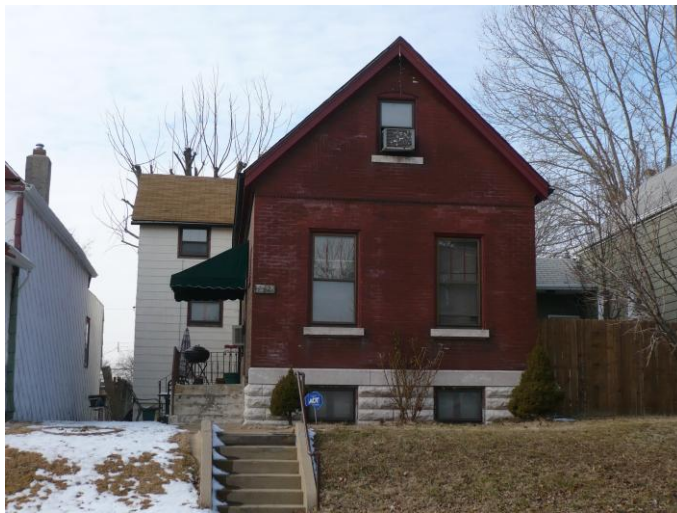
This front gabled house has a coursed limestone foundation; its façade presents two 3/1 windows to the street, with original basement window below. An ornamental pressed brick course separates the gable end. There is a frame two-story el set back off the rear off the house (left/south elevation).

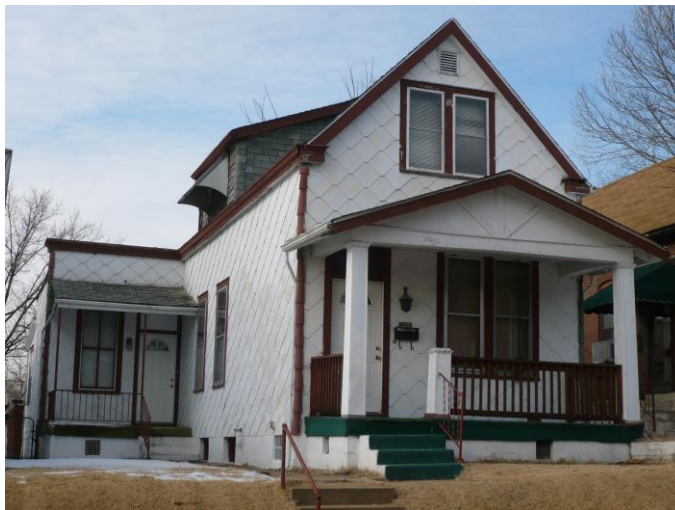
This front gabled frame building is contributing; its asbestos shingle siding may be the same shown on the Sanborn map in 1938.. The house retains original 1/1 and 2/2 windows and transom, and original millwork around windows is visible. The full-width front porch is an early addition from the Craftsman era, identified by its proportions, notched vergeboards, and the timber and stucco gable end. The front door (left) and the door in the rear el (left/south elevation) are replacements.

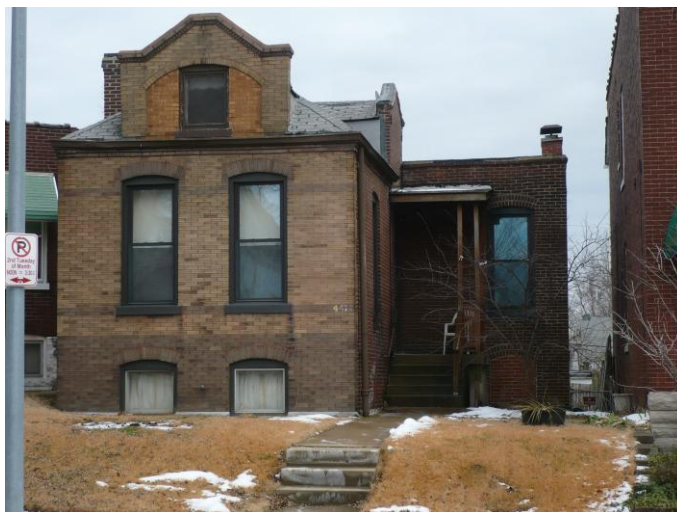
This late 19th century house has an L-shaped footprint. The main volume has two bays facing the street; both have replacement windows in segmental arched openings. The base of the façade is light brown brick. A parapet gable dormer above the façade has a wide segmental arched openings, the outer sides of which are bricked in. A similar dormer faces the right elevation from a hipped roof. The rear el at the right elevation has a flat roof. The front porch as the intersection of the wings, and the door is a replacement.

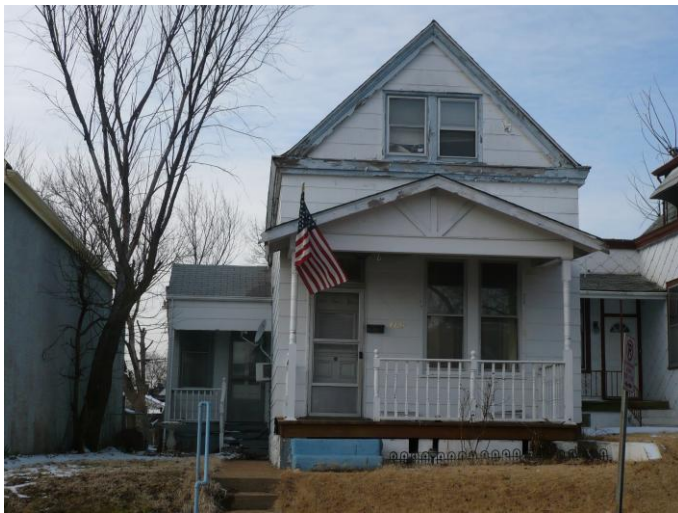
This front gabled frame building is contributing; its asbestos shingle siding may be the same shown on the Sanborn map in 1938.. The house retains original doors, 1/1 windows and transom, and original millwork. The full-width front porch is an early addition from the Craftsman era, identified by its proportions, notched vergeboards, and the timber and stucco gable end. The front door (left) and the door in the rear el (left/south elevation) are replacements.

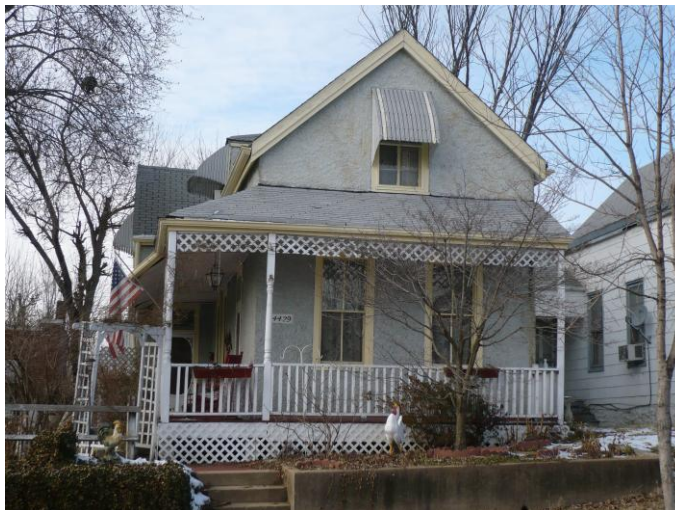
This front gabled frame building appears to have been stuccoed during the period of significance. The front porch is frame; it wraps around to the left (south) elevation, where the front door is found. At the façade are two 2/2 windows and attic window under an awning. One door is original, and the other appears to be a Craftsman-era replacement.

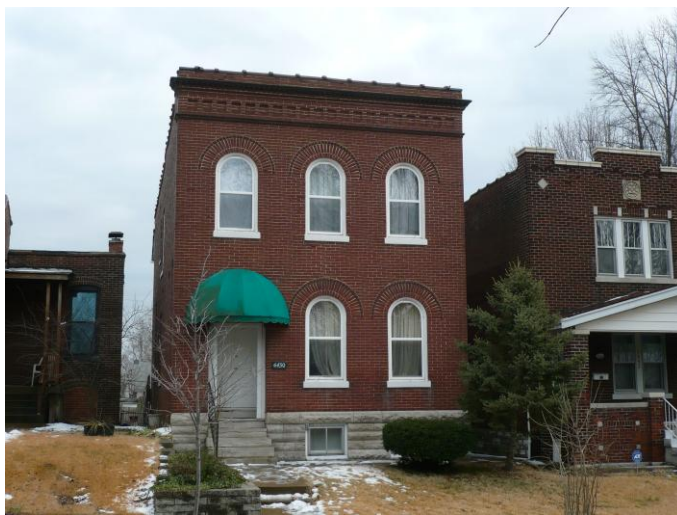
No permit was found for this building, but it appears as flats on the 1908 Sanborn map. The three-bay façade has round-arched openings at the entry, left, and the five façade windows. The cornice is brick, and the flat front parapet has clay tile coping. The foundation at the façade is coursed limestone. Replacement windows and doors.

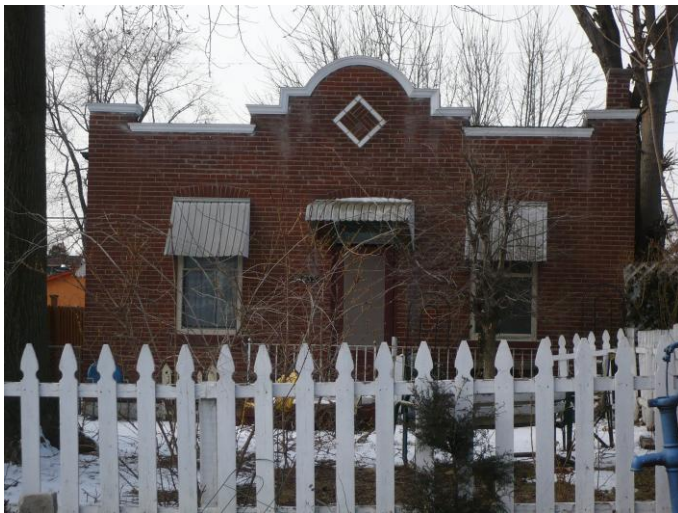
This house is set back near the rear of the lot. The front parapet wall is the chief decorative feature of this three-bay façade. The center is stepped to an arch. To either side of the replacement door there is a replacement window. Metal awnings are over all three openings. The parapet wall retains its original metal coping.

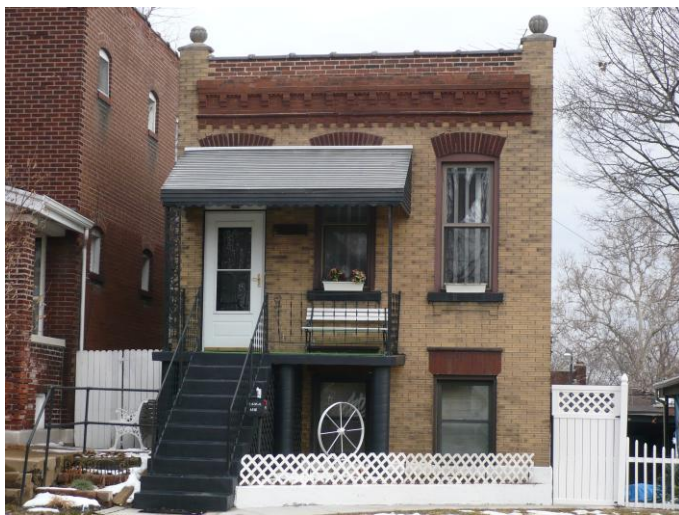
This single story house has a high raised basement. The replacement front porch is at the left two bays of the narrow three-bay façade. Its high concrete base supports metal uprights and a metal awning. Red brick forms lintels (basement) and voussoirs and a cornice. The front parapet wall is rebuilt in red brick, but original end blocks bear ball finials, likely added. Façade windows are replacements; so is the front door.

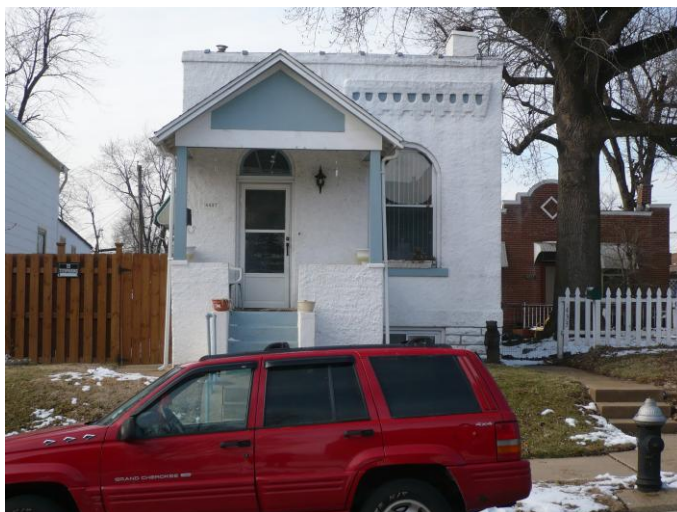
This two-bay façade has a gabled porch at the left bay; its base is brick and posts are wood. The front door (which appears to be a Craftsman-era replacement) is under a round-arched transom light. To the right, the original round-arched window opening is fitted with a new window. The cornice is simple corbelled brick. The parapet wall is flat with clay tile coping.

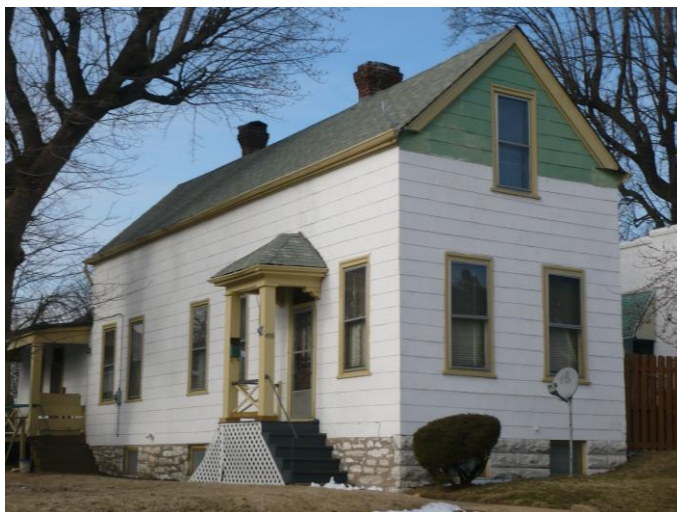
This front gabled frame building is contributing; its asbestos shingle siding may be the same shown on the Sanborn map in 1938. The front gabled house has a coursed limestone foundation; its façade presents two 1/1 windows to the street, and a third in the gable end, all with original trim. The front door is at a small hipped porch at the left elevation.

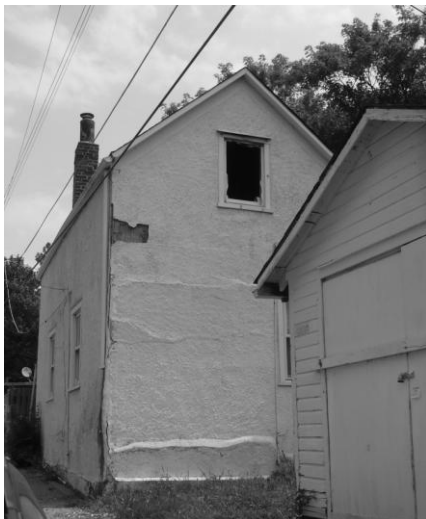
This stucco-clad side gabled house is located all the way at the rear lot line. Doors and windows are replaced, their frames covered. Metal awnings.

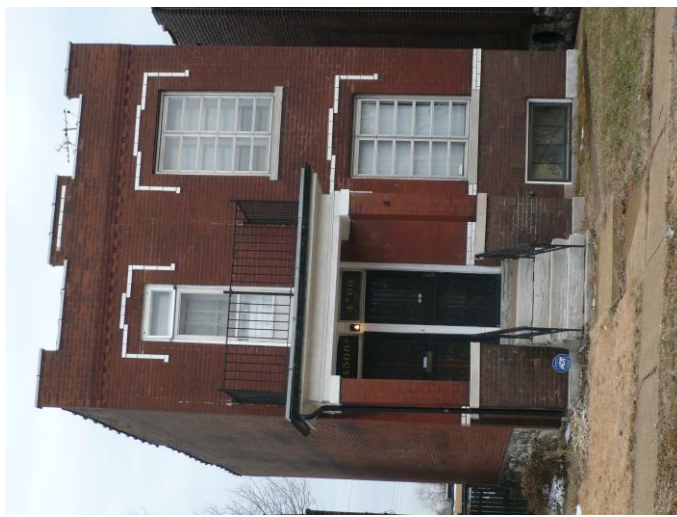
Two front doors (replacements) are at the flat-roofed brick porch at the left bay. The door above them at the balcony on the porch roof appears original. All three transoms appear original. The two windows at the right bay are replacements.

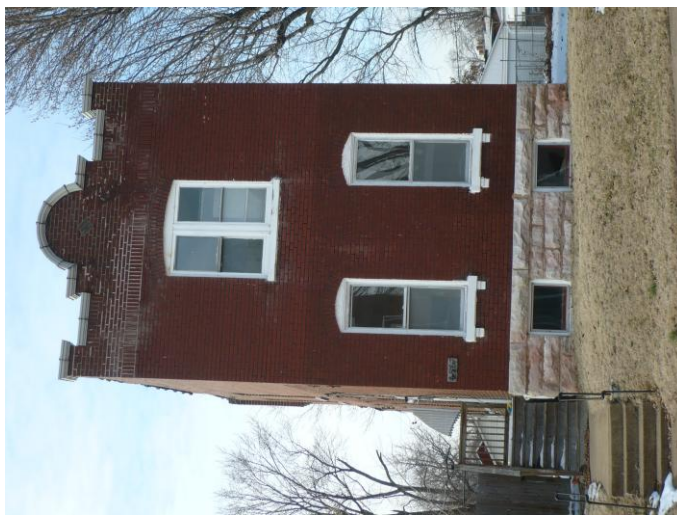
Above a coursed limestone foundation, this two story brick facade presents two wood 1/1 windows in segmental arched openings at the first story and a pair in a single wide opening centered at the second. Window surrounds retain original millwork. The parapet wall has a center step with a round-arched center. The door ( a replacement) is at a frame deck-style porch at the left (south) elevation. The permit record shows a 1914 addition, presumably the second story (not present on 1908 Sanborn map).

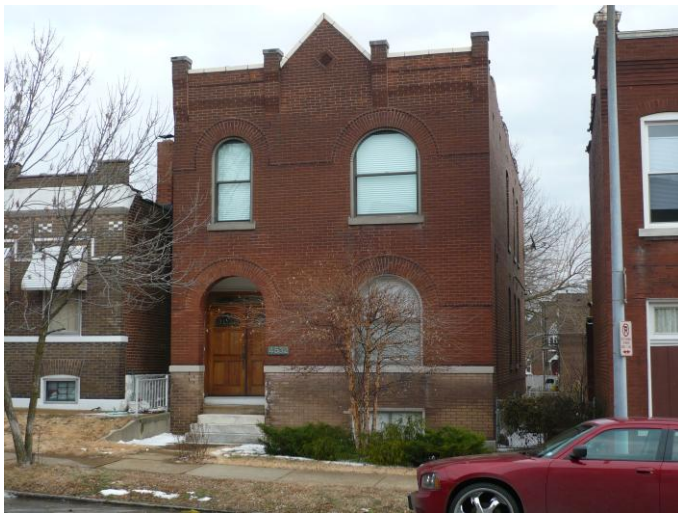
At the left bay, a round-arched opening leads to a recessed porch with two replacement doors. To the right is a 1/1 wide round-arched wood window. Both of the second floor window openings are round-arched as well but are filled with square headed replacement windows. The parapet wall has a corbelled cornice to either side of the center peak.

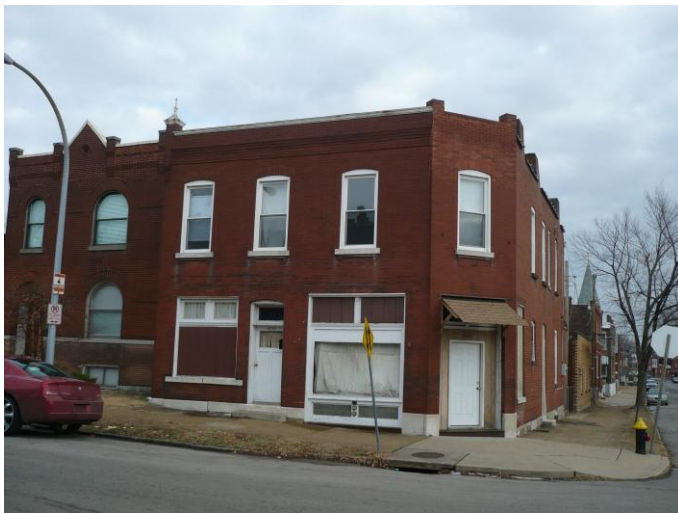
This storefront building presents a chamfered corner to the intersection; the opening within the first story is infilled with paneling and a modern white door. Both storefront windows at the Louisiana elevation retain what appears to be original millwork. The left window still has 23 open transoms but the window is boarded; the right window is open but the transoms are boarded. Between the two is a door (replacement) with original transom. Second story windows are in segmental arched openings - three at Louisiana and one facing the corner - but the windows themselves are vinyl replacements. The parapet wall retains corbelled cornice and metal coping at the Louisiana elevation, and the left end block retains its metal cap and finial.

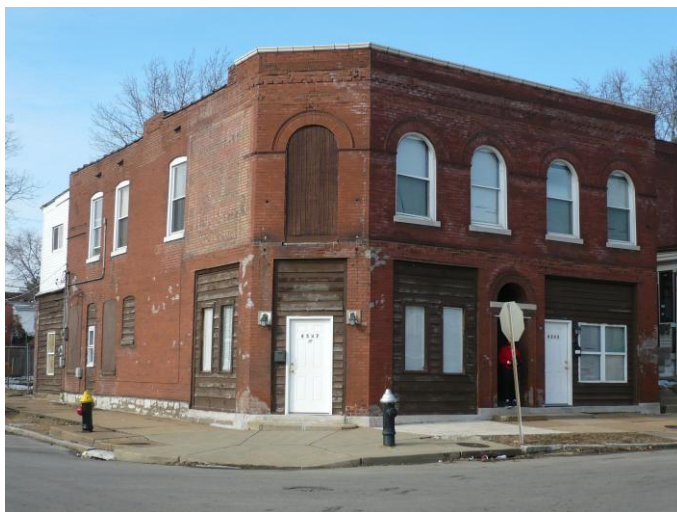
This Romanesque-inspired commercial building has a chamfered corner facing the intersection. The Louisiana elevation is articulated with a wide storefront opening to either side of a central round-arched entry to the upstairs apartments. The storefronts are filled in with wood horizontal siding and smaller modern doors and windows. The same treatment is given to the large opening facing the corner and a storefront window facing the side street. Four round-arched window openings face Louisiana, now filled in with modern windows. Facing the corner on the second story is a tall, boarded floor-to-ceiling round-arched opening which once opened on a balcony (now missing). The round-arched openings have molded brick tracing the extrados of the arches and are linked by a molded brick course at the springing point. On the side elevation, three segmental arched openings at the second floor also bear replacement windows. Above a corbelled course, the parapet wall is flat, shows signs of rebuilding, and has terra cotta coping. The side elevation is plain with clay tile coping.

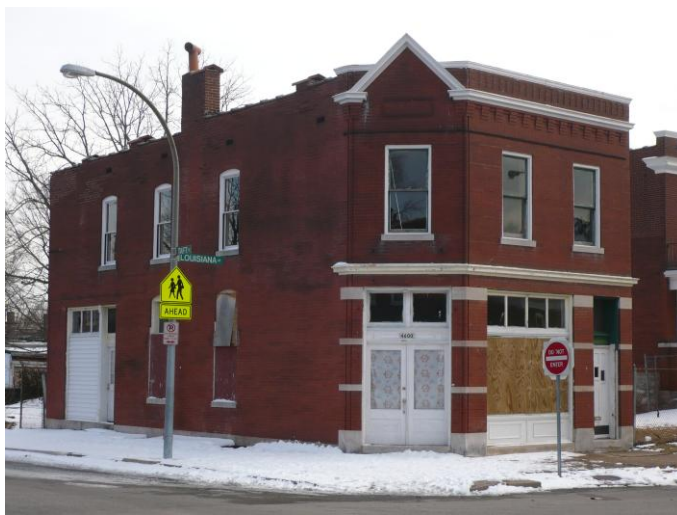
This corner storefront building has a chamfered corner facing the intersection of Louisiana and Taft. The corner opening is fitted with double doors under a pair of transoms. The second story window, like the two at the Louisiana façade and the three facing Taft, are original 1/1s. The storefront facing Louisiana has a boarded main window with paneling below and transoms above. At the right side of the elevation, a replacement door leads to the upstairs apartment. Metal cornices are over both stories at the façade. At the chamfered corner, the metal cornice has a center peak which breaks up through the parapet wall.

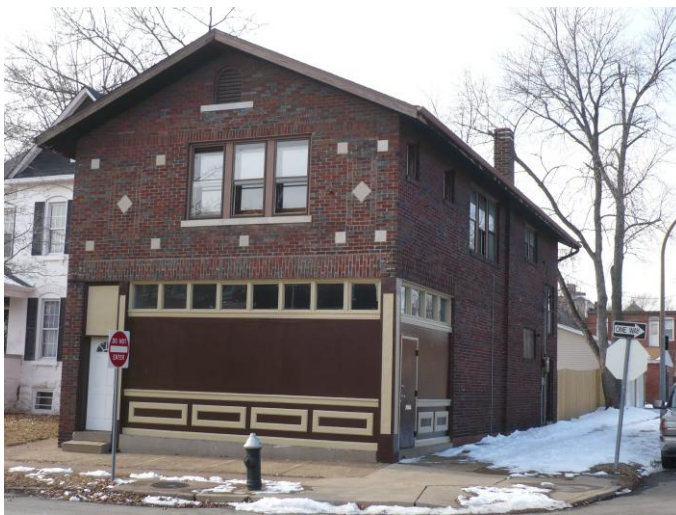
This unusual storefront building has a front gabled roof. Almost the full width of the Louisiana elevation appears as a single boarded (or paneled) window with bulkhead panels below and eight roughly square transom windows above. Cast iron piers are to either side. At the far left side of the façade there is a replacement door under a covered transom leading to the upstairs unit. The entrance to the first floor is through a replacement door in the side elevation (right/north) in a storefront which is otherwise treated as the one on the façade but only half the width. Off center at the façade's second story (centered over the storefront window) is a triple set of 1/1 windows.

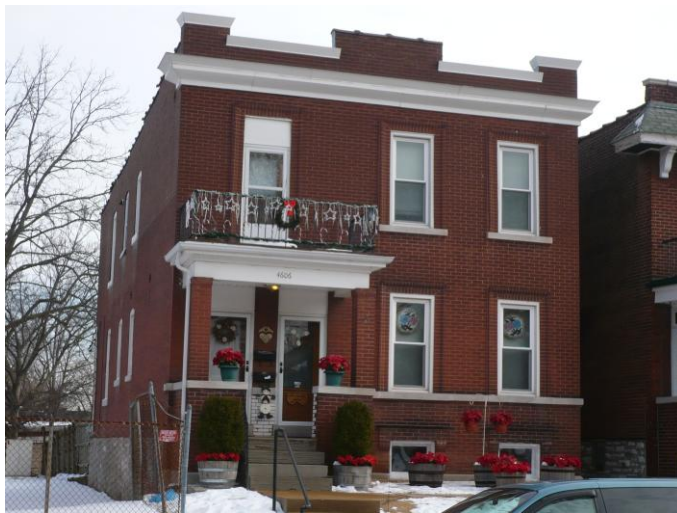
This two story red brick building has a flat-roofed brick porch at the left bay. Its roof is a balcony for the second story unit. The two front doors and balcony door are original, but their transoms are all covered. To the right, two replacement windows at each story are in brick surrounds. The metal cornice and metal coping are wrapped in aluminum.

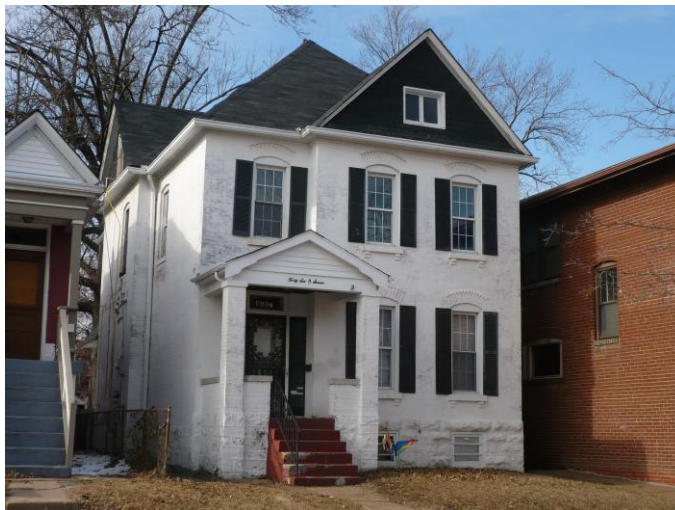
This two story brick house has a hipped main roof; the right bay of the façade projects slightly and has a front gabled roof. The gabled brick porch is at the left bay. An original 9-light door is intact and retains a transom window. The façade windows - two at the first story and three at the second - are replacements. The openings are segmental arches with rough brick voussoirs. In the gable end, the attic casement looks original, as do the basement windows. Another projecting gabled bay faces to the left (south). The 1899 date is from a building division certificate; further research could determine if this correlates with an unnumbered 1898 building permit.

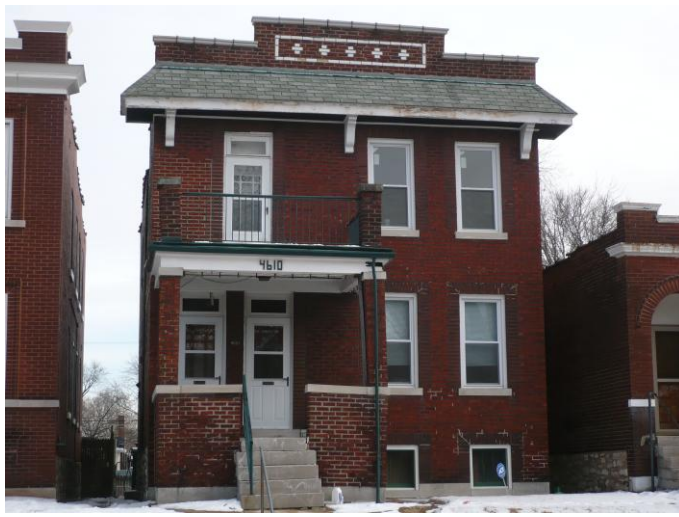
This two story red brick building has a flat-roofed brick porch at the left bay. Its roof is a balcony for the second story unit. The two front doors and balcony door are original with intact transoms. To the right, two replacement windows at each story are in brick surrounds. Above a pent roof supported on three brackets, the parapet wall has terra cotta coping.

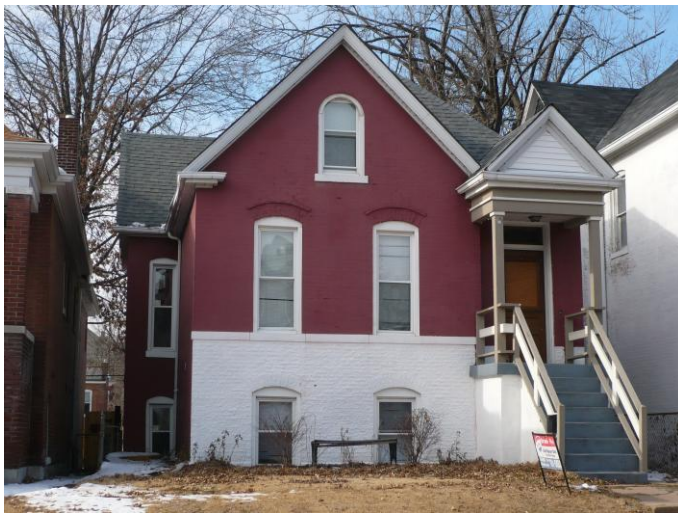
Atop a higher than usual basement, this house has a front gabled bay at the left projecting from a hipped volume. At the gabled bay, the two basement windows, the two first story windows above them, and the small round-arched window in the gable end are all new replacements. The transomed front door (original) is at a gabled porch with wood posts on a concrete base, right. The front gable has eave returns. Another gabled bay faces south at the rear of the left/south elevation. The 1899 date is from a building division certificate.

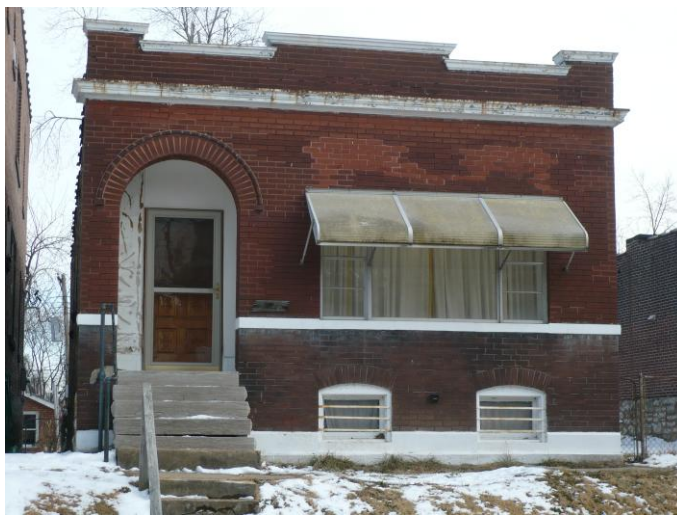
This single story house has a round-arched entry to a recessed porch at the left bay. The front door is a replacement. To the right, the two original window openings have been reconfigured; the tops are bricked in and the space between them opened up to accommodate a midcentury aluminum picture window. Basement windows are original as is the metal coping at the parapet wall.

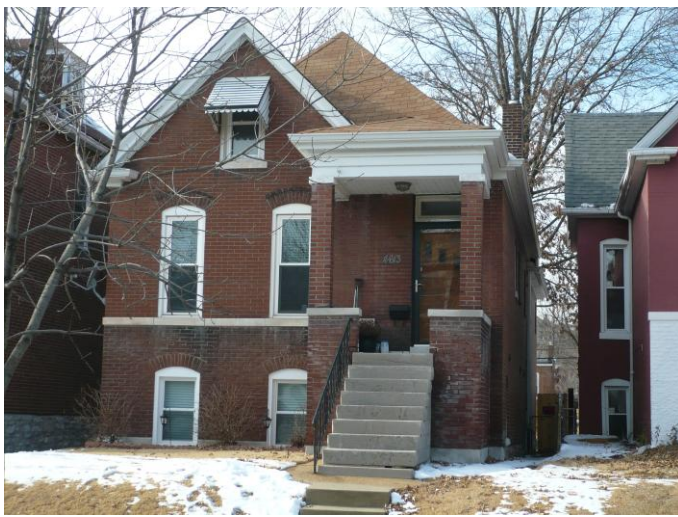
Atop a higher than usual basement, this house has a front gabled bay, left, projecting from a hipped volume. At the gabled bay, the two basement windows, the two first story windows above them, and the small round-arched window in the gable end are all new replacements. The transomed front door (not original) is at a brick porch, right. The front gable has eave returns. Another gabled bay faces south at the rear of the left/south elevation. The 1899 date is from a building division certificate.

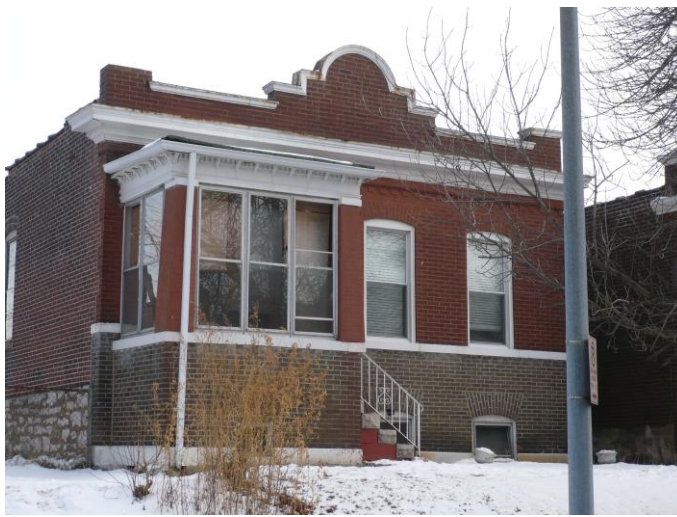
This single story house has a brick porch at the left bay. The front door and two windows (right) are replacements. Above the metal cornice, the parapet wall has a center step with a rounded center section, and metal coping remains at all escape the left end block. The porch is enclosed with storm windows.
