# Dutchtown South Community Corporation Dutchtown South Neighborhood Survey

Lynn Josse and NiNi Harris  
8/5/2010

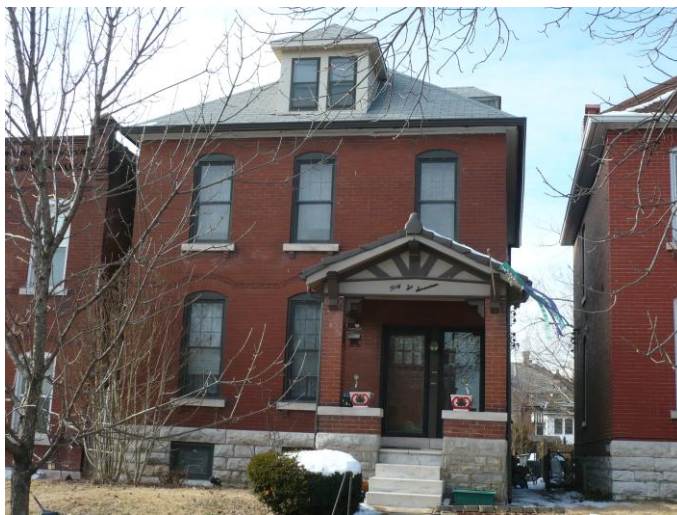
This square house type is similar to a foursquare but has three bays. Both the permit and 1908 Sanborn map indicate that it was originally a single dwelling. The façade's base is coursed limestone. The two front doors are early Craftsman-era additions replacing the original single door. The brick front porch, right, has a gabled roof with ceramic tile; its front gable end retains stucco and stickwork and its eaves are supported on two brackets. The two windows at the first floor and three at the second are replacement 1/1s in segmental arched openings. A hipped dormer faces the street.

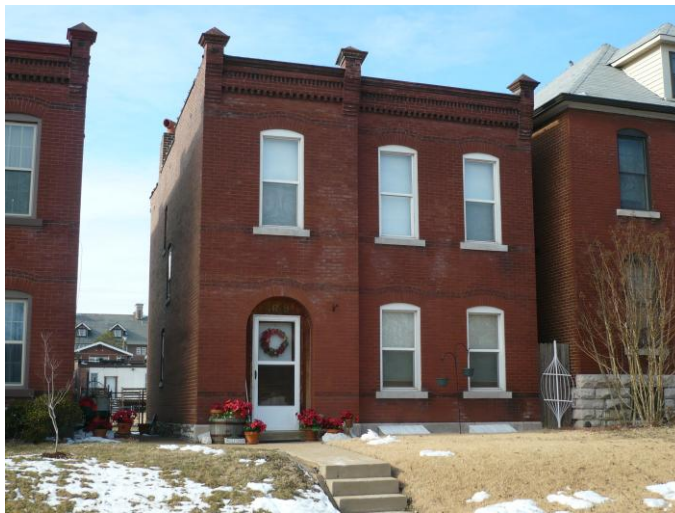
This house and the one next door at # 4623 are near twins, permitted at the same time. The front door is original, recessed slightly in a round arch at the slightly projecting left bay. There is a single window above it, and two at both stories of the right bay. The window openings are topped with segmental arches, and the windows within are replacements. Molded brick forms sill courses connecting the stone sills. Above a corbelled cornice the parapet wall retains metal coping.

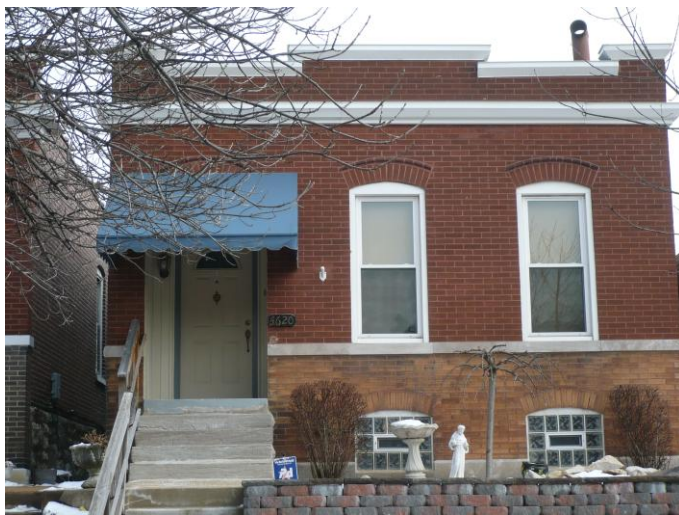
This single story house has a round-arched entry to a recessed porch at the left bay. The front door is a replacement. To the right, the two original segmental arched window openings have been filled with replacements.

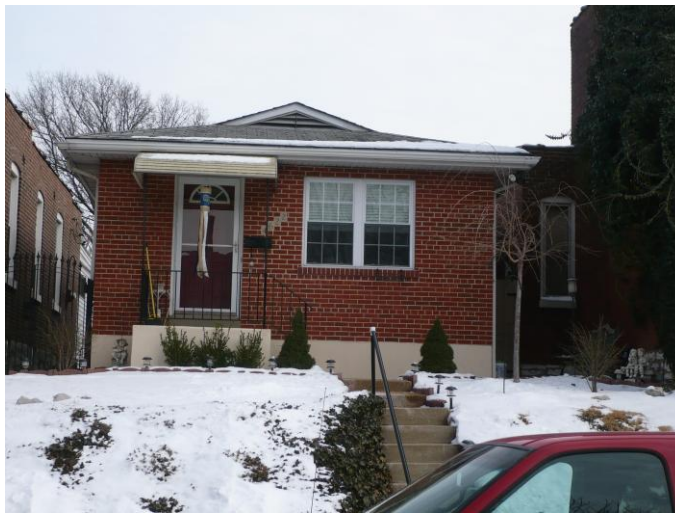
This midcentury house has a red brick exterior. The front door at5 the left bay is a modern replacement, as is the window pair at the right.

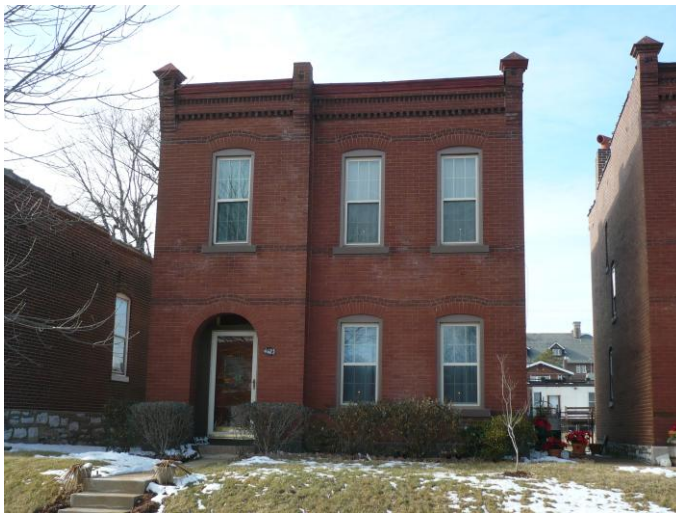
This house and the one next door at # 4619 are near twins, permitted at the same time. The front door is original, recessed slightly in a round arch at the slightly projecting left bay. There is a single window above it, and two at both stories of the right bay. The window openings are topped with segmental arches, and the windows within are replacements. Molded brick forms sill courses connecting the stone sills. Above a corbelled cornice the parapet wall retains metal coping.

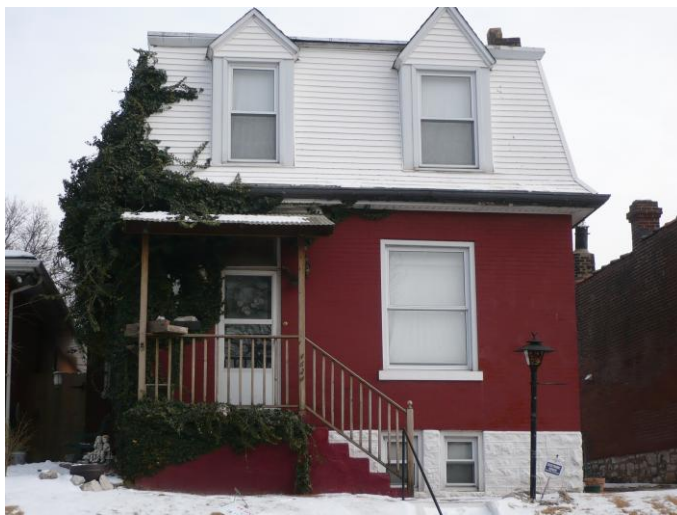
This house's façade has a painted brick first story and a mansarded second. The front porch, left, is a concrete base with wood railings and a fiberglass roof. The front door is original and retains a transom. The window at the right bay is a replacement. The two front dormers have gabled roofs, the right is both wider and steeper than the left, and both windows are replacements. The mansard is clad with modern horizontal siding.

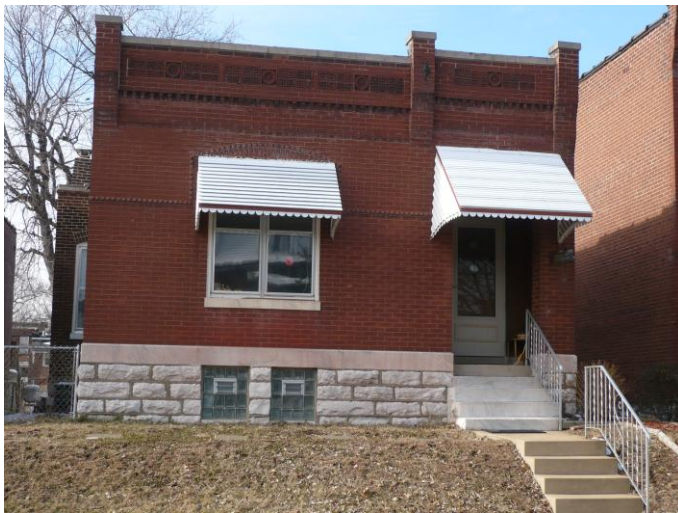
This single story house has a rock-faced coursed stone foundation at the facade. The front door is recessed at the right bay. To the left is a wide window opening. Both openings are obscured by metal awnings, but the window appears to be a replacement. The cornice is formed of corbelled and pressed brick.

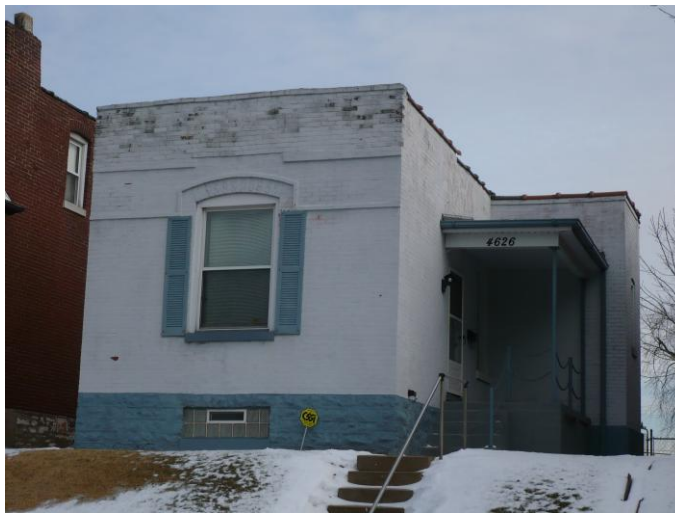
This simple house has a side door at the right (south) elevation just in front of a narrow rear el. The door is original and retains a transom window. The porch is not original. At the façade, above a limestone foundation, a single wide segmental window opening is embellished by a molded brick label course. The parapet wall has been rebuilt and is now flat.

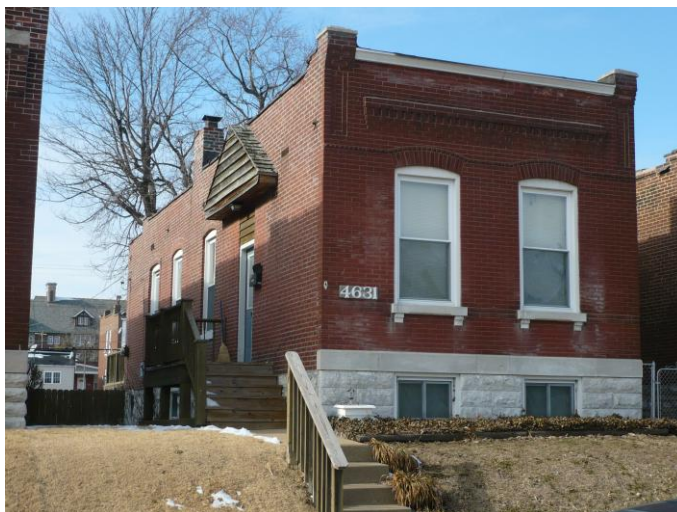
This single story house has a rock-faced coursed stone foundation at the façade. The front door (a replacement) is at the left (south) elevation at a new wood stoop, topped by the shallow remnants to a gabled roof. The two segmental arched window openings at the façade are filled with new windows. There is a sill course and a label course of textured brick. And a corbelled brick pattern as a cornice,.

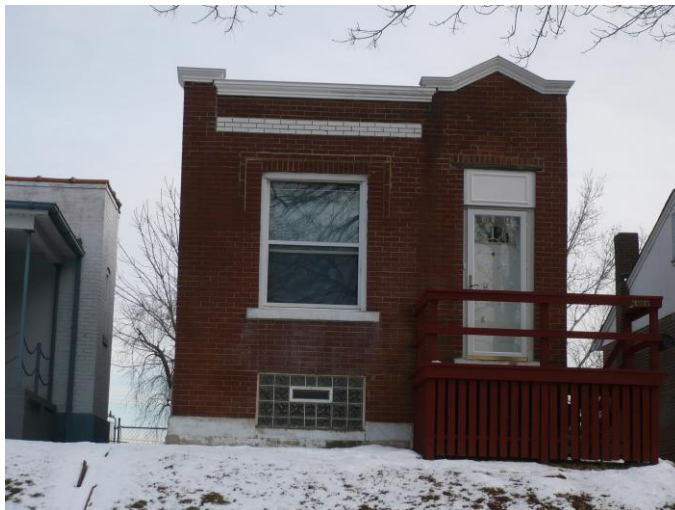
The narrow façade of this house has a narrow entry bay, right, defined by a slightly higher section of parapet wall with a shallow peak. At the left, the wide 1/1 window is a replacement. Instead of a cornice there are three courses of enameled white brick. The coping is metal.

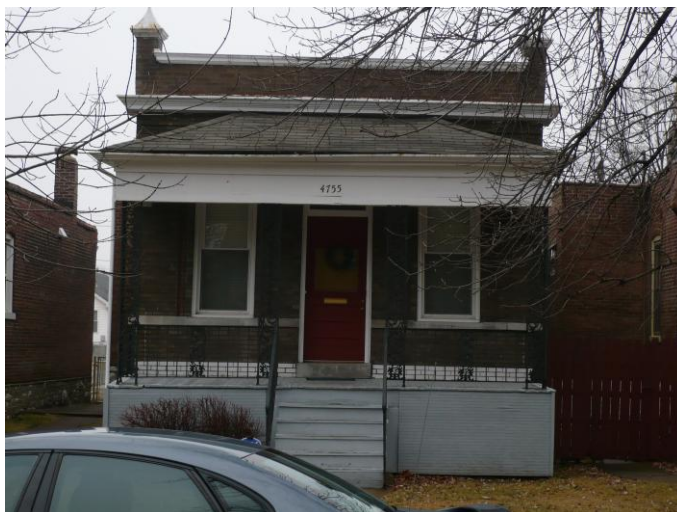
This house was constructed by the same owner and builder as the three to the north, but it was permitted six months later and was more expensive. The front door is centered. Both the door and its transom look original, but the windows to either side are replacement vinyl 1/1s. They are framed with simple molded brick. The frame full-width porch was present on the 1908 Sanborn map, but has been altered with metal supports and many replacement wood parts. The front parapet wall retains its metal coping and small pyramidal finials.

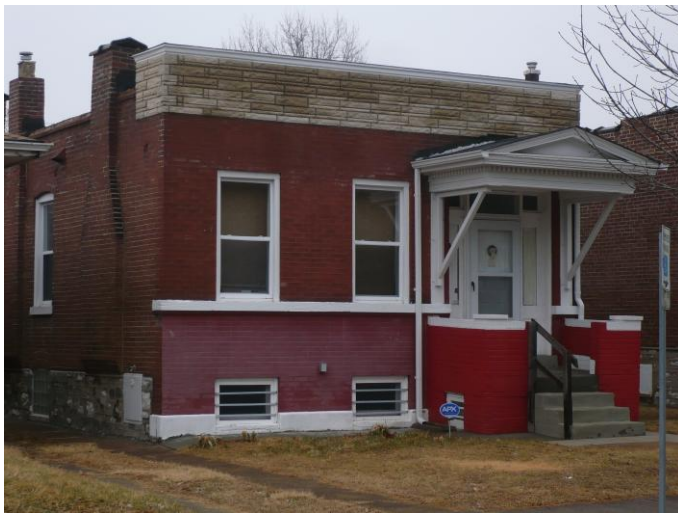
At this three-bay house, the front door and sidelights are all transomed at the right bay. The door itself is a replacement. The brick porch base is intact but its gabled roof is now supported on deep, utilitarian knee brace brackets. The dentilled entablature is original. At the left, two windows are vinyl 1/1s. The cornice/parapet area is now covered with imitation stone veneer.

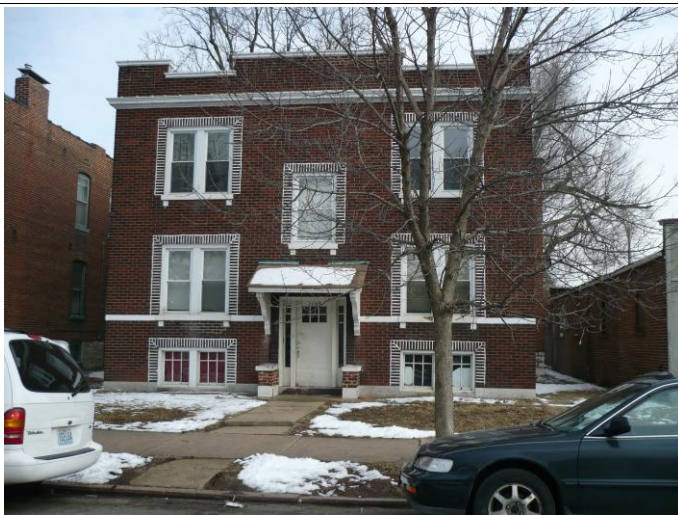
This three-bay walkup building has a symmetrical dark brick façade. The front door, located at grade in the center bay, is an original with 6 lights high in the door (it is possible a large pane below these is covered with wood). The sidelights reflect the door's design, with two square panes over a long one. The entrance is sheltered by a shed hood on two brackets. Above the door between stories is a window. At the left and right bay, window pairs at the first and second stories are replacements and basement casements appear original. Each of the window openings has a surround of stretchers along the sides and soldiers across the top with mitered corners; the mortar is now painted white, emphasizing these features. Over a terra cotta cornice, the parapet wall retains terra cotta coping.

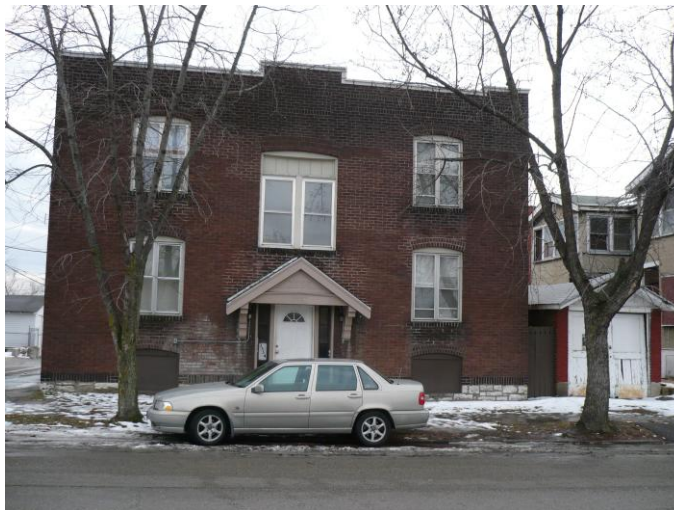
This simple, relatively small four-family building has a symmetrical three-bay façade. The front door (a replacement) is at grade, centered under a bracketed gabled hood. Above the front door between stories, a pair of windows has a boarded transom. At the first and second story of the left and right bay is a single segmental arched window opening. It appears a single wide 1/1 is within each, obscured by a pair of modern storm windows. Both basement windows are boarded. Above the limestone foundation is a brown soldier brick course. The front parapet wall has a center step, steps at either end, and terra cotta coping.

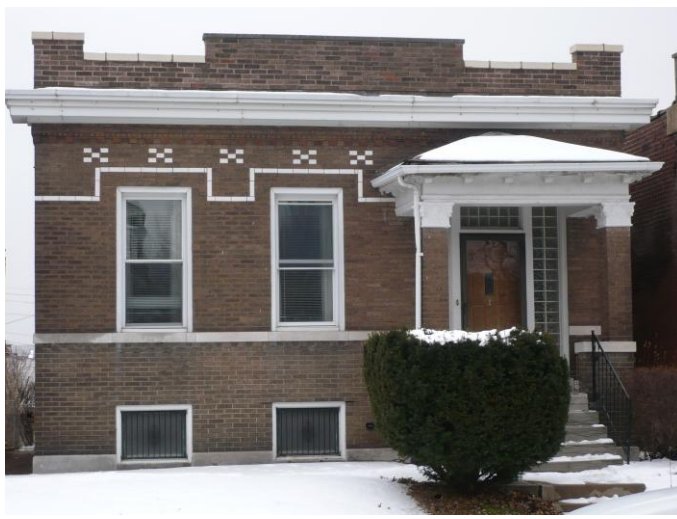
This house has a brown brick façade and common red brick side elevations. The hipped brick porch, right, shelters a replacement front door with glass block sidelights and transom lights. To the left, two 1/1 windows rest on a limestone sill course. White enameled brick forms a label course below a metal cornice. The parapet wall has a wide center step and end blocks, and terra cotta coping.

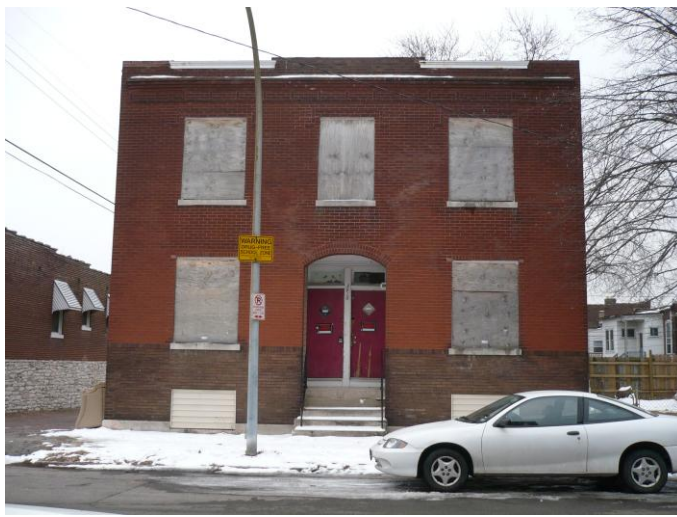
This building faces Taft at the alley. Its base is brown brick to the level of the first story window sills; walls above are red brick. At the center of three bays, steps lead into a recessed porch with a segmental arched opening. Front doors are replacements. Wide window openings at both stories of the left and right bay, and a slightly narrower one at the center bay's second story, have stone sills and square heads with brick labels. The front windows are boarded. Above a corbelled brick cornice, the parapet wall's end blocks and center step have been sheared off.

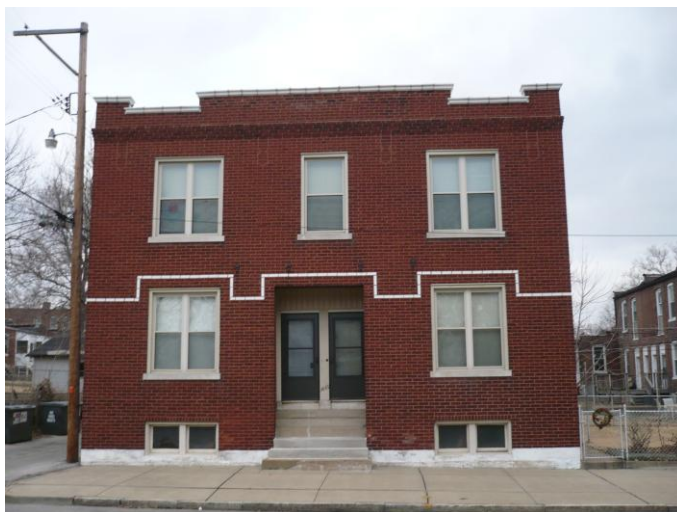
This building has a symmetrical red brick façade. Original doors are recessed behind the center opening. The doors and transoms are original. To either side at both stories are wide window openings with replacement window pairs; a single replacement window is over the front entry. Terra cotta coping at stepped parapet wall over a four-course corbelled cornice.

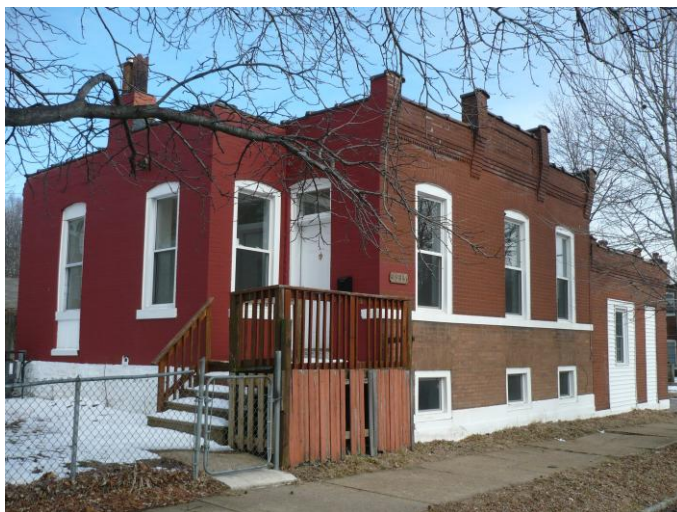
This brick house has a three-bay façade facing Taft. The cornice and parapet facing Taft are symmetrical, with brick corbels rising to a center parapet panel. Below, the window are unevenly spaced on a limestone sill course. Above the sill course the brick wall is red; the base is tan. At the right side of the façade, a single story storefront addition has a boarded door and wide door or window at grade. The corbelled cornice is similar to the main house, but much lower. The front door faces west, and an additional bay is set back at the left elevation. Door and windows are replacements, and the left elevation and wing are painted.

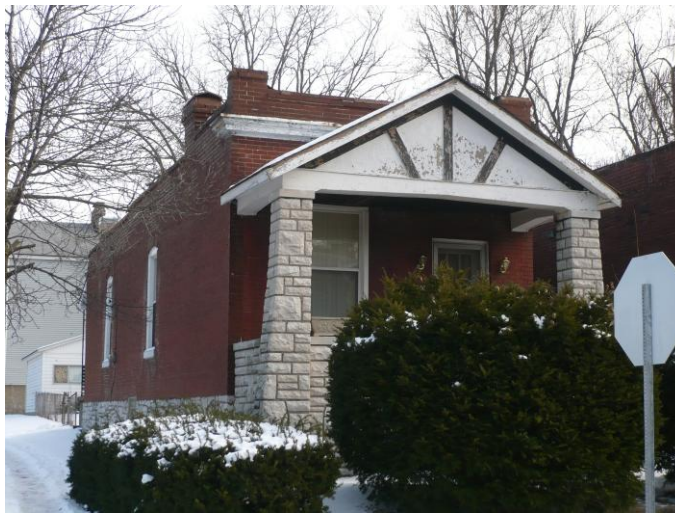
The gabled full-width limestone front porch is an addition to this front parapet house. Two battered limestone piers support a gabled roof which retains stick and stucco work in its gable end. The front door, right, appears to date from this period. The window to the left is a more modern replacement.

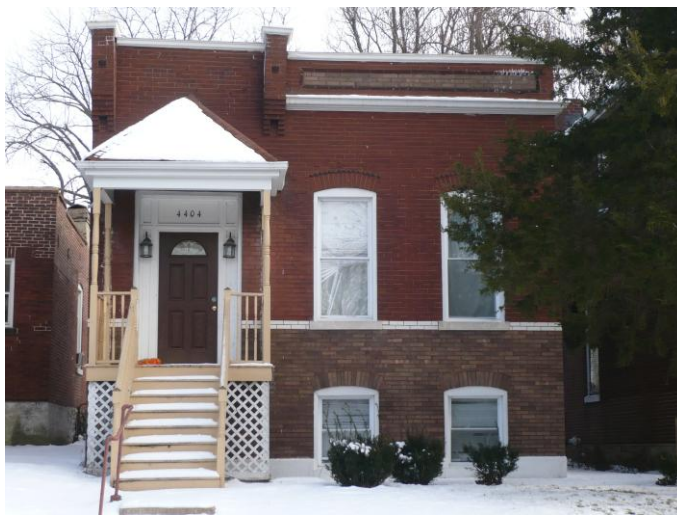
This house has a second front door under the front porch leading to the basement level. The porch at the left bay is frame (nonhistoric) with a hipped roof. The door itself is a contemporary replacement, its sidelights and transoms now filled in. The two windows at the first story and two basement windows below them are replacements in segmental arched openings. The left (entrance) bay is defined at the parapet wall with corbelled out blocks, and the parapet itself is slightly higher. At the right bays, there is a metal cornice above which a light brown brick panel is outlined by dark enameled bricks. Metal coping is intact.

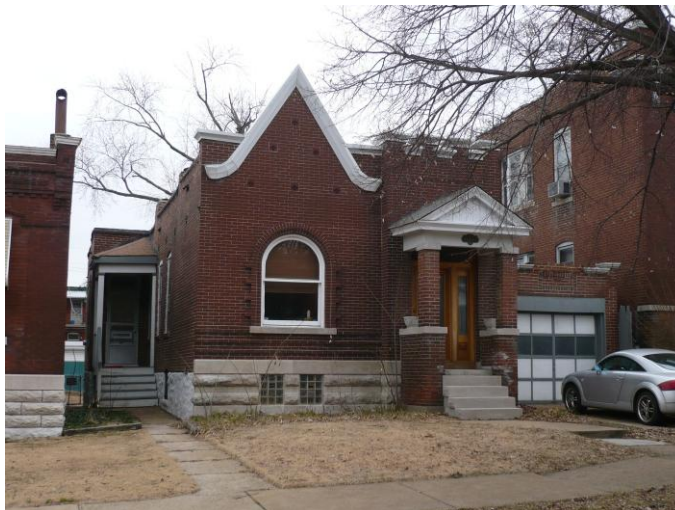
This interesting single story house has a two-bay façade with a limestone base which alternates rock-faced and smooth courses. The front porch is at the slightly projecting right bay. The brick porch (added in 1925) has a gable roof with closed pediment. The door, sidelight and transom appear original. At the right bay, a wide round-arched window retains its original 1/1 sash. The brickwork is elaborate, with brick laid in raised quoins to either side of the window and double recessed courses under it. The left bay's roofline is a tall gable that rises above the flat part of the parapet wall; its brick surface is decorated with well-space terra cotta/brick tile with raised fleur-de-lis patterns (6 total), and the gable is defined by a metal cornice which serves as the coping where the gable breaks the parapet line. (This feature is now wrapped in aluminum.) The right bay's parapet wall is crenellated. There is also a rear el at the left bay with a hipped porch and original door. The brick garage to the right is attached; it is shown as a free-standing garage on earlier Sanborn maps. The door faces the front.

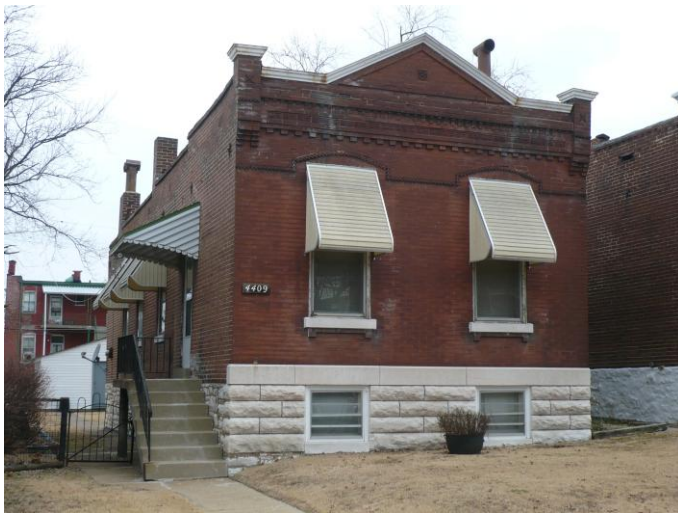
This house has a rock-faced coursed limestone foundation under the two-bay red brick façade. Two original 1/1 windows are set on stone sill. Molded brick is used as a label course and at the corbelled cornice. The parapet wall has a center peak and metal coping. The front door is at a stoop at the left (south) elevation; the door is original. South and east openings have fiberglass awnings.

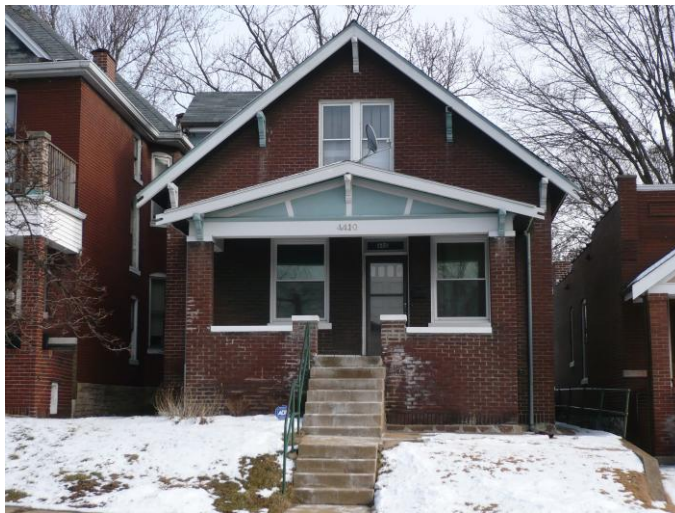
This front gabled house has an almost full-width brick porch. Eaves at both the porch's gable roof and the main roof are supported on wood brackets. The porch gable end retains its stick and stucco finish. The front door (a replacement) is off center to the right with a wide replacement window to either side. There is another window pair (original 3/1s) in the gable end.

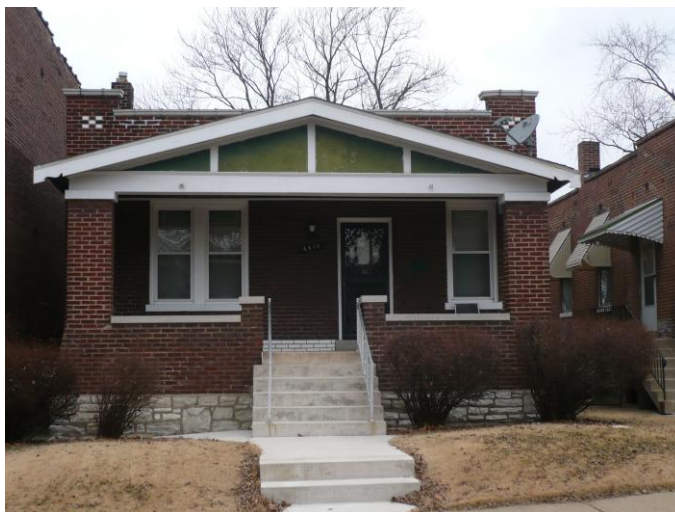
This house has a front parapet wall like many in the neighborhood, but it also has a full-width brick porch with a gabled roof. The porch roof retains stickwork and stucco in the gable end. The front door to the right of center is original, but the windows (paired at the left and a single at the right) are 1/1 replacements.

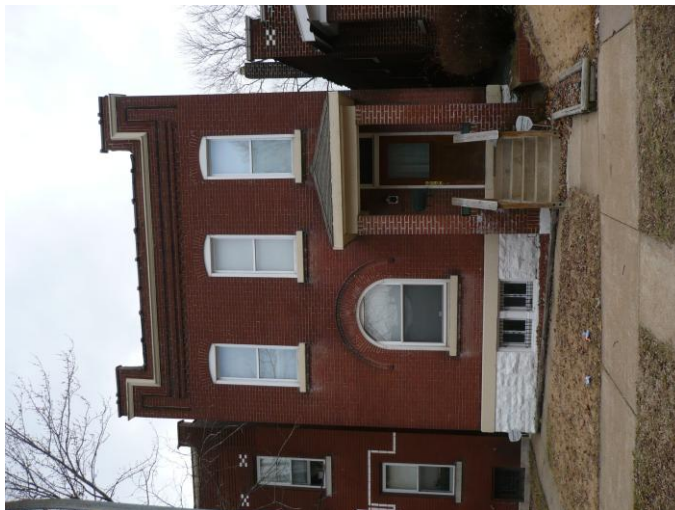
This red brick building is shown as flats on the 1908 Sanborn map. At the basement level of the façade, the limestone foundation is painted white. The hipped brick porch at the right bay replaces the earlier frame porch (date unknown). The front door and transom are original. To the left, there is a wide round-arched window opening with a replacement window within. At the second story there are three replacement square headed 1/1 windows in segmental arched openings. Molded brick outlines the first story arch and forms an unusual course at the parapet wall. There is a cyma recta course which follows the end steps of the parapet; the parapet wall has clay tile coping.

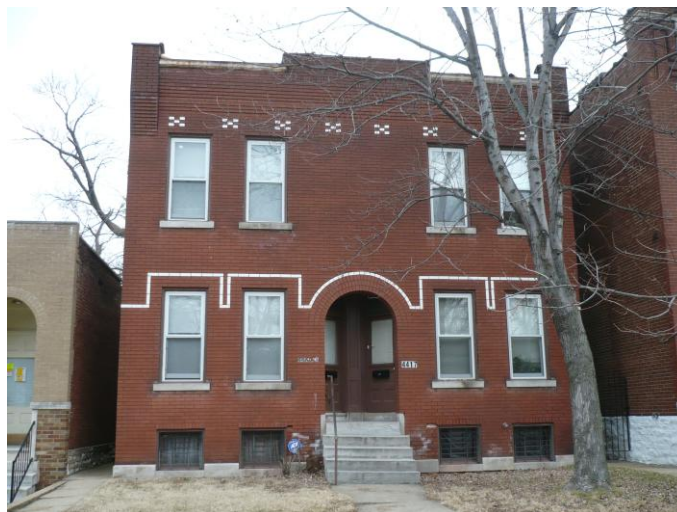
The 1938 Sanborn map indicates that this building was double flats. The two front doors are angled toward each other behind a round-arched entry. The doors and transoms are original. The second story wall above the entry is blind. At the outer bays at both stories, there are two 1/1 replacement windows on stone sills. The top 12 or 13 courses at the parapet wall corbel forward slightly; the end blocks even further. The metal coping is intact at part of the wall.

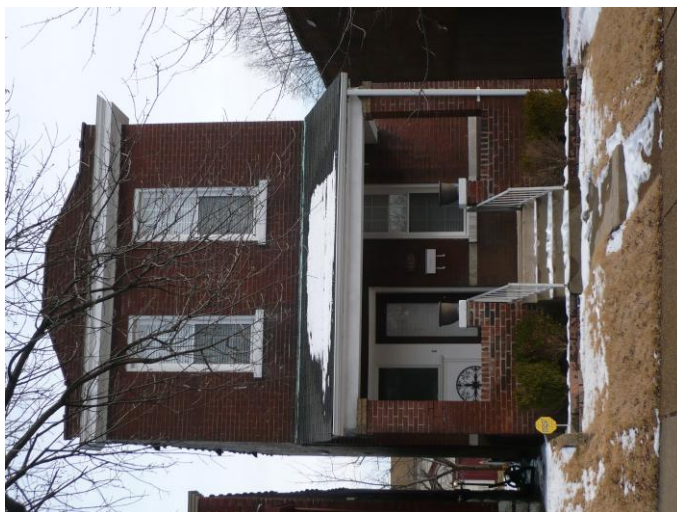
The full-width shed-roofed brick porch may the result of a permit from 1911 for a \$977 addition. The Sanborn map shows that by 1938, this single family home had been converted to flats. At the left bay, the front door appears original. The second door opening to its left is half filled with a window. The 1/1 window to the right and the two at the second story are replacements. The front parapet wall has what appears to be a truncated center peak with clay tile coping.

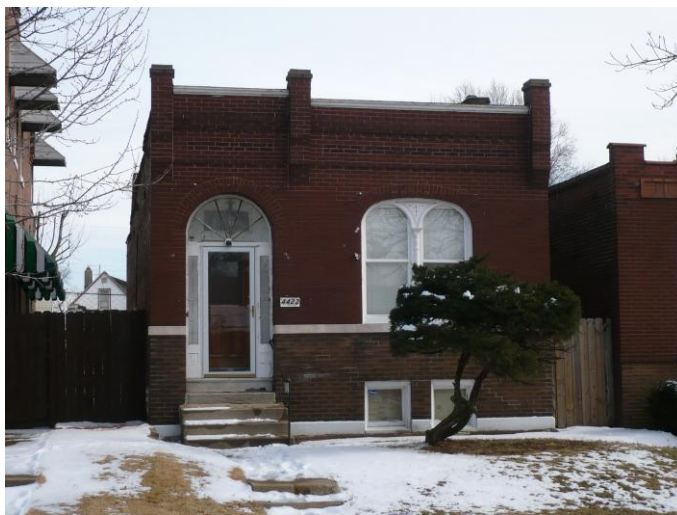
This house has a recessed front porch to the left behind a round-arched opening which is filled in with a storm door and windows. The front door and transom are original. To the right, A wide window with a semielliptical arch retains the original millwork defining two round-arched windows, but the windows themselves are replacements. The left (entrance) bay is defined at the parapet wall with corbelled out blocks, and the parapet itself is slightly higher.

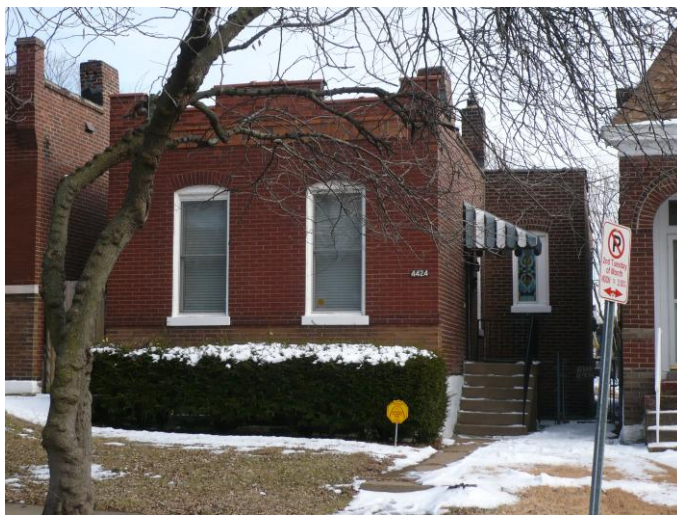
The narrow façade of this house has two replacement windows in segmental arched openings under a rebuilt brick cornice. The front door (replacement) and transom are at the right (south) elevation at a concrete stoop under a metal awning.

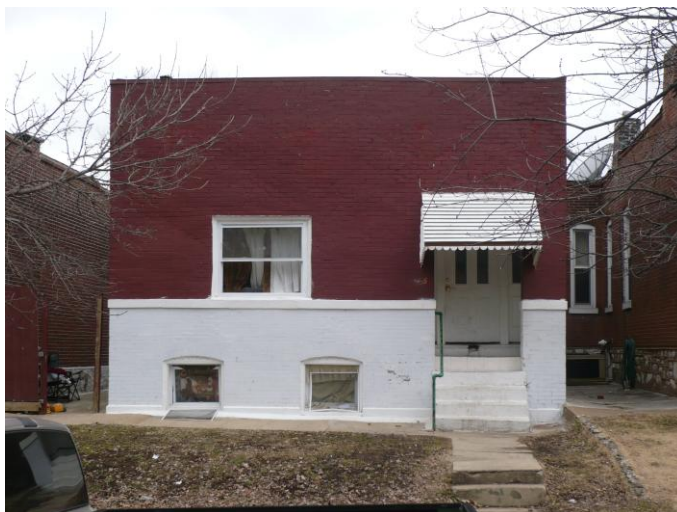
This is one of several single story brick houses in the survey area that received extensive façade alterations. Here, there is still a recessed porch at the right and a window at the left, but the window is more horizontal than vertical. The front door is a replacement. The upper façade and parapet are rebuilt. The parapet wall is flat. Contributing status would be determined by the date of alterations (as yet unknown), but it appears likely that this building was altered late and is noncontributing.

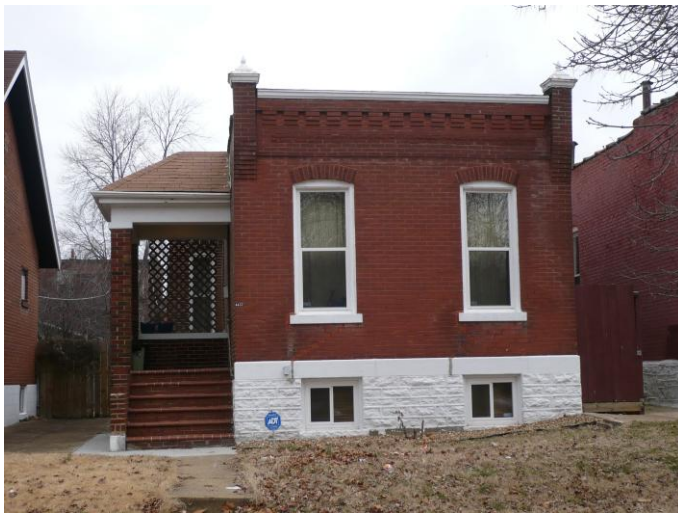
This house has a limestone foundation at the two-bay façade. There are two replacement windows in tall segmental arched openings on stone sills. The corbelled brick cornice has two corbelled out end blocks with flared pyramidal metal caps. A hipped brick porch at the left (south) elevation is a replacement, appearing to date from c. 1925. The front door is a replacement.

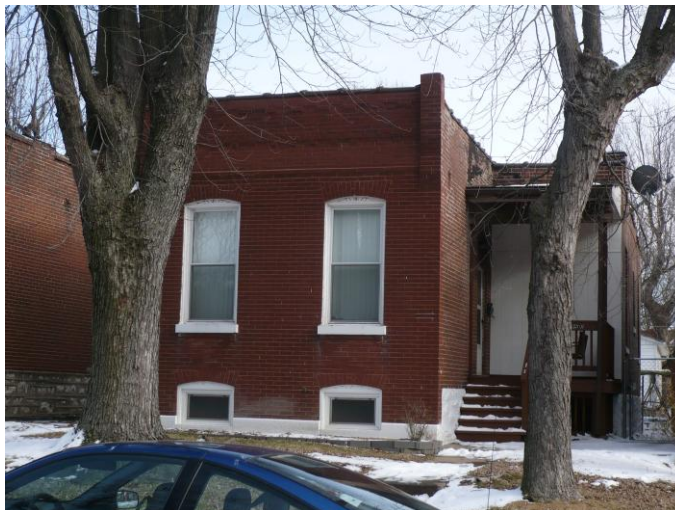
This house has a red brick façade; the front door is at the right (south) elevation. There is a rear el at the south elevation; the porch is new frame. The two windows at the façade are replacements in segmental arched openings; there is a corbelled brick cornice above them.

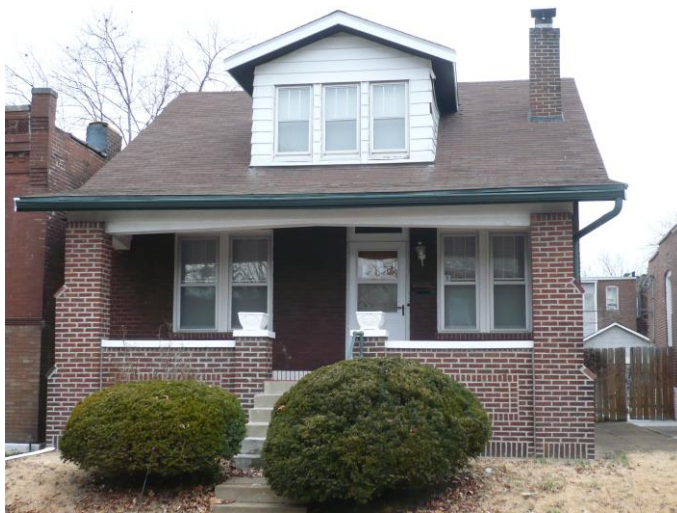
This side-gabled bungalow has a full-width porch nestled under a lower-pitched front extension of the main roof. The transomed front door (a replacement) is just to the right of center. Paired 3/1 windows are to either side. There is a front gabled dormer with modern horizontal siding and a triple set of 3/1 windows.

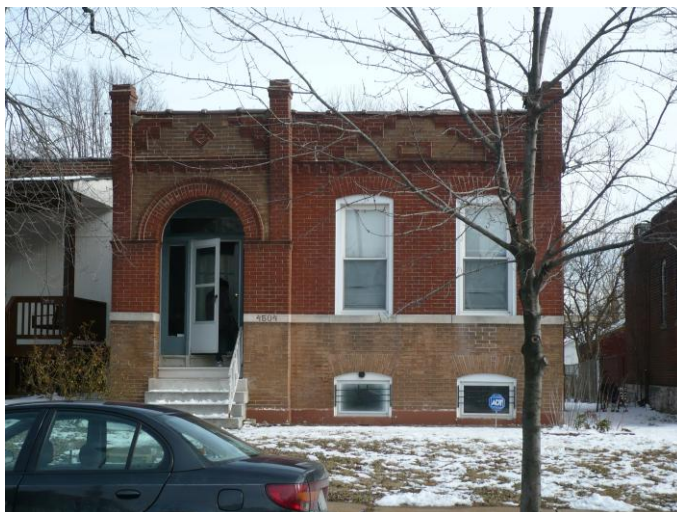
This house has a recessed front porch to the left behind a round-arched opening. The front door, beveled glass sidelights and transom are original. To the right, two replacement 1/1 windows are in segmental arched openings. The left (entrance) bay is defined at the parapet wall with corbelled out blocks. Light brown brick matching the base of the façade is laid in a step pattern, and it appears that the parapet walls have been truncated.

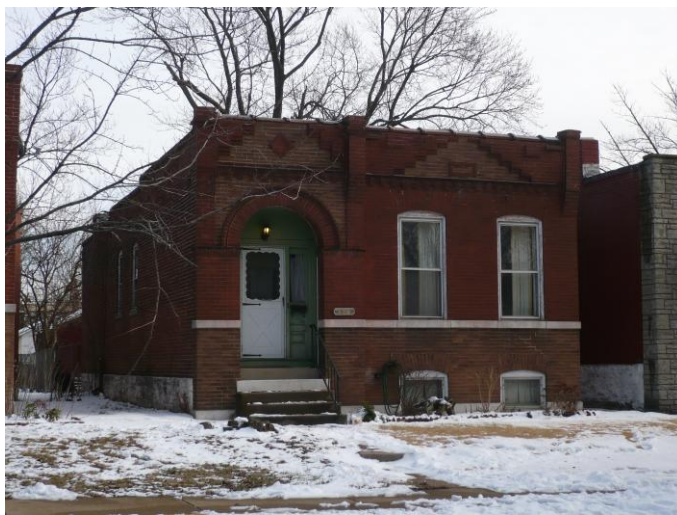
This house has a recessed front porch to the left behind a round-arched opening. The front door, sidelights and transom are original. To the right, two replacement 1/1 windows are in segmental arched openings. The left (entrance) bay is defined at the parapet wall with corbelled out blocks. Light brown brick matching the base of the façade is laid in a step pattern, and it appears that the parapet walls have been truncated.

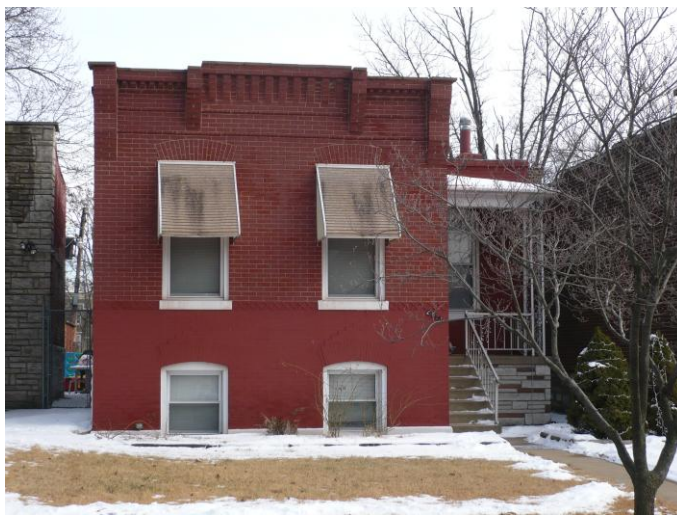
This building has a side door at the right (south) elevation; there is an el at the rear of that elevation. The porch is a concrete replacement with imitation stone veneer over the base and metal uprights. At the façade, two segmental arched window openings are fitted with replacement 1/1 windows under fiberglass awnings. The cornice is corbelled brick.

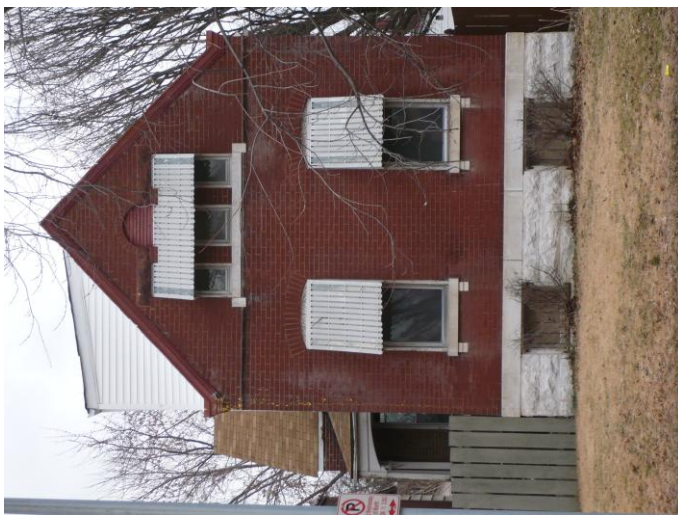
This house has a painted rock-faced coursed limestone foundation at the façade. There are two replacement 1/1 windows in segmental arched openings on stone sills; they are obscured by metal awnings. The front-gabled façade has a Palladian window arrangement in the gable end; the small 1/1 windows appear original, but the top of the arch is filled in with siding. The front door is at a hipped frame porch at the left (south) elevation. Some of the wood elements of the porch appear original. The door is a transomed replacement. Along the south side of the roof there is a large shed dormer.

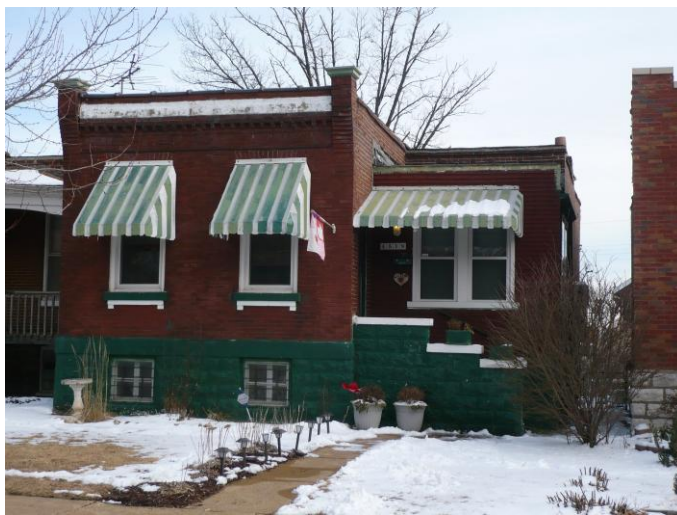
This L-shaped house has a stone and brick façade with two segmental arched window openings. They have replacement windows and metal awnings. At the right (south) elevation, the original porch is enclosed and a new stoop with cast stone base added in front. The door is not original. The corbelled brick cornice has corbelled end blocks with metal caps.

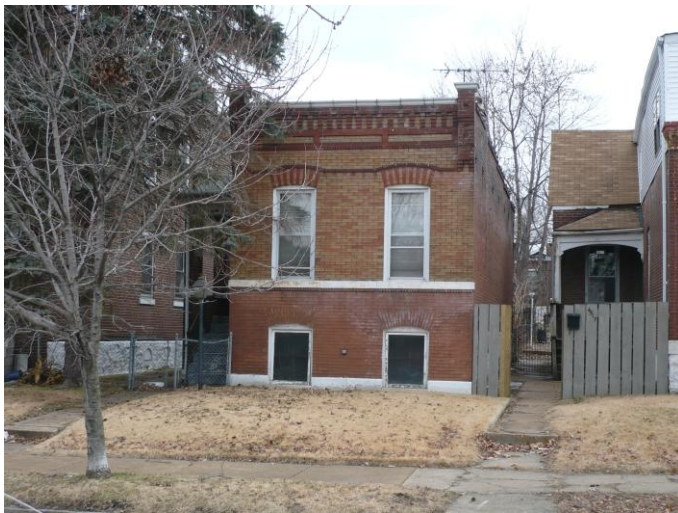
This house has a high basement. At the façade there are two original 1/1 windows in segmental arched openings at the basement level. At the upper story, the 1/1 windows are replacements. The voussoirs of their segmental arched openings alternate the tannish façade brick with red brick, connected by an ornamental pressed brick label course. The corbelled cornice combines tan and red brick and has corbelled tall end blocks. The front door is at a hipped brick porch at the left (south) elevation. The door is a replacement.

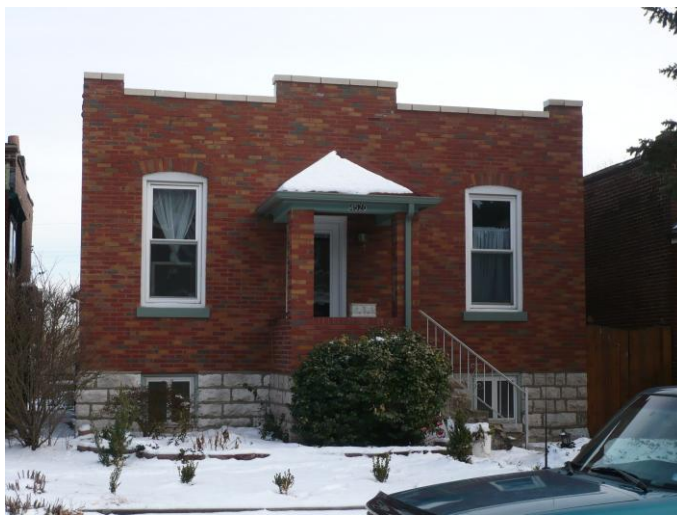
As of 1908, this house had the same L-shaped footprint as its neighbor at 4518. The present façade was added by 1938. There is a centered brick porch with a hipped roof. The front door is a replacement. The windows to either side are replacements in segmental arched openings. Other than the door and windows, the façade is completely intact. The parapet wall has squarish terra cotta coping.

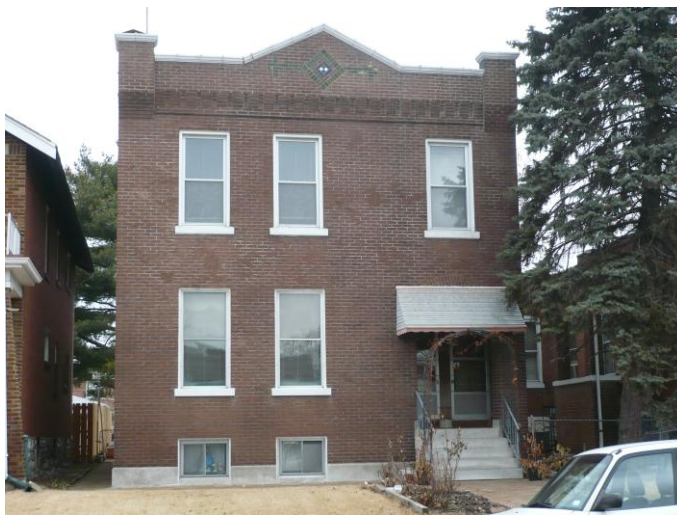
This two-story building has a recessed round-arched entry at the right bay. Porch millwork and transoms are original, but the two front doors are not. The two 1/1 windows at the first story are original, as are the two basement windows below them. The three second story windows are vinyl replacements. Above a corbelled cornice, the parapet wall has a center peak which features a green, blue and white brick pattern. The parapet has terra cotta coping.

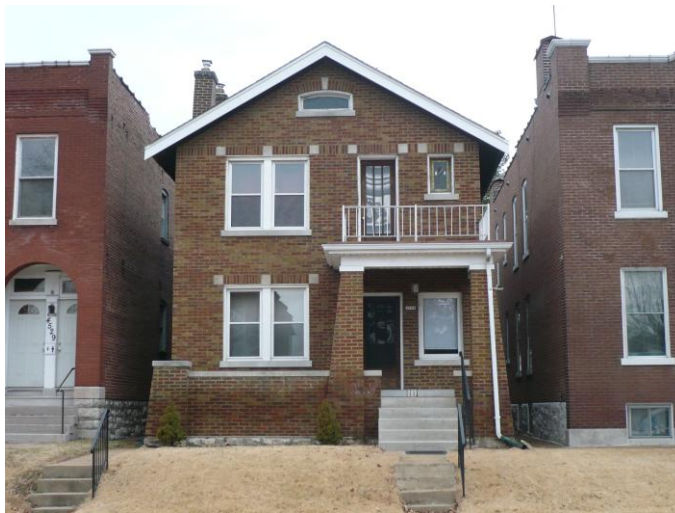
This front gabled brick building has a full-width brick porch which is unroofed at the left side of the façade. At the right, battered brick piers support a flat roof/balcony. Both the front door and balcony door appear original. A small art glass window to the right of the balcony door is intact, and the short attic window in the gable end also appears original. Other windows (a casement or fixed pane to the right of the front door, and pairs at both stories of the left bay) are replacements.

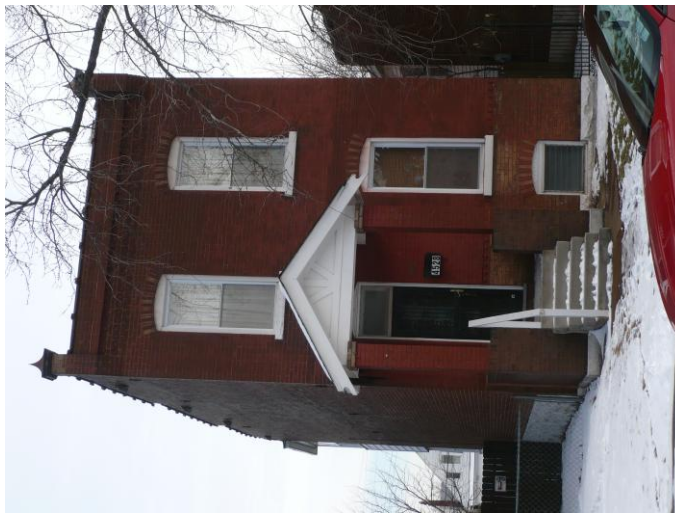
This was constructed as a single story dwelling and remained so until after 1908. There is a brick porch at the left bay with a gabled roof. The gable end has an imitation half-timbered treatment. The segmental arched window opening, right, and the two at the second story all bear replacement 1/1s. These three windows and the basement window have alternating red and tan brick voussoirs. The cornice is corbelled brick and the two end blocks retain flared pyramidal metal caps.

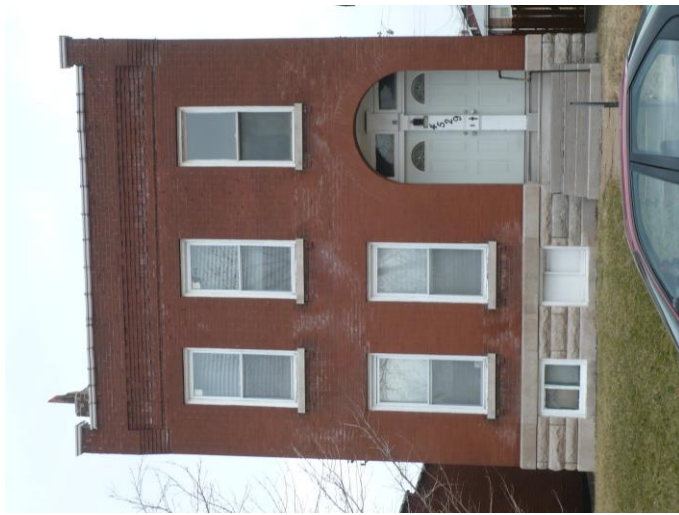
This two-story building has a coursed rock-faced limestone foundation at the façade. A round-arched recessed entry is at the right bay. Two front doors are new, although the transoms are intact. There is an original 1/1 window at the second story over the entrance. The four windows at the two left bays are replacements. Above a corbelled cornice, parapet has terra cotta coping.

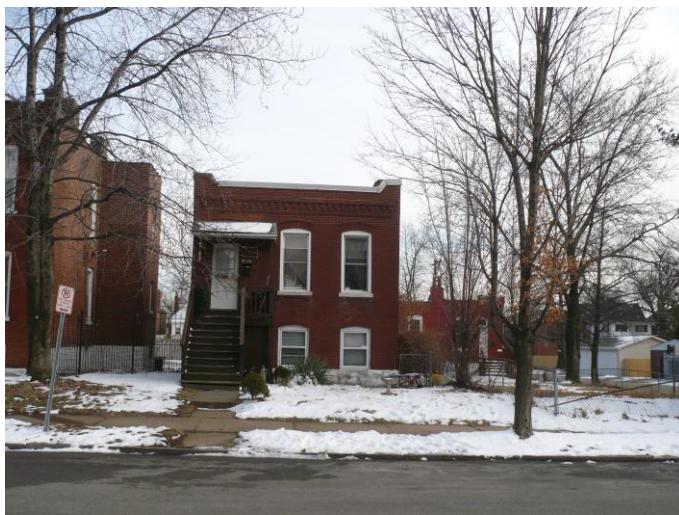
This house has a high basement level. The front door is at the left bay at a newer frame porch with a shed roof. The door is a replacement. Both stories of the right bay have segmental arched window openings with replacement windows.

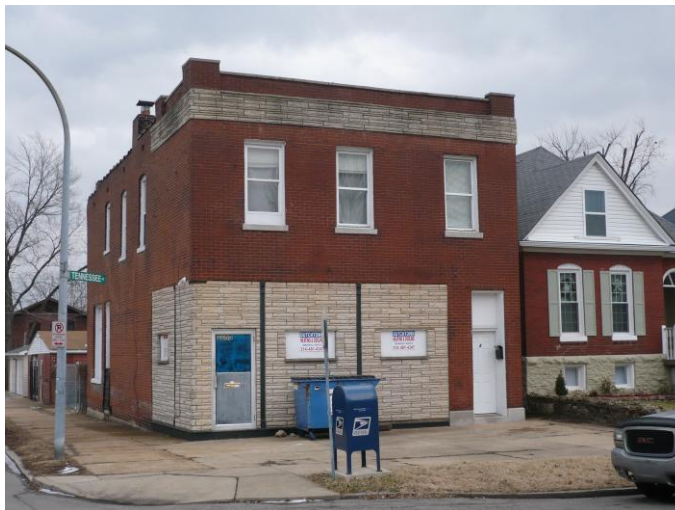
This corner storefront building retains its cast iron piers but the windows between have been filled in with imitation stone veneer and smaller windows. Doors and windows are replacements, and the cornice has been removed (replaced with imitation stone veneer), but the original brick surface and fenestration pattern is evident.

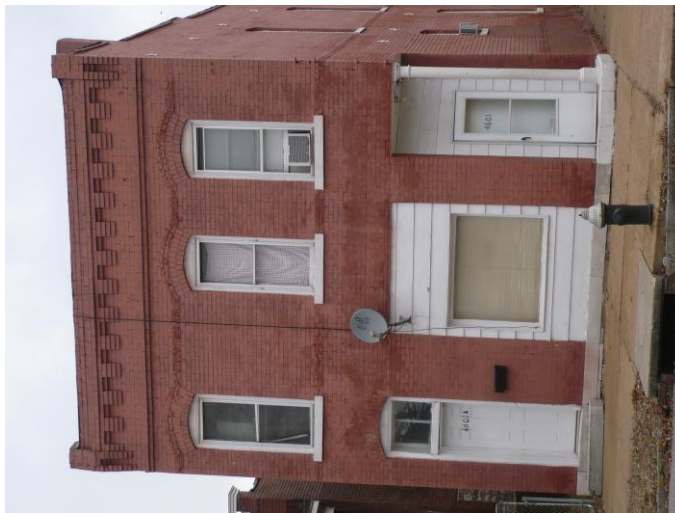
This corner storefront building retains its cast iron corner column. The entrance behind it (a replacement door in a horizontal siding surround) is chamfered. The storefront window at the center bay is also partially sided with a large fixed-pane window within. At the left bay the door to the upstairs unit is a replacement but it retains a tall transom light. Three second story windows are replacements in segmental arched openings. Above a label course, the cornice and parapet wall are corbelled brick.

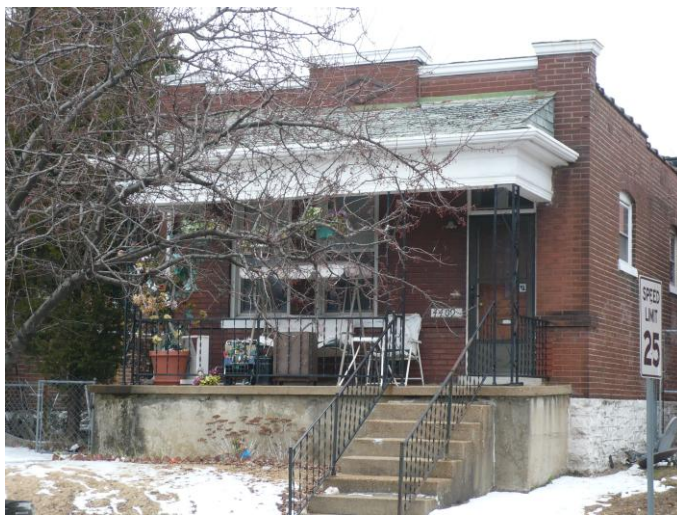
This red brick house has a full-width front porch. Its concrete base and metal uprights are replacements, but the shed roof retains its wood entablature. The front door, right, is a transomed replacement. To the left, the windows are replacements. The parapet wall retains its metal coping.
