# Dutchtown South Community Corporation Dutchtown South Neighborhood Survey

Lynn Josse and NiNi Harris  
8/5/2010

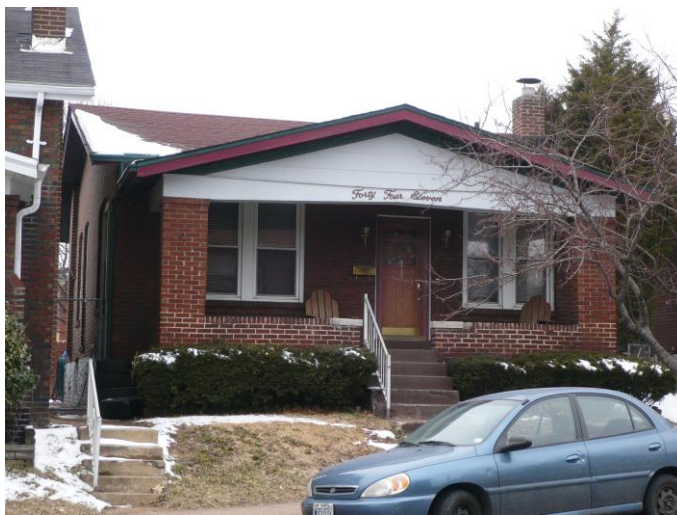
This side gabled house has a full-width gabled brick porch. A Craftsman-style wood door is just to the right of center. To either side are paired replacement windows. The porch has original wood trim but the gable end is filled with shingles.

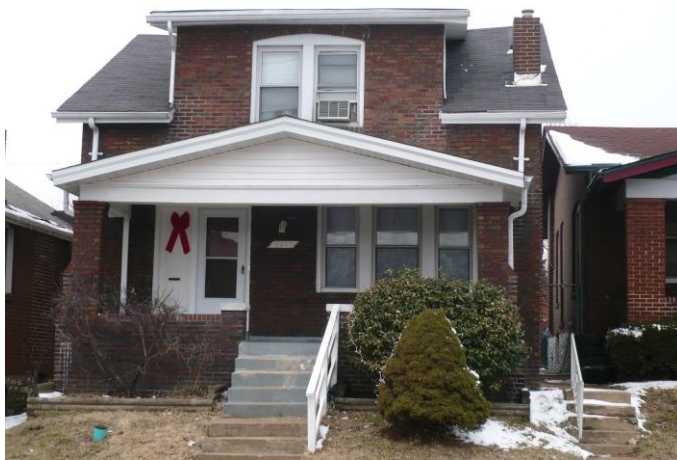
This brick bungalow has a full-width brick porch. Its gable end is now filled in with modern horizontal siding. To the left, the front door is a replacement, its sidelight covered. The triple window set to the left is also a replacement, as are the paired windows in the wide shed-roofed wall dormer centered above the porch.

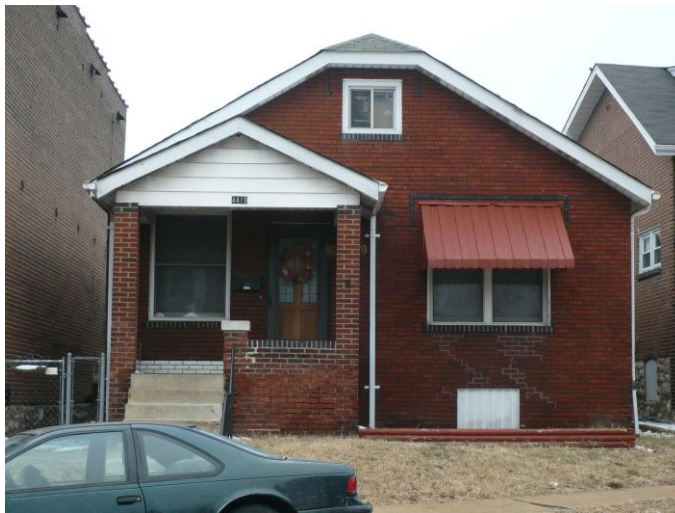
This house has a slight hip at the front gabled roof. The brick porch at the left bay has a front gabled roof. The door, left, and a 1/1 window to its left at the porch are not original. A pair of windows at the right side of the façade are replacements, partially concealed by a metal awning. Nearly black brick forms labels at the right window the tiny (replacement) gable end window and the same brick is used at sills.

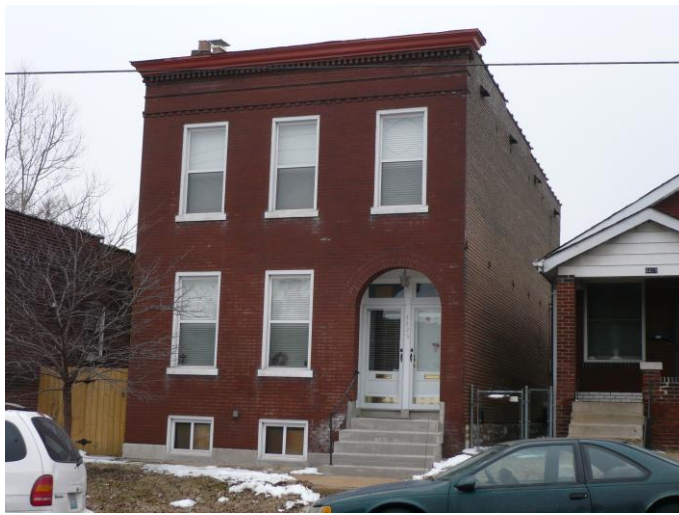
This two-story red brick building has a recessed porch behind a round-arched entry at the right bay. The two transomed doors are original, as is the rest of the porch woodwork. The two windows to the left, and the three windows at the second story, are replacements.

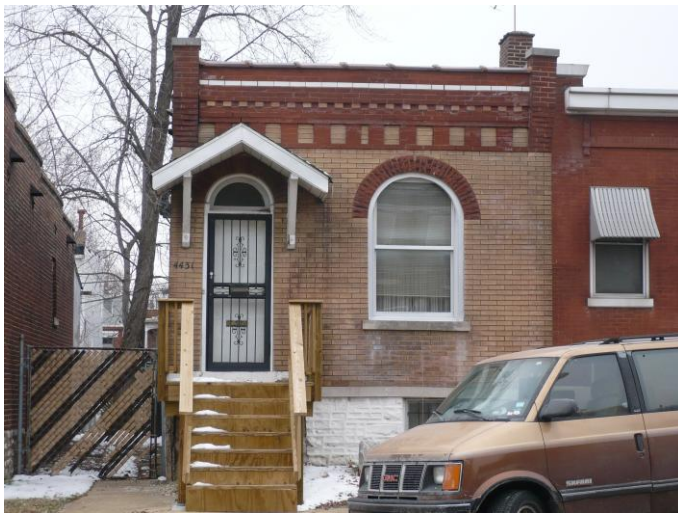
This narrow brick house has a painted limestone foundation at the façade. Instead of a front porch, there is an unpainted wood deck-style stoop at the left bay. There is also a Craftsman-era bracketed gabled hood over the round-arched entry. The door is a replacement but the arched transom is intact. At the right bay is a wide round-arched window opening housing a vinyl replacement window. The voussoirs are rough-texture contrasting red brick against the buff façade. Red brick also creates a distinctive cornice and parapet wall, which has corbelled end blocks. The flat center of the parapet wall appears rebuilt and has a single course of enameled white brick (indicating that the alteration could have been during the period of significance).

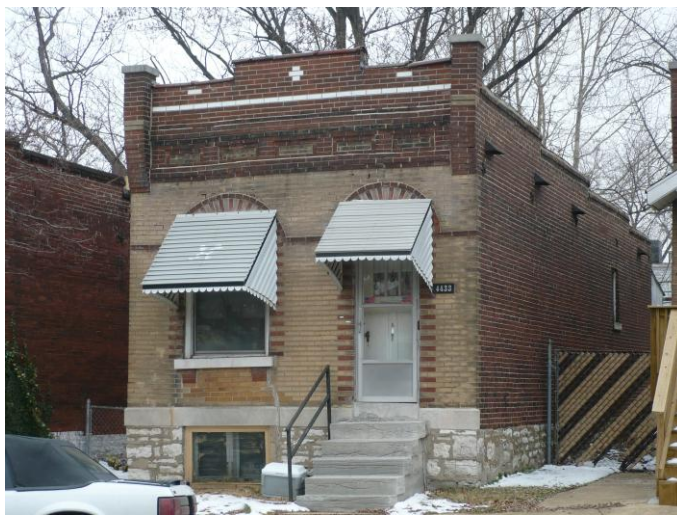
This narrow brick house has a limestone foundation at the façade. Instead of a front porch, there is a stoop at the right bay. The door is a replacement from the Craftsman era, and the arched transom is intact. At the left bay is a wide round-arched window opening housing a vinyl replacement window. Metal awnings are over both openings. Red brick contrasts with the buff façade and forms alternating voussoirs/quoins around the door and window openings and is used as a label course. Red brick also creates a distinctive cornice and parapet wall, which has corbelled end blocks. The center of the parapet wall appears to be rebuilt (during the period of significance) and has a wide center step.

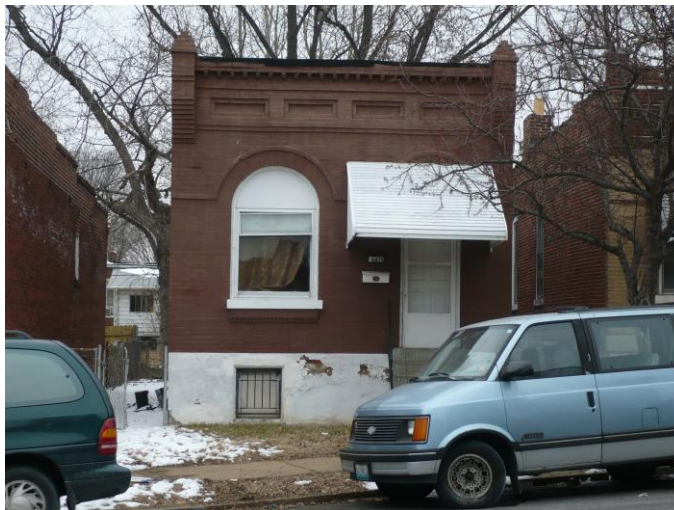
This narrow brick house has a painted and stuccoed limestone foundation at the façade. Instead of a front porch, there is a stoop at the right bay. The door is a replacement and the arched transom is intact. At the left bay is a wide round-arched window opening. Its wood 1/1 arched window is intact but the top section of the arch is boarded over the square storm window. Metal awning is over the door. A raised brick label course traces both arches. The parapet wall has corbelled end blocks; between them a raised brick strip with four recessed panels serves as a frieze.

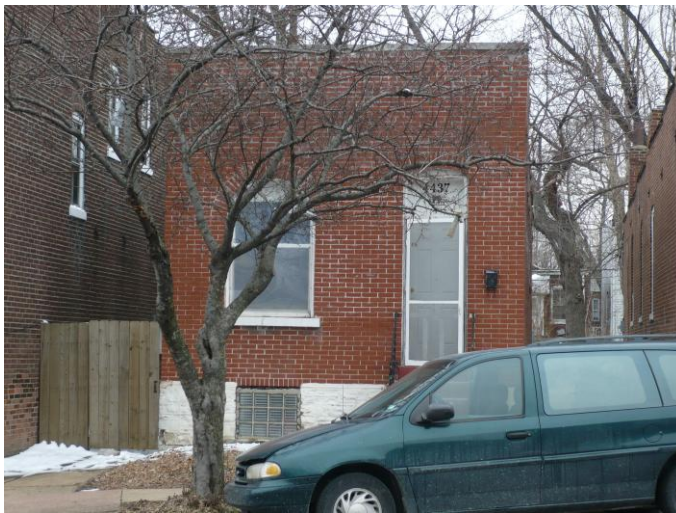
This narrow brick house has a painted limestone foundation at the façade. The façade is very plain at may be rebuilt. The front door, right, is a replacement; its transom window is covered. At the left, the wide round-arched window opening is filled with a modern replacement. The basement window below it is glass blocked and has a rowlock lintel set into the limestone foundation. The round arch has soldier voussoirs and the segmental arch over the door uses rowlock voussoirs. The front parapet wall is completely plain and flat.

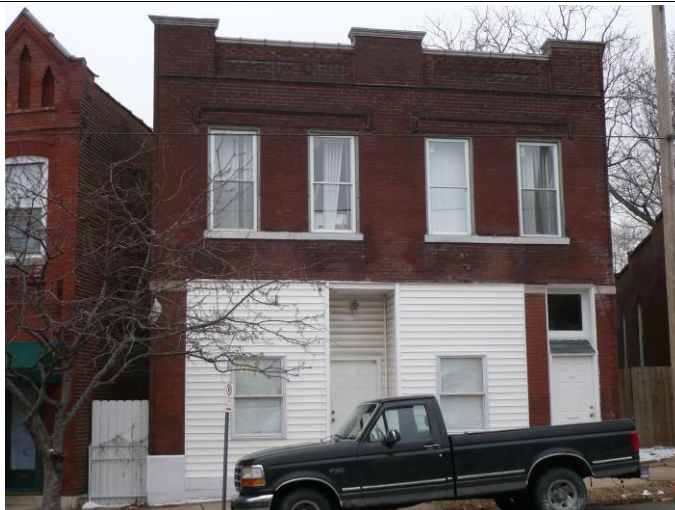
This two story red brick commercial building had a first floor that was largely defined by its fenestration. Now the majority of the first floor is covered with vinyl siding - there is still a recess to the front door, which is centered between the two sides of the storefront. To the right, a brick pier separates the storefront from the door to the upper story. Both doors are replacements; the only original material at the first floor are the three stone-topped brick piers and the transom at the right door. The second story is divided into two bays; at each, two windows, widely spaced, share a common stone sill and molded and raised brick label molding. The parapet wall has recessed panels between the end blocks and center steps; more corbelling work is below the white terra cotta coping. Metal coping is at the three raised blocks.

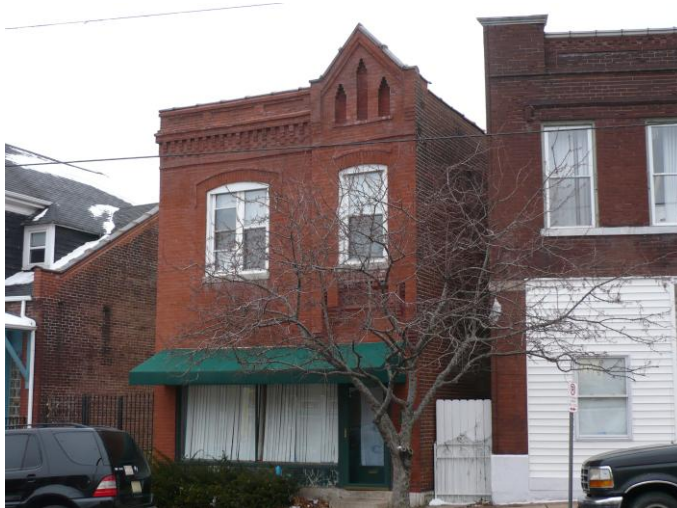
Although the permit record says this was originally a 2-story dwelling, it is shown as shops on the 1908 Sanborn. The front door, right, and storefront windows, left, appear to date from that period. The bulkhead is green marble and there is a canvas awning over the entire first story. At the second story, the narrower right bay is strongly corbelled out from the rest of the façade; this bay terminates in a gable with three recessed niches at the parapet level. The single 1/1 window is a replacement. In a segmental arched opening. At the right bay, a pair of replacement windows is in a wide segmental arched opening with a raised brick label molding. The parapet wall features corbelled work and is flat at this bay.

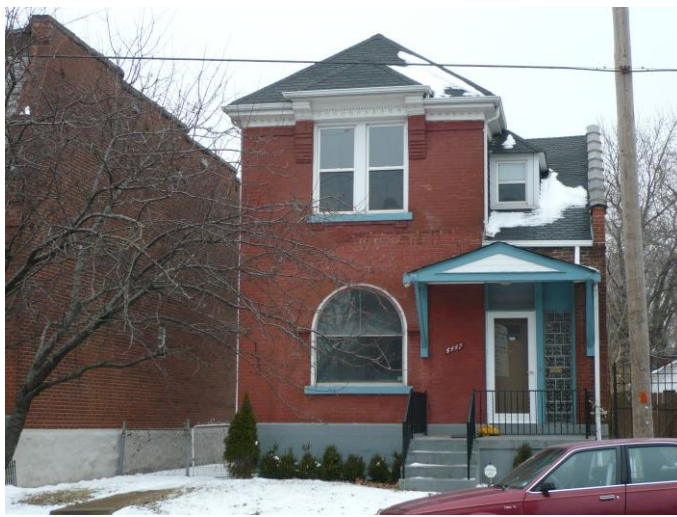
This house has a two-story hipped left bay and a side-gabled narrower right bay that comes in at a story and a half. The front door, a replacement with glass block sidelight, is at the right bay. There is a concrete stoop, and the stoop is covered by a half-width bracketed gabled hood. The 1908 Sanborn map shows a full-width frame porch (apparently hipped based on the outline it left on the façade). The left bay's wide round arched 1/1 window is intact. At the second story, the left bay has a window pair (replacements) topped directly by the wood frieze and dentil course. The top of the window is framed by two brick corbels which support the frieze (slightly projecting here) and a hipped dormer roof over the windows. At the right bay, the side gabled roof has clay tile coping at its side parapet, and there is a two-sided hipped dormer that attaches to the right wall of the left bay. Date found on building division certificate; permit not found.

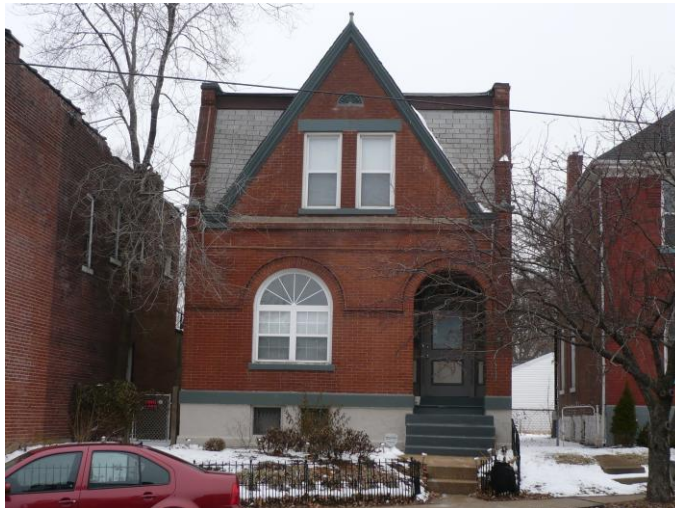
This house is shown on the 1908 Sanborn map as flats; no corresponding permit was found. The house has a limestone foundation at the façade with a thick stone water table. The porch is recessed behind a round arch at the right bay. The door, sidelights and transom appear to date from the historic period. A molded brick label course connects the porch entry and the wide round-arched window opening at the left bay. The window itself is a vinyl replacement set. The essential roof shape is locally accepted as a mansard - a steep sloping roof between two full-height side parapet walls - but in this case, there is a gabled wall dormer that is nearly the full width of the façade. The wall dormer is taller than the main roof, with metal coping and a finial at the peak. The two windows in the gable end are replacements which share a common stone sill and thick stone lintel.

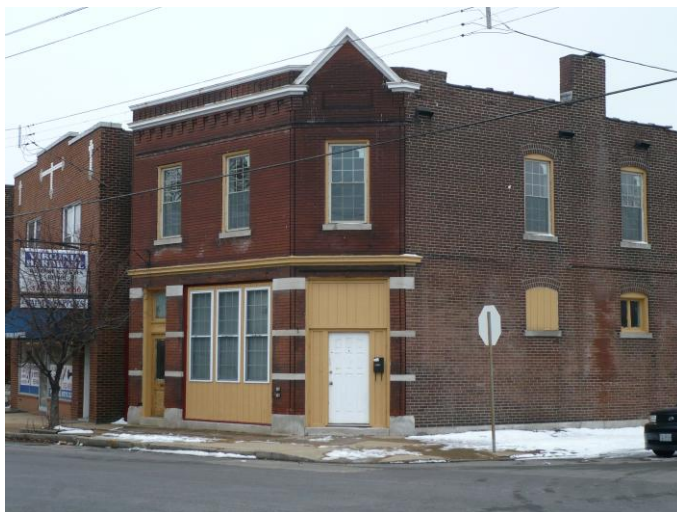
This two story corner commercial building has an irregular trapezoidal footprint following its lot lines. The façade consists of two bays facing Virginia and one which is angled toward the corner of the lot. These three bays share common detailing, including four stone-banded brick piers separating the first story bays, and metal cornices at both stories. The longer Taft elevation, in contrast, is relatively unadorned (with clay tile coping at the parapet wall, utilitarian segmental arches instead of square head windows). The door to the upstairs apartment and its transom are intact at the left bay. The storefront has been reconfigured with three modern 1/1 windows of a T1-11 bulkhead; the corner bay has a plain new door and the rest of its opening receives a T1-11 treatment. The second story windows at both street elevations are replacements. The metal cornice includes a peaked section at the corner bay which breaks the parapet wall, marking the entry bay.

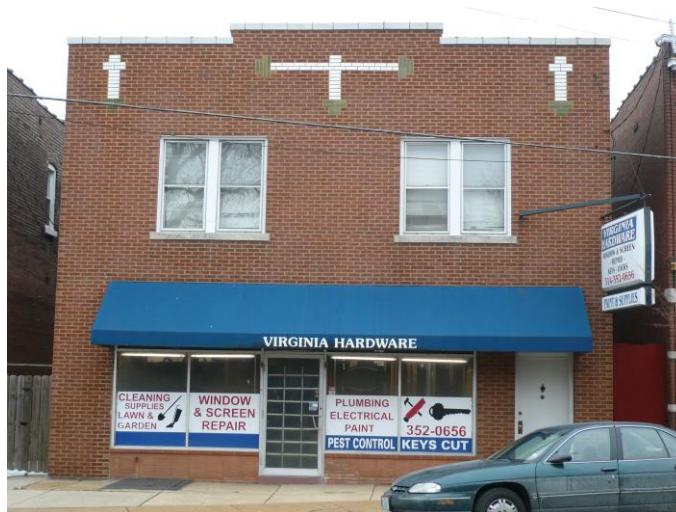
This storefront building retains its commercial use. At the first story, two large storefront windows are to either side of a metal and glass door; none of these are original, but it does retain the look and feeling of a storefront building. The door to the upper unit(s), right, is also a replacement. The two pairs of second story windows are original 1/1s. Enameled white and green brick forms three crossed in the upper façade. The parapet wall retains squared white terra cotta coping.

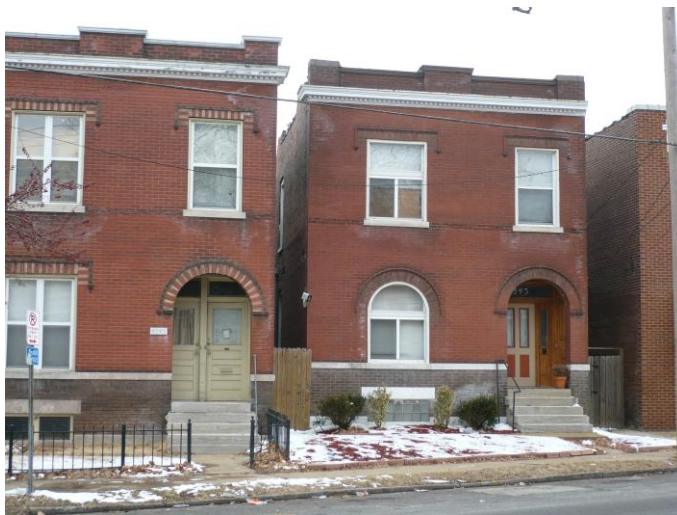
This two story building was converted from flats to single family use. A new front door is behind a round-arched opening at the right bay. The first story window, left, is also round-arched. This and the square-headed window above it are quite wide; the second story left window opening is of average width with a square head. The façade windows themselves are all replacements. Two courses of rough-textured brick connect the stone sills at the second story and form a full course. Molded brick forms labels and line the arches at the first story; every other brick at the arches and lintels is brown. Between the end blocks and center step over the metal cornice, the parapet wall is slightly recessed. Original coping is intact except at the end blocks.

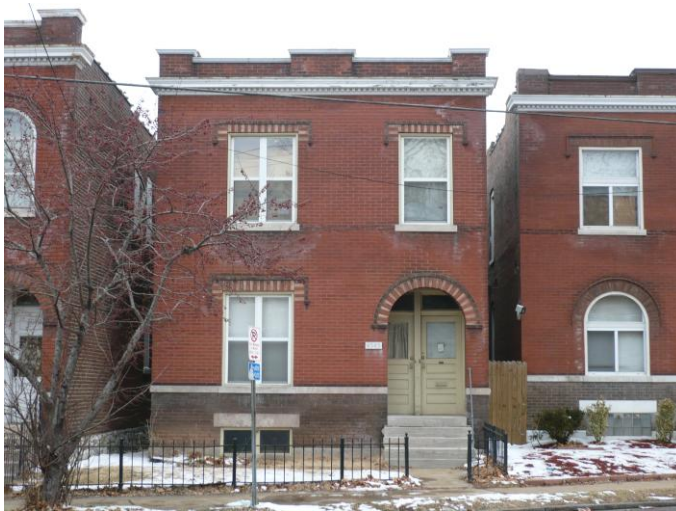
Behind a round-arched opening at the right bay, two wood front doors are intact. There is a square-headed window above at the second story; at the left bay, a wider window opening is also square-headed at both stories. The façade windows themselves are all replacements. Two courses of rough-textured brick connect the stone sills at the second story and form a full course. Molded brick forms labels and lines the arch; every other brick at the arch and lintels is tan. Between the end blocks and center step over the metal cornice, the parapet wall is slightly recessed. Original coping is intact.

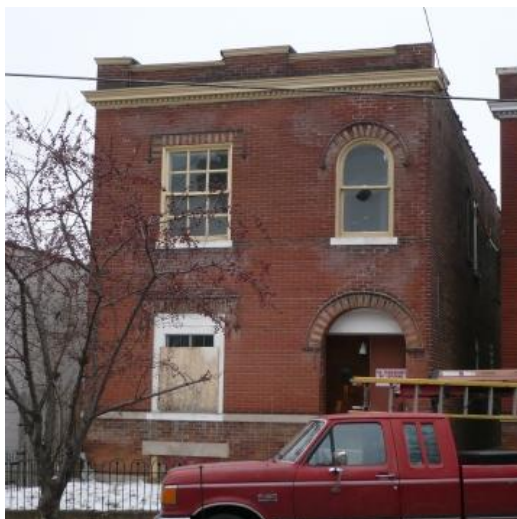
Behind a round-arched opening at the right bay, there is a replacement door; the rest of the porch is filled in with wood shingle. There are wide square-headed window openings at both stories of the left bay (both windows replaced). Over the entry, the window is an original round-arched 1/1. Two courses of rough-textured brick connect the stone sills at the second story and form a full course. Molded brick forms label and lines the arches; every other brick at the arches and lintel is tan. Between the end blocks and center step over the metal cornice, the parapet wall is slightly recessed. Original coping is intact except at the right end block.

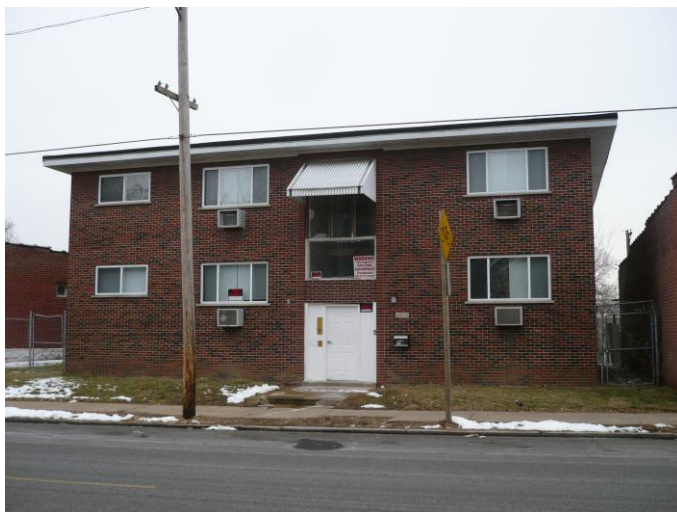
Date is from city assessor's database. The front door (a replacement) is between covered transoms at grade at the 3rd of 4 bays. Windows are replacements except for the wide hall window over the entry.

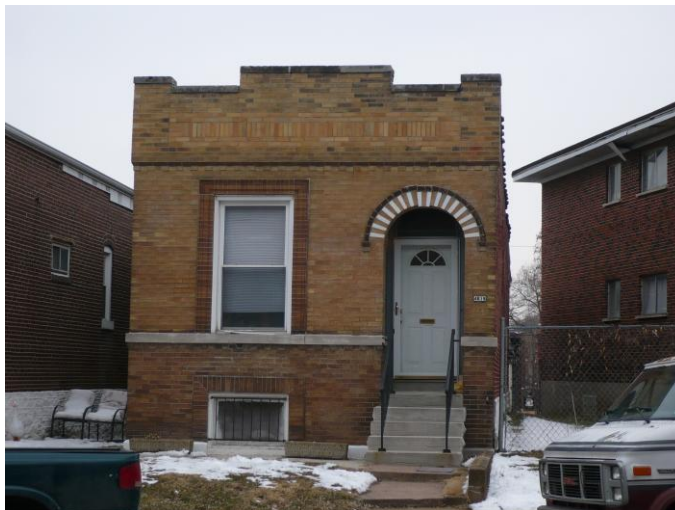
This narrow brick house has a round-arched entry at the right bay and a square headed window at the left. The front door is a replacement, but the porch interior's millwork and transom are original. The replacement window, right, has a darker brick surround. The parapet wall is slightly corbelled out. Instead of a metal cornice (common during this period) there is a panel of lighter and perhaps later tan brick (double stretcher courses above and below a soldier course). At a narrow rear el, left, there is a wood door that appears to be original.

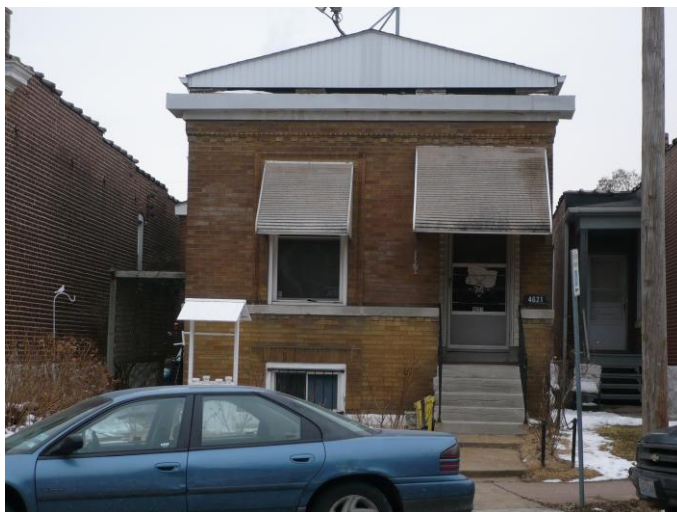
This narrow brick house has a round-arched entry at the right bay and a square headed window at the left. The front door is original. The replacement window, right, has a darker brick surround. Fiberglass awnings are at both door and window. Ornamental pressed brick outlines the arch and surrounds the window, and forms a course under the metal cornice. The metal cornice is wrapped; above it, atop the original roof a very low-pitched gabled roof has been added. Despite this, part of the original parapet wall is visible, including some of the step pattern. At a narrow rear el, left, there is a replacement door.

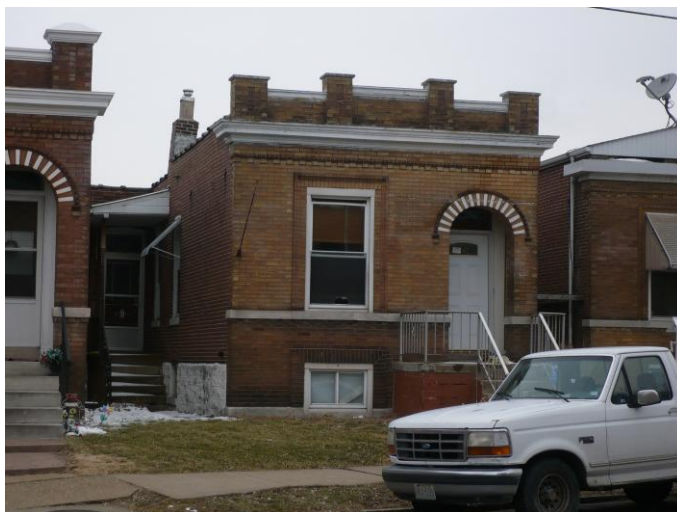
This narrow brick house has a round-arched entry at the right bay and a square headed window at the left. The front door is a replacement, as is the window. Ornamental pressed brick outlines the arch and surrounds the window, and forms a course under the metal cornice. The parapet wall has a higher center step which is defined by even higher blocks to either side. Metal coping is intact except at the four taller blocks. There is a narrow el at the rear of the left elevation with an original door and transom.

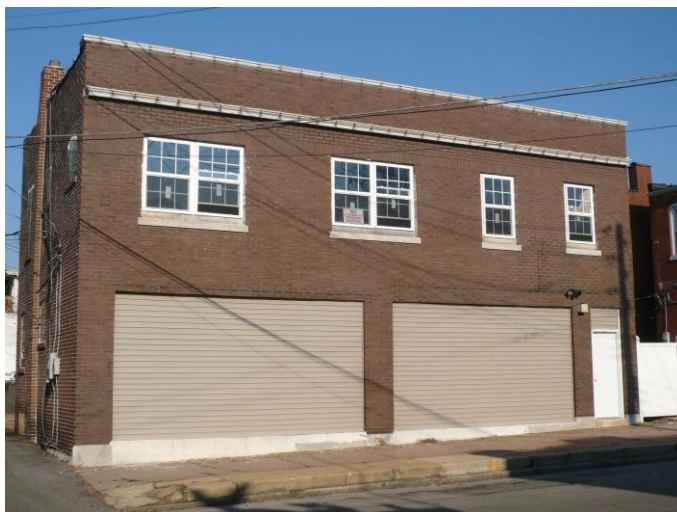
This two-story brick building was constructed around 1926, when the permit to demolish its predecessor was issued. The building appears to have been designed for two storefronts which are now completely filled in with modern siding. The door to the second story at the far right of the first story is a replacement. Second story windows, two pairs and two singles, are also replaced. Due to the stark simplicity of the design, these replacement elements do have a significant effect on integrity, but none of the original exterior brick and terra cotta has been altered and the building is still contributing.

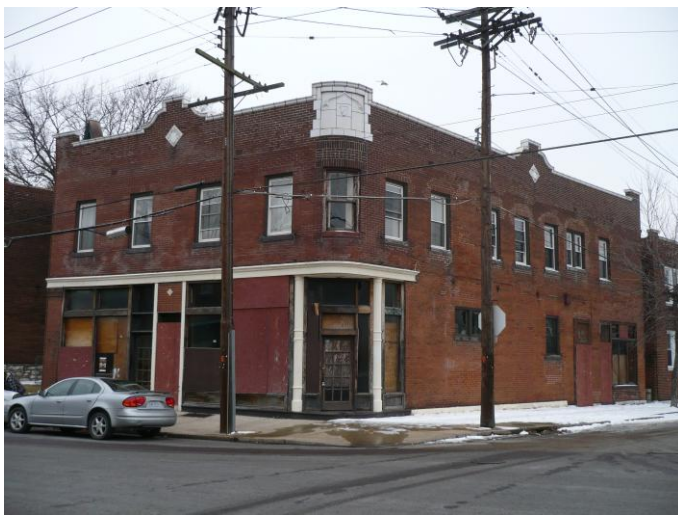
This two story brick commercial building has an irregular footprint, with a slightly obtuse angle formed by the lot lines at the intersection of Itaska and Virginia. The corner facing the intersection is rounded, including the beam over the cast iron storefront system (South St. Louis Foundry). The first story entry bay itself is chamfered, framed by two cast iron columns. The 15-light corner door is boarded (as are the rest of the first story openings). The Virginia elevation has (boarded) storefront windows flanking a boarded entrance to the second story. Wood storefront framing, bulkheads and transom framing, and most of the visible glass are intact. 2nd story windows at both elevations are replacements except for the 3/1 at the rounded corner. Both elevations have a stepped center, Flemish-style, with a terra cotta panel in the center; the rounded corner has a larger panel of white terra cotta pieces including a center shield under a label molding. Coping is terra cotta.

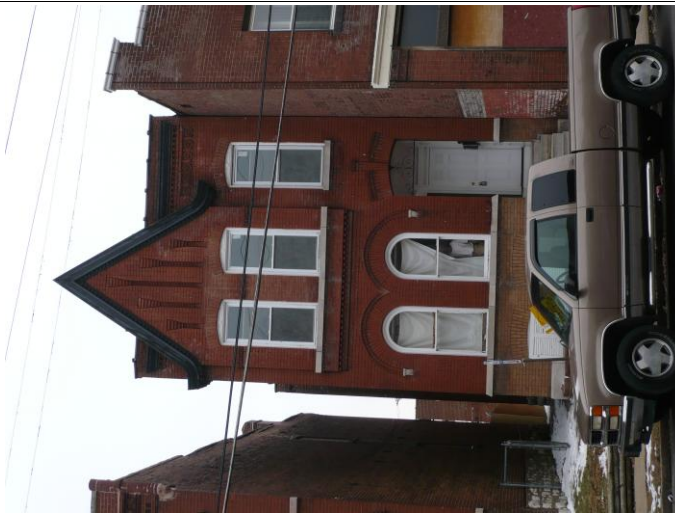
At the right side of this two-story brick facade, there is a segmental arched entry to a recessed porch. The front door is a replacement. To the left, the two 1/1 round-arched windows share a common arcaded molded brick course tracing the extrados with stone imposts at the outer end. The segmental arch at the entry has a similar molded brick outline, with brick voussoirs forming center keystone. The upper left two bays project from the façade, the two windows there and the one at the right bay are replacements in segmental arched openings. The windows at the left bay have deep reverse corbelled vertical channels over them which rise to a gable which breaks the otherwise flat parapet wall. The gable's coping and the cornice at the rest of the parapet look like copper.

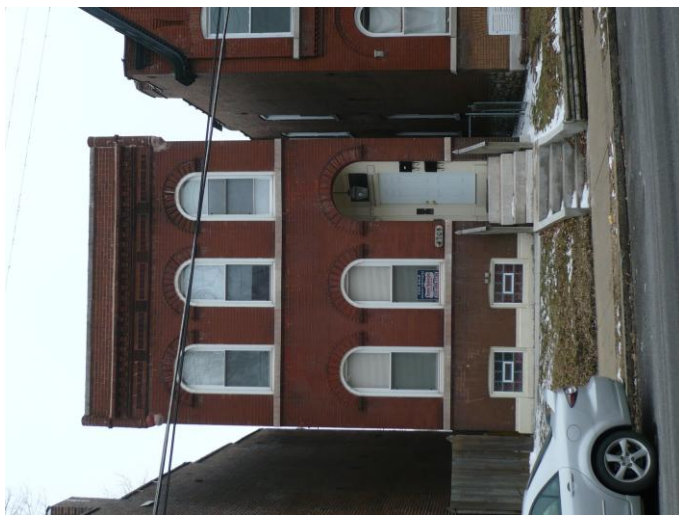
At the right side of this two-story brick facade, there is a round-arched entry to a recessed porch. The front doors are replacements. To the left the two 1/1 round-arched window openings are set on a stone sill course. There are three round-arched window openings at the second story on a stone sill course. The windows are all modern replacements. Ornamental pressed brick traces the arches and is used at the corbelled cornice. The parapet has been rebuilt; it is now flat. The date is from a building division certificate.

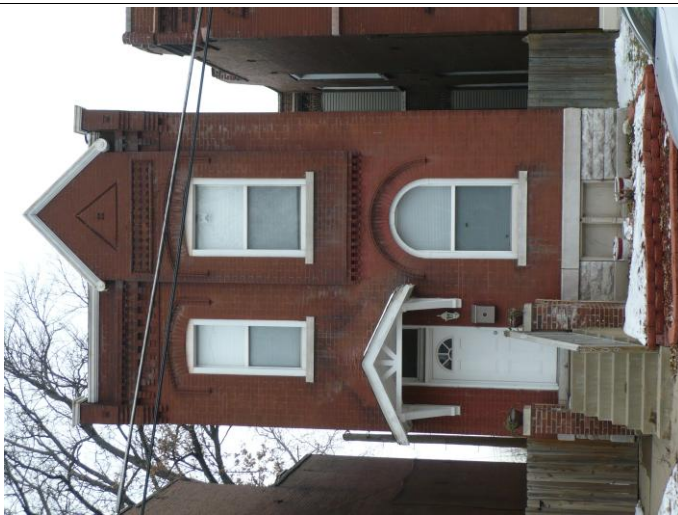
This two bay brick building is shown as flats on the Sanborn map. The base of the façade is coursed limestone. At the left bay, the front door (a replacement) is under a bracketed gabled hood. At the right bay is a wide round-arched window opening. The right bay of the second story projects, slightly corbelled out from the rest of the façade. Its wide segmental arched window opening and the average width one at the left bay are also filled with replacement windows and both have ornamental pressed brick labels. The cornice is corbelled brick with end blocks that are corbelled out further and higher. The projecting section of the right bay ascends above the parapet wall in a gable ornamented with a panel and a triangle of ornamental pressed brick. Metal coping is intact. The date is from a building division certificate.

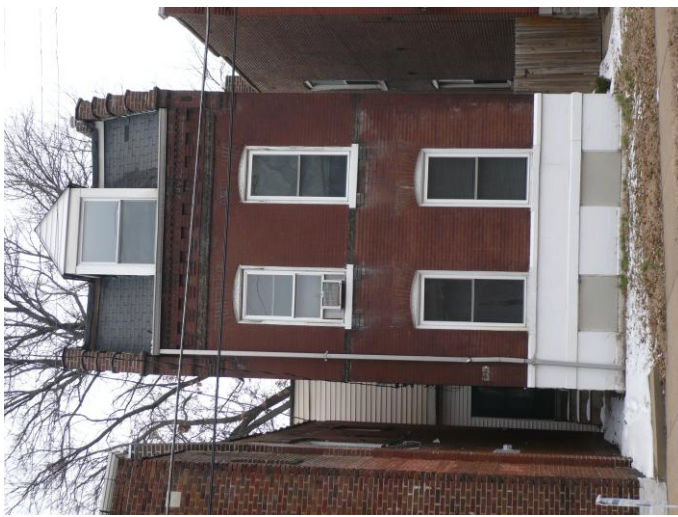
This red brick building has a smooth stone foundation at the façade. Two segmental arched window openings are at both stories; the windows themselves are replacements. Contrasting rock-faced brown brick is used to form a windowsill course at the second story and a course below the corbelled red brick cornice. The roof is not a true mansard, but a sloped roof held between two side parapet walls. The is a tall gabled dormer which does not display any original material. The front door is at a rear frame addition at the left (south) elevation. The date is from a building division certificate.

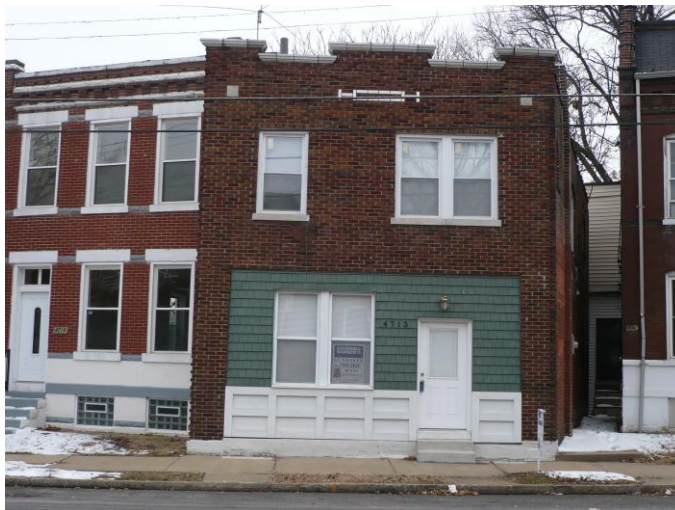
No builder or architect found, and the permit lists this as a two-story dwelling (which is likely an error since it is built up to the sidewalk). This two story brick building has an almost full-width storefront, now filled in with a door and new window pair surrounded by siding in order to create residential space.

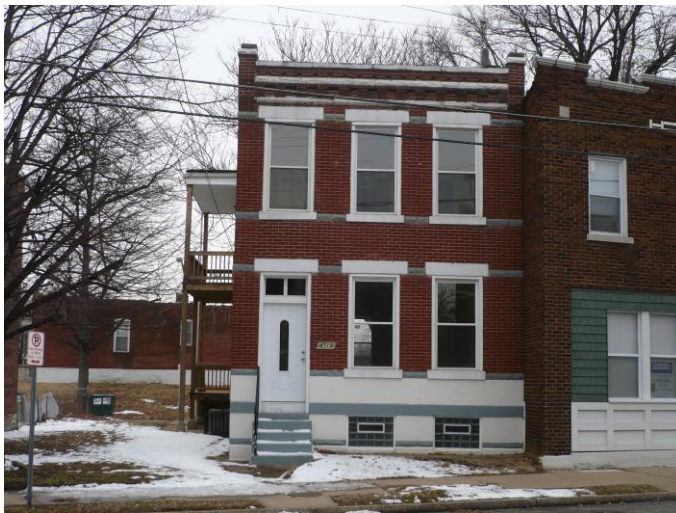
This two story red brick building, originally permitted as flats, pays homage to the earlier Greek Revival style with the long, thick stone lintels over the six main façade openings. Over a smooth stone foundation, windows are at the two right bays. The front door (a replacement with replacement transom) is at the left bay. Rock-faced limestone forms sill and lintel courses at both stories. The cornice alternates stone and corbelled brick courses and has corbelled brick end blocks at either end.

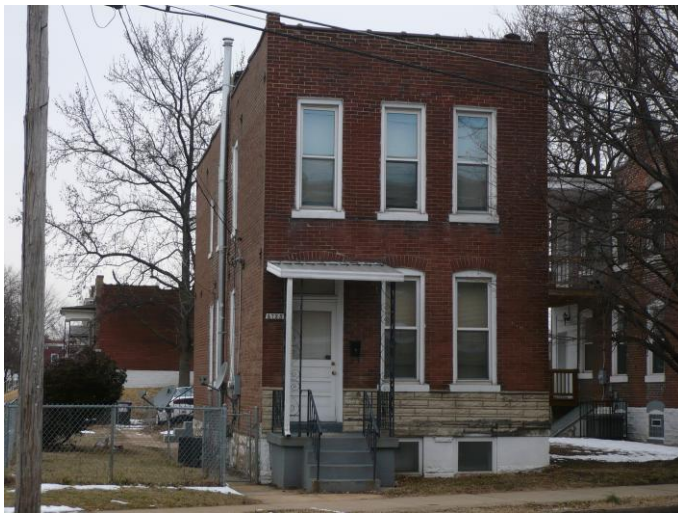
This two story red brick buildings shown as flats on the 1908 Sanborn map. The front door, left, is original and has a transom. It is located at a concrete stoop with a fiberglass awning roof. The two first story windows, right, are in tall segmental arched openings on stone sills. Below them, part of the base of the façade (between the basement and first story windows) is covered with imitation stone veneer. The three second story windows are square headed. The windows are all replacements. The parapet wall is rebuilt without any form of cornice and with clay tile coping.

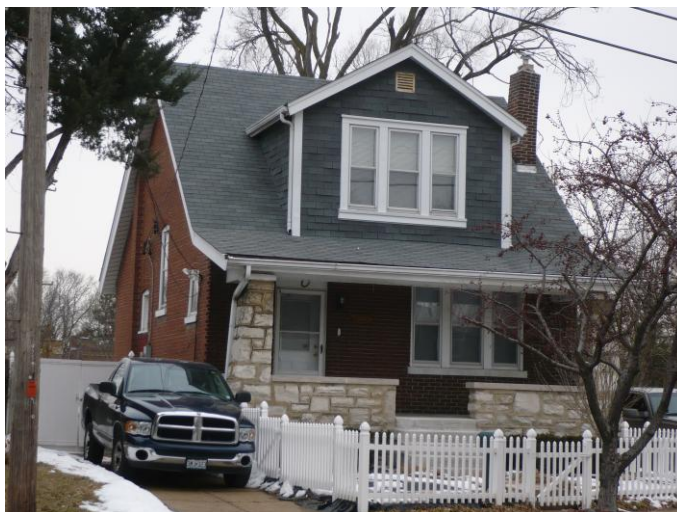
This red brick bungalow has a side gabled roof. The full-width limestone porch has battered piers which support a lower-pitched extension of the main roof. A large front gabled dormer has a triple set of replacement windows. At the facade, the front door (left) and the triple windows (right) are also replacements.

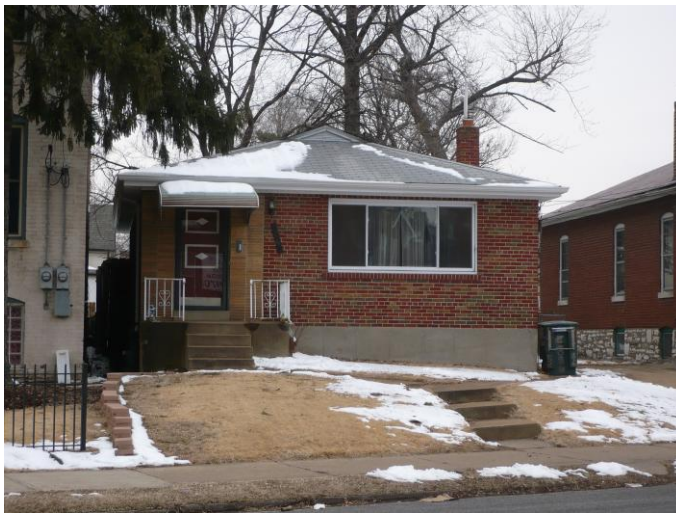
This modern house retains its front door, left, at a concrete stoop with a fiberglass awning. Two vertical courses of stacked tan Roman brick on either side of the door define the entry. To the right, the wide picture window is fitted with modern replacement sashes.

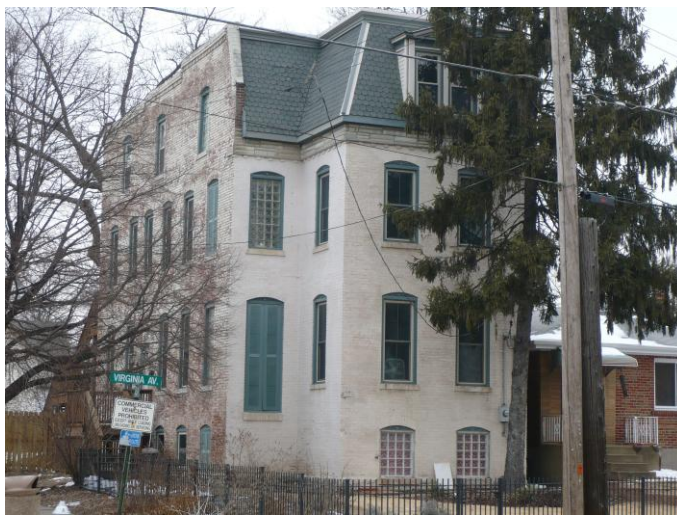
This building is one of the oldest in the survey area, being one the few shown on Hopkins atlas of 1883. Over a high basement, the façade has a recessed right bay. Here, the front door is closed over with shutters and the porch removed. The façade windows (two at each story of the projecting right bay, two on that bay's south elevation, and the one over the original door opening) are segmental arched with stone sills. The brickmold and eyebrows are intact but the original windows are not. There is a gabled dormer at the right with a small pair of replacement windows. The original cornice has been replaced by an imitation stone veneer strip. The current entrance is at the south elevation at a newer deck-style porch.
