ARCHITECTURAL/HISTORIC INVENTORY FORM - Cultural Resources Office
St. Louis Planning and Urban Design

1. Survey no. SLC-AS-053-0195	2. Survey name: Thematic Survey of Flounder Houses in St. Louis City	3. County: St. Louis [Independent City]
4. Address: (from City GEO database) 908 MORRISON AV		5. City/State: St. Louis, Missouri
Alternate address: 908 Morrison Avenue		Property Zip Code: 63104
Latitude: 38.614945		6. UTM Easting: 743839.02
Longitude: -90.199405		UTM Northing: 42277768.84
8. Historic Name (if known): N/A	11a. Historic Use (if known): Domestic	City Block 466.03
9. Present/other name (if known): Domestic	7. Township-Range-Section: N/A	City Ward 7
10. Ownership: Private		Neighborhood Number: 34

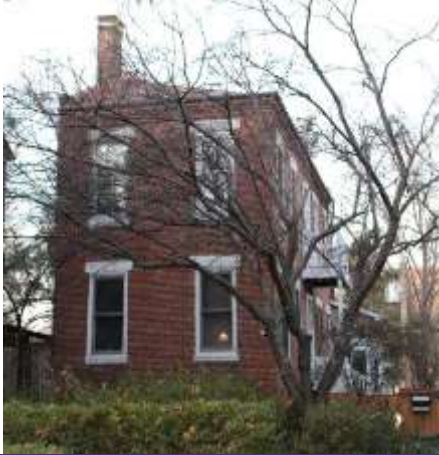
Front façade

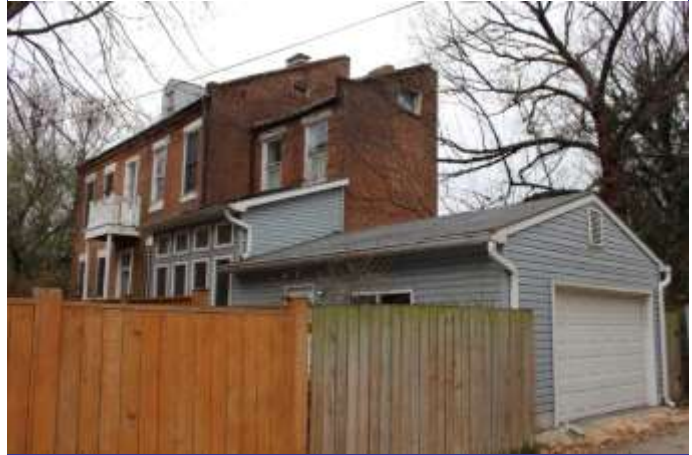
Rear and east facades

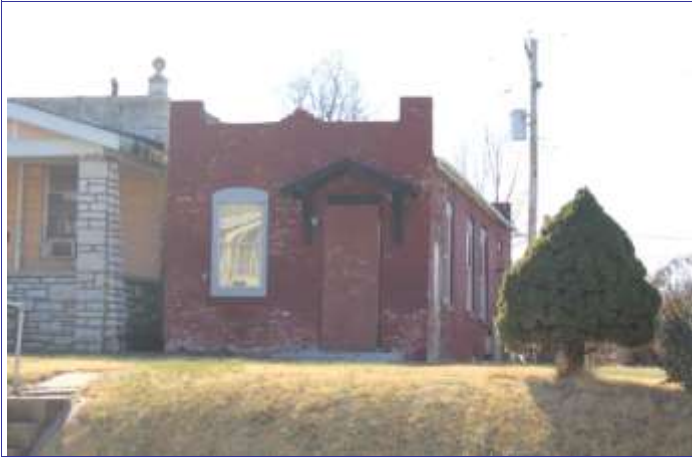
3146 MOUNT PLEASANT ST

Matching flounder next door. Damage from a leaking gutter has affected the masonry of the west façade and one bay has collapsed to the foundation.

One-story brick flounder featuring a front facing stepped parapet, which may be a later alteration. Flounder roof is concealed behind the parapet. The brick has been painted red. All the windows on the house have been replaced with vinyl and wrapped. All window and doors have segmental soldier arches and limestone sills. One bay of the west façade has collapsed, exposing the interior.

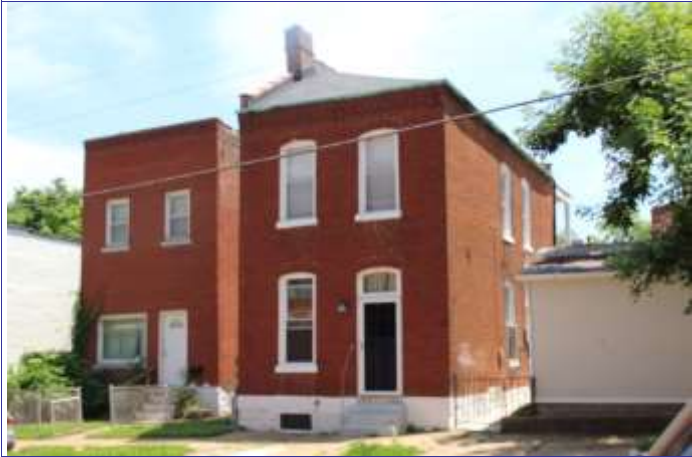
2642 OHIO AV

foundation painted

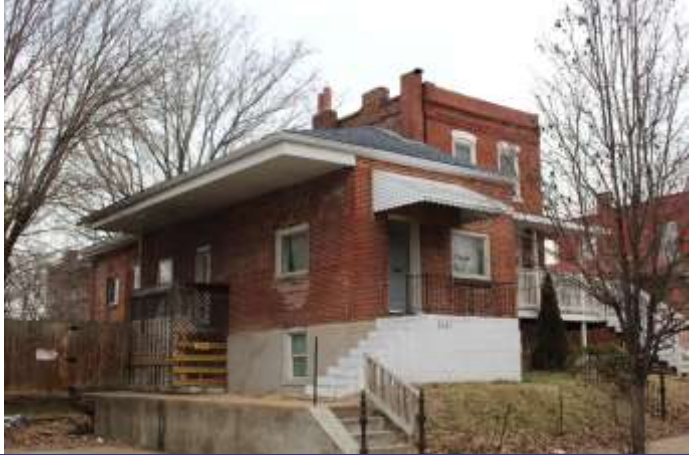
3637 OREGON AV

Raised foundation concealed with concrete parging on side and concrete block steps and porch on front.

The somewhat altered 1-story brick flounder likely originally had a side entrance through the gallery. All door and window openings have square heads and the windows are clearly altered in size. Currently, the dwelling has a front entrance approached by a modern concrete-block porch with steps. Only the roof of the gallery, which is part of the main roof of the building remains of the gallery. A small entrance porch gives access to a door centered in the gallery façade.

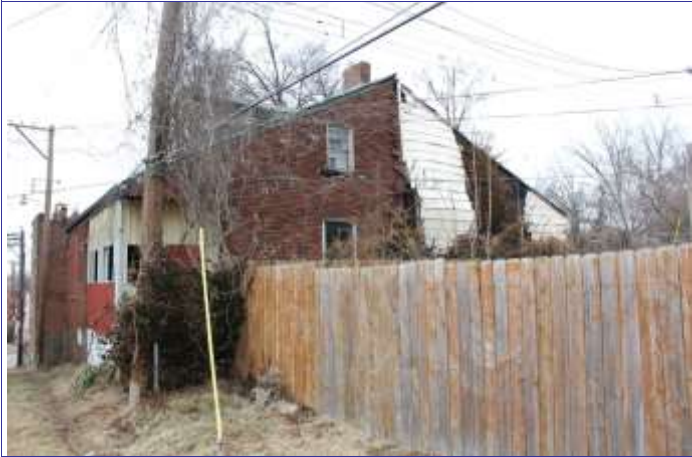
3644 OREGON AV

This appears to be a pair of semi-detached wood-framed flounders, shown on two lots on the Hopkins Atlas but as one dwelling on the 1909 Sanborn. Both are in disrepair and impending collapse.

Only the steeply-pitched roof and the rear, east, wall of this wood-framed flounder of this semi-detached flounder can be seen. The wall is covered with layers of rolled siding.

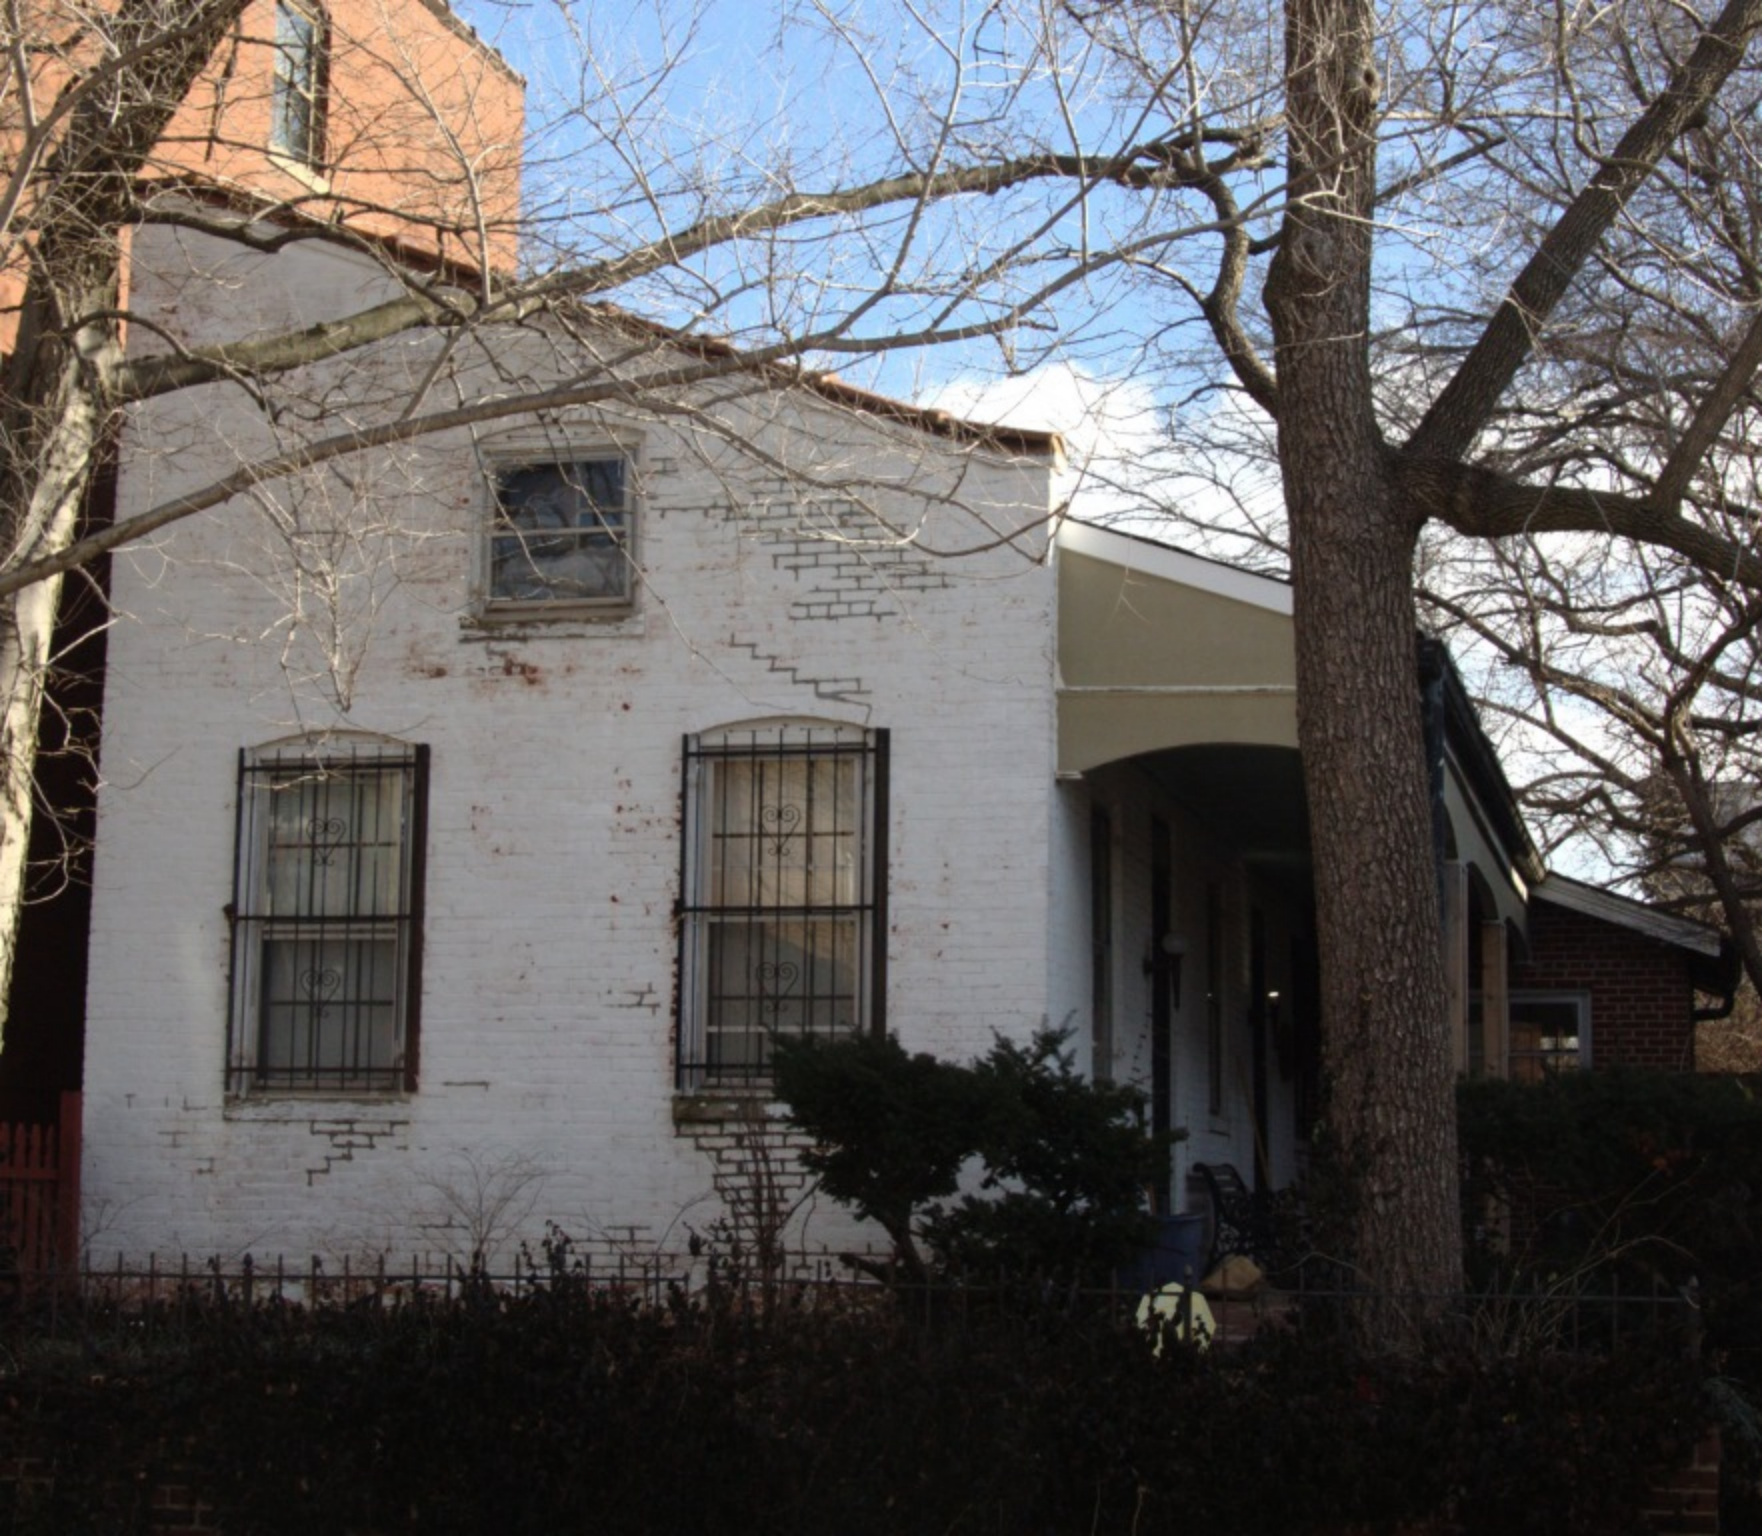
This shed-roofed brick flounder presents a two-bay façade to the street and its taller windowless wall is on the north side. A replaced wood gallery consists of wood posts supporting a shed roof edged with a fascia with arched shapes and shelters the two doors and three windows of the south wall. Window and door openings have arched heads formed of header bricks. Historic casement sash remains in the attic window facing Pennsylvania. A wider brick wing projects south beyond the gallery and has a shed roof. The rear brick wing has a flat roof and is closer to the width of the front wing.

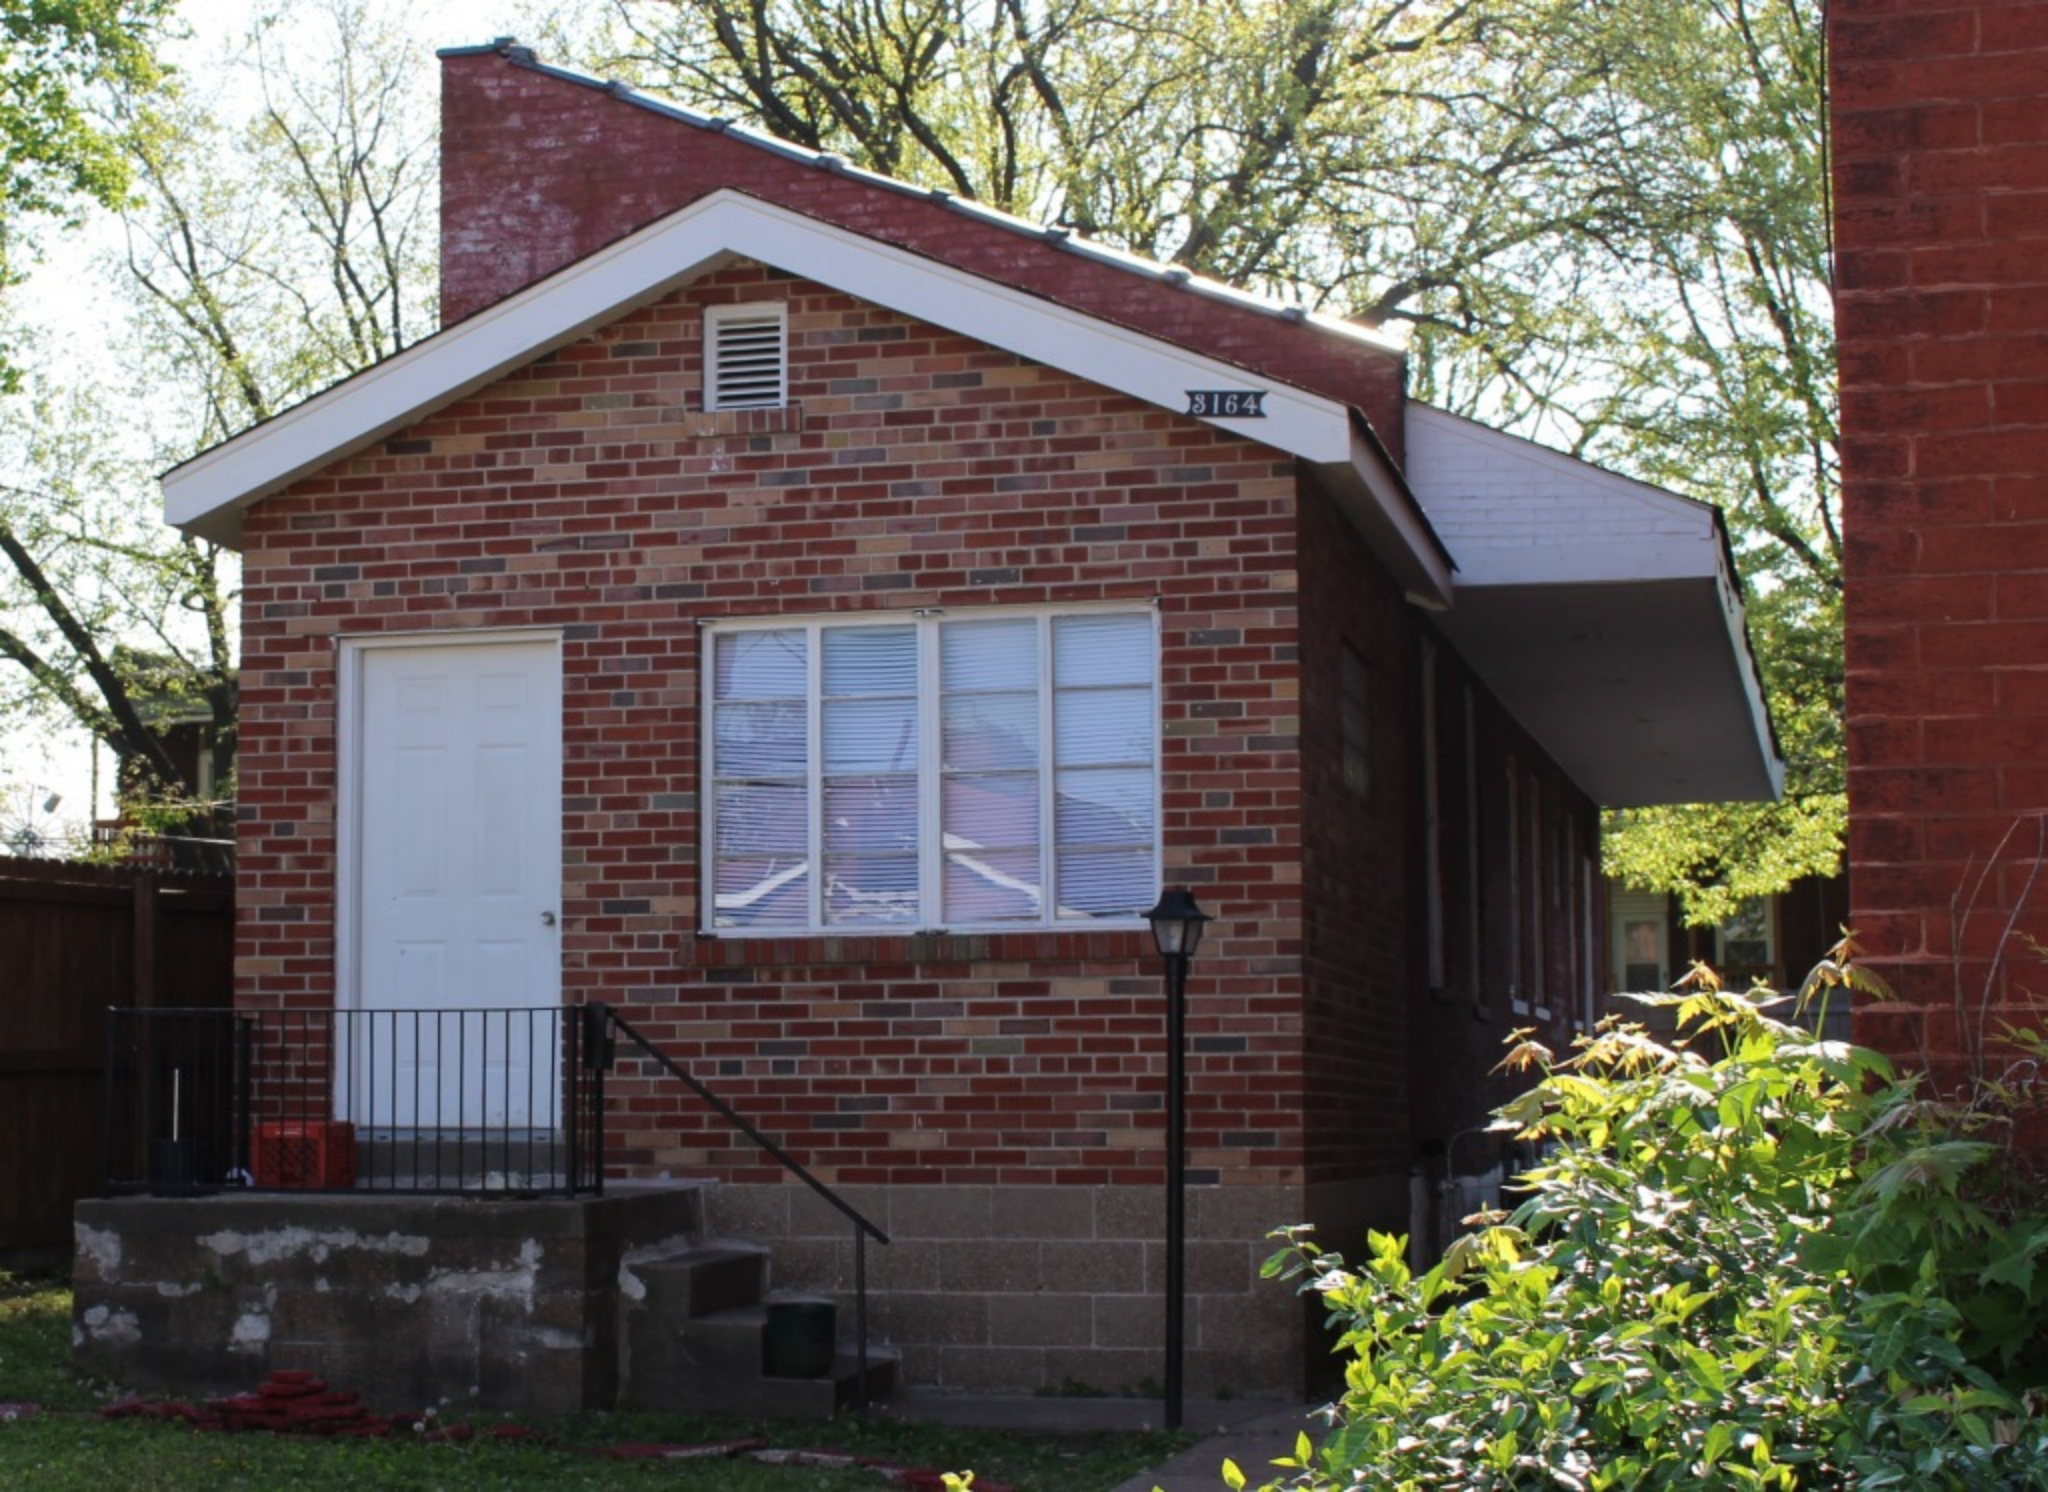
3164

A one-room deep gable-roofed brick front addition is lower than the main shed roof of this flounder set back near the alley. The flounder has attic windows in both the east and west end walls; the taller windowless wall rises on the north side at the property line. The house is shown with a full-length wood-framed porch on the south side on the Sanborn map; a shallow wood pent roof shelters the entire south side of the original portion. A door is located at the rear bay; five windows of the same size are to the west of the door, as well as one small square opening filled with glass block. All of the sash is replacement in the original portion except for the casement sash in the front attic window openings. An exterior basement staircase extends from the west wall; there are basement windows in the rear portion of the original house.

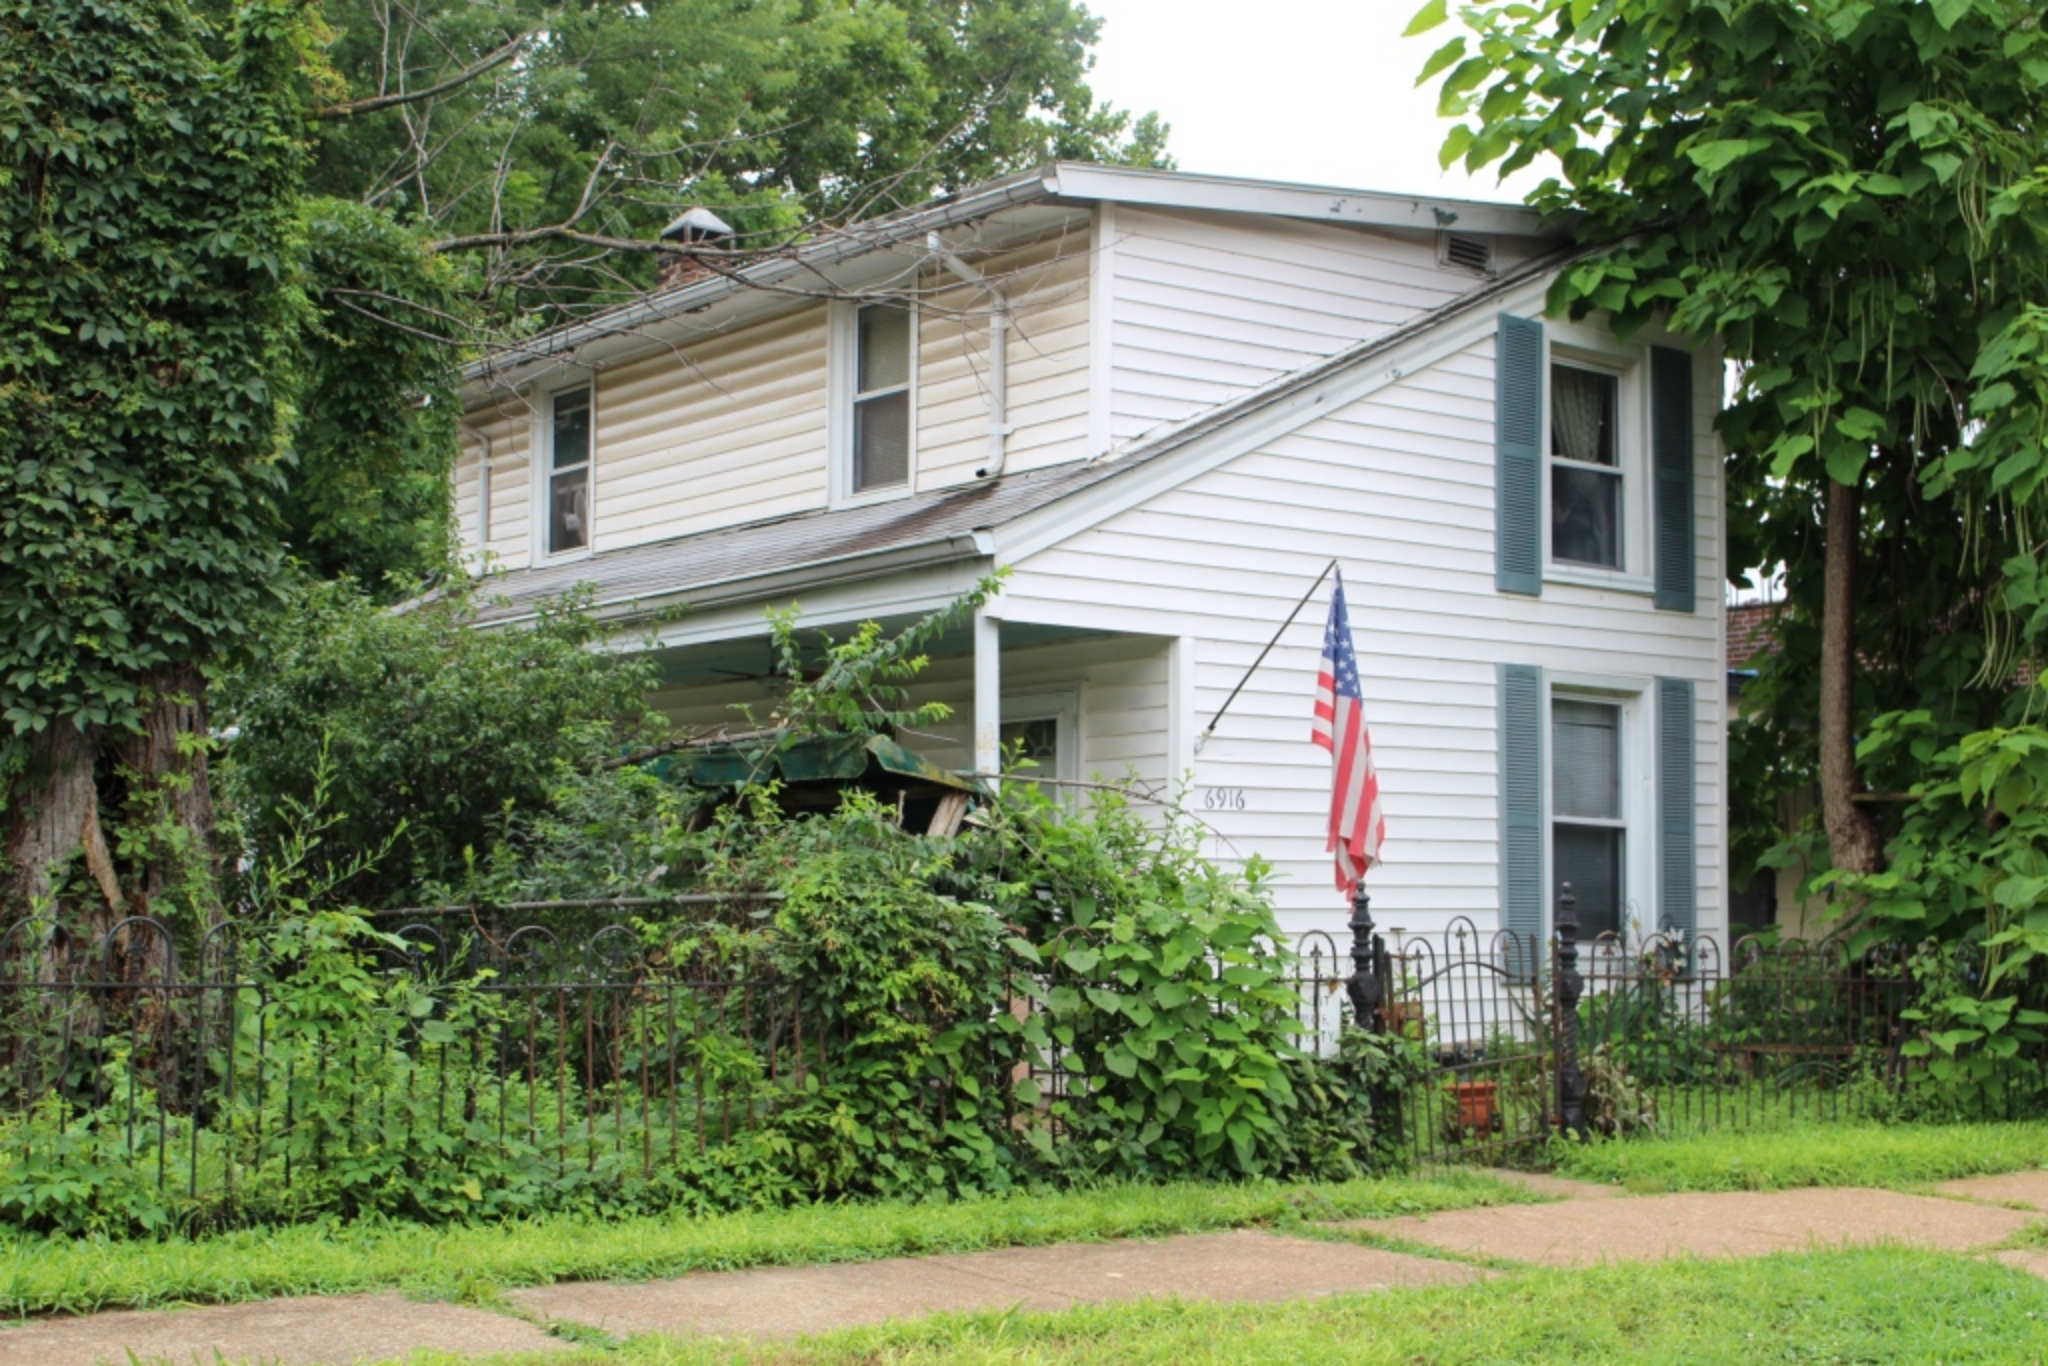
6916

The west, or street facing façade, has a single bay. The single window on each floor has been replaced with a modern doublehung window. Each window on the front façade has decorative shutters fixed in the open position. The entire building has been covered in vinyl siding and all windows and door trim has been wrapped. A full length porch runs the length of the north façade, Two metal poles support the porch roof. The north side of the building has three bays. The entry door has been replaced with a contemporary model. There is a large two bay dormer projecting from the west slope of the roof. The south side of the building is in contact with the neighboring house. The subject property slightly projects forward. There is a single doublehung window at the half-story level in this area.

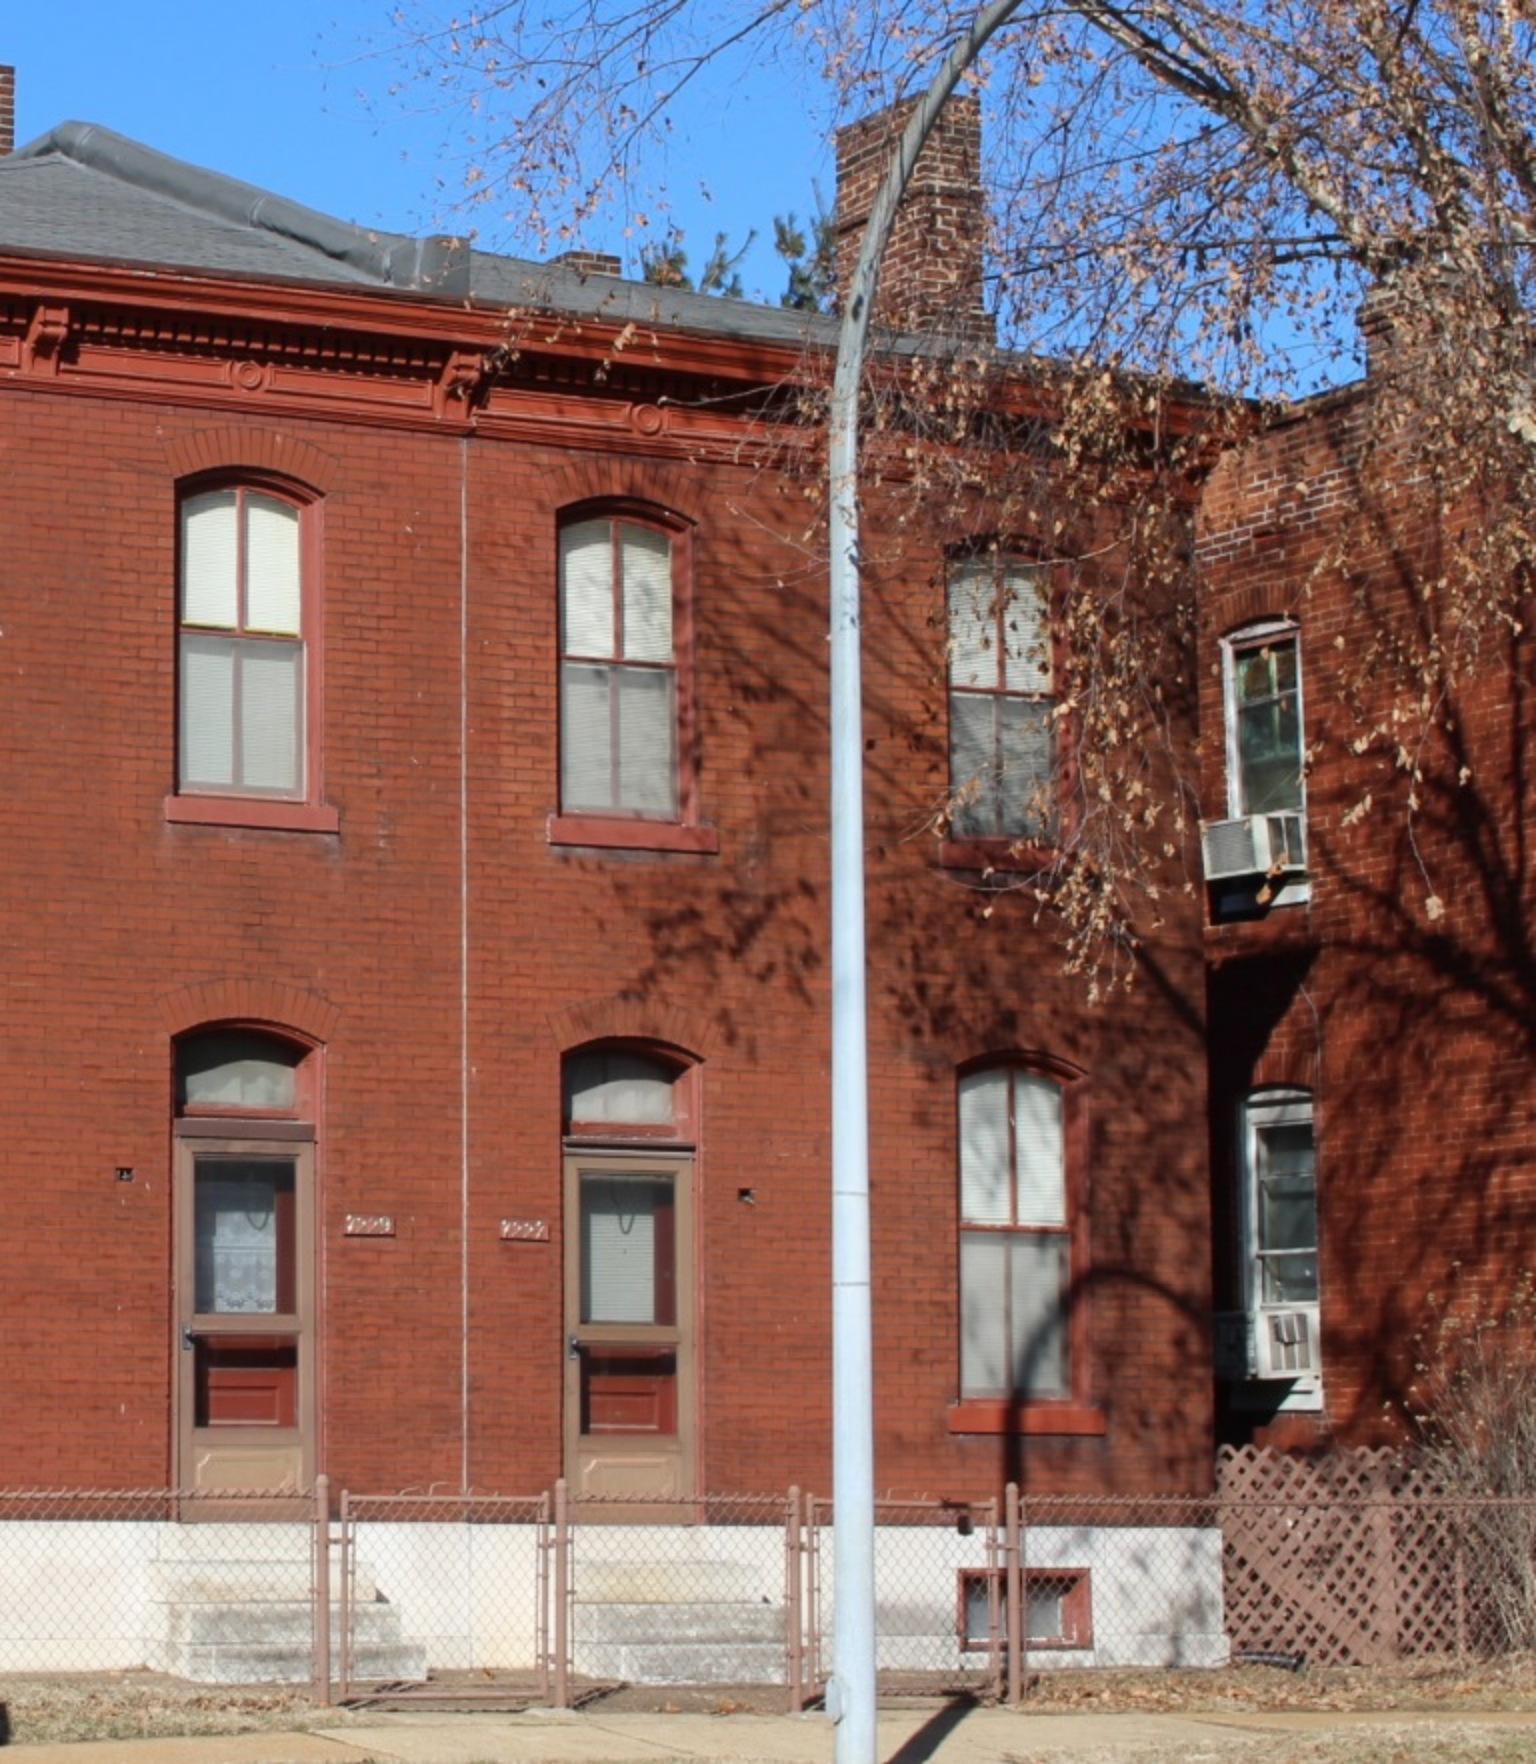
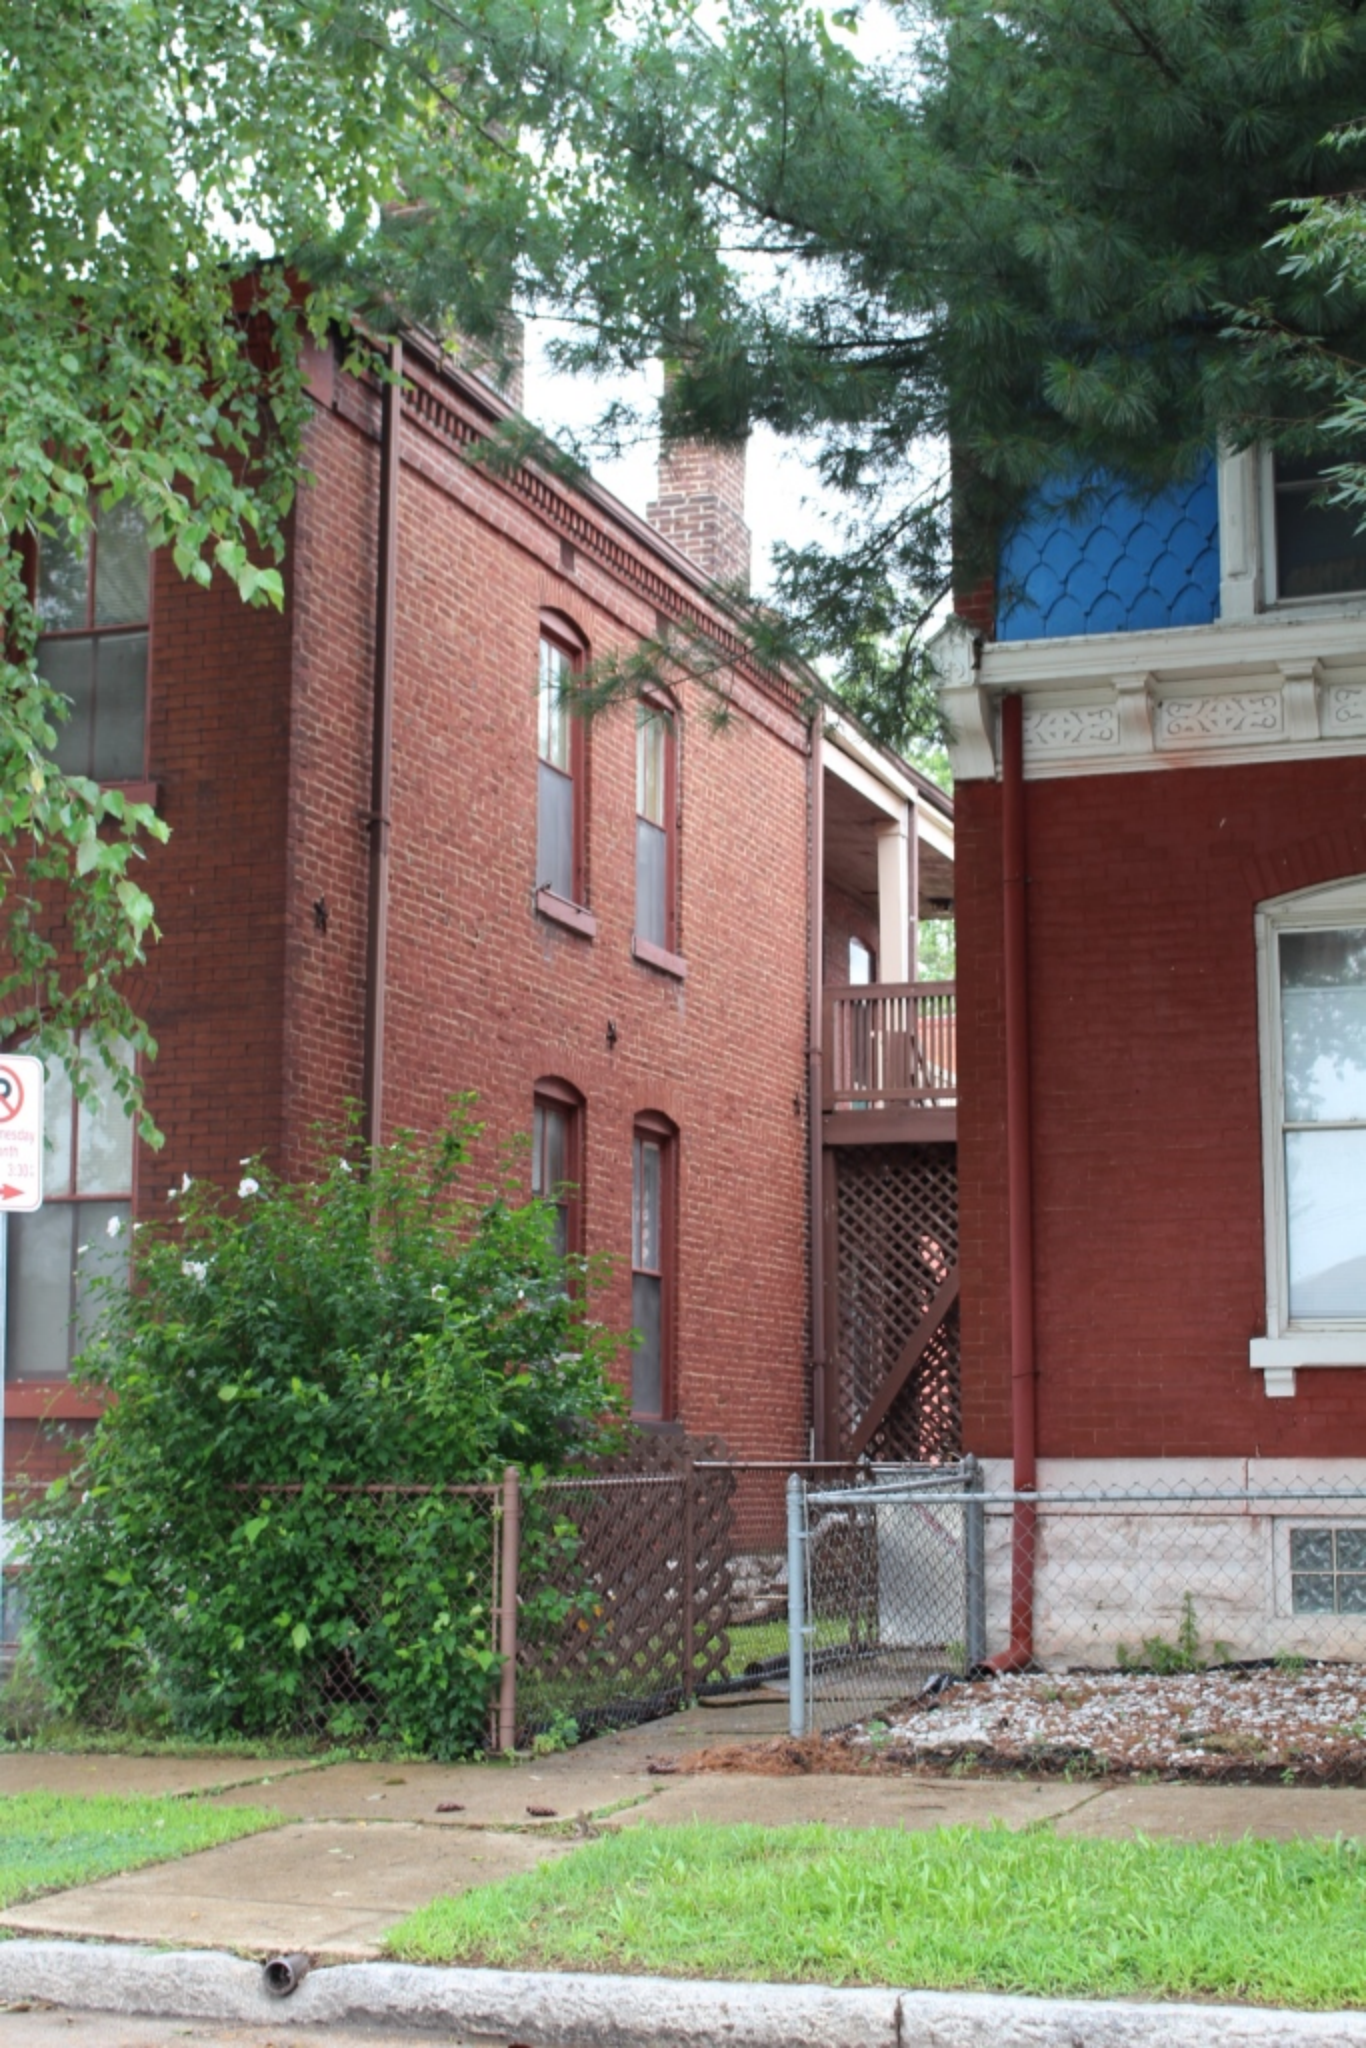
7227 and 7229 Pennsylvania Avenue are attached, identical 2-story, 2-bay flounders, of common bond brick with coursed rubble limestone foundation. On each front façade the foundation has been parged. Fenestration is 2-over-2 arched sash set under segmental arches of soldiers with stone lugsills. Entry to 7227 is in its eastern bay; entry to 7229 is in its eastern bay. Both are identical, retaining original half-light entry doors and segmentally arched transoms. The front facades are crowned by a dentilled wood cornice with brackets and panels. At each side elevation, the front cornice returns for 2 bays, but in in corbelled brick. The rear half of each façade contains a two-story recessed porch. Beyond replacement of the original roof shingles and side porch railings, the exterior of both buildings is intact.

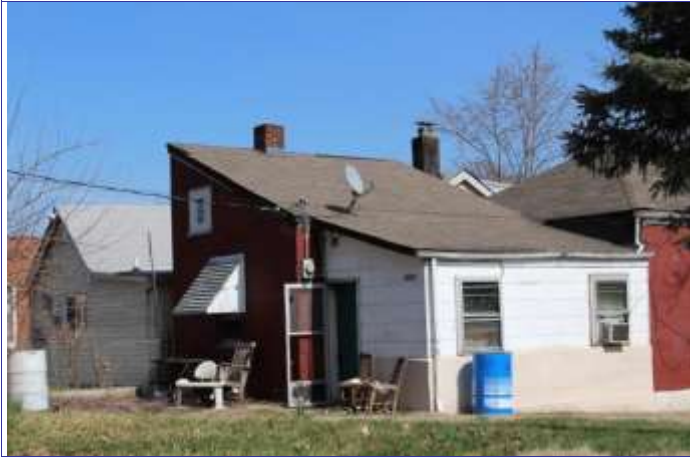
8525 PENNSYLVANIA AV

A 1-story brick flounder with its taller blind wall at the north property line. The brick extends to grade and the foundation of the building is not exposed. The west (rear) elevation has a single doublehung window at the first story, with a small square opening at the roof apex, which has been blocked down for the insertion of a metal vent. The south elevation is obscured by a shed-roof frame addition, sheathed with metal siding, that has a singleleaf door on the west and two doublehung windows on the south. A brick, hipped roof side-hall house from c. 1880 has been added at the east elevation; a portion of the flounder's east wall projects above the roof of the front block.

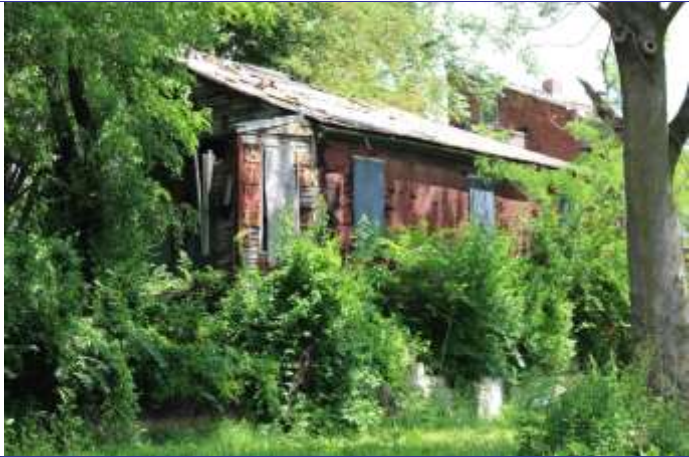
4247 RANDALL PL

Rolled brick pattern asphalt material covers clapboard exposed in a few places. Roofing is a mix of various sheets. Porch is replacement with California type balustrade.

This one-story frame founder is set back in the middle of the lot. Rolled asphalt material covers the clapboard siding. All windows and doors are boarded. A shed-roofed porch extends from the rear. The porch on the façade is a replacement wood one. The shed roof is hipped in the front and the taller wall rises on the north.

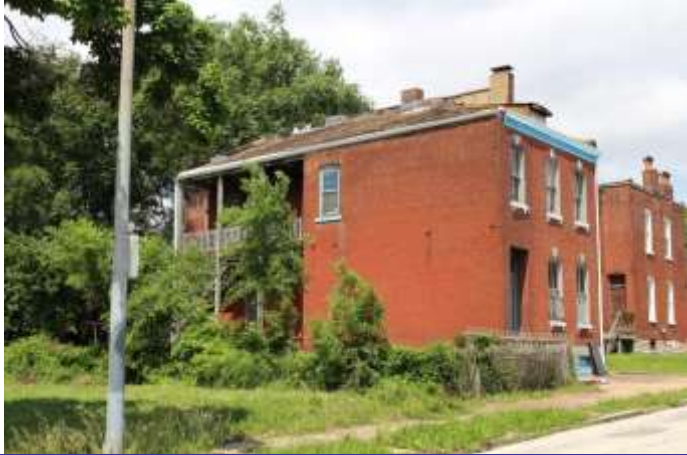
4249 RANDALL PL

Many windows have plastic and foil on the interior; front bseent windows blocked. Assumed to be occupied.

This two-family flats brick flounder has some high-style design elements. It has an ashlar water table terminating a foundation of cut and coursed limestone blocks. Stone steps lead to the inset double entrance doors; the original doors with glazed upper halves remain in place below transoms. Stone keystones mark the center of the segmentally-arched window openings formed of stretcher bricks and the stone sills are lugged. Historic arched 2/2 doublehung wood sash remains in the facade. A denticulated brick dormer edges the facade below a shed-roofed dormer projecting from the hipped front shed roof. The inset two-story wood gallery is covered by the main roof; it has been rebuilt.

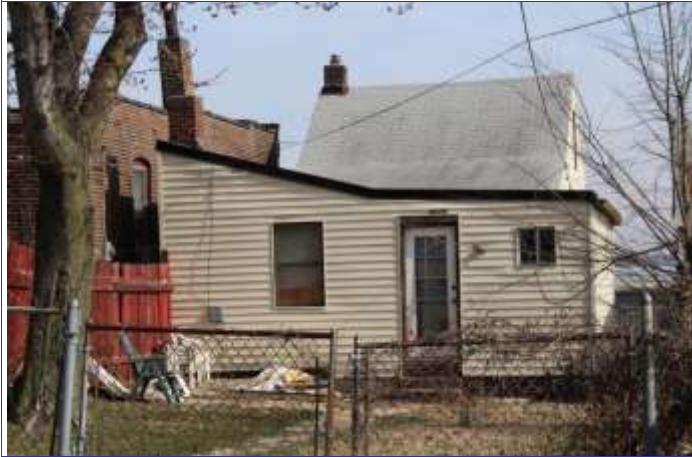
rear elevation

8115 Reilly is a one-room, one-story frame flounder atop a brick foundation. The taller blind wall is positioned at the north property line; the western (rear) wall has a single bay with a replacement doublehung window. A brick stove chimney is positioned at the ride on this façade. The southern elevation is obscured with a room addition, containing a new entry on the west, flanked by a small slider window. A 1-1/2 story one-room house is at the block front. It is connected to the flounder by a one-story, shed-roofed addition. Both the rear flounder and front block appear to be of very early date. Flounder and front block have been sheathed with vinyl siding.

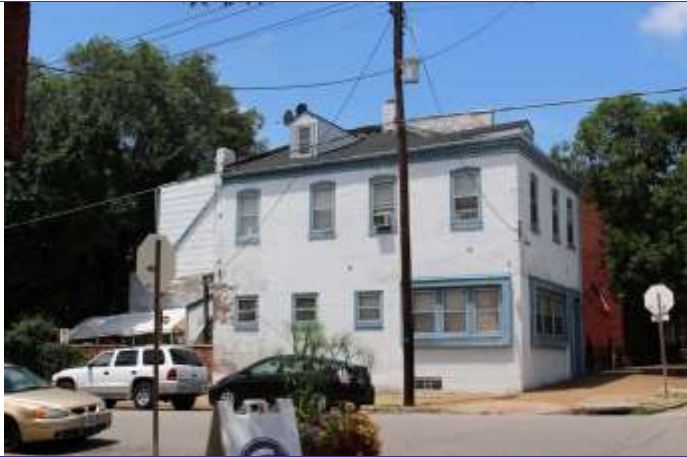
900 RUSSELL BLVD

Foundation concealed with concrete and brick is painted; brick wall hides lower story of rear wall

This 2 1/2-story brick flounder is located at a corner. Its lower story has been altered on both street facades, likely for commercial purposes and has a modern configuration of windows at the corner. The entrance on Russell is in the west bay. The window openings on 9th street are shortened, have flat lintels, and stone sills. The second-story windows on both street facades appear unaltered and have segmentally-arched heads formed of header brick and stone sills. Two dormers project from the roof, one from the front and one from the side slope. A two-story wood gallery across the rear has its own flat roof. A one-room brick structure adjacent to the gallery has a flounder form.

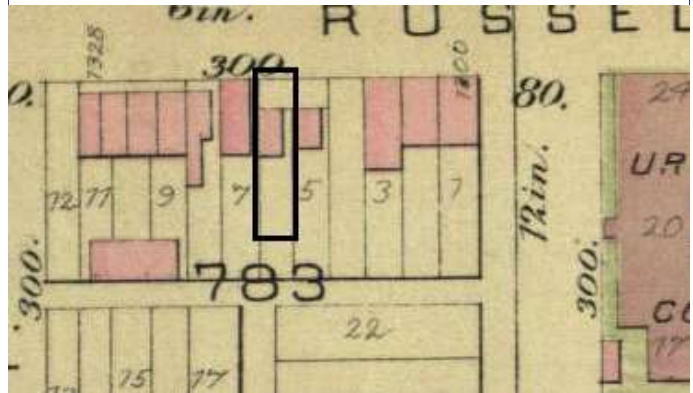
The building is in good condition and is well-maintained. The foundation has been parged.

This 1 1/2-story brick flounder with a hipped front on the shed roof is set back several feet from the building line. The narrow flounder presents two bays to the street; its entrance is near the middle of the front portion sheltered by a shed-roofed porch. Window openings have segmentally-arched heads with brick headers. A middle section has a flat roof and a rear section also has the form of a flounder.

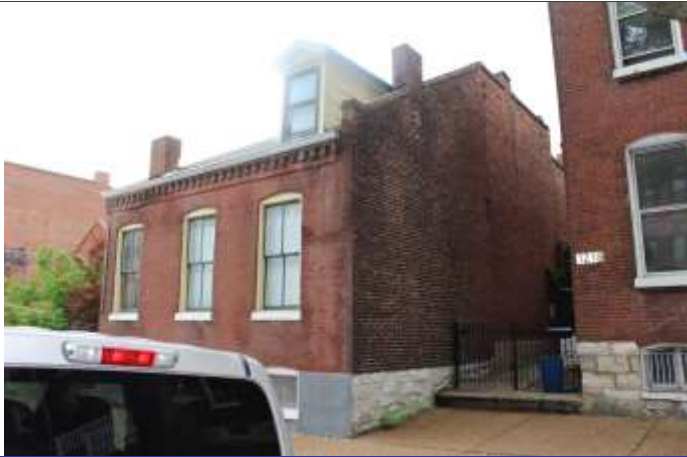
1216 RUSSELL BLVD

Building is in good condition and is well-maintained.

This 1 1/2-story brick flounder with a hipped front on the shed roof is positioned at the building line. A corbelled brick cornice spans the horizontal eaves of the 3-bay façade; a small gabled dormer extends from the front roof plane above the west bay. The east bay is a wing wall for a gallery porch that is sheltered by the main roof; a second small dormer projects from the side roof plane. The front portion of the gallery is enclosed with horizontal siding. A tall wood column supports the gallery roof over the open portion. Steps sheltered by the gallery approach one of the two entranceec. Windows have segmentally-arched heads of soldier bricks and stone sills; those on the façade hold 2/2 wood sash. A rear wing has a shed roof of a lower height as the main roof.

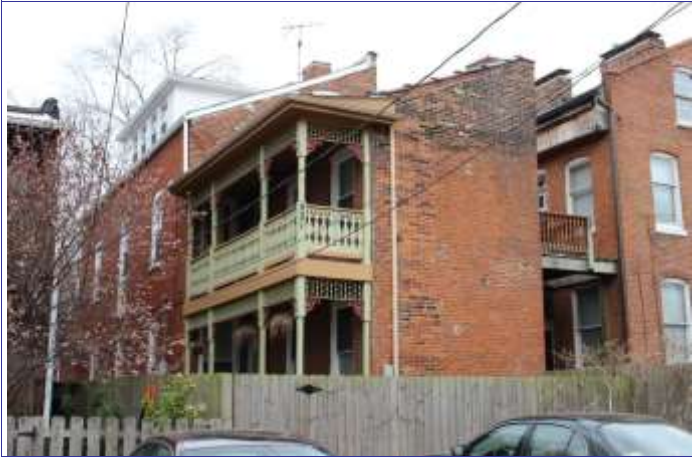
921 RUTGER ST

Altered parapet.

Two-story brick flounder with corbelled brick cornice and altered front brick parapet. There are four front (south) façade windows, two on each floor, with trabiated stone lintels and stone sills. The main entrance is on the east side of the building. It is centered on the main block of the house and is flanked by two windows with stone sills and brick soldier course lintels. The second floor of the main block on the east side has the same configuration as the first floor. The door has been converted to a window however. There roof of the main block features a shed dormer with four casement windows each divided into four lights. The rear addition has a two story wooden porch that runs the length of the east side. Each floor of the rear addition has two windows and a door that accesses the porch.
