ARCHITECTURAL/HISTORIC INVENTORY FORM - Cultural Resources Office
St. Louis Planning and Urban Design

1. Survey no. SLC-AS-053-0195	2. Survey name: Thematic Survey of Flounder Houses in St. Louis City	3. County: St. Louis [Independent City]
4. Address: (from City GEO database) 908 MORRISON AV		5. City/State: St. Louis, Missouri
Alternate address: 908 Morrison Avenue		Property Zip Code: 63104
Latitude: 38.614945		6. UTM Easting: 743839.02
Longitude: -90.199405		UTM Northing: 42277768.84
8. Historic Name (if known): N/A	11a. Historic Use (if known): Domestic	City Block 466.03
9. Present/other name (if known): Domestic	7. Township-Range-Section: N/A	City Ward 7
10. Ownership: Private		Neighborhood Number: 34

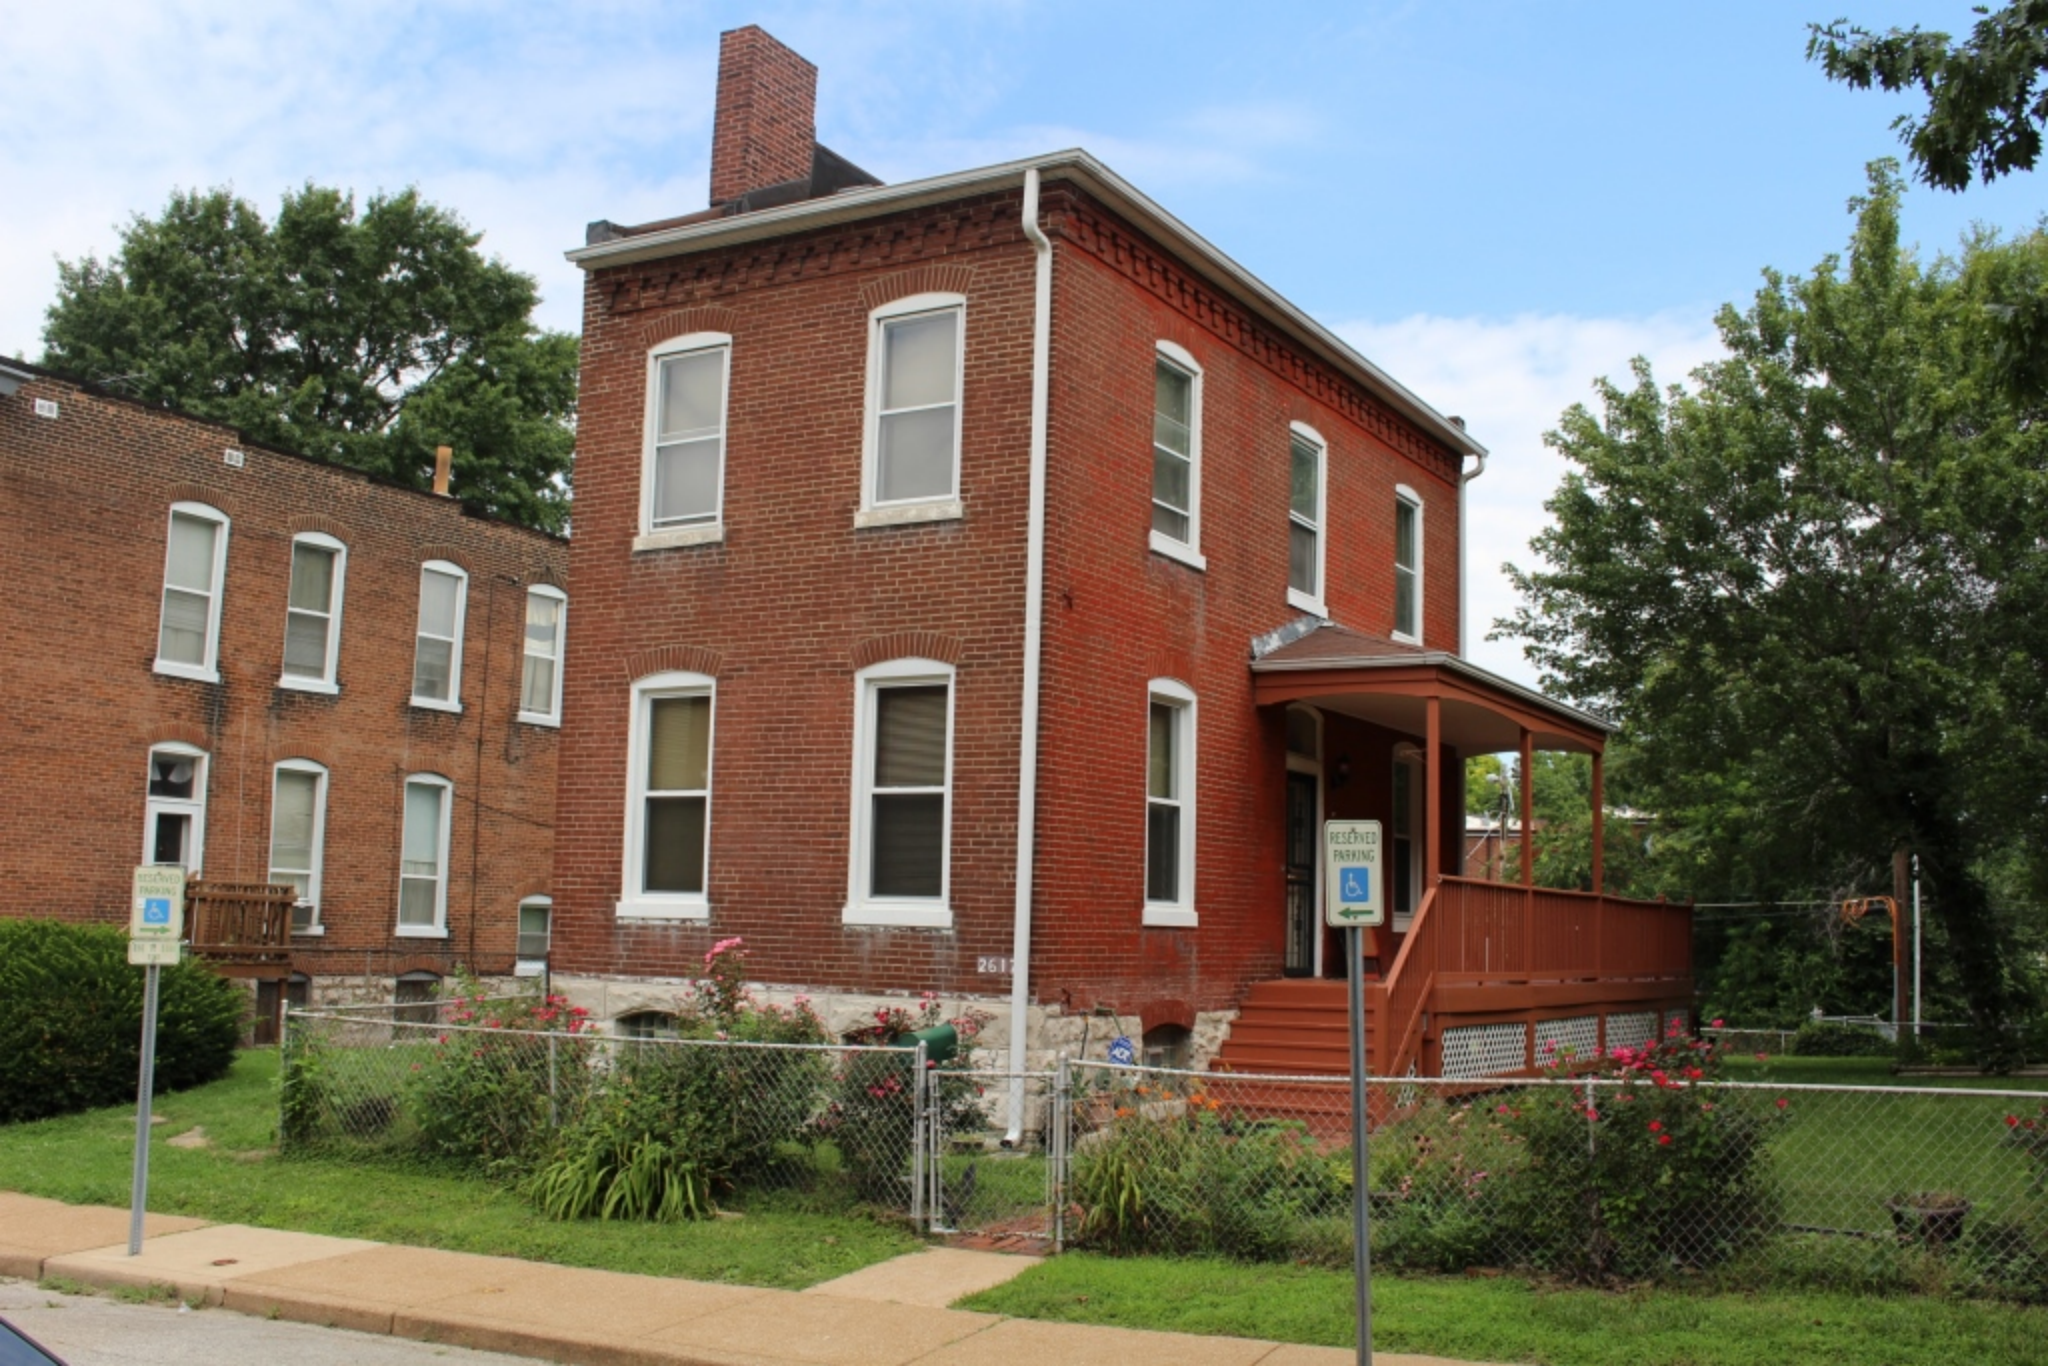
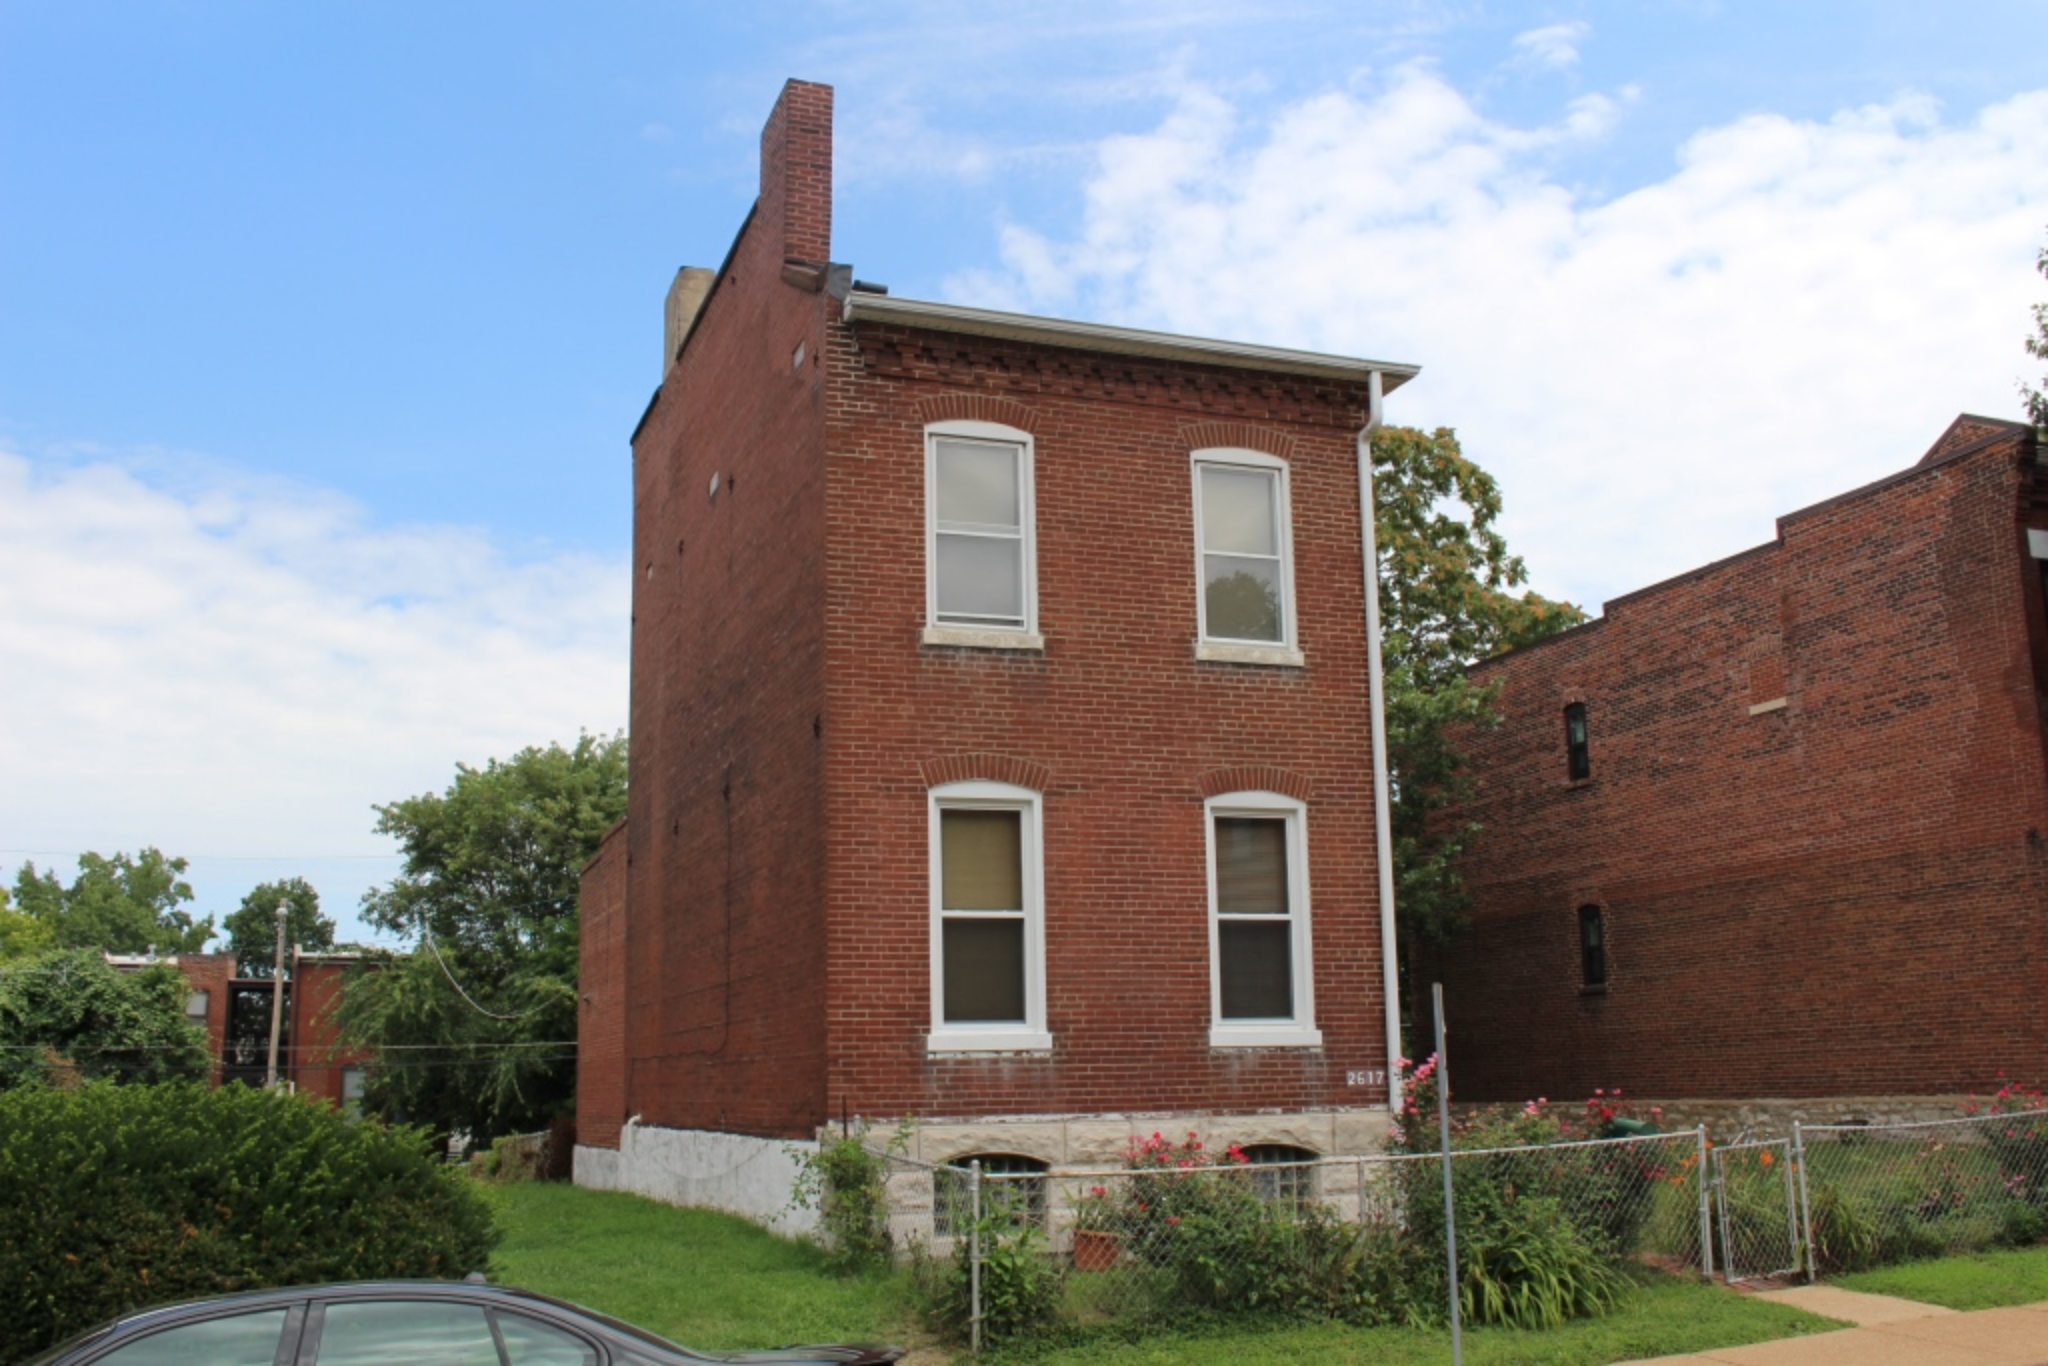
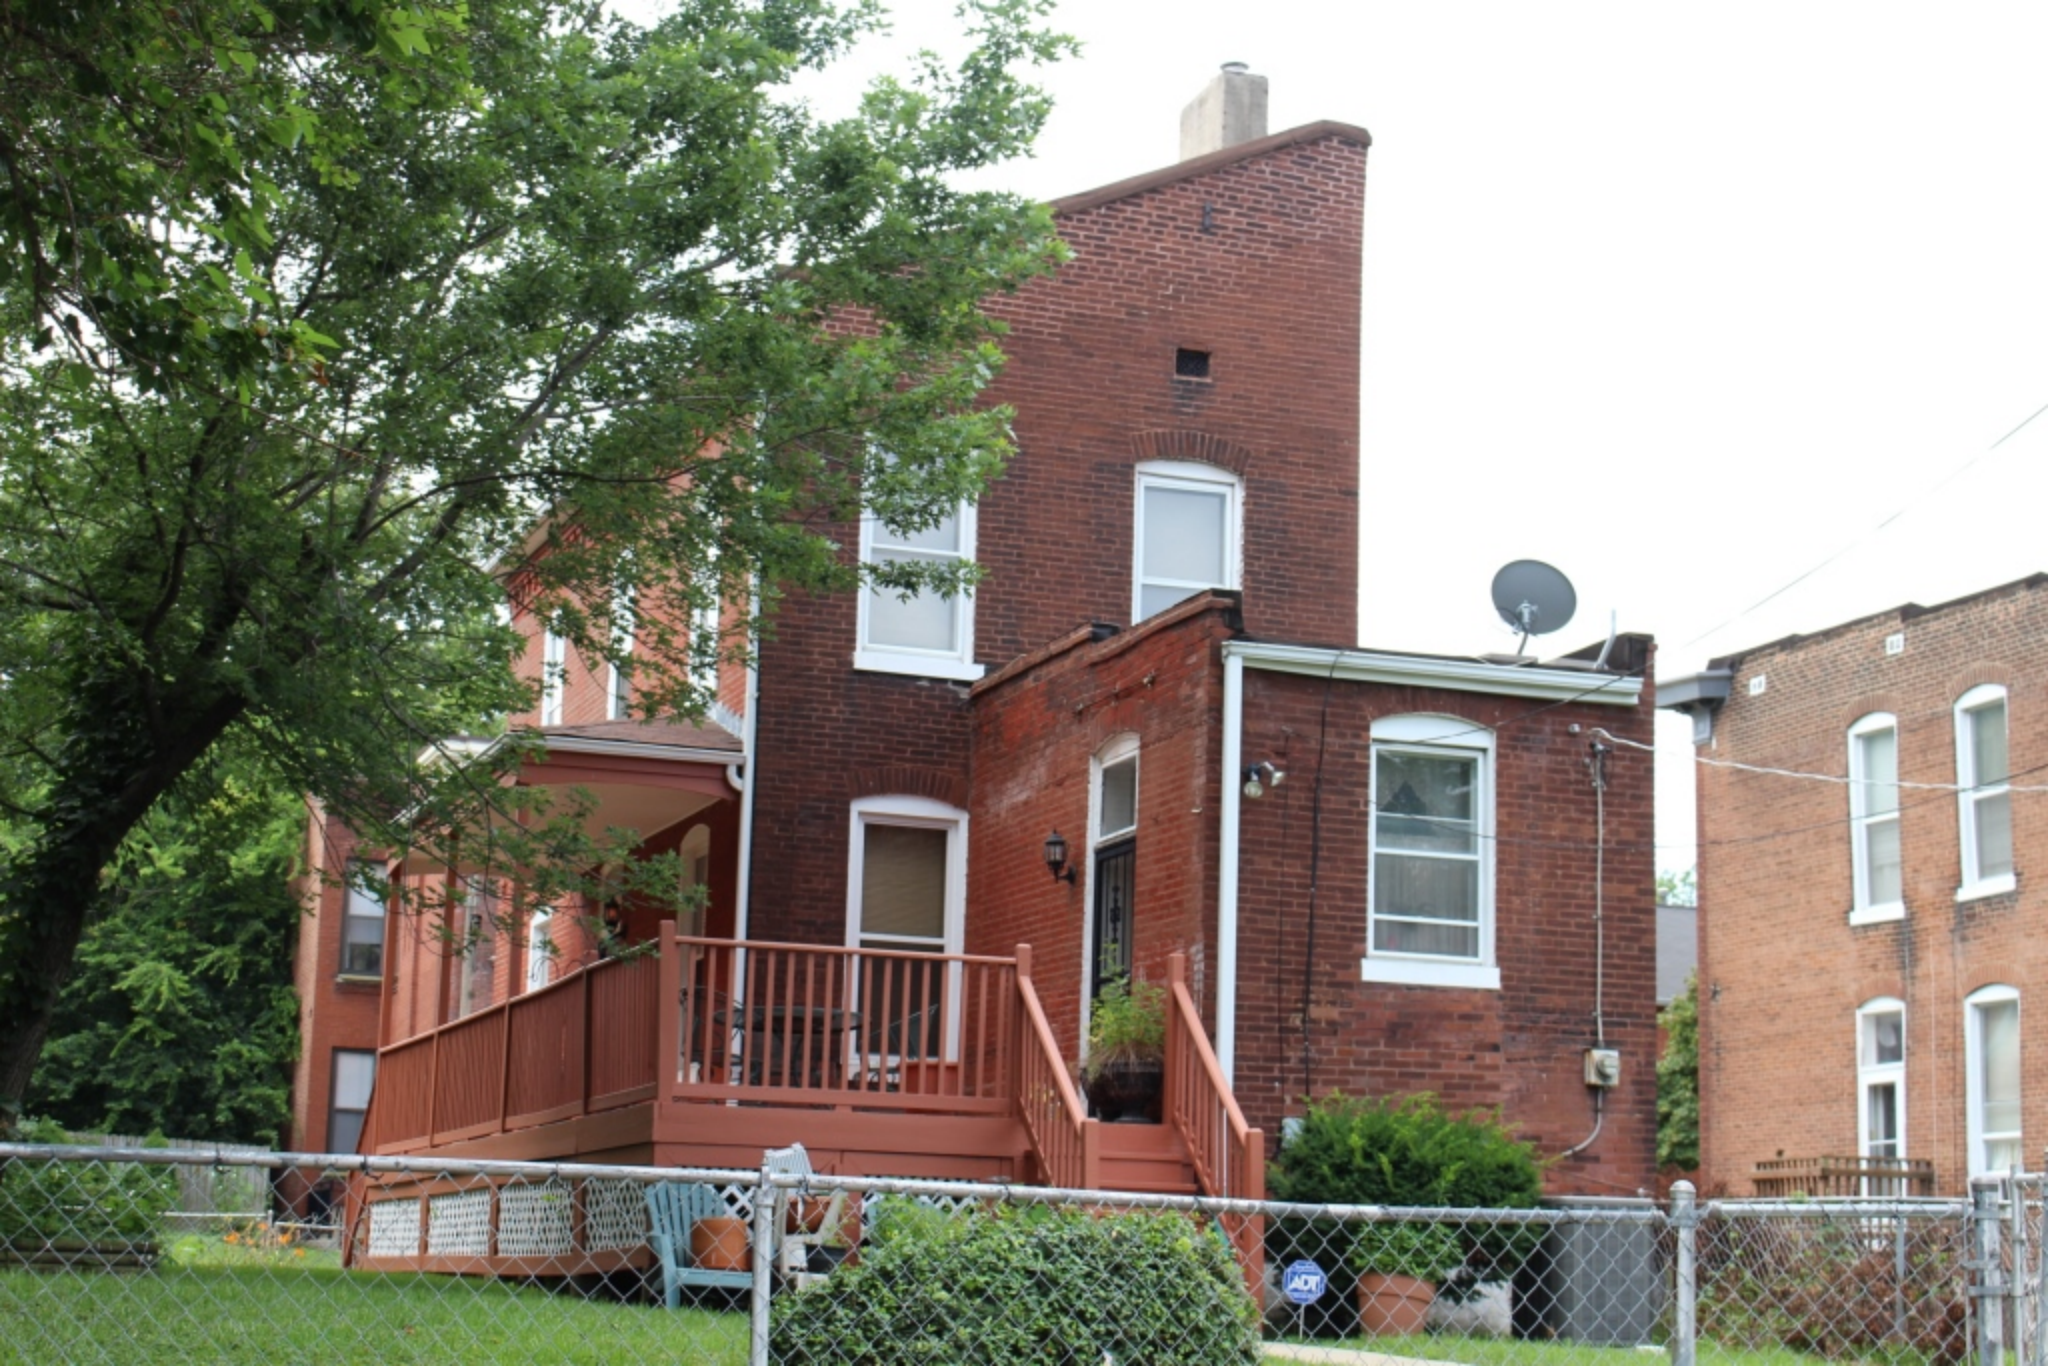
2617 RUTGER ST

This two-story with loft brick flounder has a cut and coursed limestone foundation. A corbelled cornice edges the façade and side wall eaves. The side porch has a hip roof that covers the rear bay beyond the ceter bay entrance. Door and window openings have segmentally-arched heads of soldier brick. A flat-roofed one-story brick wing extends from the rear wall. The taller windowless wall may have been a party wall.

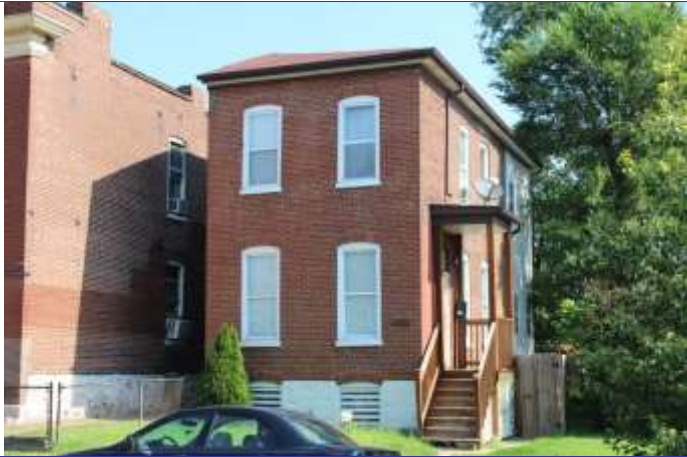
3133 RUTGER ST

This two-story brick flounder has such a shallow pitch to the shed and hipped front of the roof that if likely has only minimal loft space. A modern cornice has replaced the original cornice or conceals a corbelled cornice. The two front bays and east side bays have segmentally-arched openings of soldier brick. The entrance is in the front side bay. A replacement one-bay porch with a shed roof shelters the door. The inset rear gallery on the east side has been completely enclosed.

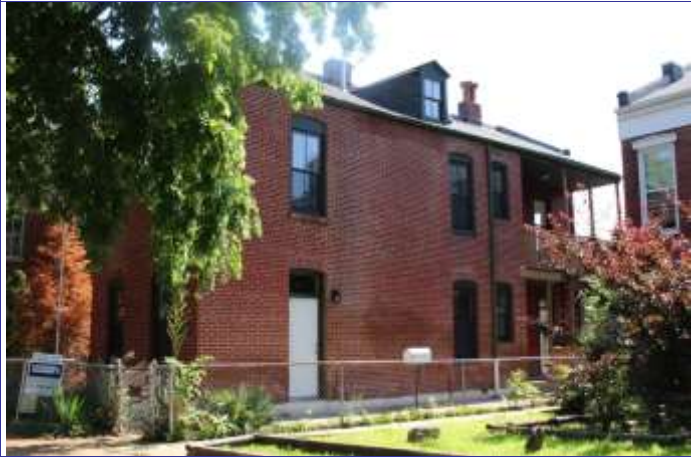
2824 SALENA ST

This 2 1/2 story brick flounder is set near the sidewalk, in front of flanking buildings on the streetfront. Two bays face the front and the entrance is in the front bay of the south side. The taller blind wall is on the north. All door and window openings have segmentally-arched openings formed of stretcher bricks and brick header sills. A corbelled brick cornice edges the eaves at only the façade. A small gabled dormer projects from the shed roof portin of the roof. A 2-story wood gallery sheltered by the main roof edges the rear of the south side.

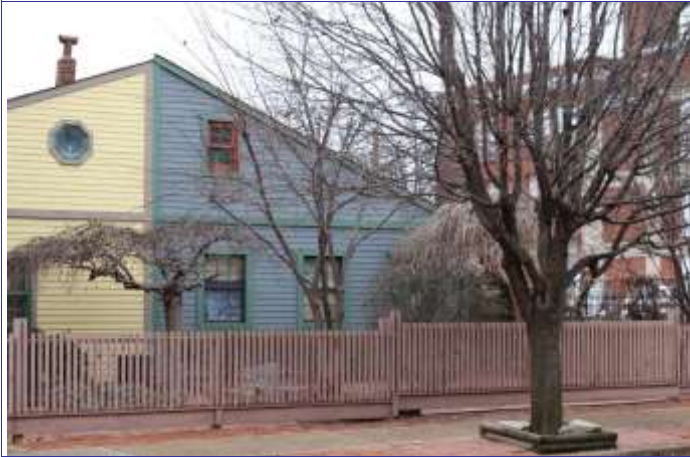
2855 SALENA ST

All exterior materials appear to be those of a somewhat recent rehabilitation. North side and rear not visible from outside the property.

This semi-detached 1 1/2-story wood-framed flounder has a shed roof. The tall blind wall is the party wall. It exterior cladding appears to be Hardiboard to resemble weatherboard. The three-bay façade consists of three windows with 6/6 doublehung wood sash. A smaller window openings in the attic has a 4/4 doubehung wood sash. The north wall is enclosed with large sheets of exterior plywood.

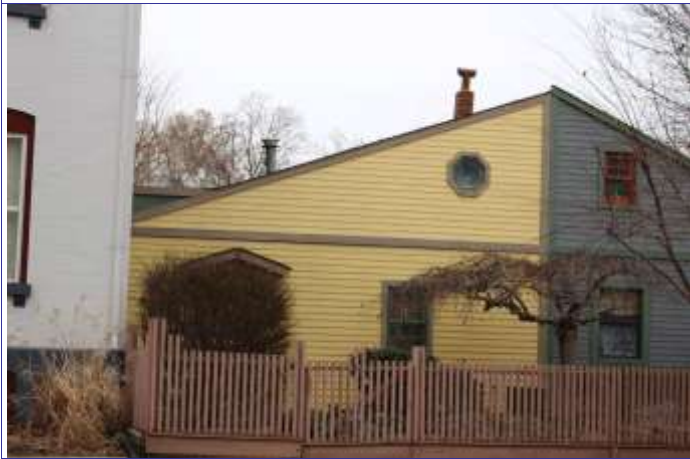
2857 SALENA ST

The rear is not visible from outside the property and the building abuts others on both the north and south.

This semi-detached 1 1/2-story wood-framed flounder has a shed roof. The tall blind wall is the party wall. It exterior cladding appears to be Hardiboard to resemble weatherboard. The two-bay façade consists of a door in the south bay sheltered by a small gabled roof and a window with 6/6 doublehung wood sash. An octagonal oriel window lights the attic. Is there a dormer?

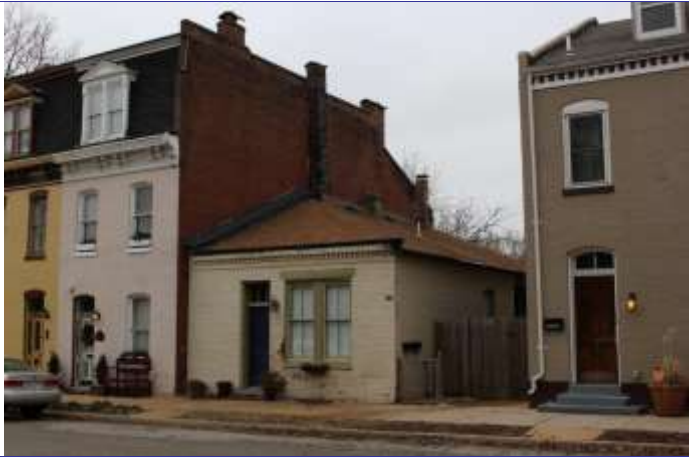
2865 SALENA ST

brick of façade meets sidewalk pavement; foundation not visible on façade; brick is painted.

This 1-story brick flounder has a hipped front roof with a simple denticulated brick cornice at the horizontal eaves of the façade. It is not raised on a foundation; the entrance in the façade is a low step from the current height of the sidewalk. A wide window opens with wood lintel and sill holds paired 2/2 doublehung wood sash separated by a wood mullion. A side window opening in front of an inset gallery on the north side has a segmentally arched head and has the same type of sash. The taller blind wall is a few inches from the building to the south.

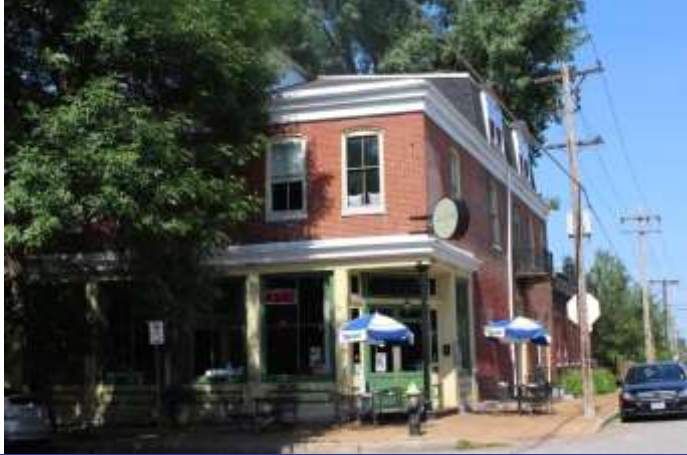
2901-3 SALENA ST

wood cornice has no brackets and is "wrapped" with modern materials/
arched sash on north side wall; sash on façade set below eyebrows

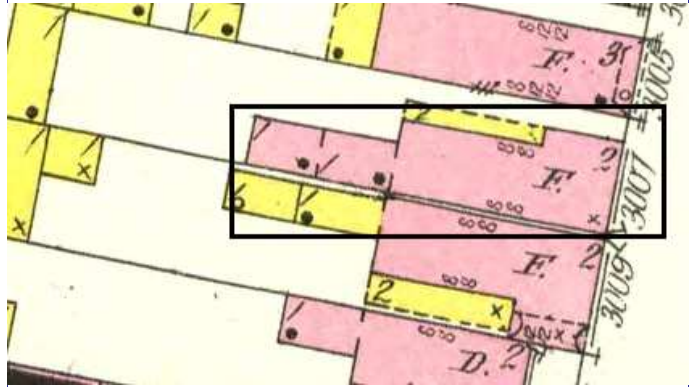
House very close to the one to the north; view of that wall very oblique.

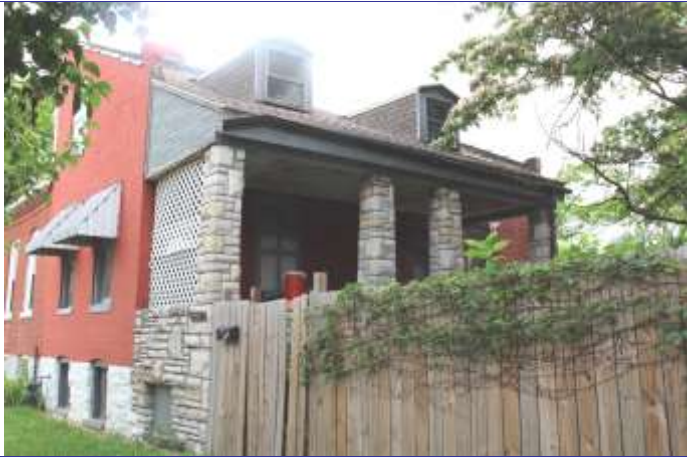
3334 SALENA ST

Gallery extensively altered; materials include Permastone lower wall with lattice above.

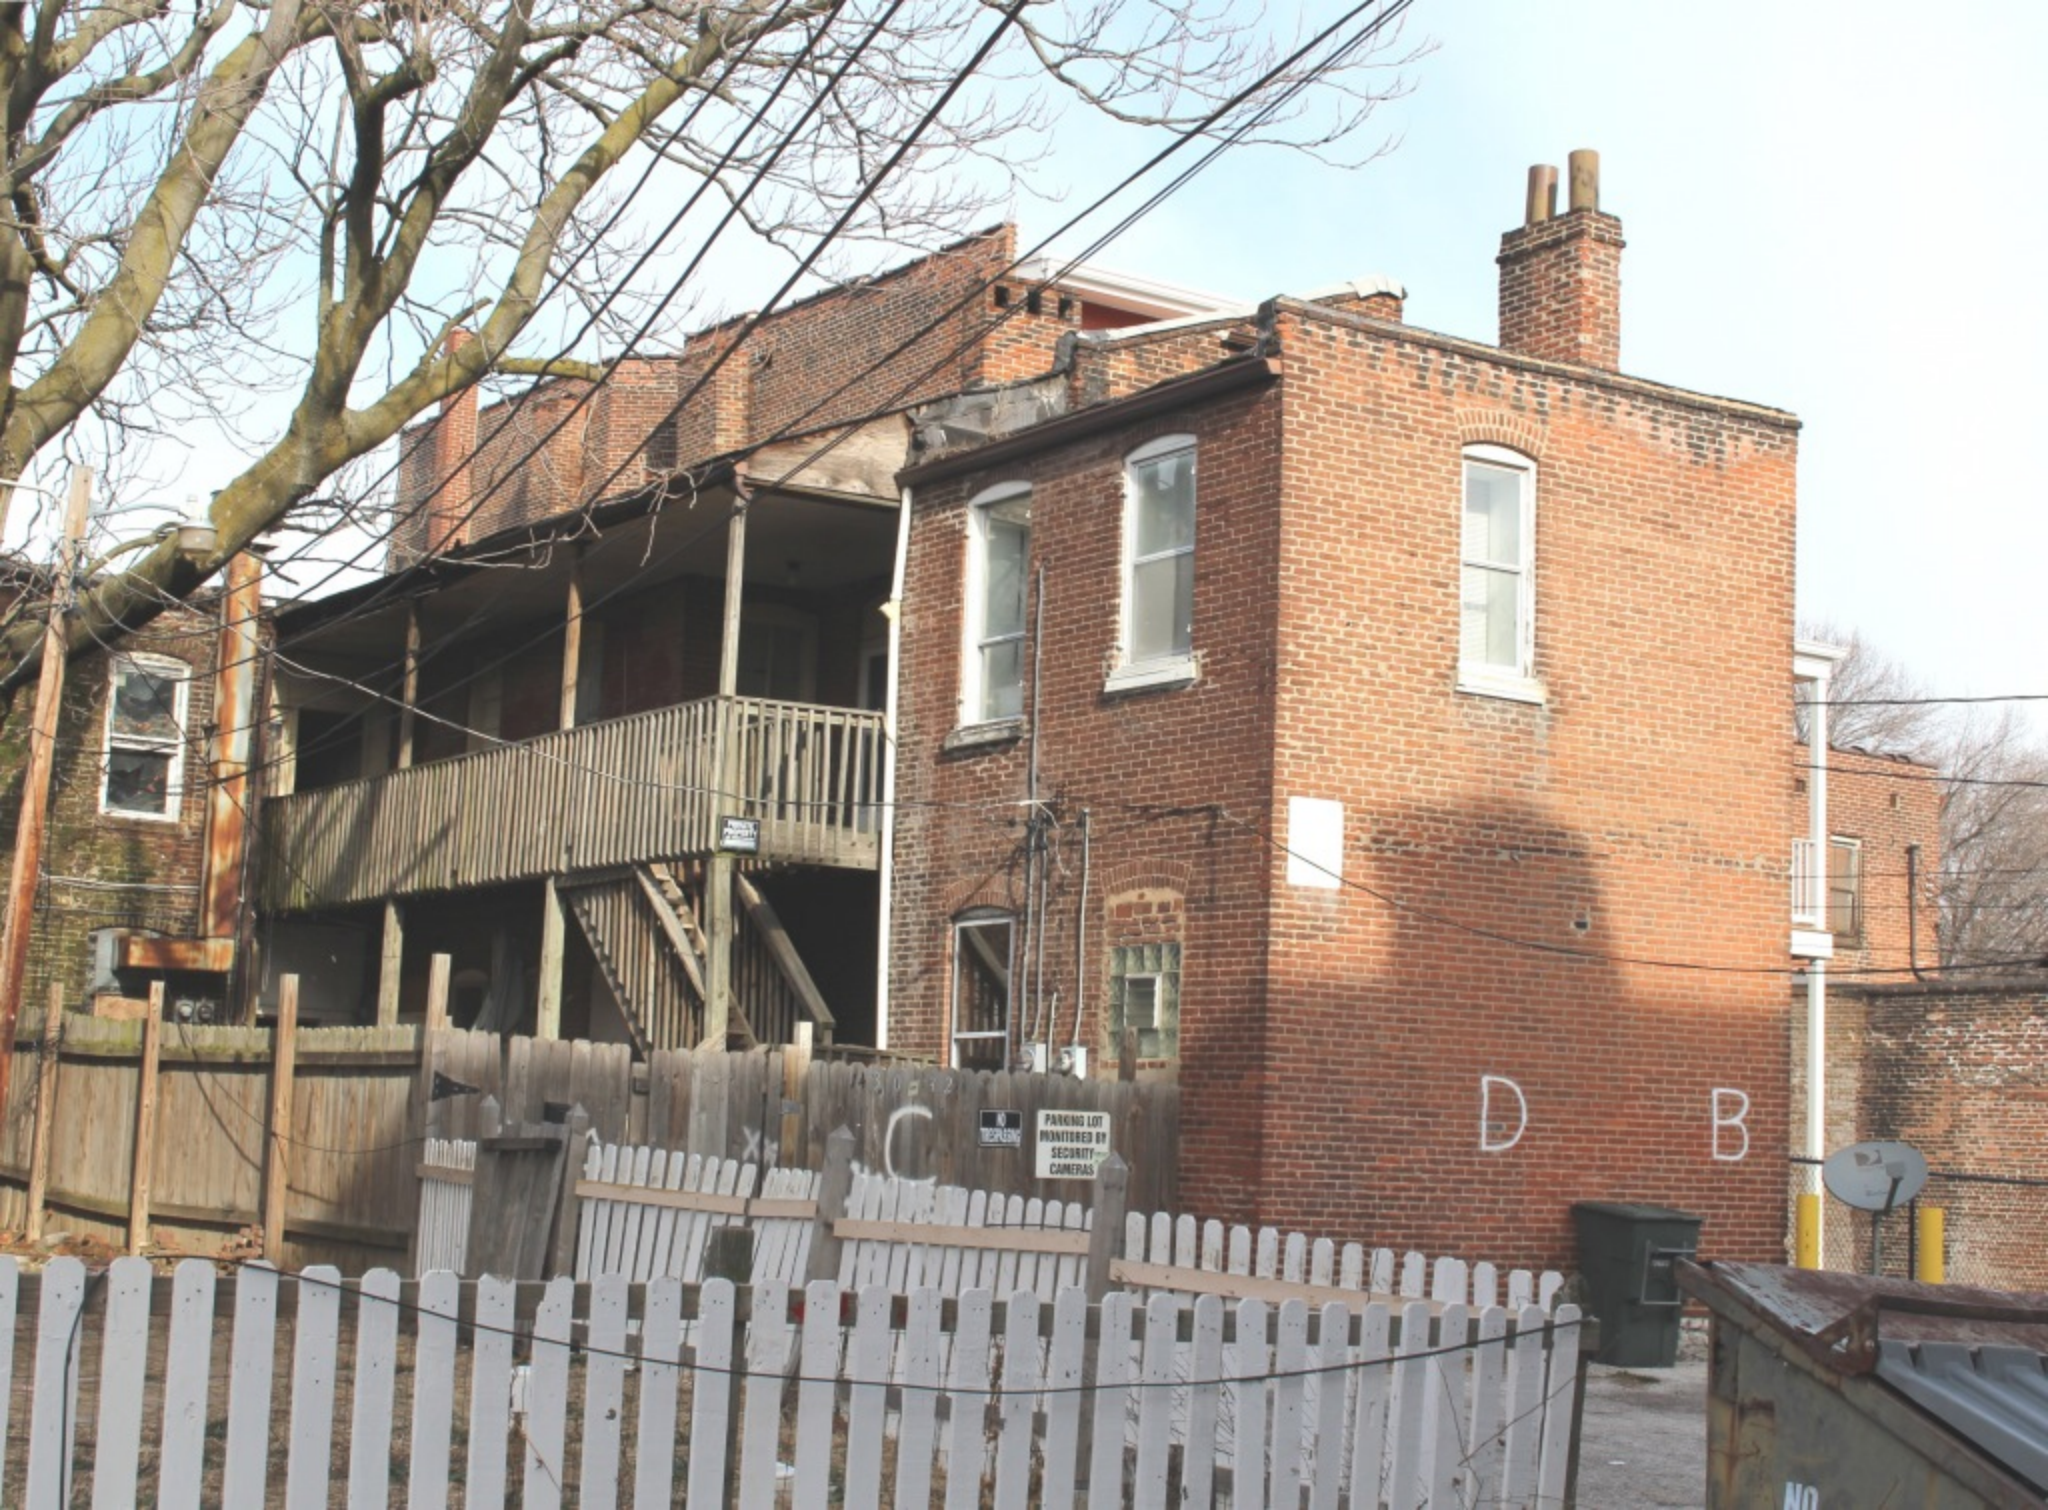
This 2-story with loft mid-lot brick flounder has a wood gallery on its west side. The exposed portion of the taller blind wall on the east side is windowless. The shed roof of the gallery extends the plane of the main roof. The gallery has the traditional open form with a staircase incorporated into it. A two-story flat-roofed portion of the structure abuts its south wall and the north wall is a party wall of the front portion.

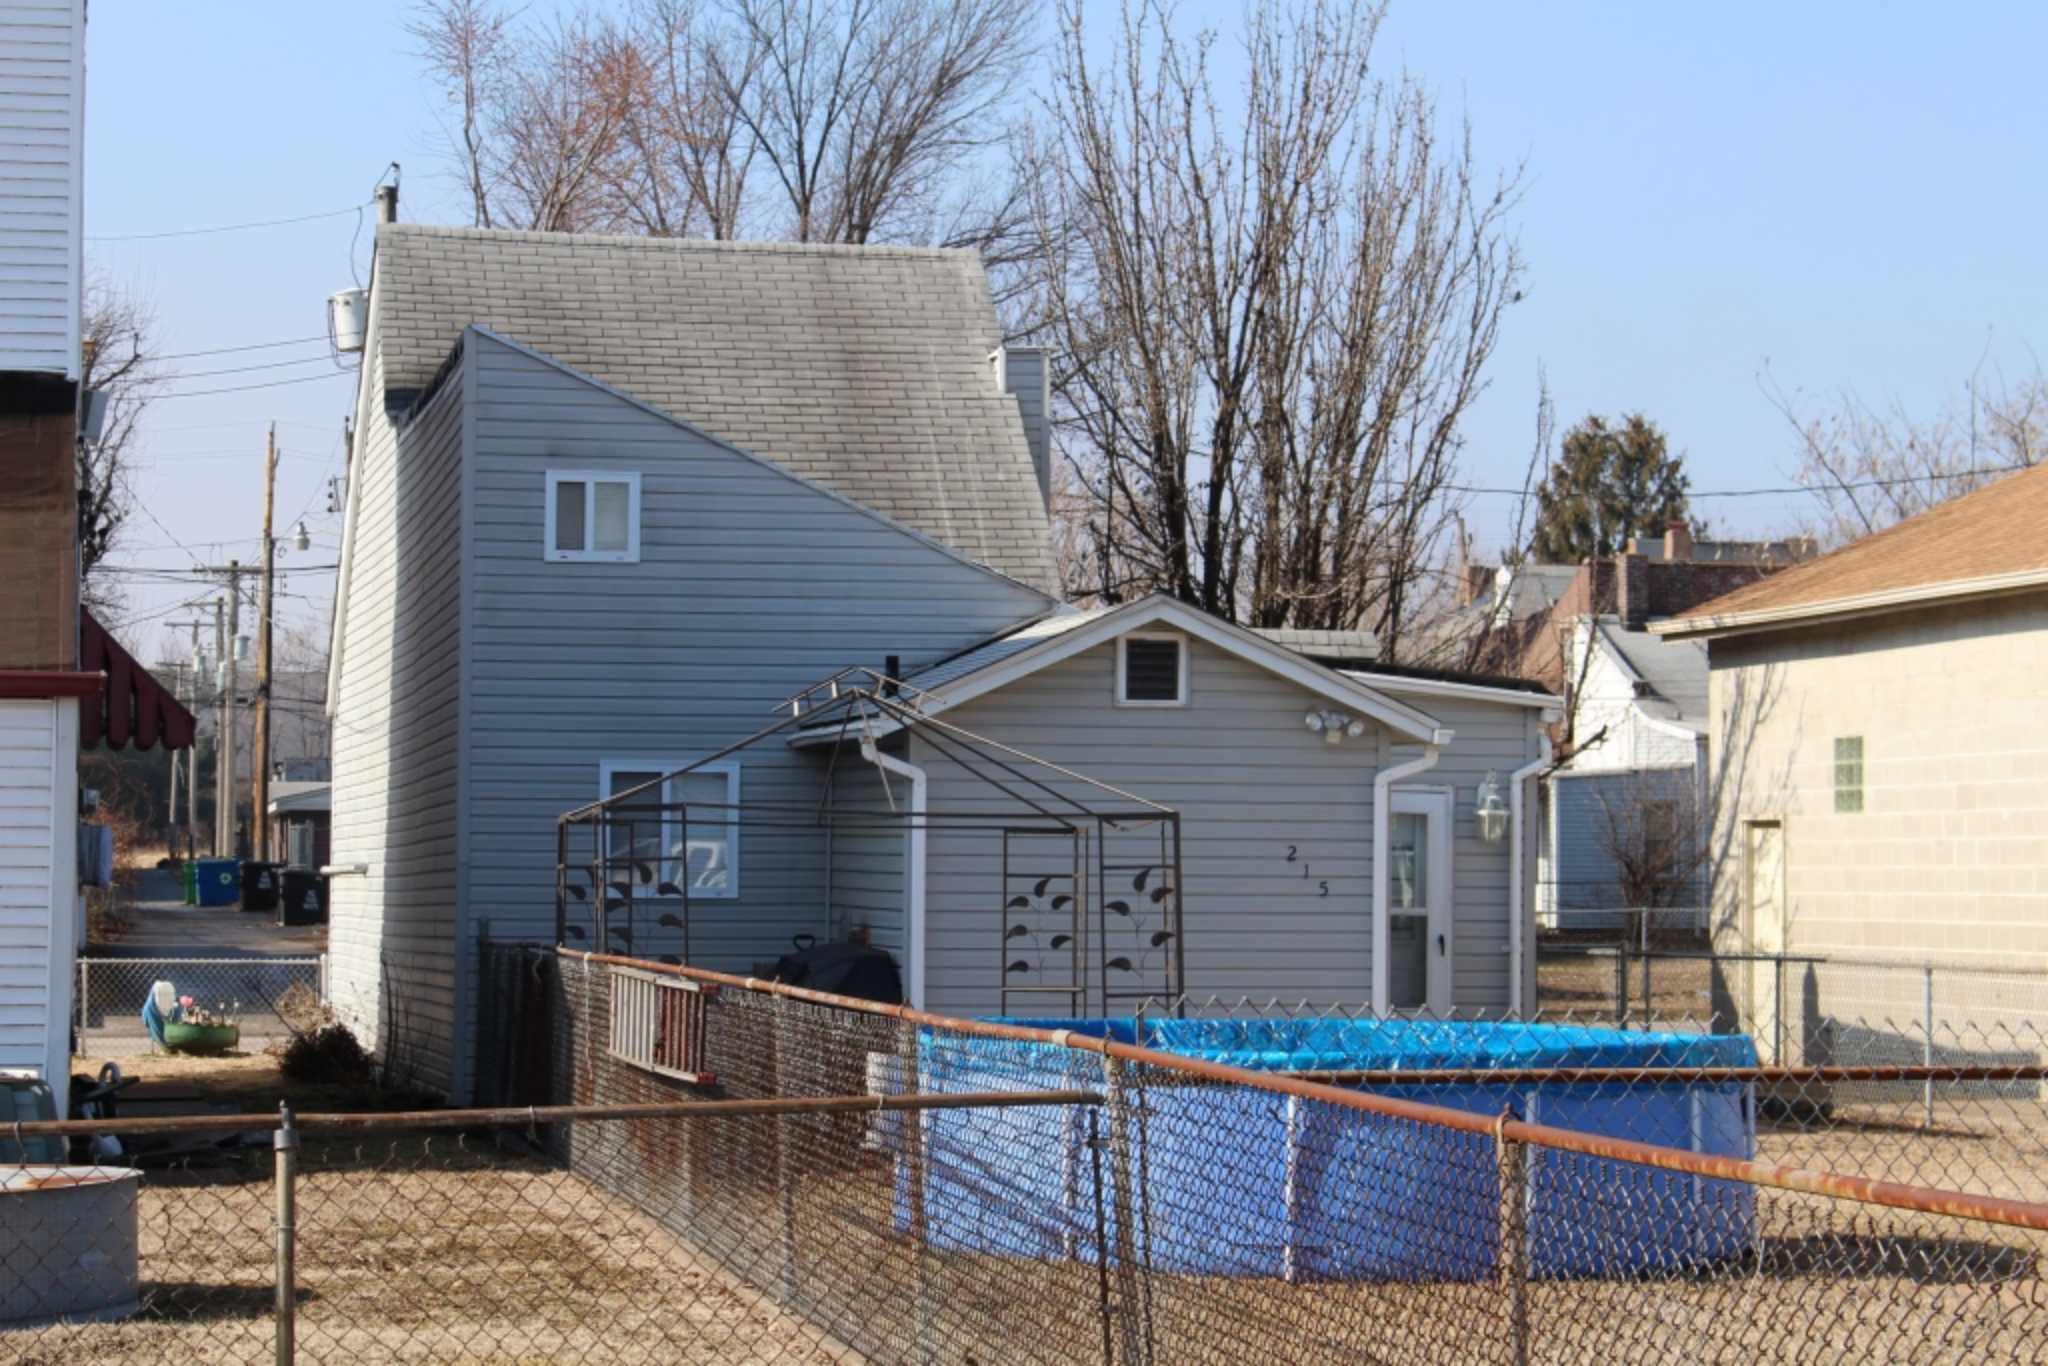
This is a 1-story frame flounder with loft space. Its tall blind wall is sited at the south property line of the parcel. Its eastern (rear) façade has two bays; the southern bay is now filled with a slider window; the northern bay is obscured by a large gable-roofed addition. Another one-story addition has been constructed at the flounder's north wall and at the front, a 1-1/2 story side-gable house with a steeply pitched roof has been placed at the street. The flounder appears to be very early, and based on siting and the connection of the flounder to the front gable roof, it was the first property on the site. Flounder, front house and additions have been sided and windows replaced with vinyl sash. Chimneys have been removed.

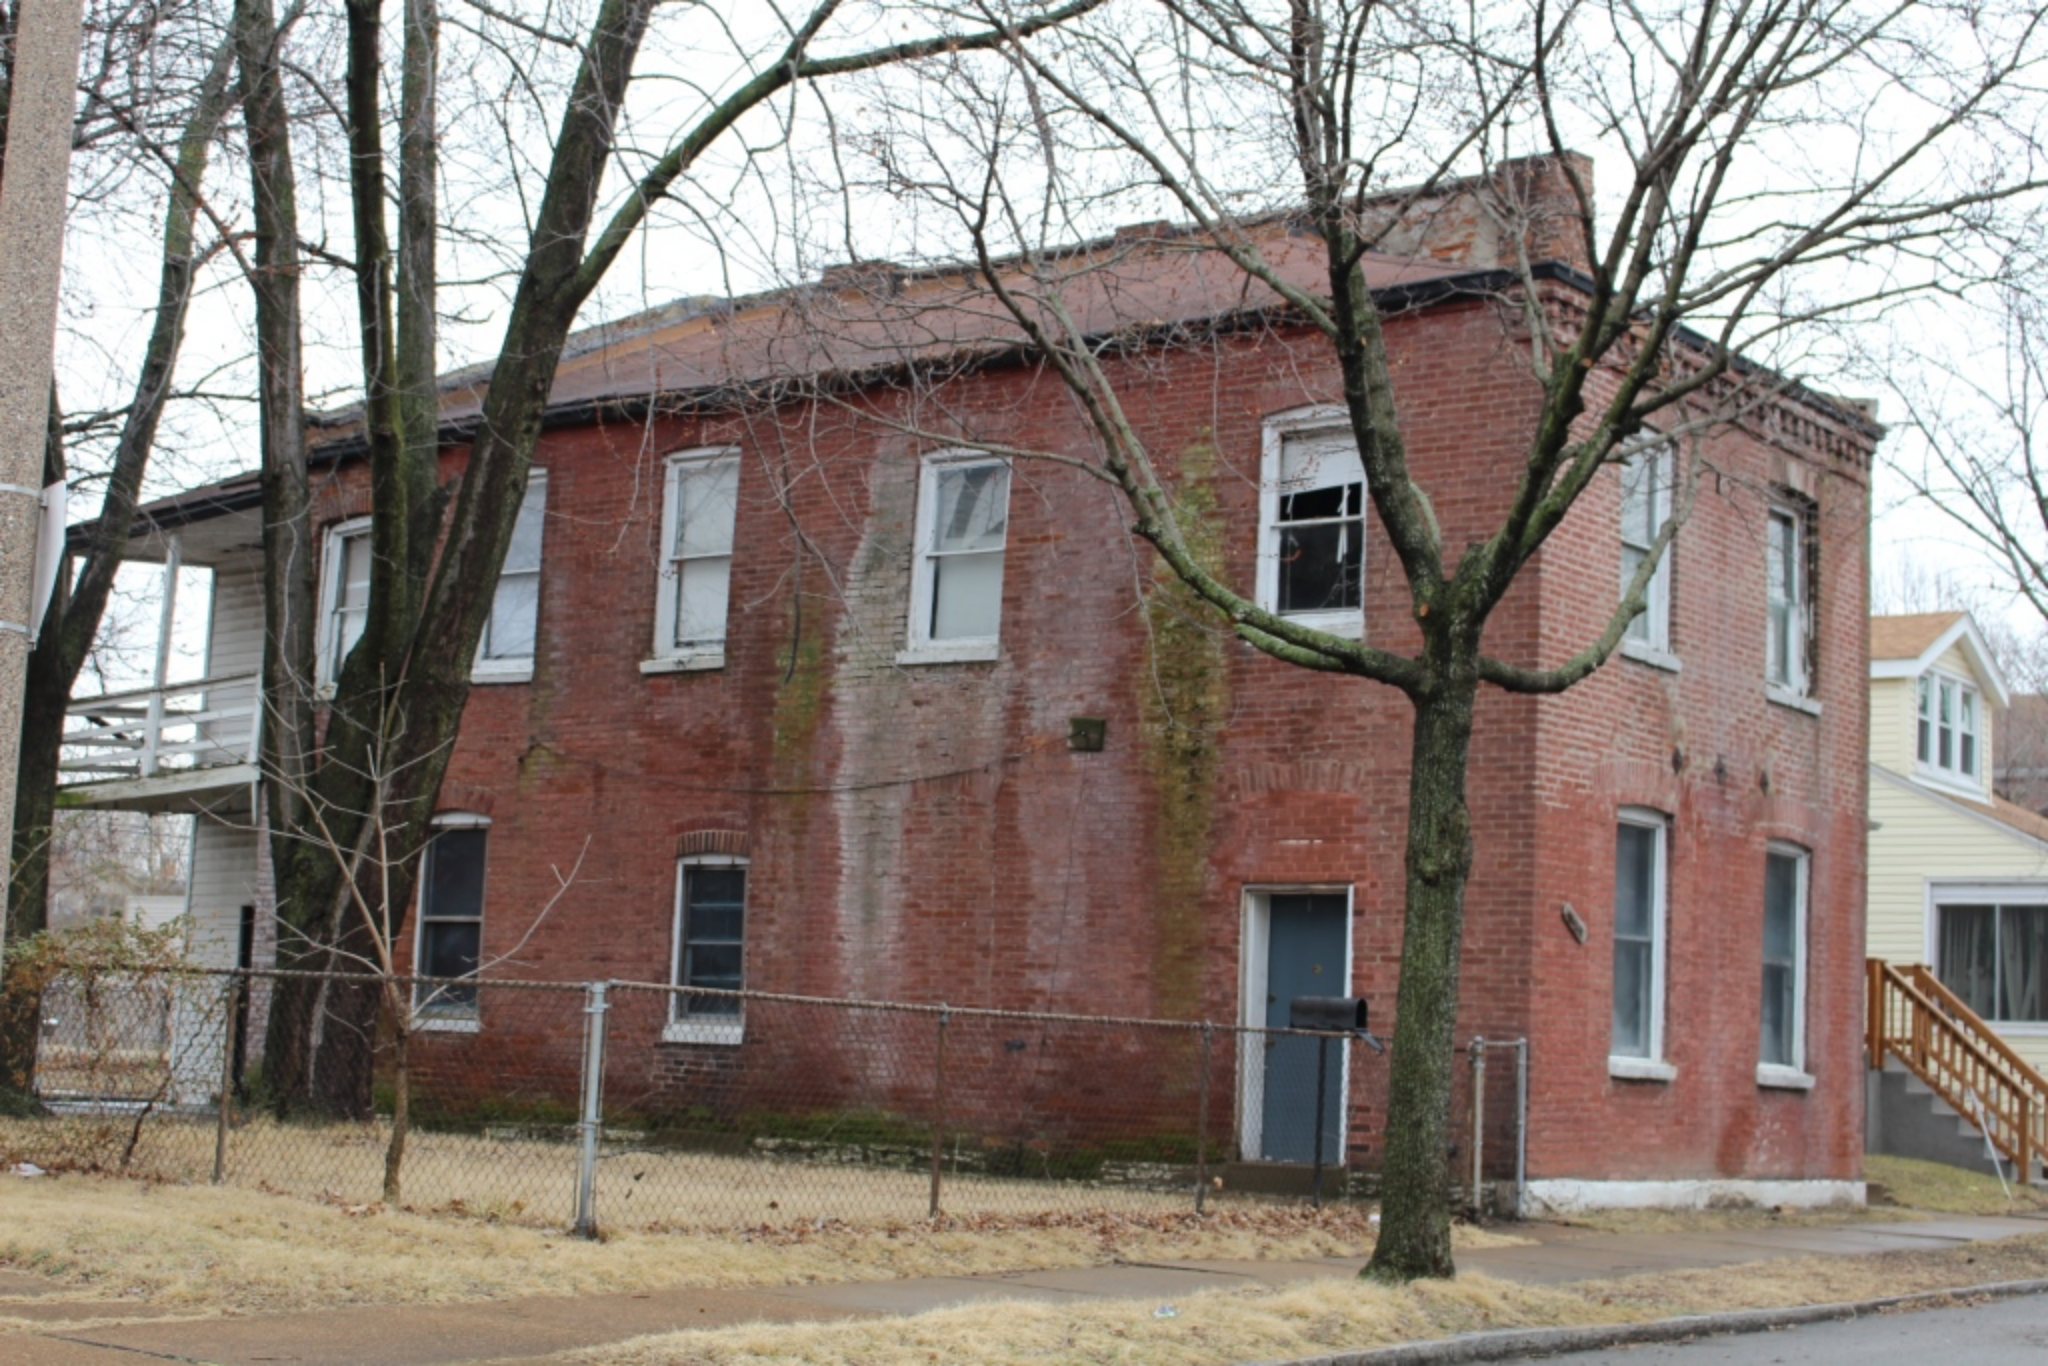
221 W Schirmer presents a simple, 2-bay common bond brick front façade to the street. Its shed roof is hipped at the front, where a dentilled brick cornice extends across the façade. Openings throughout are placed under segmental soldier arches; windows have wood sills. Two doublehung windows are placed at each story of the front façade and a limestone sill extends from grade. The long west elevations has an entry at the first story of the south bay; its original transom has been bricked in, as has the window immediately to its north. The remainder of the first 5 bays display original fenestration; the northern bay of this façade contains a 2-story recessed porch which returns along the rear façade, ending in a brick wing wall that continues the blind eastern wall of the structure. The recessed porch has been enclosed at the rear.
