ARCHITECTURAL/HISTORIC INVENTORY FORM - Cultural Resources Office
St. Louis Planning and Urban Design

1. Survey no. SLC-AS-053-0195	2. Survey name: Thematic Survey of Flounder Houses in St. Louis City	3. County: St. Louis [Independent City]
4. Address: (from City GEO database) 908 MORRISON AV		5. City/State: St. Louis, Missouri
Alternate address: 908 Morrison Avenue		Property Zip Code: 63104
Latitude: 38.614945		6. UTM Easting: 743839.02
Longitude: -90.199405		UTM Northing: 42277768.84
8. Historic Name (if known): N/A	11a. Historic Use (if known): Domestic	City Block 466.03
9. Present/other name (if known): Domestic	7. Township-Range-Section: N/A	City Ward 7
10. Ownership: Private		Neighborhood Number: 34

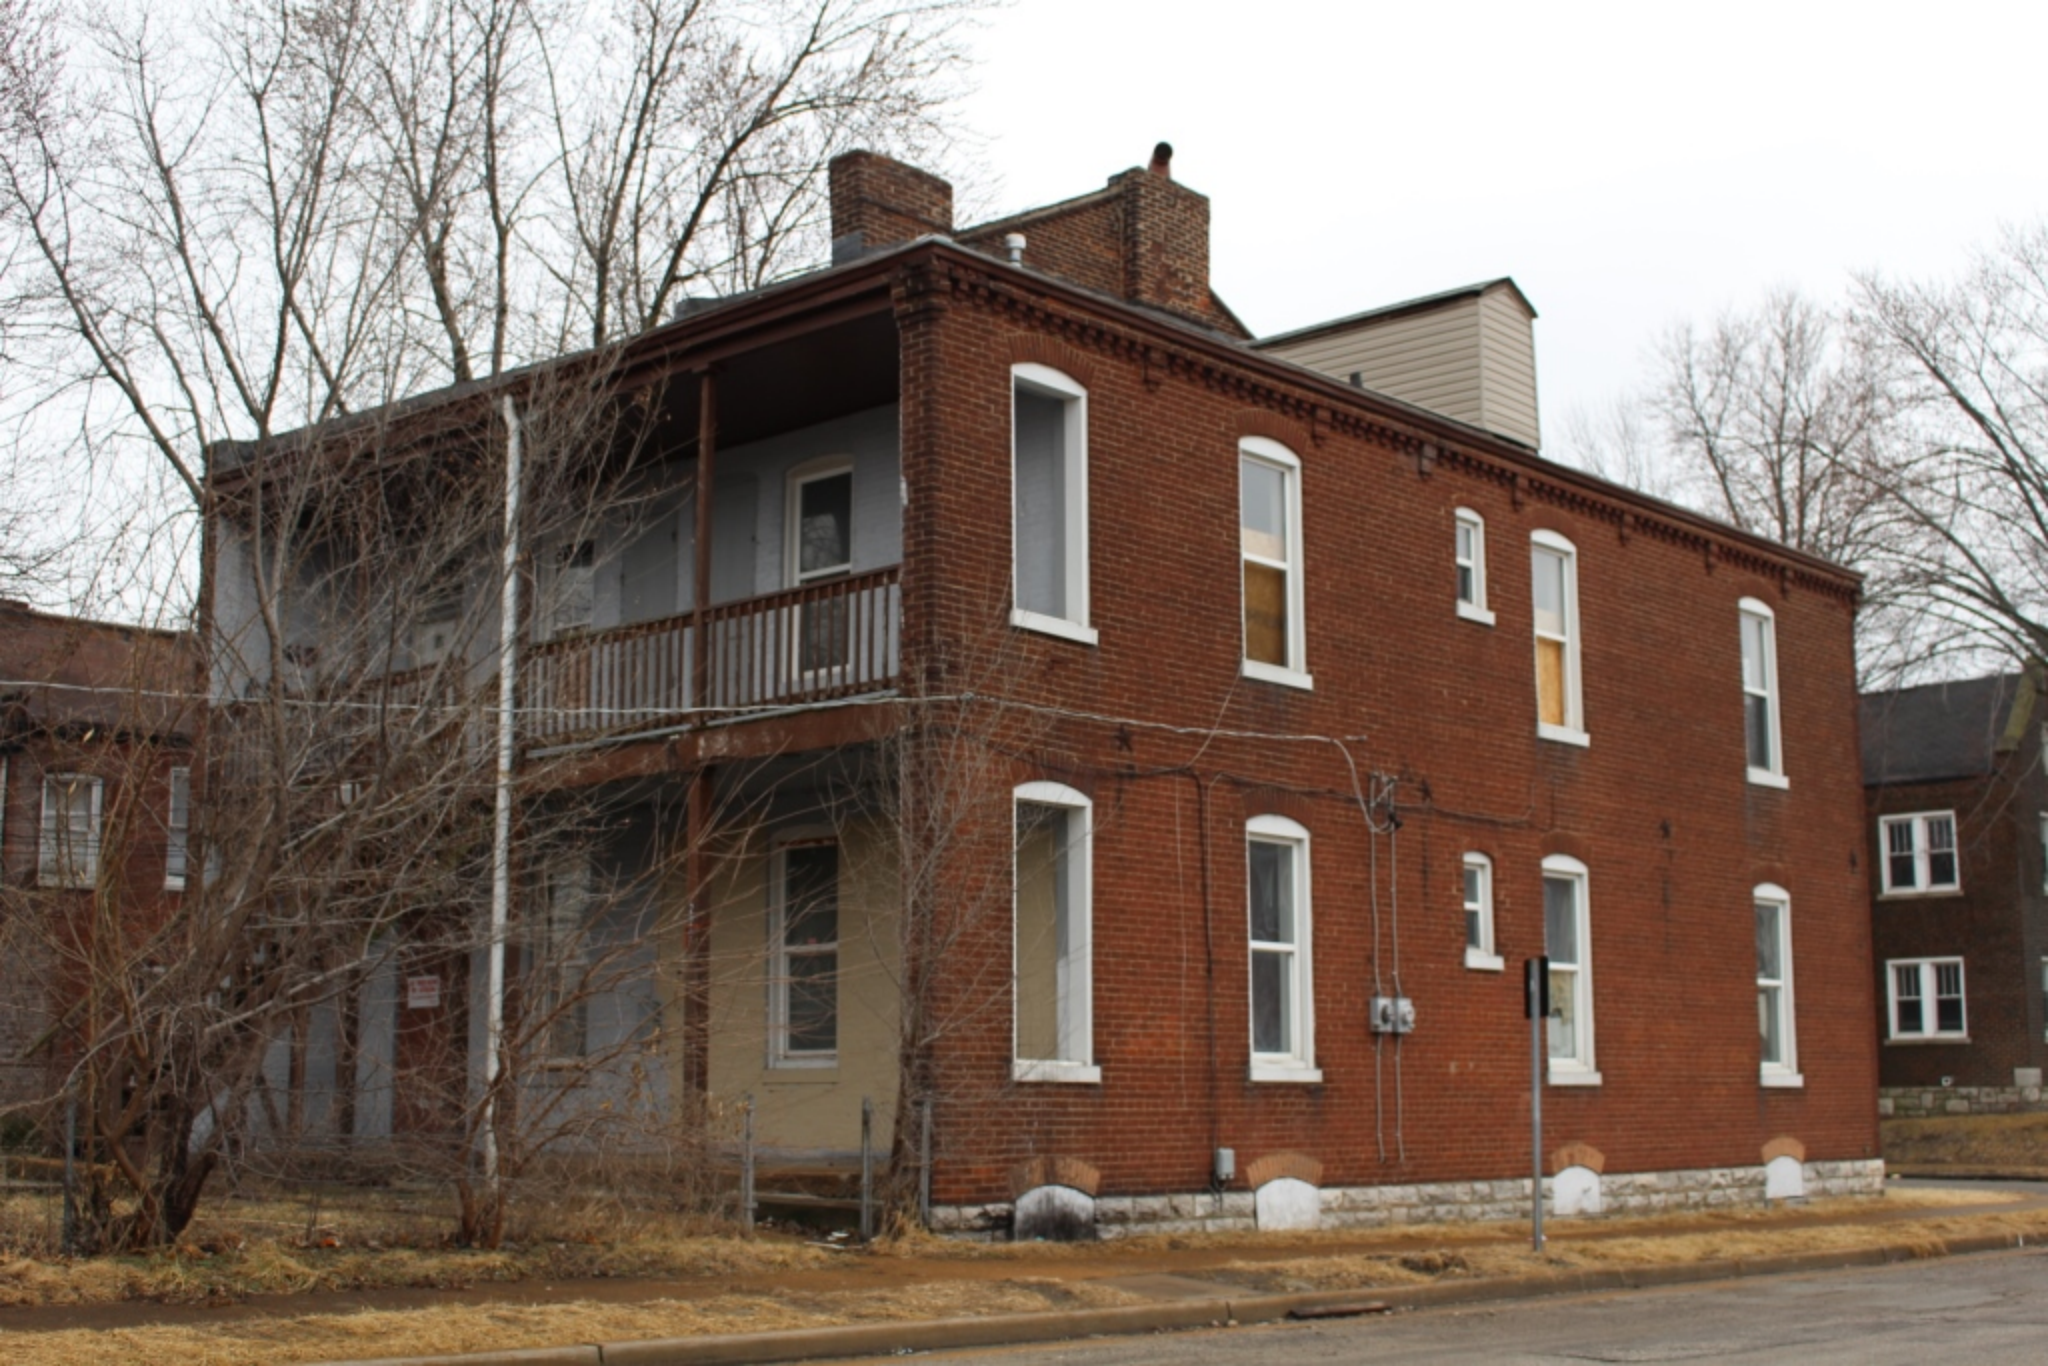
The taller wall of this 2-story, common bond brick flounder property is attached to the adjacent house at 227 W Schirmer, which is not a flounder. Materials and details of both properties are similar and they appear to have been constructed at the same time. The rubble stone foundation on both street frontages is veneered with rough-faced coursed ashlar. All openings throughout the building are placed under segmental soldier arches. The first story of the primary façade presents a single-leaf entry door (the door has been replaced) under a 1-light transom in the eastern bay, with a single doublehung window in the western bay and doublehung windows at each bay of the second story. Windows on the front façade have bracketed lugsills. A corbelled brick cornice with dentils and pendants extends across the front façade and returns the length of the 5-bay west façade. A small dormer is centered on this elevation; its window has been blocked in. A window is placed at the first and second story of each bay, with the central bay windows considerably smaller than the rest. The openings of the northernmost bay have no sash and mark the position of a 2-story recessed porch with brick wing walls that extends across the 4-bay rear elevation. All basement windows have been boarded, and the rear masonry wall painted.

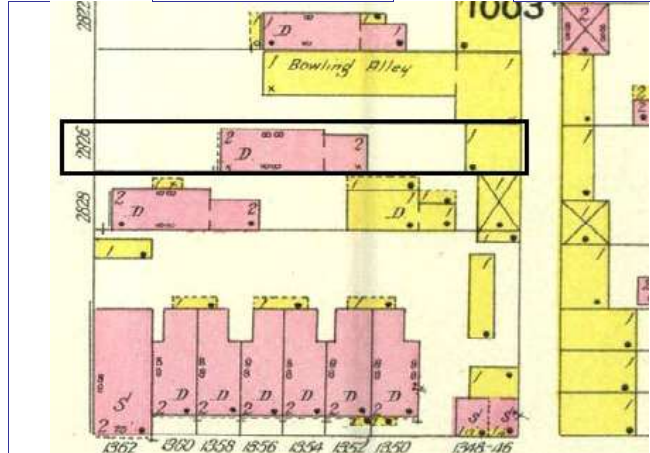
2826 SHERIDAN AV

appears to have several altered openings; blocked door in rear wall and brick rear wing shown on Sanborn suggest changes. Façade painted.

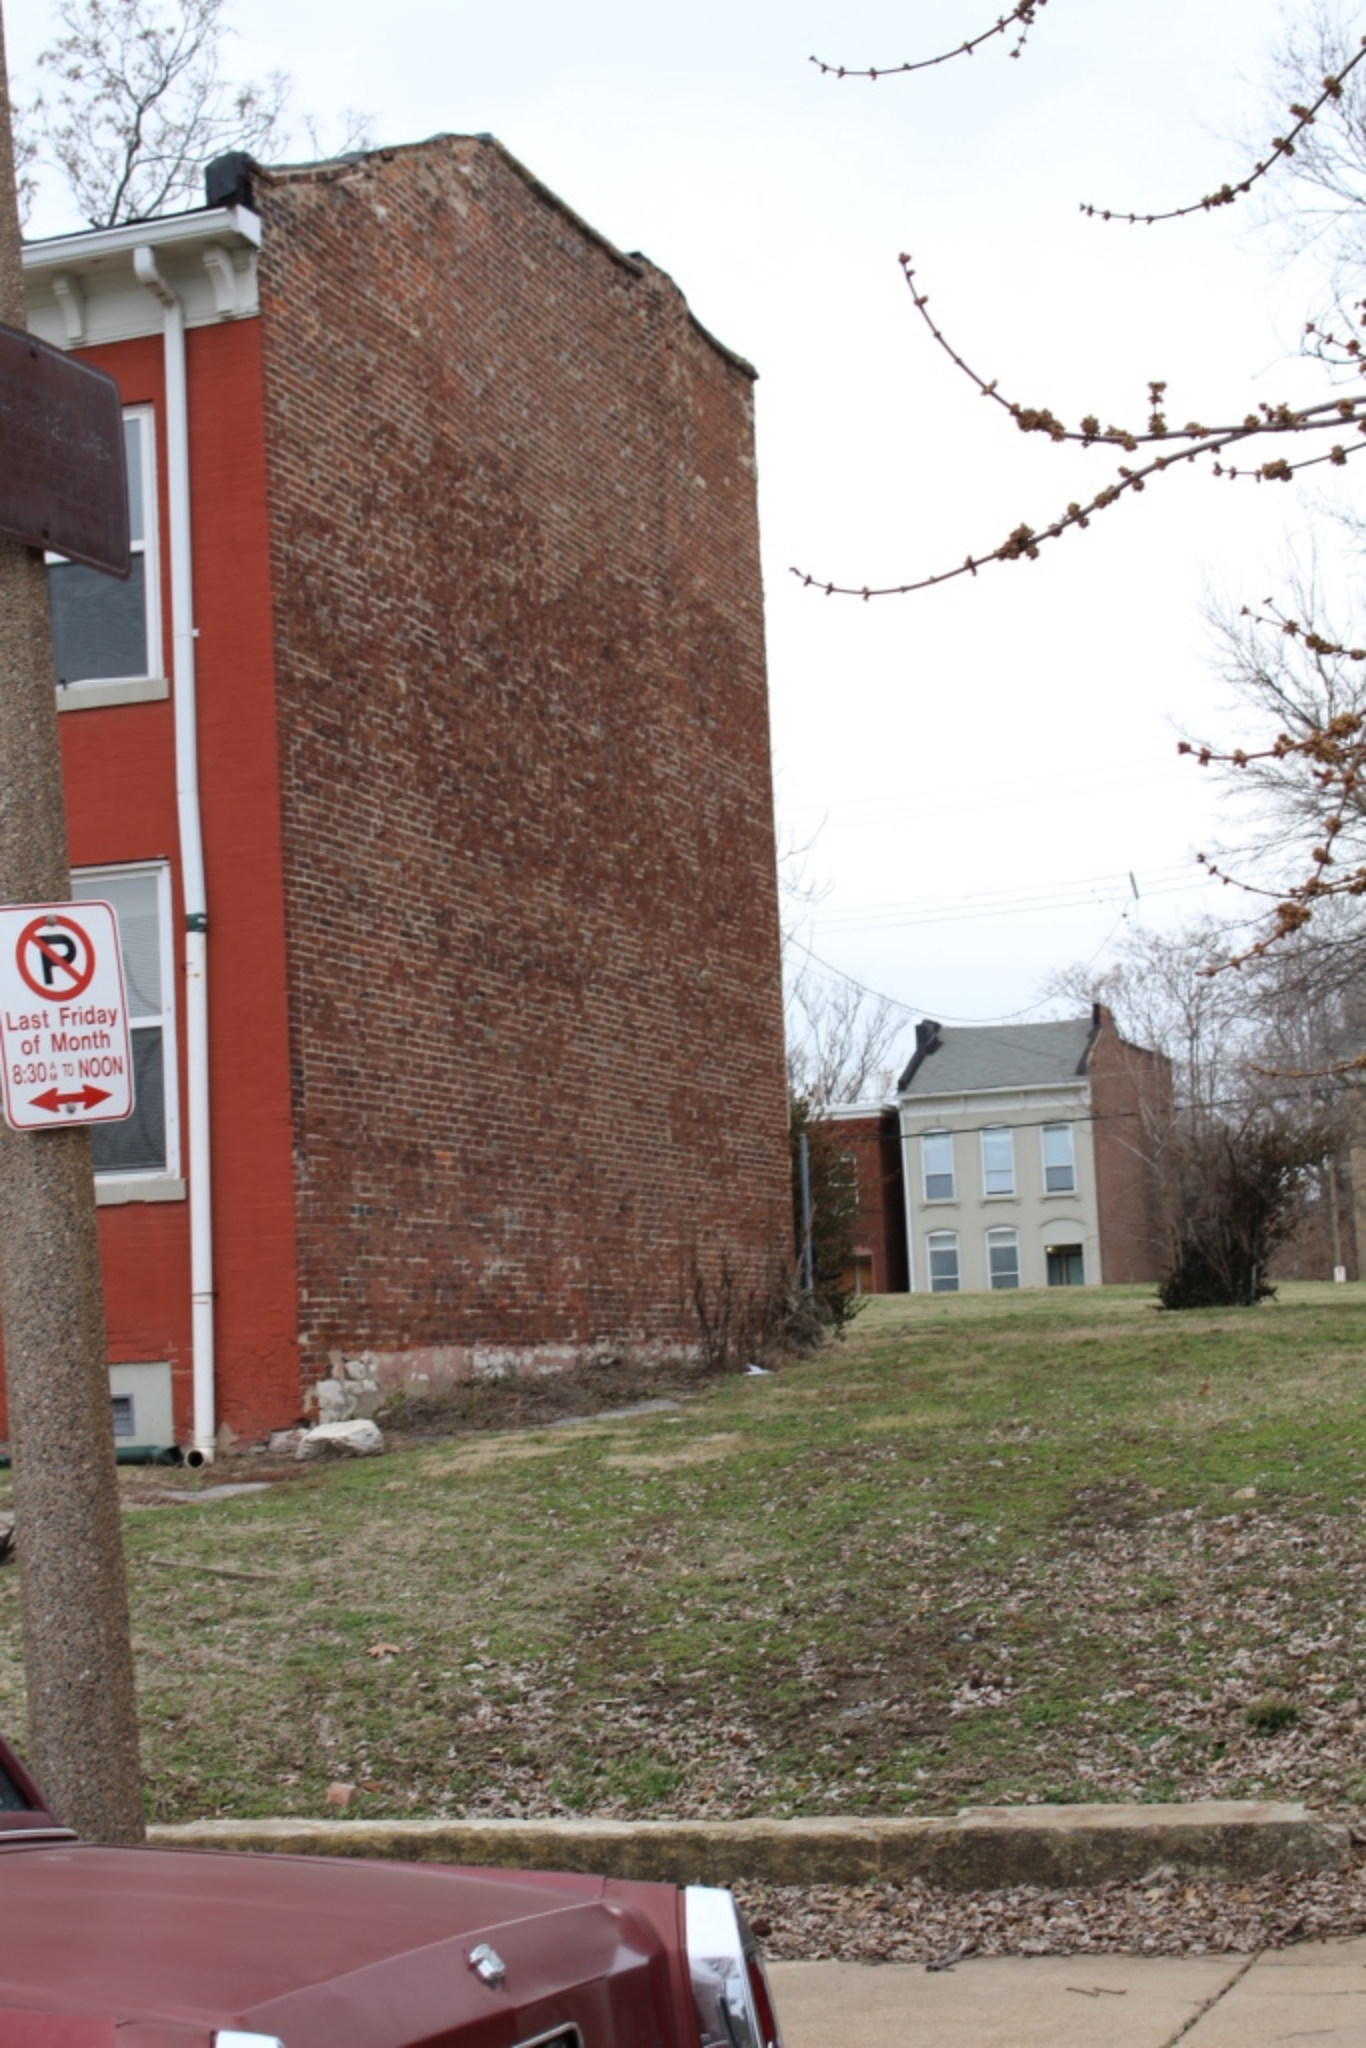
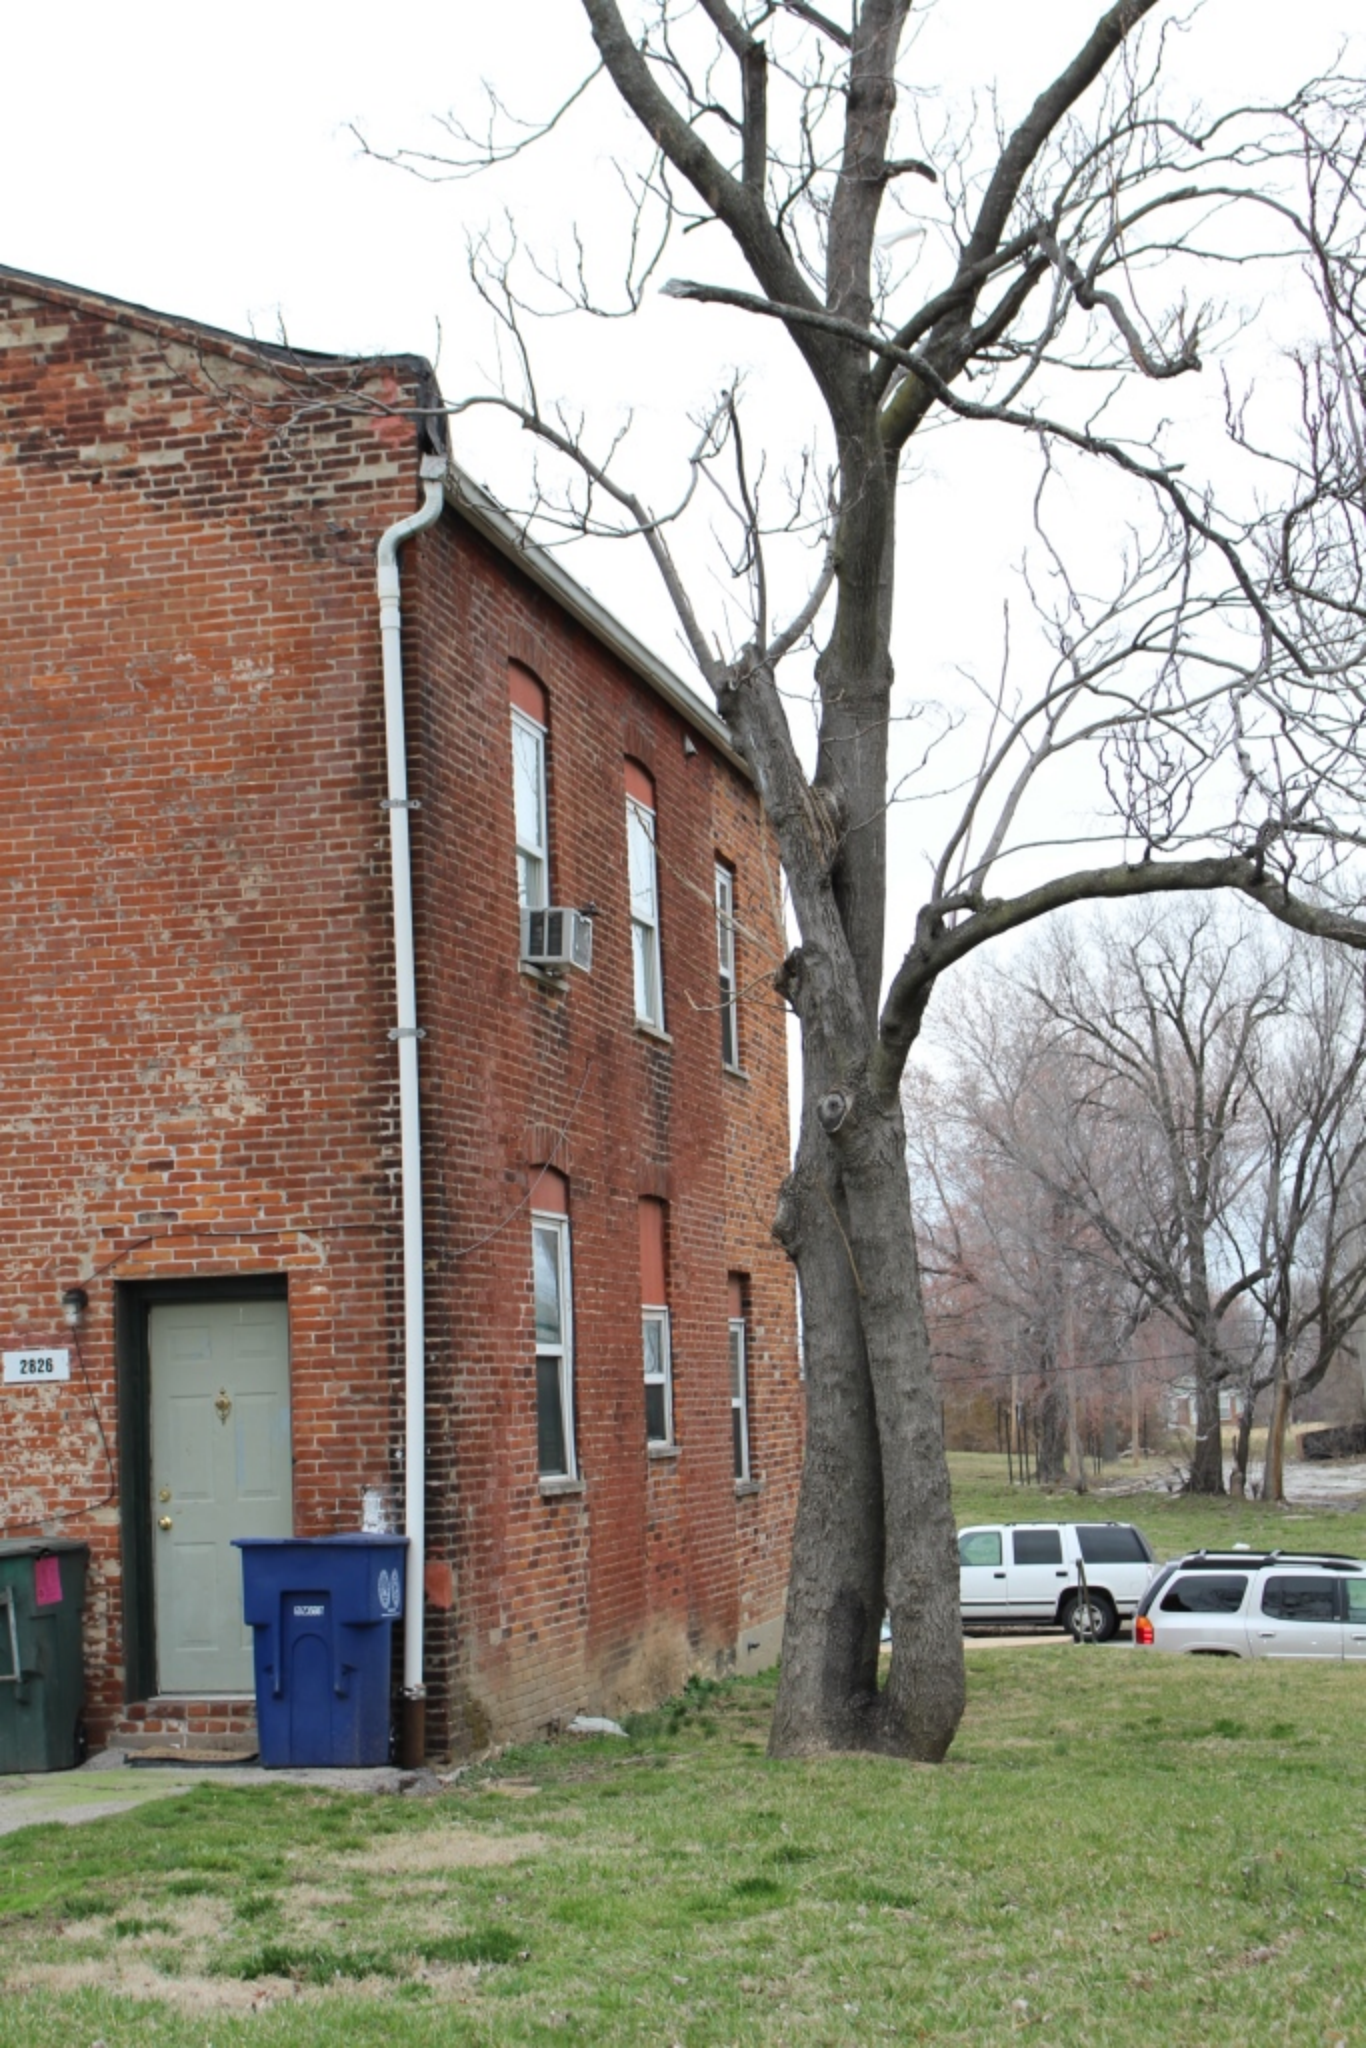
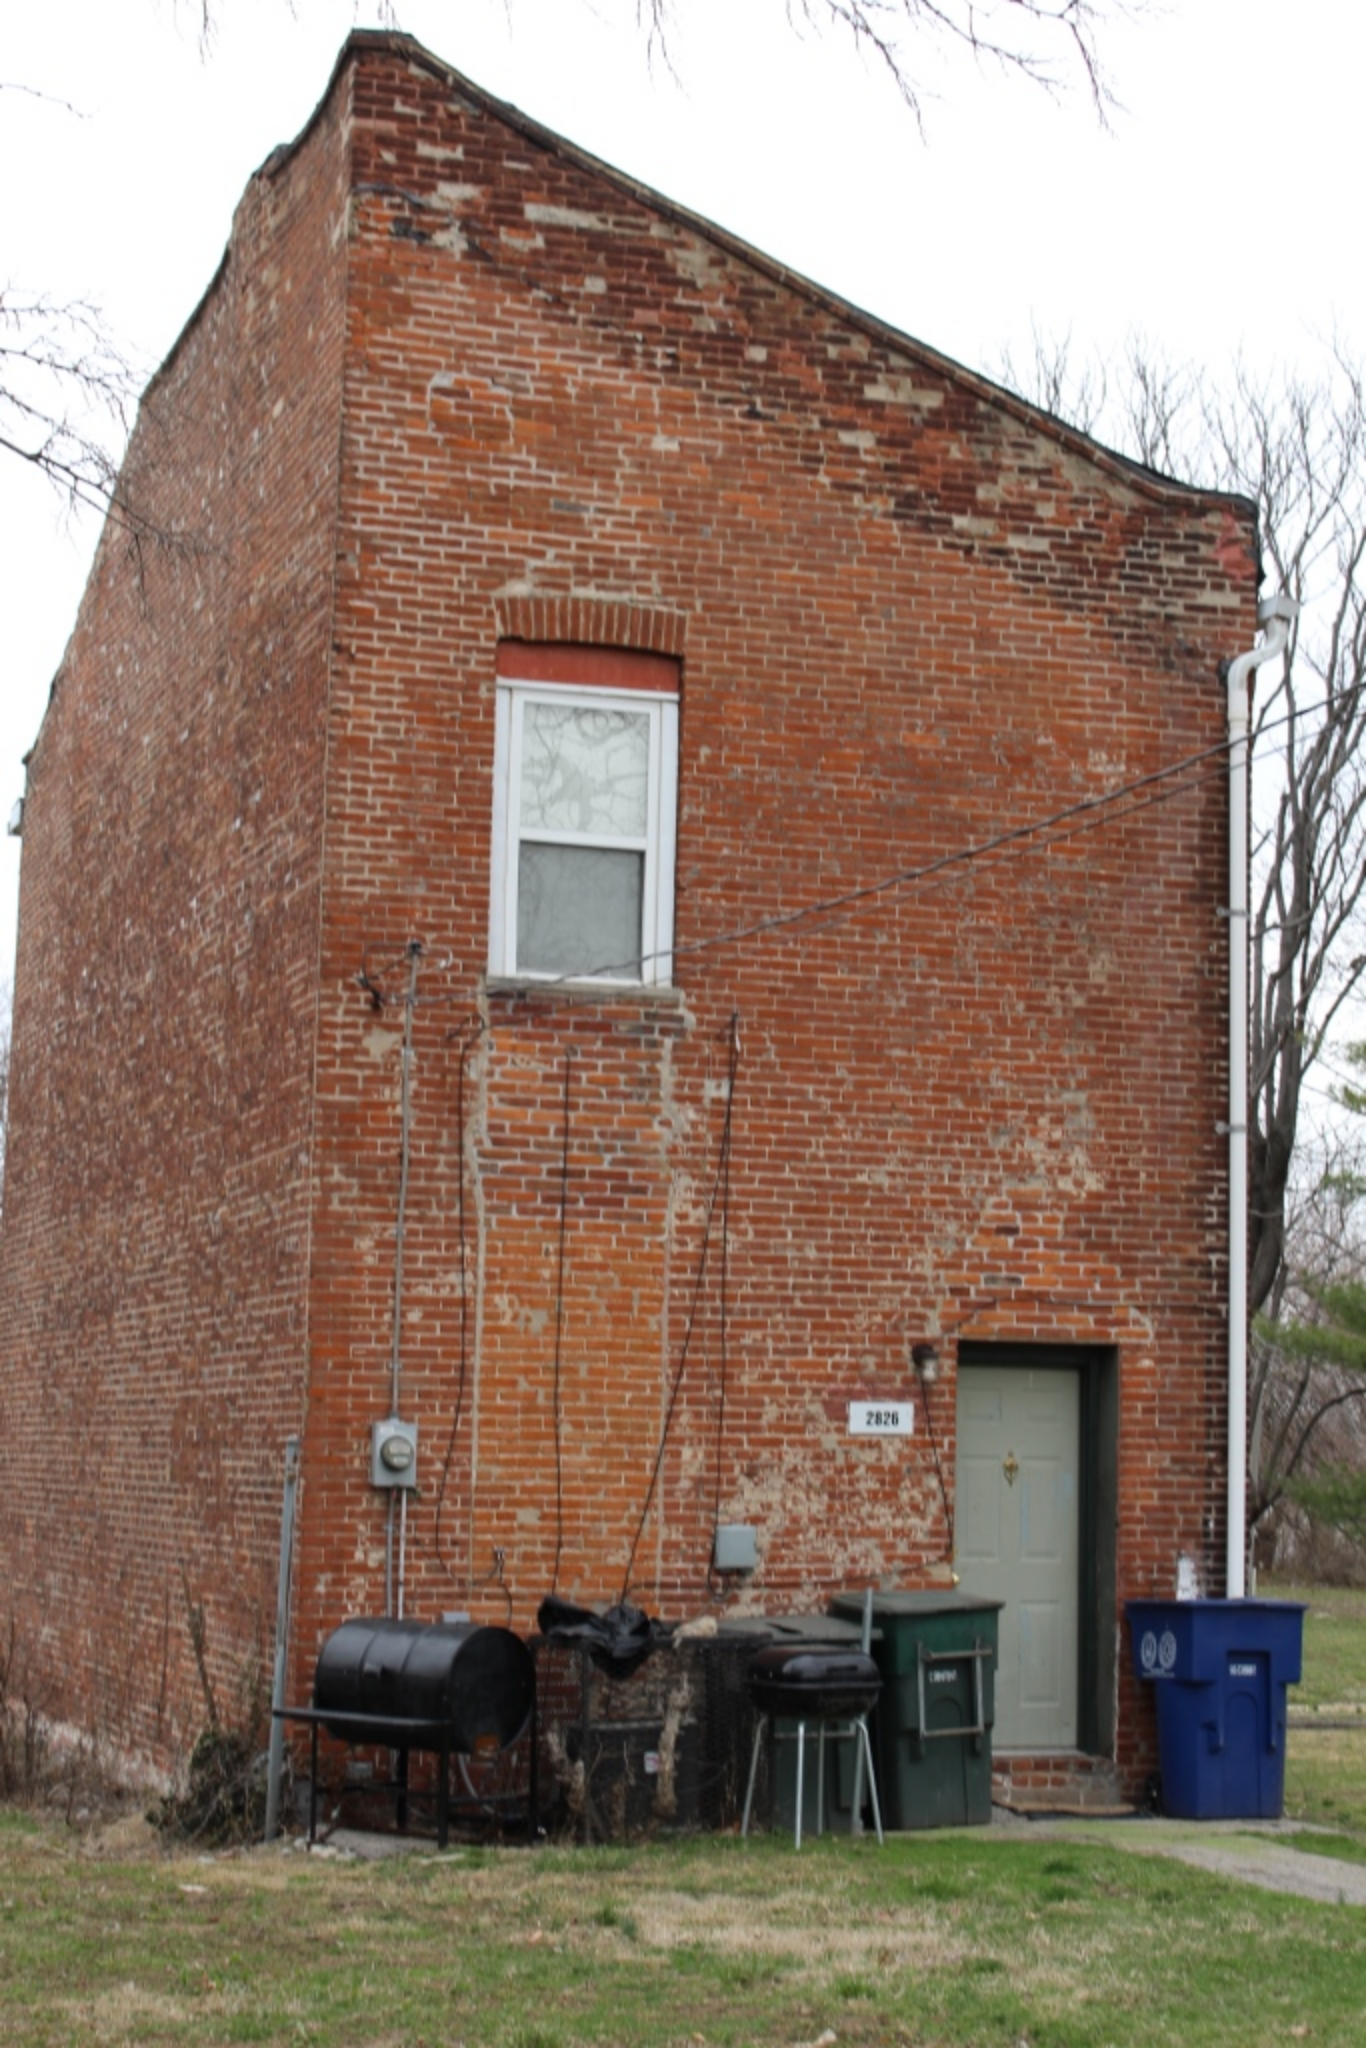
2826

The northernmost bay of the east façade has been rebuilt and the proportions of the window openings at each story have been altered. In the remaining 2 bays, window openings have segmental soldier arches and wood lugsills. Replacement sash of various stock size have been installed and the openings blocked down. The rear elevation has 2 bays with a single entry door on the east and a single window under a segmental soldier arch on the west. The western bay also appears to have been rebuilt, eliminating a first story window and altering the radius of the arch. The soft brick of this elevation shows the outline of a flounder el that was originally attached. The windowless taller wall rises on the west.

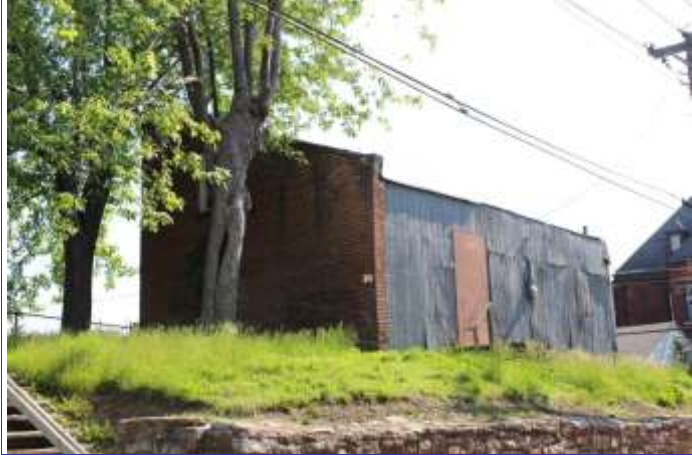
Front and south facades from Texas Ave.

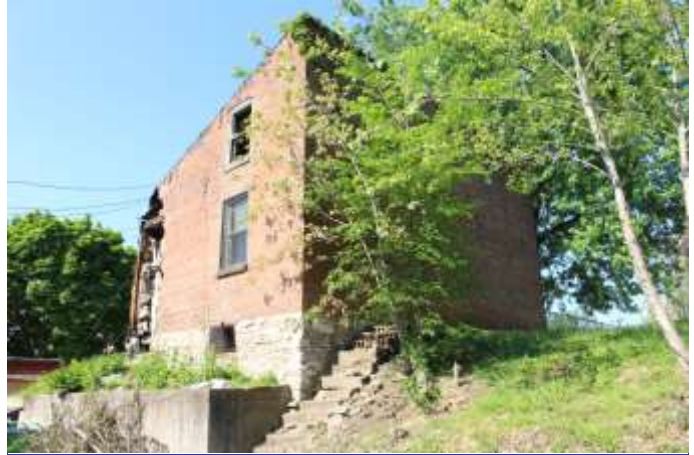
Rear and north facades from alley

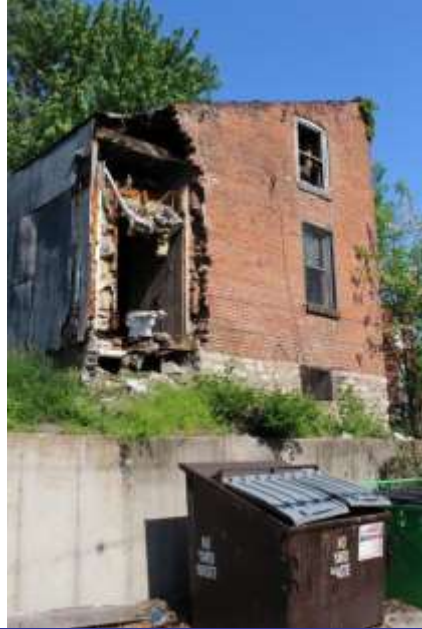
Rear (alley) façade

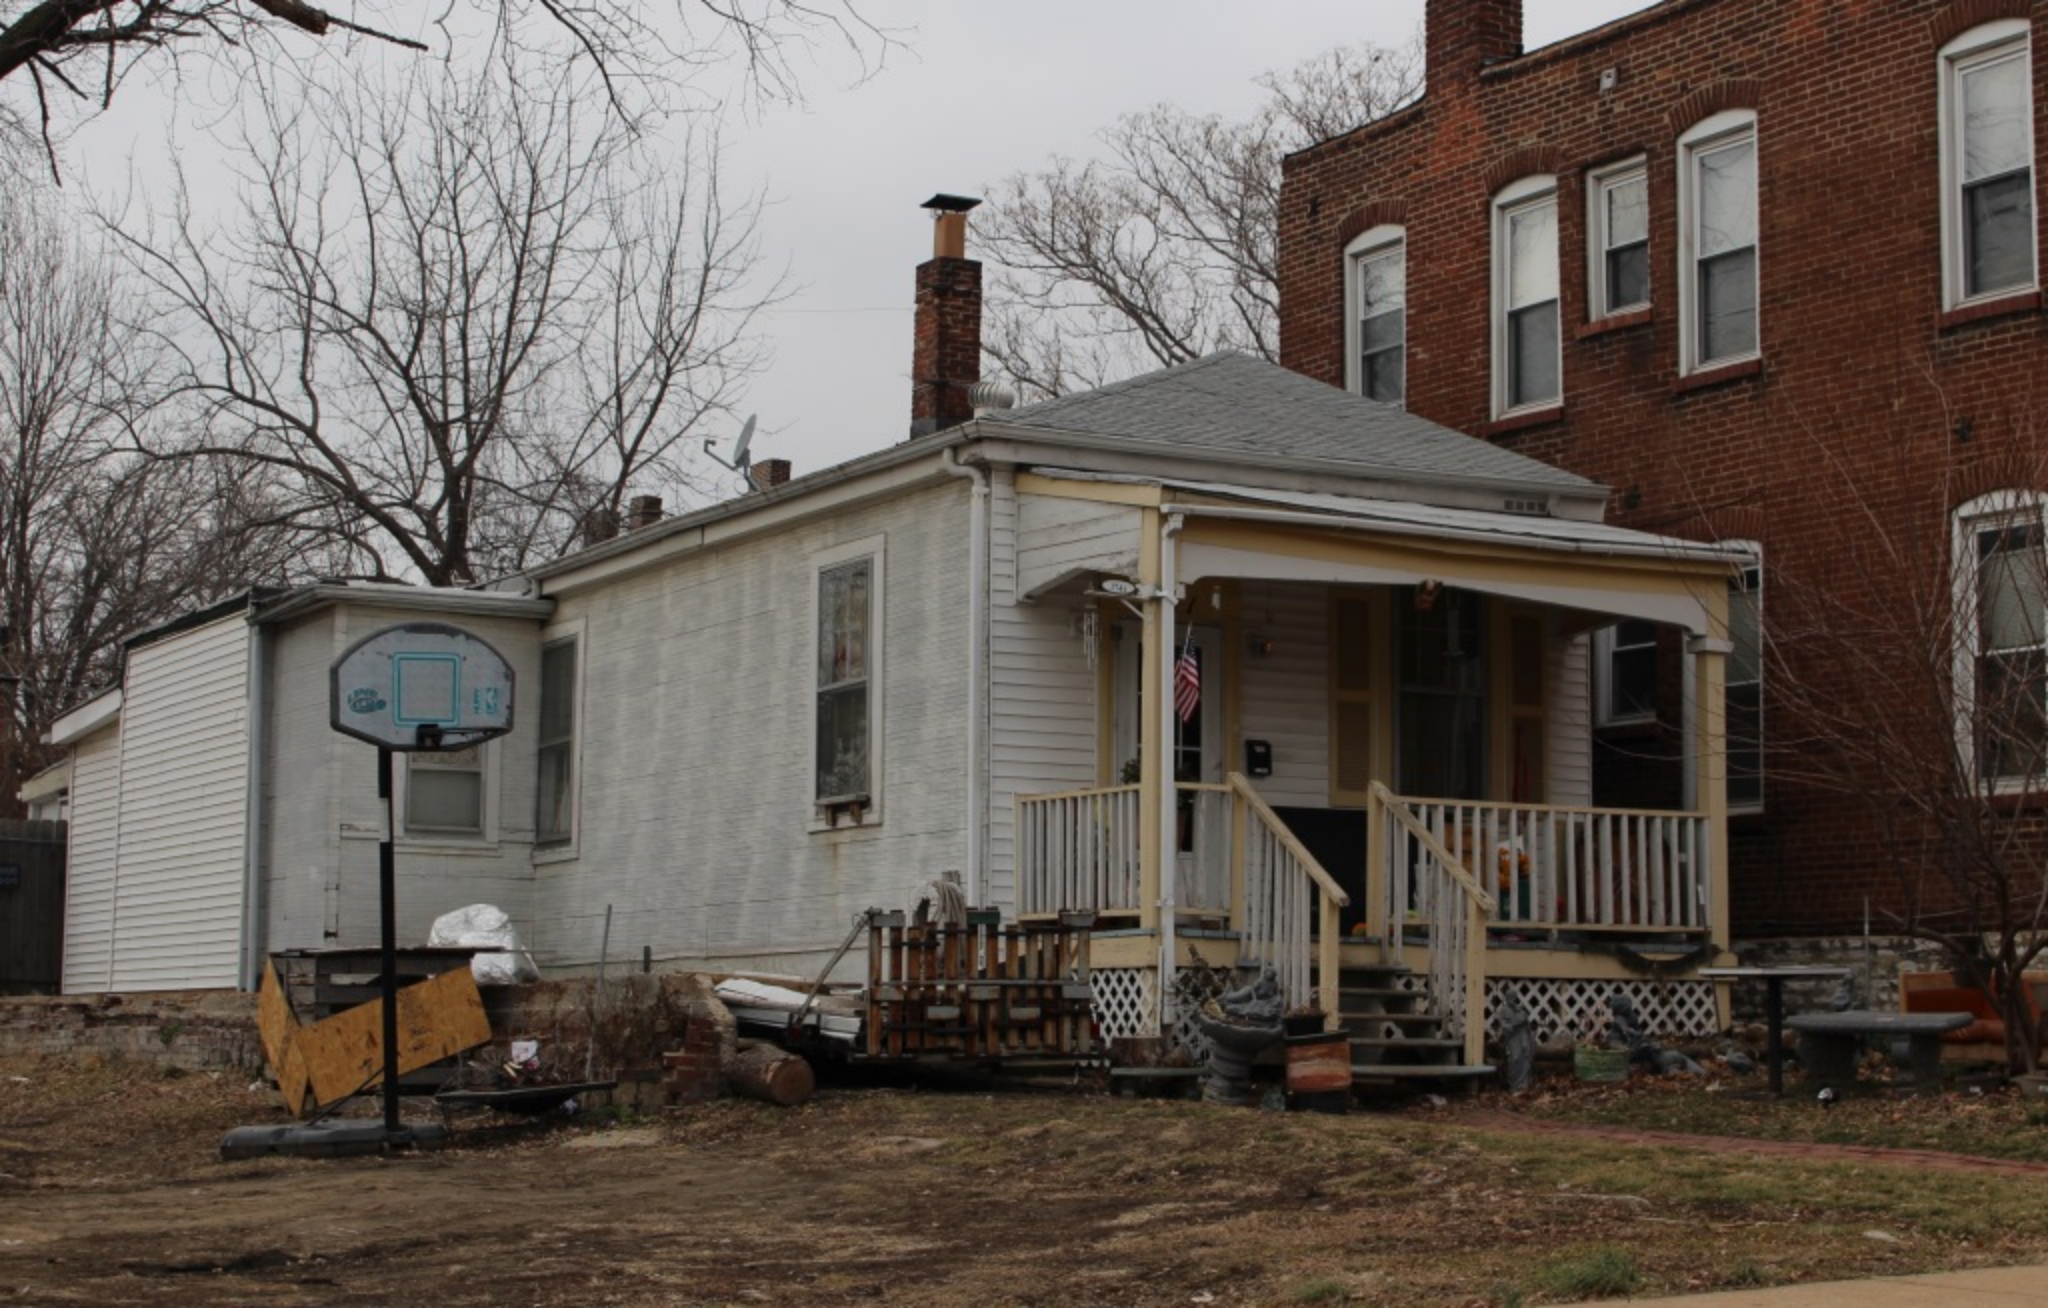
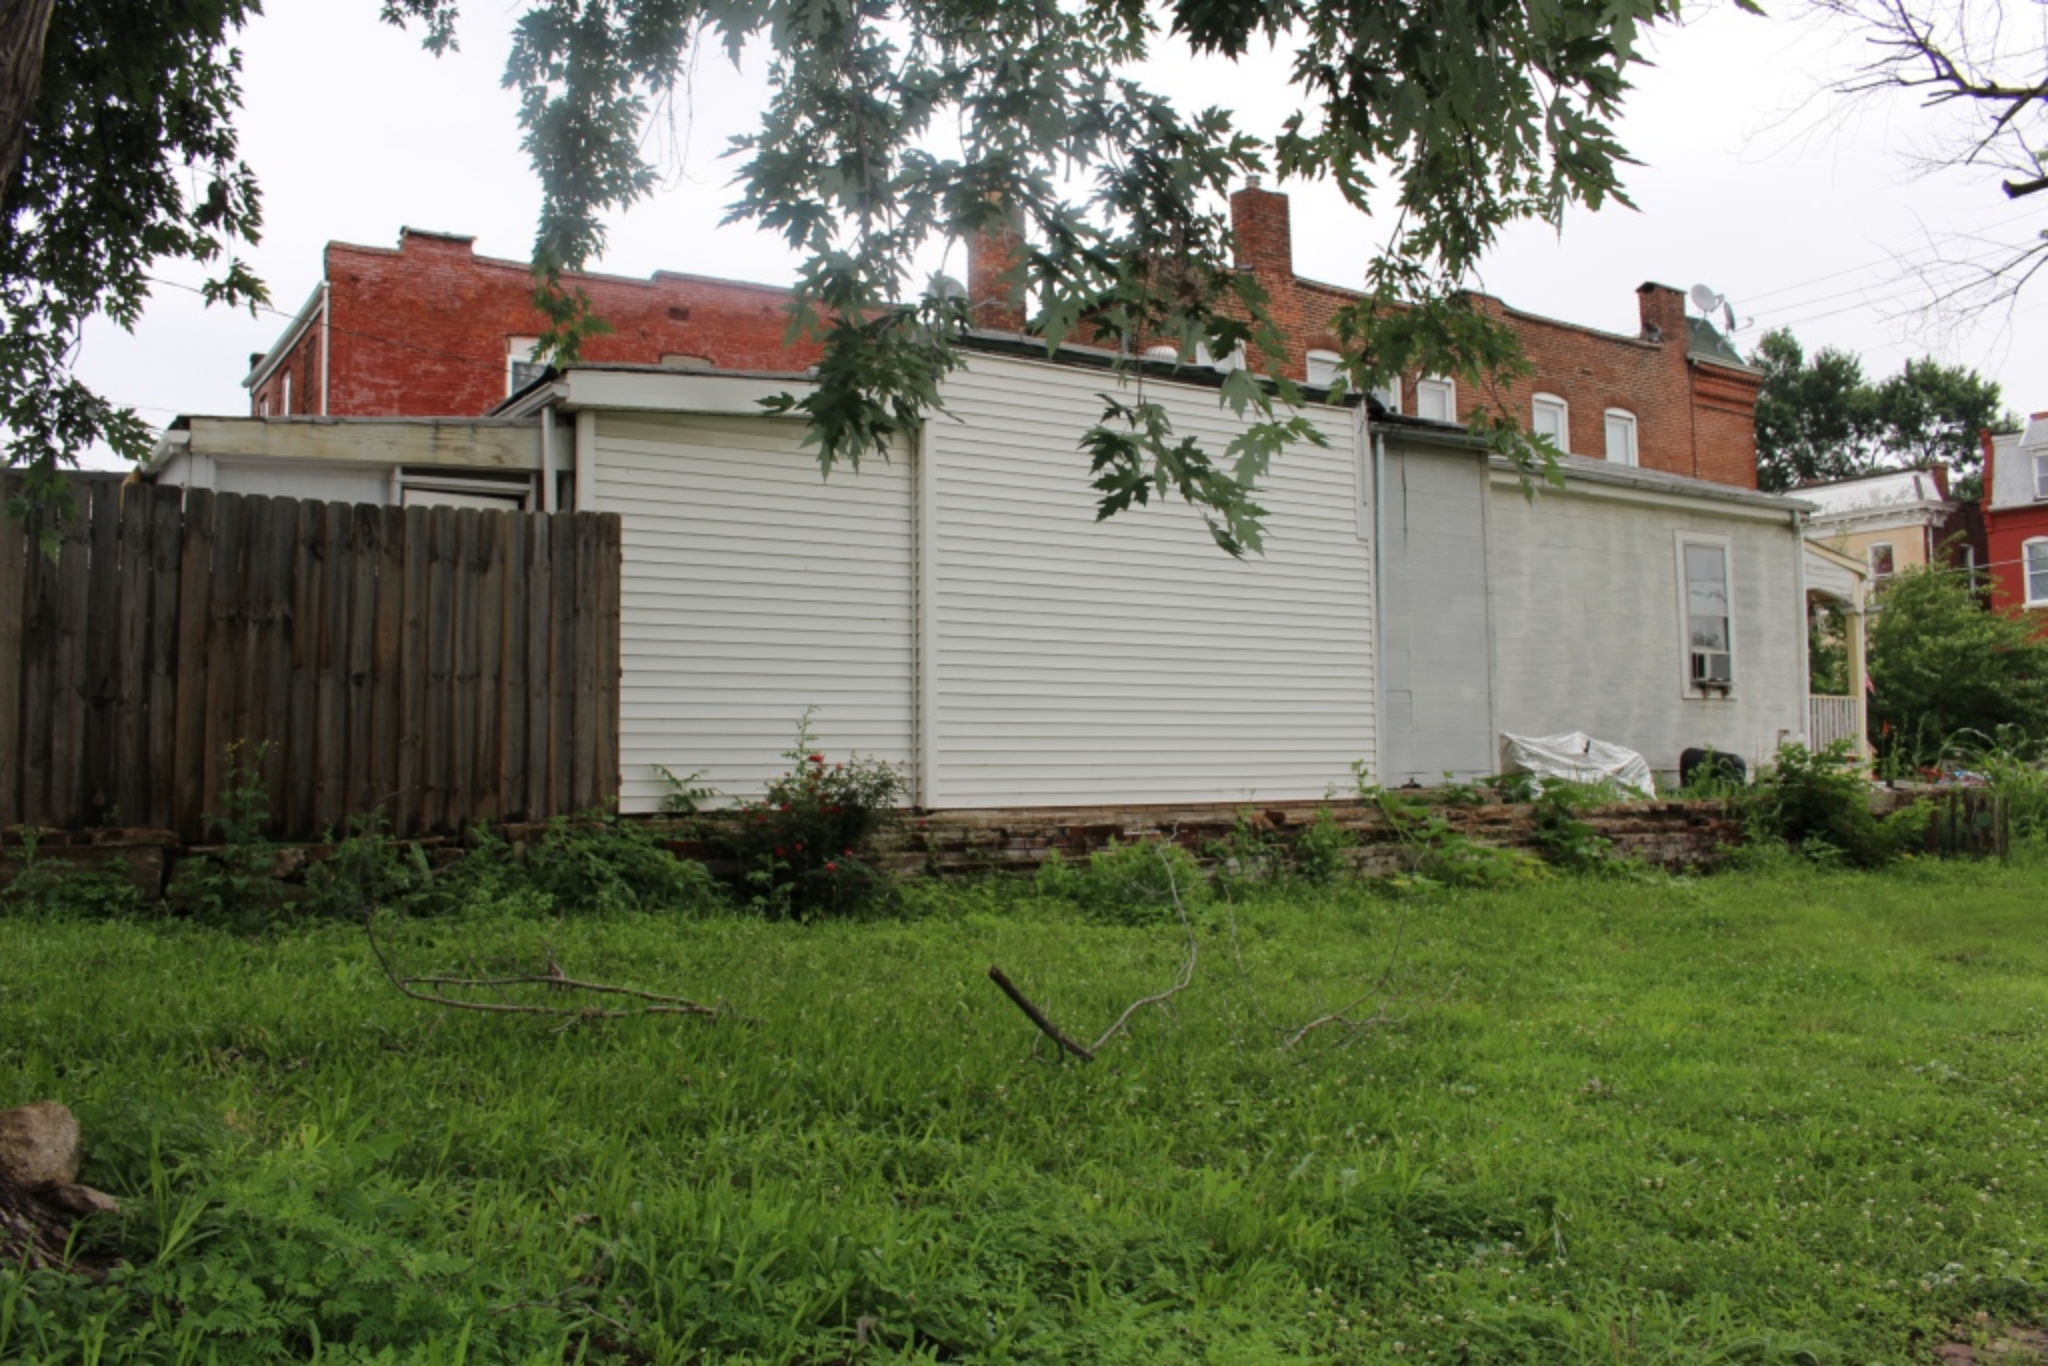
One story frame flounder with a front entry. The front façade has a single replacement door flanked by an original six-over-six window. The front façade is covered with vinyl siding and vinyl trim wraps the door and window. A newer frame porch with a shed roof runs the length of the front façade. The south façade is clad in an asbestos siding. Two original windows are visible but one is partially obscured by an addition near the rear corner. The addition does not have any windows except for two on the rear.

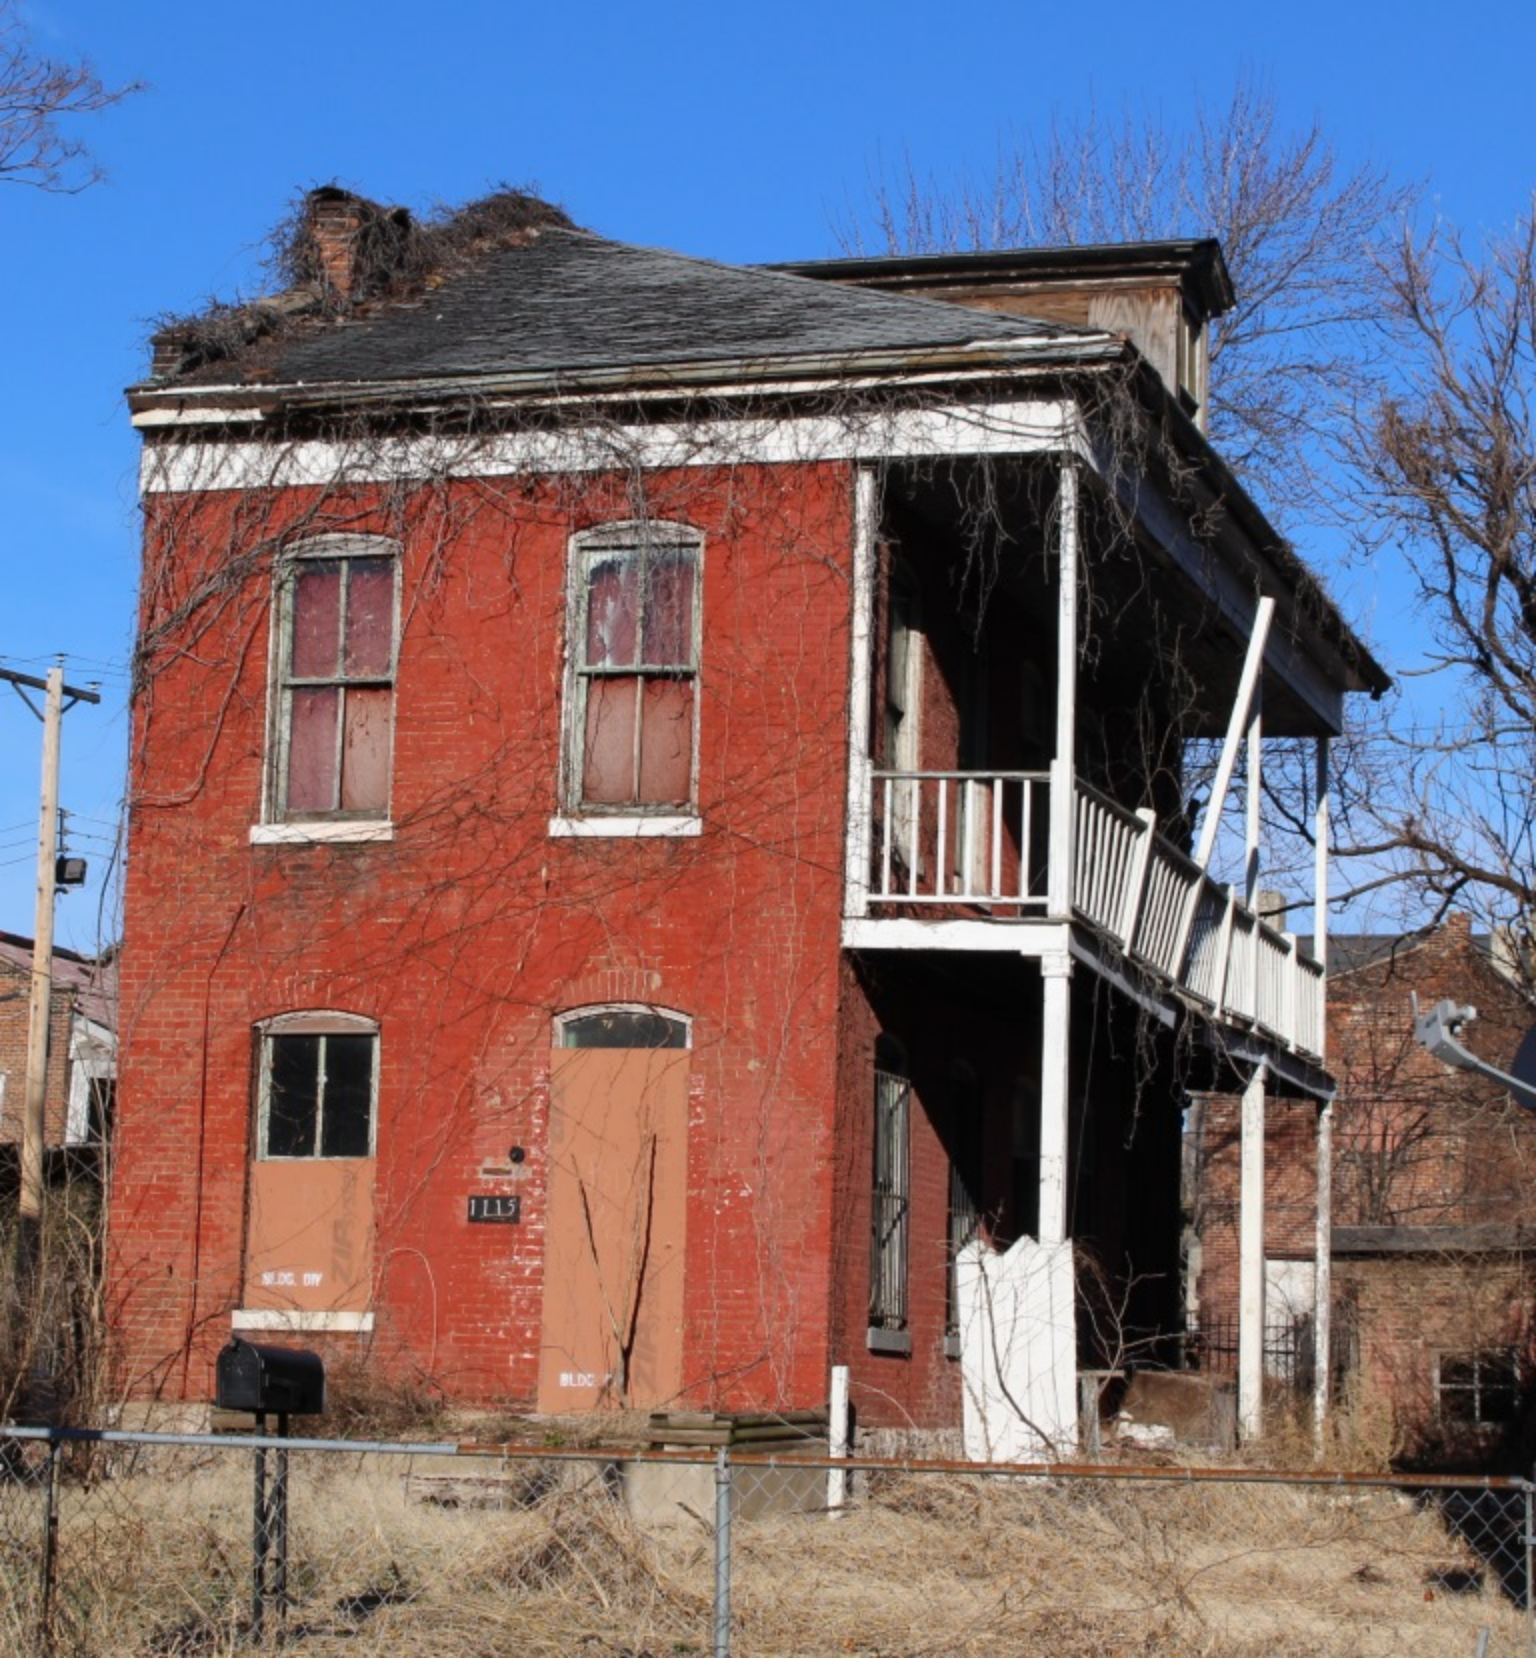
1115

The building is in a deteriorated condition and is receiving no maintenance at this time.

This 2-story brick flounder has a front entrance and a side gallery, a combinatin not commonly found. The two-bay-wide façade and east wall have openings that have segmentally-arched heads formed of stretcher brick and windows have stone sills. The entrance has a single step and no porch. The two-story side gallery extends along the side façade and is covered by the main roof. The horizontal eaves of the façade and east side have a plain wood cornice. A dormer projects from the side roof slope.
