ARCHITECTURAL/HISTORIC INVENTORY FORM - Cultural Resources Office
St. Louis Planning and Urban Design

1. Survey no. SLC-AS-053-0195	2. Survey name: Thematic Survey of Flounder Houses in St. Louis City	3. County: St. Louis [Independent City]
4. Address: (from City GEO database) 908 MORRISON AV		5. City/State: St. Louis, Missouri
Alternate address: 908 Morrison Avenue		Property Zip Code: 63104
Latitude: 38.614945		6. UTM Easting: 743839.02
Longitude: -90.199405		UTM Northing: 42277768.84
8. Historic Name (if known): N/A	11a. Historic Use (if known): Domestic	City Block 466.03
9. Present/other name (if known): Domestic	7. Township-Range-Section: N/A	City Ward 7
10. Ownership: Private		Neighborhood Number: 34

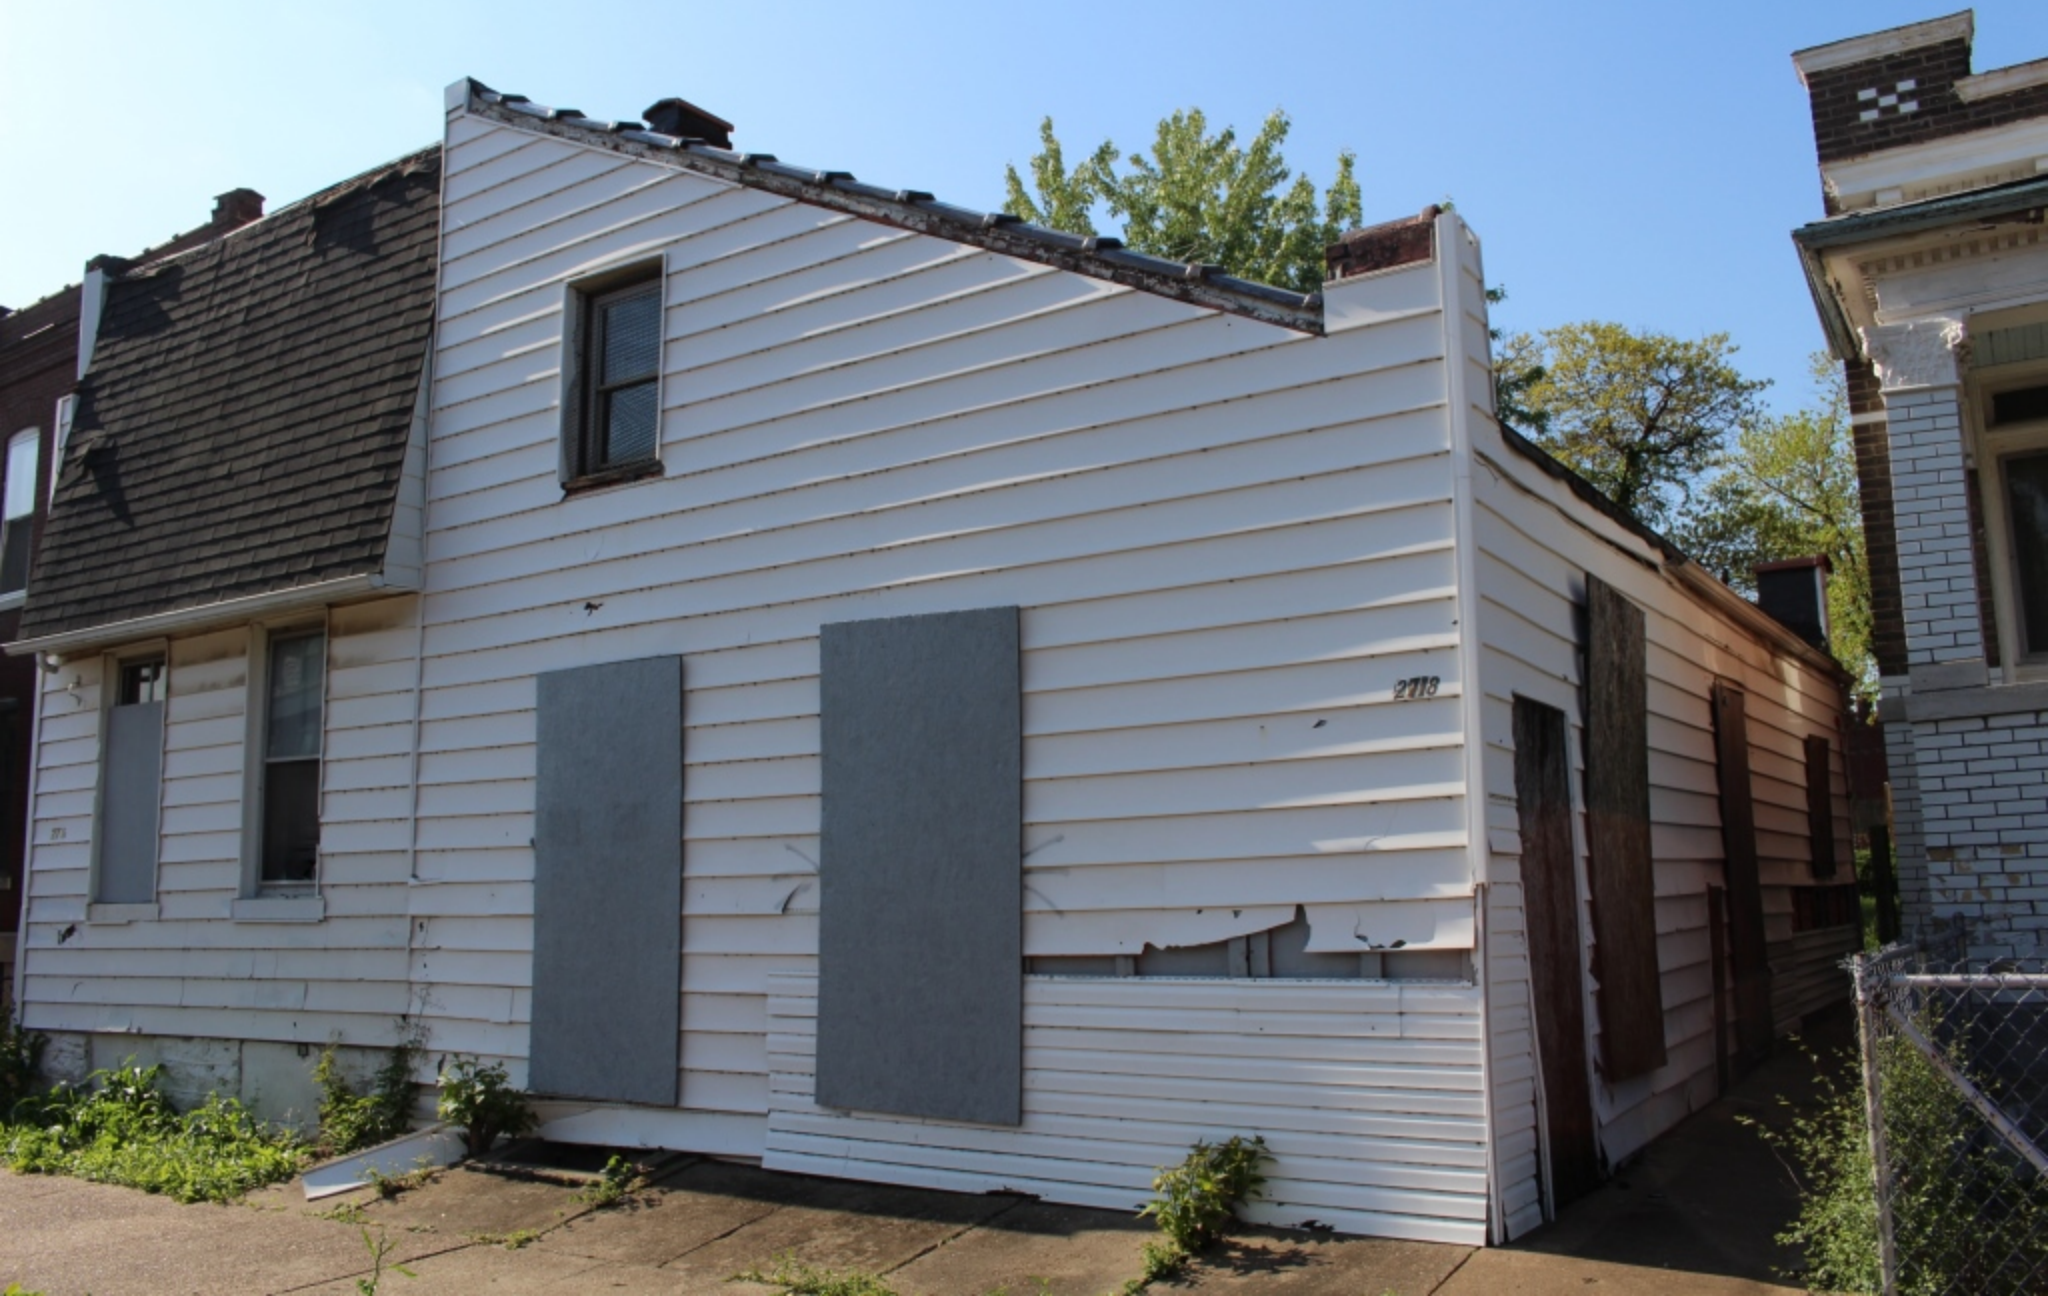
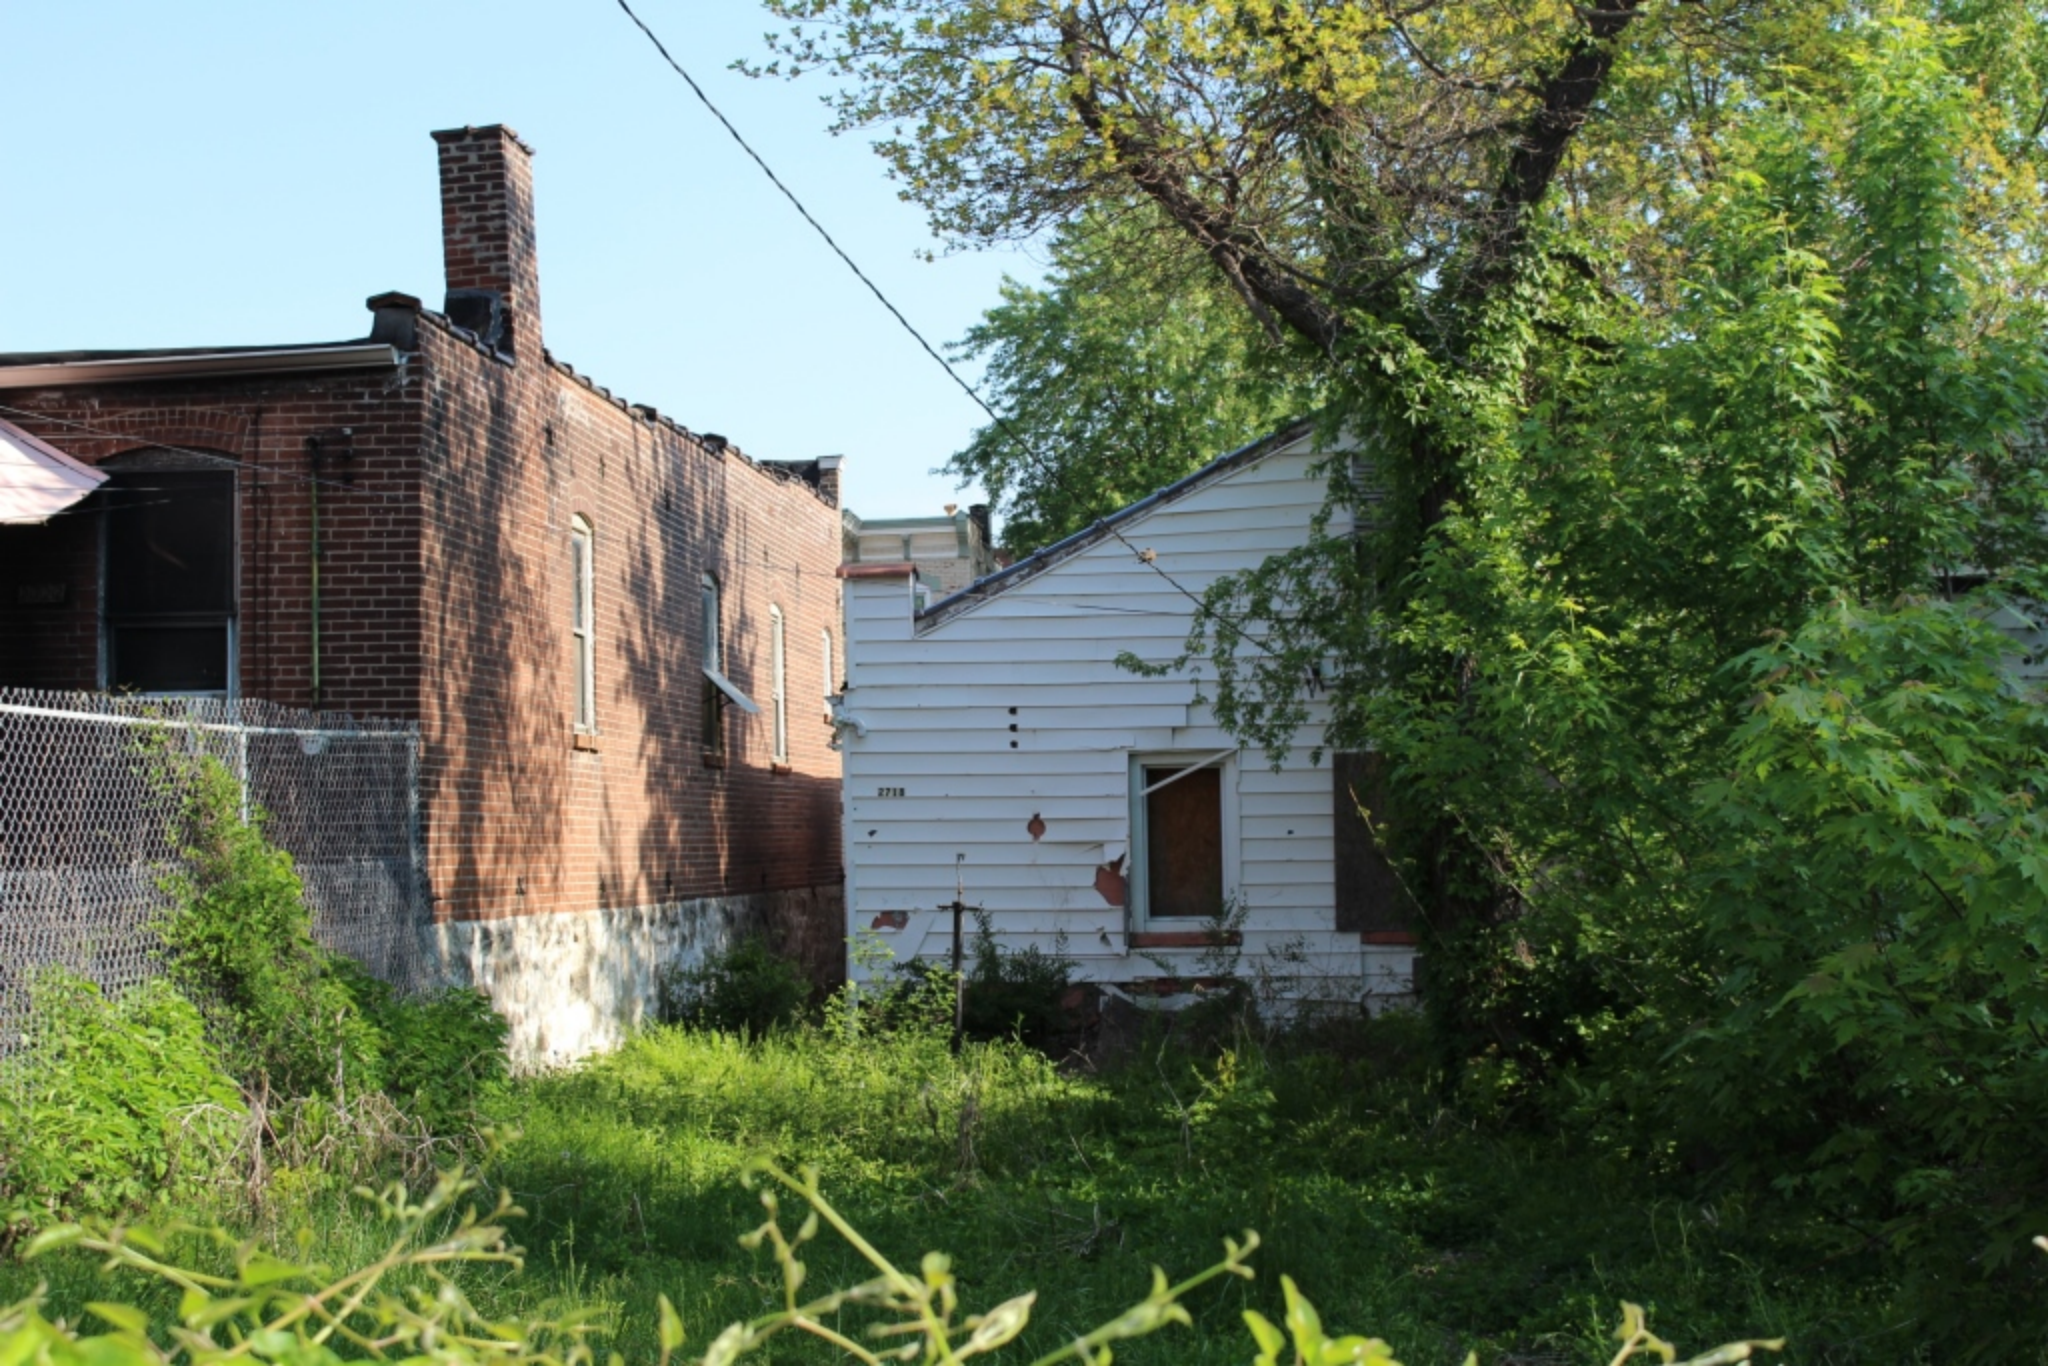
This 1 1/2-story brick flounder at the street is completely covered with vinyl siding. Breaks in the siding on the rear reveal brick underneath; breaks in the siding on the west side reveal the wood-framing enclosure of the gallery. Windows are boarded except for the attic window in the façade where a historic wood window remains in place. There is exterior access to the basement at the rear. The buiding is at the east property line where the taller, windowless wall appears to be a party wall.

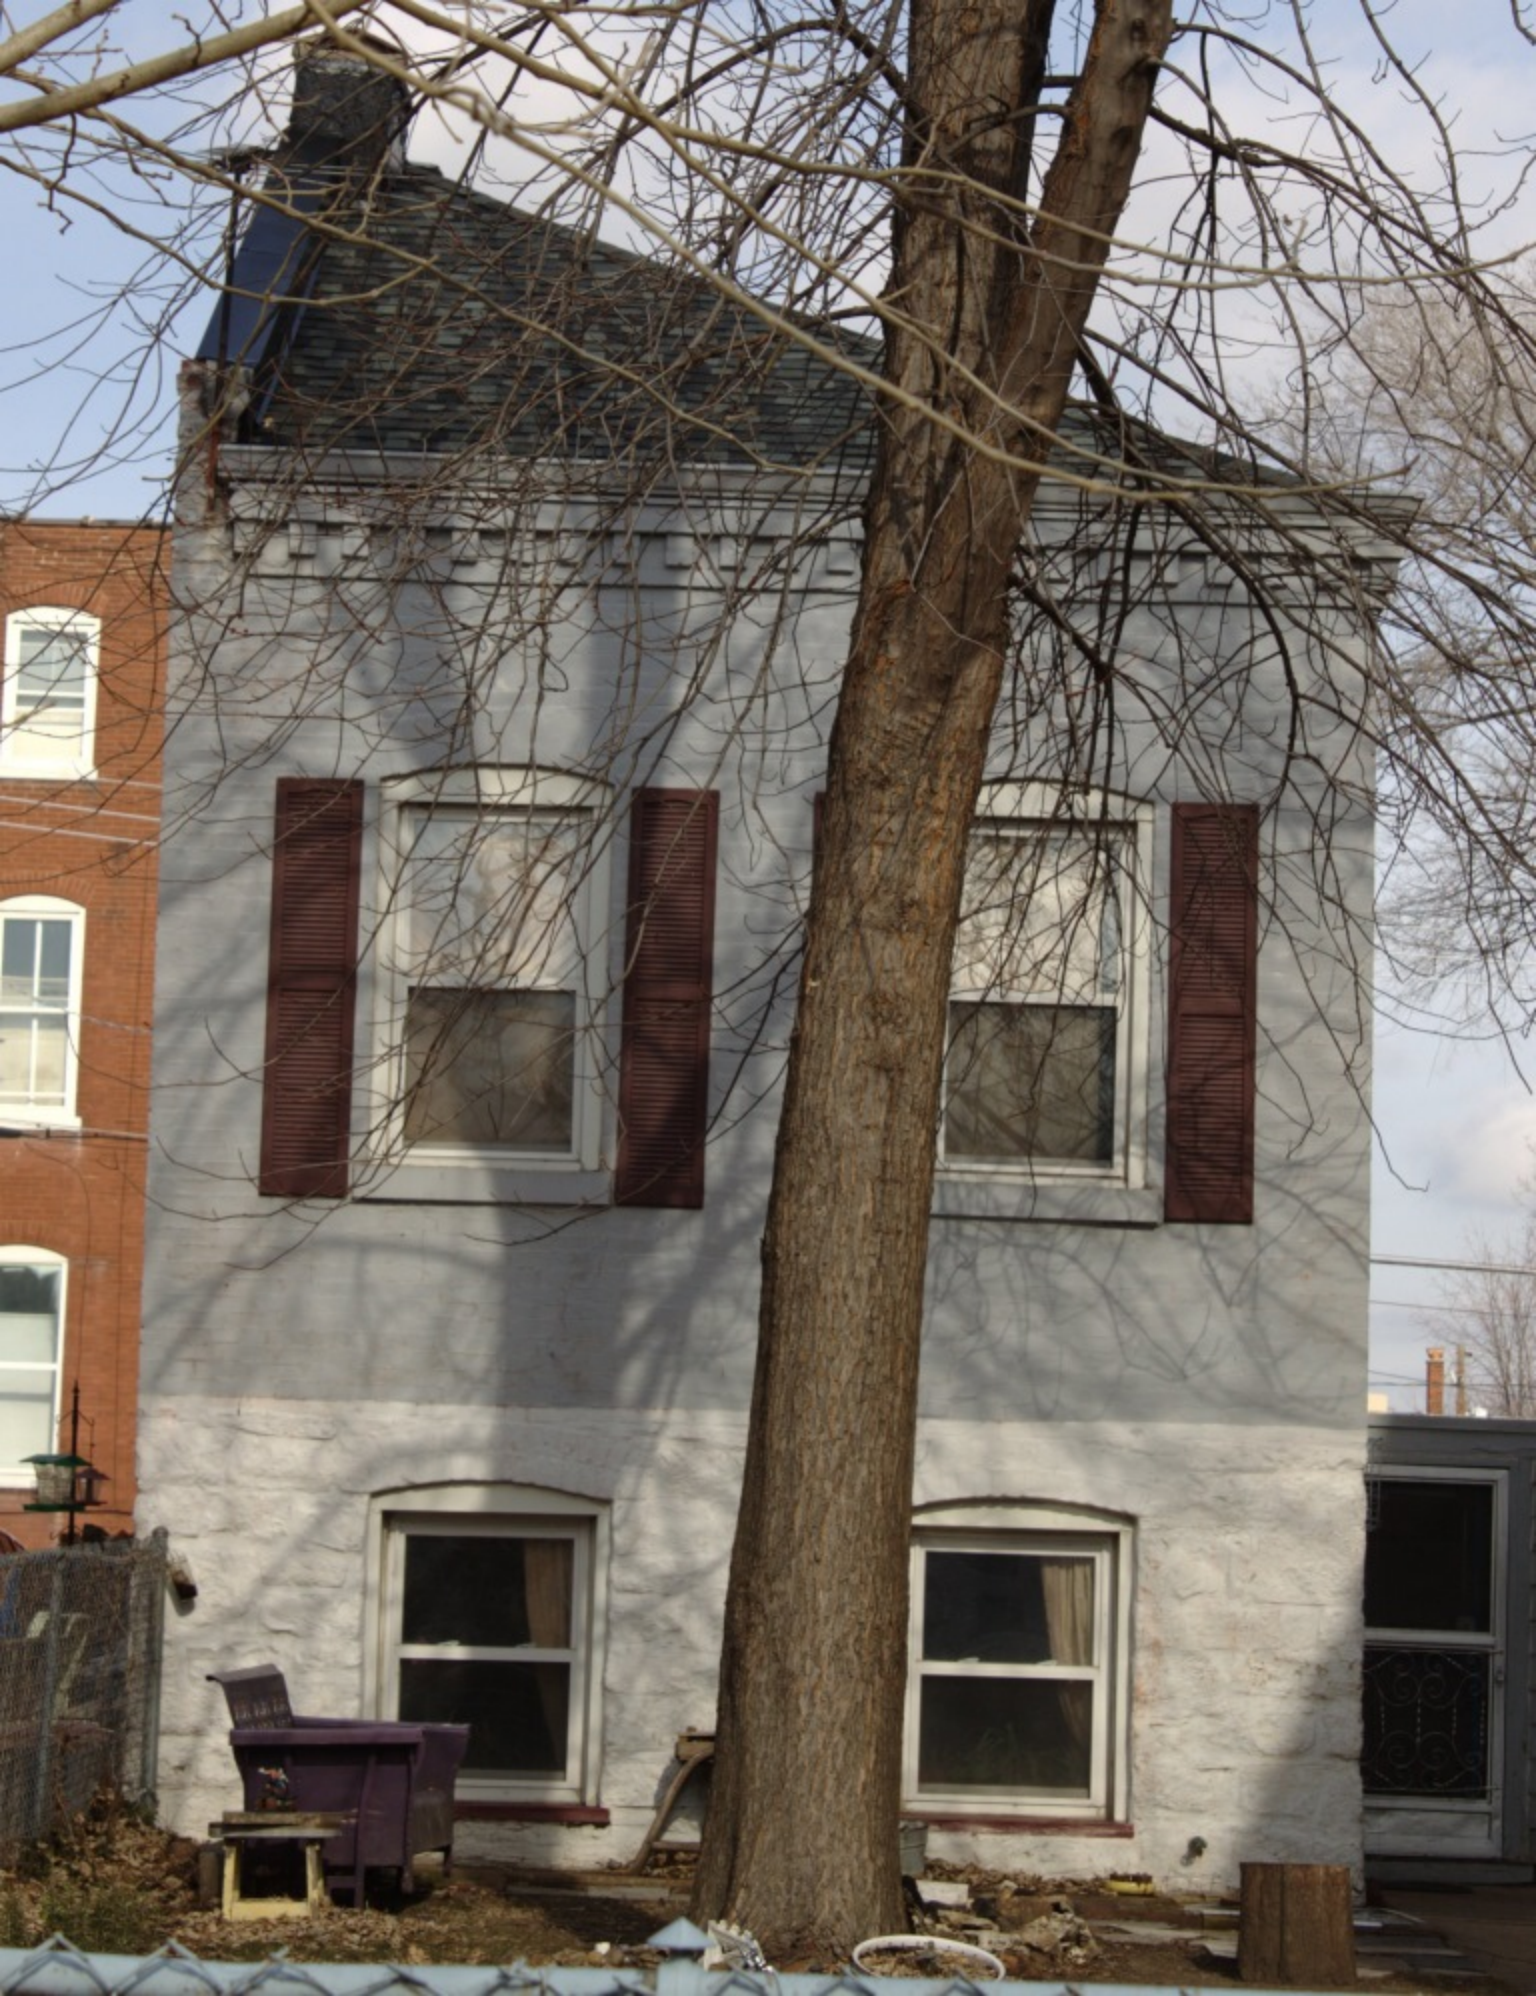
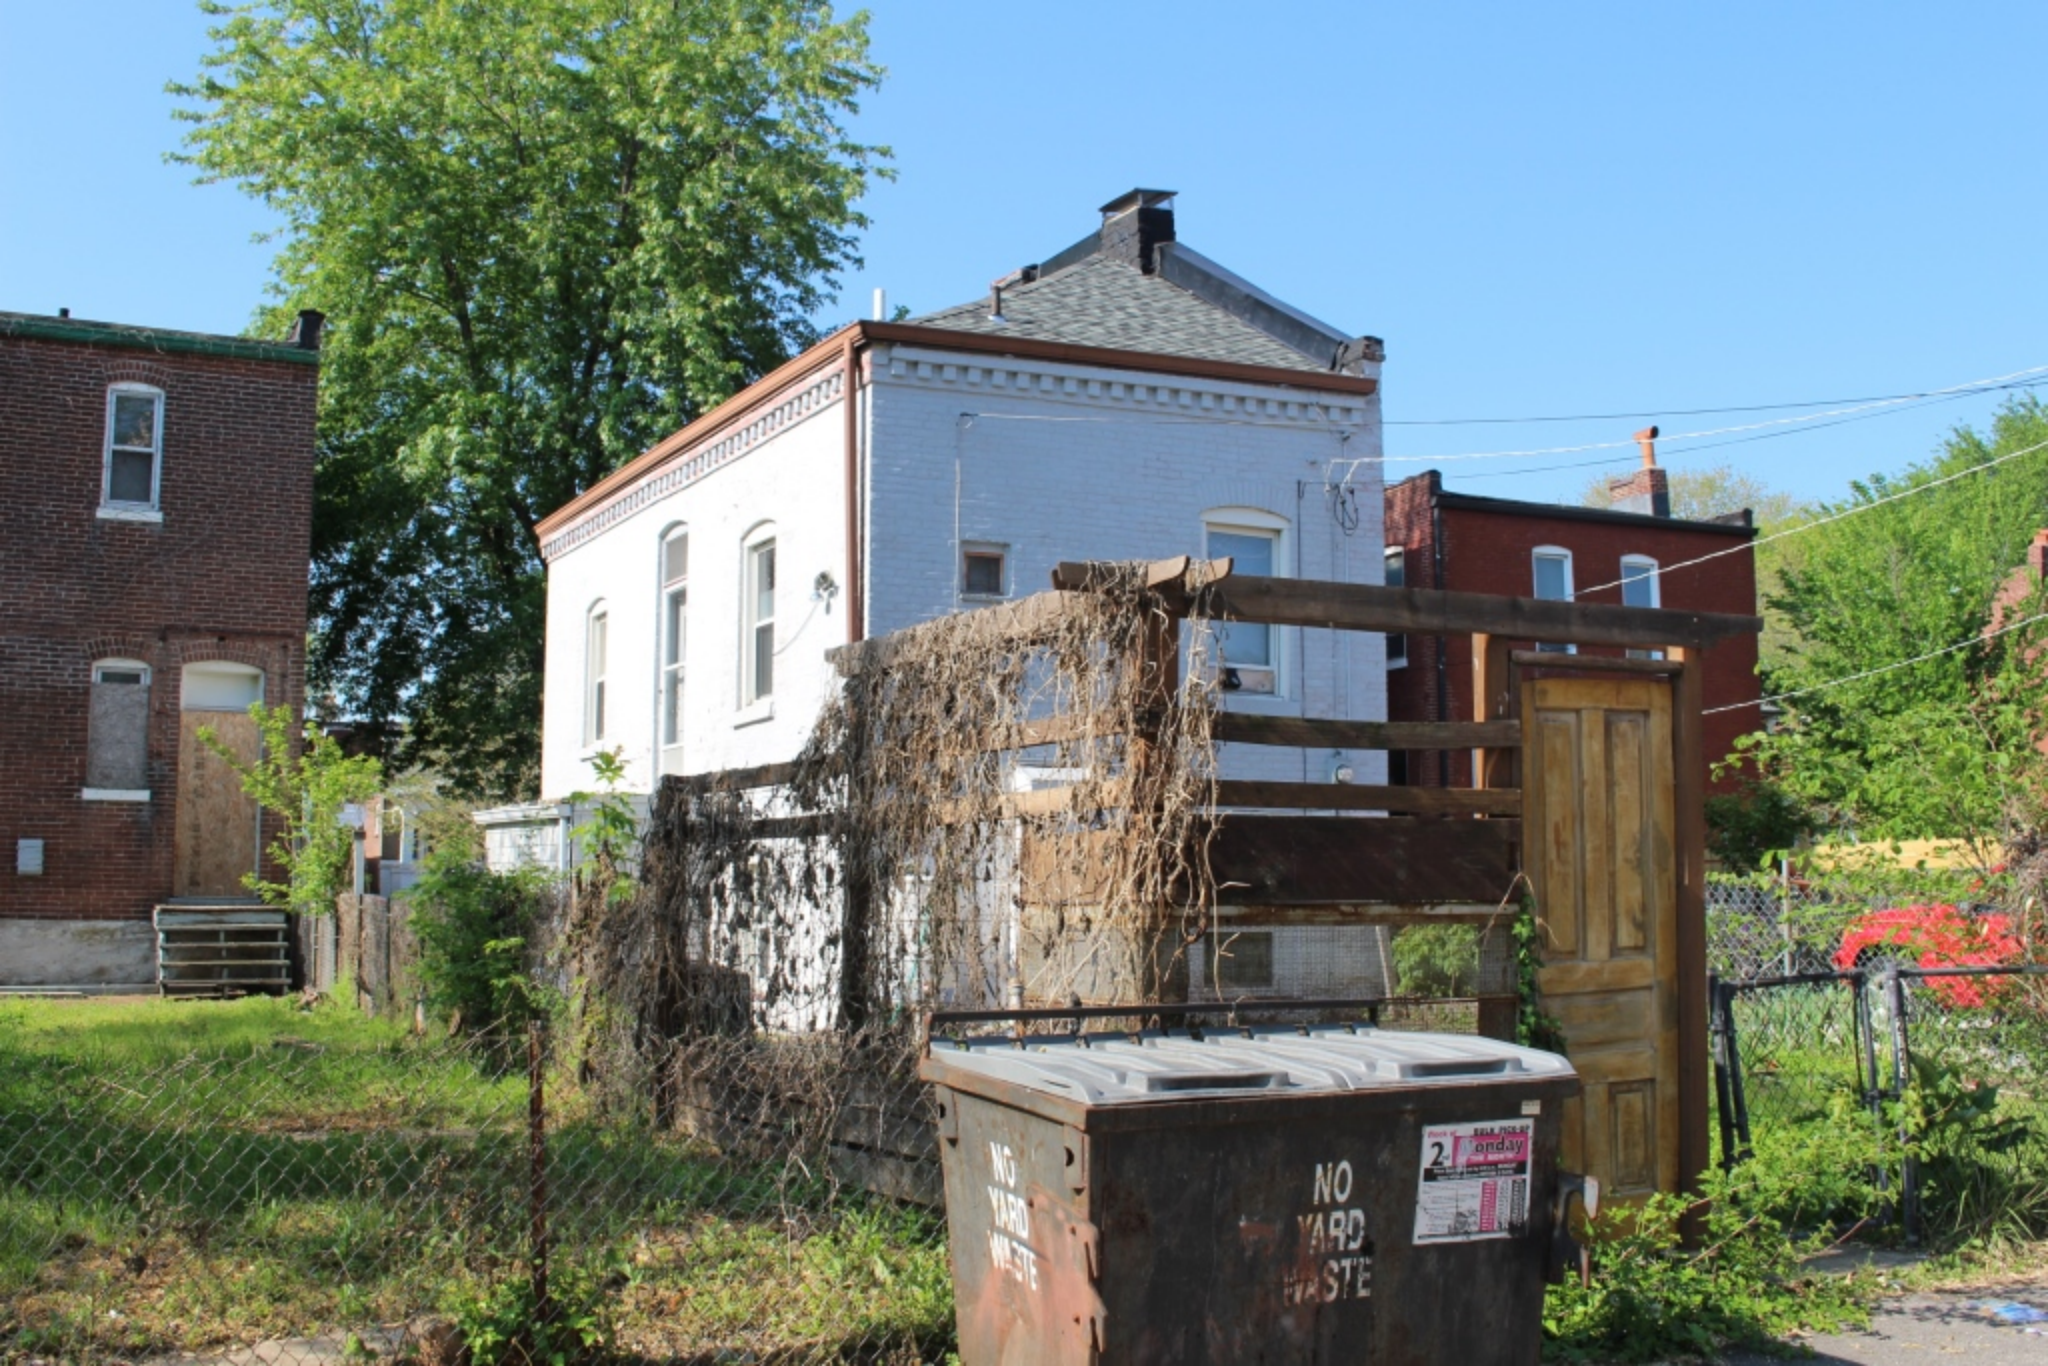
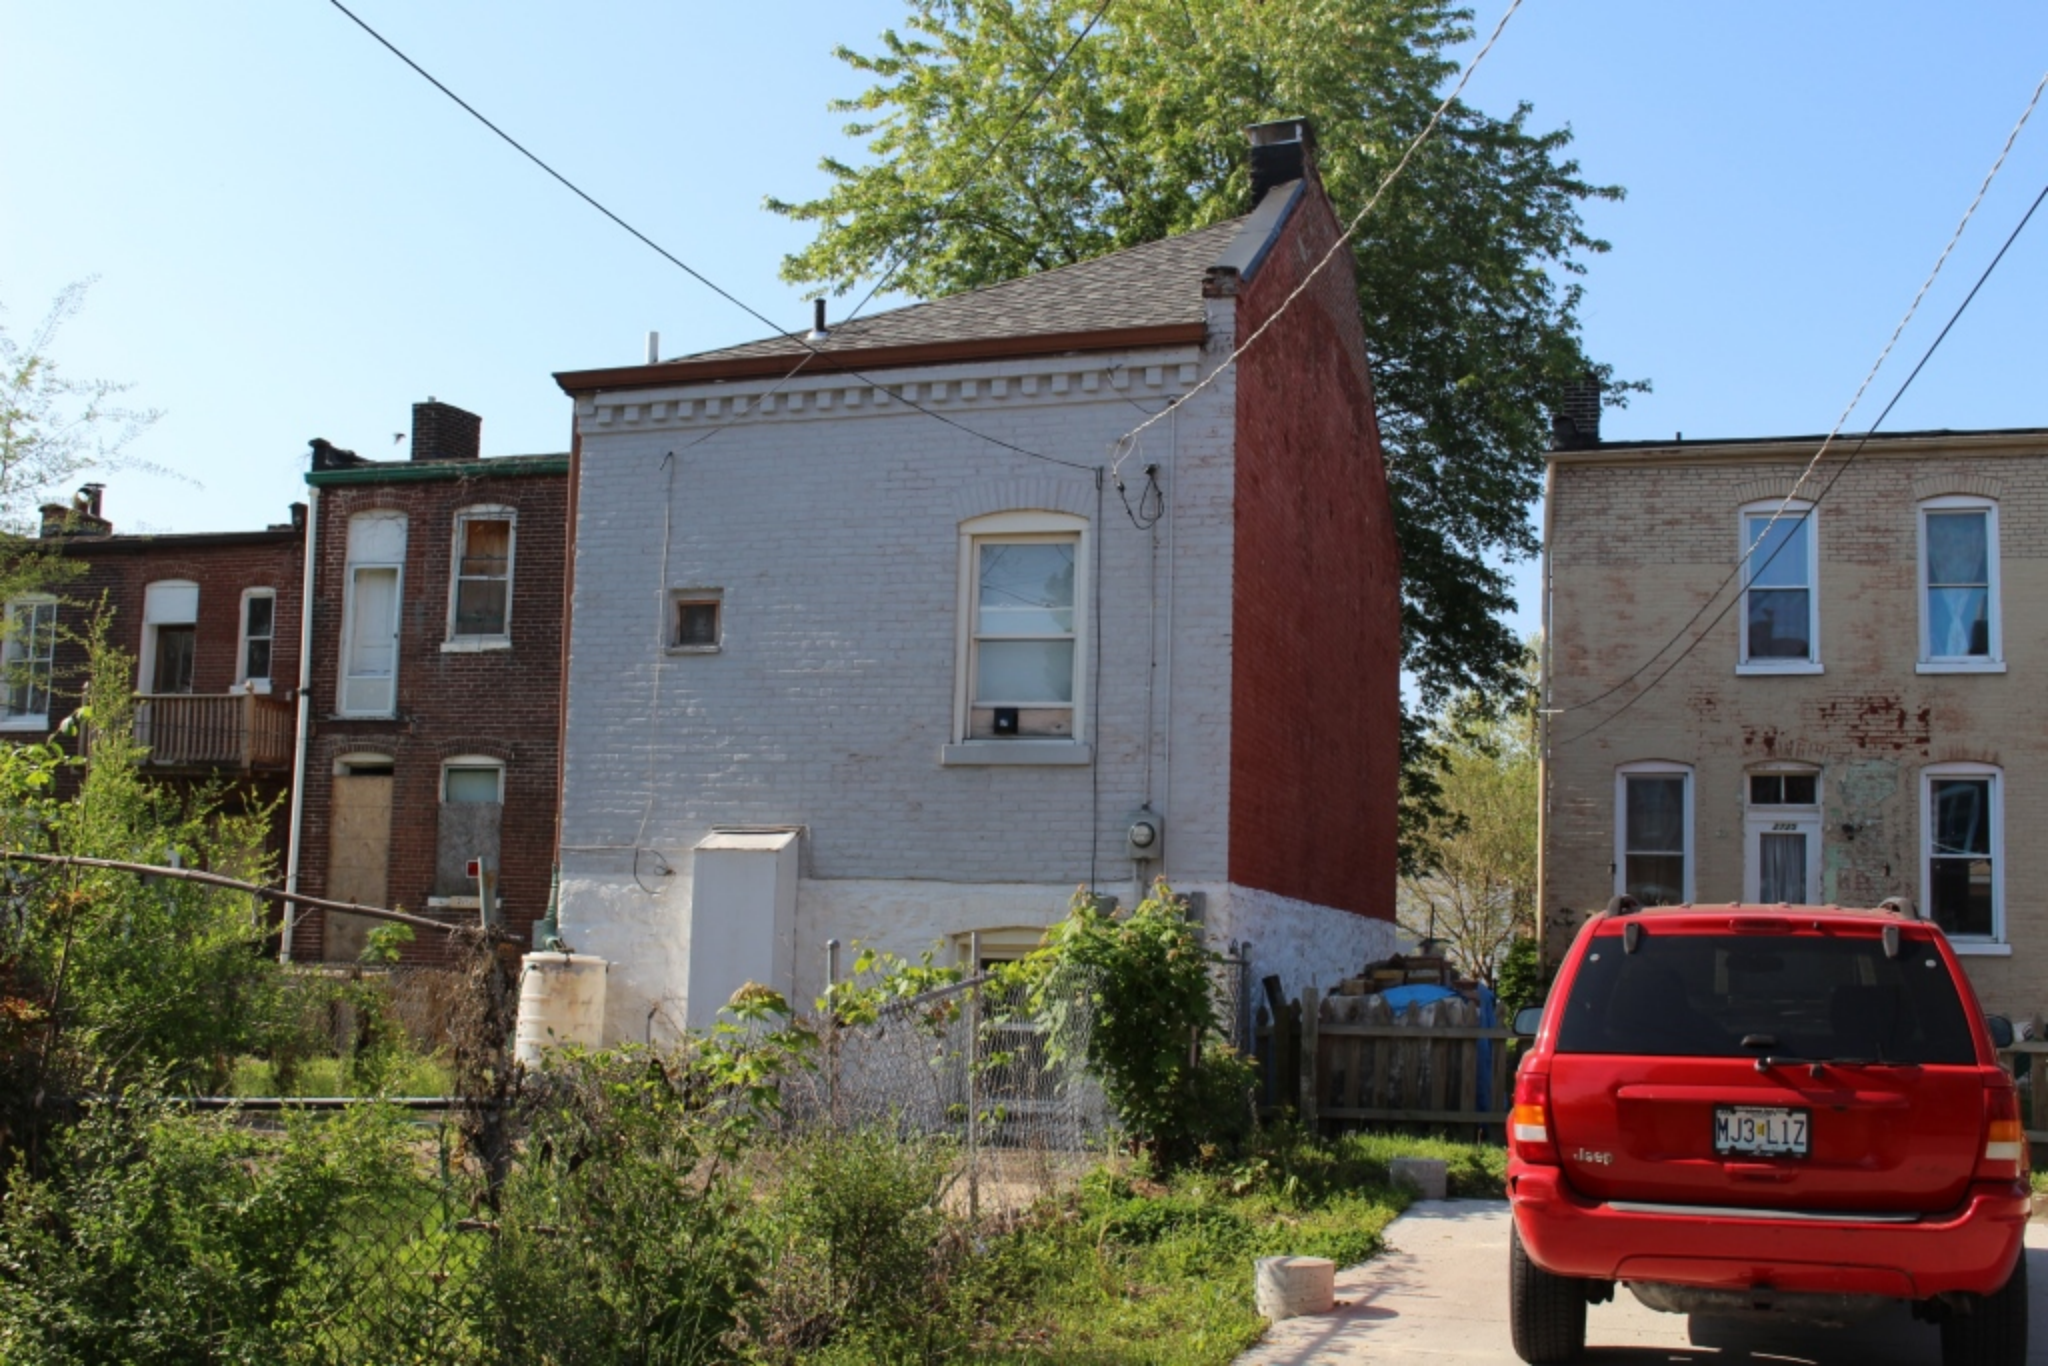
raised basement unusually high - main entrance now at that level;
foundation and all sides except windowless wall painted

This brick flounder is one story above a virtually full-height raised basement of coursed rubble limestone. The roof is hipped at the front and rear, and a denticulated brick cornice edges the three sides of the eaves. Windows at the rasied baseent level and main story have segmentally-arched openings defined with header brick. All openings have replacement vinyl sash and covered brickmold. The historic entrance is in the center bay of the east wall at the main story. The current entrance is now at grade, into the raised basement and is a projecting wood-framed structure clad with shingles with the door facing Utah.

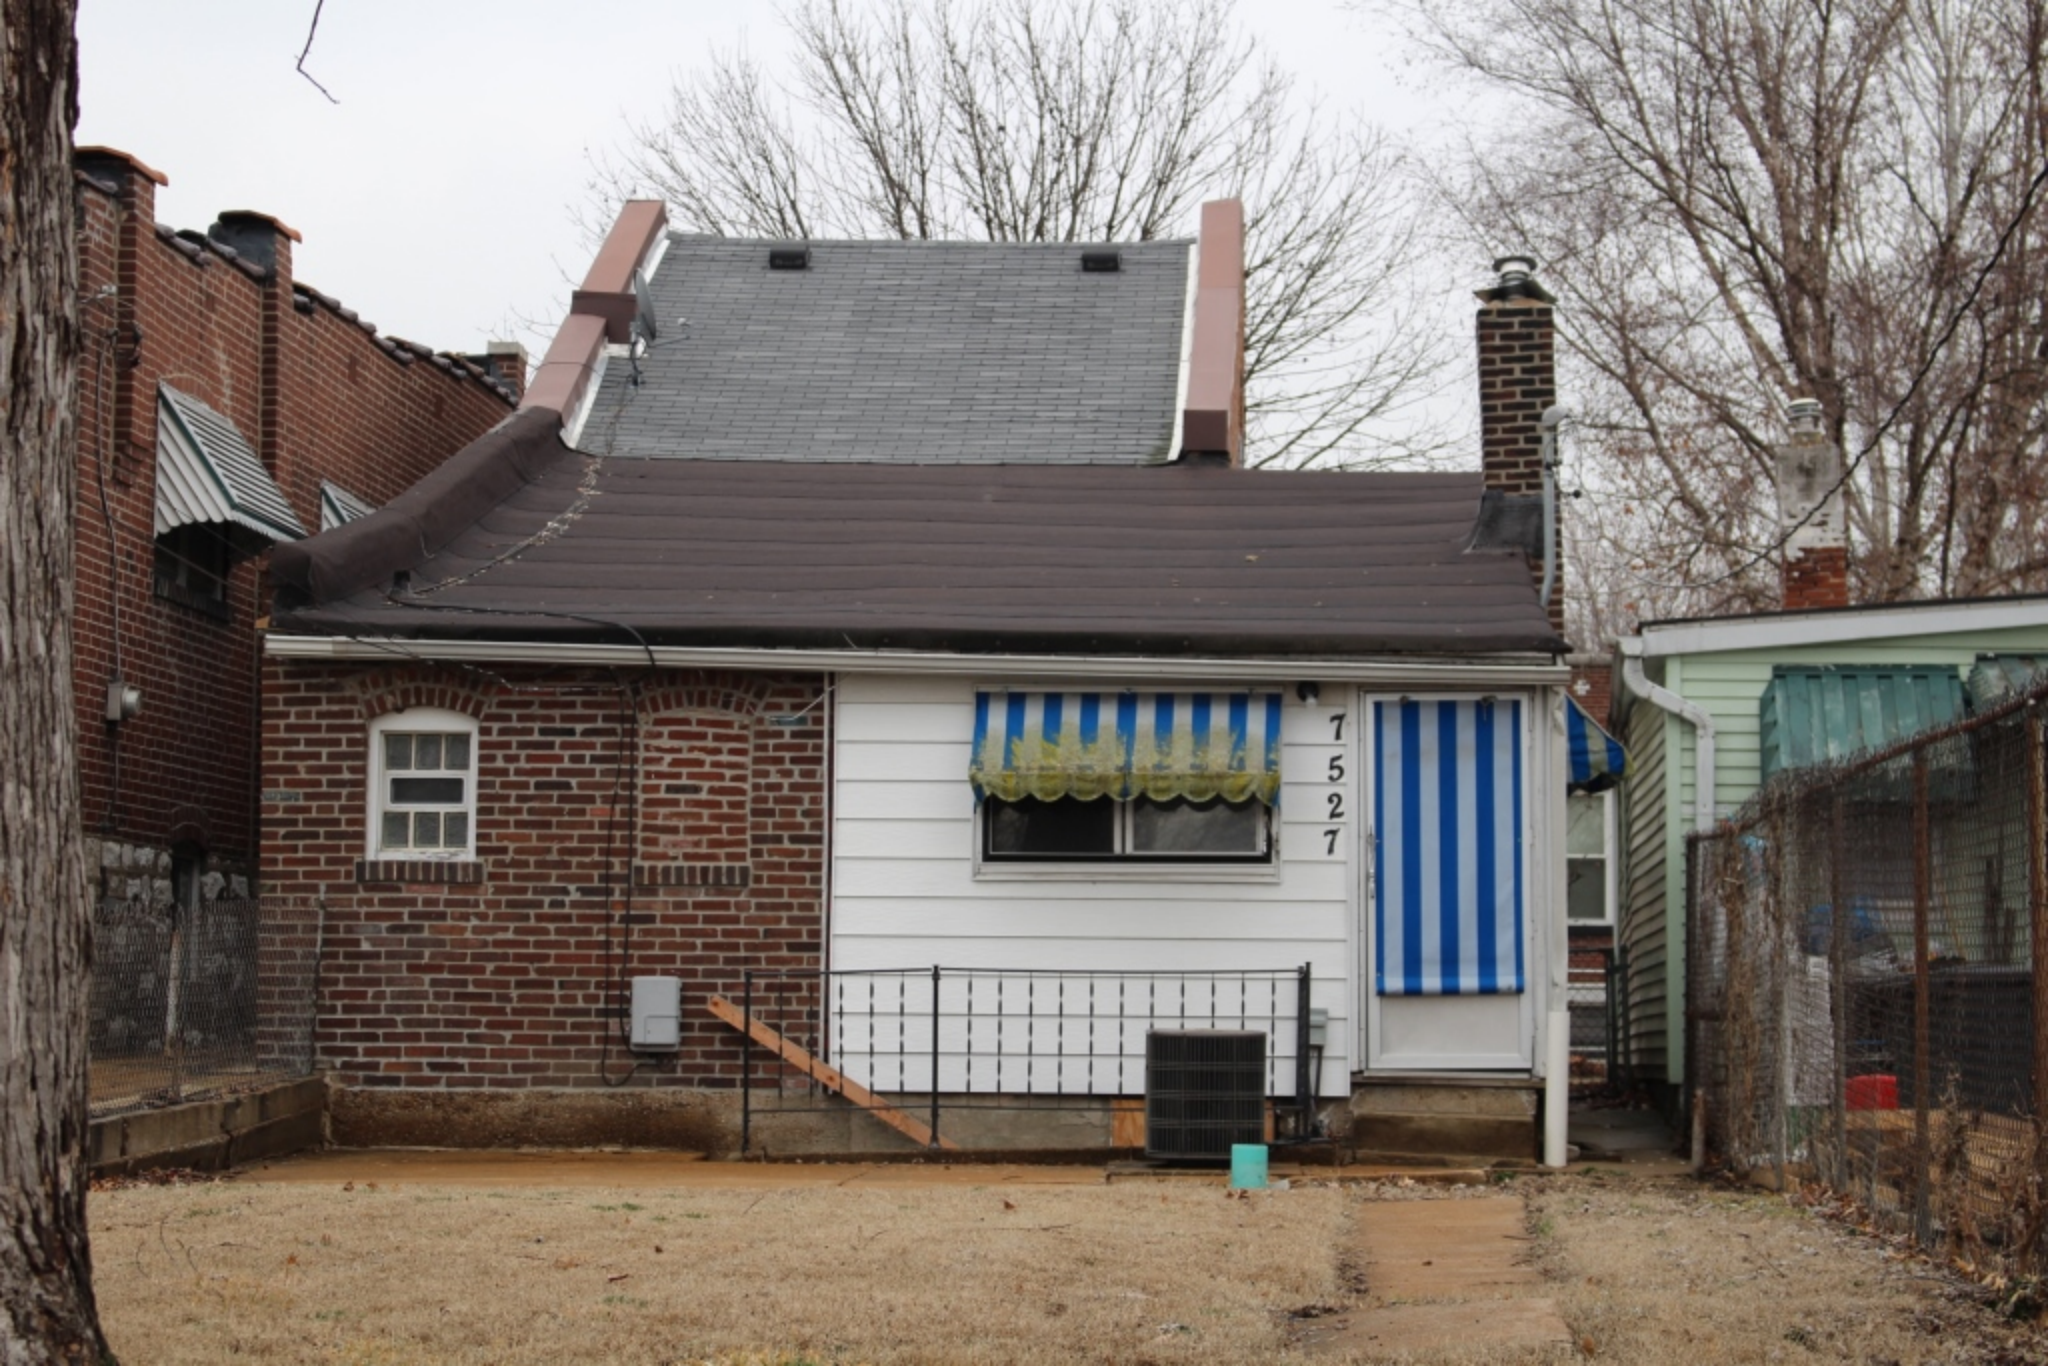
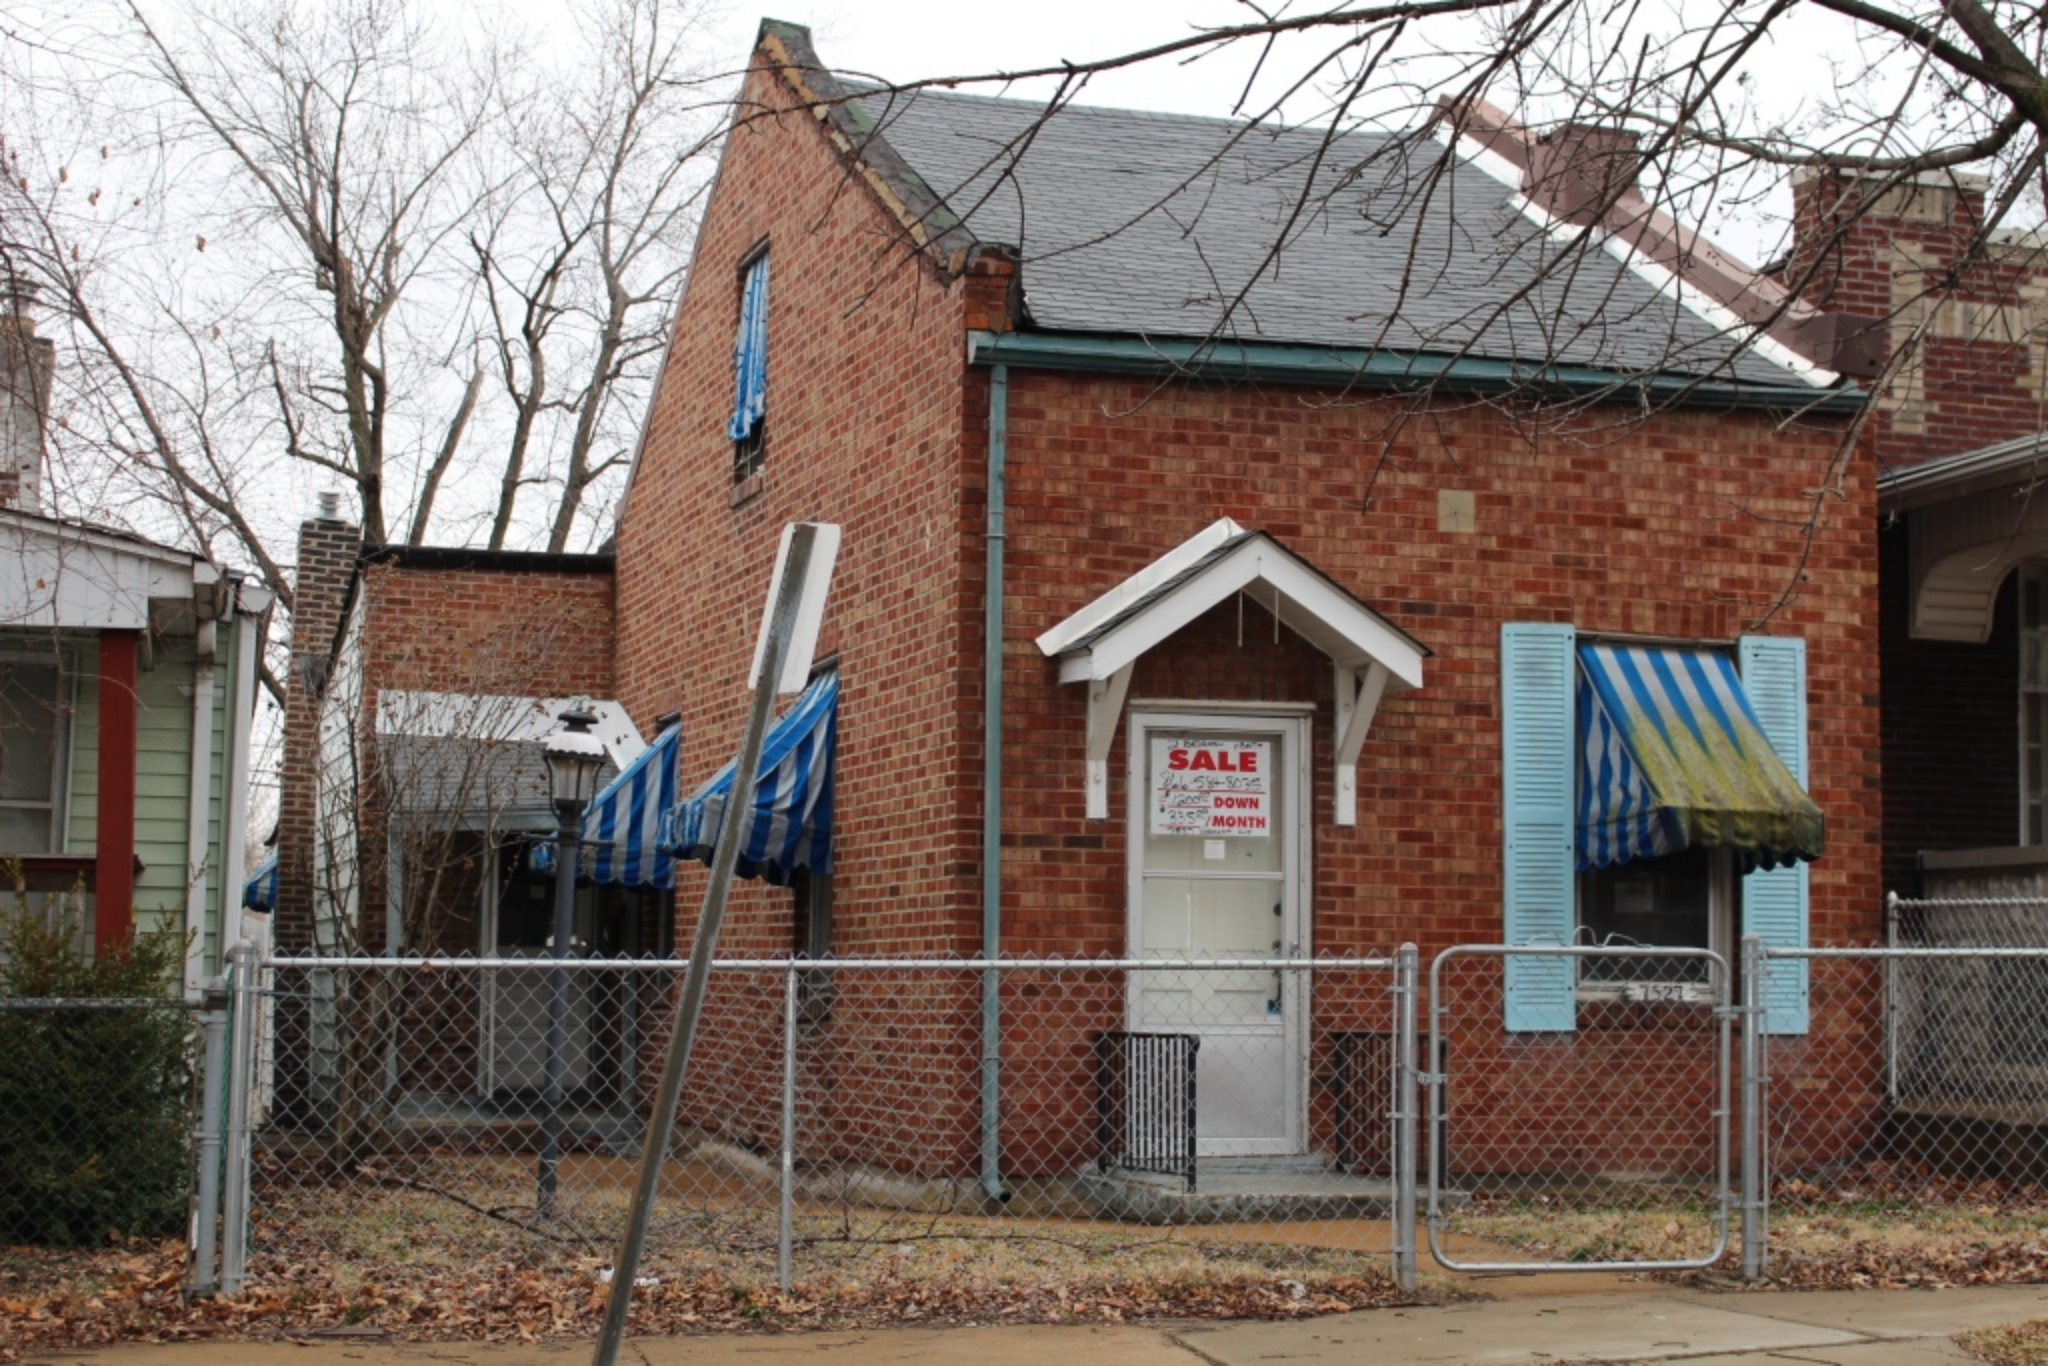
7
5
2
7

This is a 1-story frame flounder that has been substantially altered. Its tall blind window wall faces east, towards Vermont Avenue, indicating that the flounder may predate the street grid. Approximately 3/4rds of this wall is obscured with the addition of a 1-1/2 story, side gable two-room house. The remainder of the east wall has been veneered with a variagated brick to match similar brick adhered to the front block, and a sliding glass door inserted has been inserted. The south wall presents a brick stove chimney near the center of the façade with a small slider window on the west. This façade has been sided with aluminum, as has the south half of the west façade. The remainder of the west façade and the north elevation have been veneered in brick, in a different color and bond from the front elevation.
