ARCHITECTURAL/HISTORIC INVENTORY FORM - Cultural Resources Office
St. Louis Planning and Urban Design

1. Survey no. SLC-AS-053-0195	2. Survey name: Thematic Survey of Flounder Houses in St. Louis City	3. County: St. Louis [Independent City]
4. Address: (from City GEO database) 908 MORRISON AV		5. City/State: St. Louis, Missouri
Alternate address: 908 Morrison Avenue		Property Zip Code: 63104
Latitude: 38.614945		6. UTM Easting: 743839.02
Longitude: -90.199405		UTM Northing: 42277768.84
8. Historic Name (if known): N/A	11a. Historic Use (if known): Domestic	City Block 466.03
9. Present/other name (if known): Domestic	7. Township-Range-Section: N/A	City Ward 7
10. Ownership: Private		Neighborhood Number: 34

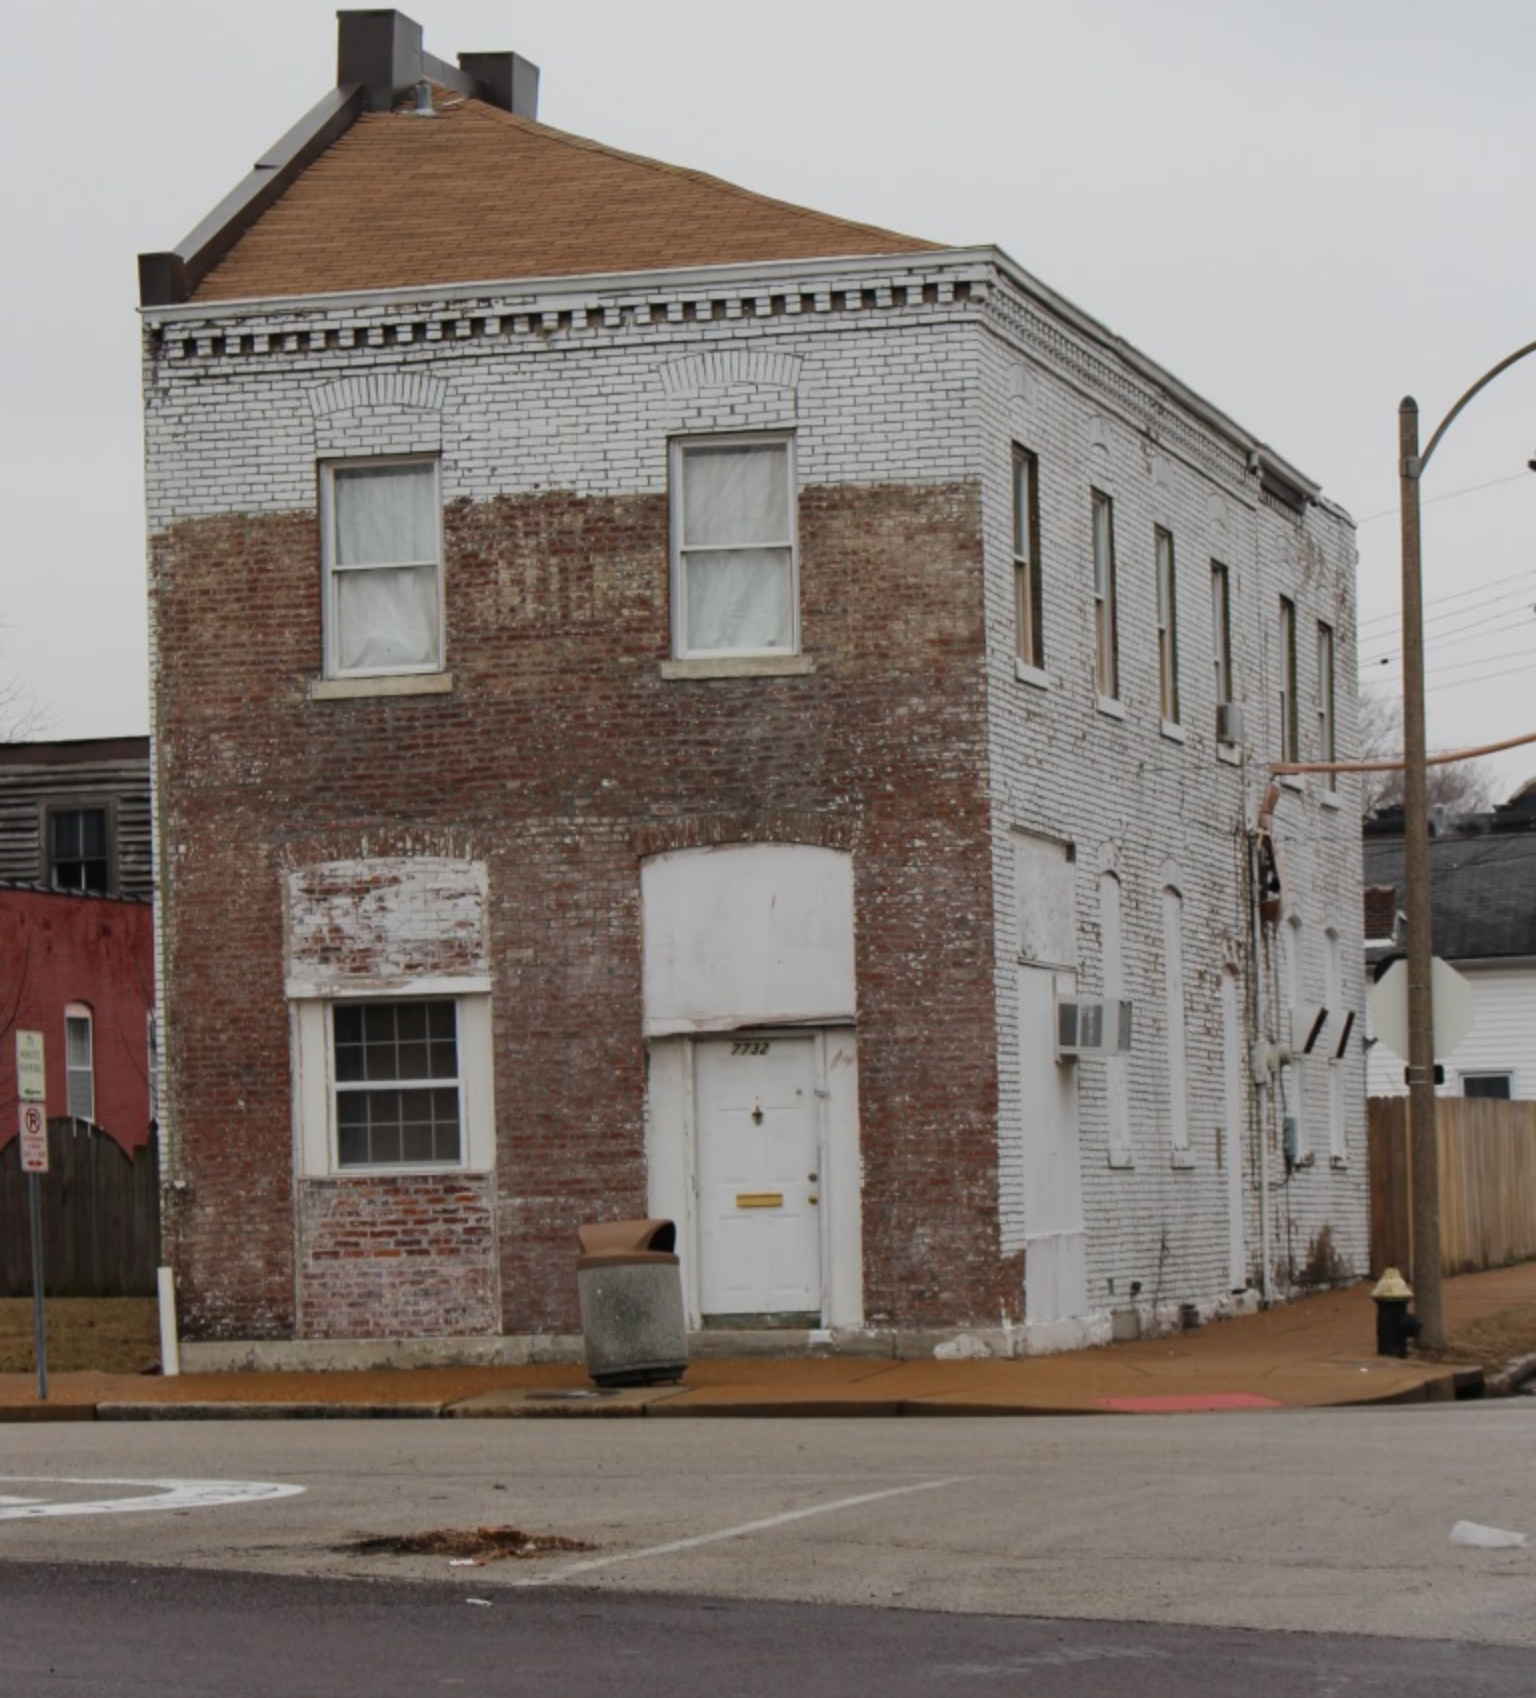
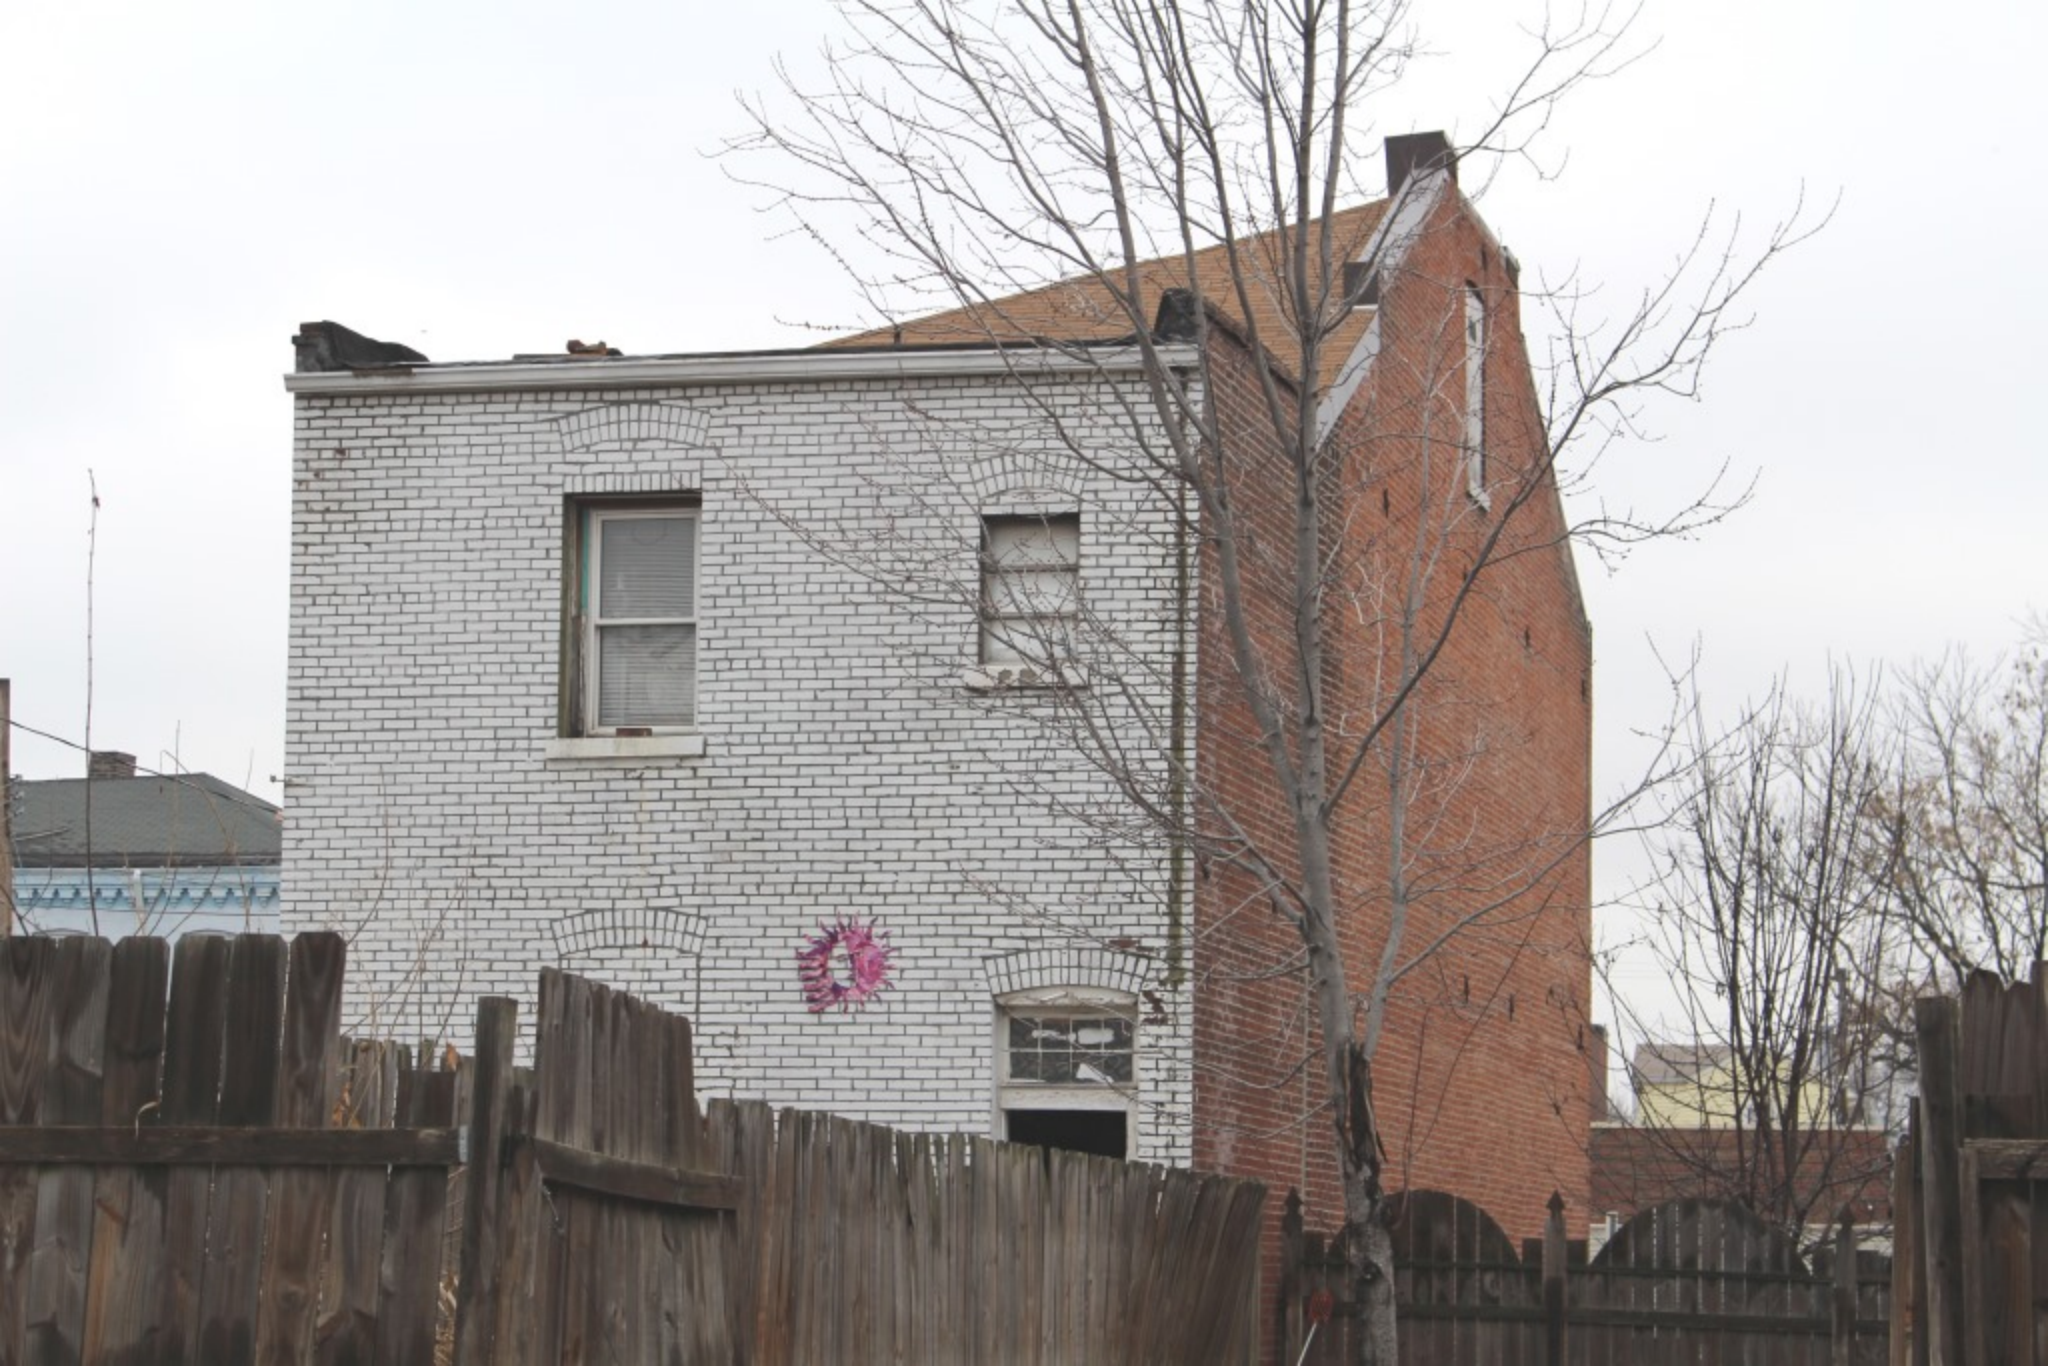
Located on a corner site, 7732 Virginia is a 2-story common bond brick flounder building with a 2-bay front façade. Its taller wall is sited at the north property line and presents a truncated gable with a single window opening at the third story. A limestone sill is exposed on all sides of the building. All openings are placed under segmental soldier arches. Windows have stone lugsills. The first story openings on the primary elevation are wider than the other window openings and may once have contained small storefronts or entries. Currently the south bay retains a entry (altered to accept a smaller door) with blocked transom. The north bay has been bricked in to accommodate a replacement doublehung window. At the second story, the two window heads have been bricked down approximately 1 foot to accommodate a lowered second floor ceiling. This has been done on all façades. A brick corbelled cornice with dentils extends across both front and south façades. The south façade had originally 4 bays. A storefront has under a steel lintel has been inserted in the westernmost bay; it is currently boarded. The rest of the first story bays have a single doublehung window at first and second stories. A two-story, two-bay addition was added c. 1900 at the rear of this façade. An attempt was made to replicate the corbelled cornice (the eastern portion has been reconstructed) and fenestration pattern of the original building, but using double rowlock arches instead of soldiers. The rear elevation of this addition has 2 bays. The front, south and east elevations have been painted.

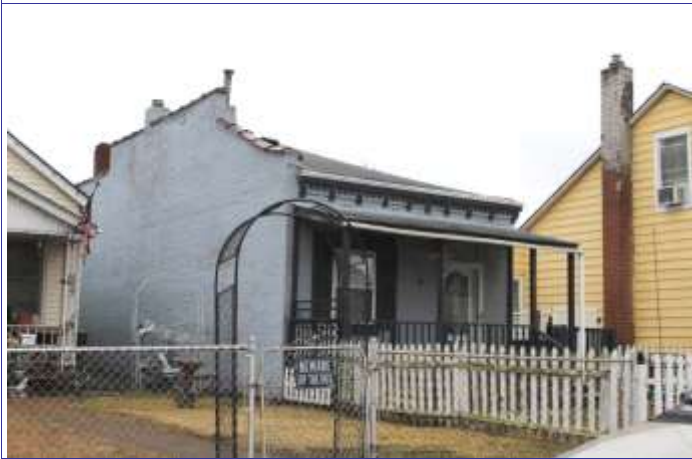
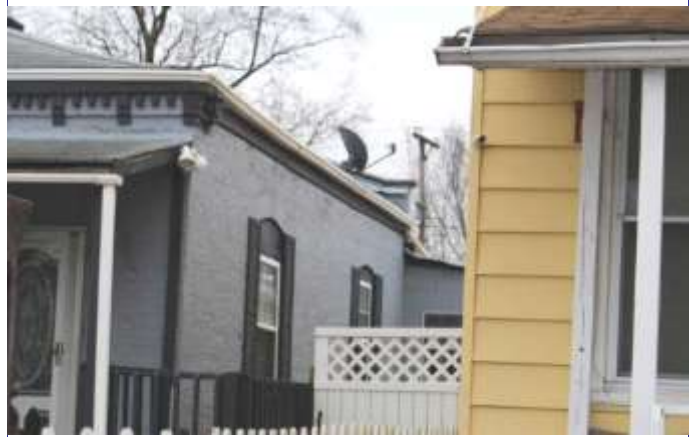
7820 VIRGINIA AV

A 1-story common bond brick flounder with hipped front roof. It has a 2-bay front facae with a window on the north and an entry with transom on the south. Above a corbelled brick cornice with dentils extends across the façade. A shed-roofed wood porch (a later addition) runs the width of the façade. The flounder's tall blind wall is situated at the north property line. The 2-bay south elevation presents 2 doublehung windows and a simple wood gutterboard. All openings are placed under segmental arches of soldiers. Windows have wood lugsills. A 1-1/2 story brick flounder ell with side gallery is attached at the rear façade. The brick has been painted.

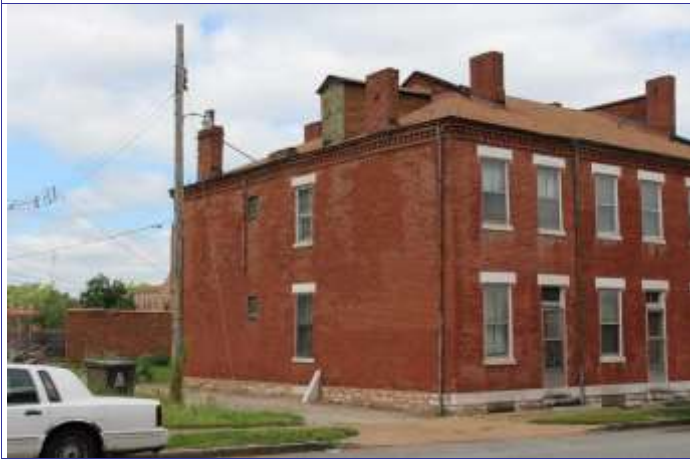
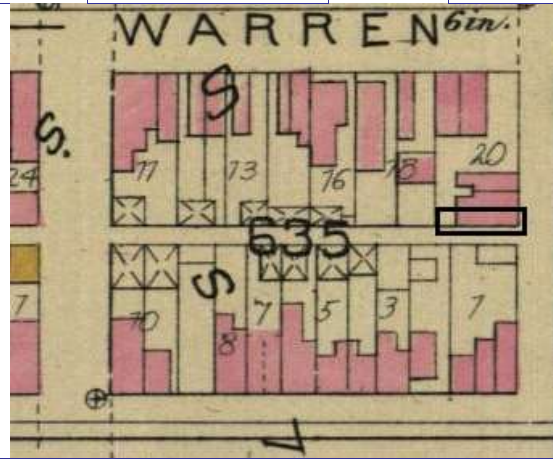
1302-8 WARREN ST

This end unit (at the alley) of a three-unit townhouse row has a hipped front and back flounder roof, in contrast to the side-gabled roofs of the other two units. A corbelled brick cornice edges all exposed walls of the unit. The two-bay wide house has one dormer in its sloping roof to light an aloft area. Stone lintels and sills frame the window openings; two types of wood sash remain in the openings. Small windows added to the side elevation are filled with glass block. The entrance also has a stone lintel and a transom above the door; it is approached by two steps. The rear façade has segmentally-arched openings with a double-row of headers forming the arch. A pent roof clad with orange clay tile shelters the rear entrance.

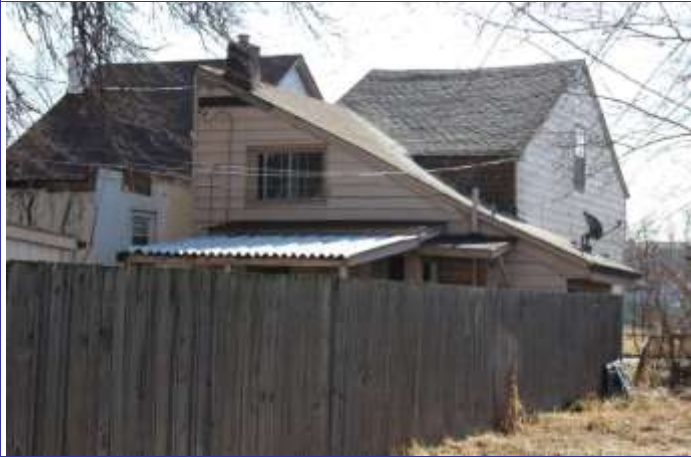
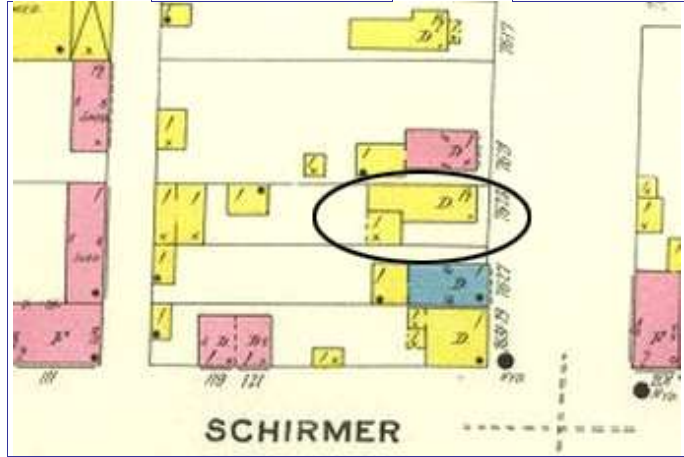
7623 WATER ST

7623 Water Street is a 1-1/2 story frame flounder, its taller blind wall placed at the north property line. It appears to predate the two-room, side-gabled house attached at its eastern wall. The west (rear) façade has 1 bay; a brick stove chimney projects at the roof ridge on this elevation. A shallow 1-story, shed-roofed bay, approximately 1 foot deep, has been added at the first story: it presents a single doublehung window on the north and a smaller window on the south. A shed-roofed porch with corrugated metal roof extends from the bay. At the second story, a slider window has been inserted. A side gallery was originally at the south façade; it has been enclosed and extended with an addition. The entire building has been sheathed with aluminum siding.

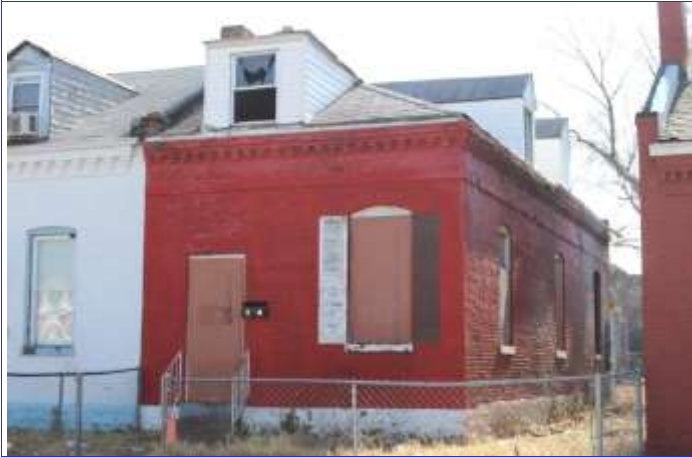
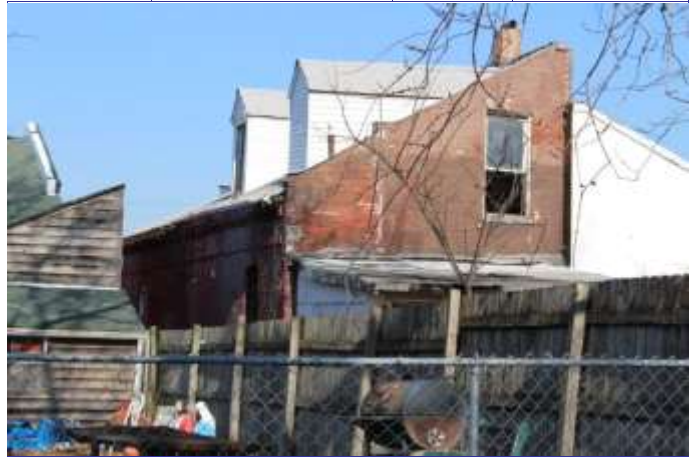
7710 WATER ST

This is a 1-1/2 story brick flounder, with its tall blind wall sited at the north property line and directly adjacent to the neighboring house. The shed roof is hipped at the front: the original dormer, placed asymmetrically near the north parapet has been replaced by a larger, shed-roofed dormer with single doublehung window. The 2-bay front elevation is distinguished by a cornice that is more detailed than most of the small vernacular flounders in the area: it displays a corbelled brick cornice with dentils at the parapet; five courses below the corbelling, a 2-course stringcourse projects slightly, creating the appearance of a frieze. The same cornice design returns along the south elevation. The front façade presents a singleleaf entry door in its northern bay; the head of the door has been rebuilt and the original transom eliminated. In the southern bay, a single doublehung window with decorative wood eyebrow, is set below a segmental soldier arch, with a wood lugsill. Windows of the south elevation are similar, but without decorative eyebrows. The 4-bay south façade had originally only 2 bays, as shown on the October 1908 Sanborn map. It retains its original narrow pedimented dormers, although the window of the rear dormer has been closed. The side gallery porch of the 1-1/2 story flounder ell at the rear of the house was replaced some time after 1908 with a brick addition that extended the south façade 2 additional bays. Details of the original building were replicated in the addition. Currently the first story of the rear elevation has been obscured with a 1-story frame addition; the original window opening on the second story appears to have been increased in height, the original segmental arch being replaced by a steel lintel. The building has been painted.

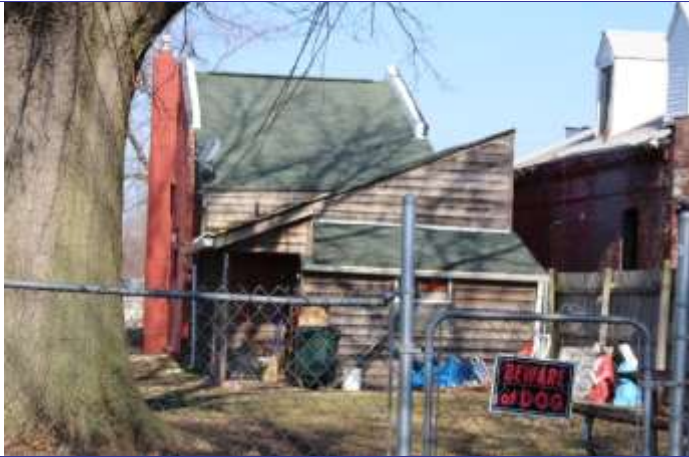
Rear flounder from alley

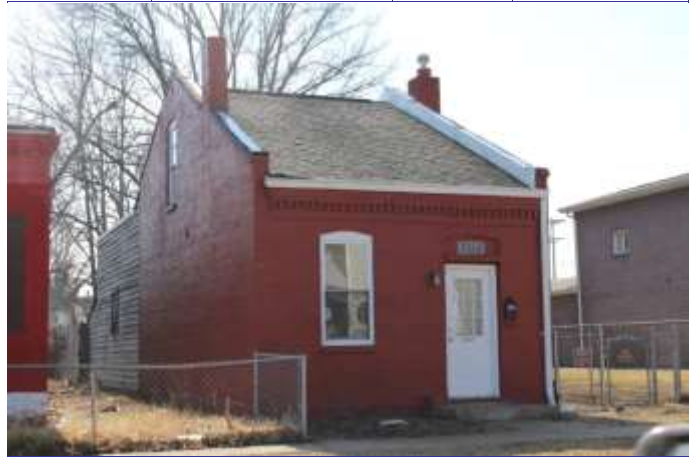
Front block showing flounder at rear

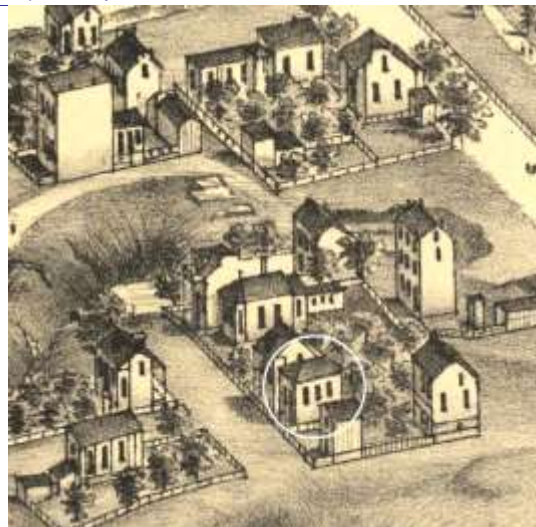
2001 WITHNELL AV

foundation heavily parged

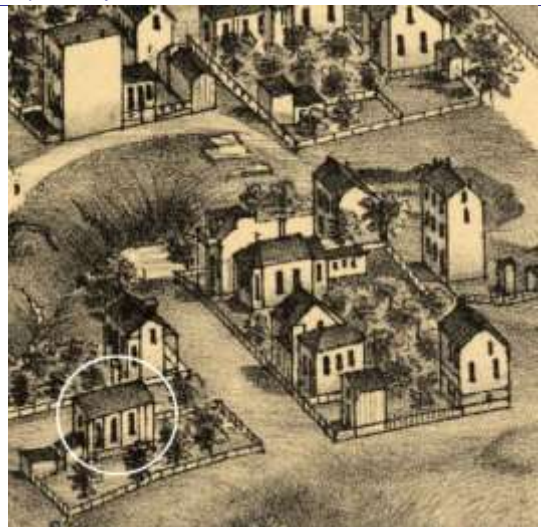
2002 WITHNELL AV

parge raised basement considered to be a full story

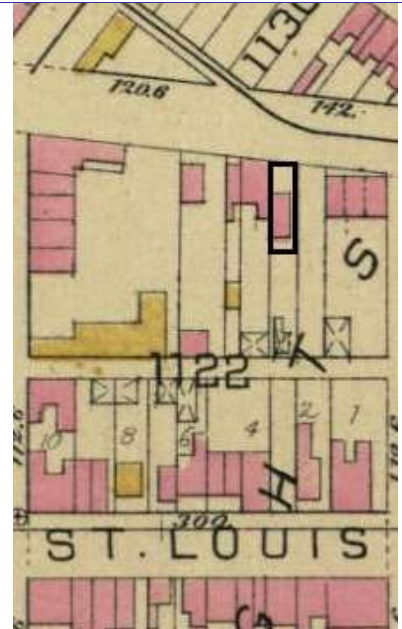
The building is in excellent condition and is well-maintained.

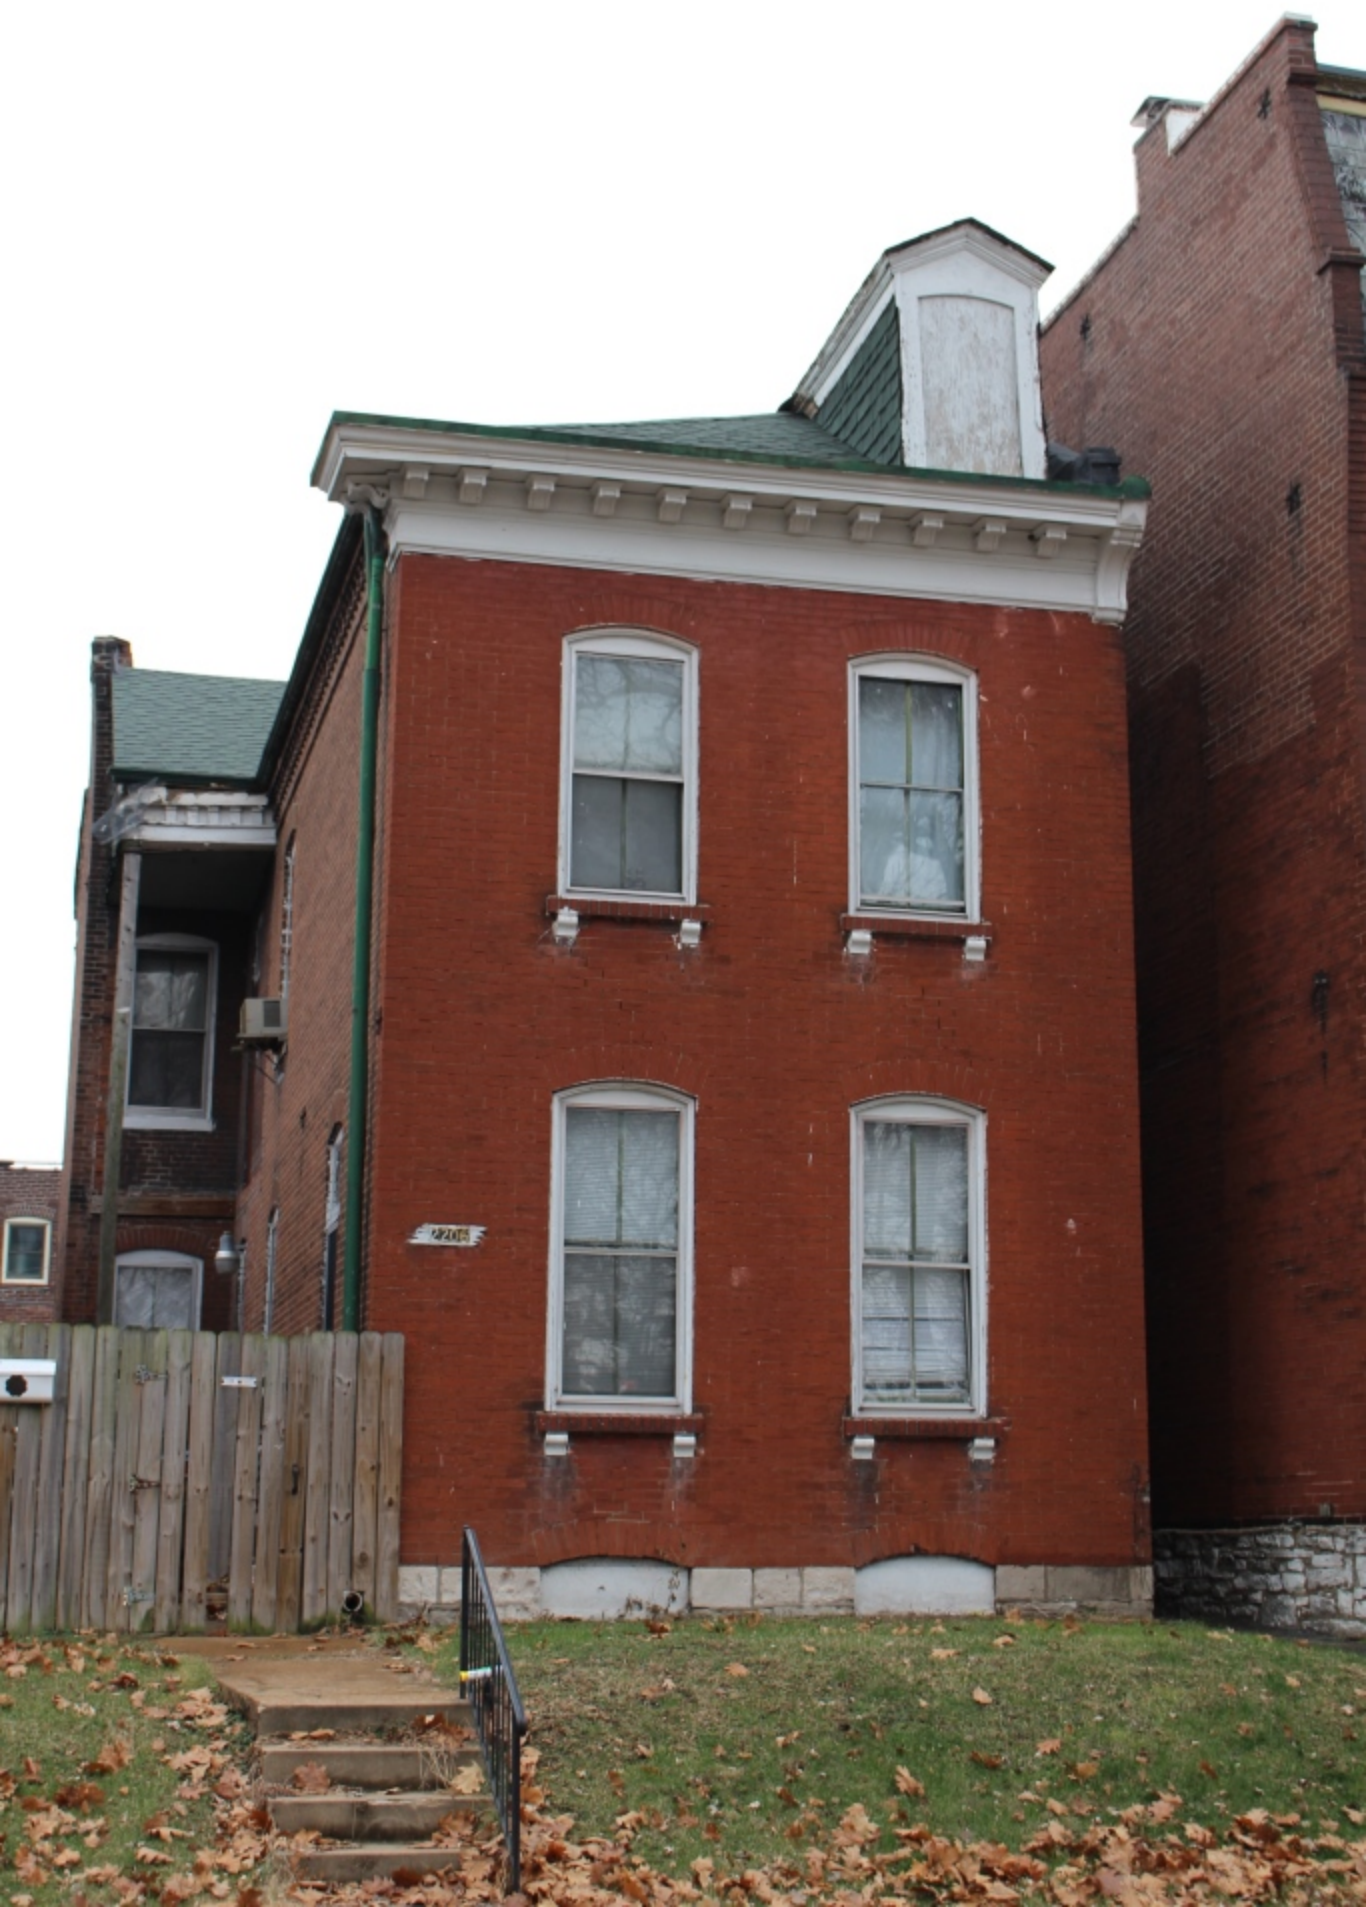
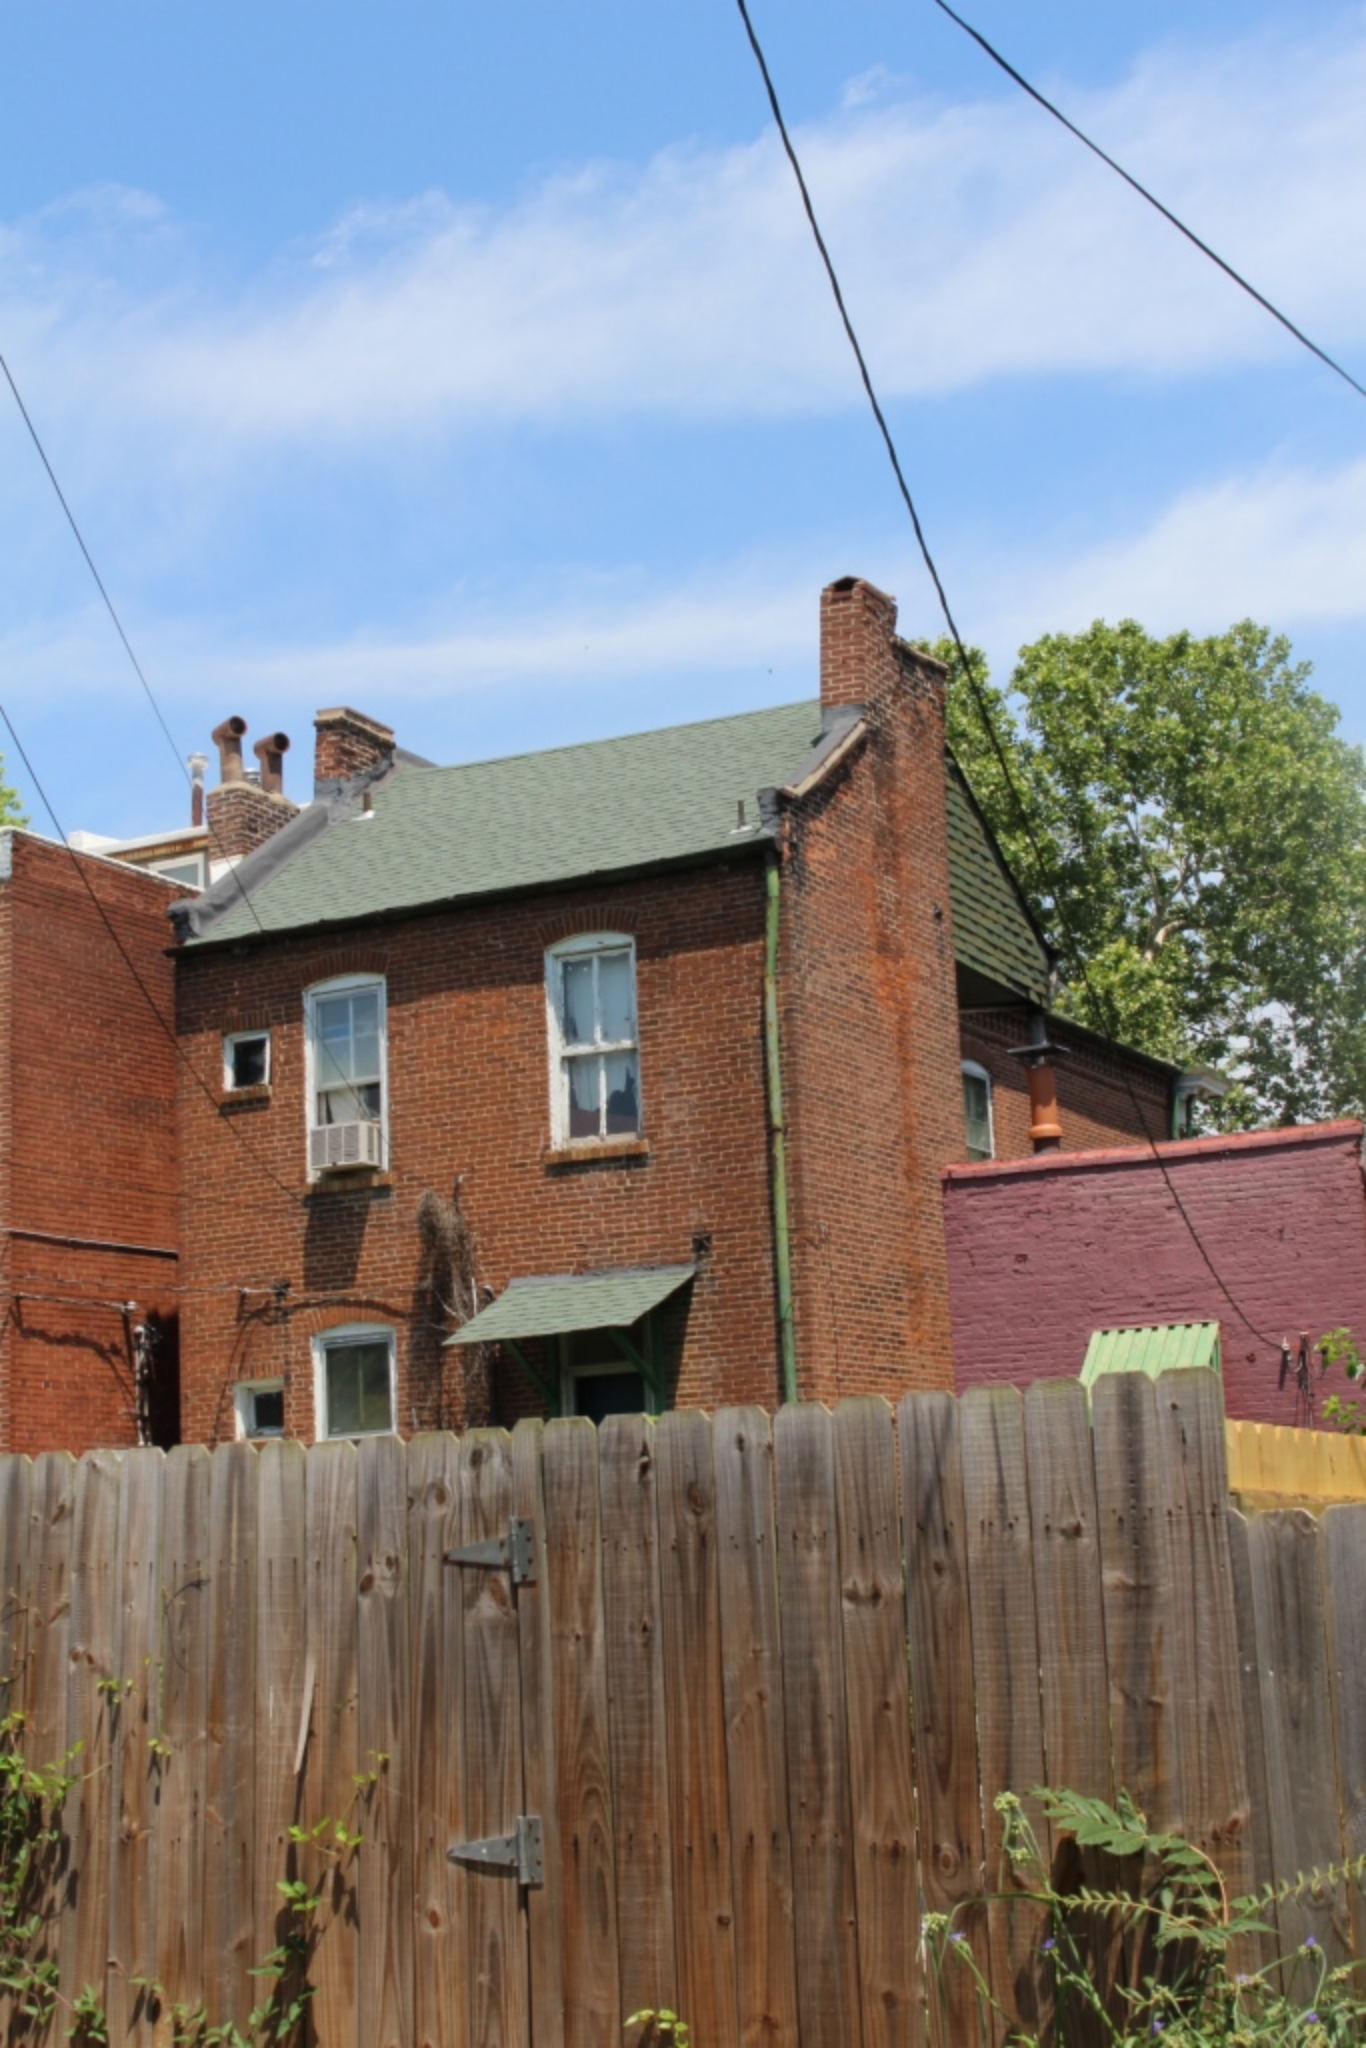
2206 WYOMING ST

Privacy fence blocks view of first story east side wall and rear bay

The building is located in a National Register District. Surrounding properties date from the mid- to late-19th century and are generally in fair to good condition and maintenance.

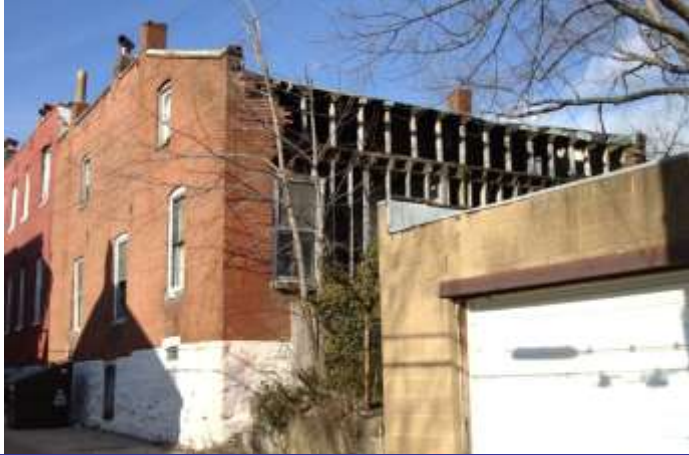
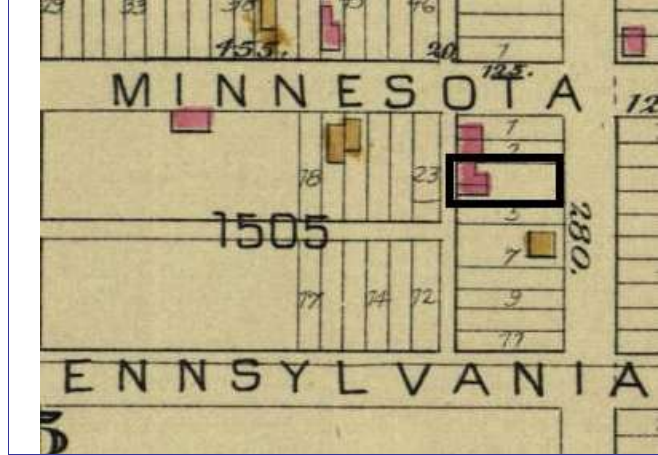
3018 WYOMING ST

Endangered by: (see Field notes for additional specifics)	Property maintenance at time of survey-see specifics in Field notes.
Structural collapse	poor
Structural condition at time of survey-see specifics in Field notes.	Neighborhood condition at time of survey-see specifics in Field notes.
poor	historic district

top portion of the west side wall has collapsed, more towards the alley than towards Wyoming; wood 2x4s brace plywood that covers the street-side portion of the wall; main story windows are boarded and only attic one exposed on faade. Foundation is covered with concrete parging on faade and Basement is covered with
