ARCHITECTURAL/HISTORIC INVENTORY FORM - Cultural Resources Office
St. Louis Planning and Urban Design

1. Survey no. SLC-AS-053-0195	2. Survey name: Thematic Survey of Flounder Houses in St. Louis City	3. County: St. Louis [Independent City]
4. Address: (from City GEO database) 908 MORRISON AV		5. City/State: St. Louis, Missouri
Alternate address: 908 Morrison Avenue		Property Zip Code: 63104
Latitude: 38.614945		6. UTM Easting: 743839.02
Longitude: -90.199405		UTM Northing: 42277768.84
8. Historic Name (if known): N/A	11a. Historic Use (if known): Domestic	City Block 466.03
9. Present/other name (if known): Domestic	7. Township-Range-Section: N/A	City Ward 7
10. Ownership: Private		Neighborhood Number: 34

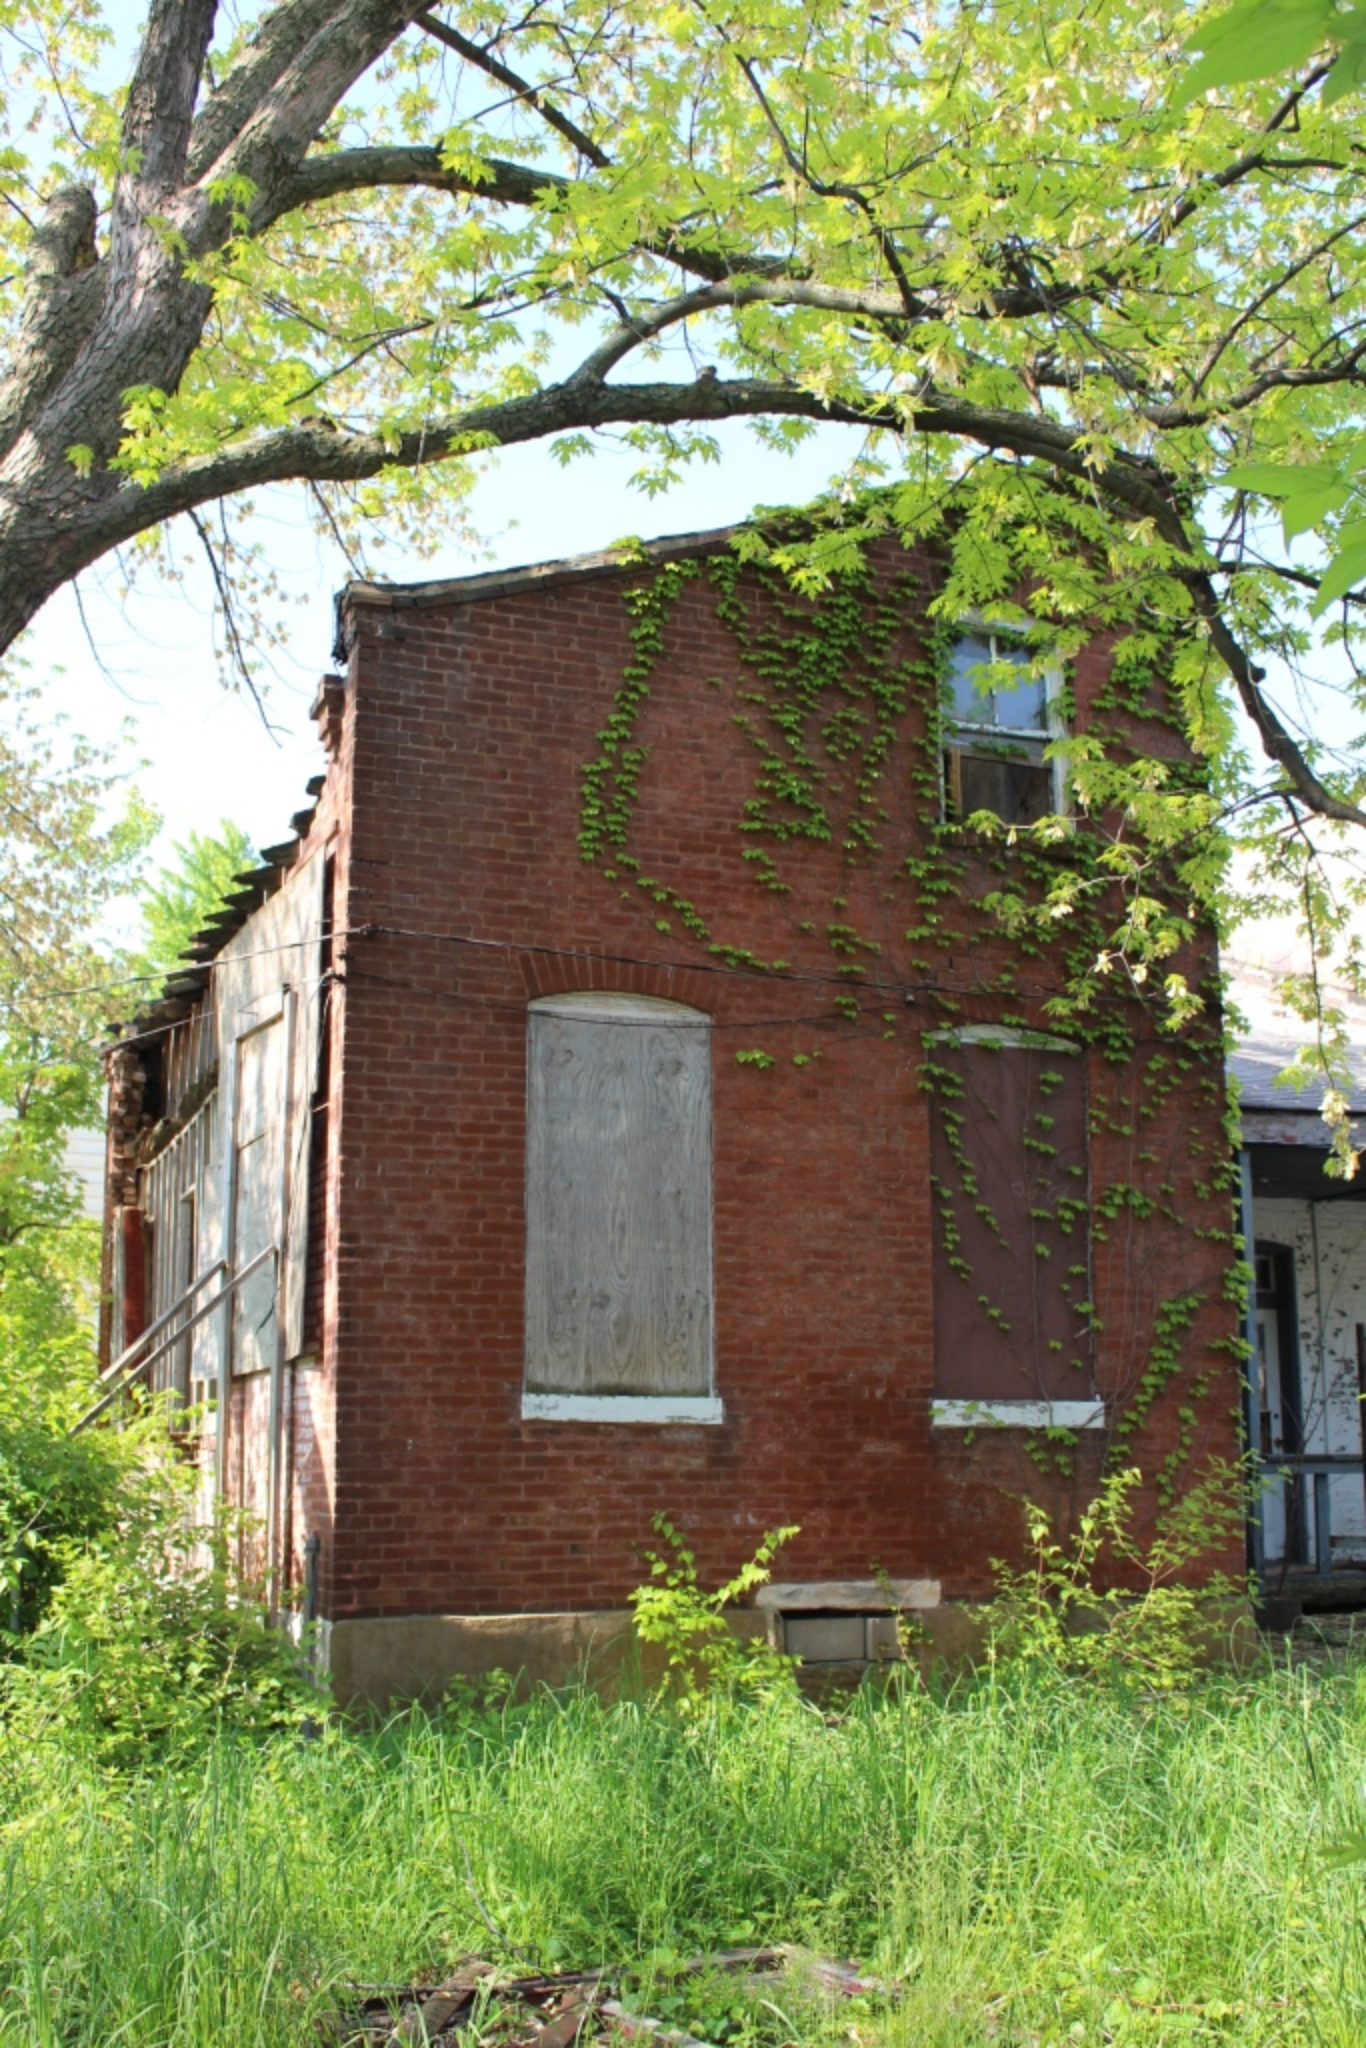
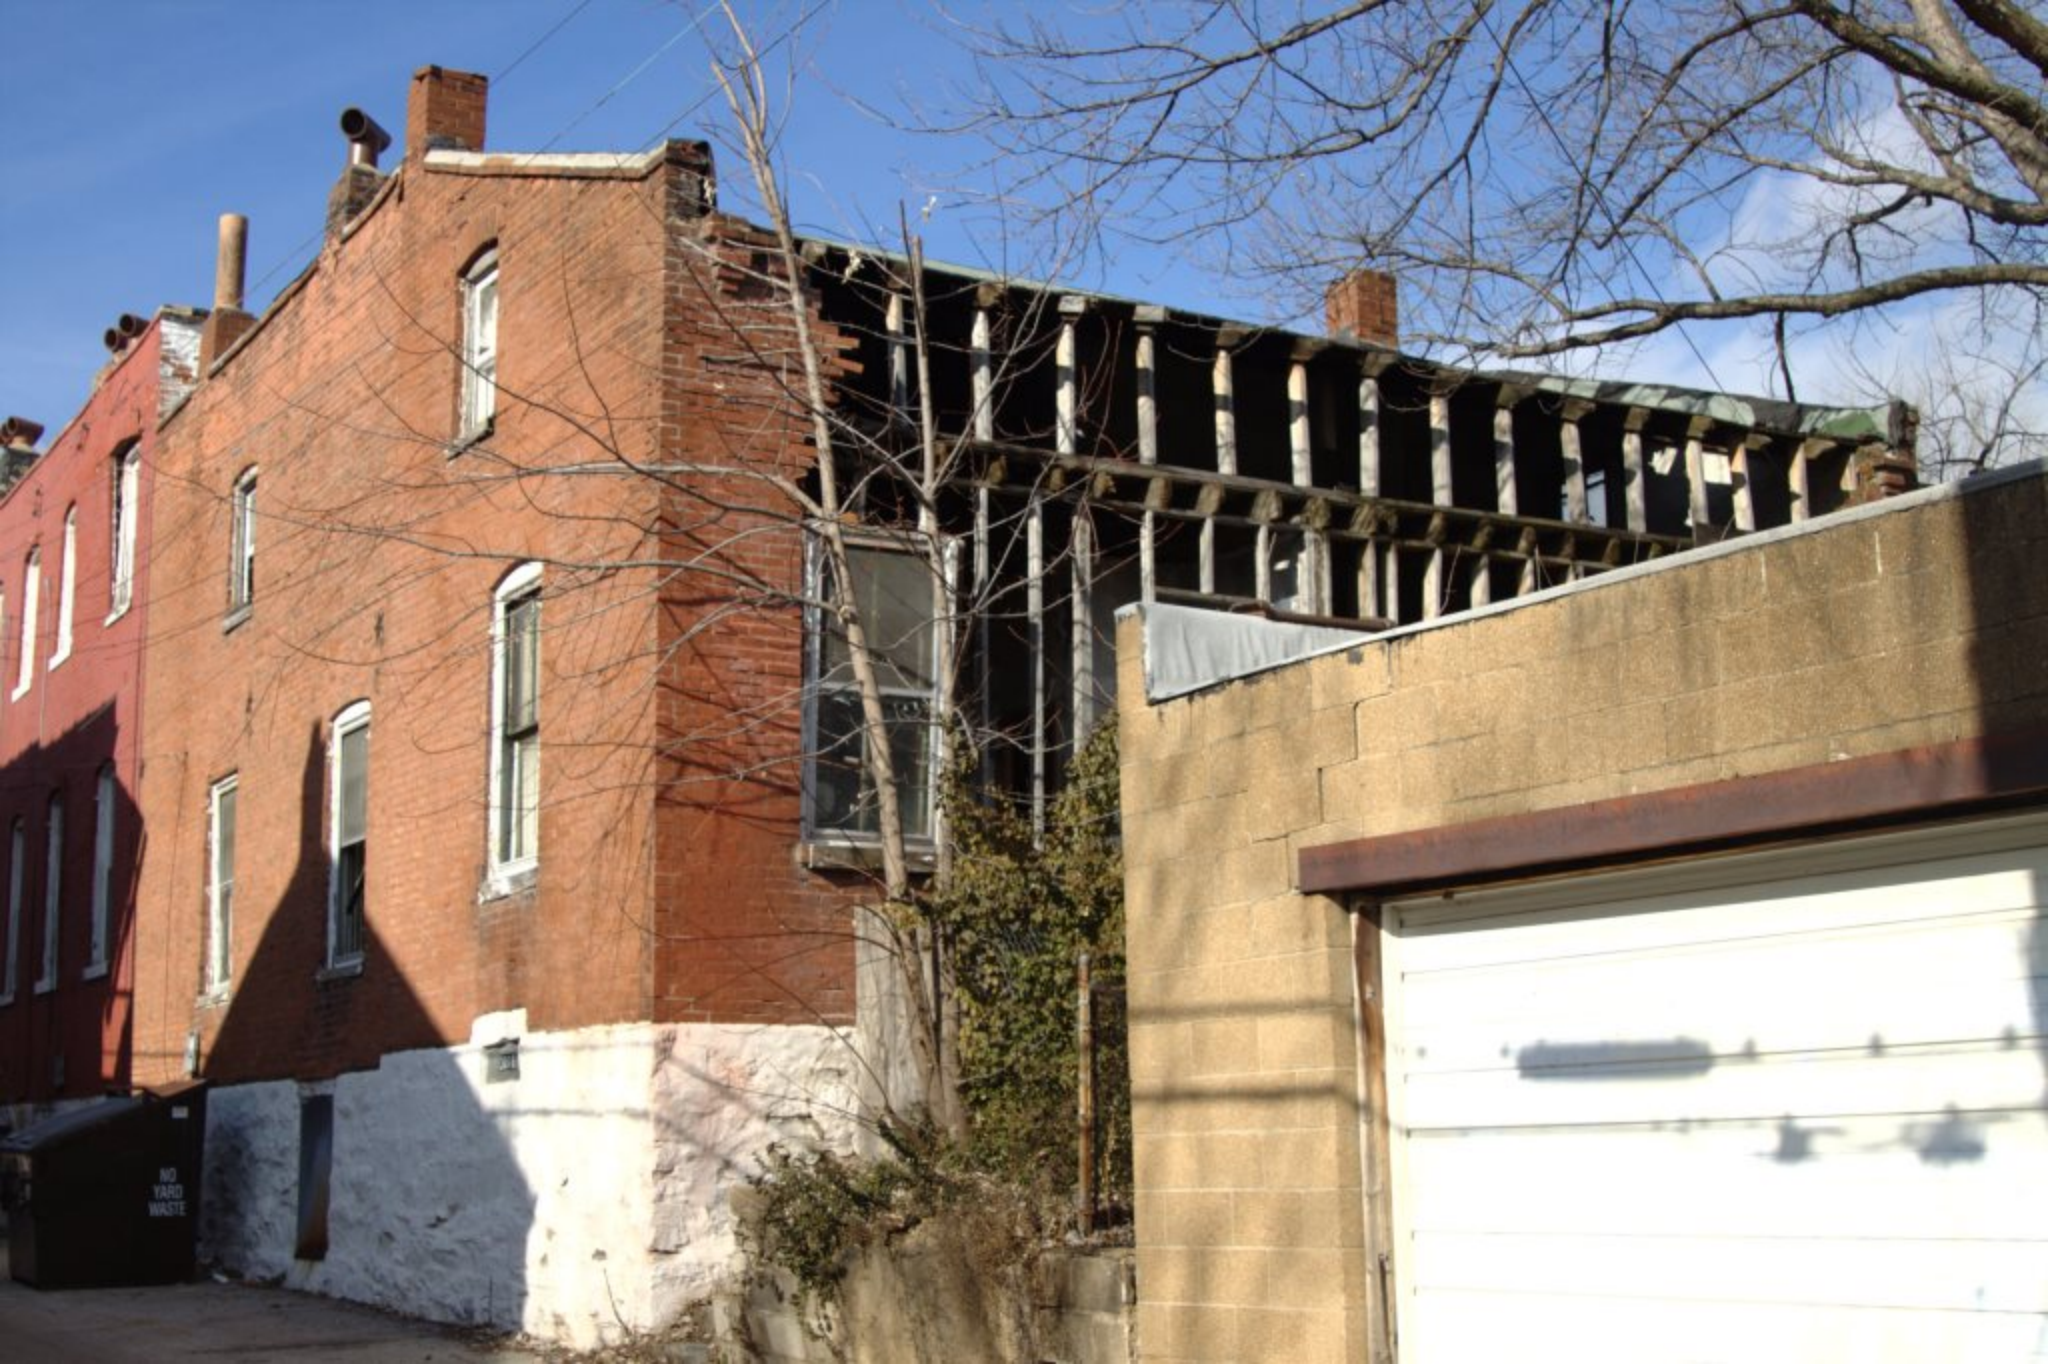
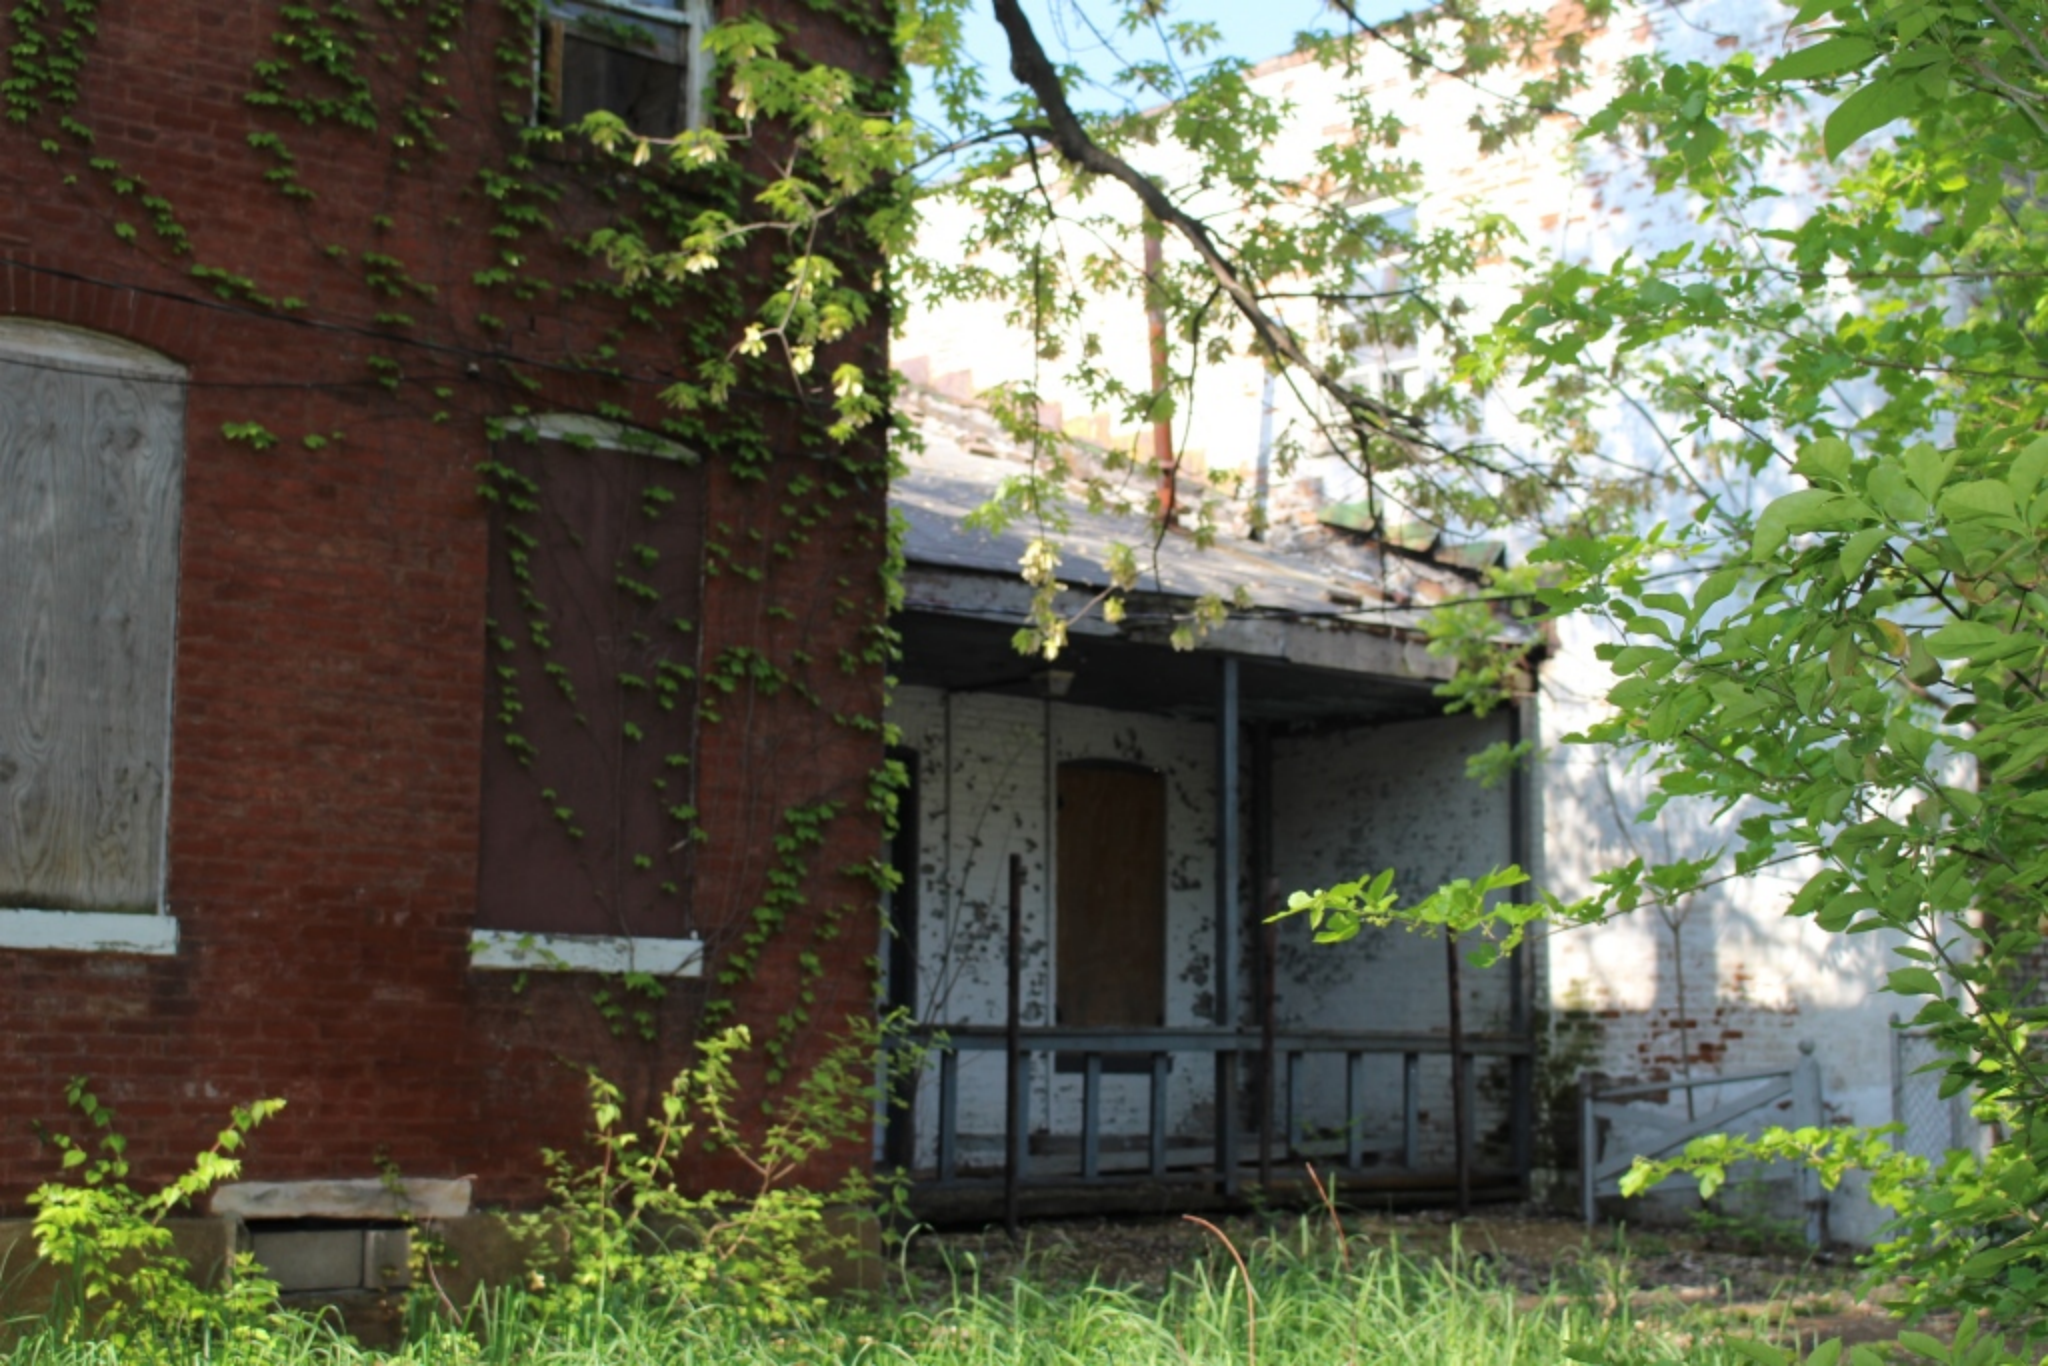
3018 WYOMING ST

This two-story brick flounder is an alley house and there is a front house on the property, as well as one to the west. The foundation is very high at the alley and low at the street-facing façade. There is one bay at the front and rear facades at the main story, and an attic window in both façades as well. The exposed window sash is all 2/2 doublehung wood. The collapse of the brick wall on the east side does not allow the determination of the number of side bays or the location of the entrance. Remnants of corbellig remain at the front and rear of the wall at the eaves. The tall windowless wall rises on the west side, as a party wall in part.

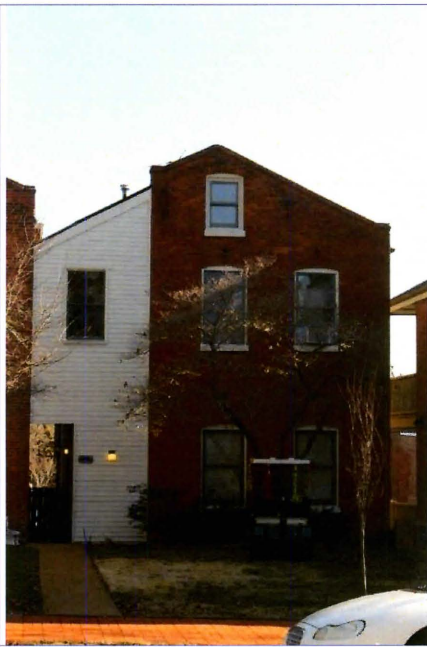
2012 S 11TH ST

Building appears to be in good condition and is well-maintained
