1. Survey No.			2. Survey name:		
JA-AS-091-240		Fairmount Phase I Survey			
3. County:			4. Address (Street No.)	reet No.) Street (name)	
			, , ,	. ,	
JA			104	S. Home Avenue	
5.City: Vicinity:		6. Geographical Reference:		7. Township/Range/Section:	
Independence			39.109917, -94.459124	1	T: 50N R: 32W 32
8.Historic name (if k	nown):	•		9. Present/other	name (if known):
10. Ownership:			11a. Historic use (if know	/n):	11b. Current use:
Private	Public		Domestic		Domestic

21. (cont.) History and significance. Expand box as necessary, or add continuation pages.

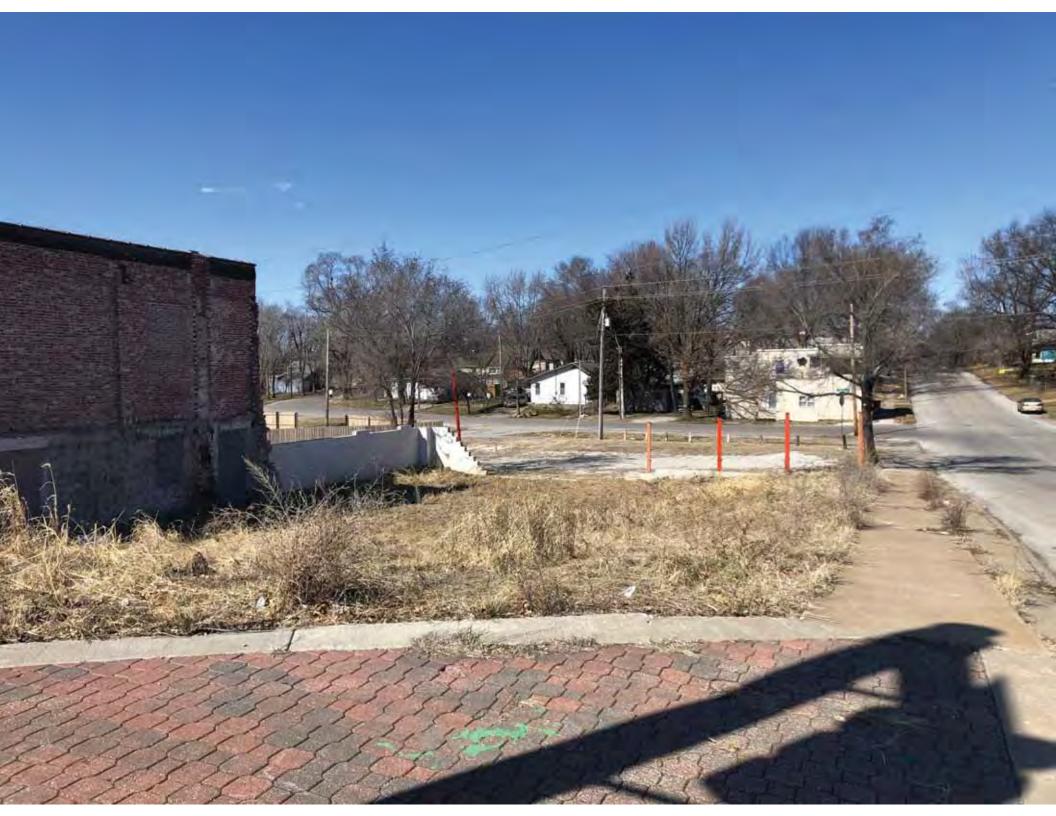
This vacant lot was historically occupied by a stucco and brick, one-part commercial block, demolished in 2017 (as observed on aerial imagery). The building functioned as a bank in 1945 (as depicted on the 1945 Sanborn Map).

Weeds and tall grass cover this corner, rectangular lot. The loss of the twentieth-century commercial building has resulted in a loss of any potential historical significance.

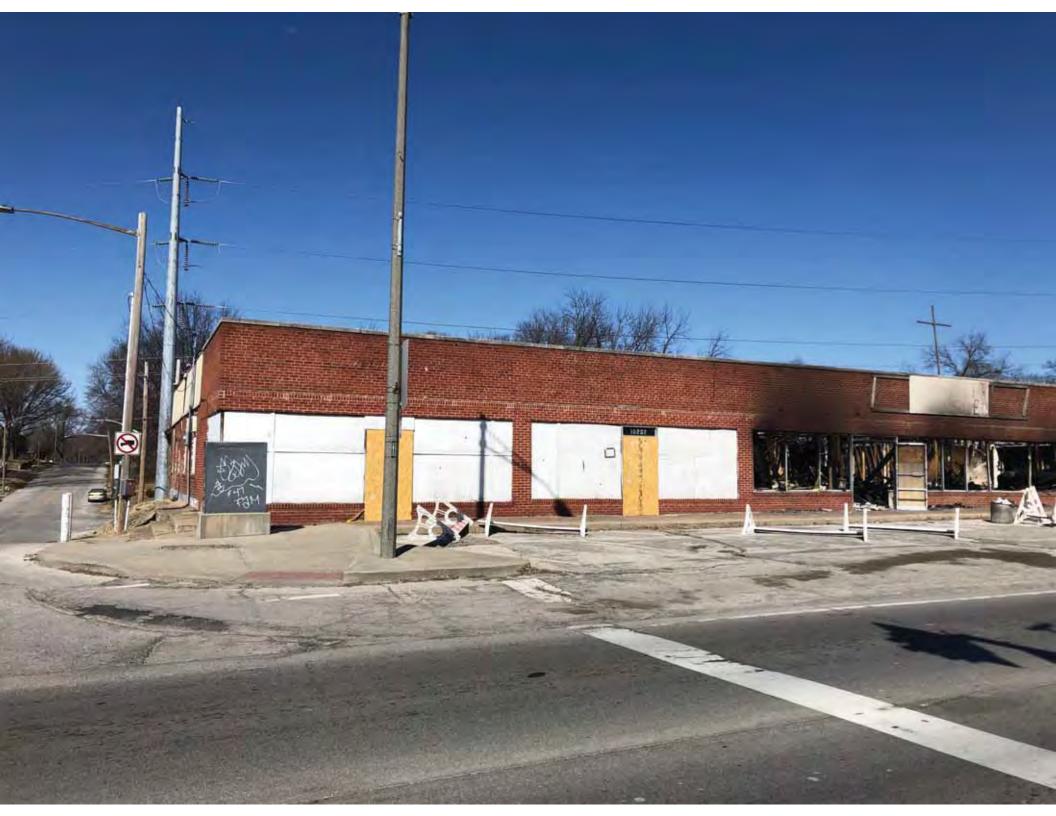
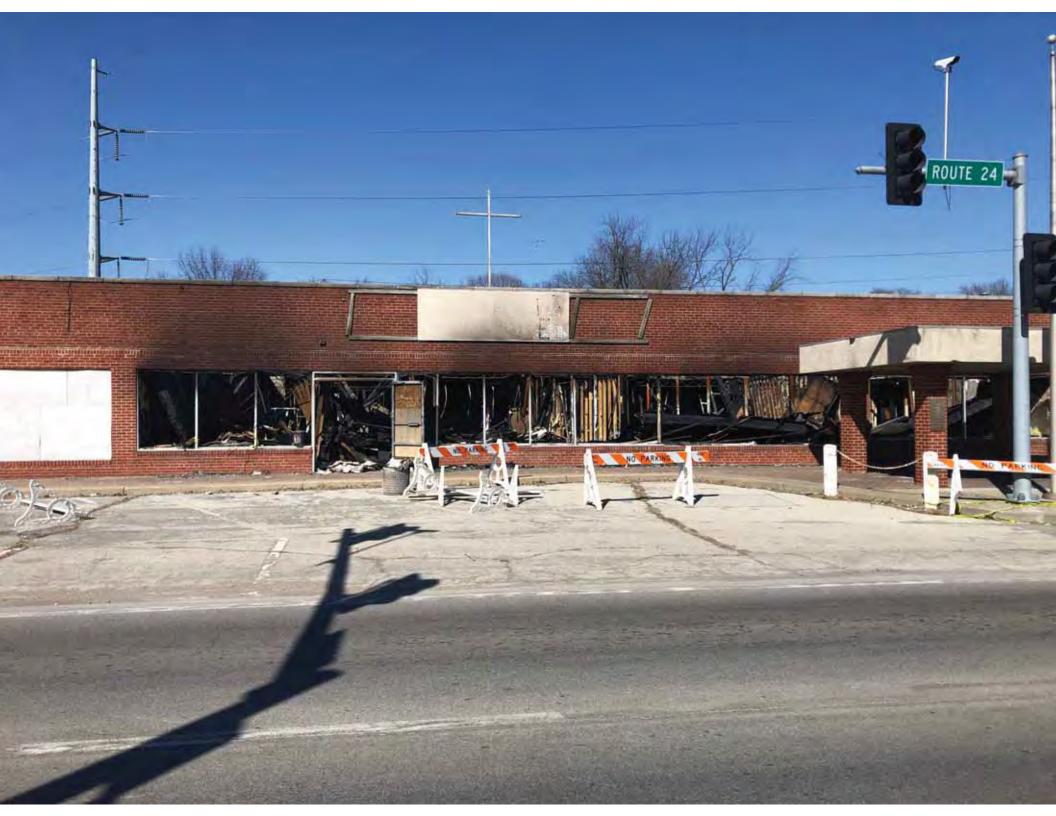
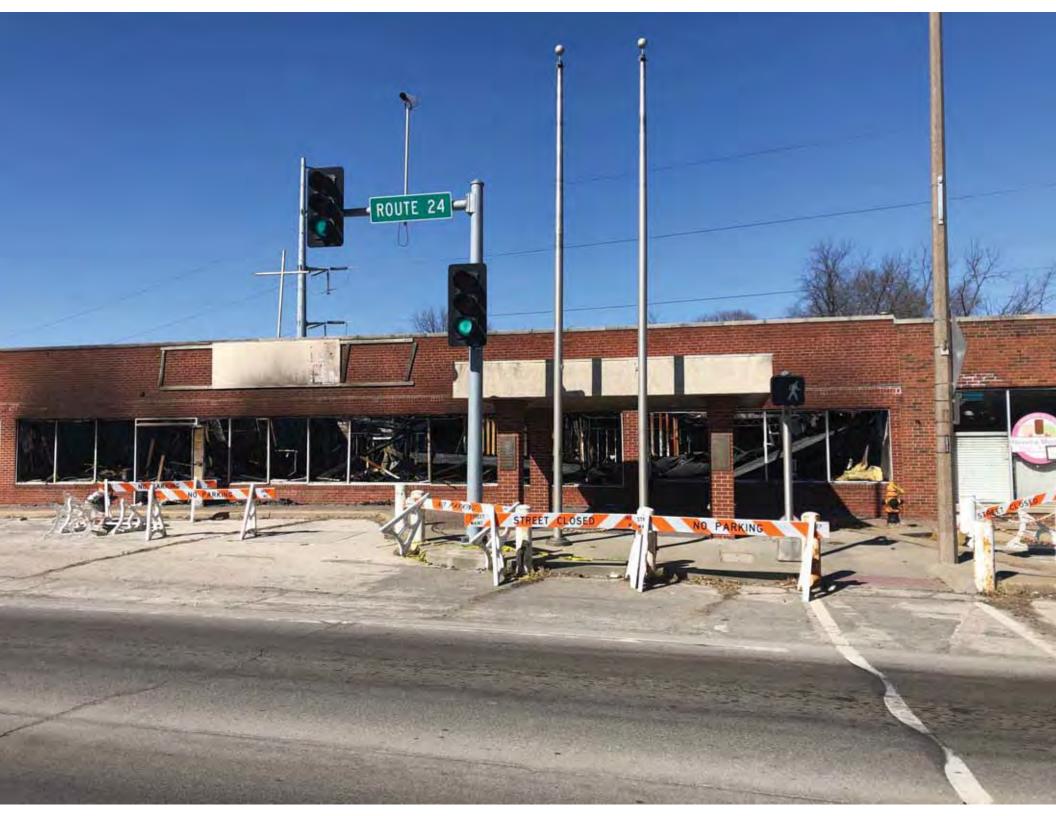
The main façade faces south. This commercial block is comprised of three storefront sections. The easternmost section had been very recently burned, in 2020, at the time of survey. The central and western sections were boarded shut likely due to fire and subsequent water damage . Features of the building, throughout the sections, include a brick exterior laid in common-bond with a Flemish header course every six courses, concrete roof coping, rowblock brick window sills, and a band of header bricks surmounting the main façade fenestration. The westernmost and central storefront sections (10200 and 10202) each feature a central entry flanked by large display windows. Fenestration typically consists of banded metal-frame display windows with a single-leaf entry door placed after the first three windows (west to east). The easternmost portion of this building (10204) has been heavily damaged by fire; the roof has collapsed and all fenestration has been destroyed. The severe burning of the twentieth-century commercial building has resulted in a loss of any potential historical significance.

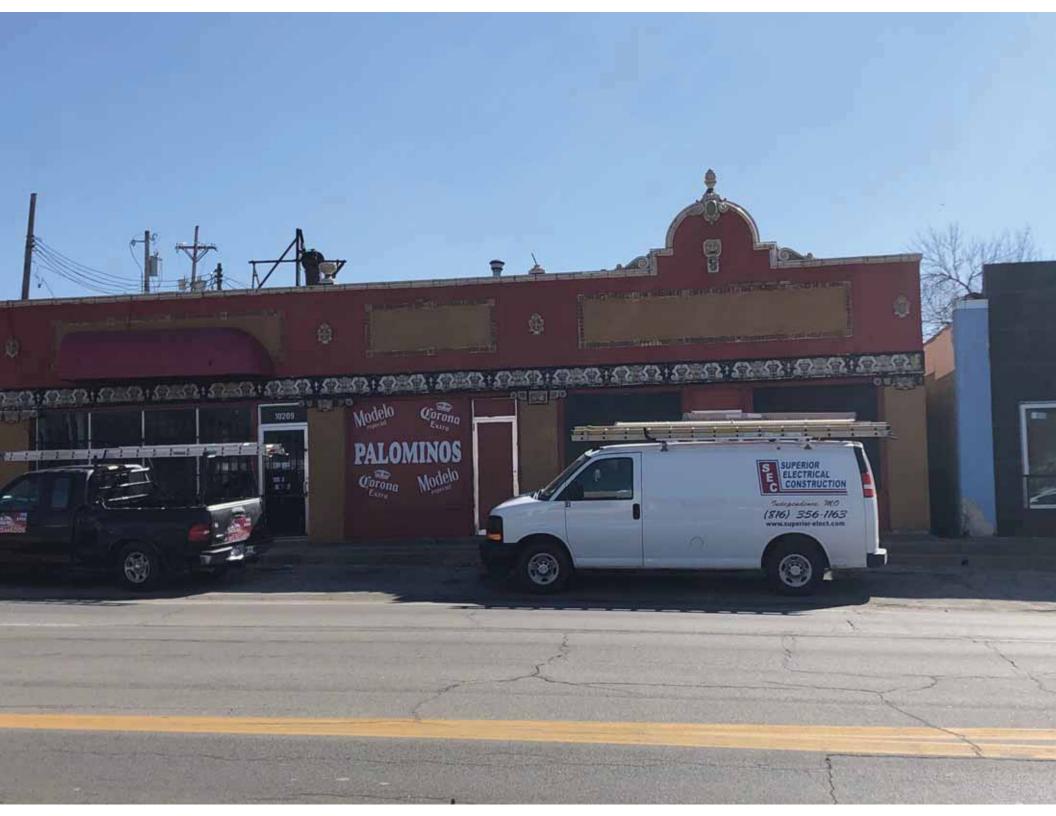
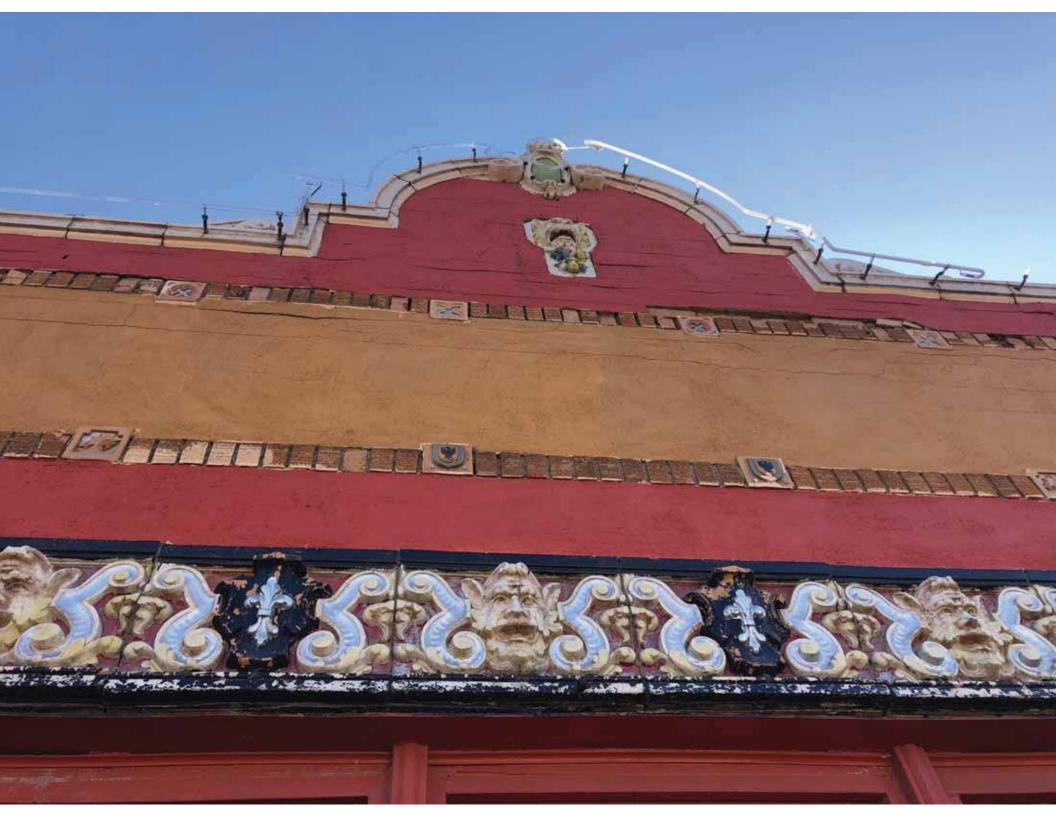
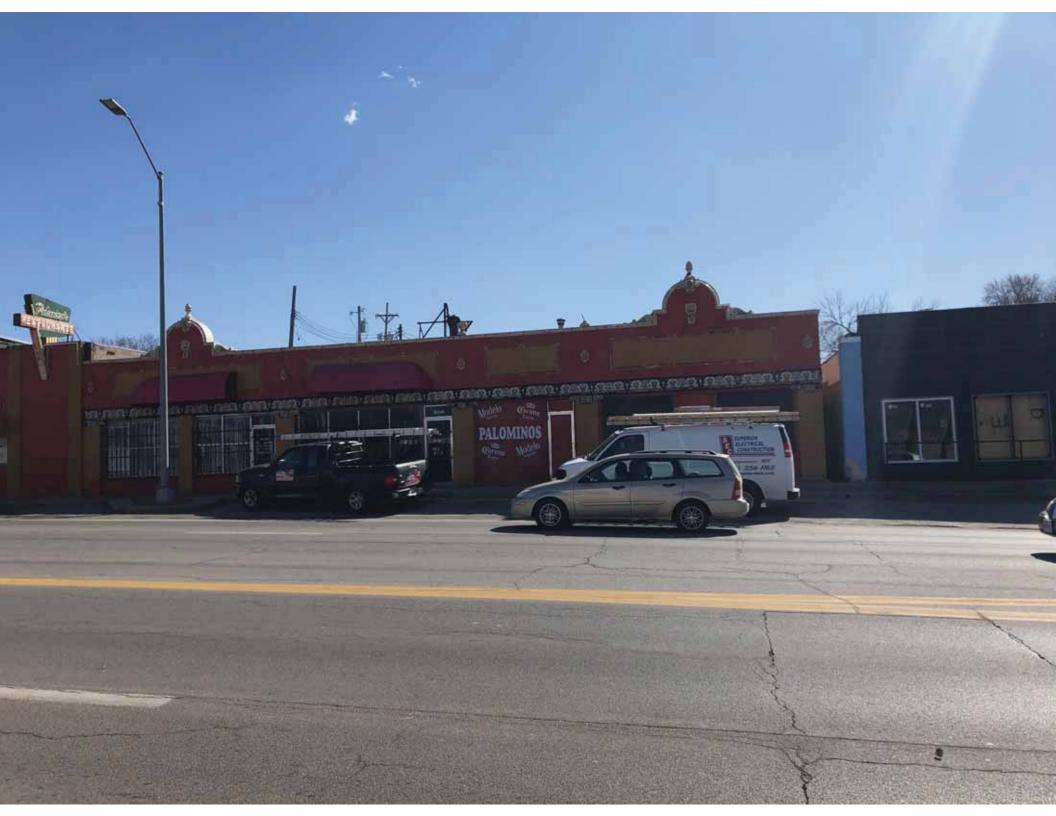
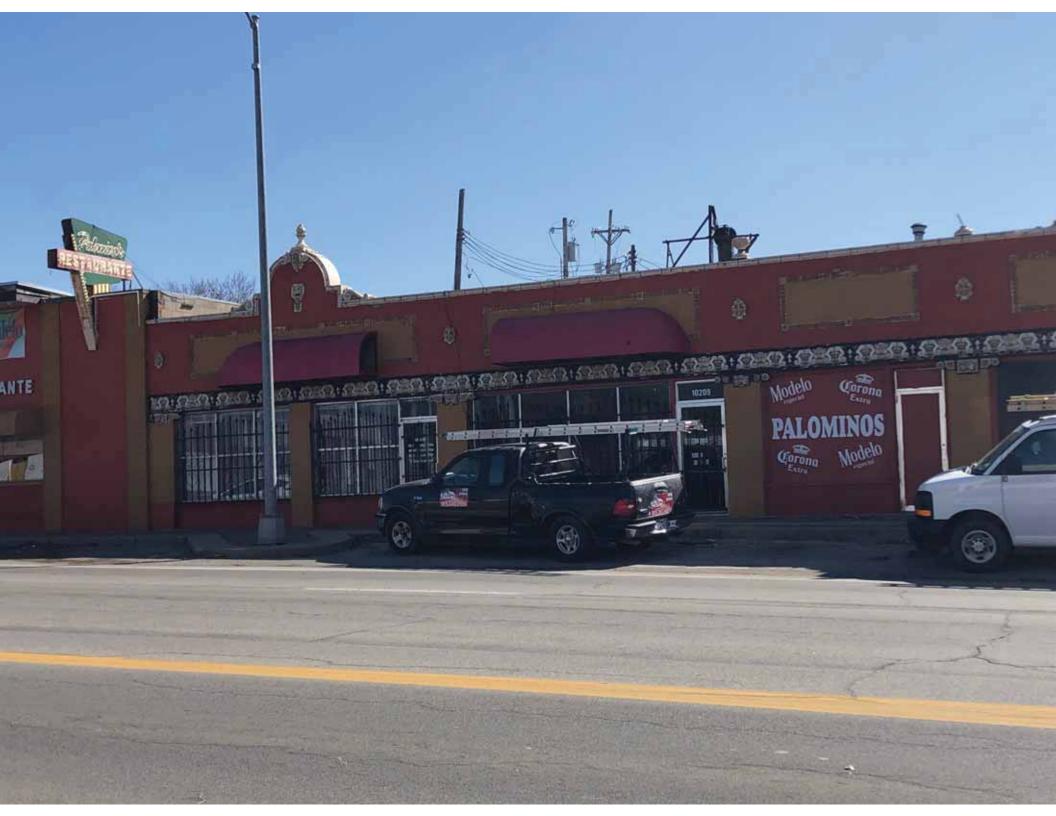
The main façade faces north. This commercial building is characterized by dark red and tan coloring and features two Spanish Colonial Revival Style roof parapets with elaborate stone coping that runs continuously along the roof edge. At the main façade, each bay is separated by brick painted tan and topped with decorative facial motifs of wood and tile material. The far eastern bay contains three one-over-one, metal windows. The second bay (from east to west) contains two one-over-one metal sash windows and a single-leaf metal frame door with transom. The third bay contains four, banded metal frame windows with a single-leaf metal frame entry door with transom. The fourth and fifth bays feature large display windows, painted and boarded shut, as well as single-leaf metal frame doors with transom. A continuous decorative band of facial and fleur de lis motifs surmounts the façade fenestration. Four, tan color blocks, surrounded by header bricks with decorative tiles, are placed in the space between the fenestration and roof parapets. Each block is separated by a small, cross motif (the third block is smaller than the remaining three blocks). Two metal stack chimneys are visible above the roof line.

This building may retain a sufficient level of integrity to be considered eligible for listing in the National Register of Historic Places under Criterion A; however, closures of archival repositories due to the COVID-19 pandemic during the architectural survey limited access to the recourses needed to evaluate its significance. Therefore, a determination of eligibility could not be made.

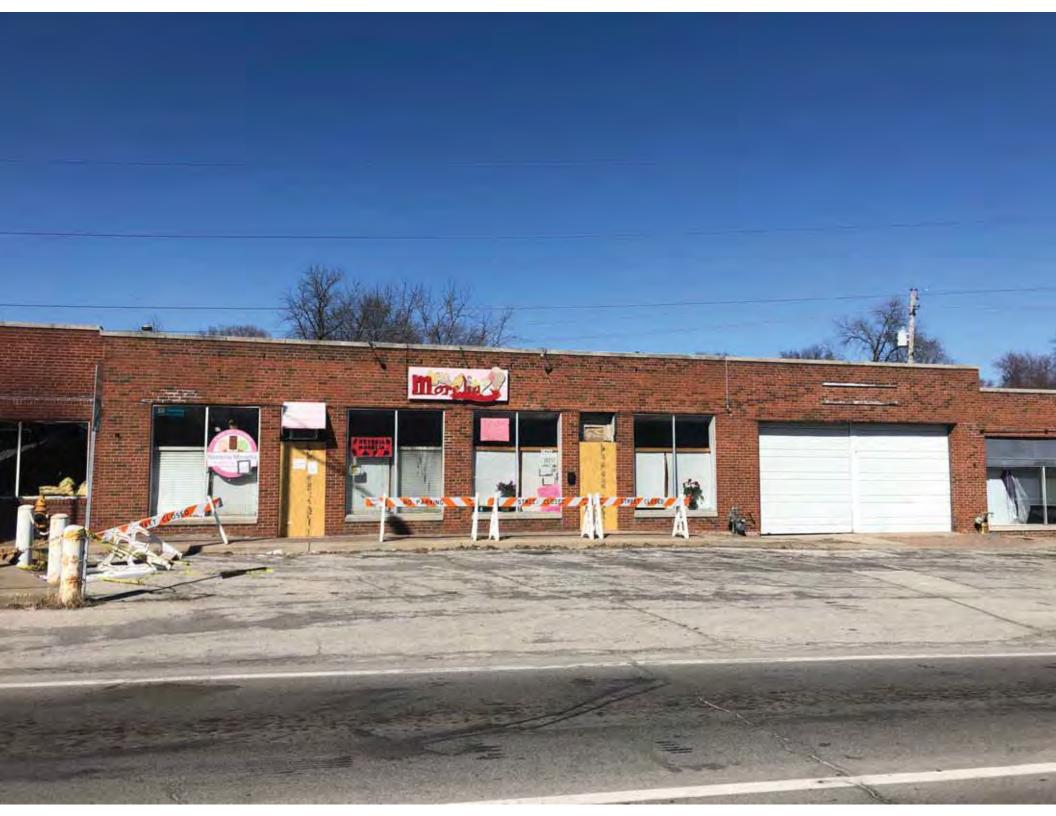
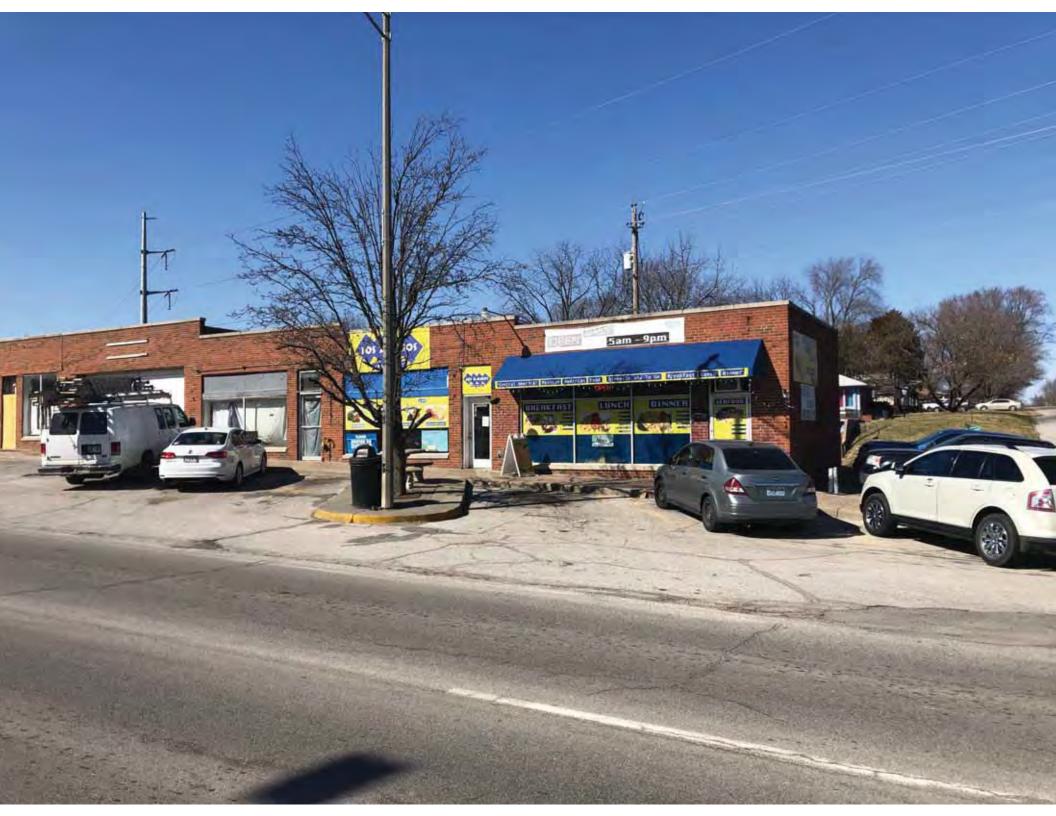
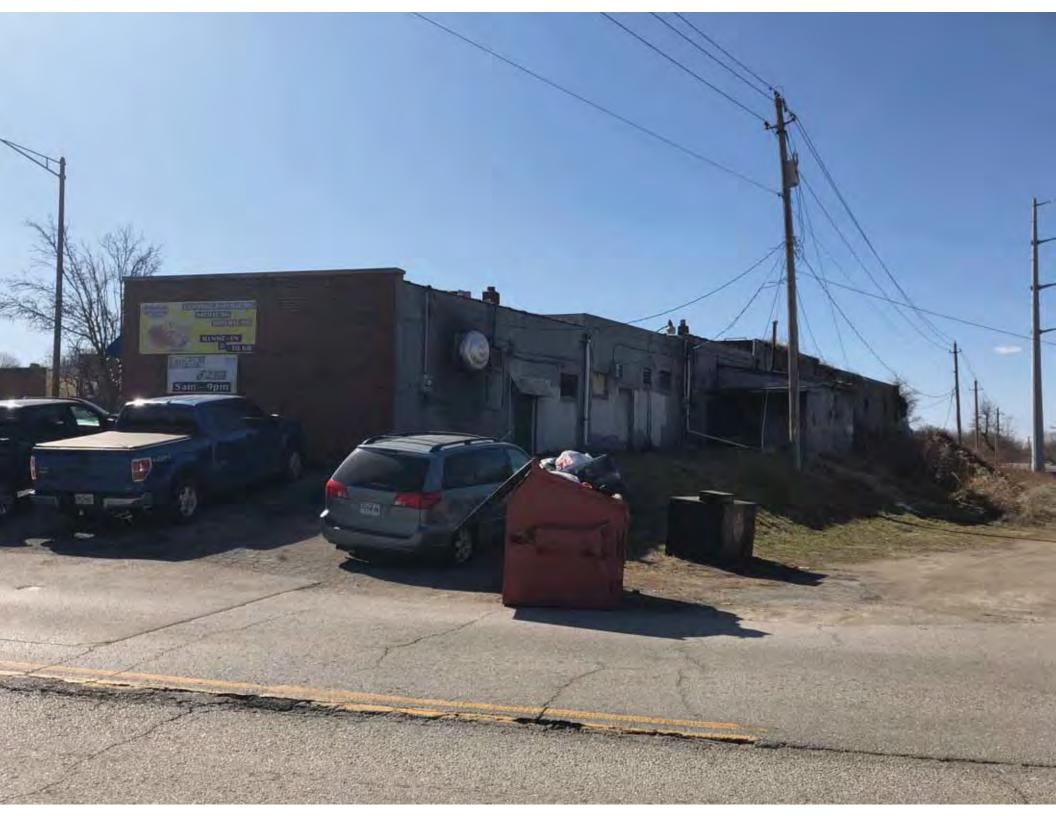
The main façade faces south. This commercial building features four sections, featuring a dropped roofline at each new section moving west to east. Features throughout all sections include a brick exterior laid in common-bond with a Flemish header course every six courses, concrete window sills, and concrete roof coping. The first section (10212) contains two retail storefronts and a two-bay overhead garage door. Each storefront consists of a central single-leaf entry door (boarded shut at the time of survey) flanked by paired, metal frame display windows. The entry doors appear to feature square transom windows, also boarded shut at the time of survey. The two-bay wide garage door is placed east of the two storefronts. The second section (10218) contains a single retail storefront featuring a single-leaf, full-glass entry door with transom placed east of a two-part, metal frame display window with full transom. The third section (10220) contains a single retail storefront featuring a single-leaf, full-glass entry door with transom placed east of a two-part, metal frame display window with full transom (painted blue). The fourth section (10222) contains a single retail storefront featuring a single-leaf, full-glass entry door with transom placed east of a tripartite, metal frame display window with full transom. A canvas awning covers this display window. This building is a common example of its type that lacks distinction and therefore historical significance.

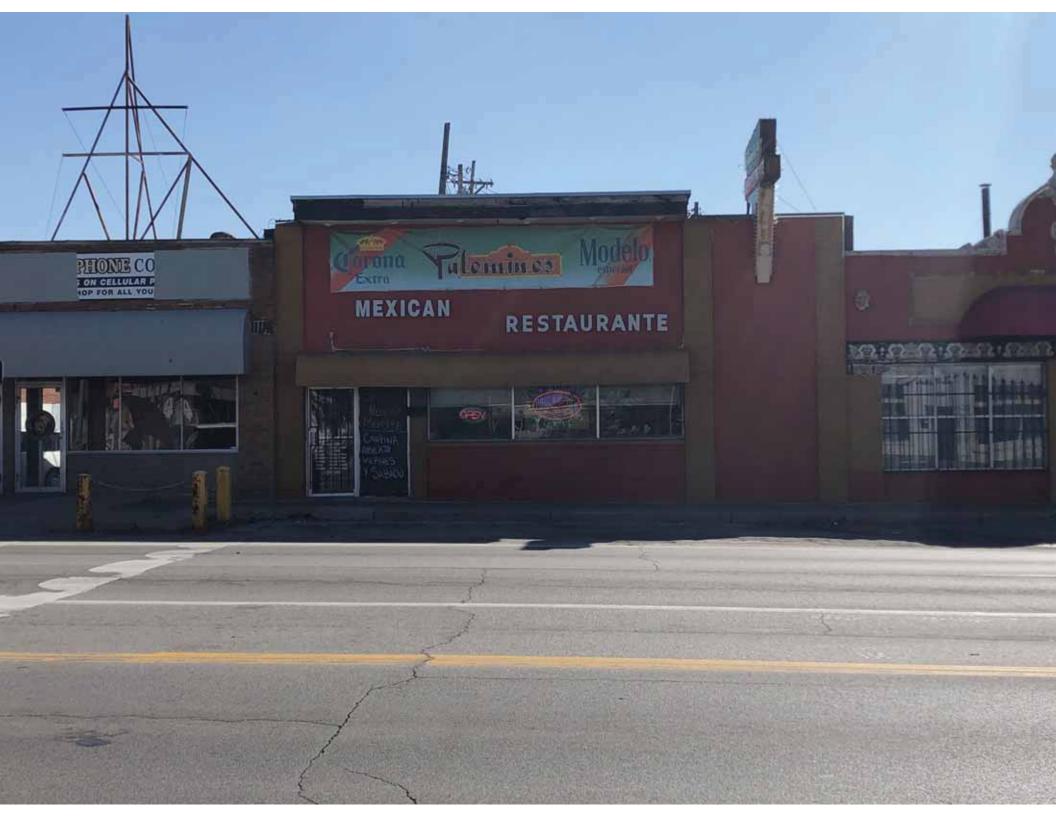
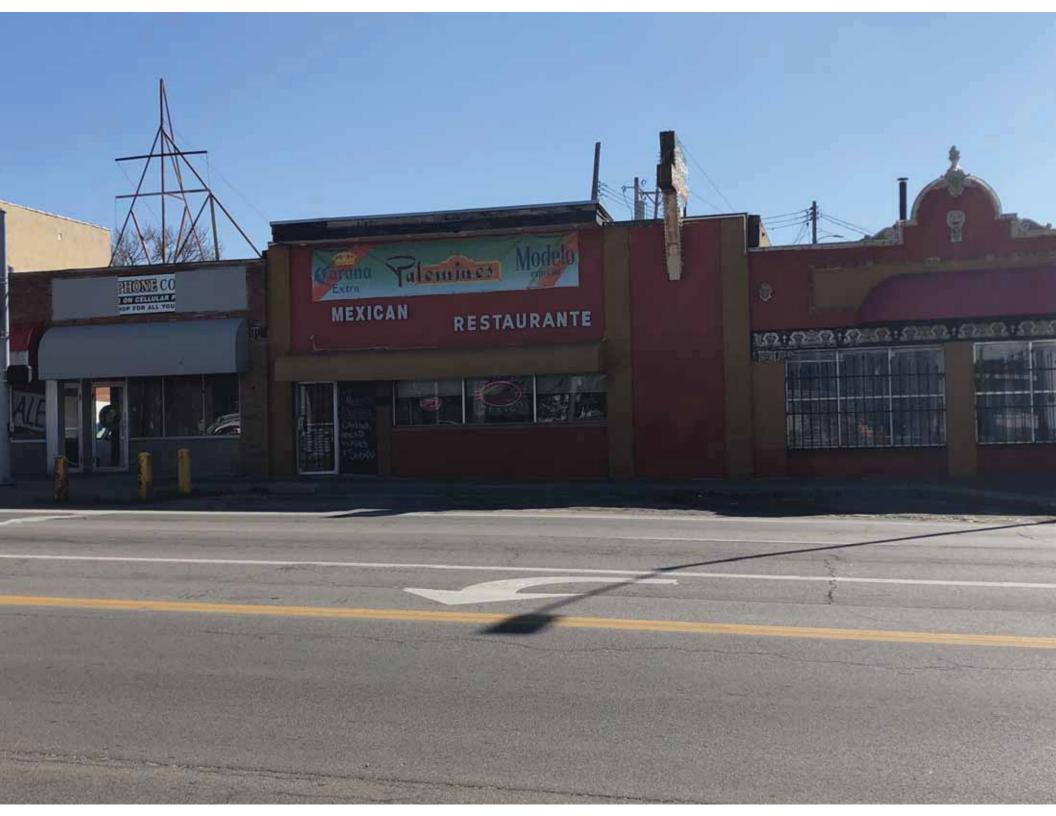
The main façade faces north. This commercial block is characterized by dark red and tan coloring matching those of the westernadjacent building (10203-10211). It appears this building was constructed c. 1950 to accompany the c. 1915, Spanish Colonial Revival style building next door; however, it does not features the same decorative detailing. A single-leaf, metal-frame entry door is placed at the east bay withthree, metal-frame windows placed in the central bay. The far western bay lacks fenestration. Additional features include a mounted, neon sign straddling the ridge line at the western bay, an extended roof overhang featuring recessed lighting, and a window awning sheltering the eastern and central bays. This building is a common example of its type that lacks distinction and therefore historical significance.

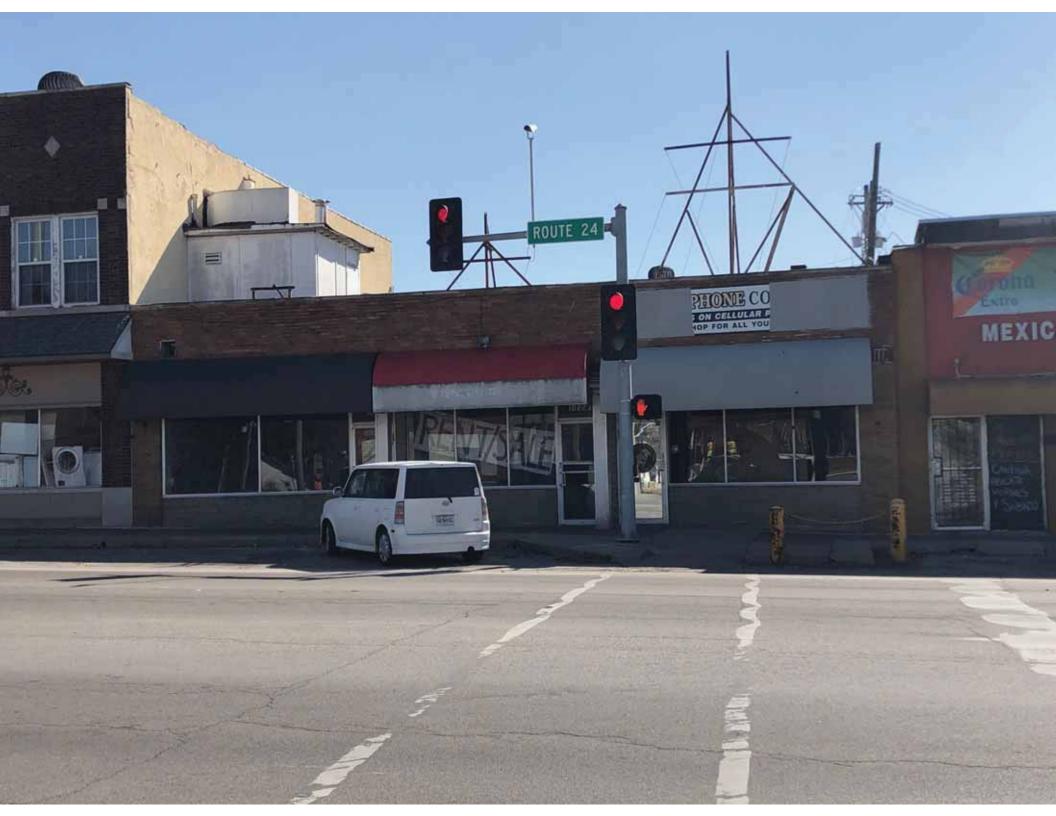
The main façade faces north. This brick-clad commercial block is comprised of three storefronts each occupying one bay of the building (all three appeared vacant at the time of survey). The brick is laid in a common bond with a Flemish header course every six courses. The east storefront features a single-leaf, full-glass, metal entry door with transom placed west of two aluminum frame display windows. The central storefront features a single-leaf, full-glass, metal entry door with transom placed west of three aluminum frame display windows. The west storefront mirrors the middle bay configuration. The central bay is recessed forming angled storefronts on either side. Additional features include stone facing below each window bay and two free-standing wood columns set in front of the central storefront; these columns originally may have supported a roof feature. This building is a common example of its type that lacks distinction and therefore historical significance.

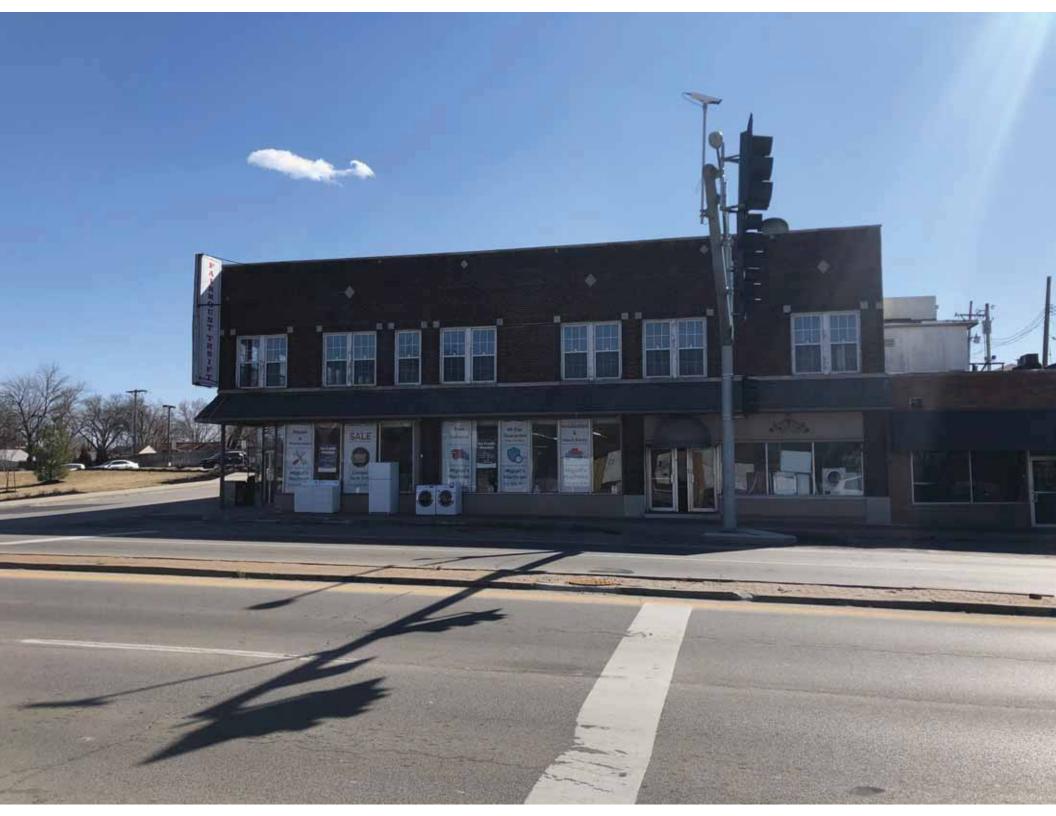
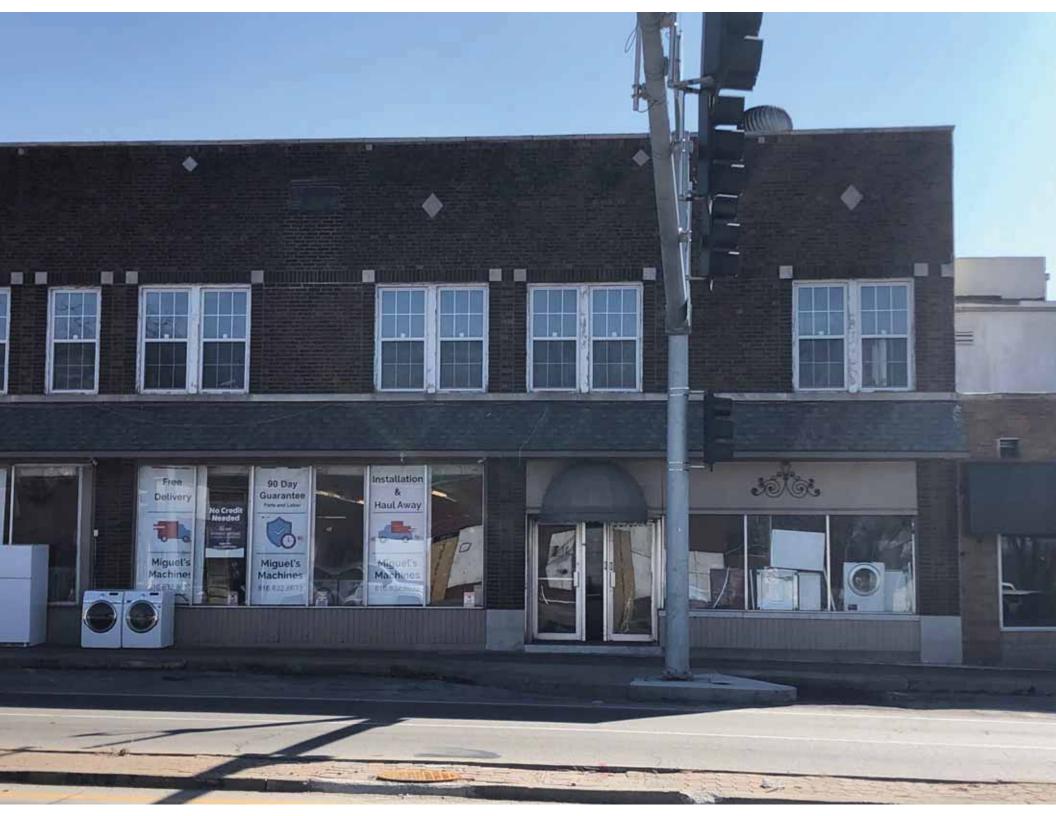
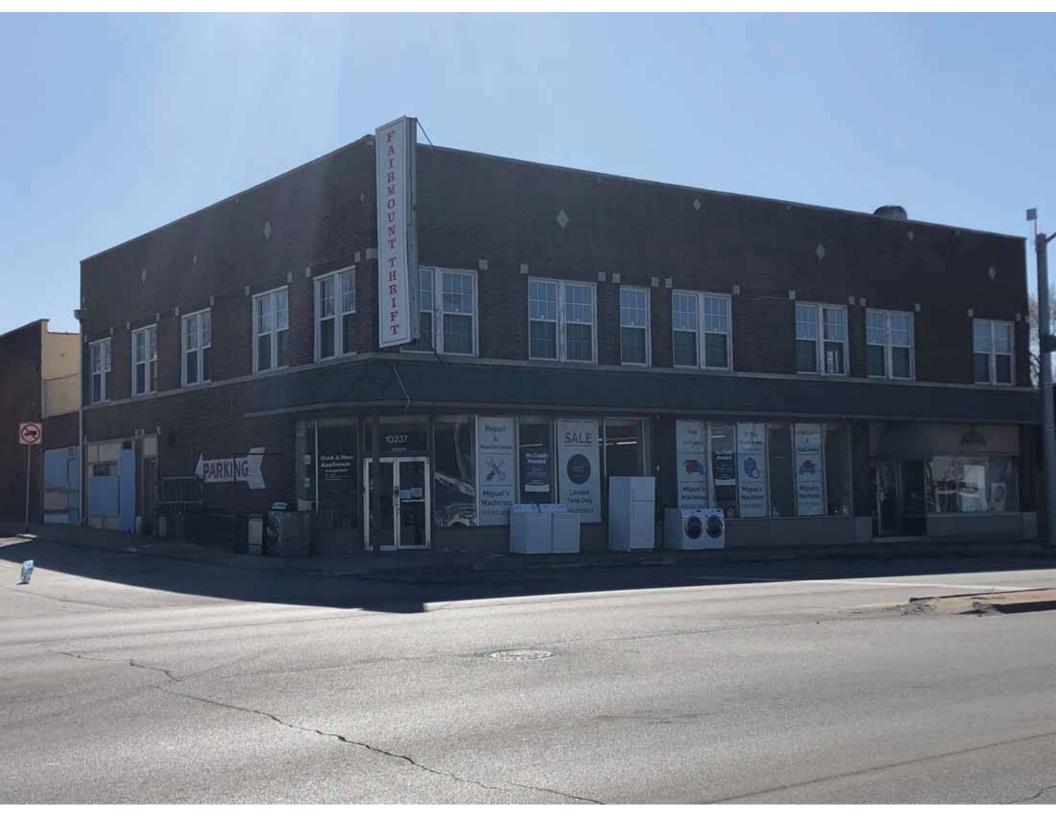
The main façade faces north. This commercial building features a canted entry at its northeast corner and secondary storefronts at the far western bay of the main façade and far southern bay of the east façade. The storefront at the western bay of the main façade appeared vacant at the time of survey; it features two single-leaf, full glass metal entry doors placed east of three large display windows. The corner store, occupied by Miguel's Machines, features two bays of tall and narrow metal-frame window openings at the main façade . The storefront at the far southern bay of the eastern façade features two single-leaf metal entry doors placed north of paired display windows with wood framing. This storefront is clad in vertical wood planking with wide trim. All first story windows are set above vertical beadboard skirting. A continuous pent roof, clad in asphalt shingles, is supported at the corner entry with single metal pole and separates the first and second stories. The second story, characterized by brick laid in a common bond (with 4+ course of Flemish headers) features paired and single sets of six-over-six vinyl sash windows at both façade s. Each window opening is surrounded by bands of stretcher bricks and features square tiles at the upper corners (detailing also seen at the east façade storefront). Additional features include a stone belt course set just under the second story windows and diamond-shaped insets of varying sizes above the second story windows.

This building may retain a sufficient level of integrity to be considered eligible for listing in the National Register of Historic Places under Criteria A and C; however, closures of archival repositories due to the COVID-19 pandemic during the architectural survey limited access to the recourses needed to evaluate its significance. Therefore, a determination of eligibility could not be made.

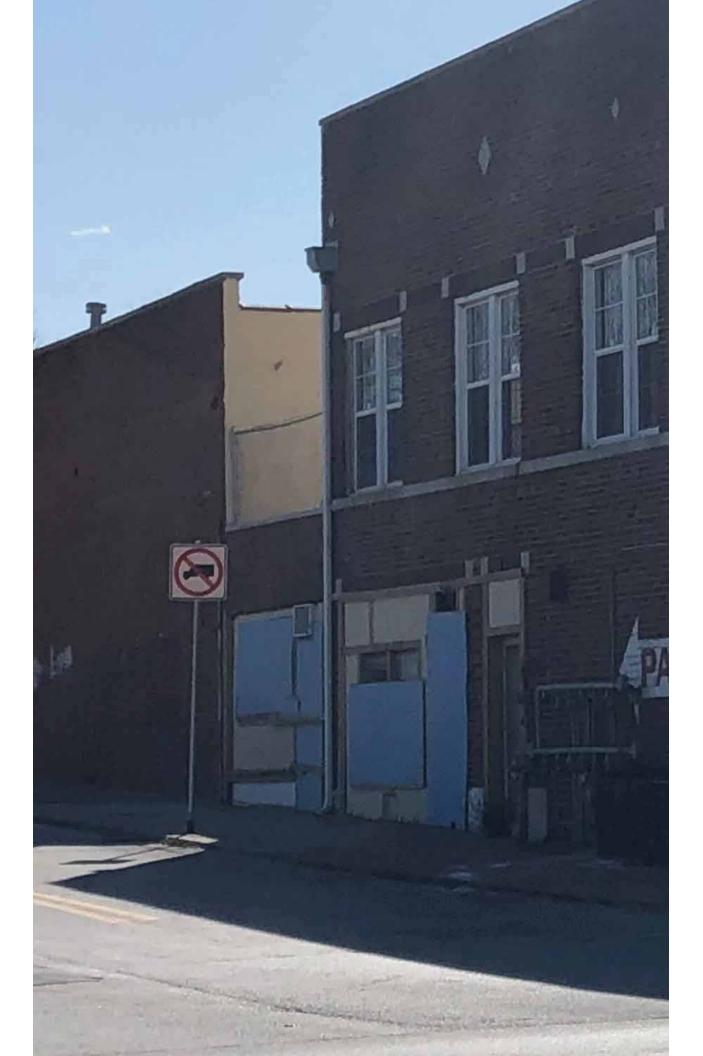
The main façade faces east. This narrow, single-story, storefront building is appended to the rear façade of the corner store at 10227-10237 E. Independence Avenue. The main façade features a single-leaf, full-glass entry door with transom placed north of a paired storefront windows with wide wood surround. The façade was boarded shut at the time of survey. The brick is laid in common bond with a Flemish header course every six courses. The roof features concrete coping topped with a chain-link fence spanning the space between the adjacent buildings. Due to loss of original materials and other alterations, this building lacks sufficient integrity of design, materials and workmanship to be considered eligible for listing in the NRHP.

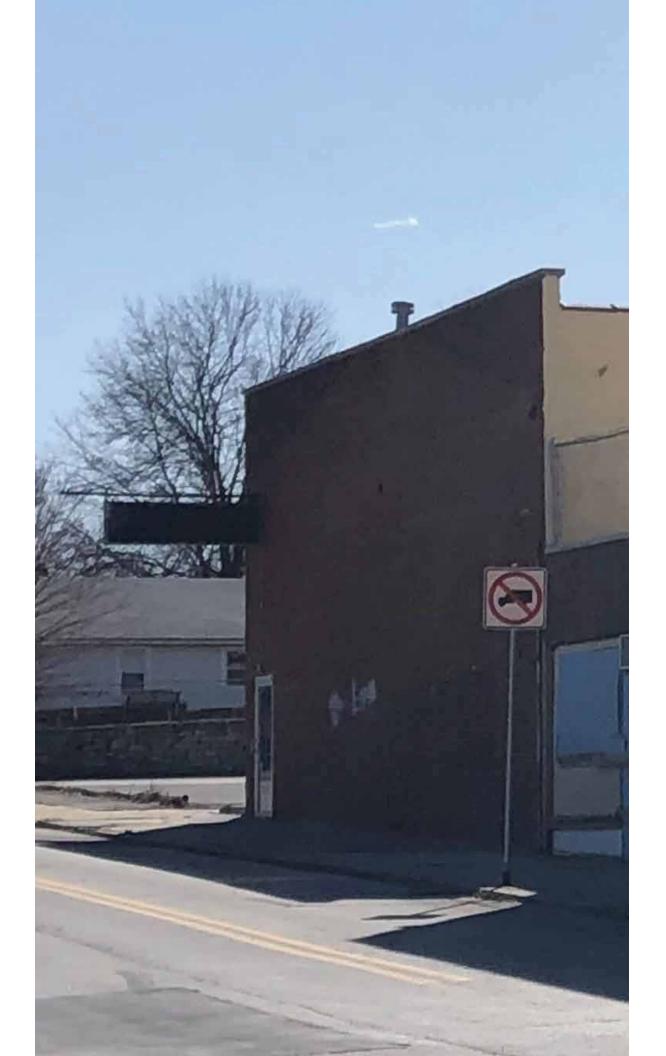
The main façade faces east. This commercial building features a wide main façade containing single entry door at its far southern bay; two openings located at the northern bays have been infilled with brick. The main façade also features an extended front wall with concrete coping. Sections of brick near the roof edge appear to have been replaced at an unknown date. The secondary façade features a brief stepped roof and stucco-faced brick walls. A shed roof, concrete block addition was appended to the western bay of the south façade at an unknown date. Due to loss of original materials and other alterations, this building lacks sufficient integrity of design, materials and workmanship to be considered eligible for listing in the NRHP.

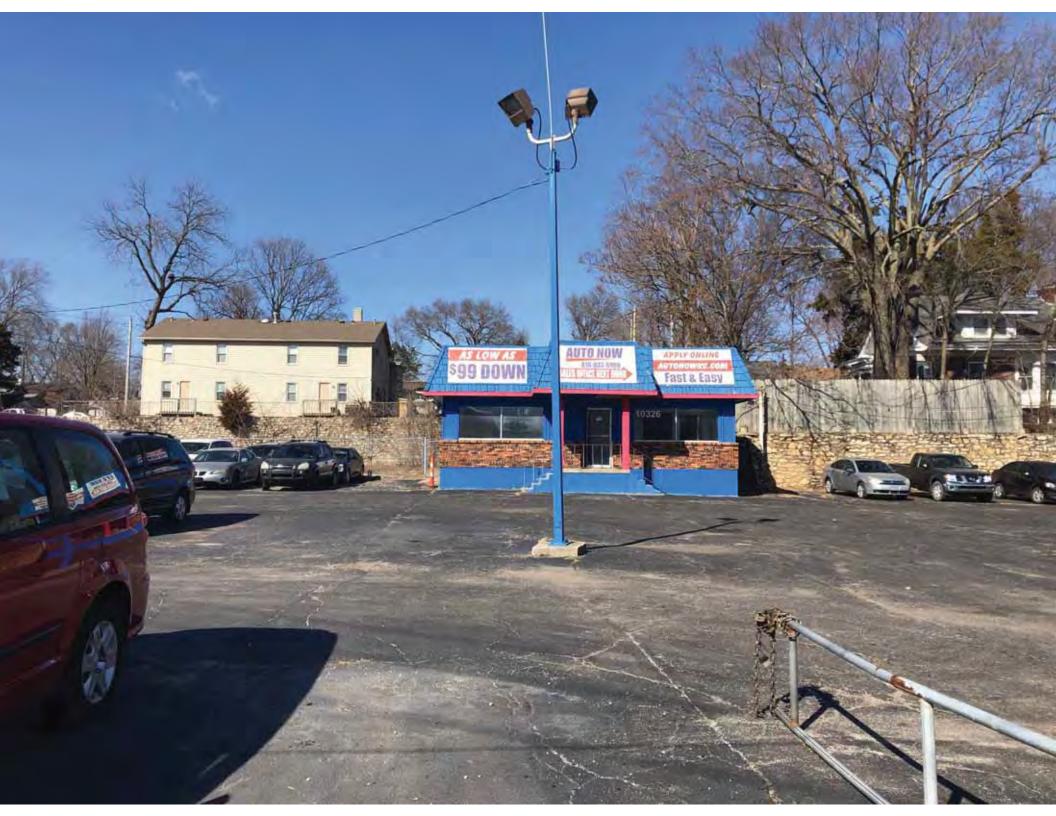
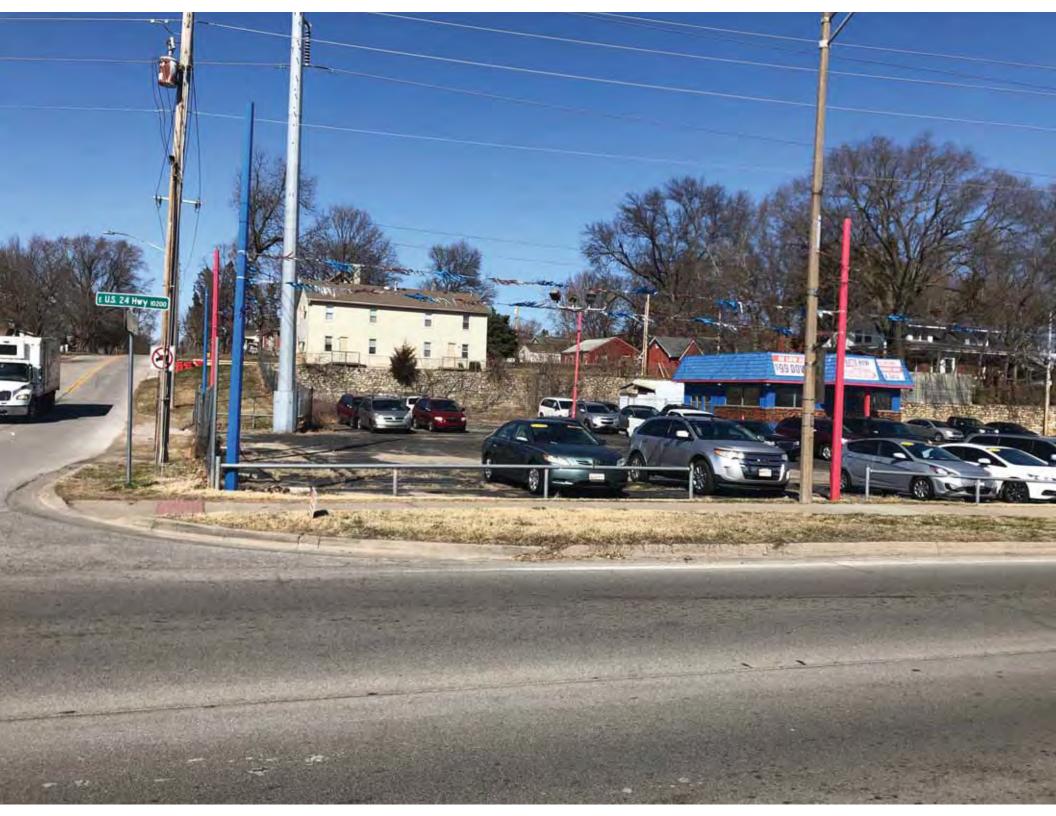
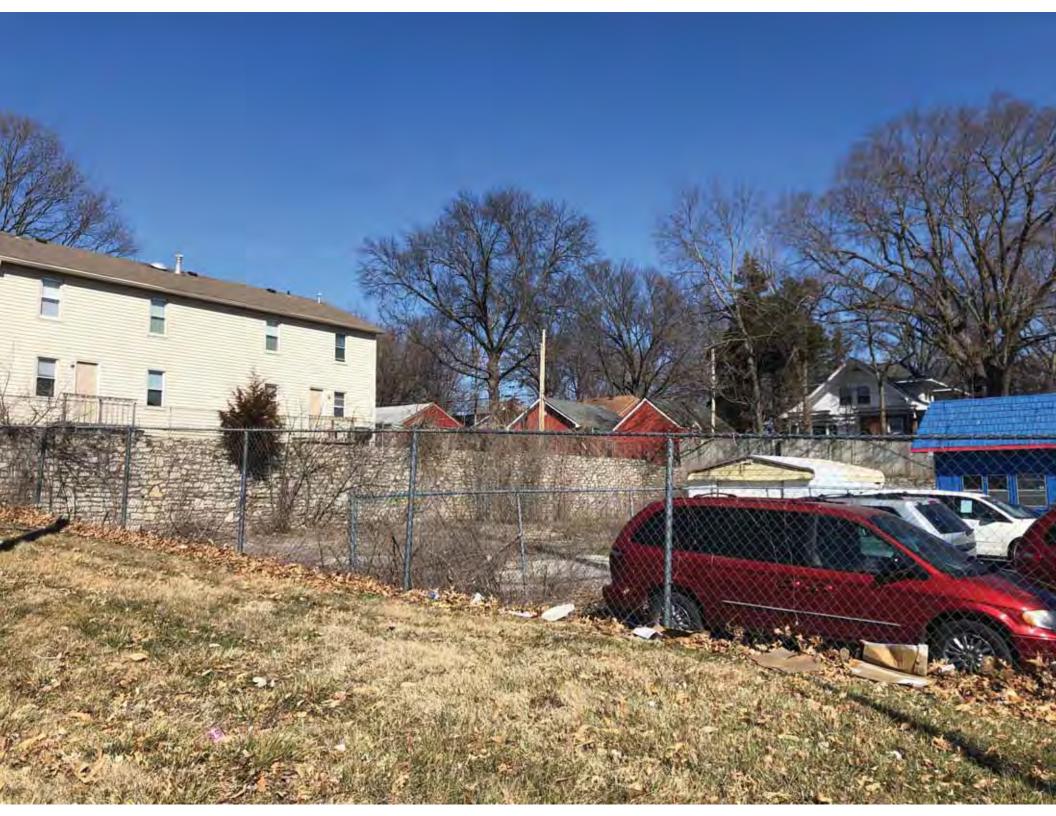
The main façade faces south. This single-story commercial building features a front-facing T-Plan with a projecting, central entry porch. The porch features two square posts with a double sided concrete staircase. The false mansard roof is clad in painted wood shakes. A central, full-glass entry door is flanked by fixed pane, aluminum framed windows with a single division; these windows repeat at the southern bays of the secondary façades. Fenestration at the west façade includes one-over-one aluminum sash units. Additional features include a band of brick facing at the lower third of each façade. This building was constructed less than 50 years ago and therefore does not meet the age requirement for NRHP evaluation. Additionally, this building does not possess exceptional significance under Criteria Consideration G for properties less than 50 years in age.

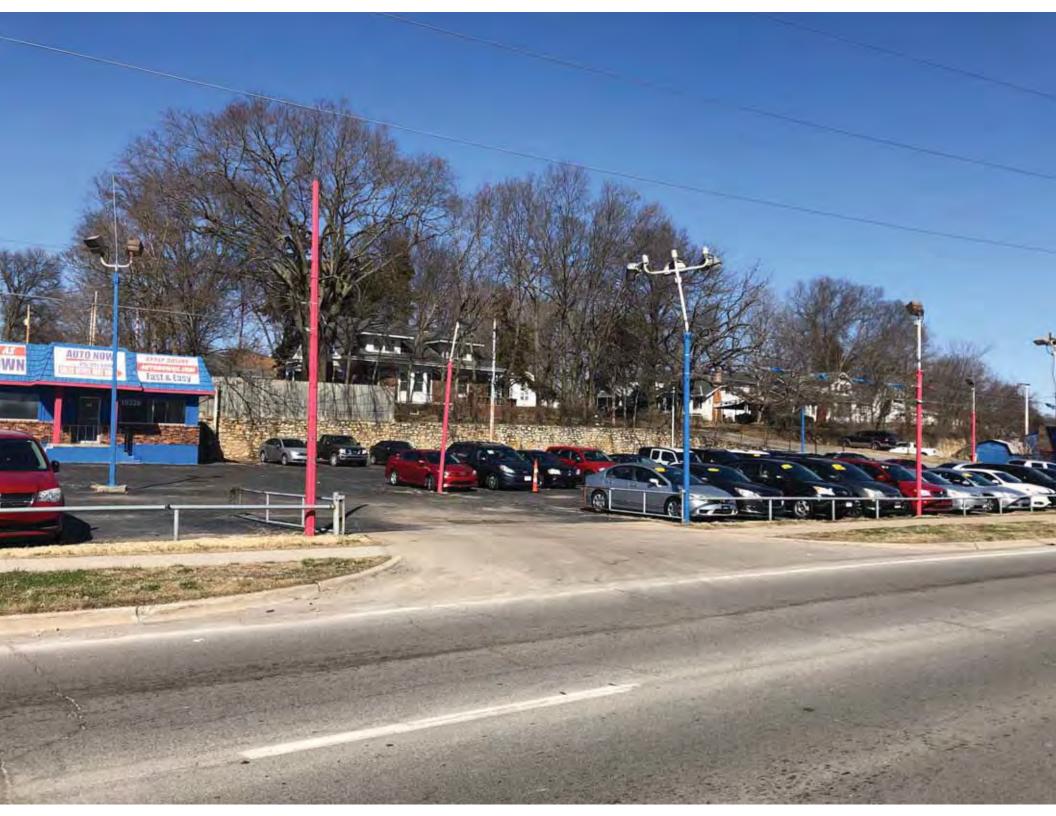
This is a flat parking lot paved with asphalt and associated with the adjacent commercial property to the west (JA-AS-091-350). This lot does not appears to convey any significant historical associations.
