1. Survey No.			2. Survey name:		
JA-AS-091-240		Fairmount Phase I Survey			
3. County:			4. Address (Street No.)	reet No.) Street (name)	
			, , ,	. ,	
JA			104	S. Home Avenue	
5.City: Vicinity:		6. Geographical Reference:		7. Township/Range/Section:	
Independence			39.109917, -94.459124	1	T: 50N R: 32W 32
8.Historic name (if k	nown):	•		9. Present/other	name (if known):
10. Ownership:			11a. Historic use (if know	/n):	11b. Current use:
Private	Public		Domestic		Domestic

21. (cont.) History and significance. Expand box as necessary, or add continuation pages.

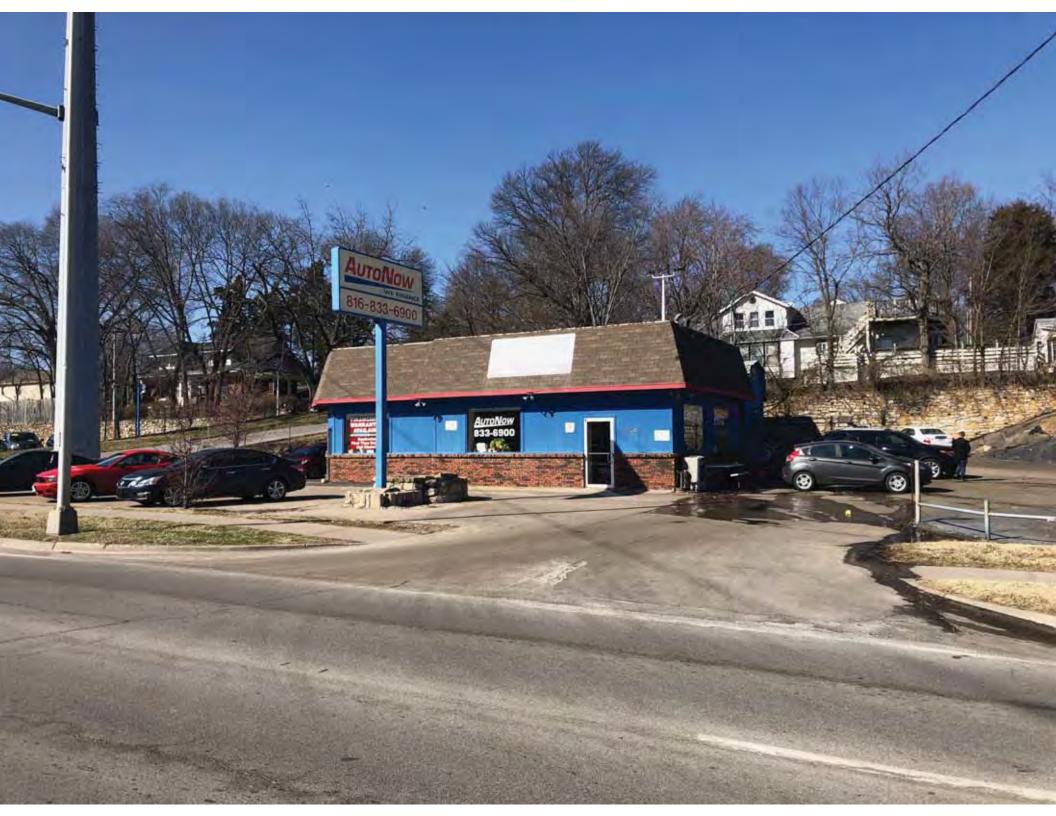
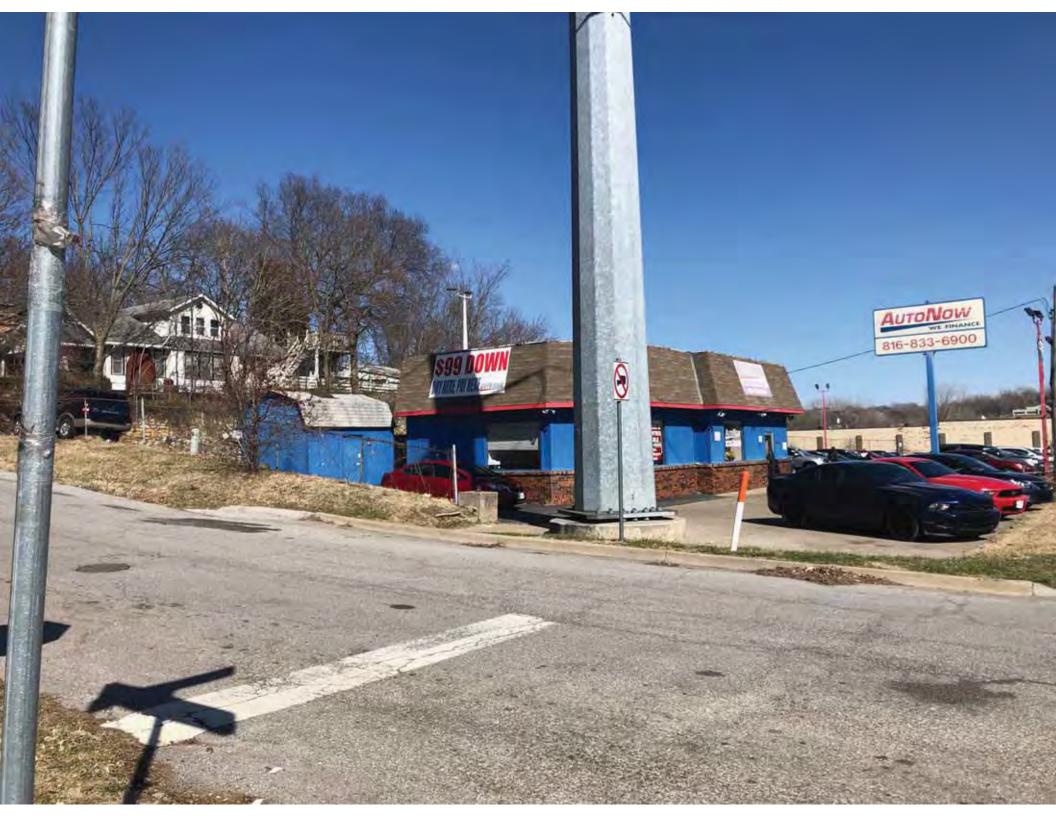
The main façade faces south. This single-story commercial building has an irregular footprint and features a false mansard roof, clad in asphalt shingles. A full-glass, main entry door is placed east of two large, single-pane storefront windows, which repeat at the secondary façades. A secondary, single-leaf entry door is placed at the southwest corner of the façade. The building is skirted with brick facing. This building is a common example of its type that lacks distinction and therefore historical significance.

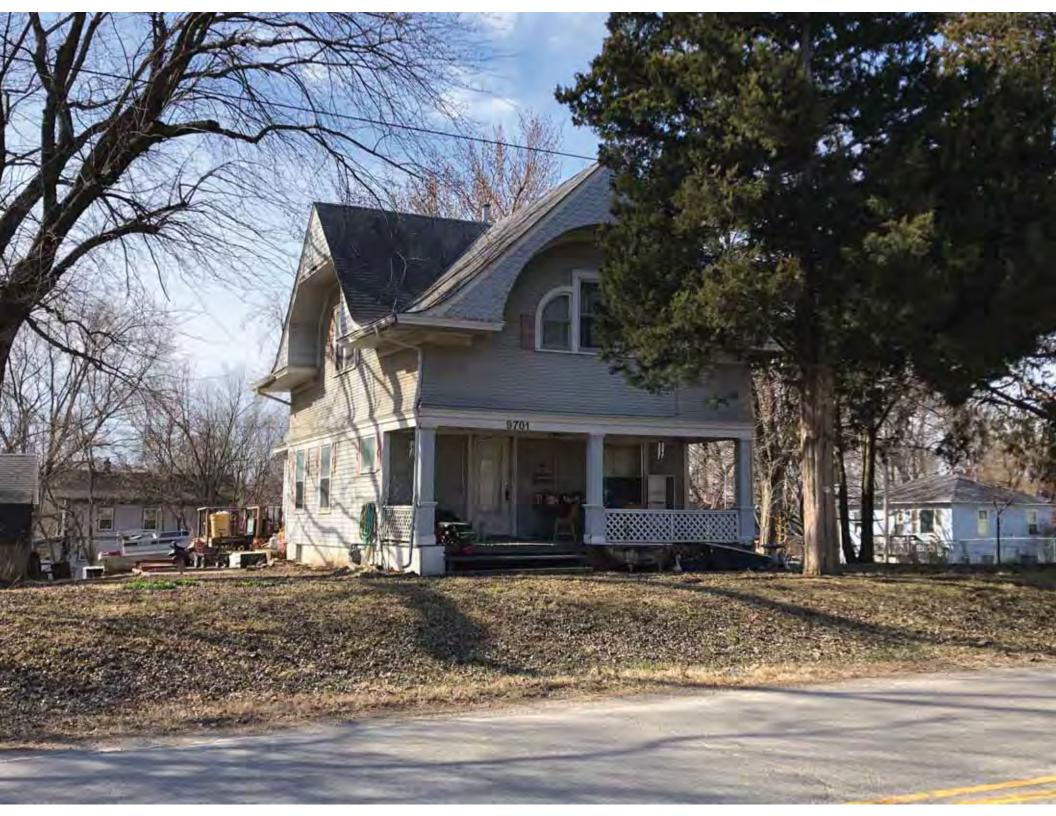
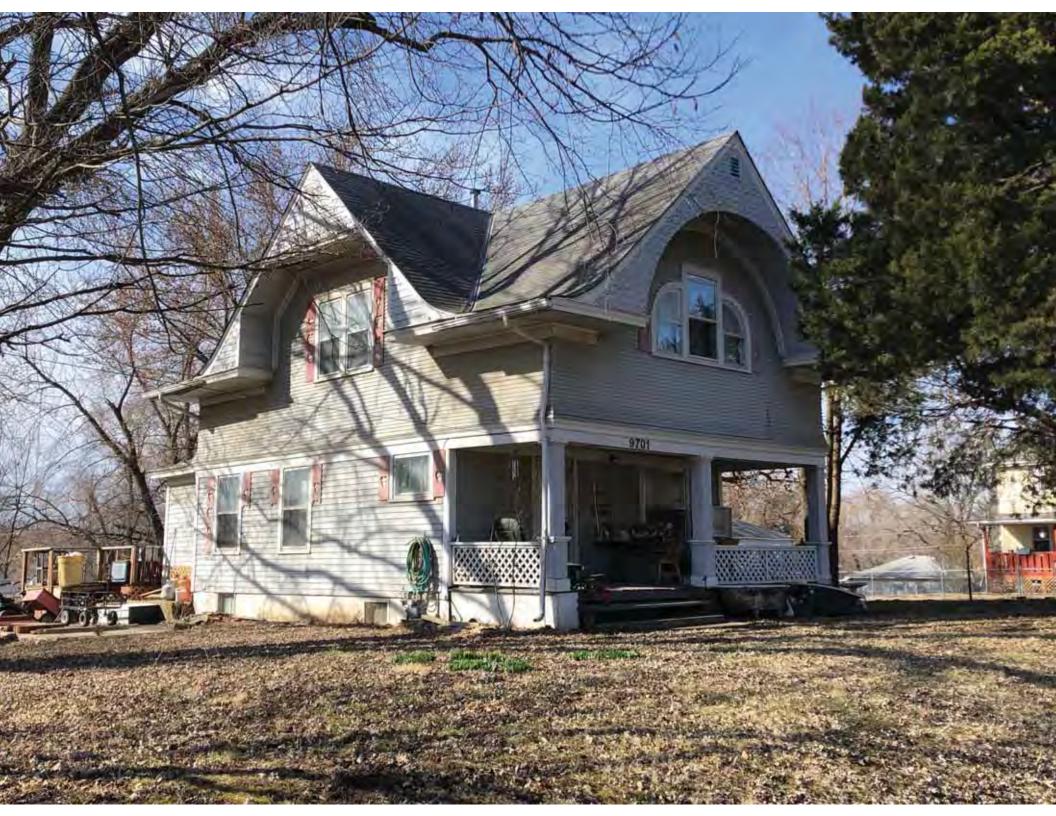
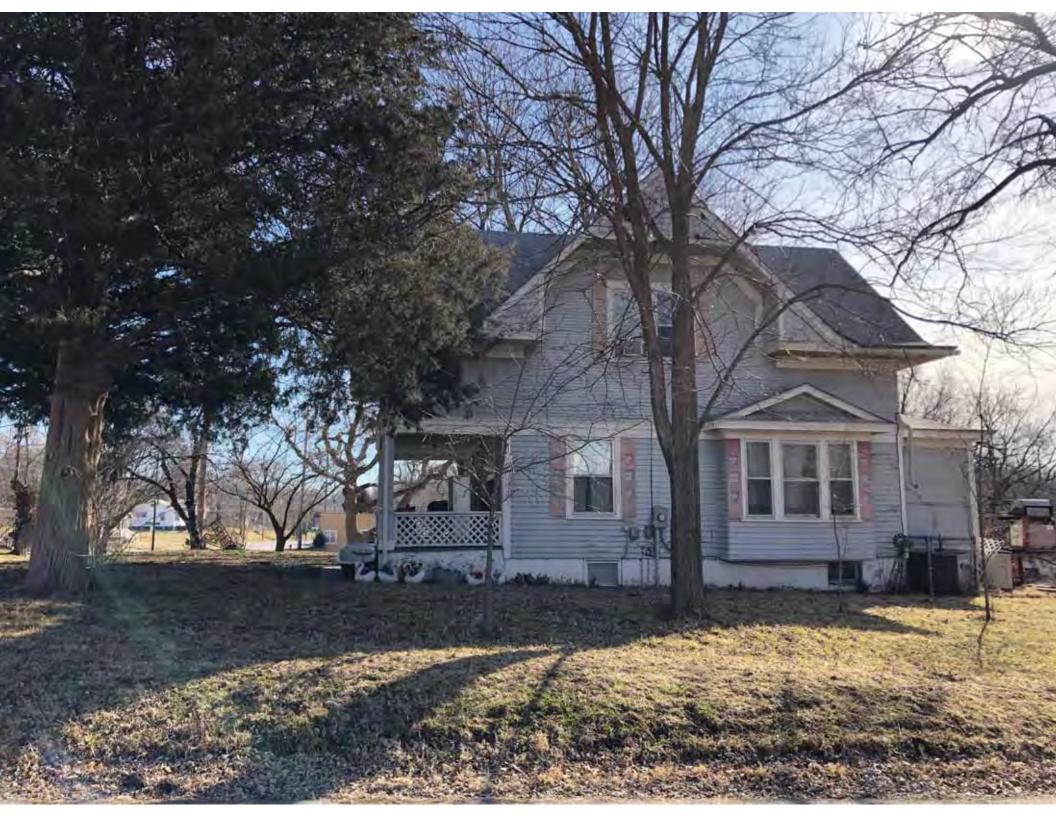
The main façade faces north. This cross gable, Shingle-style house features two, full cross gables and a rear, enclosed porch addition. All four gable ends, clad in patterned wood shingles, feature distinct second story fenestration set under a semi-circular shingled bargeboard. The main façade gable end contains a Palladian-like window while the remaining façades contain paired, one-over-one sash windows. The gable ends create broad overhanging eaves at all elevations. The second story features narrow wood clapboard siding, slightly flared at its intersection with the first story. At the first story, characterized by vinyl siding, a single-leaf main entry door is placed east of a large, one-over-one sash window. The full-width, recessed porch features three, wood columns, set on wooden piers, and a non-original lattice railing. Additional features include a replacement metal stack ridge chimney, a gabled bay window at the west façade, and a hipped, enclosed porch to the rear.

This residence is individually eligible for listing in the NRHP under Criterion C in the area of architecture. Built in 1910 and featuring a distinctive semi-circular arched boxed gable, this property is a unique and representative example of the Shingle style in the Inter-City district.

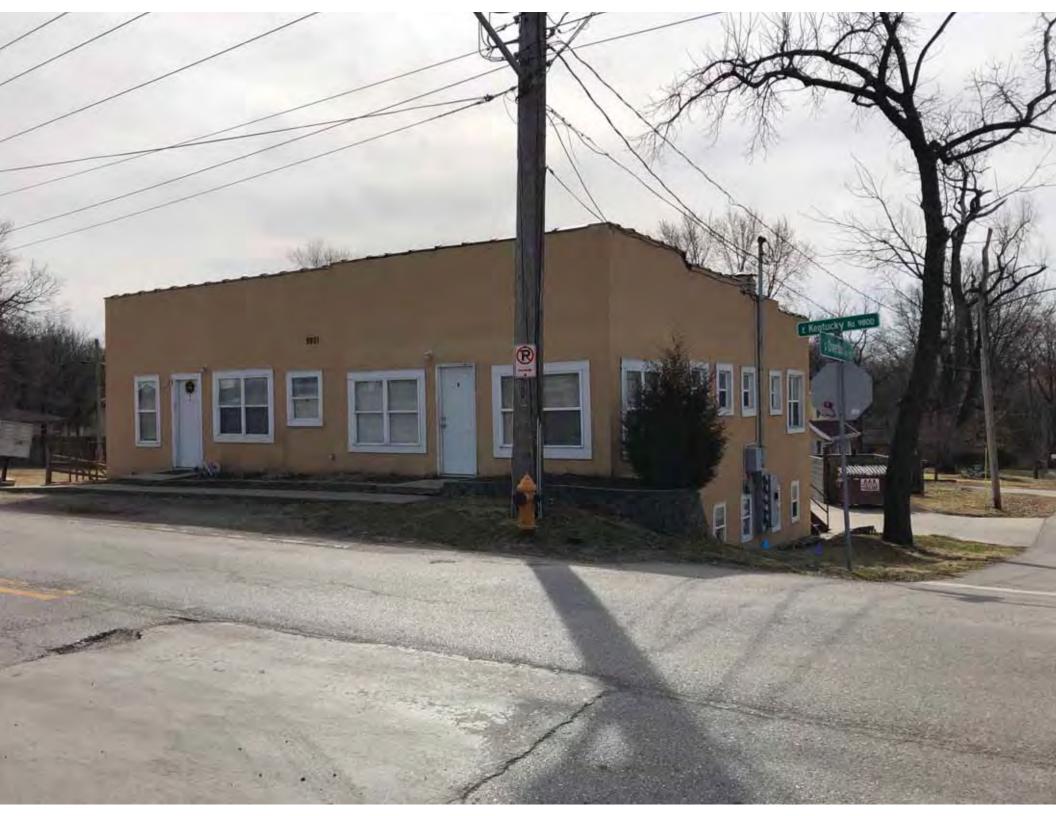
The main façade faces north. The main façade features two, single-leaf, six-panel doors flanked by paired or single one-over-one vinyl sash windows; a small sash window is placed centrally between. At the main façade, two sections are marked by a slight increase in roof height at the western half. Tile roof coping is visible around the roof edge. The roof is stepped at the secondary façades, which feature varied paired and single, one-over-one vinyl sash windows openings at the banked lower and upper stories. The rear (south) façade, which abuts an expansive asphalt parking lot, features similar fenestration patterns to the main façade at both stories. The second story units are accessed by metal staircases. This building is a common example of its type that lacks distinction and therefore historical significance. Additionally, due to loss of original materials, this building lacks sufficient integrity of materials and workmanship to be considered eligible for listing in the NRHP.

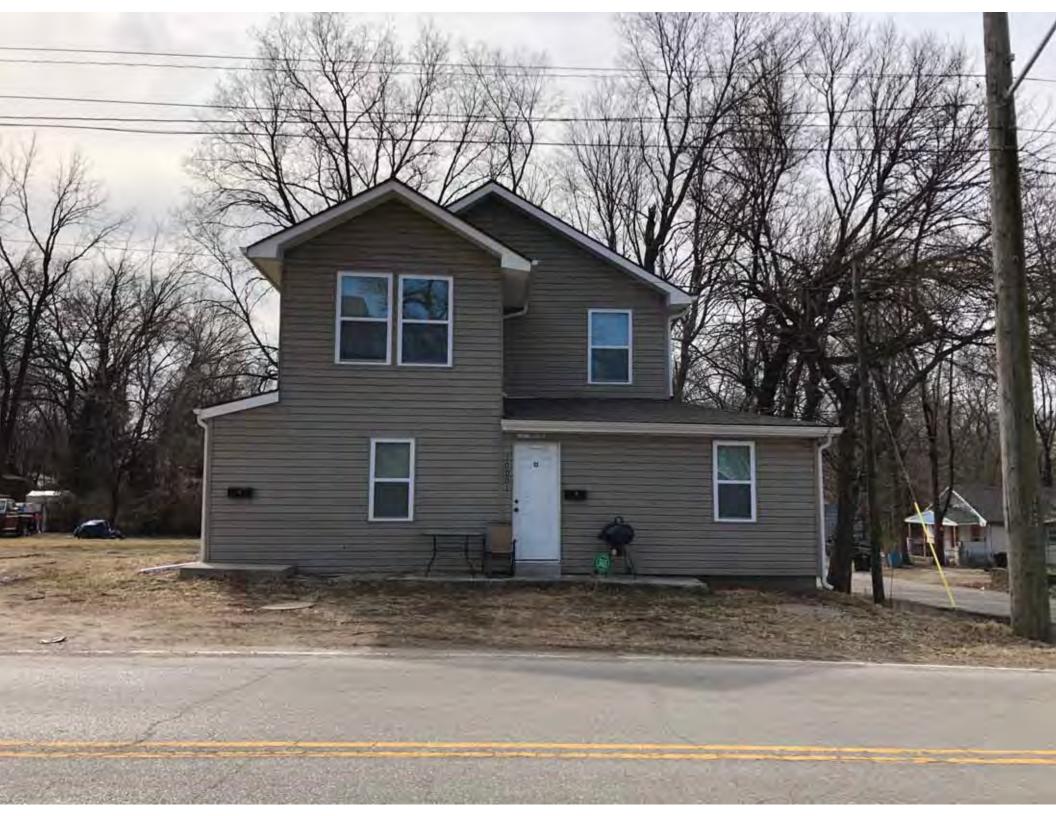
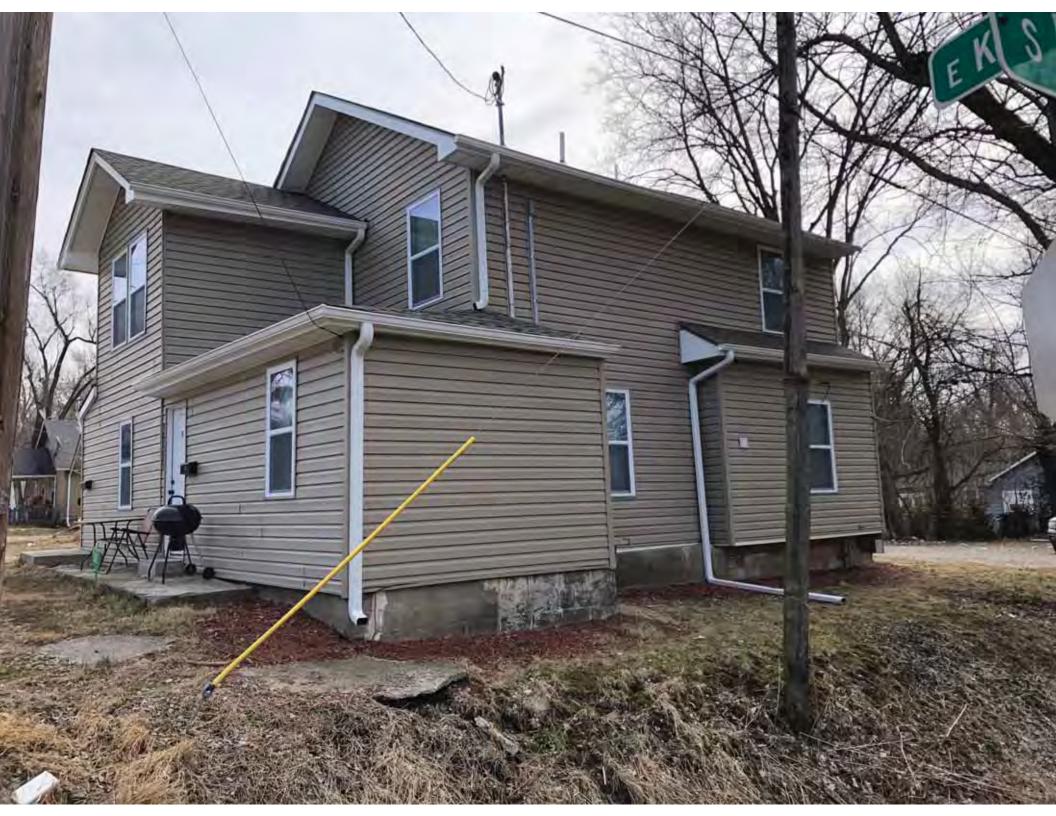
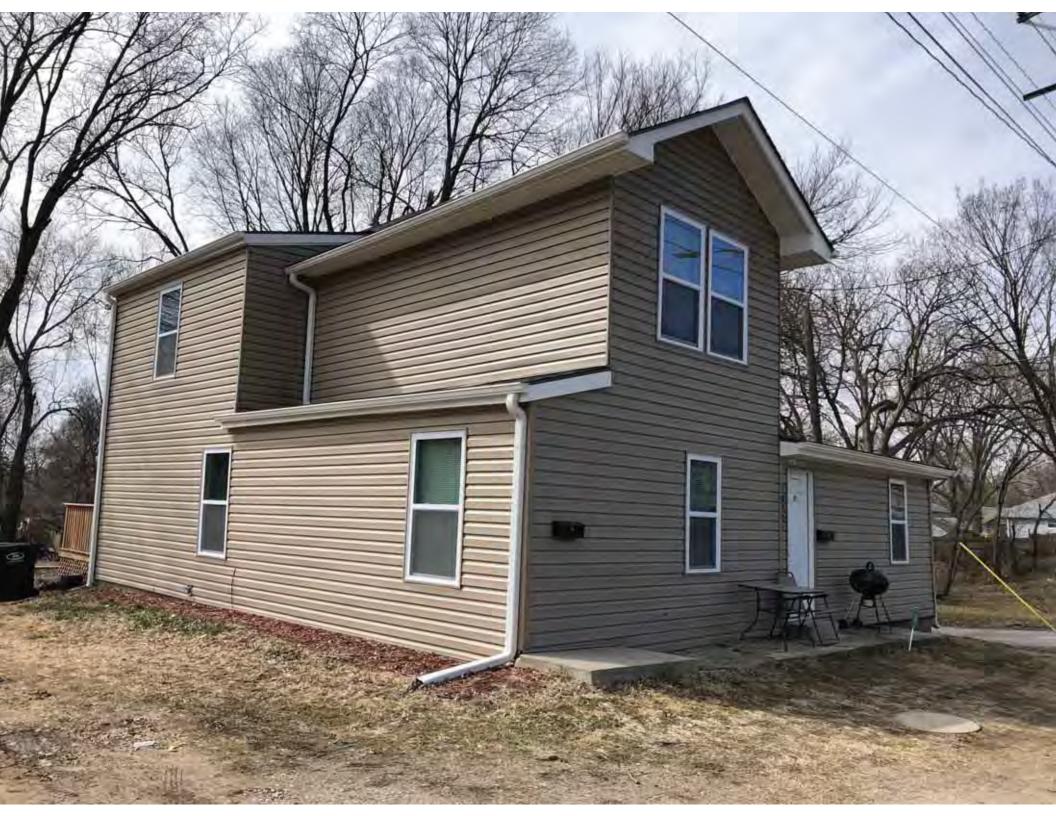
The main façade faces north. This former commercial building has been converted into a residential property and consists of a twostory, front gable main block with a two-story, front-facing gable protruding from the east bay and a single-story, enclosed wrap porch at the northwest corner. The hipped porch contains a single-leaf, six-panel vinyl entry door placed east of a replacement one-over-one vinyl sash window. The front-facing gable features a single window at its first story and paired windows at the second, which replaced a group of three wood sash windows in the last fifteen years (as seen on 2011 Google Street Views image capture of the property). An additional window is placed at the main façade above the porch roof. Additional features include a single-story, shed roof addition at the east façade and a shed roof bay window at the west façade. Due to loss of original materials, changes to form, and other alterations, this building lacks sufficient integrity of design, materials and workmanship to be considered eligible for listing in the NRHP.

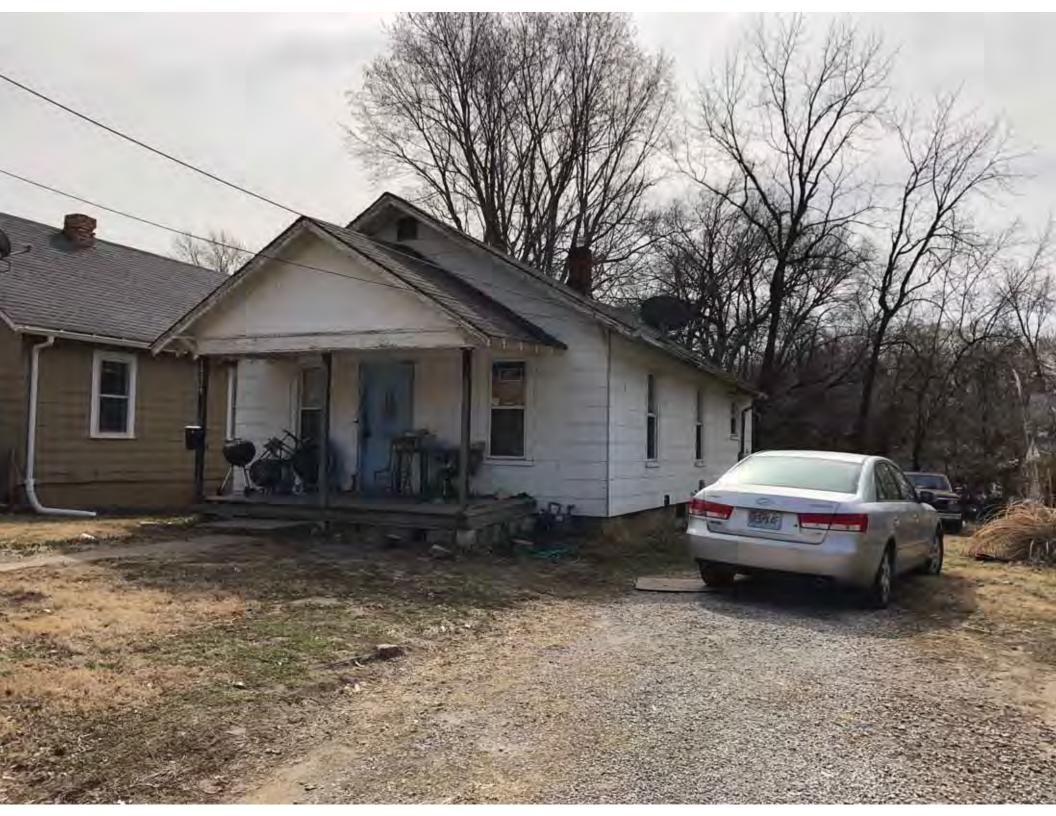
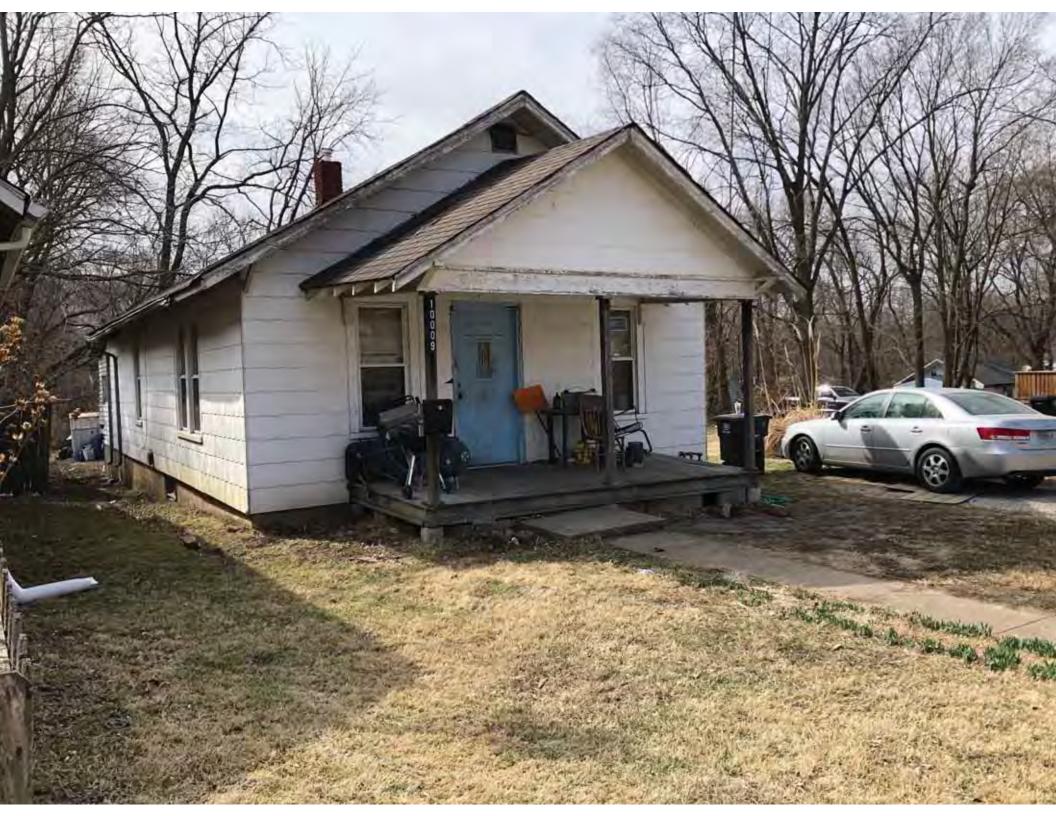
The main façade faces north. A single-leaf, wood-paneled entry door is flanked by replacement, one-over-one vinyl sash windows, which repeat at the secondary façades. The full-width, gabled porch features exposed rafters tails, knee bracing and three wood posts supporting the roof. Additional features include a brick chimney placed at the west side of the gable roof and partial-width, rear porch enclosed at an unknown date. The subject of this form and the house to the east, 10011 E. Kentucky Avenue (JA-AS-091-357) share similar form and massing. Although the construction date and form of this house indicate a likely Craftsman original styling, few character-defining elements of the style remain due to loss of original materials and alterations. This building is a common example of its type that lacks distinction and therefore historical significance. Additionally, due to loss of original materials, this building lacks sufficient integrity of materials and workmanship to be considered eligible for listing in the NRHP.

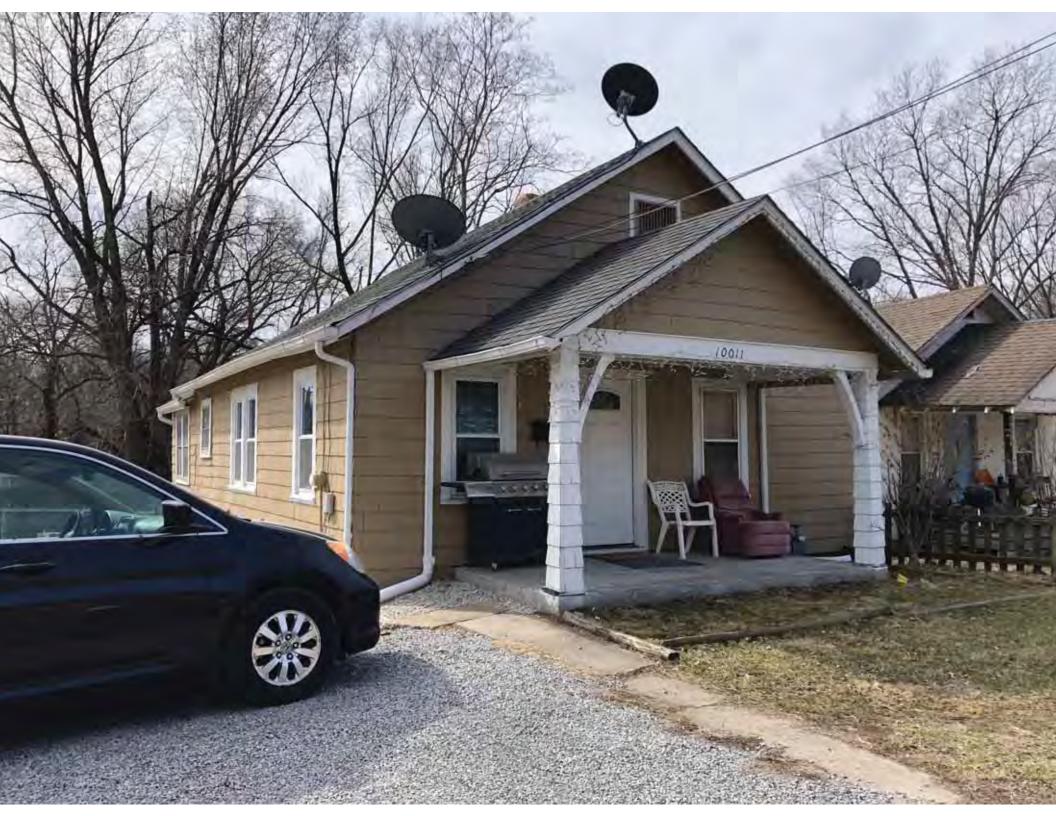
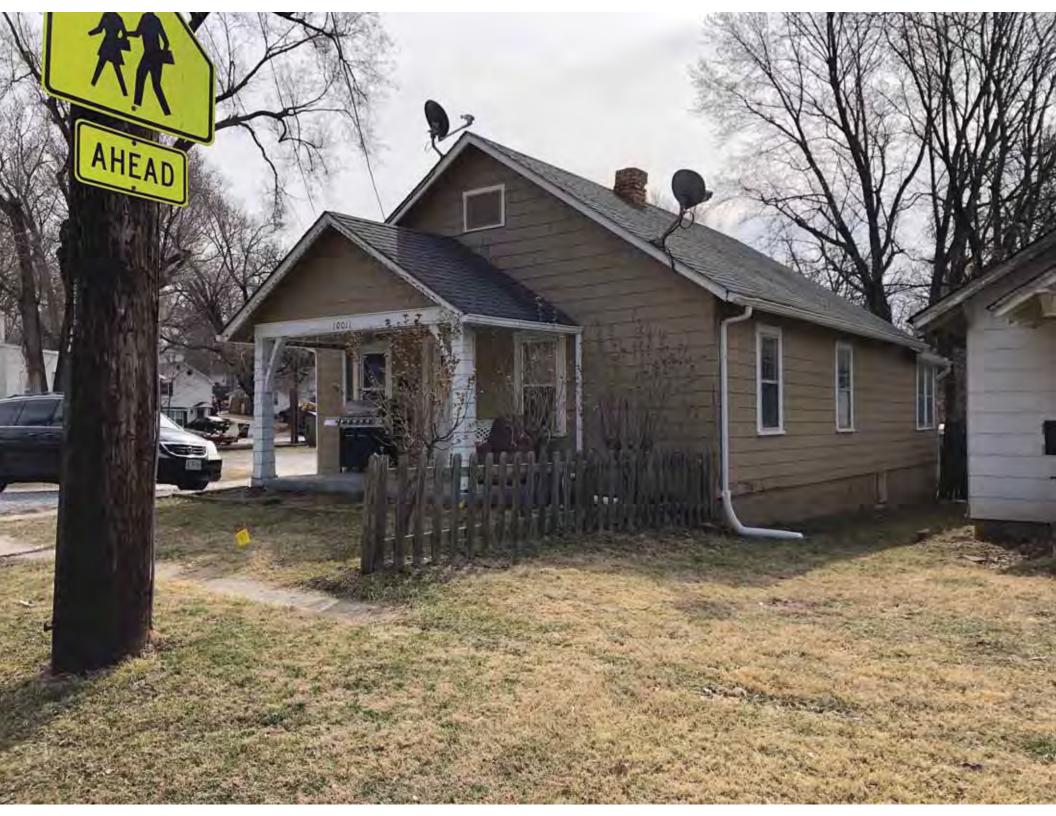
The main façade faces north. An asymmetrically-placed main entry is flanked by replacement, one-over-one, vinyl sash windows, which repeat at the secondary façades. The entry consists of a single-leaf, four-panel door with upper arched window. The partial-width, gabled porch features two battered columns clad in non-original wood shingle siding. Additional features include a brick chimney placed near the ridge at the west side of the gabled roof, a banked basement-level garage entrance at the east façade, and a rear porch enclosed at an unknown date. The subject of this form and the house to the west, 10009 E. Kentucky Avenue (JA-AS-091-356) share similar form and massing. Although the construction date and form of this house indicate a likely Craftsman original styling, few character-defining elements of the style remain due to loss of original materials and alterations. This building is a common example of its type that lacks distinction and therefore historical significance. Additionally, due to loss of original materials, this building lacks sufficient integrity of materials and workmanship to be considered eligible for listing in the NRHP.

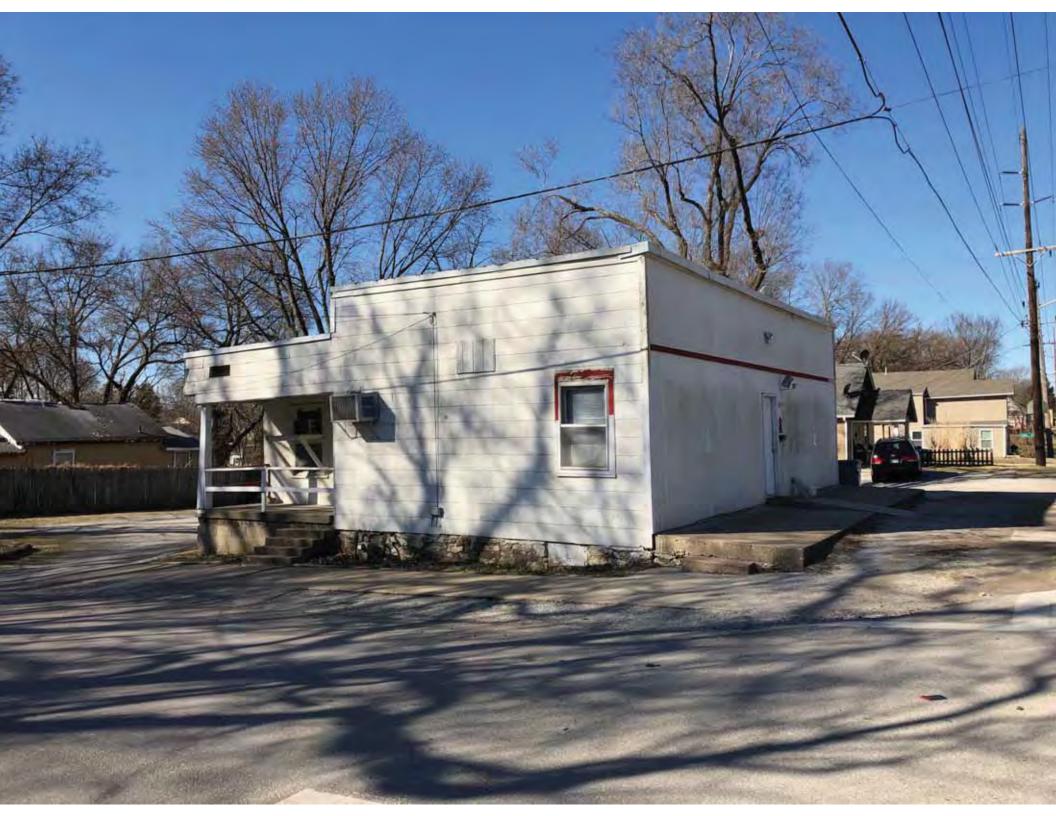
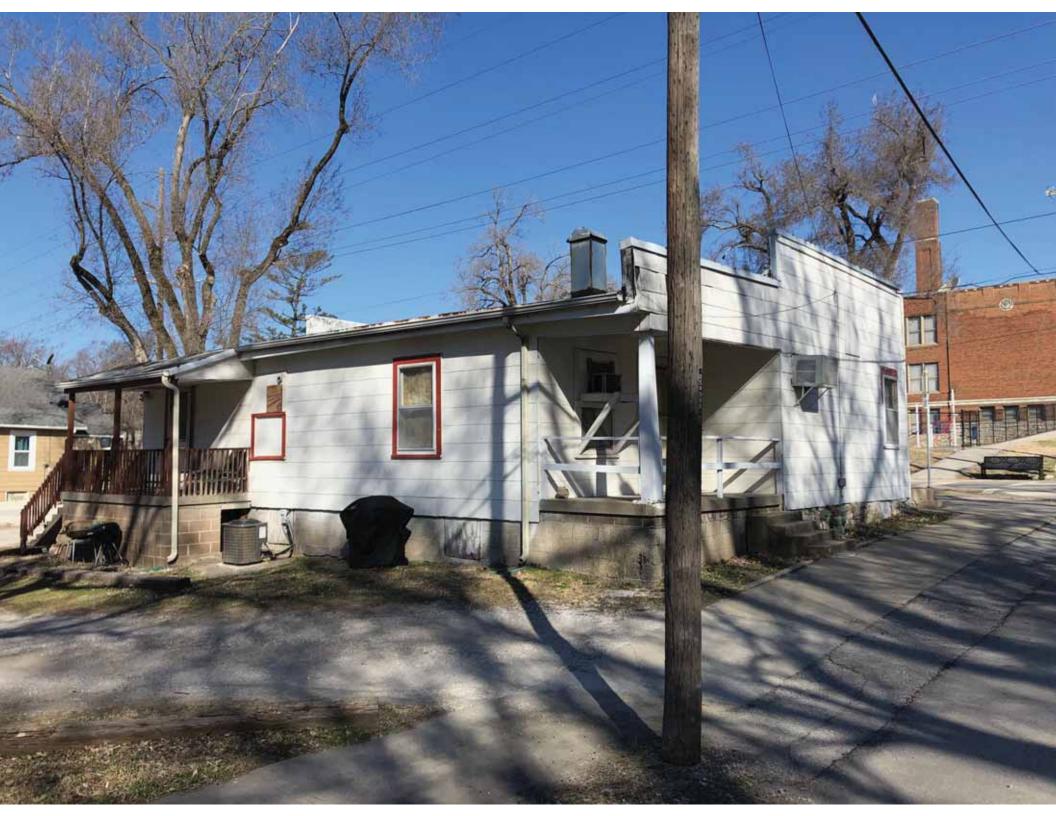
This building originally had a combined commercial/residential use. A commercial storefront faces north (toward E. Kentucky Avenue). The living quarters face east (towards S. Cedar Avenue). The current function of the commercial storefront is unclear; it has potentially been incorporated into the residence. The commercial storefront, characterized by vertical plank siding at its main façade and a stone foundation (visible at the east elevation), contains a single-leaf, six-panel, vinyl entry door centered at the north façade and a single window opening at its west façade. The secondary façades are clad in asbestos siding, matching the residential portion of the building. The residential quarters, attached to the rear façade of the commercial block, is characterized by a shed roof, concrete block foundation, and asbestos siding. An east façade front porch is supported by a single battered wood column and horizontal wood railing. A single-leaf, wood panel entry door is placed to the north of a single window opening (heavily modified) at the east façade. A second porch extends from the far west bay of the south façade and features wood post supports and simple squared railing, set on a tall concrete block foundation. This shed roof porch shelters a secondary entrance door. The parcel is filled with a gravel parking lot on the south and west sides of the building. This building is a common example of its type that lacks distinction and therefore historical significance. Additionally, due to loss of original materials, this building lacks sufficient integrity of materials and workmanship to be considered eligible for listing in the NRHP.

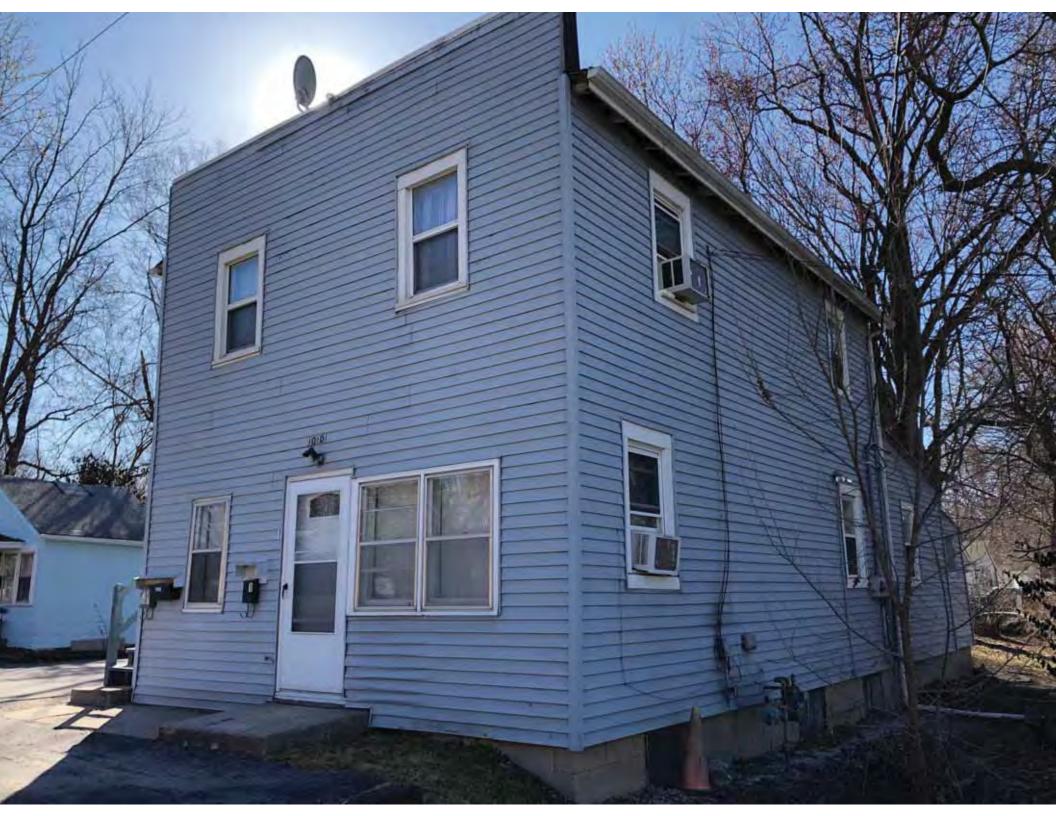
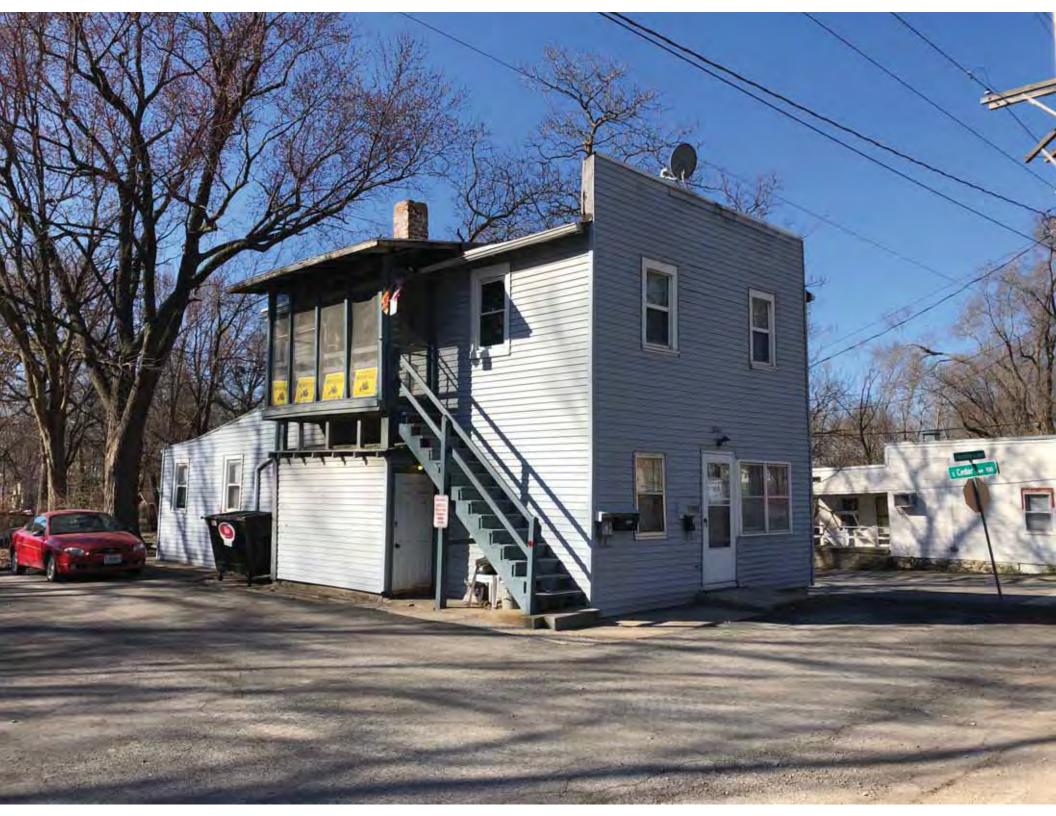
The main façade faces north. A central main entry is placed between a replacement, one-over-one window with aluminum storm to the east and paired one-over-one windows with aluminum storms directly to the west (there is no space between the door and the paired windows). Two, evenly spaced one-over-one windows are placed at the second story. A low-pitched gable roof is hidden behind the extended storefront roof at the main façade . Replacement, one-over-one windows repeat at the secondary façades. The east façade features a shed roof entry addition with exposed rafter tails surmounted by a second story shed roof, screened porch accessed by a wooden staircase. Additional features include a brick chimney at the east side of the gable roof and multiple rear, shed roof additions. Due to loss of original materials, changes to form, and other alterations, this building lacks sufficient integrity of design, materials and workmanship to be considered eligible for listing in the NRHP.

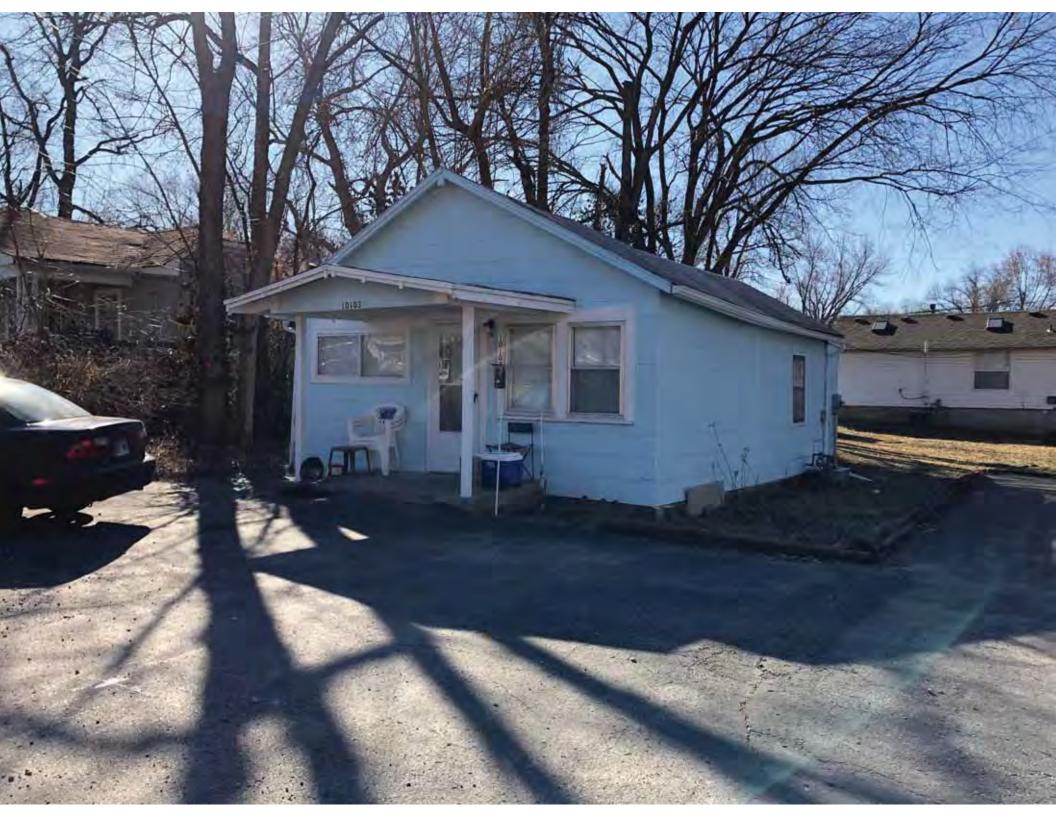
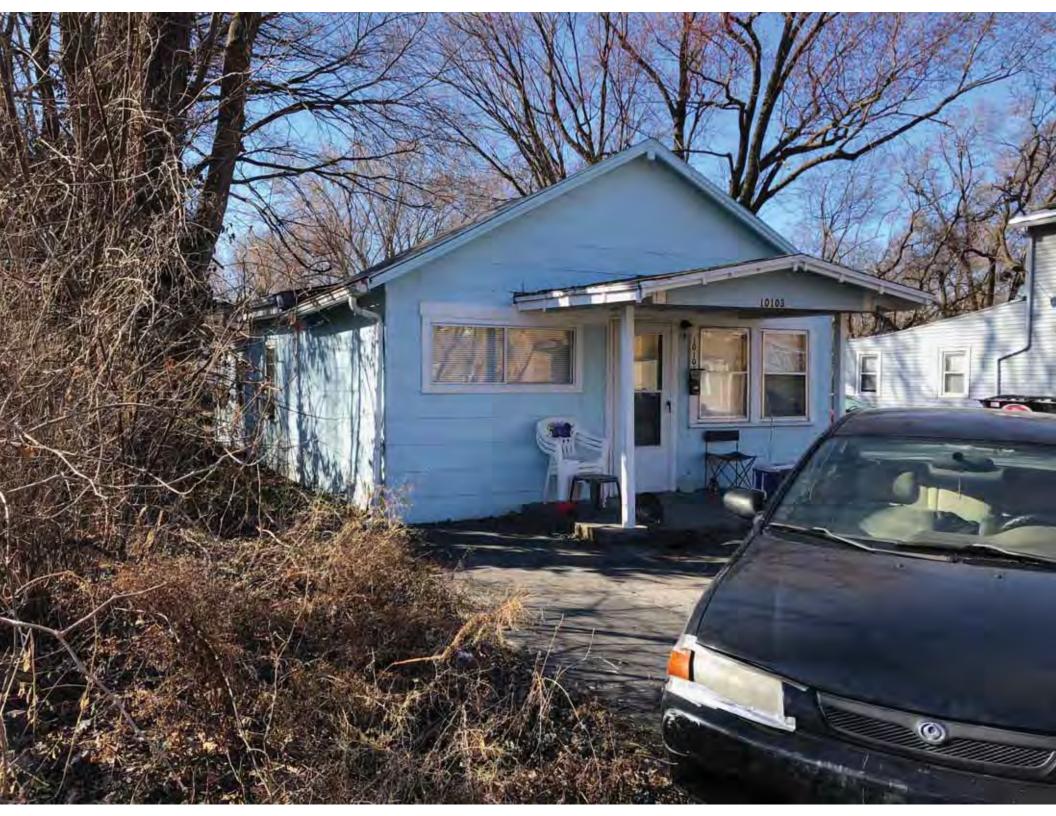
The main façade faces north. A central main entry is flanked by a sliding window to the east and paired one-over-one vinyl sash windows with wood surround to the west. Single one-over-one windows repeat at the secondary façades. The main entry consists of a single-leaf door with a metal storm door. A partial-width, gabled, open front porch features two wood posts and false bracketing details lining the roof edge. 1951 Sanborn maps indicate two, two-story rear blocks, no longer evident on the residence. The rear blocks appear to have been removed by 1990 (as observed on aerial imagery). Although the construction date and form of this house indicate a likely Craftsman original styling, few character-defining elements of the style remain due to loss of original materials and alterations. This building is a common example of its type that lacks distinction and therefore historical significance. Additionally, due to loss of original materials, this building lacks sufficient integrity of materials and workmanship to be considered eligible for listing in the NRHP.

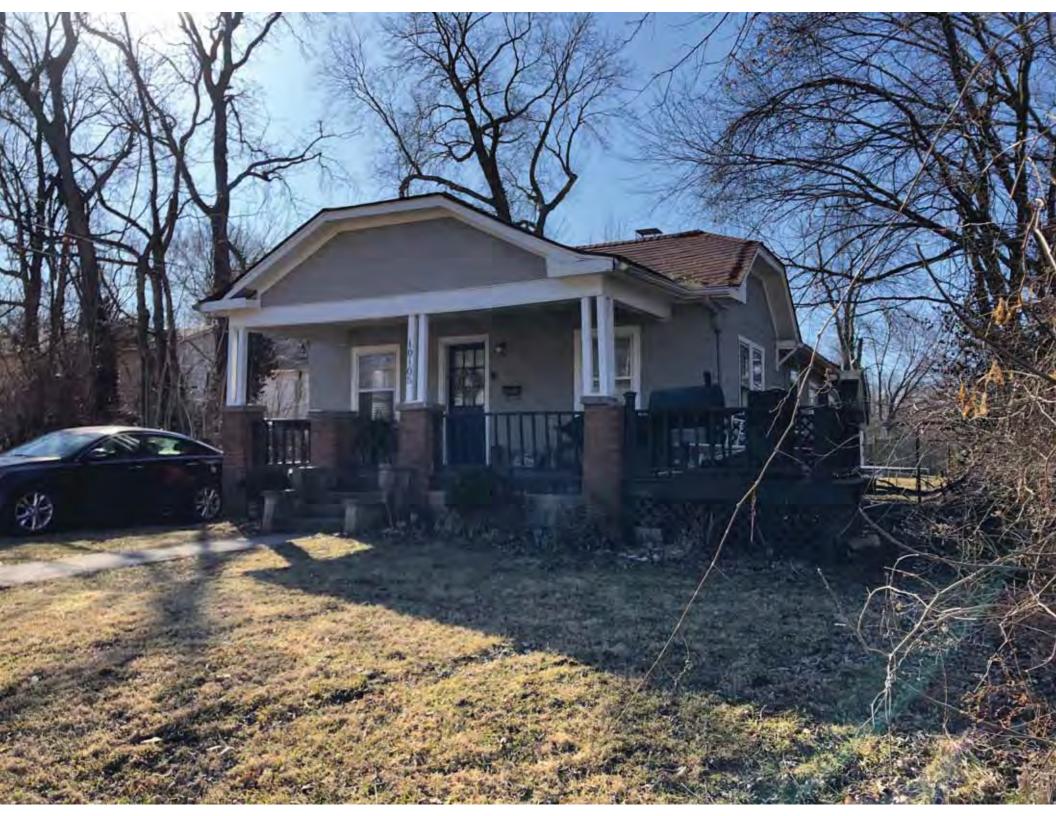
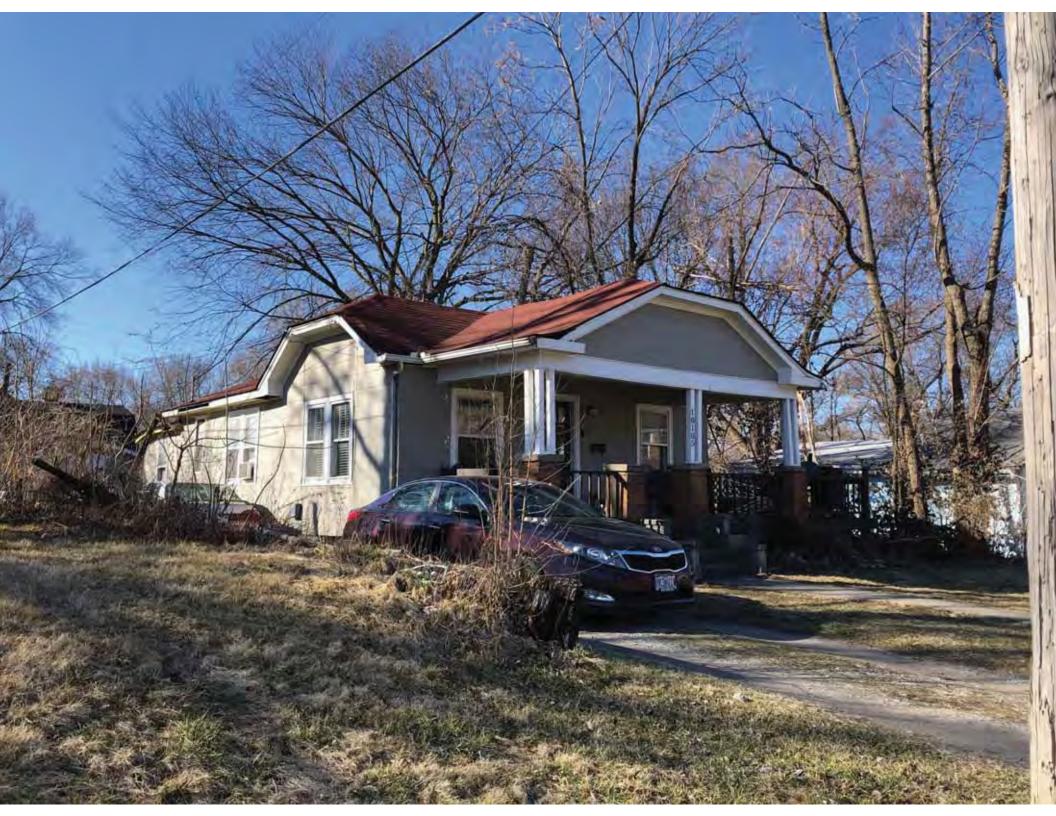
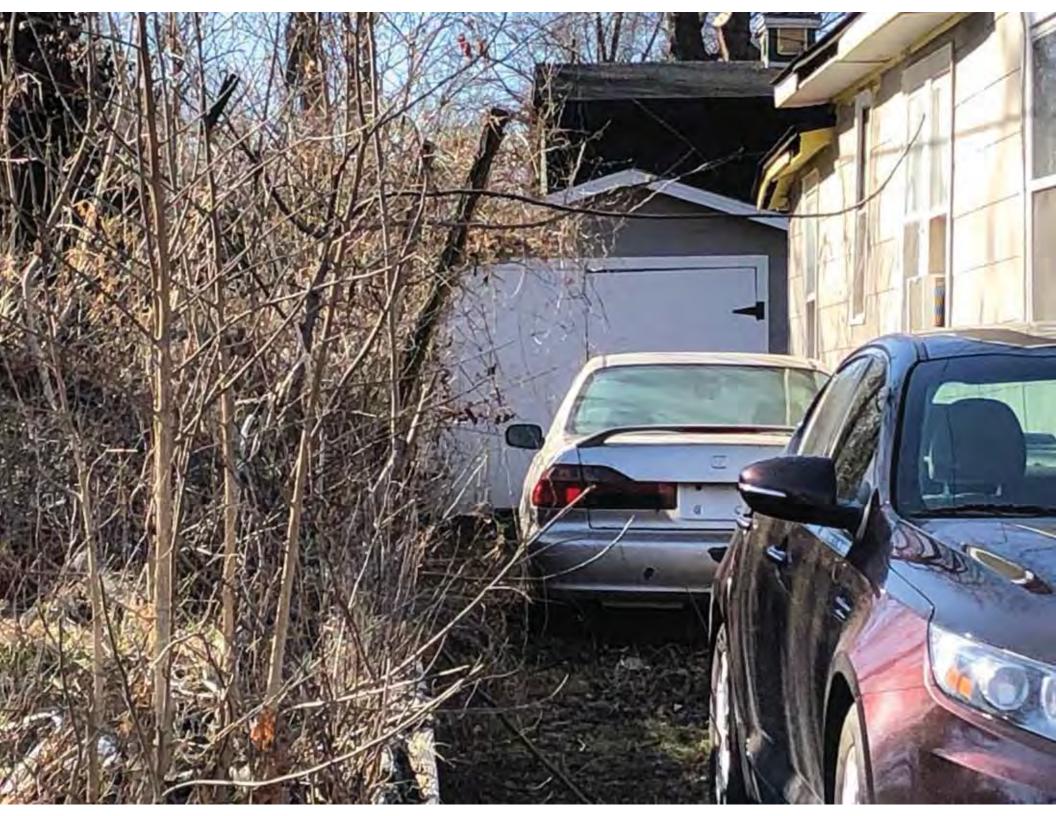
The main façade faces north. An asymmetrically-placed main entry is flanked by original three-over-one wood sash windows with aluminum storms and wood surrounds. The secondary facades features four-over-one wood sash windows with wood surrounds. The main entry consists of a single-leaf, wood door with a multi-lite window in the upper half and lower horizontal panels. The full-width, open porch features a hipped gable roof supported by three sets of paired wood columns set on brick plinths; a fourth brick plinth lacks columns. Additional features include a rear slope chimney (material undetermined) and a rear porch that was extended and enclosed at an unknown date. This house retains few of its original Craftsman-style details. This building is a common example of its type that lacks distinction and therefore historical significance. Additionally, due to some loss of original materials, including siding, this building has diminished integrity of materials and workmanship.
