1. Survey No.			2. Survey name:		
JA-AS-091-240		Fairmount Phase I Survey			
3. County:			4. Address (Street No.)	reet No.) Street (name)	
			, , ,	. ,	
JA			104	S. Home Avenue	
5.City: Vicinity:		6. Geographical Reference:		7. Township/Range/Section:	
Independence			39.109917, -94.459124	1	T: 50N R: 32W 32
8.Historic name (if k	nown):	•		9. Present/other	name (if known):
10. Ownership:			11a. Historic use (if know	/n):	11b. Current use:
Private	Public		Domestic		Domestic

21. (cont.) History and significance. Expand box as necessary, or add continuation pages.

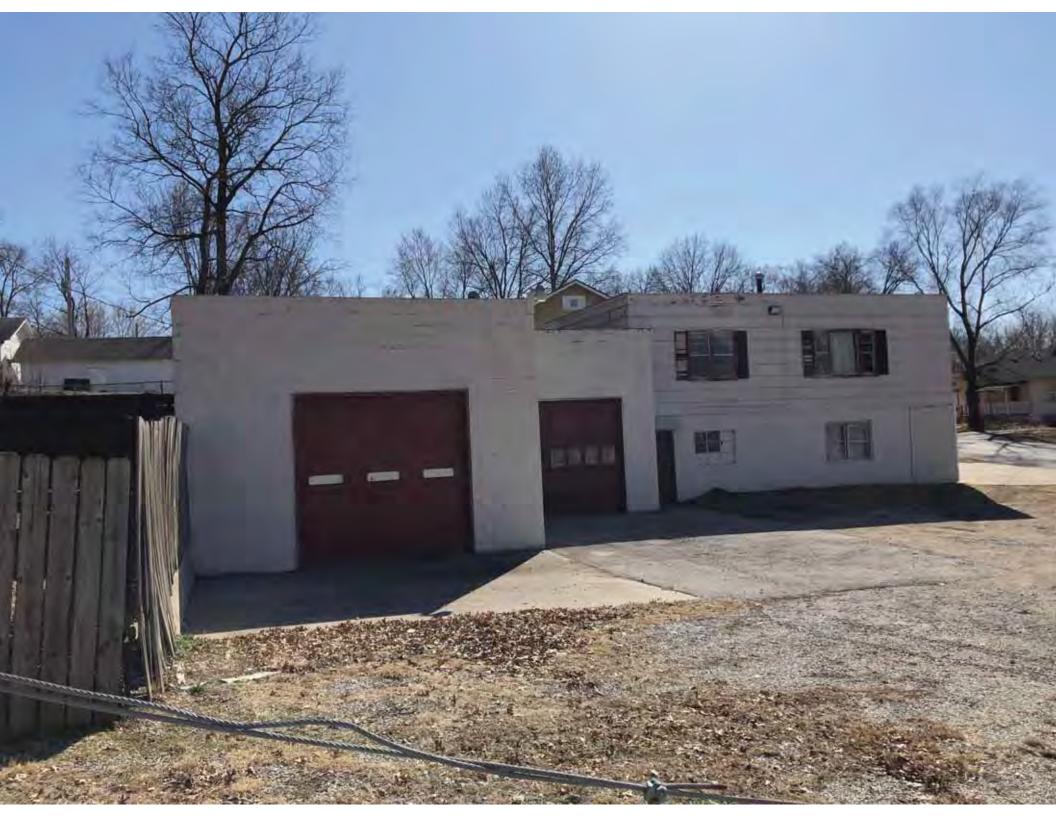
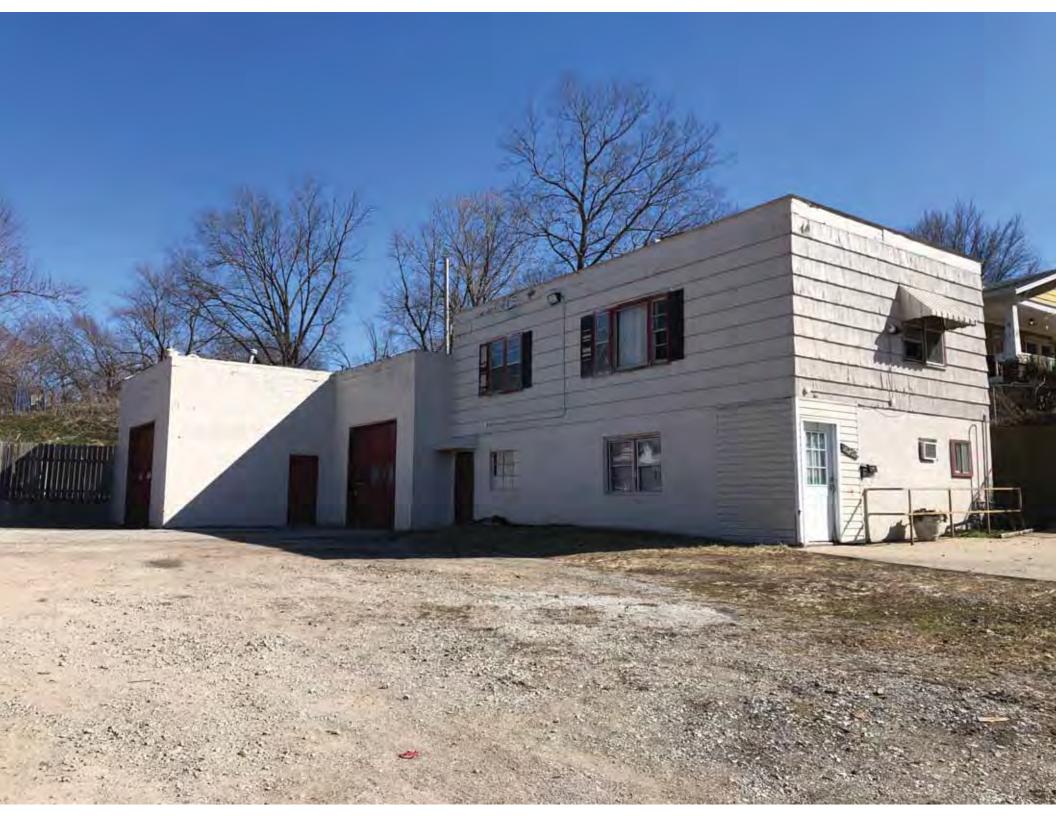
The main façade faces north. This building contains two apartment units and two single-bay, attached garage blocks. The building is comprised of a two-story rectangular apartment block and two, attached garage bays at the northeast corner, both facing north. The garage bays and first story of the apartment block are characterized by concrete block, while the second story of the apartment units is clad in asbestos siding. At the main façade of the apartment block, a single-leaf entry door is placed east of a multi-lite casement window and a pair of one-over-one sash windows with aluminum storms. Fenestration of the second story includes a pair of one-over-one windows and a three-part picture window. The west façade of the apartment block features a vinyl clad entry at the northwest corner, containing a single-leaf, vinyl panel door with multi-lite window, set north of a two part casement window. The second story of the west façade features paired one-over-one vinyl sash windows. Additional features include a rear (south) façade second story staircase and shed roof entry porch centered at the rear façade. This building may retain sufficient level of integrity to be considered for NRHP eligibility; however, it is a common example of its type that lacks distinction and therefore historical significance.

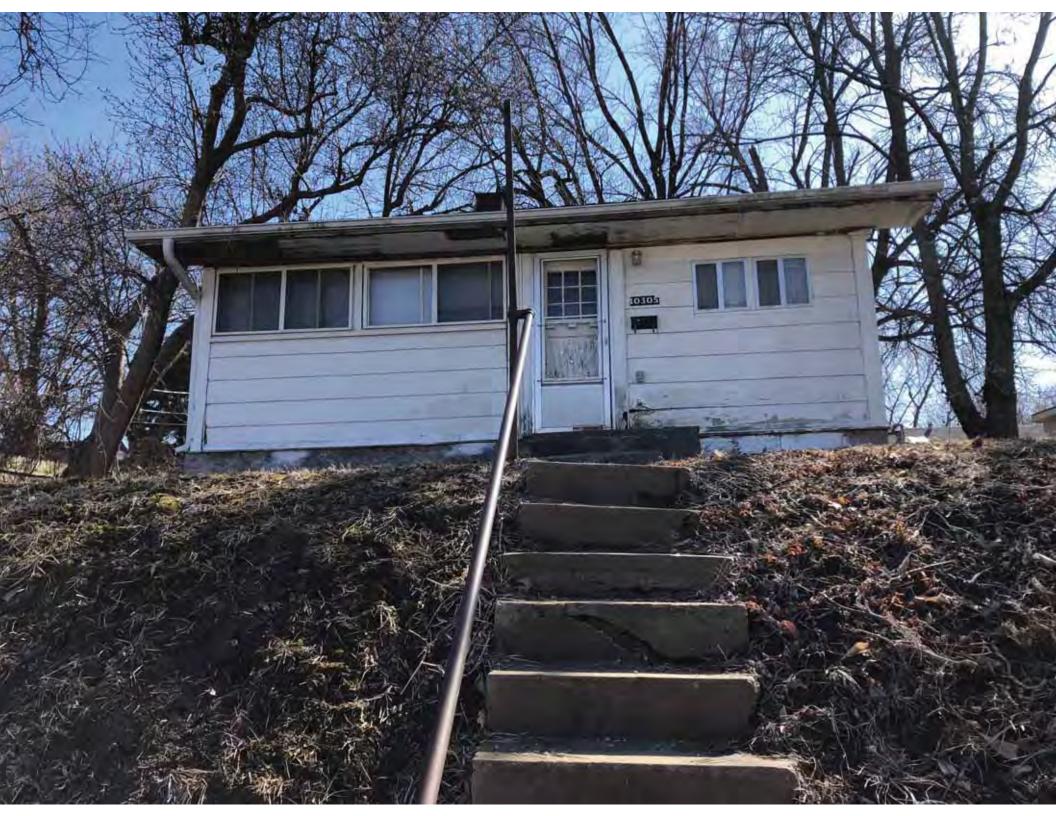
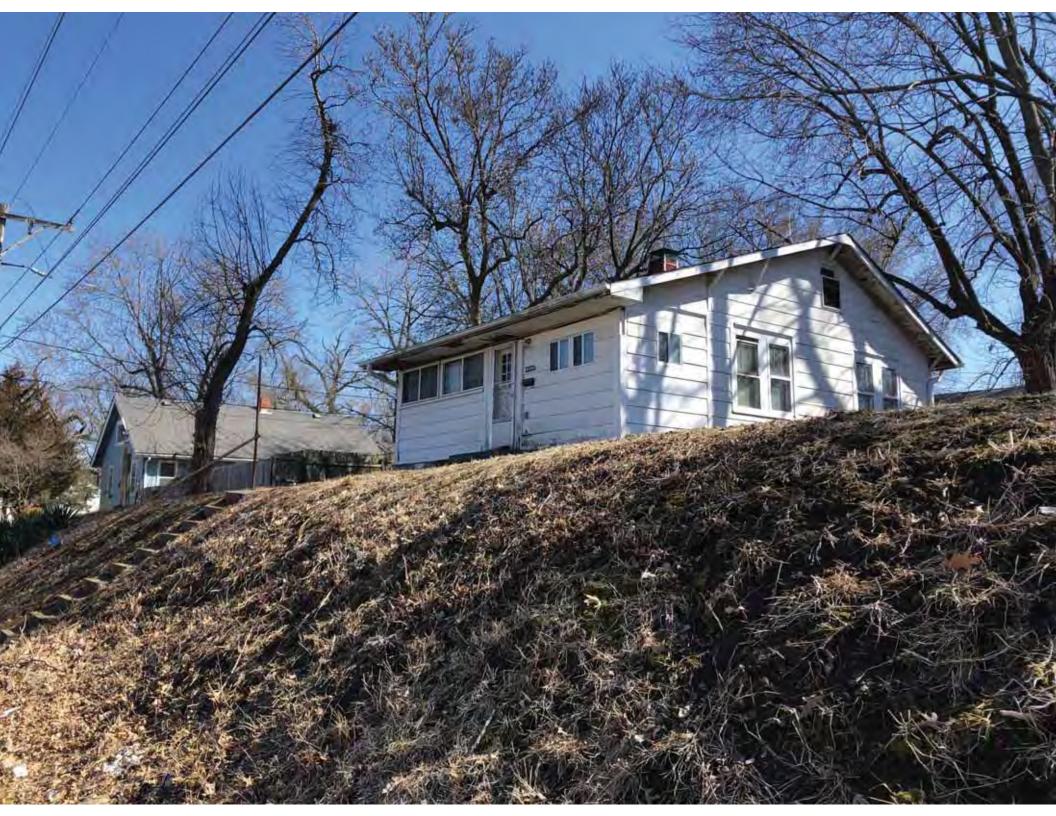
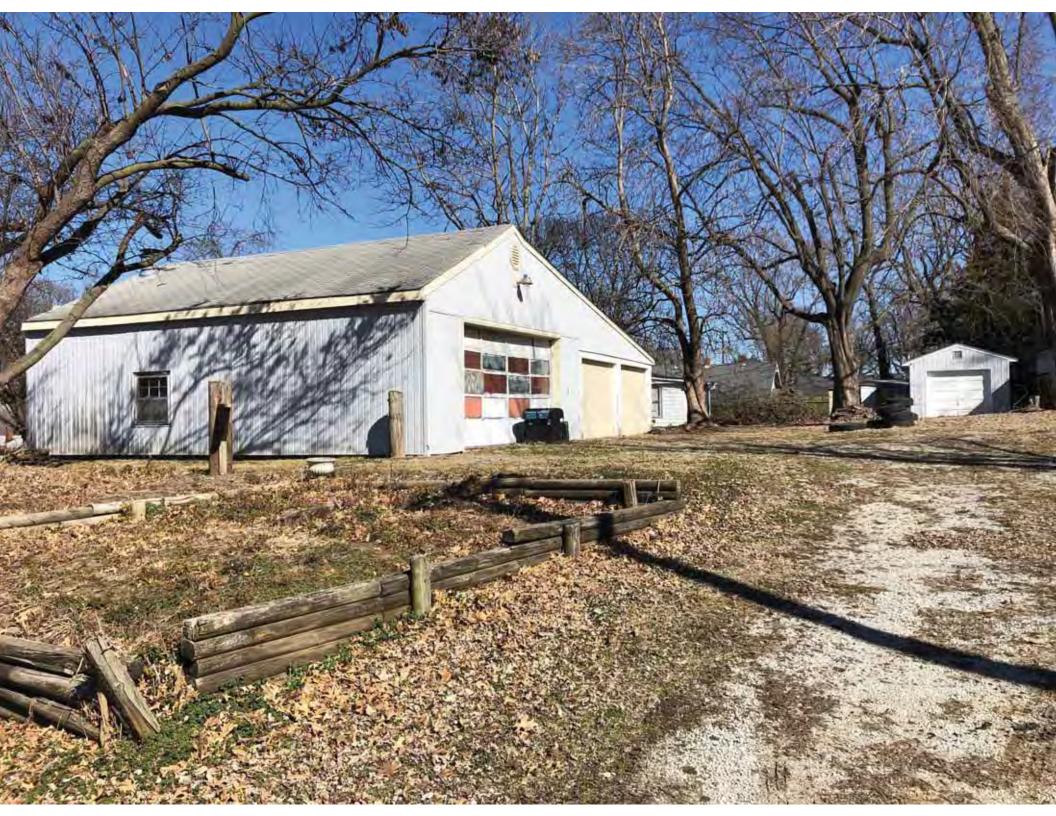
The main façade faces north. An asymmetrically-placed main entry is flanked by two paired, sliding windows to the east and two, twopart casement windows to the west. The main entry consists of a wood door with upper multi-lite window and lower wood panel decorated with three dentils below the window and enclosed with a metal storm door. The full-width front porch has been fully enclosed as an addition with asbestos siding; two corner wood columns and visible brick pier indicate the prior presence of an open front porch. The secondary façades contain paired, one-over-one sash windows and knee bracing at the gable ends. Additional features include a brick ridge chimney, a shed roof bay window at the east façade, and a partial-width, rear shed roof addition. Due to loss of original materials, changes to form, and other alterations, this building lacks sufficient integrity of design, materials and workmanship to be considered eligible for listing in the NRHP.

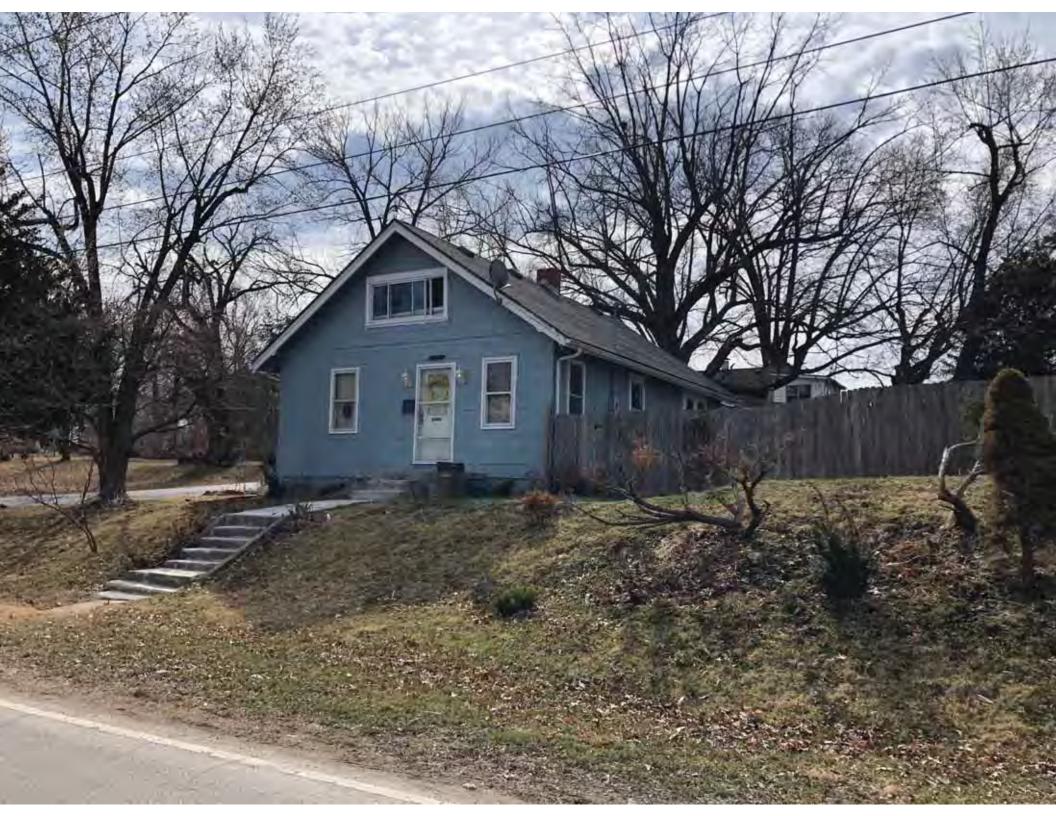
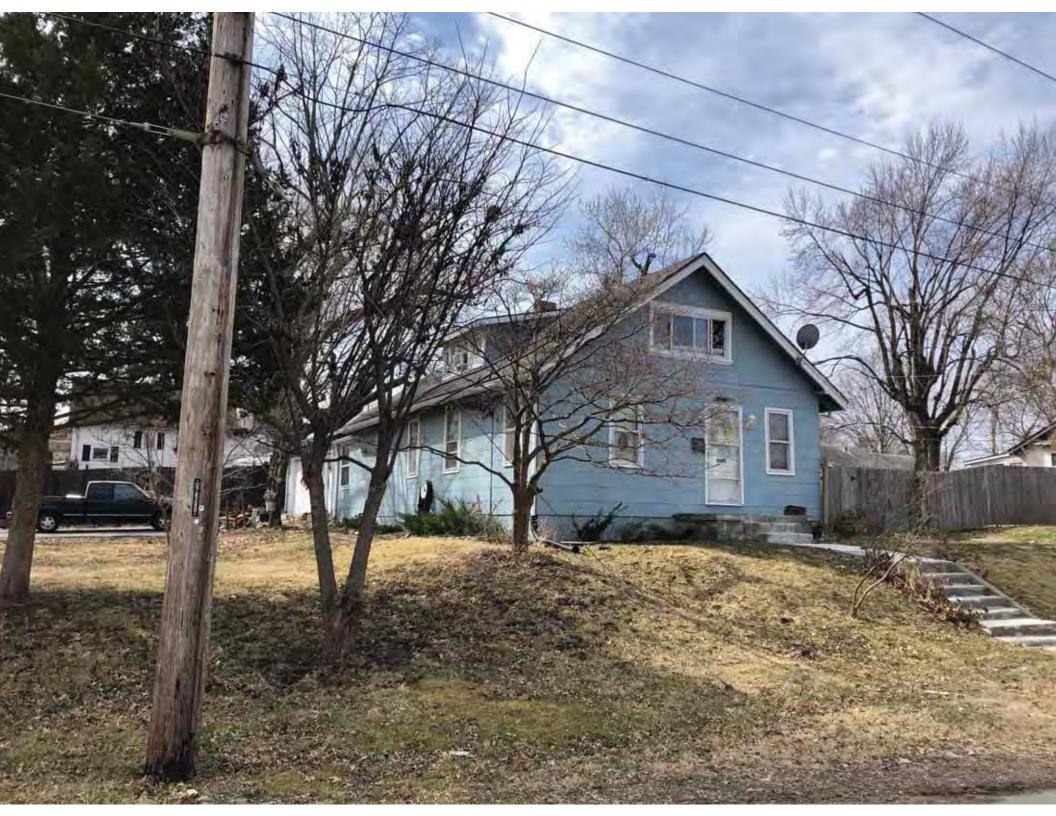
The main façade faces north. This house features a front-gable roof and rear garage addition (which appears on a 1990 historic aerial image). An asymmetrically-placed main entry is flanked by replacement one-over-one vinyl sash windows with vinyl surrounds, which repeat at the secondary façades. A sliding window is located centrally in the gable end. The entry consists of a single-leaf apron door with two lower, vertical panels. This frame house is clad in replacement asbestos siding. A shed roofed dormer is centrally located at the west façade and a brick chimney straddles the ridge of the roof. An original full-width front porch was enclosed at an unknown date. Although the construction date and original form indicate a likely Craftsman original styling, few (if any) character defining features remain due to loss of original materials, alterations, and additions. Due to loss of original materials, changes to form, and other alterations, this building lacks sufficient integrity of design, materials and workmanship to be considered eligible for listing in the NRHP.

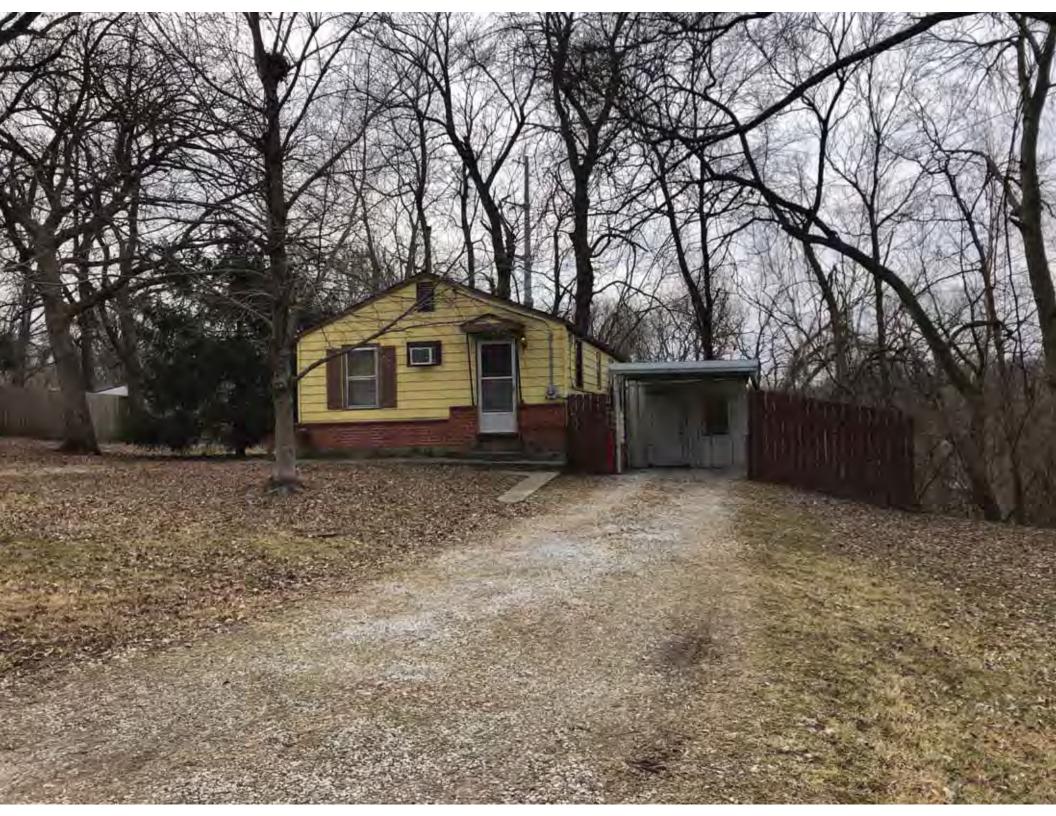
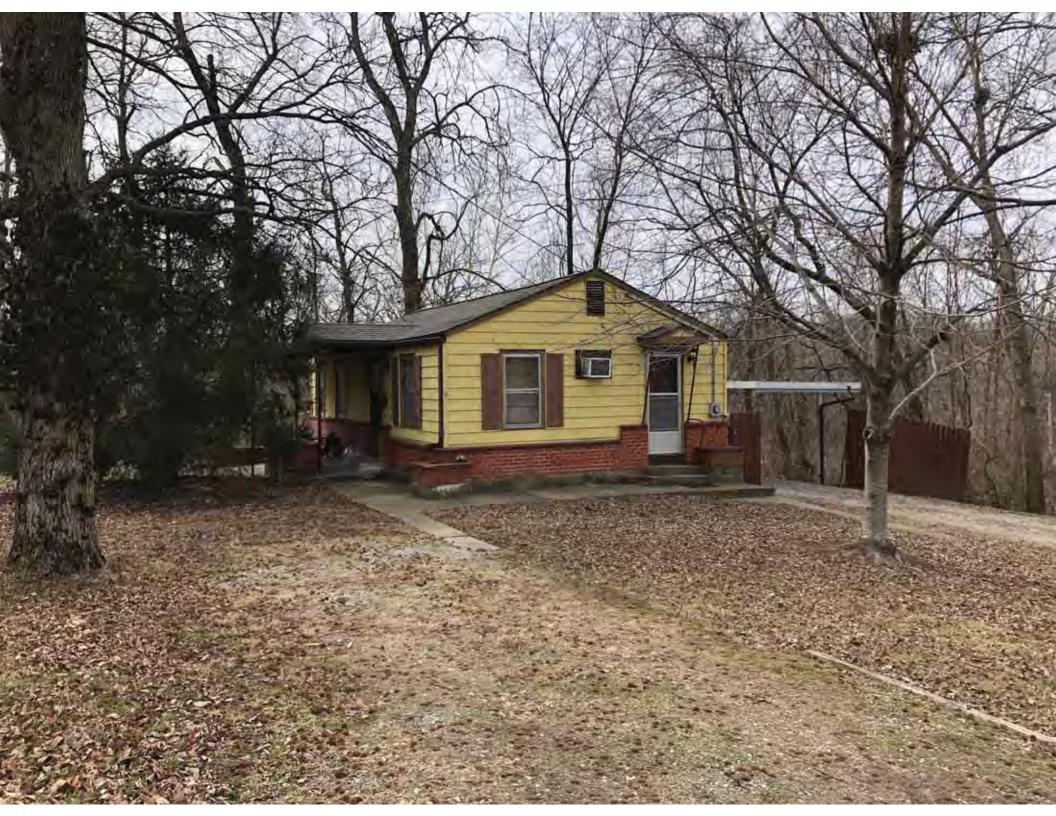
The main façade faces north. A single-leaf main entry door withgabled hood, is placed west of a replacement, one-over-one aluminum sash window withwood surround, which repeat at the east façade. The west façade is not visible from the right-of-way. Brick skirting lines the base of the house. A secondary entrance is located at the central bay of the east façade, which features a cross-gabled open porch, supported by two metal poles. This building may retain sufficient level of integrity to be considered for NRHP eligibility; however, it is a common example of its type that lacks distinction and therefore historical significance.

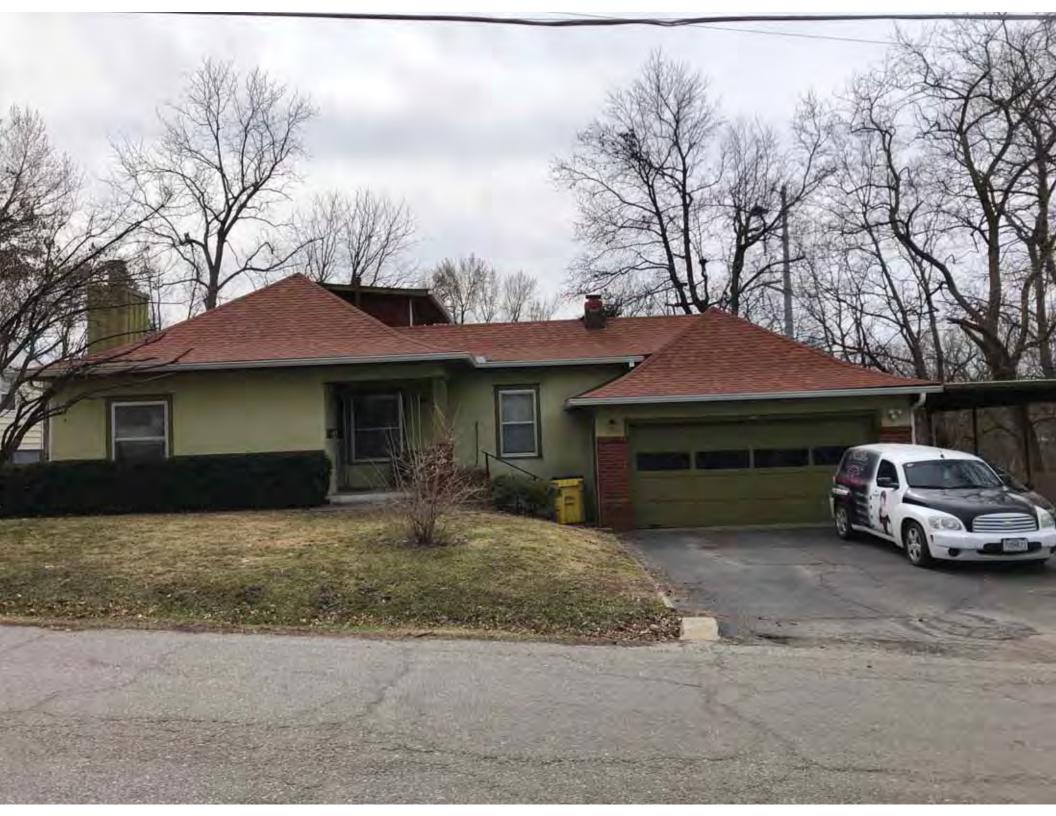
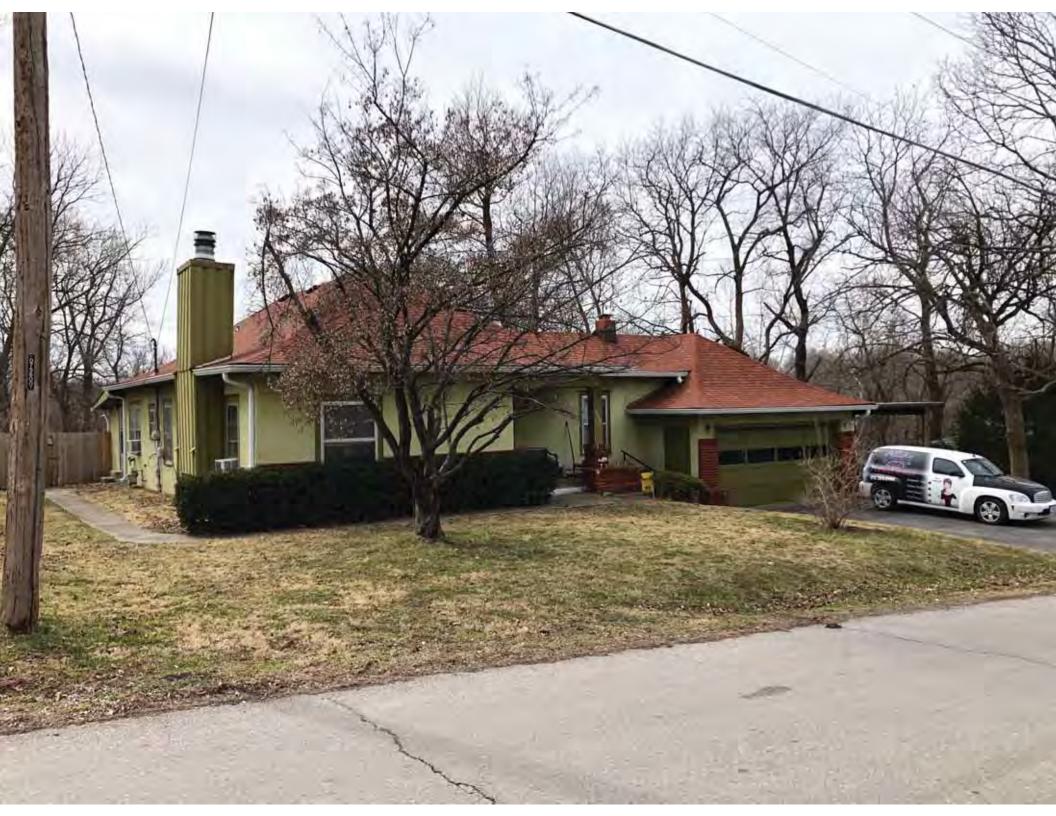
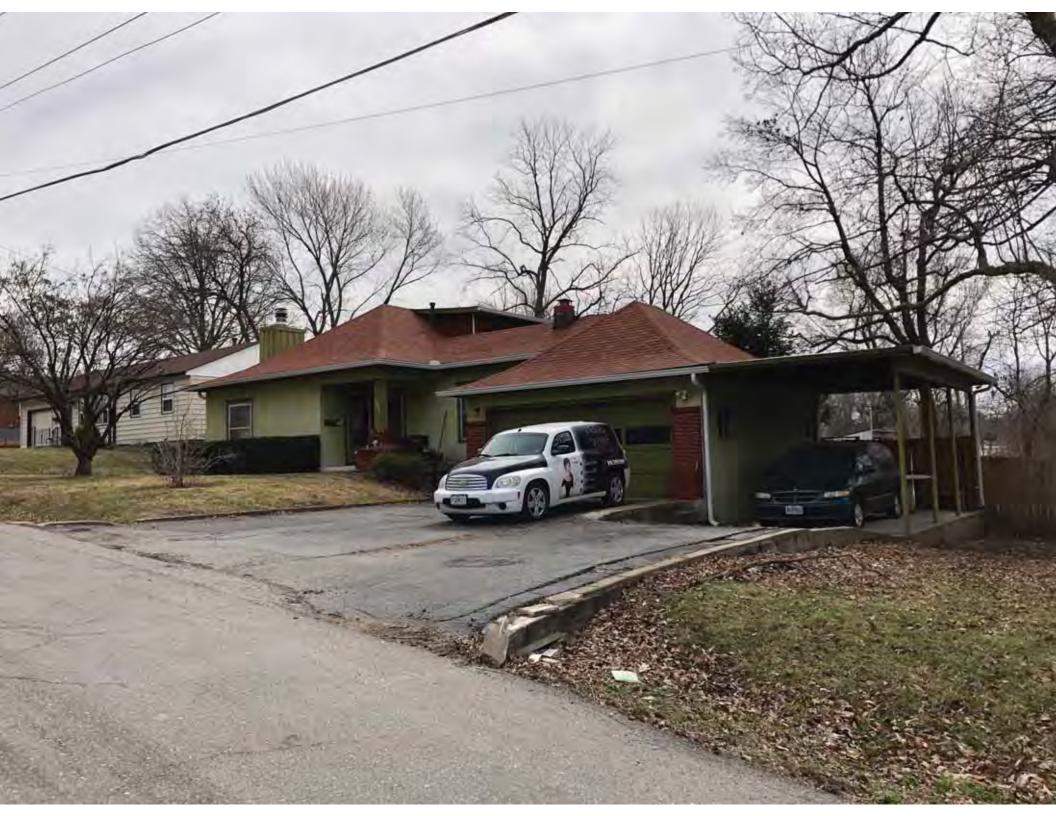
The main façade faces north. This house has been significantly altered from its original form with additions and alterations. This house features an original hipped, rectangular block (as depicted on 1945 and 1957 Sanborn Maps) with a c. 1960 ell addition, as observed on historic aerial imagery. The ell addition extends from the northern bay of the west façade and features a front-facing, hipped extension containing a two-car overhead garage door. Overall, the main façade forms a skewed U-plan with central, recessed porch entry. The partial porch features a single stuccoed column, supported by a brick pier. The main façade features replacement, one-over-one vinyl sash windows with wood surrounds, which repeat at the secondary façades. A shed roof extension is visible above the main roof line at the west façade of the rectangular block. Additional features include a large, exterior chimney clad in wood plank siding and a small brick chimney placed at the front roof slope. This building retains a sufficient level of integrity to be considered for NRHP eligibility; however, it is a common example of its type that lacks distinction and therefore historical significance.

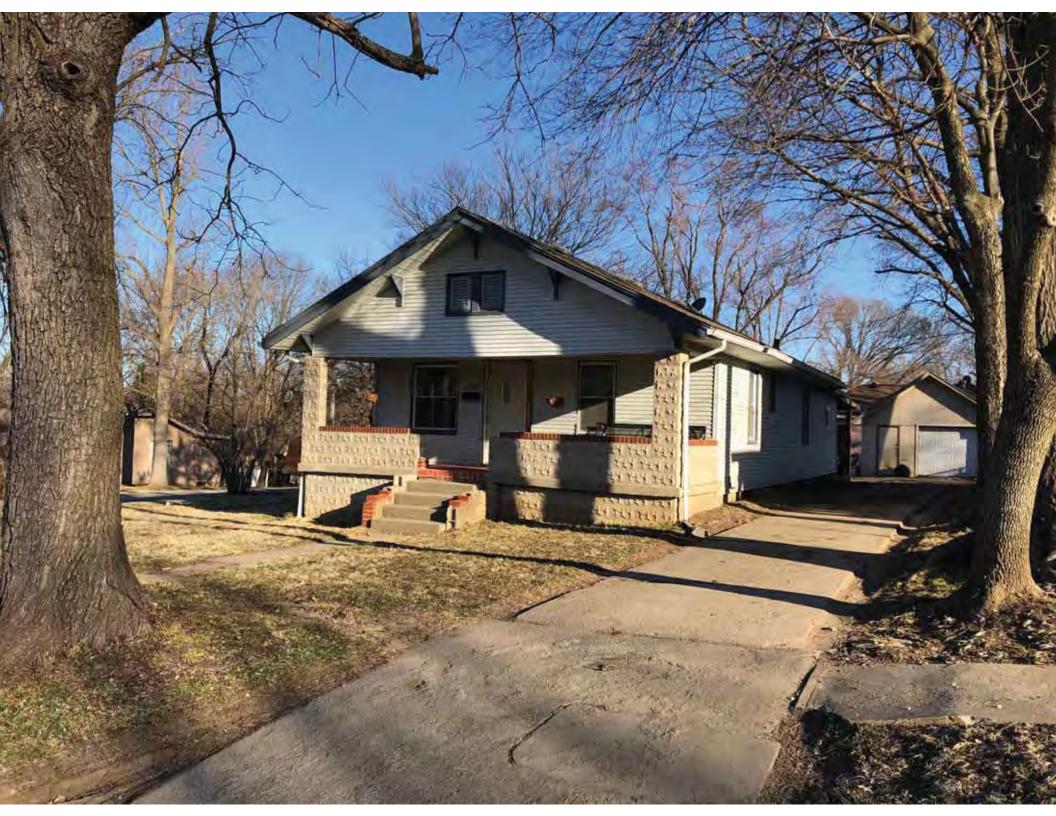
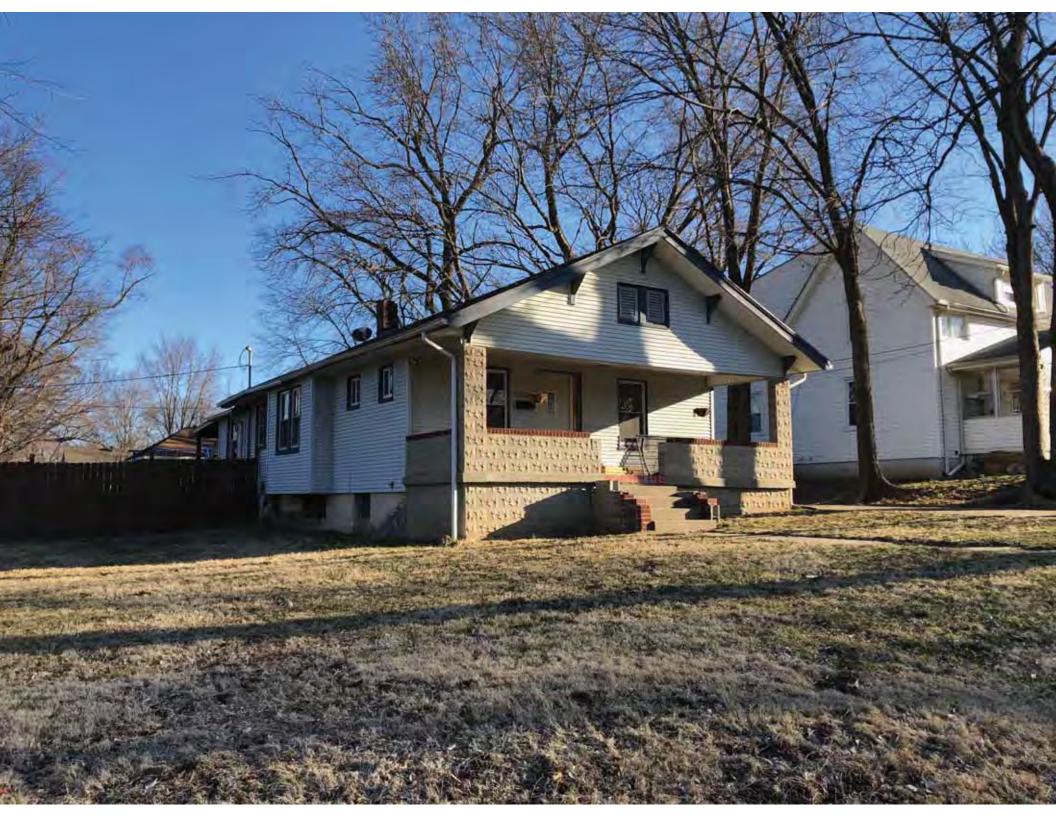
The main façade faces south. An asymmetrically-placed main entry is flanked by replacement, one-over-one vinyl sash windows with wood surrounds, which repeat as pairs and single window units at the secondary façades. The main entry consists of a single-leaf, York, paneled wood door with single obscure glass window. The full-width porch features cast concrete block columns and rail set on a matching foundation wall. The solid rail is capped with brick. The gable end features paired louvered vents and knee bracing. Additional features include a brick chimney placed at the west side of the gable roof and a bay window placed centrally at the west façade. A rear porch was enclosed at an unknown date. This building is a common example of its type that lacks distinction and therefore historical significance. Additionally, due to loss of original materials, this building lacks sufficient integrity of materials and workmanship to be considered eligible for listing in the NRHP.

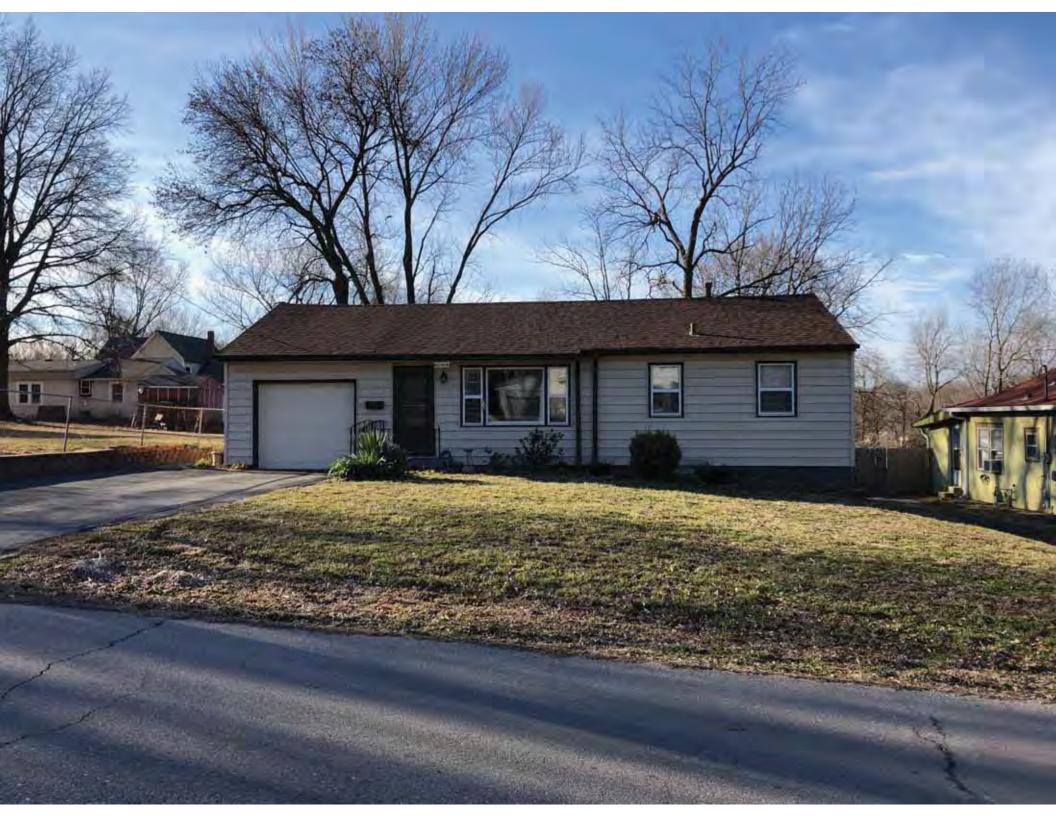
The main façade faces north. This Ranch house features a side-gabled roof and an addition to the rear. The frame house is clad in vinyl siding and contains an attached one-bay garage, an offset entrance door, 3-part picture window, and two replacement one-over-one vinyl sash windows at its main façade. The entry consists of a single-leaf, six-panel door with full-glass storm door. Historic aerial imagery shows an ell addition was constructed between 1963 and 1969, which was extended by 1990. Due to loss of original materials, changes to form, and other alterations, this building lacks sufficient integrity of design, materials and workmanship to be considered eligible for listing in the NRHP.
