National Register of Historic Places Registration Form

historic name Christman's Department Store, Christman's Annex, Paramount Building
other names/site number Fifth and Main Historic District (preferred)

street & number 501-513 South Main Street, 502-508 Virginia Street [N/A] not for publication
city or town Joplin [N/A] vicinity
state Missouri code MO county Jasper code 097 zip code 63357

**Fifth and Main Historic District (preferred)
Jasper County, Missouri**

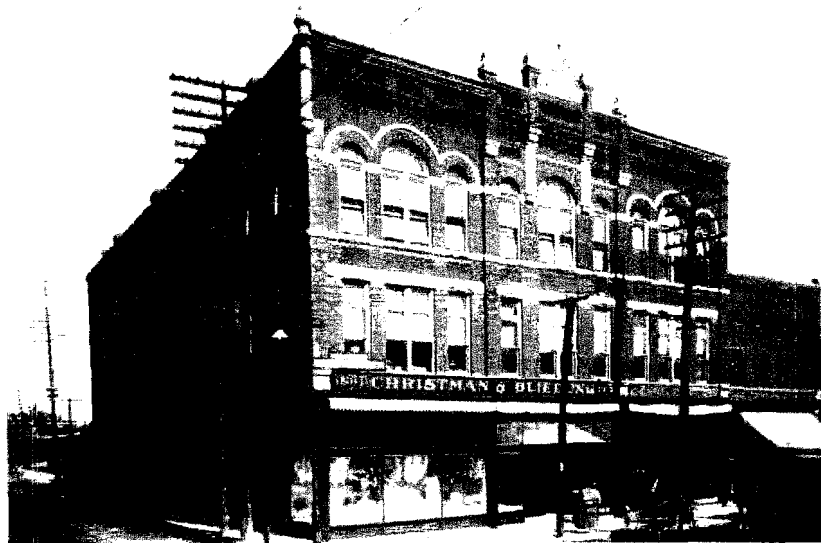
Figure Four: Christman's, Dubuque Block, 501-505 Main Street, ca. 1902
Source: Joplin Picture Book, 1902.

On September 13, 1890, they opened Christman and Bliedung Dry Goods at 211 Main Street.¹⁵ A year later, Charles Christman came to visit his brother, and he also decided to put down roots in Joplin. He purchased a furniture store at Third and Main Street that he and another brother, Fred Christman, operated under the name Christman Brothers Furniture.¹⁶ Both the Christman & Bliedung Dry Goods and Christman Brothers Furniture businesses were quite successful. Within just a few years, the two stores moved into a new building further downtown, in the heart of Joplin's commercial district. This new building, known as the "Dubuque Block," was a three-story building, at the corner of Fifth and Main Streets. (See Figure Four.) It appears to have been built for the Christman businesses.

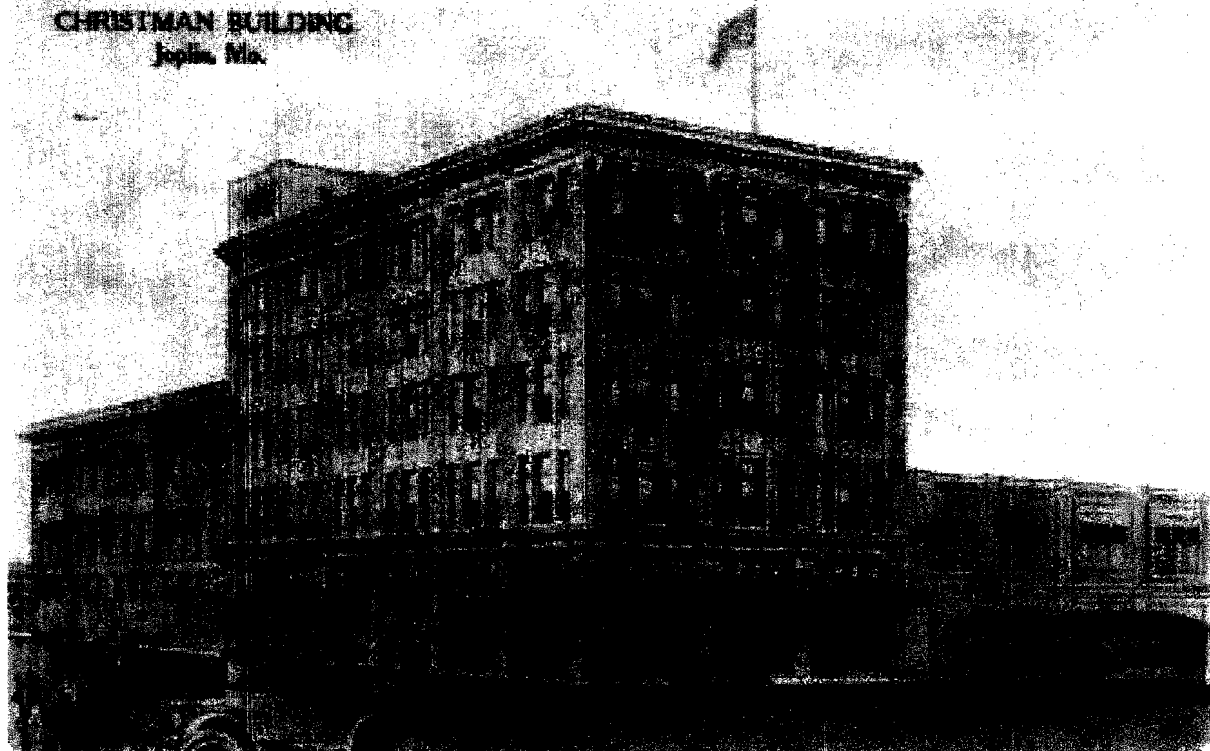
Figure Nine: Architect’s Drawing of the New Christman’s Building. This illustration was published in various sources of the day. Source: Property Owner’s files.

In what was undoubtedly an effort to keep up with their competition, Christman's also built a new building in 1917. They hired prominent local architects, August and Alfred Michaelis to design a modern new building for the store. Not wanting to sacrifice their prime location in downtown Joplin, the Christmans decided to construct the new building on the site of their current store. They used the annex on Virginia as a temporary store during the construction project. As noted in one article about the company, "in 1916, the stock of the company on the Main Street side was removed to the Virginia Avenue side and the five-story front was constructed."³³

In addition to incorporating new technology into the Christman Building, the Michaelis brothers designed the building using many of the principles of the popular Chicago Style. Typical of the Chicago Style, the Christman Building has a two-part vertical block form and a façade with minimal ornamentation and Chicago Style windows, which have a large central fixed-pane window flanked by 1/1 double-hung windows.³⁵ The Chicago Style was developed primarily by several Chicago architectural firms, including Sullivan and Adler, Burnham and Root and Holabird and Roche. These architects used innovative materials and technology in the late nineteenth and early twentieth
