**MISSOURI HISTORIC PROPERTY INVENTORY FORM**

REFERENCE NUMBER		A. HISTORIC NAME 109 Independence St						
B. COUNTY  031 Cape Girardeau		C. OTHER NAME (S)						
D. ADDRESS  109 Independence St				E. CITY  Cape Girardeau		F. VICINITY  <input type="checkbox"/>	G. RESTRICTED	H. ACREAGE

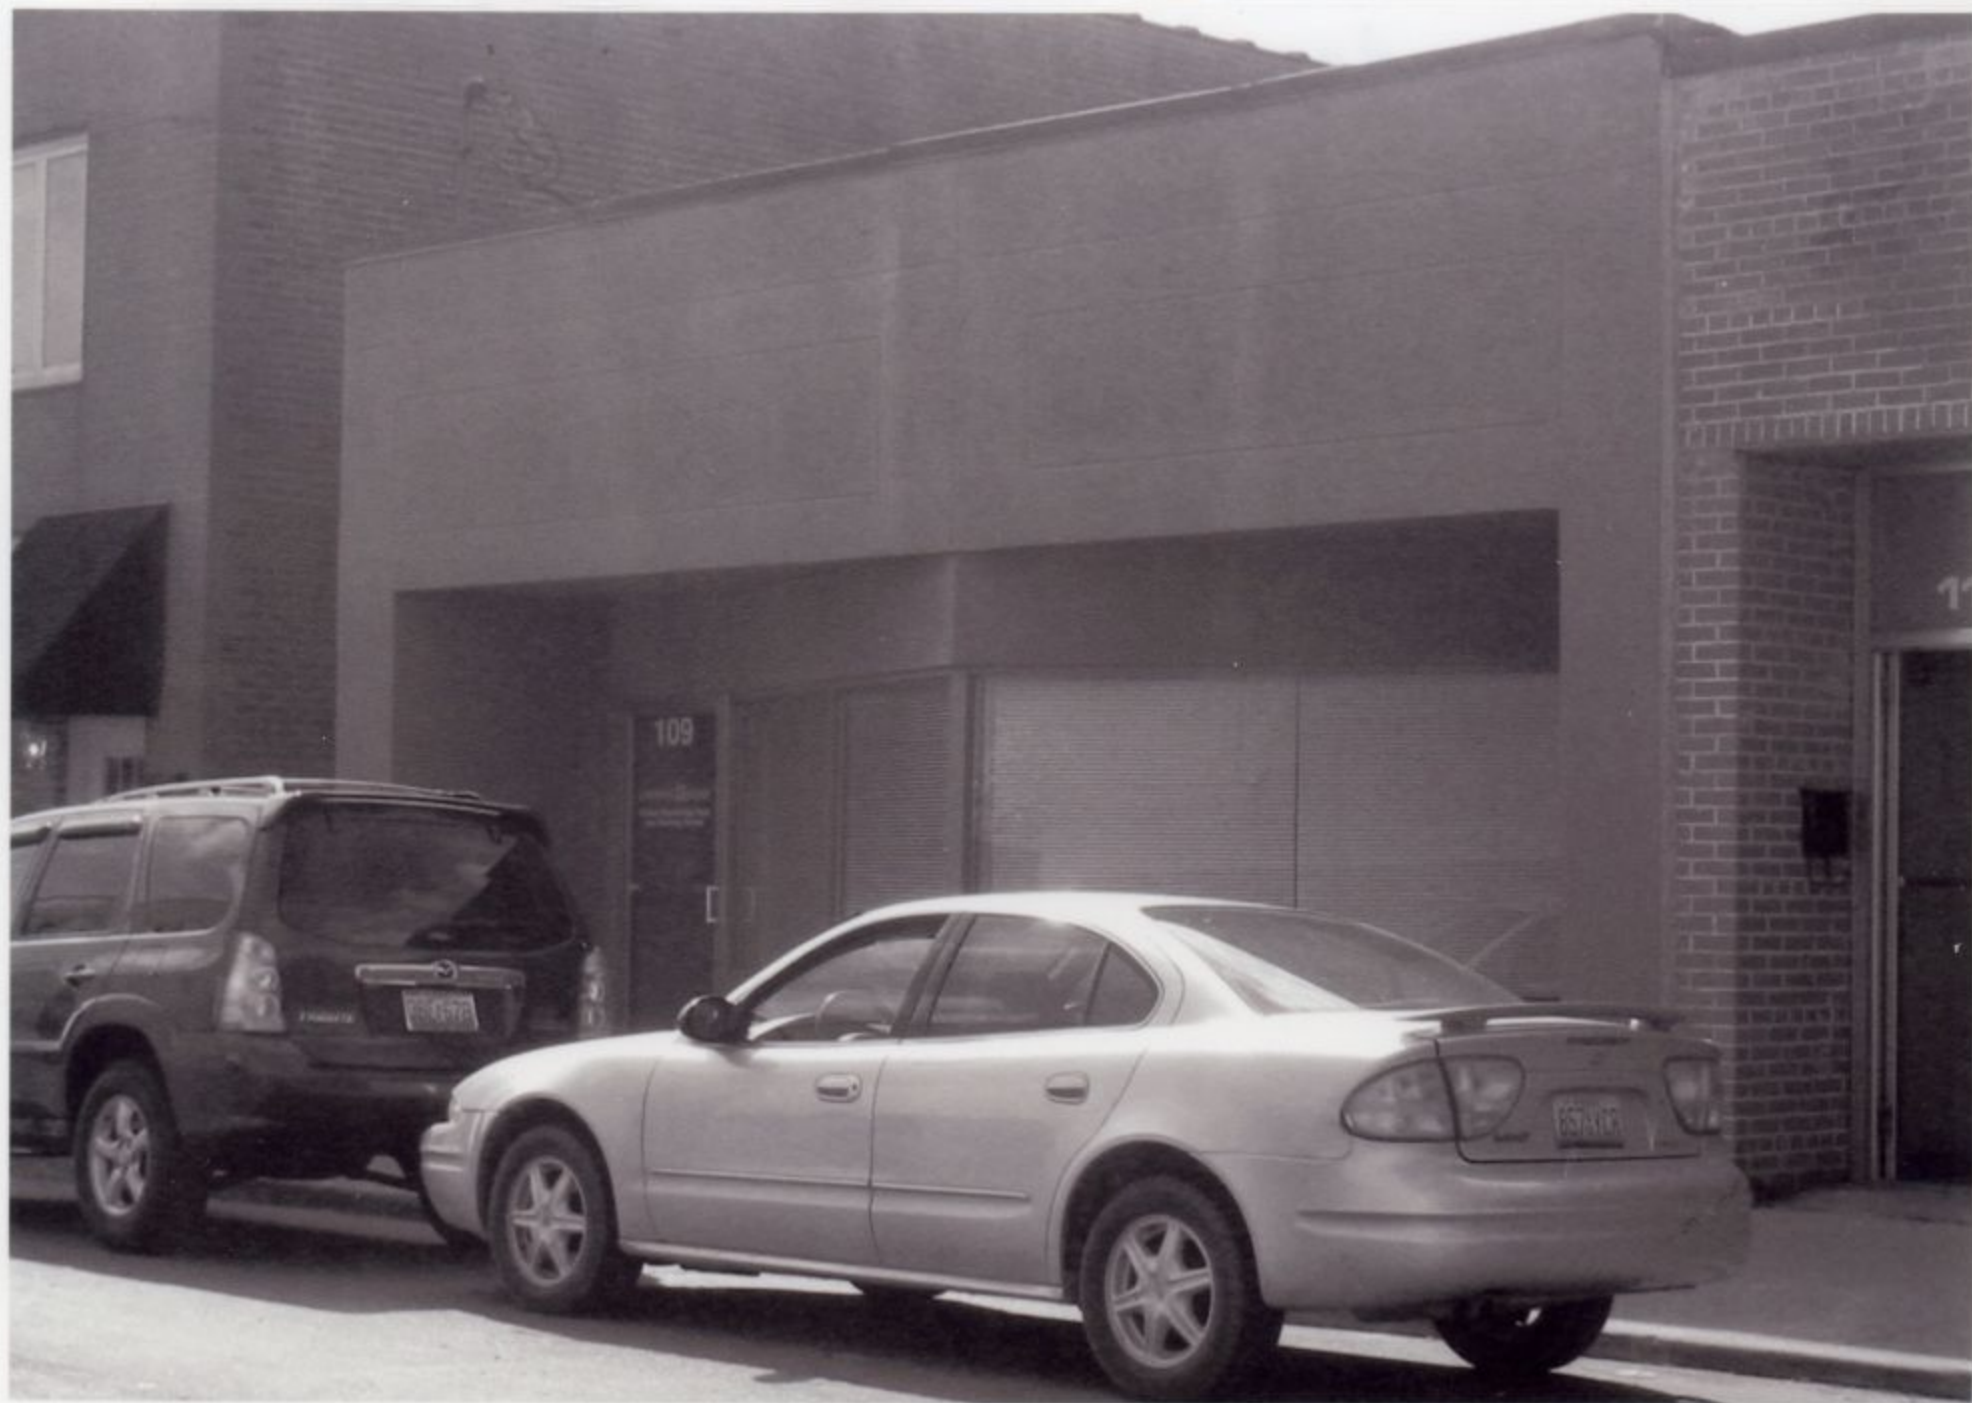
CG-AS-011-001

3.	/ / / / /		/ / / / /				3.	
4.	/ / / / /		/ / / / /				4.	
R. SIGNIFICANT PERSON(S)  1.  2.  3.					T. SIGNIFICANCE  109 Independence St is a one story concrete building with a flat roof. It shares a wall with the building to its left. It has an open ally to the right. The storefront has an inset glass door on both ends of the front façade with 2 angled storefront windows meeting in the middle. It is important to the area because it continues with the large storefront windows and glass door façade.

1. 1. 2. 3.	
2.O. STRUCTURAL SYSTEMS	2.P. EXTERIOR WALL MATERIALS		2.Q. OTHER MATERIALS	
1.	1. concrete		1. 3.	
2.	2.		2. 4.	
2.R. ROOF SHAPES	2.S. ROOF MATERIALS		2.T. ROOF FEATURES

1. FT Flat	1. tar and gravel		1. 4.	
2.	2.		2.	2.U. FOUNDATION MATERIALS
				1.
3.	3.		3.	2.
2.V. PORCHES				2.W. PLAN
1.		2.		3.
2.X. FURTHER DESCRIPTION		2.Y. DESCRIPTION OF ENVIRONMENT AND OUTBUILDINGS commercial area/district

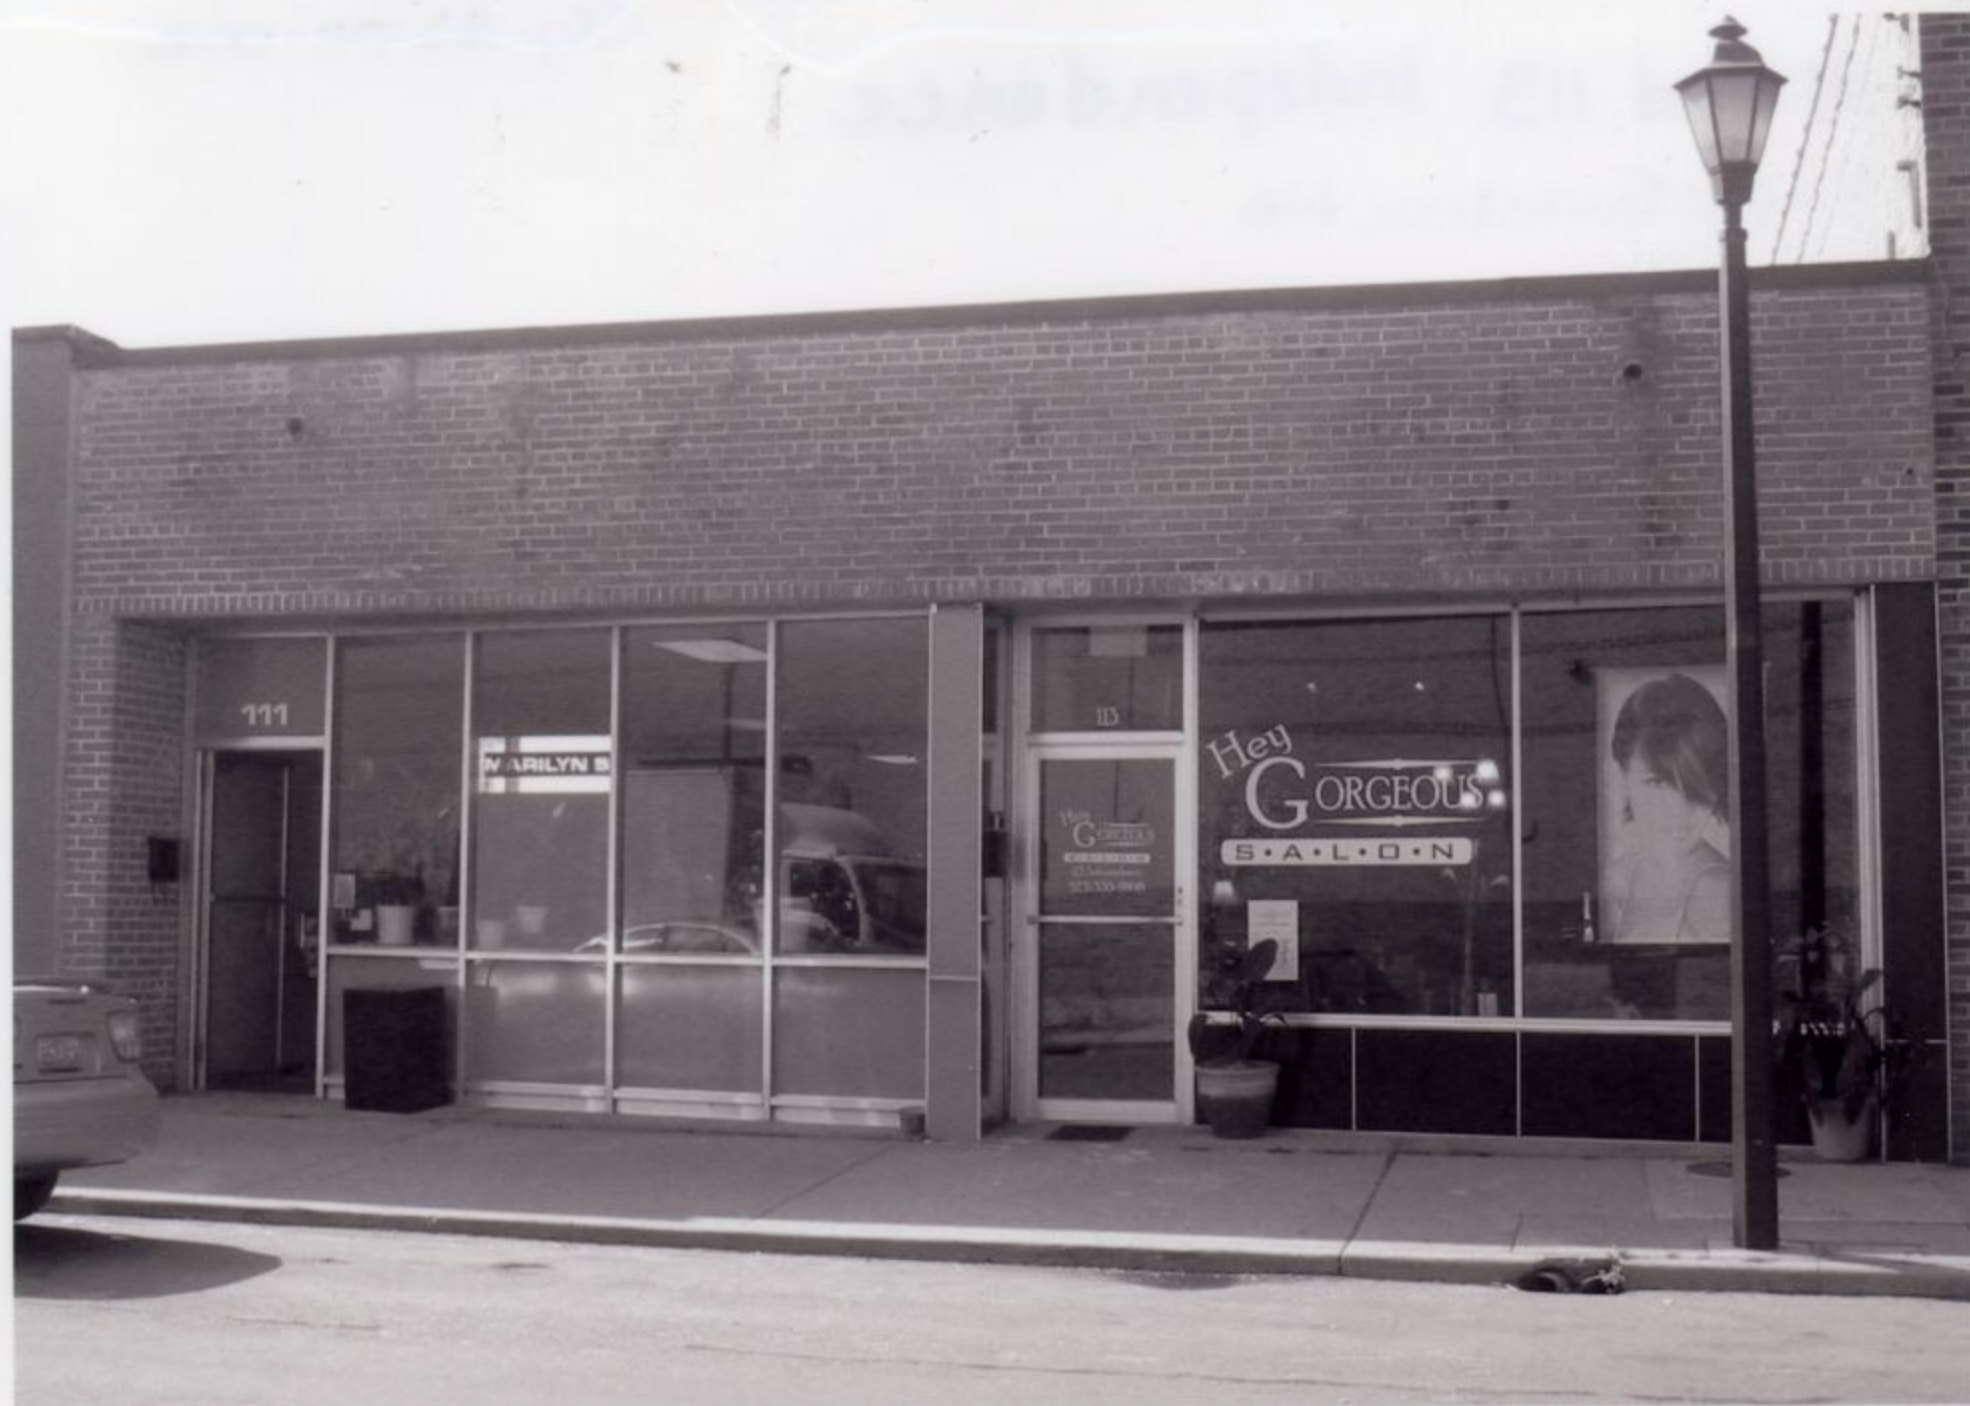
3.	/ / / / / /		/ / / / / /				3.	
4.	/ / / / / /		/ / / / / /				4.	
R. SIGNIFICANT PERSON(S)  1.  2.  3.					T. SIGNIFICANCE  111 and 113 Independence St is a one story brick building with a flat roof. The building is divided into 2 separate store fronts. The first half has a glass door to the far right with a set of elongated windows taking up the remaining part of the wall. The second half is identical to the first half. The brickwork ties the building in with the surrounding area.

1. 1. 2. 3.	
2.O. STRUCTURAL SYSTEMS	2.P. EXTERIOR WALL MATERIALS		2.Q. OTHER MATERIALS	
1.	1. brick		1. 3.	
2.	2.		2. 4.	
2.R. ROOF SHAPES	2.S. ROOF MATERIALS		2.T. ROOF FEATURES

1. FT Flat	1. tar and gravel		1. 4.	
2.	2.	2.	2.U. FOUNDATION MATERIALS	
			1.	
3.	3.	3.	2.	
2.V. PORCHES			2.W. PLAN	
1.		2.		3.
2.X. FURTHER DESCRIPTION		2.Y. DESCRIPTION OF ENVIRONMENT AND OUTBUILDINGS commercial area/district

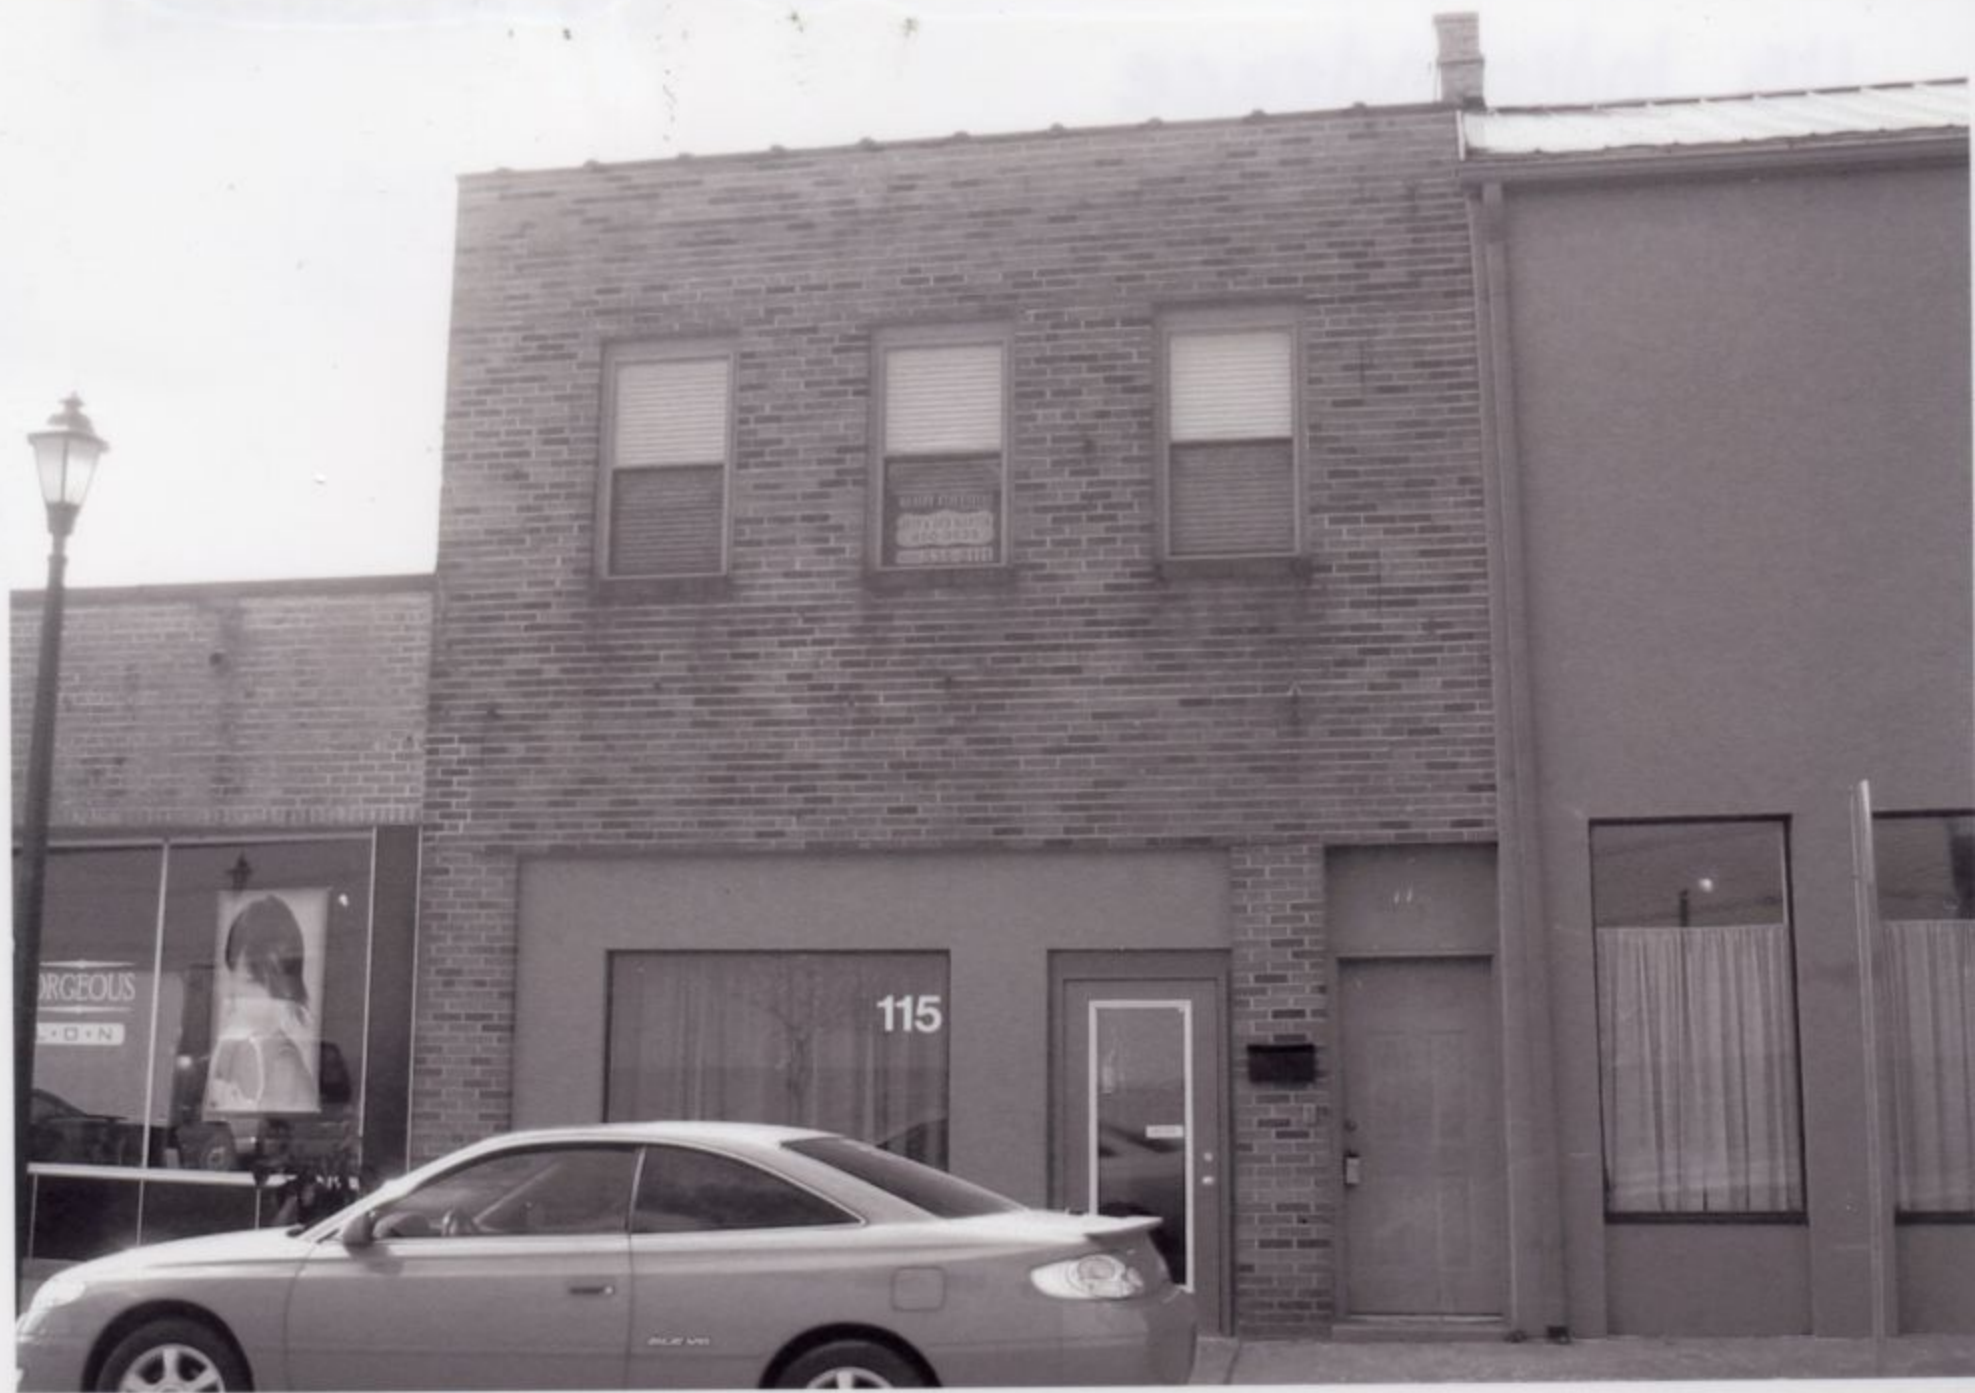
CG-AS-011-003

3.	/ / / / /		/ / / / /				3.	
4.	/ / / / /		/ / / / /				4.	
R. SIGNIFICANT PERSON(S)  1.  2.  3.					T. SIGNIFICANCE  115 Independence is a 2 story brick building with a flat roof. The building is flush with the other buildings on the block and shares walls with the neighboring buildings. The main entrance is similar to the other buildings with a large store front window next to a glass door. The entrance for the upstairs is located at the far left of the front façade. There are also 3 double sash windows placed symmetrically on the 2nd floor. The building also fits into the area because of the brickwork, which is similar to the majority of the buildings in the area. The roofline has terra cotta capping.

1. FT Flat	1. tar and gravel		1. 4.	
2.	2.	2.	2.U. FOUNDATION MATERIALS	
			1.	
3.	3.	3.	2.	
2.V. PORCHES			2.W. PLAN	
1.		2.		3.
2.X. FURTHER DESCRIPTION		2.Y. DESCRIPTION OF ENVIRONMENT AND OUTBUILDINGS commercial area/district

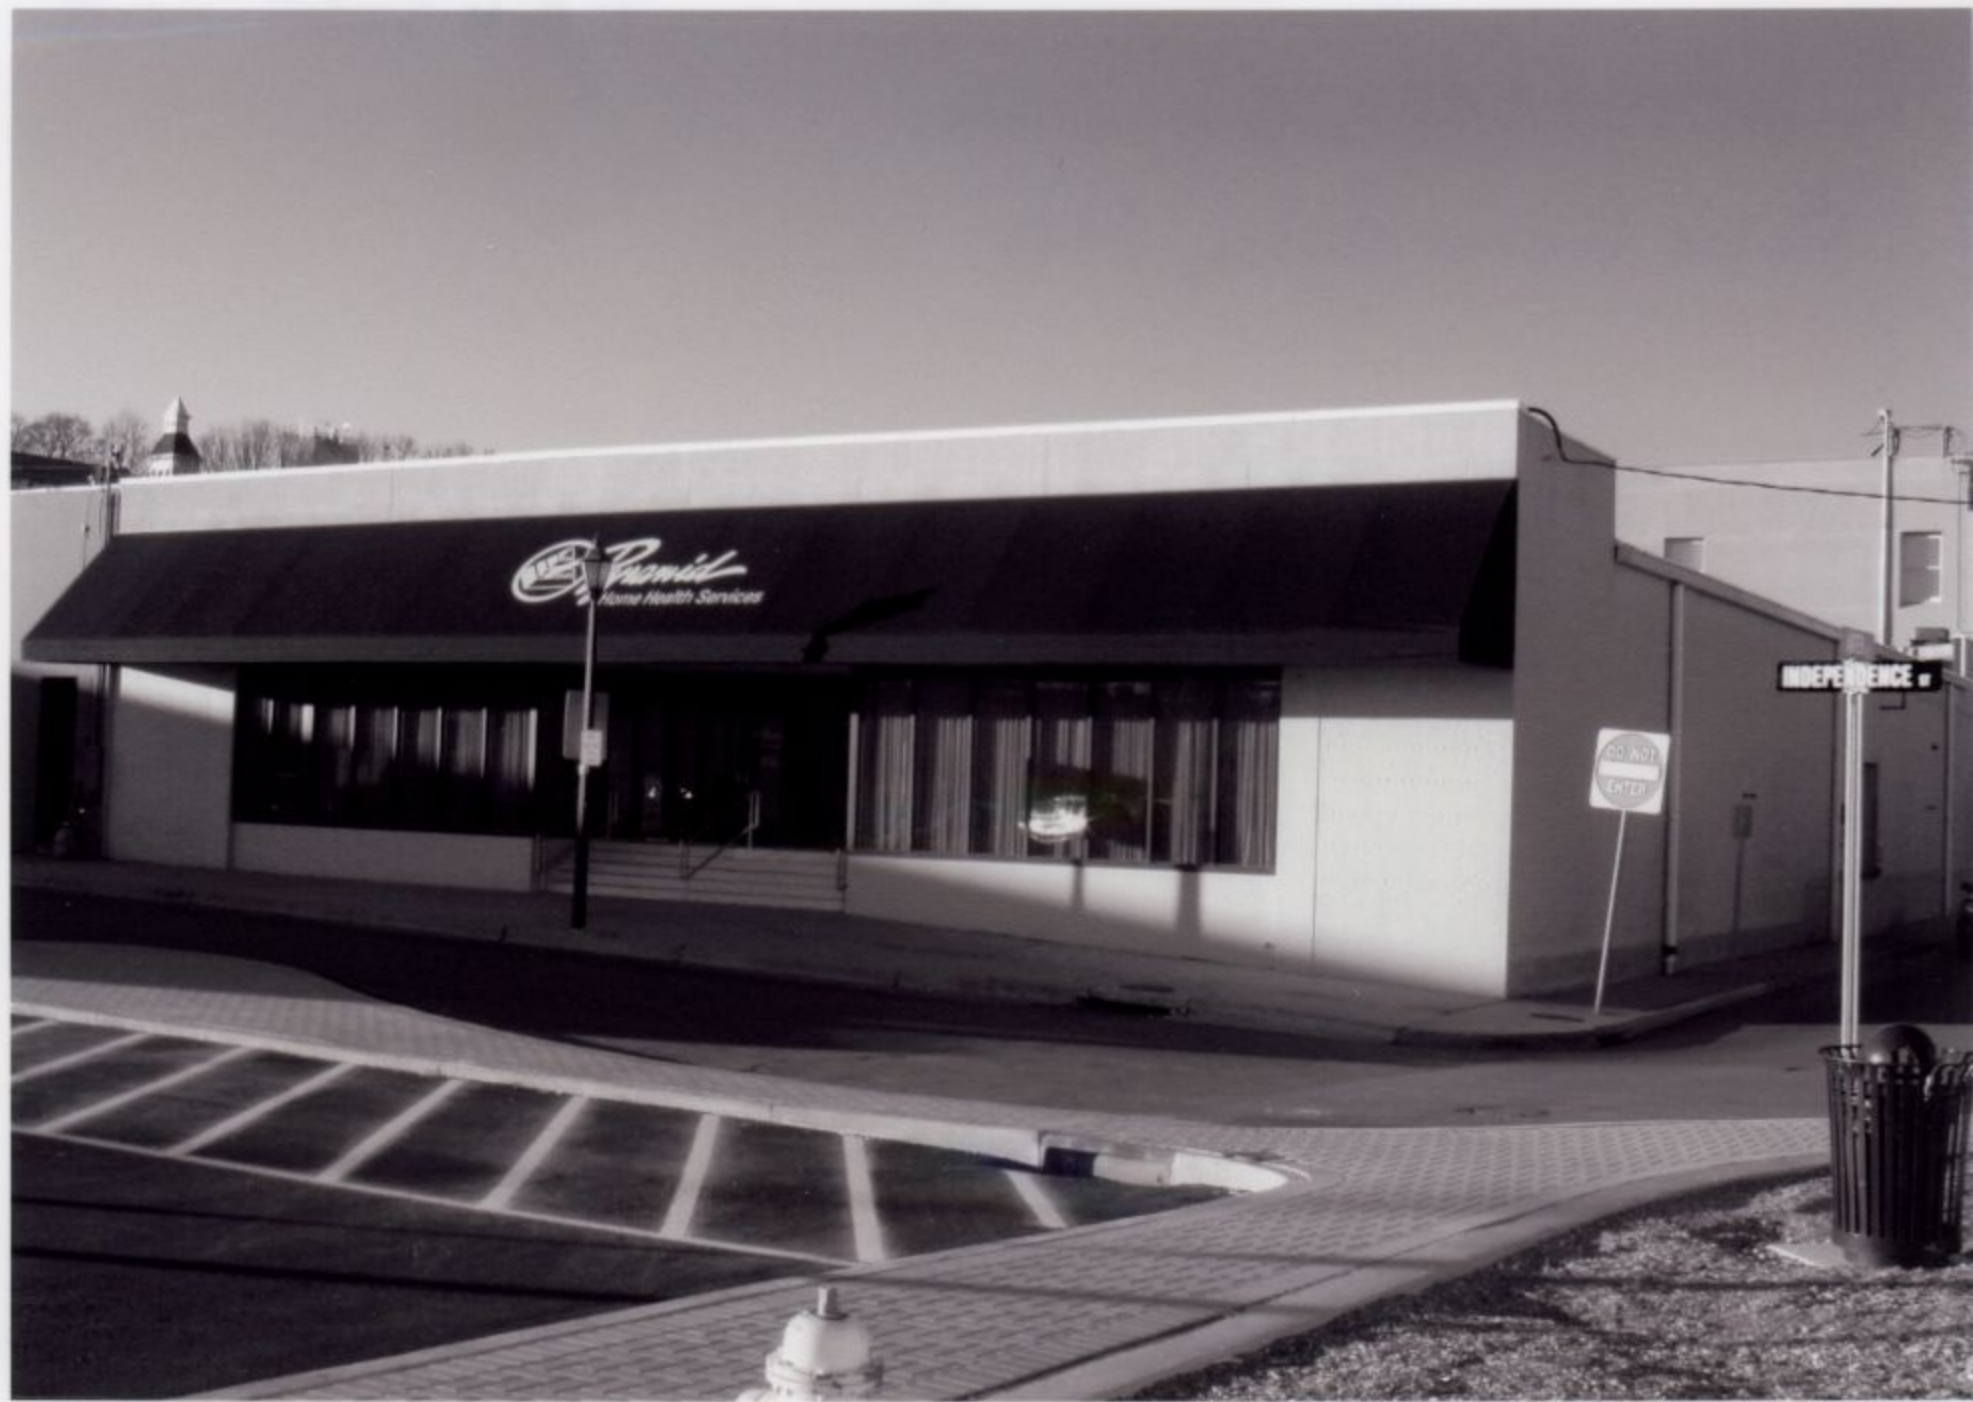
3.		/ / / / /		/ / / / /				3.	
4.		/ / / / /		/ / / / /				4.	
R. SIGNIFICANT PERSON(S) 1. 2. 3.						T. SIGNIFICANCE  This one story commercial building with a flat roof and parapet is composed of a common bond brick pattern. The south facing, extensively renovated façade has stairs leading to a recessed entrance with a glass double door has a transom light and is flanked by twelved windows on either side. An awning spans the entire length of this façade. Dryvit extends around the windows. The east facing façade has a concrete foundation, hollow core door, and a loading bay window.

2.	2. T. & G.		2.U. FOUNDATION MATERIALS  1. Conc. Block	
3.	3.		2. Brick	
2.V. PORCHES 1. AW Awning			2.W. PLAN RC Rectangle	
2.X. FURTHER DESCRIPTION			2.Y. DESCRIPTION OF ENVIRONMENT AND OUTBUILDINGS

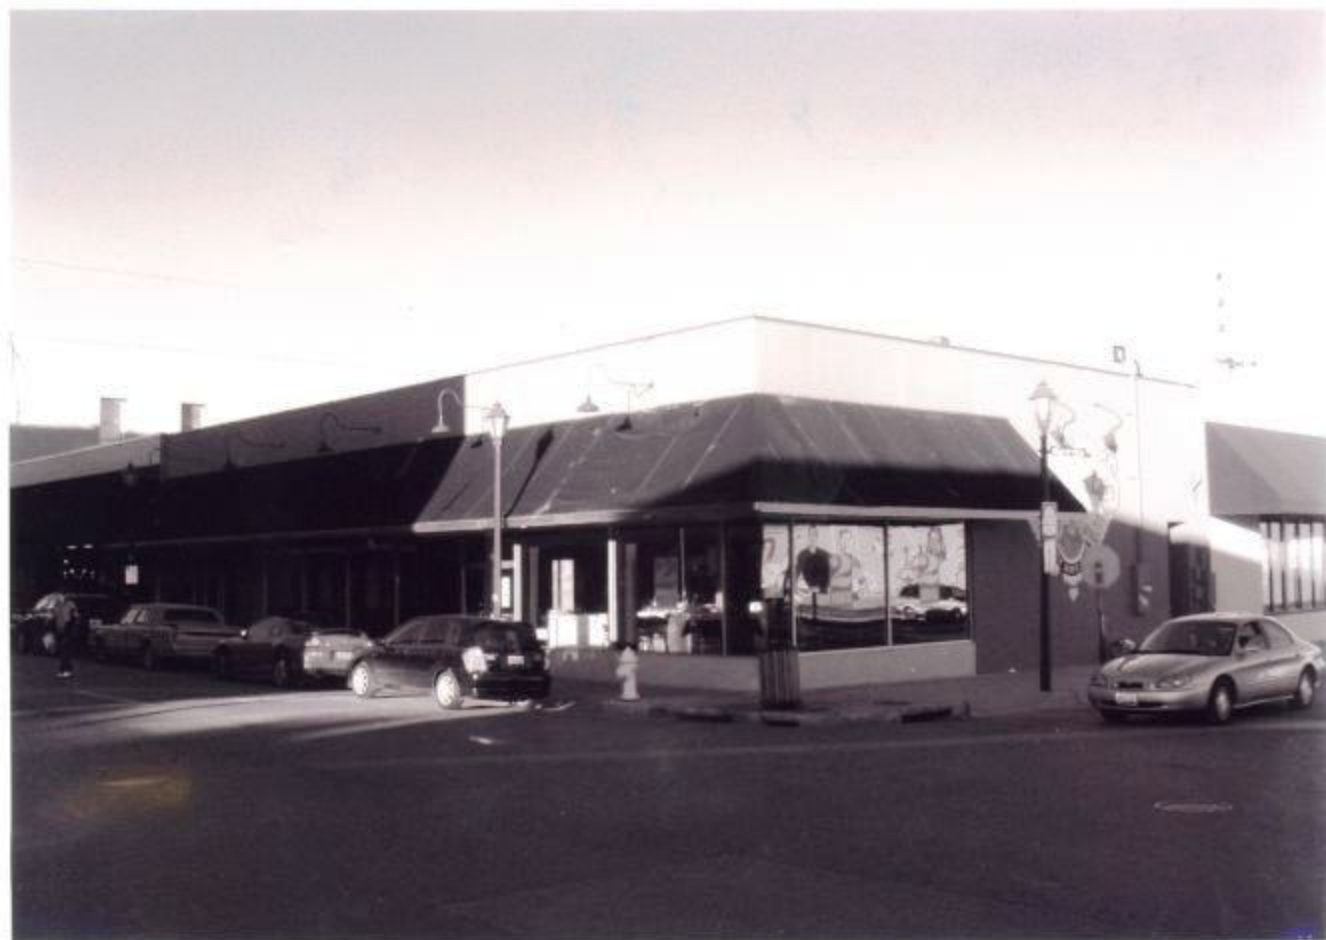
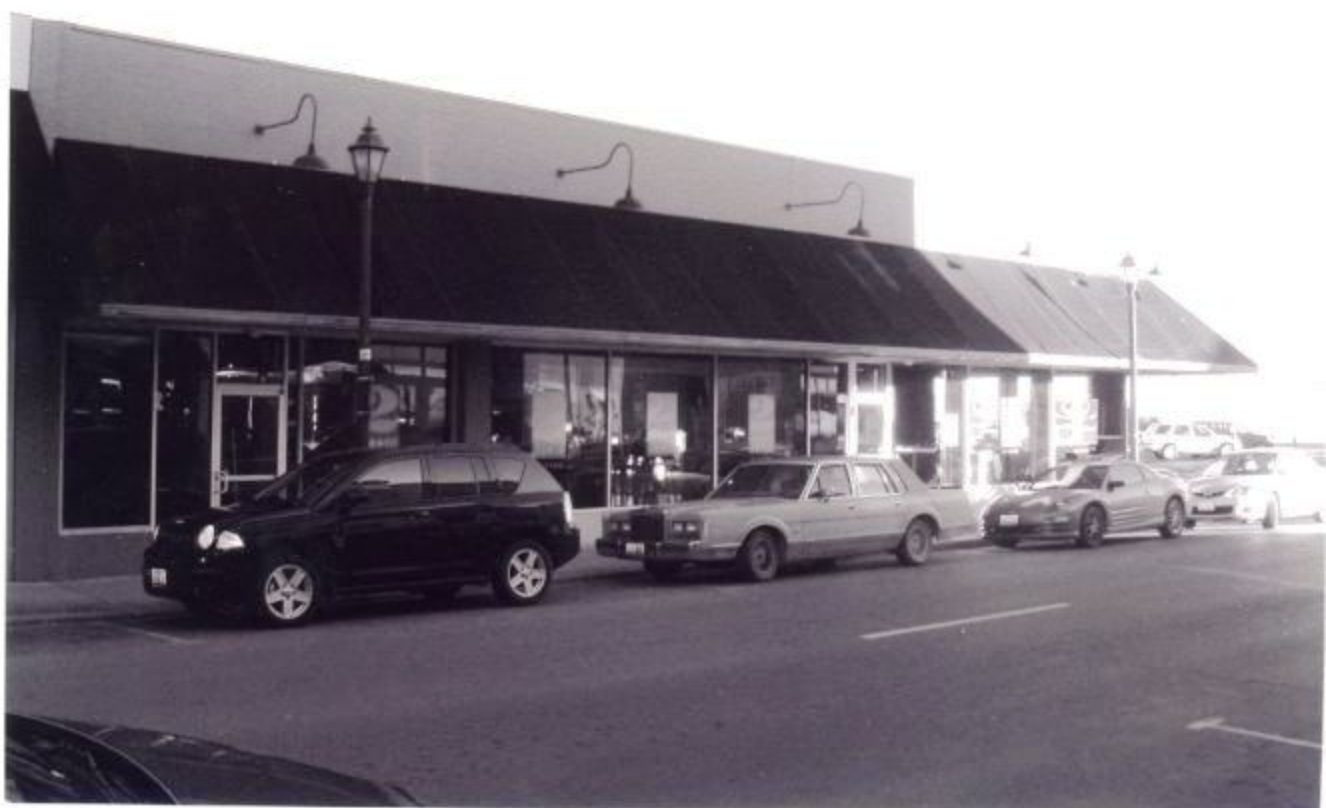
CG-AS-011-007  
**MISSOURI HISTORIC PROPERTY INVENTORY FORM**

3.		/ / / / /		/ / / / /				3.
4.		/ / / / /		/ / / / /				4.
R. SIGNIFICANT PERSON(S)  1. 2. 3.					T. SIGNIFICANCE  This one story commercial building with a flat roof is composed of stretcher pattern brick. The west facing storefront has two sections with a brick divider. The northern section of has four plate glass windows and a glass door with a transom and two large plate glass windows on either side of the door. The southern section has two plate glass windows and two glass doors with transoms seperated by a center divide. A concrete foundation extends from under the façade's windows to beneath the south façade's two plate glass windows. An awning covers the west façade's windows and entrance and extends around the south façade over the windows.

2.R. ROOF SHAPES 1. FT Flat		2.S. ROOF MATERIALS 1. B. U.	
2. 2.		2.T. ROOF FEATURES 1. 4.	
3.		2.U. FOUNDATION MATERIALS 1. Cont. Wall	
		2. Conc. Block

2.V. PORCHES 1. AW Awning 2. 3.			2.W. PLAN RC Rectangle
2.X. FURTHER DESCRIPTION		2.Y. DESCRIPTION OF ENVIRONMENT AND OUTBUILDINGS	
2.Z. SOURCES OF INFORMATION		PREPARED BY Travis Ratermann and Brooke Culler	ORGANIZATION Southeast Missouri State University
		DATE March 27, 2007

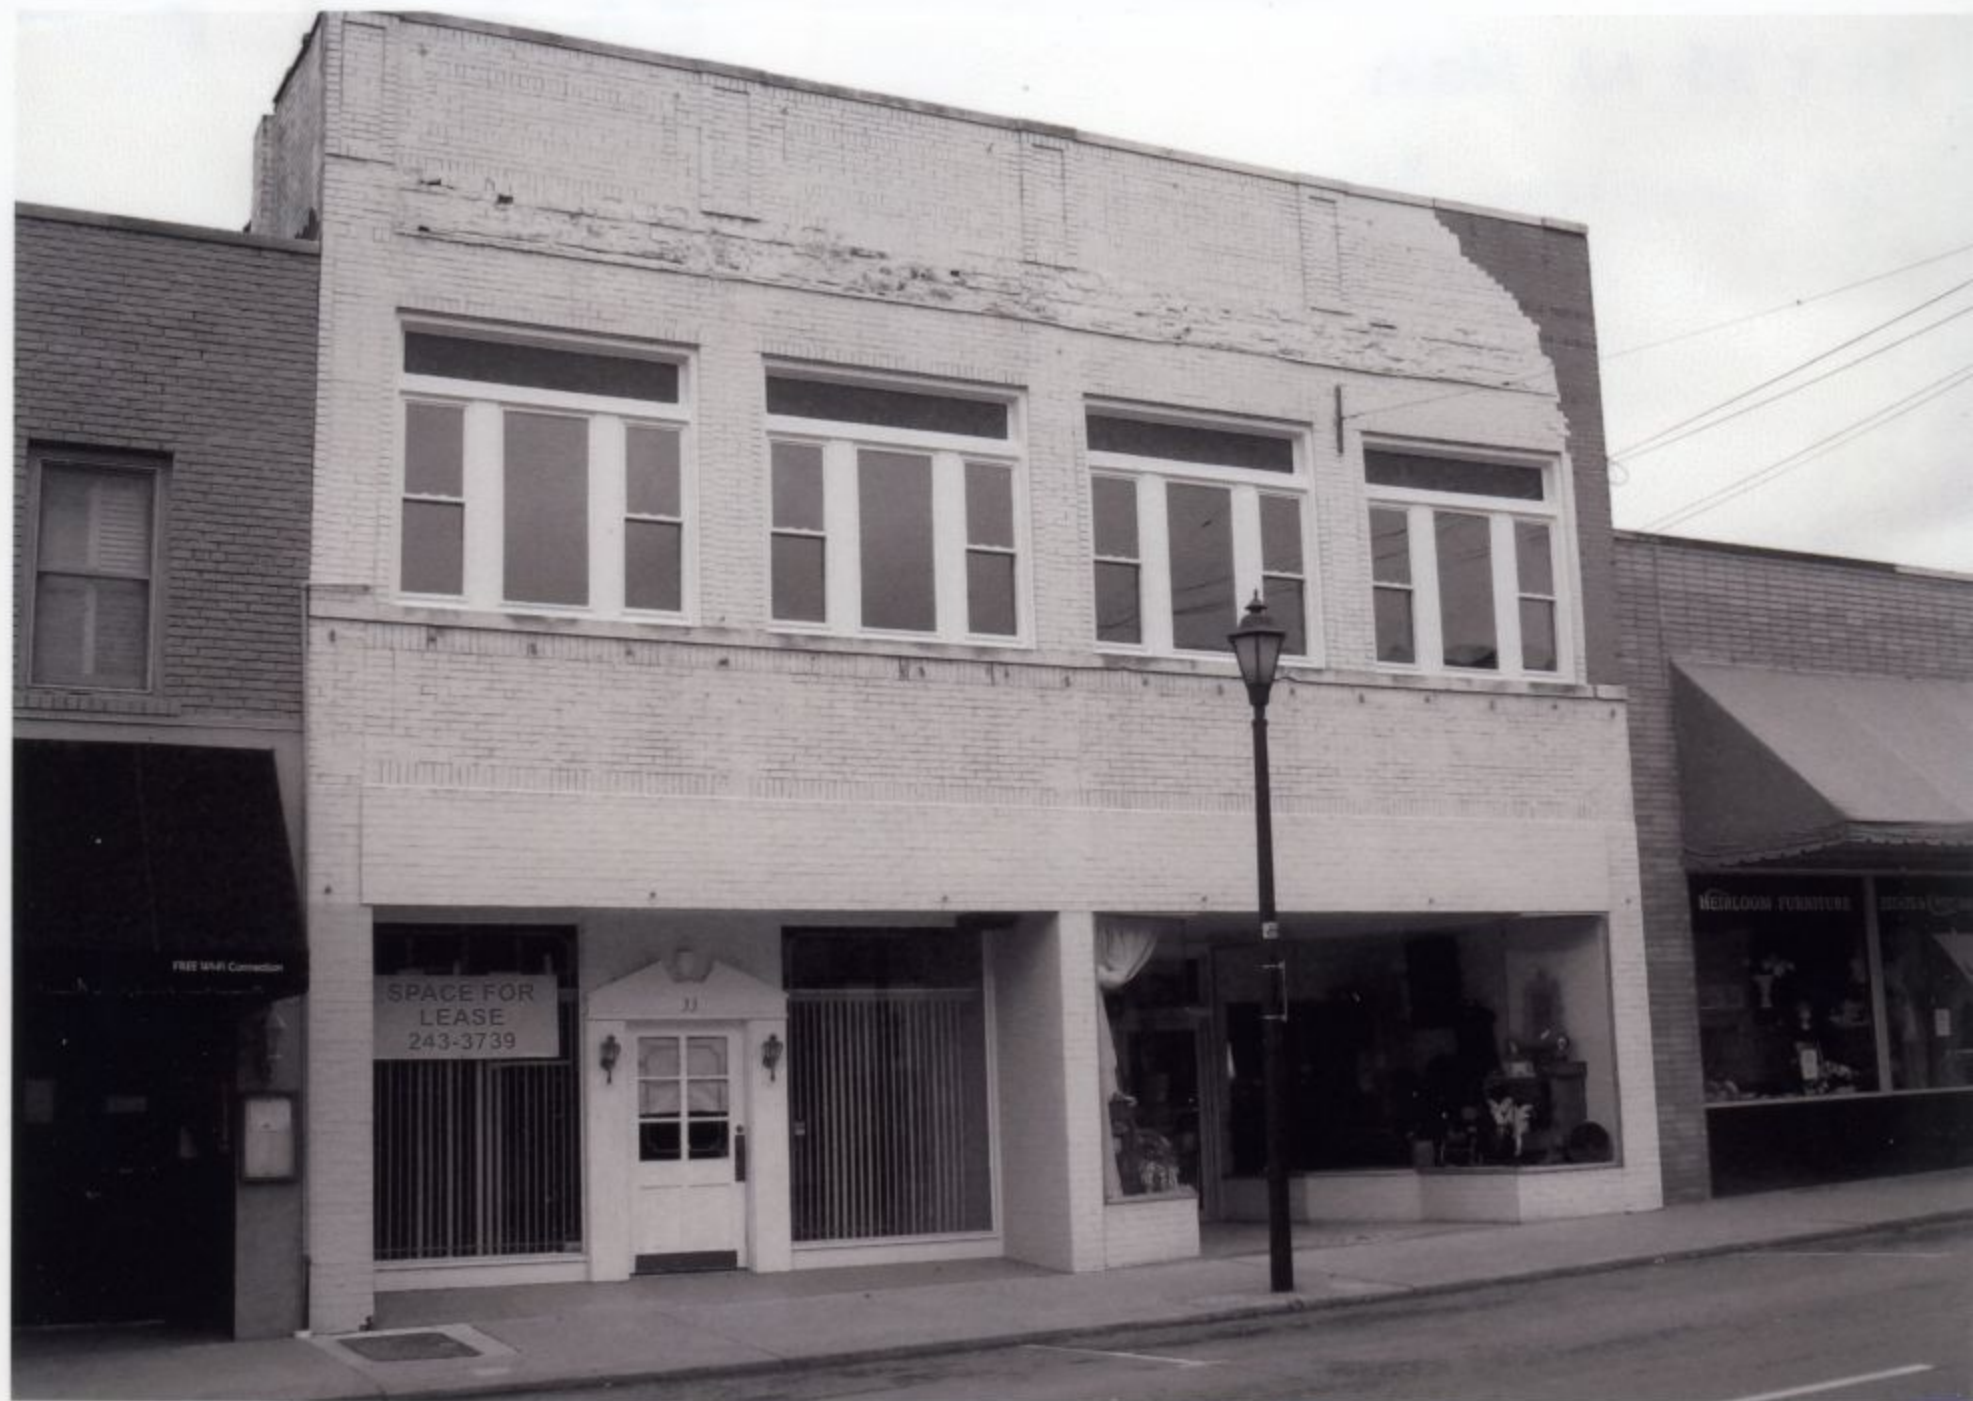
3.	/ / / / /		/ / / / /				3.	
4.	/ / / / /		/ / / / /				4.	
R. SIGNIFICANT PERSON(S)  1.  2.  3.				T. SIGNIFICANCE  33 and 35 N Main St spans 40 feet of the street and, it is labeled and addressed as two separate businesses with two separate addresses, but is still one whole structure. Though the brick structures have been altered and separated to hold two stores as opposed to one, the building still maintains its original appearance. There are several elements that are in need of repair. Most importantly the building contains five decorative brick rectangles along the cornice line left from the original construction. Standing at two stories, the two store fronts are recessed with two floor ceiling display windows and a single entrance in the center. The southern entrance has a broken pediment above the door with pilasters on the sides, and the northern entrance is a simple glass door with tramson light above it. There is a wide brick belt course above the two separate fronts and four large windows above that.

1. FT Flat	1.		1. 4.	
2.	2.		2.	2.U. FOUNDATION MATERIALS
				1.
3.	3.		3.	2.
2.V. PORCHES			2.W. PLAN	
1. R1 Recessed - 1 story		2.	3.	RC Rectangle
2.X. FURTHER DESCRIPTION		2.Y. DESCRIPTION OF ENVIRONMENT AND OUTBUILDINGS

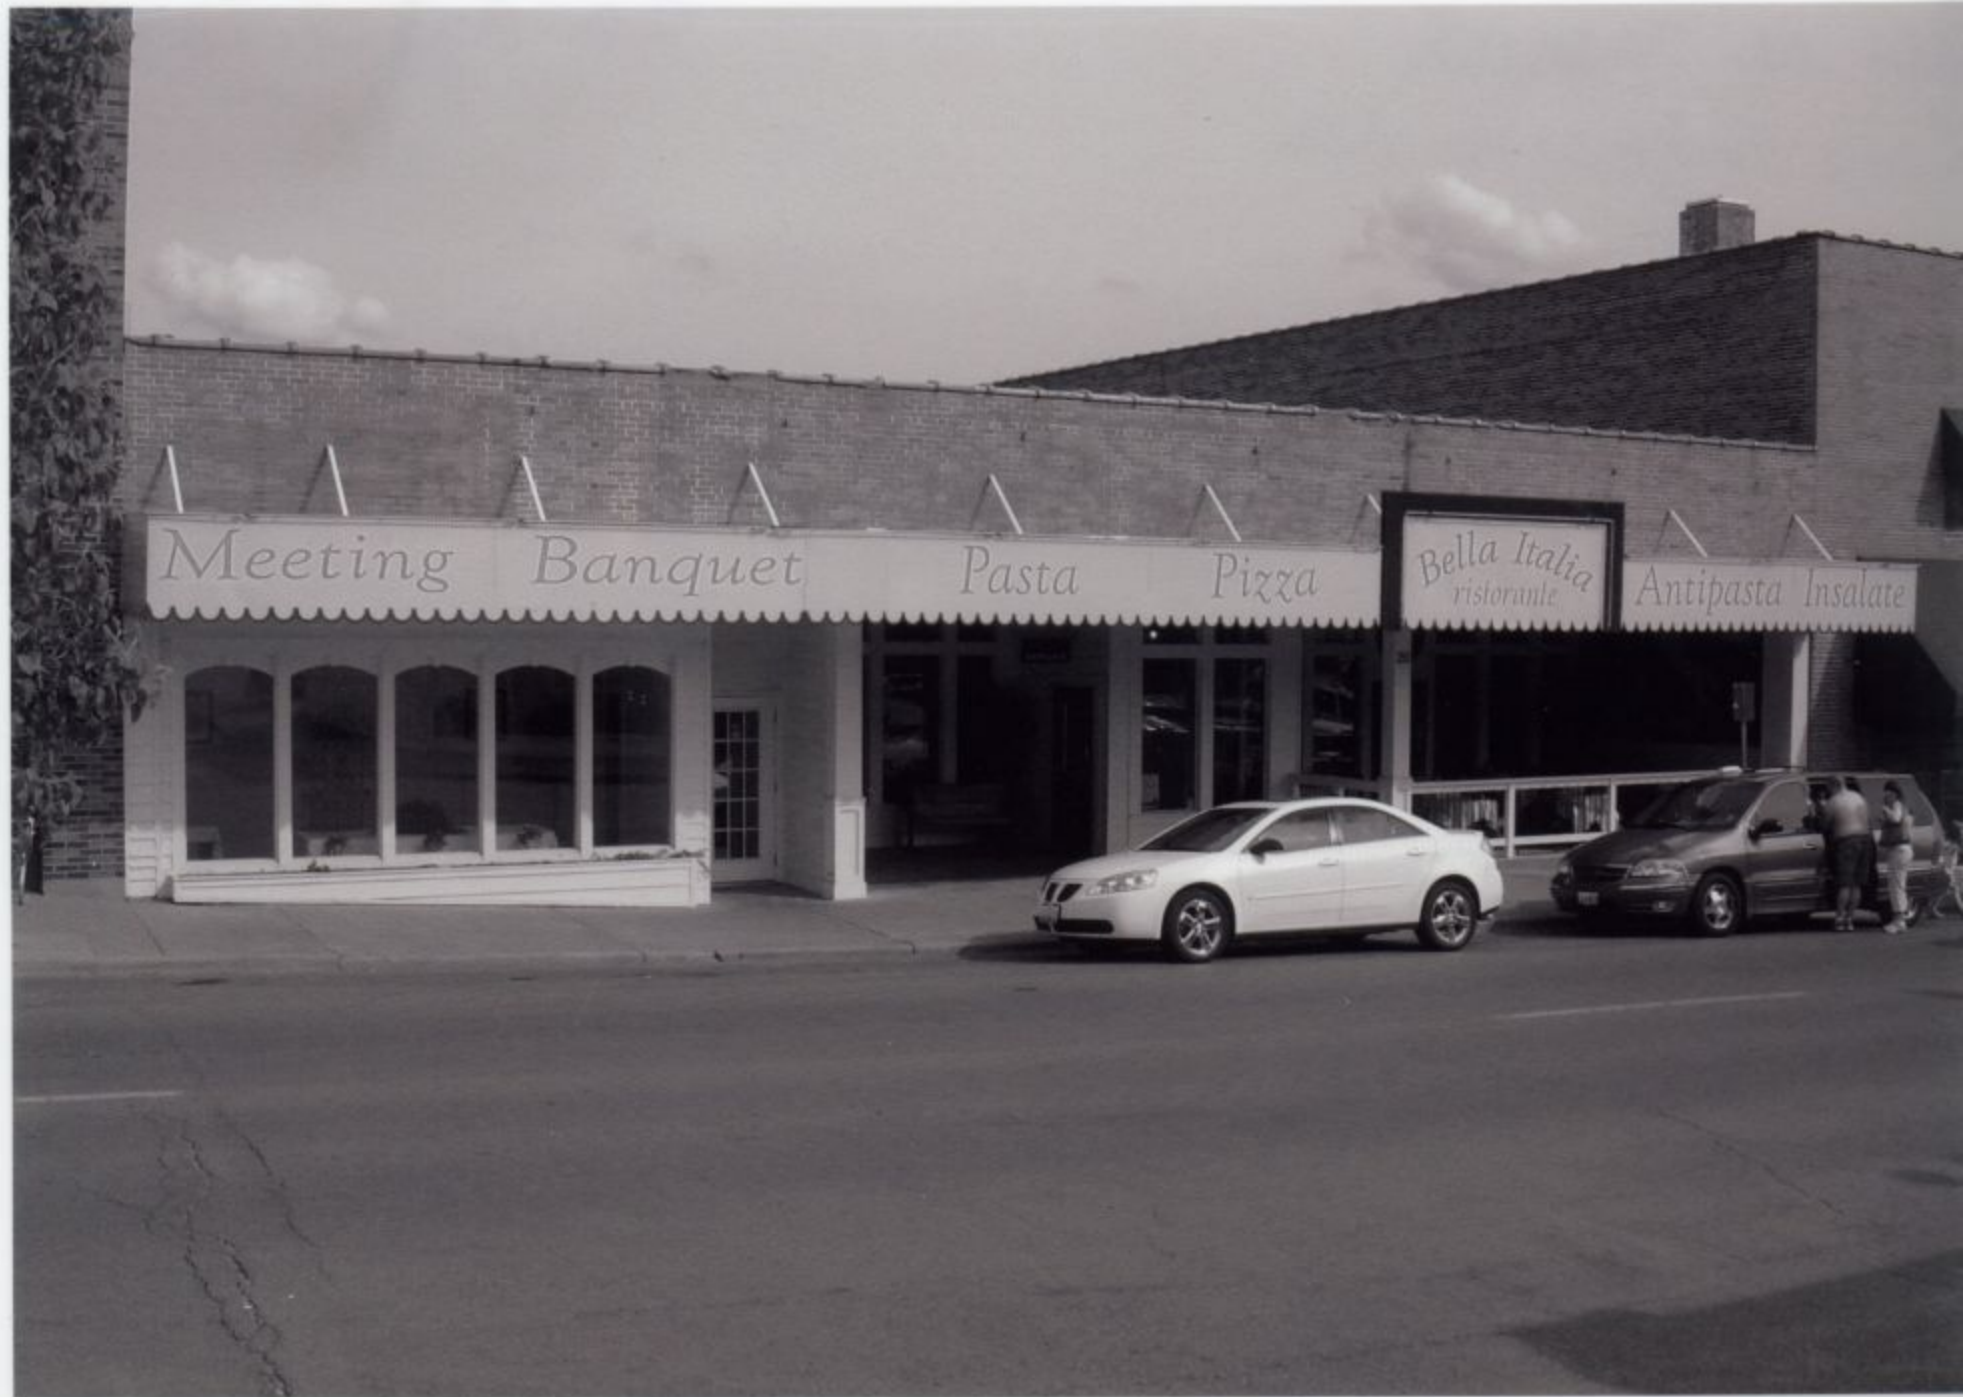
CG AS-011-030  
**MISSOURI HISTORIC PROPERTY INVENTORY FORM**

3.	/ / / / /		/ / / / /			3.		
4.	/ / / / /		/ / / / /			4.		
R. SIGNIFICANT PERSON(S)				T. SIGNIFICANCE				
1.				The one-part commercial block building at 20 N. Spanish was built c. 1966. The façade is constructed of stretcher patterned brick with a smooth cornice line topped with terra cotta coping. The original open front design allowed a maximum area of display windows for retail business. One of the longest tenants, the Dollar General Store, moved into the building in 1973. In 1999 the building was renovated and opened as the Bella Italia restaurant in 2003. The restaurant burned in 2005. While rehabilitating the interior of the building, the front façade was redesigned with a 15 foot setback to allow a patio which accommodates outdoor seating for the restaurant.

1.      3.	
2.R. ROOF SHAPES		2.S. ROOF MATERIALS	
1. FT Flat		1.	
2.		2.	
3.		3.	
		2.T. ROOF FEATURES	
		1.      4.	
		2.	
		2.U. FOUNDATION MATERIALS	
		1. 65
