**MISSOURI HISTORIC PROPERTY INVENTORY FORM**

REFERENCE NUMBER		A. HISTORIC NAME 109 Independence St						
B. COUNTY  031 Cape Girardeau		C. OTHER NAME (S)						
D. ADDRESS  109 Independence St				E. CITY  Cape Girardeau		F. VICINITY  <input type="checkbox"/>	G. RESTRICTED	H. ACREAGE

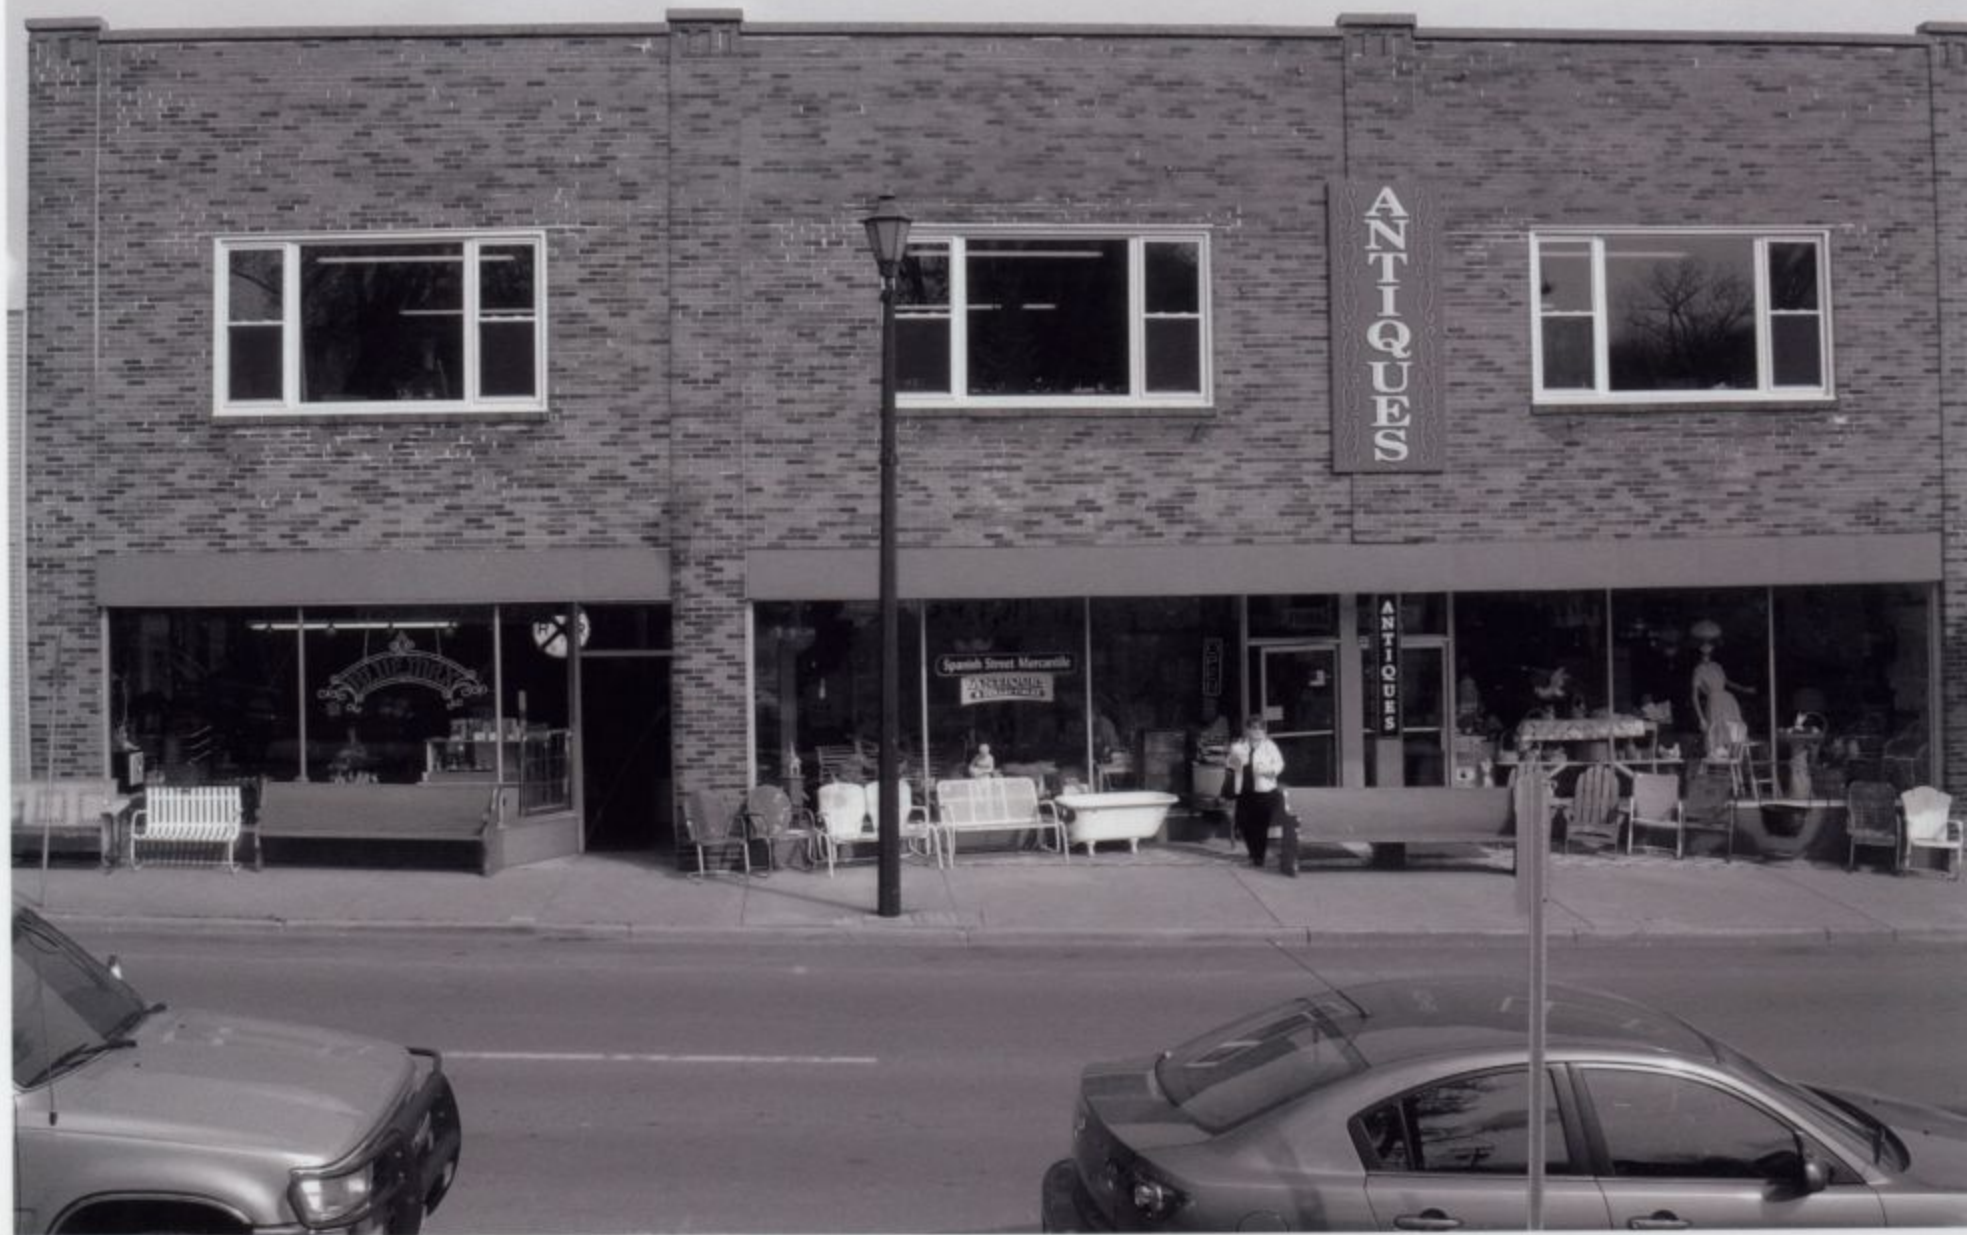
CG-14, 031-031

3.	/ / / / /		/ / / / /				3. 050		
4.	/ / / / /		/ / / / /				4.		
R. SIGNIFICANT PERSON(S)					T. SIGNIFICANCE				
1.					<p>The two-part commercial block building was built in 1941 to house the National Youth Administration. The smooth three bay multicolored brick façade is broken up by four projecting brick piers. The top of the piers are decorated with three recessed bricks. Three first floor open-front shops are comprised of large aluminum framed plate glass windows which cant toward each entrance. The recessed entrances have terra cotta tile floors. The second story contains three symmetrically placed Chicago style windows. The cornice is capped with limestone.</p>

2.R. ROOF SHAPES 1. FT Flat		2.S. ROOF MATERIALS 1.		2.T. ROOF FEATURES 1.                      4.	
2.		2.		2.U. FOUNDATION MATERIALS 1. 65	
3.		3.		2.                      3.

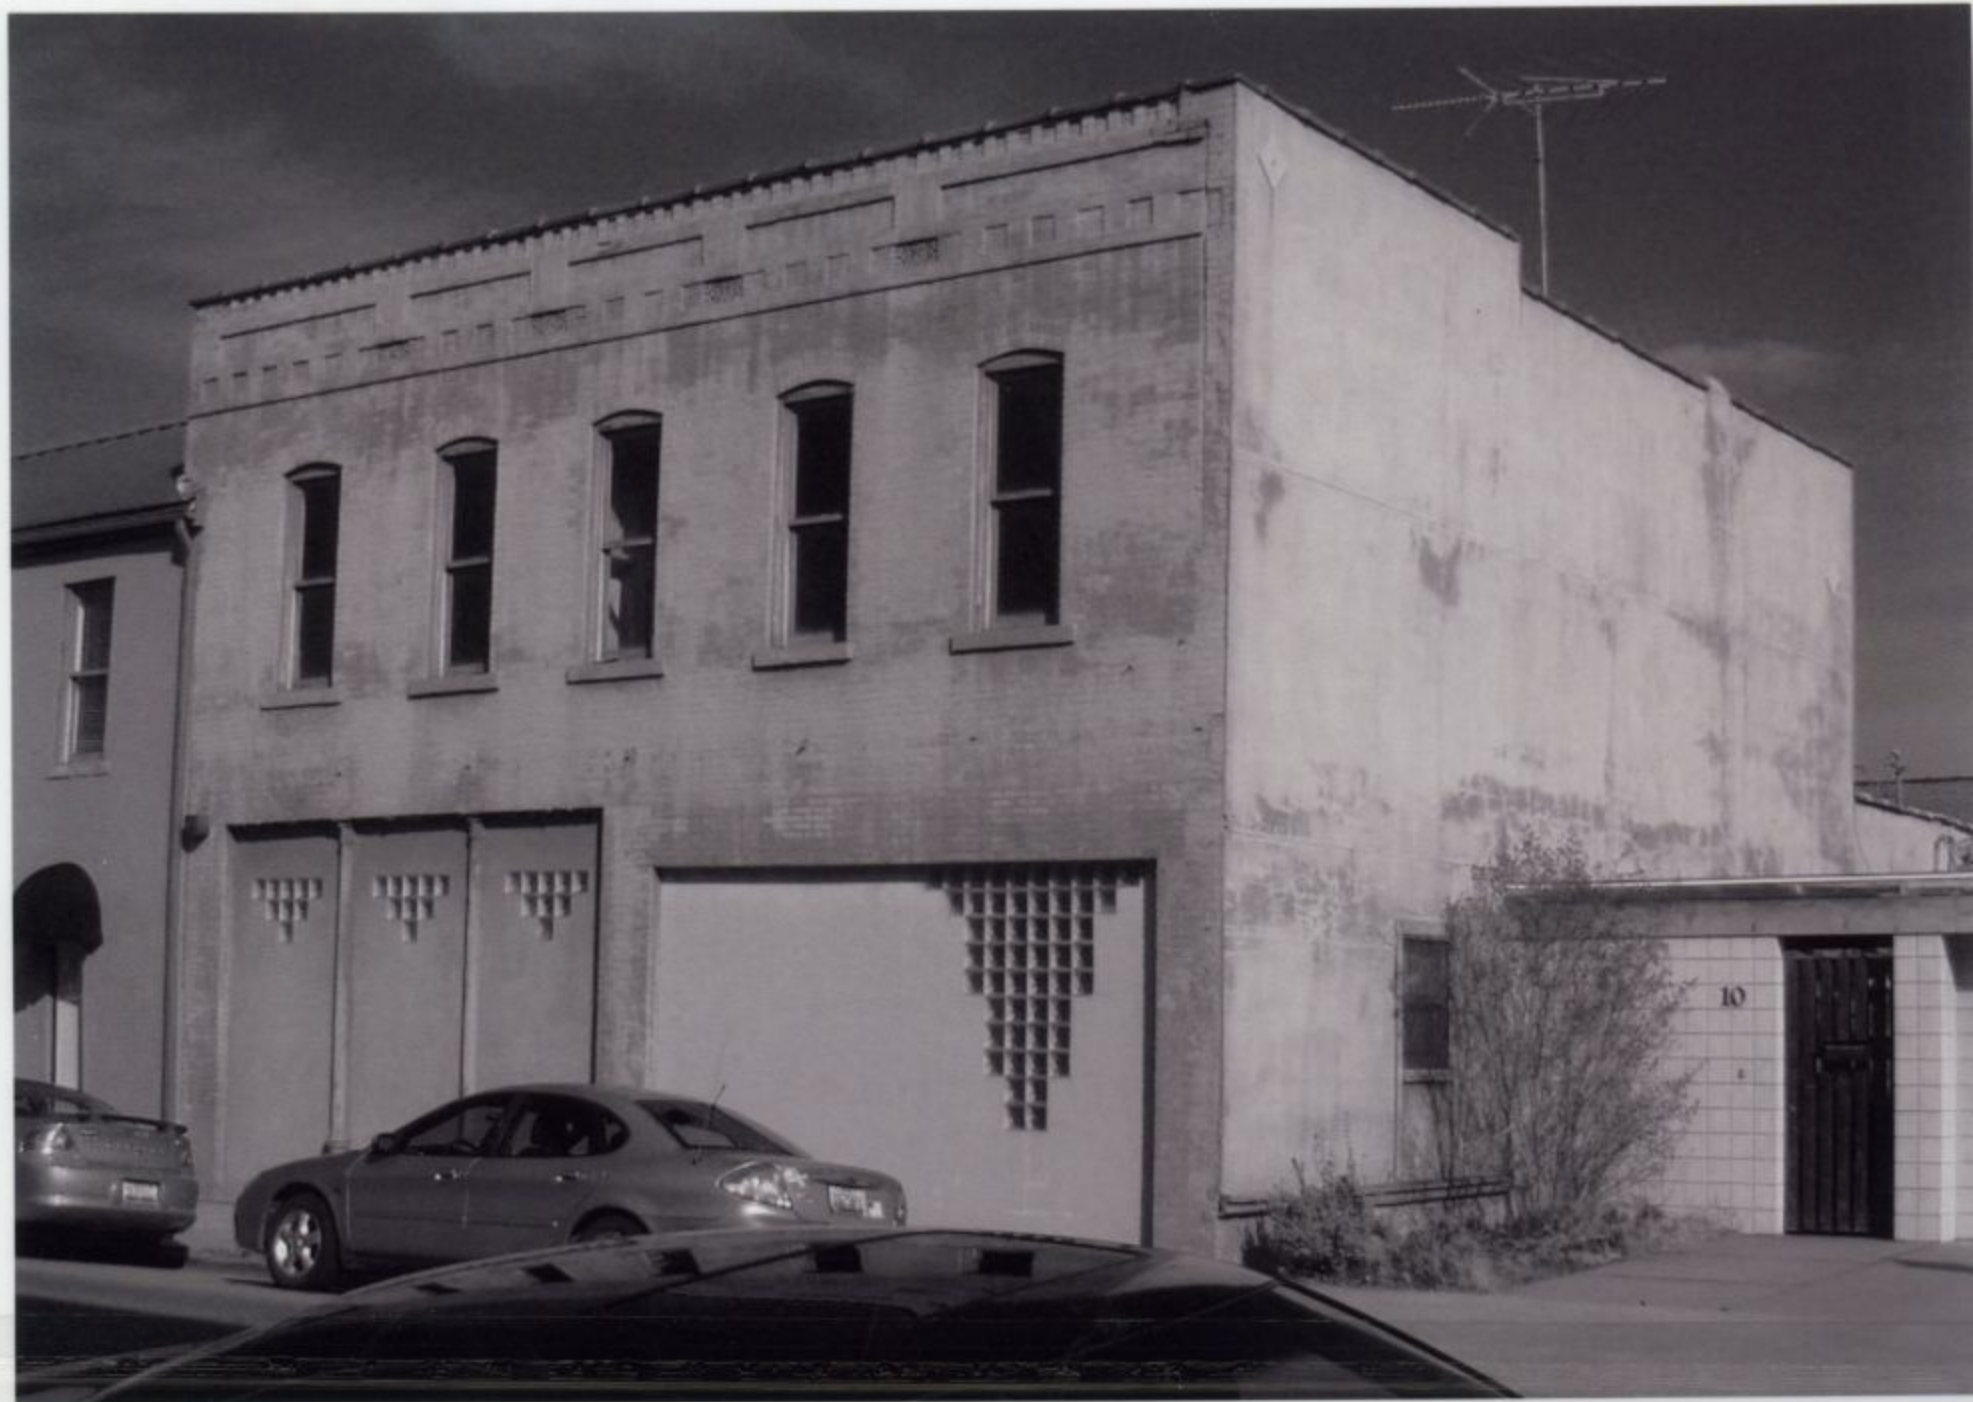
CG-AS-011-03.4

3.	/ / / / /		/ / / / /				3.	
4.	/ / / / /		/ / / / /				4.	
R. SIGNIFICANT PERSON(S) 1. 2. 3.				T. SIGNIFICANCE  10 South Spanish Street, built of brick, concrete, and cinderblock, is a 2 story building set in the historic downtown area of Cape Girardeau. It has many features similar to the historic neighborhood such as: large elongated windows along the second floor, flat roof and roofline, and modified storefront features. The original front entrance and windows have been replaced with stucco covered walls and inverted triangular glass blocks. The entrance, now on the side of the building, is an enclosed courtyard and garage. Although modified, the building holds an appearance that feels full of history.
