UNITED STATES DEPARTMENT OF THE INTERIOR  
NATIONAL PARK SERVICENATIONAL REGISTER OF HISTORIC PLACES  
INVENTORY -- NOMINATION FORM

Chilton-Williams Farm Complex

CHILTON-WILLIAMS FARM COMPLEX

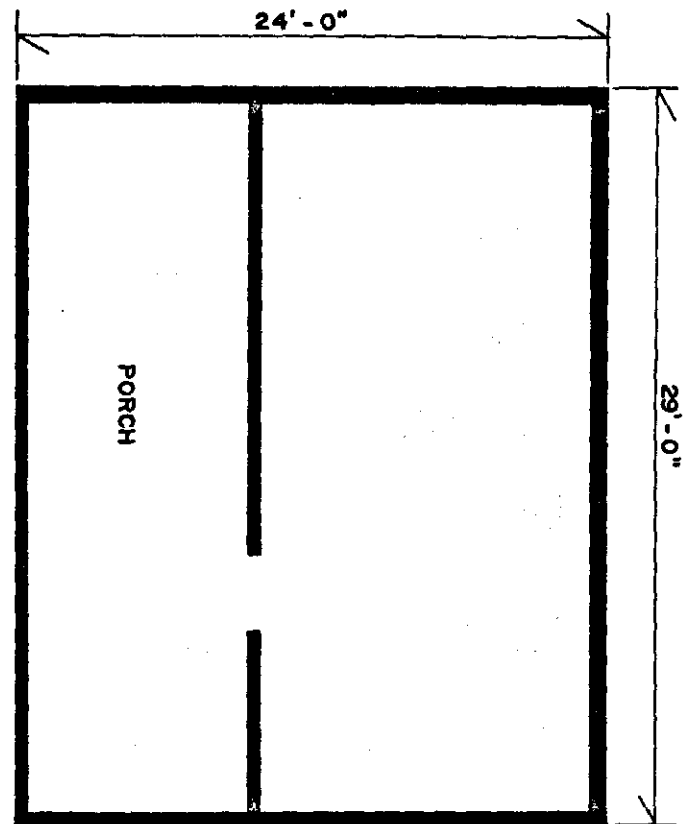
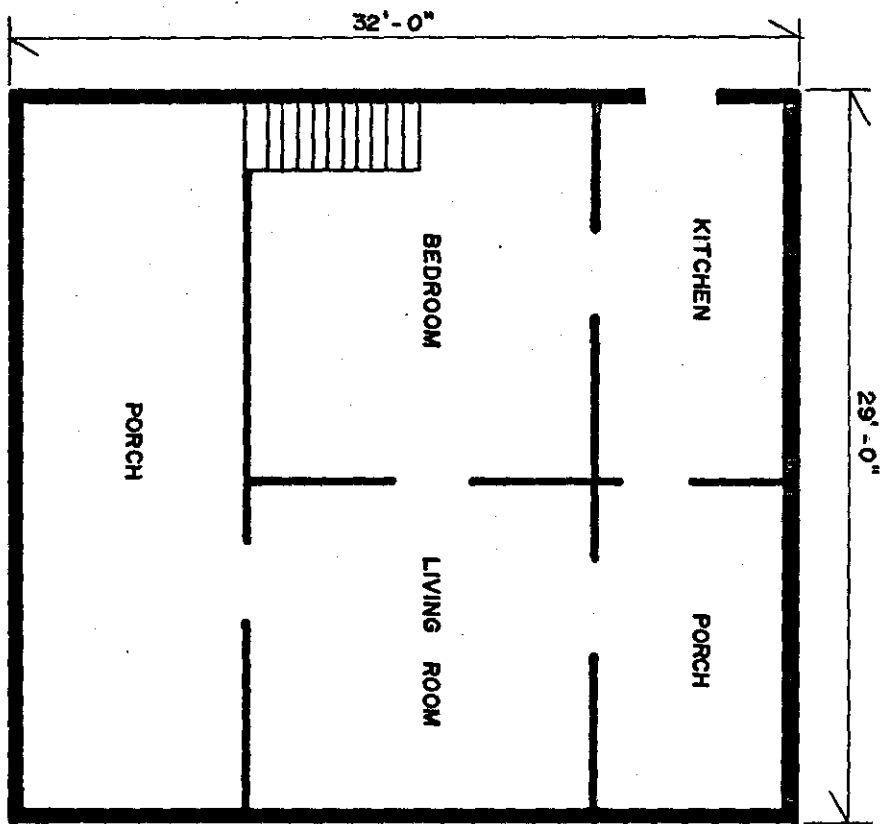
CHILTON HOUSE

Interior: First floor: There are three rooms and an enclosed porch. The living room at the south end is 13'6" square. A single window and a sandstone fireplace are in the south wall, a window and entrance door in the west. (The wood mantel and facade have been removed.) A doorway in the north wall connects with a 13'6" x 15'9" bedroom. To the rear are an 8' x 13'6" porch and an 8' x 13'6" kitchen. Hardwood floors are in the living room and kitchen, and pine boards the other rooms. Walls and ceilings are 1 1/2" painted tongue and groove boards, which have been covered with wallpaper.

Second Floor: A single large room with walls and ceiling of 1 1/2" boards occupies the entire floor. It is reached by a 30' wide enclosed staircase that runs through the first floor bedroom.

SECOND FLOOR

FIRST FLOOR

Building #315 - Chilton House: A two-story frame 29' x 32' building facing the Old Powder Mill Road about 100 yards south of the Current River. It is oriented east-west. There are no outbuildings, though originally an outhouse, chicken house, smoke house and shed were immediately to the rear. Ruins of the first Owl's Bend Post Office (1923) and a blacksmith shop are immediately across the road and a storm cellar on the north side of the yard.

Exterior: Gable roof, covered with corrugated iron; front wall covered with 1 1/2" flush horizontal boards. The other three sides are sheathed with 4 1/2" clapboard, painted white. It has hand-hewn beams and sandstone piers. A two-story veranda extends across the front and an enclosed porch is in the southeast corner. An outside rough cut stone chimney is in the center of the south end.

Openings: There are five doors and twelve windows. The front has three bays, the center of which on both floors are doors. Both doors have false wooden transoms. An additional door at the north end of the first floor gives access to a stair to the second floor. There is a single window on each floor in the north wall and a kitchen door opened onto a roofless wood porch, now missing. In the south wall is a single window between the chimney and west corner on each floor. Two windows are in the rear wall of the second story. All windows are double sash with 6 x 6 lights.

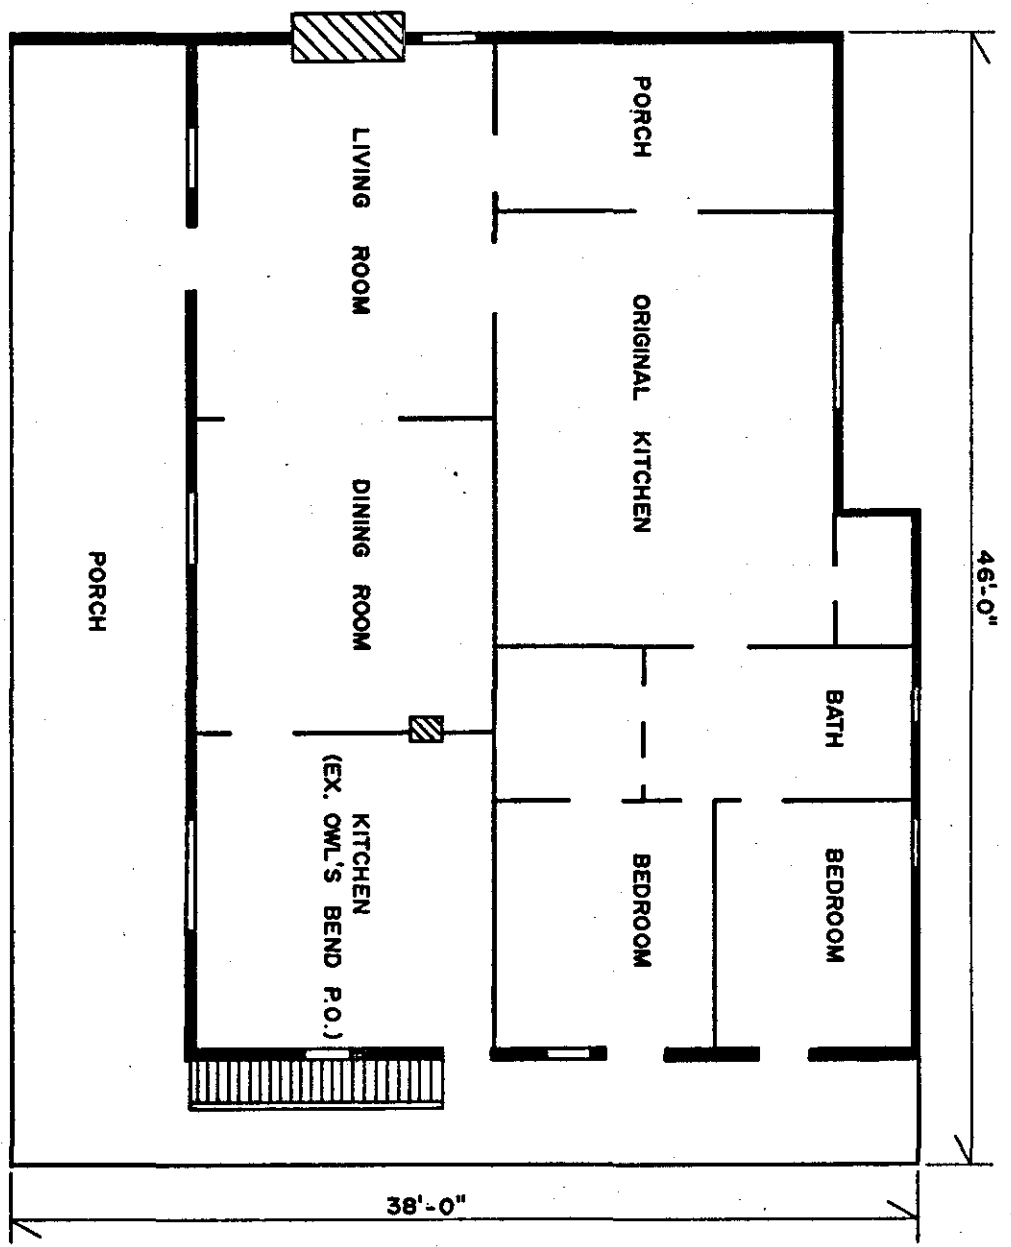
WILLIAMS-BALTZ HOUSE

Interior: There are a total of six rooms, a bath and a closet. The older part consists of three original rooms and an enclosed porch at the northwest corner. West, is a 13' x 15' living room originally known as the "fireplace room." It was a combination living room and parents' bedroom. Walls and ceiling are tongue and groove boards. The stone fireplace is 40" wide and 42" high. There is a simple wood mantel.

Adjoining was the bedroom, remodelled for a dining room and connected to the living room by a 7 1/2' opening. Behind these rooms is the original kitchen which became a 13' x 18' bedroom.

The east section has a 12' x 12' front room now connected with the dining room and last used as the kitchen. It was built in 1937 for the Owl's Bend Post Office, and had only an outside entrance. Behind are two bedrooms. Each have doors to the east porch and bathroom between them and the original kitchen. All newer rooms have plaster board walls. There are two rooms in the attic. One is unfinished, the other sheathed with pine boards. All floors are pine. The house had electricity and plumbing.

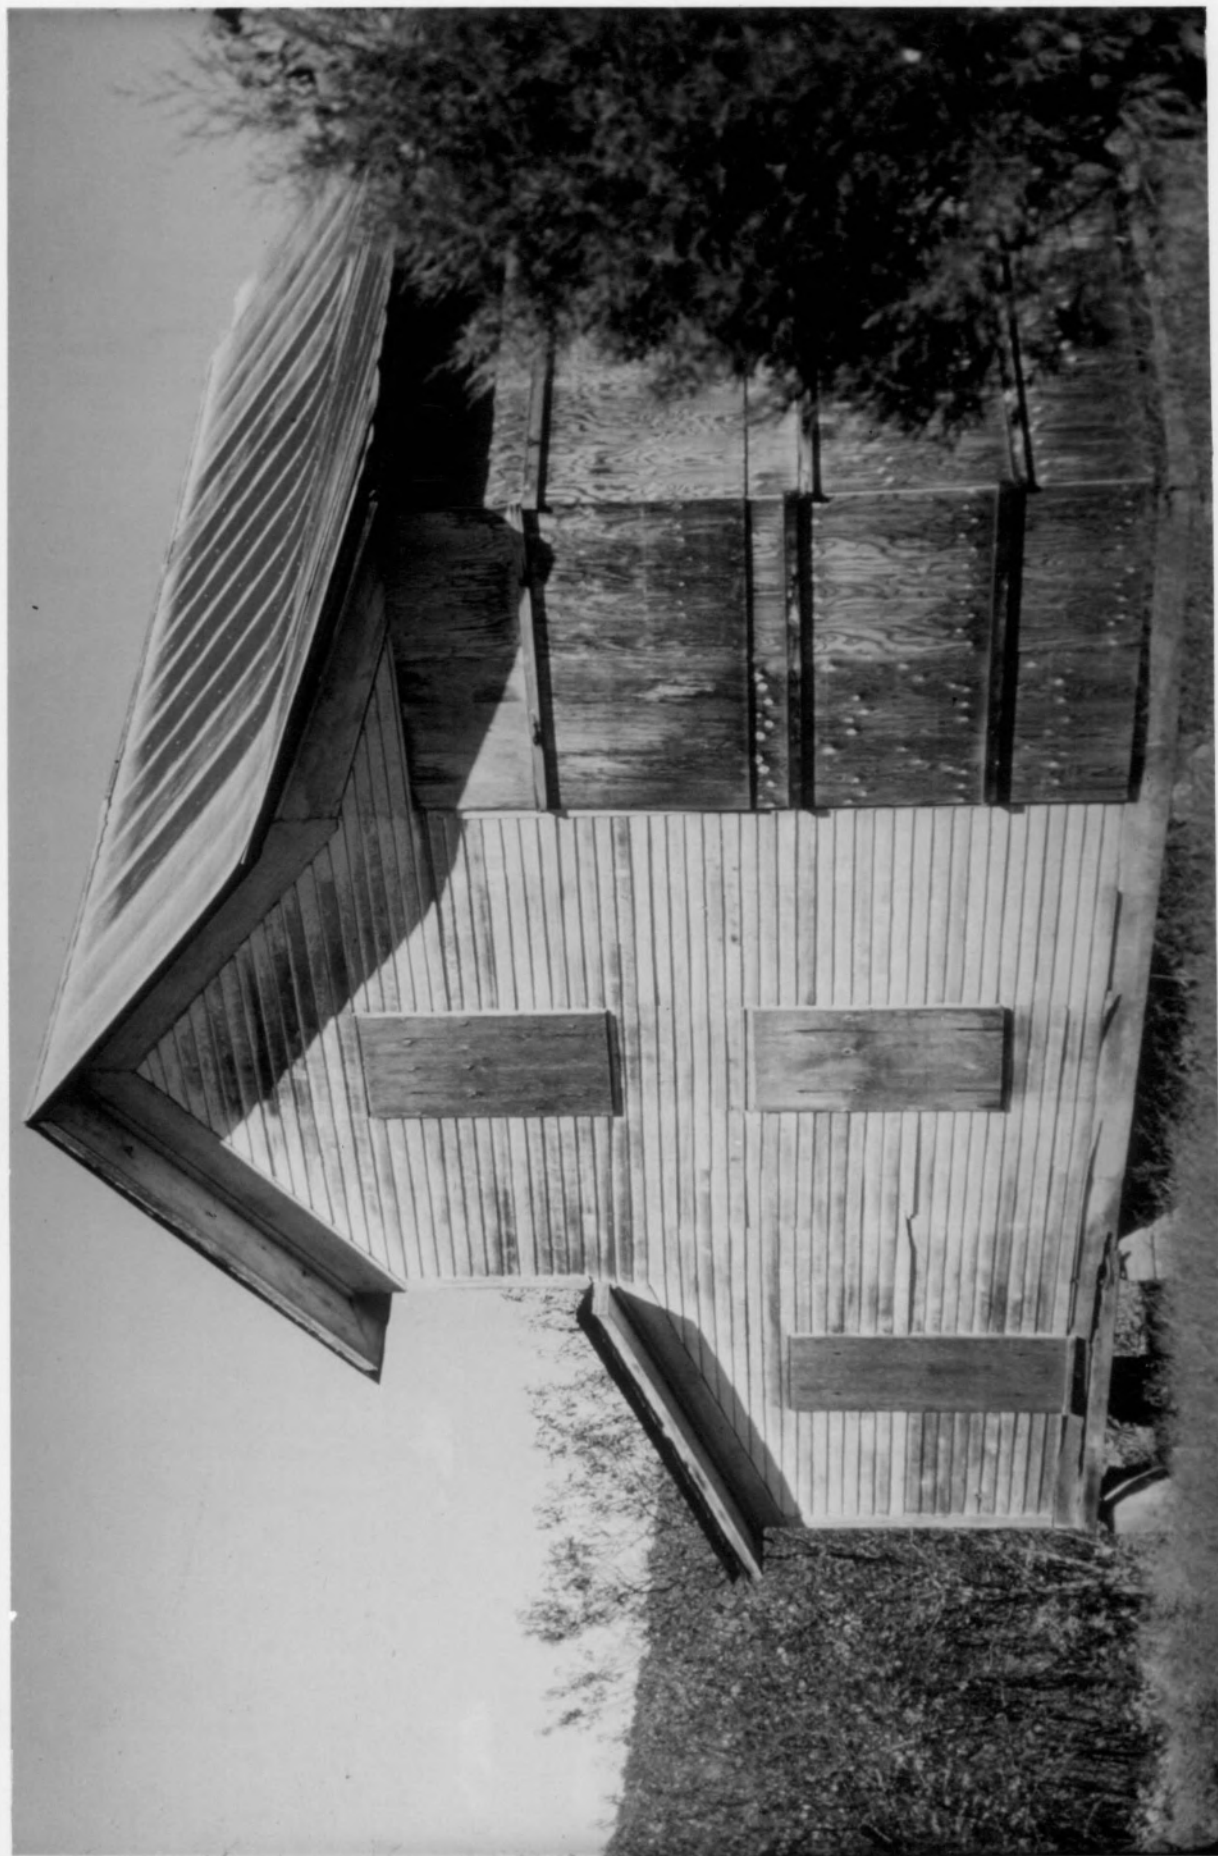
CHILTON-WILLIAMS FARM COMPLEX #2

facing south along a lane that runs east to various outbuildings and fields. In the yard is a privy, shed, a few trees and some rose bushes. The division between the west (older) and east section clearly shows.

Exterior: Gable roof, covered with corrugated iron; walls are 5 1/4" drop siding painted white. A single dormer window is in the east front roof. Foundations in the west sections are stone piers, those in the east, concrete. A covered porch extends across both front and east sides. An outside stair on the east porch leads to the second floor. There is a stone outside chimney in the west end and a brick chimney near the dormer window.

Openings: The west portion is four bays wide and consists of a pair of doors flanked by two 2 over 2 double sash windows. Between the chimney and an enclosed rear porch is another window, and a pair are in the west side, rear. There are three cottage windows in the front of the east section and a single window and three doors in the east wall; one window in the north. A single window is in the east attic wall.

Condition: Good. Boarded up and locked and sprayed regularly with preservative.

WILLIAMS-BALTX HOUSE  
EMINENCE, SHANNON COUNTY, MISSOURI  
PHOTOGRAPHER: WILLIAM L. PHILYAW

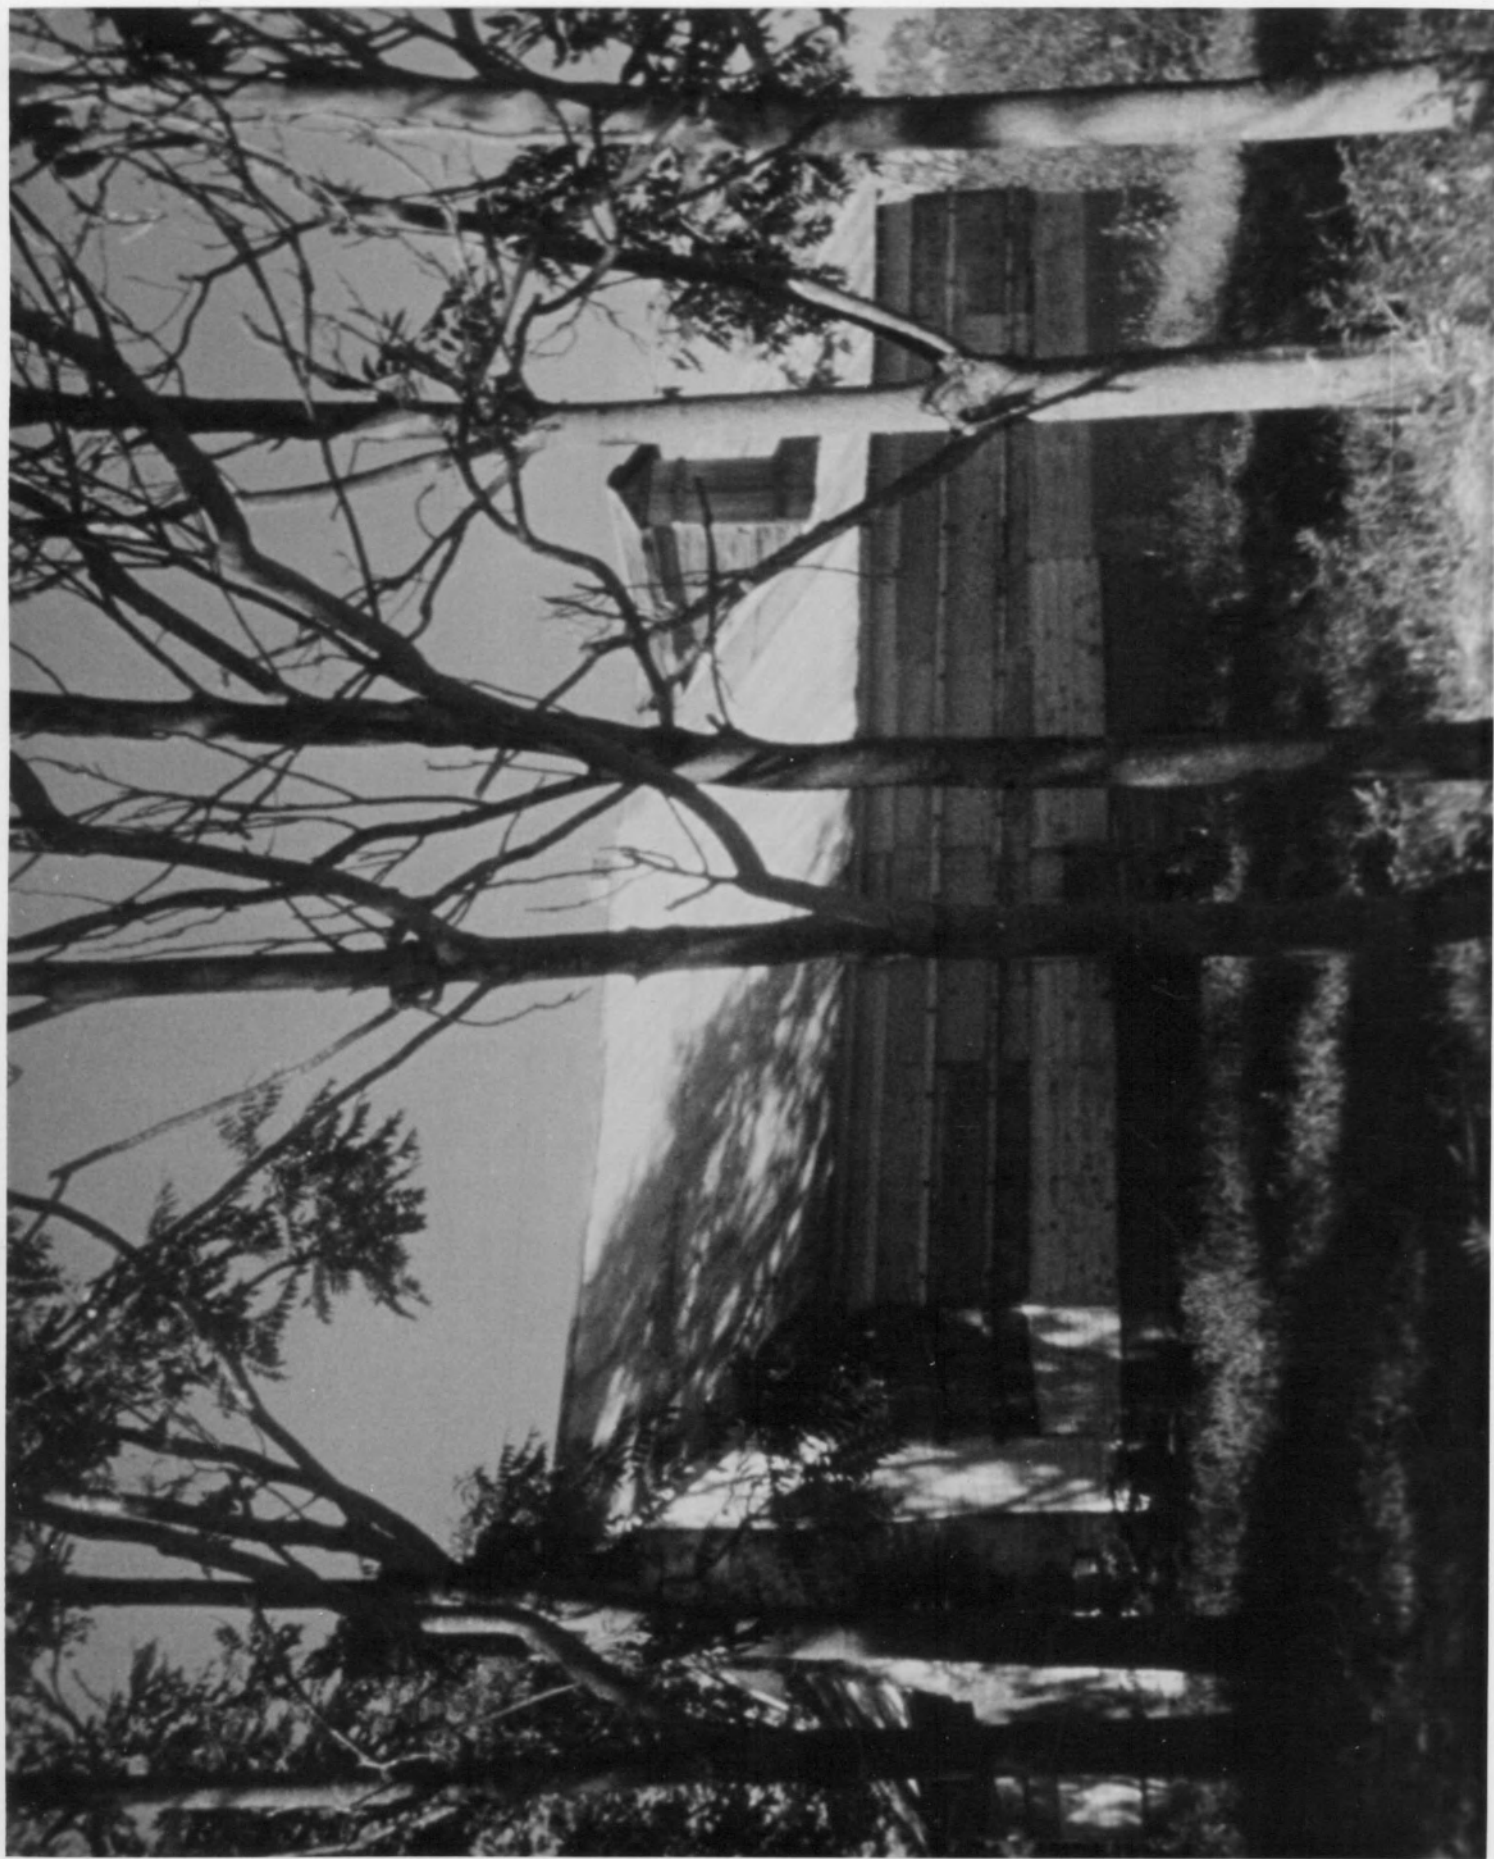
CHILTON-WILLIAMS FARM COMPLEX #3

Exterior: Center gambrel roof, and shed extensions covered with corrugated iron. Walls sheathed with vertical rough sawn oak and pine boards. The foundations are concrete and wood blocks.

Openings: Two doors are in the north ends of the extensions and another under the gable overhang.

Interior: Divided into three areas, a 40' x 52' center and two 15' x 52' extensions. Feed troughs are on the sides of the central portion. All lower floors are dirt. The loft is floored with rough sawn pine and oak planks.

Condition: Large sections of the roof are missing.

BARN

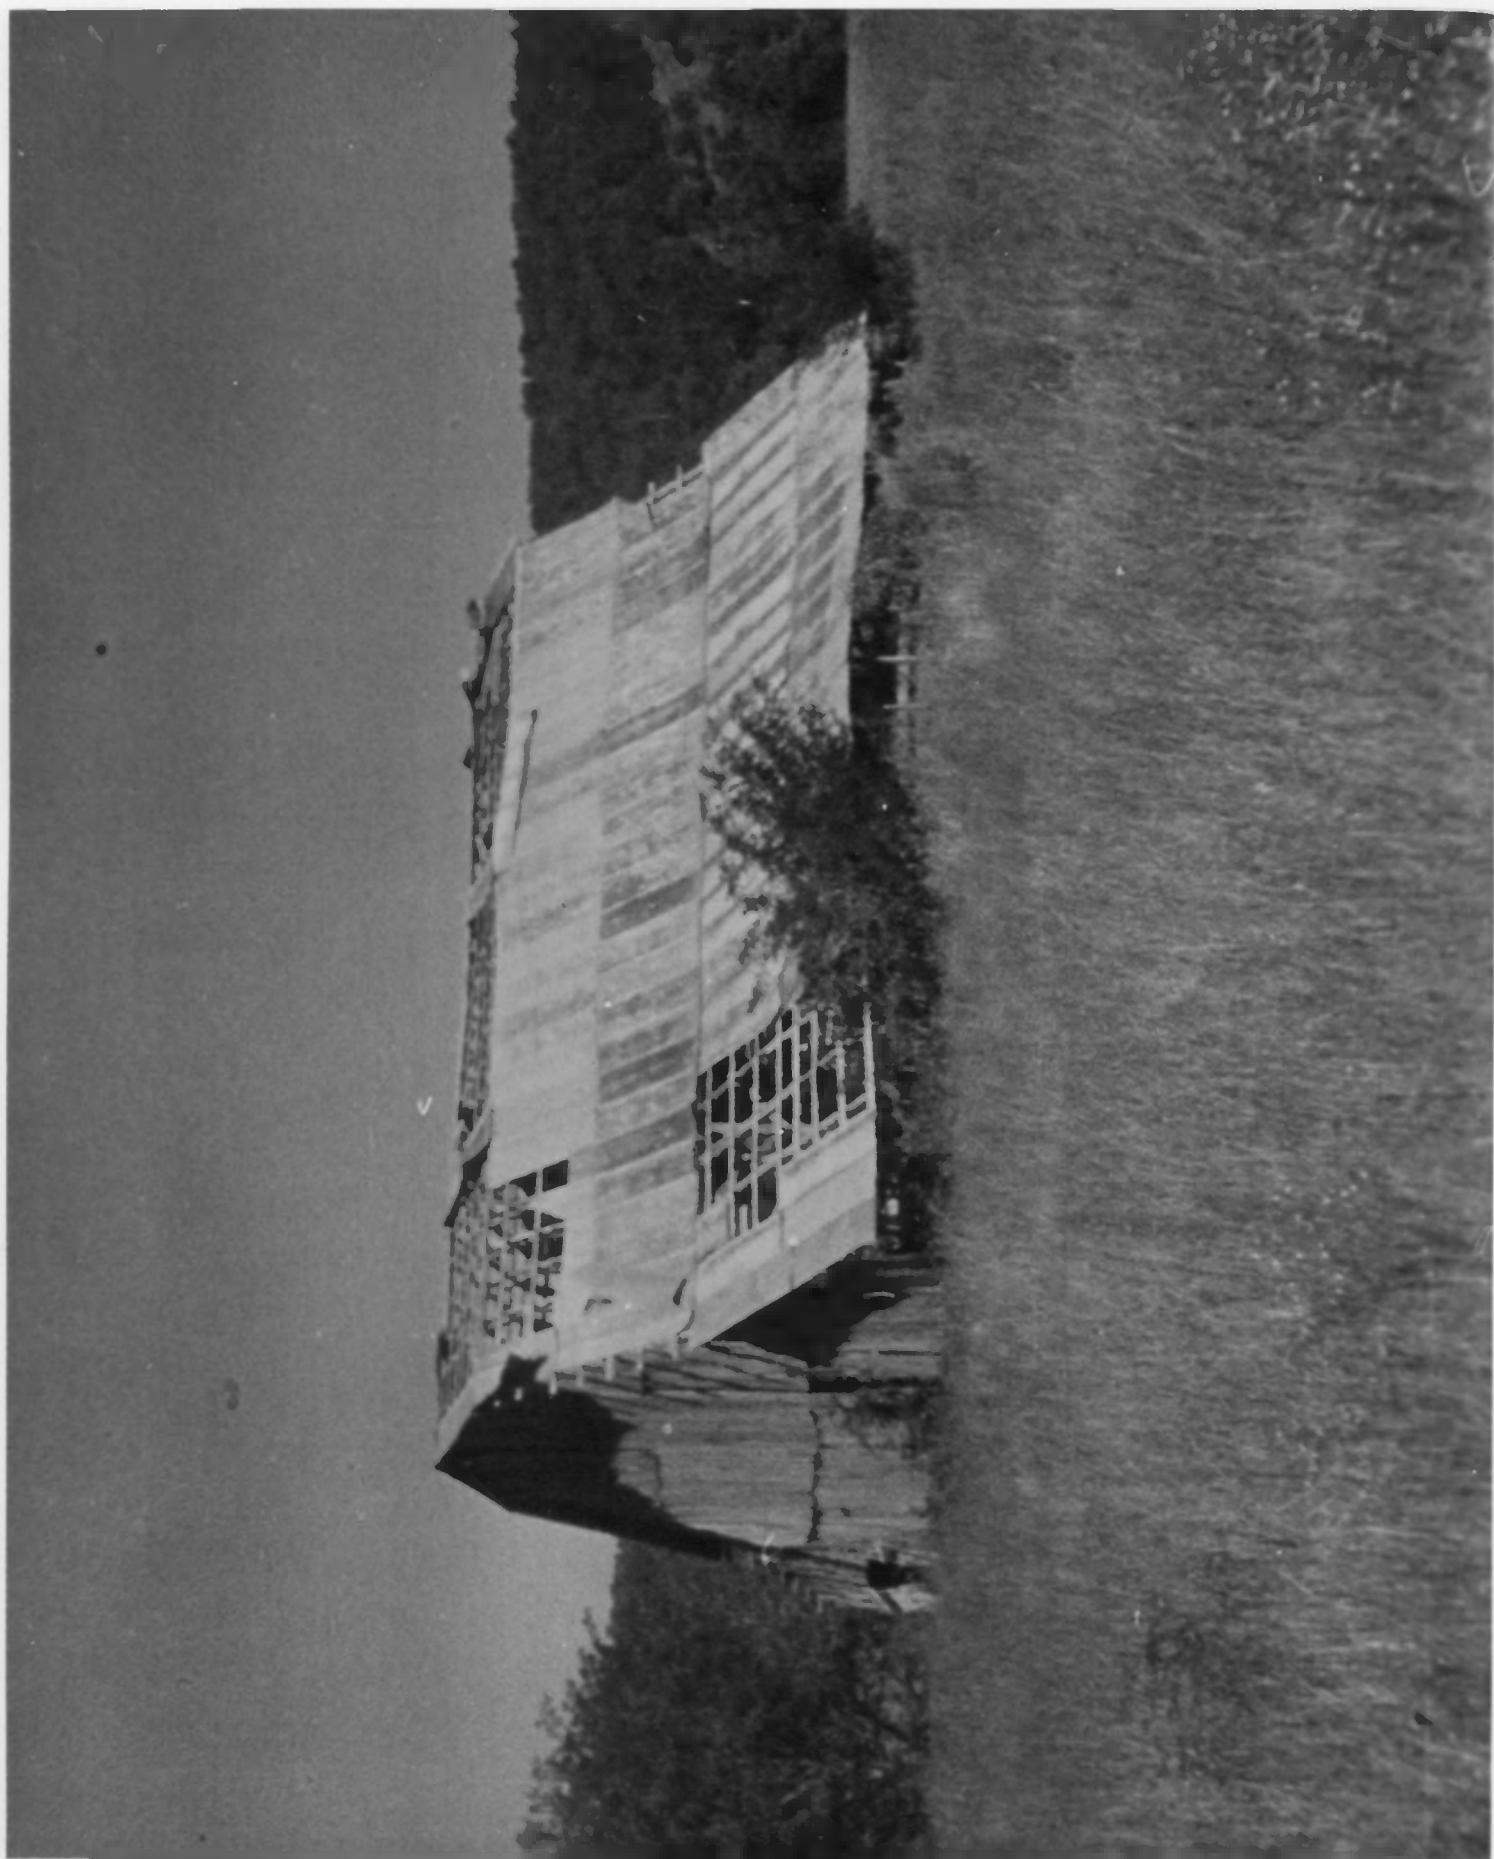
CHILTON-WILLIAMS FARM COMPLEX #4  
SMOKEHOUSE

Building #326 - Smoke House: An 11'8" x 7'8" single-story building immediately to the rear of the house. The gable roof is covered with corrugated iron. A 3' x 11' concrete porch is on the east end. Its walls are rough sawn pine boards covered with green asphalt shingles. The interior floor is concrete.

Condition: Good. Boarded and locked.

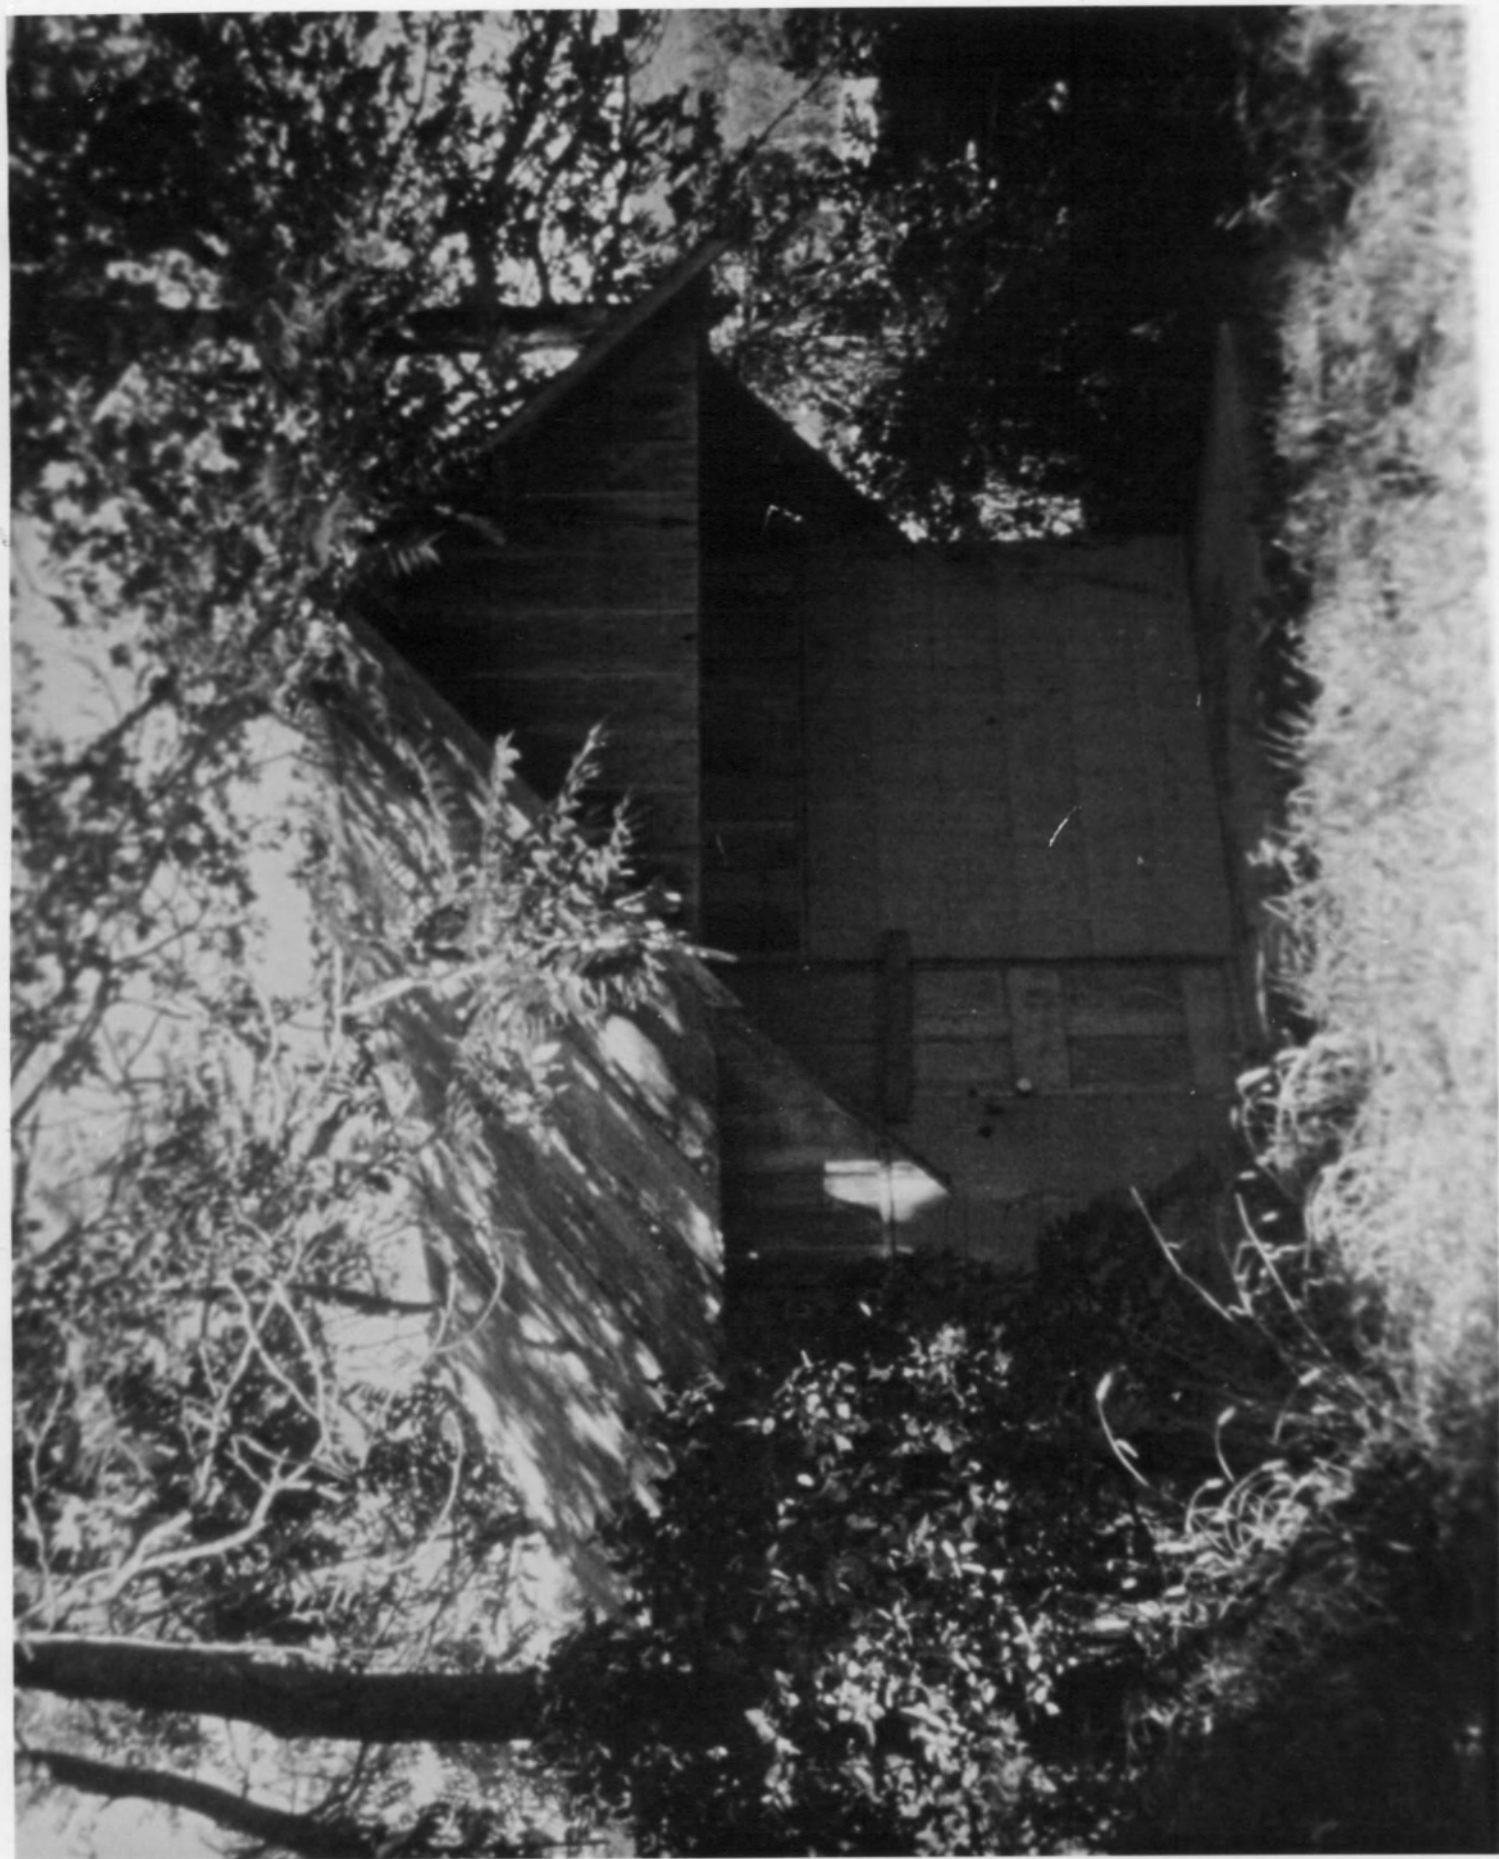
CHILTON-WILLIAMS FARM COMPLEX #5  
CORN CRIB

Buildings #322, 323 - Corn Crib: Two identical unpainted 12' x 36' single-story frame structures between the barn and house. The gable roofs are covered with corrugated iron and sides with rough sawn oak boards with ventilation spreading. Foundations are concrete blocks.

Condition: Good.

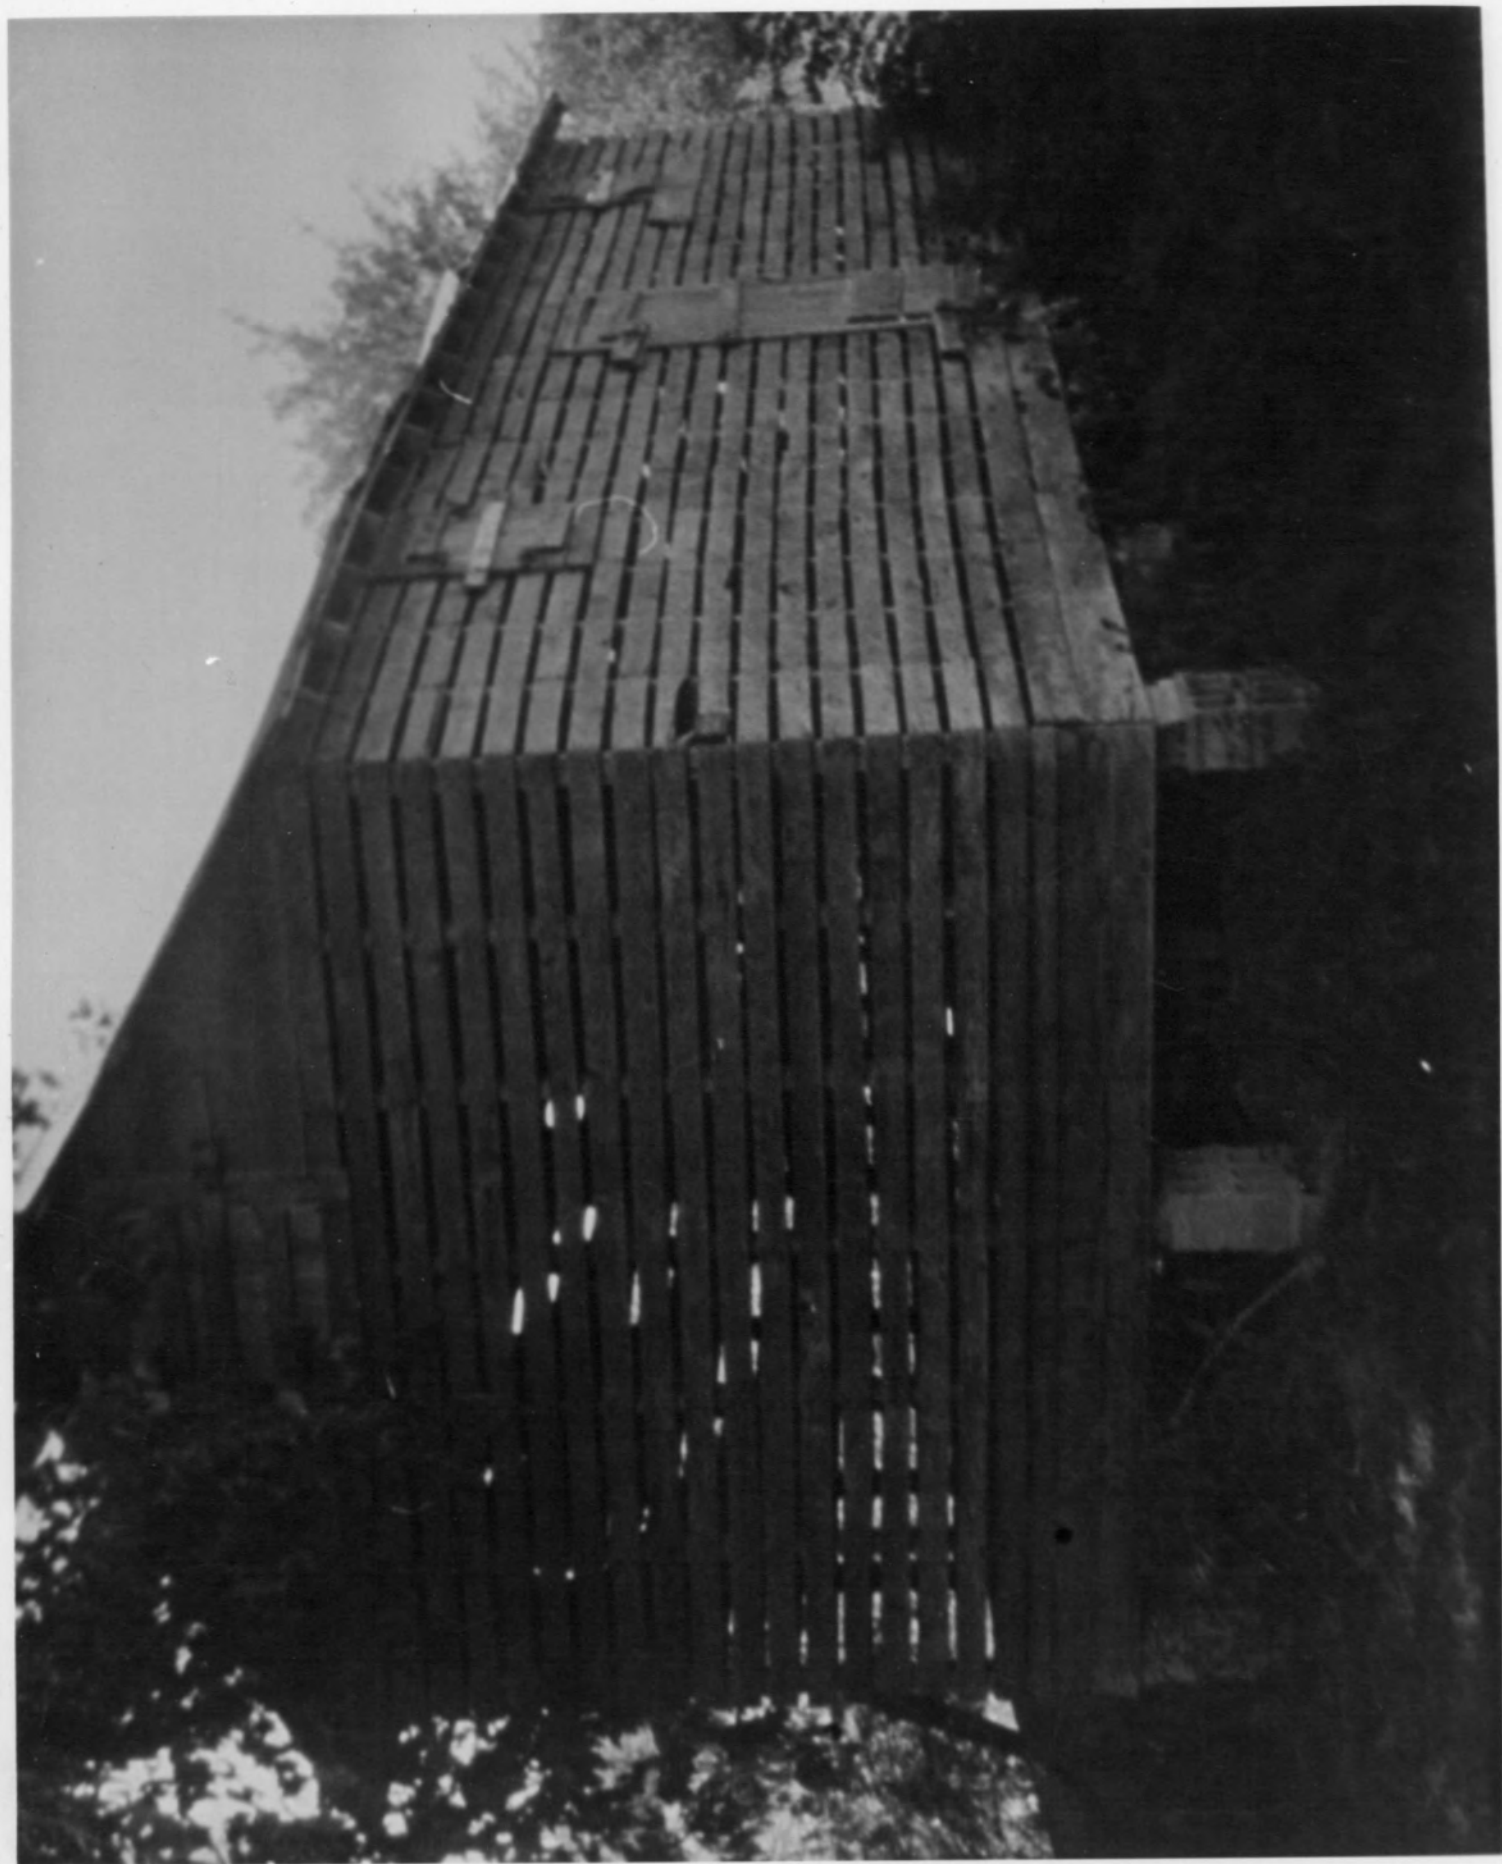
CHILTON-WILLIAMS FARM COMPLEX #6  
CHILTON HOUSE

Condition: Good. Boarded up and locked. Sprayed regularly with preservative.

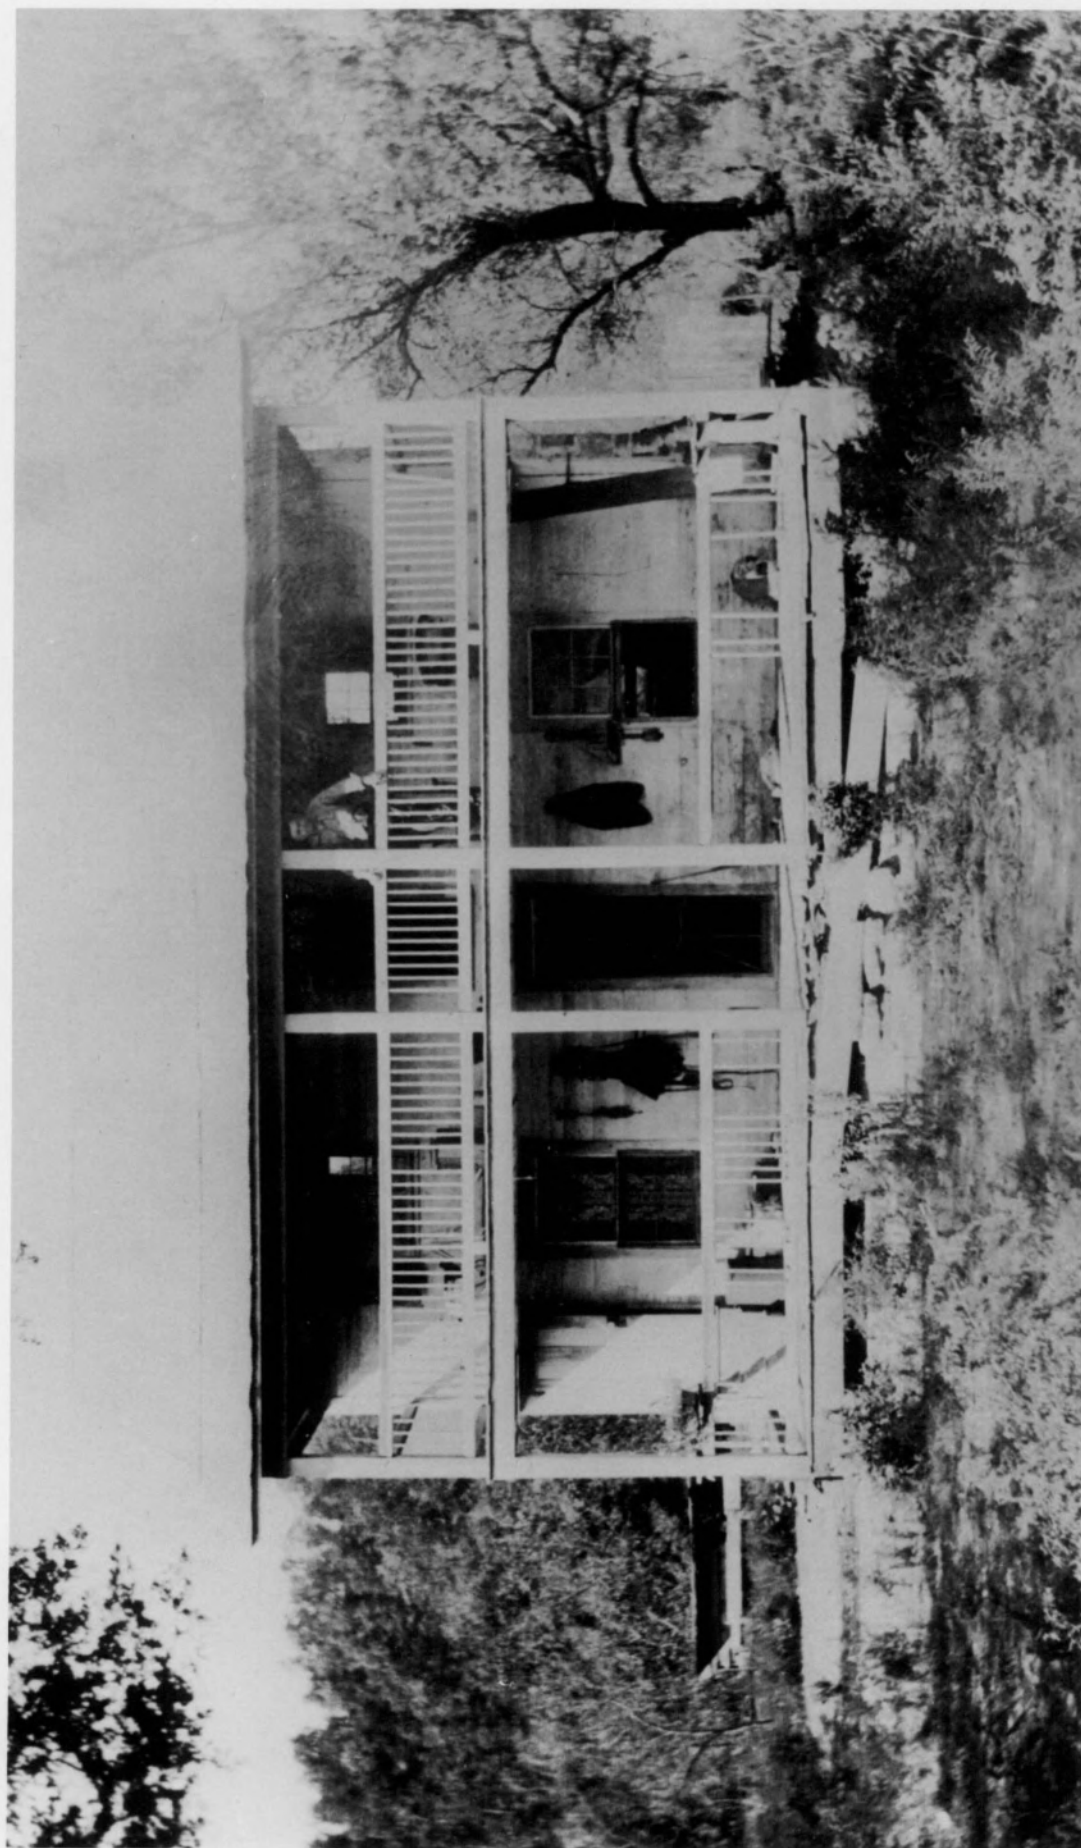
VIEW CIRCA 1920, FROM THE WEST
