# ARCHITECTURAL SURVEY OF CLIFTON HEIGHTS

JUNE 1991

ST. LOUIS, MISSOURI

LANDMARKS ASSOCIATION OF ST. LOUIS, INC.

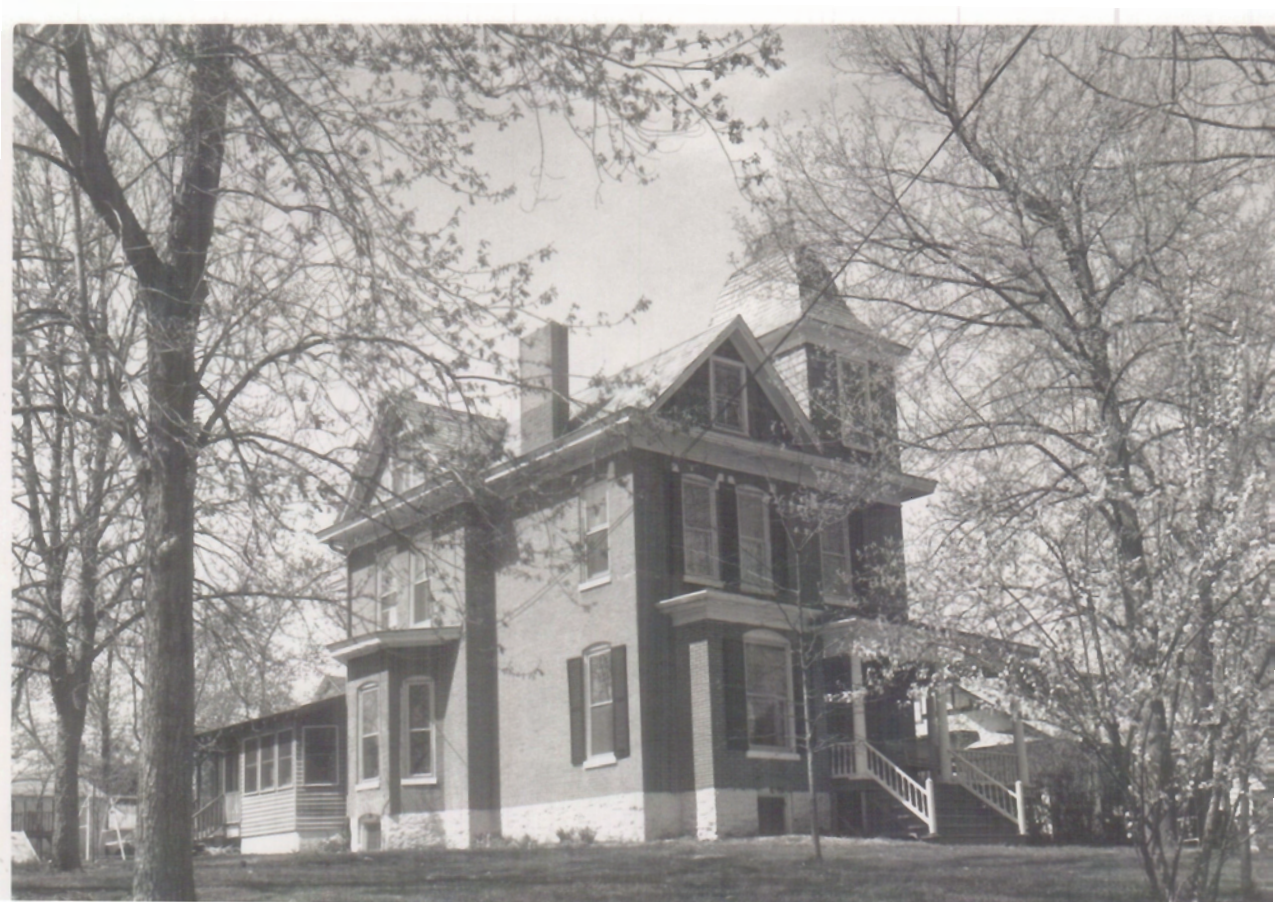
9. Ownership: Private	10. Visible from public road? Yes	11. Endangered? No	
12. Original name:			
13. Present name/owner's name:			
14. Street address: 6212 Bowman Ave		15. Style: Queen Anne

16. Date(s): c. 1895 - 1900			
17. Architect: unknown		18. Builder: unknown	
19. Original Use: residence		20. Present Use: residence	
21. No. of stories: 2 1/2	22. Basement? yes	23. Wall construction: masonry

24. Foundation material: stone		25. Roof type/material: gabled/slate	
26. No. Bays: Front 2      Side 3	27. Wall treatment: red brick		
28. Plan shape: see site map	29. Changes: Addition? rear      Altered?

30. Exterior condition: good		31. Open to public? no	
32. Other Surveys in which included: Heritage/St. Louis survey, 1971			
33. Further description of important features: A corner tower features a four-sided slate bell roof with cresting & a finial; the sides of the tower are sheathed with patterned multichrome slate tiles. Segmentally arched front (and one 2nd story side) windows have stone voussoirs at the ends; stone sills. Straight-sided bay window at first story front; angled bay window on south side. Frame porch has turned wood columns & balustrade. 1-story rear frame addition.

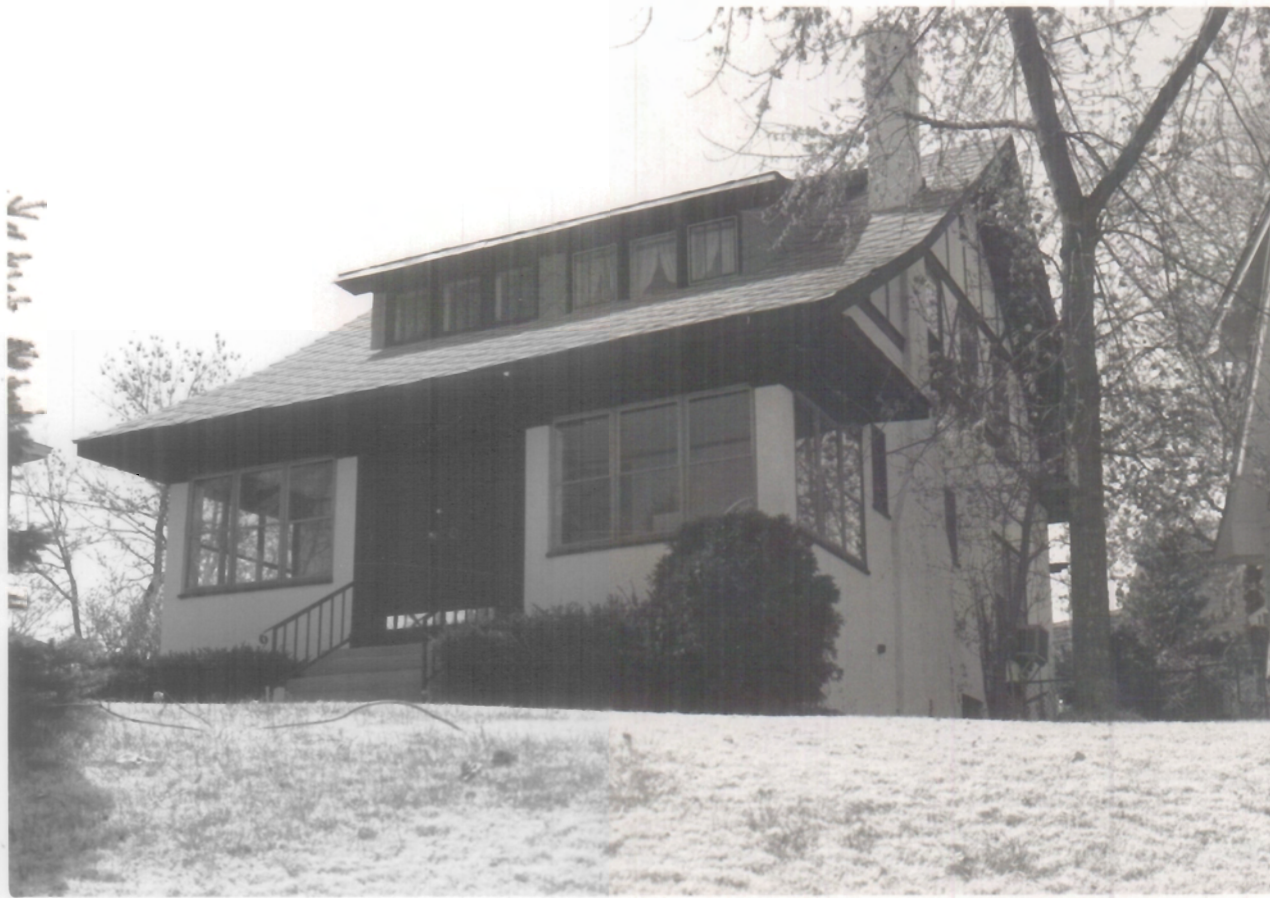
24. Foundation material: stuccoed		25. Roof type/material: side gable	
26. No. Bays: Front 3 Side 3		27. Wall treatment: stuccoed	
28. Plan shape: see site map		29. Changes: Addition? Altered?

30. Exterior condition: good		31. Open to public? no	
32. Other Surveys in which included: Heritage/St. Louis survey, 1971			
33. Further description of important features: This house features undulating patterned roof shingles. The narrow shed-roof dormer is recessed in the roof so its windows are actually longer than they appear. The roof extends to become the roof of the full-width, enclosed porch. No permits appear post-1926 for an alteration of the porch, so it is perhaps original, although the double doors appear to be replacements. Side gable is "half-timbered."

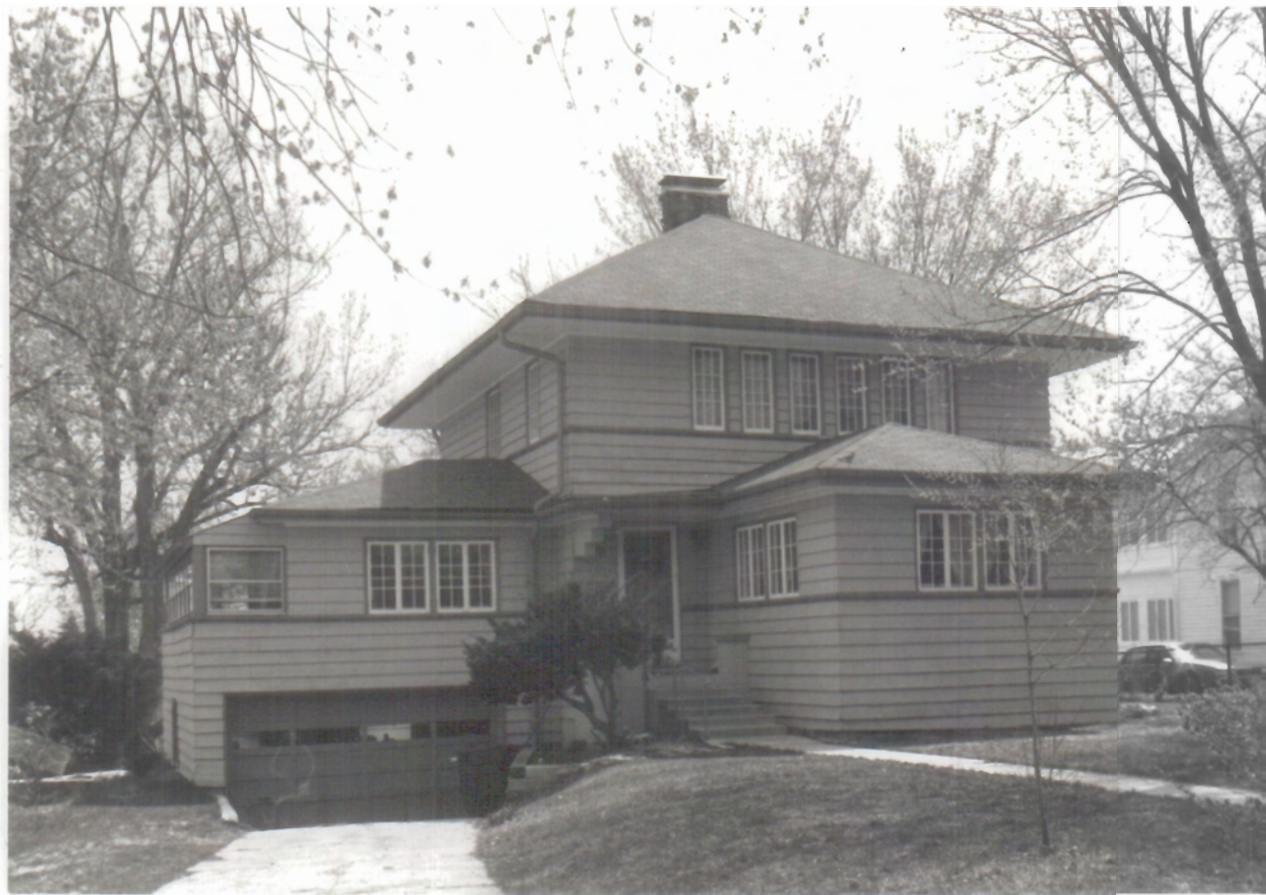
33. Further description of important features: The roof has wide overhanging eaves. Windows are multipane casements. Narrow wood banding at sills. Front 1-story room also hipped. Bracketed entrance overhang. Garage and room at side are done in similar style but were a later addition, according to a neighbor who lived here c. 1907-20. South side clapboarding and chimney in fairly poor shape.

34. History and Significance: This house is known as the "Ladies Home Journal House" because the plans were supposed to have come from an issue of the magazine. Heritage/St. Louis found a permit taken out by Mary E. Wright in 1910 for a \$3,500 frame house, R. Dawson & Son, arch. They initially dismissed it because Geo. W. Clinton was known to be the first owner; however, Mary E. Wright was his mother-in-law and lived with him before & after this house was built, and she owned this lot. Although the plat # is wrong, permit is surely for this house.

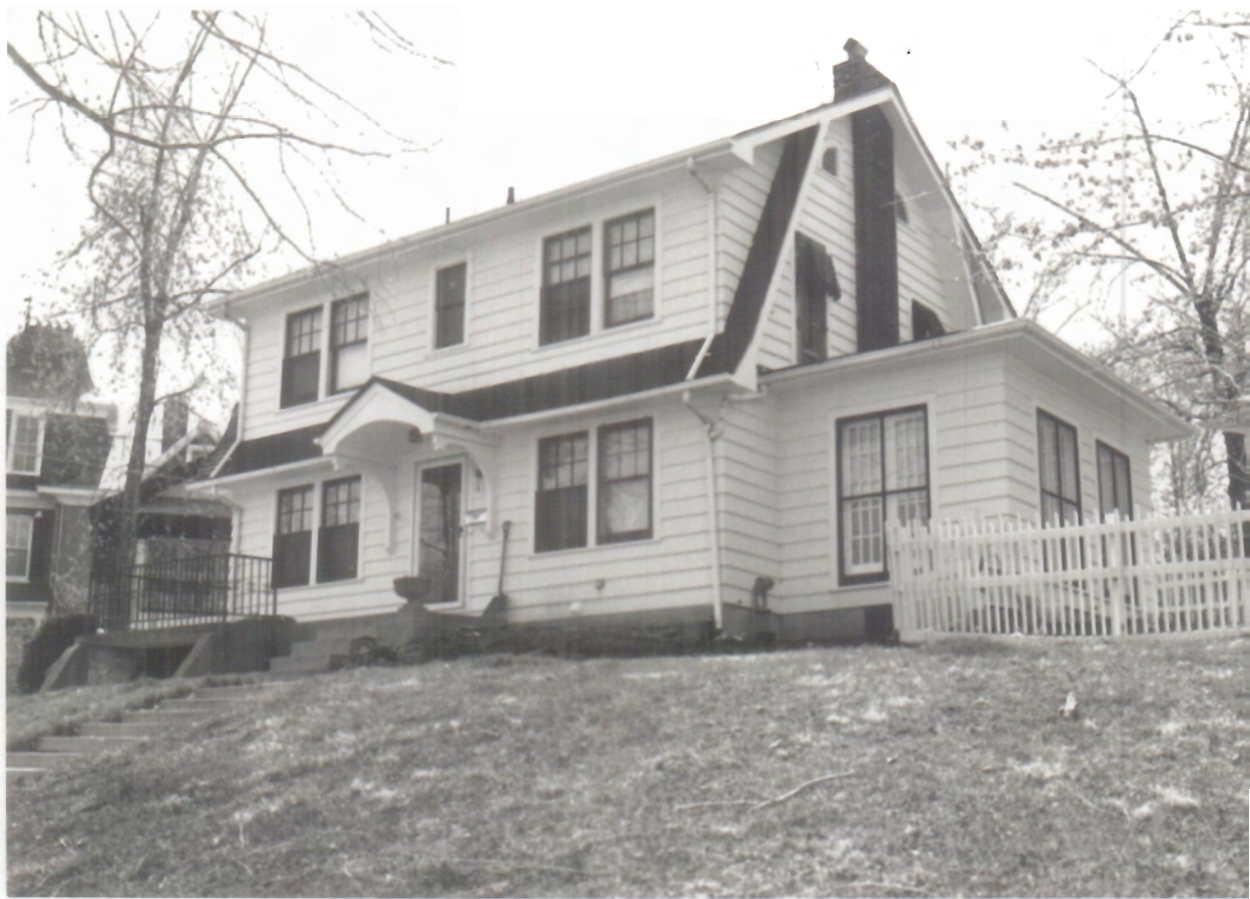
33. Further description of important features: \*This house is really a side-gabled 2-story, but the inset eaves form the roofline of a gambrel, giving the impression of a full-width dormer mounted on a gambrel roof. Paired windows are 6-over-1. A gabled hood shelters the doorway, supported by curved wood brackets. A one-story flat-roofed room at the west side has multipane (french doors?) windows and 2nd-story access. One feature of this (cont'd. below)

34. History and Significance: house different from others of its type is the drive-in basement/garage at the left, possible because of the steep grade. This house is very similar to survey #36, #37 and #65, all houses built by H. C. Vollmar c. 1927. Building permits prior to c. 1926 are not available for this city block and this house is not listed in those 1926 and newer. Music teacher Carl Rossow lived in this house in 1930 but not in 1925, leading to a circa date of 1925.

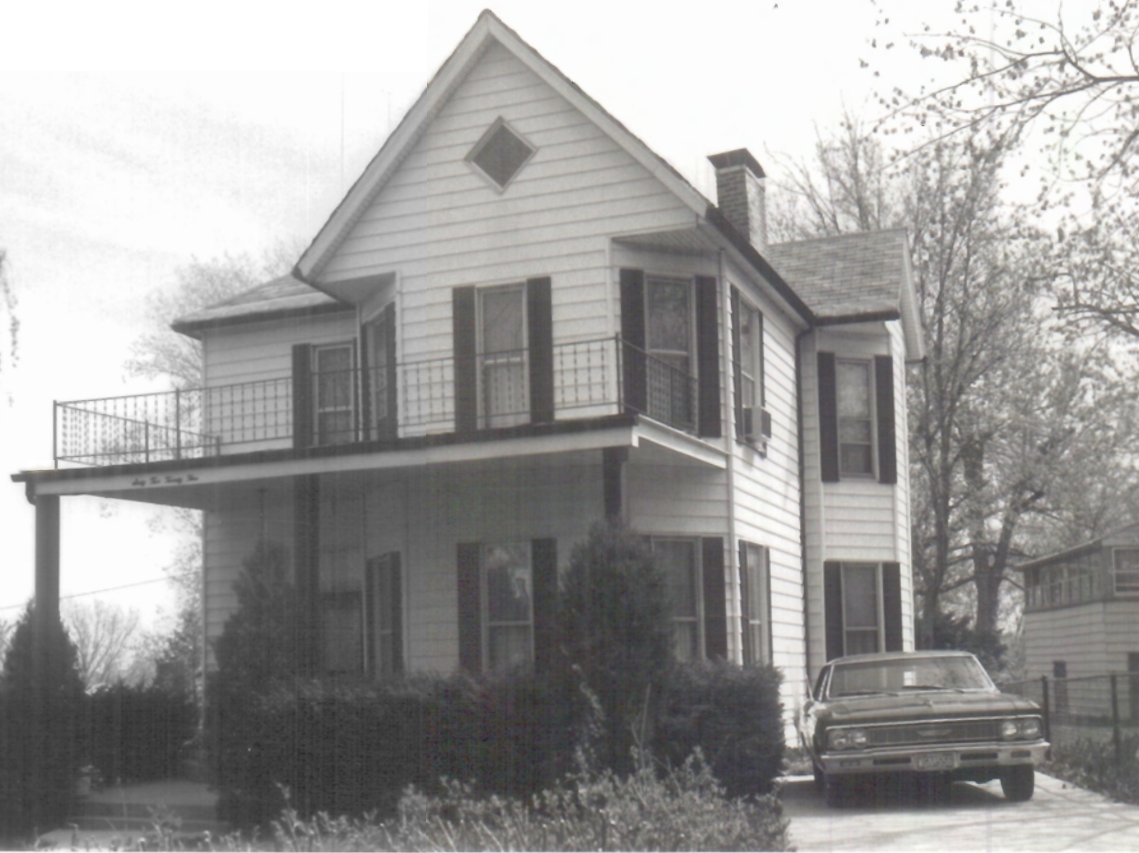
33. Further description of important features: The projecting front gable of this house is cut out at the corners of both stories for the placement of angled windows. Across the front of the resulting bay window, a flat-roofed porch wraps around and is topped with an iron railing. Square wood posts support it. The configuration of the porch is probably the same as the original, but the execution is doubtless more spare. The same cut-out treatment (cont'd. below)

34. History and Significance: has been given to the side gable. Windows are 1-over-1. Diamond-shaped windows in the gables. Building permit unavailable. Heritage/St. Louis files say John W. Taylor lived here from 1892-95. He was an inspector and member of the Episcopalian church. By 1898, he had moved to 2518 Clifton (now razed and replaced).

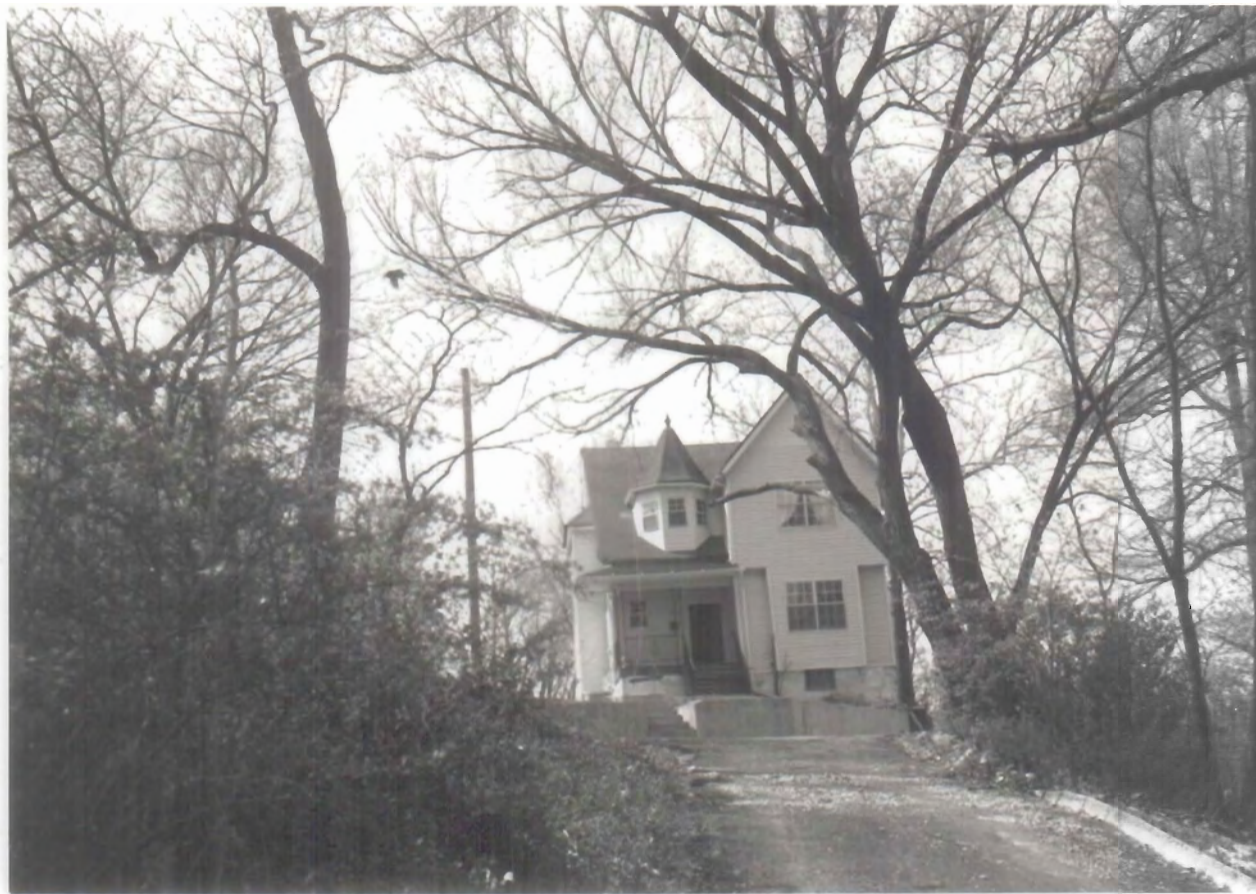
33. Further description of important features: The front-facing gable of this house has the corners at the first story cut out to form a shallow projecting bay. Below the side gable, a 2-story bay projects. In the corner ell, a polygonal tower with a finial rises above a small porch. Siding may be vinyl. House is located at the end of a long private drive.

34. History and Significance: No inactive building permits are accessible for this city block, so definite dating is difficult. Daniel Tevis, listed as being in the insurance business at 721 Olive, lived in this house as early as 1901.

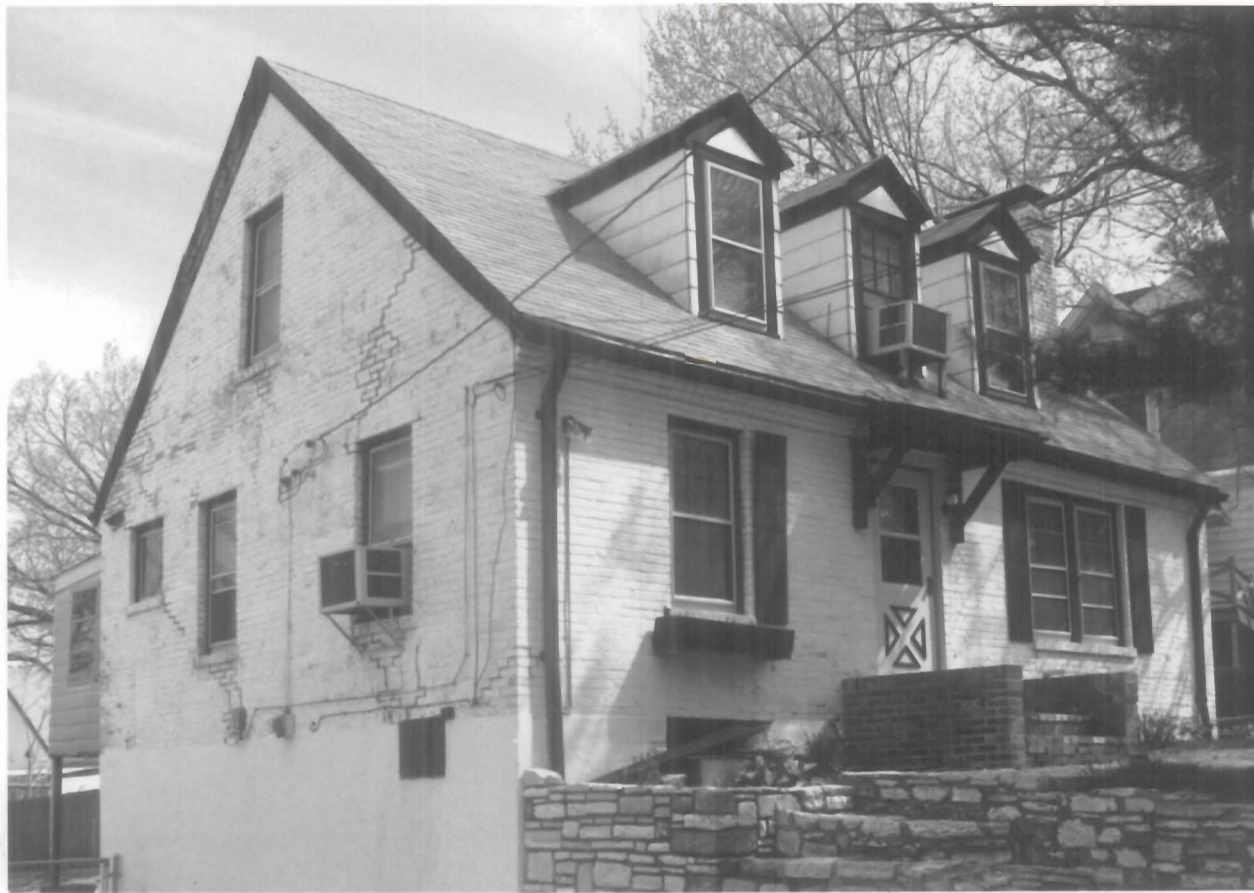
No. 002	3. Location of Negatives: Missouri Office of Historic Preservation, P. O. Box 176, Jefferson City, MO 65102		
1. City/County: City of St. Louis, MO	4. Prepared by: Cynthia Hill Longwisch, Landmarks Assn. of St. Louis, 917 Locust, 7th Floor, St. Louis, MO 63101

24. Foundation material: stuccoed		25. Roof type/material: side gable	
26. No. Bays: Front 3 Side 3		27. Wall treatment: painted brick	
28. Plan shape: see site map		29. Changes: Addition? rear Altered?

30. Exterior condition: good		31. Open to public? no	
32. Other Surveys in which included: Heritage/St. Louis survey, 1971			
33. Further description of important features: Window have flat arches, 6-over-1 panes, brick sills. Three dormers on front elevation. Modest brick cornice. Unpainted brick stoop of more recent vintage. One side chimney. Like many houses in the area, the foundation material is obscured by a stucco-like wash.

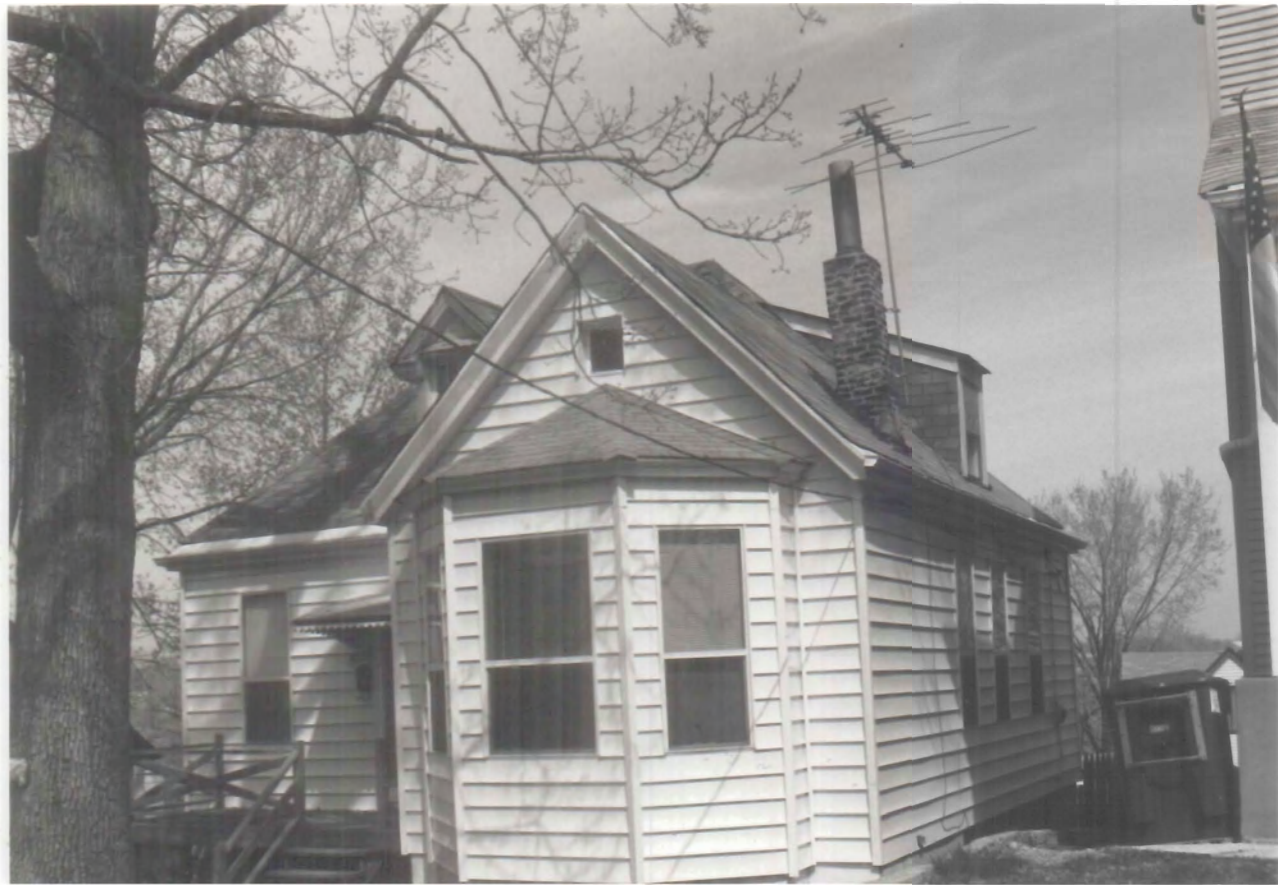
1. No. 003	3. Location of Negatives: Missouri Office of Historic Preservation, P. O. Box 176, Jefferson City, MO 65102		
2. City/County: City of St. Louis, MO	4. Prepared by: Cynthia Hill Longwisch, Landmarks Assn. of St. Louis, 917 Locust, 7th Floor, St. Louis, MO 63101

24. Foundation material: concrete		25. Roof type/material: gabled/asphalt	
26. No. Bays: Front 3 Side 3		27. Wall treatment: vinyl siding	
28. Plan shape: see site map	29. Changes: Addition?		Altered? yes

30. Exterior condition: good		31. Open to public? no	
32. Other Surveys in which included: Heritage/St. Louis survey, 1971			
33. Further description of important features: A three-sided bay window extends from the gabled front end. Windows are replacements. Dormers on front and side elevations. Wooden deck on front probably replaces an original porch.

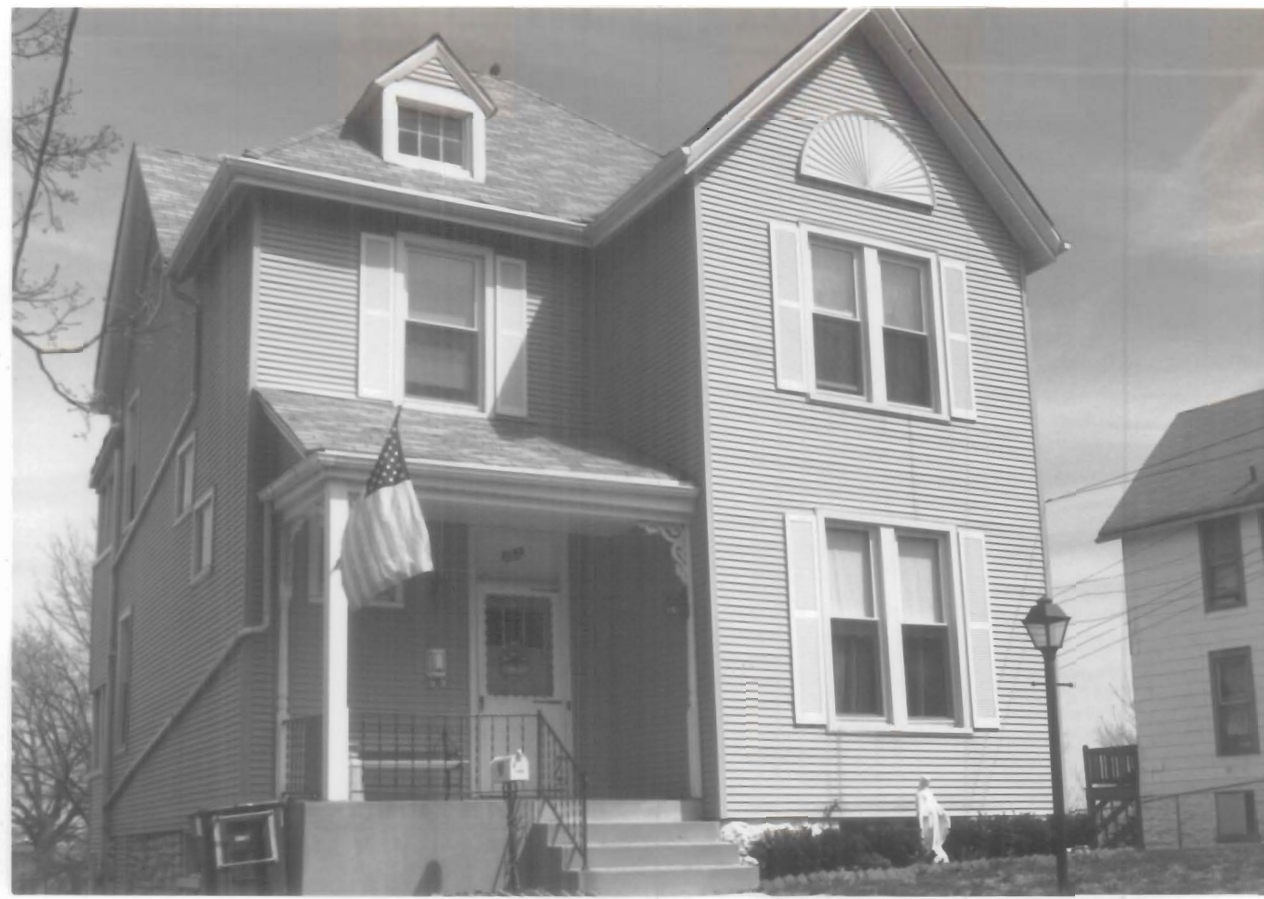
1. No. 004	3. Location of Negatives: Missouri Office of Historic Preservation, P. O. Box 176, Jefferson City, MO 65102		
2. City/County: City of St. Louis, MO	4. Prepared by: Cynthia Hill Longwisch, Landmarks Assn. of St. Louis, 917 Locust, 7th Floor, St. Louis, MO 63101

24. Foundation material: stone		25. Roof type/material: gabled/asphalt	
26. No. Bays: Front 2 Side 3		27. Wall treatment: clapboarding	
28. Plan shape: see site map		29. Changes: Addition? Altered?

30. Exterior condition: good		31. Open to public? no	
32. Other Surveys in which included: Heritage/St. Louis survey, 1971			
33. Further description of important features: A sunburst medallion highlights the front gable of this house, which also features carved gingerbread brackets on the small front porch. Windows have been replaced. Porch appears to have been repoured more or less recently.

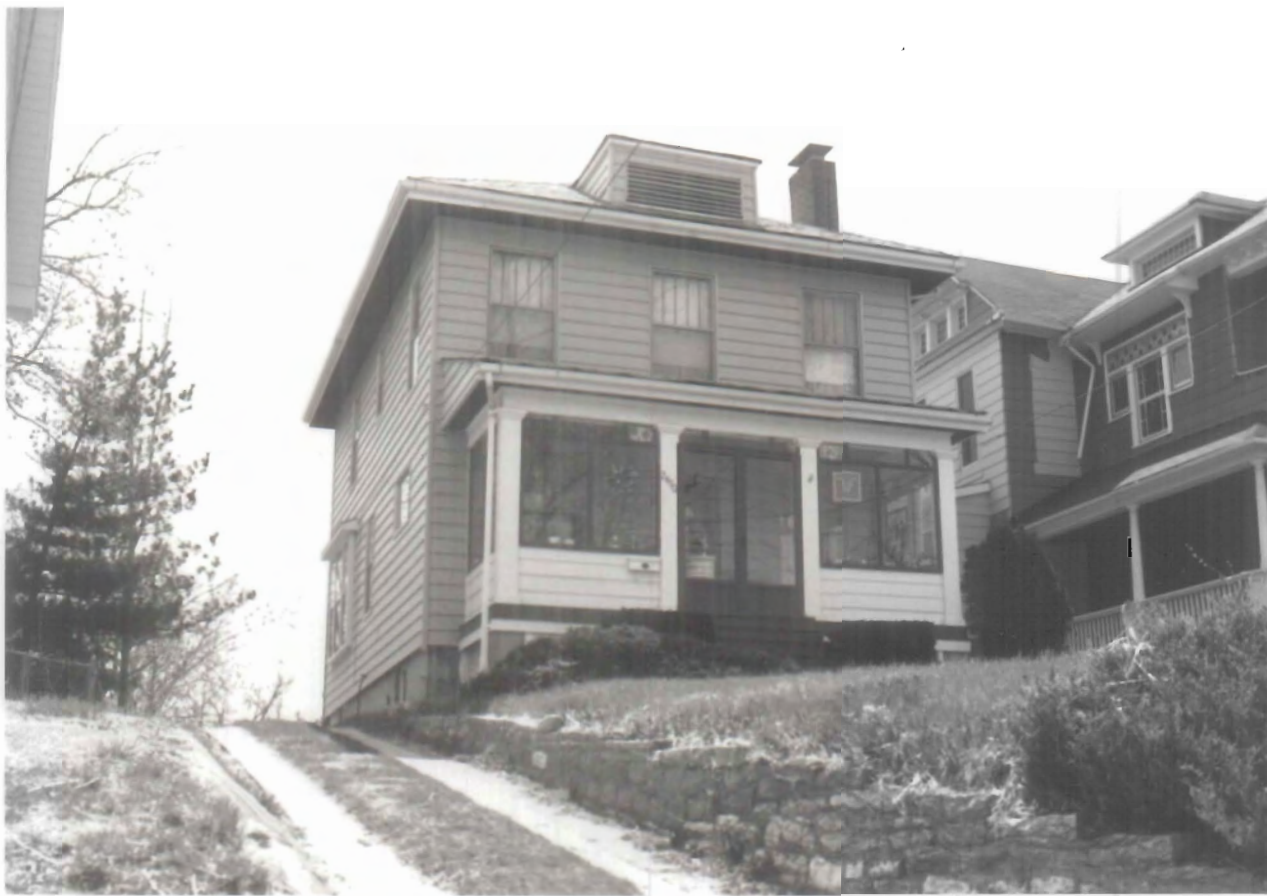
1. No. 139	3. Location of Negatives: Missouri Office of Historic Preservation, P. O. Box 176, Jefferson City, MO 65102		
2. City/County: City of St. Louis, MO

19. Original Use: residence		20. Present Use: residence	
21. No. of stories: 2	22. Basement? yes	23. Wall construction: frame	
24. Foundation material: stuccoed		25. Roof type/material: hipped

26. No. Bays: Front 3 Side 3		27. Wall treatment: vinyl siding	
28. Plan shape: see site map	29. Changes: Addition?		Altered? yes
30. Exterior condition: good		31. Open to public? no

32. Other Surveys in which included: Heritage/St. Louis survey, 1971			
33. Further description of important features: The 5-over-1 double-hung sash on this house are a variation of the 3-over-1 seen throughout Clifton Heights. A front-facing dormer has been fitted with a vent rather than a window. Window at left side projects very slightly and has narrow hood, apparently an alteration. Wide porch has been infilled with windows and doors to provide an enclosed space; the original frame side walls and square wood (cont'd. below)

34. History and Significance: pillars are still clearly in place. No building permits this early are available for this city block. William F. Sherman, salesman for Hamilton Brown Shoe Co., is listed in directories as living in this house in 1901.

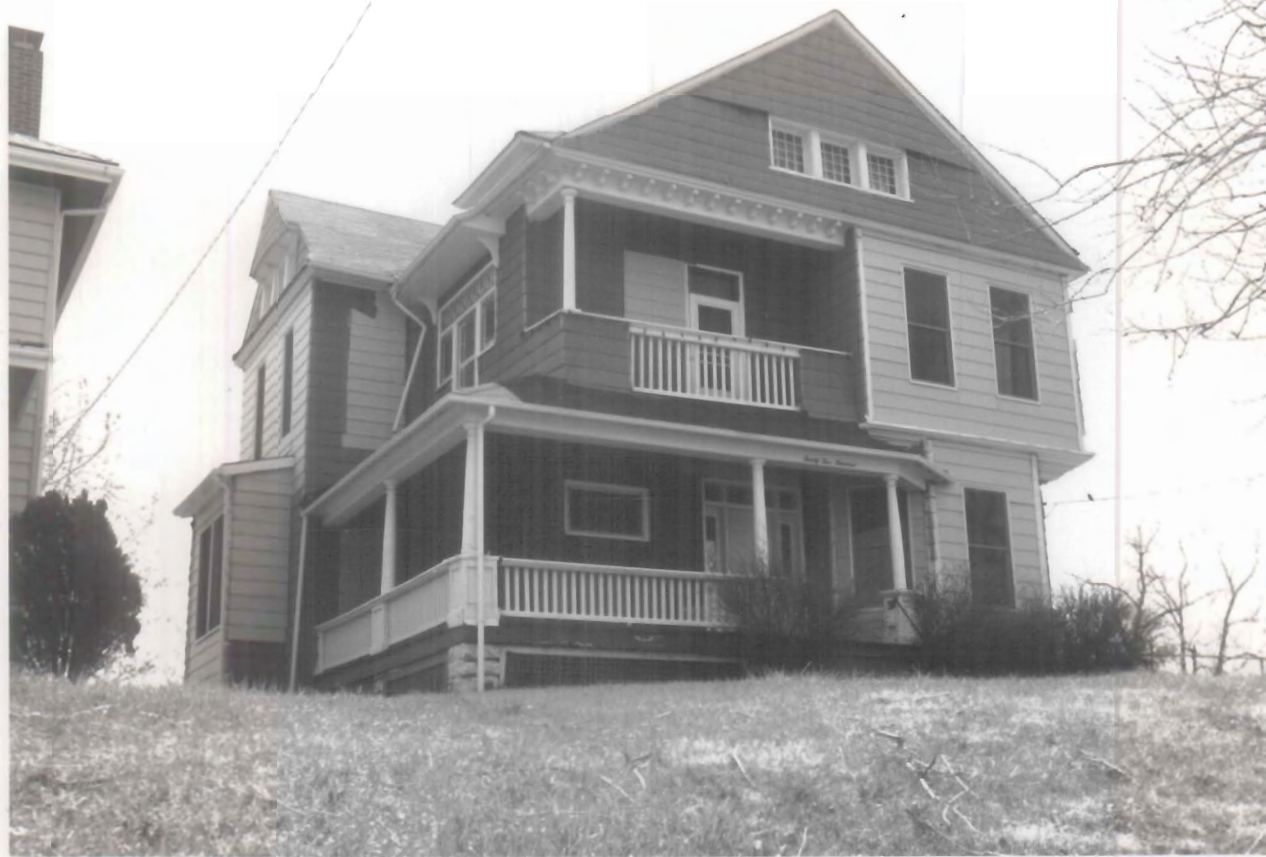
1. No. 138	3. Location of Negatives: Missouri Office of Historic Preservation, P. O. Box 176, Jefferson City, MO 65102		
2. City/County: City of St. Louis, MO	4. Prepared by: Cynthia Hill Longwisch, Landmarks Assn. of St. Louis, 917 Locust, 7th Floor, St. Louis, MO 63101

21. No. of stories: 2 1/2	22. Basement? yes	23. Wall construction: frame	
24. Foundation material: stone		25. Roof type/material: gabled	
26. No. Bays: Front 3 Side 3		27. Wall treatment: asbes.& alum. sidg.

28. Plan shape: see site map		29. Changes: Addition? Altered?	
30. Exterior condition: fair/good		31. Open to public? no	
32. Other Surveys in which included: Heritage/St. Louis survey, 1971

33. Further description of important features: Triple deeply inset windows in the front gable feature multiple small panes. A large wrap-around porch at the first story is topped by a second, smaller open porch with bracketed cornice above. Both have turned wood columns. House has a rambling, asymmetrical shape with many angles. Door has side and fanlights. Right side of facade has cutout corners to form bay window. Half asbestos, half aluminum siding.

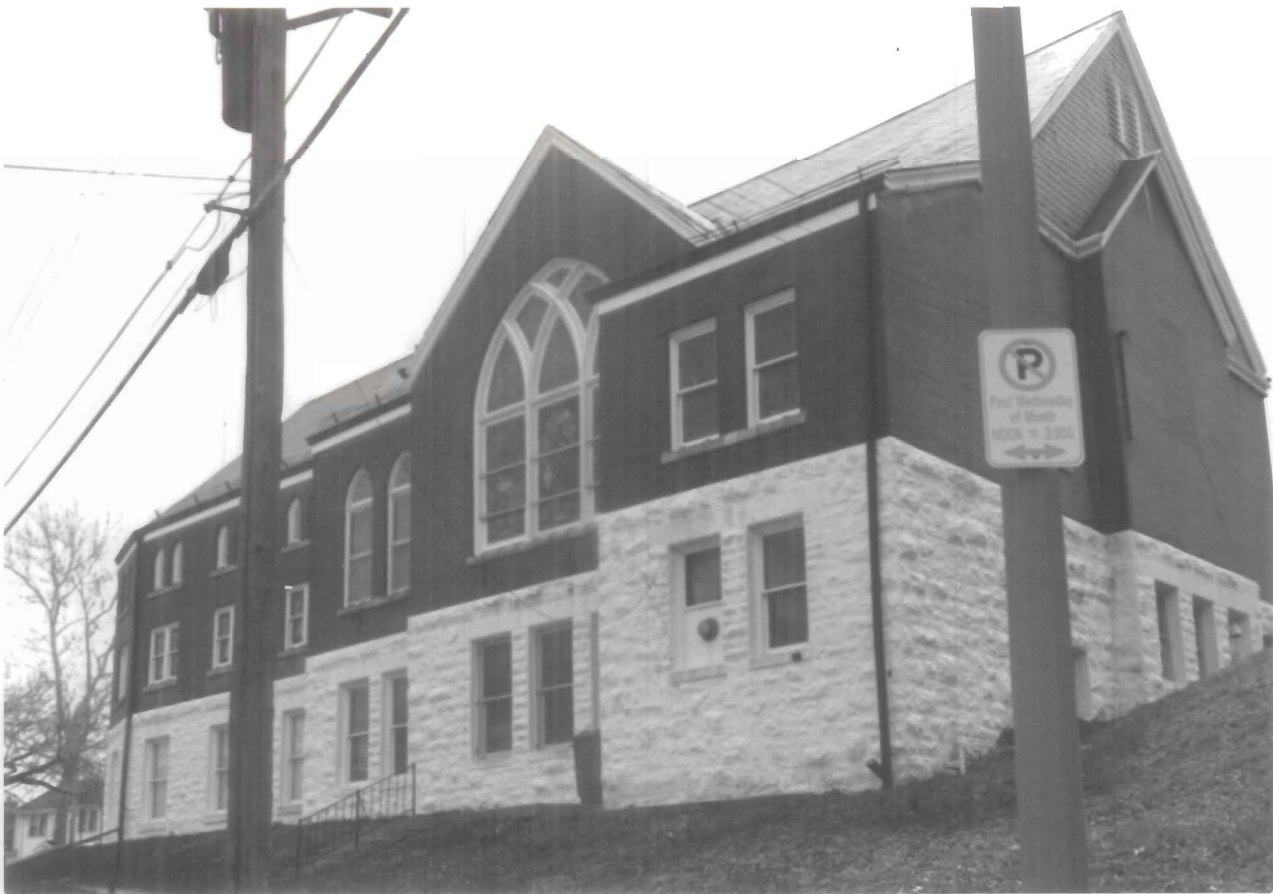
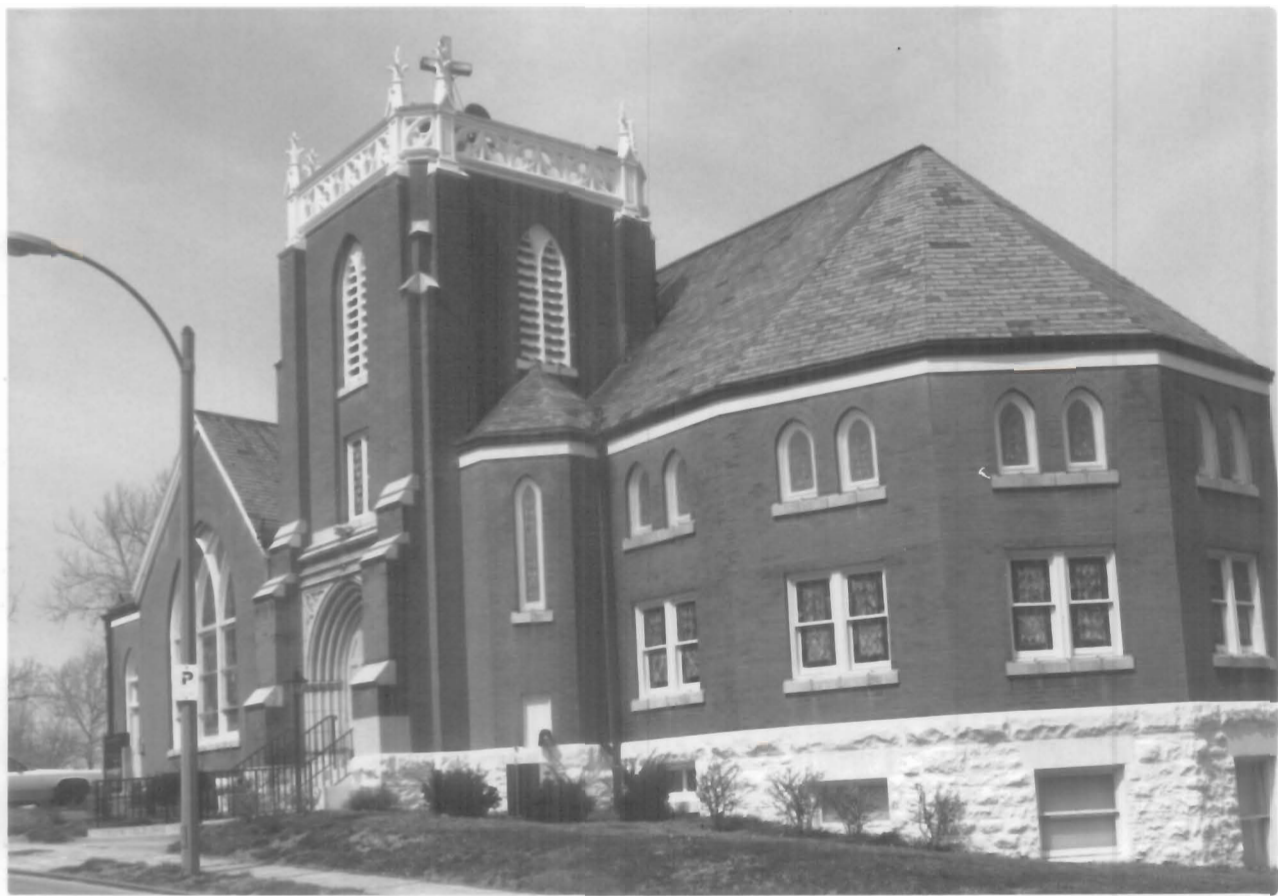
19. Original Use: church		20. Present Use: church	
21. No. of stories: 2	22. Basement? yes	23. Wall construction: masonry	
24. Foundation material: stone		25. Roof type/material: complex

26. No. Bays: Front 9 Side n/a		27. Wall treatment: red brick	
28. Plan shape: see site map		29. Changes: Addition? Altered?	
30. Exterior condition: good		31. Open to public? yes

32. Other Surveys in which included: Heritage/St. Louis survey, 1971			
33. Further description of important features: A square, flat-roofed bell tower also houses the entrance; a wood tracery railing with corner finials tops the tower. Stone-capped buttresses flank the limestone compound gothic arched entrance highlighted by stone tracery. Large gothic stained glass windows are centered on the north and south sides of the west wing. The polygonal apse extends to the east/northeast, with paired double-rowlock (cont'd. below)

34. History and Significance: gothic-arched stained glass windows above and paired flat-arched stained glass windows below, all with stone sills. The grade slopes away from the church on the north, exposing the basement level. The original church was erected in 1892 and burned in 1905. It was named for Dr. Benjamin St. James Fry, the primary early promoter of Clifton Hts. and a Methodist minister. Fry lived at 2933 Lucas, but was responsible for bringing many Methodists to this area from 1885 until his death in 1892. Cost: \$16,000

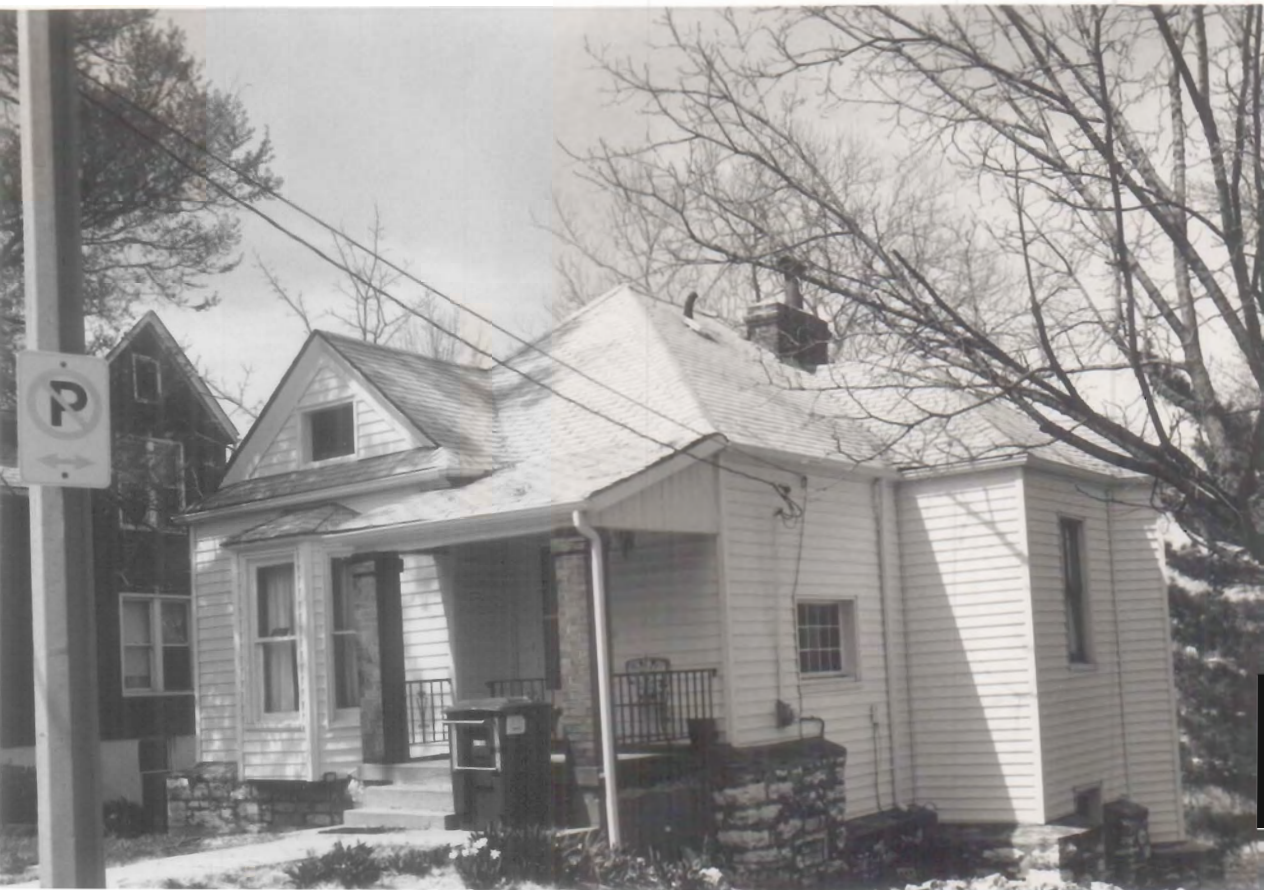
33. Further description of important features: The central pyramidally-hipped roof of this cottage is gabled at the front with a secondary hip at the north side. A shed-roof porch has straight brick pillars. Bay window under the gabled left end, front elevation. Window to right of porch appears to have been altered. Rear 1-story frame addition.

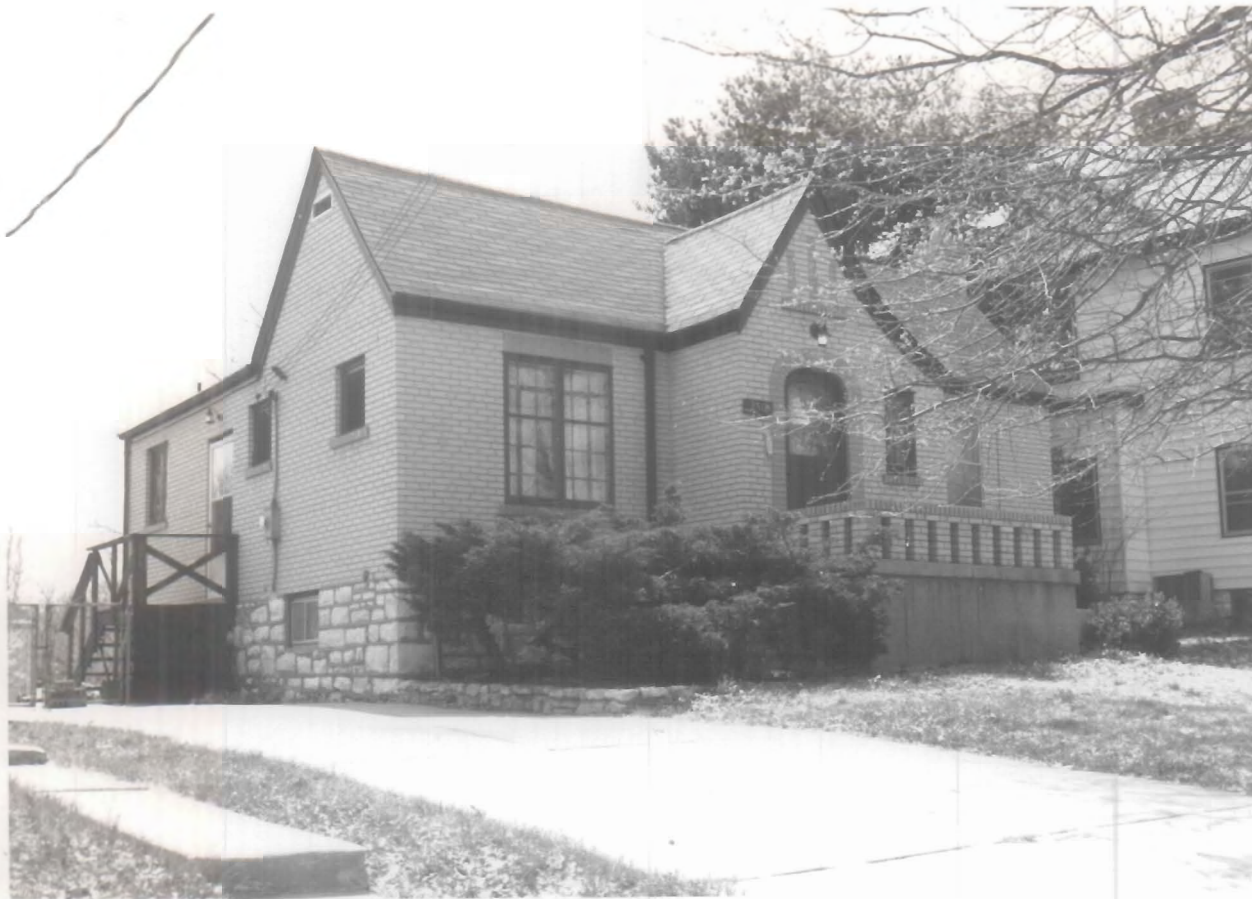
1. No. 161	3. Location of Negatives: Missouri Office of Historic Preservation, P. O. Box 176, Jefferson City, MO 65102		
2. City/County: City of St. Louis, MO	4. Prepared by: Cynthia Hill Longwisch, Landmarks Assn. of St. Louis, 917 Locust, 7th Floor, St. Louis, MO 63101

21. No. of stories: 1	22. Basement? yes	23. Wall construction: masonry	
24. Foundation material: stone		25. Roof type/material: gabled	
26. No. Bays: Front 4 Side 4		27. Wall treatment: buff brick

33. Further description of important features: The entrance of this house is highlighted by an asymmetrical gable. Front elevation windows and doors are trimmed with a darker buff brick. The front door has a basket-handle arch. Main front window is of the casement type and has a soldier lintel and sill of the darker buff brick. An unroofed front porch has a brick balustrade with a top header course of the darker brick. Low rear addition is apparently original.

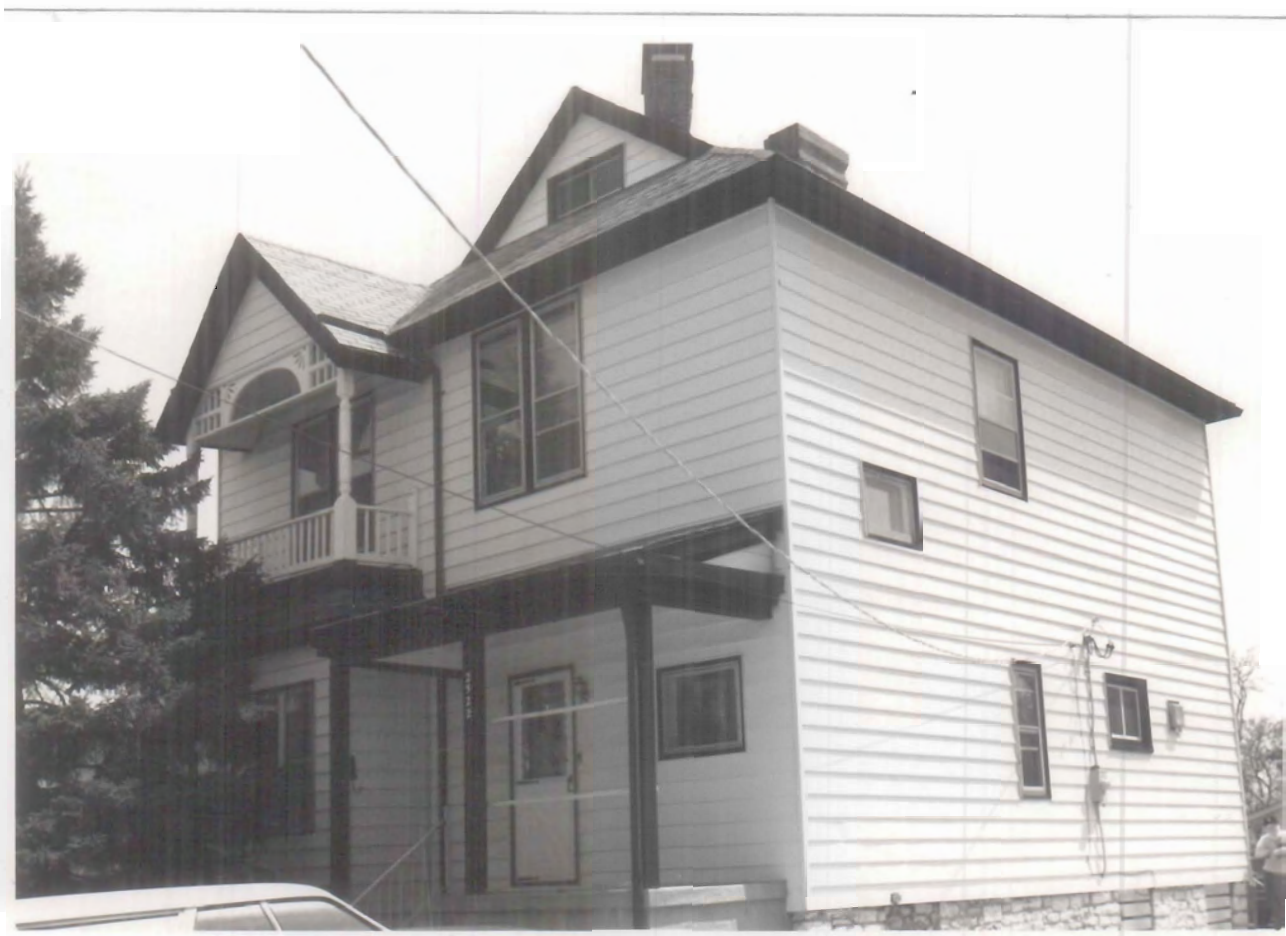
24. Foundation material: stone	25. Roof type/material: complex
--------------------------------	---------------------------------

30. Exterior condition: good	31. Open to public? no
------------------------------	------------------------

33. Further description of important features: Another unfortunate example of modernization, this house still retains a bit of its original detailing. All the windows have been replaced and several altered. The hipped roof has a small windowed gable at right and a gabled 2nd-story porch at left. This porch surmounts a projecting bay at the bottom story, and features bracketed fretwork, turned spindles and a wood balustrade. A second bay window (cont'd. below)

34. History and Significance: is located on the left (northeast) side at the first story. The entrance porch has a shed roof and wood posts with no railing. No inactive building permits are available for this city block. Heritage/St. Louis records indicate that Samuel Pye, manager of the Western Methodist Book Concern, lived here from 1888-91. Pye was an original Clifton Hts. Trustee; he moved to 3510 Lindell in 1892. This information is based on the presumed original building of this block.
