# ARCHITECTURAL SURVEY OF CLIFTON HEIGHTS

JUNE 1991

ST. LOUIS, MISSOURI

LANDMARKS ASSOCIATION OF ST. LOUIS, INC.

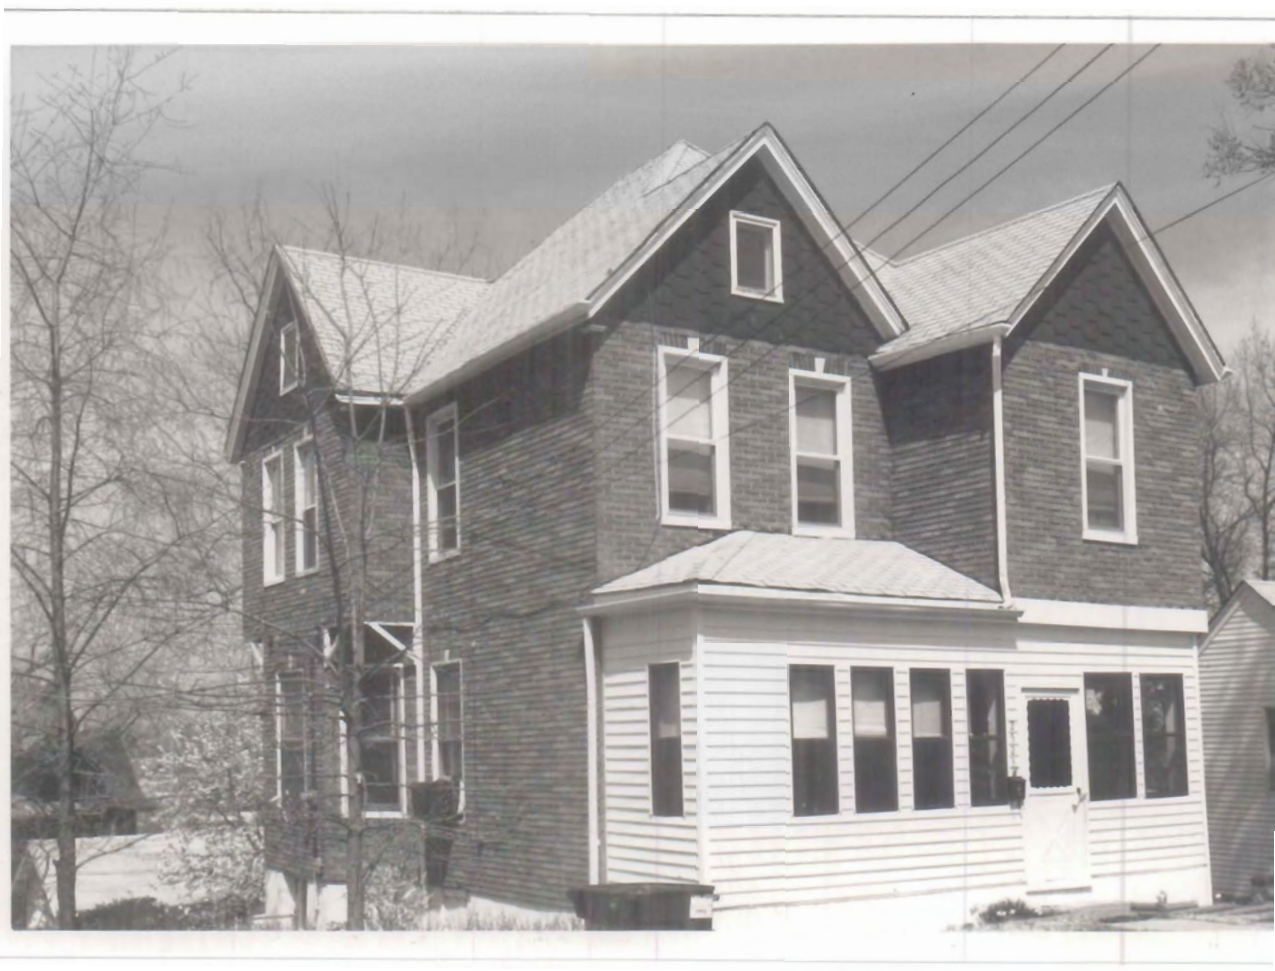
19. Original Use: residence		20. Present Use: residence	
21. No. of stories: 2	22. Basement? yes	23. Wall construction: frame	
24. Foundation material: concrete		25. Roof type/material: complex

26. No. Bays: Front 3 Side 5		27. Wall treatment: asphalt siding	
28. Plan shape: see site map		29. Changes: Addition? yes Altered? yes	
30. Exterior condition: good		31. Open to public? no

32. Other Surveys in which included: Heritage/St. Louis survey, 1971			
33. Further description of important features: The main roof of this house is hipped, with multiple gables facing in different directions. Twin gables on the front elevation have different depths, probably originally forming an ell for an open porch, now enclosed. A south side gabled bay projects from the house, its corners cut out and bracketed at the first story to allow angled windows to form a more traditional bay window configuration. 1-over-1 (cont'd. below)

34. History and Significance: double-hung sash windows. House is covered with brick-look siding, except for the first story front elevation, which has been altered. Rear second story frame porch is up on "stilts." Inactive building permits for this city block have not been microfilmed and so are unavailable, making exact dating impossible.

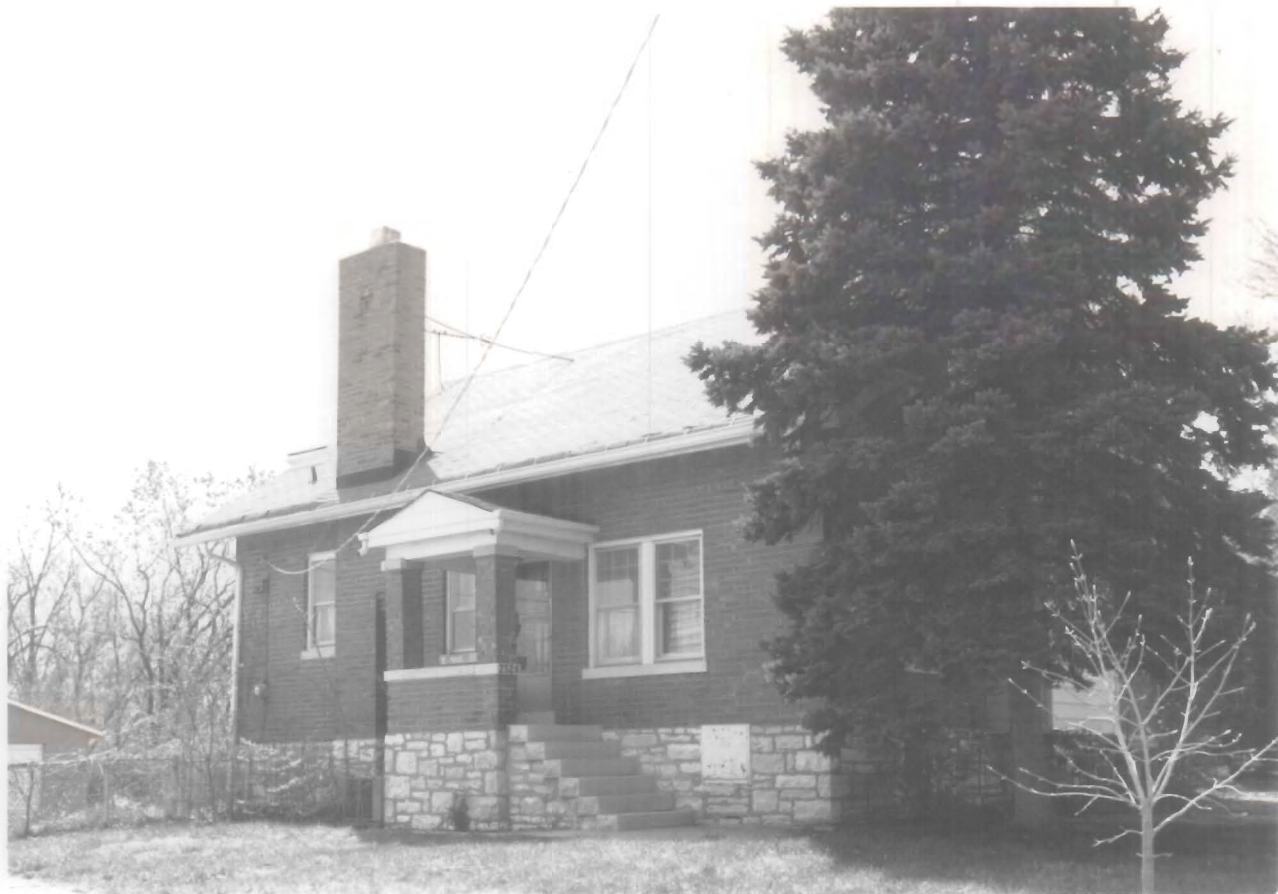
24. Foundation material: stone		25. Roof type/material: front gable	
26. No. Bays: Front 3 Side 4		27. Wall treatment: red brick	
28. Plan shape: see site map		29. Changes: Addition? rear Altered? yes

30. Exterior condition: fair/good		31. Open to public? no	
32. Other Surveys in which included: Heritage/St. Louis survey, 1971			
33. Further description of important features: A round vent is located in the front gable end of this house. Large, blocklike brackets are located at the front eaves; these appear to have been "modernized" into clunky boxes by the application of (aluminum?) siding. This siding also appears on the frame bay window that projects from the front elevation. A small porch at the left (north east) side has brick pillars and a gabled roof. Windows (cont'd. below)

34. History and Significance: are 6-over-1 with flat arches and stone sills. A 1-story frame addition is attached at rear. No pre-1926 building permits are available for this city block, so the date of construction is unknown. A permit was taken out on 7/20/1926 for the alteration of this dwelling by B. Kindsen; no specifics were given, but it may have been for the rear addition.

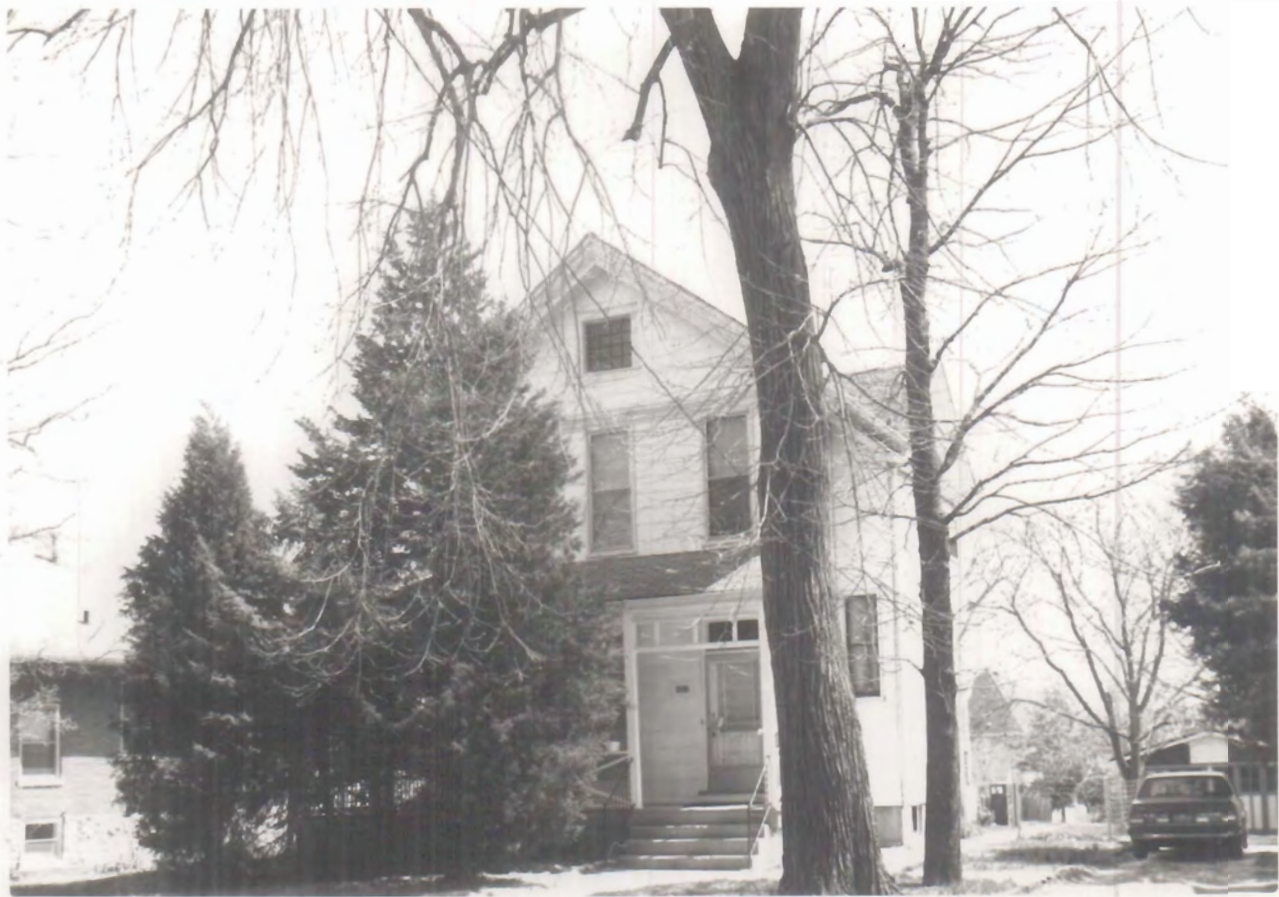
33. Further description of important features: The front gable on this house has a heavy molded wood cornice that returns at the base of the gable to enclose the pediment; a square, multipane window is located above. Three 1-over-1 double-hung sash windows are evenly spaced across the 2nd story gable end. A wrap-around porch is supported by thin square posts. It features a decorative open cornice. Transomed door. Rear frame porch.

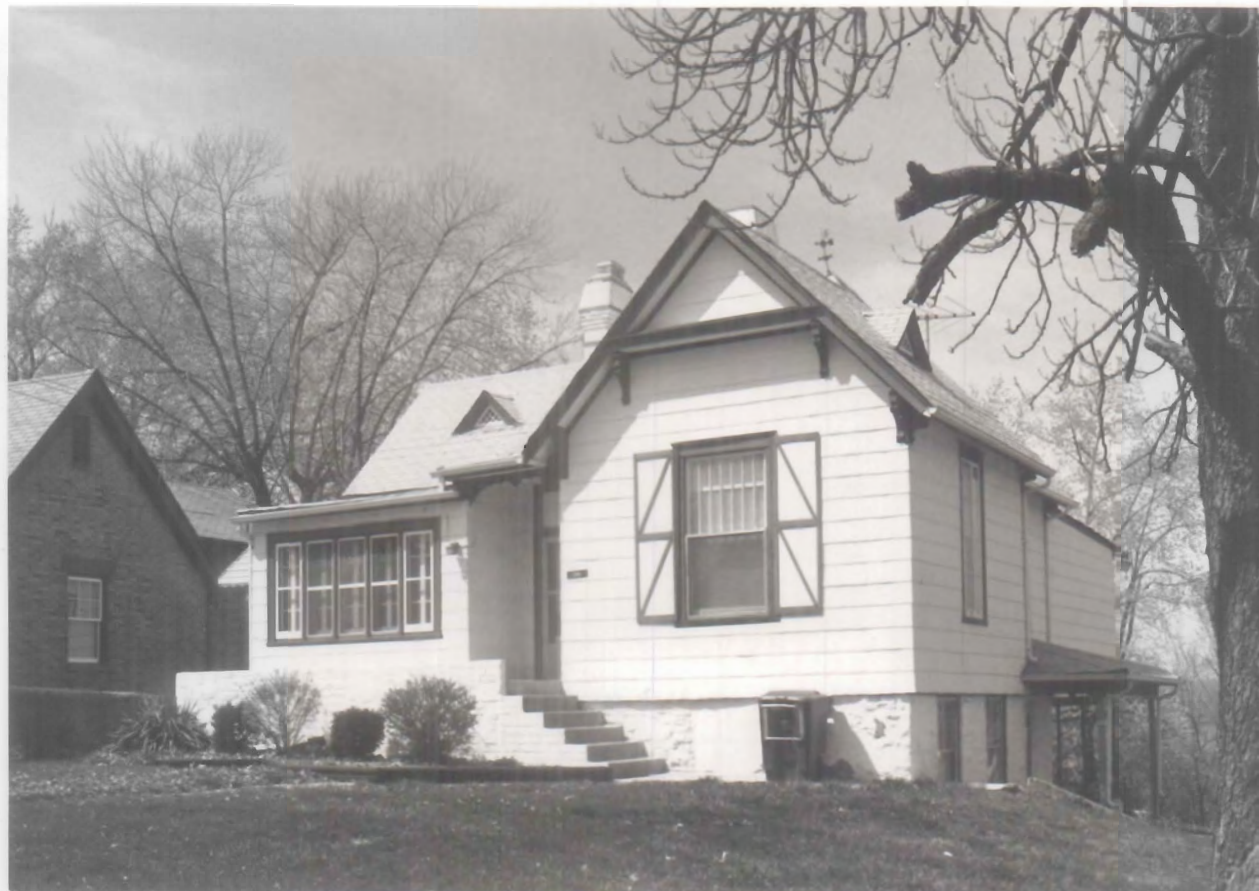
33. Further description of important features: This house has a little of the fantasy cottage in its aspect. The chimneys are shaped by corbeling. Triangular eyebrow dormers on the north and east sides have tiny diamond panes. The front gable is bisected by a wood cornice supported by curved brackets; more brackets appear lower down at the eave. Carved decoration is also present overhead at the top of the steps. The original porch is probably (cont'd. below)

34. History and Significance: enclosed at left; what is left is an uncovered, patiolike, elevated front expanse sheathed in (perma?)stone. Rear frame addition is up on "stilts" to keep it level with the house on the steep rear grade. The inactive building permits for this city block were not microfilmed, so an exact date is not possible. However, the house was owned in 1930 by Patrick J. Hussey, whose daughter (the owner of the house in 1970) told Heritage/St. Louis researchers that she believed the house was built by 1900.

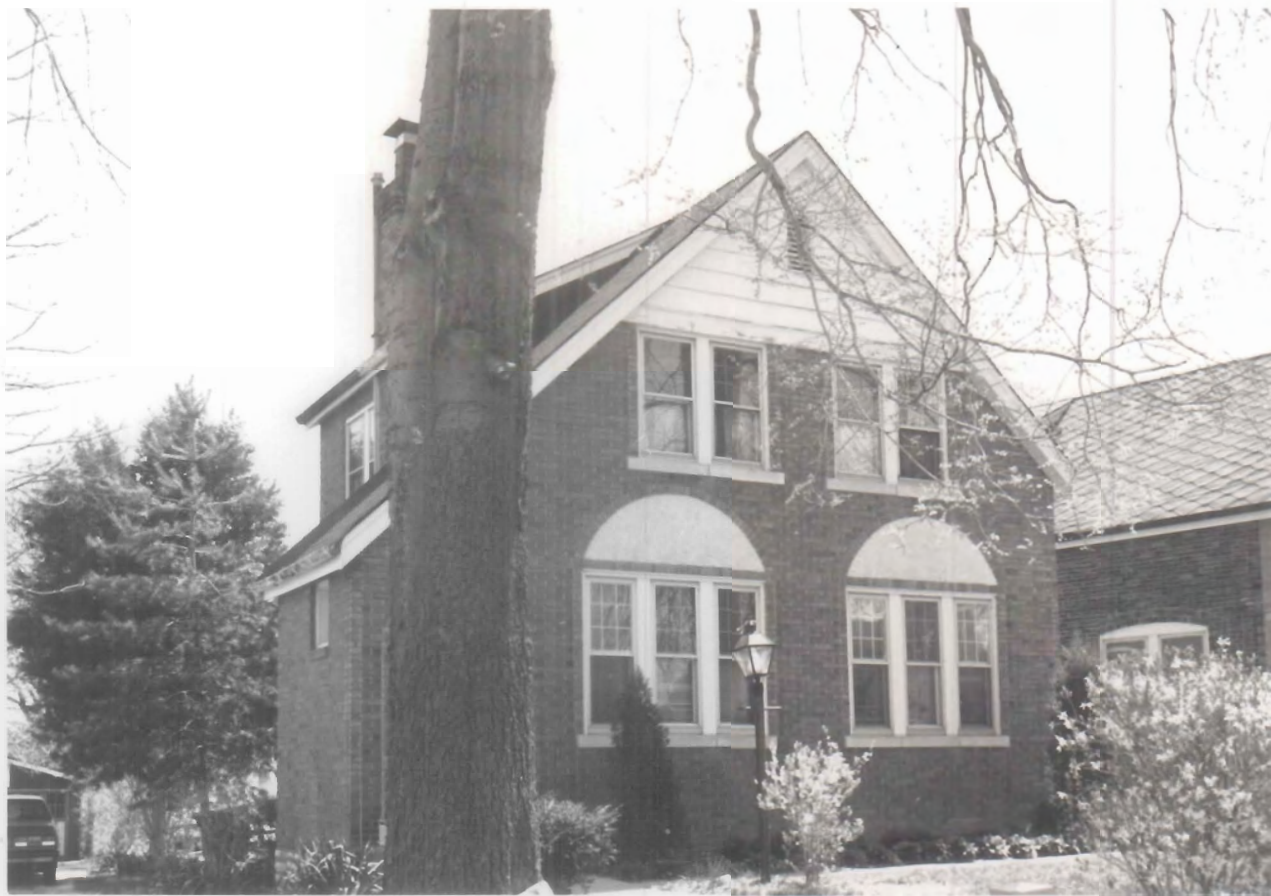
1. No. 157	3. Location of Negatives: Missouri Office of Historic Preservation, P. O. Box 176, Jefferson City, MO 65102		
2. City/County: City of St. Louis, MO	4. Prepared by: Cynthia Hill Longwisch, Landmarks Assn. of St. Louis, 917 Locust, 7th Floor, St. Louis, MO 63101

33. Further description of important features: Two sets of paired 1-over-1 windows appear in the asymmetrical gable end of this house; siding has been used above. Two tripartite windows with 6-over-1 double-hung sash and stone sills have blind (stuccoed) round arches bisected by a soldier course. Round-arched doorway at left. Shed roof dormer on left side. 1-story rear frame addition.

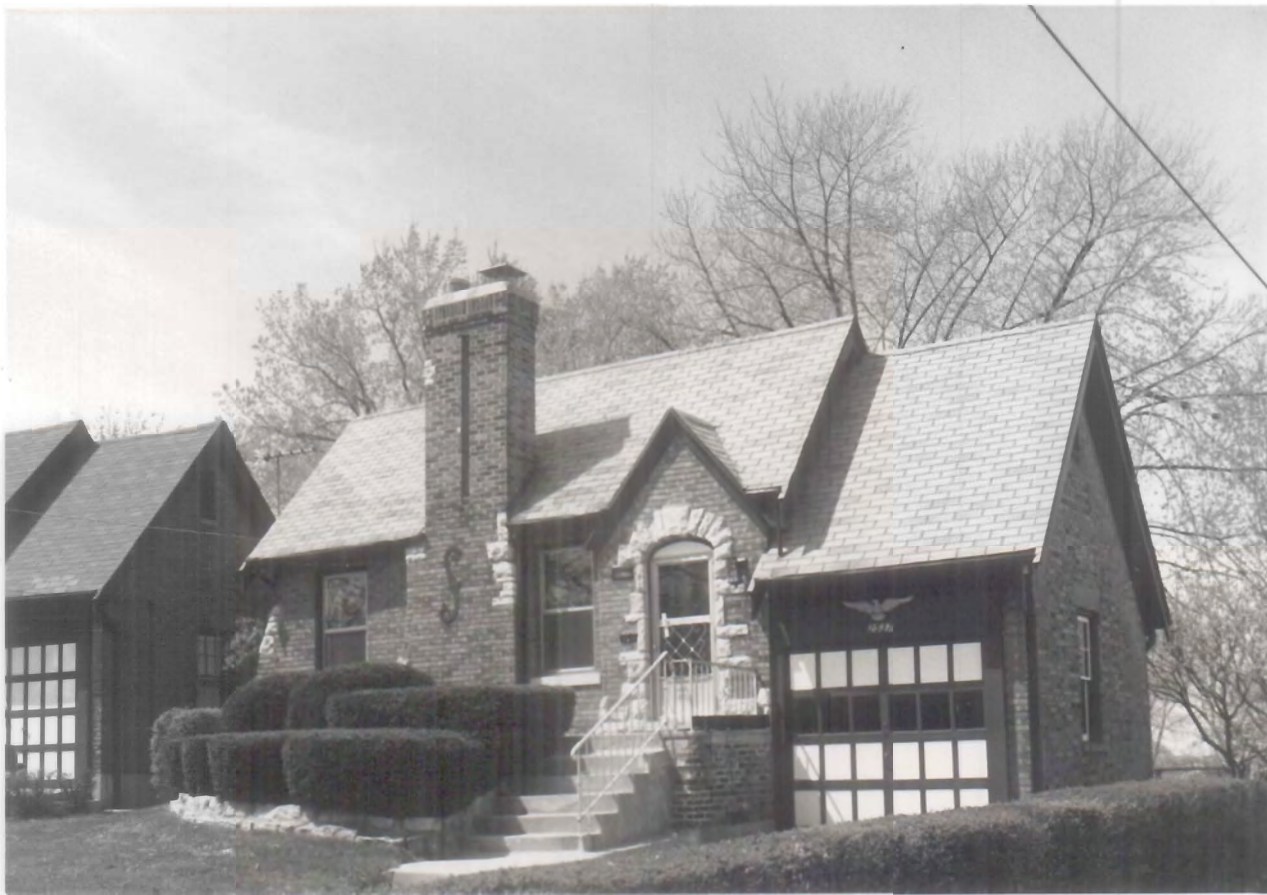
33. Further description of important features: A limestone door surround and randomly-placed limestone accents at the corners highlight this house. The large chimney dominates the design's front elevation. A garage is incorporated into the overall plan. 1-over-1 paned windows have stone sills.

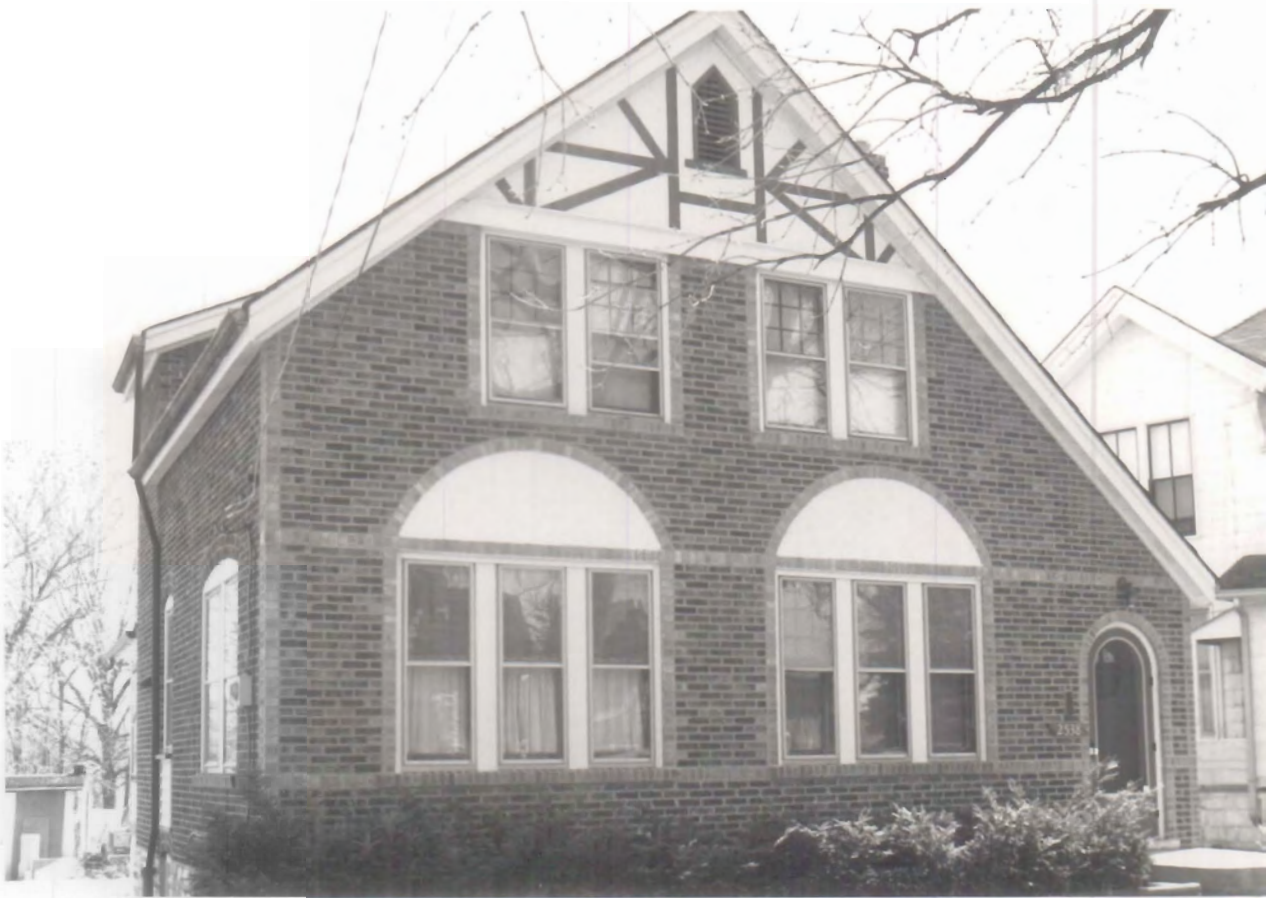
1. No. 156	3. Location of Negatives: Missouri Office of Historic Preservation, P. O. Box 176, Jefferson City, MO 65102		
2. City/County: City of St. Louis, MO

32. Other Surveys in which included: Heritage/St. Louis survey, 1971			
33. Further description of important features: The asymmetrical gable end of this house extends downward at the right side to provide room for a round-arched doorway. Roof is covered with undulating-patterned shingles. Two tripartite windows in front feature blind (stuccoed) arches bisected by a soldier course of lighter-color brick, which also enframes the windows and outlines the corners of the house. Paired windows above are 9-over-1. Half- (cont'd. below)

34. History and Significance: timbering in the gable end. Shed-roof dormer at left side. Side openings have double-rowlock segmental arches. Rear 1-sty addn Oliver Graf took out the permit for this house and for 2534 (survey #157) next door in 1928. The 24 x 24' houses each had hot water heat and cost \$3,500 each. Real estate man Albert Koberman of 4324 Beethoven is listed as the builder. Graf moved into this house himself.

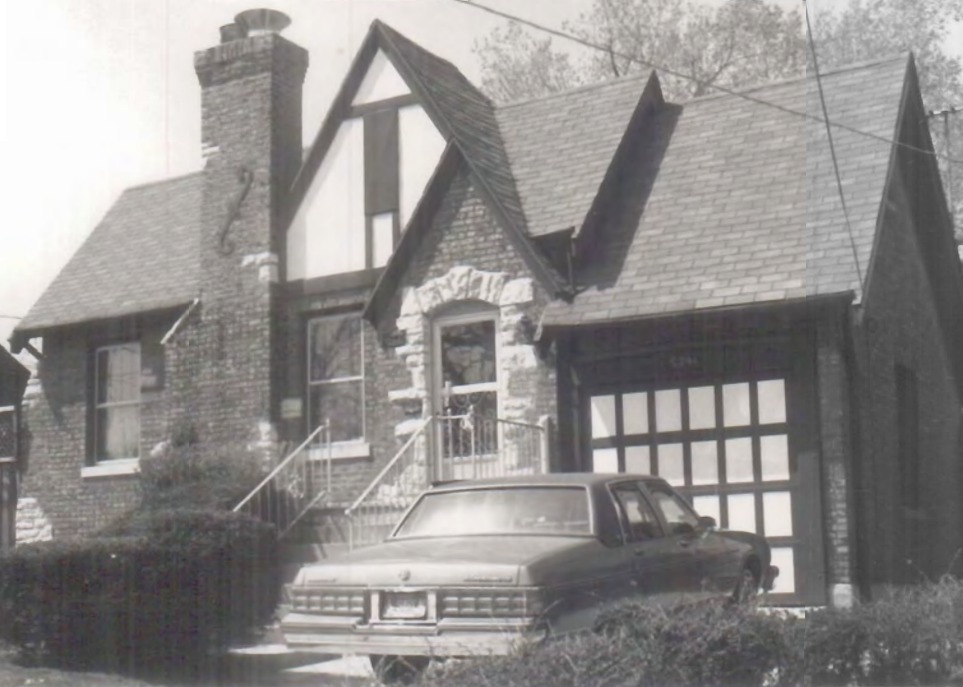
33. Further description of important features: The doorway is in a gable-with-in-a-gable, the upper gable "half-timbered." Randomly-placed limestone accents the corners and provides a door surround. The chimney is a central element in the design and the garage is incorporated into the plan. 1-over-1 windows have stone sills.

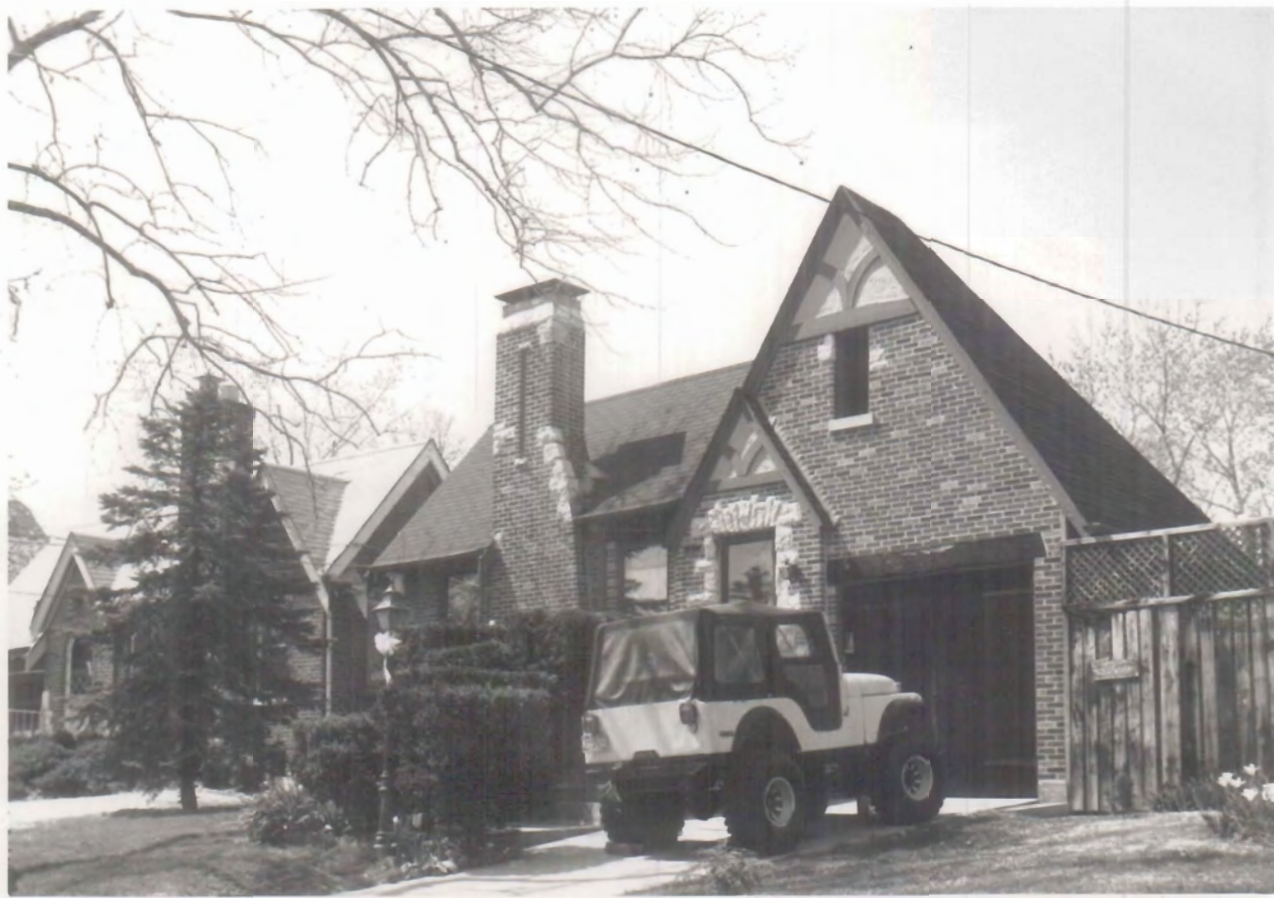
1. No. 130	3. Location of Negatives: Missouri Office of Historic Preservation, P. O. Box 176, Jefferson City, MO 65102		
2. City/County: City of St. Louis, MO	4. Prepared by: Cynthia Hill Longwisch, Landmarks Assn. of St. Louis, 917 Locust, 7th Floor, St. Louis, MO 63101

33. Further description of important features: A large gable in the north end of the facade encompasses a smaller gable over the entrance and the linteled, carriage-house style garage door; "half-timbering" appears in the gable peaks. Stone is used randomly on corners and as the door surround. The large chimney is central to the design of the house. A 1965 brick enclosure for the 1965 swimming pool makes the house substantially larger than its neighbors.

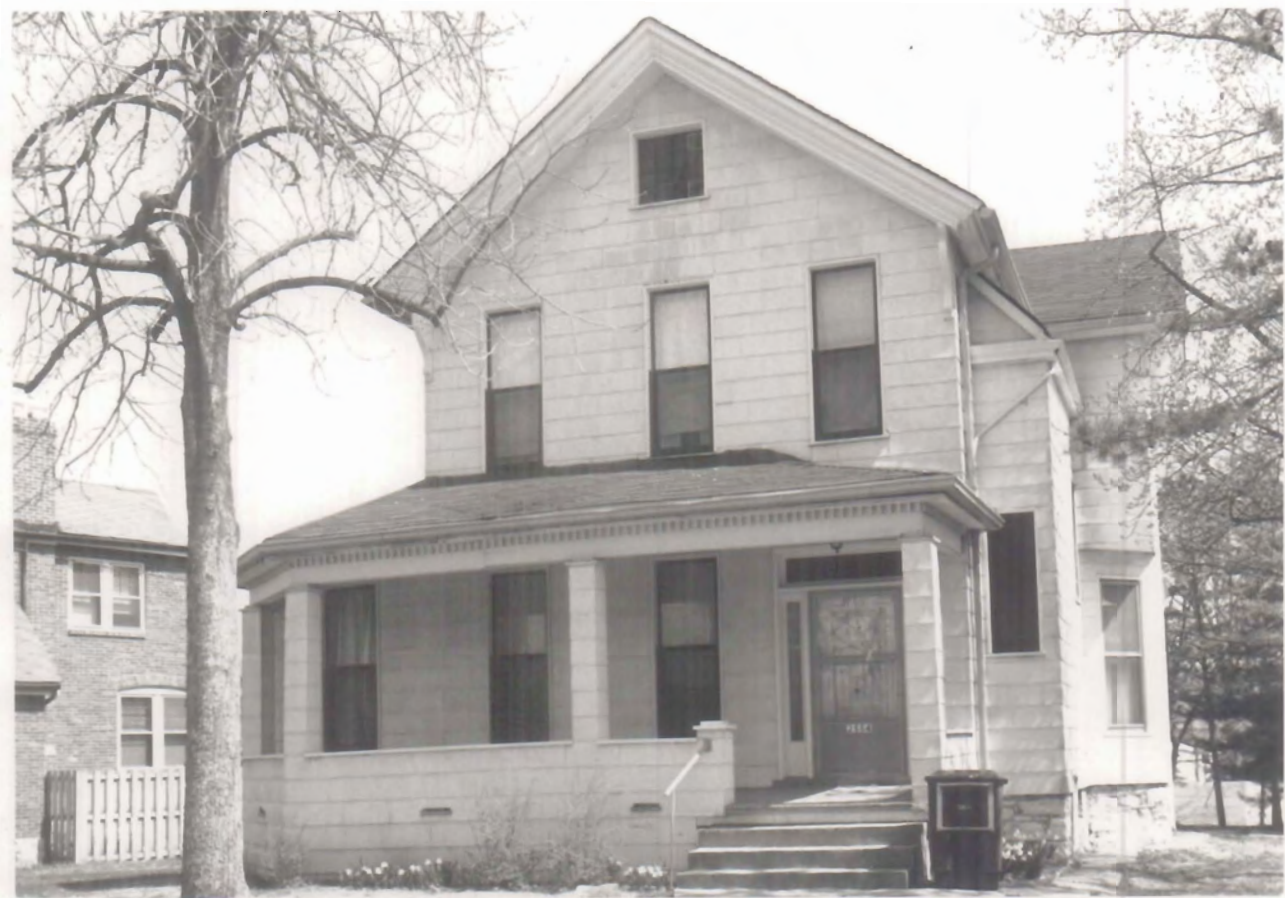
33. Further description of important features: The front gable of this house has a heavy molded wood cornice. An angled, wrap-around porch at the first story is supported by square posts sheathed in the same siding as the house. It features a dentilled cornice. At the south side of the house, a projecting, gabled bay is cut out at the corners on the first story for angled window placement in a bay window. Door has sidelights and fanlight. 1-over-1 windows.

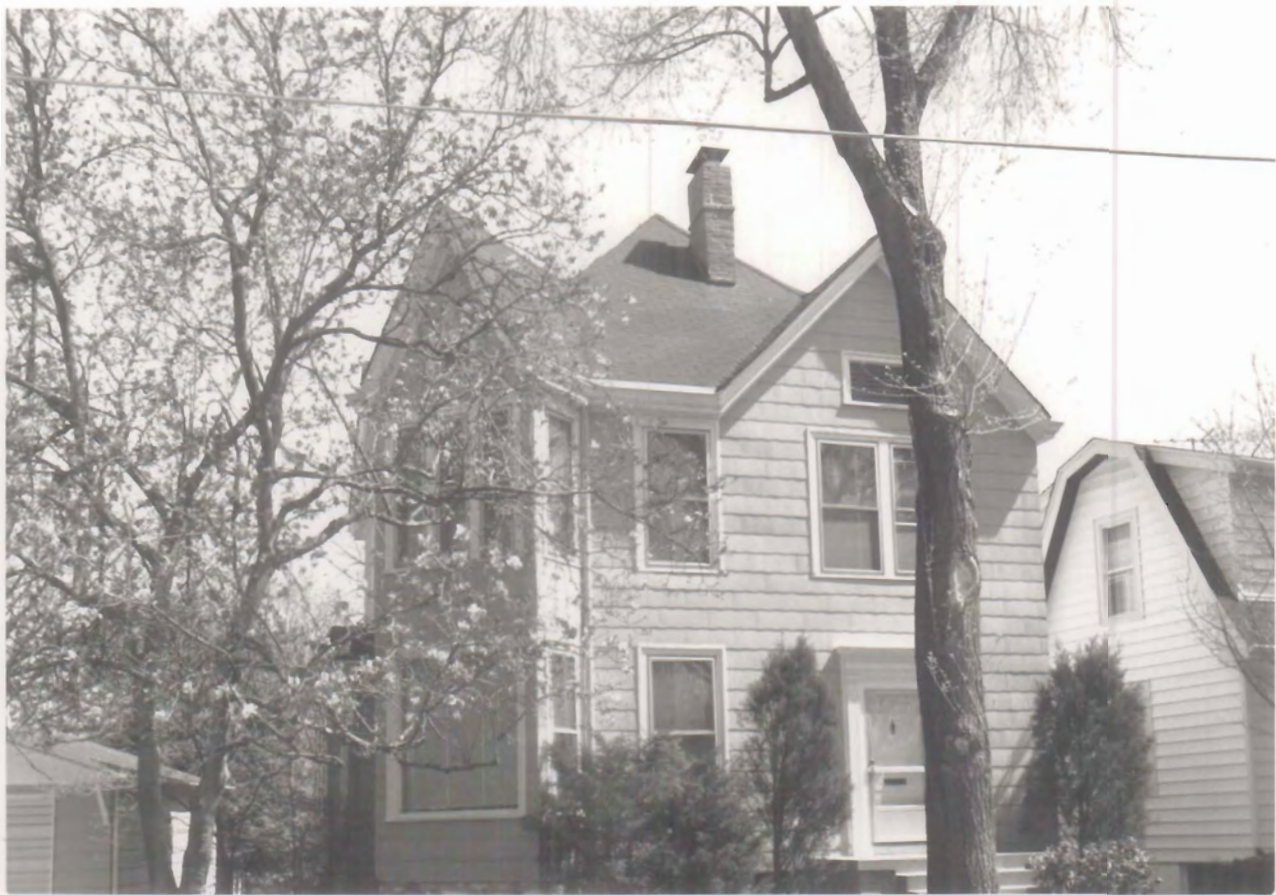
1. No. 154	3. Location of Negatives: Missouri Office of Historic Preservation, P. O. Box 176, Jefferson City, MO 65102		
2. City/County: City of St. Louis, MO

33. Further description of important features: The main roof of this house is pyramidally hipped; gables project from that. An angled corner bay is topped with a gable at the left (northwest) corner; the first-floor window of this bay has been replaced, while above, the original tripartite window remains. Other windows are 1-over-1 double-hung sash. Rectangular window is sideways in right gable. Door surround features engaged pilasters and a dentilled entablature.

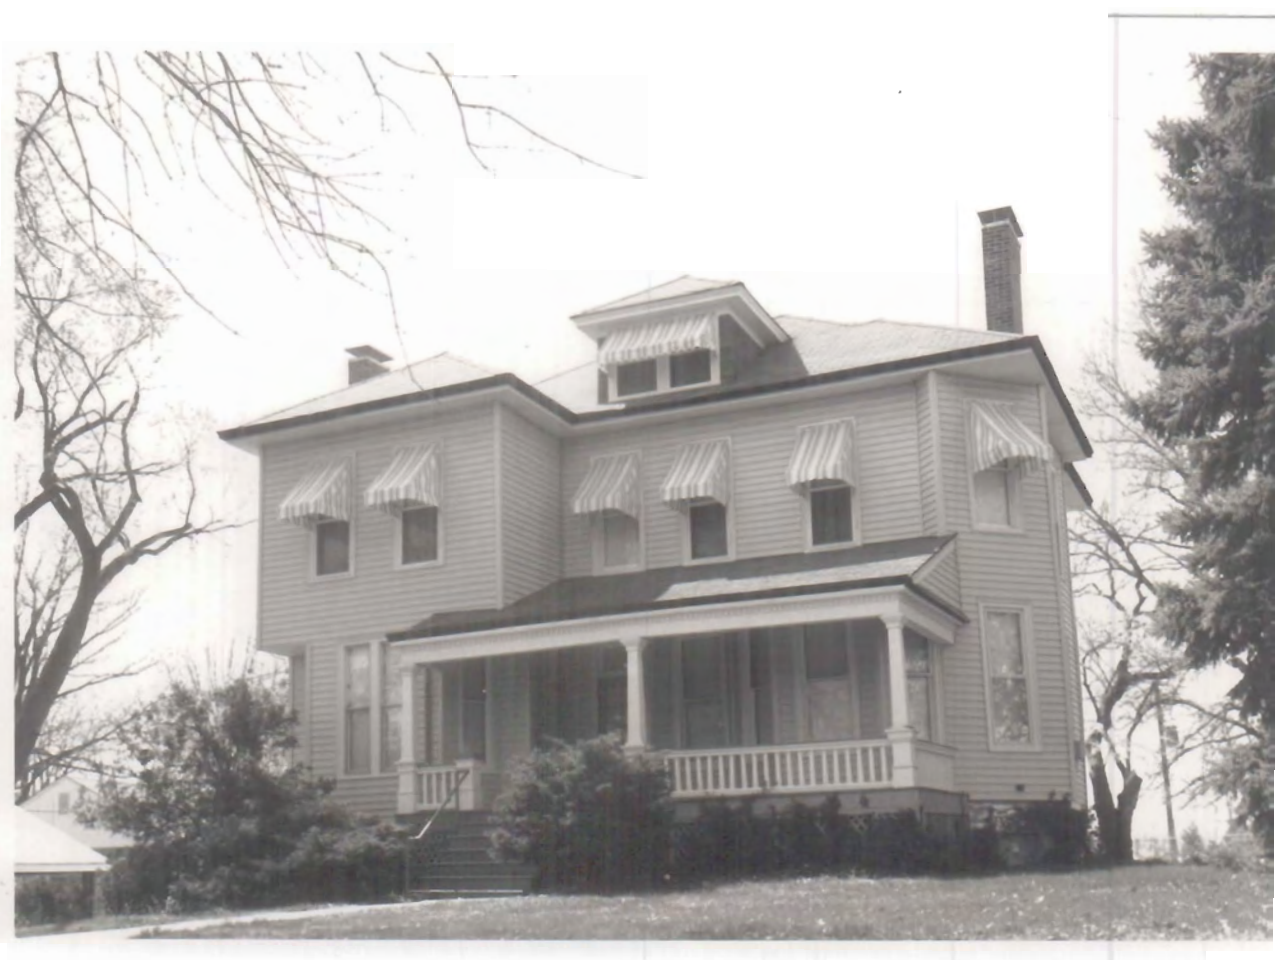
1. No. 127	3. Location of Negatives: Missouri Office of Historic Preservation, P. O. Box 176, Jefferson City, MO 65102		
2. City/County: City of St. Louis, MO	4. Prepared by: Cynthia Hill Longwisch, Landmarks Assn. of St. Louis, 917 Locust, 7th Floor, St. Louis, MO 63101

30. Exterior condition: good		31. Open to public? no	
32. Other Surveys in which included: Heritage/St. Louis survey, 1971			
33. Further description of important features: A hipped-roof dormer on the front elevation echoes the repeated angles of the roofline. 1-over-1 double-hung sash windows. Right (north) side angled; left side has cutouts at ground floor corners to place angled windows, forming a "bay window." A long frame porch is supported by square wood columns; wood balustrade; dentilled cornice. The siding is recent (vinyl?), replacing old asbestos siding.

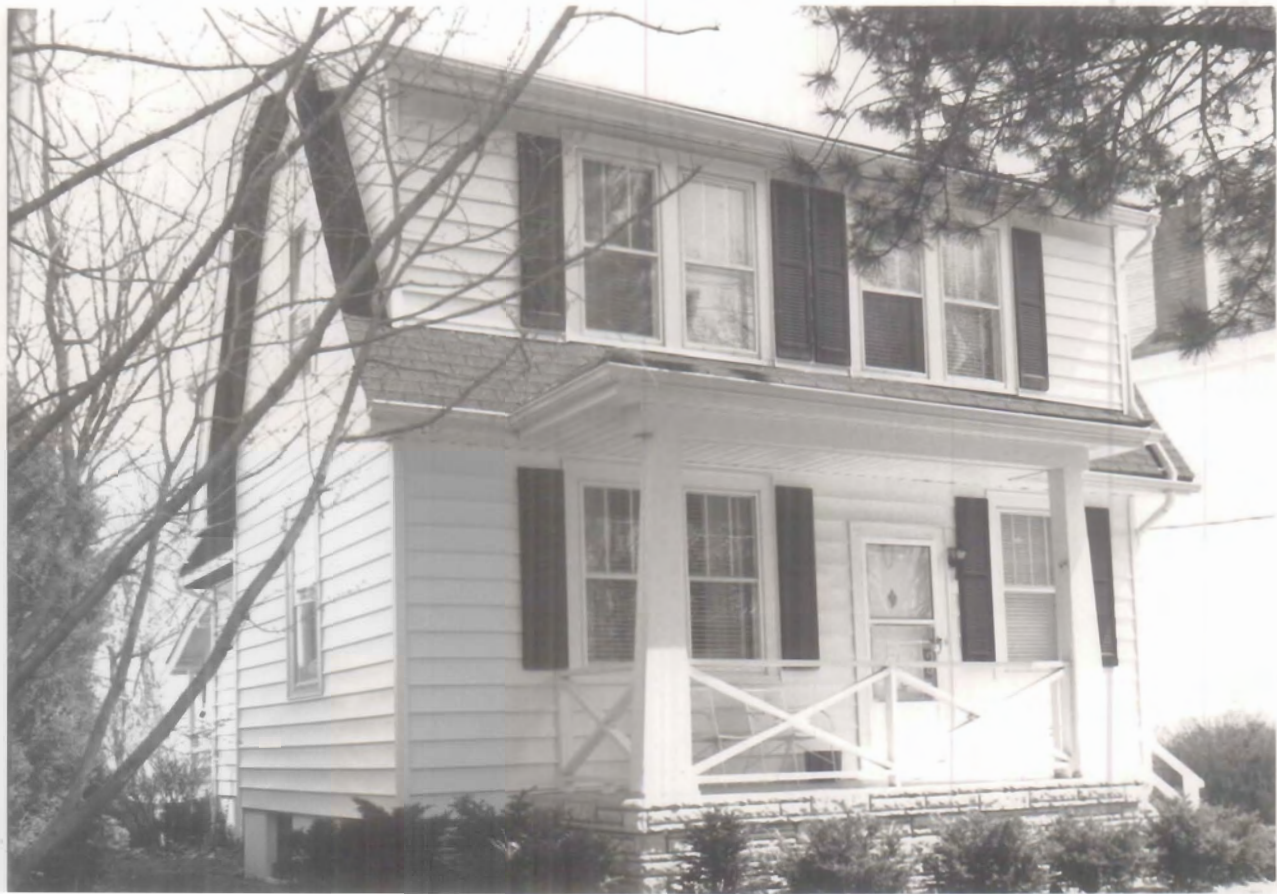
1. No. 152	3. Location of Negatives: Missouri Office of Historic Preservation, P. O. Box 176, Jefferson City, MO 65102		
2. City/County: City of St. Louis, MO	4. Prepared by: Cynthia Hill Longwisch, Landmarks Assn. of St. Louis, 917 Locust, 7th Floor, St. Louis, MO 63101

24. Foundation material: stone		25. Roof type/material: complex	
26. No. Bays: Front 4 Side 2		27. Wall treatment: aluminum siding	
28. Plan shape: see site map		29. Changes: Addition? Altered? yes

30. Exterior condition: good		31. Open to public? no	
32. Other Surveys in which included: Heritage/St. Louis survey, 1971			
33. Further description of important features: This house has been so altered as to obscure its original style, which was probably a modest Queen Anne; it really should have been left off the survey. It is a good example of the blurring of detailing and how the alteration of windows can destroy the original character of a house.

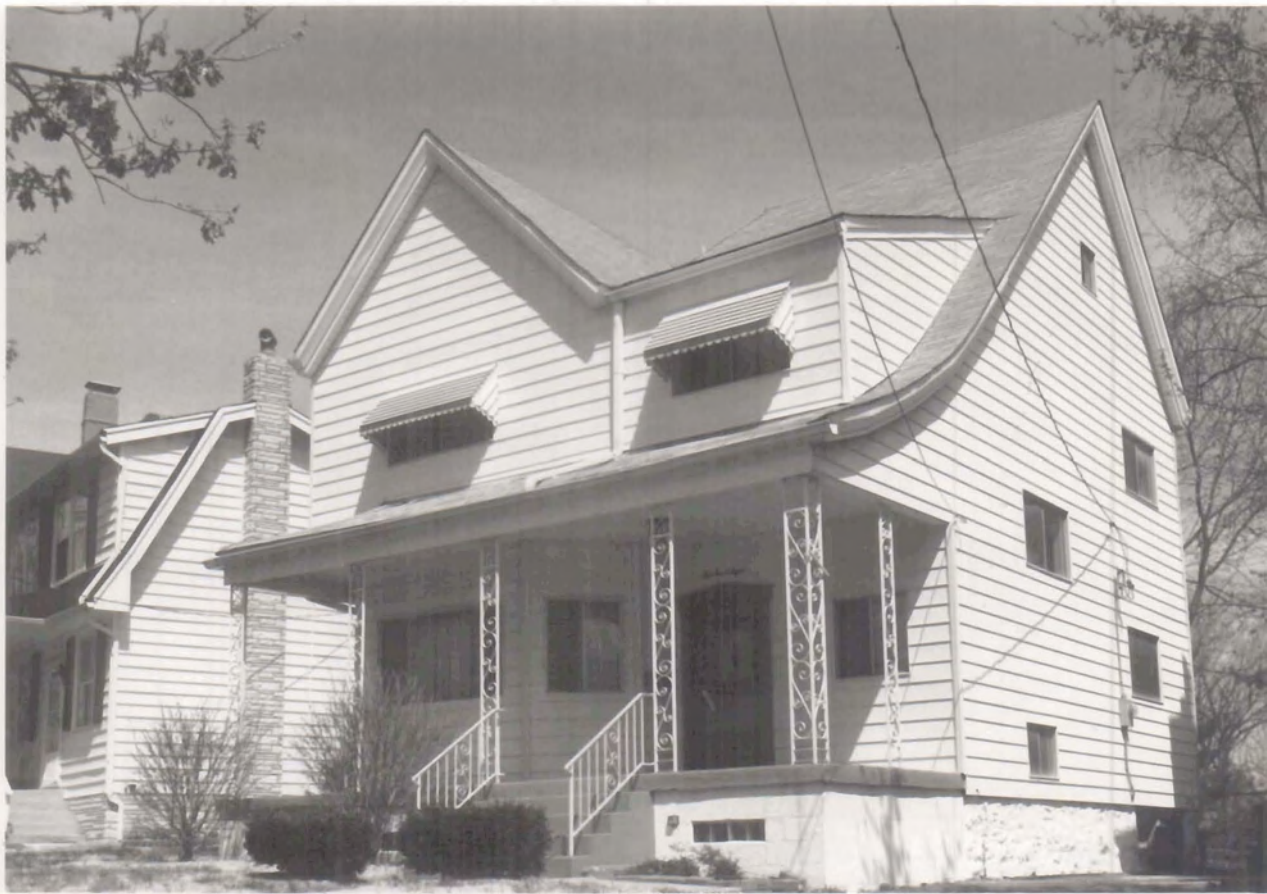
1. No. 151	3. Location of Negatives: Missouri Office of Historic Preservation, P. O. Box 176, Jefferson City, MO 65102		
2. City/County: City of St. Louis, MO	4. Prepared by: Cynthia Hill Longwisch, Landmarks Assn. of St. Louis, 917 Locust, 7th Floor, St. Louis, MO 63101

24. Foundation material: stone		25. Roof type/material: cross gable	
26. No. Bays: Front 3 Side 2		27. Wall treatment: clapboarding	
28. Plan shape: see site map		29. Changes: Addition? Altered?

30. Exterior condition: good		31. Open to public? no	
32. Other Surveys in which included: Heritage/St. Louis survey, 1971			
33. Further description of important features: The clipped gables of this house feature imbricated wood shingles and a small, divided window. Below, 1-over-1 windows are possibly replacements. A porch extends across the front and wraps around; it features wood spindles above and wood balustrading; square wood posts. Open rear porch.

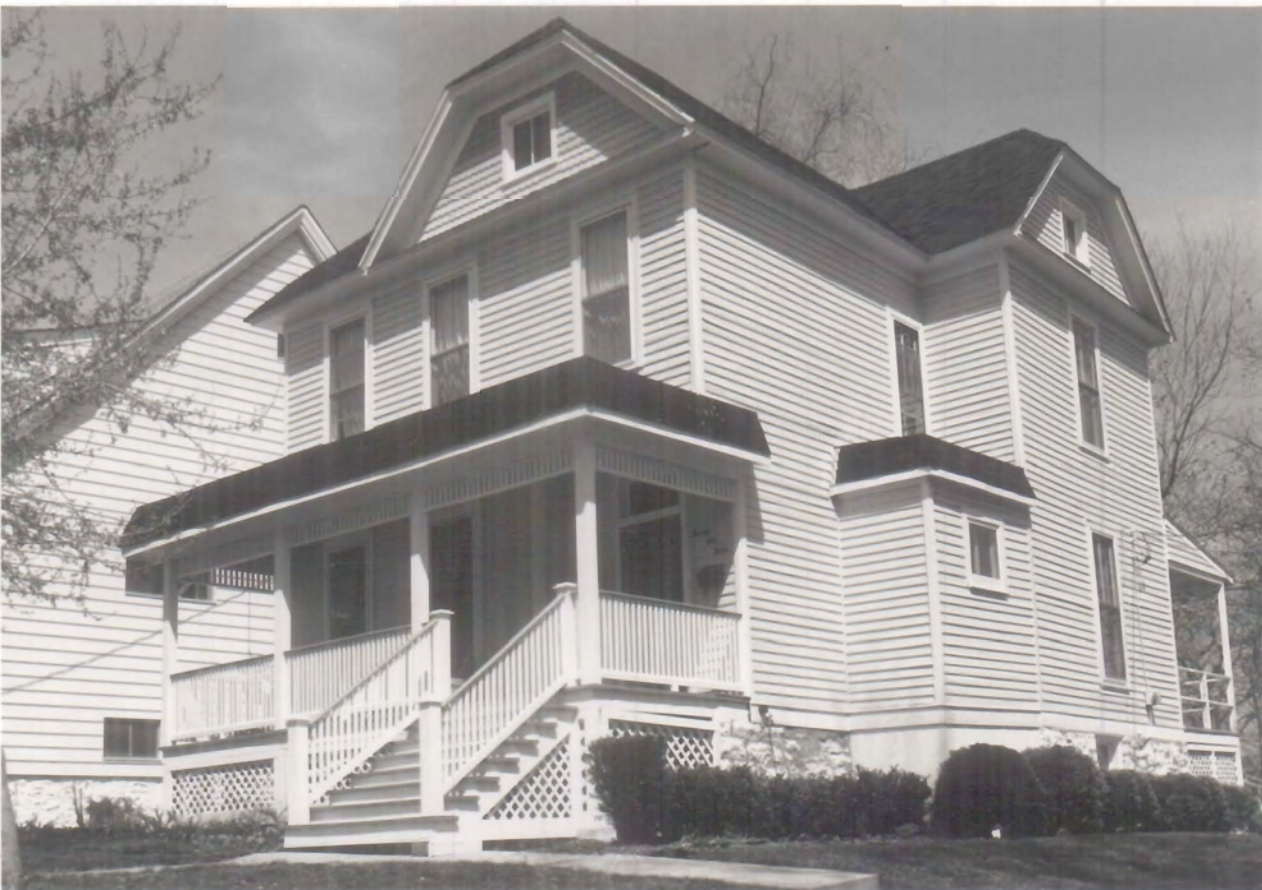
1. No. 126	3. Location of Negatives: Missouri Office of Historic Preservation, P. O. Box 176, Jefferson City, MO 65102		
2. City/County: City of St. Louis, MO	4. Prepared by: Cynthia Hill Longwisch, Landmarks Assn. of St. Louis, 917 Locust, 7th Floor, St. Louis, MO 63101

24. Foundation material: stone		25. Roof type/material: complex	
26. No. Bays: Front 2 Side 2		27. Wall treatment: clapboarding	
28. Plan shape: see site map		29. Changes: Addition? Altered?

30. Exterior condition: fair/good		31. Open to public? no	
32. Other Surveys in which included: Heritage/St. Louis survey, 1971			
33. Further description of important features: The original undulating pattern of the roofing shingles is still intact. A wrap-around porch is supported by thin wood posts. Paired front windows. Side bay window at first story.

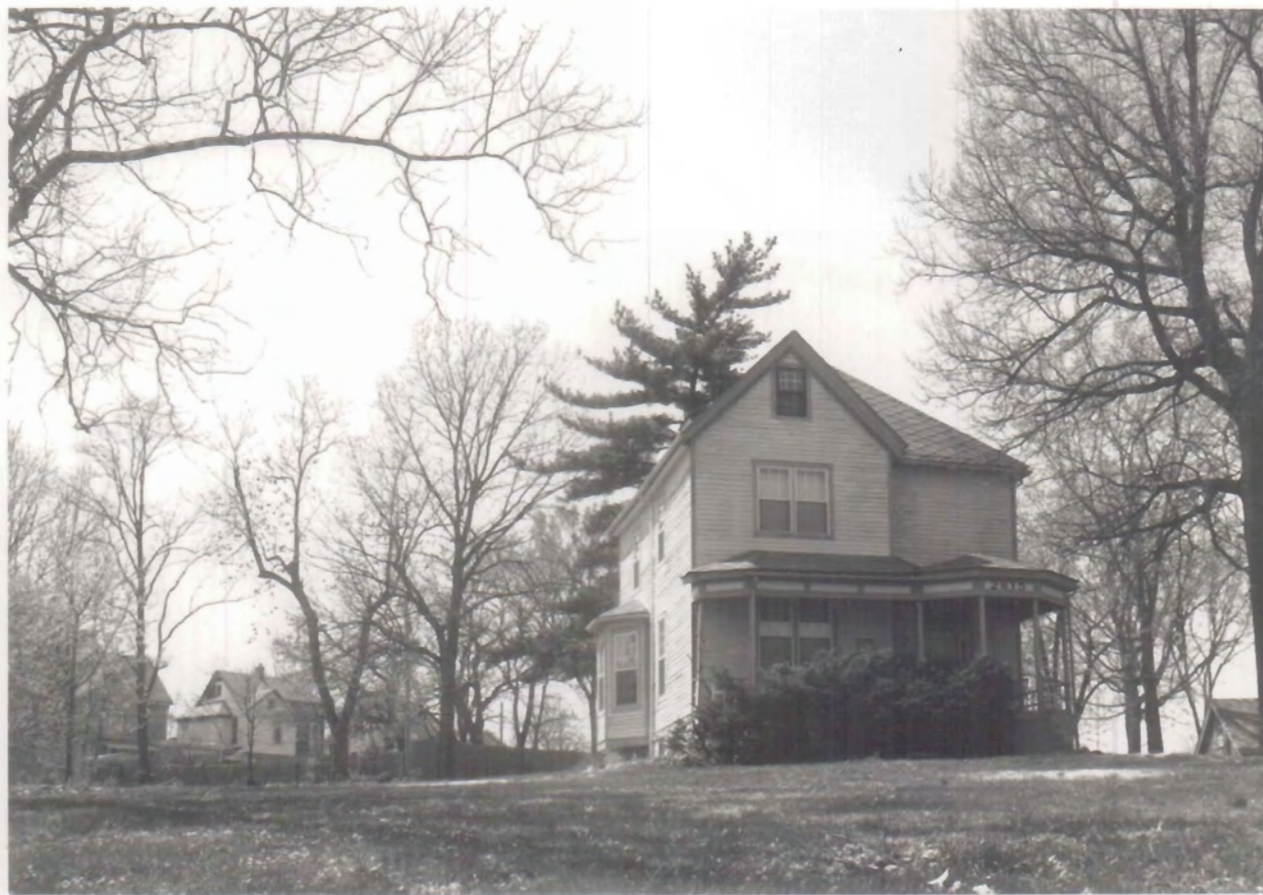
1. No. 150	3. Location of Negatives: Missouri Office of Historic Preservation, P. O. Box 176, Jefferson City, MO 65102		
2. City/County: City of St. Louis, MO	4. Prepared by: Cynthia Hill Longwisch, Landmarks Assn. of St. Louis, 917 Locust, 7th Floor, St. Louis, MO 63101

24. Foundation material: stuccoed		25. Roof type/material: complex	
26. No. Bays: Front 3 Side 4		27. Wall treatment: stuccoed/1/2 timber	
28. Plan shape: see site map		29. Changes: Addition? rear Altered? yes

30. Exterior condition: good		31. Open to public? no	
32. Other Surveys in which included: Heritage/St. Louis survey, 1971			
33. Further description of important features: The entire exterior of this house has been stuccoed and rectilinearly "half-timbered." The hipped roof has front- and side-facing gables with diamond-shaped gable windows. A small front porch has round arches and a permastone base. A side entrance in a projecting bay faces toward the front. Rear one-story addition. This house was probably originally a Queen Anne or variation thereof before it was entombed.

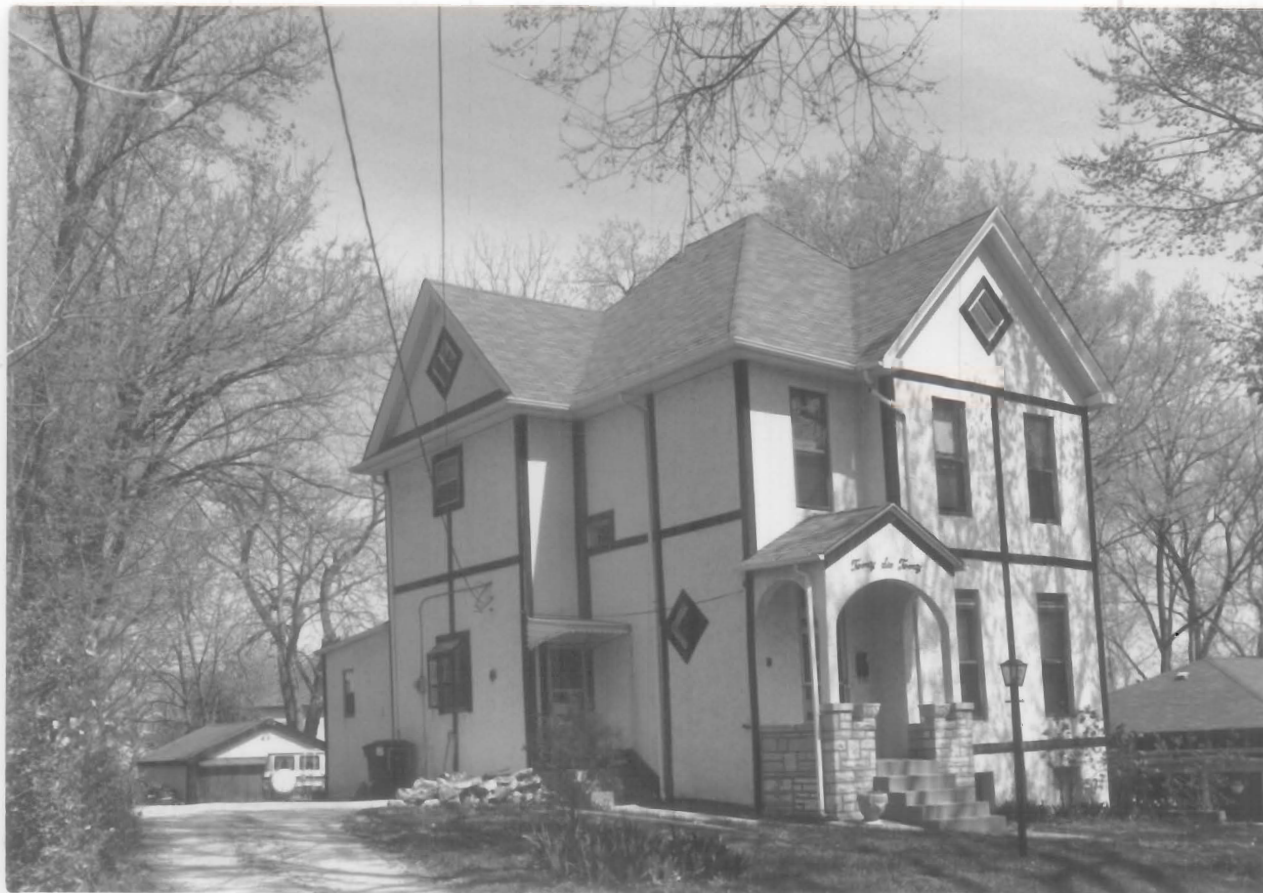
1. No. 125	3. Location of Negatives: Missouri Office of Historic Preservation, P. O. Box 176, Jefferson City, MO 65102		
2. City/County: City of St. Louis, MO	4. Prepared by: Cynthia Hill Longwisch, Landmarks Assn. of St. Louis, 917 Locust, 7th Floor, St. Louis, MO 63101

24. Foundation material: stone		25. Roof type/material: complex	
26. No. Bays: Front 2 Side 2		27. Wall treatment: buff & red brick	
28. Plan shape: see site map		29. Changes: Addition? rear Altered?

30. Exterior condition: good		31. Open to public? no	
32. Other Surveys in which included: Heritage/St. Louis survey, 1971			
33. Further description of important features: This house is a virtual twin of survey #124 next door. The buff brick facade gives way to a red brick body of the house. A gabled wood porch features a pressed sunburst design in the gable, fretwork, turned posts and wood balusters. The door is transomed. Upper facade windows have pressed-brick segmental arches, while at the first story the pressed brick arch is round, with a divided fanlight. Both main (cont'd. below)

34. History and Significance: openings are paired 1-over-1 double-hung sash windows. All have stone sills. Raised string sill course on facade at both stories. Rear one-story frame addition. Dormer on west elevation. See Item 34, survey #124, for additional information.
