# ARCHITECTURAL SURVEY OF CLIFTON HEIGHTS

JUNE 1991

ST. LOUIS, MISSOURI

LANDMARKS ASSOCIATION OF ST. LOUIS, INC.

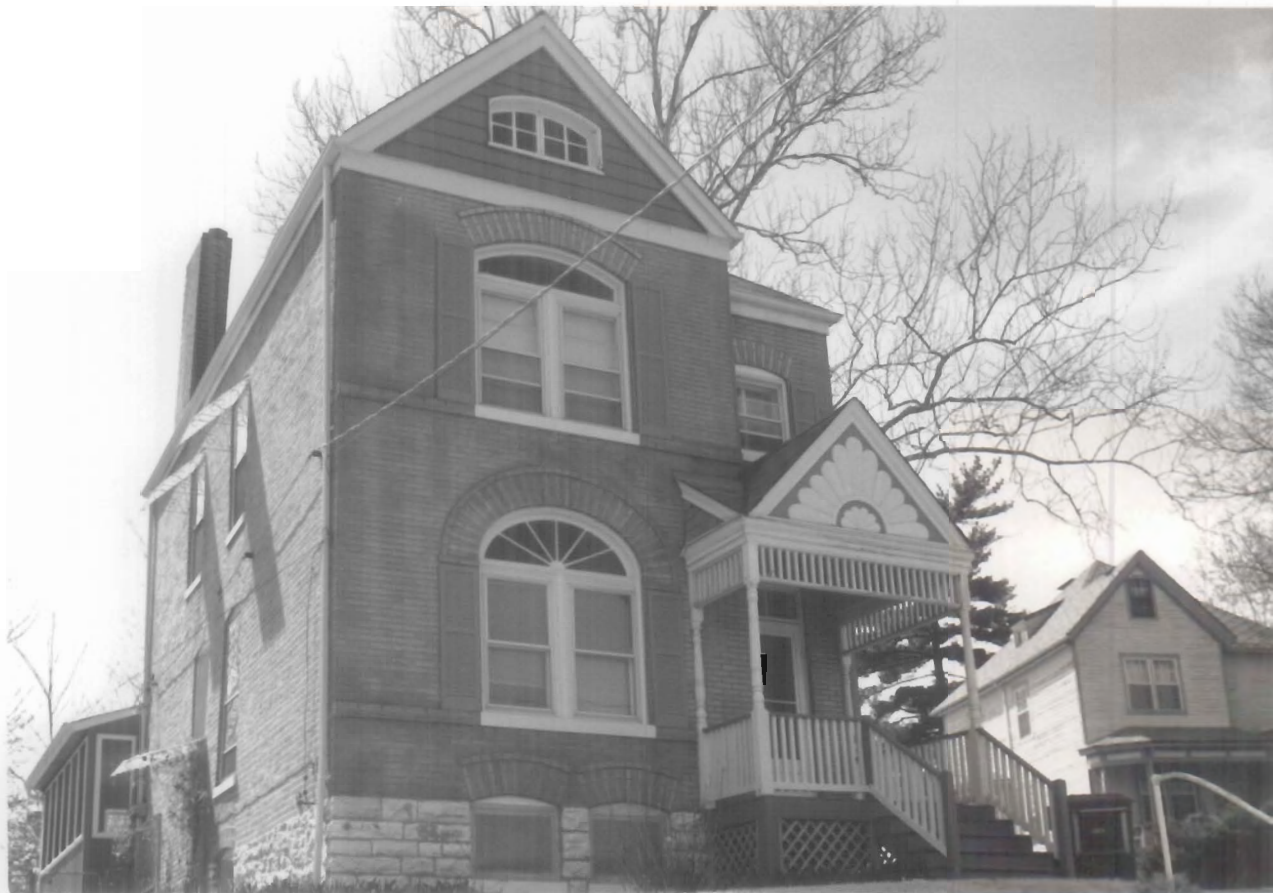
33. Further description of important features: This house and survey #125 next door are virtual twins. The hipped and gabled roof has a hipped-roof dormer. Windows on the front elevation have pressed-brick segmental arches (2nd story) and a pressed-brick round arch (1st story). The main second story opening is a pair of 1-over-1 windows with an arched transom; below, a divided fanlight highlights paired 1-over-1 windows; all have stone sills. Metal (cont'd. below)

34. History and Significance: cornice. Raised string sill courses on facade. Buff brick facade, red brick body of house. A gabled frame porch has a pressed sunburst design, fretwork, and turned posts. Transomed door. Seg. side arches. Heritage/St. Louis records indicate that a "Miss Elizabeth Wade described the house as 'old' in 1912." No further documentation was apparently made. Since both the statement and the source are vague, dating by this method is difficult. The design could have been done anywhere from 1890 - 1905

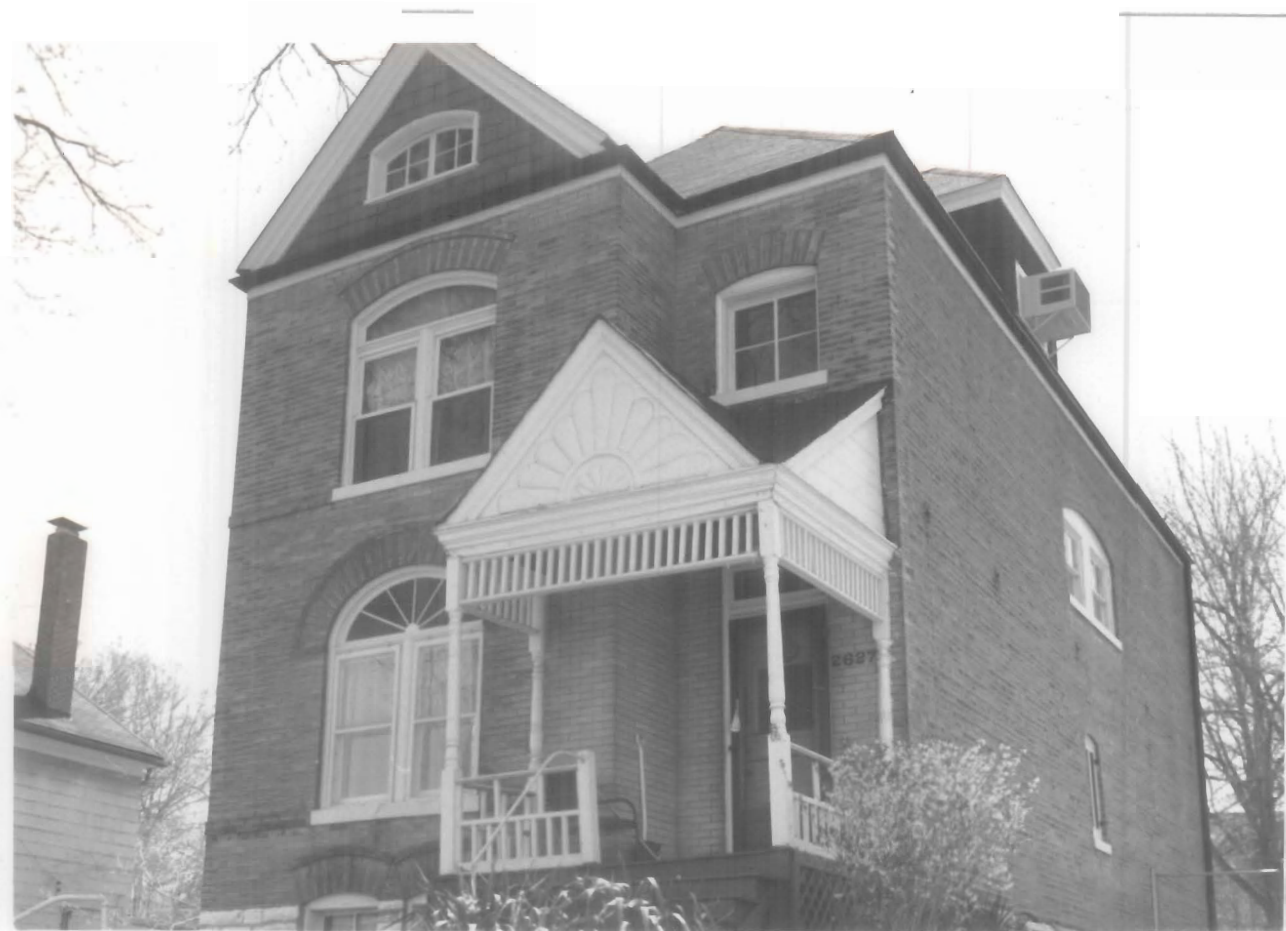
1. No. 123	3. Location of Negatives: Missouri Office of Historic Preservation, P. O. Box 176, Jefferson City, MO 65102		
2. City/County: City of St. Louis, MO	4. Prepared by: Cynthia Hill Longwisch, Landmarks Assn. of St. Louis, 917 Locust, 7th Floor, St. Louis, MO 63101

24. Foundation material: stone		25. Roof type/material: hipped	
26. No. Bays: Front 2 Side 1		27. Wall treatment: asbestos siding	
28. Plan shape: see site map		29. Changes: Addition? Altered?

30. Exterior condition: fair/good		31. Open to public? no	
32. Other Surveys in which included: Heritage/St. Louis survey, 1971			
33. Further description of important features: A hipped-roof dormer on the front elevation has two windows. The frame porch has imbricated wood shingles in the gable end, a dentilled cornice and round wood columns. The doorway features sidelights and a rectangular fanlight. The house is very similar to survey #122 next door.

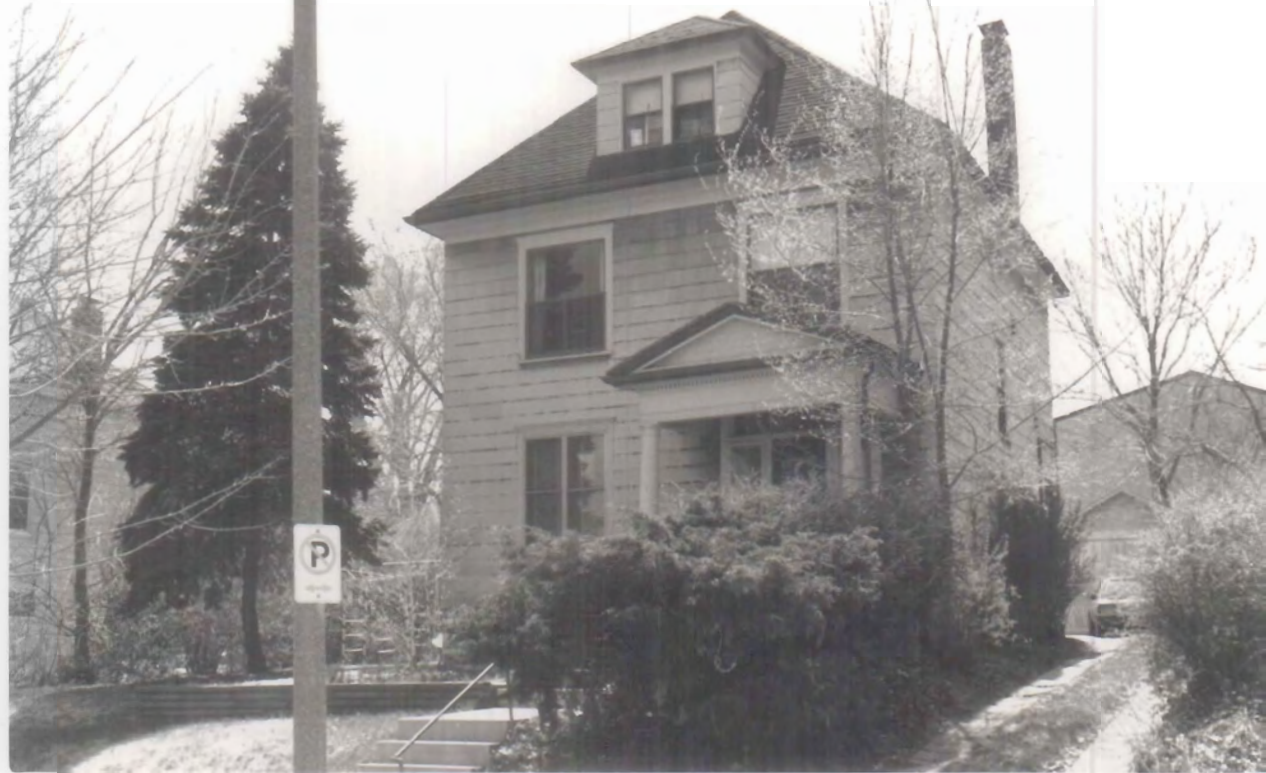
1. No. 122	3. Location of Negatives: Missouri Office of Historic Preservation, P. O. Box 176, Jefferson City, MO 65102		
2. City/County: City of St. Louis, MO	4. Prepared by: Cynthia Hill Longwisch, Landmarks Assn. of St. Louis, 917 Locust, 7th Floor, St. Louis, MO 63101

24. Foundation material: stone		25. Roof type/material: hipped	
26. No. Bays: Front 2 Side 2		27. Wall treatment: aluminum siding	
28. Plan shape: see site map		29. Changes: Addition? Altered?

30. Exterior condition: good		31: Open to public? no	
32. Other Surveys in which included: Heritage/St. Louis survey, 1971

33. Further description of important features: A dormer with a hipped roof is located facing the front; it has paired windows. The windows in this house are of the casement type and appear to be replacements, at least insofar as the pane configuration goes. A small porch with a hipped roof is supported by round wood columns.

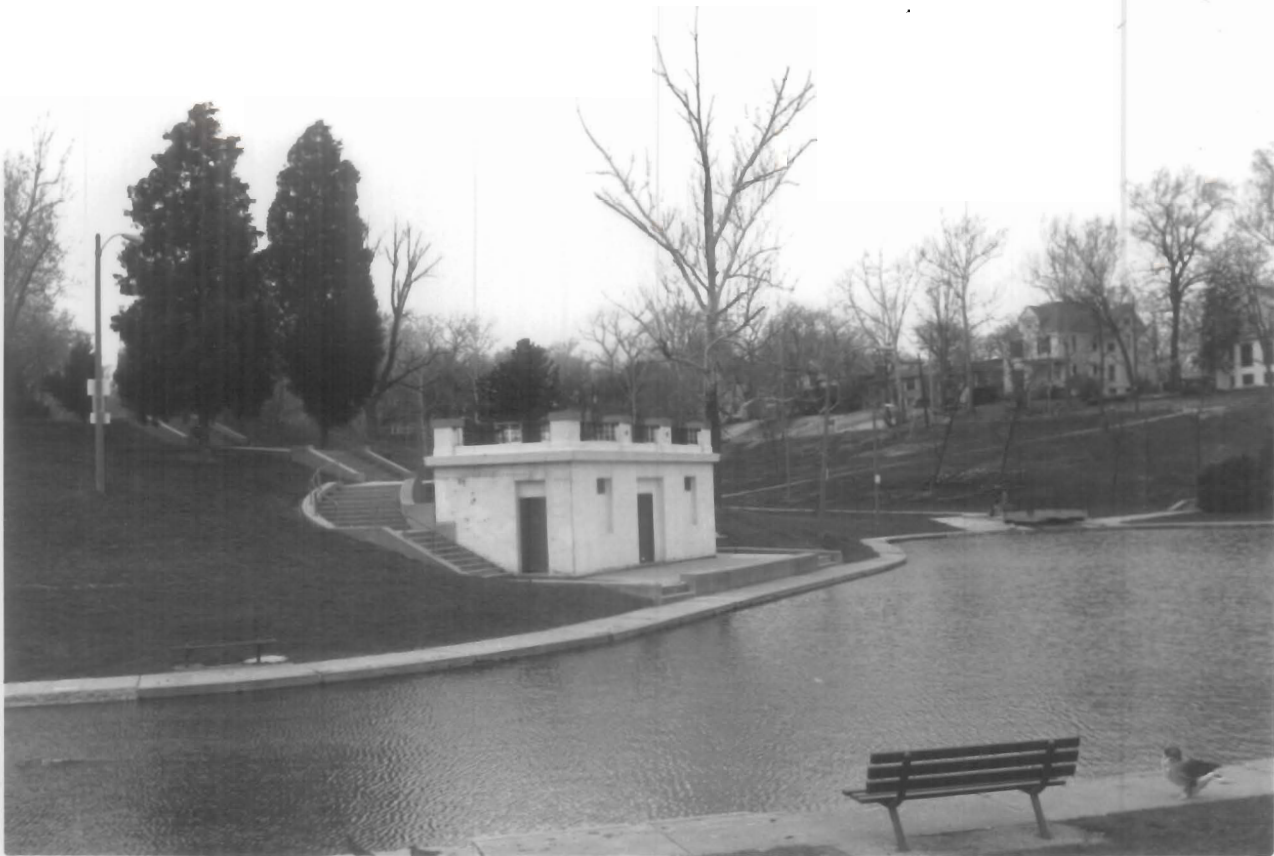
24. Foundation material: concrete      25. Roof type/material: mock gambrel\*

30. Exterior condition: good      31: Open to public? no

33. Further description of important features: \*Like Vollmar's other gambrels, this one is really a 2-story side gable with an inset eave to simulate a true gambrel with a full-width dormer. Triple windows are 6-over-1. A one-story flat-roofed side addition is original; it has long multipane windows. Gabled and bracketed hood over door. Rear frame addition.

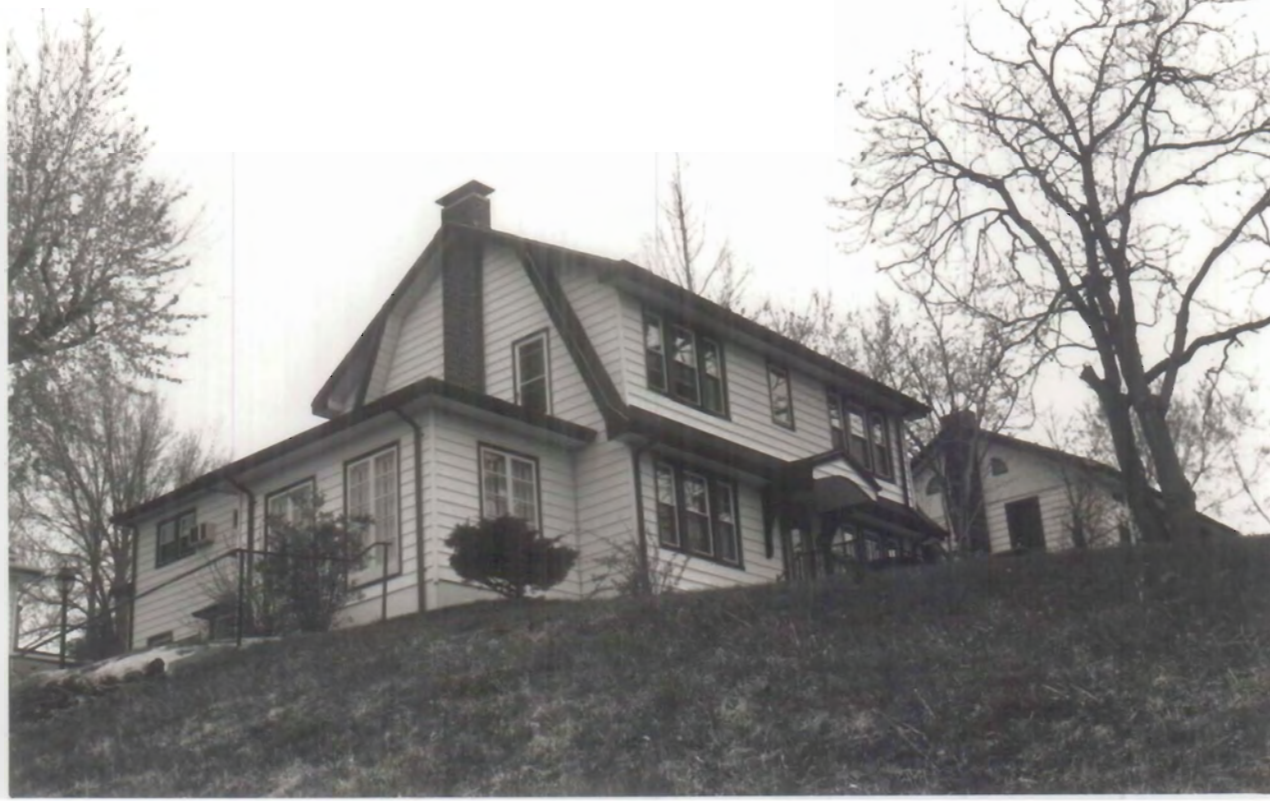
1. No. 202	3. Location of Negatives: Missouri Office of Historic Preservation, P. O. Box 176, Jefferson City, MO 65102		
2. City/County: City of St. Louis, MO

19. Original Use: residence		20. Present Use: residence	
21. No. of stories: 2	22. Basement? yes	23. Wall construction: frame	
24. Foundation material: concrete		25. Roof type/material: side gable

26. No. Bays: Front 4 Side 2		27. Wall treatment: wood clapboarding	
28. Plan shape: see site map		29. Changes: Addition? Altered?	
30. Exterior condition: good		31. Open to public? no

32. Other Surveys in which included: Heritage/St. Louis survey, 1971			
33. Further description of important features: The windows of this house are primarily paired 6-over-1 double-hung sash. A gabled and bracketed hood shelters the centered doorway. A one-story flat-roofed addition on the north side is original.

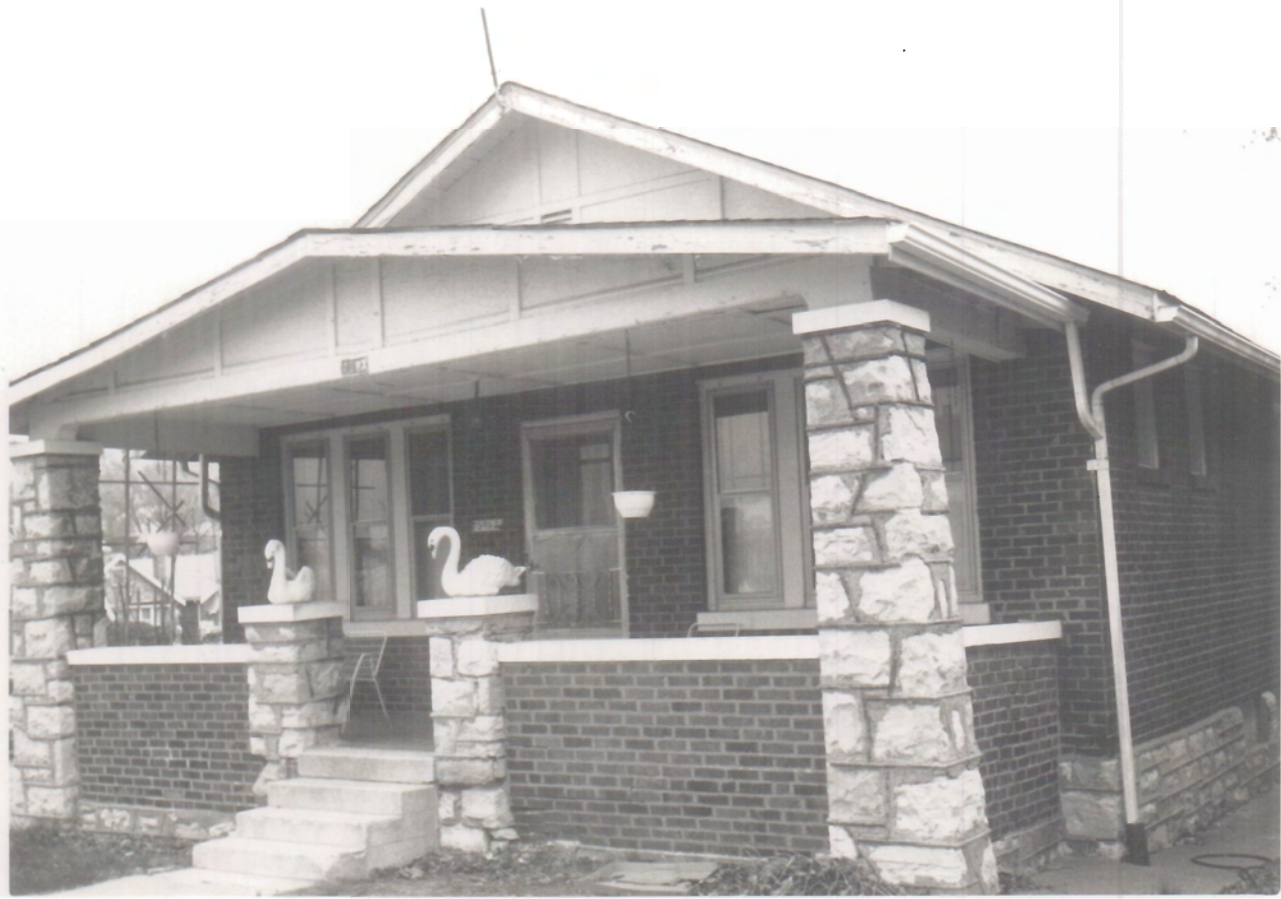
21. No. of stories: 1	22. Basement? yes	23. Wall construction: masonry	
24. Foundation material: limestone		25. Roof type/material: front gable	
26. No. Bays: Front 3 Side 4		27. Wall treatment: brown brick

28. Plan shape: see site map		29. Changes: Addition? Altered?	
30. Exterior condition: fair/good		31. Open to public? no	
32. Other Surveys in which included: Heritage/St. Louis survey, 1971

33. Further description of important features: The full-width porch roof of this house has a front gable separate from and shallower than that of the house itself. The tapered support pillars and smaller posts at the opening are of quarry-faced ashlar limestone. Porch side walls are brick with stone railing. Tripled windows flank centered door and have Craftsman-style 9-over-1 panes and stone sills.

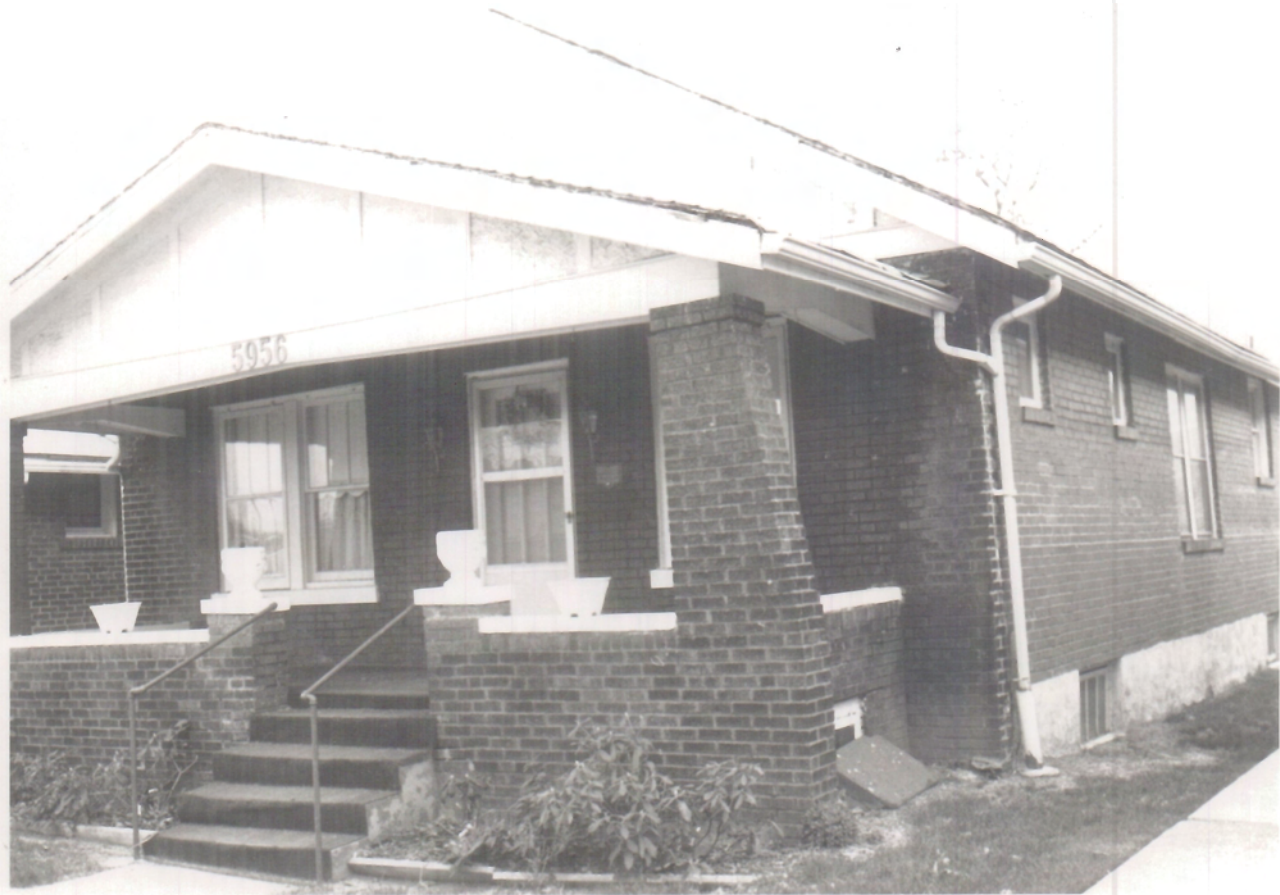
24. Foundation material: stuccoed	25. Roof type/material: front gable
-----------------------------------	-------------------------------------

30. Exterior condition: good	31. Open to public? no
------------------------------	------------------------

33. Further description of important features: Front gabled porch roof is supported by tapering brick pillars. Porch has brick side walls with stone railing and extends almost across the width of the house. Paired 3-over-1 double-hung sash windows and a single of the same type flank the centered front door. Side openings are flat-arched and have brick sills while stone sills are present on the front elevation.

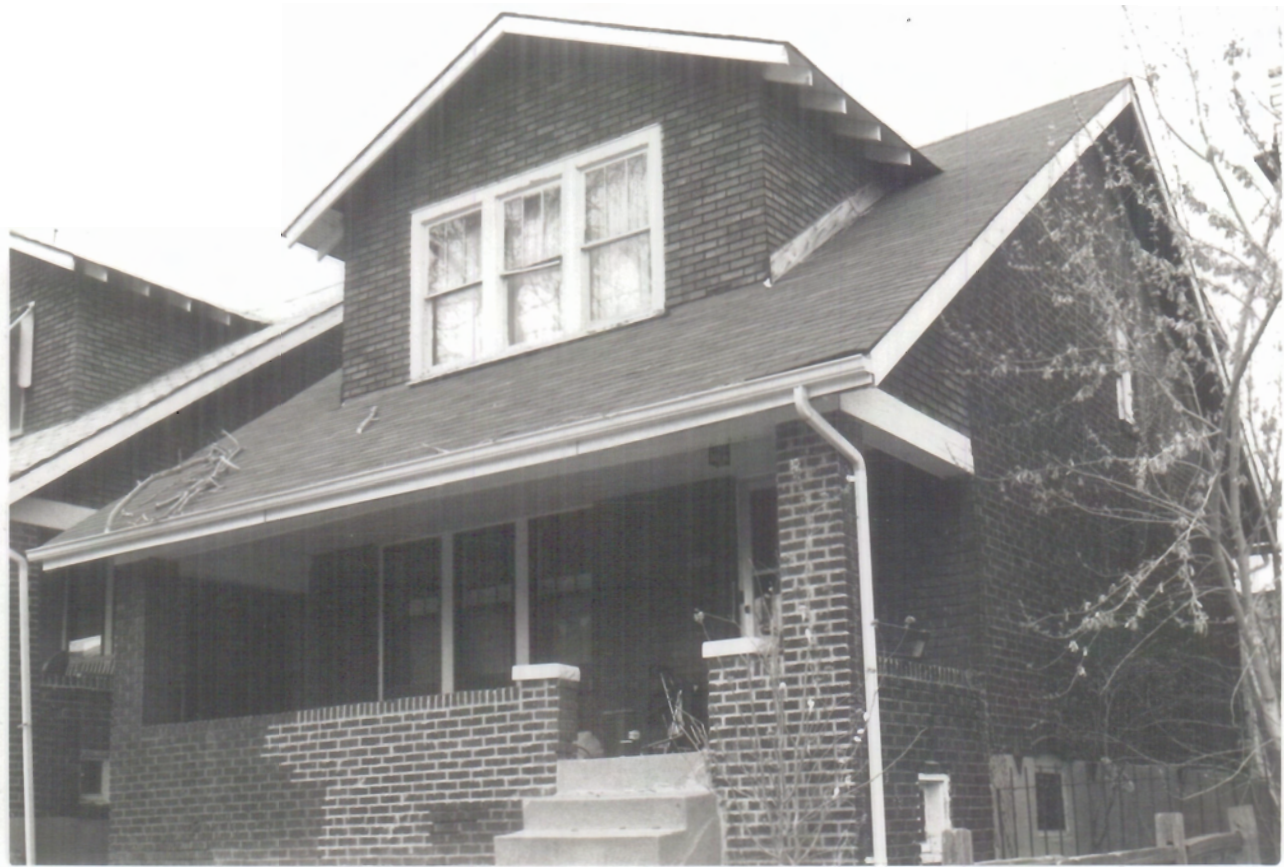
1. No. 072	3. Location of Negatives: Missouri Office of Historic Preservation, P. O. Box 176, Jefferson City, MO 65102		
2. City/County: City of St. Louis, MO	4. Prepared by: Cynthia Hill Longwisch, Landmarks Assn. of St. Louis, 917 Locust, 7th Floor, St. Louis, MO 63101

21. No. of stories: 1 1/2	22. Basement? yes	23. Wall construction: masonry	
24. Foundation material: concrete		25. Roof type/material: side gable	
26. No. Bays: Front 2 Side 1		27. Wall treatment: textured red brick

28. Plan shape: see site map		29. Changes: Addition? Altered?	
30. Exterior condition: good		31. Open to public? no	
32. Other Surveys in which included: Heritage/St. Louis survey, 1971

33. Further description of important features: The frame dormer of this house is gabled with exposed rafter ends and sided with brick-look asphalt siding. It has triple 3-over-1 double-hung sash windows, which are repeated at the front elevation below. A roofline with wide overhanging eaves extends to become the roof of the full-width porch, supported by straight brick pillars. The brick porch side walls have had extensive repointing; they are (cont'd. below)

34. History and Significance: topped with a header course and square stones at the opening. Side openings are segmentally arched. This house and its neighbor, survey #71, were listed on the same 1927 permit taken out by local builder H. C. Vollmar. The 24 x 26' house cost \$3,000 and had hot air heat. Vollmar was very active locally during the 1920s and lived nearby at 6105 Simpson.

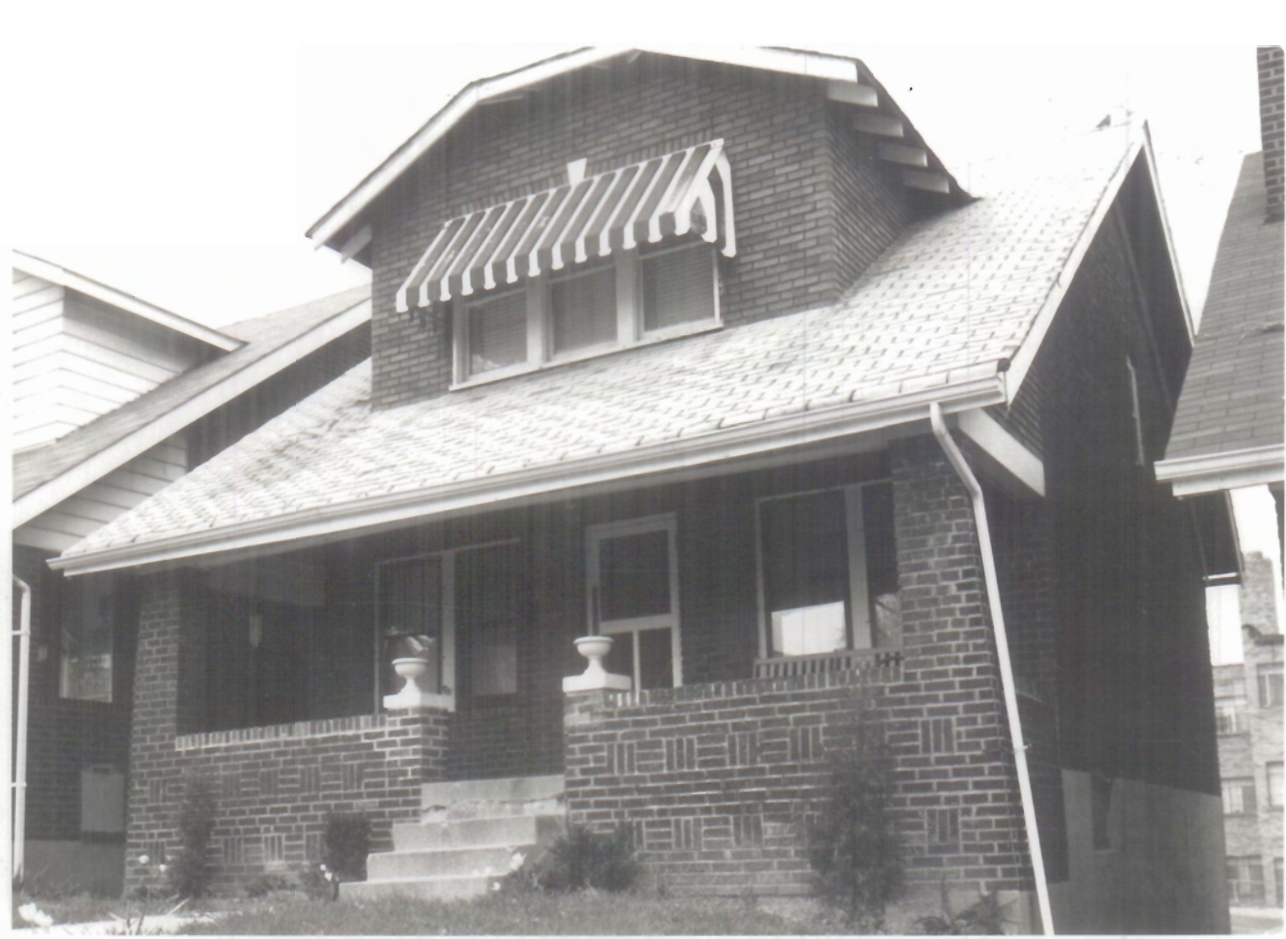
1. No. 071	3. Location of Negatives: Missouri Office of Historic Preservation, P. O. Box 176, Jefferson City, MO 65102		
2. City/County: City of St. Louis, MO	4. Prepared by: Cynthia Hill Longwisch, Landmarks Assn. of St. Louis, 917 Locust, 7th Floor, St. Louis, MO 63101

21. No. of stories: 1 1/2	22. Basement? yes	23. Wall construction: masonry	
24. Foundation material: concrete		25. Roof type/material: side gable	
26. No. Bays: Front 3 Side 1		27. Wall treatment: textured red brick

28. Plan shape: see site map		29. Changes: Addition? Altered?	
30. Exterior condition: fair/good		31. Open to public? no	
32. Other Surveys in which included: Heritage/St. Louis survey, 1971

33. Further description of important features: Dormer has brick-look siding, hipped gable and exposed rafter ends; triple 3-over-1 double-hung sash windows. House roof extends to form porch roof. Tapered brick pillars support porch roof. Brick side walls of porch have visible repair work; two courses of basket-weave brickwork and a top header course are highlights. Centered doorway is flanked by paired 3-over-1 double-hung sash. Segmentally arched side windows.

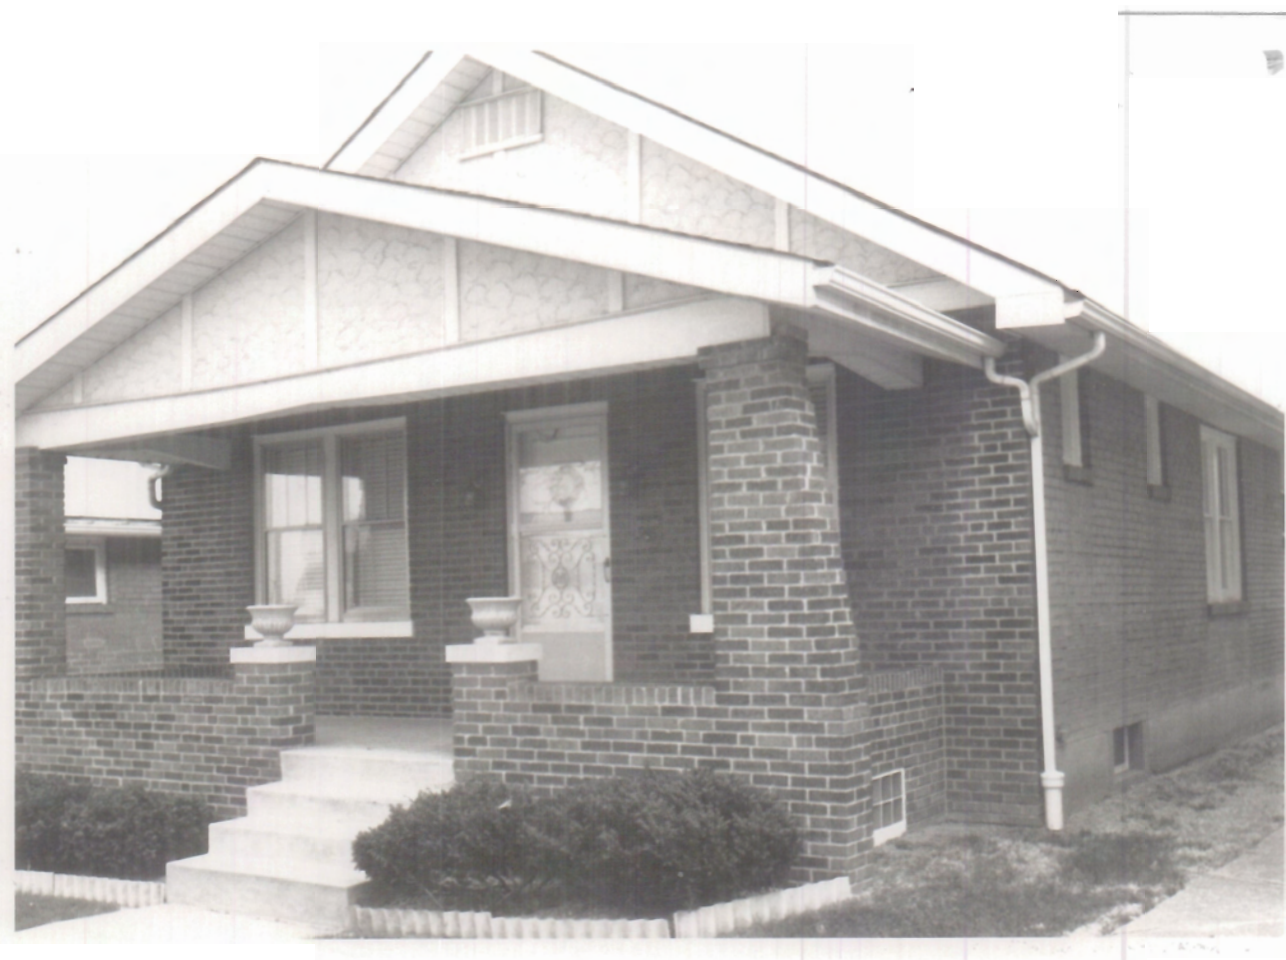
1. No. 075		3. Location of Negatives: Missouri Office of Historic Preservation, P. O. Box 176, Jefferson City, MO 65102	
2. City/County: City of St. Louis, MO		4. Prepared by: Cynthia Hill Longwisch, Landmarks Assn. of St. Louis, 917 Locust, 7th Floor, St. Louis, MO 63101

21. No. of stories: 1	22. Basement? yes	23. Wall construction: masonry	
24. Foundation material: concrete		25. Roof type/material: front gable	
26. No. Bays: Front 3 Side 3		27. Wall treatment: red/multichrome brk

28. Plan shape: see site map		29. Changes: Addition? Altered?	
30. Exterior condition: good		31. Open to public? no	
32. Other Surveys in which included: Heritage/St. Louis survey, 1971

33. Further description of important features: Front-gabled porch roof is separate from house and supported by tapered brick pillars. Front facade, porch side walls and pillars are of multichrome brick while body of house is plain red brick. Short porch side walls have a top header course and short posts capped with stone. Paired and single 3-over-1 double-hung sash windows with stone sills flank the front door. Side windows are flat-arched with brick sills.

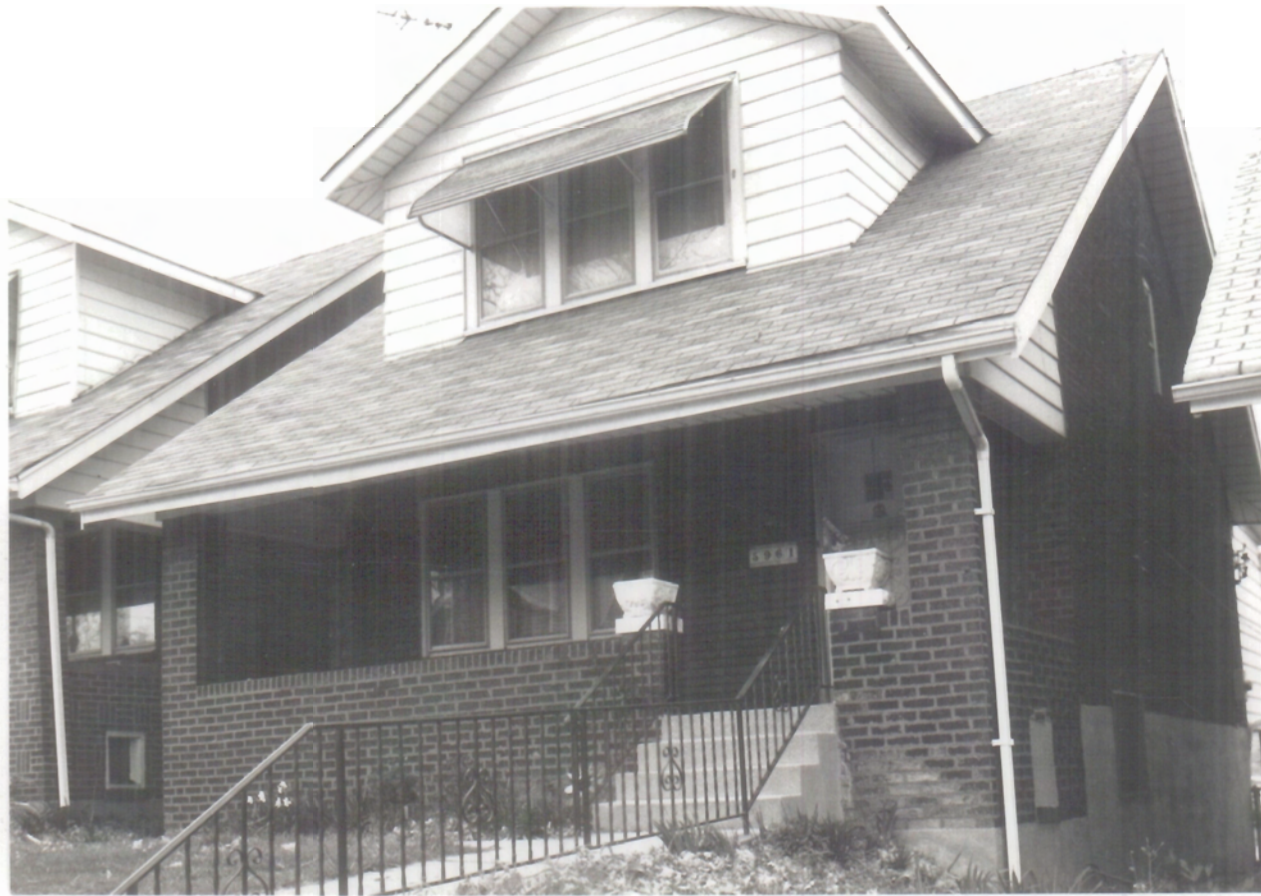
1. No. 070	3. Location of Negatives: Missouri Office of Historic Preservation, P. O. Box 176, Jefferson City, MO 65102		
2. City/County: City of St. Louis, MO	4. Prepared by: Cynthia Hill Longwisch, Landmarks Assn. of St. Louis, 917 Locust, 7th Floor, St. Louis, MO 63101

24. Foundation material: concrete		25. Roof type/material: side gable	
26. No. Bays: Front 2 Side 1		27. Wall treatment: textured red brick	
28. Plan shape: see site map		29. Changes: Addition? rear Altered?

30. Exterior condition: good		31. Open to public? no	
32. Other Surveys in which included: Heritage/St. Louis survey, 1971			
33. Further description of important features: Large frame dormer is gabled and has triple 3-over-1 double-hung sash windows, which also appear below in the front elevation. Overhanging roof extends to become roof of full-width porch. Straight brick pillars support roof at outside corners. Plain brick side walls of porch are topped with a header course and capped with limestone at the opening. Door is at the right side. Segmentally arched (cont'd. below)

34. History and Significance: side windows. Rear frame addition. This house is the sixth of six listed on a single 1927 building permit taken out by H. C. Vollmar. For additional information, see Item 34 of survey #65.

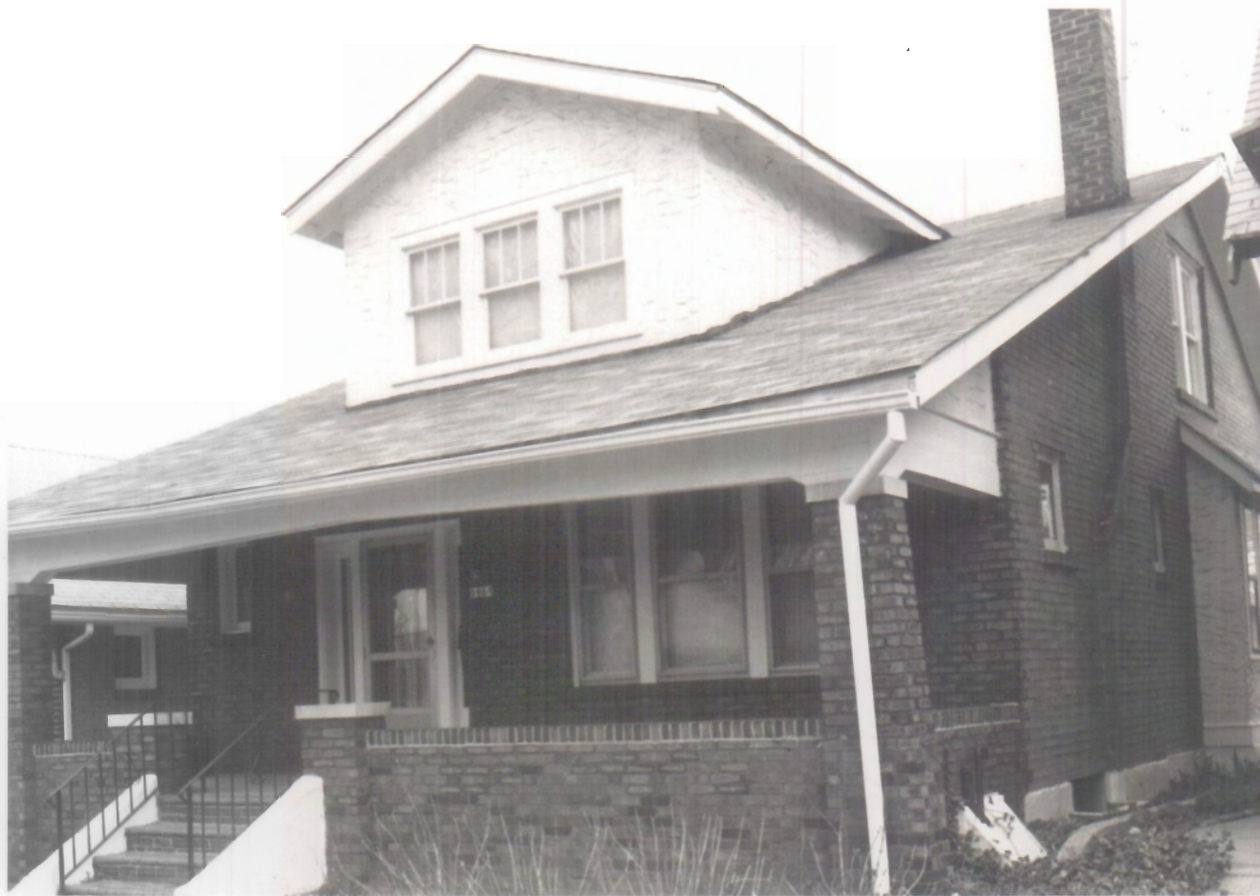
1. No. 076	3. Location of Negatives: Missouri Office of Historic Preservation, P. O. Box 176, Jefferson City, MO 65102		
2. City/County: City of St. Louis, MO	4. Prepared by: Cynthia Hill Longwisch, Landmarks Assn. of St. Louis, 917 Locust, 7th Floor, St. Louis, MO 63101

21. No. of stories: 1 1/2	22. Basement? yes	23. Wall construction: masonry	
24. Foundation material: concrete		25. Roof type/material: side gable	
26. No. Bays: Front 3 Side 3		27. Wall treatment: red/multichrome brk

28. Plan shape: see site map		29. Changes: Addition?	Altered? yes
30. Exterior condition: good		31: Open to public? no	
32. Other Surveys in which included: Heritage/St. Louis survey, 1971

33. Further description of important features: Large front dormer has been stuccoed; it has three, 3-over-1 double-hung sash windows also found on the front elevation. The roof extends to become the full-width porch roof, supported by tapering brick pillars. The porch and front facade are laid in multichrome brick while the body of the house is plain red brick. On the north side, a projecting bay window is also covered with rough-finish stucco.

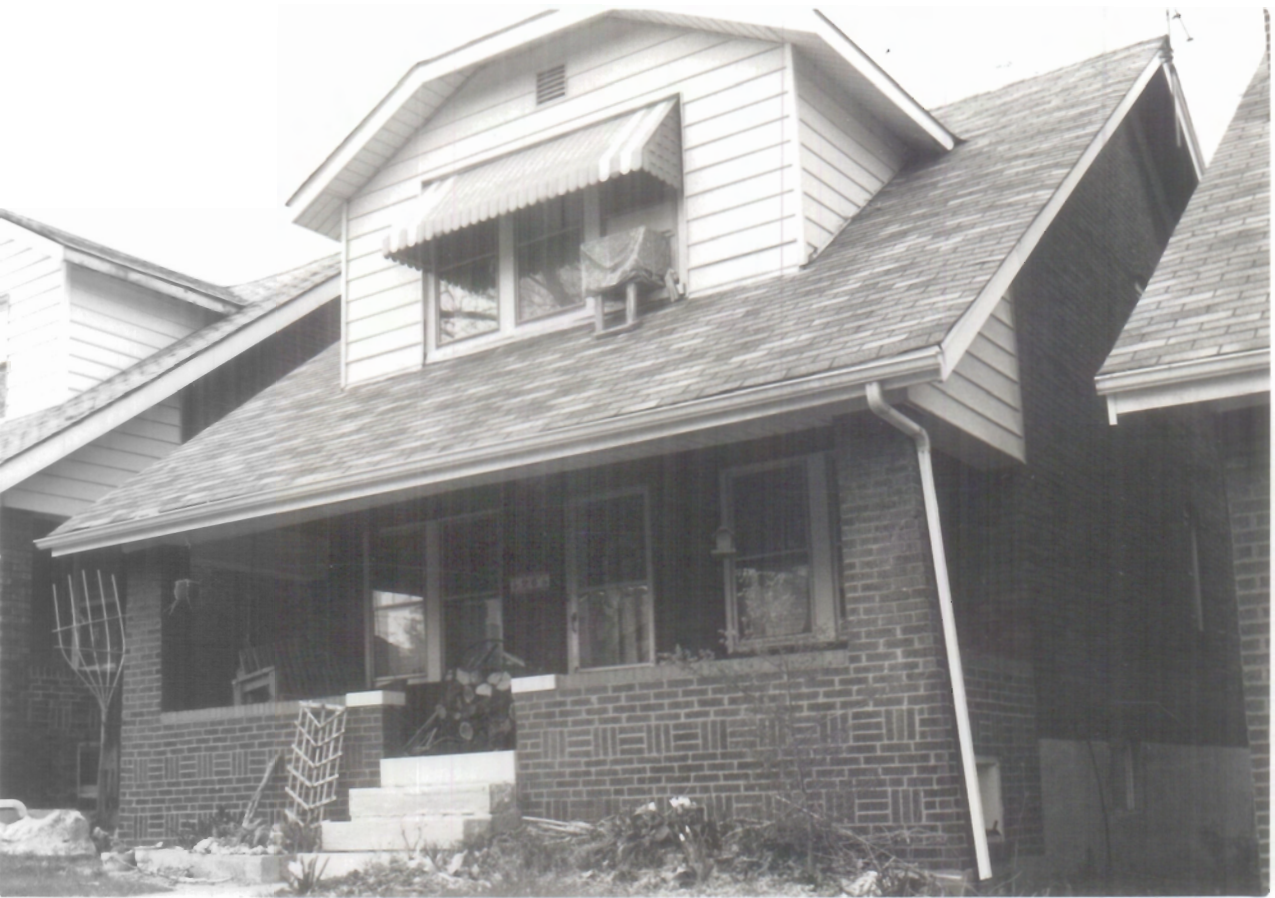
1. No. 069	3. Location of Negatives: Missouri Office of Historic Preservation, P. O. Box 176, Jefferson City, MO 65102		
2. City/County: City of St. Louis, MO	4. Prepared by: Cynthia Hill Longwisch, Landmarks Assn. of St. Louis, 917 Locust, 7th Floor, St. Louis, MO 63101

24. Foundation material: concrete		25. Roof type/material: side gable	
26. No. Bays: Front 3 Side 3		27. Wall treatment: textured red brick	
28. Plan shape: see site map		29. Changes: Addition? Altered?

30. Exterior condition: good		31. Open to public? no	
32. Other Surveys in which included: Heritage/St. Louis survey, 1971			
33. Further description of important features: Gable of large frame dormer is hipped; triple 3-over-1 double-hung sash windows centered in dormer. Roof has overhanging eaves and extends to become roof of full-width porch. Tapering brick pillars. Short brick porch walls have two courses of basketweave brick-work and a top row of headers; stones cap opening. Centered doorway flanked by paired 3-over-1 double-hung sash windows. Segmentally arched side windows.

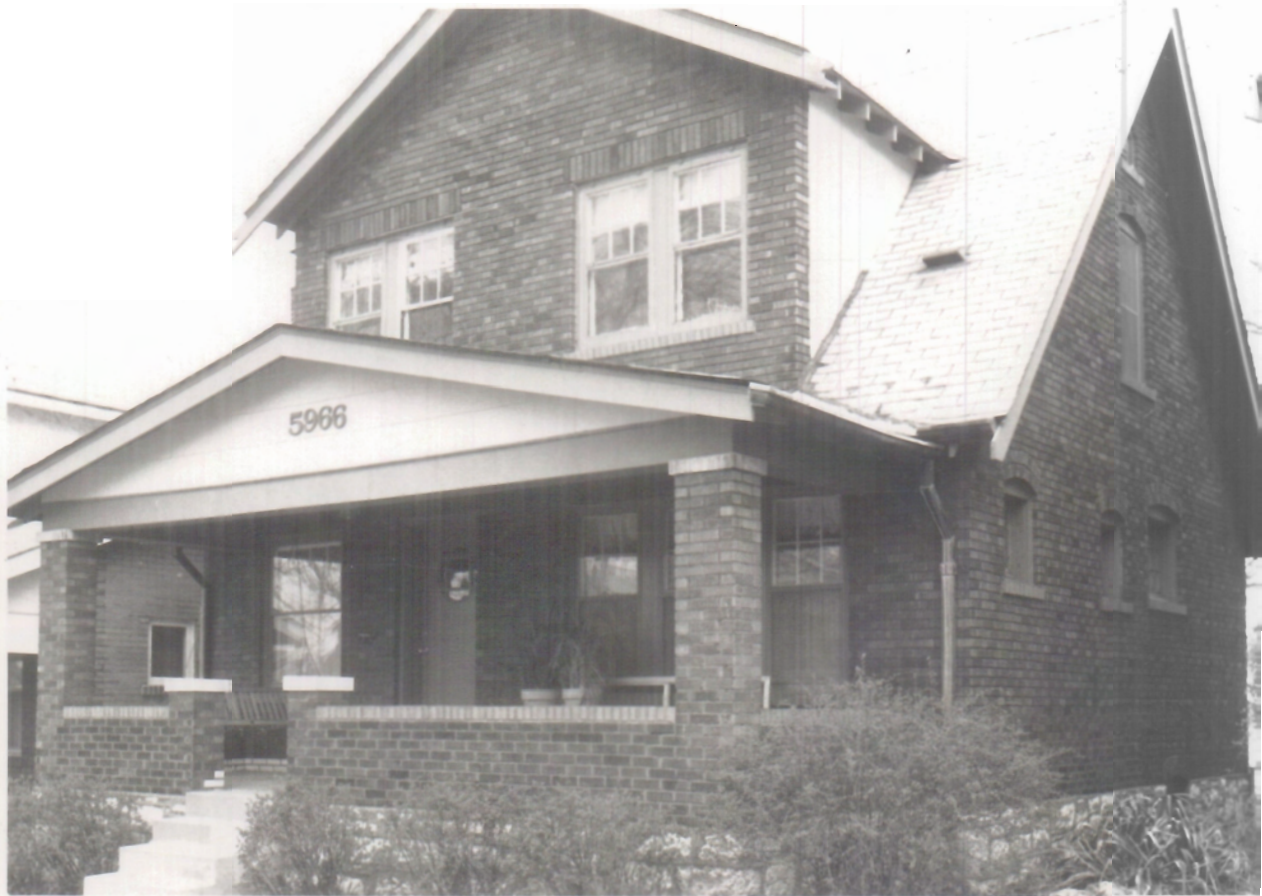
1. No. 077	3. Location of Negatives: Missouri Office of Historic Preservation, P. O. Box 176, Jefferson City, MO 65102		
2. City/County: City of St. Louis, MO	4. Prepared by: Cynthia Hill Longwisch, Landmarks Assn. of St. Louis, 917 Locust, 7th Floor, St. Louis, MO 63101

21. No. of stories: 2	22. Basement? yes	23. Wall construction: masonry	
24. Foundation material: stone		25. Roof type/material: side gable	
26. No. Bays: Front 3 Side 3		27. Wall treatment: textured red brick

28. Plan shape: see site map		29. Changes: Addition?	Altered?
30. Exterior condition: good		31: Open to public? no	
32. Other Surveys in which included: Heritage/St. Louis survey, 1971

33. Further description of important features: Extremely large, frame front dormer almost qualifies as a separate gable; it has exposed rafter ends and is faced with brick. Paired, 6-over-1 double-hung sash windows have soldier arches. A full-width gabled porch is supported by straight brick pillars. One single and a set of triple 6-over-1 windows with brick sills flank the doorway. Side openings have brick sills and double rowlock segmental arches.

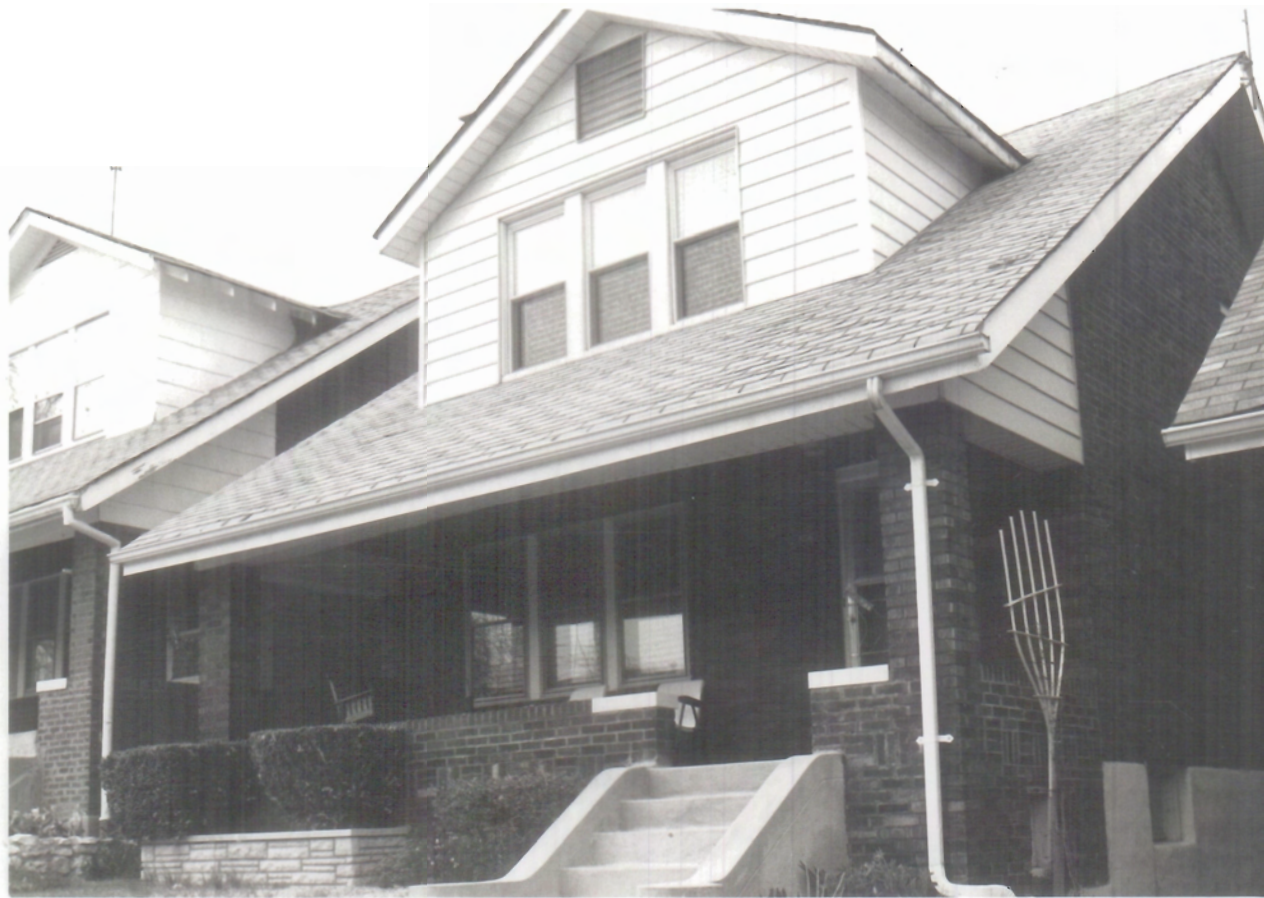
1. No. 068	3. Location of Negatives: Missouri Office of Historic Preservation, P. O. Box 176, Jefferson City, MO 65102		
2. City/County: City of St. Louis, MO	4. Prepared by: Cynthia Hill Longwisch, Landmarks Assn. of St. Louis, 917 Locust, 7th Floor, St. Louis, MO 63101

24. Foundation material: concrete		25. Roof type/material: side gable	
26. No. Bays: Front 2 Side 1		27. Wall treatment: red brick	
28. Plan shape: see site map		29. Changes: Addition? Altered?

30. Exterior condition: good		31. Open to public? no	
32. Other Surveys in which included: Heritage/St. Louis survey, 1971			
33. Further description of important features: The gabled frame dormer of this house is vented and has triple 3-over-1 double-hung sash windows that are repeated on the lower front elevation. The roofline has wide overhangs and extends to cover the full-width porch. Straight brick pillars support the roof. The short brick side walls feature a course of basketweave brickwork and have stone caps at the opening. Side windows are segmentally arched. (cont'd. below)

34. History and Significance: Steps and permastone planter in front of the porch are new. H. C. Vollmar took out the 1927 permit that listed this and five other houses. For more information, see Item 34 of survey #65.

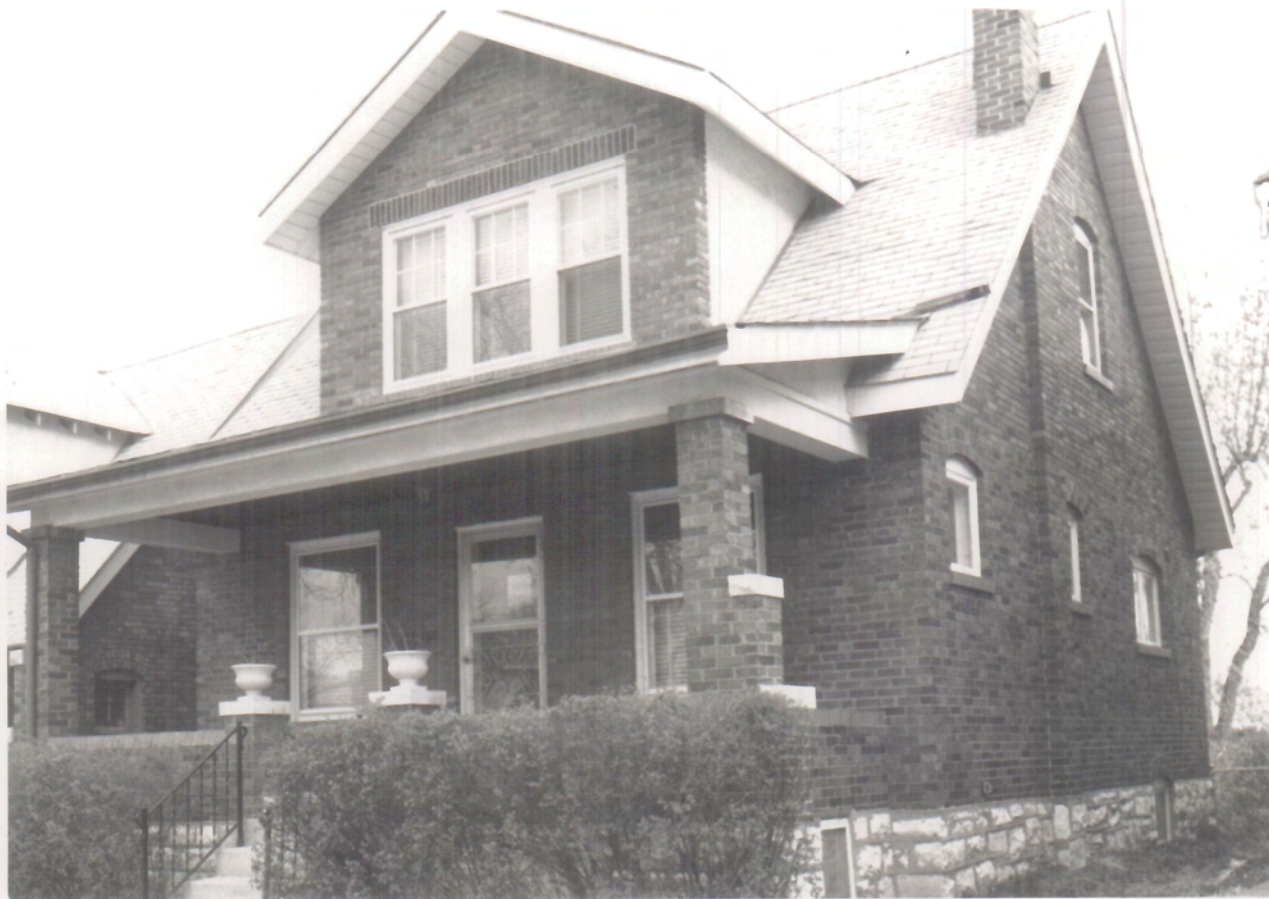
1. No. 078	3. Location of Negatives: Missouri Office of Historic Preservation, P. O. Box 176, Jefferson City, MO 65102		
2. City/County: City of St. Louis, MO	4. Prepared by: Cynthia Hill Longwisch, Landmarks Assn. of St. Louis, 917 Locust, 7th Floor, St. Louis, MO 63101

21. No. of stories: 2	22. Basement? yes	23. Wall construction: masonry	
24. Foundation material: stone		25. Roof type/material: side gable	
26. No. Bays: Front 3 Side 3	27. Wall treatment: multichrome brick

28. Plan shape: see site map	29. Changes: Addition?	Altered?	
30. Exterior condition: good		31. Open to public? no	
32. Other Surveys in which included: Heritage/St. Louis survey, 1971

33. Further description of important features: The large frame dormer on this house is faced with brick and includes a soldier course above triple 6-over-1 double-hung sash windows. The roof has a wide overhang and rather steep pitch; the porch roof is attached to the house and acts as an extension of the main roof but has a shallower pitch. Stepped brick pillars with stone ornamentation support the porch roof. A center doorway is flanked by single, (cont'd. below)

34. History and Significance: 8-over-1 double-hung sash windows with flat arches. Side windows are segmentally arched; some are stained glass. The Anna Inv. Co. is listed as the owner on the 1928 building permit. This company does not appear in city directories within this time frame. The Keithly Constr. Co., 4906 Southwest (also builders of survey #77) were the builders and Vincil F. Hunter, an architect with the Board of Public Service, designed it.
