# ARCHITECTURAL SURVEY OF CLIFTON HEIGHTS

JUNE 1991

ST. LOUIS, MISSOURI

LANDMARKS ASSOCIATION OF ST. LOUIS, INC.

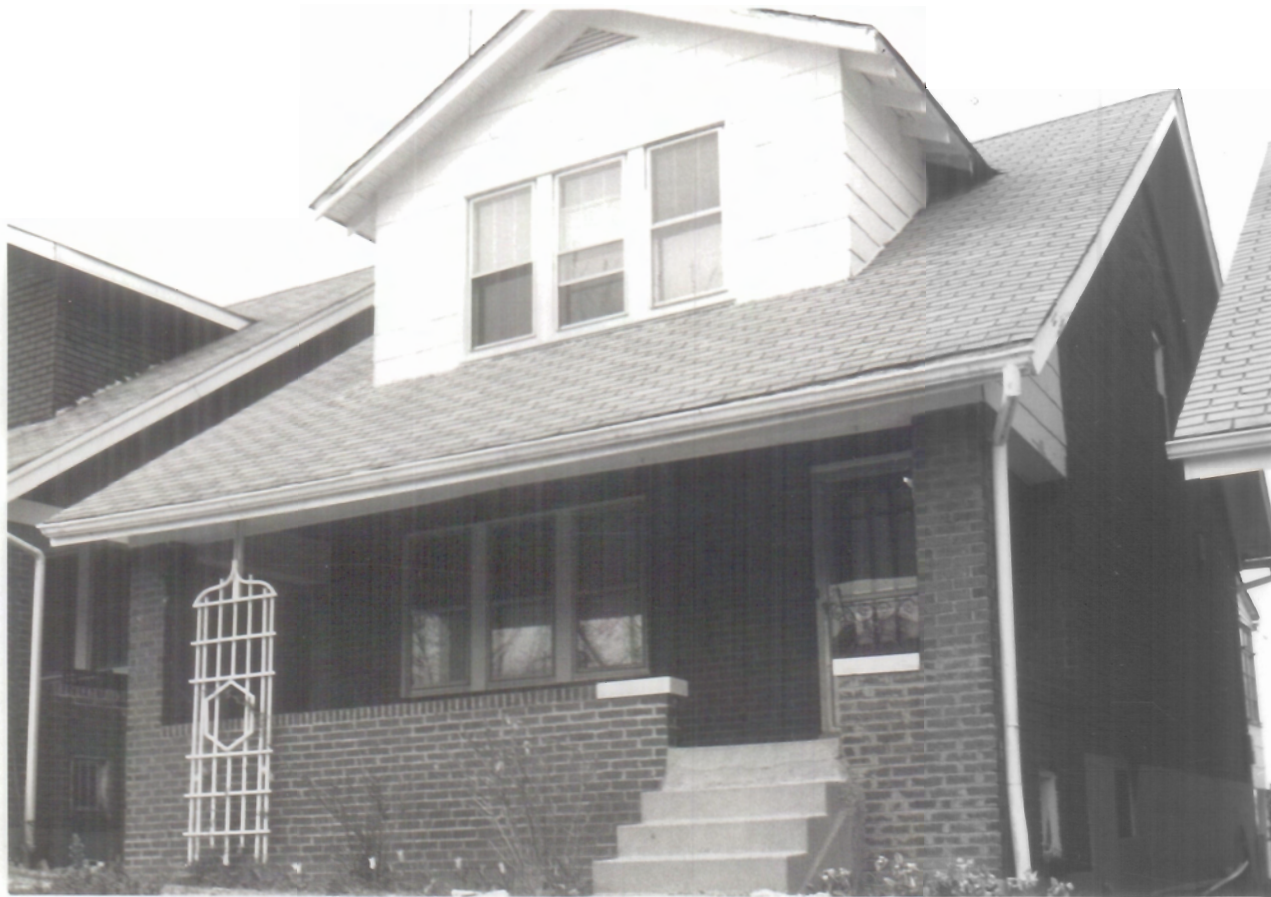
1. No. 067	3. Location of Negatives: Missouri Office of Historic Preservation, P. O. Box 176, Jefferson City, MO 65102		
2. City/County: City of St. Louis, MO	4. Prepared by: Cynthia Hill Longwisch, Landmarks Assn. of St. Louis, 917 Locust, 7th Floor, St. Louis, MO 63101

24. Foundation material: concrete		25. Roof type/material: side gable	
26. No. Bays: Front 2 Side 1		27. Wall treatment: red brick	
28. Plan shape: see site map		29. Changes: Addition? rear Altered?

30. Exterior condition: good		31. Open to public? no	
32. Other Surveys in which included: Heritage/St. Louis survey, 1971

33. Further description of important features: The gabled frame dormer of this house has exposed rafter ends and triple, 3-over-1 double-hung sash windows. The roofline extends to form the full-width porch roof, supported by straight brick pillars at the corners. Short solid brick side walls are capped with a header course and have stone insets at the steps. The doorway features Craftsman style panes. Triple windows on the front elevation (cont'd. below)

34. History and Significance: are also 3-over-1 double-hung sash. Rear frame addition.  
This house is the third in a series of six houses all listed on a single permit taken out by H. C. Vollmar in 1927. For additional information, see Item 34 of survey #65.

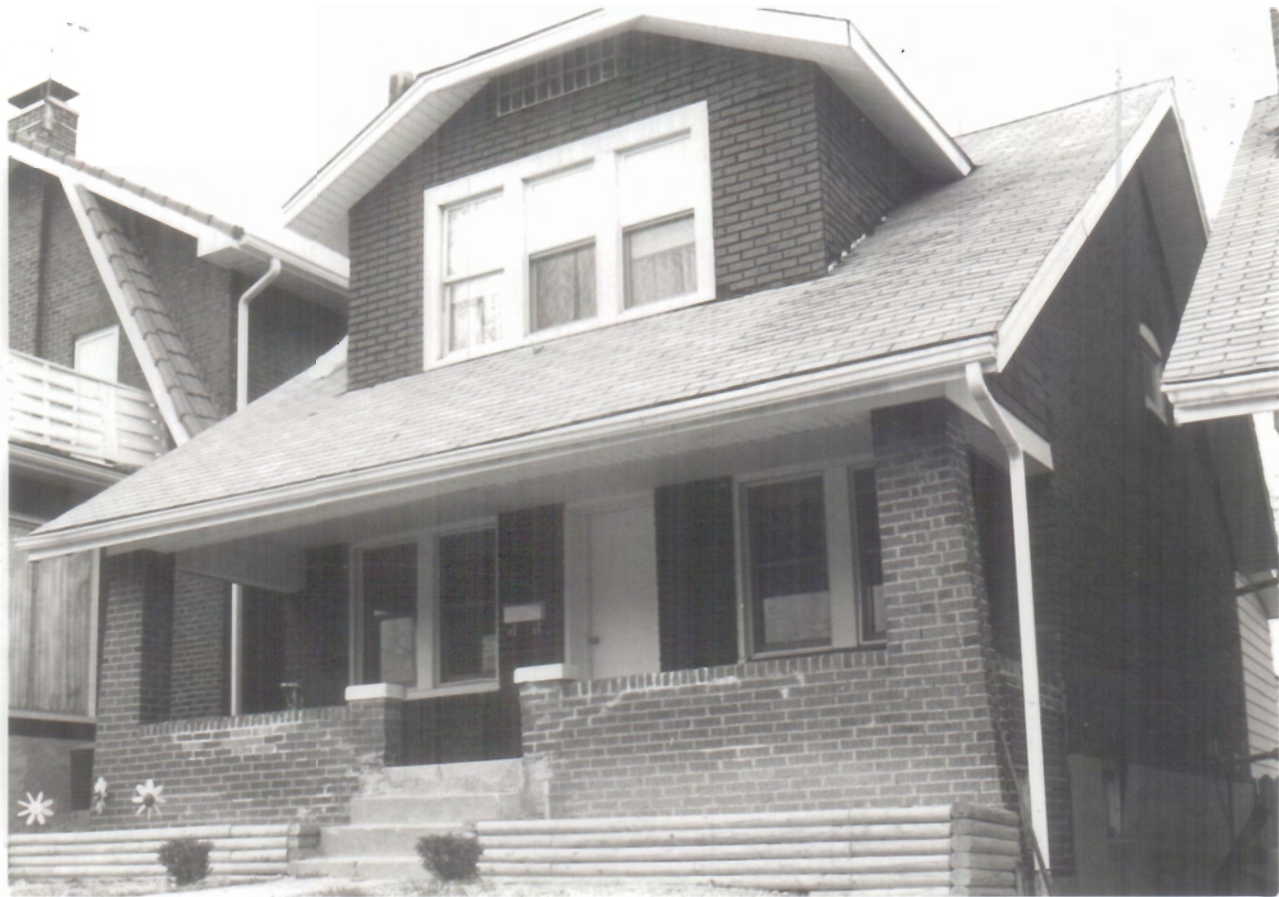
24. Foundation material: concrete		25. Roof type/material: side gable	
26. No. Bays: Front 3 Side 2		27. Wall treatment: brown brick	
28. Plan shape: see site map		29. Changes: Addition? rear Altered?

30. Exterior condition: good		31. Open to public? no	
32. Other Surveys in which included: Heritage/St. Louis survey, 1971			
33. Further description of important features: The large frame dormer on this house has a hipped gable, triple windows, and brick-look asphalt siding. The roof of the house extends to form the porch roof; it has wide eaves. The porch features tapered brick pillars and short solid brick walls topped with a header course; short, stone-capped posts. Paired windows flank the center entrance. Side windows are segmentally arched. Rear frame addition.

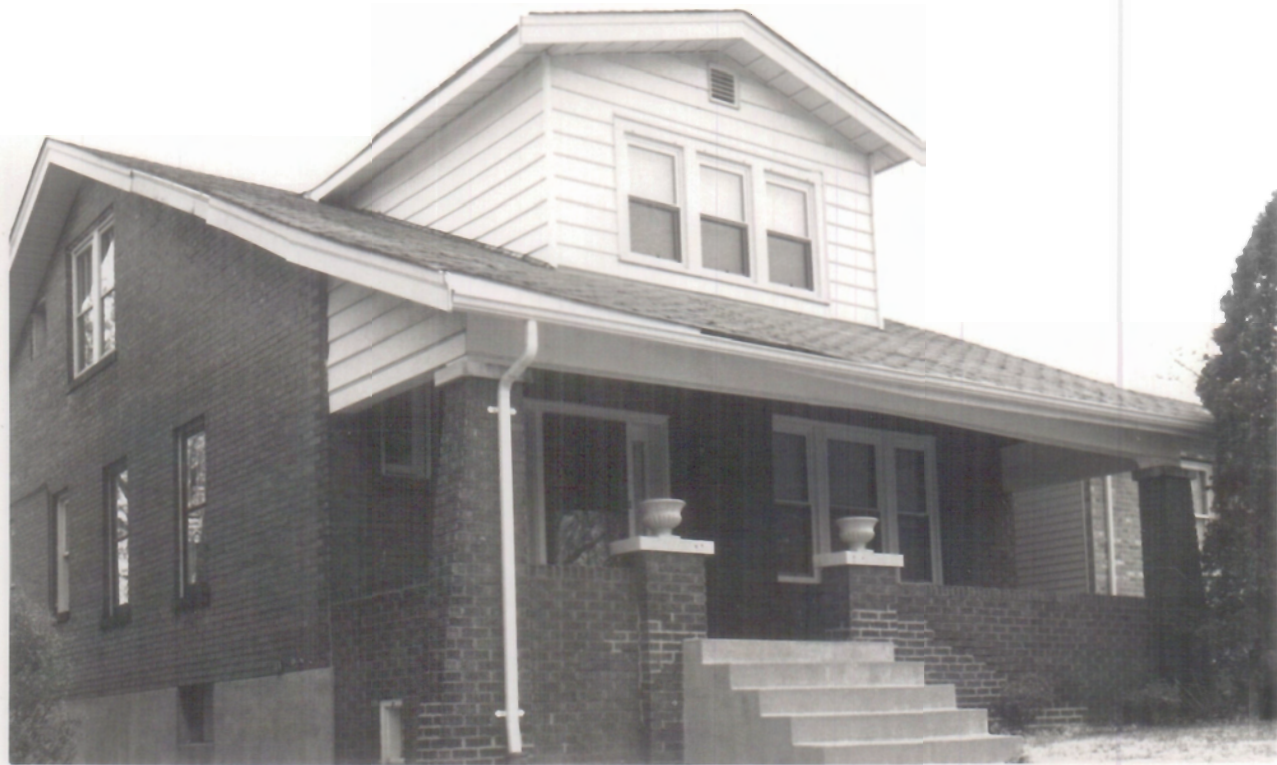
1. No. 079	3. Location of Negatives: Missouri Office of Historic Preservation, P. O. Box 176, Jefferson City, MO 65102		
2. City/County: City of St. Louis, MO	4. Prepared by: Cynthia Hill Longwisch, Landmarks Assn. of St. Louis, 917 Locust, 7th Floor, St. Louis, MO 63101

21. No. of stories: 1 1/2	22. Basement? yes	23. Wall construction: masonry	
24. Foundation material: concrete		25. Roof type/material: side gable	
26. No. Bays: Front 3	Side 4	27. Wall treatment: red brick

28. Plan shape: see site map		29. Changes: Addition?	Altered?
30. Exterior condition: good		31. Open to public? no	
32. Other Surveys in which included: Heritage/St. Louis survey, 1971

33. Further description of important features: Large frame dormer has triple (replacement?) windows. The roofline extends to become the porch roof, supported by tapering brick pillars. The brick side walls of the porch have been repointed in places and the steps are a new unit. Triple 1-over-1 windows are to the right of the sidelighted doorway and a small stained glass window is to its left. Side windows have flat arches.

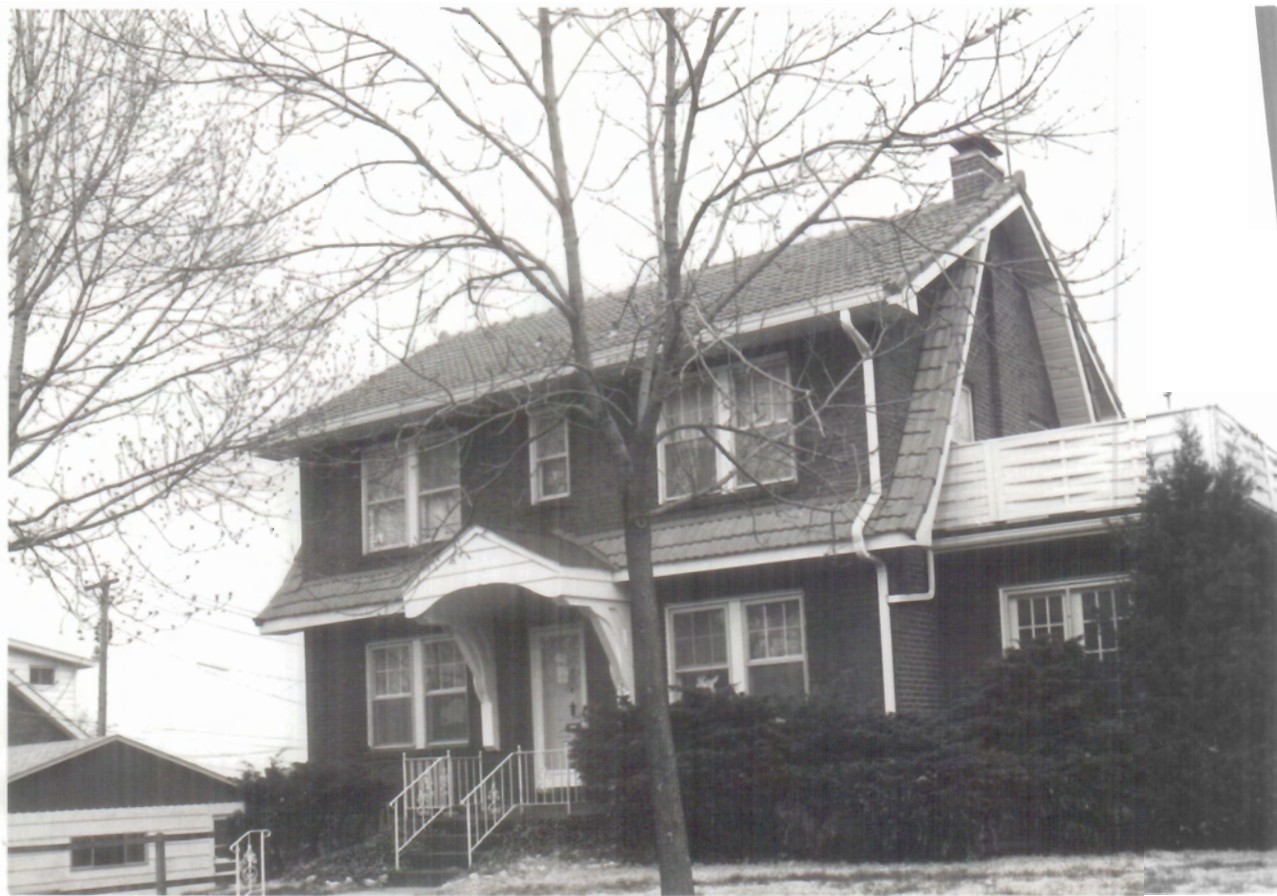
1. No. 065	3. Location of Negatives: Missouri Office of Historic Preservation, P. O. Box 176, Jefferson City, MO 65102
------------	---

24. Foundation material: concrete	25. Roof type/material: "gambrel"/tile
-----------------------------------	--

30. Exterior condition: good	31. Open to public? no
------------------------------	------------------------

33. Further description of important features: This house, like survey #36 and #37, features a "mock gambrel" roof: a standard two-story side gable is intersected with gambrel-shaped eaves. The effect is one of a gambrel roof with full-width dormers. The roof features orange clay tile. The centered entrance is sheltered by a gable frame hood supported by heavy wood brackets. Windows are paired, 6-over-1 double-hung sash. A one-story, (cont'd. below)

34. History and Significance: flat-roofed room, apparently original, extends to the south; it has a new basketweave railing and second-floor access. Prolific local builder Harry C. Vollmar took out the permit for this house along with five others on a single permit in 1927 (survey #65 - 70). The 24 x 27' buildings were allotted a cost of \$3,500 apiece, and it was noted that they were to have hot air heat. Several Vollmars were in the St. Louis construction business in the 1920s & '30s; H. C. lived nearby at 6105 Simpson.

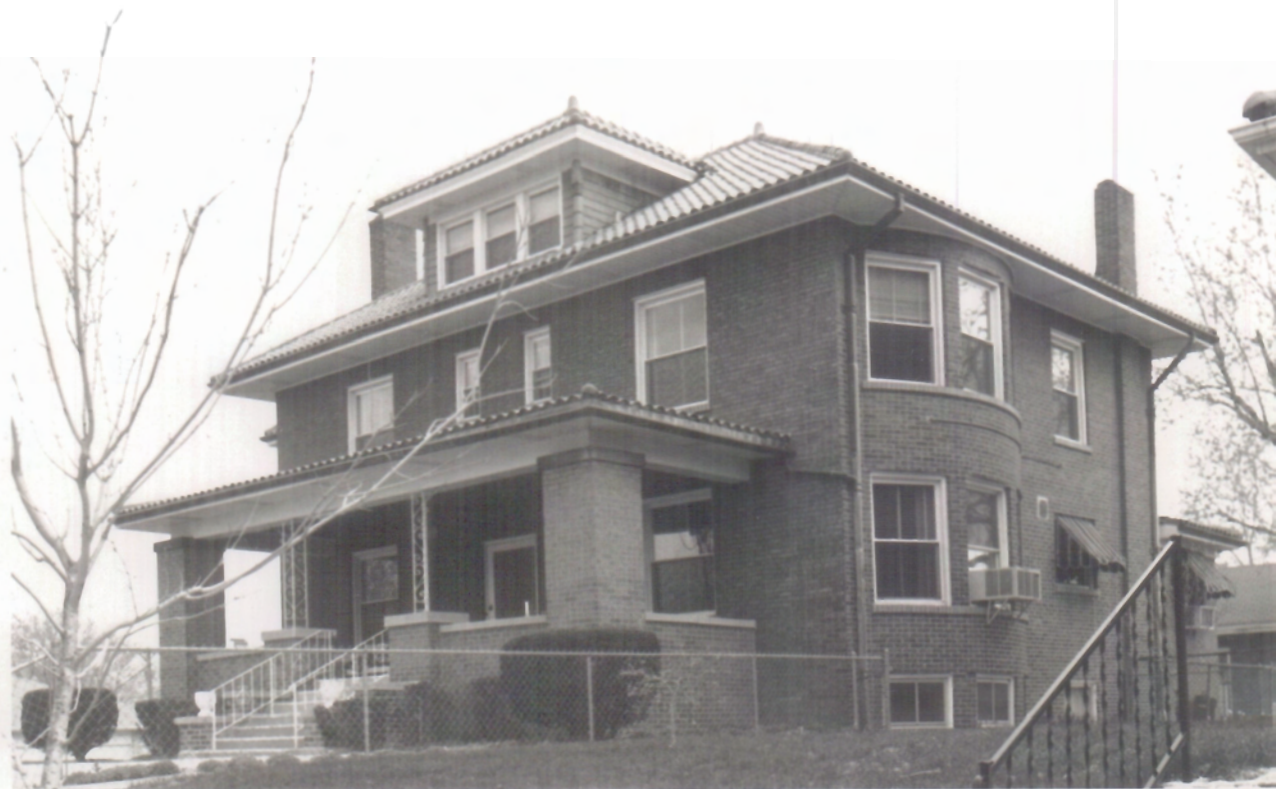
1. No. 080		3. Location of Negatives: Missouri Office of Historic Preservation, P. O. Box 176, Jefferson City, MO 65102	
2. City/County: City of St. Louis, MO		4. Prepared by: Cynthia Hill Longwisch, Landmarks Assn. of St. Louis, 917 Locust, 7th Floor, St. Louis, MO 63101

21. No. of stories: 2 1/2	22. Basement? yes	23. Wall construction: masonry	
24. Foundation material: stone		25. Roof type/material: hipped/tile	
26. No. Bays: Front 3 Side 4		27. Wall treatment: red brick

28. Plan shape: see site map		29. Changes: Addition? Altered?	
30. Exterior condition: good		31. Open to public? no	
32. Other Surveys in which included: Heritage/St. Louis survey, 1971

33. Further description of important features: Red tile on the roof and porch and dormer roofs highlight this large house. A hipped-roof porch is supported by very large square brick pillars. Round bay projects on north side; rectilinear, room-size bay projects on south side. Brick sills, flat arches. Solid brick short porch walls are topped with a stone railing and end posts have stone caps. One-story rear addition/original feature (?). Large corner lot.

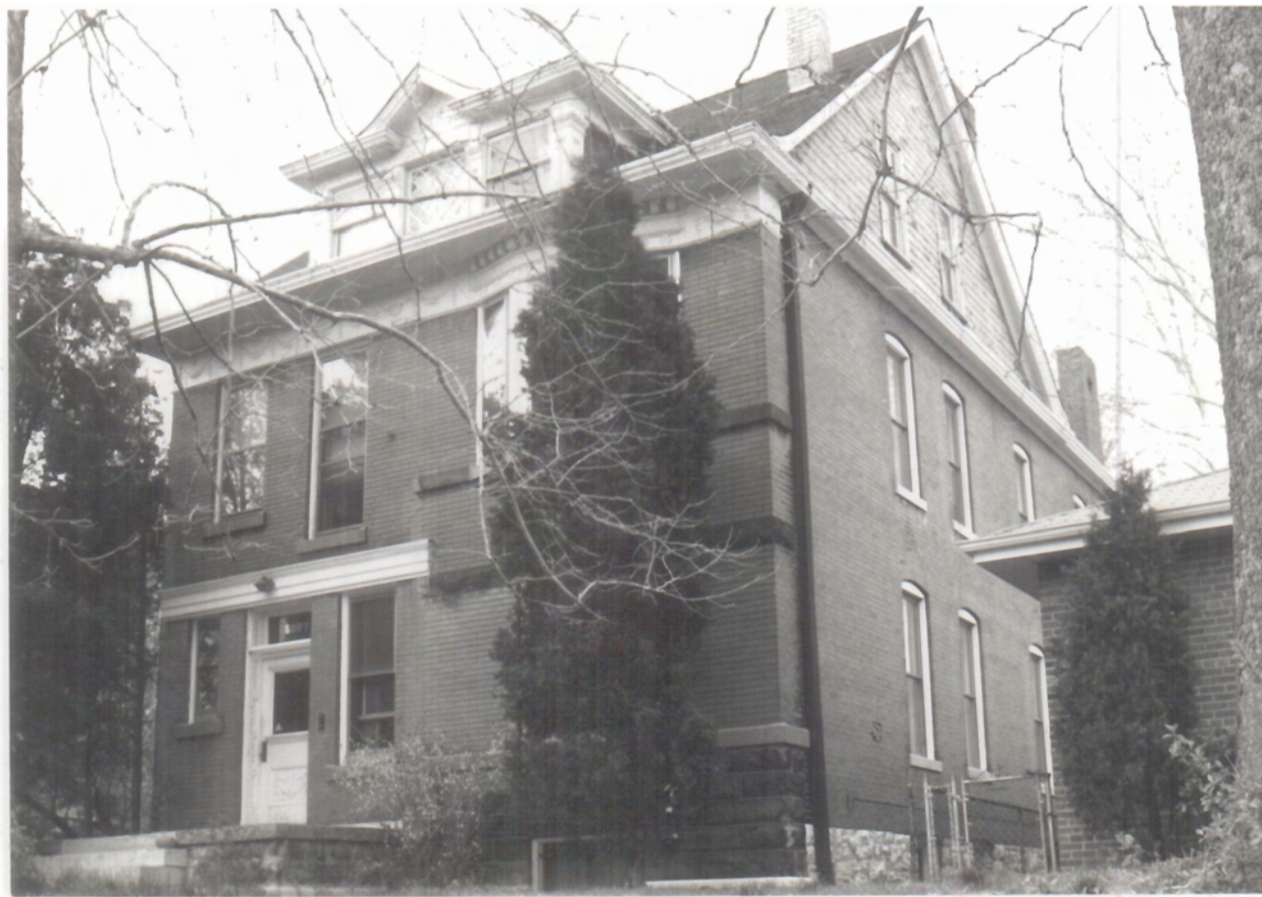
1. No. 207	3. Location of Negatives: Missouri Office of Historic Preservation, P. O. Box 176, Jefferson City, MO 65102		
2. City/County: City of St. Louis, MO	4. Prepared by: Cynthia Hill Longwisch, Landmarks Assn. of St. Louis, 917 Locust, 7th Floor, St. Louis, MO 63101

24. Foundation material: stone		25. Roof type/material: side gable	
26. No. Bays: Front 4 Side 4		27. Wall treatment: red brick/frame	
28. Plan shape: see site map		29. Changes: Addition? Altered? yes

30. Exterior condition: good		31. Open to public? no	
32. Other Surveys in which included: Heritage/St. Louis survey, 1971			
33. Further description of important features: An elaborately ornamented dormer is located front and center on this large house; it has diamond-paned windows and a heavy cornice. A wide cornice overhangs a fascia with carved swags. A bay window at the 2nd story is highlighted by rounded modillions. Red sandstone used to face the basement and for sills and decorative sill and lintel coursing on the front elevation. A porch roof is apparently (cont'd. below)

34. History and Significance: permanently missing, leaving the (replacement) door looking a little bare. It has a transom and a wood lintel/cornice. Heritage/St. Louis files state that Richard Eitman, president, Carondelet Avenue Furniture Mfg. Co., lived in this house at least 1887-93, with son Frederick (a clerk at the Post Office) continuing to live here at least through 1915. Their local source says that Eitman was both the original owner and the

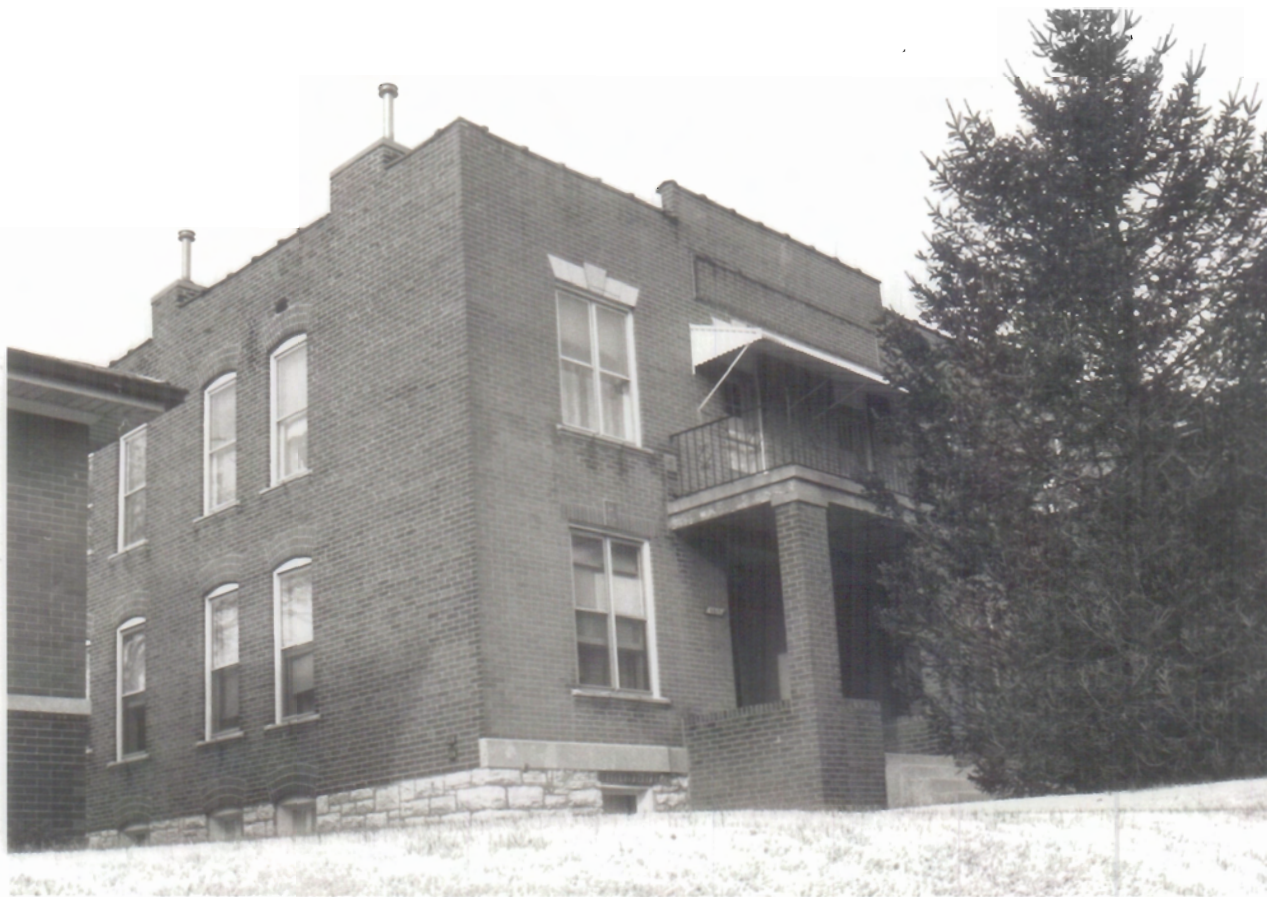
1. No. 208	3. Location of Negatives: Missouri Office of Historic Preservation, P. O. Box 176, Jefferson City, MO 65102		
2. City/County: City of St. Louis, MO	4. Prepared by: Cynthia Hill Longwisch, Landmarks Assn. of St. Louis, 917 Locust, 7th Floor, St. Louis, MO 63101

24. Foundation material: stone		25. Roof type/material: flat	
26. No. Bays: Front 4 Side 4		27. Wall treatment: red brick	
28. Plan shape: see site map		29. Changes: Addition? Altered?

30. Exterior condition: good		31. Open to public? no	
32. Other Surveys in which included: Heritage/St. Louis survey, 1971			
33. Further description of important features: The flat roof of this multi-family residence has a short parapet; below, a raised rectangular area may have held the building's name originally. A brick-pillared porch has a railing above and short brick walls below. Stone water table. Upper front windows have stone jack arches; same arches repeated below in brick; windows are paired 1-over-1. Side windows triple-rowlock segmentally arched. Terra cotta coping & sills.

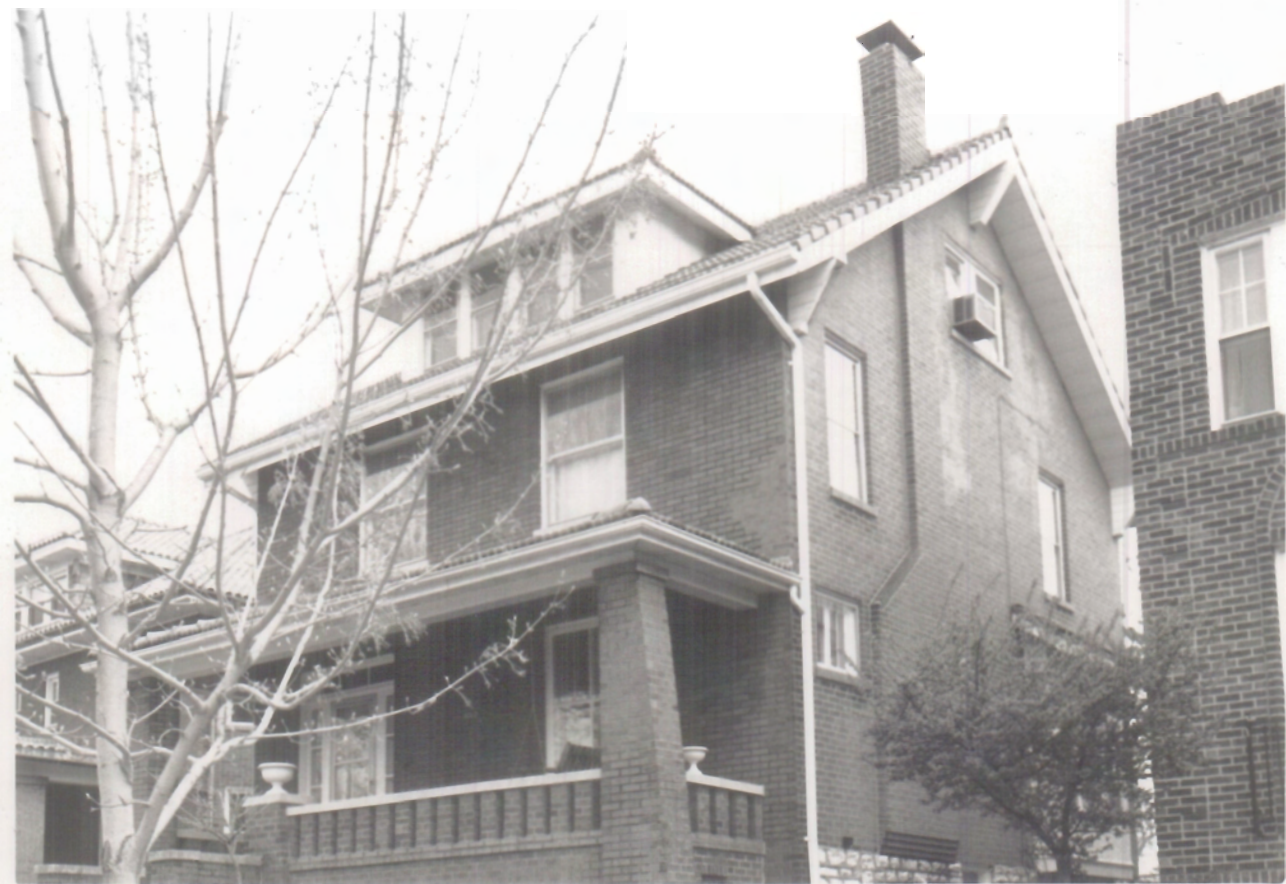
1. No. 081	3. Location of Negatives: Missouri Office of Historic Preservation, P. O. Box 176, Jefferson City, MO 65102		
2. City/County: City of St. Louis, MO

19. Original Use: residence		20. Present Use: residence	
21. No. of stories: 2 1/2	22. Basement? yes	23. Wall construction: masonry	
24. Foundation material: stone		25. Roof type/material: side gab./tile

26. No. Bays: Front 2 Side 3		27. Wall treatment: red brick	
28. Plan shape: see site map		29. Changes: Addition? Altered?	
30. Exterior condition: good		31. Open to public? no

32. Other Surveys in which included: Heritage/St. Louis survey, 1971			
33. Further description of important features: The red clay tile roof of this house has wide overhanging eaves with large wood brackets. A dormer is located on the front elevation. Porch has hipped tile roof supported by tapering brick pillars at the outside corners. Porch has brick balusters with a stone railing. Doorway features sidelights and fanlight. Chimney is raised from the house wall and corbeled at the base.

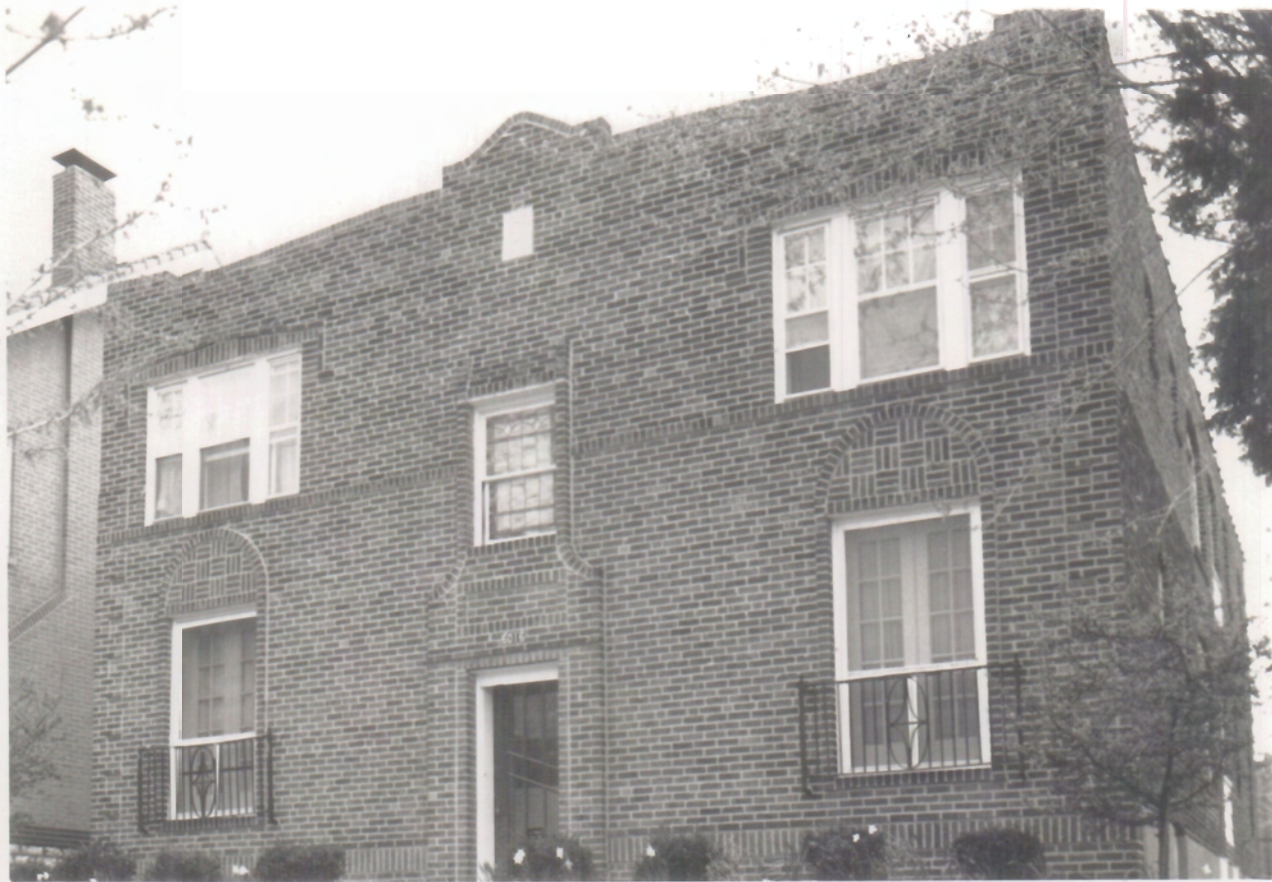
1. No. 082	3. Location of Negatives: Missouri Office of Historic Preservation, P. O. Box 176, Jefferson City, MO 65102		
2. City/County: City of St. Louis, MO	4. Prepared by: Cynthia Hill Longwisch, Landmarks Assn. of St. Louis, 917 Locust, 7th Floor, St. Louis, MO 63101

21. No. of stories: 2	22. Basement? yes	23. Wall construction: masonry	
24. Foundation material: concrete		25. Roof type/material: flat	
26. No. Bays: Front 3 Side 6		27. Wall treatment: brown brick

28. Plan shape: see site map		29. Changes: Addition? Altered?	
30. Exterior condition: good		31. Open to public? no	
32. Other Surveys in which included: Heritage/St. Louis survey, 1971

33. Further description of important features: This small apartment building features a shaped curvilinear brick parapet and brickwork detailing throughout, including round blind arches infilled with basketweave patterning, soldier sill and water table courses and a raised center door surround/pavilion incorporating a stained glass window above. Upper front windows have shaped soldier course lintels that wrap around. Side openings have double rowlock (cont'd. below)

34. History and Significance: segmental arches. Terra cotta inset crest below parapet. First story openings are french doors with non-functional "balconies." Local builder Harry C. Vollmar took out the permit to build a "tenement" for \$10,000 in 1926. The 36 x 56' building was to have hot water heat. Vollmar built extensively in Clifton Heights, usually single-family dwellings, and he lived at 6105 Simpson.

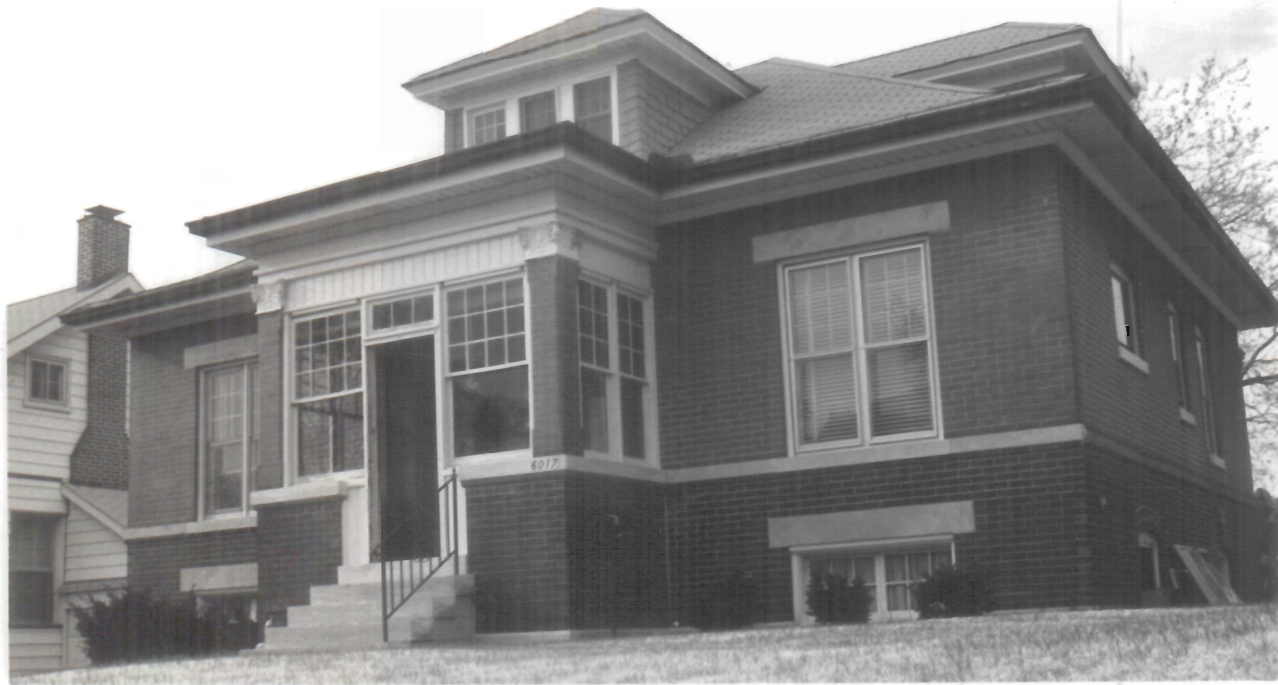
1. No. 209	3. Location of Negatives: Missouri Office of Historic Preservation, P. O. Box 176, Jefferson City, MO 65102		
2. City/County: City of St. Louis, MO	4. Prepared by: Cynthia Hill Longwisch, Landmarks Assn. of St. Louis, 917 Locust, 7th Floor, St. Louis, MO 63101

21. No. of stories: 1 1/2	22. Basement? yes	23. Wall construction: masonry	
24. Foundation material: concrete		25. Roof type/material: hipped	
26. No. Bays: Front 3 Side 3		27. Wall treatment: red brick

28. Plan shape: see site map		29. Changes: Addition? Altered? yes	
30. Exterior condition: good		31. Open to public? no	
32. Other Surveys in which included: Heritage/St. Louis survey, 1971

33. Further description of important features: The pyramidally hipped roof of this house has hipped-roof dormers with triple 6-over-1 windows. A flat-roofed, small porch is supported by brick pillars with Corinthian capitals; the porch has been infilled with windows. Paired windows on the front elevation are 9-over-1 and have stone lintels, as do front basement windows. Stone water table above egg & dart pressed brick course. Side windows double rowlock seg. arched.

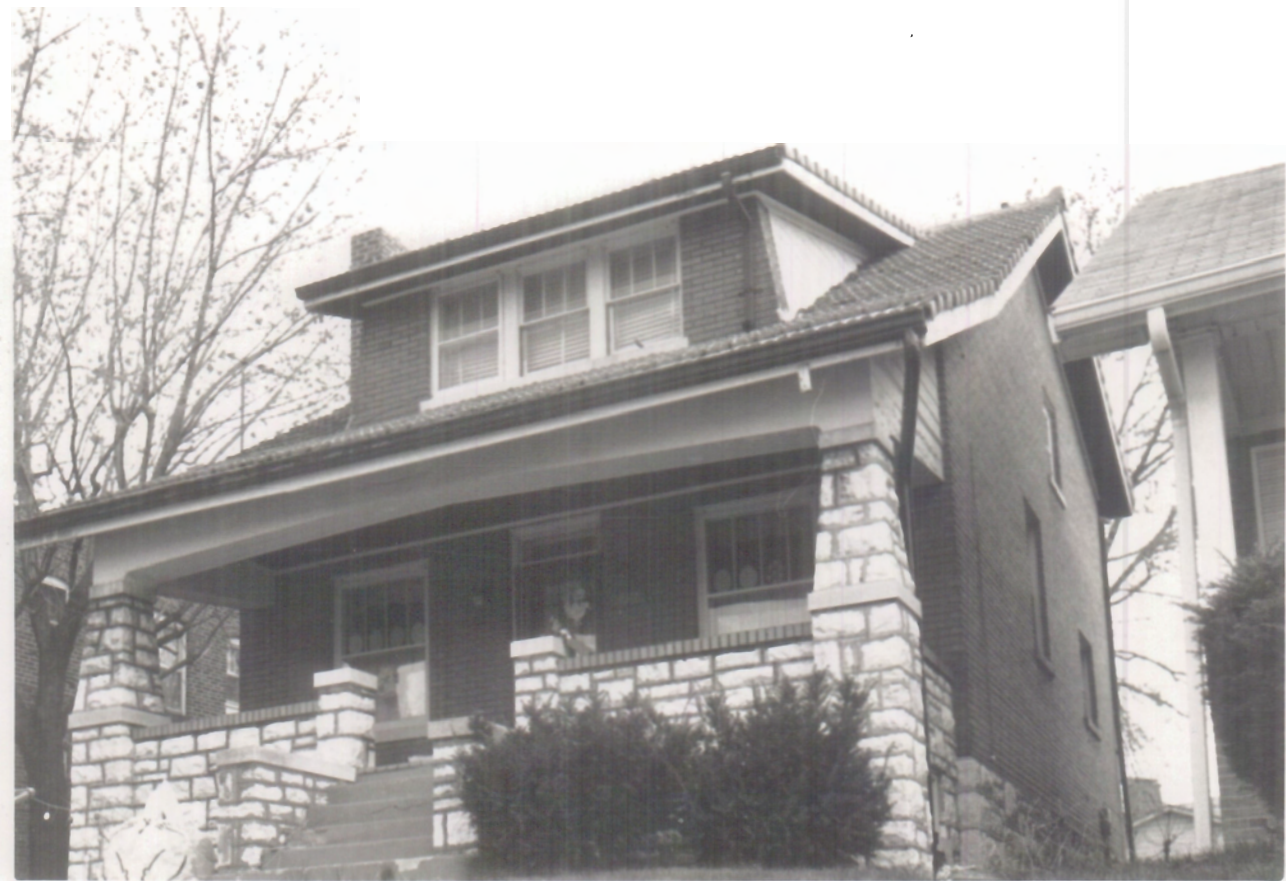
1. No. 083	3. Location of Negatives: Missouri Office of Historic Preservation, P. O. Box 176, Jefferson City, MO 65102		
2. City/County: City of St. Louis, MO	4. Prepared by: Cynthia Hill Longwisch, Landmarks Assn. of St. Louis, 917 Locust, 7th Floor, St. Louis, MO 63101

24. Foundation material: stone		25. Roof type/material: side gab./tile	
26. No. Bays: Front 3 Side 3		27. Wall treatment: red brick	
28. Plan shape: see site map		29. Changes: Addition? Altered?

30. Exterior condition: good		31. Open to public? no	
32. Other Surveys in which included: Heritage/St. Louis survey, 1971			
33. Further description of important features: A frame shed dormer has triple 3-over-1 double-hung sash windows. The red clay tile roof of the house extends to form the full-width porch roof, supported by tapering limestone pillars. The porch side walls are also of limestone, with a brick header course on top. Center doorway has transom; it is flanked by windows divided into multiple vertical panes over a single pane; stone sills. Side openings are flat-arched.

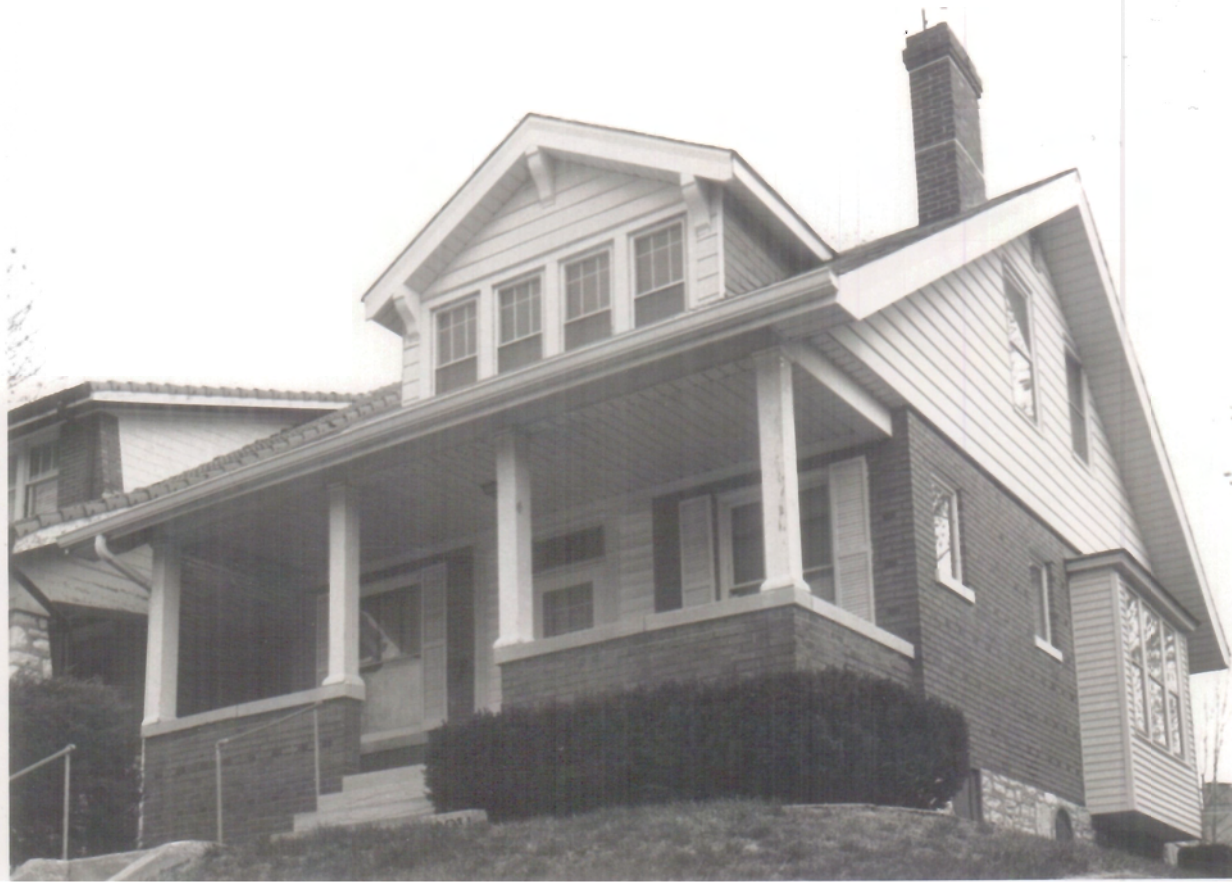
1. No. 084	3. Location of Negatives: Missouri Office of Historic Preservation, P. O. Box 176, Jefferson City, MO 65102		
2. City/County: City of St. Louis, MO	4. Prepared by: Cynthia Hill Longwisch, Landmarks Assn. of St. Louis, 917 Locust, 7th Floor, St. Louis, MO 63101

21. No. of stories: 1 1/2	22. Basement? yes	23. Wall construction: brick/fr	
24. Foundation material: stone		25. Roof type/material: side gable	
26. No. Bays: Front 3 Side 4		27. Wall treatment: red brick/cull hdrs

28. Plan shape: see site map		29. Changes: Addition? Altered? yes	
30. Exterior condition: good		31. Open to public? no	
32. Other Surveys in which included: Heritage/St. Louis survey, 1971

33. Further description of important features: A bracketed frame dormer features four 6-over-1 (uneven spacing - see photo) double-hung windows. The upper story is frame while the lower is brick with cull header bricks in every 7th course. The roofline extends to become part of the full-width porch, supported by four thin, square wood pillars set atop the stone railing of the brick side walls. The centered doorway is flanked by single 3-over-1 (cont'd. below)

34. History and Significance: double-hung sash windows. A side bay window appears to be either new or altered from the original look. Owner Charles W. Woodward, a foreman at Emerson Electric (moved out by 1923), hired woodworker Joseph Gunn and carpenter/contractor Donald M. Cormack of 6900 Wise to build this house for \$3,000 in 1914. The 25 x 28' house was to have furnace heat. The permit does not list a professional architect, but the permit is not entirely clear whether Woodward or the builders did the actual designing.

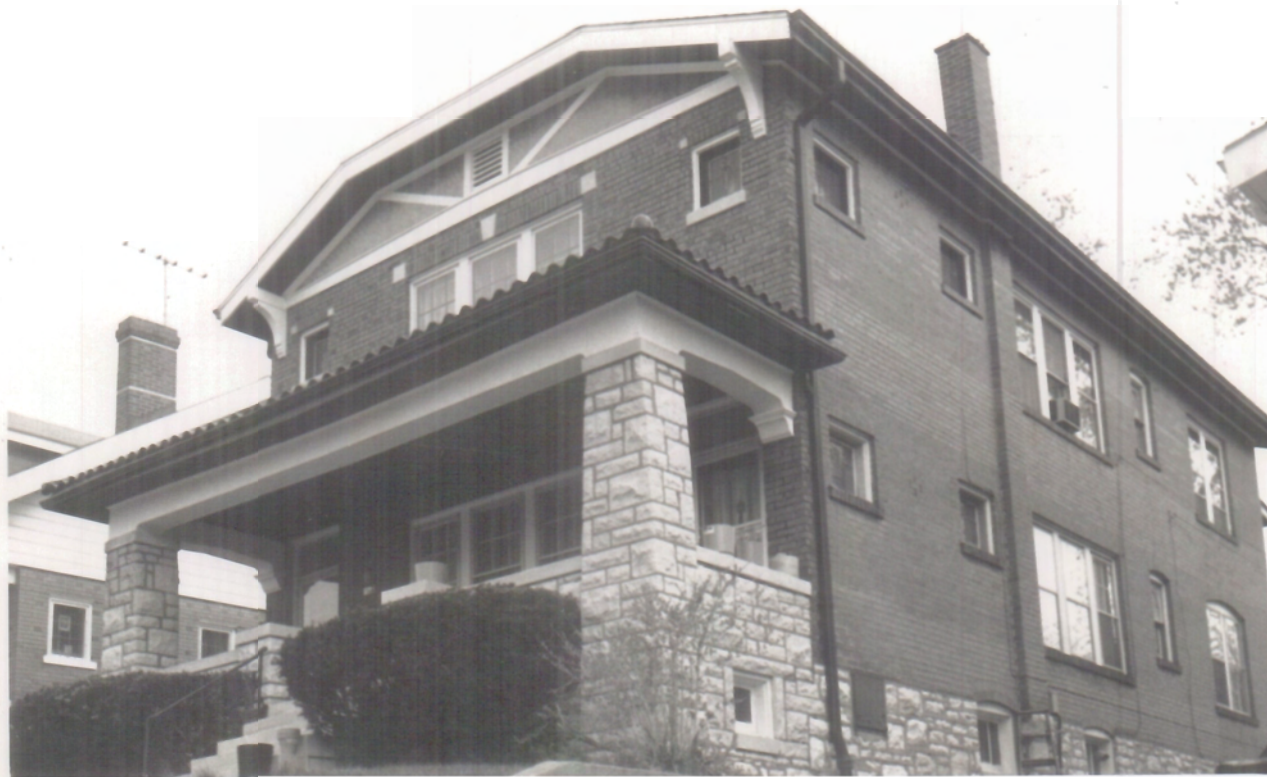
1. No. 085	3. Location of Negatives: Missouri Office of Historic Preservation, P. O. Box 176, Jefferson City, MO 65102		
2. City/County: City of St. Louis, MO	4. Prepared by: Cynthia Hill Longwisch, Landmarks Assn. of St. Louis, 917 Locust, 7th Floor, St. Louis, MO 63101

21. No. of stories: 2	22. Basement? yes	23. Wall construction: masonry	
24. Foundation material: stone		25. Roof type/material: front gable*	
26. No. Bays: Front 3 Side 5		27. Wall treatment: red/multi brick

28. Plan shape: see site map		29. Changes: Addition? Altered?	
30. Exterior condition: good		31. Open to public? no	
32. Other Surveys in which included: Heritage/St. Louis survey, 1971

33. Further description of important features: *The front gable of this house is hipped; the bracketed gable end features a stucco and wood infill. The tiled porch roof is supported by tapering stone pillars. The short porch walls are also limestone. The facade is laid in a multichrome brick while the body of the house is red brick. Upper front windows are highlighted by square inset stones and sills; outer two windows are of stained glass. At the (cont'd. below)

34. History and Significance: first story, triple windows are flanked by two transomed doors with narrow, Craftsman-style paning. Side windows are mixed: some segmental arches, some flat.  
The permit for this house was taken out by realtor Robert Hanna, who is listed as the owner, builder and architect; he did not live in this house. The 27 x 48' "tenement" house cost \$7,000 and had hot water heat.

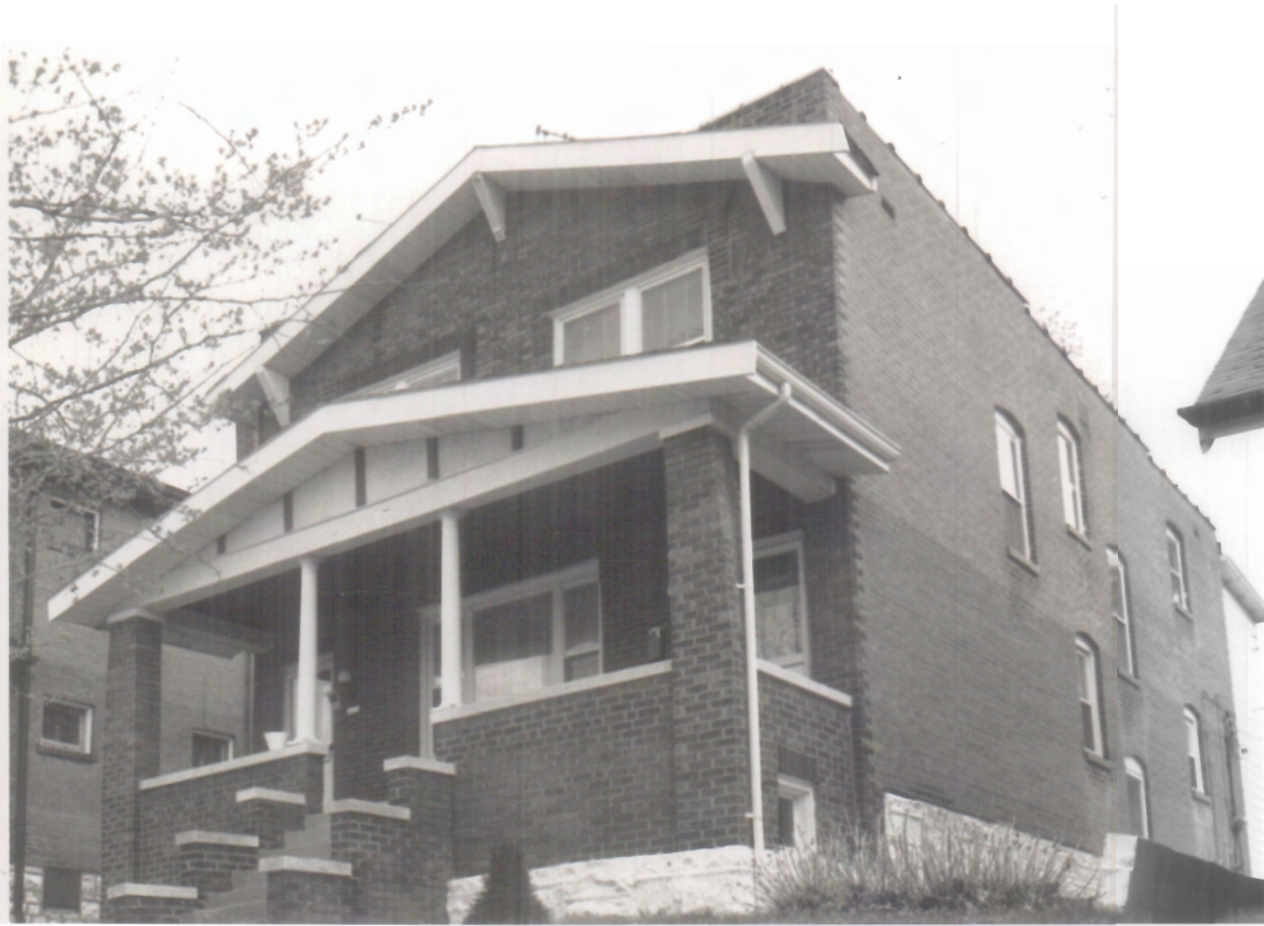
1. No. 086	3. Location of Negatives: Missouri Office of Historic Preservation, P. O. Box 176, Jefferson City, MO 65102		
2. City/County: City of St. Louis, MO	4. Prepared by: Cynthia Hill Longwisch, Landmarks Assn. of St. Louis, 917 Locust, 7th Floor, St. Louis, MO 63101

24. Foundation material: stone		25. Roof type/material: flat	
26. No. Bays: Front 3 Side 4		27. Wall treatment: textured red brick	
28. Plan shape: see site map		29. Changes: Addition? rear Altered? yes

30. Exterior condition: good		31. Open to public? no	
32. Other Surveys in which included: Heritage/St. Louis survey, 1971

33. Further description of important features: A gabled, bracketed cornice across the front of this flat-roofed house gives the impression of a gabled roof. The gabled porch is supported by brick pillars and round wood columns, the latter of which are probably not original. Short, stepped brick walls with stone tops flank the steps and reflect the porch wall design. A large center front window probably replaces paired originals; two doors (cont'd. below)

34. History and Significance: with Craftsman style paning flank the window. Darker brick soldier arches return at the sides of the front windows. Side windows have double rowlock segmental arches. The building permit for this "tenement" was taken out by M. R. Karhauk, who was listed as the owner, builder and architect. The name does not appear in city directories, so perhaps it was misspelled on the permit or he was not from St. Louis. The house cost \$6,000; the permit gives no other information.

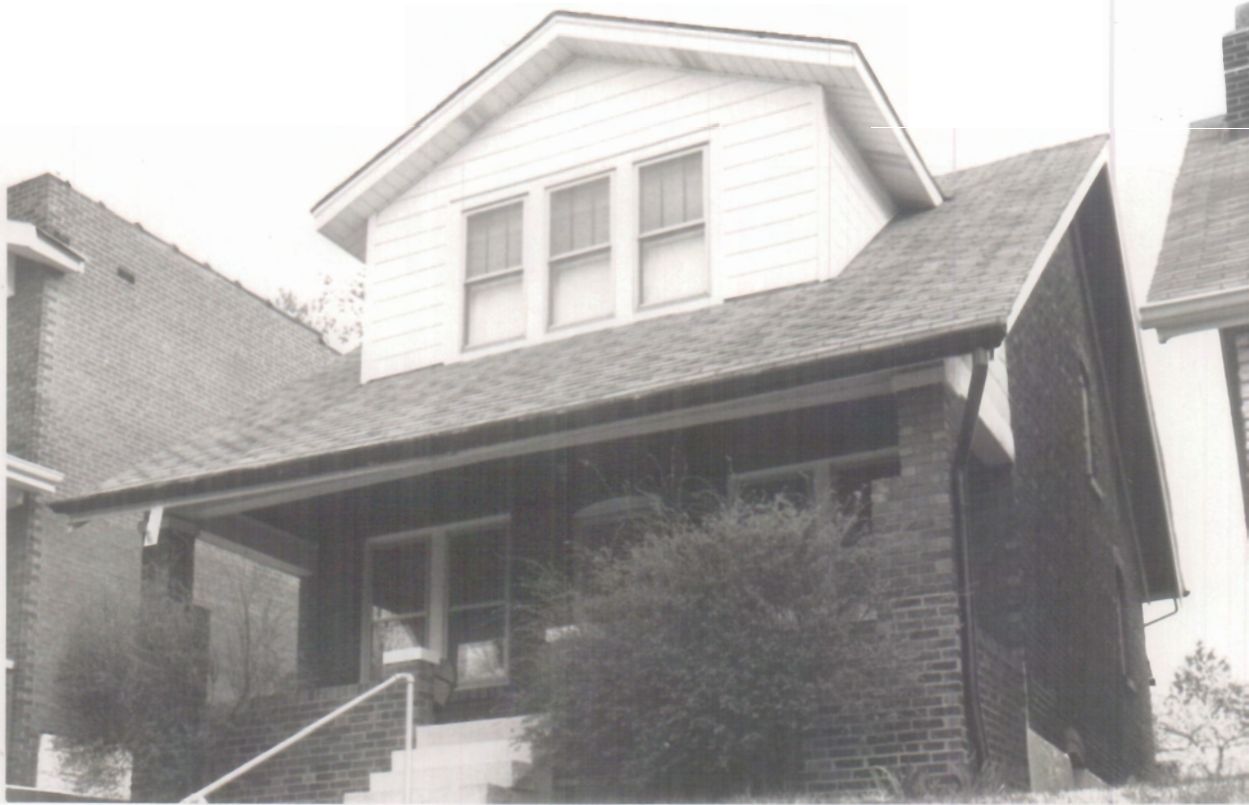
3. Further description of important features: The large frame dormer of this house has triple 3-over-1 double-hung sash windows. The roofline extends to form the roof of the full-width porch, supported by stepped brick pillars. Very short brick porch side walls are topped with a header course. The center, segmentally arched doorway is flanked by paired 3-over-1 double-hung sash windows. The openings are segmentally arched. Wide eave overhangs.

4. History and Significance: The permit for this and two other houses (survey #88 and #89; 6100 & 6104 Columbia) were together on one, dated 1924, taken out by Harry C. Vollmar, local builder. The 24 x 26' houses cost \$4,000 apiece and had furnace heat. Vollmar and his relatives were very active in building in St. Louis; he lived at nearby 6105 Simpson (survey #174) and worked extensively in the St. Louis area.

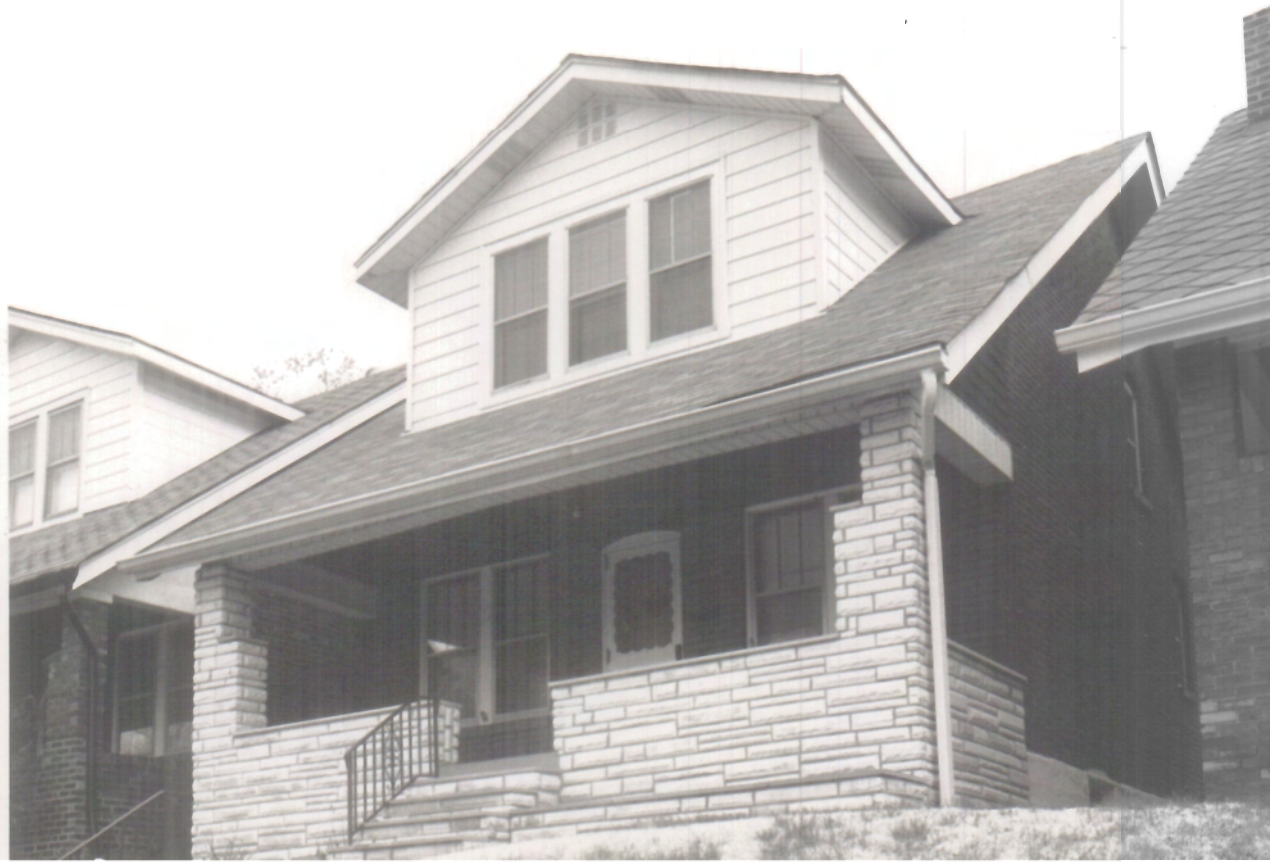
1. No. 088	3. Location of Negatives: Missouri Office of Historic Preservation, P. O. Box 176, Jefferson City, MO 65102		
2. City/County: City of St. Louis, MO	4. Prepared by: Cynthia Hill Longwisch, Landmarks Assn. of St. Louis, 917 Locust, 7th Floor, St. Louis, MO 63101

24. Foundation material: concrete		25. Roof type/material: side gable	
26. No. Bays: Front 3 Side 3		27. Wall treatment: textured brown brk.	
28. Plan shape: see site map		29. Changes: Addition? Altered? ?

30. Exterior condition: good		31. Open to public? no	
32. Other Surveys in which included: Heritage/St. Louis survey, 1971			
33. Further description of important features: The gabled frame dormer of this house has three 3-over-1 double-hung sash windows. The roofline extends forward to become the roof of the full-width porch, supported by stepped pillars sheathed, along with the walls and foundation, with coursed stone resembling permastone; this may be an alteration. The segmentally-arched doorway is flanked by paired 3-over-1 double-hung sash. Side windows have segmental arches.

34. History and Significance: This house and the two houses on either side are listed on a single permit taken out in 1924 by local builder Harry C. Vollmar. The houses cost \$4,000 apiece and had furnace heat. Vollmar worked in the Clifton Heights area primarily during the 1920s.
