# ARCHITECTURAL SURVEY OF CLIFTON HEIGHTS

JUNE 1991

ST. LOUIS, MISSOURI

LANDMARKS ASSOCIATION OF ST. LOUIS, INC.

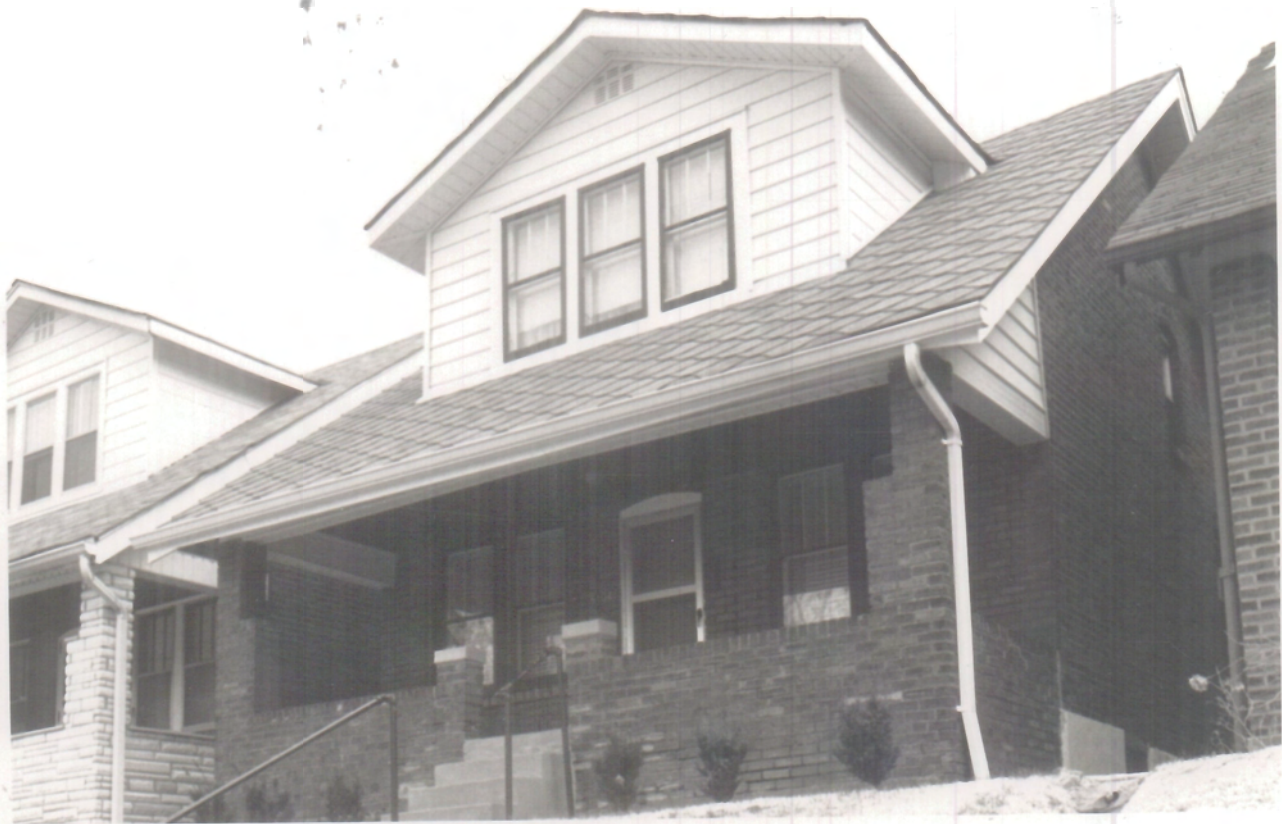
1. No. 089	3. Location of Negatives: Missouri Office of Historic Preservation, P. O. Box 176, Jefferson City, MO 65102		
2. City/County: City of St. Louis, MO	4. Prepared by: Cynthia Hill Longwisch, Landmarks Assn. of St. Louis, 917 Locust, 7th Floor, St. Louis, MO 63101

24. Foundation material: concrete		25. Roof type/material: side gable	
26. No. Bays: Front 3 Side 3		27. Wall treatment: red brick	
28. Plan shape: see site map		29. Changes: Addition?	Altered?

30. Exterior condition: good		31: Open to public? no	
32. Other Surveys in which included: Heritage/St. Louis survey, 1971			
33. Further description of important features: The original undulating-patterned shingles remain on this house. A large frame dormer has triple 3-over-1 double-hung sash windows. The roof extends to become the porch roof, supported by stepped brick pillars. The brick side walls of the porch are topped with a header course; stone caps its short pillars. A segmentally arched doorway is flanked by paired 3-over-1 windows. Side windows have double (cont'd. below)

34. History and Significance: rowlock segmental arches. This house is the third of three listed on a single permit taken out by H. C. Vollmar in 1924. The 24 x 26' houses cost \$4,000 each and had furnace heat. Vollmar was very active in building houses in the vicinity. He lived at 6105 Simpson.

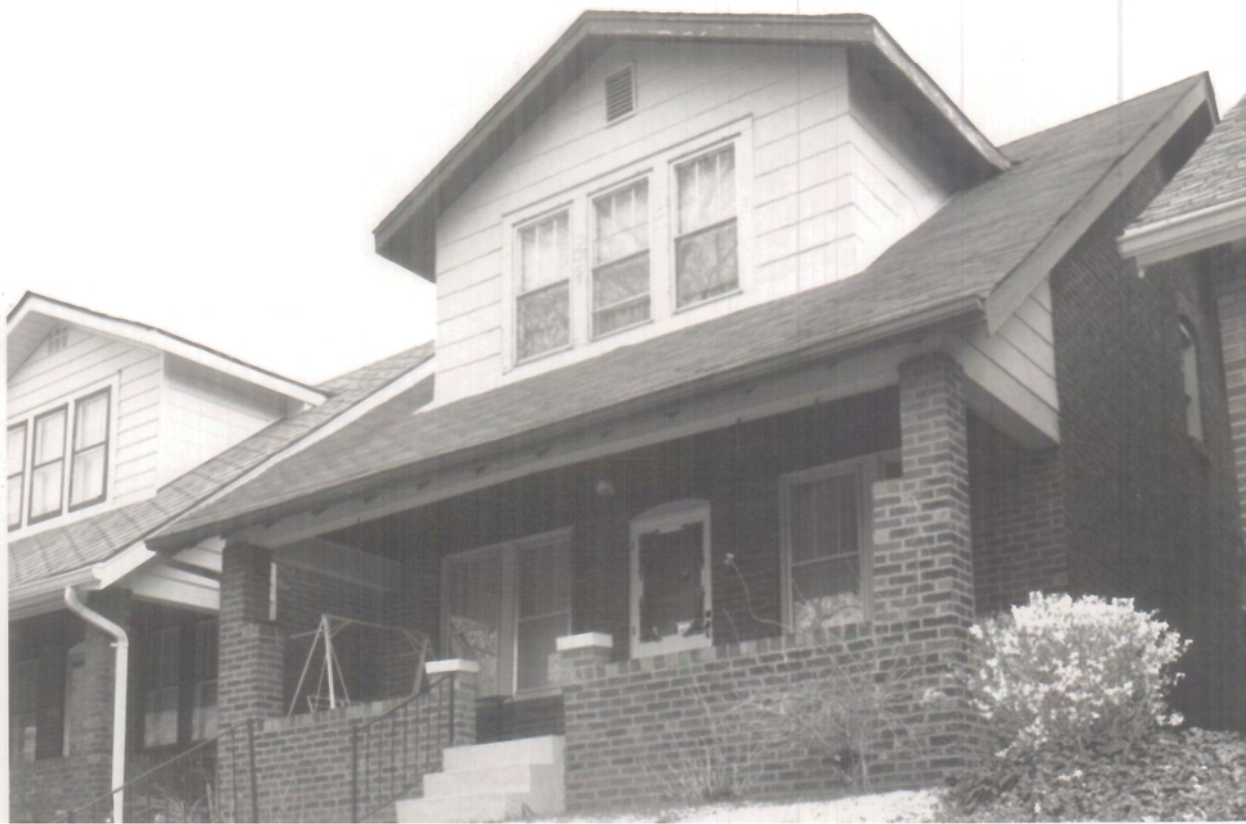
1. No. 090	3. Location of Negatives: Missouri Office of Historic Preservation, P. O. Box 176, Jefferson City, MO 65102		
2. City/County: City of St. Louis, MO	4. Prepared by: Cynthia Hill Longwisch, Landmarks Assn. of St. Louis, 917 Locust, 7th Floor, St. Louis, MO 63101

21. No. of stories: 1 1/2	22. Basement? yes	23. Wall construction: masonry	
24. Foundation material: concrete		25. Roof type/material: side gable	
26. No. Bays: Front 3	Side 3	27. Wall treatment: brown brick

33. Further description of important features: Frame dormer has wide overhang- ing eaves and three 3-over-1 double-hung sash windows. The roofline extends to become the porch roof, with exposed rafter ends. Stepped brick pillars support the roof. Brick short side walls of the porch have a top header course and stone-capped posts at the opening. Centered, segmentally arched doorway is flanked by paired 3-over-1 double-hung sash windows. Side (cont'd. below)

34. History and Significance: openings are segmentally arched. Local builder Harry C. Vollmar took out the permit for this and two neighboring houses (survey #91 & #92, 6110 & 6112 Columbia) on the same date in 1924. The 24 x 26' houses were to cost \$4,000 each and have furnace heat. H. C. was one of several members of the Vollmar family who worked as St. Louis contractors. He was very active in the Clifton Heights area, during the 1920s in particular, and he lived at 6105 Simpson.

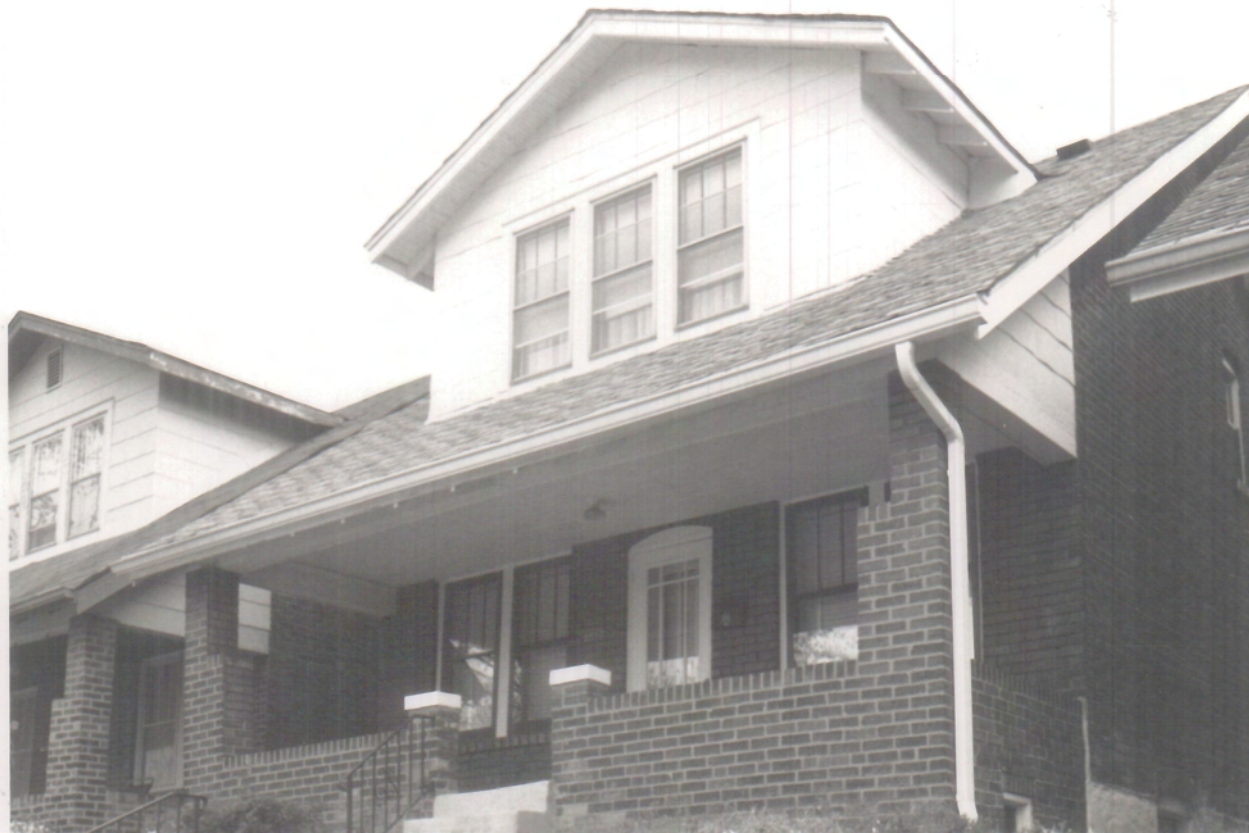
1. No. 091	3. Location of Negatives: Missouri Office of Historic Preservation, P. O. Box 176, Jefferson City, MO 65102		
2. City/County: City of St. Louis, MO	4. Prepared by: Cynthia Hill Longwisch, Landmarks Assn. of St. Louis, 917 Locust, 7th Floor, St. Louis, MO 63101

24. Foundation material: concrete		25. Roof type/material: side gable	
26. No. Bays: Front 3 Side 3		27. Wall treatment: brown brick	
28. Plan shape: see site map		29. Changes: Addition? Altered?

34. History and Significance: paired 3-over-1 windows. Side windows are segmentally arched.

This house was on a single permit (along with survey #90 & #92, on either side) taken out in 1924 by builder H. C. Vollmar. Vollmar was quite prolific during the 1920s in this vicinity. The houses cost \$4,000 each and had furnace heat.

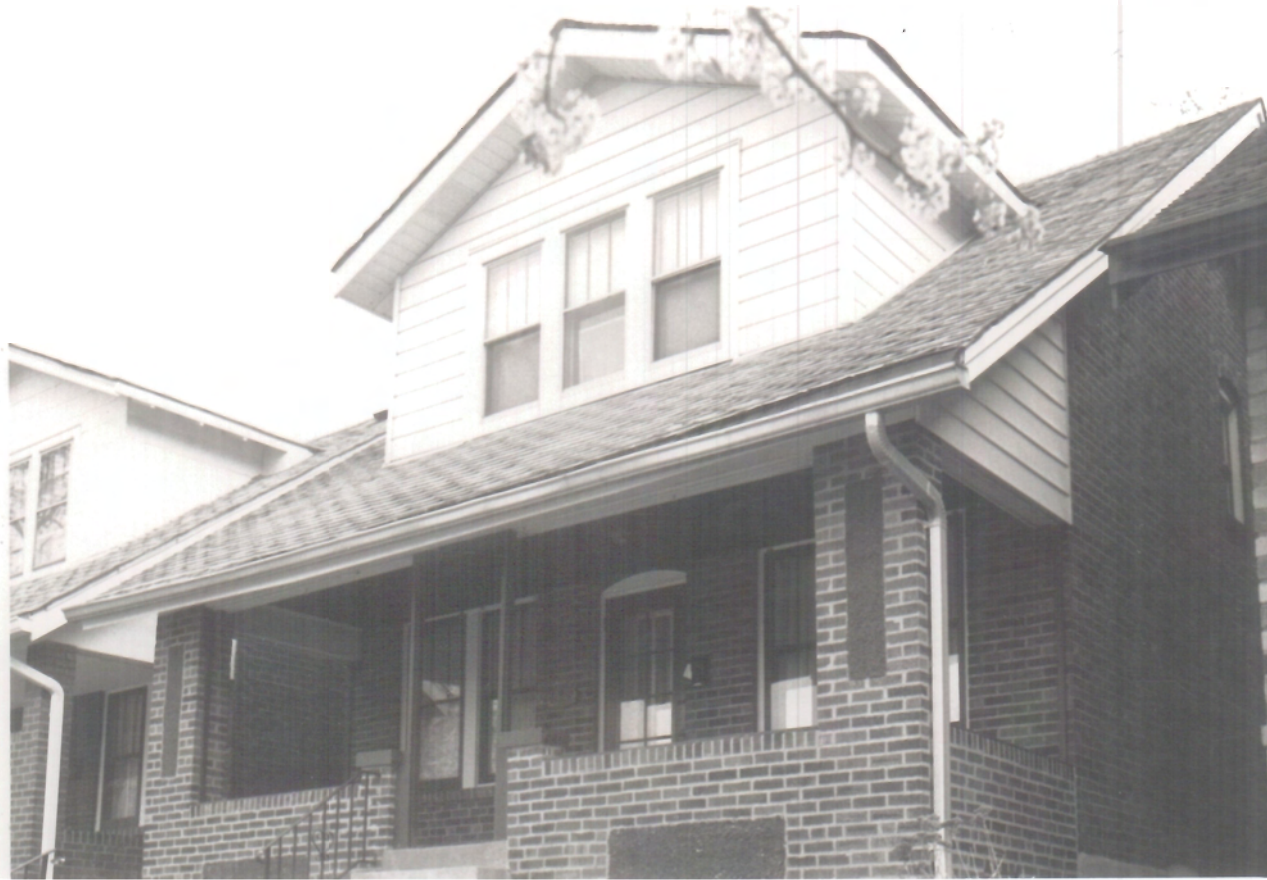
1. No. 092	3. Location of Negatives: Missouri Office of Historic Preservation, P. O. Box 176, Jefferson City, MO 65102		
2. City/County: City of St. Louis, MO	4. Prepared by: Cynthia Hill Longwisch, Landmarks Assn. of St. Louis, 917 Locust, 7th Floor, St. Louis, MO 63101

24. Foundation material: concrete		25. Roof type/material: side gable	
26. No. Bays: Front 3      Side 2	27. Wall treatment: brown/multi brick		
28. Plan shape: see site map	29. Changes: Addition?	Altered?

33. Further description of important features: The frame, gabled dormer on this house has triple 3-over-1 double-hung sash windows, which appear again below in pairs flanking the segmentally arched door. The roof of the house extends to become the porch roof, supported by straight brick pillars. The porch walls have a top header course and odd decorative rectangular stuccoed inserts that also appear on survey #94, another Vollmar house. (cont'd. below)

34. History and Significance: A wooden door-type frame is inset at the porch entrance, its purpose unclear; it is too thin to be supportive and nothing is attached to it.  
This house and the two houses to the east were listed on a single permit taken out by H. C. Vollmar in 1924. The 24 x 26' houses were to have furnace heat and cost \$4,000 apiece. Vollmar was a local contractor who lived nearby at 6105

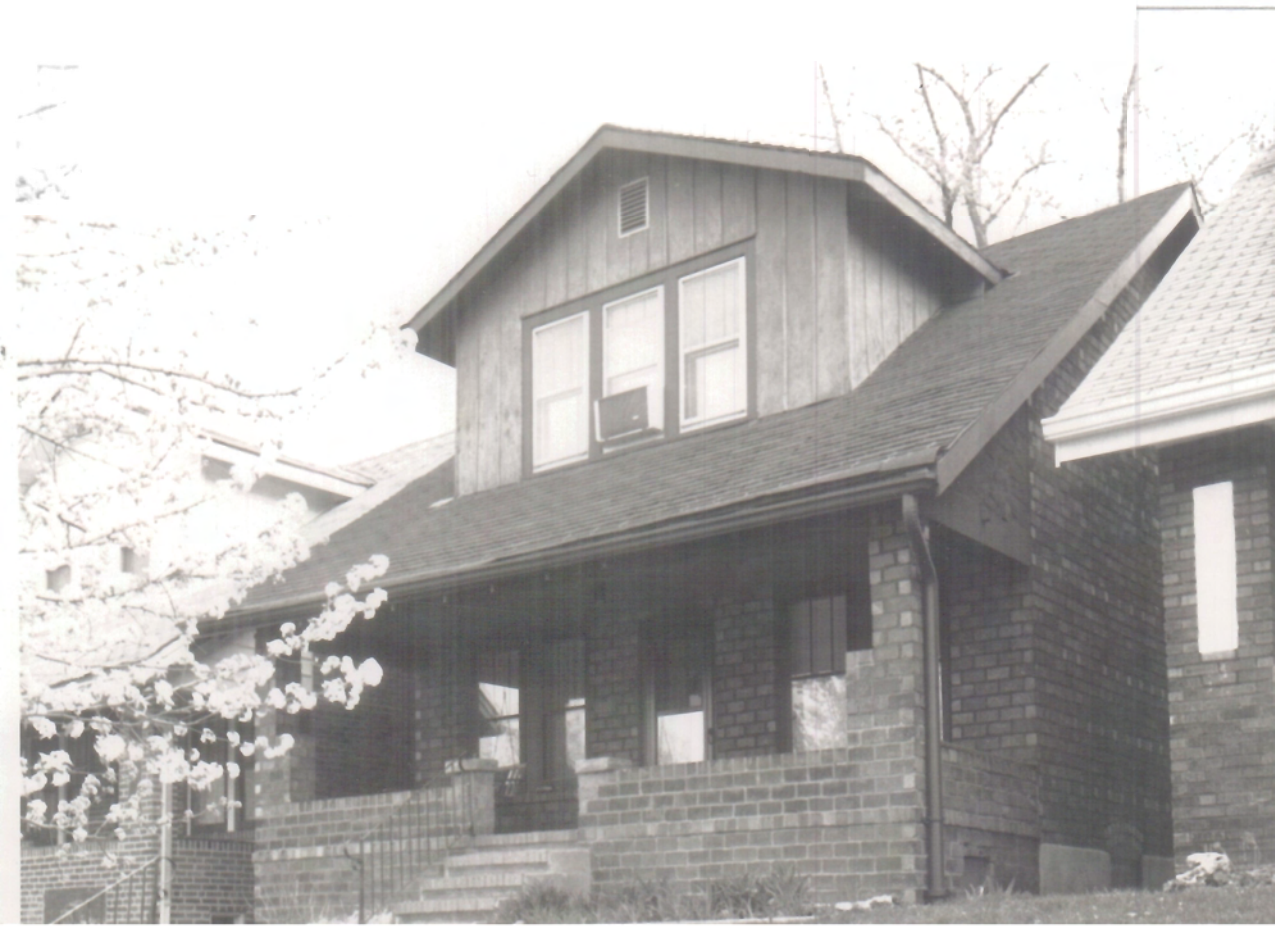
1. No. 093	3. Location of Negatives: Missouri Office of Historic Preservation, P. O. Box 176, Jefferson City, MO 65102		
2. City/County: City of St. Louis, MO	4. Prepared by: Cynthia Hill Longwisch, Landmarks Assn. of St. Louis, 917 Locust, 7th Floor, St. Louis, MO 63101

21. No. of stories: 1 1/2	22. Basement? yes	23. Wall construction: masonry	
24. Foundation material: concrete		25. Roof type/material: side gable	
26. No. Bays: Front 3	Side 3	27. Wall treatment: cinder block?

28. Plan shape: see site map		29. Changes: Addition?	Altered? yes
30. Exterior condition: good		31. Open to public? no	
32. Other Surveys in which included: Heritage/St. Louis survey, 1971

34. History and Significance: supported by stepped pillars. Centered door is segmentally arched, as are side openings.

The permit for this house was listed along with survey #94 and #95 to the west on a single permit taken out by local builder H. C. Vollmar. The 24 x 26' houses were to cost \$4,000 apiece and have furnace heat. The other two houses on the permit are built of regular brick and there is no indication on the permit that any other material would be used.

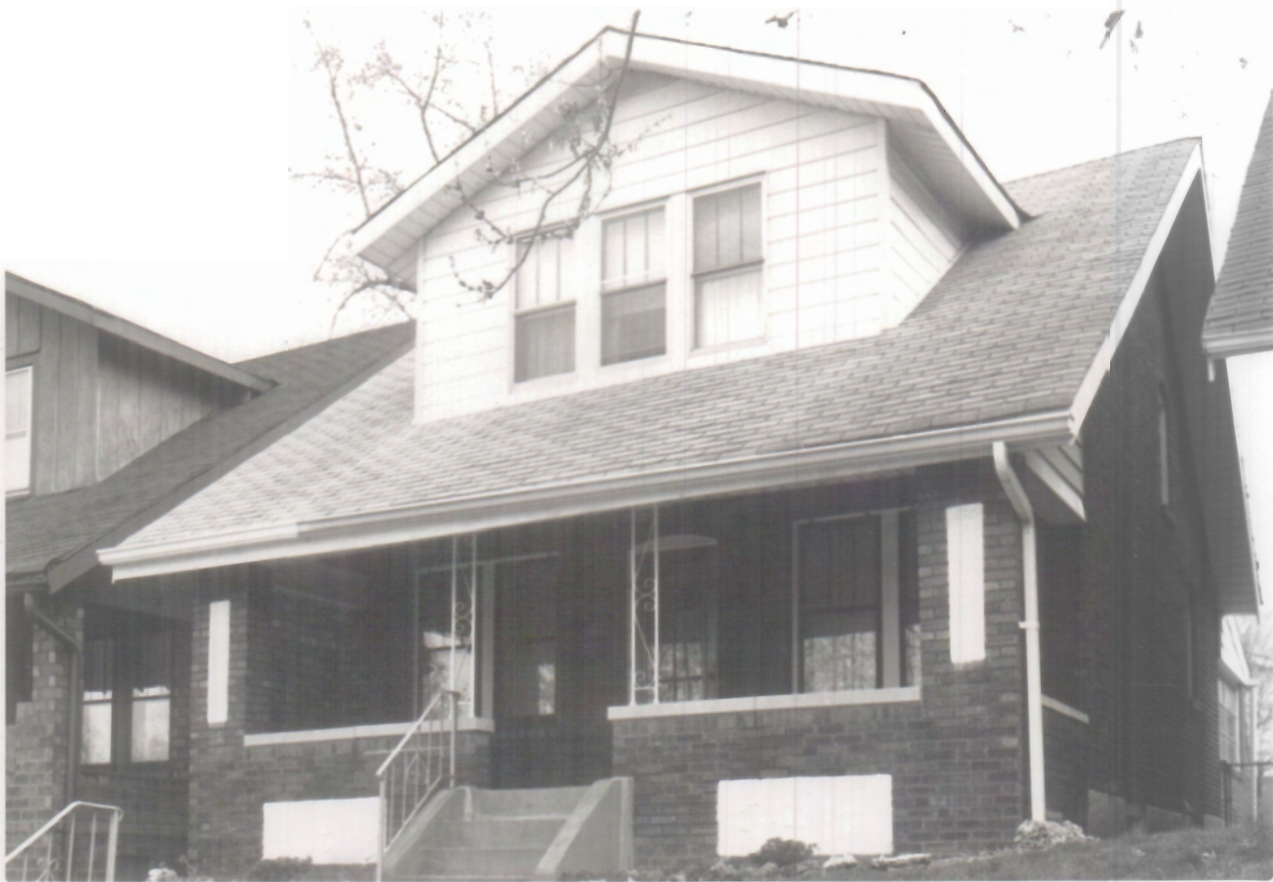
1. No. 094	3. Location of Negatives: Missouri Office of Historic Preservation, P. O. Box 176, Jefferson City, MO 65102		
2. City/County: City of St. Louis, MO	4. Prepared by: Cynthia Hill Longwisch, Landmarks Assn. of St. Louis, 917 Locust, 7th Floor, St. Louis, MO 63101

24. Foundation material: concrete		25. Roof type/material: side gable	
26. No. Bays: Front 3 Side 3		27. Wall treatment: brown brick	
28. Plan shape: see site map		29. Changes: Addition? Altered?

33. Further description of important features: The gabled frame dormer on this house has three 3-over-1 double-hung sash windows. The roofline extends to become the porch roof, supported by straight brick pillars (two wrought-iron posts add support). The brick porch is highlighted by painted rectangular stucco insets similar to those of survey #92, also a Vollmar house. The centered doorway is segmentally arched and flanked by paired 3-over-1 double-hung (cont'd. below)

34. History and Significance: sash windows. Side openings are segmentally arched. Replacement concrete steps.  
This house is the second of three listed on a single permit taken out in 1924 by Harry C. Vollmar, a busy local builder. The houses were to cost \$4,000 each and have furnace heat; their size was listed as 24 x 26' each. Vollmar built many Clifton Heights houses during the 1920s; he lived at 6105 Simpson (survey #174)

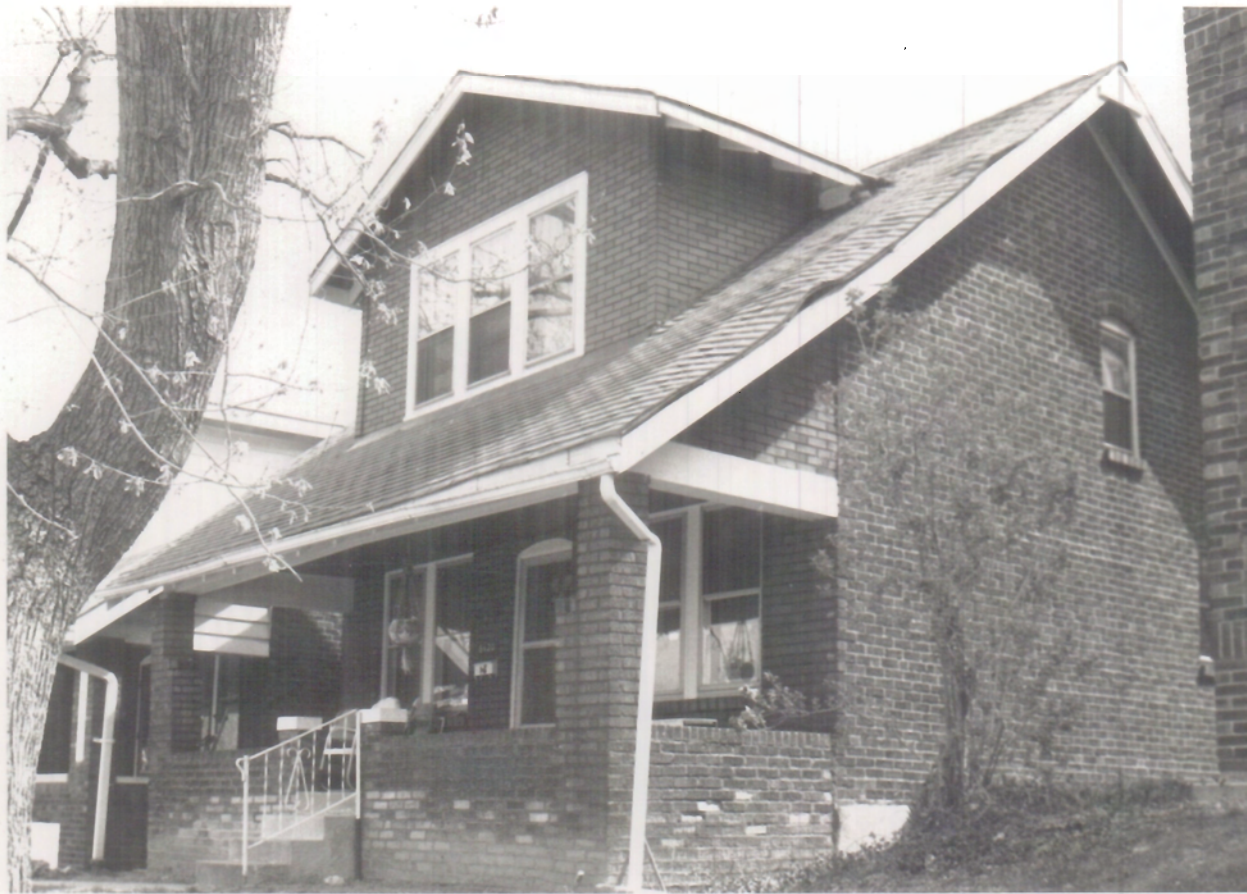
1. No. 095	3. Location of Negatives: Missouri Office of Historic Preservation, P. O. Box 176, Jefferson City, MO 65102		
2. City/County: City of St. Louis, MO	4. Prepared by: Cynthia Hill Longwisch, Landmarks Assn. of St. Louis, 917 Locust, 7th Floor, St. Louis, MO 63101

24. Foundation material: concrete		25. Roof type/material: side gable	
26. No. Bays: Front 3 Side 3		27. Wall treatment: red brick	
28. Plan shape: see site map		29. Changes: Addition? Altered? yes

30. Exterior condition: good/fair		31. Open to public? no	
32. Other Surveys in which included: Heritage/St. Louis survey, 1971			
33. Further description of important features: The gabled frame dormer of this house is covered with brick-look asphalt siding. Its triple 3-over-1 double-hung sash windows are repeated below in pairs flanking the segmentally arched centered doorway. The roof has wide eaves and extends to form the roof of the full-width porch, supported by stepped brick pillars. The brick short porch walls are topped with a header course and stone caps at the (cont'd. below)

34. History and Significance: opening. Double-rowlock segmentally arched side windows. Some rebuilding of the porch is in evidence. Harry C. Vollmar took out the permit for survey #93-4-5 in 1924, listing a cost for each 24 x 26' house as \$4,000. They were to have furnace heat. Vollmar was a prolific local builder who had other St. Louis relatives in the contracting business. He was primarily active in Clifton Heights during the 1920s.

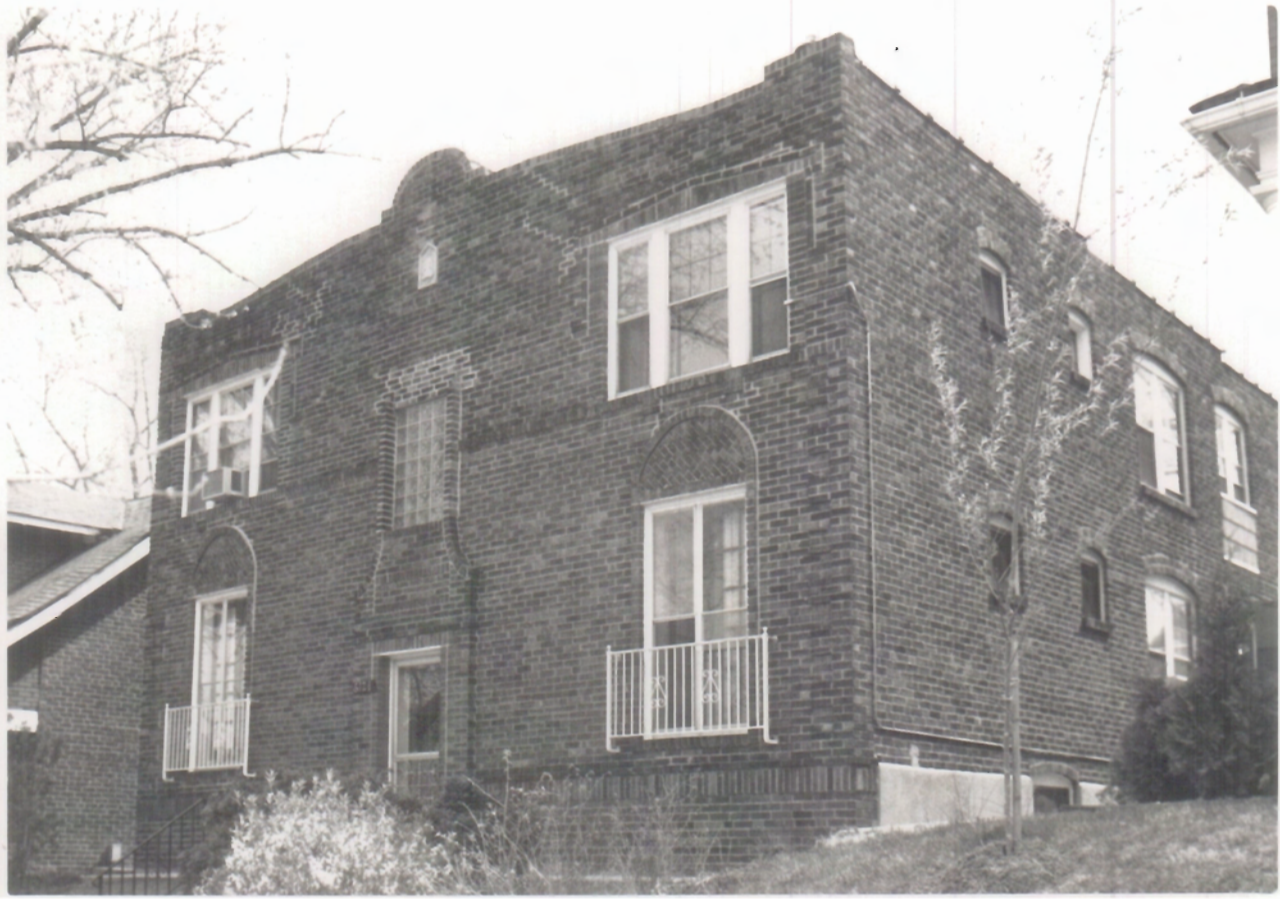
1. No. 096	3. Location of Negatives: Missouri Office of Historic Preservation, P. O. Box 176, Jefferson City, MO 65102		
2. City/County: City of St. Louis, MO	4. Prepared by: Cynthia Hill Longwisch, Landmarks Assn. of St. Louis, 917 Locust, 7th Floor, St. Louis, MO 63101

21. No. of stories: 2	22. Basement? yes	23. Wall construction: masonry	
24. Foundation material: concrete		25. Roof type/material: flat	
26. No. Bays: Front 3 Side 6		27. Wall treatment: brown/multi brick

33. Further description of important features: This apartment building is very similar to survey #82, 6016 Columbia, built a year later by Vollmar. It features a curvilinear brick parapet and rather elaborate brickwork throughout, including round blind arches filled with herringbone brickwork above paired french doors, a raised center entrance pavilion, a soldier course water table and the shaped, wrap-around soldier course lintels of the (cont'd. below)

34. History and Significance: second story front windows. A terra cotta crest is inset below the parapet. Repair work is in evidence below the crest, and the original window below has been infilled with glass brick. Non-functional "balconies" at first story. Side openings are double-rowlock segmental arches. H. C. Vollmar took out the permit for this "tenement" in 1925 for \$10,000. The 36 x 56' building was to have hot water heat. Vollmar's Clifton Heights work was primarily single-family dwellings.

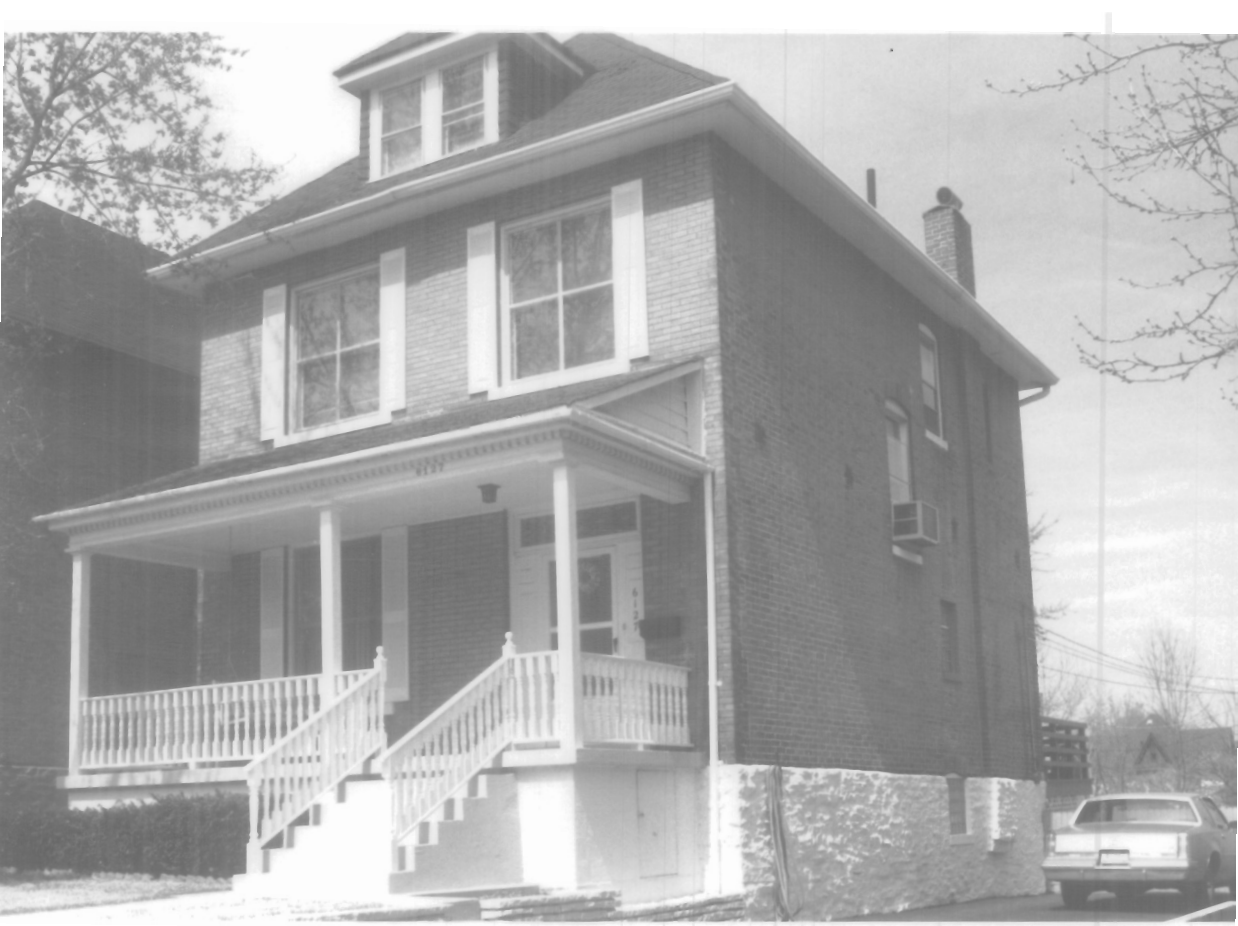
1. No. 210	3. Location of Negatives: Missouri Office of Historic Preservation, P. O. Box 176, Jefferson City, MO 65102		
2. City/County: City of St. Louis, MO	4. Prepared by: Cynthia Hill Longwisch, Landmarks Assn. of St. Louis, 917 Locust, 7th Floor, St. Louis, MO 63101

24. Foundation material: stone		25. Roof type/material: hipped	
26. No. Bays: Front 2 Side 2		27. Wall treatment: buff & red brick	
28. Plan shape: see site map		29. Changes: Addition? Altered?

30. Exterior condition: good		31. Open to public? no	
32. Other Surveys in which included: Heritage/St. Louis survey, 1971			
33. Further description of important features: The facade of this foursquare house is buff/brown brick while the body of the house is red brick. Front windows have flat arches; sides are segmental. Full-width front porch has shed roof, supported by thin square posts; its cornice is dentilled and the balustrade is of turned spindles (replacements?). Transomed door has paneling at sides. Stone sills. Hipped-roof dormer. Almost identical to survey #211.

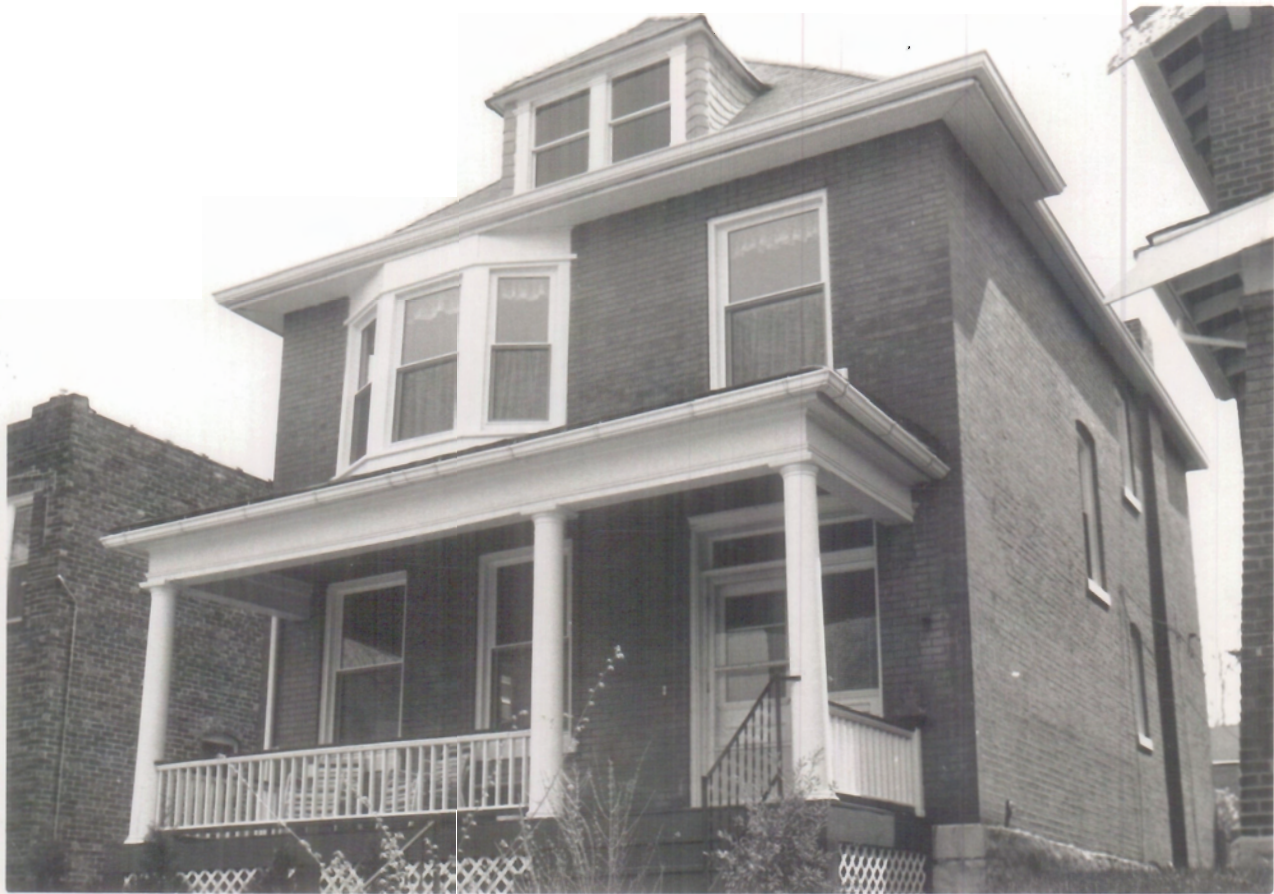
1. No. 097	3. Location of Negatives: Missouri Office of Historic Preservation, P. O. Box 176, Jefferson City, MO 65102		
2. City/County: City of St. Louis, MO	4. Prepared by: Cynthia Hill Longwisch, Landmarks Assn. of St. Louis, 917 Locust, 7th Floor, St. Louis, MO 63101

21. No. of stories: 2	22. Basement? yes	23. Wall construction: masonry	
24. Foundation material: stone		25. Roof type/material: hipped	
26. No. Bays: Front 3 Side 2		27. Wall treatment: red brick

33. Further description of important features: The roof of this house has an extra-wide overhang across the front, returning at the sides. A hipped-roof dormer dominates above. The nearly full-width porch has 3 round wood columns and a plain wood balustrade. Windows are all 1-over-1 double-hung sash, including those of the second-story bay window above the porch. Side windows have double-rowlock segmental arches. Stone foundation is stuccoed. Transomed door.

34. History and Significance: J. B. Buss hired architect Ross C. H. Hallock to design this house in 1906. Buss is possibly John B. Buss, president of Reliance Pneumatic Tool Co., although he is not listed as having lived here. Hallock lived at 6317 Clifton Ave. and worked at 2715 Clifton. He is listed as an architect, although nothing more could be found on him. George Busen & Son were contractors located at 6934 Eyler Avenue. The permit lists the house at

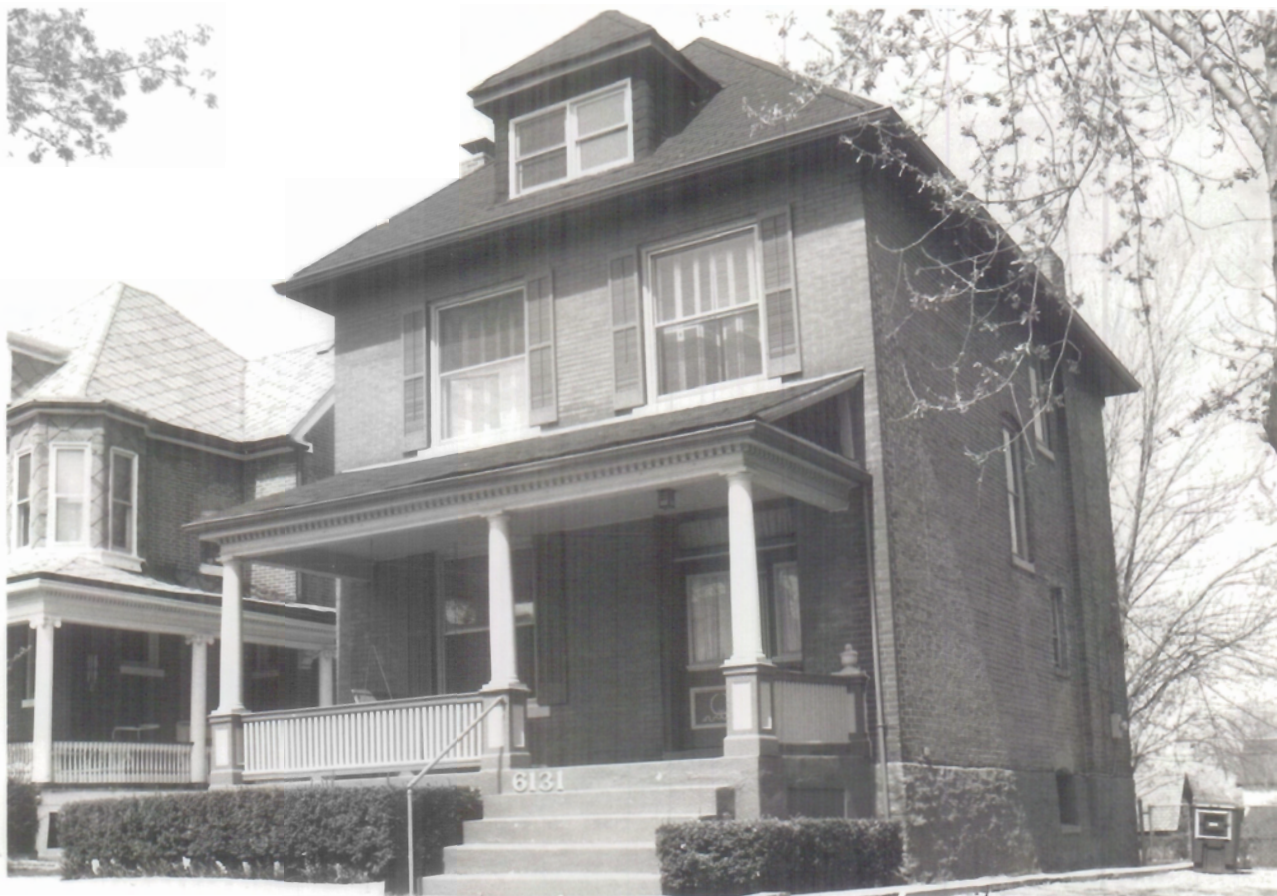
1. No. 211	3. Location of Negatives: Missouri Office of Historic Preservation, P. O. Box 176, Jefferson City, MO 65102		
2. City/County: City of St. Louis, MO	4. Prepared by: Cynthia Hill Longwisch, Landmarks Assn. of St. Louis, 917 Locust, 7th Floor, St. Louis, MO 63101

24. Foundation material: stone		25. Roof type/material: hipped	
26. No. Bays: Front 2 Side 2		27. Wall treatment: red brick	
28. Plan shape: see site map		29. Changes: Addition? Altered? yes

30. Exterior condition: good		31. Open to public? no	
32. Other Surveys in which included: Heritage/St. Louis survey, 1971			
33. Further description of important features: The pyramidally hipped roof of this house has a hipped-roof dormer. Windows are all replacements. Porch has shed roof supported by round Doric columns; wood balustrade; dentilled cornice. Front door has garland carving, transom, sidelight at right. Facade is laid with red mortar, sides with regular mortar. Very similar in overall design to house next door, survey #210.

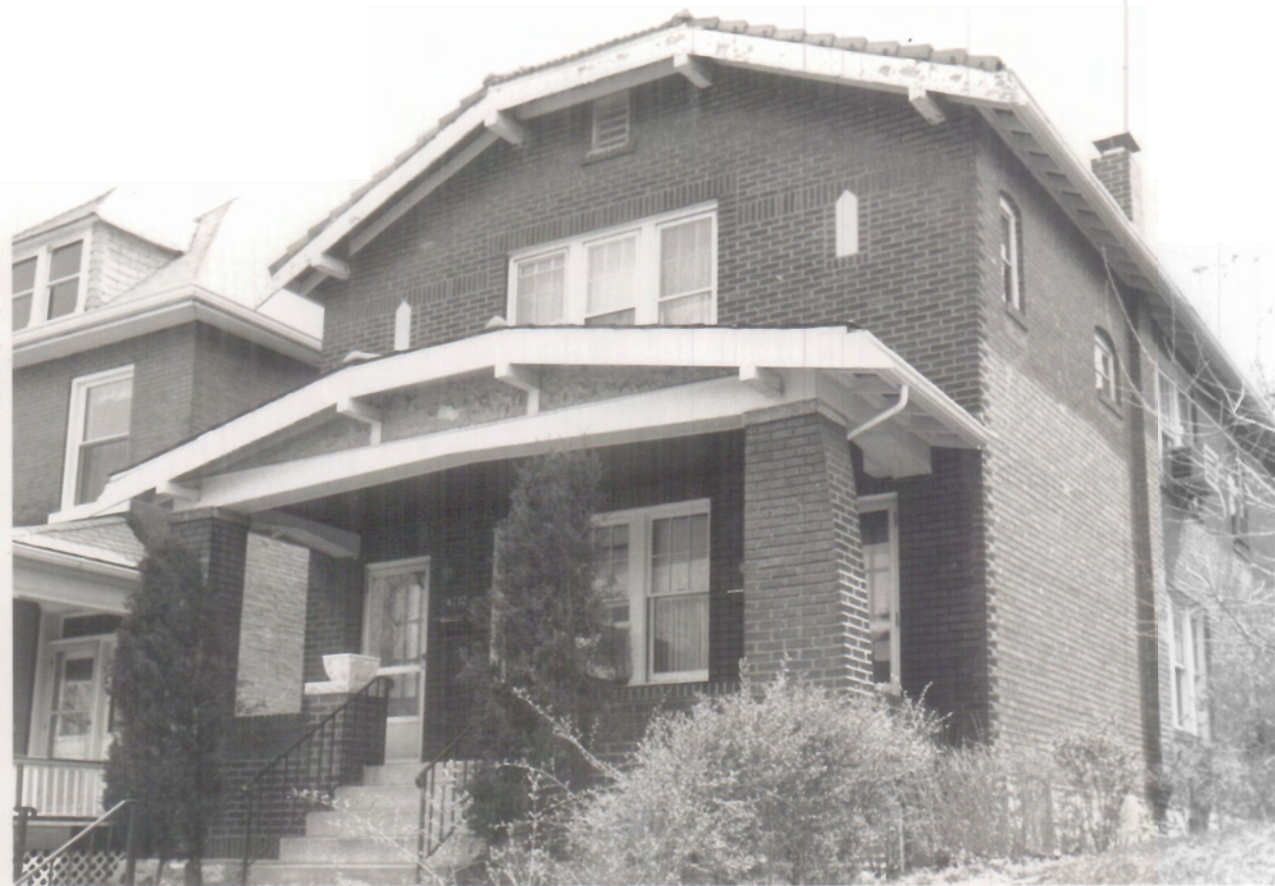
21. No. of stories: 2	22. Basement? yes	23. Wall construction: masonry	
24. Foundation material: stone		25. Roof type/material: hipped/tile	
26. No. Bays: Front 3 Side 5		27. Wall treatment: textured red brick

33. Further description of important features: This house has a shallowly hip-ped red clay tile roof with exposed rafters and wood brackets. A heavy, bracketed porch roof has exposed rafters and is supported by large, tapered brick pillars. The body of the building is regular red brick while the porch and facade are textured. Front elevation windows are 6-over-1; those at the second story have a soldier lintel course that wraps around and (cont'd. below)

34. History and Significance: extends across the front, bisected by inset terra cotta lozenges. Two multipane doors flank the triple center windows. Side openings have double-rowlock segmental arches. Carpenter Fred A. Anderson is listed as the owner, architect and builder of this "tenement." The 20 x 46' building was to have hot air heat and cost \$6,000. Anderson lived at 5420 Nottingham and presumably built it as a rental property.

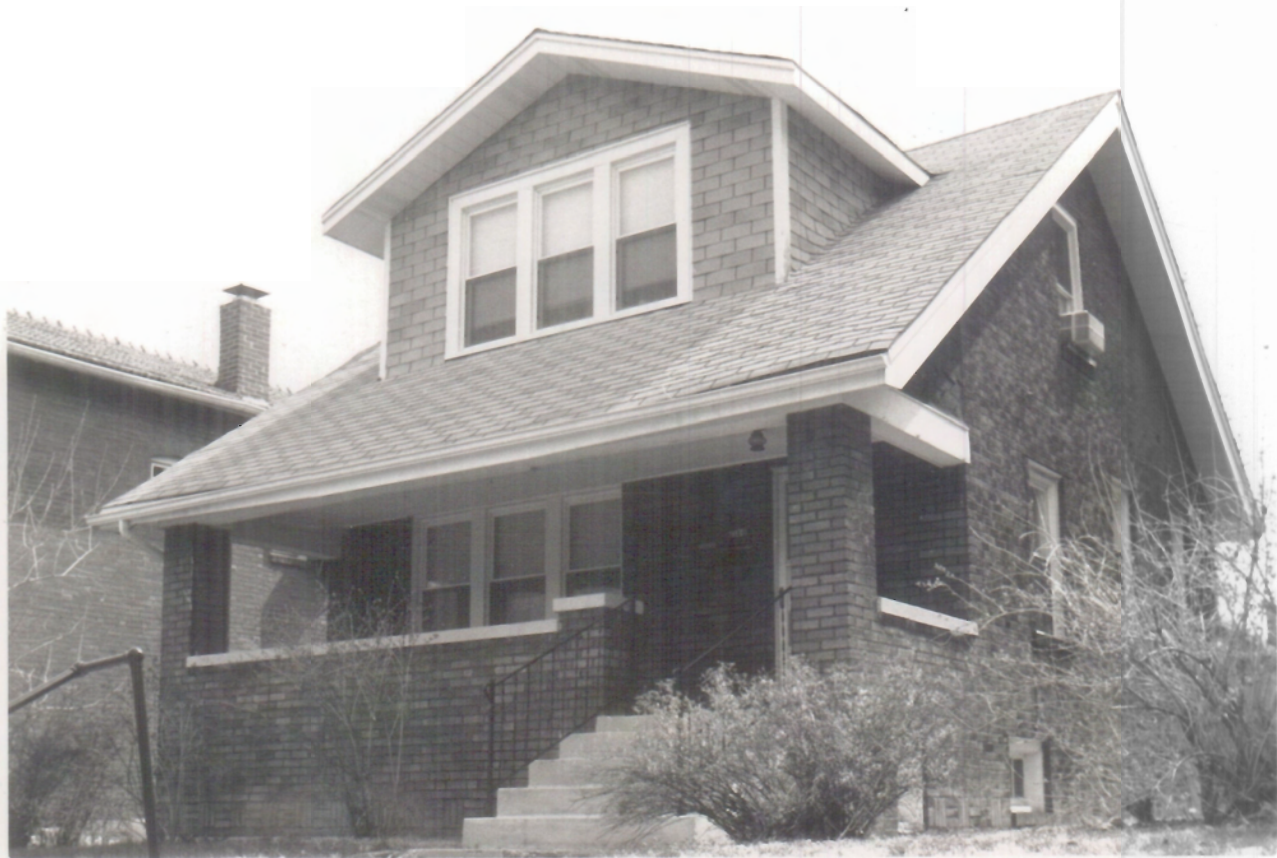
1. No. 099	3. Location of Negatives: Missouri Office of Historic Preservation, P. O. Box 176, Jefferson City, MO 65102		
2. City/County: City of St. Louis, MO	4. Prepared by: Cynthia Hill Longwisch, Landmarks Assn. of St. Louis, 917 Locust, 7th Floor, St. Louis, MO 63101

24. Foundation material: stone		25. Roof type/material: side gable	
26. No. Bays: Front 2 Side 3		27. Wall treatment: red brick	
28. Plan shape: see site map		29. Changes: Addition? Altered?

30. Exterior condition: good		31. Open to public? no	
32. Other Surveys in which included: Heritage/St. Louis survey, 1971			
33. Further description of important features: The gabled dormer of this house has triple 1-over-1 windows and is covered with brick-look asphalt siding. The roof of the house extends to become the roof of the full-width porch, supported by straight brick pillars. The brick short side walls of the porch have a course of basketweave patterning near the bottom and are topped with a stone rail. Triple windows are 1-over-1, presumably replacements. (cont'd. below)

34. History and Significance: Side openings have flat arches. Edward F. Wenneker, a salesman with the A. R. Schollmeyer Real Estate Co., took out the permit for this house and the one next door (survey #100) in 1923. He lived at 6221 Simpson. Frederick Street was a carpenter living at 6040 Arthur; no builder/contractor/architect named Pope is listed in directories, and although several are named as carpenters, none are shown as associates of Street. The two 24 x 26' houses cost \$4,000 apiece and had furnace heat.

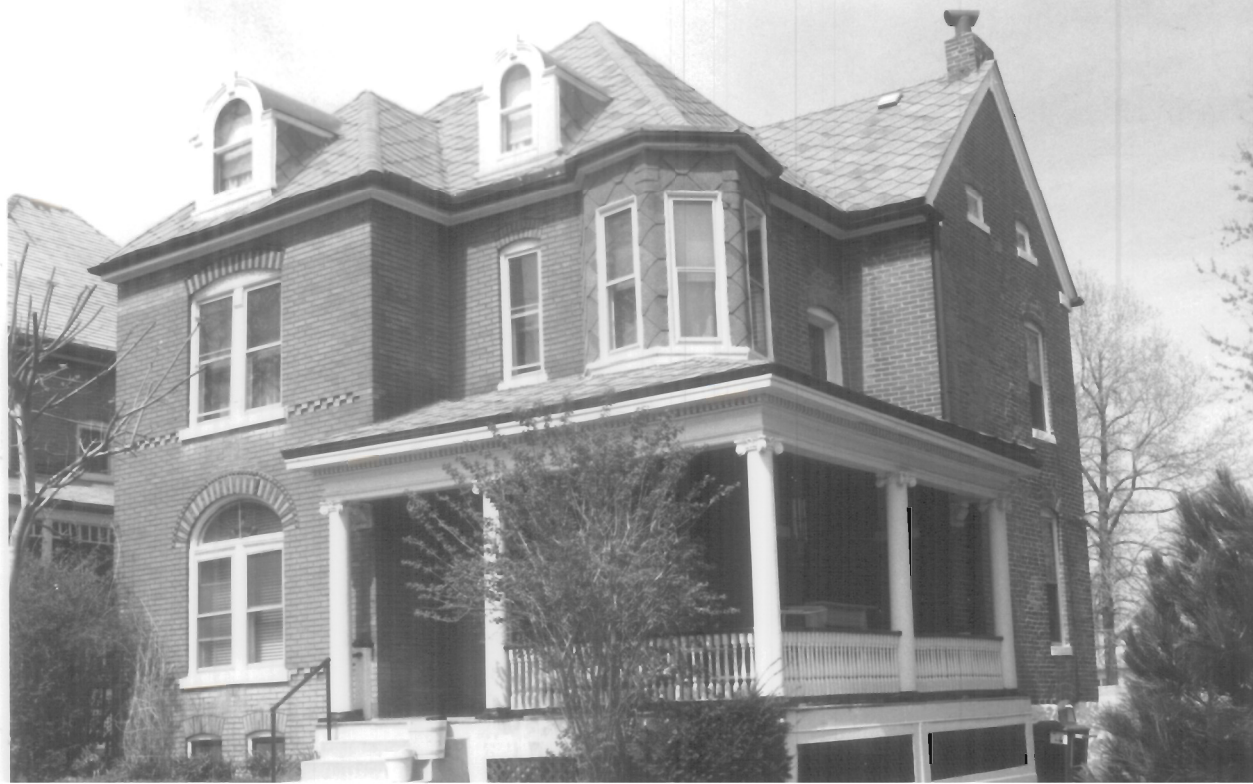
1. No. 212	3. Location of Negatives: Missouri Office of Historic Preservation, P. O. Box 176, Jefferson City, MO 65102		
2. City/County: City of St. Louis, MO	4. Prepared by: Cynthia Hill Longwisch, Landmarks Assn. of St. Louis, 917 Locust, 7th Floor, St. Louis, MO 63101

24. Foundation material: stone		25. Roof type/material: complex	
26. No. Bays: Front 3 Side 3		27. Wall treatment: red brick	
28. Plan shape: see site map		29. Changes: Addition? Altered?

30. Exterior condition: good		31. Open to public? no	
32. Other Surveys in which included: Heritage/St. Louis survey, 1971			
33. Further description of important features: The hipped and gabled roof of this house features undulating-patterned shingles. A corner porch has a dentilled cornice, turned wood Ionic columns and spindle balustrade; it is surmounted by a polygonal, flat-roofed "tower," covered with patterned shingles. Front facade windows have gauged-brick hoods with pressed-brick dogtooth molding above: segmental arch at 2nd story, round arch below. (cont'd. below)

34. History and Significance: Band of notched checkerboard brickwork at 2nd story sill. Side windows have double rowlock segmental soldier arches; all windows are 1-over-1 with stone sills. Round-arched dormers at attic. House is quite similar to its neighbor, survey #213; no building permit was found.

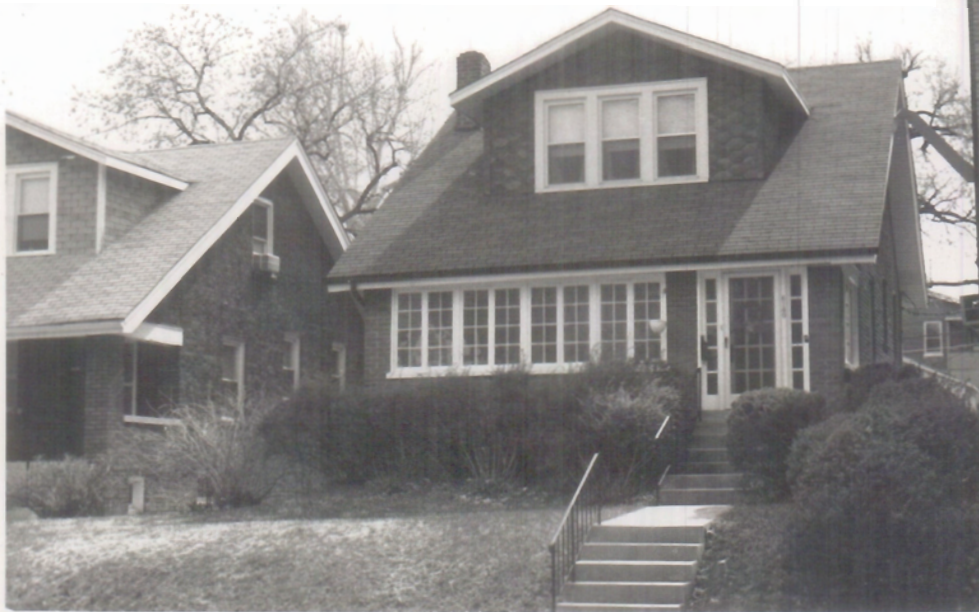
1. No. 100	3. Location of Negatives: Missouri Office of Historic Preservation, P. O. Box 176, Jefferson City, MO 65102		
2. City/County: City of St. Louis, MO	4. Prepared by: Cynthia Hill Longwisch, Landmarks Assn. of St. Louis, 917 Locust, 7th Floor, St. Louis, MO 63101

24. Foundation material: obscured		25. Roof type/material: side gable	
26. No. Bays: Front 9 Side 3		27. Wall treatment: red brick	
28. Plan shape: see site map		29. Changes: Addition? Altered? yes

33. Further description of important features: The gabled frame dormer of this house is covered with undulating-patterned shingles; it has three 1-over-1 double-hung sash windows. The roof of the house extends to cover the full-width porch. The porch may have originally been open; it now has 8, 8-paned windows across the front elevation and a multipaned door with sidelights. Side windows are segmentally arched.

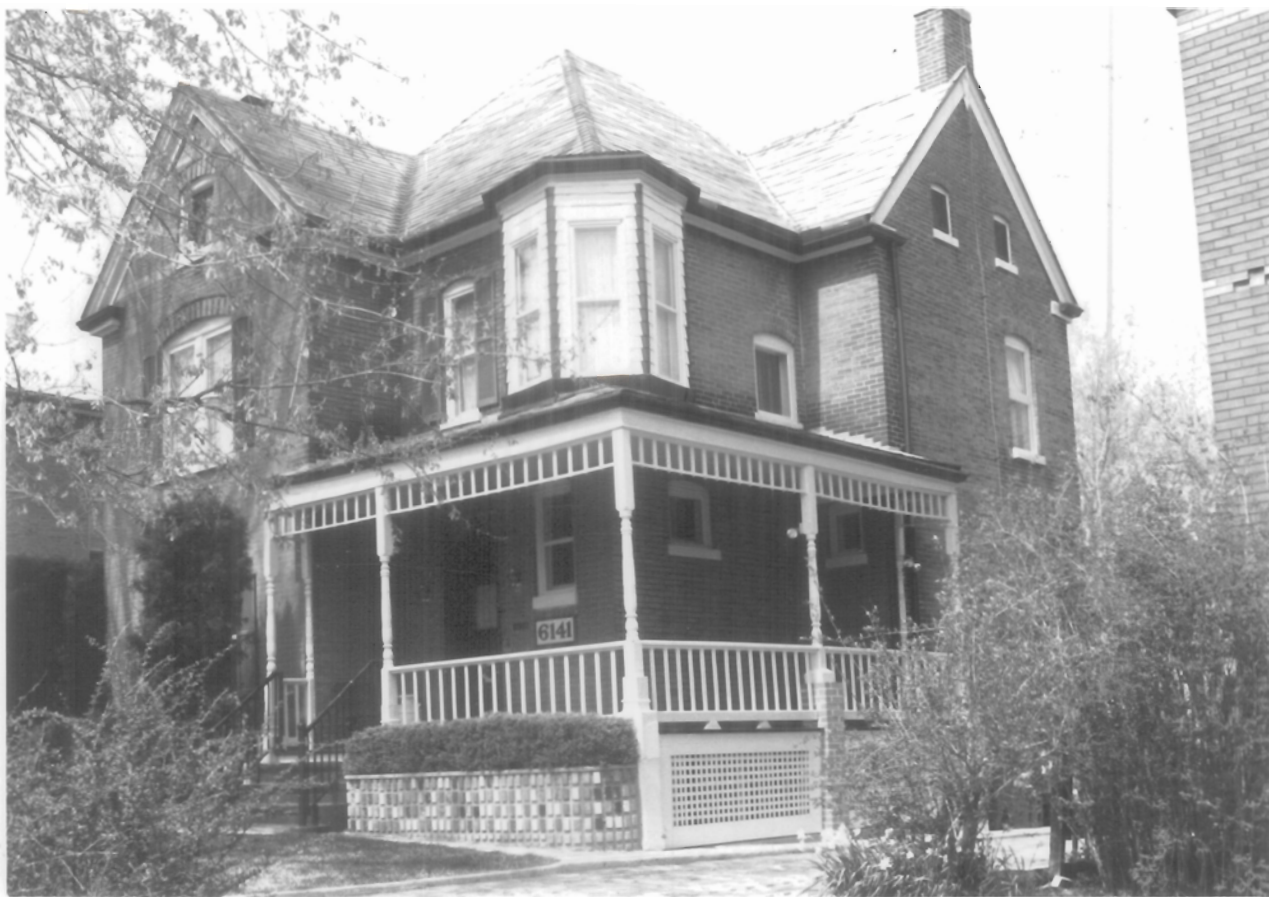
1. No. 213	3. Location of Negatives: Missouri Office of Historic Preservation, P. O. Box 176, Jefferson City, MO 65102		
2. City/County: City of St. Louis, MO	4. Prepared by: Cynthia Hill Longwisch, Landmarks Assn. of St. Louis, 917 Locust, 7th Floor, St. Louis, MO 63101

24. Foundation material: stone		25. Roof type/material: complex	
26. No. Bays: Front 3 Side 3		27. Wall treatment: brown brick	
28. Plan shape: see site map		29. Changes: Addition?	Altered? yes

33. Further description of important features: The hipped roof of this house is also gabled. A corner porch has spindle posts, a rectilinear fretwork cornice and a wood balustrade. Above, a flat-roofed polygonal "tower" is covered with clapboarding. Front elevation windows have gauged-brick arches with pressed-brick dogtooth molding above: segmental arch at 2nd story, round arch at 1st. The latter has a semicircular divided fanlight. (cont'd. below)

34. History and Significance: A stringcourse of buff brick is inset at the second-story sill line on the front elevation; the neighboring similar house (survey #212) has a notched band of brickwork there, and it is possible that this solid course replaces that type of design in this house. Side windows have double-rowlock segmental soldier arches; all have stone sills. A planter of (ceramic?) tile has been built in front of the porch. No building permit found
