# ARCHITECTURAL SURVEY OF CLIFTON HEIGHTS

JUNE 1991

ST. LOUIS, MISSOURI

LANDMARKS ASSOCIATION OF ST. LOUIS, INC.

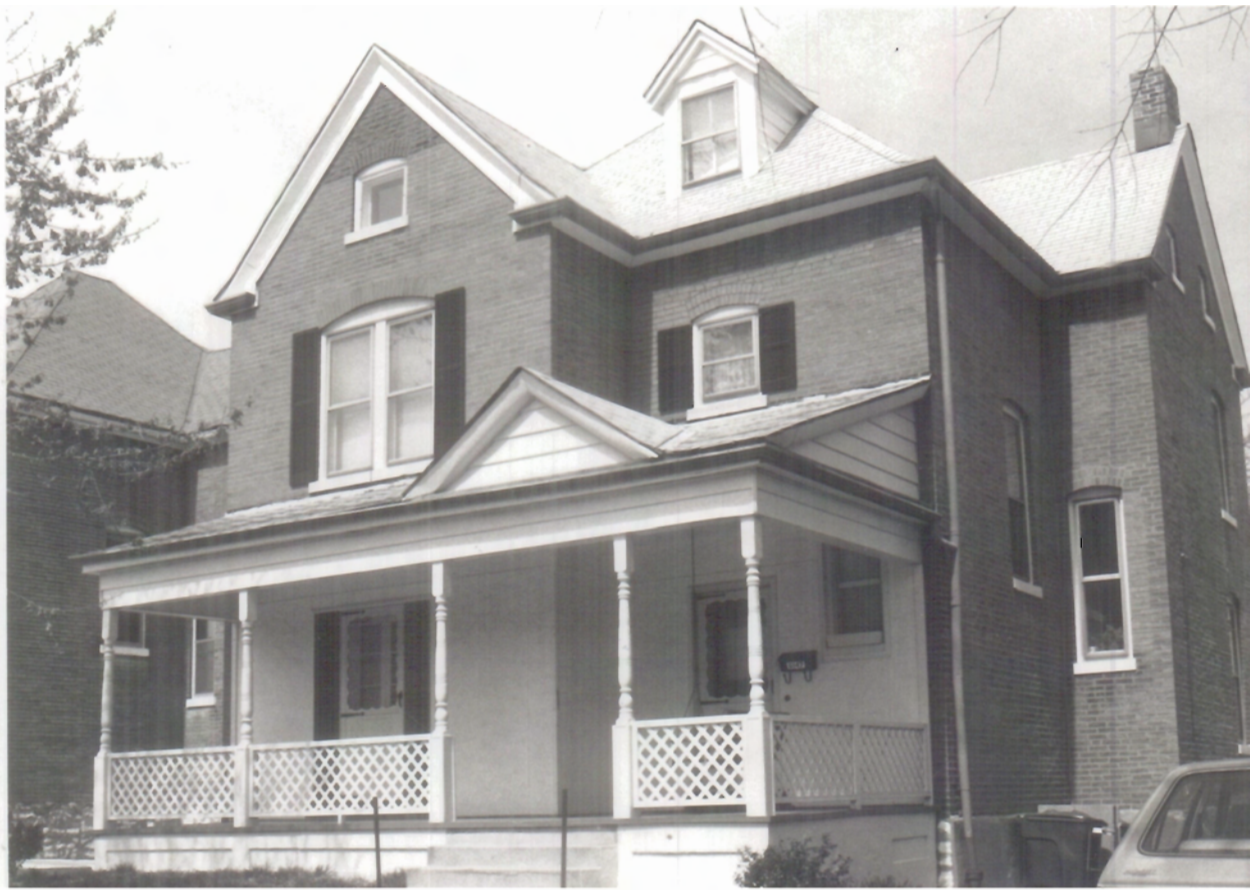
1. No. 214	3. Location of Negatives: Missouri Office of Historic Preservation, P. O. Box 176, Jefferson City, MO 65102		
2. City/County: City of St. Louis, MO	4. Prepared by: Cynthia Hill Longwisch, Landmarks Assn. of St. Louis, 917 Locust, 7th Floor, St. Louis, MO 63101

24. Foundation material: stone		25. Roof type/material: complex	
26. No. Bays: Front 2 Side 2		27. Wall treatment: brown brick	
28. Plan shape: see site map		29. Changes: Addition? Altered? yes

30. Exterior condition: good		31. Open to public? no	
32. Other Surveys in which included: Heritage/St. Louis survey, 1971			
33. Further description of important features: The roof of this house is both hipped and gabled, featuring a high-set gabled dormer. Side and upper windows are segmentally arched. A shed-roof porch has a small gable; turned spindles support it; sides are new latticework. House has been divided into multifamily, as evidenced by the two doors (see survey #215 for probable original configuration).

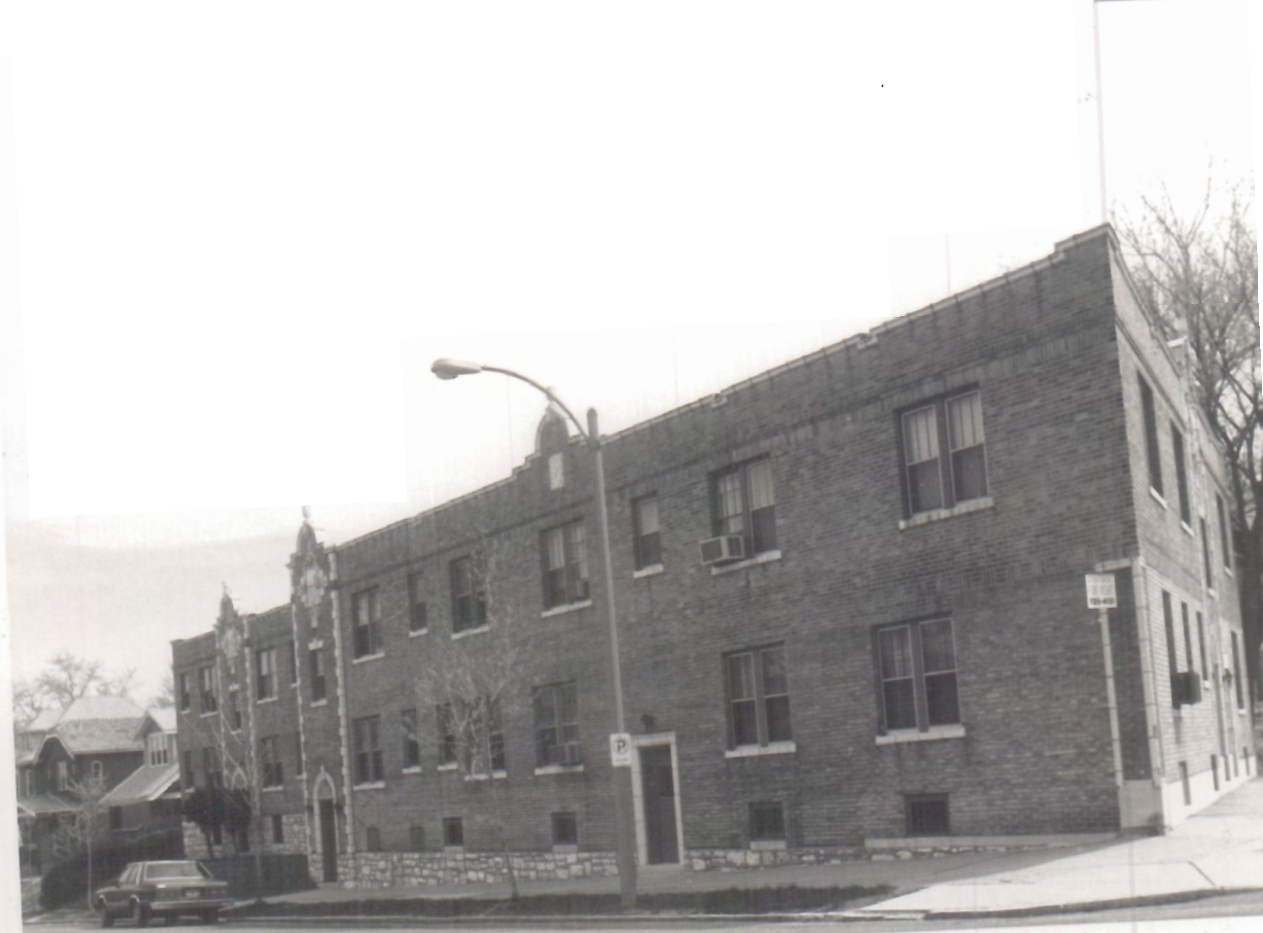
1. No. 101	3. Location of Negatives: Missouri Office of Historic Preservation, P. O. Box 176, Jefferson City, MO 65102		
2. City/County: City of St. Louis, MO	4. Prepared by: Cynthia Hill Longwisch, Landmarks Assn. of St. Louis, 917 Locust, 7th Floor, St. Louis, MO 63101

21. No. of stories: 2	22. Basement? yes	23. Wall construction: masonry	
24. Foundation material: stone		25. Roof type/material: flat	
26. No. Bays: Front 15 Side 6		27. Wall treatment: buff brick

34. History and Significance: crests highlight the parapets. The Clifton side of the building (photo, right) has been infilled at the first story. The permit specifies "tenements and stores;" it is evident that the commercial portion has been given over to apartment space.

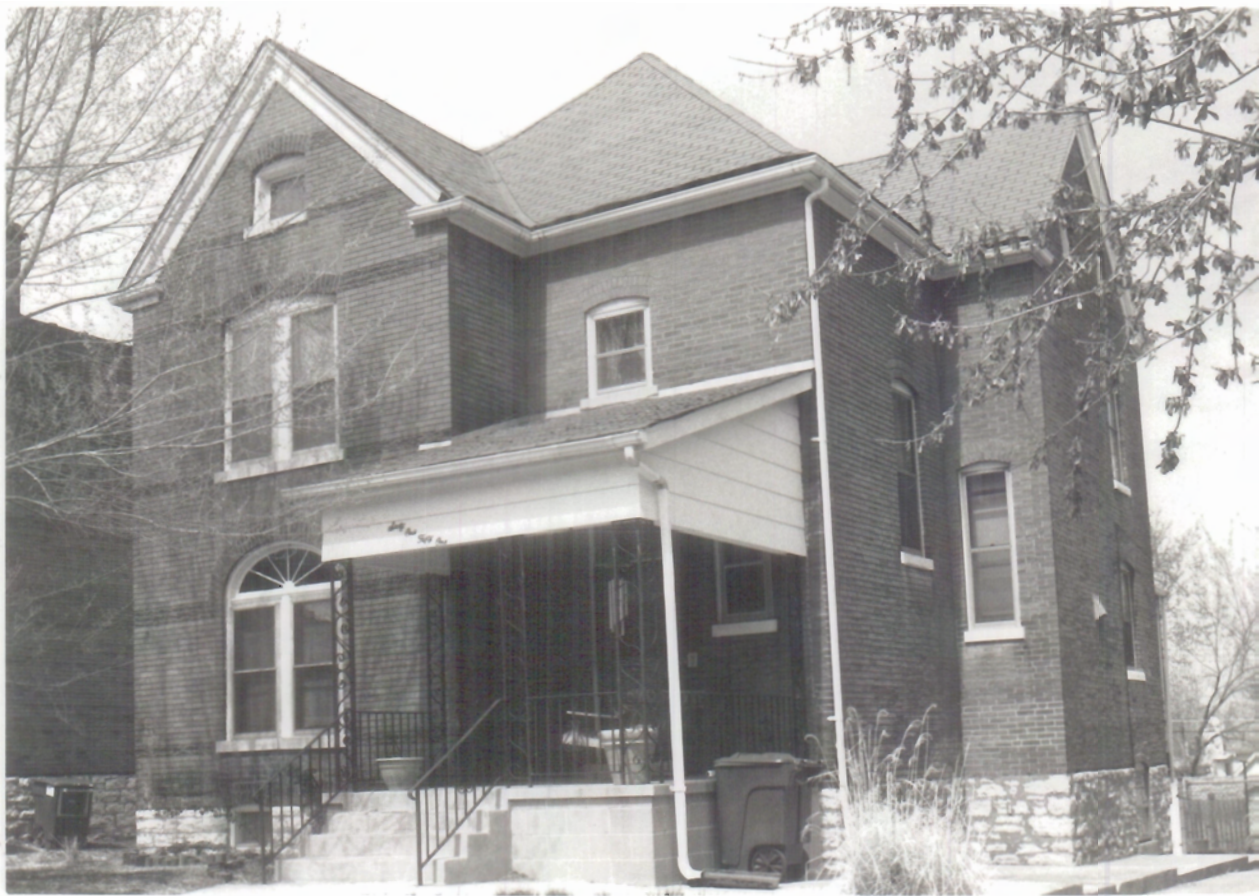
1. No. 215		3. Location of Negatives: Missouri Office of Historic Preservation, P. O. Box 176, Jefferson City, MO 65102	
2. City/County: City of St. Louis, MO		4. Prepared by: Cynthia Hill Longwisch, Landmarks Assn. of St. Louis, 917 Locust, 7th Floor, St. Louis, MO 63101

24. Foundation material: stone		25. Roof type/material: complex	
26. No. Bays: Front 3 Side 2		27. Wall treatment: red brick	
28. Plan shape: see site map		29. Changes: Addition? rear Altered? yes

30. Exterior condition: good		31. Open to public? no	
32. Other Surveys in which included: Heritage/St. Louis survey, 1971			
33. Further description of important features: This hipped-and-gabled-roof house is very similar to the house next door (survey #214). The builder chose to limit ornamentation to the projecting gabled bay at left; it features sill and lintel courses of what appears to be quarry-faced dark red brick (seems too close to standard brick size to be red stone). The gable and 2nd-story windows have segmental soldier arches and the 1st-story window (cont'd. below)

34. History and Significance: is round-arched with a divided semicircular fan-light. Windows are 1-over-1 and all have stone sills. Side windows segmentally arched. Shed-roofed porch is supported by iron posts; base is concrete block; the whole porch appears to be an alteration.

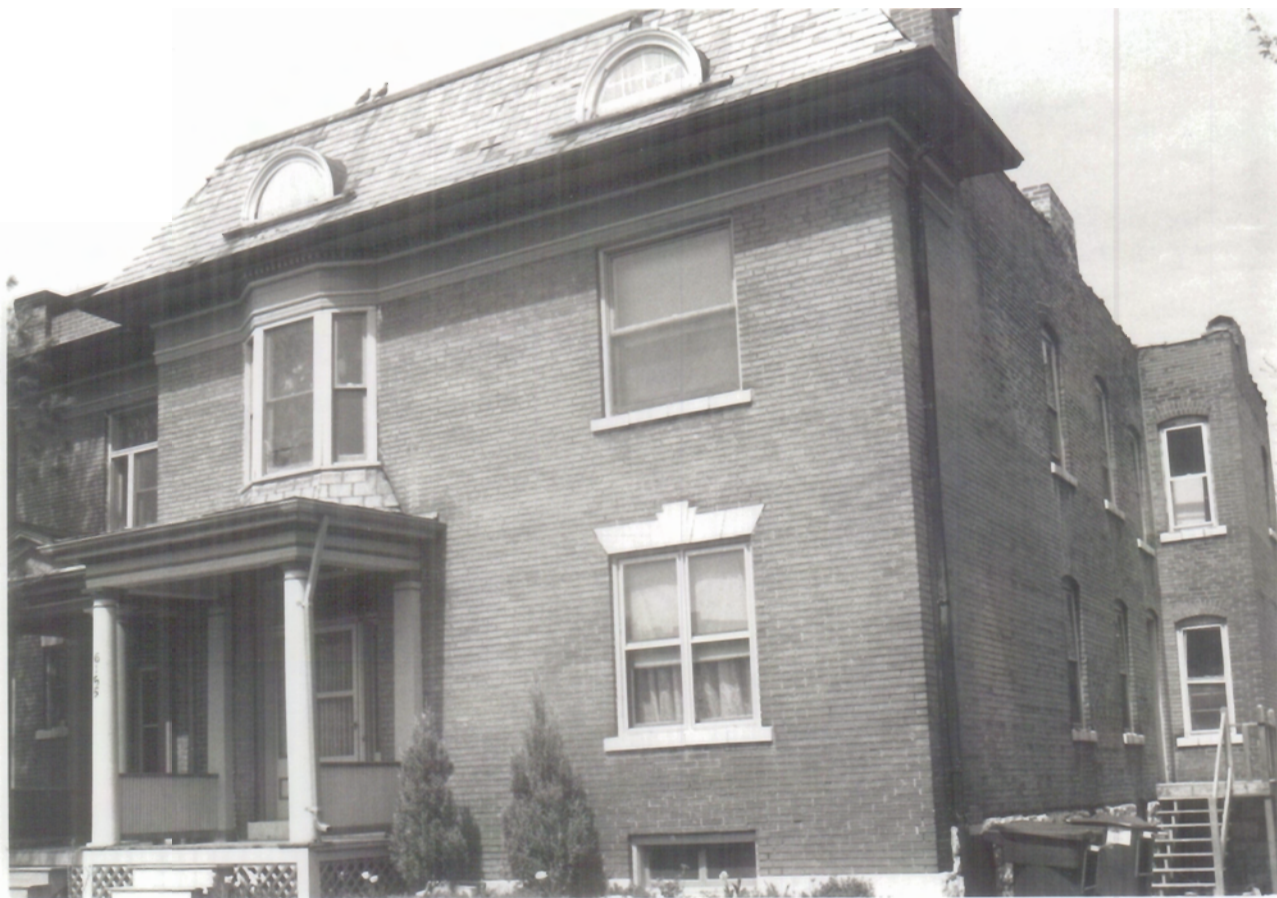
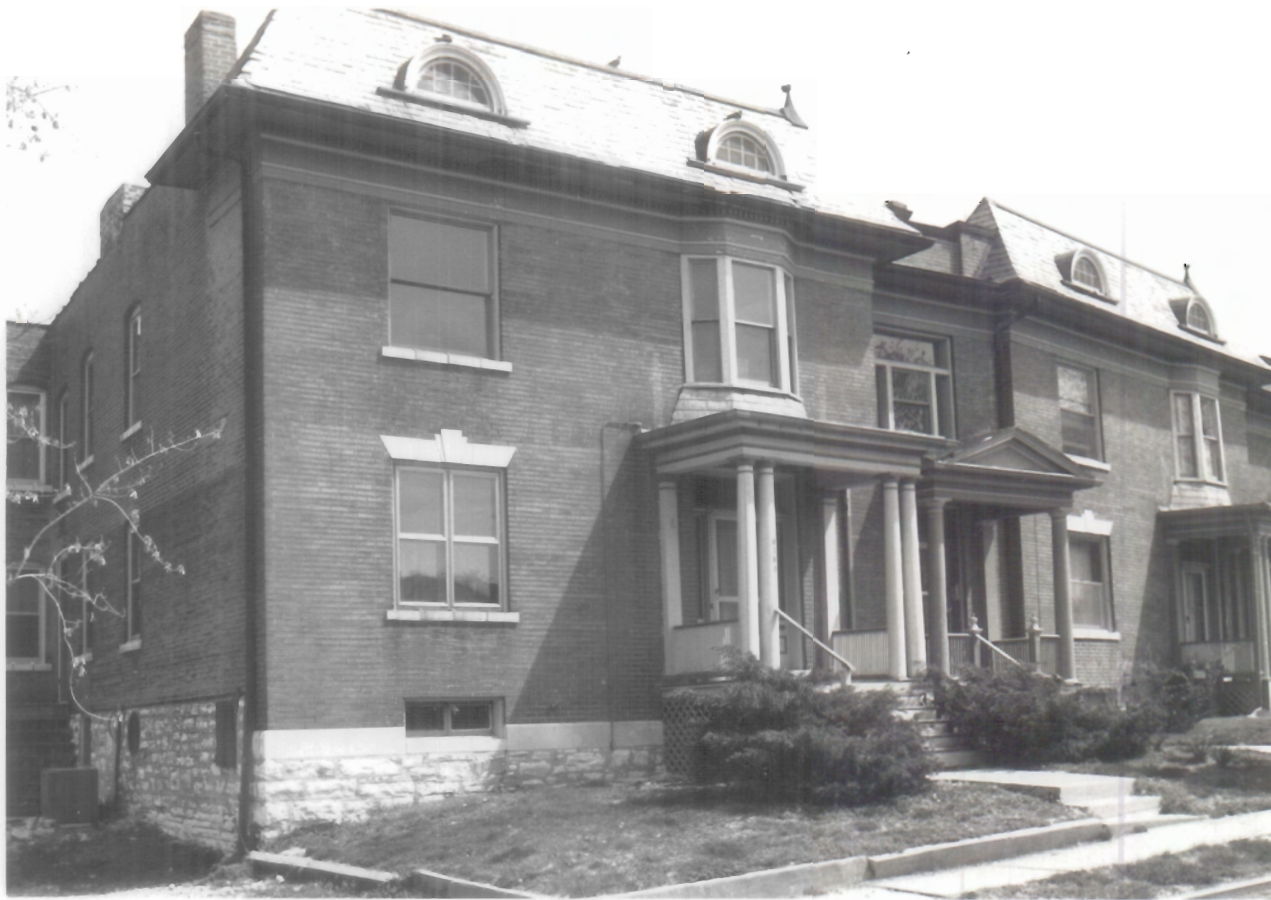
1. No. 216	3. Location of Negatives: Missouri Office of Historic Preservation, P. O. Box 176, Jefferson City, MO 65102		
2. City/County: City of St. Louis, MO	4. Prepared by: Cynthia Hill Longwisch, Landmarks Assn. of St. Louis, 917 Locust, 7th Floor, St. Louis, MO 63101

19. Original Use: residence		20. Present Use: residence	
21. No. of stories: 2	22. Basement? yes	23. Wall construction: masonry	
24. Foundation material: stone		25. Roof type/material: flat*/slate

32. Other Surveys in which included: Heritage/St. Louis survey, 1971			
33. Further description of important features: This is a group of three attached multifamily flats all built at the same time in the same style. *The flat roofs have hipped, slate false fronts somewhat in the Second Empire style; they have round-arched multipane dormers; some finials remain. Lower story front windows have terra cotta jack arches; those above have flat arches; terra cotta sills. Facade line varies; some project more than others. (cont'd. below)

4. History and Significance: Small porches supported by single or paired turned wood Doric columns; porches alternate gabled and flat roofs. Above, those with flat roofs have bay windows with slate bases. Dentilled wood cornice. Heritage/St. Louis was able to locate a building permit for this complex: J. H. Higginbotham (res. 6158 Simpson), owner, hired local architect/builder W. T. Clymer to build these flats for \$15,000 in 1906. Higginbotham was a local big-

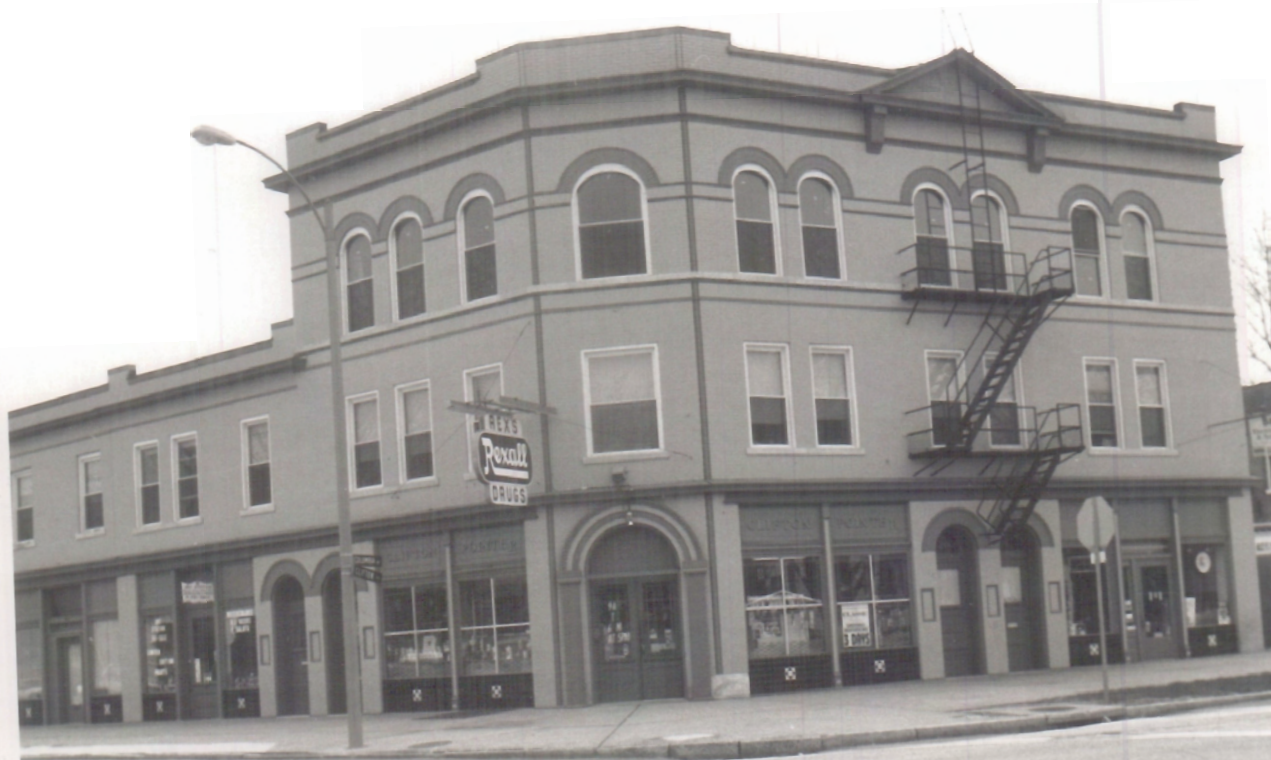
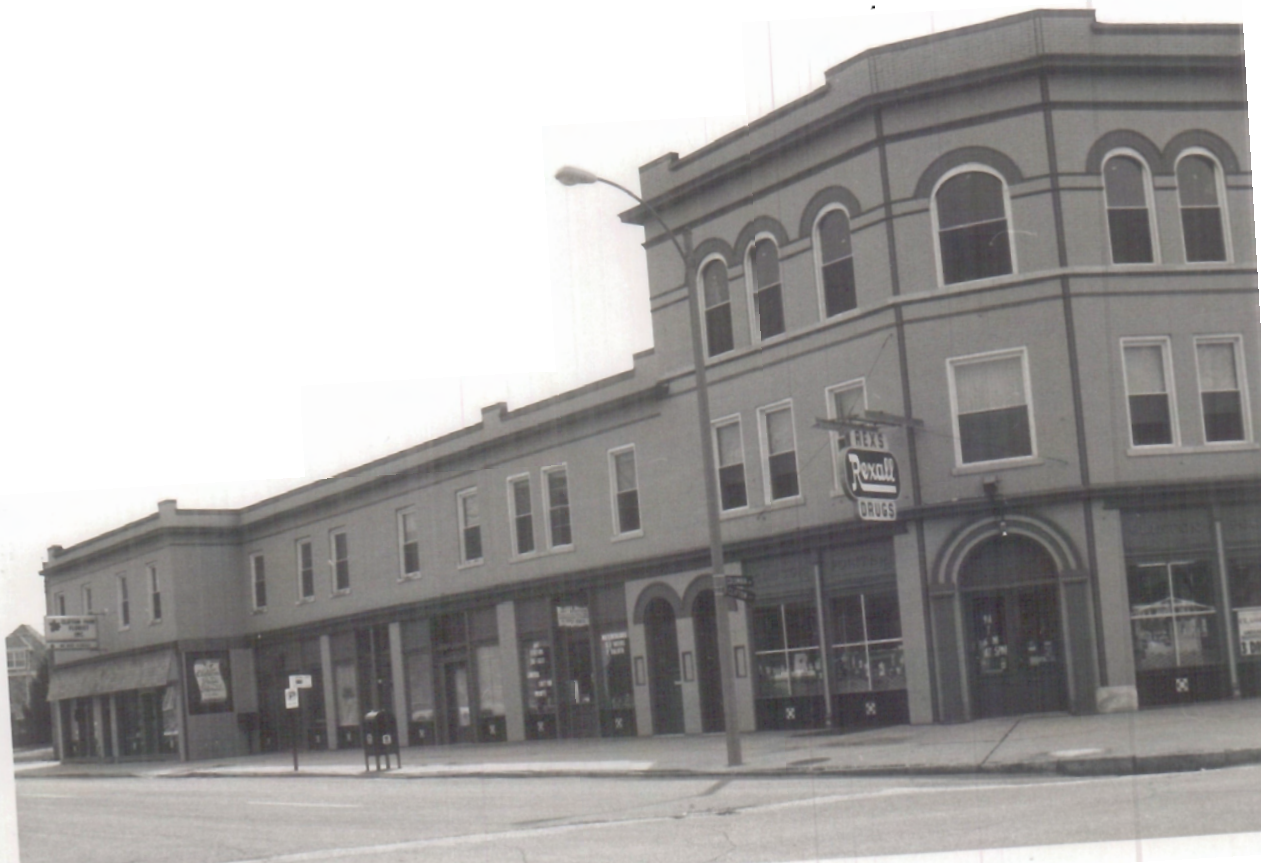
1. No. 102	3. Location of Negatives: Missouri Office of Historic Preservation, P. O. Box 176, Jefferson City, MO 65102		
2. City/County: City of St. Louis, MO	4. Prepared by: Cynthia Hill Longwisch, Landmarks Assn. of St. Louis, 917 Locust, 7th Floor, St. Louis, MO 63101

19. Original Use: commer./resid.		20. Present Use: commercial	
21. No. of stories: 2 & 3	22. Basement? yes	23. Wall construction: masonry	
24. Foundation material: stone		25. Roof type/material: flat

32. Other Surveys in which included: Heritage/St. Louis survey, 1971			
33. Further description of important features: The 3-story corner section of this building has an angled entrance with a pressed brick round arch. Columnar pressed brick is inset at the corners to make the transition to flat brick. Metal cornices are located above the first and third stories. Third-story windows are round-arched and connected by raised string courses and a stone sill course. Second-story windows are flat-arched. At the ground floor, (cont'd. below)

34. History and Significance: display windows have tile bases with inset checkerboard designs. Entrances to upper floors are paired with round pressed-brick arches. Small bracketed gable set at third story roofline facing Columbia. Cornerstone dated Oct. 3, 1903: Clifton Heights Lodge; no architect. This building was built in several stages, according to the permits, beginning in 1903 with a 3-story "stores, hall & flats" for \$12,000 built by Ross C. Hallock

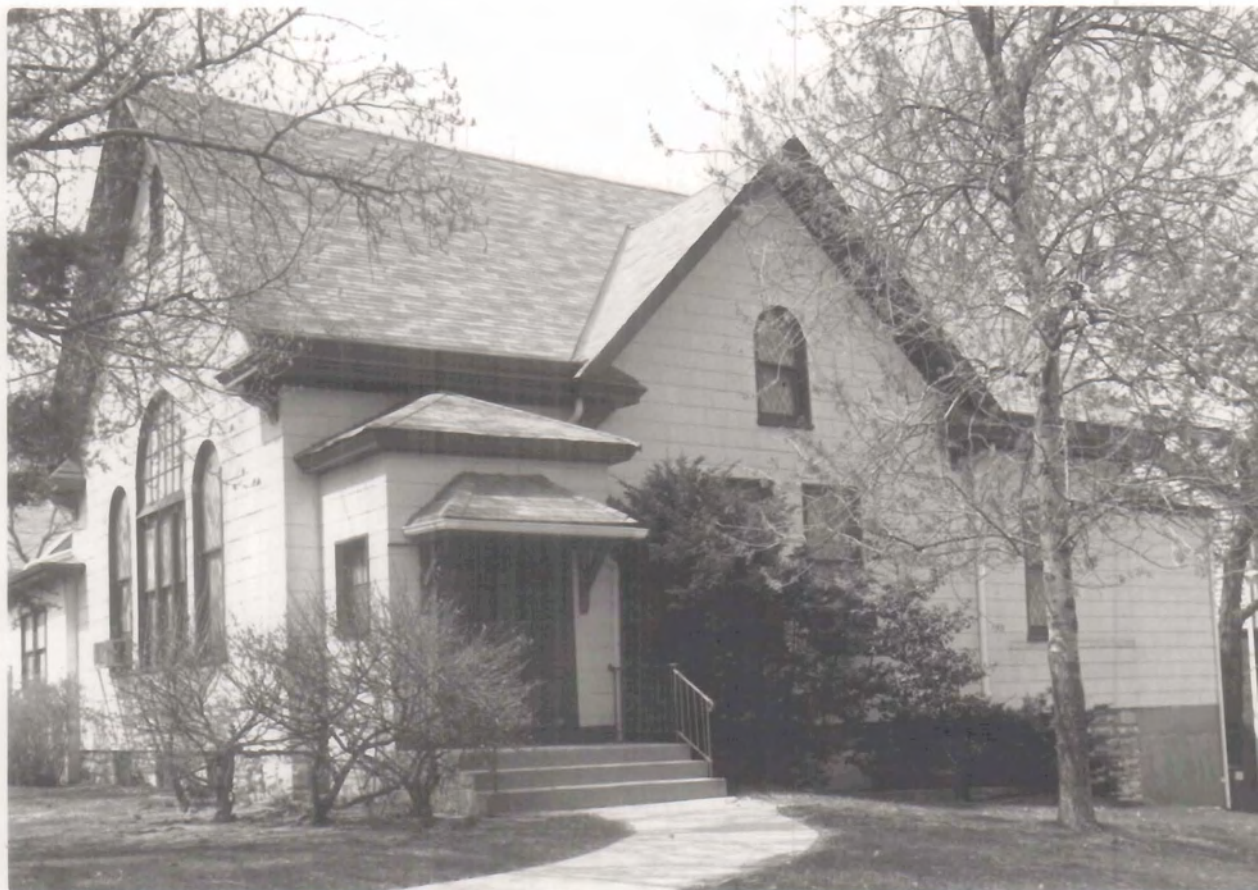
1. No. 121	3. Location of Negatives: Missouri Office of Historic Preservation, P. O. Box 176, Jefferson City, MO 65102		
2. City/County: City of St. Louis, MO	4. Prepared by: Cynthia Hill Longwisch, Landmarks Assn. of St. Louis, 917 Locust, 7th Floor, St. Louis, MO 63101

21. No. of stories: 2	22. Basement? yes	23. Wall construction: frame	
24. Foundation material: stone		25. Roof type/material: gabled	
26. No. Bays: Front	Side	27. Wall treatment: asbestos siding

33. Further description of important features: A large, round-arched stained glass window on the Columbia Ave. (front) elevation is divided into multiple small panes above. It is flanked by two smaller round-arched stained glass windows. Gables have smaller round-arched windows. Entryway has a hipped roof and projects from the building; a bracketed hood shelters the door. A rear addition has a concrete foundation.

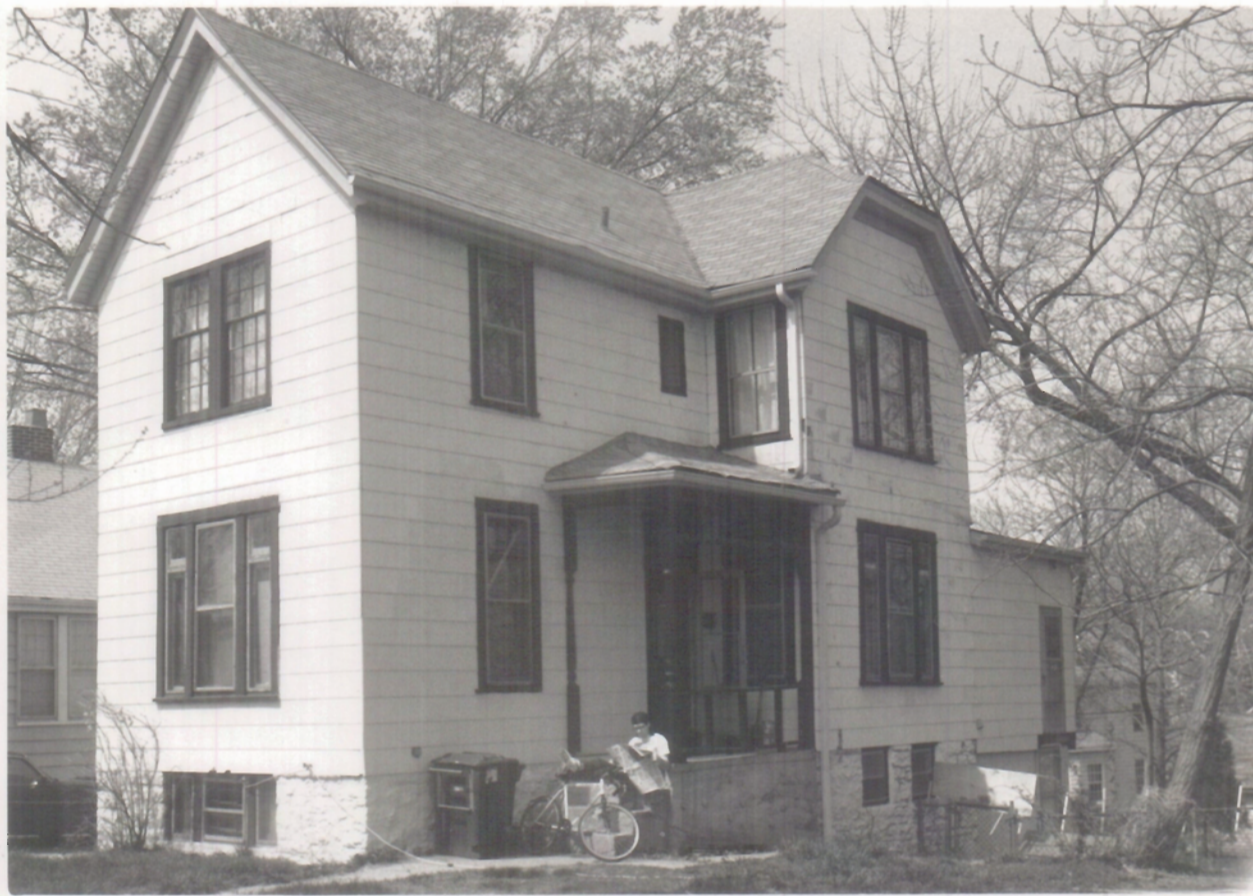
24. Foundation material: stone		25. Roof type/material: gabled/hipped	
26. No. Bays: Front 1 Side 4		27. Wall treatment: asbestos siding	
28. Plan shape: see site map		29. Changes: Addition? rear Altered?

30. Exterior condition: fair/good		31. Open to public? no	
32. Other Surveys in which included: Heritage/St. Louis survey, 1971			
33. Further description of important features: 6-over-9 double-hung sash windows in the front gable end; those below are tripartite 1-over-1. The side gable is hipped. A small porch is tucked into the corner formed by the ell; it has turned posts and no side walls. A rear, one-story frame addition is attached.

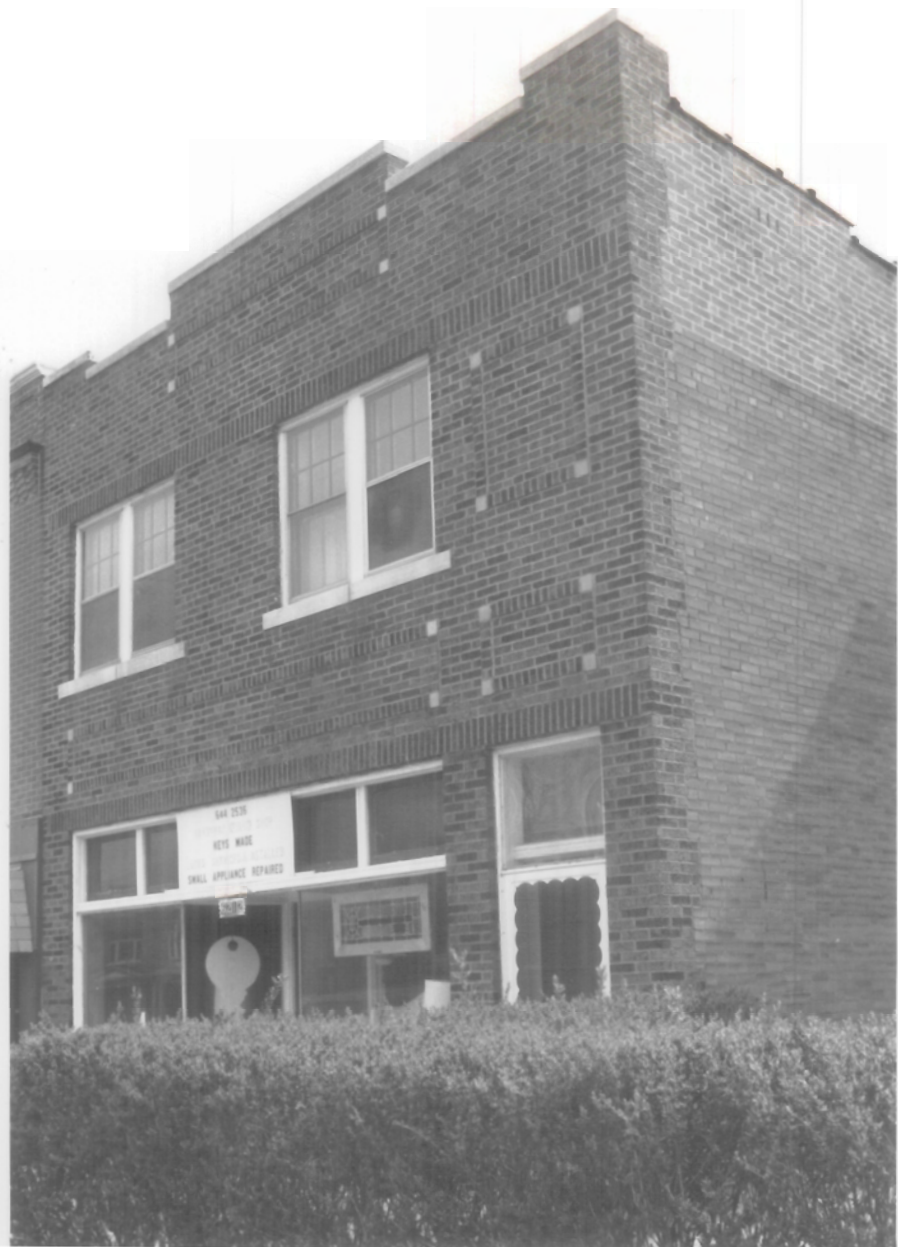
1. No. 104	3. Location of Negatives: Missouri Office of Historic Preservation, P. O. Box 176, Jefferson City, MO 65102		
2. City/County: City of St. Louis, MO	4. Prepared by: Cynthia Hill Longwisch, Landmarks Assn. of St. Louis, 917 Locust, 7th Floor, St. Louis, MO 63101

21. No. of stories: 2	22. Basement? yes	23. Wall construction: masonry	
24. Foundation material: concrete		25. Roof type/material: flat	
26. No. Bays: Front 2	Side blind	27. Wall treatment: red/multi brick

33. Further description of important features: The facade of this building is of red/brown multichrome brick, while the body of the building is red brick. The parapeted roofline has stone coping, and square stone insets highlight brick patterning on the facade above the first story. Two soldier lintel courses cross the facade, one at each story. Windows above are 6-over-1 double-hung sash. First-story display windows appear to be very little changed.

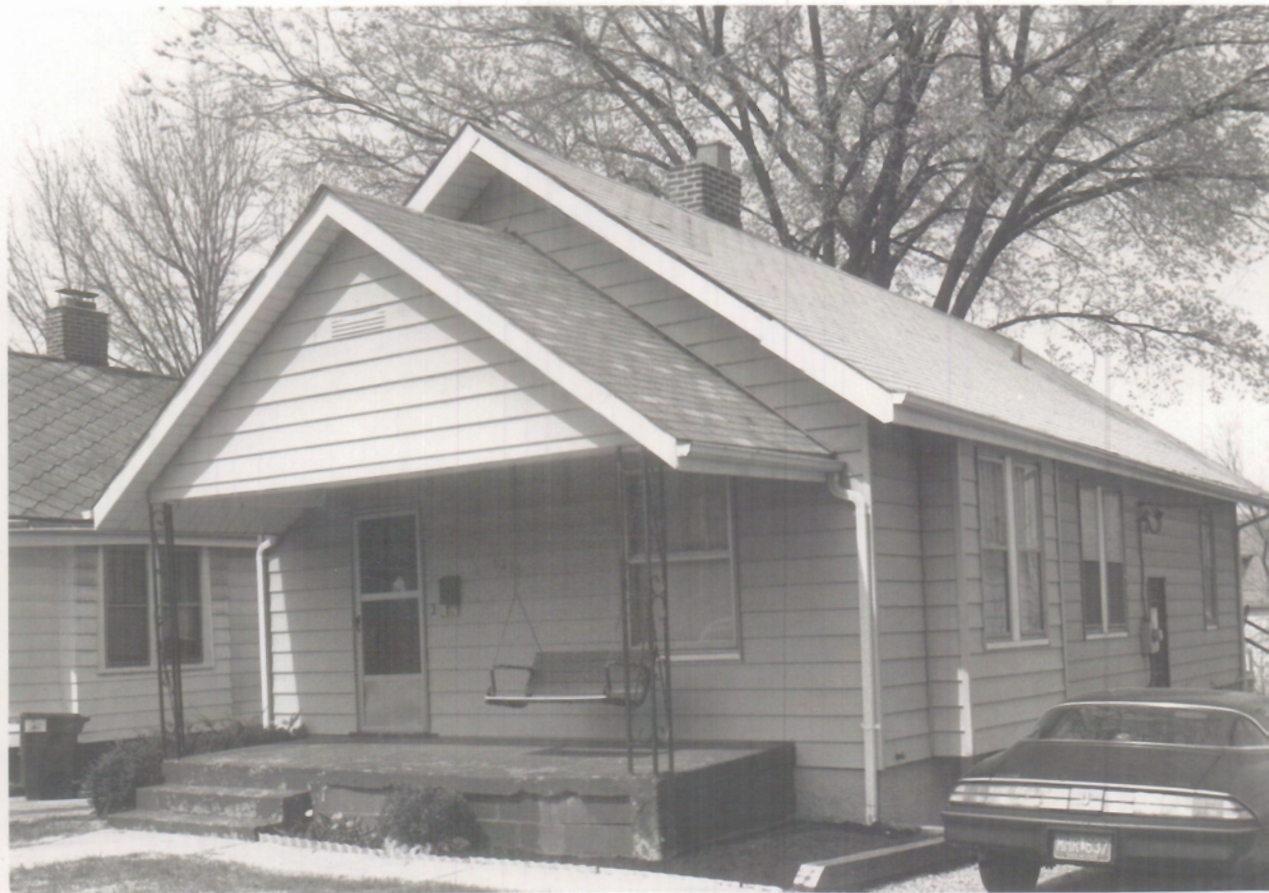
24. Foundation material: stuccoed		25. Roof type/material: front gable	
26. No. Bays: Front 2 Side 4		27. Wall treatment: vinyl siding	
28. Plan shape: see site map		29. Changes: Addition? Altered? yes

30. Exterior condition: good		31. Open to public? no	
32. Other Surveys in which included: Heritage/St. Louis survey, 1971			
33. Further description of important features: A gabled porch roof echoes the roofline at the front; it is supported by wrought-iron posts set into concrete poured over concrete blocks. The original porch supports were almost certainly more substantial. A two-window bay projects on the east side. This house is similar in design to others in the area being built during the mid- to late-1920s, although the design was usually executed in brick.

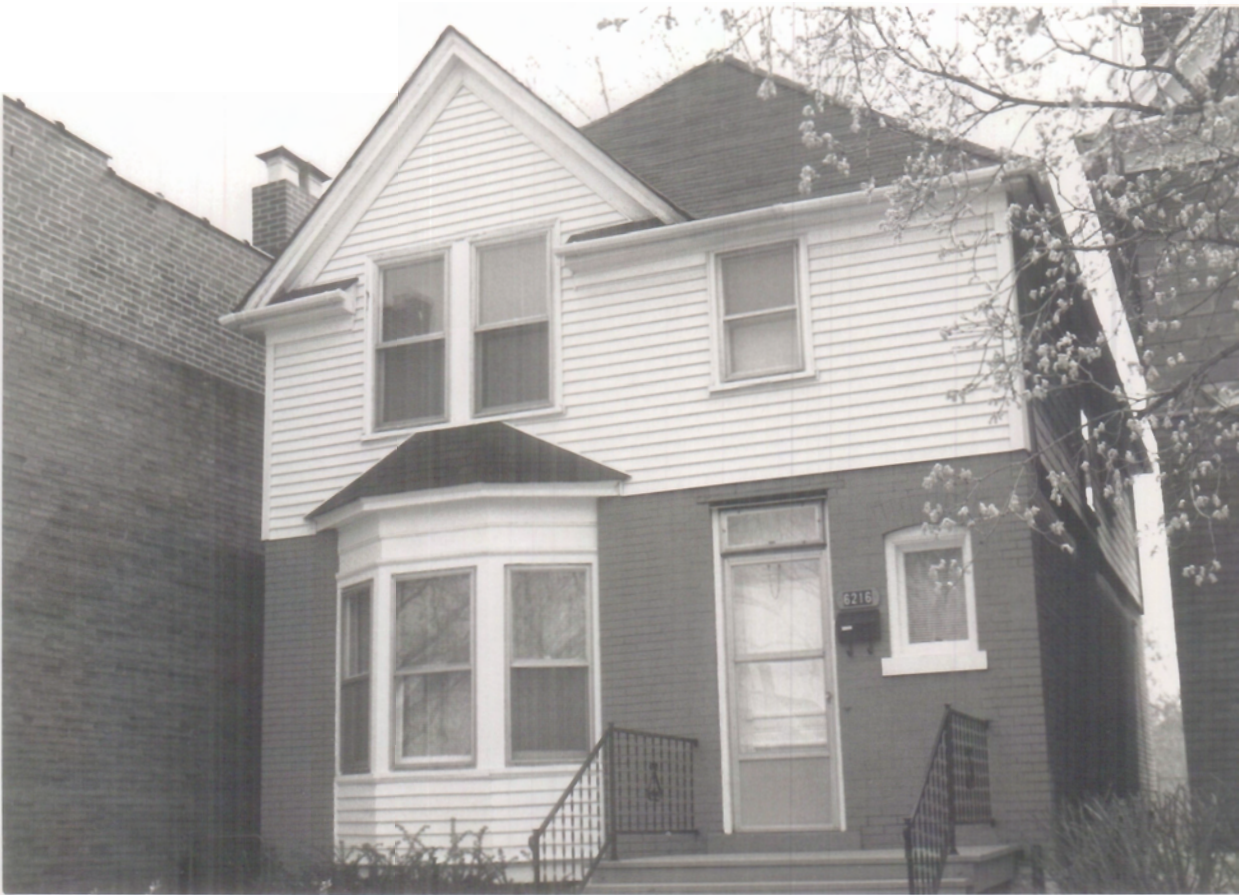
1. No. 105	3. Location of Negatives: Missouri Office of Historic Preservation, P. O. Box 176, Jefferson City, MO 65102		
2. City/County: City of St. Louis, MO	4. Prepared by: Cynthia Hill Longwisch, Landmarks Assn. of St. Louis, 917 Locust, 7th Floor, St. Louis, MO 63101

24. Foundation material: stone		25. Roof type/material: hipped	
26. No. Bays: Front 3 Side 1		27. Wall treatment: painted brick/frame	
28. Plan shape: see site map		29. Changes: Addition? Altered? yes

30. Exterior condition: good		31. Open to public? no	
32. Other Surveys in which included: Heritage/St. Louis survey, 1971

33. Further description of important features: A frame bay window projects from the first story of this house; above, a gable interrupts the roofline. The lower part of this house is brick while the upper is frame covered with siding. The doorway is transomed; beside it, a small, stone-silled window has a segmental arch. This house was a virtual twin to its neighbor, survey #106, before it was denuded of its porch.

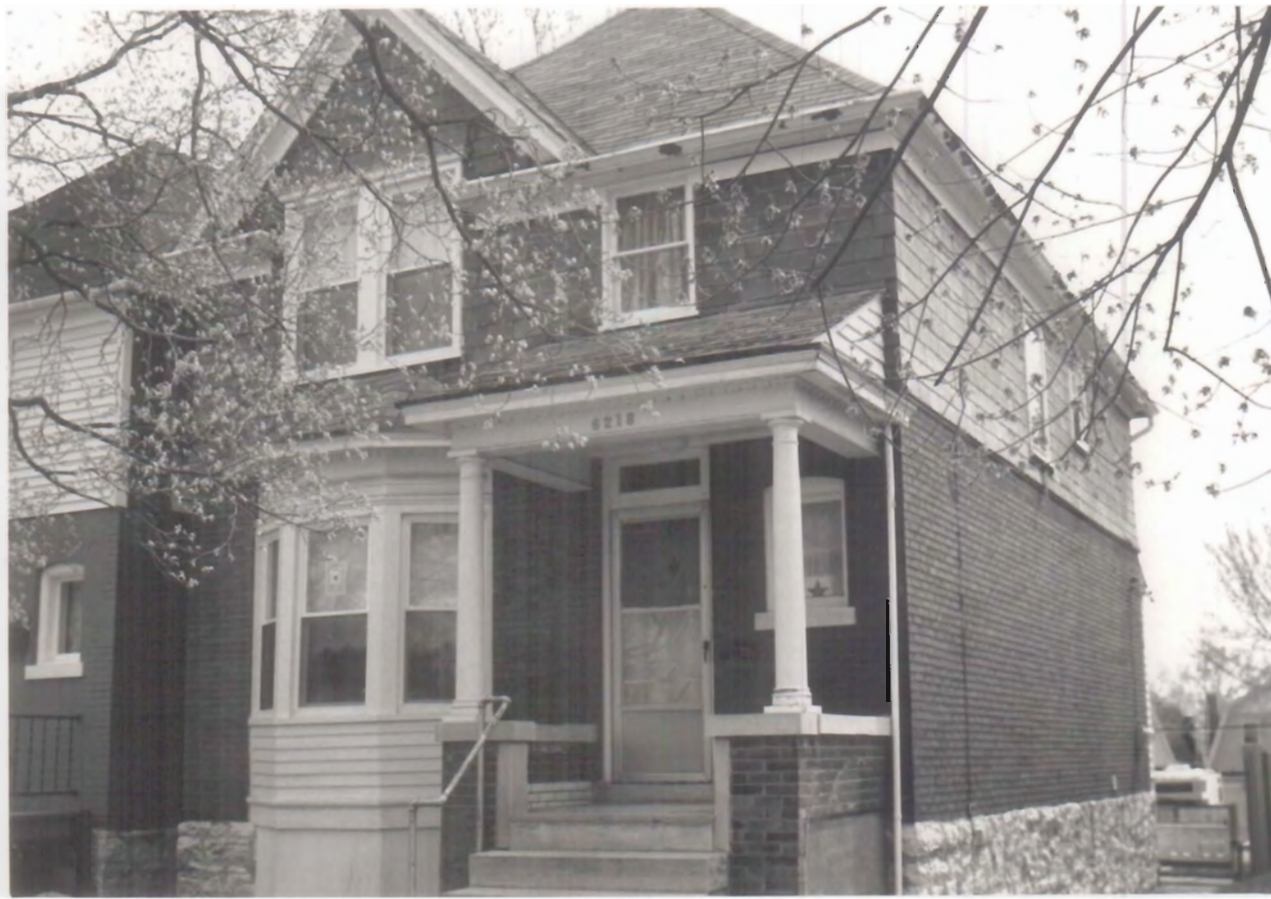
1. No. 106	3. Location of Negatives: Missouri Office of Historic Preservation, P. O. Box 176, Jefferson City, MO 65102		
2. City/County: City of St. Louis, MO	4. Prepared by: Cynthia Hill Longwisch, Landmarks Assn. of St. Louis, 917 Locust, 7th Floor, St. Louis, MO 63101

24. Foundation material: stone		25. Roof type/material: hipped	
26. No. Bays: Front 3	Side 2	27. Wall treatment: brick/frame	
28. Plan shape: see site map	29. Changes: Addition?		Altered?

30. Exterior condition: good		31. Open to public? no	
32. Other Surveys in which included: Heritage/St. Louis survey, 1971			
33. Further description of important features: This house is an unaltered version of survey #105 next door. Its hipped roof has a gable with paired 1-over-1 windows. Below, a projecting bay window features delicate dentilling. A porch shelters the transomed doorway; round wood columns support its roof. A small, segmentally arched window next to the door has a stone sill. The second story is sheathed in asbestos siding.

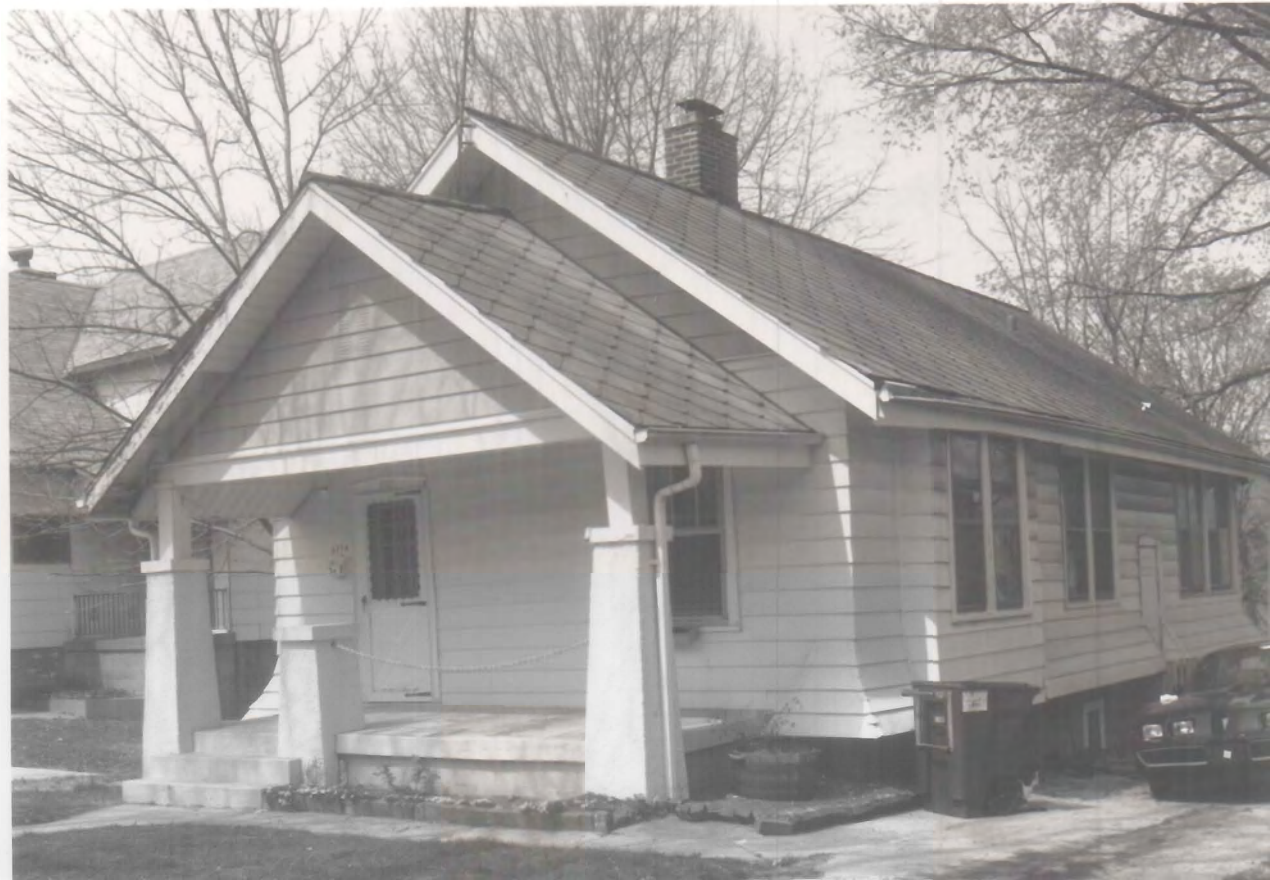
1. No. 118	3. Location of Negatives: Missouri Office of Historic Preservation, P. O. Box 176, Jefferson City, MO 65102		
2. City/County: City of St. Louis, MO	4. Prepared by: Cynthia Hill Longwisch, Landmarks Assn. of St. Louis, 917 Locust, 7th Floor, St. Louis, MO 63101

24. Foundation material: concrete		25. Roof type/material: front gable	
26. No. Bays: Front 2 Side 4		27. Wall treatment: aluminum siding	
28. Plan shape: see site map		29. Changes: Addition? Altered? yes

30. Exterior condition: good		31. Open to public? no	
32. Other Surveys in which included: Heritage/St. Louis survey, 1971			
3. Further description of important features: House has original, undulating- attened roofing. Front gable echoed in porch roof, supported by heavy, taper- ing stuccoed pillars. Porch has no side walls and appears to have been redone. The most important feature of this house as it appears today is the flared skirt formed by the aluminum siding around the bottom. It is not known whether this merely covers the original styling or if it is a style of its (cont'd. below)

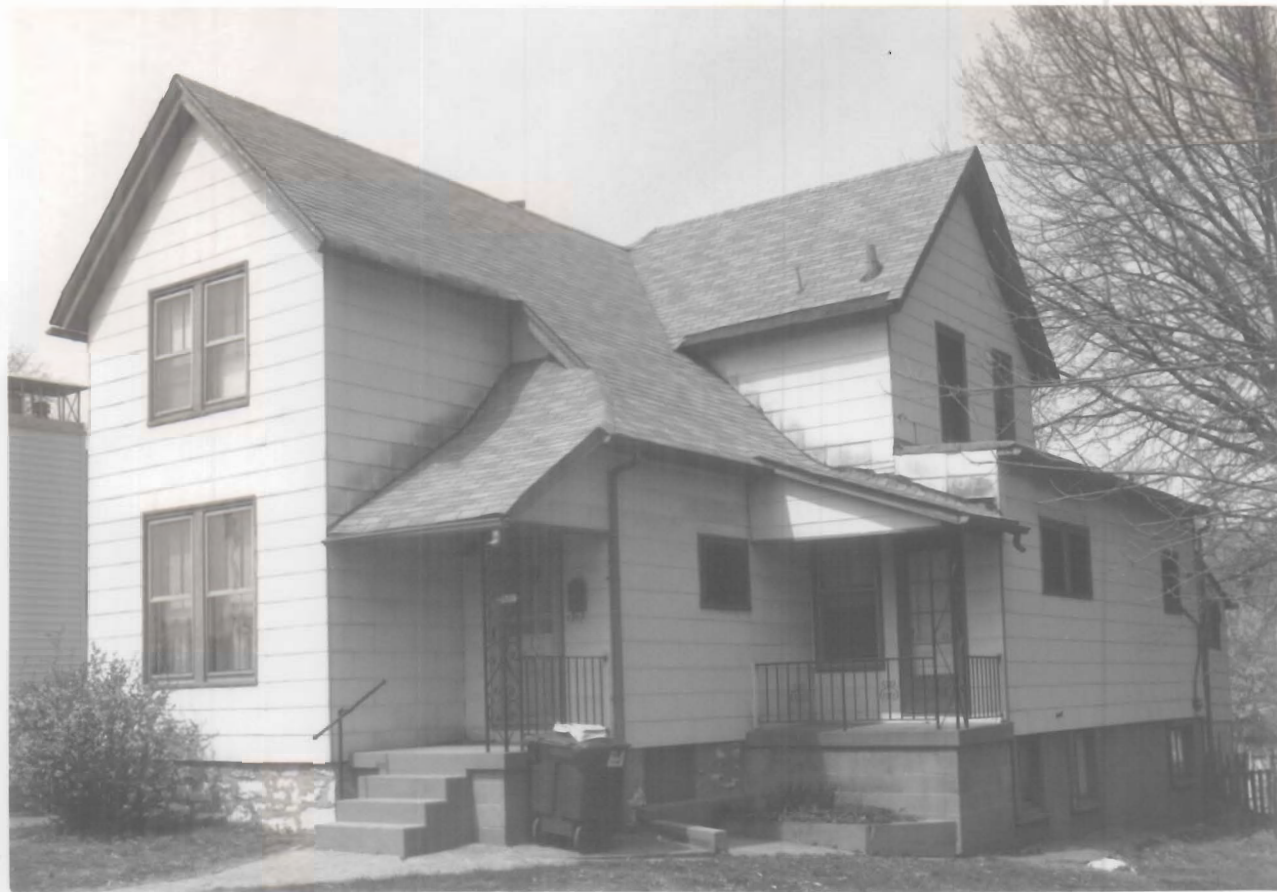
1. No. 117	3. Location of Negatives: Missouri Office of Historic Preservation, P. O. Box 176, Jefferson City, MO 65102		
2. City/County: City of St. Louis, MO	4. Prepared by: Cynthia Hill Longwisch, Landmarks Assn. of St. Louis, 917 Locust, 7th Floor, St. Louis, MO 63101

24. Foundation material: stone		25. Roof type/material: gabled ell	
26. No. Bays: Front 4 Side		27. Wall treatment: asbestos siding	
28. Plan shape: see site map		29. Changes: Addition? yes Altered? yes

30. Exterior condition: fair/good		31. Open to public? no	
32. Other Surveys in which included: Heritage/St. Louis survey, 1971			
33. Further description of important features: This house appears to have begun life as a gabled ell; later additions seem to have been made in the corner of the ell, where an entrance is boxed in, and on the east side, where a one-story, flat-roofed addition projects. The resulting roofline in the ell is a bit unwieldy. The one-story portion has a concrete foundation. Windows are 3-over-1 double-hung sash, paired on the front elevation.

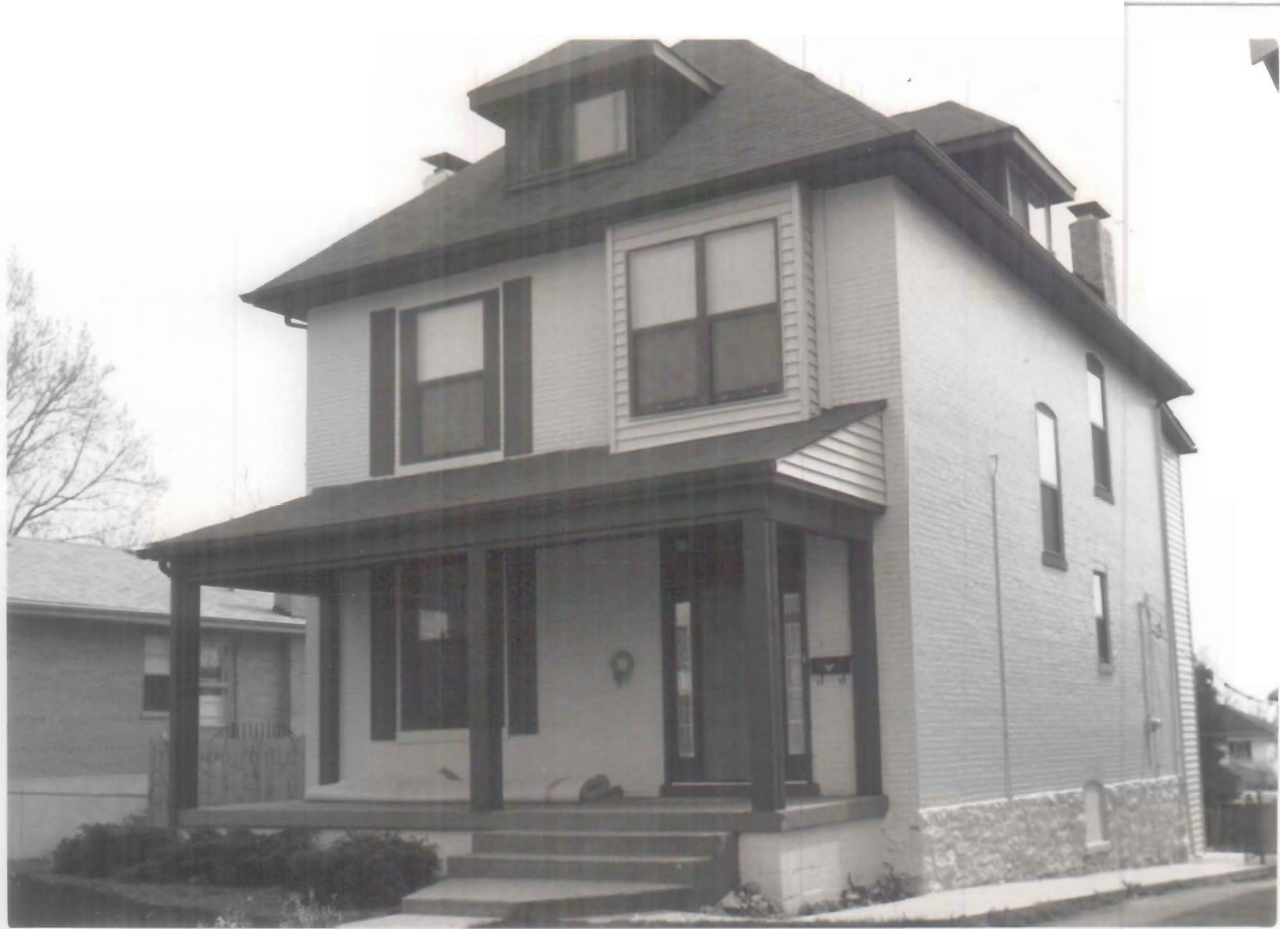
1. No. 107	3. Location of Negatives: Missouri Office of Historic Preservation, P. O. Box 176, Jefferson City, MO 65102		
2. City/County: City of St. Louis, MO	4. Prepared by: Cynthia Hill Longwisch, Landmarks Assn. of St. Louis, 917 Locust, 7th Floor, St. Louis, MO 63101

21. No. of stories: 2	22. Basement? yes	23. Wall construction: masonry	
24. Foundation material: stone		25. Roof type/material: hipped	
26. No. Bays: Front 2 Side 2		27. Wall treatment: painted brick

28. Plan shape: see site map		29. Changes: Addition? rear Altered? yes	
30. Exterior condition: good		31. Open to public? no	
32. Other Surveys in which included: Heritage/St. Louis survey, 1971

33. Further description of important features: Dormers on this pyramidally-tipped roof house also have hipped roofs. Windows are replacements. A nearly full-width porch of concrete over concrete block with wood posts is apparently a replacement. An upper front elevation window was probably originally more baylike in its projection; it is now sided. Door has sidelights. Side windows are segmentally arched. Rear two-story frame addition.
