# ARCHITECTURAL SURVEY OF CLIFTON HEIGHTS

JUNE 1991

ST. LOUIS, MISSOURI

LANDMARKS ASSOCIATION OF ST. LOUIS, INC.

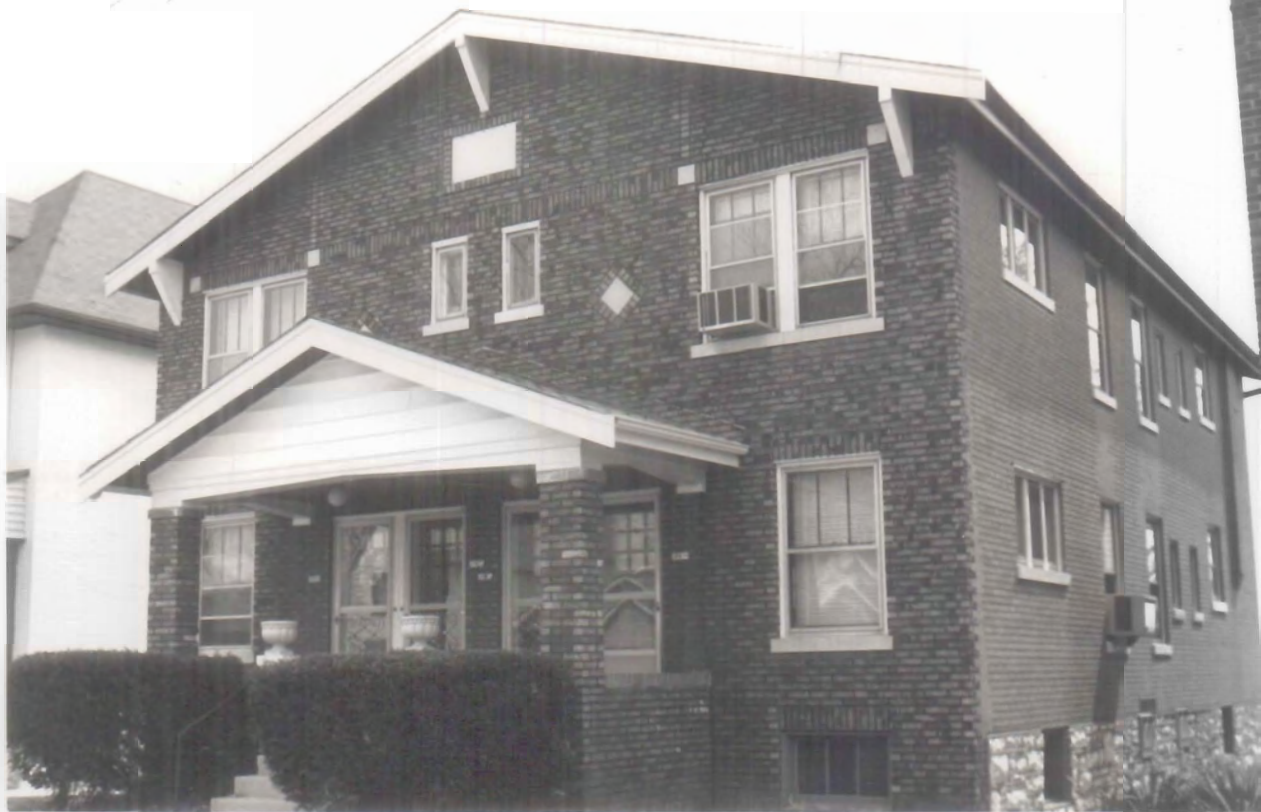
1. No. 108	3. Location of Negatives: Missouri Office of Historic Preservation, P. O. Box 176, Jefferson City, MO 65102		
2. City/County: City of St. Louis, MO	4. Prepared by: Cynthia Hill Longwisch, Landmarks Assn. of St. Louis, 917 Locust, 7th Floor, St. Louis, MO 63101

24. Foundation material: stone		25. Roof type/material: front gable	
26. No. Bays: Front 6 Side 6		27. Wall treatment: brown/multi brick	
28. Plan shape: see site map		29. Changes: Addition? Altered?

30. Exterior condition: good		31. Open to public? no	
32. Other Surveys in which included: Heritage/St. Louis survey, 1971			
33. Further description of important features: This building has wide eaves; wood brackets on the front elevation. The facade and porch are of brown/multi-chrome brick while the body of the building is red brick. A soldier lintel at the second story is intersected at the corners of the paired, 3-over-1 windows by square stone or terra cotta inserts. A larger, rectangular insert is located at the gable above two small stained glass windows. (cont'd. below)

34. History and Significance: The gabled porch is supported by straight brick pillars; the porch shelters the four entrance doors. Flat arches on sides. Patternmaker Edwin Hunkler of 5067 Arlington hired contractor John F. Haug to design and build this 35 x 48' "tenement" in 1928 for \$8,000.

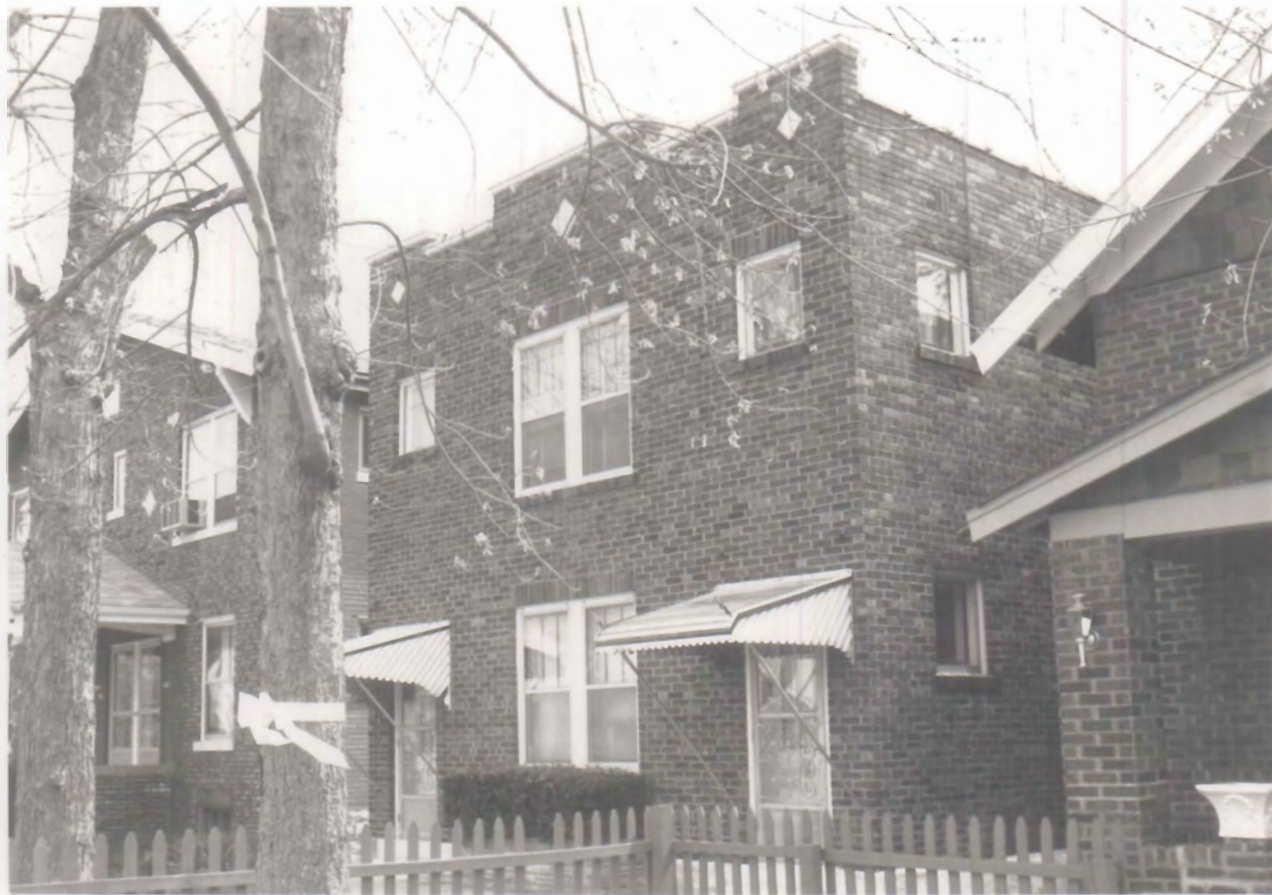
1. No. 109		3. Location of Negatives: Missouri Office of Historic Preservation, P. O. Box 176, Jefferson City, MO 65102	
2. City/County: City of St. Louis, MO		4. Prepared by: Cynthia Hill Longwisch, Landmarks Assn. of St. Louis, 917 Locust, 7th Floor, St. Louis, MO 63101

24. Foundation material: stone		25. Roof type/material: flat	
26. No. Bays: Front 3 Side 4		27. Wall treatment: brown brick	
28. Plan shape: see site map		29. Changes: Addition? Altered?

30. Exterior condition: good		31. Open to public? no	
32. Other Surveys in which included: Heritage/St. Louis survey, 1971

3. Further description of important features: A parapeted roofline features tile terra cotta coping and is highlighted just below by inset terra cotta diagonals. Windows have soldier arches and brick sills. Paired, centered windows both stories have 3-over-1 double-hung sash. Doors at either side are covered with newer aluminum awnings; they have only a very low stoop; no porch. The foundation is covered with stucco. Flat arches on side openings.

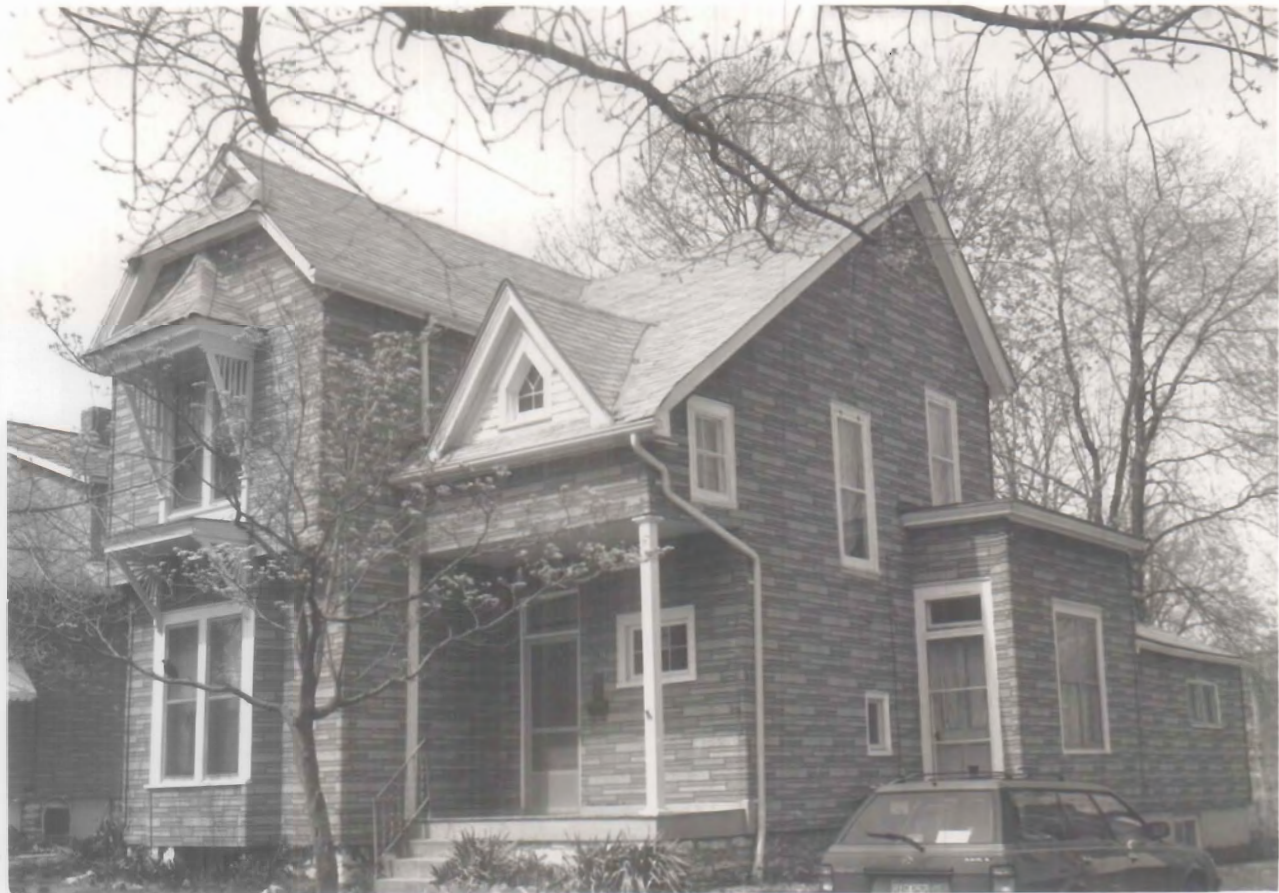
1. No. 116		3. Location of Negatives: Missouri Office of Historic Preservation, P. O. Box 176, Jefferson City, MO 65102	
2. City/County: City of St. Louis, MO		4. Prepared by: Cynthia Hill Longwisch, Landmarks Assn. of St. Louis, 917 Locust, 7th Floor, St. Louis, MO 63101

24. Foundation material: stone		25. Roof type/material: complex	
26. No. Bays: Front 3 Side 4		27. Wall treatment: asphalt siding	
28. Plan shape: see site map		29. Changes: Addition? yes Altered?

30. Exterior condition: good		31. Open to public? no	
32. Other Surveys in which included: Heritage/St. Louis survey, 1971			
33. Further description of important features: The roofline of this house is quite irregular, featuring gables, flat roofs, overhangs, hipping and a dormer. A steep gable above the shallow porch has a gothic window. The end of the front facing gable at the left is "hipped" - see photo - above a pair of 1-over-1 windows; these have a hipped-roof hood that is supported by screenlike wood brackets. Below, a flat-roofed hood with fanlike wood brackets (cont'd. below)

4. History and Significance: shields the paired windows at the first story. A flat-roofed projecting bay on the east side has an additional entrance. A one-story frame addition is attached to the rear. No inactive (pre-1950) building permits for this city block are not available.

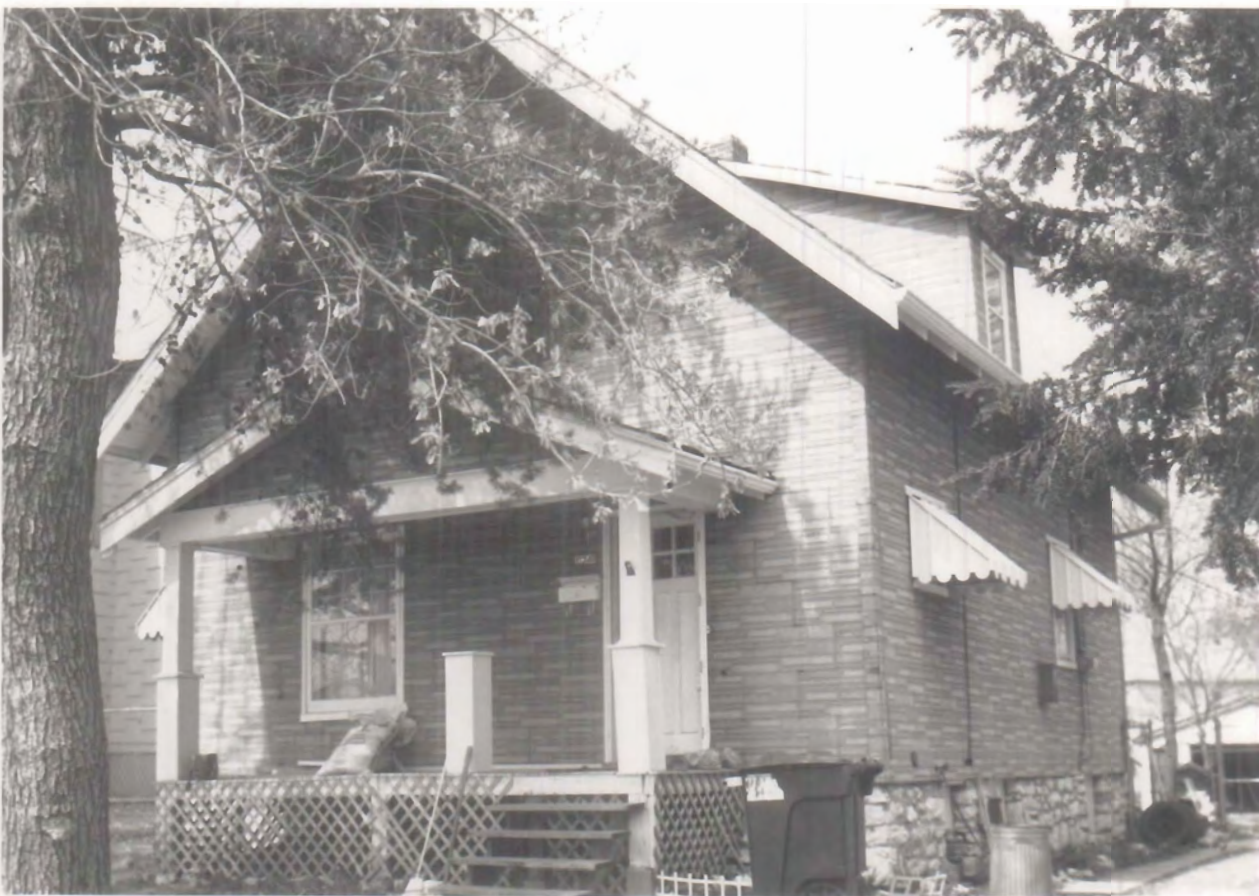
24. Foundation material: stone      25. Roof type/material: front gable

30. Exterior condition: fair/good      31. Open to public? no

33. Further description of important features: A shed-roof dormer extends from either side of the gabled roof on this house. Eaves overhang and have exposed after ends. Windows have flat arches; front window is 9-over-1 double-hung ash. Front porch is supported by wood posts; porch appears to have been altered, and steps are not original. Asphalt siding applied in 1957, according to building permit.

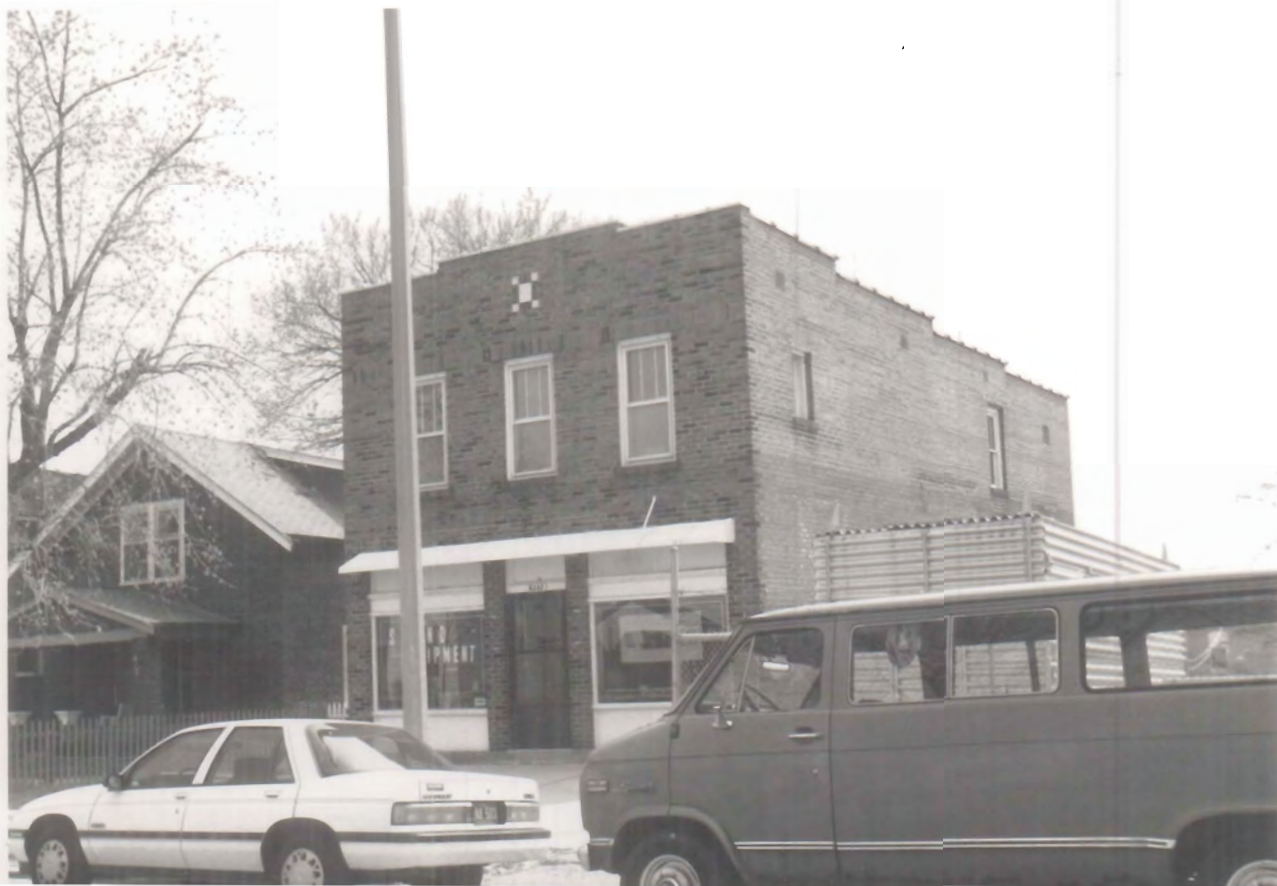
1. No. 111	3. Location of Negatives: Missouri Office of Historic Preservation, P. O. Box 176, Jefferson City, MO 65102		
2. City/County: City of St. Louis, MO	4. Prepared by: Cynthia Hill Longwisch, Landmarks Assn. of St. Louis, 917 Locust, 7th Floor, St. Louis, MO 63101

24. Foundation material: concrete		25. Roof type/material: flat	
26. No. Bays: Front 3 Side 4		27. Wall treatment: red/multi brick	
28. Plan shape: see site map		29. Changes: Addition?	Altered? yes

30. Exterior condition: good		31. Open to public? yes; limited	
32. Other Surveys in which included: Heritage/St. Louis survey, 1971			
33. Further description of important features: The roofline of this building has a tiny parapet and is "stepped" down at the sides; terra cotta coping. Second story windows on the front elevation have a soldier lintel course. The windows are 3-over-1 double-hung sash. Side windows have flat arches. Brick sills. The first story display windows have had some alteration and now have a narrow aluminum awning. Inset terra cotta squares at top, front elevation.

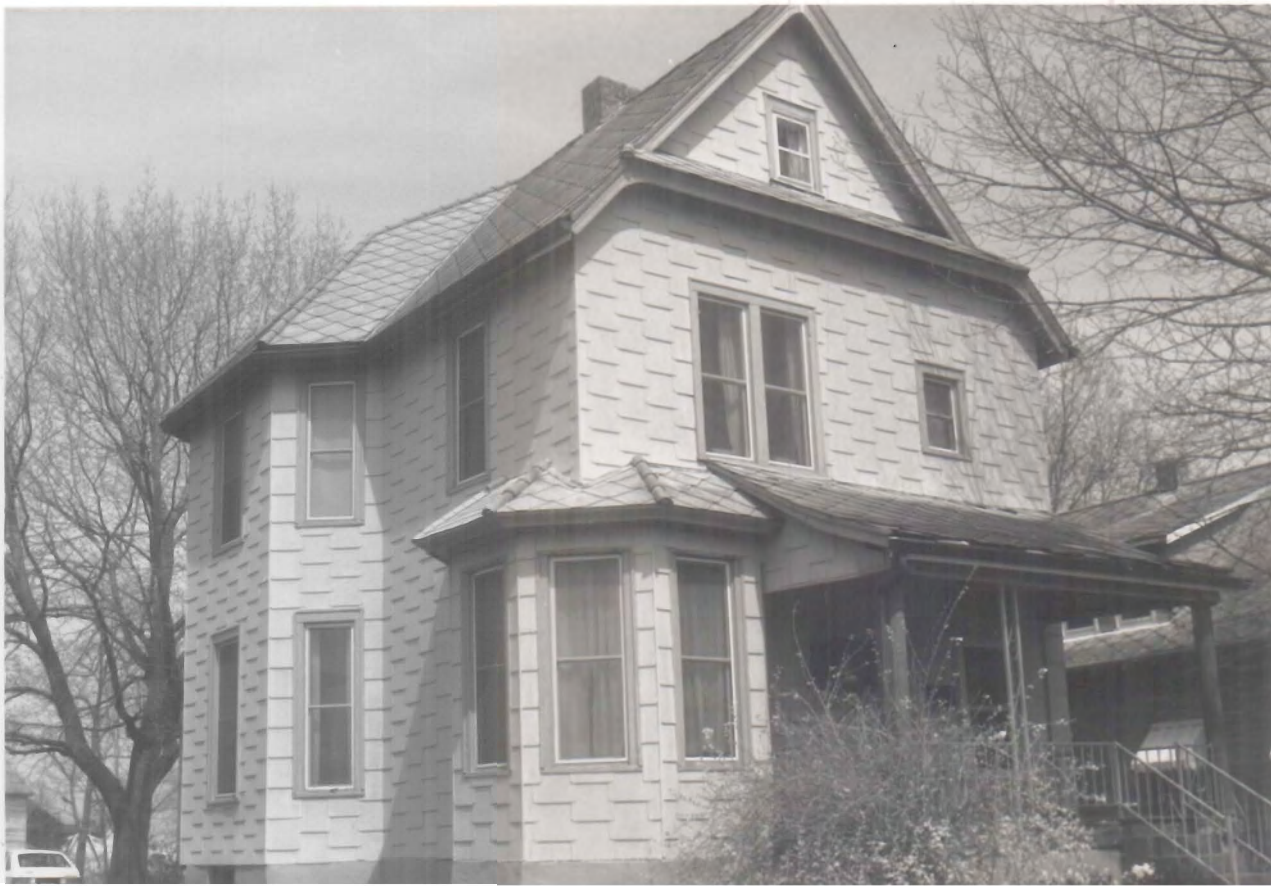
1. No. 114	3. Location of Negatives: Missouri Office of Historic Preservation, P. O. Box 176, Jefferson City, MO 65102		
2. City/County: City of St. Louis, MO	4. Prepared by: Cynthia Hill Longwisch, Landmarks Assn. of St. Louis, 917 Locust, 7th Floor, St. Louis, MO 63101

24. Foundation material: stuccoed		25. Roof type/material: complex	
26. No. Bays: Front 3 Side 3		27. Wall treatment: siding	
28. Plan shape: see site map		29. Changes: Addition? rear Altered?

30. Exterior condition: fair/good		31. Open to public? no	
32. Other Surveys in which included: Heritage/St. Louis survey, 1971			
33. Further description of important features: Evidently, the original building materials are still in place on this house. The roof is covered with shingles of an undulating pattern, while the walls are covered with overlapping planks of undetermined material. A 1-story multisided bay projects at the northwest corner. Two-story bays project at either side, the one on the east having a gable. The porch has round wood pillars. Windows (cont'd. below)

34. History and Significance: have 1-over-1 double-hung sash. The front gable defined by a narrow eave that crosses it below the small attic window. One-story rear frame addition. pre-1950 building permits for this city block are not available.

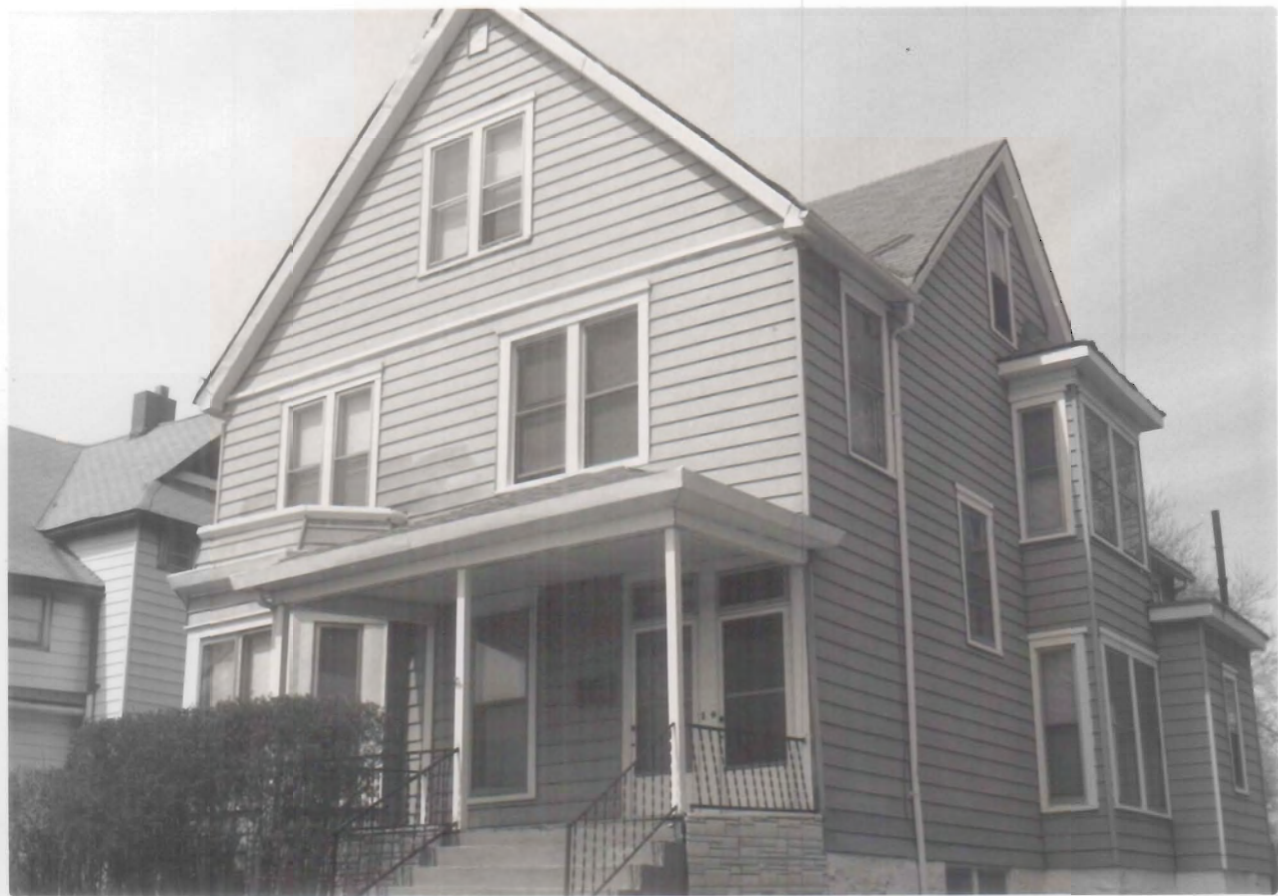
1. No. 113	3. Location of Negatives: Missouri Office of Historic Preservation, P. O. Box 176, Jefferson City, MO 65102		
2. City/County: City of St. Louis, MO	4. Prepared by: Cynthia Hill Longwisch, Landmarks Assn. of St. Louis, 917 Locust, 7th Floor, St. Louis, MO 63101

24. Foundation material: stone		25. Roof type/material: multigabled	
26. No. Bays: Front 3 Side 4		27. Wall treatment: aluminum siding	
28. Plan shape: see site map		29. Changes: Addition? rear Altered? yes

30. Exterior condition: good		31. Open to public? no	
32. Other Surveys in which included: Heritage/St. Louis survey, 1971			
33. Further description of important features: All windows are 1-over-1 double hung sash. A 2-story bay projects on the east side. The porch is supported by very thin square wood posts and it has an iron railing and permastone sheathing below. Two transomed front doors. One-story bay window at front. Rear one-story frame addition dates to 1951.

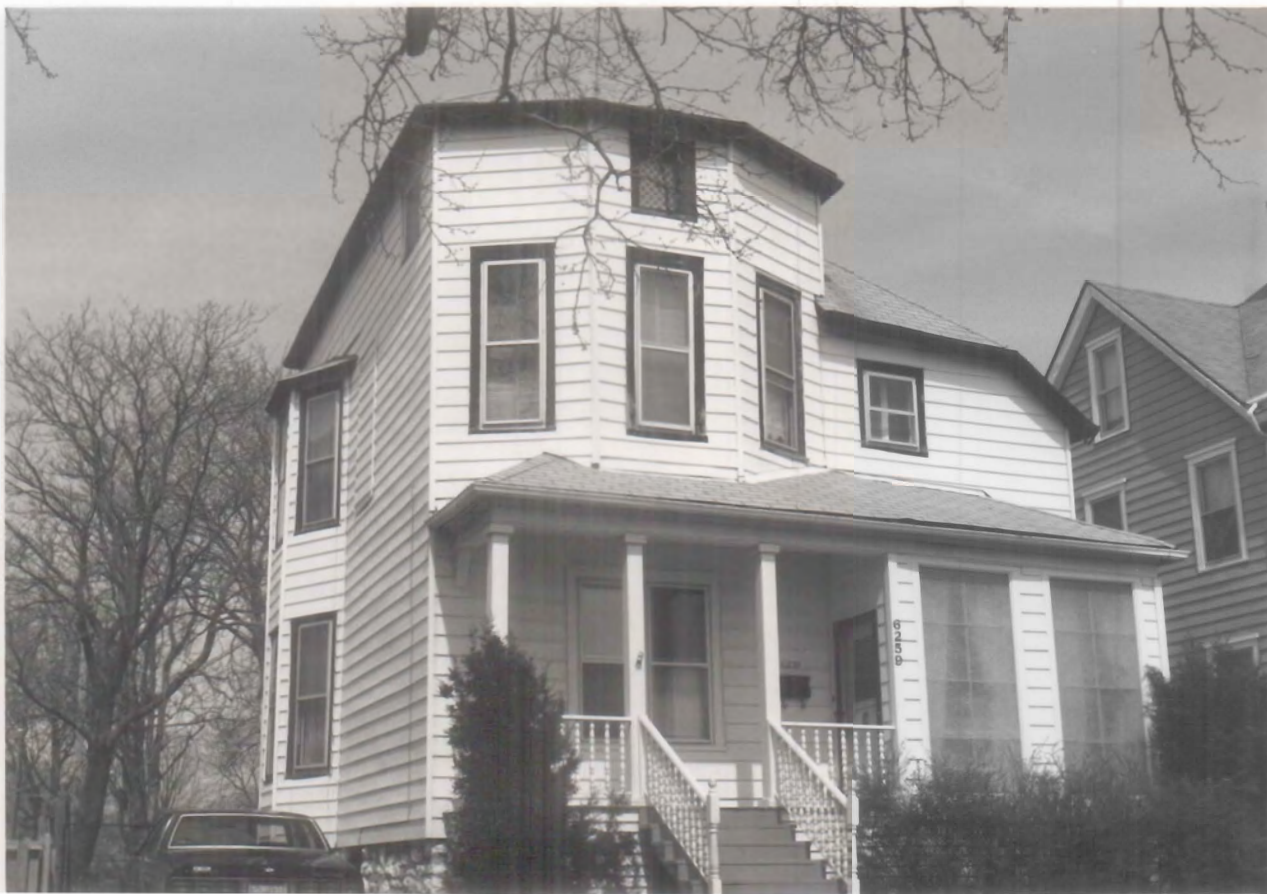
24. Foundation material: stone		25. Roof type/material: hipped	
26. No. Bays: Front 2 Side 2		27. Wall treatment: vinyl siding	
28. Plan shape: see site map		29. Changes: Addition? Altered? yes

30. Exterior condition: good		31. Open to public? no	
32. Other Surveys in which included: Heritage/St. Louis survey, 1971			
33. Further description of important features: The detailing of this building has been somewhat homogenized with alterations and siding. However, the original intent appears to have been of a picturesque/Queen Anne bent. The porch has been partially infilled to provide extra living space. What remains is supported by thin square wood posts; turned wood balustrade. 1-over-1 replacement windows. 2-story side projecting bay window. Roof is (cont'd. below)

4. History and Significance: hipped at several levels and angles. inactive (pre-1950, in this case) building permits were microfilmed for this city block. The house appears to date to the early part of the century.

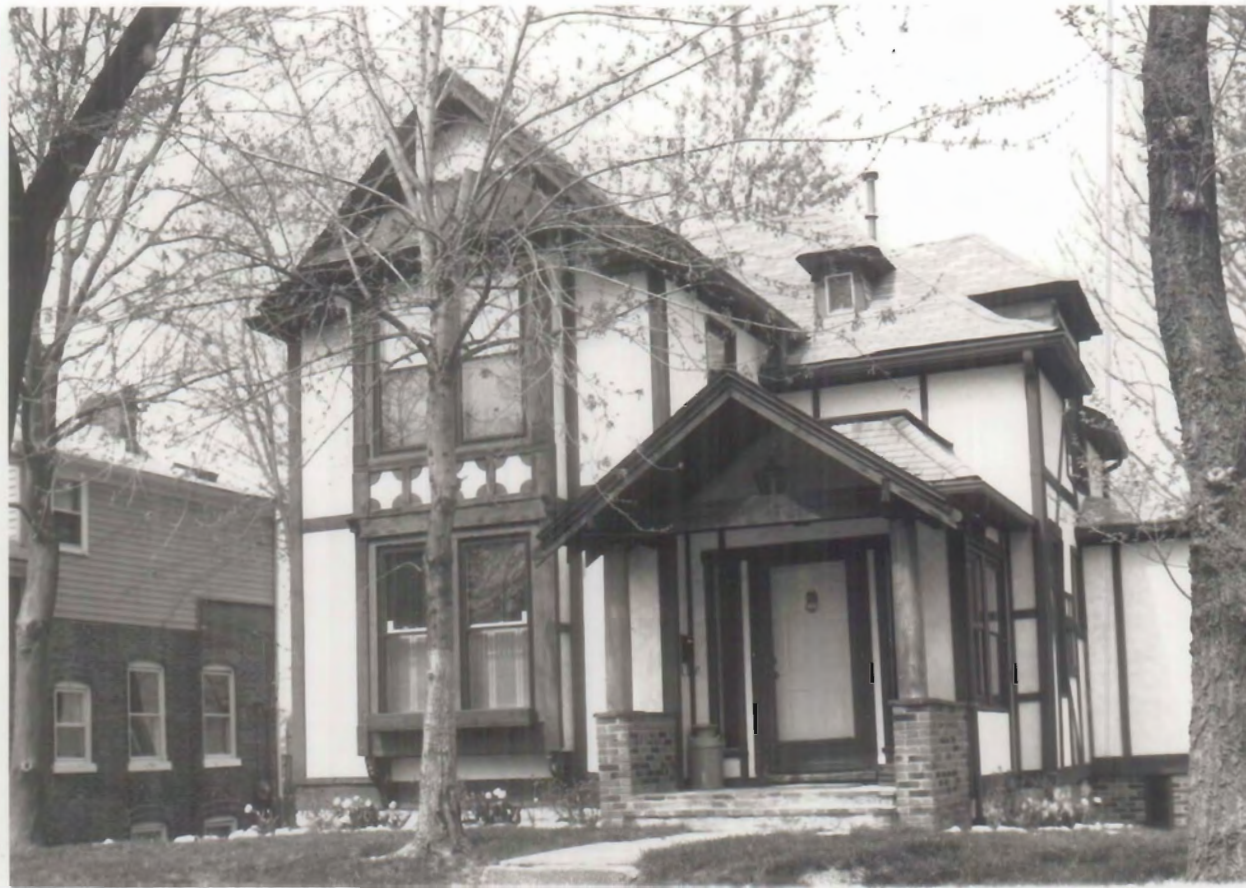
1. No. 189	3. Location of Negatives: Missouri Office of Historic Preservation, P. O. Box 176, Jefferson City, MO 65102		
2. City/County: City of St. Louis, MO	4. Prepared by: Cynthia Hill Longwisch, Landmarks Assn. of St. Louis, 917 Locust, 7th Floor, St. Louis, MO 63101

24. Foundation material: stone		25. Roof type/material: complex	
26. No. Bays: Front 2 Side 4		27. Wall treatment: stucco/half timber	
28. Plan shape: see site map		29. Changes: Addition? yes Altered? yes

30. Exterior condition: good		31. Open to public? no	
32. Other Surveys in which included: Heritage/St. Louis survey, 1971			
33. Further description of important features: This house evidently began life as a Queen Anne, with a multilevel hipped and gabled roof that includes dormers of different sizes. The remnant of the original porch roofline is visible behind the large porch gable. At some point, stucco and rectilinear "half-timbering" was applied to the exterior. A projecting front bay became quasi-medieval. A large rear deck and 1-story side addition are also present....

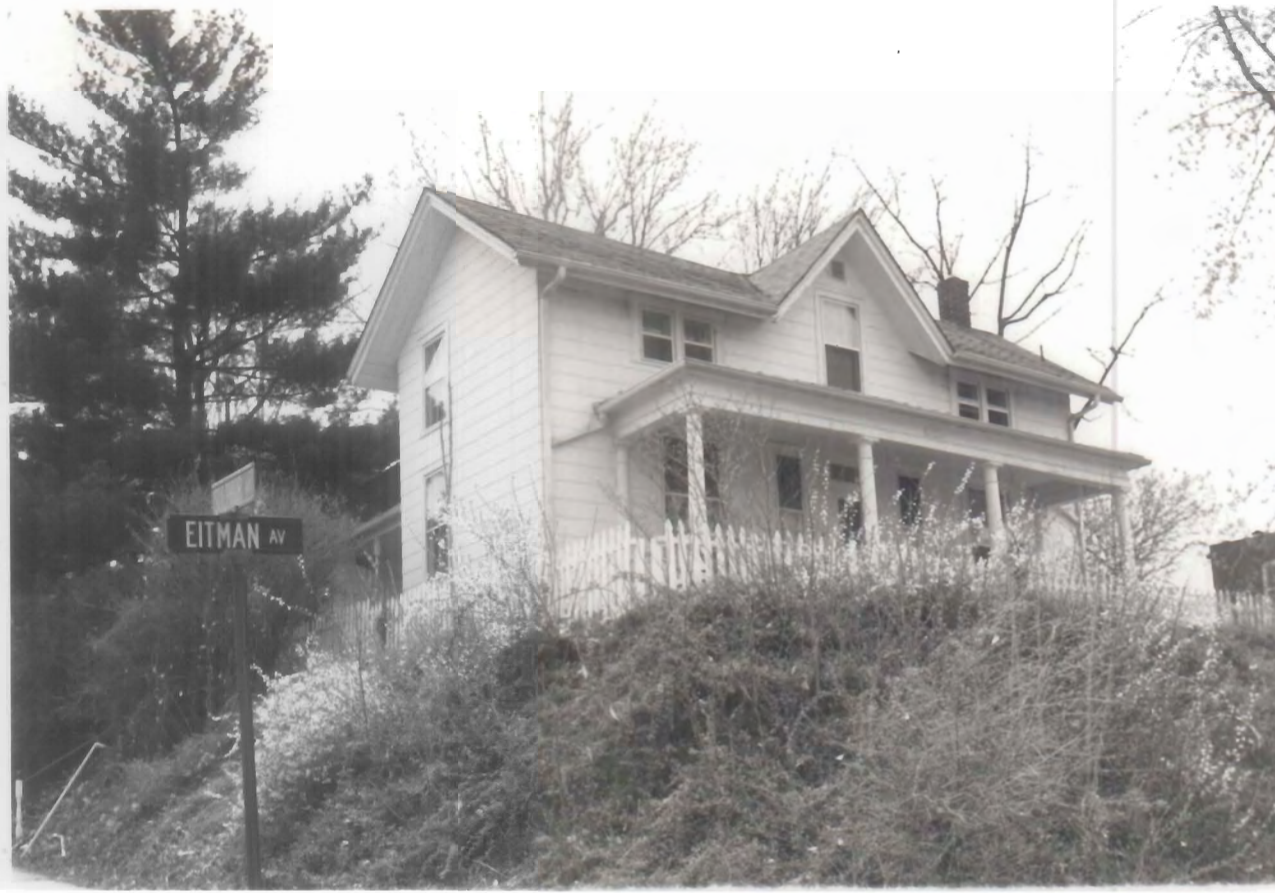
1. No. 206	3. Location of Negatives: Missouri Office of Historic Preservation, P. O. Box 176, Jefferson City, MO 65102		
2. City/County: City of St. Louis, MO	4. Prepared by: Cynthia Hill Longwisch, Landmarks Assn. of St. Louis, 917 Locust, 7th Floor, St. Louis, MO 63101

24. Foundation material: obscured		25. Roof type/material: side gable	
26. No. Bays: Front 5 Side 6		27. Wall treatment: asbestos siding	
28. Plan shape: see site map		29. Changes: Addition? rear Altered? yes

30. Exterior condition: good		31. Open to public? no	
32. Other Surveys in which included: Heritage/St. Louis survey, 1971			
33. Further description of important features: A steeply-pitched gable interrupts the front roofline of this side-gabled house. A hipped-roof porch is supported by turned wood Doric columns. Windows at 2nd story front are paired and smaller than the others. Transomed door. A 1 1/2 story section at the far south end of the house is attached to the main portion by a long, thin section that has an open porch along the east side. 6-over-6 windows on rear section.

The house and its additions give up few exterior clues as to their age. The house is essentially a generic I-House with a gable and classical pillars; the modest rear additions, almost completely obscured both summer and winter by trees and plants and its hilltop location, appear to have little in the way of stylistic detailing, typical of much middle-class rural architecture.

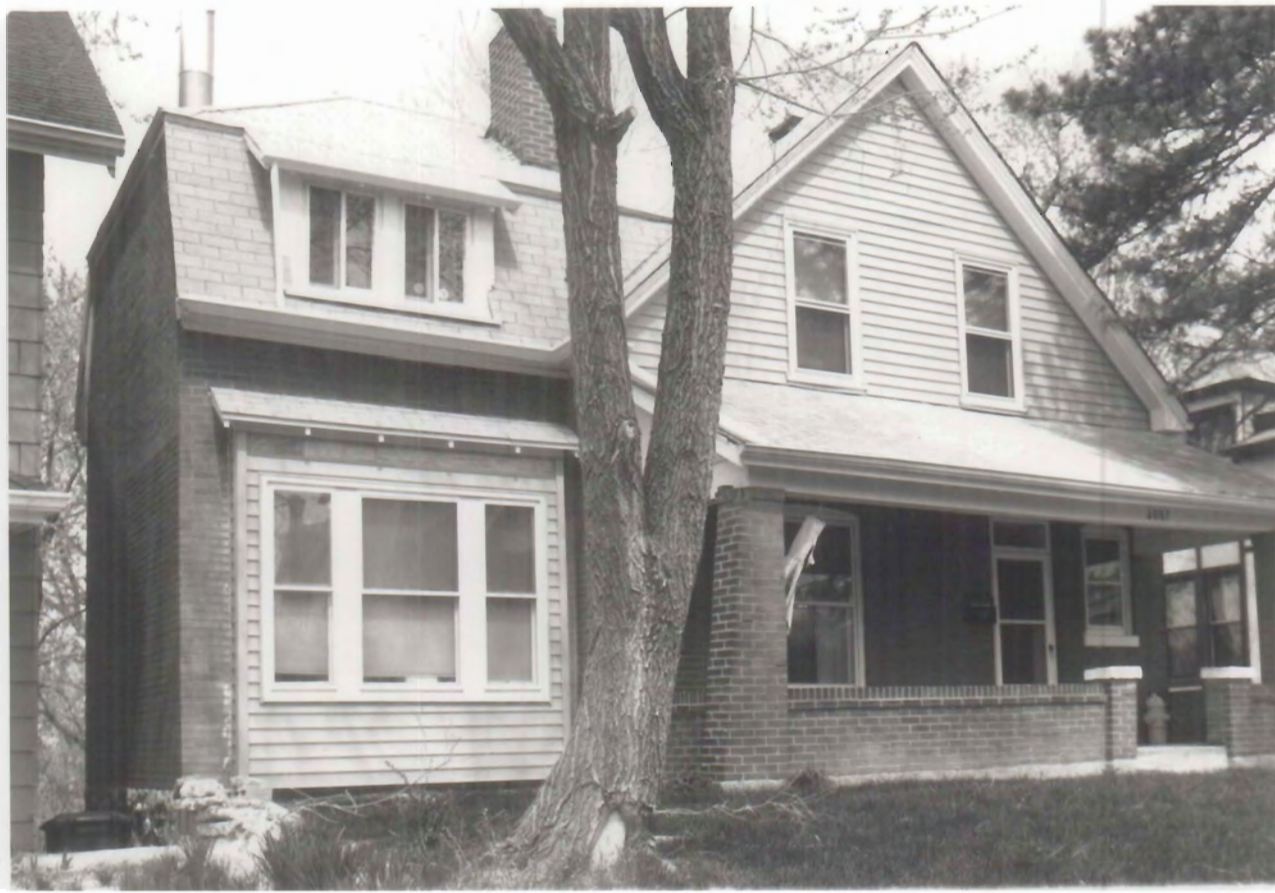
24. Foundation material: concrete		25. Roof type/material: complex	
26. No. Bays: Front 4 Side 3		27. Wall treatment: red brick/frame	
28. Plan shape: see site map	29. Changes: Addition? ?		Altered? yes

30. Exterior condition: good		31. Open to public? no	
32. Other Surveys in which included: Heritage/St. Louis survey, 1971			
33. Further description of important features: At first glance, this house seems to be a bungalow with a strange addition. However, the materials are the same and the transition places so smooth that it appears that it could have been built all at the same time. The right side has a front gable, while the left is hipped. A porch across the right side is supported by tapering brick pillars; it has brick short side walls. A shed-roof dormer is located (cont'd. below)

34. History and Significance: in the left section. Below, a frame bay window with exposed rafter ends may be an alteration. Most of the windows are 1-over-1; except for the bay window, all first-floor windows and all side windows have segmental arches. No pre-1926 (inactive) building permits are available for this city block.

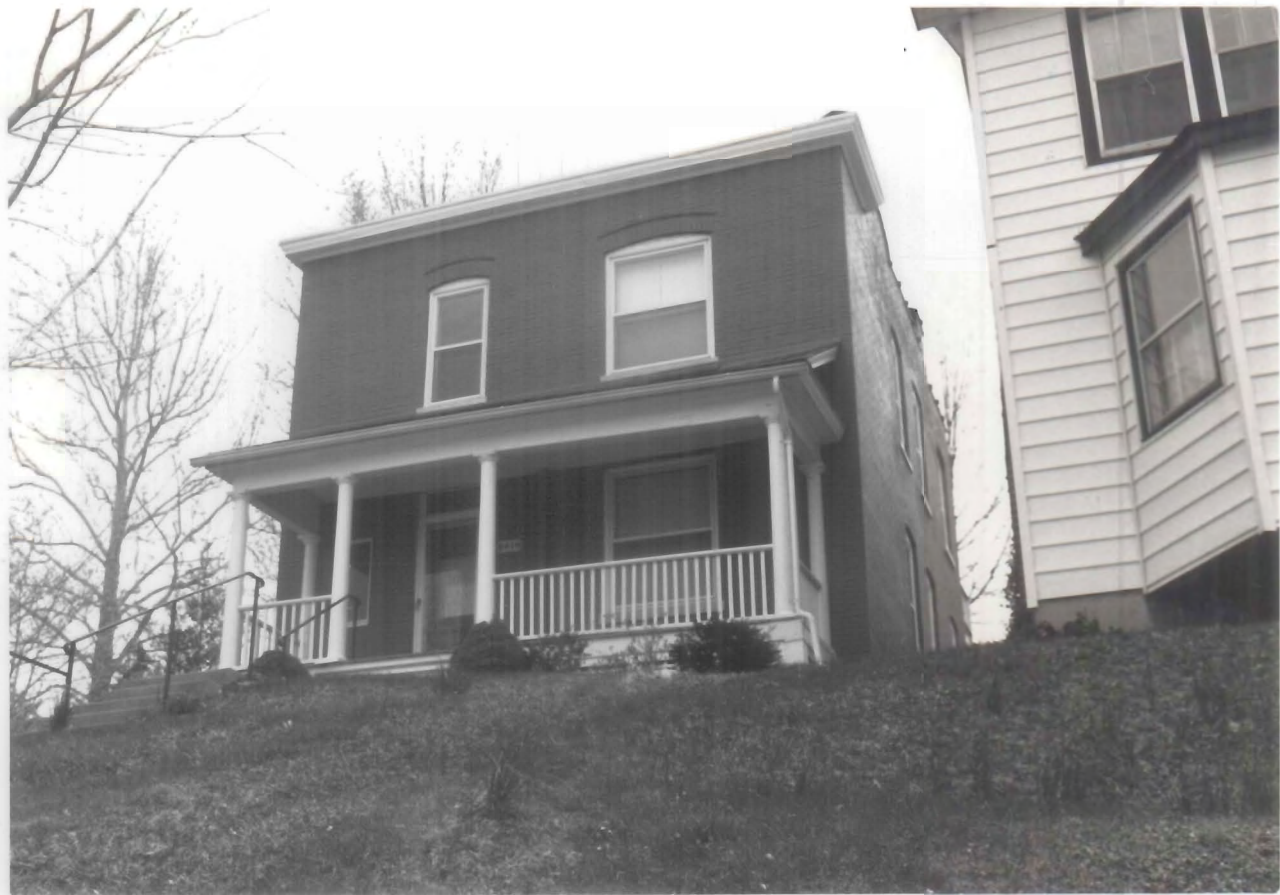
24. Foundation material: not visible	25. Roof type/material: side gable
--------------------------------------	------------------------------------

30. Exterior condition: good	31. Open to public? no
------------------------------	------------------------

3. Further description of important features: Windows are segmentally arched, with pressed-brick hoods at second story front. Full-width porch supported by six round wood Doric columns. Transomed door. Molded cornice at roofline turns. Windows are 1-over-1.

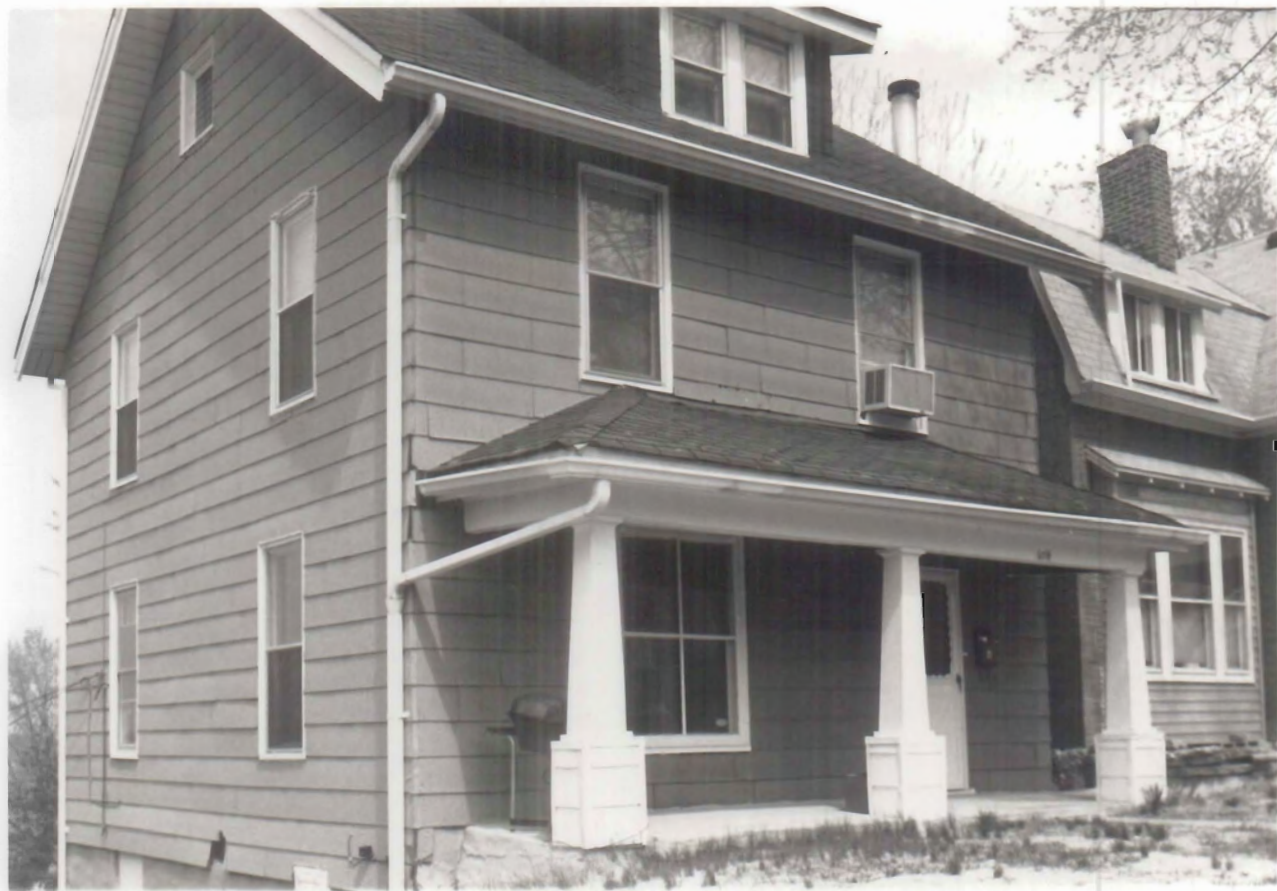
1. No. 191	3. Location of Negatives: Missouri Office of Historic Preservation, P. O. Box 176, Jefferson City, MO 65102		
2. City/County: City of St. Louis, MO	4. Prepared by: Cynthia Hill Longwisch, Landmarks Assn. of St. Louis, 917 Locust, 7th Floor, St. Louis, MO 63101

24. Foundation material: concrete		25. Roof type/material: side gable	
26. No. Bays: Front 2 Side 2		27. Wall treatment: asbestos siding	
28. Plan shape: see site map	29. Changes: Addition?		Altered?

30. Exterior condition: fair/good		31. Open to public? no	
32. Other Surveys in which included: Heritage/St. Louis survey, 1971			
33. Further description of important features: If this house had a hipped roof, it would be a foursquare. Instead, the side-gabled roof has wide overhangs and a dormer with paired 1-over-1 windows. A full-width porch has a hipped roof and tapering, wood pillars and no side walls. All windows are 1-over-1 except first story front: 2-over-2.

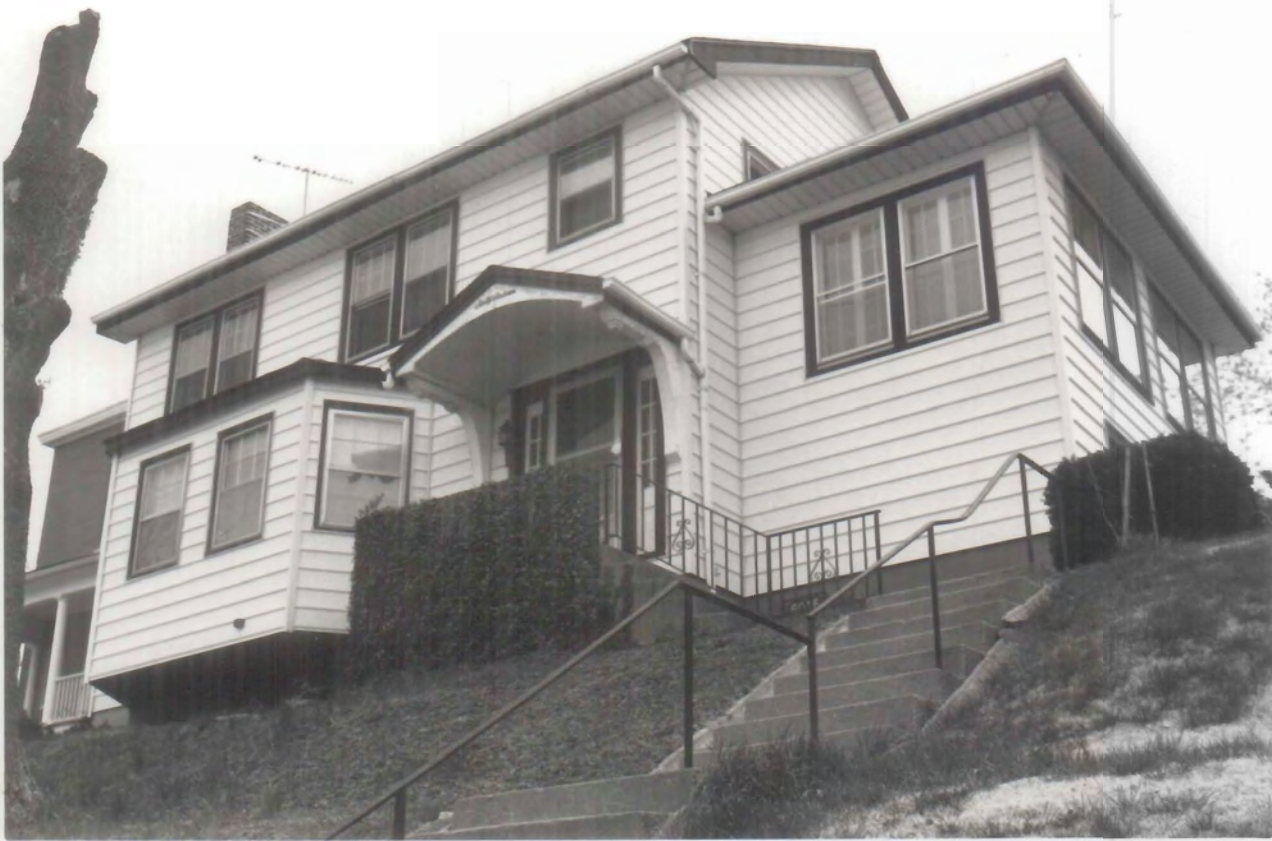
21. No. of stories: 2	22. Basement? yes	23. Wall construction: frame	
24. Foundation material: concrete		25. Roof type/material: side gable	
26. No. Bays: Front 6 Side 2		27. Wall treatment: aluminum siding

33. Further description of important features: This side-gabled house has 6-over-1 double-hung sash windows, nearly all paired (except for the bay window, which is an alteration). A gabled hood over the door has long brackets; the door has multipane sidelights. A one-story side addition is original.

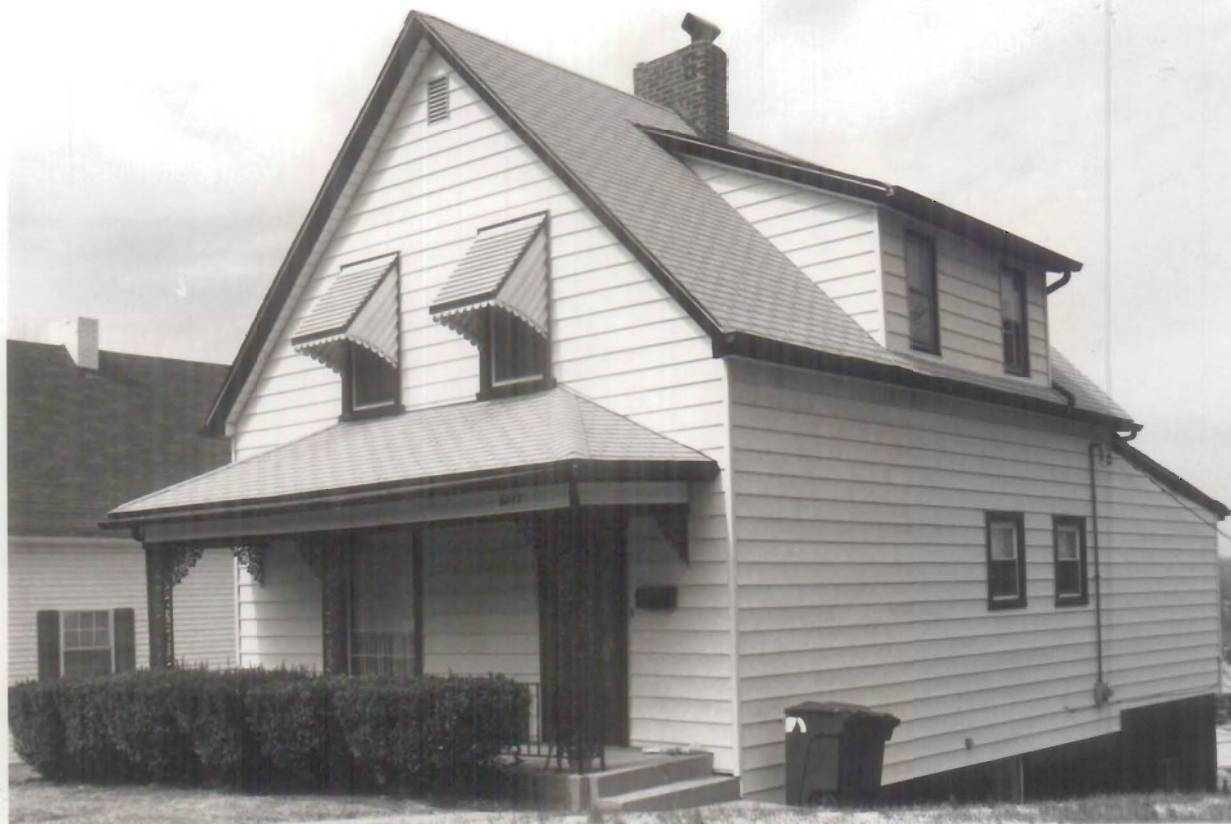
1. No. 192	3. Location of Negatives: Missouri Office of Historic Preservation, P. O. Box 176, Jefferson City, MO 65102		
2. City/County: City of St. Louis, MO	4. Prepared by: Cynthia Hill Longwisch, Landmarks Assn. of St. Louis, 917 Locust, 7th Floor, St. Louis, MO 63101

24. Foundation material: stuccoed		25. Roof type/material: front gable	
26. No. Bays: Front 2 Side 2		27. Wall treatment: vinyl siding	
28. Plan shape: see site map		29. Changes: Addition? rear Altered? yes

30. Exterior condition: good		31. Open to public? no	
32. Other Surveys in which included: Heritage/St. Louis survey, 1971			
33. Further description of important features: This house probably had some modest Queen Anne detailing before remodeling struck. It is very similar to its neighbors, survey #193 & #194, and all may have been built at the same time. A shed-roof dormer with two windows is on the east side. A hipped-roof porch is supported by non-original iron posts. Side windows have been altered. A shed-roof rear addition is present on all three and may have been original.

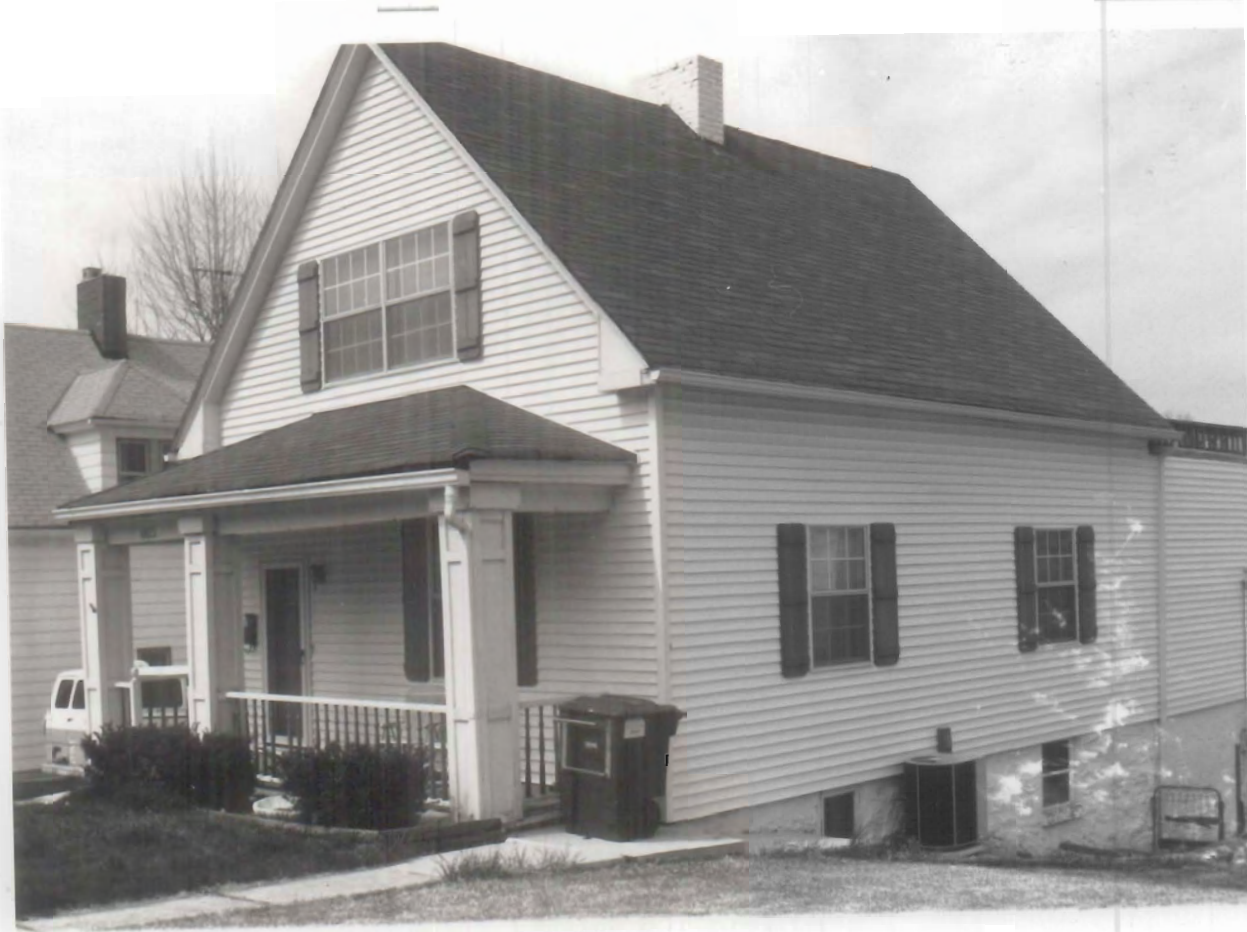
1. No. 193	3. Location of Negatives: Missouri Office of Historic Preservation, P. O. Box 176, Jefferson City, MO 65102		
2. City/County: City of St. Louis, MO	4. Prepared by: Cynthia Hill Longwisch, Landmarks Assn. of St. Louis, 917 Locust, 7th Floor, St. Louis, MO 63101

24. Foundation material: stone		25. Roof type/material: front gable	
26. No. Bays: Front 2 Side 2		27. Wall treatment: aluminum siding	
28. Plan shape: see site map		29. Changes: Addition? rear Altered? yes

30. Exterior condition: good		31. Open to public? no	
32. Other Surveys in which included: Heritage/St. Louis survey, 1971			
33. Further description of important features: This house is very similar to survey #192 & #194, on either side and may have been done at the same time. A front gable has paired replacement windows; below, a hipped porch roof is supported by paneled wood pillars. Porch's spindle balustrade is not original. Rear one-story addition is flat-roofed; probably original to house except roof was originally sloping (see #192 & #194).
