# ARCHITECTURAL SURVEY OF CLIFTON HEIGHTS

JUNE 1991

ST. LOUIS, MISSOURI

LANDMARKS ASSOCIATION OF ST. LOUIS, INC.

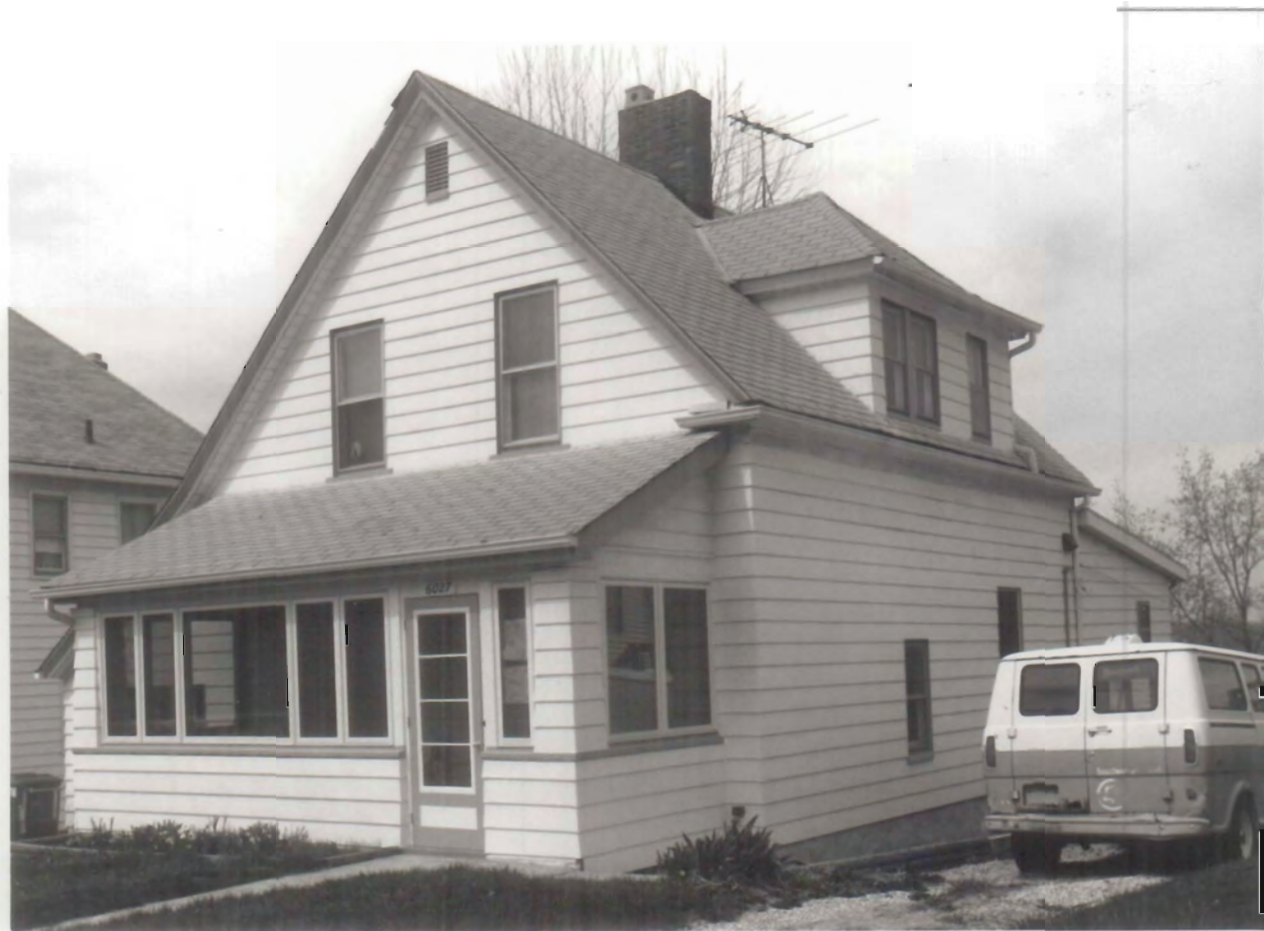
1. No. 194	3. Location of Negatives: Missouri Office of Historic Preservation, P. O. Box 176, Jefferson City, MO 65102		
2. City/County: City of St. Louis, MO	4. Prepared by: Cynthia Hill Longwisch, Landmarks Assn. of St. Louis, 917 Locust, 7th Floor, St. Louis, MO 63101

24. Foundation material: stone		25. Roof type/material: front gable	
26. No. Bays: Front 2 Side 3		27. Wall treatment: aluminum siding	
28. Plan shape: see site map		29. Changes: Addition? rear Altered? yes

30. Exterior condition: good		31. Open to public? no	
32. Other Surveys in which included: Heritage/St. Louis survey, 1971			
33. Further description of important features: This house is very similar to survey #192 & #193 and all may have the same builder/date. A hipped dormer has paired and a single window. Two 1-over-1 windows in gable end. Enclosed porch probably started out open. Rear 1-story addition has shed roof; it is probably original. Original detailing probably very modest Queen Anne.

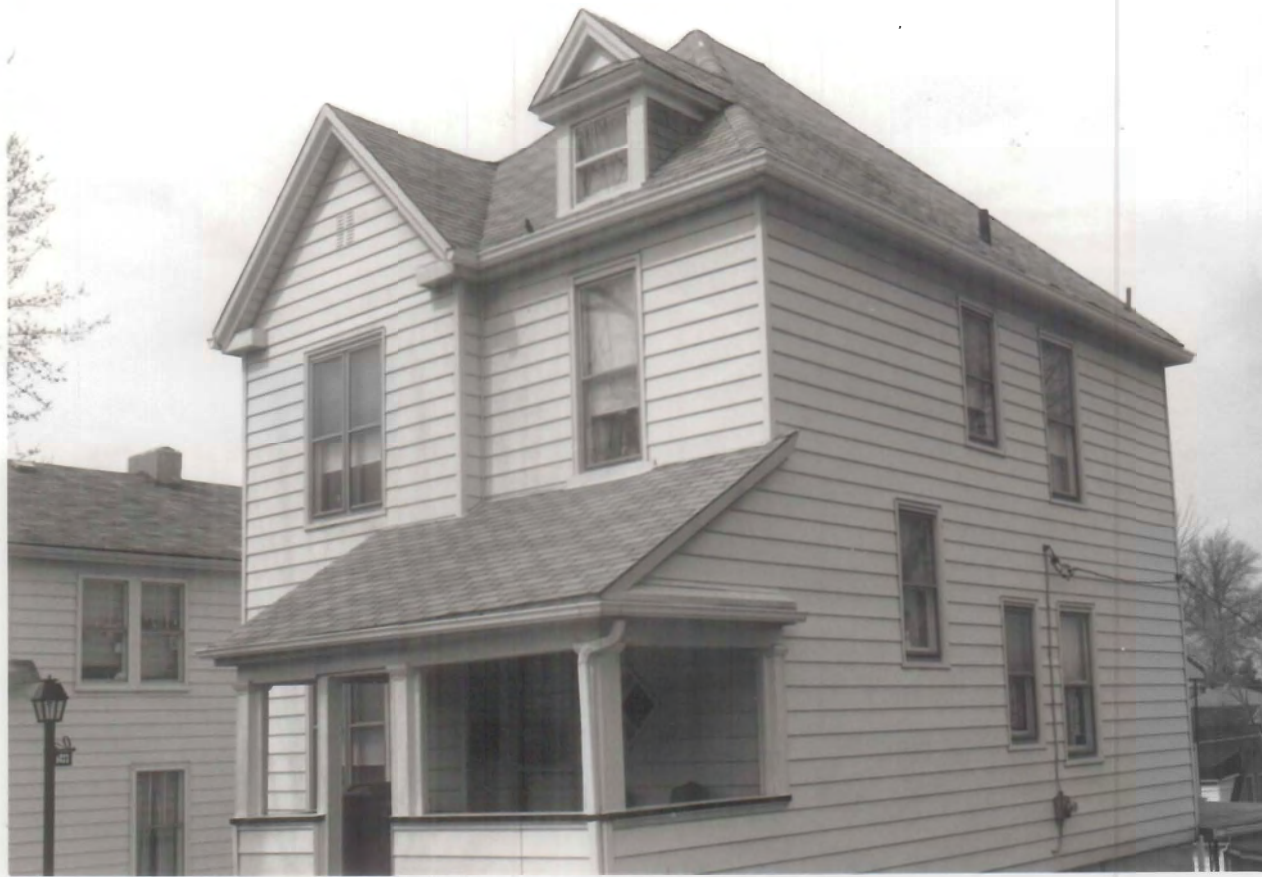
1. No. 195	3. Location of Negatives: Missouri Office of Historic Preservation, P. O. Box 176, Jefferson City, MO 65102		
2. City/County: City of St. Louis, MO	4. Prepared by: Cynthia Hill Longwisch, Landmarks Assn. of St. Louis, 917 Locust, 7th Floor, St. Louis, MO 63101

24. Foundation material: stone		25. Roof type/material: complex	
26. No. Bays: Front 3 Side 3		27. Wall treatment: aluminum siding	
28. Plan shape: see site map		29. Changes: Addition? rear Altered? yes

30. Exterior condition: good		31. Open to public? no	
32. Other Surveys in which included: Heritage/St. Louis survey, 1971			
33. Further description of important features: The main roof of this house is hipped, with a gable and dormer to add interest. The dormer is small and pedimented. A front gable projects slightly from body of house. Front porch has shed roof supported by paneled wood posts. Stone foundation is stuccoed. One-story rear addition.

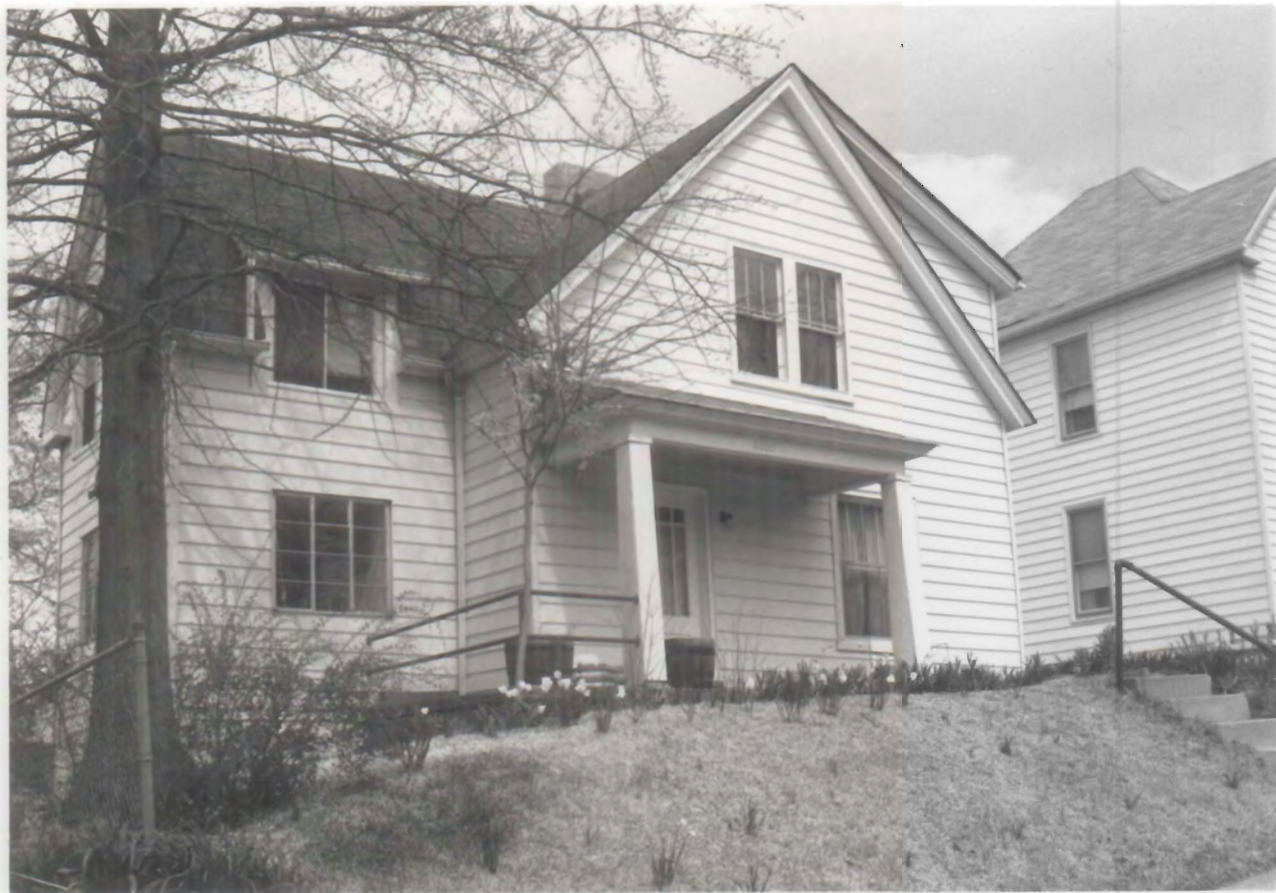
1. No. 196	3. Location of Negatives: Missouri Office of Historic Preservation, P. O. Box 176, Jefferson City, MO 65102		
2. City/County: City of St. Louis, MO	4. Prepared by: Cynthia Hill Longwisch, Landmarks Assn. of St. Louis, 917 Locust, 7th Floor, St. Louis, MO 63101

24. Foundation material: stone		25. Roof type/material: gabled	
26. No. Bays: Front 3 Side 2		27. Wall treatment: vinyl siding	
28. Plan shape: see site map		29. Changes: Addition? Altered? yes

30. Exterior condition: good		31. Open to public? no	
32. Other Surveys in which included: Heritage/St. Louis survey, 1971			
33. Further description of important features: The front-facing gabled of this house has paired 3-over-1 double-hung sash windows. Below, a shed-roof porch is supported by tapered, square wood pillars; it has no side walls. The doorway has Craftsman paning. At the right side, a "dormer" rises - really a part of the house intersected by the front gable. At left, both shed-roof dormer intersecting the eave and the window below are replacements.

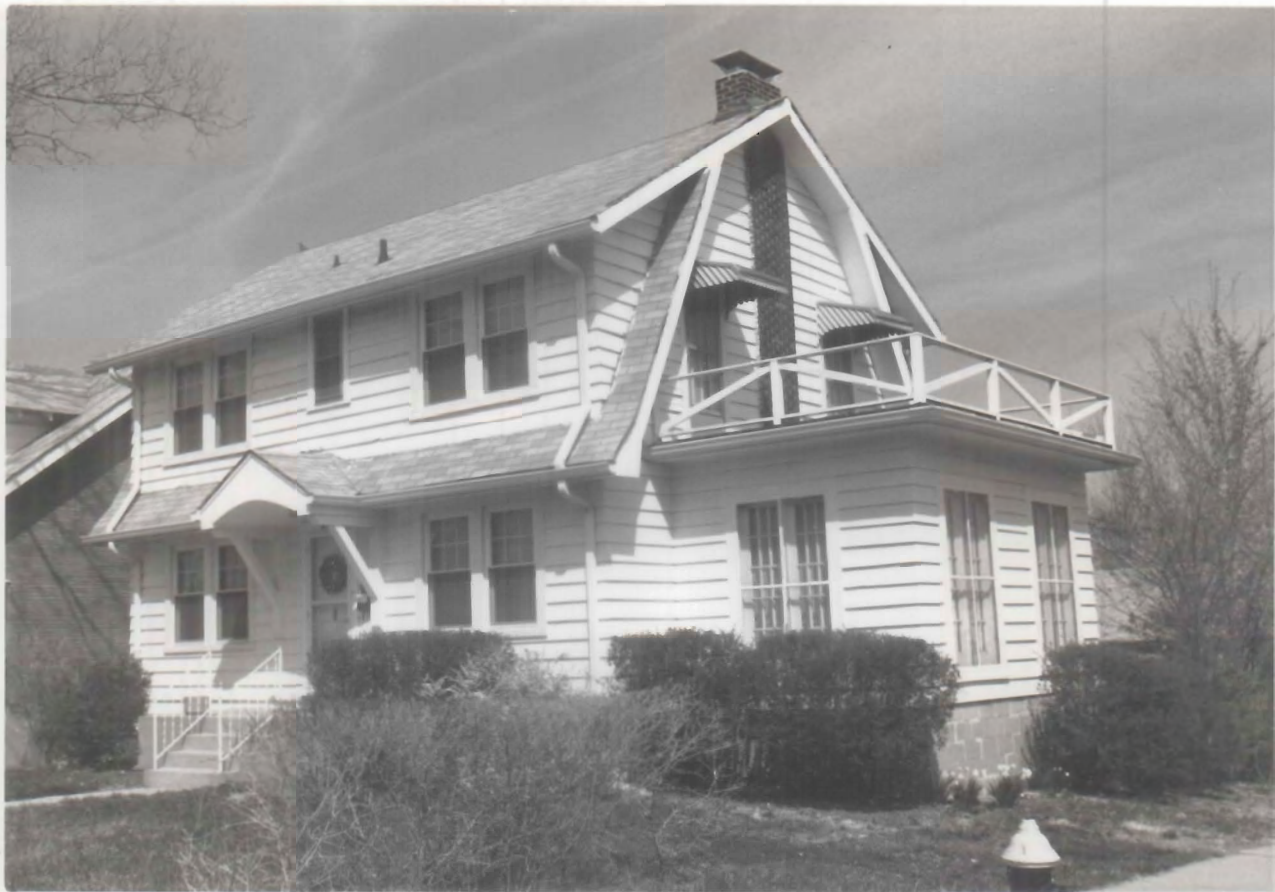
1. No. 036	3. Location of Negatives: Missouri Office of Historic Preservation, P. O. Box 176, Jefferson City, MO 65102		
2. City/County: City of St. Louis, MO	4. Prepared by: Cynthia Hill Longwisch, Landmarks Assn. of St. Louis, 917 Locust, 7th Floor, St. Louis, MO 63101

24. Foundation material: concrete		25. Roof type/material: mock gambrel*	
26. No. Bays: Front 3 Side 2		27. Wall treatment: wood clapboarding	
28. Plan shape: see site map		29. Changes: Addition? Altered?

30. Exterior condition: good		31. Open to public? no	
32. Other Surveys in which included: Heritage/St. Louis survey, 1971			
33. Further description of important features: *Interesting roofline treatment features a standard side gable intersected with gambrel-shaped eaves. The effect is one of a gambrel roof with full-width dormers, both front and back. Paired windows. Centered entrance is highlighted by a gabled hood supported by wood brackets. A one-story, flat-roofed room, apparently original, extends to the east; it has an upper railing and second-floor door access.

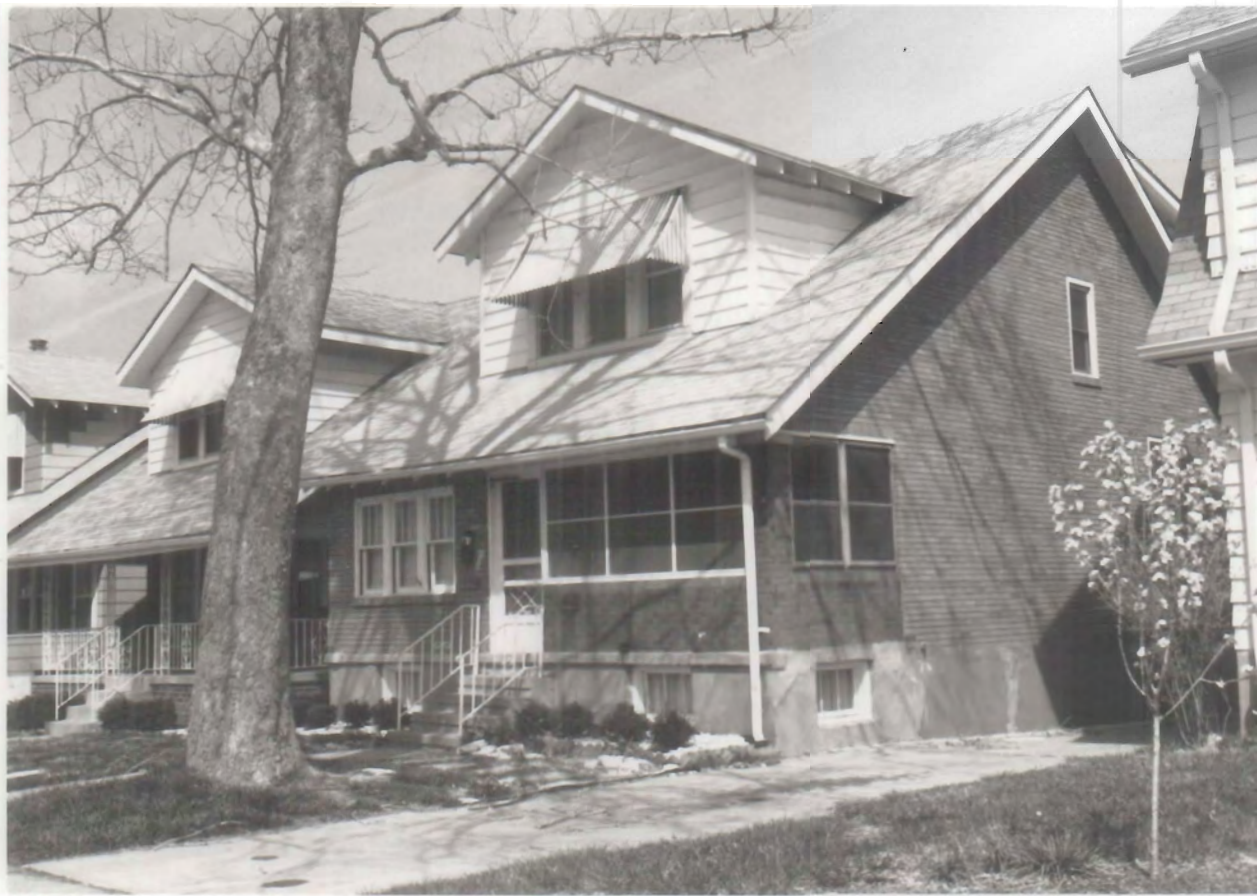
1. No. 035	3. Location of Negatives: Missouri Office of Historic Preservation, P. O. Box 176, Jefferson City, MO 65102		
2. City/County: City of St. Louis, MO	4. Prepared by: Cynthia Hill Longwisch, Landmarks Assn. of St. Louis, 917 Locust, 7th Floor, St. Louis, MO 63101

24. Foundation material: stuccoed		25. Roof type/material: side gable	
26. No. Bays: Front	Side 3	27. Wall treatment: red/orange brick	
28. Plan shape: see site map		29. Changes: Addition?	Altered? yes

30. Exterior condition: good		31. Open to public? no	
32. Other Surveys in which included: Heritage/St. Louis survey, 1971			
33. Further description of important features: Center dormer is gabled and has three windows; overhanging eaves with exposed rafter ends. Roof extends over a porch that is now enclosed. Unlike the other houses in this group, the porch did not originally extend the width of the house; rather, an extra front room on the west side is original. The original porch was open and took up the remainder of the front; it is now enclosed with brick and screens.

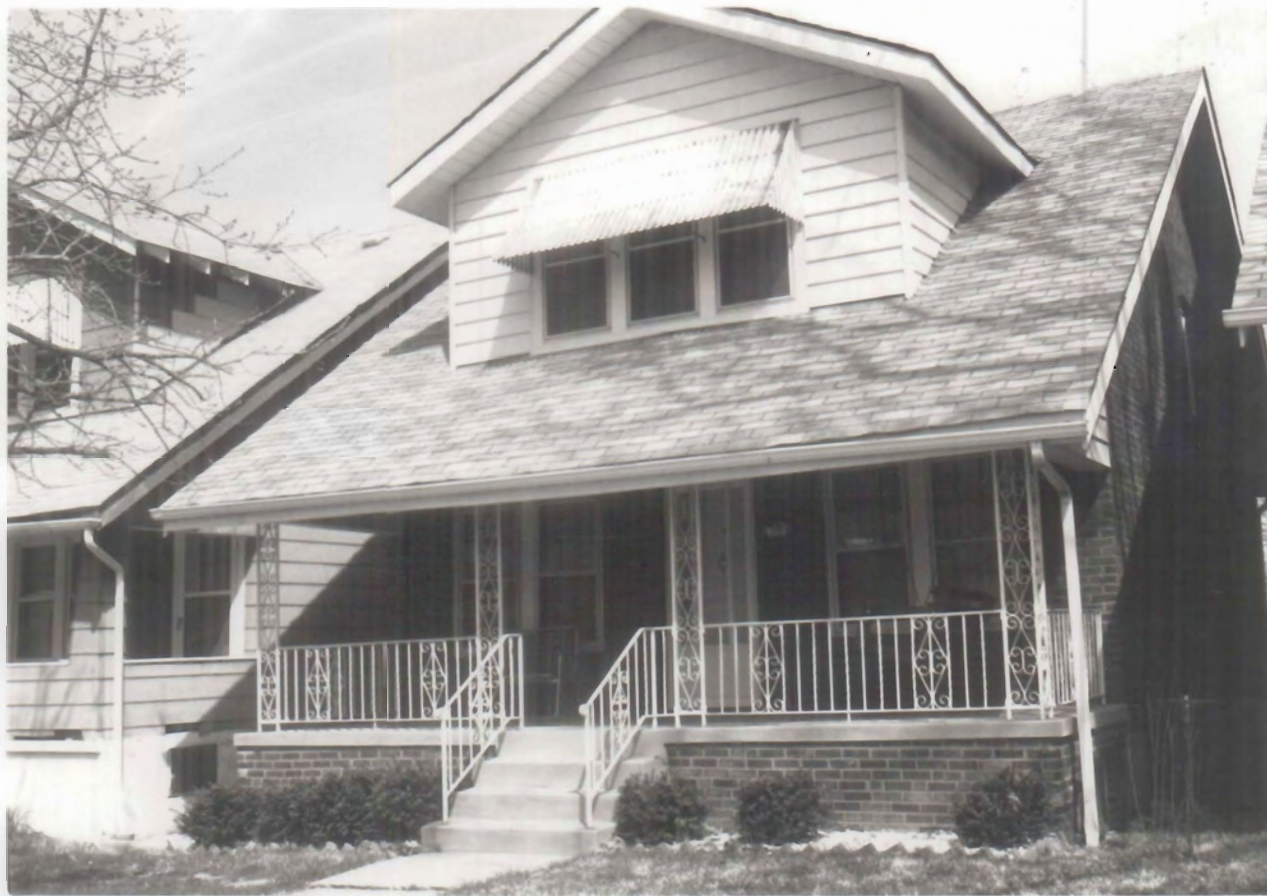
1. No. 034	3. Location of Negatives: Missouri Office of Historic Preservation, P. O. Box 176, Jefferson City, MO 65102		
2. City/County: City of St. Louis, MO	4. Prepared by: Cynthia Hill Longwisch, Landmarks Assn. of St. Louis, 917 Locust, 7th Floor, St. Louis, MO 63101

24. Foundation material: concrete		25. Roof type/material: side gable	
26. No. Bays: Front 3 Side 1		27. Wall treatment: textured brick	
28. Plan shape: see site map		29. Changes: Addition? Altered?

30. Exterior condition: good		31. Open to public? no	
32. Other Surveys in which included: Heritage/St. Louis survey, 1971			
33. Further description of important features: Center gabled dormer is sided and has triple windows and overhanging eaves. Roofline extends over porch and has overhanging eaves. Porch roof supported by wrought-iron pillars; wrought-iron railings. Paired, 3-over-3 windows flank center doorway.

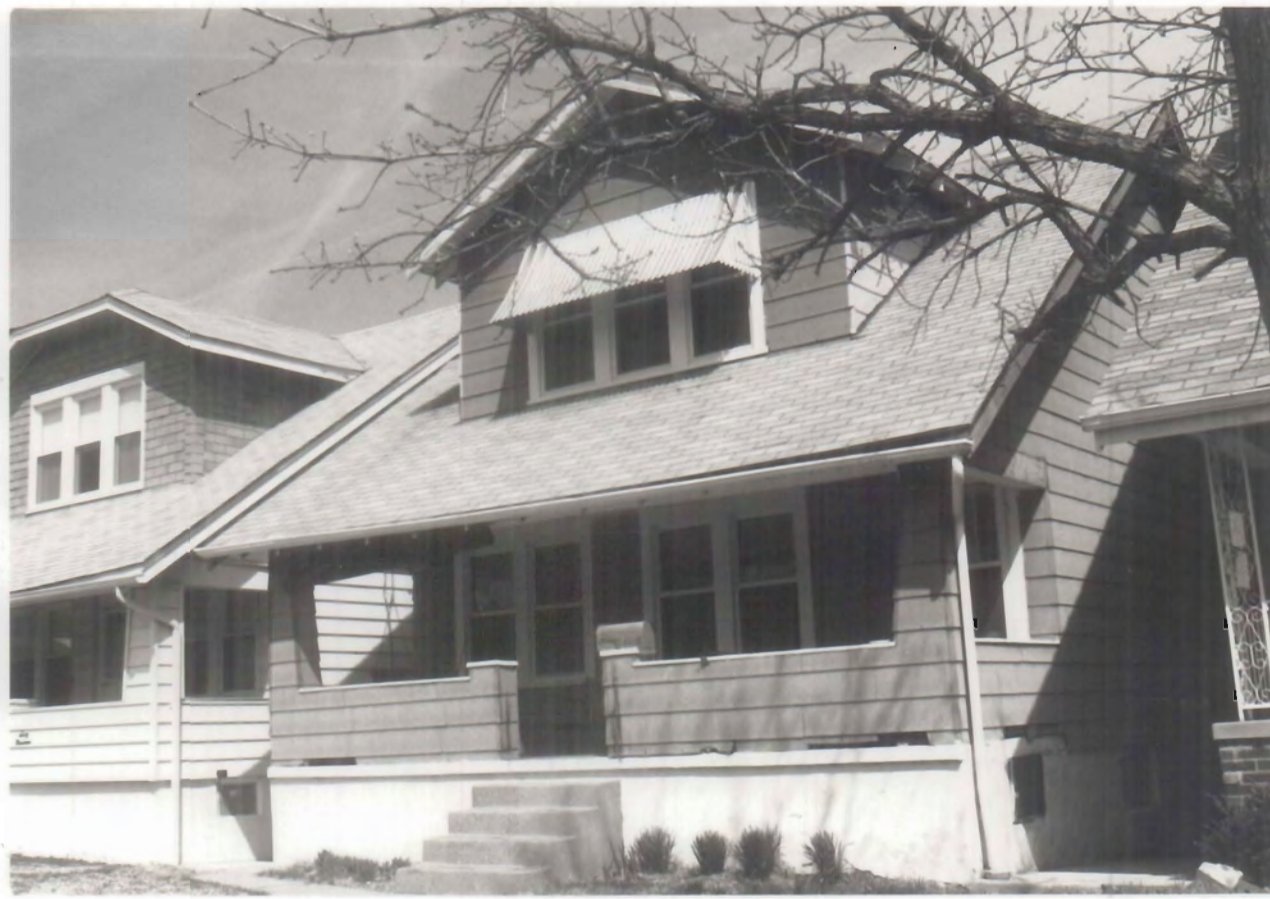
24. Foundation material: stuccoed		25. Roof type/material: side gable	
26. No. Bays: Front 3 Side 1		27. Wall treatment: asbestos siding	
28. Plan shape: see site map		29. Changes: Addition? Altered?

30. Exterior condition: fair/good		31. Open to public? no	
32. Other Surveys in which included: Heritage/St. Louis survey, 1971			
33. Further description of important features: Gabled front dormer has triple windows and overhanging eaves. Roofline extends over porch and features exposed rafter ends and overhanging eaves. Tapered porch pillars; solid porch side walls.

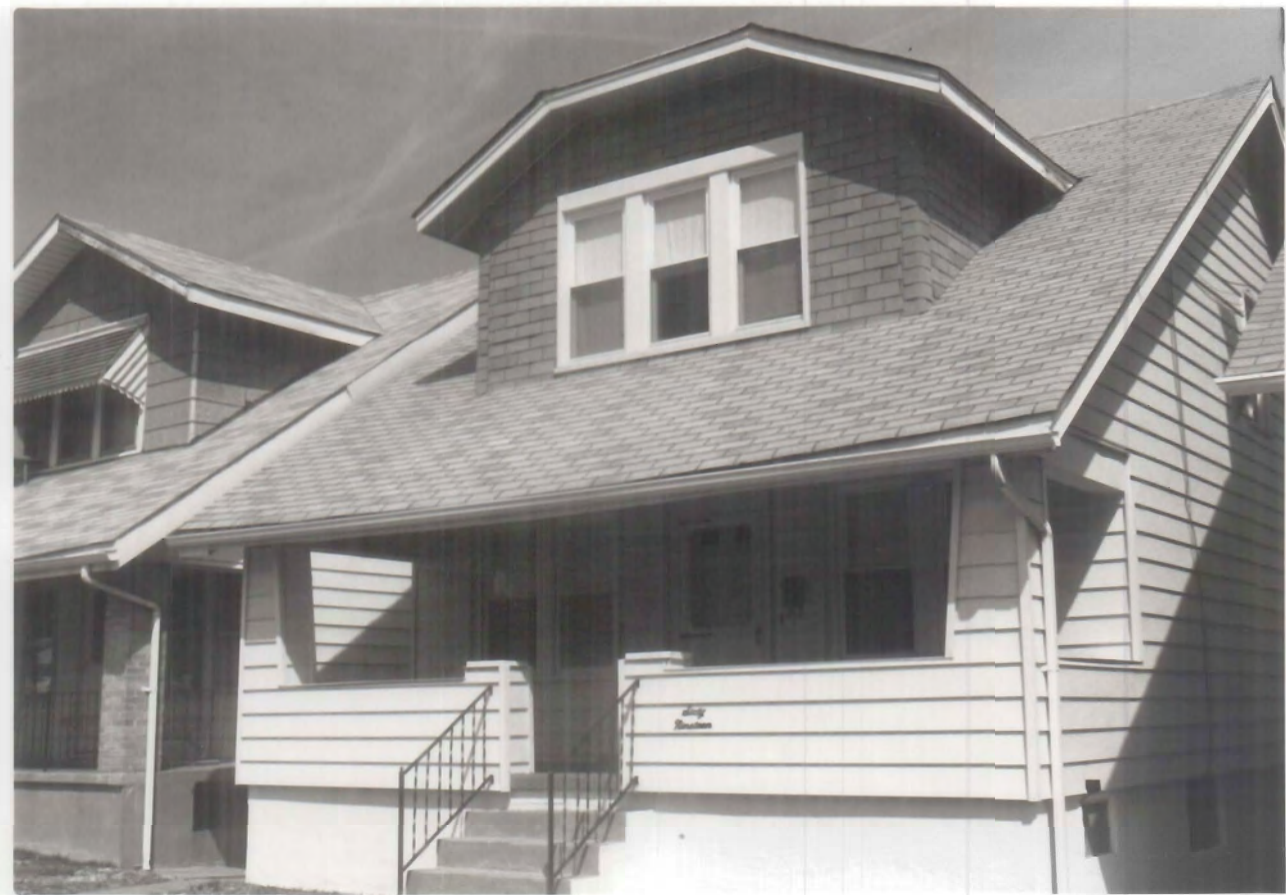
24. Foundation material: stuccoed		25. Roof type/material: side gable	
26. No. Bays: Front 3 Side 1		27. Wall treatment: vinyl siding	
28. Plan shape: see site map		29. Changes: Addition?	Altered? yes

30. Exterior condition: good		31. Open to public? no	
32. Other Surveys in which included: Heritage/St. Louis survey, 1971			
33. Further description of important features: Wider-width siding is the main alteration to this house. Its large front dormer features a hipped gable with the tripled (replacement) windows. Tapering columns support porch roof, which is an extension of the house roof. Solid porch side walls. Overhanging eaves. Paired (replacement) windows flank center doorway.

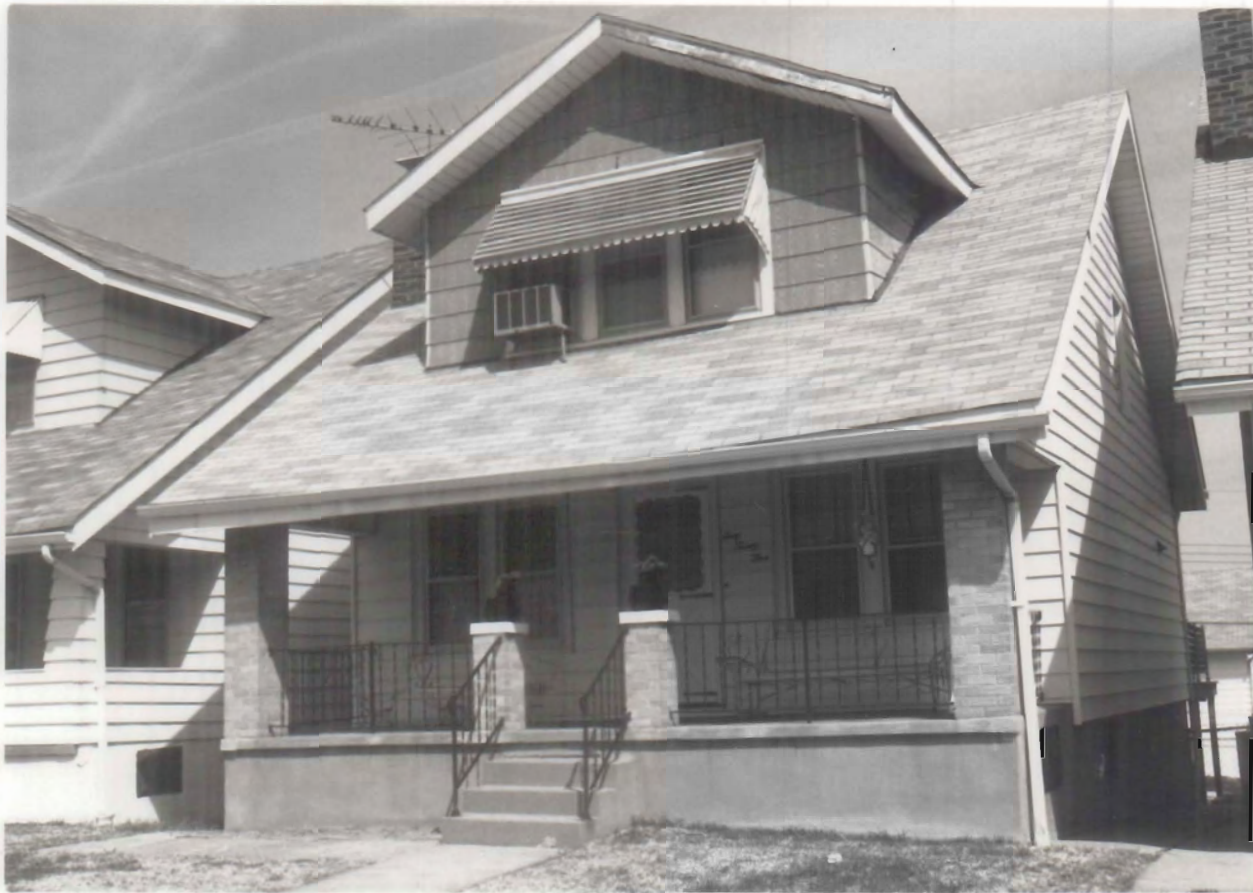
24. Foundation material: stuccoed		25. Roof type/material: side gable	
26. No. Bays: Front 3 Side 1		27. Wall treatment: vinyl siding	
28. Plan shape: see site map		29. Changes: Addition? Altered? yes

30. Exterior condition: good		31. Open to public? no	
32. Other Surveys in which included: Heritage/St. Louis survey, 1971			
33. Further description of important features: Work appears to have been done to the front porch; concrete base and brick pillars appear to be newer than house. Large gabled dormer has triple, 3-over-1 pane windows and overhanging eaves, as does the house. House roof extends to cover porch. Porch has iron railing rather than solid side walls. Paired, 3-over-1 windows flank the center doorway.

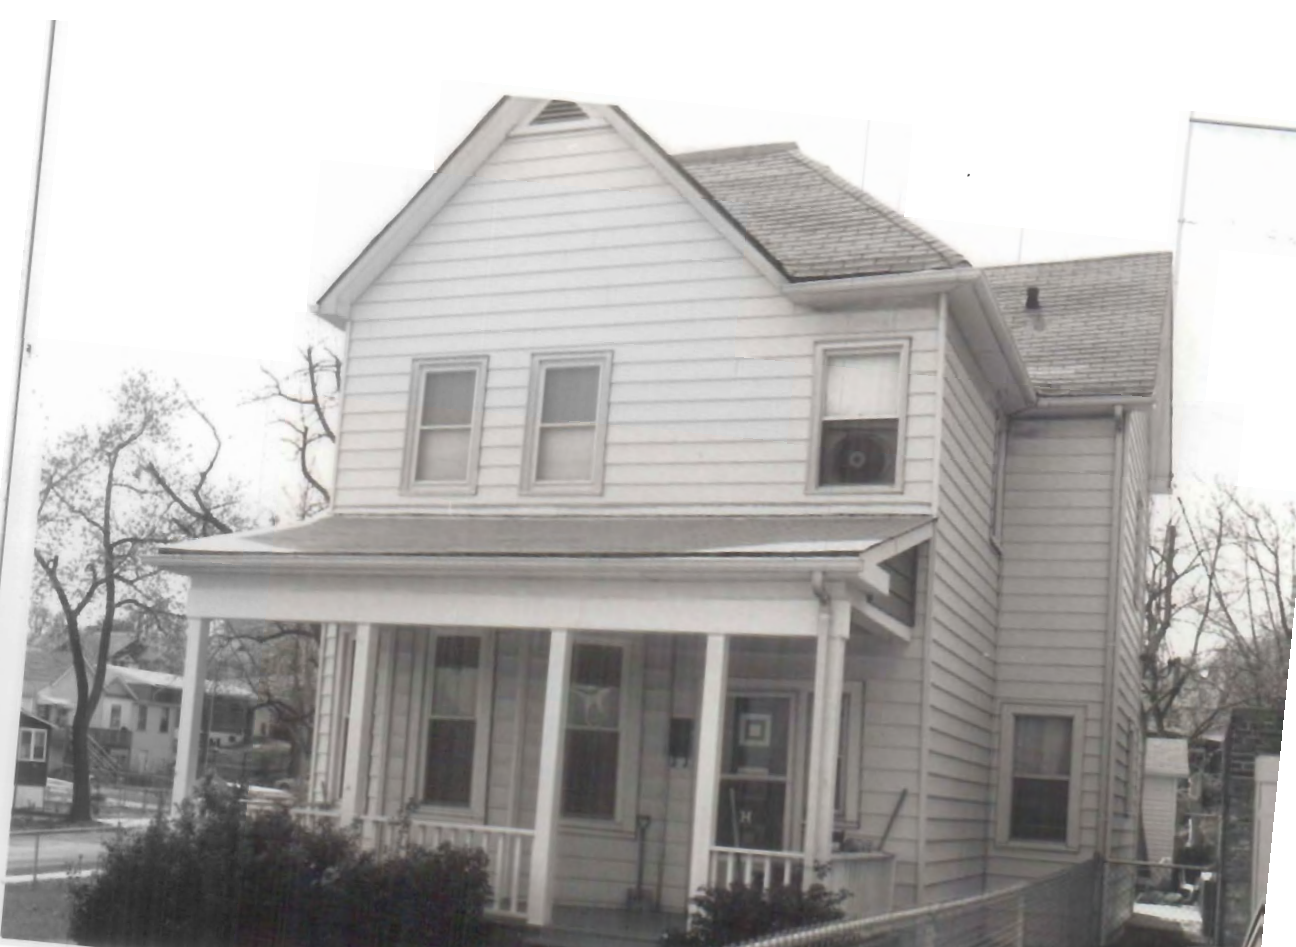
24. Foundation material: concrete		25. Roof type/material: complex	
26. No. Bays: Front 4 Side 2		27. Wall treatment: vinyl siding	
28. Plan shape: see site map	29. Changes: Addition?		Altered? yes

30. Exterior condition: good		31. Open to public? no	
32. Other Surveys in which included: Heritage/St. Louis survey, 1971			
33. Further description of important features: Main roofline is a truncated pyramid with gables. Windows appear to be replacements: 1-over-1. A full-width porch is supported by thin square wood posts; it shelters a door with one side-light/window and an angled bay window. At the west side, a gabled projection has both front- and side-facing windows.

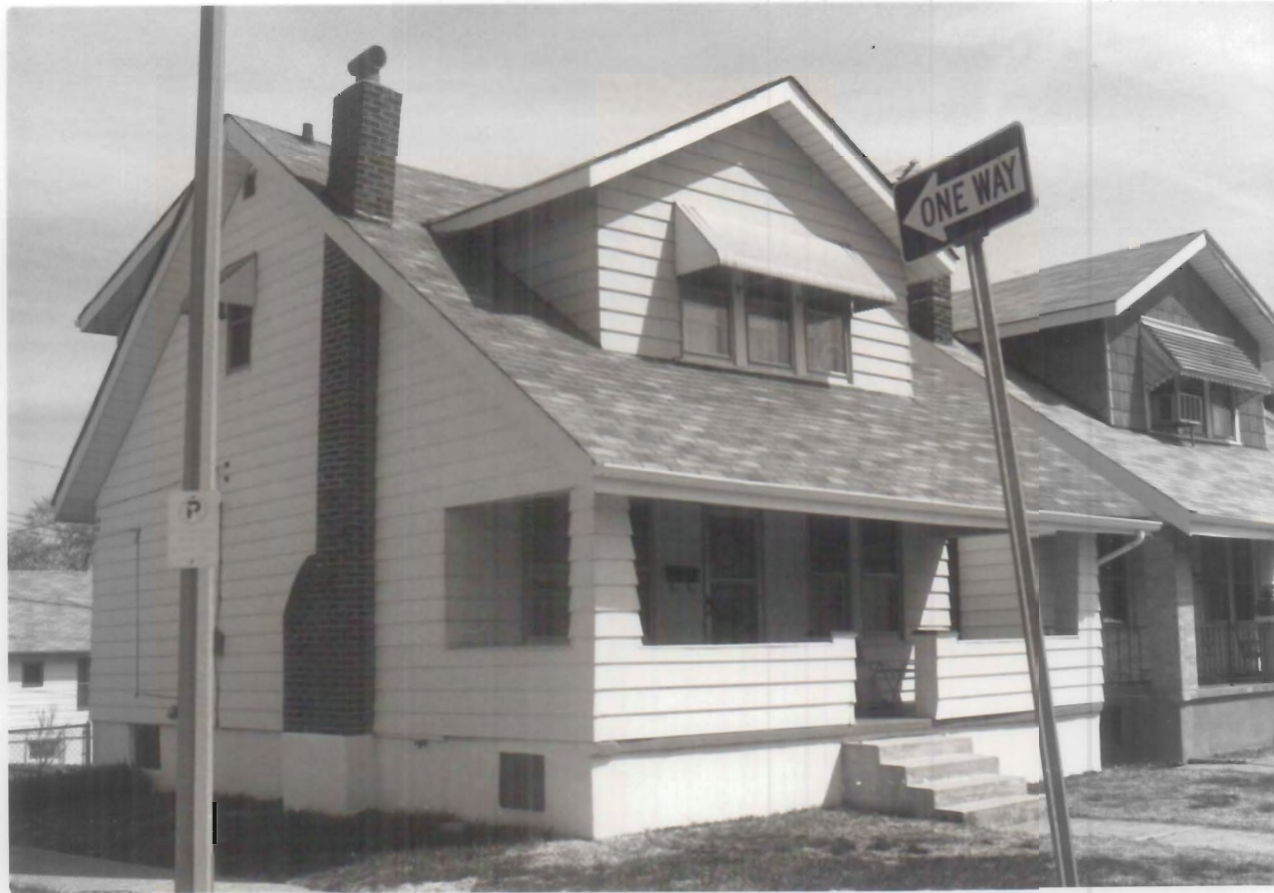
24. Foundation material: stuccoed		25. Roof type/material: side gable	
26. No. Bays: Front 3 Side 1		27. Wall treatment: vinyl siding	
28. Plan shape: see site map		29. Changes: Addition? Altered? yes

30. Exterior condition: good		31. Open to public? no	
32. Other Surveys in which included: Heritage/St. Louis survey, 1971			
33. Further description of important features: Wider-width siding is primary alteration. Large front dormer has overhanging eaves and tripled (replacement) windows. Roof of house extends to cover porch. Porch has tapering columns and solid side walls. Paired (replacement) windows flank center doorway.

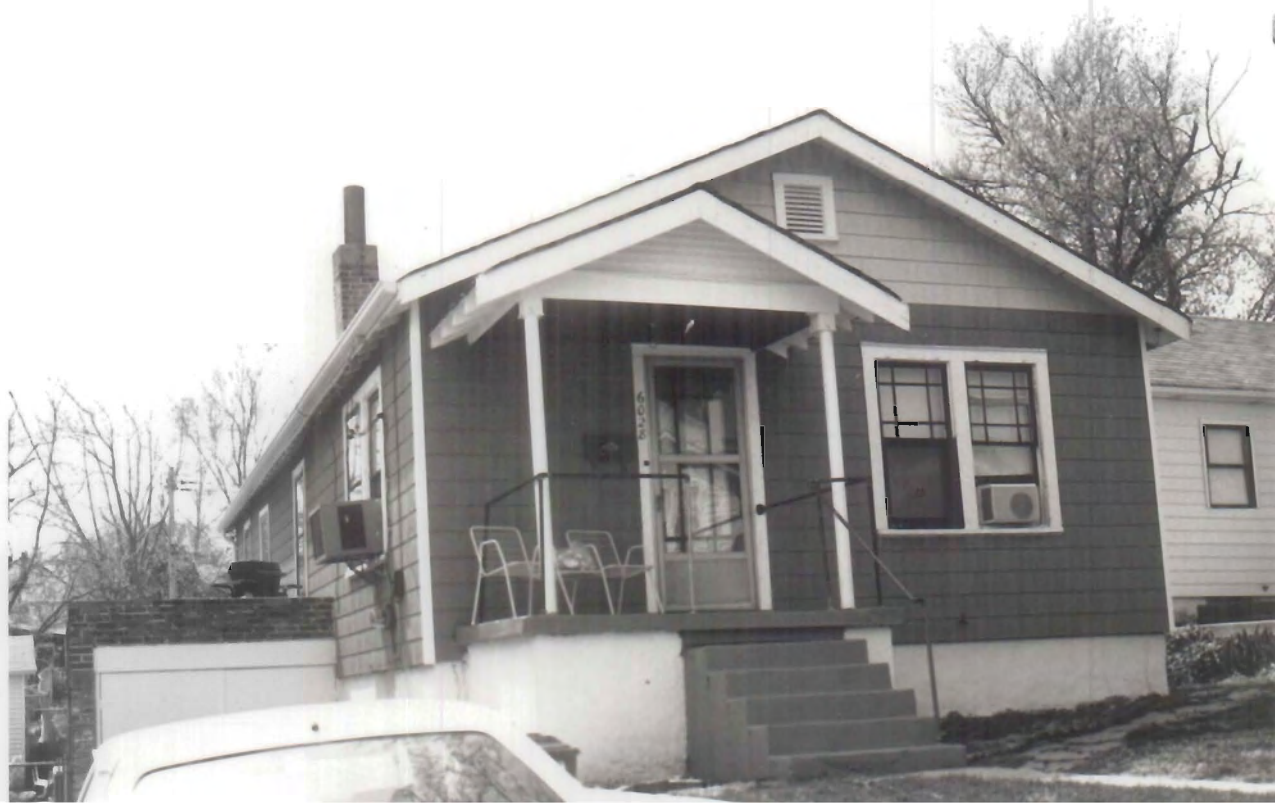
26. No. Bays: Front 2 Side 4		27. Wall treatment: siding*	
28. Plan shape: see site map	29. Changes: Addition? yes Altered?		
30. Exterior condition: good		31. Open to public? no

32. Other Surveys in which included: Heritage/St. Louis survey, 1971			
33. Further description of important features: Both the house and the porch roofs have exposed rafter ends. Windows are Craftsman 9-over-1 double-hung sash. Small porch is supported by thin (metal pipe?) posts. A brick garage extends from the east side, making use of the slope in grade so that it is essentially incorporated into the basement. *A 1967 building permit says "apply plastic glass siding to frame dwelling."

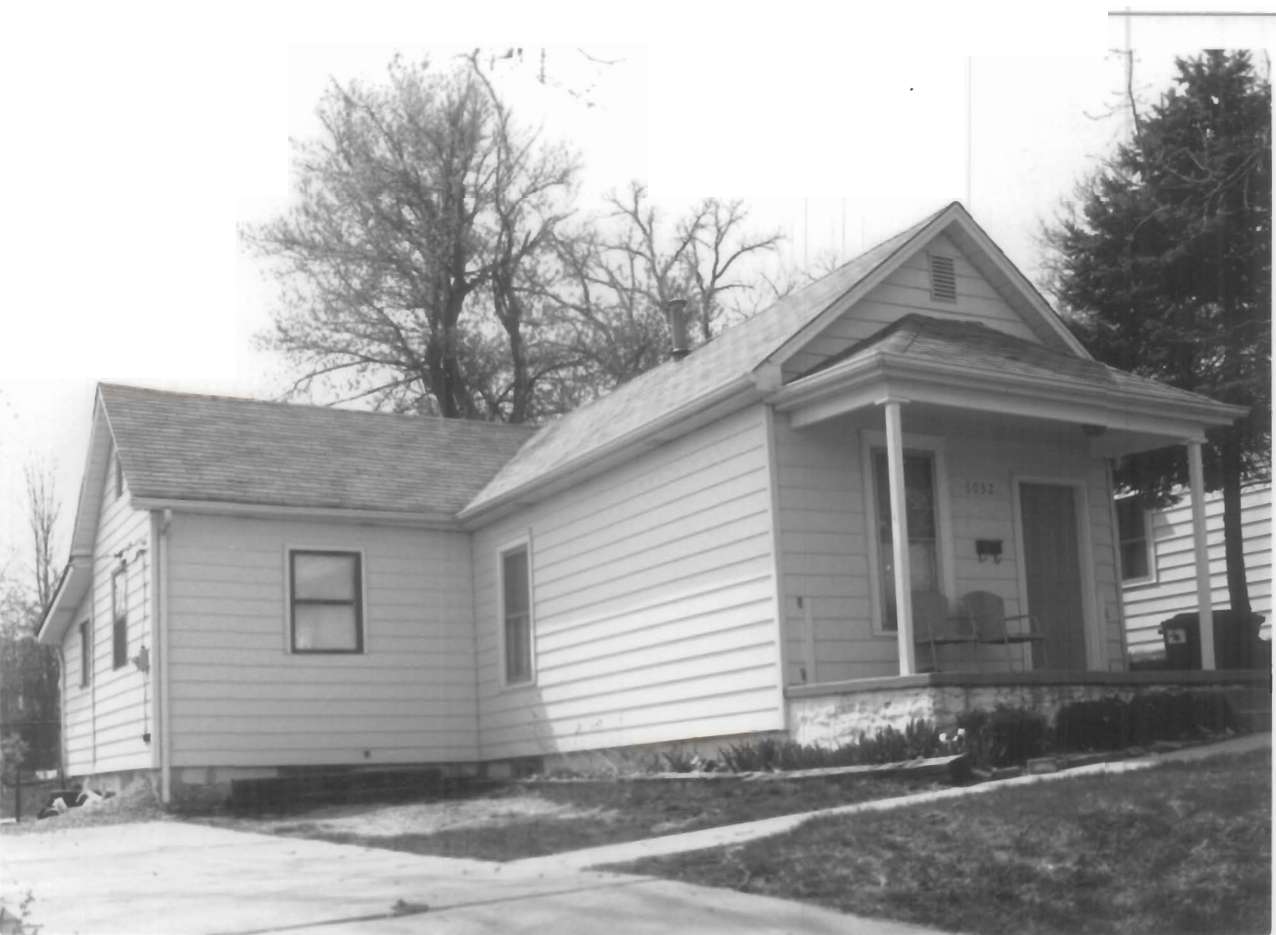
3. Further description of important features: This house was originally a -bay shotgun (original bays above in parentheses). A porch on the front of the house is supported by thin wood posts. Windows are 2-over-2 double-hung ash. A rear addition extends to the east and south.

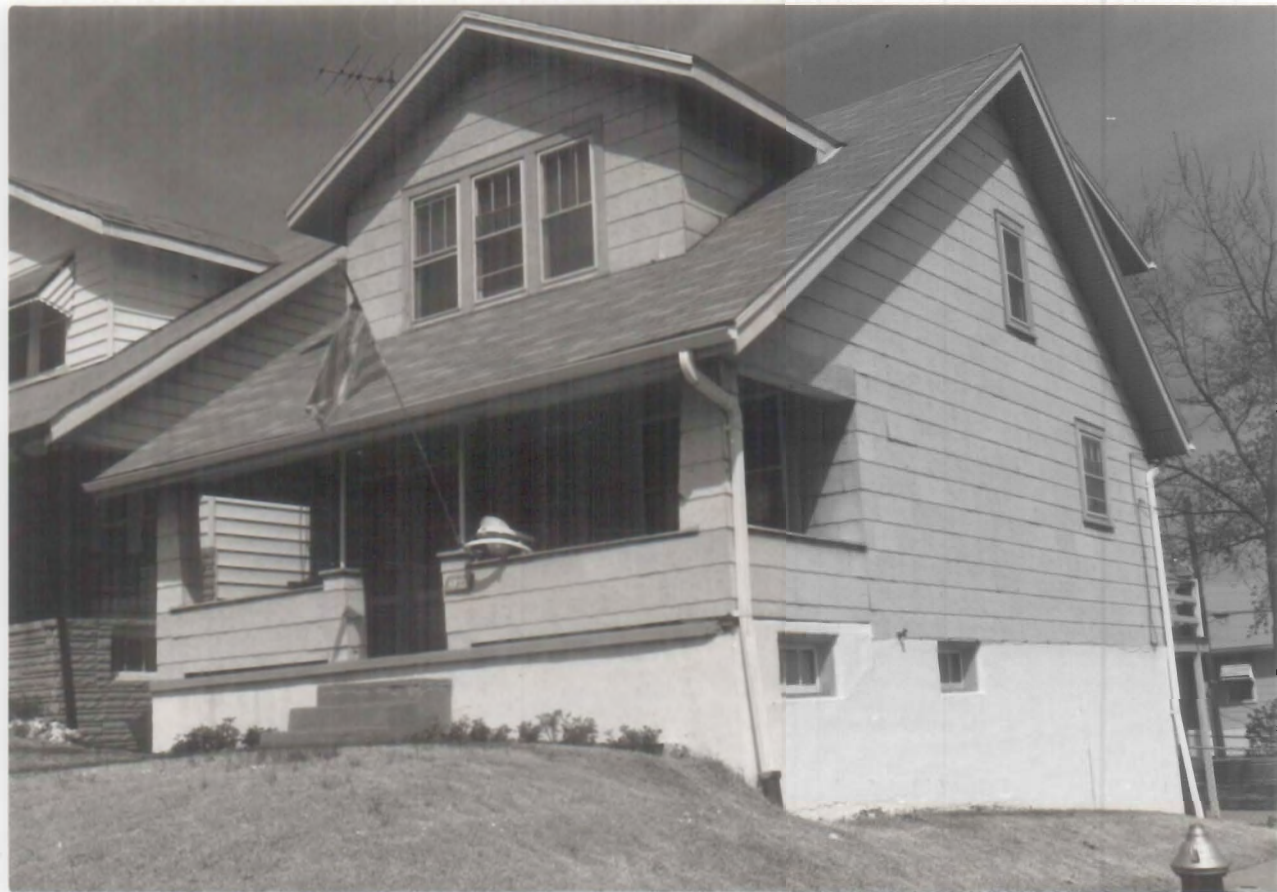
24. Foundation material: stuccoed		25. Roof type/material: side gable	
26. No. Bays: Front 3 Side 2		27. Wall treatment: asbestos siding	
28. Plan shape: see site map		29. Changes: Addition? Altered?

30. Exterior condition: good		31. Open to public? no	
32. Other Surveys in which included: Heritage/St. Louis survey, 1971			
33. Further description of important features: Gabled front dormer has triple window with 3-over-3 panes; like the house, it has overhanging eaves. A full-width porch is covered by an extension of the house roof. Tapering pillars support porch roof. Porch has solid short side walls. Paired, 3-over-3 windows flank center door.

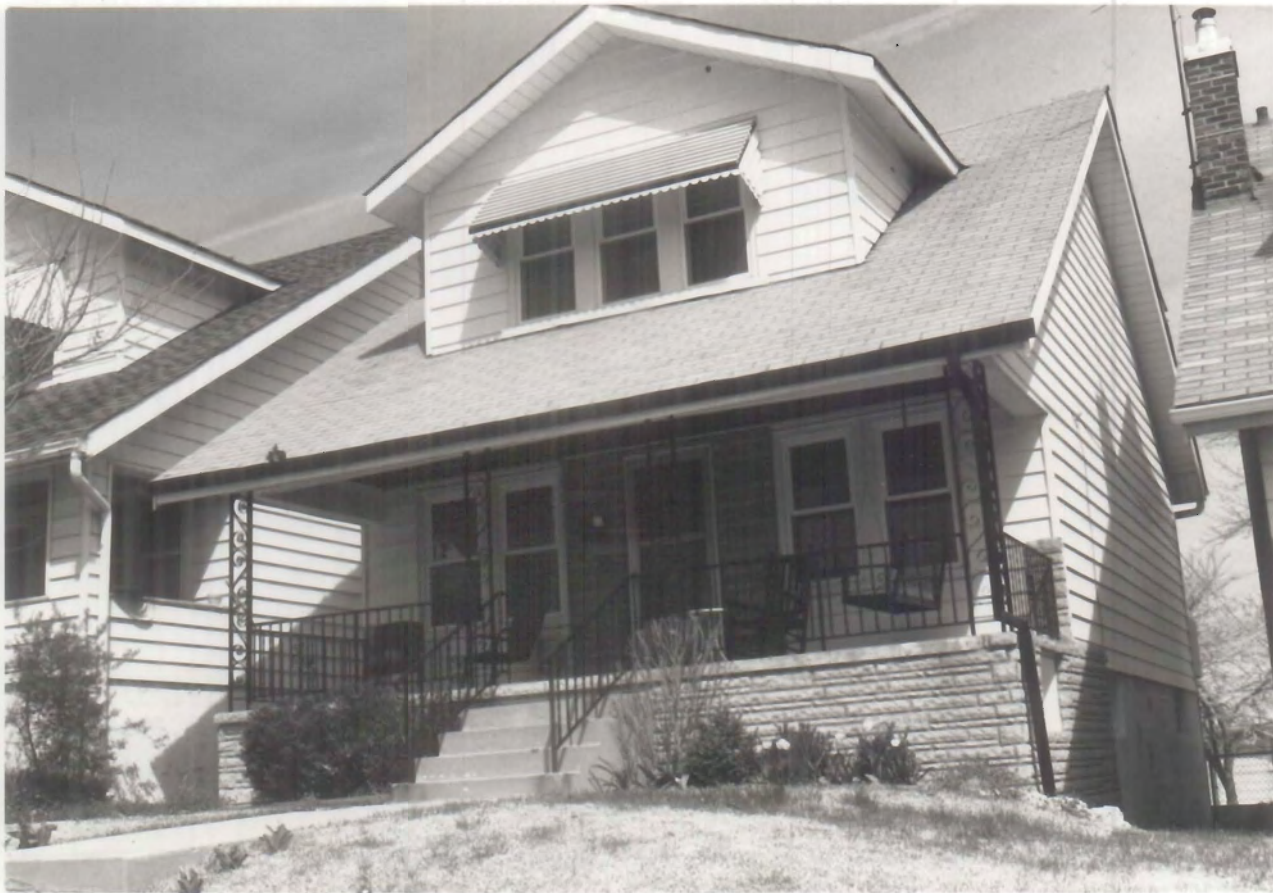
24. Foundation material: stuccoed		25. Roof type/material: side gable	
26. No. Bays: Front 3 Side 1		27. Wall treatment: vinyl siding	
28. Plan shape: see site map		29. Changes: Addition? Altered? yes

30. Exterior condition: good		31. Open to public? no	
32. Other Surveys in which included: Heritage/St. Louis survey, 1971			
33. Further description of important features: Main alterations are applied stone on foundation of full-width porch and door surround, and vinyl siding. Dormer has triple windows and overhanging eaves, as does house. Roof extends to cover porch, supported by wrought-iron posts. Porch does not have solid sides like most in this group, instead having iron railings. Paired windows flank center doorway; windows are 1-over-1 replacements.

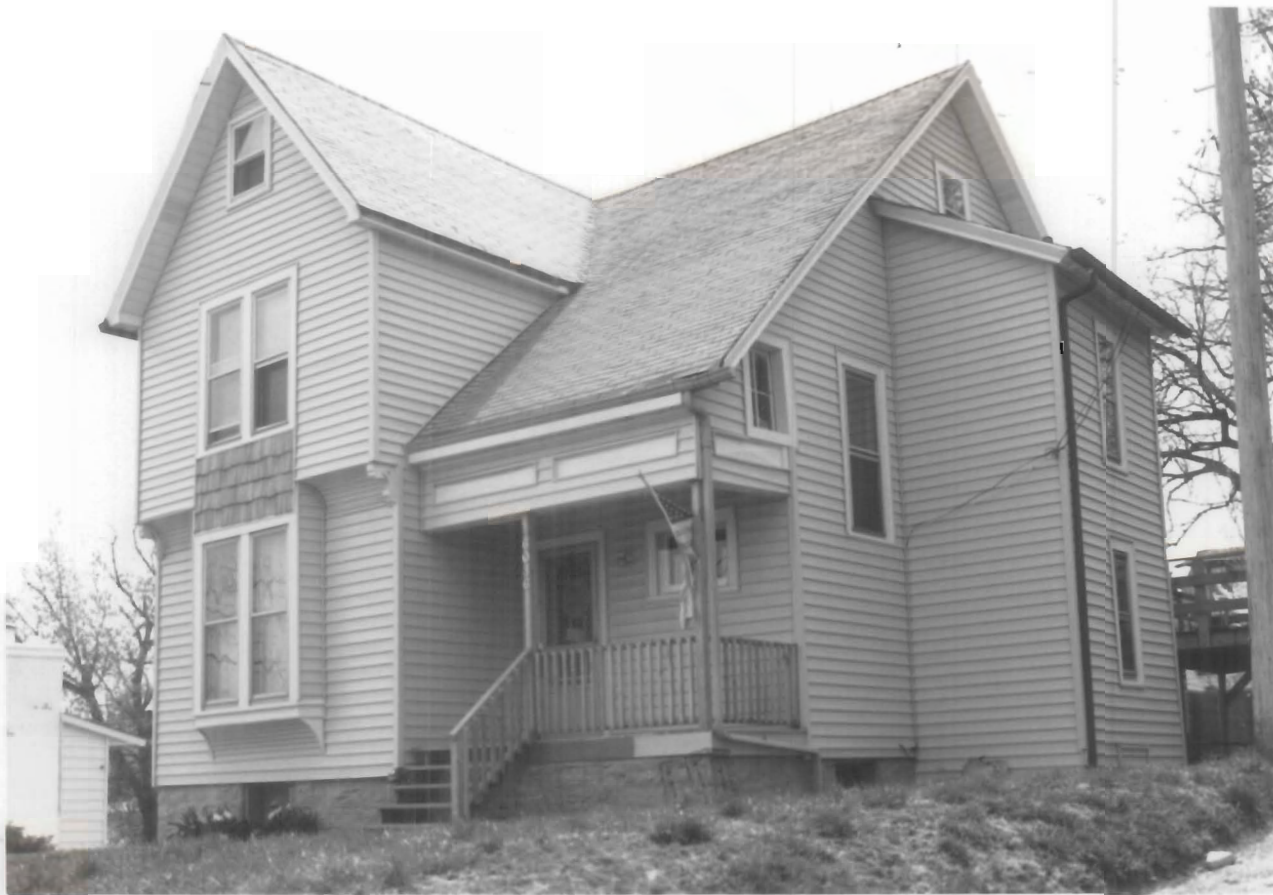
3. Further description of important features: The front gable projects above the first story slightly, the transitional area resembles a tambour door, curving around the rounded inside top of the bay window (photo); this motif is repeated at the bottom of the bay window. An open porch has a paneled cornice. Projecting bays on both side elevations. A 1971 Heritage/St. Louis photo shows that the shingled area between floors on the front bay was (cont'd. below)

4. History and Significance: originally covered with imbrication; this is certainly an unfortunate and unnecessary alteration. The porch railing in that photo is paneled to more or less match the cornice; while it probably was not original, it was more appropriate than the present treated-wood deck railing. Building permits prior to c. 1925 are available for this city block.
