# ARCHITECTURAL SURVEY OF CLIFTON HEIGHTS

JUNE 1991

ST. LOUIS, MISSOURI

LANDMARKS ASSOCIATION OF ST. LOUIS, INC.

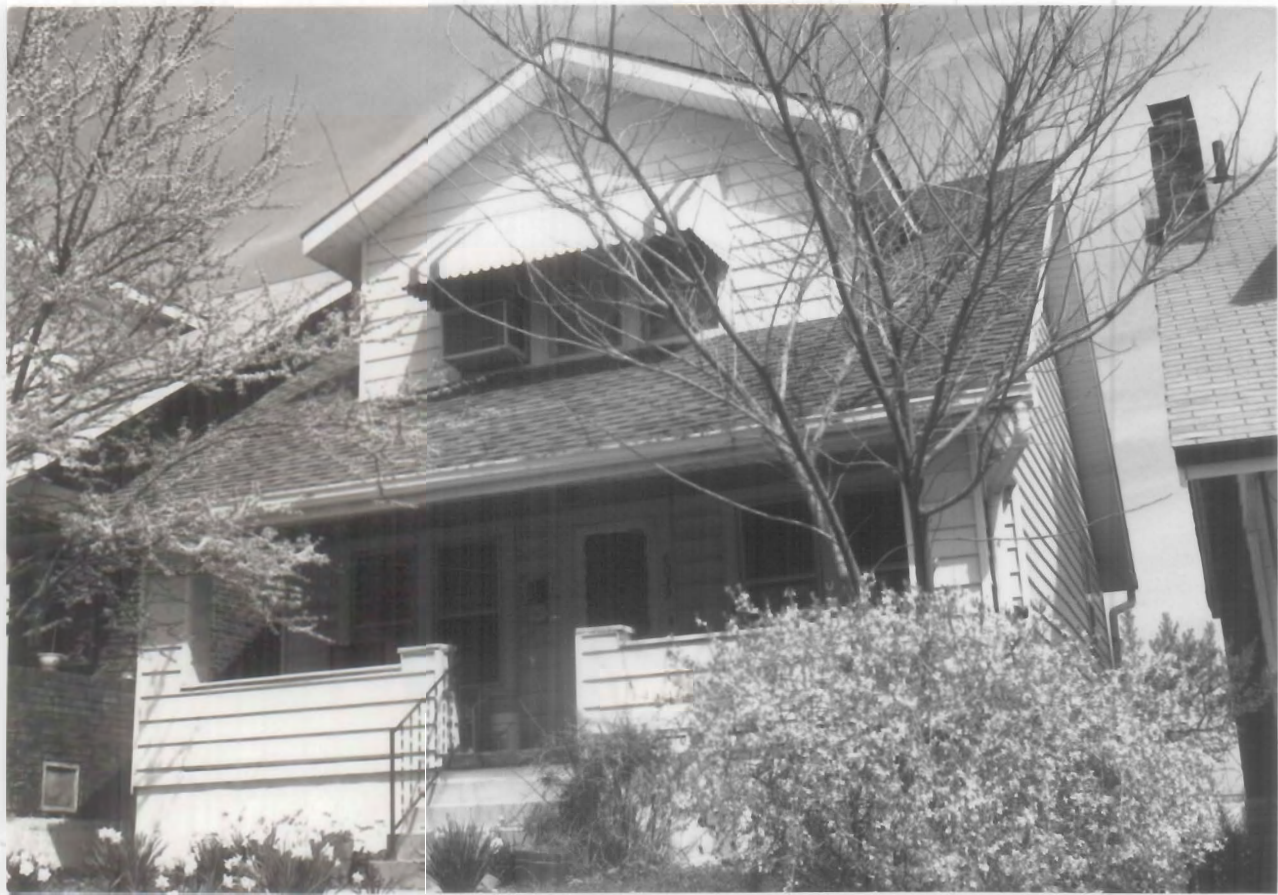
24. Foundation material: stuccoed		25. Roof type/material: side gable	
26. No. Bays: Front 3 Side 2		27. Wall treatment: vinyl siding	
28. Plan shape: see site map		29. Changes: Addition?      Altered? yes

30. Exterior condition: good		31. Open to public? no	
32. Other Surveys in which included: Heritage/St. Louis survey, 1971			
33. Further description of important features: The wider-width vinyl siding appears to be the only significant change from the original design. Large, centered dormer has overhanging eaves and triple windows with 3-over-1 panes. House roof extends to include full-width porch. Paired, 3-over-1 double-hung wood sash windows flank the center door.

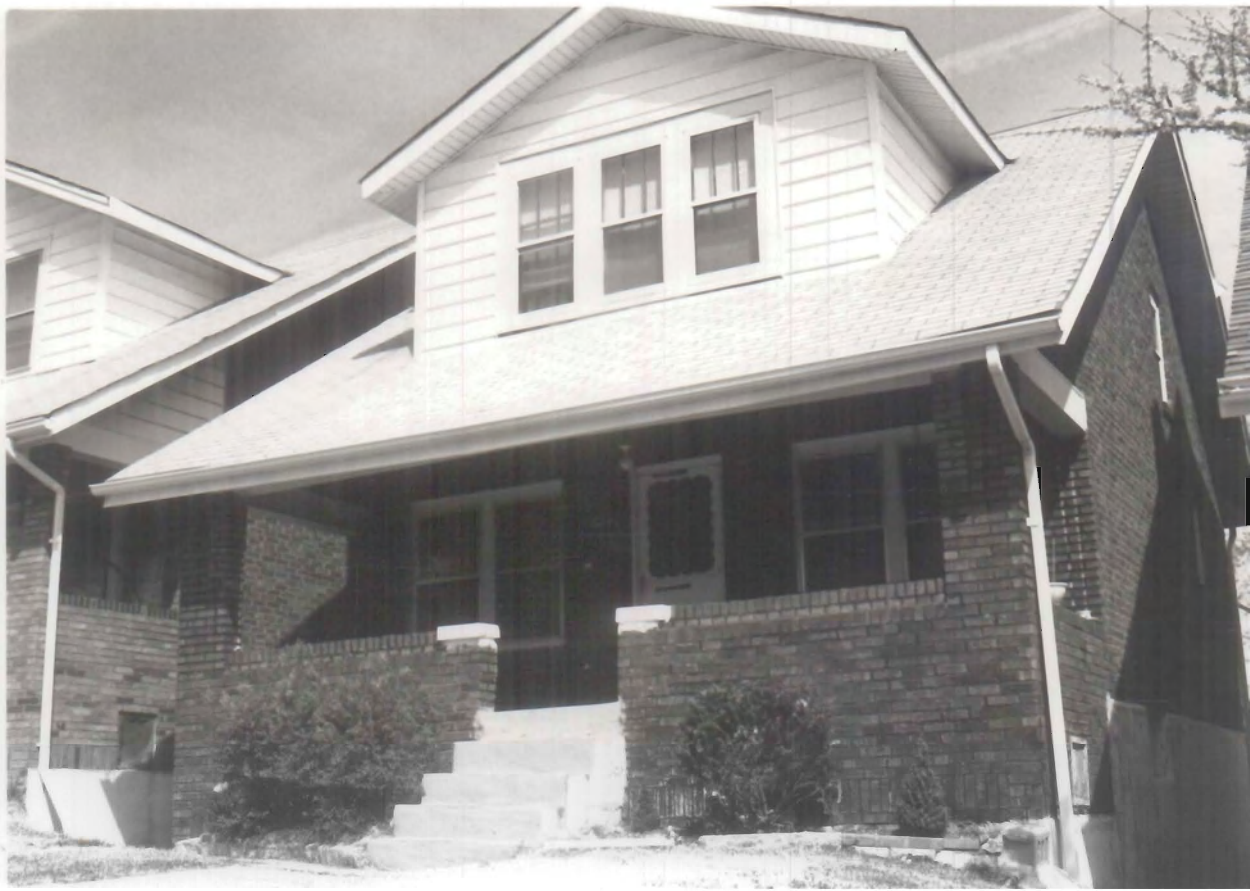
24. Foundation material: stuccoed		25. Roof type/material: side gable	
26. No. Bays: Front 3 Side 3		27. Wall treatment: textured brick	
28. Plan shape: see site map		29. Changes: Addition? Altered?

30. Exterior condition: good		31. Open to public? no	
32. Other Surveys in which included: Heritage/St. Louis survey, 1971			
33. Further description of important features: Very similar to survey #24-35. Large frame dormer has overhanging eaves and triple, 3-over-1 panes, which are also found on the front elevation. Roofline extends to form porch roof. Porch extends full width of the house and is supported by brick columns. Solid brick porch sidewalls. Paired windows flank center doorway.

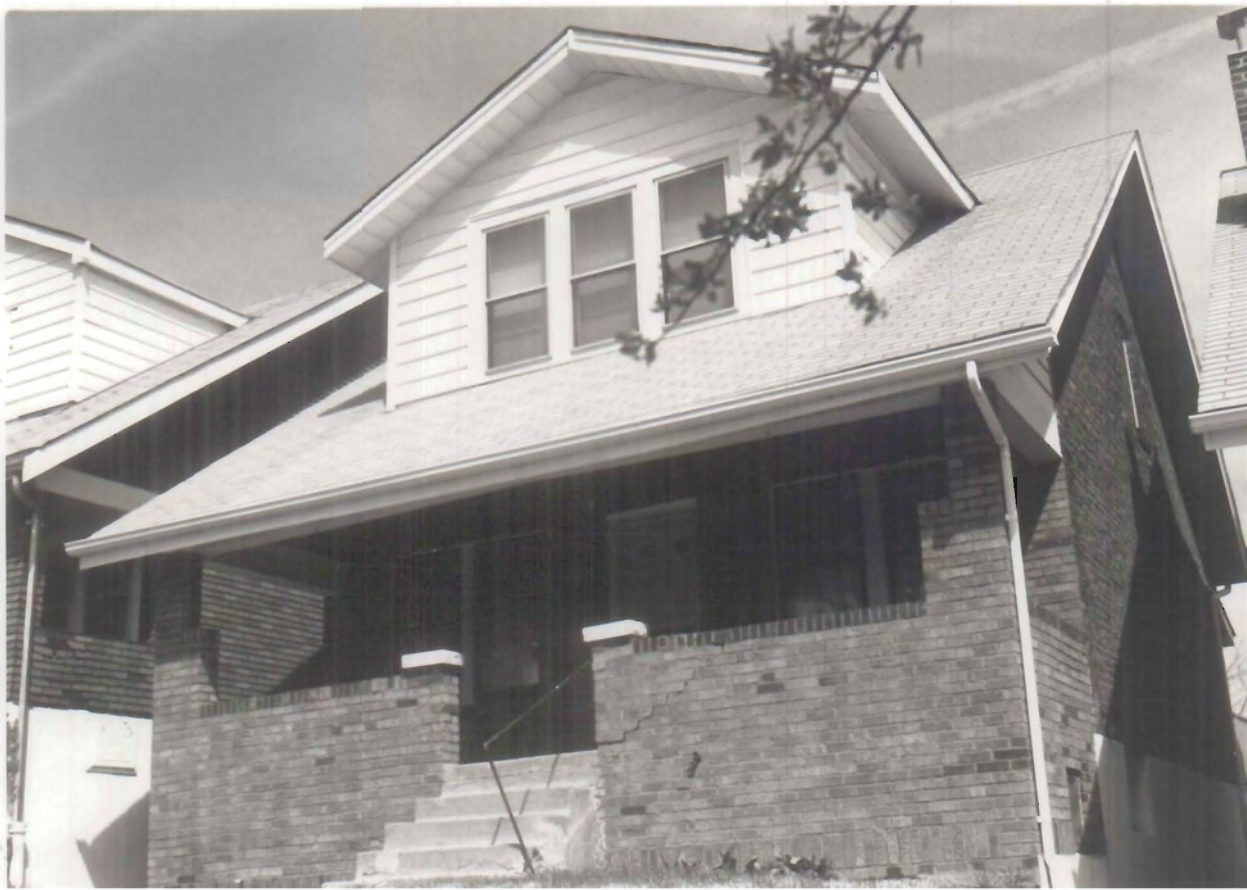
24. Foundation material: stuccoed		25. Roof type/material: side gable	
26. No. Bays: Front 3 Side 2		27. Wall treatment: red brick	
28. Plan shape: see site map	29. Changes: Addition?		Altered?

30. Exterior condition: good		31. Open to public? no	
32. Other Surveys in which included: Heritage/St. Louis survey, 1971			
33. Further description of important features: Large front dormer features triple windows and overhanging eaves, as does the rest of the house. House roof extends forward to cover porch across the width of the house. Short brick walls of porch are solid and topped with a header course. 3-over-1, paired, double-hung wood sash windows flank the center doorway. Like many houses in the immediate vicinity, the foundation has been stuccoed to obscure the material.

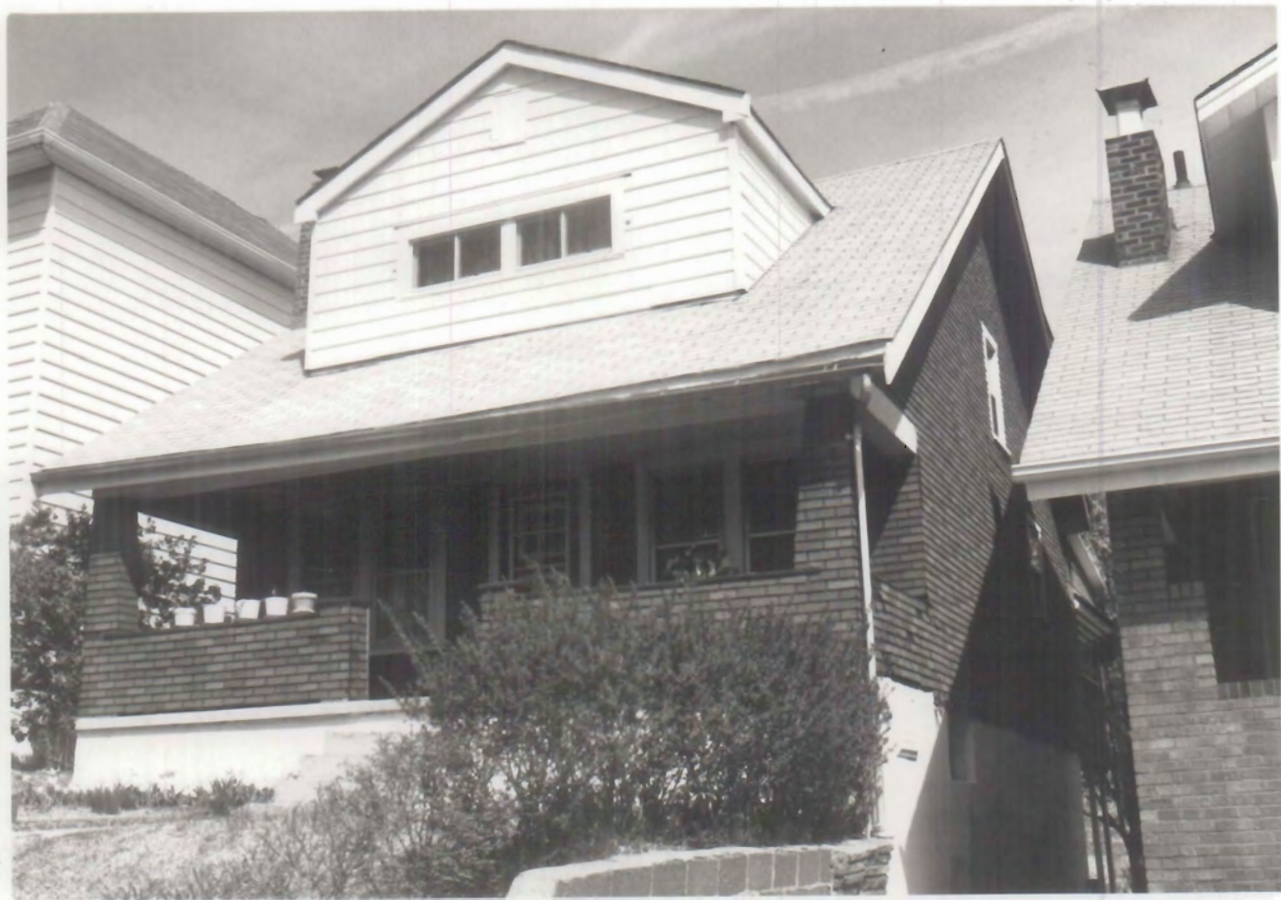
24. Foundation material: stuccoed		25. Roof type/material: side gable	
26. No. Bays: Front 3 Side 3		27. Wall treatment: asphalt shingles	
28. Plan shape: see site map		29. Changes: Addition? Altered? yes

33. Further description of important features: The windows of the large dormer have been reduced in size and the dormer sided. The roofline extends to form the porch roof, supported by tapering columns. Front windows are paired and have simple wood frames. This is one of 12 very similar houses in a row (survey #24 - 35), probably all built at nearly the same time and probably by the same builder - H. C. Vollmar is a likely candidate (see survey #38 - 73).

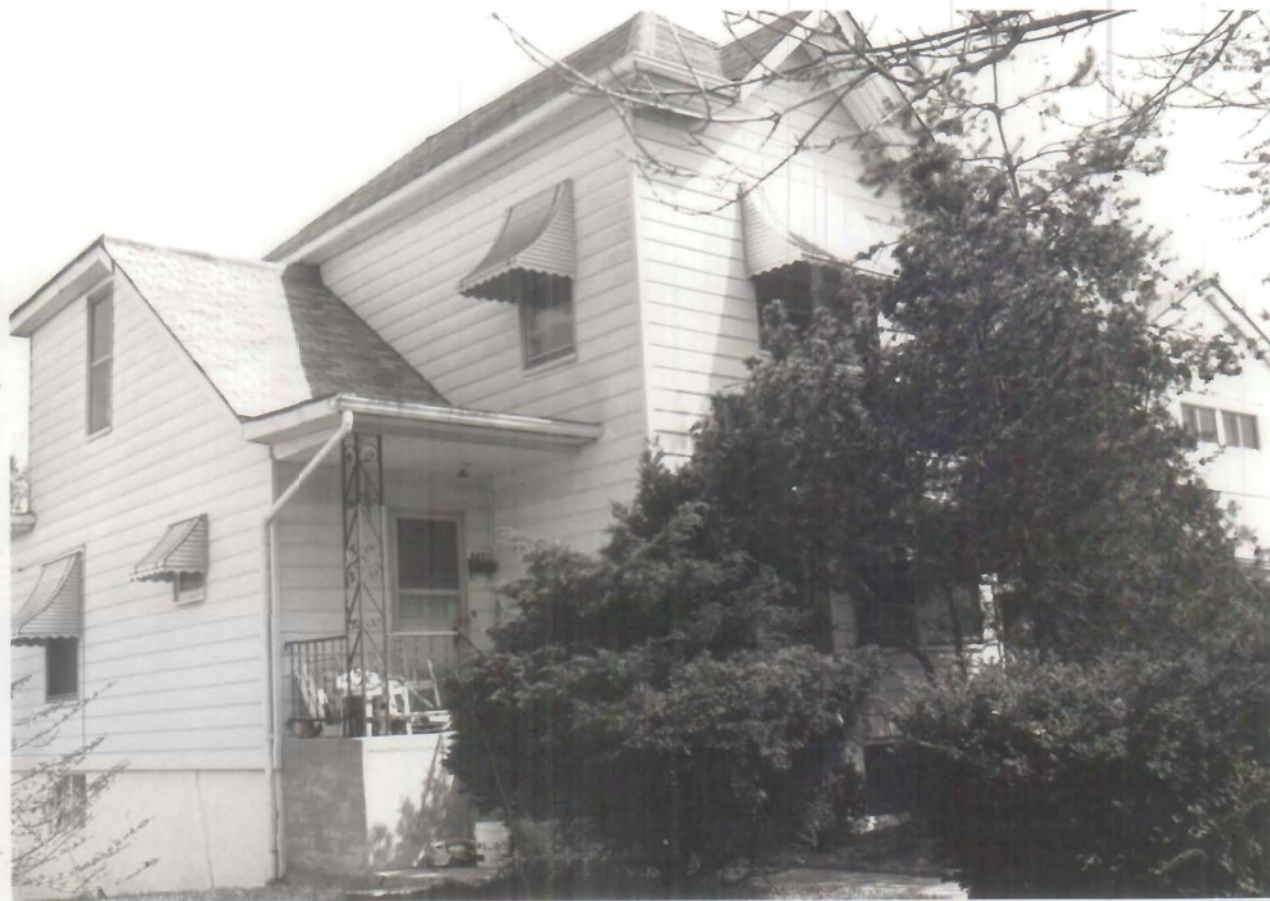
24. Foundation material: stone		25. Roof type/material: gabled/pyramid	
26. No. Bays: Front 2 Side 3		27. Wall treatment: aluminum siding	
28. Plan shape: see site map		29. Changes: Addition? ? Altered? yes

30. Exterior condition: good		31. Open to public? no	
32. Other Surveys in which included: Heritage/St. Louis survey, 1971			
33. Further description of important features: It appears that liberties were taken with this house when the aluminum siding was applied. A truncated pyramid roofline has a small gable in front and an odd, multi-level roofline over the west side. This side, which incorporates the entrance, appears to be either an addition or a much-altered original feature.

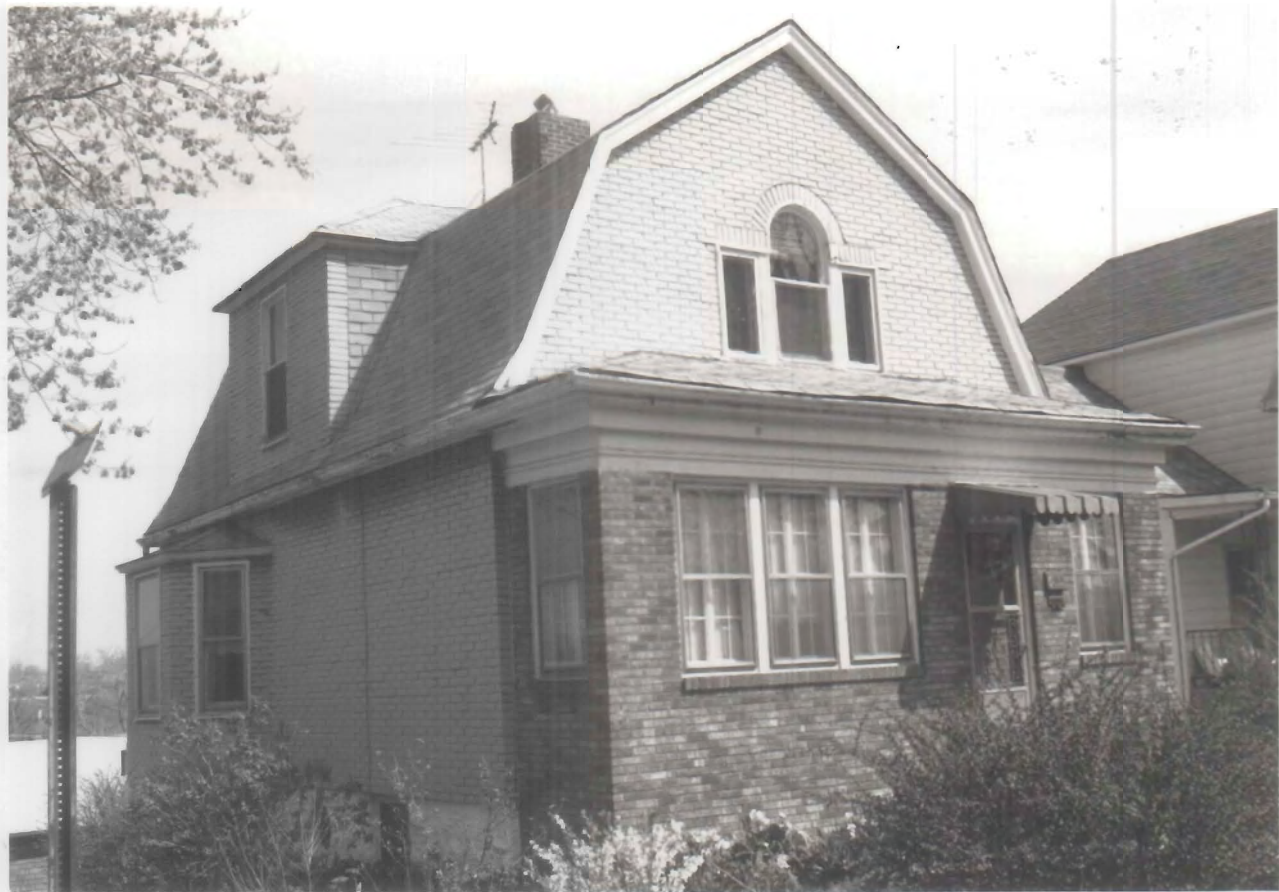
1. No. 021	3. Location of Negatives: Missouri Office of Historic Preservation, P. O. Box 176, Jefferson City, MO 65102		
2. City/County: City of St. Louis, MO

19. Original Use: residence		20. Present Use: residence	
21. No. of stories: 1 1/2	22. Basement? yes	23. Wall construction: masonry	
24. Foundation material: stone		25. Roof type/material: front gable

26. No. Bays: Front 3 Side 2		27. Wall treatment: brown brick	
28. Plan shape: see site map		29. Changes: Addition? Altered?	
30. Exterior condition: good		31. Open to public? no

32. Other Surveys in which included: Heritage/St. Louis survey, 1971			
33. Further description of important features: A heavy, brick-pillared porch extends across the front of this house. All openings except first story front windows (which are flat arches) are segmentally arched. Brick sills. Soldier course just above foundation. Rear frame porch.

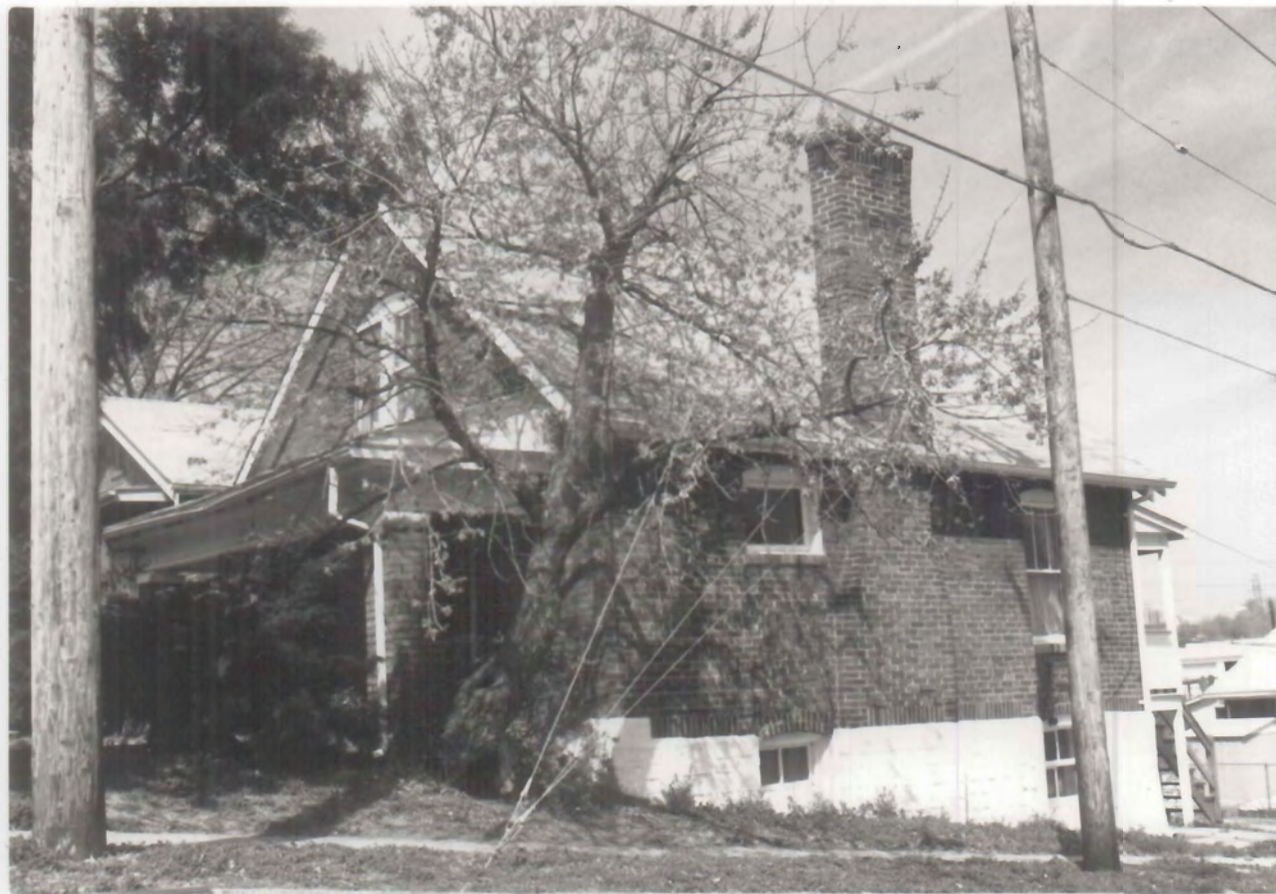
1. No. 020	3. Location of Negatives: Missouri Office of Historic Preservation, P. O. Box 176, Jefferson City, MO 65102		
2. City/County: City of St. Louis, MO	4. Prepared by: Cynthia Hill Longwisch, Landmarks Assn. of St. Louis, 917 Locust, 7th Floor, St. Louis, MO 63101

24. Foundation material: stone		25. Roof type/material: front gable	
26. No. Bays: Front 2 Side 4		27. Wall treatment: multichrome brick	
28. Plan shape: see site map		29. Changes: Addition? Altered? ?

30. Exterior condition: good		31. Open to public? no	
32. Other Surveys in which included: Heritage/St. Louis survey, 1971			
33. Further description of important features: The projecting right front bay of this house appears to be a possibly late-1950s alteration. Narrow, coursed stone has been applied to the lower front elevation. The round-arched front door features double rowlock brick and provides a hint at an attempt at Tudor detailing. Side windows have flat arches. At the top of the gable, a small wood crest appears, along with a pointed-arched attic vent.

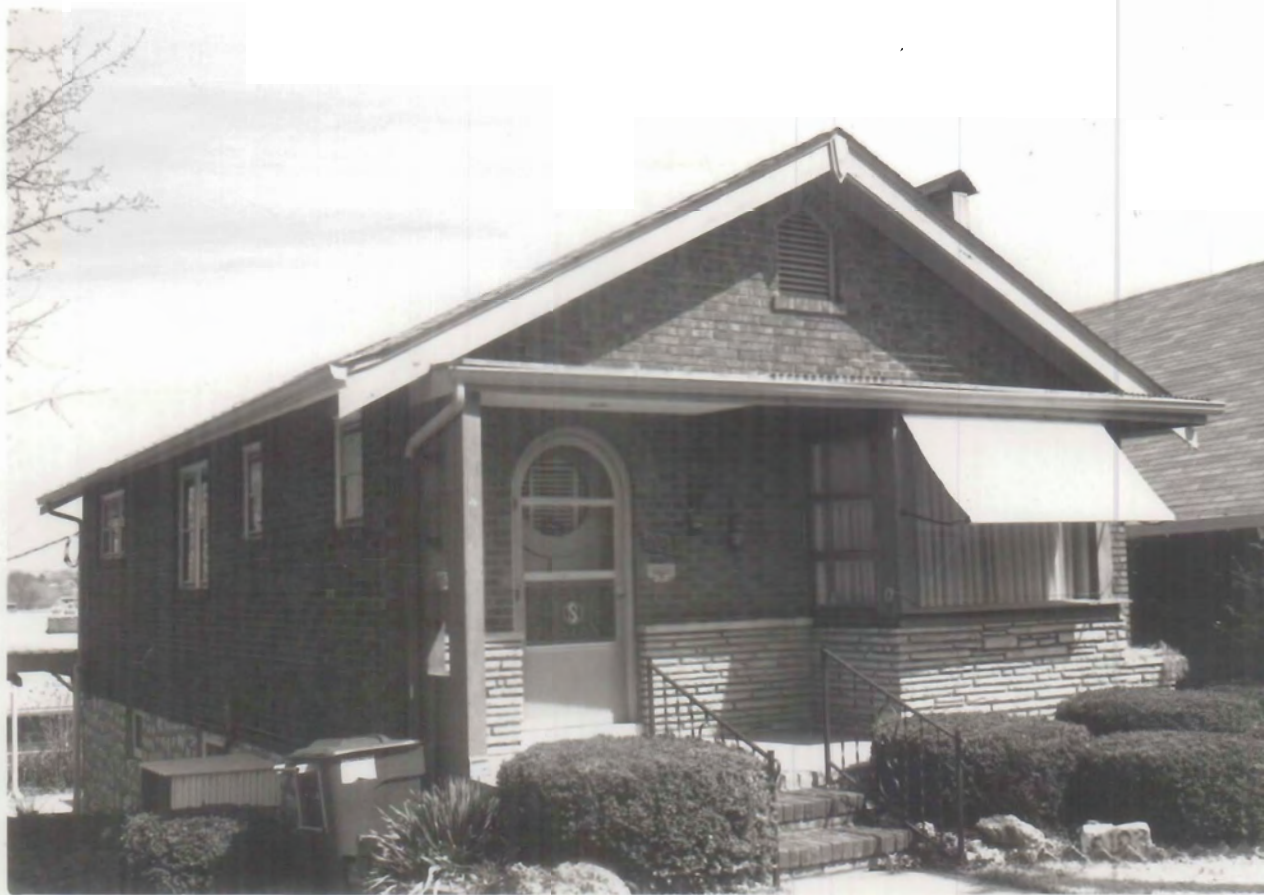
1. No. 167	3. Location of Negatives: Missouri Office of Historic Preservation, P. O. Box 176, Jefferson City, MO 65102		
2. City/County: City of St. Louis, MO	4. Prepared by: Cynthia Hill Longwisch, Landmarks Assn. of St. Louis, 917 Locust, 7th Floor, St. Louis, MO 63101

24. Foundation material: stone		25. Roof type/material: complex	
26. No. Bays: Front 3 Side 3		27. Wall treatment: asphalt siding	
28. Plan shape: see site map		29. Changes: Addition? Altered? yes

30. Exterior condition: fair/good		31. Open to public? no	
32. Other Surveys in which included: Heritage/St. Louis survey, 1971			
33. Further description of important features: Somewhat similar in design to house next door (survey #166). The projecting front gable has cut-outs at the first story to form a straight-sided bay window. Porch in northwest corner is enclosed, possibly original or similar to it. 2-story (east) side bay window. 1-over-1 double-hung sash.

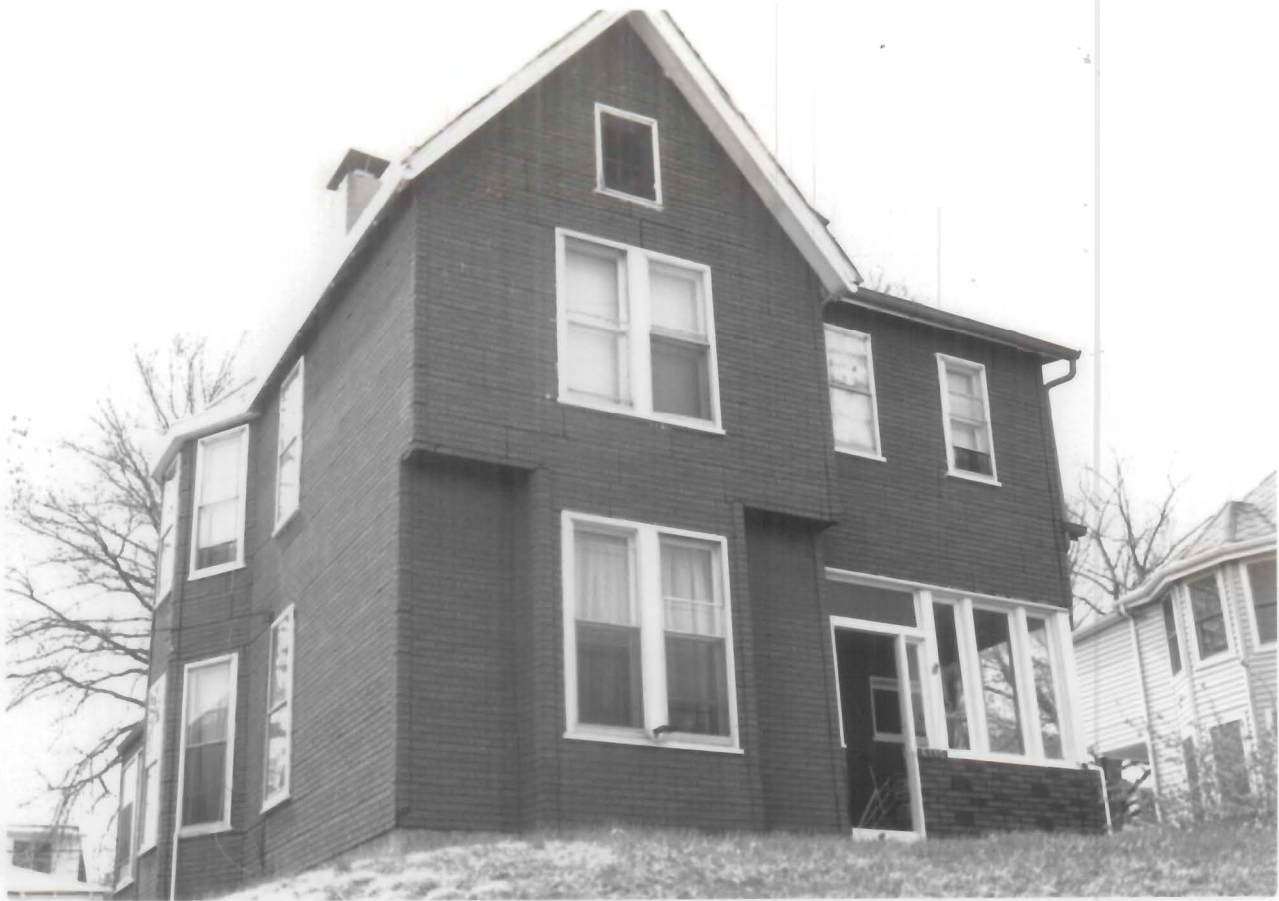
1. No. 019	3. Location of Negatives: Missouri Office of Historic Preservation, P. O. Box 176, Jefferson City, MO 65102		
2. City/County: City of St. Louis, MO	4. Prepared by: Cynthia Hill Longwisch, Landmarks Assn. of St. Louis, 917 Locust, 7th Floor, St. Louis, MO 63101

21. No. of stories: 2	22. Basement? yes	23. Wall construction: masonry	
24. Foundation material: stone		25. Roof type/material: front gable	
26. No. Bays: Front 3 Side 4		27. Wall treatment: textured brick

28. Plan shape: see site map		29. Changes: Addition? rear Altered?	
30. Exterior condition: good		31. Open to public? no	
32. Other Surveys in which included: Heritage/St. Louis survey, 1971

33. Further description of important features: Multichrome textured brick was used for this house, which features soldier arches and stone lintels on the front elevation and similar lintels or jack arches on the side elevations. Windows are paired; upper story front windows are highlighted by inset stonework. A brick-pillared open porch extends across much of the front elevation. Eaves feature wide overhangs. Windows are 6-over-1 double-hung wood sash.

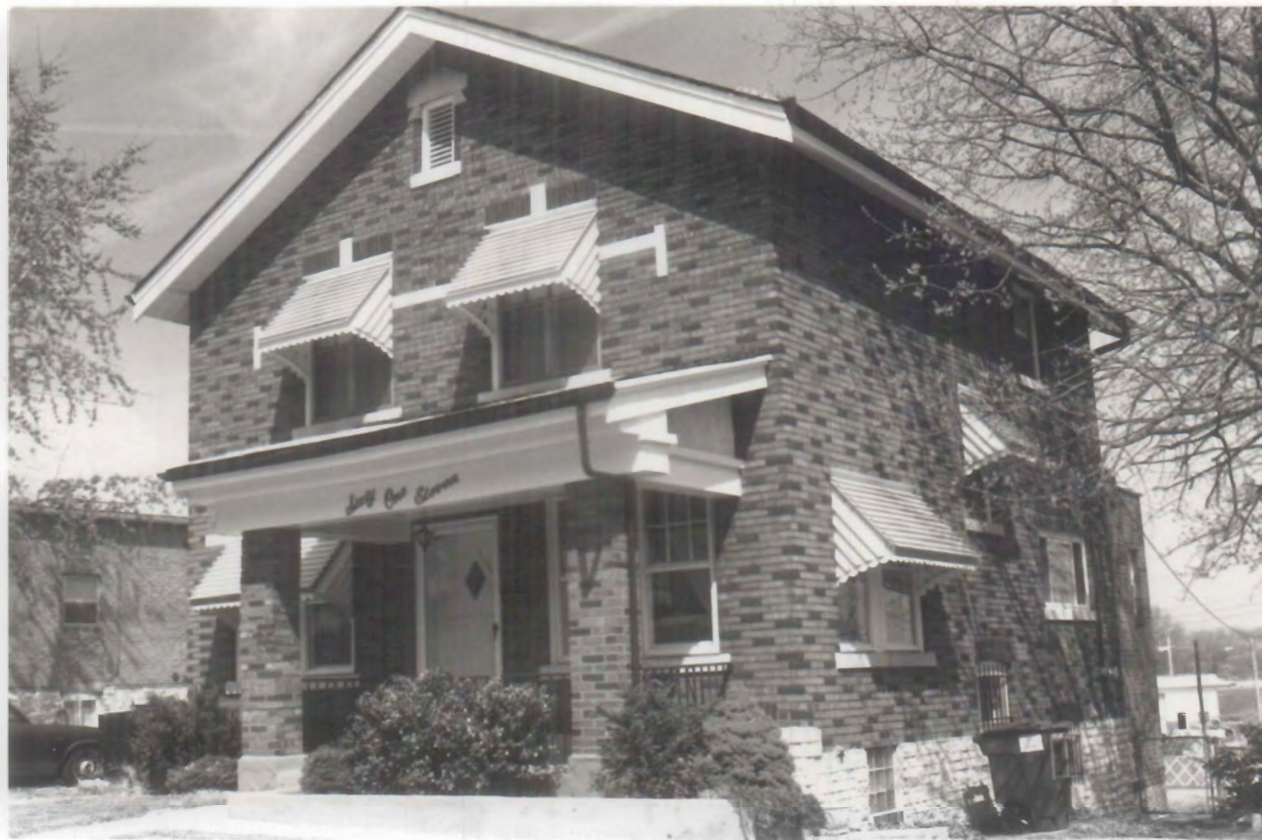
33. Further description of important features: The undulating patterned roofing shingles of this house remain intact, but some of the original detailing is doubtless gone with the modernization process. A projecting front gable has cut-out corners at the first story to form a straight-sided bay window. To the right, a shallow shed-roof dormer looks out over a long slope above an enclosed porch that was probably originally open. Windows are 1-over-1. (cont'd. below)

34. History and Significance: At the west side, two successively smaller shed-like, windowless bays project; these are apparently original. On the east side, a two-story bay window projects, featuring a nearly conical roof (visible in photo for survey #167, at right). The inactive (pre-1925) building permits for this city block are unavailable, precluding definite dating.

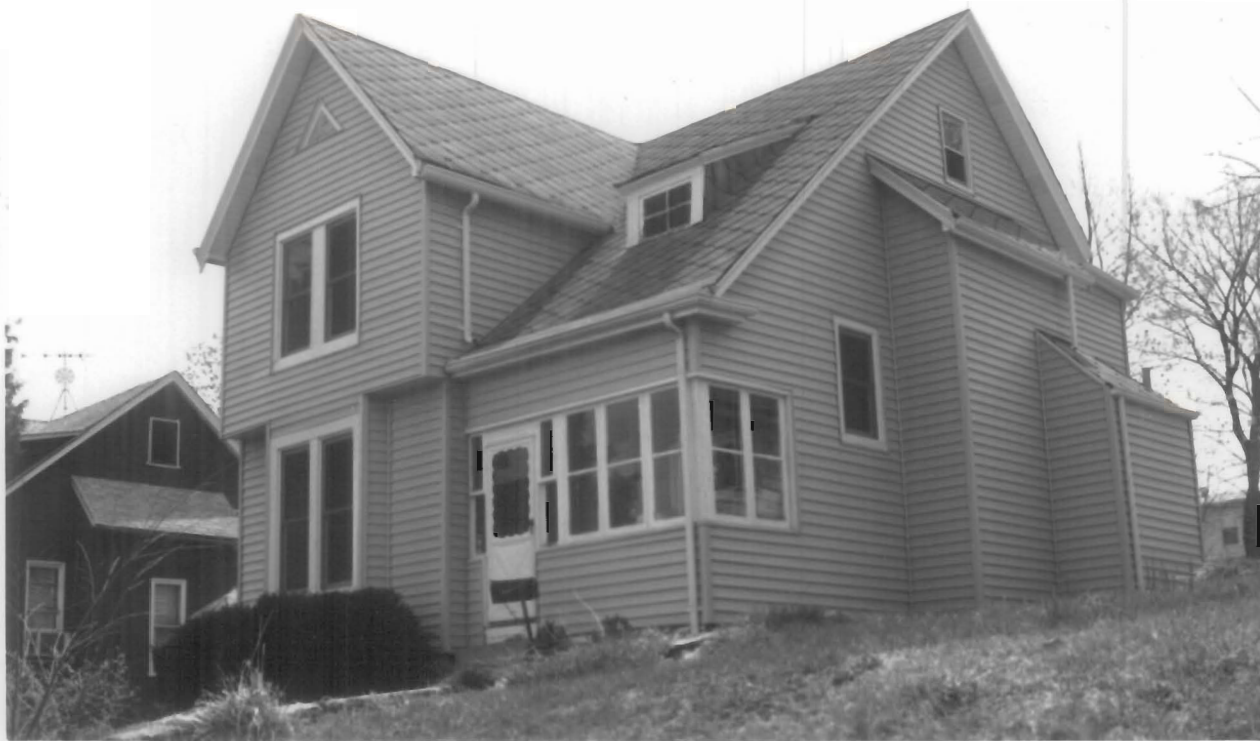
1. No. 165	3. Location of Negatives: Missouri Office of Historic Preservation, P. O. Box 176, Jefferson City, MO 65102		
2. City/County: City of St. Louis, MO	4. Prepared by: Cynthia Hill Longwisch, Landmarks Assn. of St. Louis, 917 Locust, 7th Floor, St. Louis, MO 63101

24. Foundation material: stone		25. Roof type/material: hipped	
26. No. Bays: Front 3 Side 2		27. Wall treatment: aluminum siding	
28. Plan shape: see site map		29. Changes: Addition? Altered? yes

30. Exterior condition: good		31. Open to public? no	
32. Other Surveys in which included: Heritage/St. Louis survey, 1971			
33. Further description of important features: The main roof of this house is a truncated pyramid. A porch in the corner of the ell has been enclosed; it was almost certainly an open, Queen Anne design before aluminization occurred. Paired windows on front elevation; all are 1-over-1 double-hung sash. Rear wood deck at second story.

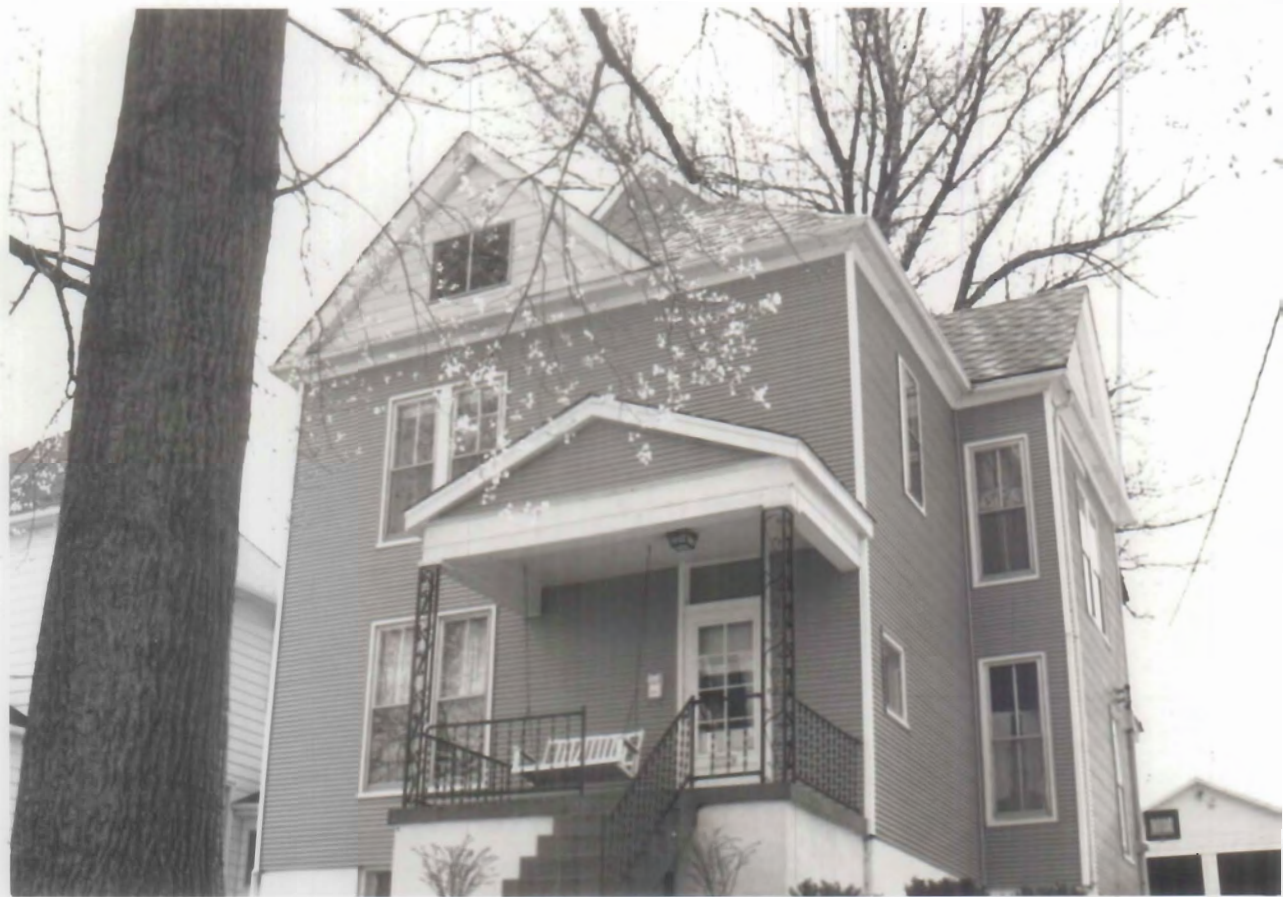
33. Further description of important features: The front gable of this house is frame, covered with siding. The lower story features a buff/grey brick facade with the remainder of the house brown brick; a double-row string course of red brick crosses the front of the house at sill level, somewhat higher on the sides and rear. Windows have flat arches. A concrete front porch the width of the house has a shed roof supported by decorative iron posts.

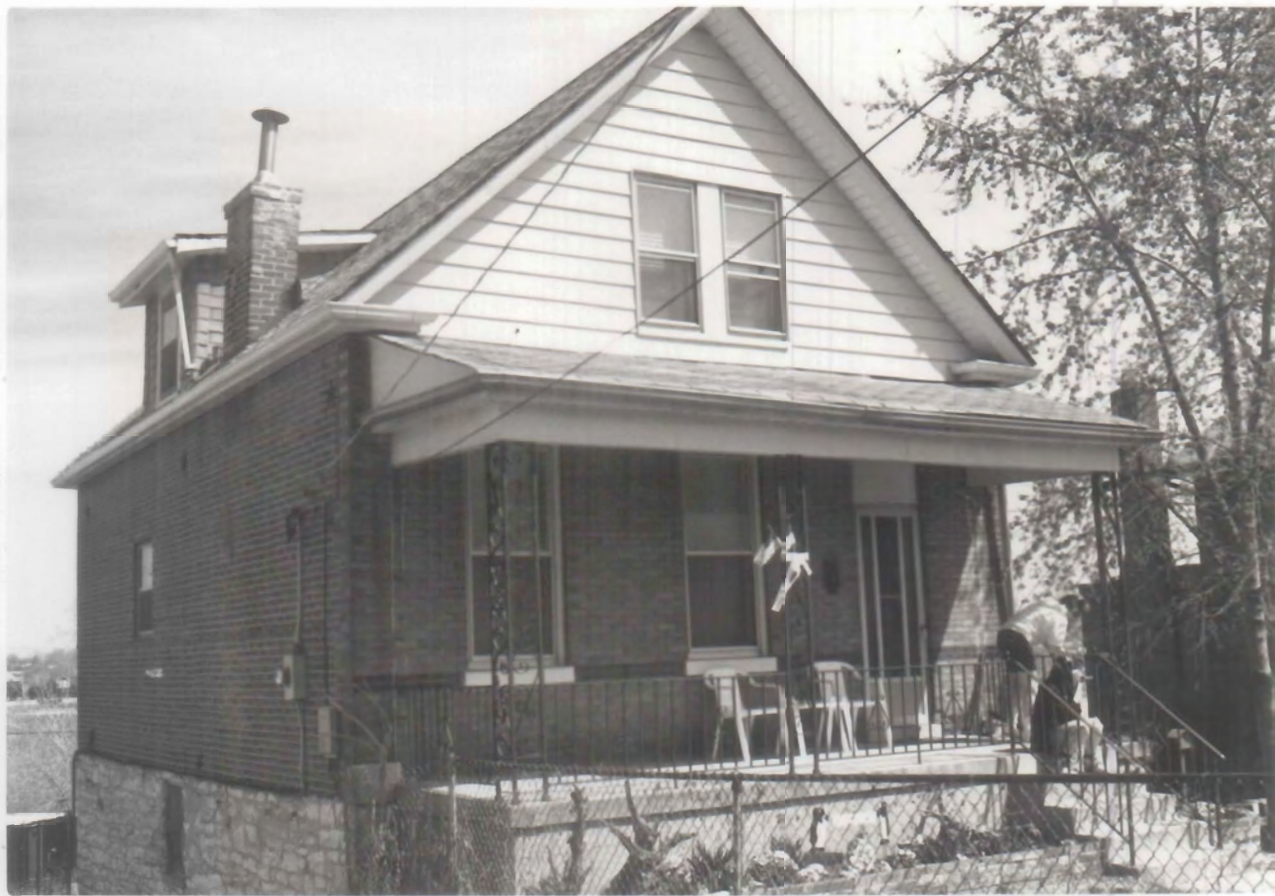
33. Further description of important features: The large gabled dormer of this house has triple 3-over-1 double-hung sash windows, repeated below at the front elevation. The roof extends to become the roof of the full-width porch, supported by tapered pillars sheathed in siding. A shed-roof dormer is on the rear elevation. The house is built on a steep grade with much of the foundation exposed. A concrete block retaining wall flanks the driveway.

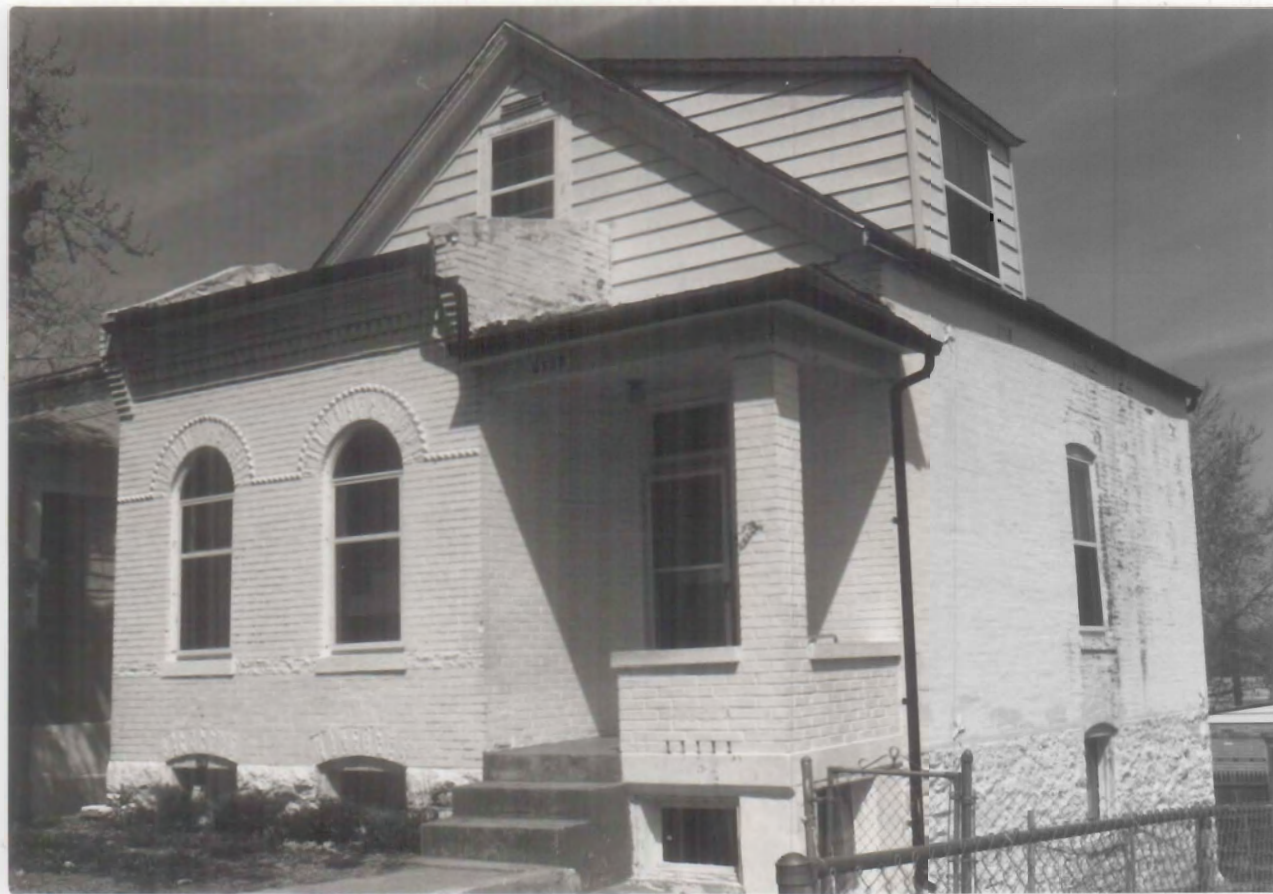
1. No. 016	3. Location of Negatives: Missouri Office of Historic Preservation, P. O. Box 176, Jefferson City, MO 65102		
2. City/County: City of St. Louis, MO	4. Prepared by: Cynthia Hill Longwisch, Landmarks Assn. of St. Louis, 917 Locust, 7th Floor, St. Louis, MO 63101

21. No. of stories: 1	22. Basement? yes	23. Wall construction: masonry	
24. Foundation material: stone		25. Roof type/material: flat	
26. No. Bays: Front 3 Side		27. Wall treatment: red brick

28. Plan shape: see site map		29. Changes: Addition? Altered? porch	
30. Exterior condition: good		31. Open to public? no	
32. Other Surveys in which included: Heritage/St. Louis survey, 1971

33. Further description of important features: Single front elevation window is round-arched with soldier arch and string course molding. Corbeled brick cornice features brick dentilling. Porch has been infilled with frame construction. Terra cotta coping.

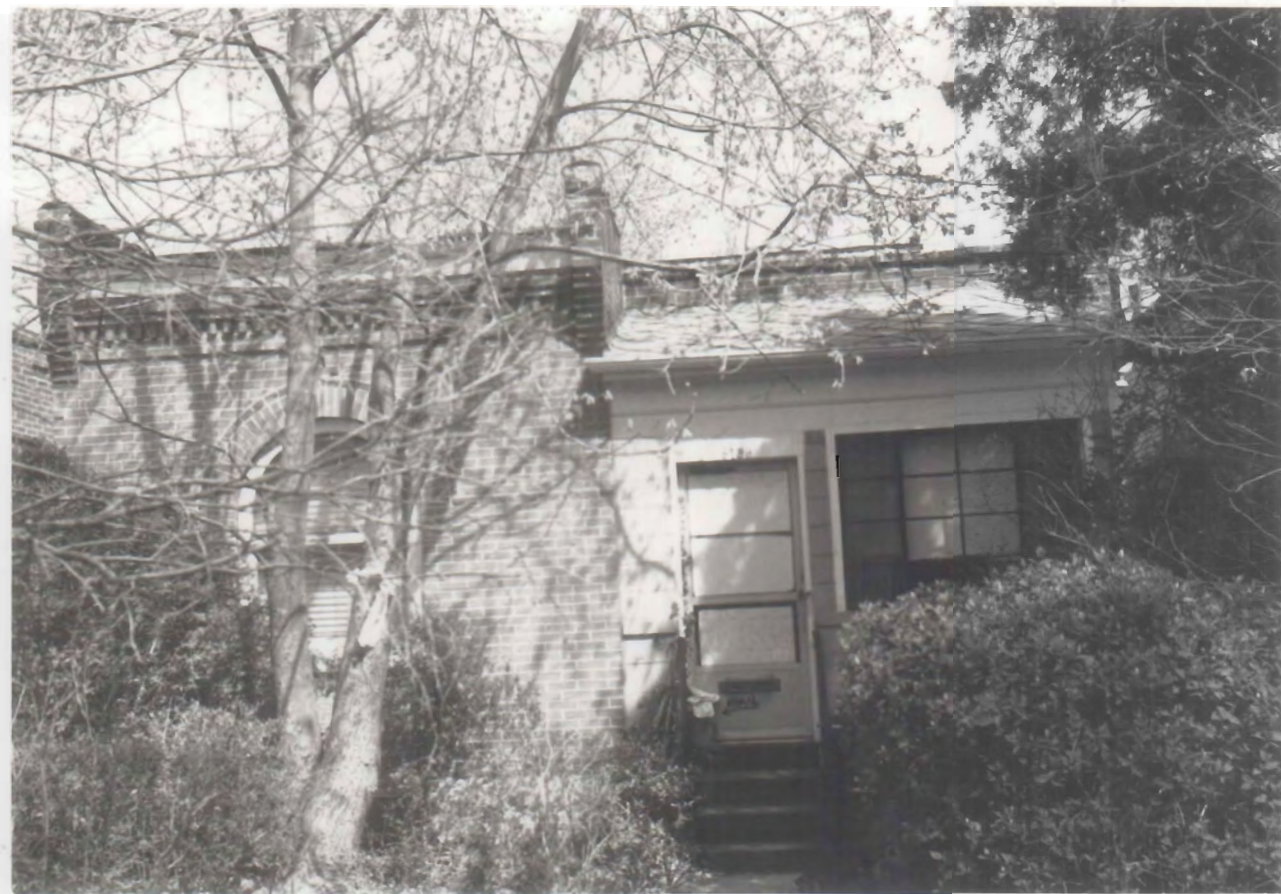
1. No. 015	3. Location of Negatives: Missouri Office of Historic Preservation, P. O. Box 176, Jefferson City, MO 65102		
2. City/County: City of St. Louis, MO	4. Prepared by: Cynthia Hill Longwisch, Landmarks Assn. of St. Louis, 917 Locust, 7th Floor, St. Louis, MO 63101

24. Foundation material: stone		25. Roof type/material: flat	
26. No. Bays: Front 3 Side 1		27. Wall treatment: red brick	
28. Plan shape: see site map		29. Changes: Addition? rear Altered?

30. Exterior condition: fair/good		31. Open to public? no	
32. Other Surveys in which included: Heritage/St. Louis survey, 1971			
33. Further description of important features: Dentilled, corbeled brick cornice. Round-arched windows in front elevation are highlighted by gauged-brick and stone arches topped by a course of dogtooth pressed brick. Stone sills. Transom over door. Terra cotta coping. Rear frame porch addition dates to 1961.

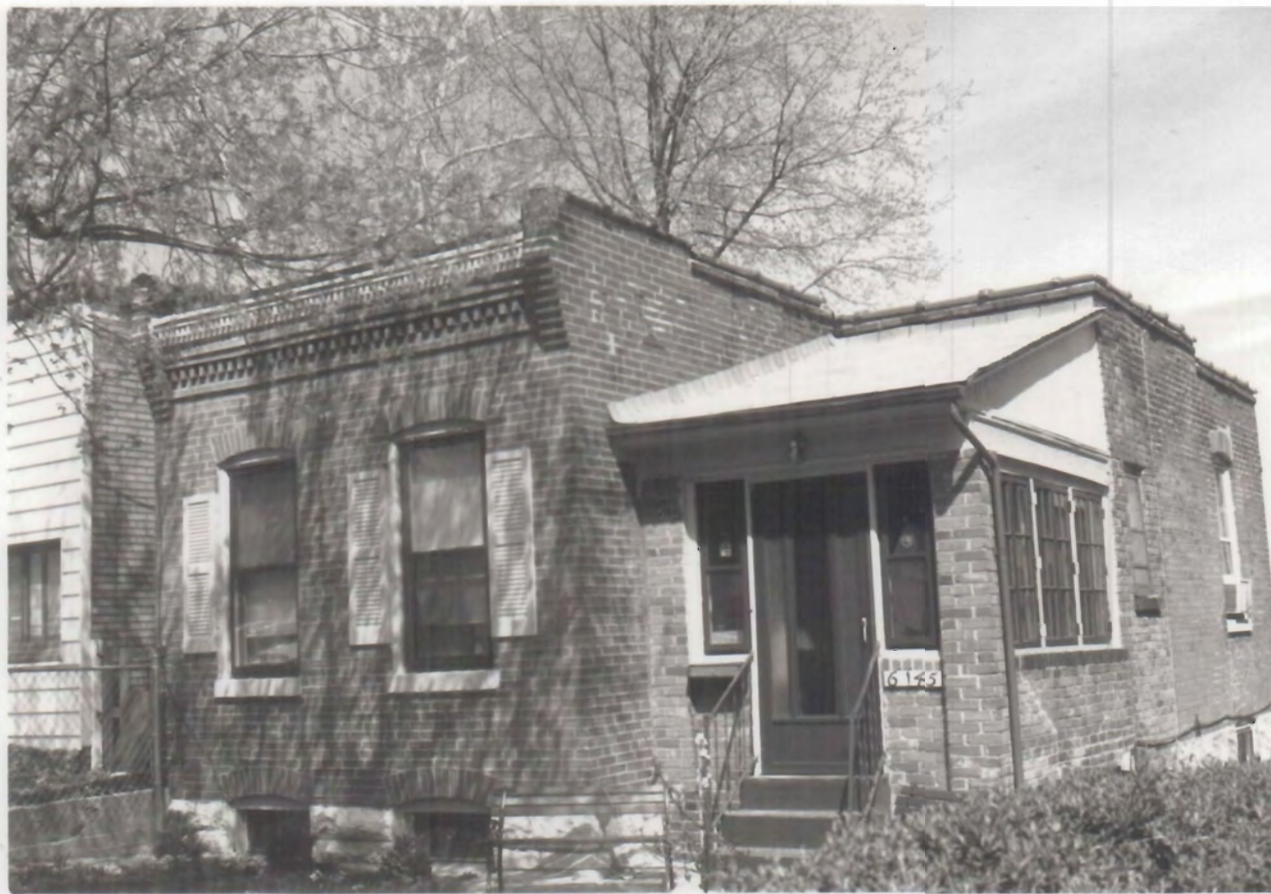
1. No. 140	3. Location of Negatives: Missouri Office of Historic Preservation, P. O. Box 176, Jefferson City, MO 65102		
2. City/County: City of St. Louis, MO

19. Original Use: residence		20. Present Use: residence	
21. No. of stories: 2	22. Basement? yes	23. Wall construction: frame	
24. Foundation material: concrete		25. Roof type/material: side gable

26. No. Bays: Front 4 Side 3		27. Wall treatment: aluminum siding	
28. Plan shape: see site map		29. Changes: Addition? Altered? yes	
30. Exterior condition: good		31. Open to public? no

32. Other Surveys in which included: Heritage/St. Louis survey, 1971			
33. Further description of important features: The 6-over-1 windows of this house may have false muntins. A gabled frame hood over the door is supported by wood brackets. A one-story room addition at the side appears original. The house is built on a steep grade with a portion of the basement extending forward in the driveway to provide both a garage and an unroofed, patiolike porch.
