# ARCHITECTURAL SURVEY OF CLIFTON HEIGHTS

JUNE 1991

ST. LOUIS, MISSOURI

LANDMARKS ASSOCIATION OF ST. LOUIS, INC.

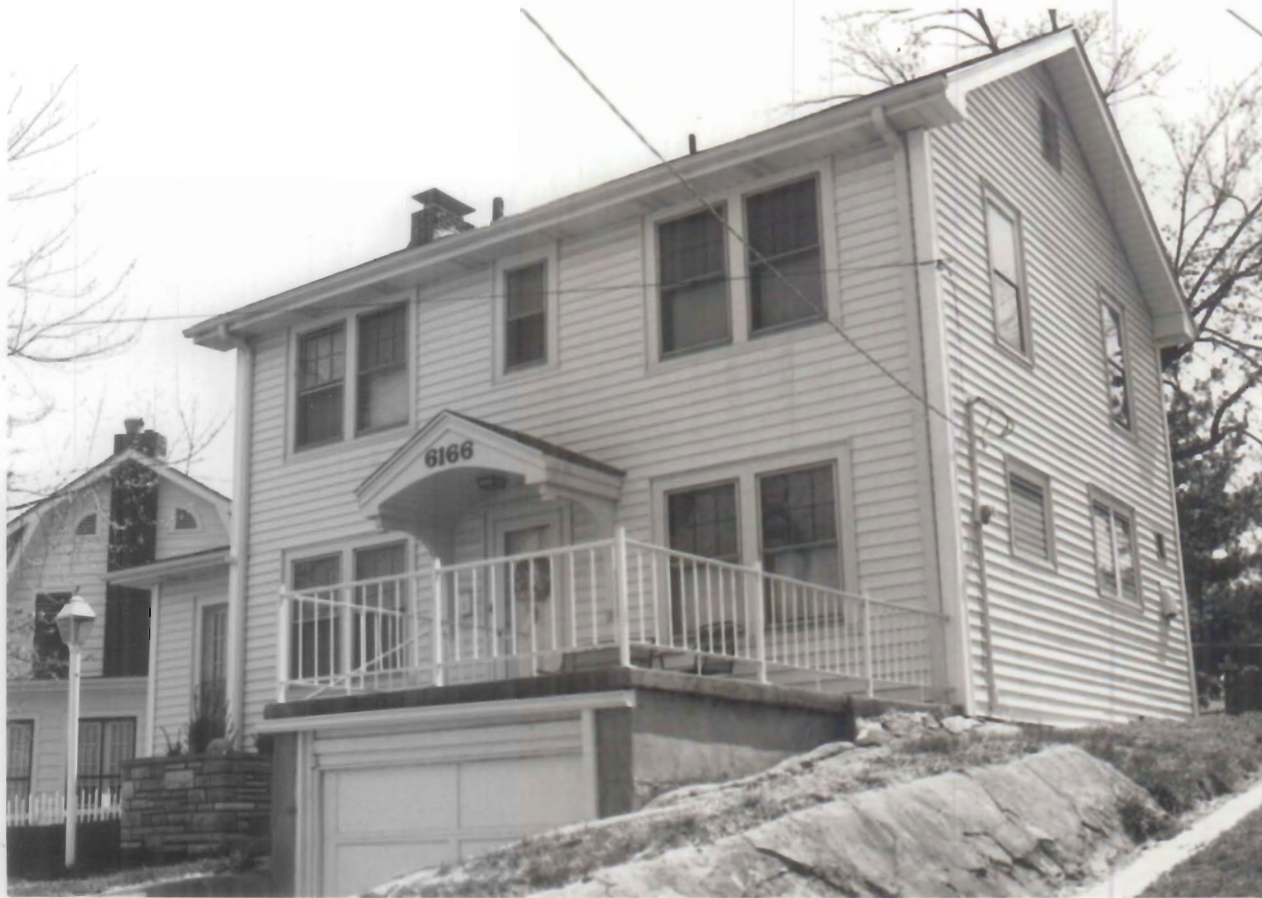
1. No. 013	3. Location of Negatives: Missouri Office of Historic Preservation, P. O. Box 176, Jefferson City, MO 65102		
2. City/County: City of St. Louis, MO

19. Original Use: residence		20. Present Use: residence	
21. No. of stories: 2	22. Basement? yes	23. Wall construction: frame	
24. Foundation material: stone		25. Roof type/material: gabled/pyramid

26. No. Bays: Front 3 Side 3		27. Wall treatment: vinyl siding	
28. Plan shape: see site map		29. Changes: Addition? Altered? yes	
30. Exterior condition: good		31. Open to public? no

32. Other Surveys in which included: Heritage/St. Louis survey, 1971			
<p>33. Further description of important features: The truncated pyramidal roof-line is interrupted by various gables on this house. Possibly closer to Queen Anne in original styling, this house unfortunately has had several windows covered up with siding. A corner porch, although new, appears to retain its basic original design, albeit lacking embellishments. An oval-glass door remains. This house is an unfortunate victim of modernization.</p>			
<p>34. History and Significance: No building permits were available for this city block. Heritage/St. Louis files state that "during [the] period of 1892-1907 various Episcopalian religious functions - baptisms - marriages - funerals took place at this address. The Rev. Collins lived at 6275 Famous in 1898 - not listed in 1892 or 1895. Perhaps his predecessor or successor lived here."</p>

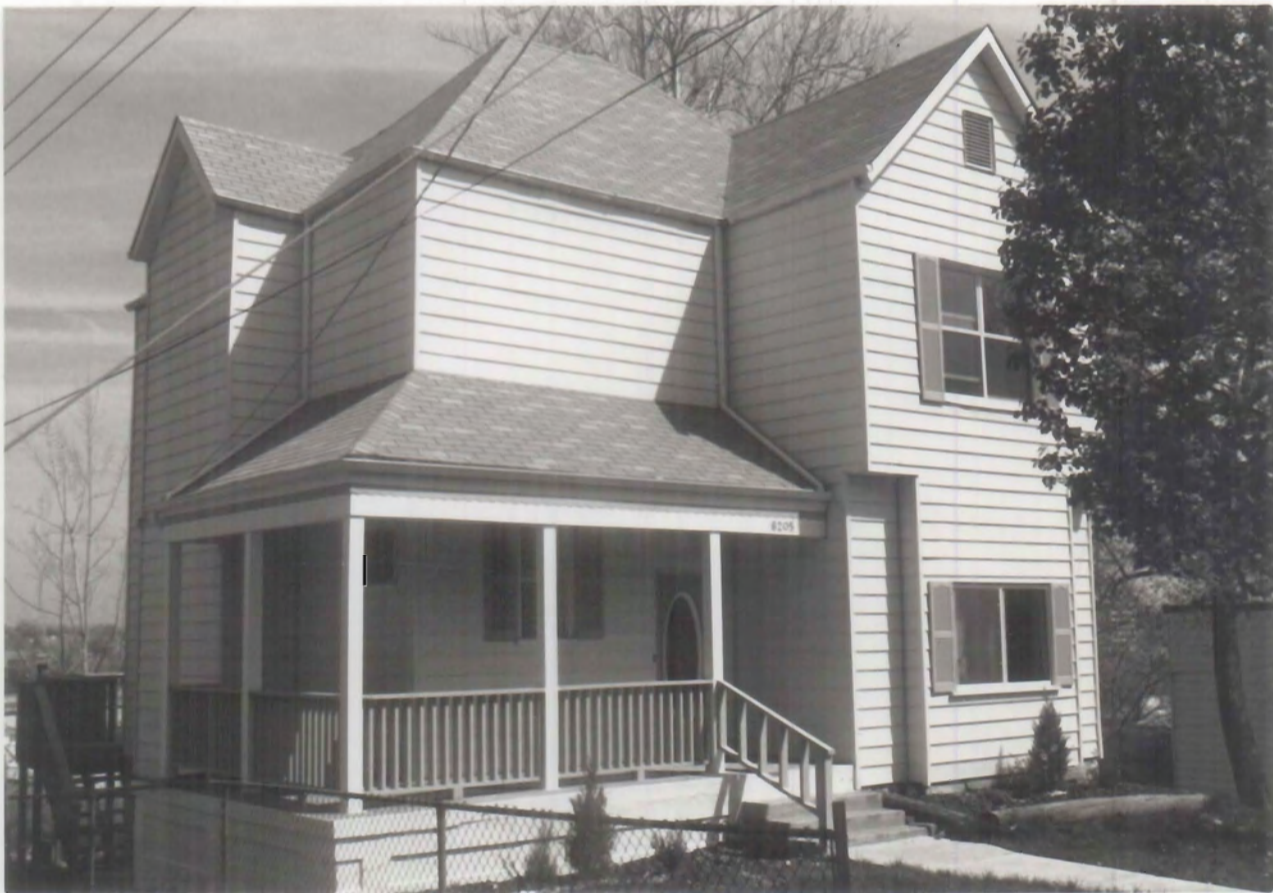
1. No. 012	3. Location of Negatives: Missouri Office of Historic Preservation, P. O. Box 176, Jefferson City, MO 65102		
2. City/County: City of St. Louis, MO	4. Prepared by: Cynthia Hill Longwisch, Landmarks Assn. of St. Louis, 917 Locust, 7th Floor, St. Louis, MO 63101

24. Foundation material: stone		25. Roof type/material: gabled/pyramid	
26. No. Bays: Front 3 Side 5		27. Wall treatment: vinyl siding	
28. Plan shape: see site map	29. Changes: Addition?		Altered? yes

30. Exterior condition: good		31. Open to public? no	
32. Other Surveys in which included: Heritage/St. Louis survey, 1971			
33. Further description of important features: A polygonal tower with conical roof emerges at the corner from the porch roof. The porch fascia features imbricated wood shingles; turned posts below may be replacements. Door has a transom. Windows have all been replaced. Roofline is irregular, with a pyramidal roof interrupted by gables.

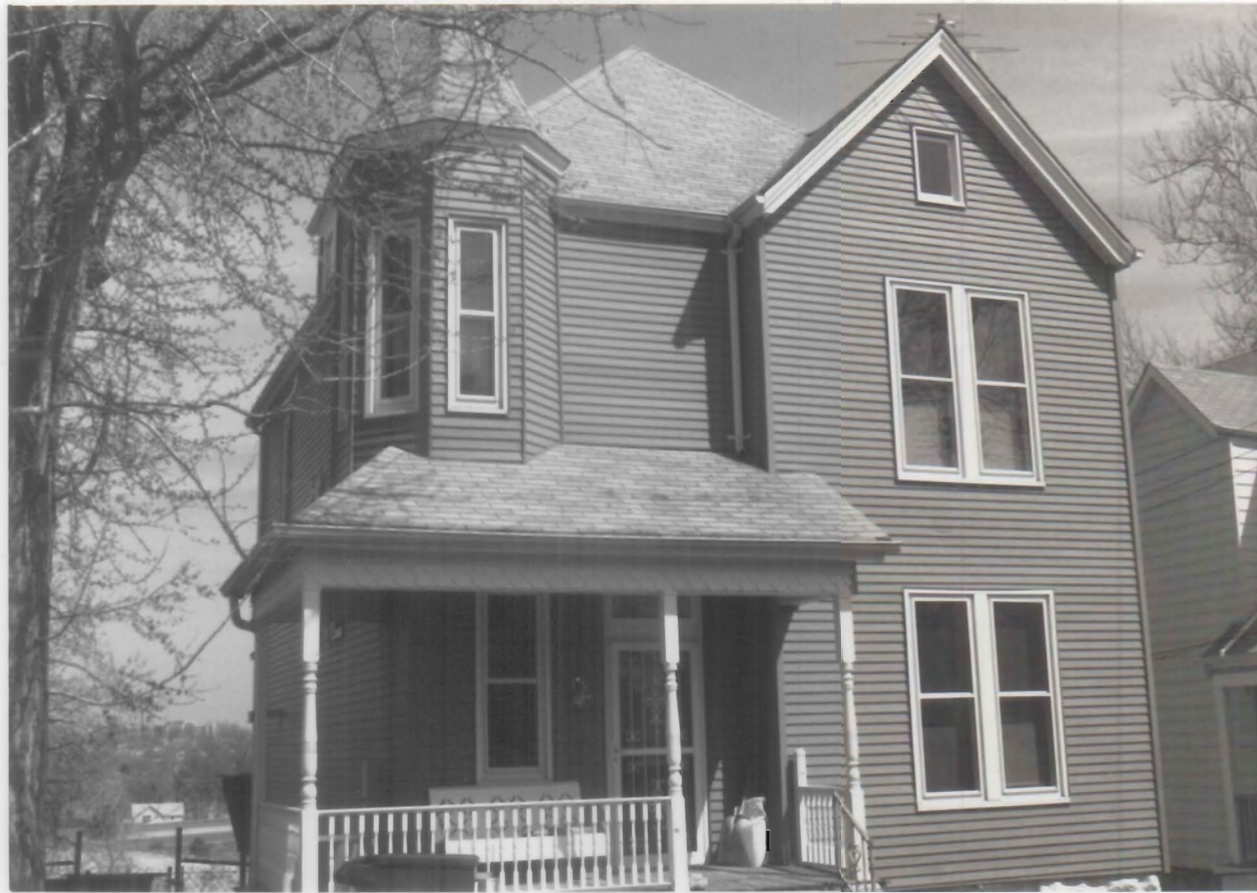
1. No. 011	3. Location of Negatives: Missouri Office of Historic Preservation, P. O. Box 176, Jefferson City, MO 65102		
2. City/County: City of St. Louis, MO	4. Prepared by: Cynthia Hill Longwisch, Landmarks Assn. of St. Louis, 917 Locust, 7th Floor, St. Louis, MO 63101

24. Foundation material: stone		25. Roof type/material: gabled/pyramid	
26. No. Bays: Front 3 Side 5		27. Wall treatment: vinyl siding	
28. Plan shape: see site map		29. Changes: Addition? Altered? yes

30. Exterior condition: good		31. Open to public? no	
32. Other Surveys in which included: Heritage/St. Louis survey, 1971			
33. Further description of important features: Irregular roofline; projecting east side bay is cut out at the first story corners for angled windows. One-over-one windows appear to be replacements. Shed-roof front porch has been infilled to create a room.

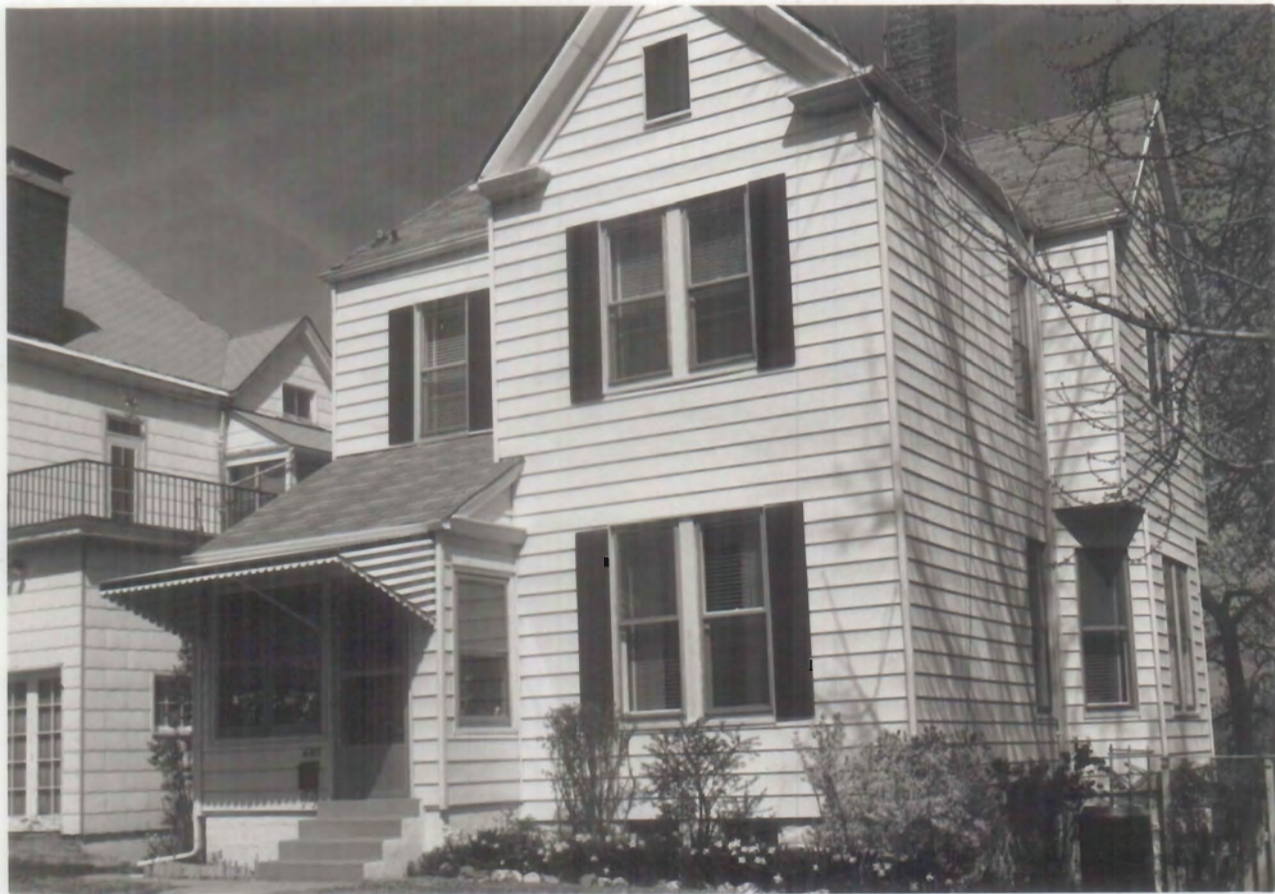
1. No. 010	3. Location of Negatives: Missouri Office of Historic Preservation, P. O. Box 176, Jefferson City, MO 65102		
2. City/County: City of St. Louis, MO	4. Prepared by: Cynthia Hill Longwisch, Landmarks Assn. of St. Louis, 917 Locust, 7th Floor, St. Louis, MO 63101

24. Foundation material: stone		25. Roof type/material: gabled/pyramid	
26. No. Bays: Front 3 Side 2		27. Wall treatment: asbestos siding	
28. Plan shape: see site map		29. Changes: Addition? Altered? yes

30. Exterior condition: good		31. Open to public? no	
32. Other Surveys in which included: Heritage/St. Louis survey, 1971			
33. Further description of important features: Doorway (not visible in photo due to extensive shrubbery) features an unornamented pediment and sidelights now infilled with glass brick. Windows tend to be paired. A one-story addition on the east side has triple french doors (possibly infilling a garage bay) and an iron railing. This feature appears on several houses in this survey; it is not clear if these were garages, later additions, (cont'd. below)

34. History and Significance: or part of the original plans. A central, truncated pyramid roof features multiple gables.

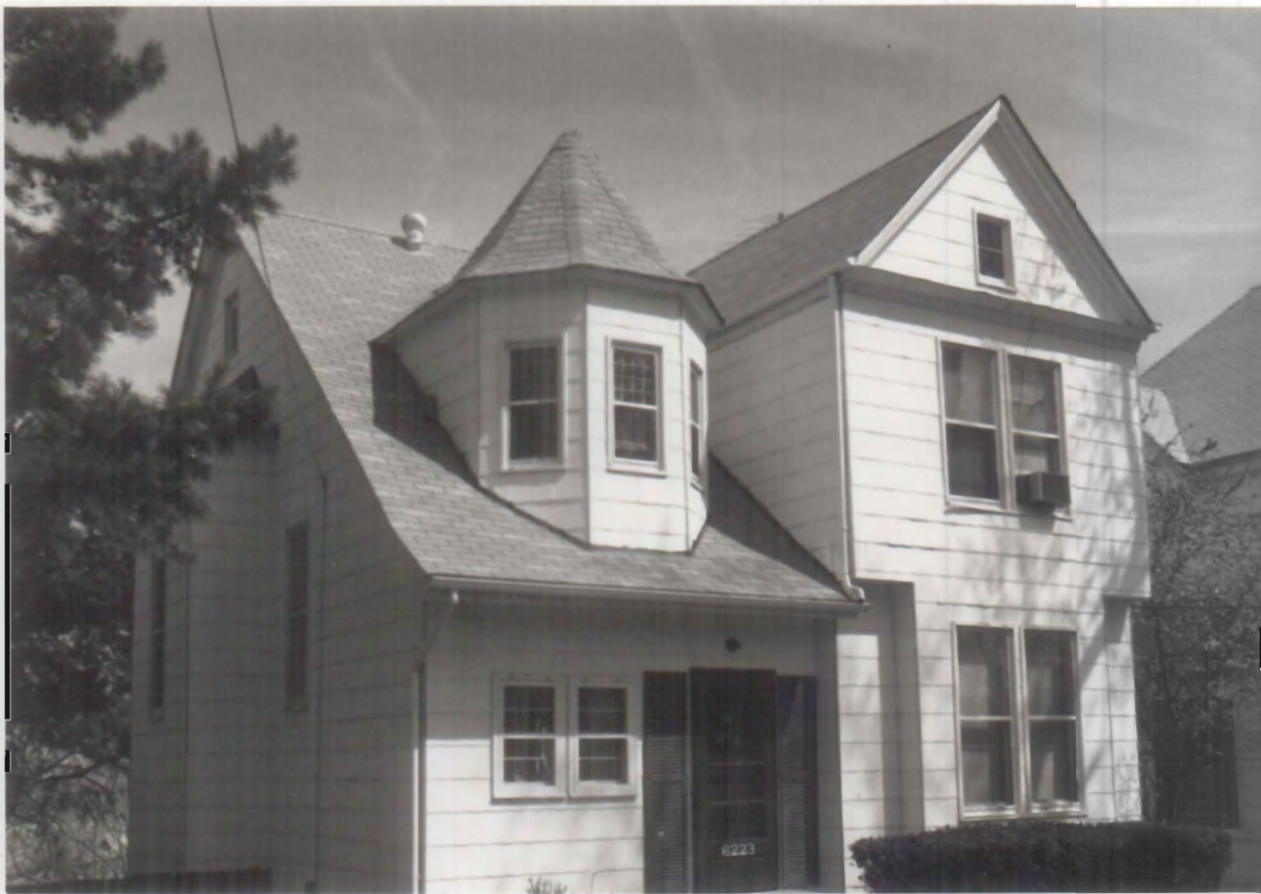
1. No. 008	3. Location of Negatives: Missouri Office of Historic Preservation, P. O. Box 176, Jefferson City, MO 65102		
2. City/County: City of St. Louis, MO

19. Original Use: residence		20. Present Use: residence	
21. No. of stories: 2	22. Basement? yes	23. Wall construction: fr/brick	
24. Foundation material: stone		25. Roof type/material: pyramid/gabled

26. No. Bays: Front 3 Side 3		27. Wall treatment: brick/asbestos sid.	
28. Plan shape: see site map		29. Changes: Addition? Altered?	
30. Exterior condition: good		31. Open to public? no

32. Other Surveys in which included: Heritage/St. Louis survey, 1971			
33. Further description of important features: Square corner tower is pyramid-ally roofed and rests on corner porch. Porch features imbricated wood shingles. Roof is truncated pyramid with gables and dormers. Upper story is frame, covered with asphalt siding; lower story is brick, with segmentally arched openings, the window in the projecting bay having pressed brick hood molding. Stone sills at first story. Front door has transom.

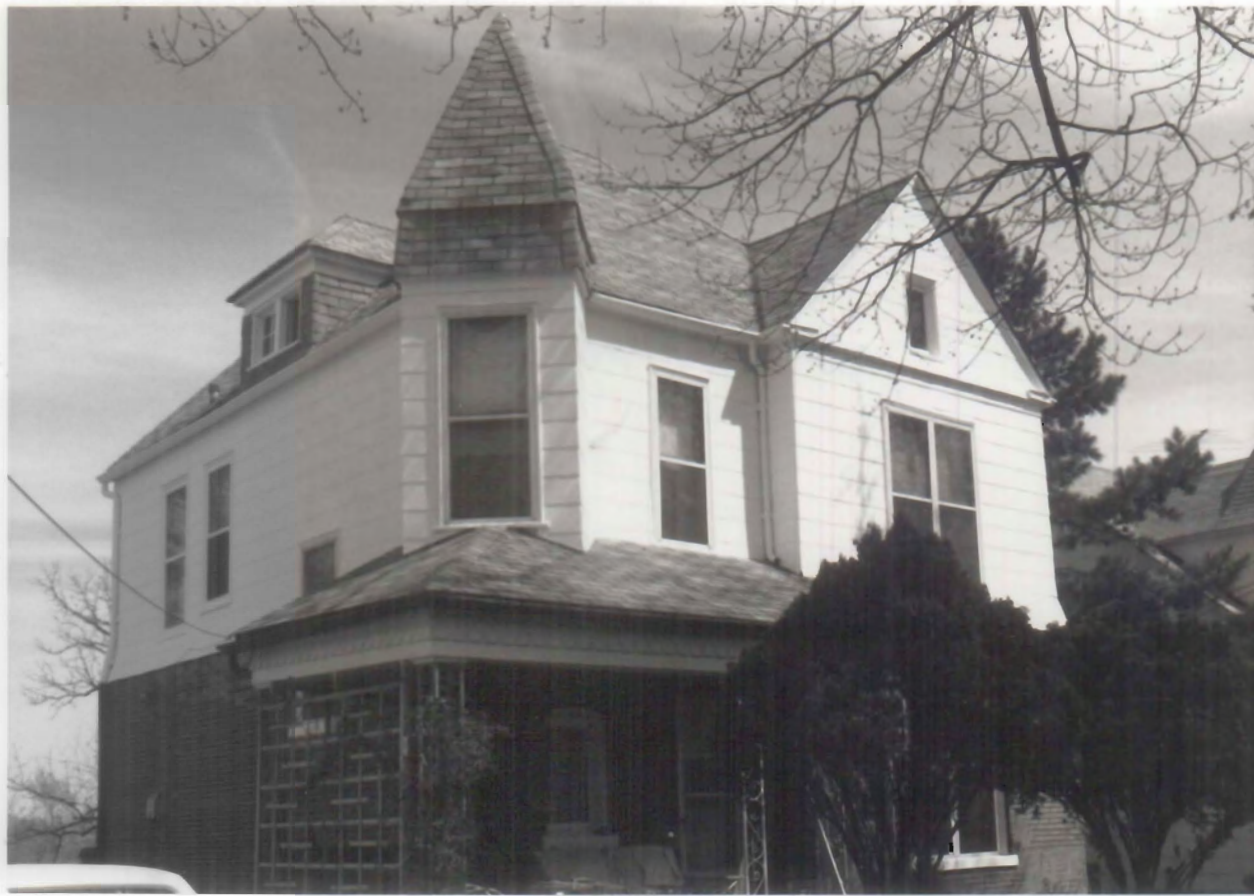
1. No. 007	3. Location of Negatives: Missouri Office of Historic Preservation, P. O. Box 176, Jefferson City, MO 65102		
2. City/County: City of St. Louis, MO	4. Prepared by: Cynthia Hill Longwisch, Landmarks Assn. of St. Louis, 917 Locust, 7th Floor, St. Louis, MO 63101

24. Foundation material: stone		25. Roof type/material: cross gable*	
26. No. Bays: Front 3 Side 2		27. Wall treatment: asbestos siding	
28. Plan shape: see site map	29. Changes: Addition?		Altered?

30. Exterior condition: good		31. Open to public? no	
32. Other Surveys in which included: Heritage/St. Louis survey, 1971			
33. Further description of important features: *The roofline of this house features a truncated pyramid in the center of the cross gables. Windows appear to be replacements and are 1-over-1 double-hung sash, often in pairs. A small concrete pad without roof serves as a porch; there is no evidence that there ever was a full porch. Front door features a transom. One window on the primary elevation is boarded.

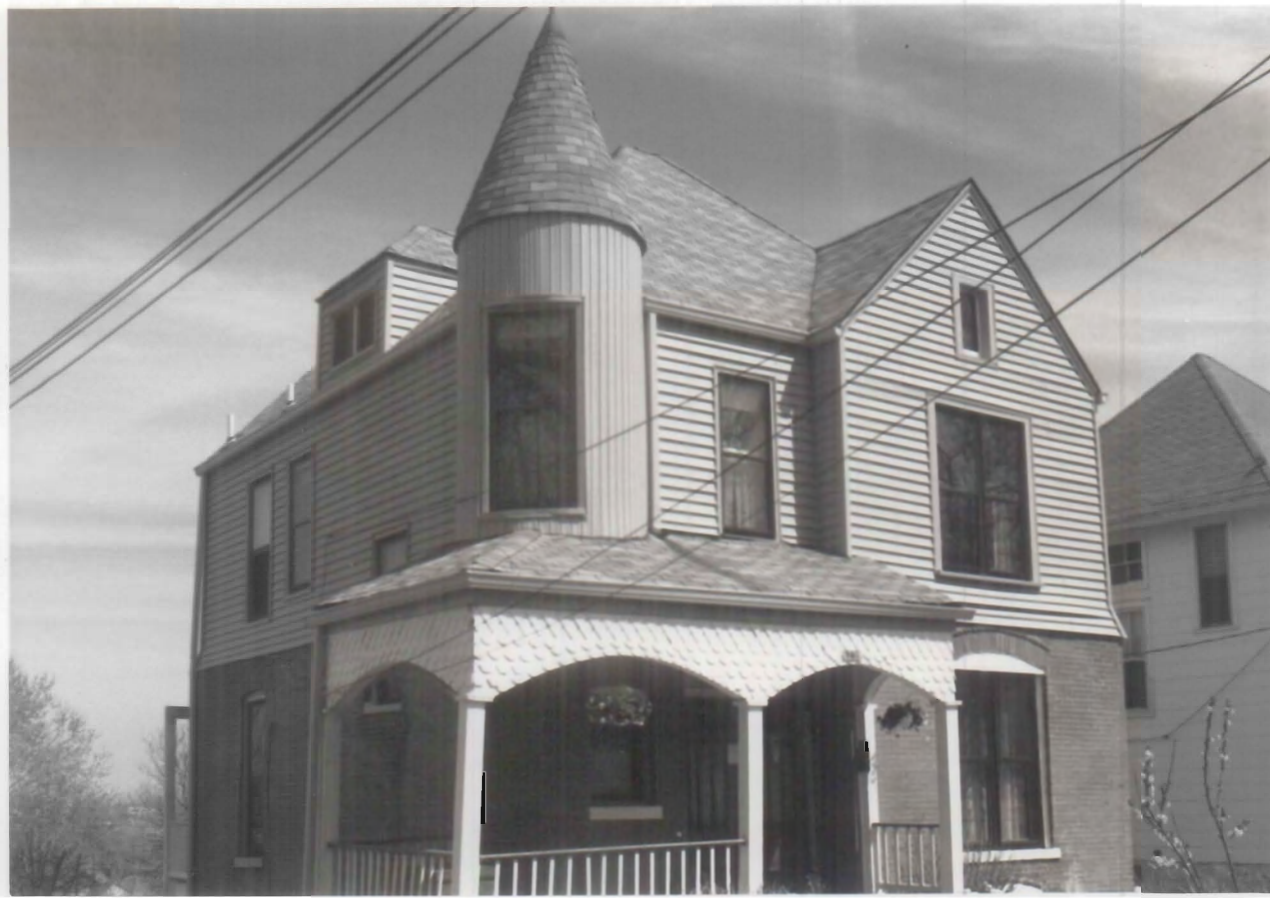
1. No. 005	3. Location of Negatives: Missouri Office of Historic Preservation, P. O. Box 176, Jefferson City, MO 65102		
2. City/County: City of St. Louis, MO	4. Prepared by: Cynthia Hill Longwisch, Landmarks Assn. of St. Louis, 917 Locust, 7th Floor, St. Louis, MO 63101

24. Foundation material: stone		25. Roof type/material: trunc. pyramid	
26. No. Bays: Front 3 Side 3		27. Wall treatment: asbestos siding	
28. Plan shape: see site map		29. Changes: Addition? Altered?

30. Exterior condition: fair/good		31. Open to public? no	
32. Other Surveys in which included: Heritage/St. Louis survey, 1971			
33. Further description of important features: A round corner tower with conical roof highlights the corner porch. Front gable features a round-arched window. Majority of the windows are one-over-one double-hung sash.

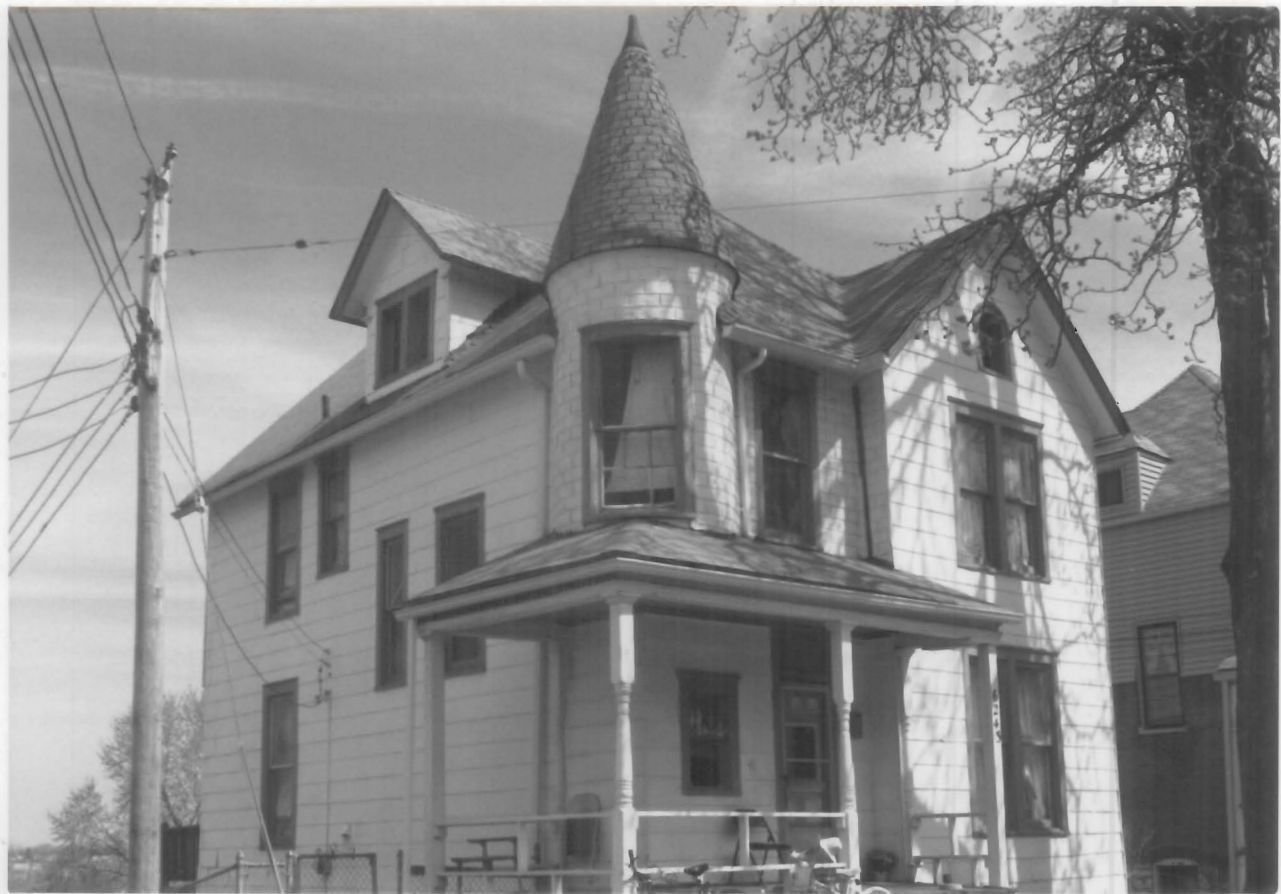
1. No. 200	3. Location of Negatives: Missouri Office of Historic Preservation, P. O. Box 176, Jefferson City, MO 65102		
2. City/County: City of St. Louis, MO

19. Original Use: residence		20. Present Use: residence	
21. No. of stories: 2	22. Basement? yes	23. Wall construction: frame	
24. Foundation material: obscured		25. Roof type/material: complex

26. No. Bays: Front 3 Side 2		27. Wall treatment: non-wood siding	
28. Plan shape: see site map		29. Changes: Addition? Altered?	
30. Exterior condition: fair/good		31. Open to public? no

32. Other Surveys in which included: Heritage/St. Louis survey, 1971			
33. Further description of important features: Although this house has had good recent maintenance, the walls do not appear true to the naked eye, especially at the right side. The house has a combination hipped and gabled roof. Windows are 6-over-6 replacements. A small shed-roof porch is tucked into the corner of the ell; its balustrade and railing appear to be new.

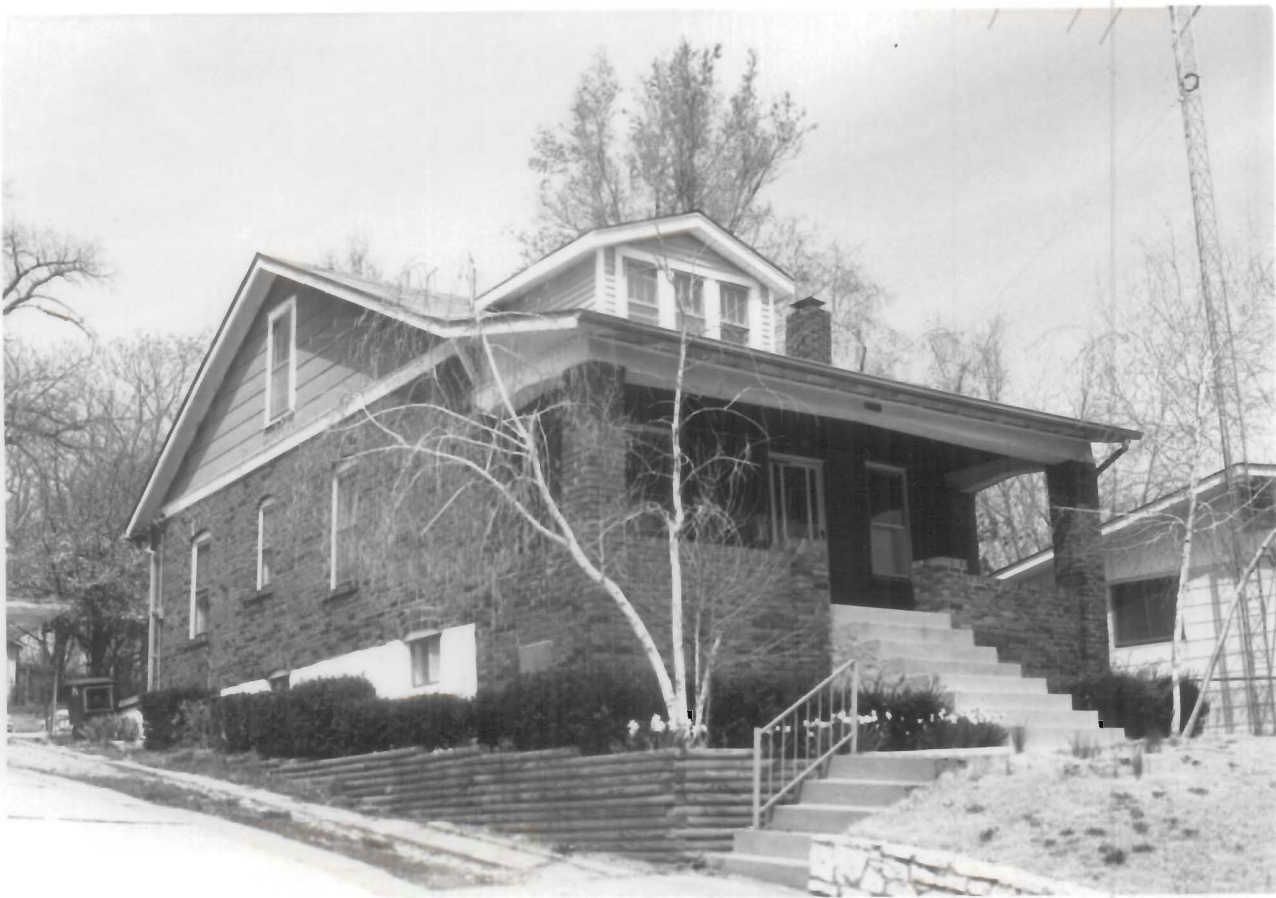
24. Foundation material: stuccoed

30. Exterior condition: good

33. Further description of important features: Upper windows are 6-over-1, while below they are 6-over-6, all double-hung sash. Lower windows are in a bank of four. A bracketed hood shelters the double doors. A permastone planter is located across the front. At the side, a flat-roofed one-story addition houses a garage below and a room above.

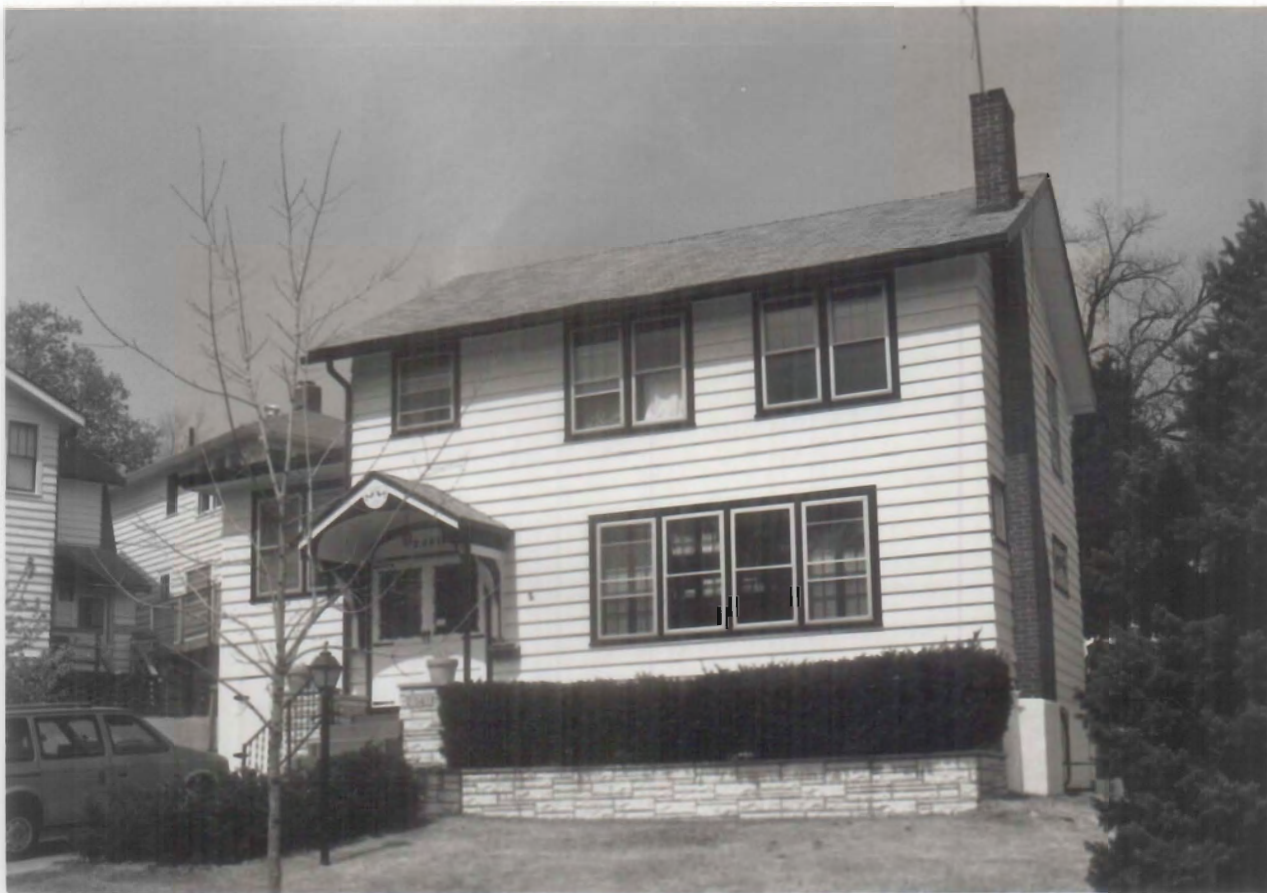
24. Foundation material: stuccoed

30. Exterior condition: good

33. Further description of important features: \*This house is really a side-gabled 2-story with an inset eave made to resemble a gambrel with a full-width dormer. Centered entrance has a round-arched, bracketed hood. Paired 3-over-1 windows flank it. A one-story side addition found in all Vollmar's gambrels has had window alterations and lacks the characteristic railing and 2nd story doorway.

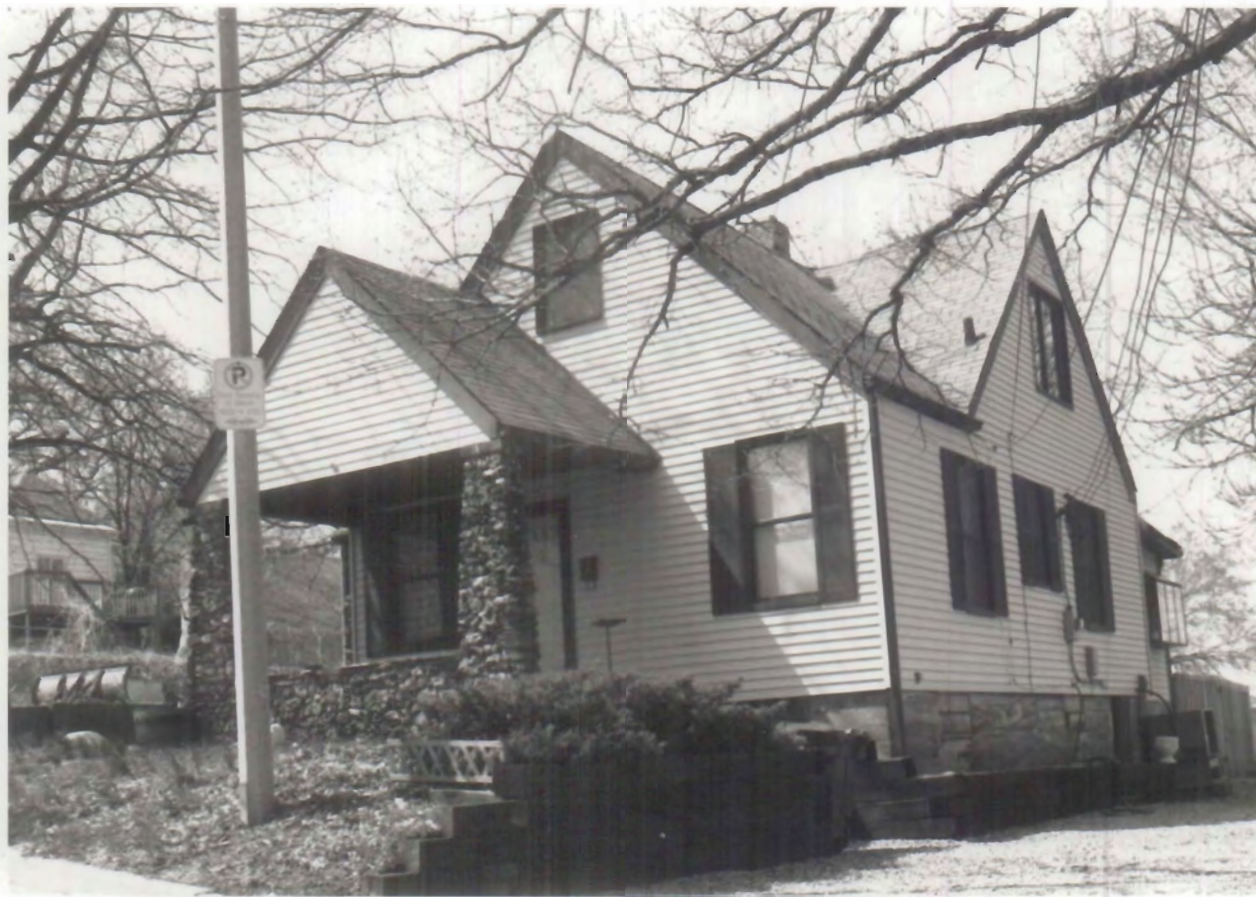
24. Foundation material: concrete		25. Roof type/material: gabled/asphalt	
26. No. Bays: Front 3 Side 4		27. Wall treatment: vinyl siding	
28. Plan shape: see site map		29. Changes: Addition? rear Altered? yes

30. Exterior condition: good		31. Open to public? no	
32. Other Surveys in which included: Heritage/St. Louis survey, 1971			
33. Further description of important features: Stone has been applied to the bungaloid porch pillars and chimney (latter not visible in photo). Windows appear to be replacements.

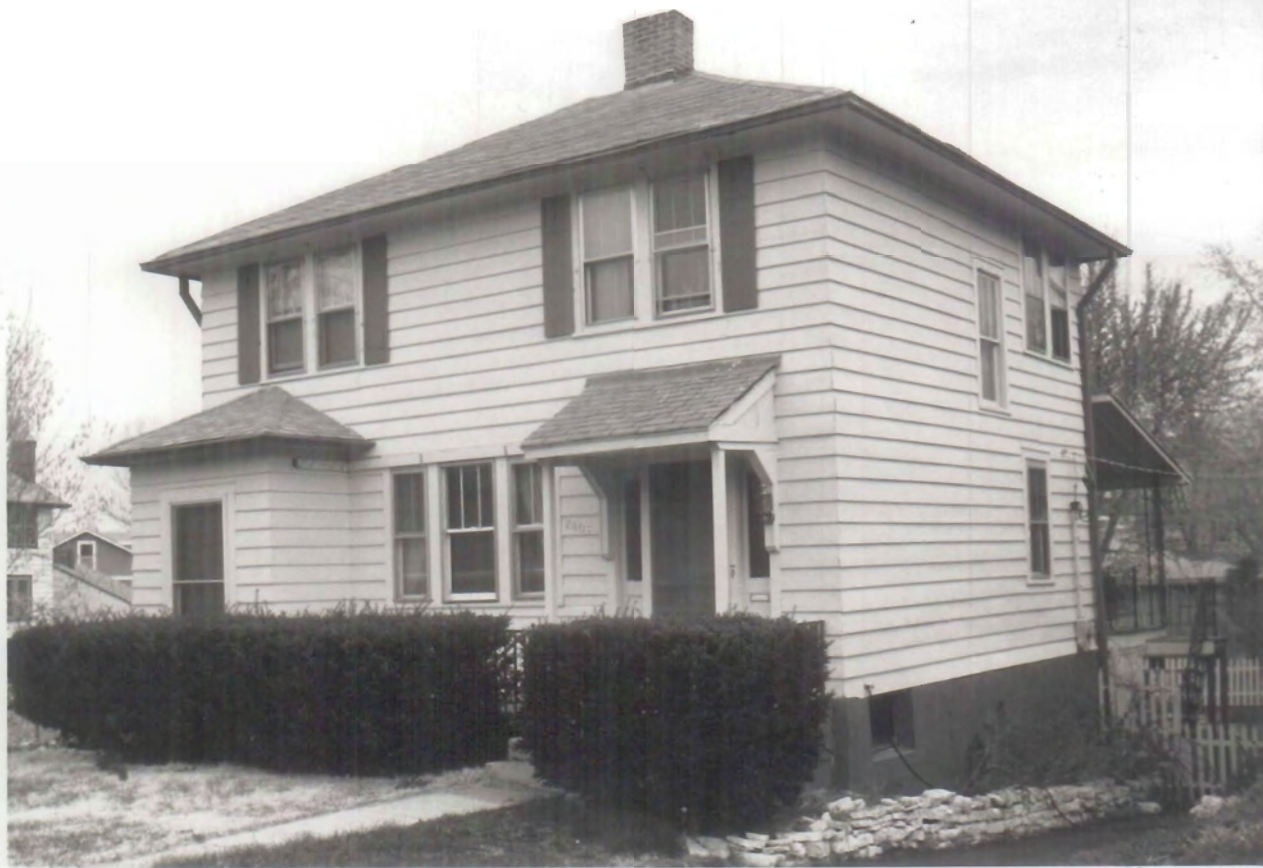
33. Further description of important features: The pyramidally-hipped roof of this house has wide eaves. Paired 3-over-1 double-hung sash on the 2nd story front elevation; 3-over-1 joined by 2 2-over-1 windows in center of 1st story. Bracketed shed-roof hood over entrance. Hipped-roof bay at 1st story, left. Rear frame porch.

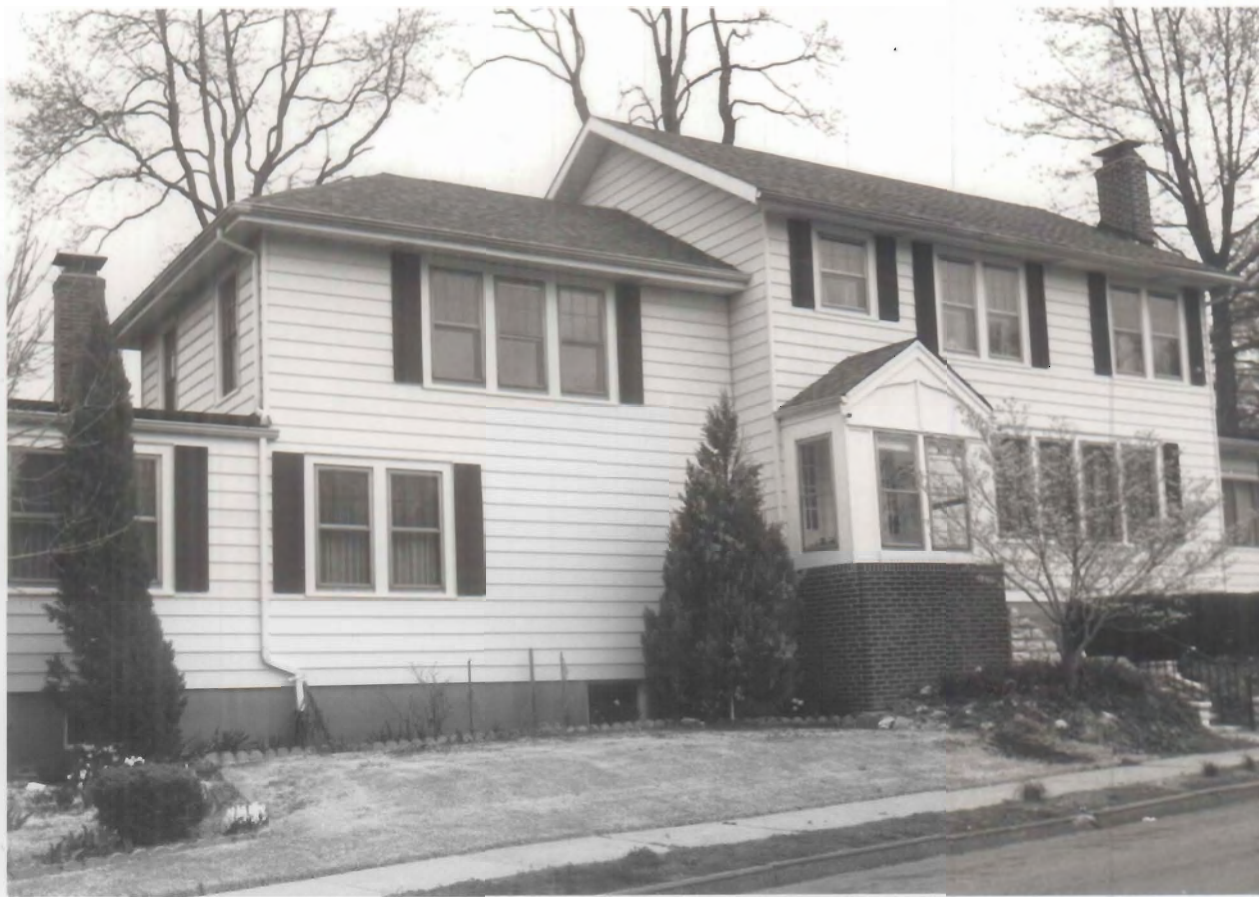
33. Further description of important features: The original part of this house began as a side gable, 3-bay, probably with a one-story, flat-roofed (left) side addition. That addition was given a second story and a hipped roof and then it got a 1-story addition with a flat roof. Entrance is obscured by a non-original "gabled telephone booth" porch. Windows are 6-over-1 double-hung sash.

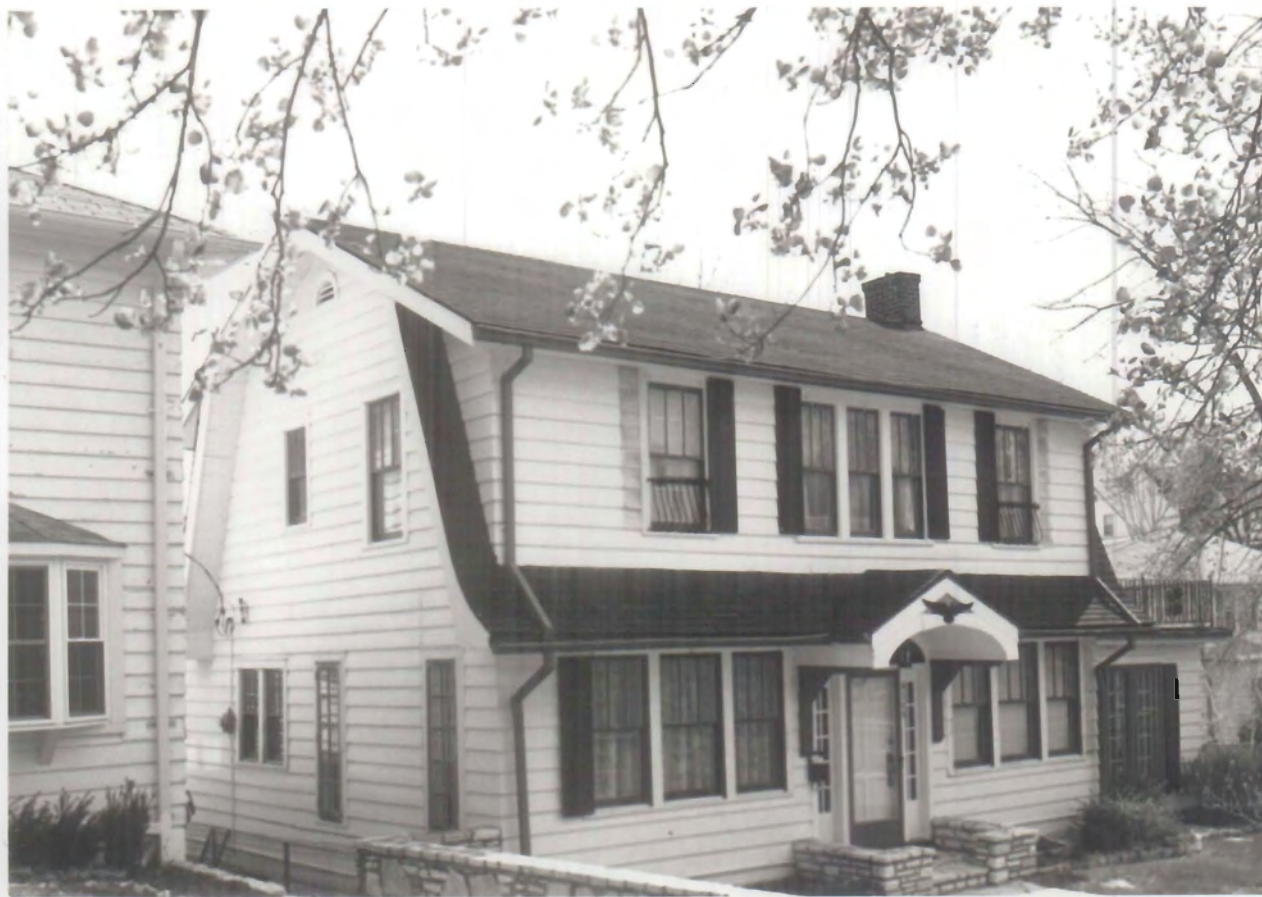
1. No. 174	3. Location of Negatives: Missouri Office of Historic Preservation, P. O. Box 176, Jefferson City, MO 65102		
2. City/County: City of St. Louis, MO

32. Other Surveys in which included: Heritage/St. Louis survey, 1971			
33. Further description of important features: *This house is a two-story side gable with a gambrel-shaped eave attached to the side of the house to give the appearance of a gambrel with a full-width dormer. A centered door is sheltered by a gabled hood supported by brackets. A semicircular fanlight and sidelights distinguish the door. Windows are 3-over-1 double-hung sash; they appear in groups of 3 flanking and above the door. A one-story flat- (cont'd. below)

34. History and Significance: roofed side projection has a top railing. A drive-in rear (lower level) garage is a feature allowed by the slope of the grade. Extensive use of stone in landscaping: walks and low garden walls. No building permits issued before late 1925 are available. Builder Harry C. Vollmar lived in this house in 1925; it is very similar to a number of houses he built in the area. It is very likely that he or he and his brother, also a builder, built this house.

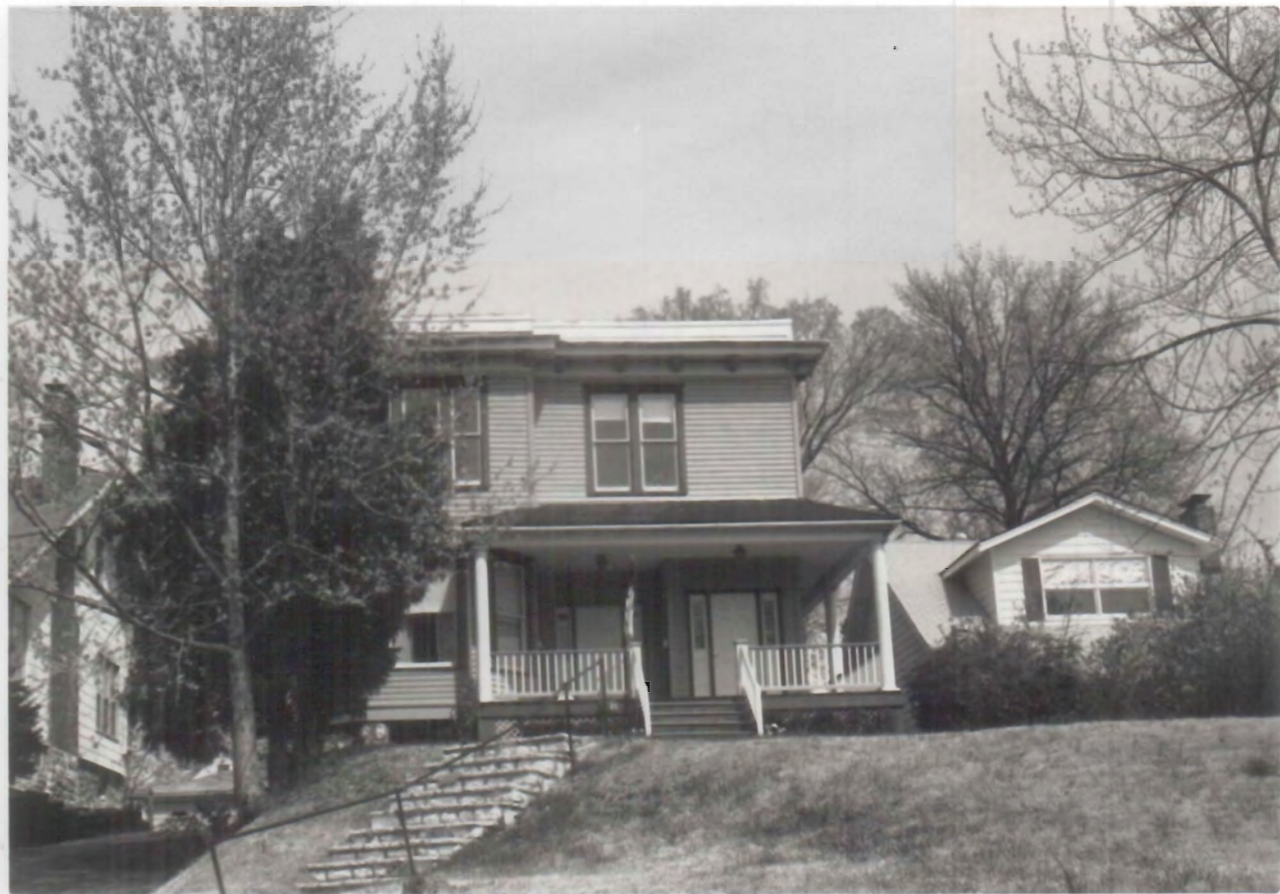
1. No. 180	3. Location of Negatives: Missouri Office of Historic Preservation, P. O. Box 176, Jefferson City, MO 65102		
2. City/County: City of St. Louis, MO	4. Prepared by: Cynthia Hill Longwisch, Landmarks Assn. of St. Louis, 917 Locust, 7th Floor, St. Louis, MO 63101

33. Further description of important features: This house has a flat roof, banded just below on the front elevation by a large, bracketed cornice that returns at the sides for a short distance. The wrap-around porch is supported by fluted columns. Windows are paired or tripled, 1-over-1 double-hung sash. The projecting bay at left is angled at the first story to form a bay window. Under the porch, there are two doors with sidelights, one (cont'd. below)

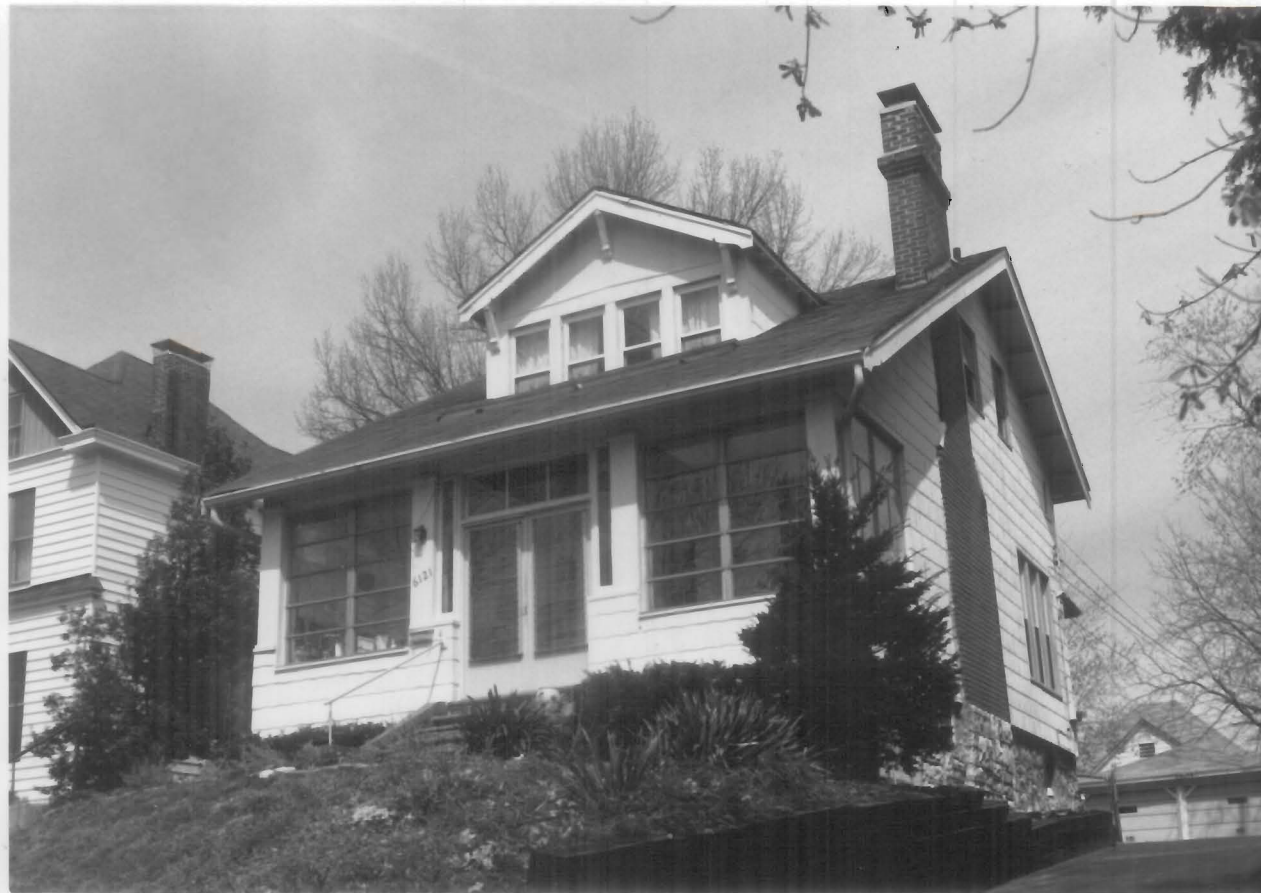
33. Further description of important features: The dormer of this house features 3 brackets and exposed rafter ends; its four windows are longer than they appear, having a recess in front of the dormer. The roof extends to form the full-width porch roof. The porch, supported by frame pillars, has been enclosed to form a sunroom. A one-story frame addition is at the west side.

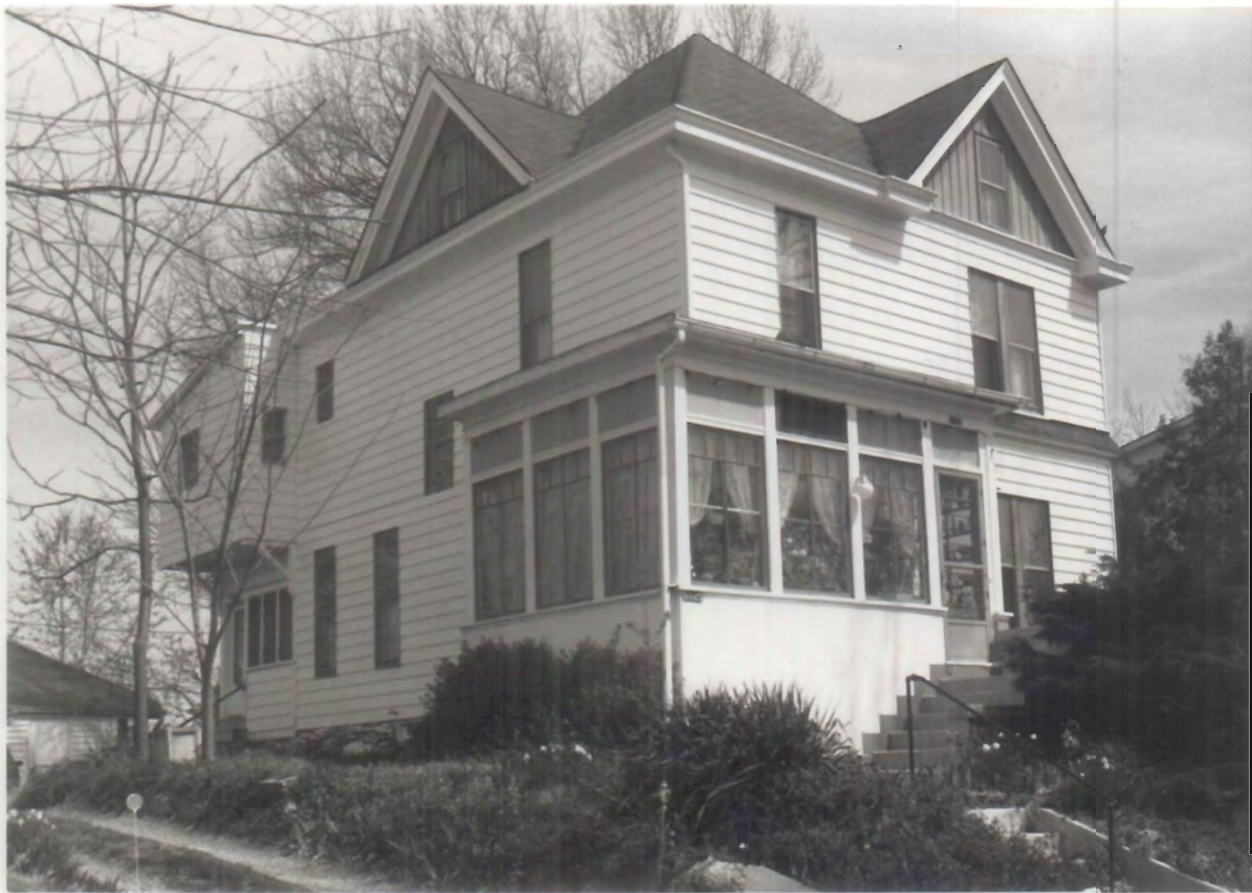
1. No. 182		3. Location of Negatives: Missouri Office of Historic Preservation, P. O. Box 176, Jefferson City, MO 65102	
2. City/County: City of St. Louis, MO		4. Prepared by: Cynthia Hill Longwisch, Landmarks Assn. of St. Louis, 917 Locust, 7th Floor, St. Louis, MO 63101

30. Exterior condition: good		31. Open to public? no	
32. Other Surveys in which included: Heritage/St. Louis survey, 1971			
33. Further description of important features: The pyramidally hipped main roof of this house has small steep gables; the heavy cornice is interrupted at the front elevation for one such gable. Windows are 1-over-1 and seem to be replacements. The corner porch is enclosed to form a sunroom. At the rear, an odd, shed-roofed section (addition or original?) is cantilevered over the side, with brackets beneath. Detailing of this house was probably lost when sided.
