# ARCHITECTURAL SURVEY OF CLIFTON HEIGHTS

JUNE 1991

ST. LOUIS, MISSOURI

LANDMARKS ASSOCIATION OF ST. LOUIS, INC.

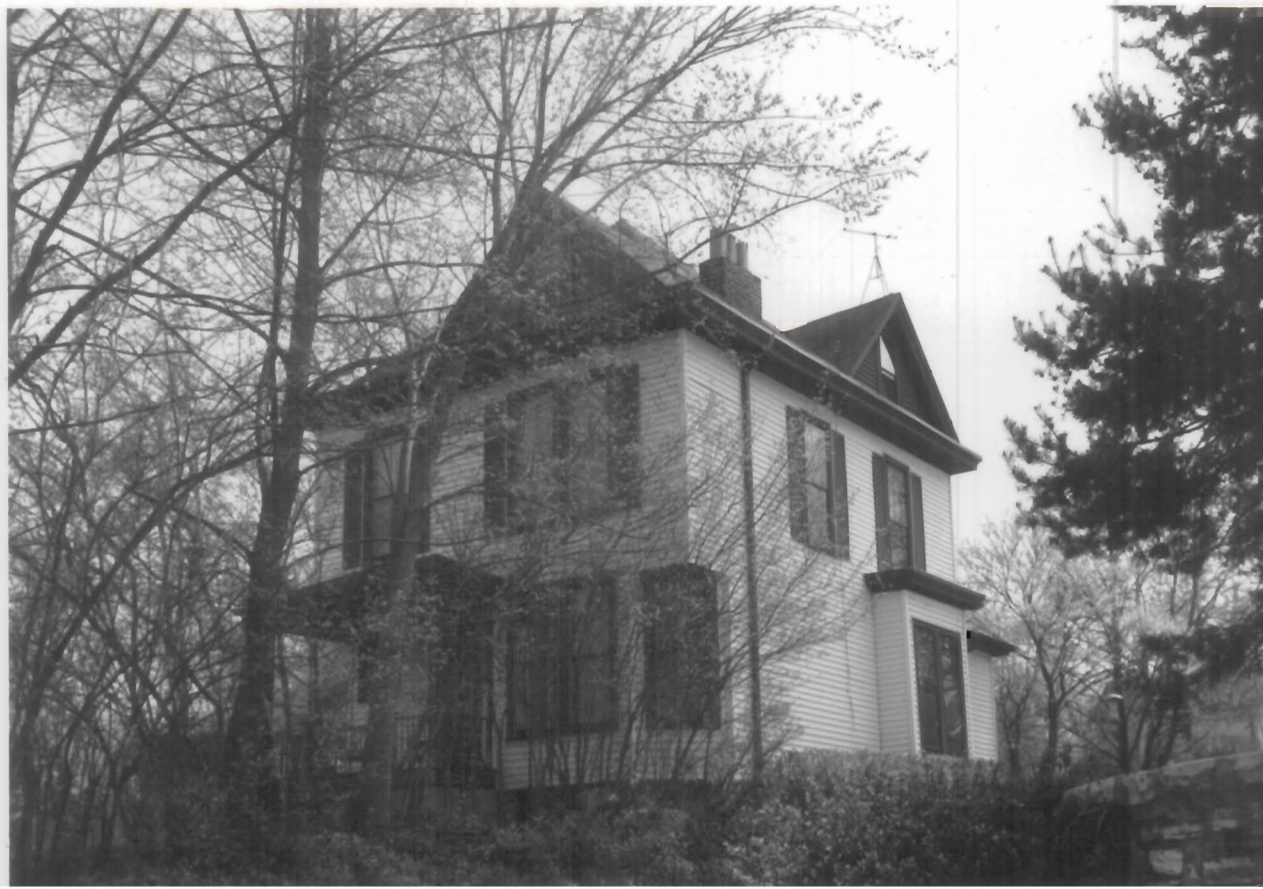
1. No. 223	3. Location of Negatives: Missouri Office of Historic Preservation, P. O. Box 176, Jefferson City, MO 65102		
2. City/County: City of St. Louis, MO	4. Prepared by: Cynthia Hill Longwisch, Landmarks Assn. of St. Louis, 917 Locust, 7th Floor, St. Louis, MO 63101

30. Exterior condition: good		31. Open to public? no	
32. Other Surveys in which included: Heritage/St. Louis survey, 1971			
33. Further description of important features: The roofline of this house is hipped and gabled; the northwest corner of the house is cut out at the 1st story to provide for an angled corner window. A one-story, flat-roofed bay window is located on the west side. Rear, 1-sty. addition. A porch is located in the corner of the ell, at left in photo.

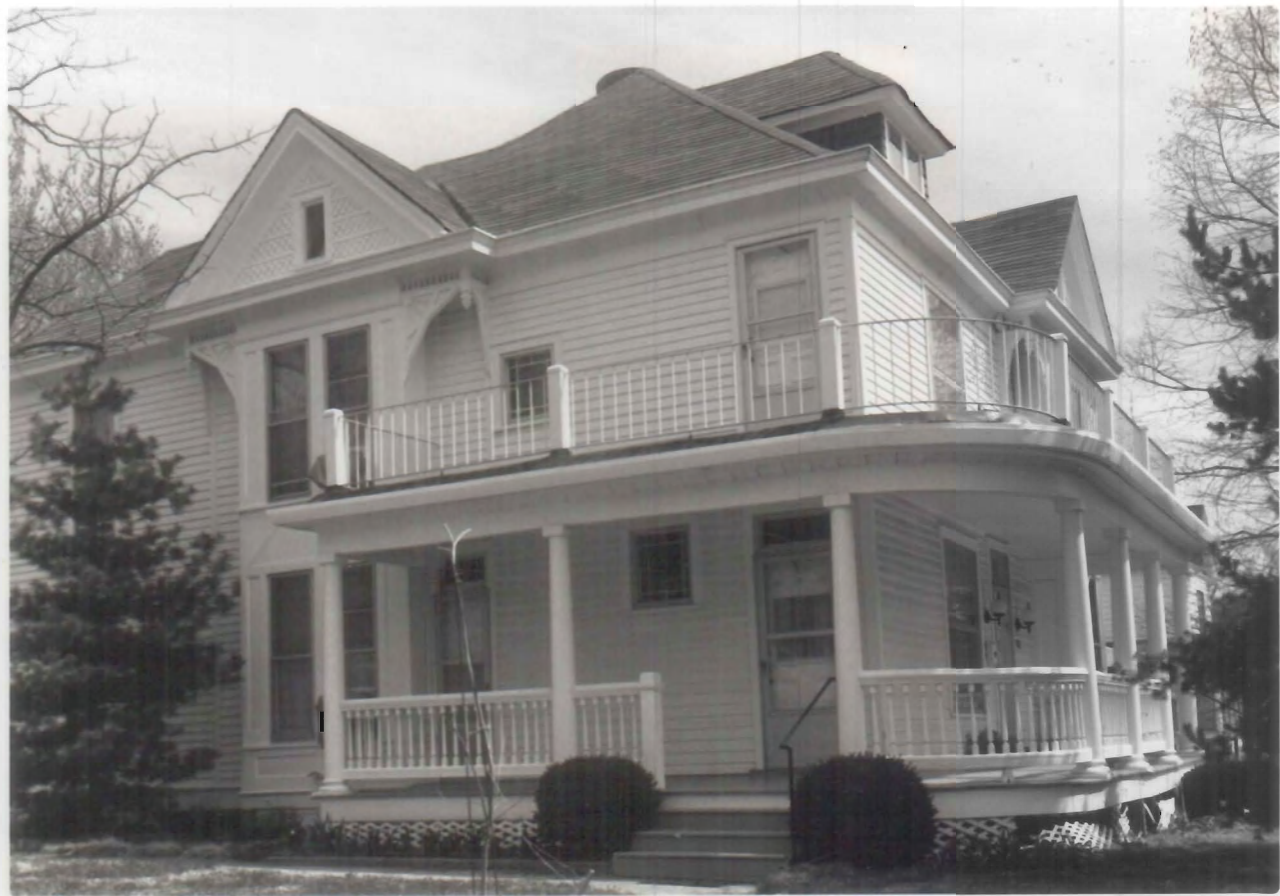
1. No. 183	3. Location of Negatives: Missouri Office of Historic Preservation, P. O. Box 176, Jefferson City, MO 65102		
2. City/County: City of St. Louis, MO	4. Prepared by: Cynthia Hill Longwisch, Landmarks Assn. of St. Louis, 917 Locust, 7th Floor, St. Louis, MO 63101

30. Exterior condition: good		31. Open to public? no	
32. Other Surveys in which included: Heritage/St. Louis survey, 1971			
33. Further description of important features: The dominant feature of this house is its curved, true wrap-around porch. Round wood pillars support it; a balustrade of turned spindles is surmounted by a molded wood handrail; above is an iron railing with short wood posts. Second-story door allows access. The cornice breaks for gabled projections, the pediments imbricated; below the cornice, fretwork, fanlike brackets and finials decorate the (cont'd. below)

34. History and Significance: 2nd story of the bays. Windows are 1-over-1, for the most part, except for squares (in stairwell?) surrounded by small rectangles of stained glass. Hipped-roof dormer. One-story addition at northeast corner has small 2-over-1 windows - may be \$1500 1902 addition mentioned in Heritage/St. Louis files. Geo. Whitson, clerk, Railway Mail Service, owned it in 1898. Used as 2-family dwelling in early 'teens - family of survey #184 lived here while their house was being built next door. --Heritage/St. Louis

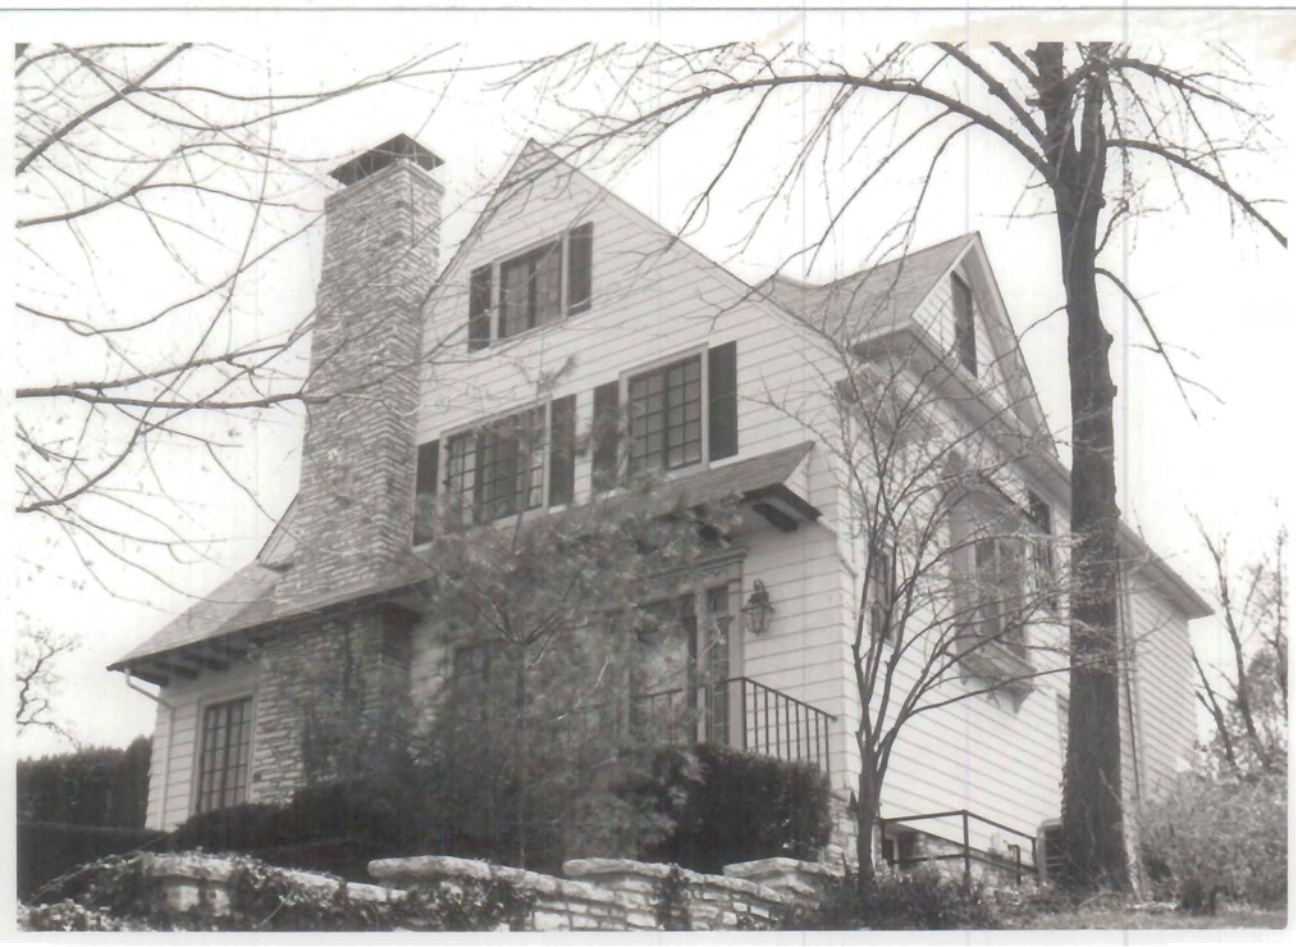
33. Further description of important features: A stone chimney dominates the facade of this house, which features a large front gable and three side gables. A narrow, shingled hood extends across the width of the front to shield the windows and door below; it has thick exposed rafters. Windows are multipane casement. Door has carved surround with fluted pilasters and stained glass sidelights that match glass in the narrow, side bay window (original glass?).

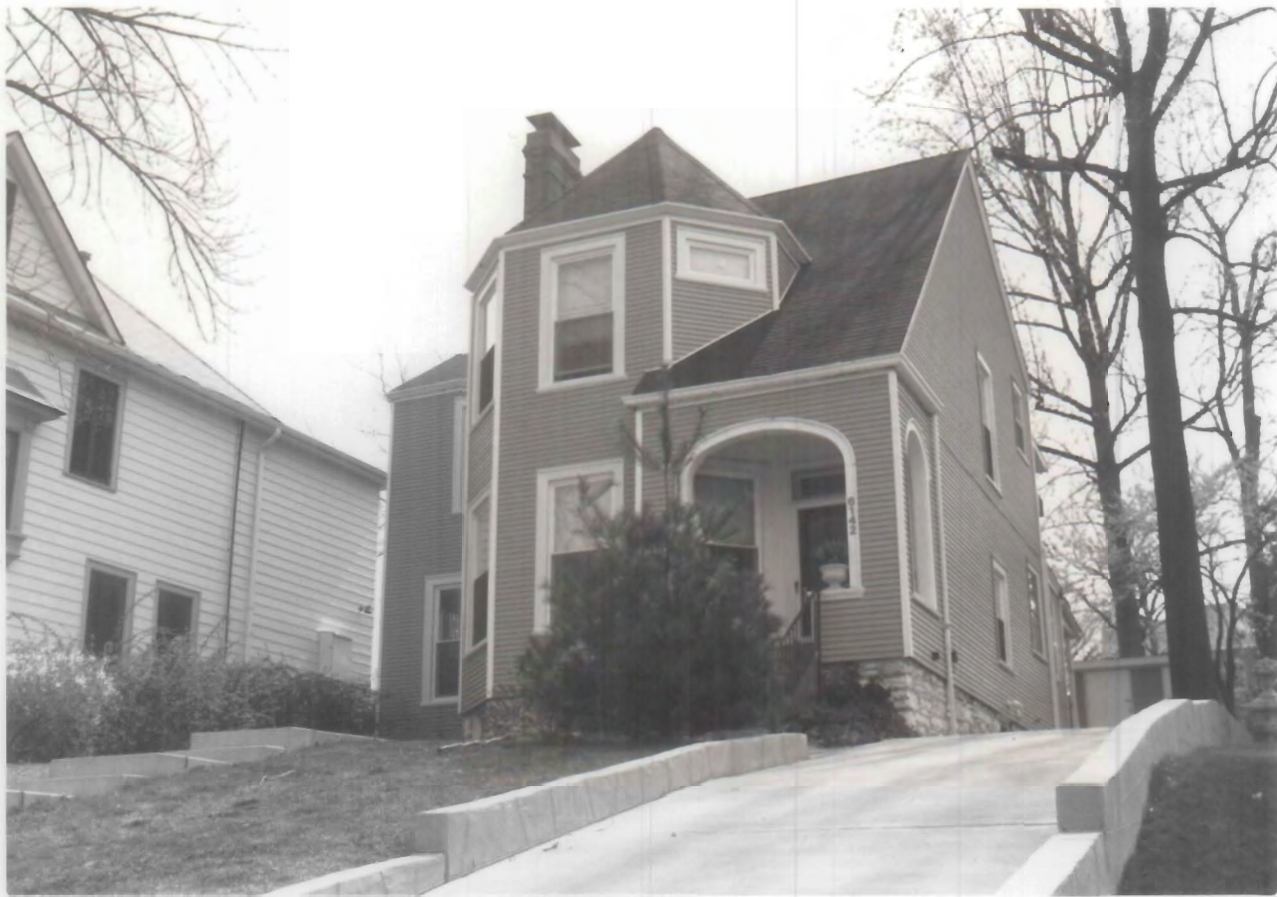
1. No. 221	3. Location of Negatives: Missouri Office of Historic Preservation, P. O. Box 176, Jefferson City, MO 65102		
2. City/County: City of St. Louis, MO	4. Prepared by: Cynthia Hill Longwisch, Landmarks Assn. of St. Louis, 917 Locust, 7th Floor, St. Louis, MO 63101

30. Exterior condition: good		31. Open to public? no	
32. Other Surveys in which included: Heritage/St. Louis survey, 1971			
33. Further description of important features: A large, polygonal, conical-roofed tower dominates the facade of this house. It juts up through a long, sloping side-gabled section. Beside it, a small corner porch features basket-handle arches. Windows are 1-over-1 (replacements?). Transomed front door. 1-sty rear addition.

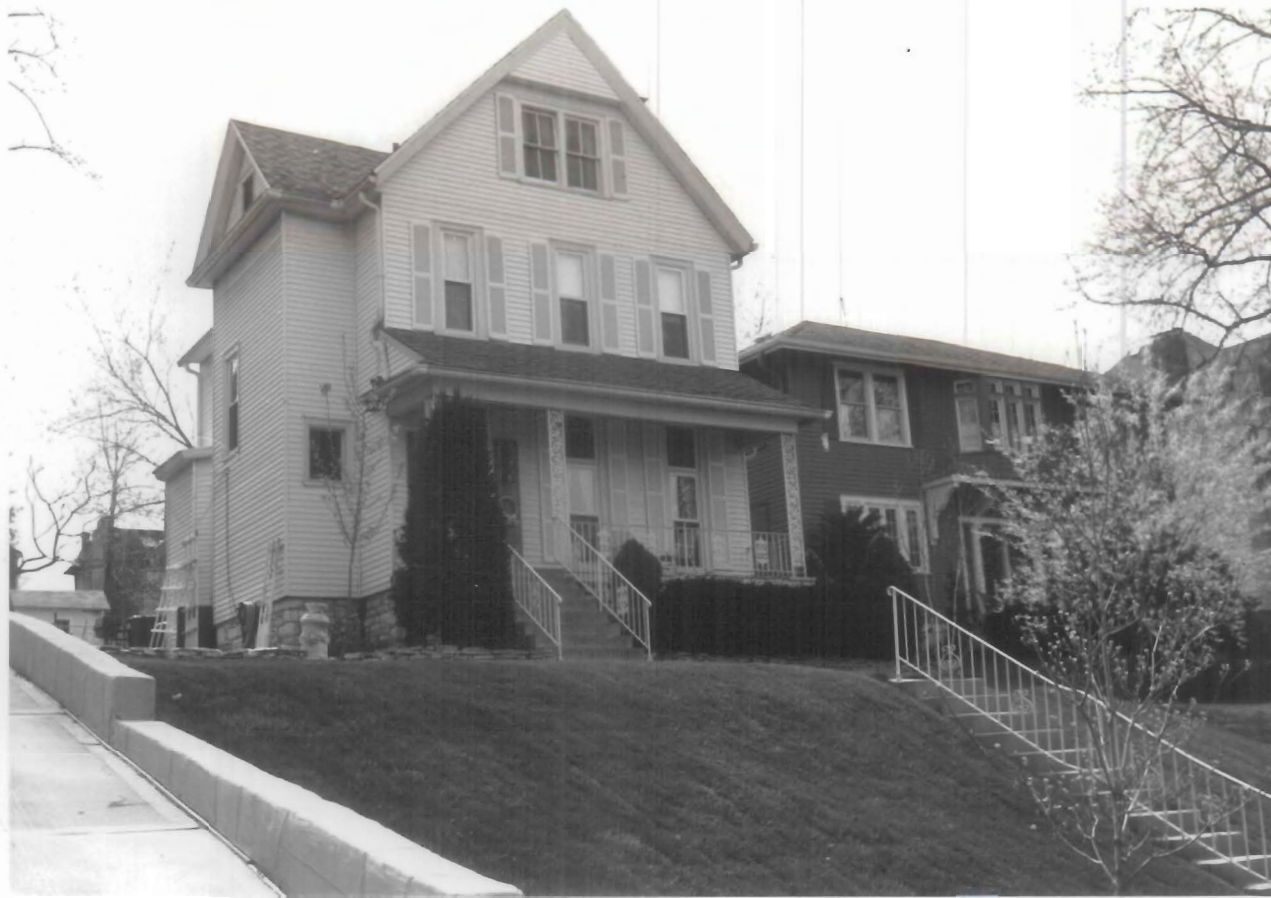
1. No. 220	3. Location of Negatives: Missouri Office of Historic Preservation, P. O. Box 176, Jefferson City, MO 65102		
2. City/County: City of St. Louis, MO	4. Prepared by: Cynthia Hill Longwisch, Landmarks Assn. of St. Louis, 917 Locust, 7th Floor, St. Louis, MO 63101

30. Exterior condition: good		31. Open to public? no	
32. Other Surveys in which included: Heritage/St. Louis survey, 1971			
33. Further description of important features: The peak of the front gable of this house projects slightly; below are paired, 2-over-2 double-hung sash windows. At the 2nd story, 3 narrow, 1-over-1 windows are evenly spaced above a shed-roof full-width porch supported by iron (replacement) posts. Narrow and exceptionally long windows at 1st story have 3 stacked panes. Stained glass fanlight may not be original. Projecting side gable intersected by cornice.

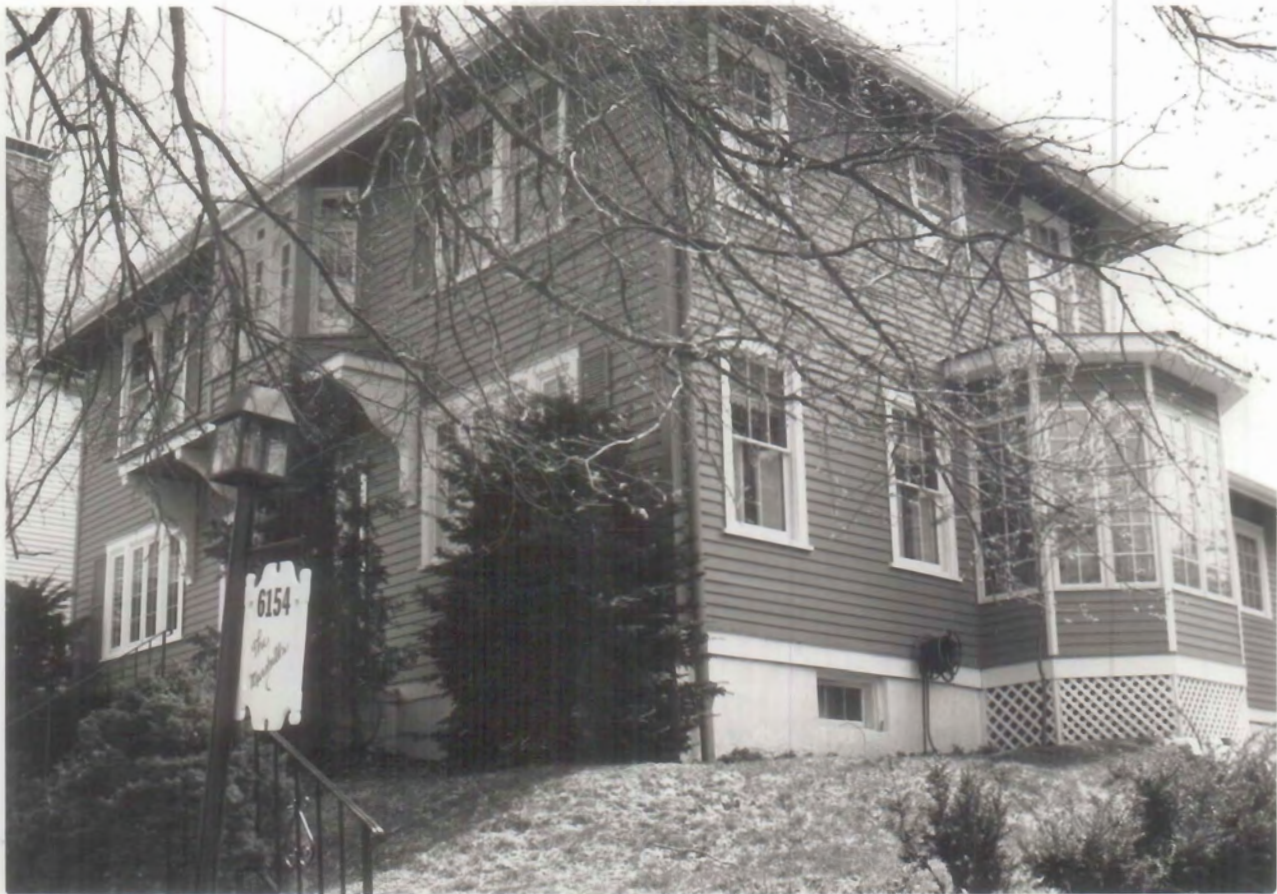
33. Further description of important features: This house has a hipped and gabled roof. A curved wrap-around porch is the highlight of the house, with turned Ionic columns, elaborate, scalloped handrails, spindle balustrade and paneled bottom posts. One of the windows under the porch roof has a Greek Revival pediment; another is round. At right behind the porch, a bay window projects from the second story; it features a bracketed (cont'd. below)

34. History and Significance: cornice and tapers to a point at the bottom. Windows are 1-over-1. Heavy cornice. House is on hill overlooking park. John Henry Higginbotham, wife and 5 children lived here in 1889. He was a member and steward of the Fry Methodist Church and a well-known major promoter of Clifton Heights. c. 1920, William B. Higginbotham returned from NY to live here after the deaths of his parents. His oldest daughter then lived here until her death c. 1969-70: her husband continued to live here. --Heritage/St. Louis

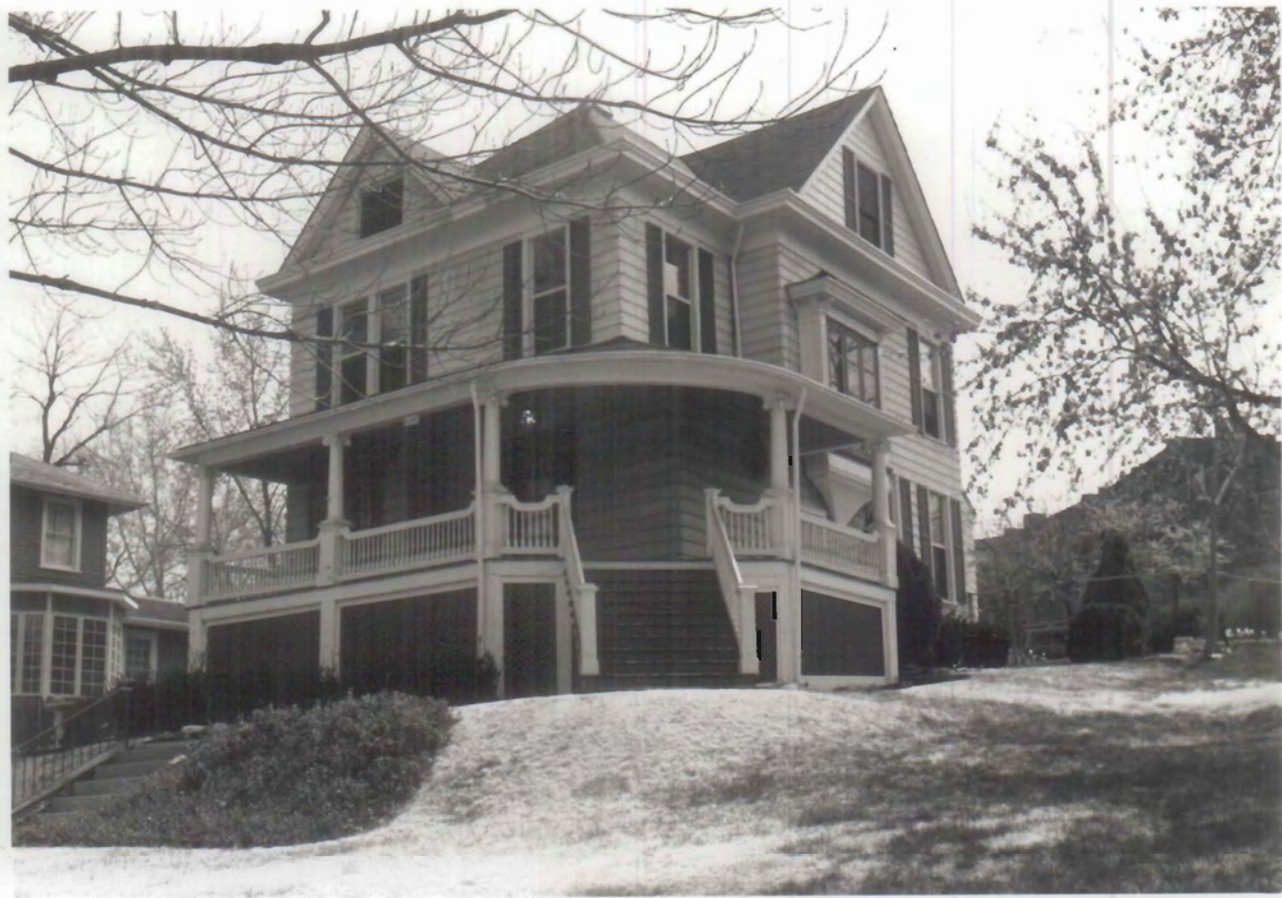
33. Further description of important features: The exterior wall surfaces of this house are all stuccoed, and appear to be that way in a 1970-71 photo. The house has a hipped and gabled roof. A large, double-deck porch on the north-west elevation is an alteration; a more traditional, rectangular porch crossed the facade in the photo; it appears to have had a rather odd, mansardlike upper deck. The house is in a prime location overlooking the park.

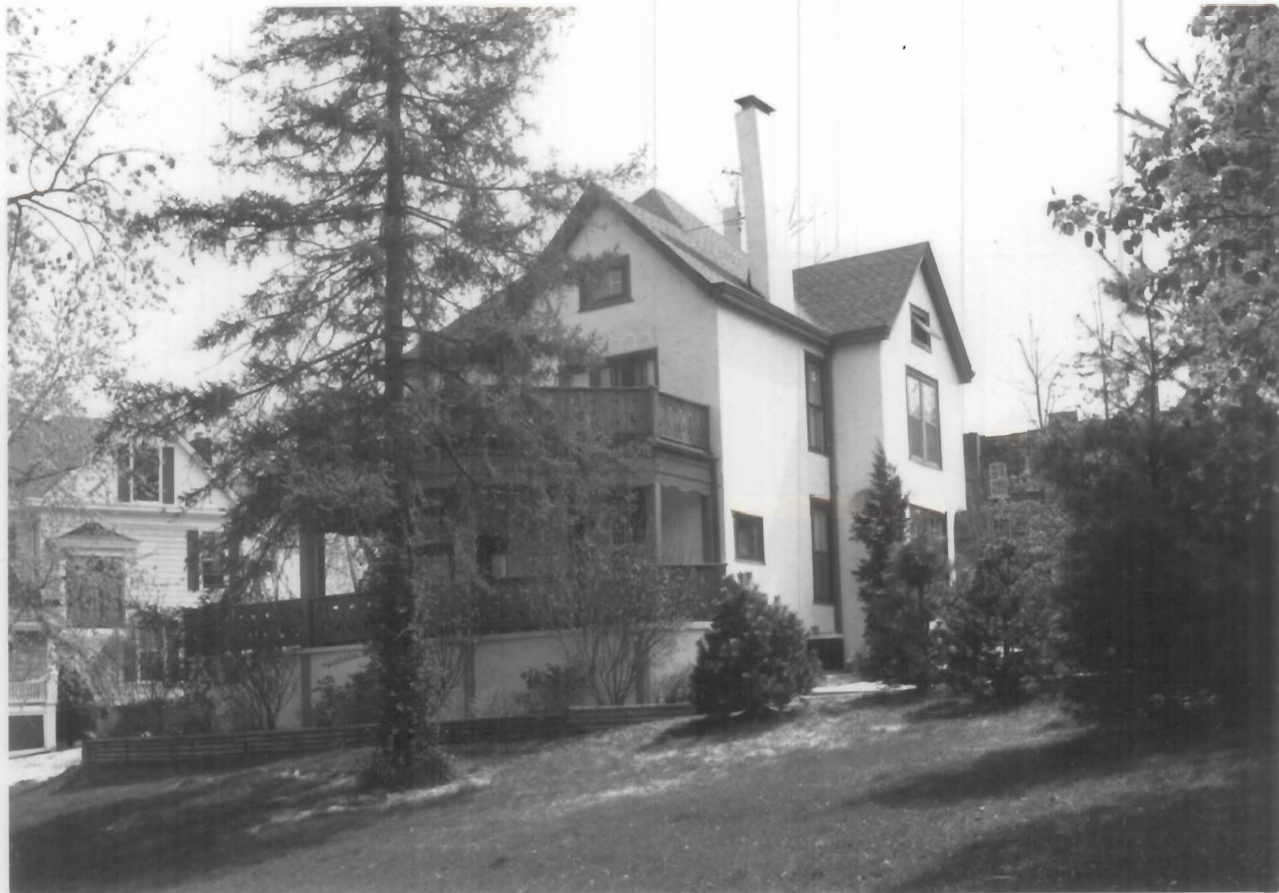
33. Further description of important features: The entrance of this house is marked by a 2nd-story sunroom supported by square corinthian columns. This is in the center of an open, turned-stone-balustraded patio. Windows are 1-over-1 with stone jack arches and sills. The cross gambrel provides a full second story, and access from it is allowed onto a deep semicircular bow window on the south and a flat-roofed projection on the north, both with (cont'd. below)

34. History and Significance: iron railings. The first story is painted brick while the second is sheathed in asbestos siding. Some of the windows are stained glass, but are probably not original to the house. John E. Mitchell, who was married to Ellen Higginbotham (of one of the oldest & most prominent Clifton Heights families), built this house in 1910, according to Heritage/St. Louis files. Mitchell was the president of Alsop Process in 1915 and later president of John Mitchell Co., shoe machinery manufacturers.

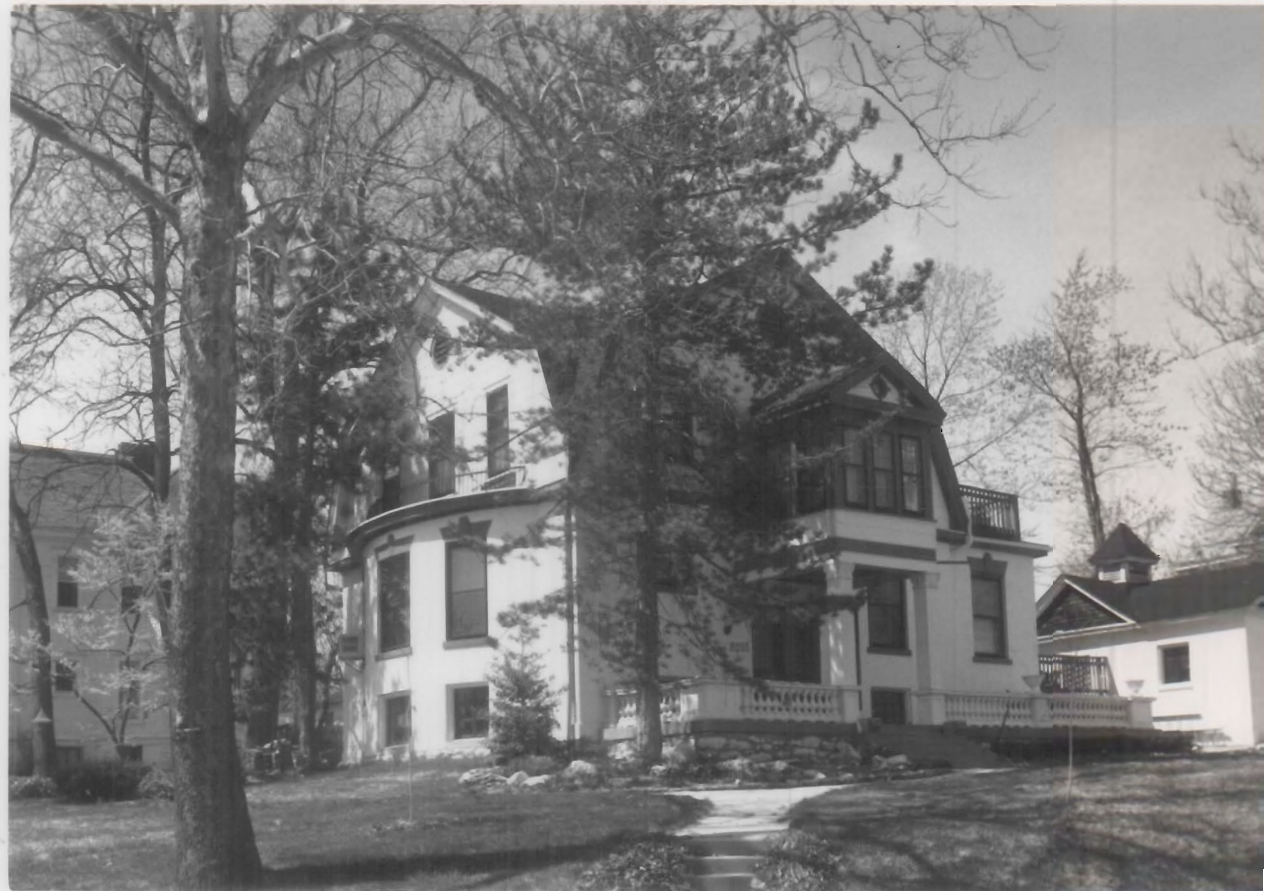
1. No. 145	3. Location of Negatives: Missouri Office of Historic Preservation, P. O. Box 176, Jefferson City, MO 65102		
2. City/County: City of St. Louis, MO

33. Further description of important features: This large house has a four-square front section, topped with a truncated pyramid roof with a gabled dormer. The roof here might have originally had a widow's walk. A wide cornice is interrupted for the dormer; it has 3 small windows, imbrication & a sunburst. A frame porch is inset at the right corner; it has round wood pillars. Between the stories, a wide band of imbricated wood shingling encircles (cont'd. below)

34. History and Significance: the house. At the back of the house, a projecting gabled bay is cut out at the corners to provide a 2-story bay window, topped with scrolled wood brackets. Windows are 1-over-1; double door is transomed. No building permits prior to 1926 are available for this city block. Edward F. H. Wenneker, manager of the Wenneker-Morris Candy Co., is listed at this house in 1898. He was also a Trustee of Fry Methodist Church. His wife continued to own the property at least until 1920. --Heritage/St. Louis files

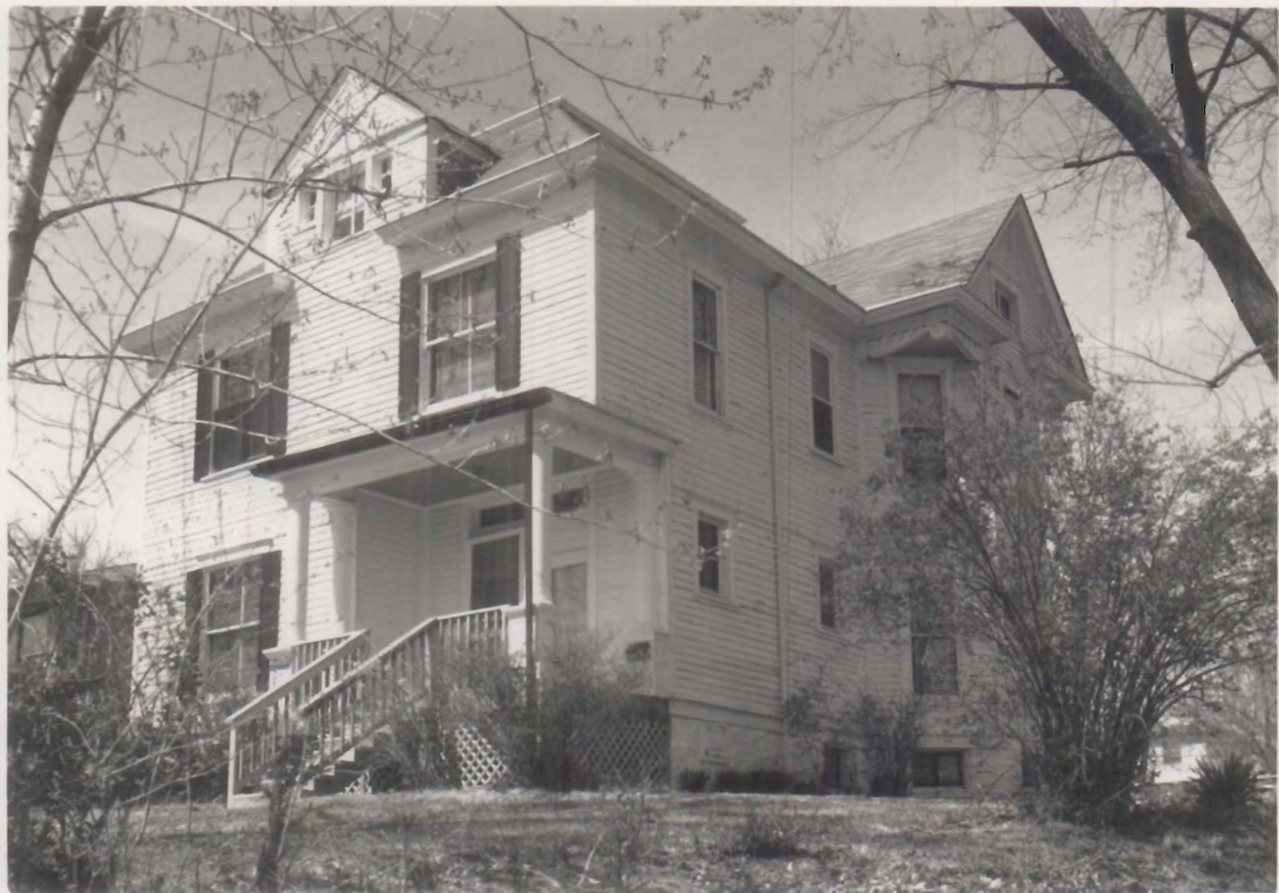
1. No. 146	3. Location of Negatives: Missouri Office of Historic Preservation, P. O. Box 176, Jefferson City, MO 65102		
2. City/County: City of St. Louis, MO

32. Other Surveys in which included: Heritage/St. Louis survey, 1971			
33. Further description of important features: Without building permits, it is difficult to even speculate what has happened with the building of this house. The taller, rear portion is of a slight Queen Anne bent, with cut-out corners to form a bay window. On the front is a hipped-roof, dormered section with a heavy full-width porch supported by brick pillars. The foundation of the front part is concrete scored to resemble brick. A Bungleanne?

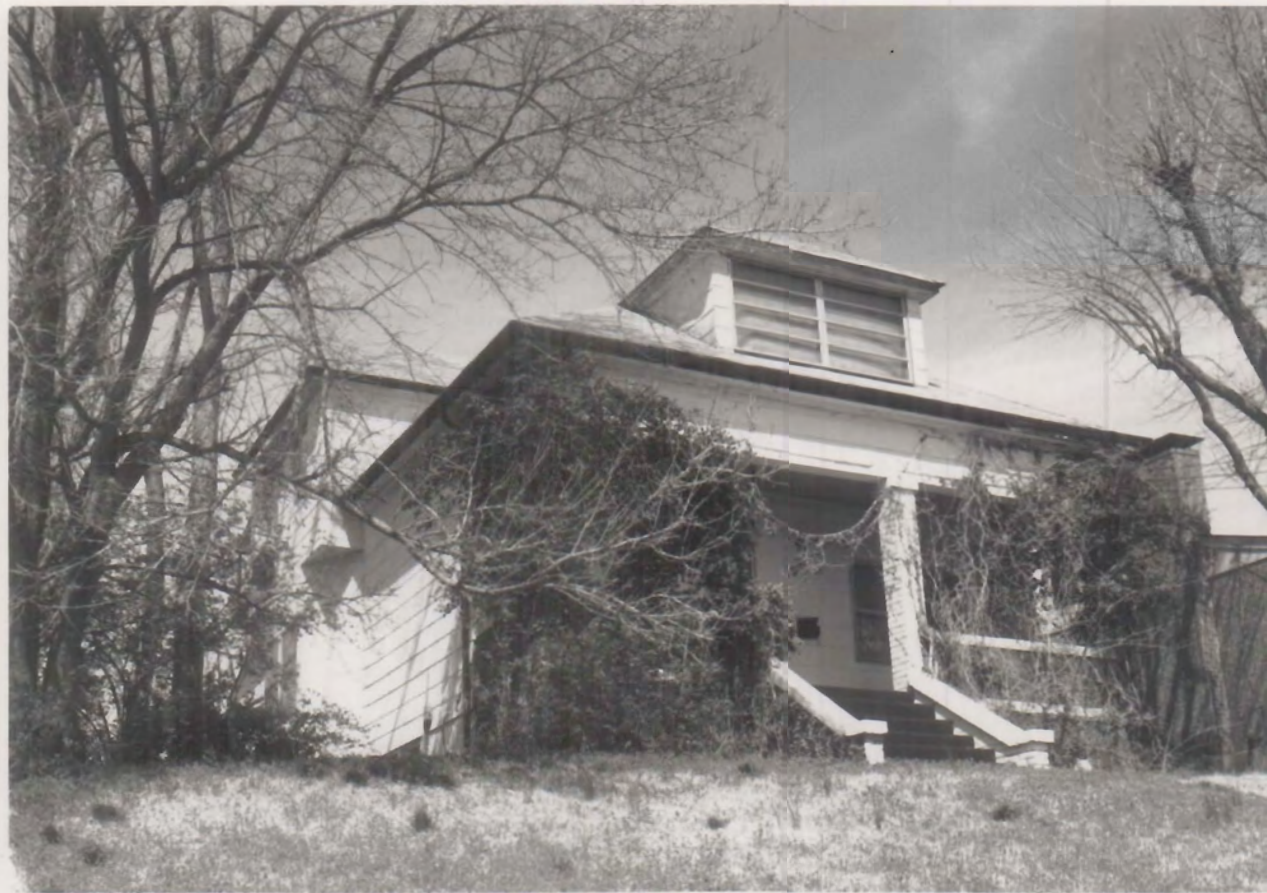
1. No. 147		3. Location of Negatives: Missouri Office of Historic Preservation, P. O. Box 176, Jefferson City, MO 65102	
2. City/County: City of St. Louis, MO		4. Prepared by: Cynthia Hill Longwisch, Landmarks Assn. of St. Louis, 917 Locust, 7th Floor, St. Louis, MO 63101

33. Further description of important features: The roofline of this house is hipped at several places, possibly as rear additions were added. Paired windows at the front upper story "break through" the roofline with a little gable. A smaller, rectangular window with a slight Greek Revival pedimented enframing is located to the left at the 2nd story; its twin is around the corner. A wrap-around porch has turned spindles above and as a balustrade; (cont'd. below)

34. History and Significance: this porch, while in keeping with the character of the house, was added between 1970 when Heritage/St. Louis photographed it and 1991. In 1970 it was totally devoid of a porch and an apparent imprint of one seems to be only at the corner beneath the two rectangular windows. The upper story of this house is covered with imbricated wood shingling; clapboards below. Fred Pritzer, a member of Fry Methodist Church and an editor by trade, lived in this house in 1901 but was not listed here in 1902. --Heritage/St. Louis files

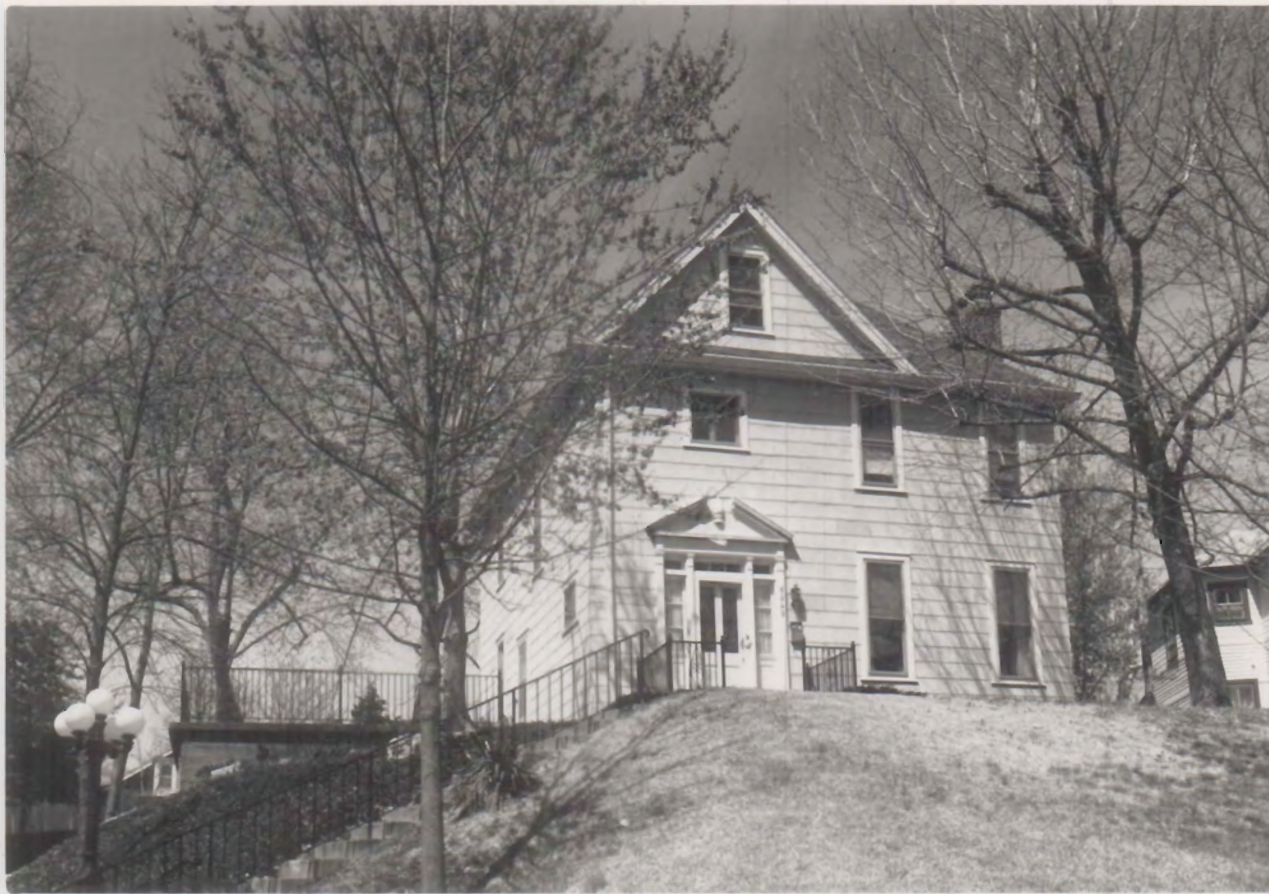
34. History and Significance: gable at the south side shelters a two-story bay window. The house is sited back from the street at a considerable distance in an almost wooded setting facing the park.

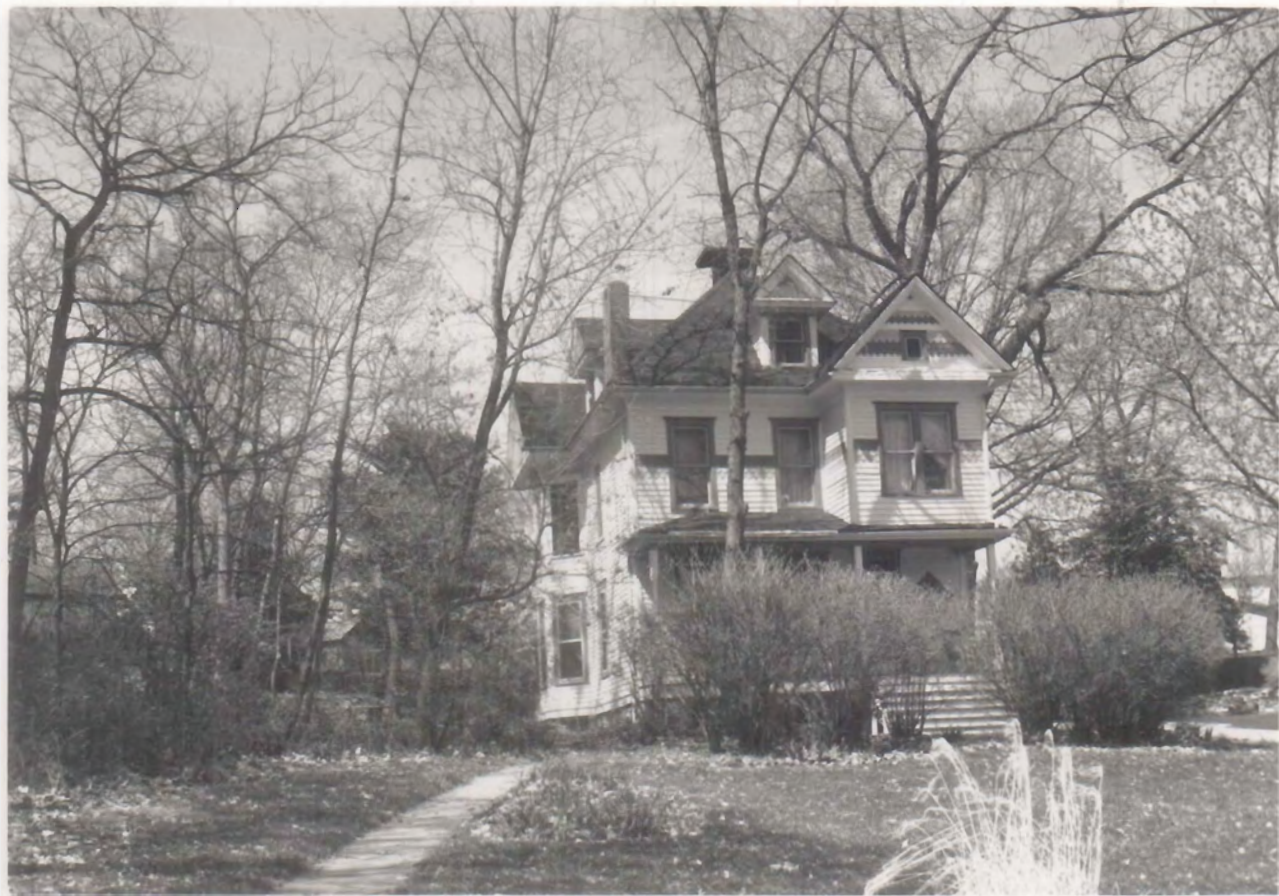
1. No. 176	3. Location of Negatives: Missouri Office of Historic Preservation, P. O. Box 176, Jefferson City, MO 65102		
2. City/County: City of St. Louis, MO	4. Prepared by: Cynthia Hill Longwisch, Landmarks Assn. of St. Louis, 917 Locust, 7th Floor, St. Louis, MO 63101

33. Further description of important features: A gabled dormer in the front elevation has triple 6-over-1 windows. The house roof extends to become the porch roof, supported by tapered (outside corners) and straight pillars. Paired 3-over-1 double-hung sash windows flank the center doorway, which also has vertical Craftsman paning. On the east side, two new "greenhouse windows" flank the chimney.

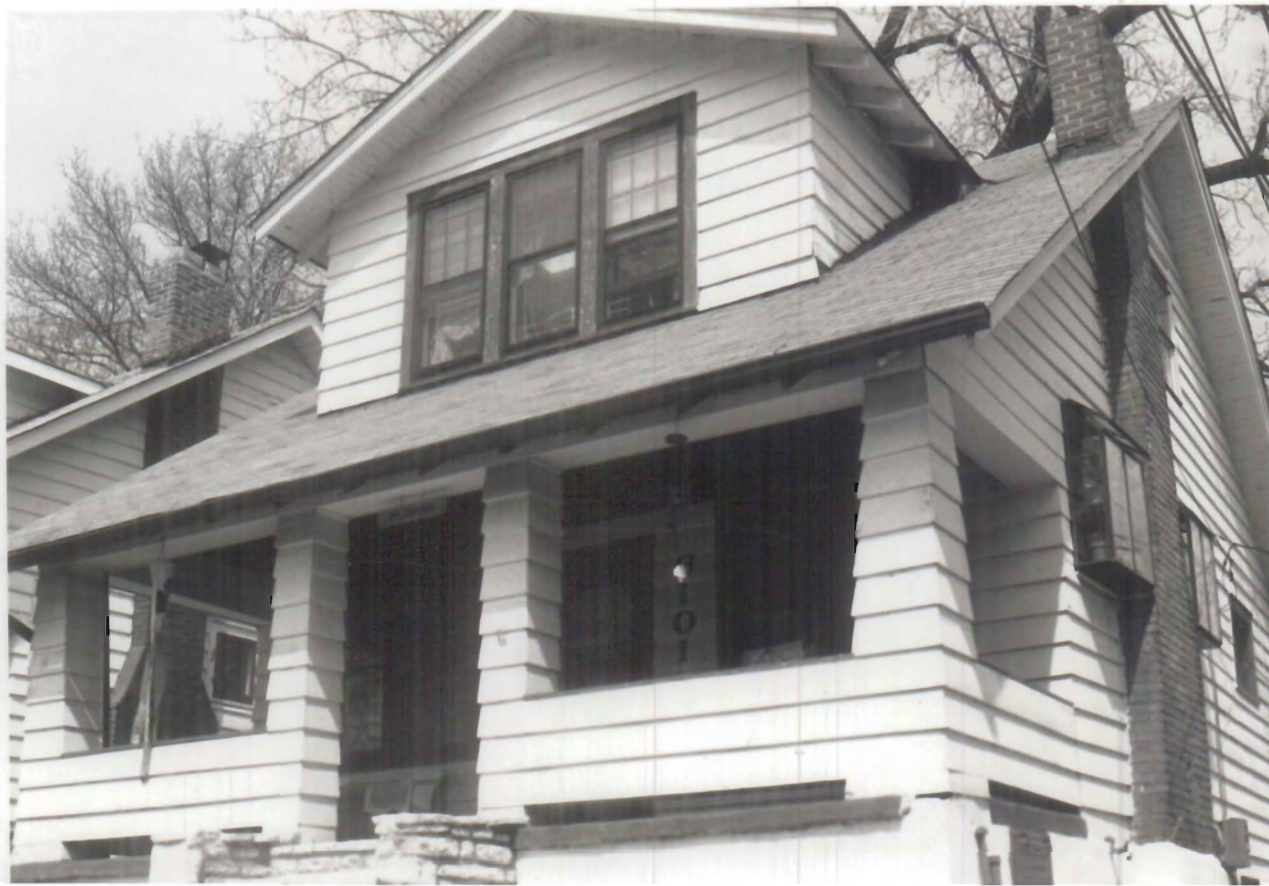
1. No. 177	3. Location of Negatives: Missouri Office of Historic Preservation, P. O. Box 176, Jefferson City, MO 65102		
2. City/County: City of St. Louis, MO

33. Further description of important features: Triple windows in the gabled dormer are 3-over-1 double-hung sash; those below are the same, except paired, flanking the doorway. The roof extends to become the porch roof, supported by heavy tapering, stuccoed pillars at the corners. A wood railing encloses the porch. Stone has been applied to the front of the foundation and to the steps. Windows in side elevations tend to be smaller. Rear 1-story frame addition.

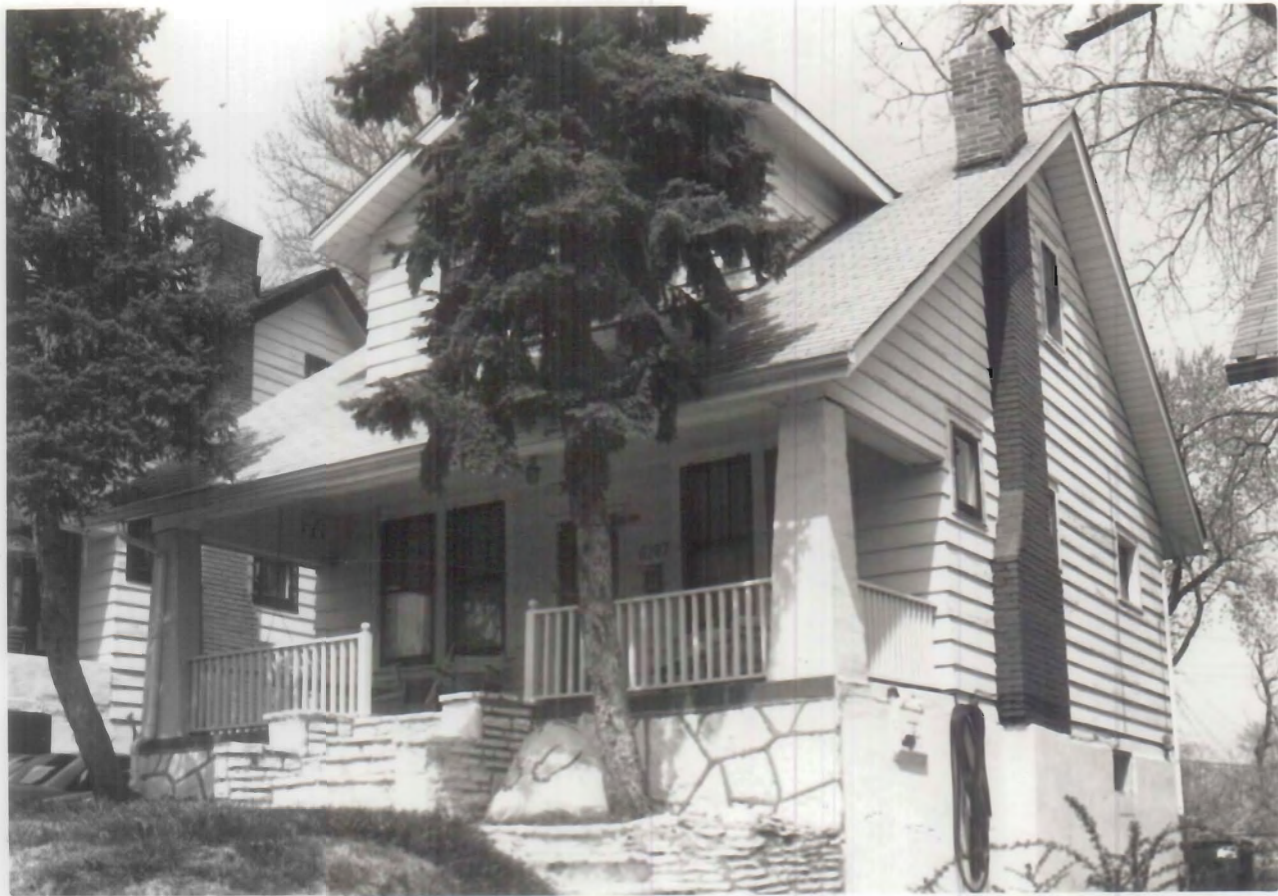
1. No. 178	3. Location of Negatives: Missouri Office of Historic Preservation, P. O. Box 176, Jefferson City, MO 65102		
2. City/County: City of St. Louis, MO	4. Prepared by: Cynthia Hill Longwisch, Landmarks Assn. of St. Louis, 917 Locust, 7th Floor, St. Louis, MO 63101

33. Further description of important features: The gabled dormer of this house has exposed rafter ends and three 3-over-1 double-hung windows. Paired windows of the same type flank the door. The roof extends to become the porch roof, supported by square pillars. The pillars and side walls of the porch have been stuccoed.

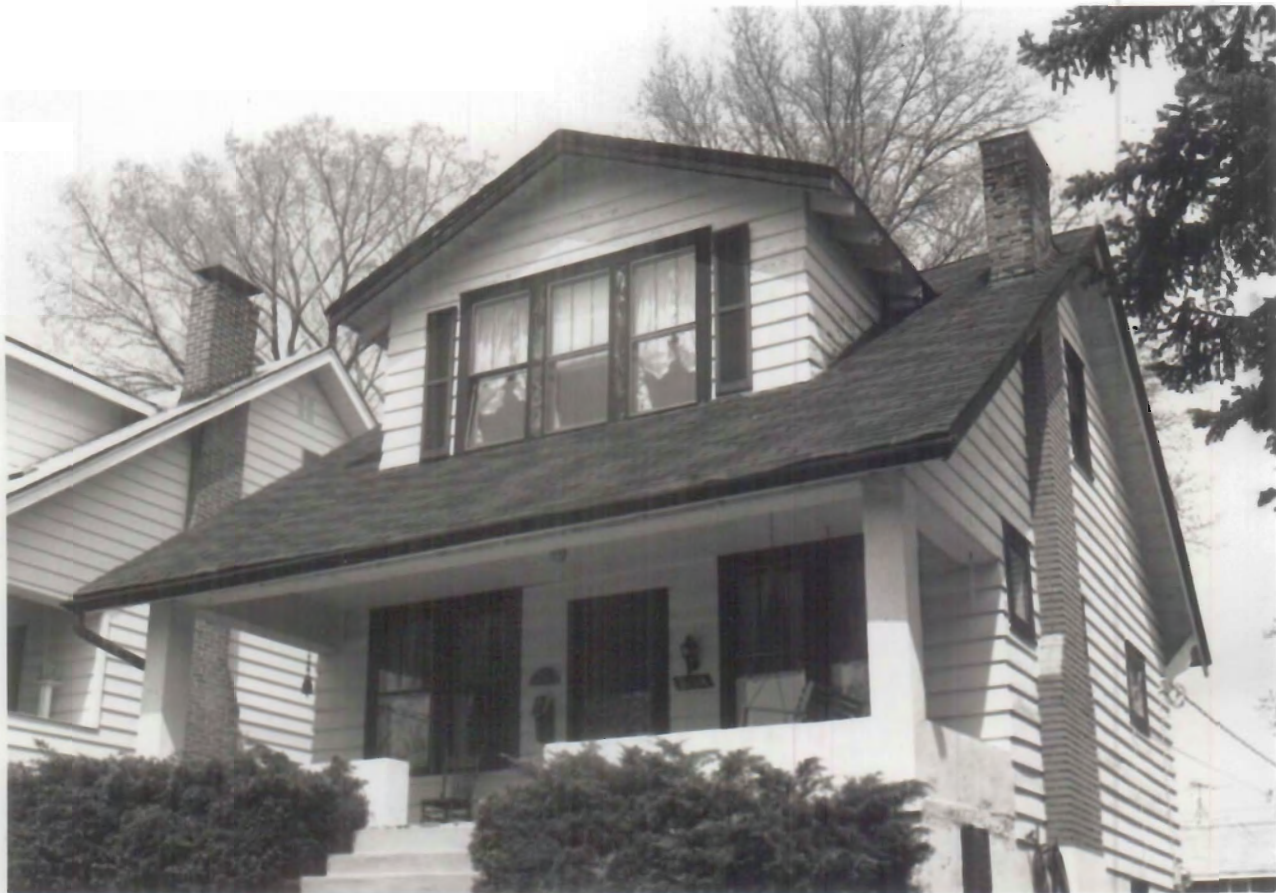
34. History and Significance: Although pre-1925 building permits are not available in 1991, in 1970-71 (before microfilming), Heritage/St. Louis researchers found some permits for the Simpson Terrace bungalows. This one was for this house and its neighbor at 6109. They cost \$4,000 apiece; no other information was given. Vollmar was a local builder; he almost certainly built all four bungalows on Simpson Terrace.
