# ARCHITECTURAL SURVEY OF CLIFTON HEIGHTS

JUNE 1991

ST. LOUIS, MISSOURI

LANDMARKS ASSOCIATION OF ST. LOUIS, INC.

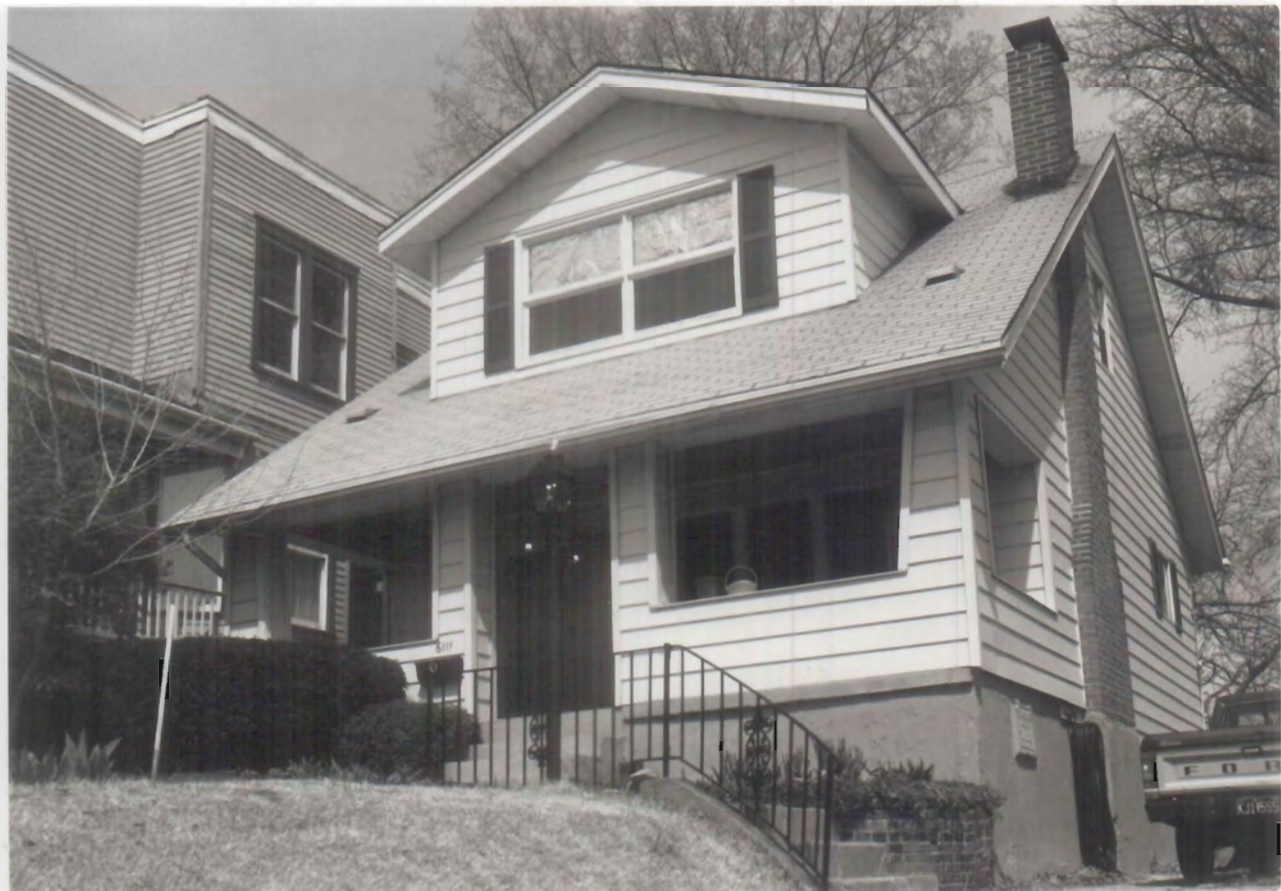
33. Further description of important features: The original triple window of this dormer has been altered to form a double unit. The roof of the house extends to form the porch roof, supported by tapering pillars at the outside corners and straight pillars at the opening, all sheathed in siding. Triple windows on the front first story; door offset to left.

34. History and Significance: Although pre-1925 building permits are not available in 1991, in 1970-71 (before microfilming), Heritage/St. Louis researchers found some permits for the Simpson Terrace bungalows. This one was for this house and its neighbor at 6109. They cost \$4,000 apiece; no other information was given. Vollmar was a local builder; he almost certainly built all four bungalows on Simpson Terrace.

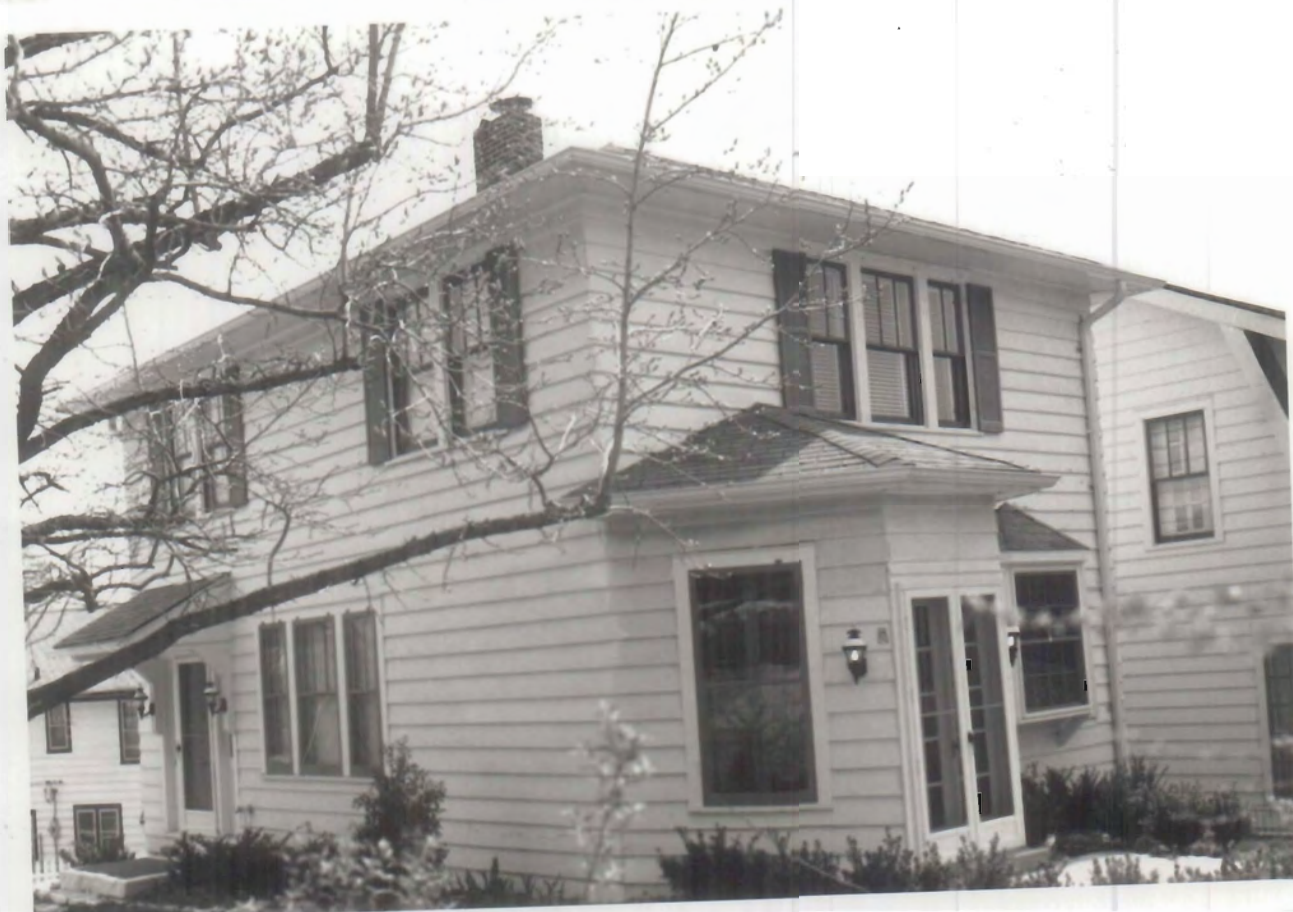
1. No. 175	3. Location of Negatives: Missouri Office of Historic Preservation, P. O. Box 176, Jefferson City, MO 65102		
2. City/County: City of St. Louis, MO	4. Prepared by: Cynthia Hill Longwisch, Landmarks Assn. of St. Louis, 917 Locust, 7th Floor, St. Louis, MO 63101

24. Foundation material: obscured		25. Roof type/material: hipped	
26. No. Bays: Front 3 Side 3		27. Wall treatment: clapboarding	
28. Plan shape: see site map		29. Changes: Addition? Altered? yes

30. Exterior condition: good		31. Open to public? no	
32. Other Surveys in which included: Heritage/St. Louis survey, 1971			
33. Further description of important features: Almost a foursquare, this house has a pyramidally hipped roof. Windows are 3-over-1 double-hung sash, paired or tripled. A side door (photo, left) has a shed-roof bracketed hood, while a front entrance of double doors is located in a projecting, windowed bay. A "greenhouse" window has been attached to the front elevation next to the entrance bay.

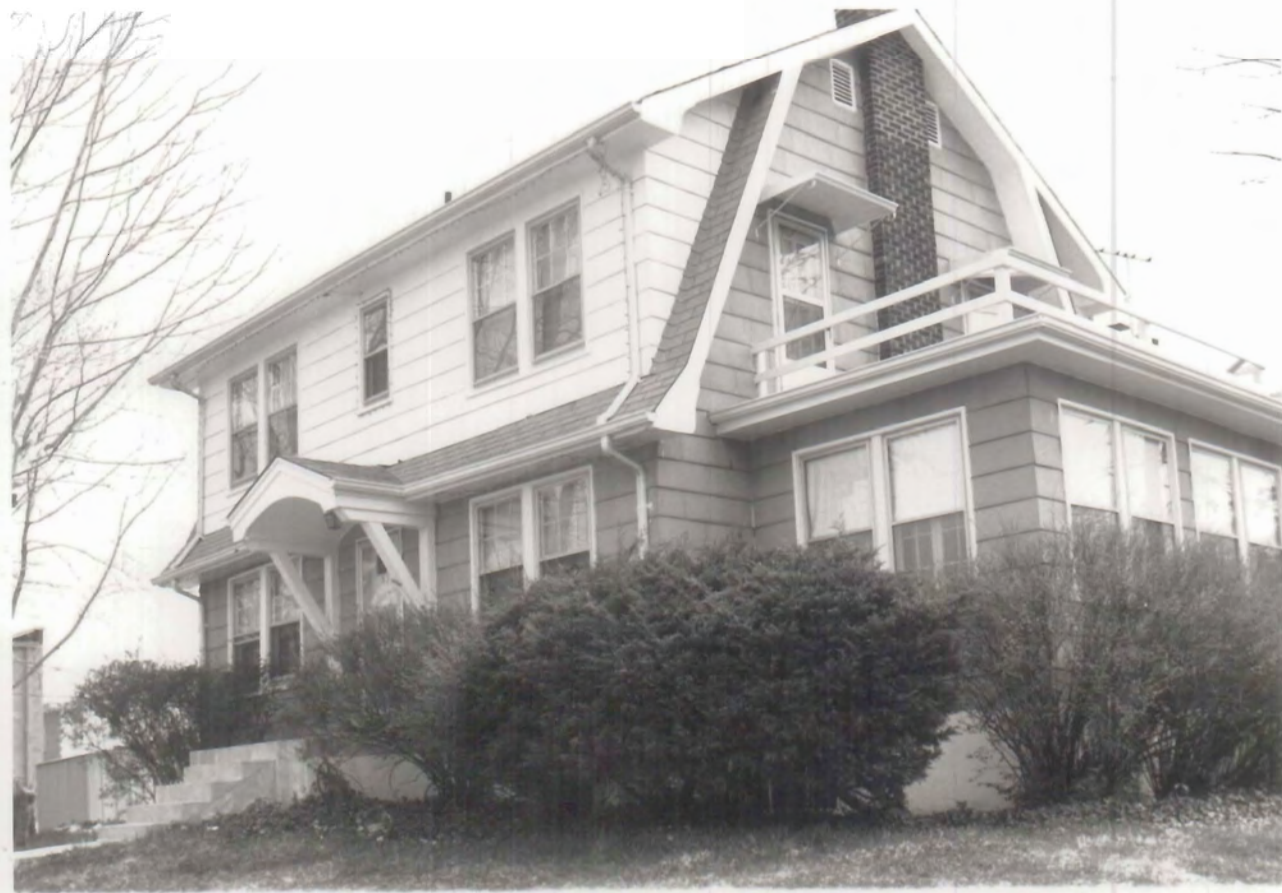
1. No. 037	3. Location of Negatives: Missouri Office of Historic Preservation, P. O. Box 176, Jefferson City, MO 65102		
2. City/County: City of St. Louis, MO	4. Prepared by: Cynthia Hill Longwisch, Landmarks Assn. of St. Louis, 917 Locust, 7th Floor, St. Louis, MO 63101

24. Foundation material: concrete		25. Roof type/material: mock gambrel*	
26. No. Bays: Front 3 Side 2		27. Wall treatment: aluminum siding	
28. Plan shape: see site map		29. Changes: Addition? Altered?

30. Exterior condition: good		31. Open to public? no	
32. Other Surveys in which included: Heritage/St. Louis survey, 1971			
33. Further description of important features: *Interesting roofline treatment features a standard side gable intersected with gambrel-shaped eaves. The effect is one of a gambrel roof with full-width dormers, both front and back. Paired windows. Centered entrance is highlighted by a gabled hood supported by wood brackets. A one-story, flat-roofed room, apparently original, extends to the west; it has an upper railing and second-floor door access.

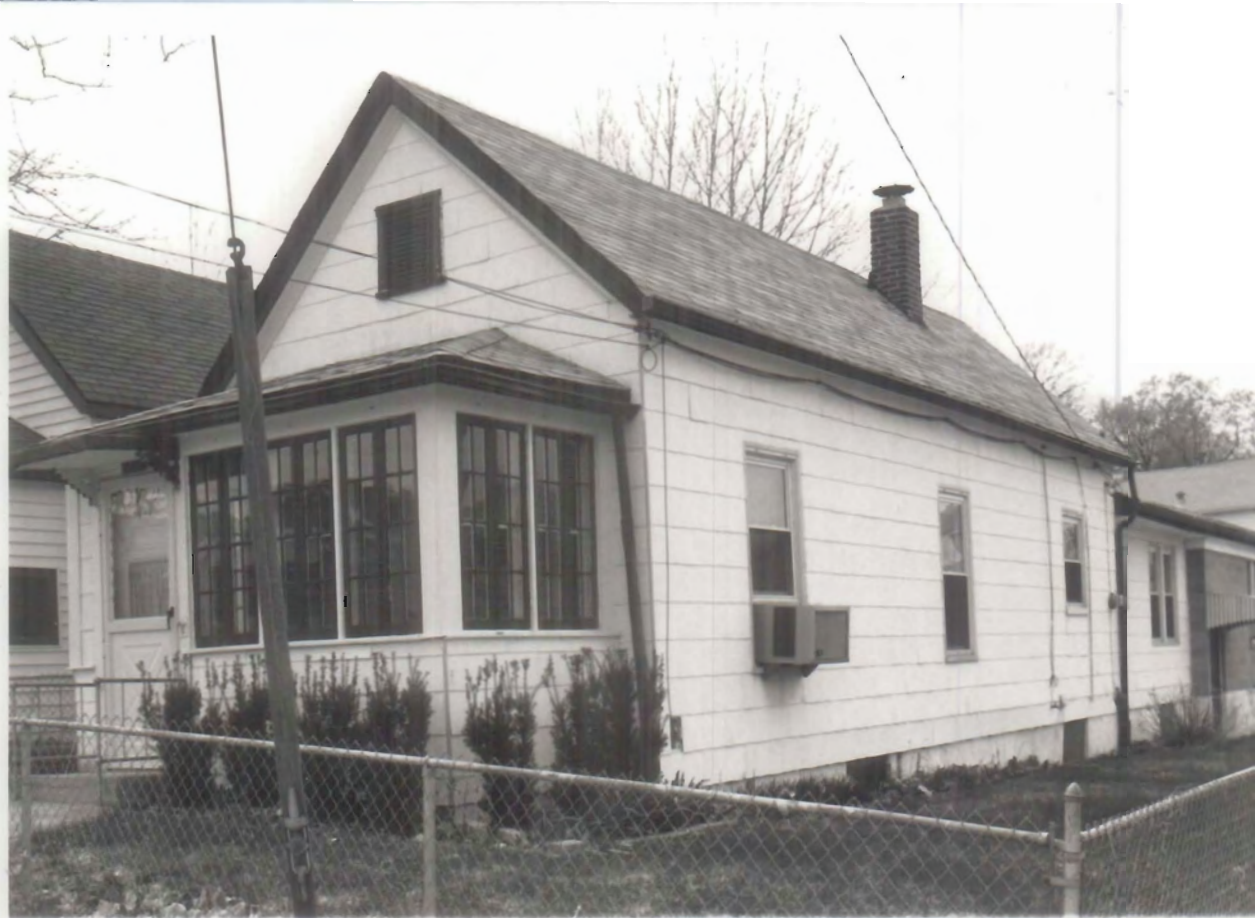
1. No. 185	3. Location of Negatives: Missouri Office of Historic Preservation, P. O. Box 176, Jefferson City, MO 65102		
2. City/County: City of St. Louis, MO	4. Prepared by: Cynthia Hill Longwisch, Landmarks Assn. of St. Louis, 917 Locust, 7th Floor, St. Louis, MO 63101

21. No. of stories: 1	22. Basement? yes	23. Wall construction: frame*	
24. Foundation material: stuccoed		25. Roof type/material: front gable	
26. No. Bays: Front 2 Side 9		27. Wall treatment: asbestos siding*

28. Plan shape: see site map		29. Changes: Addition? yes! Altered? yes	
30. Exterior condition: fair/good		31. Open to public? no	
32. Other Surveys in which included: Heritage/St. Louis survey, 1971

33. Further description of important features: *This house has four rear additions, one behind the other, almost the entire length of the lot. The original part is a front-gabled shotgun with a porch enclosed with multipane case-ment windows. A shorter frame addition behind that has the same siding. Behind that is a cinder block addition, then an enclosed frame breezeway, then what was frame garage. Side windows of the first two sections are 1-over-1 double-hung.

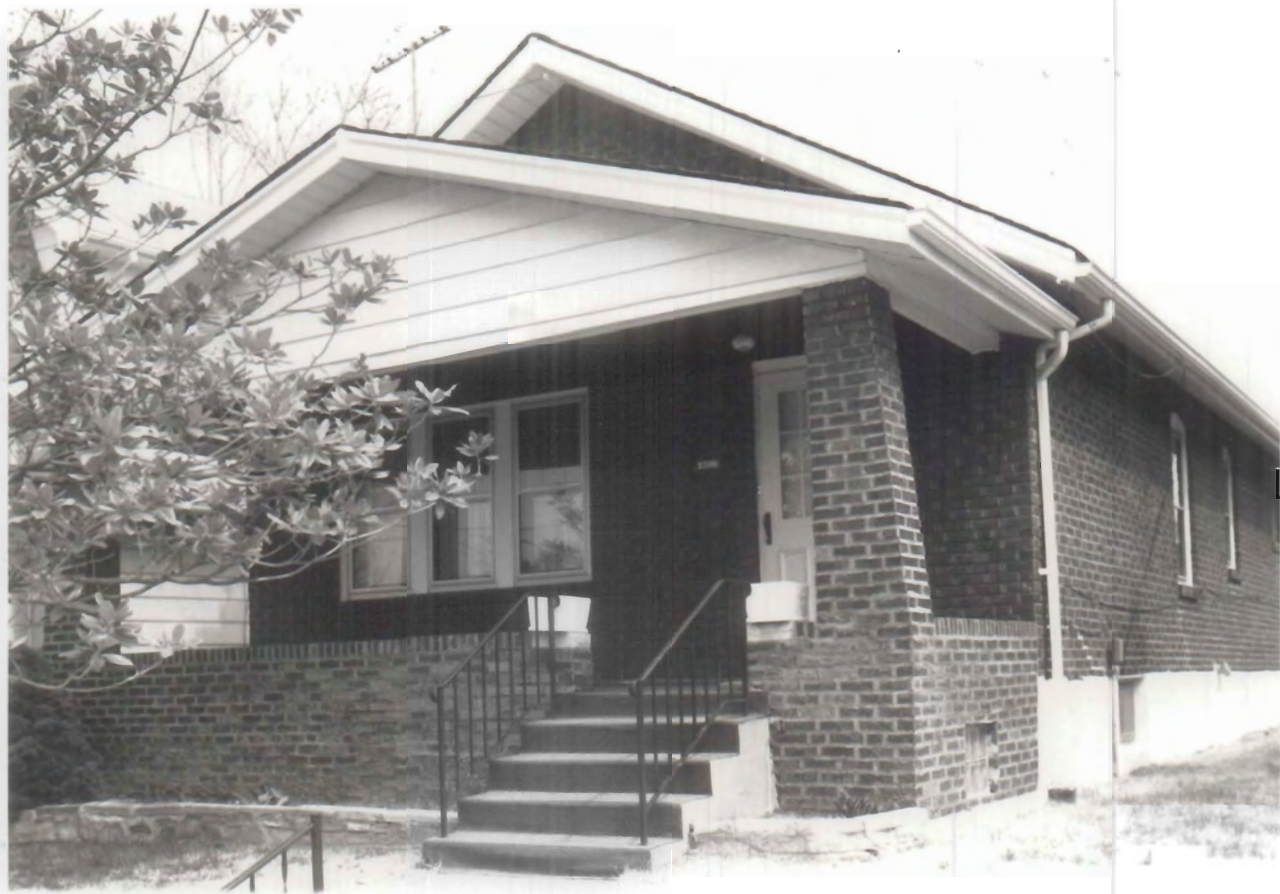
1. No. 038	3. Location of Negatives: Missouri Office of Historic Preservation, P. O. Box 176, Jefferson City, MO 65102		
2. City/County: City of St. Louis, MO	4. Prepared by: Cynthia Hill Longwisch, Landmarks Assn. of St. Louis, 917 Locust, 7th Floor, St. Louis, MO 63101

21. No. of stories: 1	22. Basement? yes	23. Wall construction: masonry	
24. Foundation material: stuccoed		25. Roof type/material: front gable	
26. No. Bays: Front 2 Side 3		27. Wall treatment: brown brick

28. Plan shape: see site map		29. Changes: Addition? yes Altered?	
30. Exterior condition: good		31. Open to public? no	
32. Other Surveys in which included: Heritage/St. Louis survey, 1971

33. Further description of important features: A gabled, full-width porch extends across the front of this house, its brick pillars tapering toward the tops. A low brick sidewall encloses the porch slightly. Tripled windows in the front elevation have flat arches. Side windows are segmentally arched.

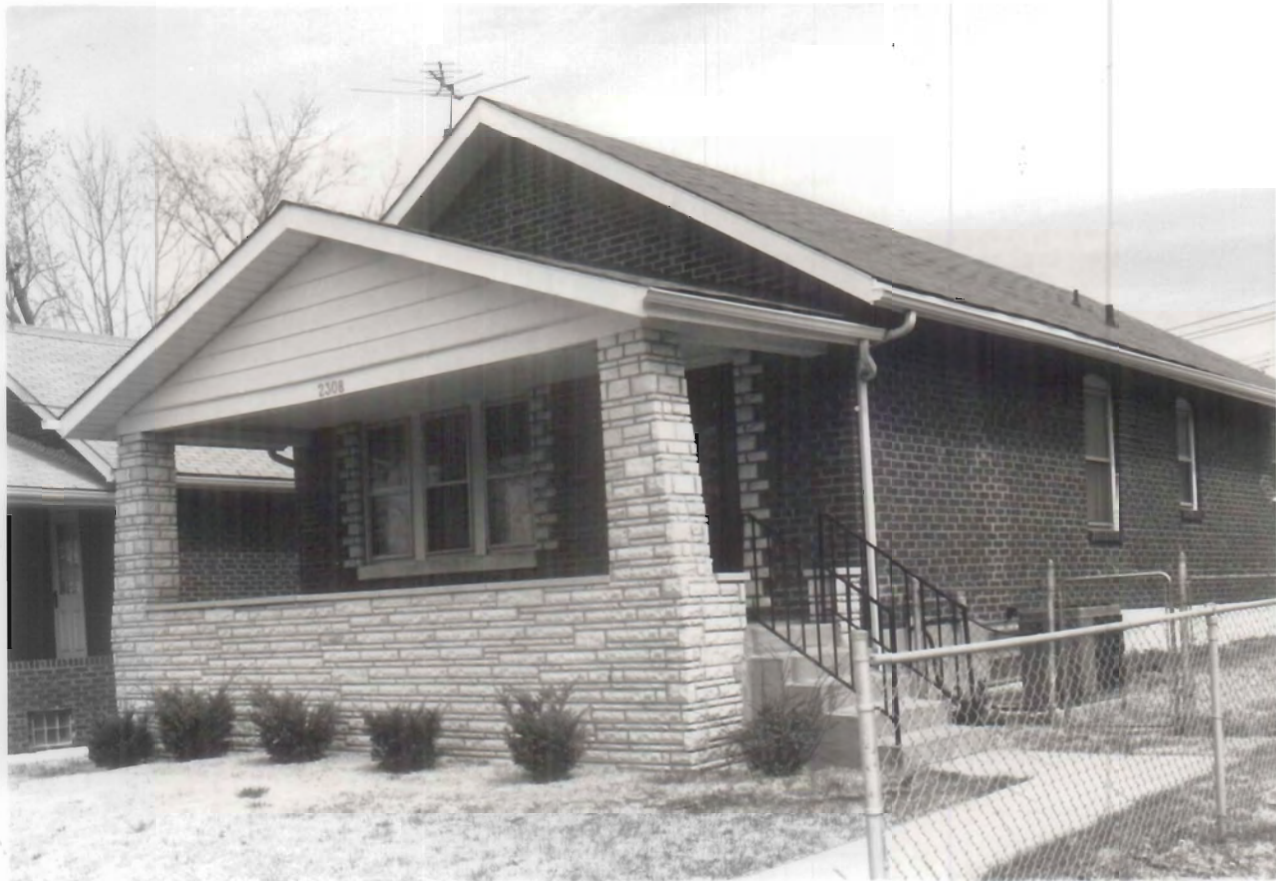
1. No. 039	3. Location of Negatives: Missouri Office of Historic Preservation, P. O. Box 176, Jefferson City, MO 65102		
2. City/County: City of St. Louis, MO	4. Prepared by: Cynthia Hill Longwisch, Landmarks Assn. of St. Louis, 917 Locust, 7th Floor, St. Louis, MO 63101

24. Foundation material: stuccoed		25. Roof type/material: front gable	
26. No. Bays: Front 2 Side 4		27. Wall treatment: brown brick	
28. Plan shape: see site map		29. Changes: Addition? rear Altered? yes

30. Exterior condition: good		31. Open to public? no	
32. Other Surveys in which included: Heritage/St. Louis survey, 1971			
33. Further description of important features: The front porch of this house is gabled and separate from the main roof; its tapering pillars, low sidewalls and foundation have been covered with what appears to be permastone. This material also appears on the front elevation window and door surrounds. The entrance to the porch is on the south side, rather than the usual front access. Side windows are segmentally arched. Rear frame addition.

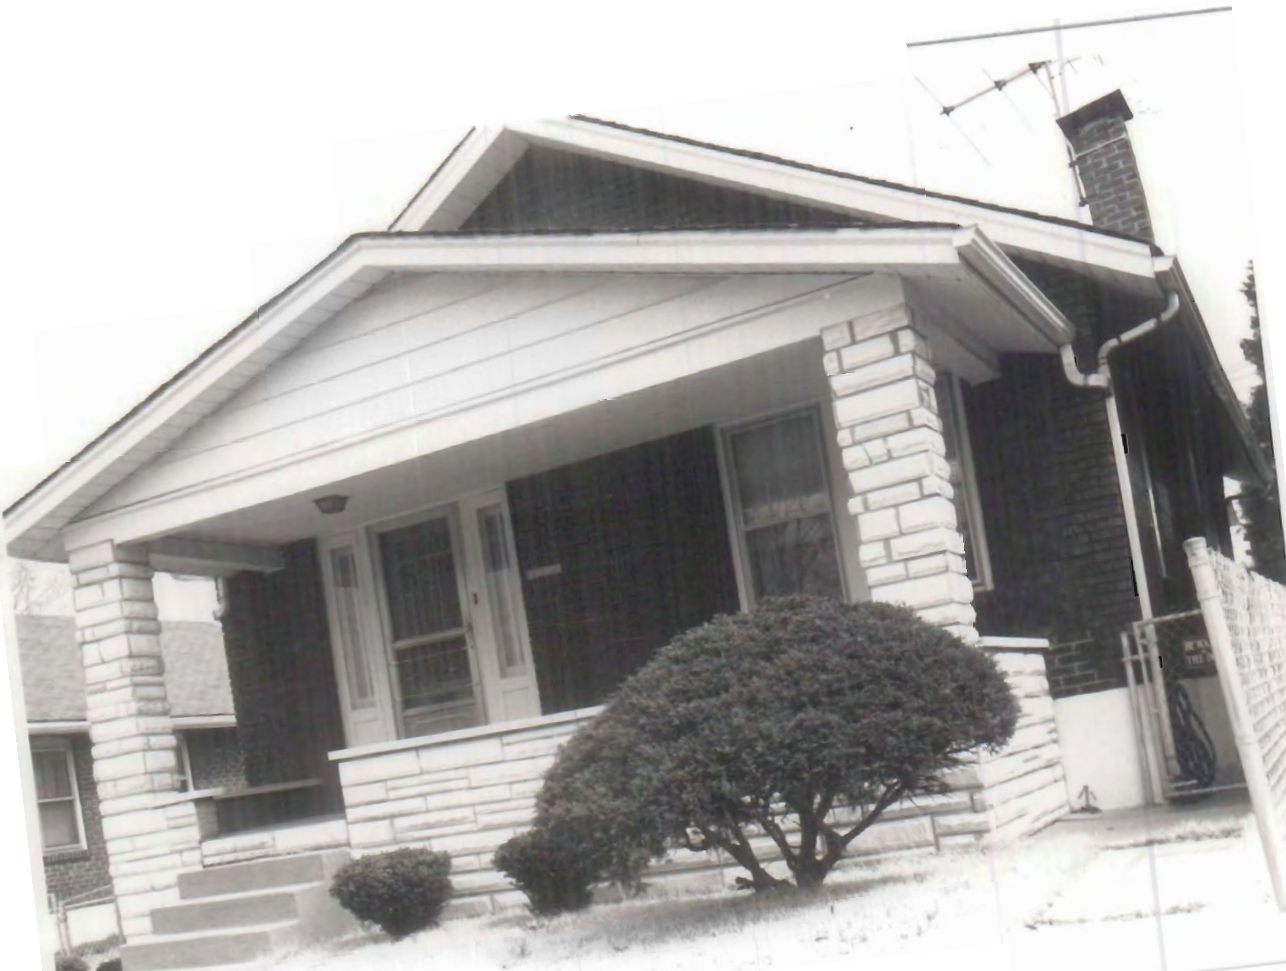
1. No. 040	3. Location of Negatives: Missouri Office of Historic Preservation, P. O. Box 176, Jefferson City, MO 65102		
2. City/County: City of St. Louis, MO	4. Prepared by: Cynthia Hill Longwisch, Landmarks Assn. of St. Louis, 917 Locust, 7th Floor, St. Louis, MO 63101

21. No. of stories: 1	22. Basement? yes	23. Wall construction: masonry	
24. Foundation material: stuccoed		25. Roof type/material: front gable	
26. No. Bays: Front 2 Side 4		27. Wall treatment: red textured brick

28. Plan shape: see site map		29. Changes: Addition? rear Altered? ?	
30. Exterior condition: good		31. Open to public? no	
32. Other Surveys in which included: Heritage/St. Louis survey, 1971

33. Further description of important features: The front porch of this house extends across most of the front elevation and features a gabled roof separate from the roofline of the house. The straight pillars, low sidewalls and foundation of the porch are sheathed with what appears to be coursed limestone, an apparent alteration. Front windows are paired and have brick sills. Front door has narrow, divided sidelights. Side and basement windows (cont'd. below)

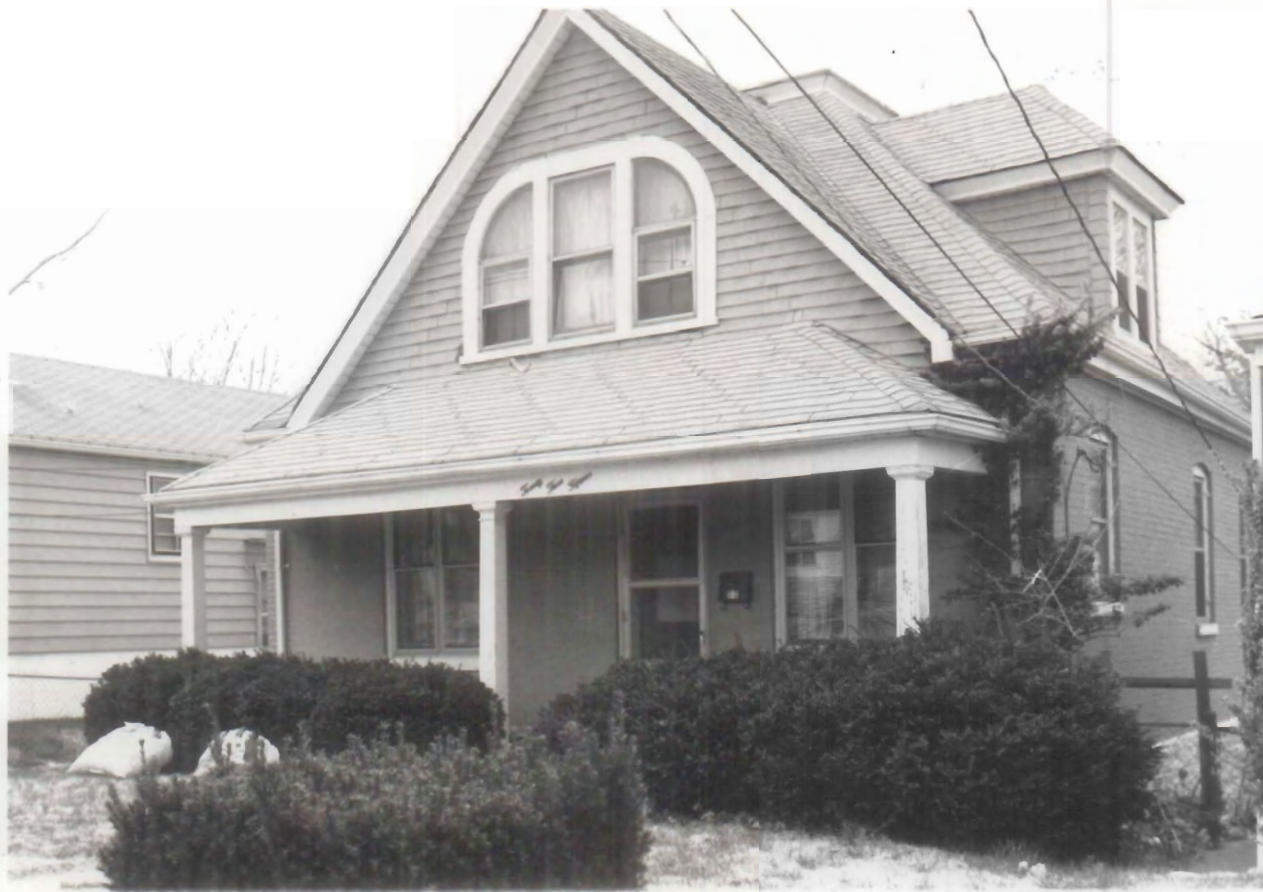
1. No. 186	3. Location of Negatives: Missouri Office of Historic Preservation, P. O. Box 176, Jefferson City, MO 65102		
2. City/County: City of St. Louis, MO

19. Original Use: residence		20. Present Use: residence	
21. No. of stories: 1 1/2	22. Basement? yes	23. Wall construction: brick/fr	
24. Foundation material: stone		25. Roof type/material: complex

26. No. Bays: Front 3 Side 2		27. Wall treatment: red brick & frame	
28. Plan shape: see site map		29. Changes: Addition? Altered?	
30. Exterior condition: good		31. Open to public? no

32. Other Surveys in which included: Heritage/St. Louis survey, 1971			
33. Further description of important features: The main roof of this house, although a truncated pyramid, has a very large front-facing gable and hipped dormer, forming a multilevel roofline. In the frame gable end, a tripartite window is curved at the upper corners. A full-width front porch is even with the grade, while much of the basement is exposed at the rear due to grade slope. Squared wood posts support the porch roof. 1-over-1 paired (cont'd. below)

34. History and Significance: windows flank the center door. Side windows are segmentally arched with double rowlocks and stone sills. No inactive building permits are available for this city block.

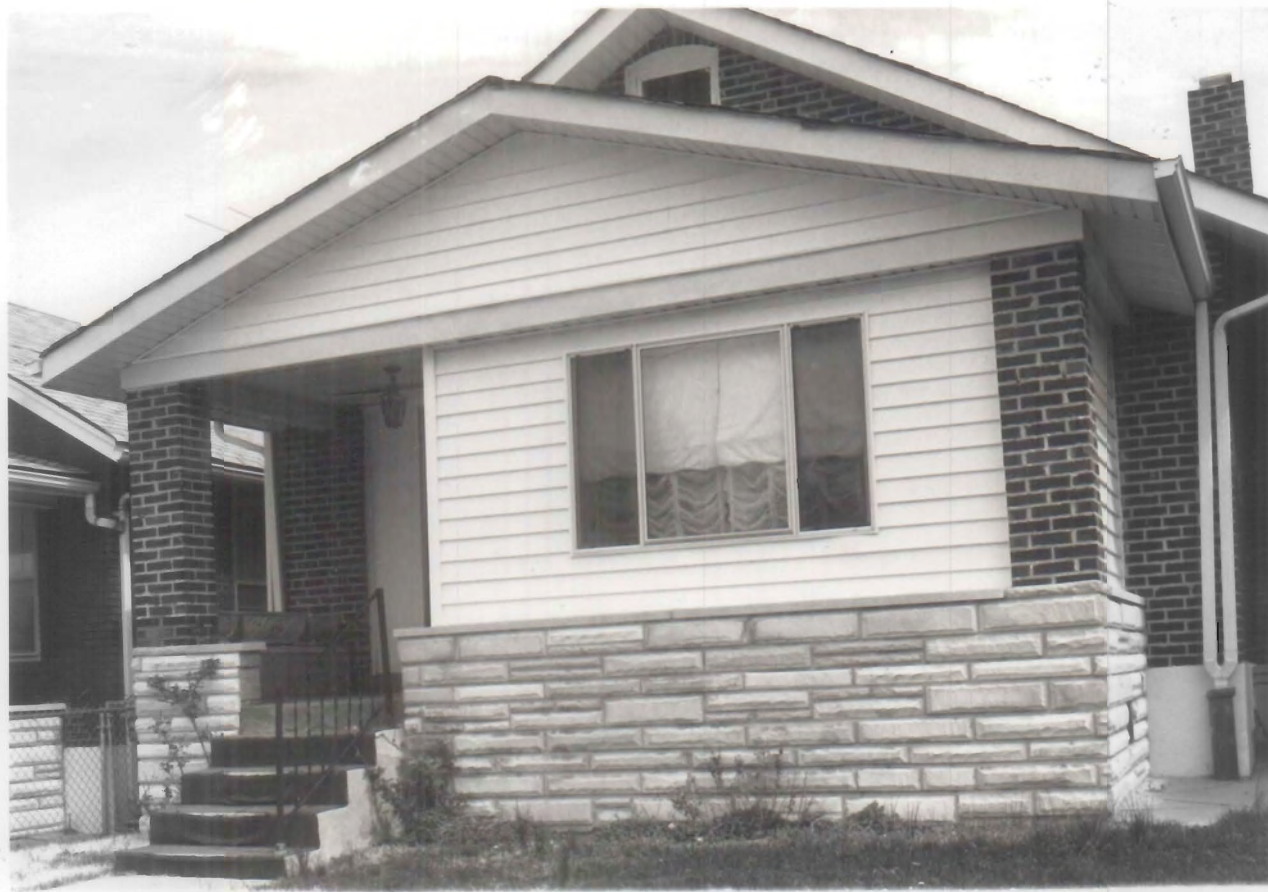
1. No. 041	3. Location of Negatives: Missouri Office of Historic Preservation, P. O. Box 176, Jefferson City, MO 65102		
2. City/County: City of St. Louis, MO	4. Prepared by: Cynthia Hill Longwisch, Landmarks Assn. of St. Louis, 917 Locust, 7th Floor, St. Louis, MO 63101

21. No. of stories: 1	22. Basement? yes	23. Wall construction: masonry	
24. Foundation material: stuccoed		25. Roof type/material: front gable	
26. No. Bays: Front 2 Side 4		27. Wall treatment: brown brick

28. Plan shape: see site map		29. Changes: Addition? rear Altered? yes	
30. Exterior condition: good		31. Open to public? no	
32. Other Surveys in which included: Heritage/St. Louis survey, 1971

33. Further description of important features: The gable end of this house has a segmentally arched window. Below, an almost full-width, front-gabled porch has been partially infilled with frame to provide added living space. The straight brick pillars are both still intact. The low porch sidewall has been covered with coursed limestone. The doorway, at the left, is sheltered under the small amount of porch left. Small rear frame addition may be a porch.

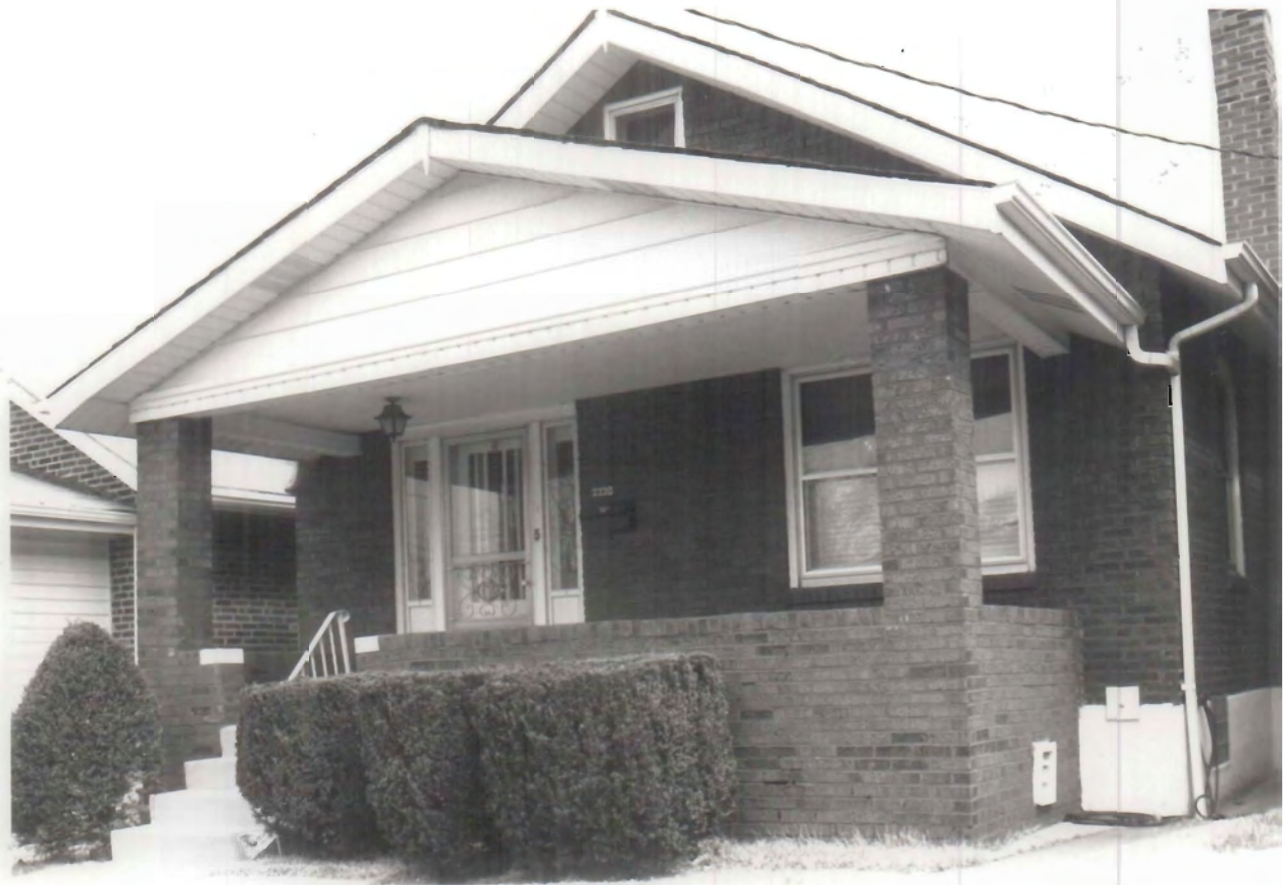
24. Foundation material: stuccoed	25. Roof type/material: front gable
-----------------------------------	-------------------------------------

30. Exterior condition: good	31. Open to public? no
------------------------------	------------------------

3. Further description of important features: The front gable of this house is a flat-arched window. A separately gabled porch extends across most of the front elevation, supported by straight brick pillars. Low brick porch sidewalls have inset stone caps at the top of the steps. Front windows are paired. Front door has narrow sidelights; door itself has narrow glass panels divided by muntins. Segmentally-arched side windows.

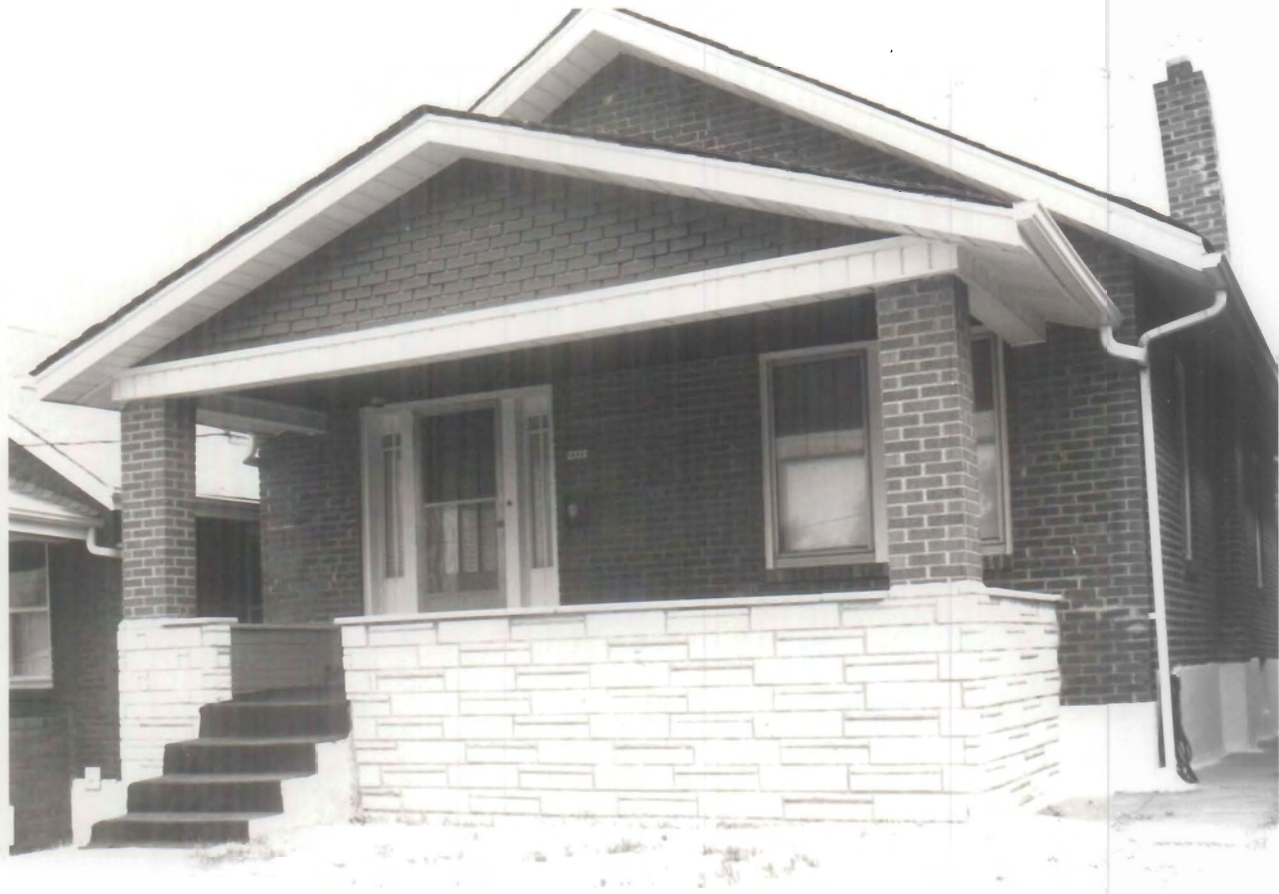
24. Foundation material: stuccoed

30. Exterior condition: good

33. Further description of important features: Gabled front porch extends across most of the width of the house, having a separate roof from the house. Its gable is infilled with brick-look asphalt siding. Two straight brick pillars support the porch at the outside corners. The low sidewalls are covered with stone or a stonelike material, possibly a later alteration. Paired front windows have flat arches; side windows are segmentally arched. (cont'd below)

34. History and Significance: Front door has narrow, divided sidelights and has itself narrow muntin divisions. Rear frame addition or porch. House is one of seven listed on single permit in 1926 taken out by H. C. Vollmar, local builder. See Item 34, survey #40 and #41 for more information.

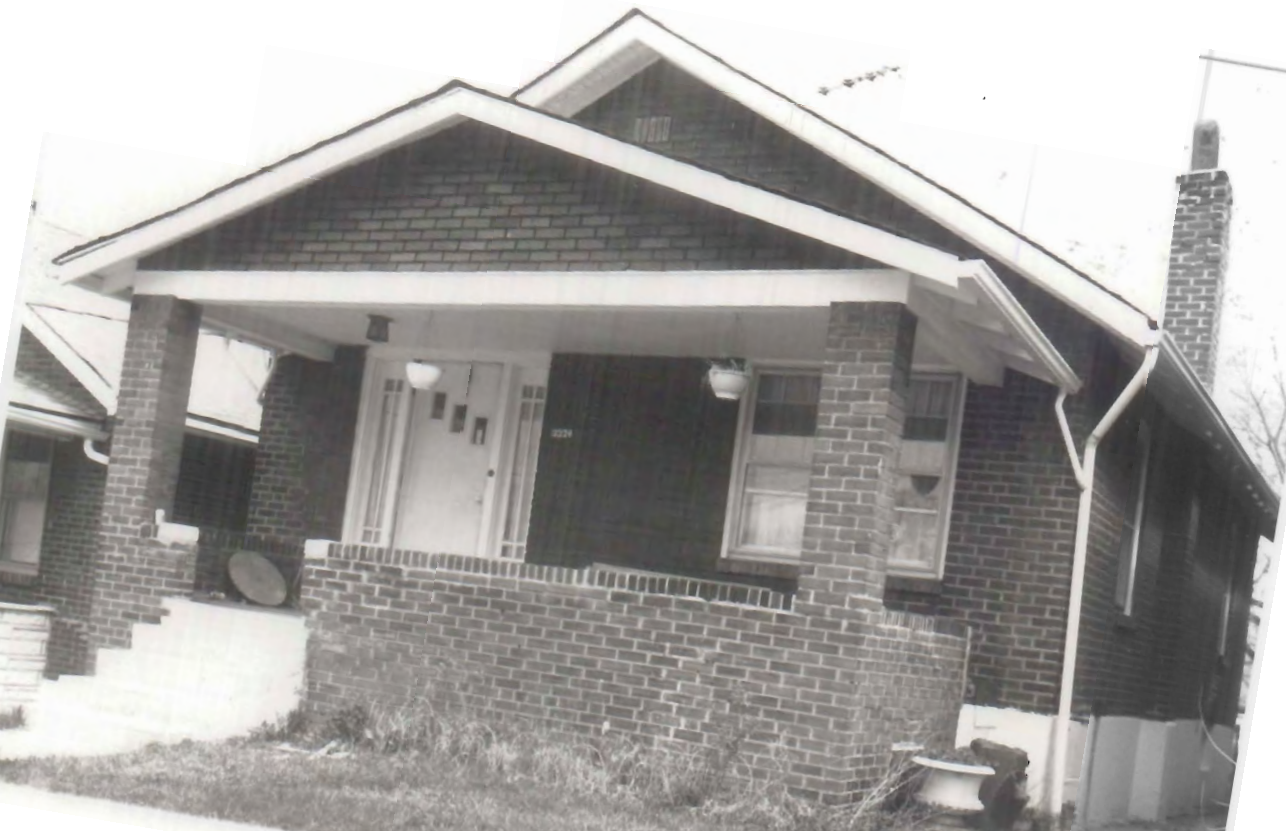
1. No. 044	3. Location of Negatives: Missouri Office of Historic Preservation, P. O. Box 176, Jefferson City, MO 65102		
2. City/County: City of St. Louis, MO	4. Prepared by: Cynthia Hill Longwisch, Landmarks Assn. of St. Louis, 917 Locust, 7th Floor, St. Louis, MO 63101

21. No. of stories: 1	22. Basement? yes	23. Wall construction: masonry	
24. Foundation material: stuccoed		25. Roof type/material: front gable	
26. No. Bays: Front 2 Side 4		27. Wall treatment: brown brick

28. Plan shape: see site map		29. Changes: Addition? Altered?	
30. Exterior condition: good		31. Open to public? no	
32. Other Surveys in which included: Heritage/St. Louis survey, 1971

33. Further description of important features: Front gable of porch is covered with brick-look asphalt siding; side eaves have exposed rafters. Porch is supported by straight brick pillars at the outside corners; low solid brick side-walls are topped by a header course with stone end caps at the steps. Paired front windows have flat arches. Doorway has Craftsmanlike sidelights with a replacement door. Segmentally arched side windows. Rear frame porch.

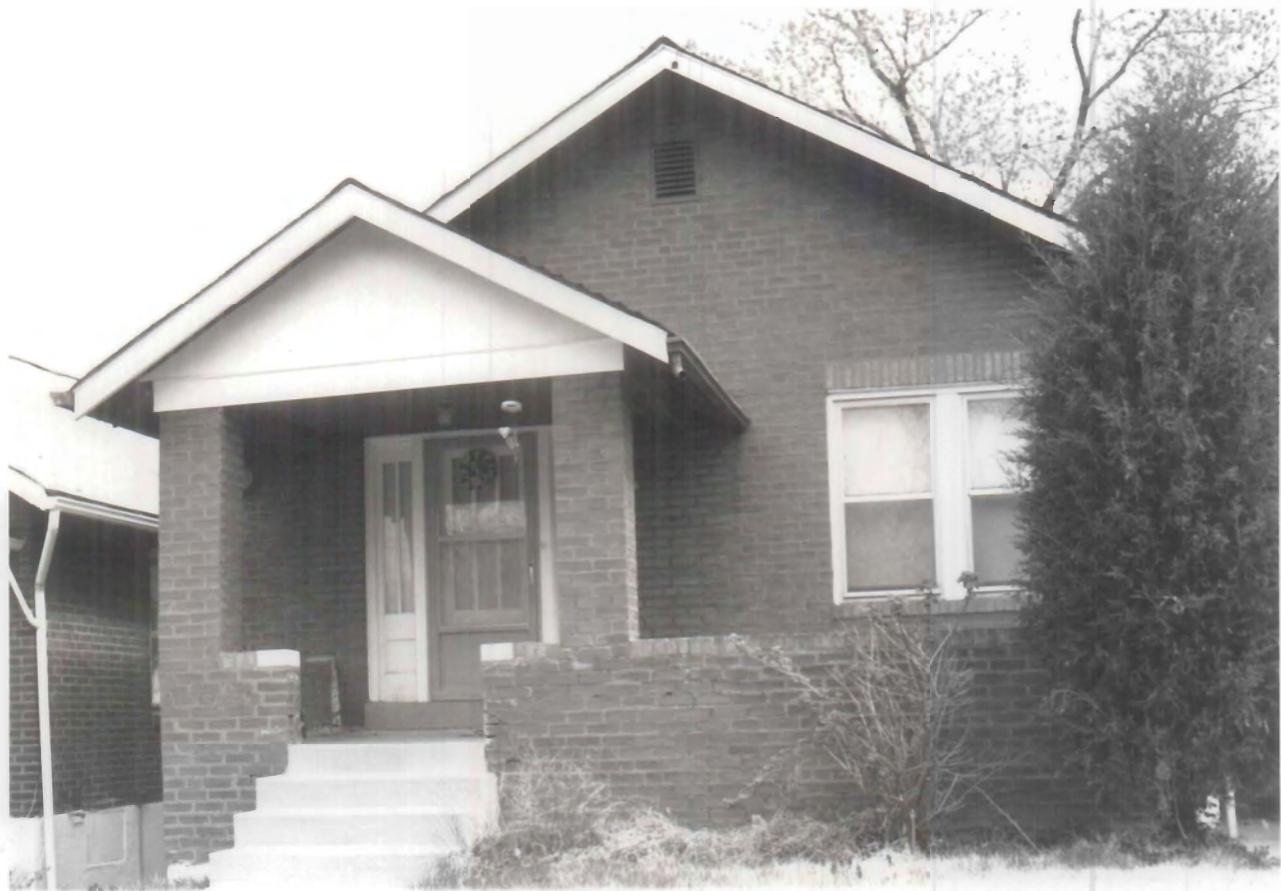
1. No. 045	3. Location of Negatives: Missouri Office of Historic Preservation, P. O. Box 176, Jefferson City, MO 65102		
2. City/County: City of St. Louis, MO	4. Prepared by: Cynthia Hill Longwisch, Landmarks Assn. of St. Louis, 917 Locust, 7th Floor, St. Louis, MO 63101

24. Foundation material: stuccoed		25. Roof type/material: front gable	
26. No. Bays: Front 2 Side 4		27. Wall treatment: red brick	
28. Plan shape: see site map		29. Changes: Addition? Altered? ?

30. Exterior condition: good		31. Open to public? no	
32. Other Surveys in which included: Heritage/St. Louis survey, 1971			
33. Further description of important features: The porch on this house is front-gabled, but unlike the others built at the same time in that it does not extend across the whole width of the front elevation. 2 straight brick pillars support a gabled porch roof that essentially just covers the doorway. The low brick sidewalls do extend across the front elevation to form a patiolike, uncovered porch. There is no visible evidence that this is not (cont'd. below)

34. History and Significance: original. Paired front windows have soldier arches. Door features narrow, divided sidelights and narrow vertical glass panes in the door itself. Segmentally arched side windows. House is one of seven listed on a single 1926 permit by H. C. Vollmar. See item 34 of survey #40 and #41 for more information.

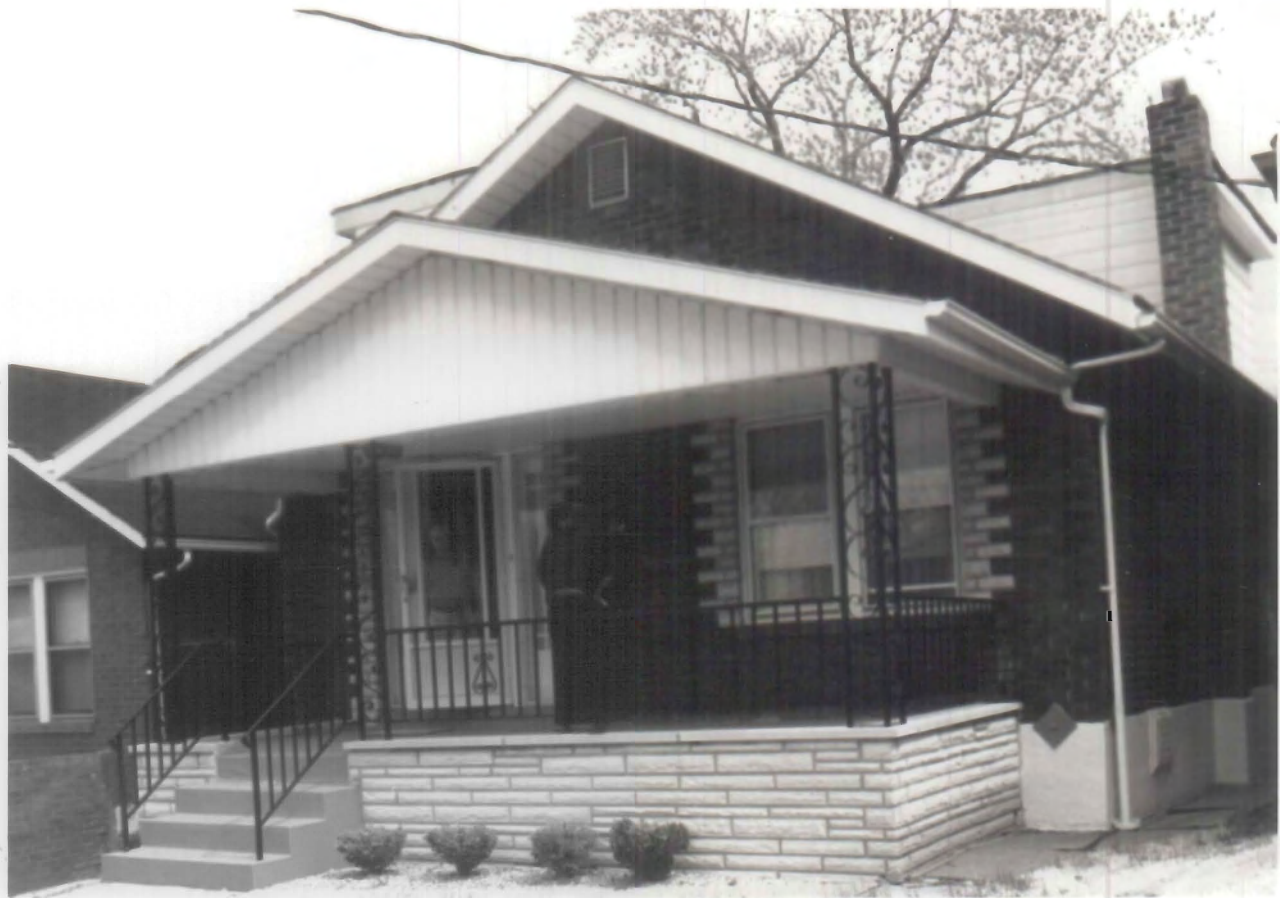
21. No. of stories: 1 1/2	22. Basement? yes	23. Wall construction: masonry	
24. Foundation material: stuccoed		25. Roof type/material: front gable	
26. No. Bays: Front 2 Side 4		27. Wall treatment: textured brown brk.

28. Plan shape: see site map		29. Changes: Addition? yes Altered? yes	
30. Exterior condition: good		31. Open to public? no	
32. Other Surveys in which included: Heritage/St. Louis survey, 1971

33. Further description of important features: Front-gabled porch extends almost all the way across the front elevation; it is supported by wrought-iron posts. Iron railing around porch; permastone on porch foundation and front window and door surrounds - not original features. Craftsman-type sidelights on front door. Large, obtrusive frame dormers on north and south elevations were added in 1966 when the attic was made into living space.

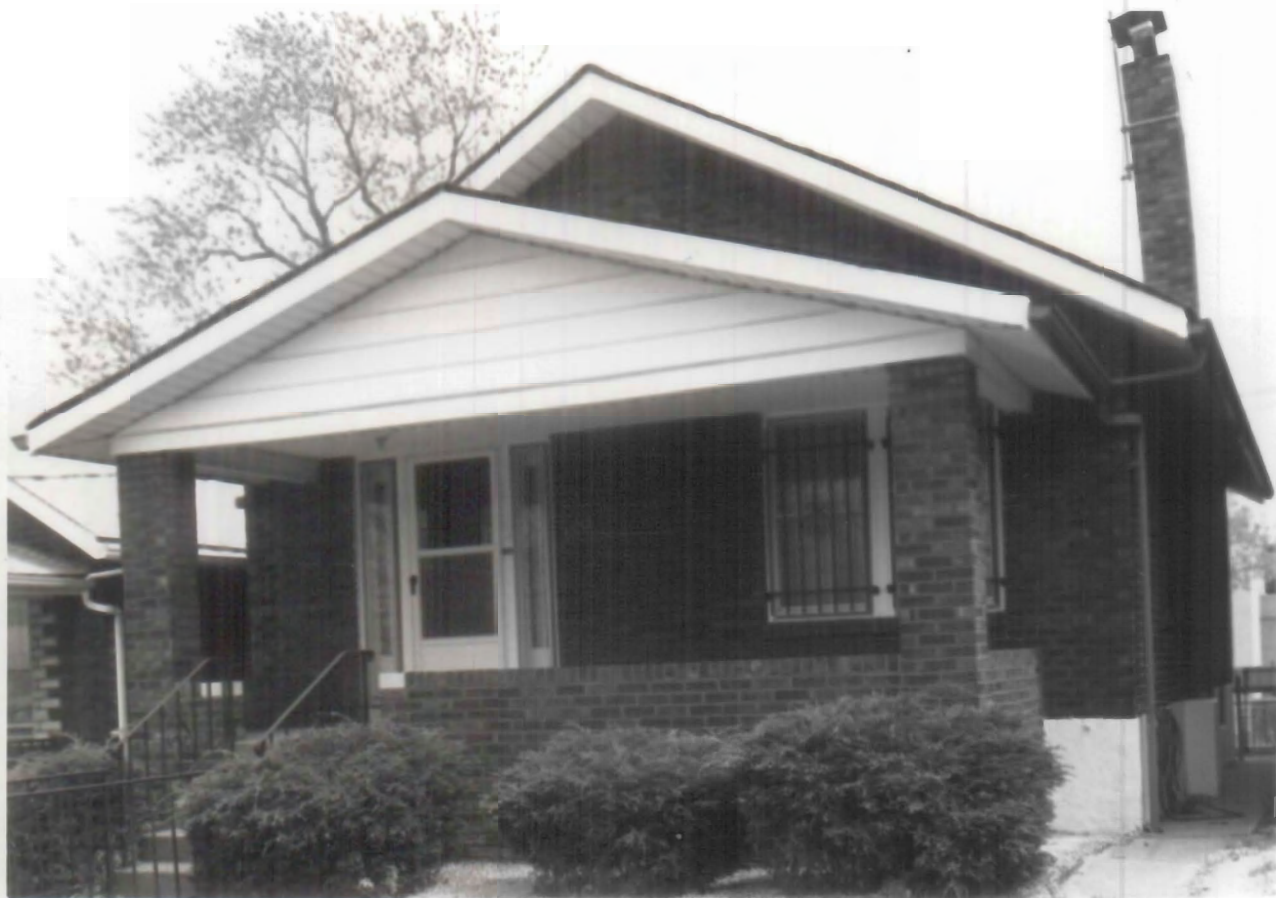
1. No. 047	3. Location of Negatives: Missouri Office of Historic Preservation, P. O. Box 176, Jefferson City, MO 65102		
2. City/County: City of St. Louis, MO	4. Prepared by: Cynthia Hill Longwisch, Landmarks Assn. of St. Louis, 917 Locust, 7th Floor, St. Louis, MO 63101

21. No. of stories: 1	22. Basement? yes	23. Wall construction: masonry	
24. Foundation material: stuccoed		25. Roof type/material: front gable	
26. No. Bays: Front 2 Side 4		27. Wall treatment: textured brown brk.

28. Plan shape: see site map		29. Changes: Addition? Altered?	
30. Exterior condition: good		31. Open to public? no	
32. Other Surveys in which included: Heritage/St. Louis survey, 1971

33. Further description of important features: The front porch roof is gabled separately from the roofline of the house. It extends almost the width of the house and is supported at the outside corners by straight brick pillars. Short solid brick side walls on the porch are laid with a header course on top. Paired front windows have flat arches. Doorway has narrow sidelights. Side windows are segmentally arched.

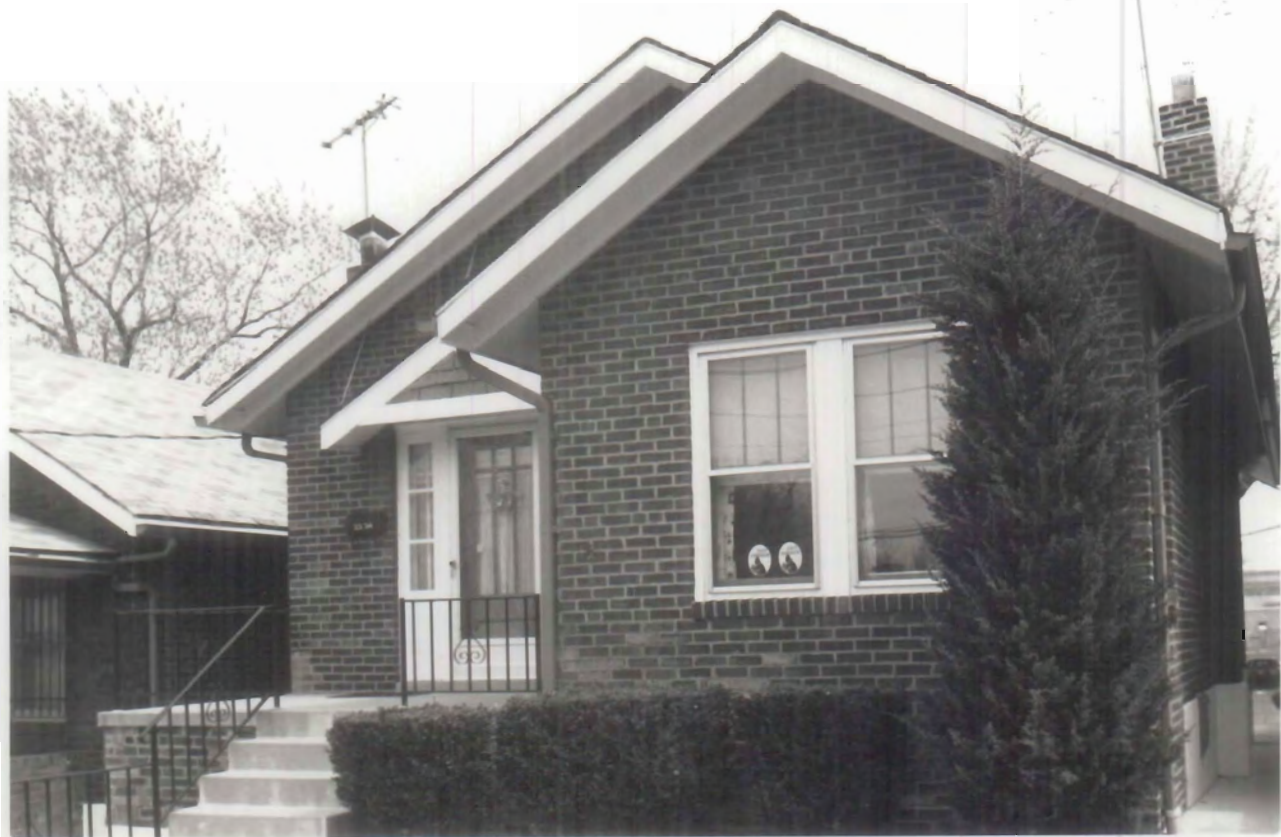
1. No. 048	3. Location of Negatives: Missouri Office of Historic Preservation, P. O. Box 176, Jefferson City, MO 65102		
2. City/County: City of St. Louis, MO	4. Prepared by: Cynthia Hill Longwisch, Landmarks Assn. of St. Louis, 917 Locust, 7th Floor, St. Louis, MO 63101

21. No. of stories: 1	22. Basement? yes	23. Wall construction: masonry	
24. Foundation material: stuccoed		25. Roof type/material: front gable	
26. No. Bays: Front 2 Side		27. Wall treatment: brown brick

28. Plan shape: see site map		29. Changes: Addition? Altered?	
30. Exterior condition: good		31. Open to public? no	
32. Other Surveys in which included: Heritage/St. Louis survey, 1971

33. Further description of important features: The gabled right bay of this house projects, lining up with the edge of an unroofed porch. It features paired, flat-arched windows of 3-over-1 double-hung sash with brick sills. The main body of the house is also gabled, this gable echoed by the hood above the front door. The door also features sidelights and Craftsman-style paning in the door itself. A brick and concrete porch has an iron railing.
