# ARCHITECTURAL SURVEY OF CLIFTON HEIGHTS

JUNE 1991

ST. LOUIS, MISSOURI

LANDMARKS ASSOCIATION OF ST. LOUIS, INC.

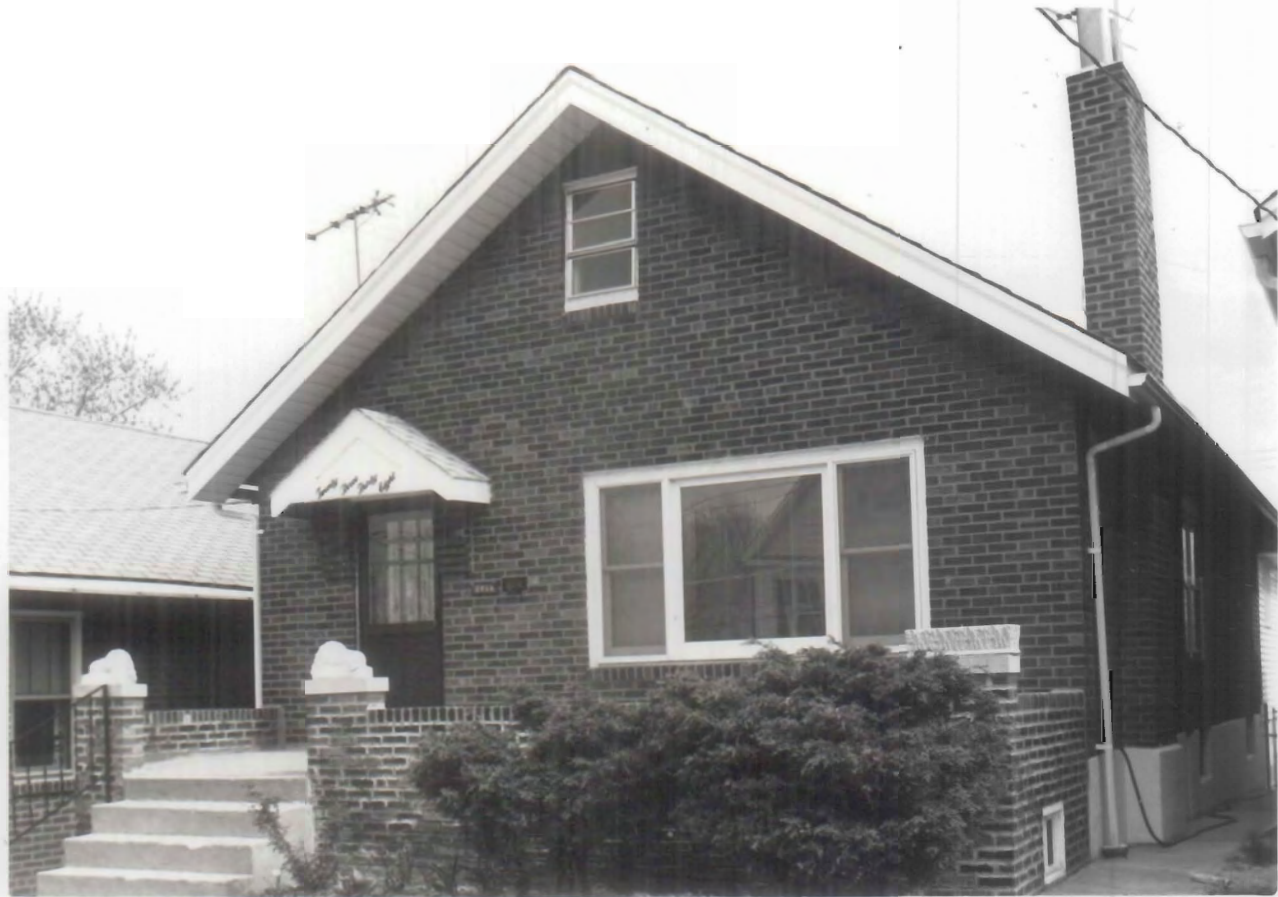
1. No. 049	3. Location of Negatives: Missouri Office of Historic Preservation, P. O. Box 176, Jefferson City, MO 65102		
2. City/County: City of St. Louis, MO	4. Prepared by: Cynthia Hill Longwisch, Landmarks Assn. of St. Louis, 917 Locust, 7th Floor, St. Louis, MO 63101

24. Foundation material: stuccoed		25. Roof type/material: front gable	
26. No. Bays: Front 2 Side 3		27. Wall treatment: textured brick	
28. Plan shape: see site map		29. Changes: Addition? Altered? yes

30. Exterior condition: good		31. Open to public? no	
32. Other Surveys in which included: Heritage/St. Louis survey, 1971			
33. Further description of important features: This house has had some alteration work done to the facade; it probably originally looked very much like survey #55, with triple windows and a small gabled porch supported by brick pillars (now cut off and topped with stone); unroofed portion has short brick side walls and extends the width of the facade. The doorway now has a gabled frame hood. A single window is located in the front gable. (cont'd. below)

34. History and Significance: Door has 6-over-3 Craftsman-style panes. Side windows are segmentally arched.

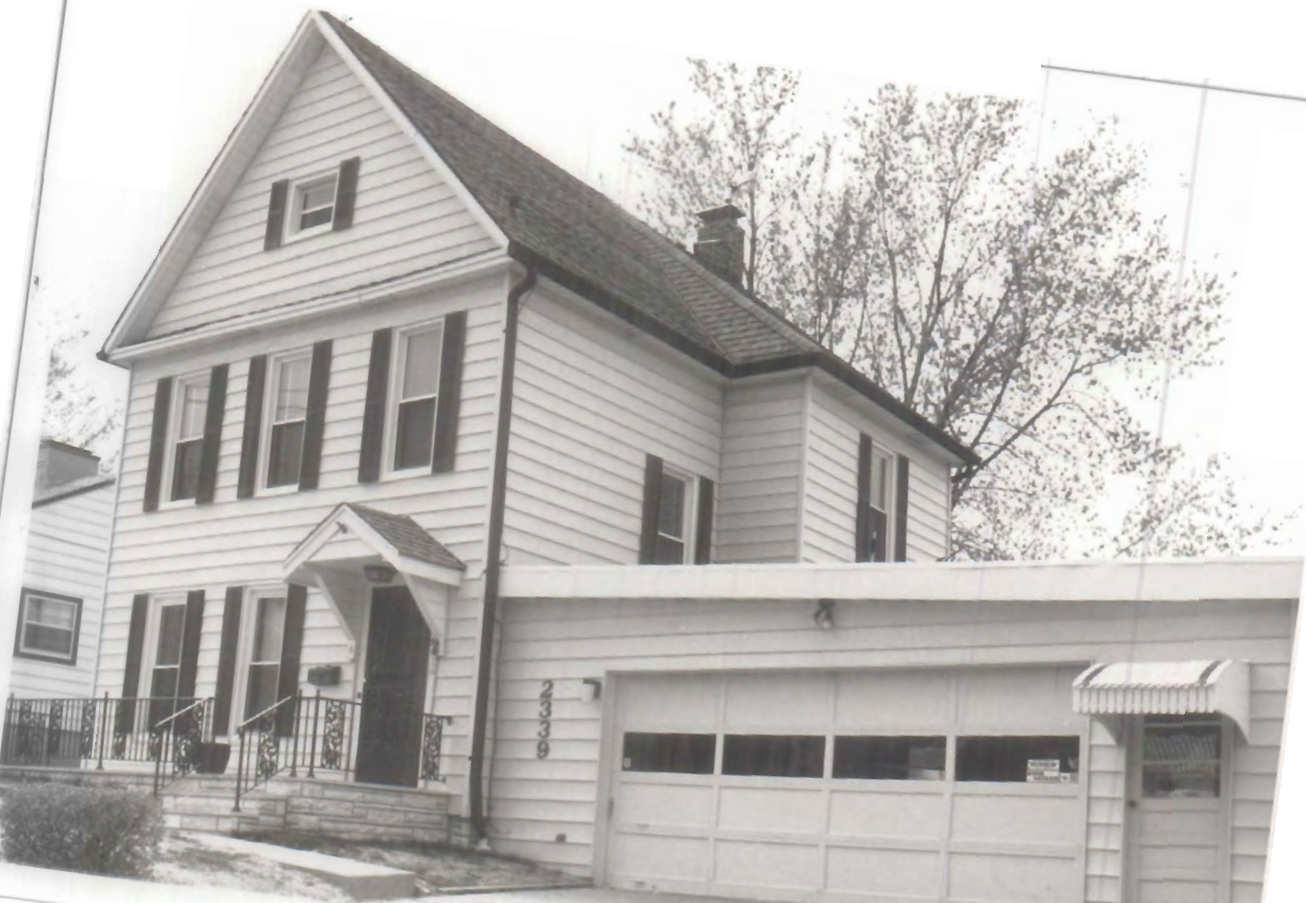
1. No. 187	3. Location of Negatives: Missouri Office of Historic Preservation, P. O. Box 176, Jefferson City, MO 65102		
2. City/County: City of St. Louis, MO

19. Original Use: residence		20. Present Use: residence	
21. No. of stories: 2 1/2	22. Basement? yes	23. Wall construction: frame	
24. Foundation material: permastoned		25. Roof type/material: front gable

26. No. Bays: Front 3 Side 2		27. Wall treatment: (aluminum?) siding	
28. Plan shape: see site map		29. Changes: Addition? side Altered? yes	
30. Exterior condition: good		31. Open to public? no

32. Other Surveys in which included: Heritage/St. Louis survey, 1971			
33. Further description of important features: This house is sort of a neu-ered Queen Anne, thanks to modernization. The bracketed door hood has a Craftsman feel, while the new shutters give it a more Colonial Revival air. Windows are 1-over-1 replacements. Very large 1-story attached garage addition. Patio-like, unroofed porch has iron railing and permastoned foundation. Projecting north side bay is interestingly joined at the roof.

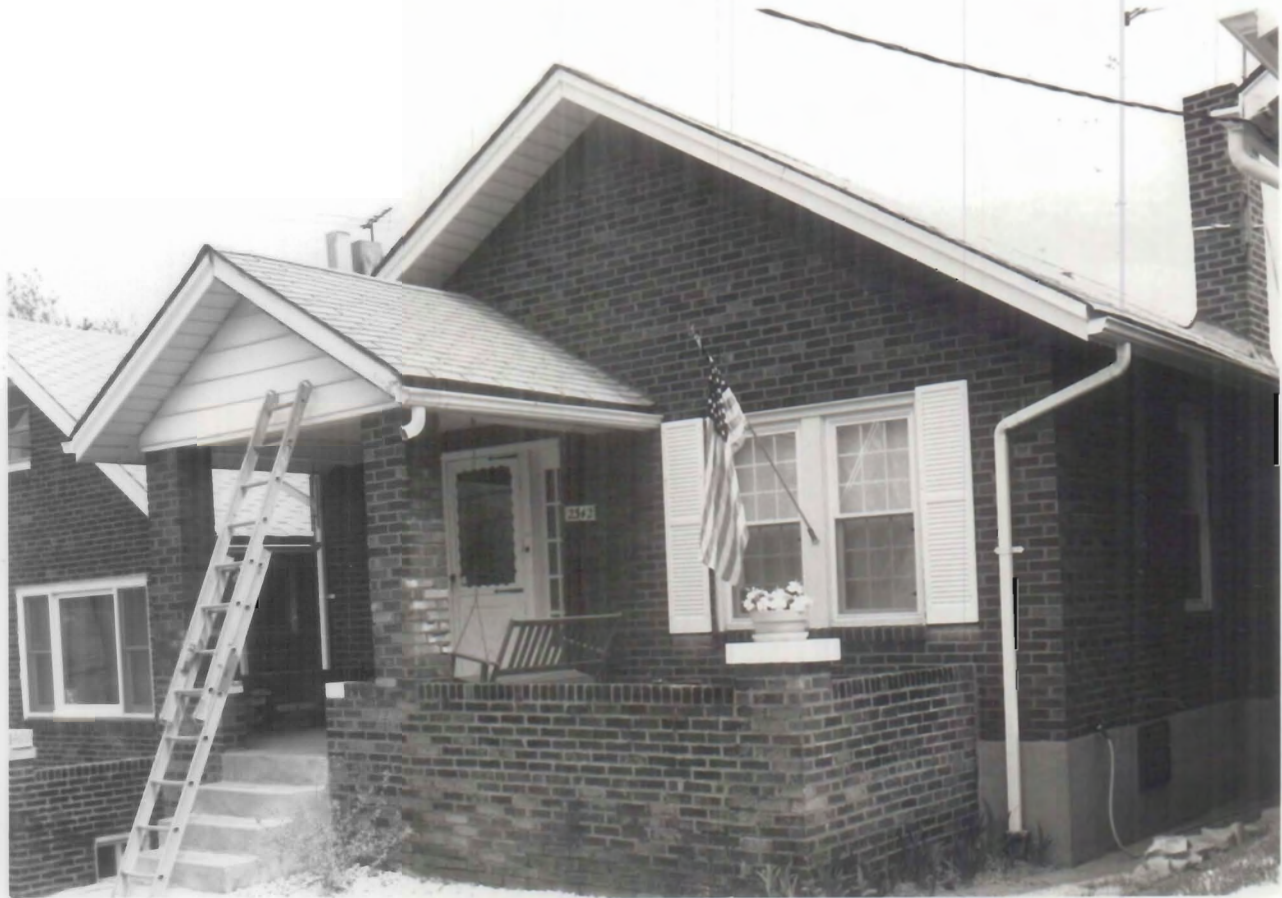
1. No. 050	3. Location of Negatives: Missouri Office of Historic Preservation, P. O. Box 176, Jefferson City, MO 65102		
2. City/County: City of St. Louis, MO	4. Prepared by: Cynthia Hill Longwisch, Landmarks Assn. of St. Louis, 917 Locust, 7th Floor, St. Louis, MO 63101

24. Foundation material: concrete		25. Roof type/material: front gable	
26. No. Bays: Front 2 Side		27. Wall treatment: textured brown brk.	
28. Plan shape: see site map		29. Changes: Addition?	Altered?

30. Exterior condition: good		31. Open to public? no	
32. Other Surveys in which included: Heritage/St. Louis survey, 1971			
33. Further description of important features: Although the front porch, with its solid brick sidewalls, extends across most of the width of the house, only the portion in front of the door is roofed, featuring a substantial gable supported by straight brick pillars. Paired windows have flat arches and are replacements. Front door has multipaned sidelights. Side windows are segmentally arched.

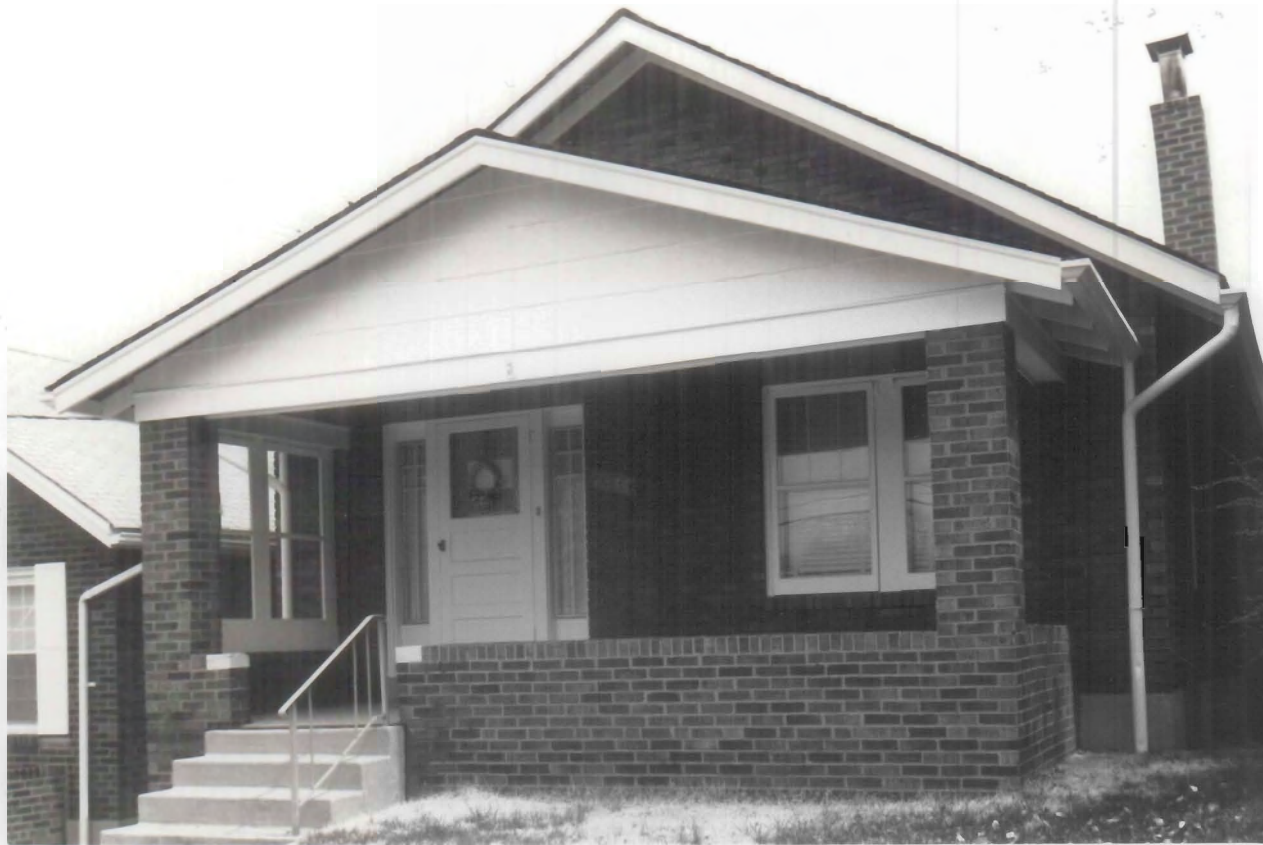
1. No. 051	3. Location of Negatives: Missouri Office of Historic Preservation, P. O. Box 176, Jefferson City, MO 65102		
2. City/County: City of St. Louis, MO	4. Prepared by: Cynthia Hill Longwisch, Landmarks Assn. of St. Louis, 917 Locust, 7th Floor, St. Louis, MO 63101

24. Foundation material: concrete		25. Roof type/material: front gable	
26. No. Bays: Front 2 Side 4		27. Wall treatment: textured brick	
28. Plan shape: see site map	29. Changes: Addition?		Altered?

30. Exterior condition: good		31. Open to public? no	
32. Other Surveys in which included: Heritage/St. Louis survey, 1971			
33. Further description of important features: Gabled front porch extends almost full width of front of house. It is supported by straight brick pillars and has short solid brick sidewalls topped with a header course. Paired front windows are 3-over-1 double-hung sash; front door has 4-over-2 Craftsman-style sidelights. Rafter ends visible. Wood frame windows have been installed in north end of porch, presumably to block snow/rain from front door.

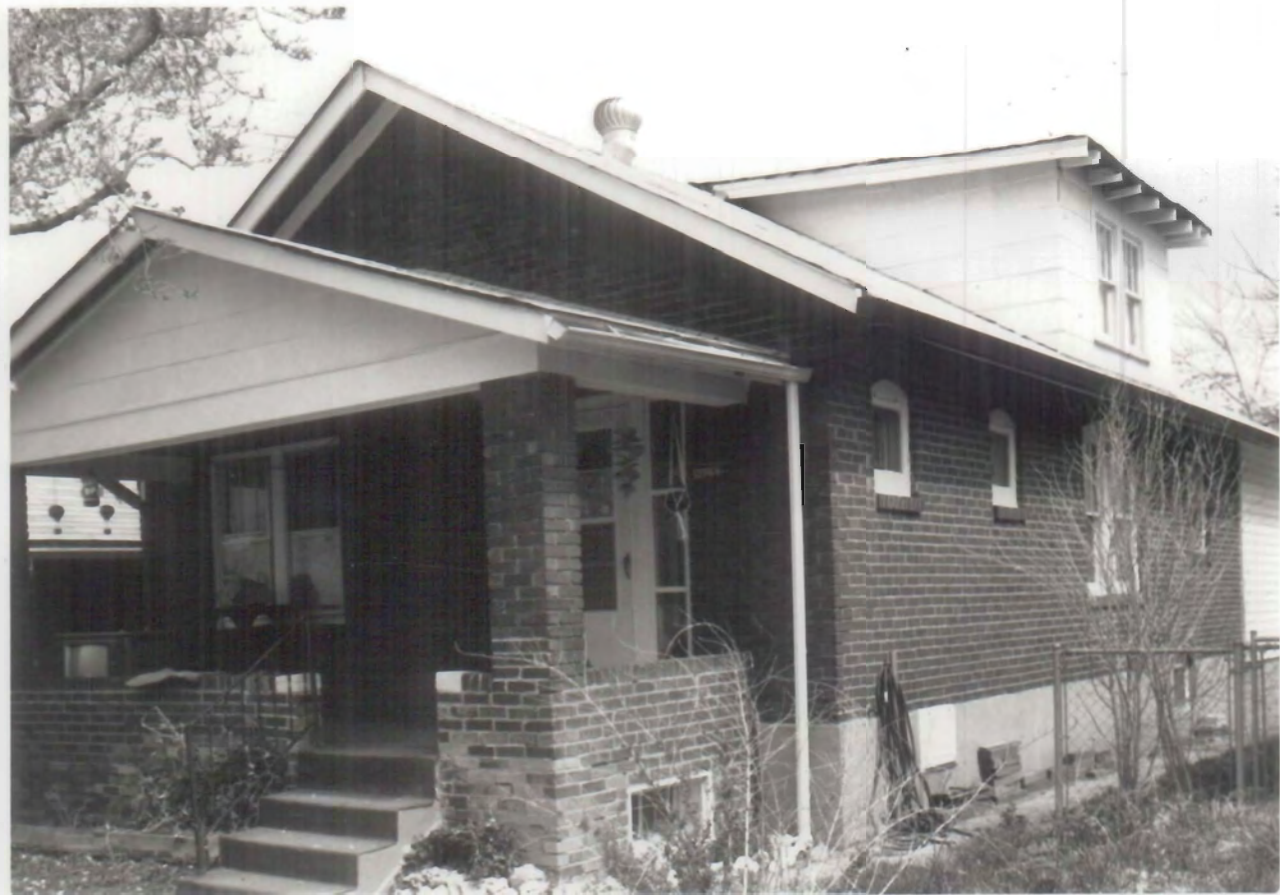
24. Foundation material: concrete

30. Exterior condition: good

33. Further description of important features: A gabled front porch extends across the front of this house, its roof separate from the roof of the house. It is supported at the outside corners by straight brick pillars. Paired, 3-over-1 windows in front elevation; front door has sidelights. Segmentally arched side windows. Large frame dormer for conversion of attic into living space. Rear frame addition.

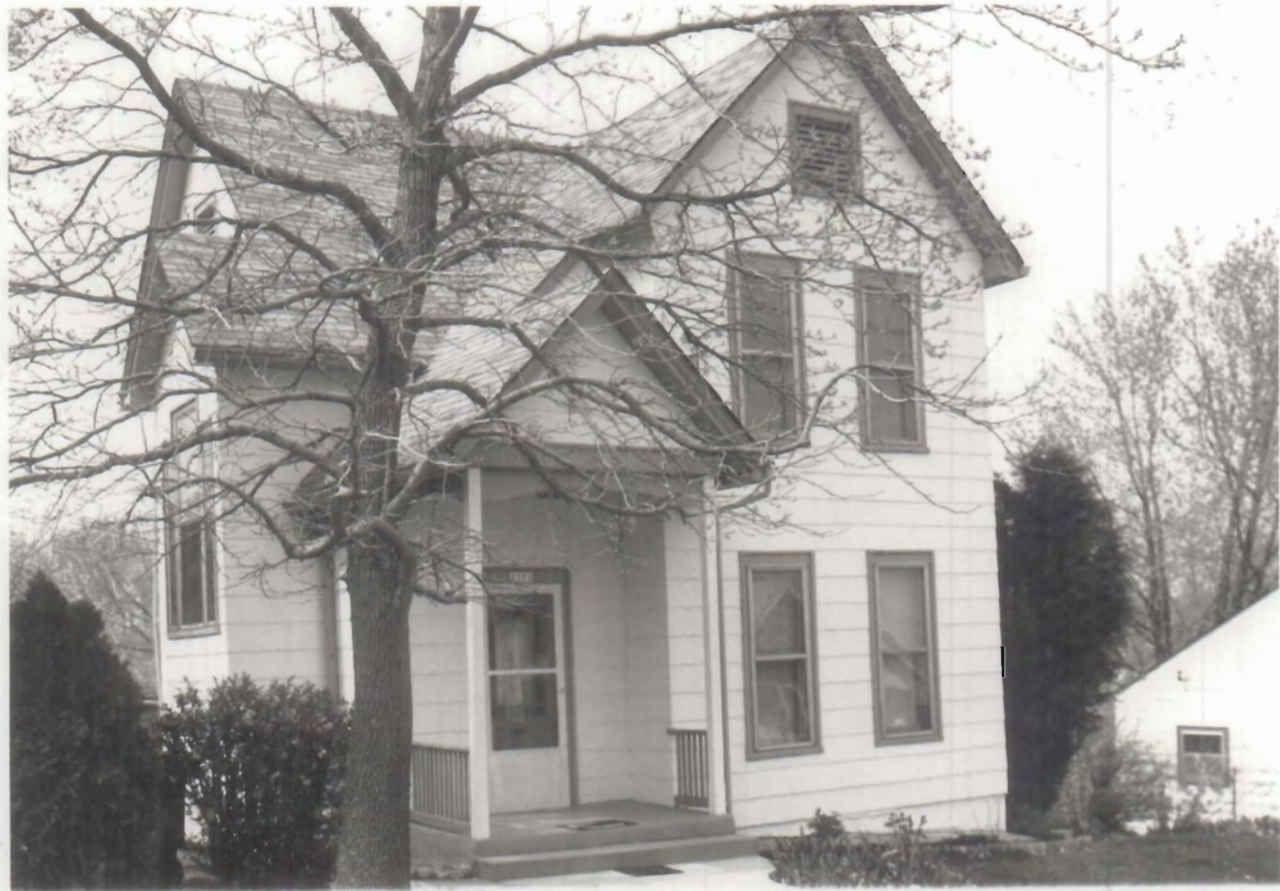
1. No. 188	3. Location of Negatives: Missouri Office of Historic Preservation, P. O. Box 176, Jefferson City, MO 65102		
2. City/County: City of St. Louis, MO	4. Prepared by: Cynthia Hill Longwisch, Landmarks Assn. of St. Louis, 917 Locust, 7th Floor, St. Louis, MO 63101

24. Foundation material: stuccoed		25. Roof type/material: gabled	
26. No. Bays: Front 3 Side 2		27. Wall treatment: asbestos siding	
28. Plan shape: see site map		29. Changes: Addition? Altered?

30. Exterior condition: good		31. Open to public? no	
32. Other Surveys in which included: Heritage/St. Louis survey, 1971			
33. Further description of important features: The roofline of this house is basically a gabled ell with smaller projecting gables. Windows are 1-over-1 double-hung sash, none paired. The front porch has an unusually high ceiling; its gabled roof is supported by thin square posts. Projecting bays at both side elevations; the south side projection juts out in the middle of the first story; it must be at a stairwell.

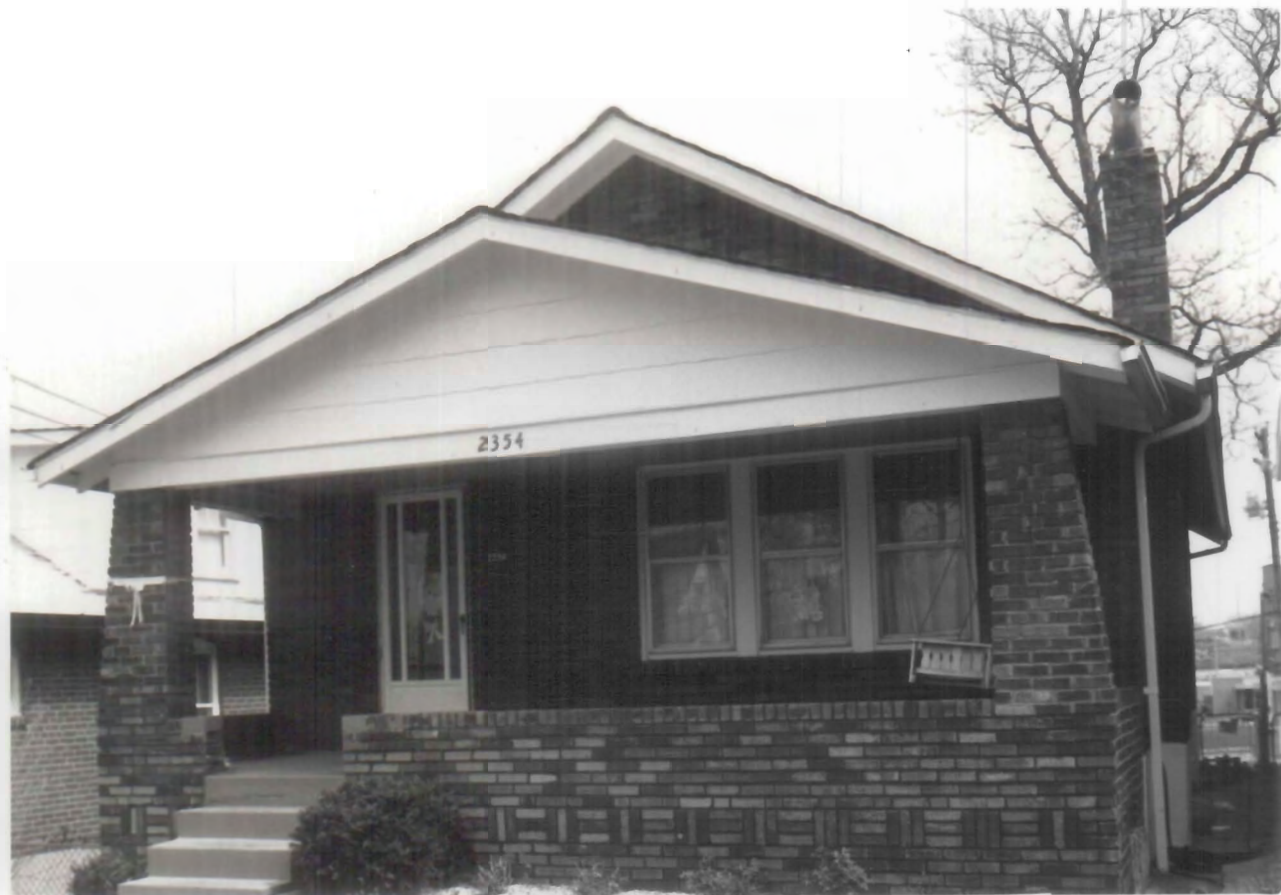
1. No. 053	3. Location of Negatives: Missouri Office of Historic Preservation, P. O. Box 176, Jefferson City, MO 65102		
2. City/County: City of St. Louis, MO

19. Original Use: residence		20. Present Use: residence	
21. No. of stories: 1	22. Basement? yes	23. Wall construction: masonry	
24. Foundation material: concrete		25. Roof type/material: front gable

26. No. Bays: Front 2 Side 3		27. Wall treatment: textured brown brk.	
28. Plan shape: see site map		29. Changes: Addition? Altered?	
30. Exterior condition: good		31. Open to public? no

33. Further description of important features: Gabled front porch is supported by tapered brick pillars at the corners; it extends across almost the width of the house. A short brick side wall features a row of basketweave patterning and is topped by a header course. Triple front windows have flat arches and 3-over-1 double-hung sash. Unlike Vollmar's 1926 houses, doorway has no sidelights. Segmentally arched side windows.

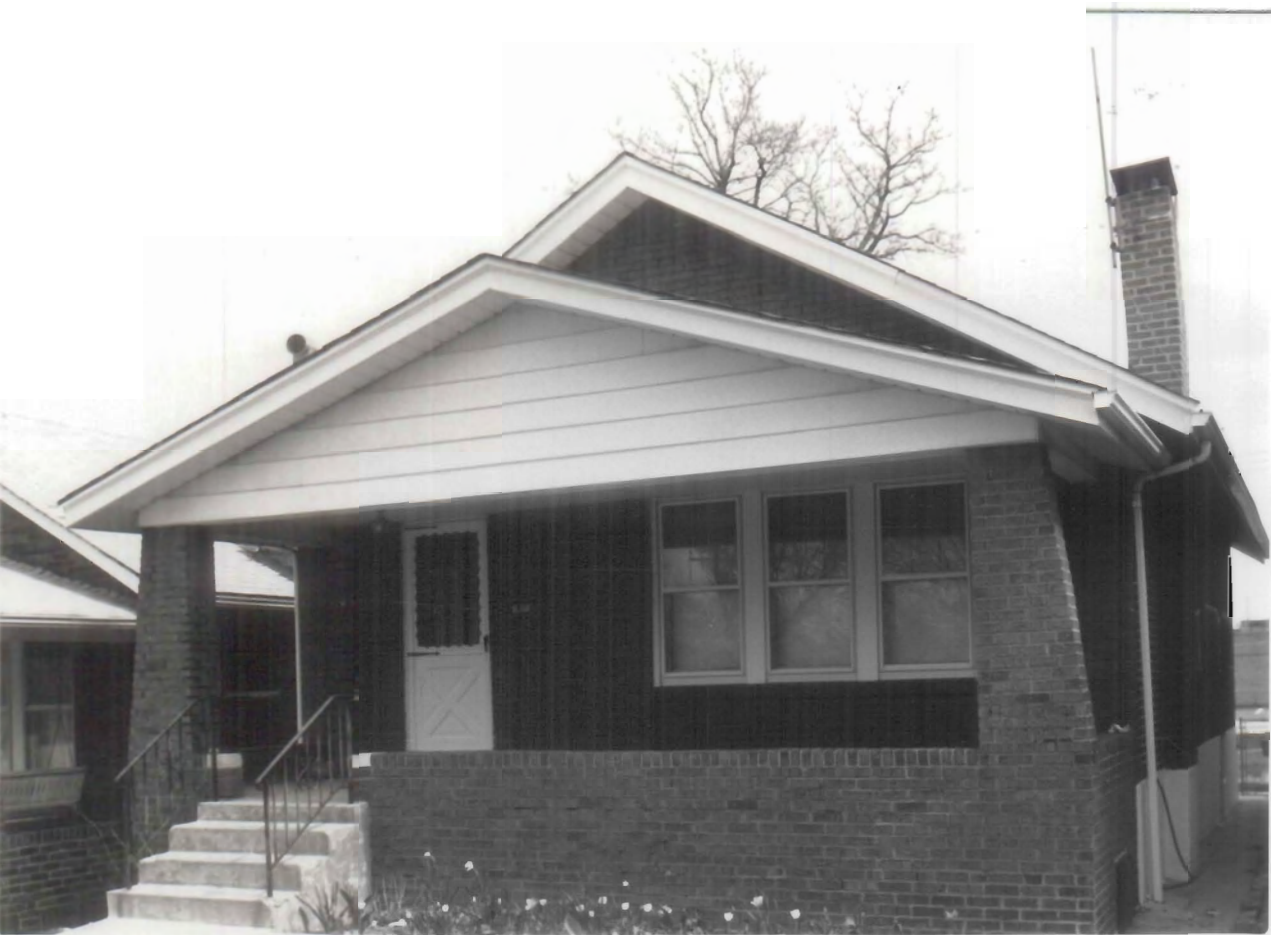
1. No. 054	3. Location of Negatives: Missouri Office of Historic Preservation, P. O. Box 176, Jefferson City, MO 65102		
2. City/County: City of St. Louis, MO	4. Prepared by: Cynthia Hill Longwisch, Landmarks Assn. of St. Louis, 917 Locust, 7th Floor, St. Louis, MO 63101

24. Foundation material: concrete		25. Roof type/material: front gable	
26. No. Bays: Front 2 Side 3		27. Wall treatment: textured red brick	
28. Plan shape: see site map		29. Changes: Addition? rear Altered?

30. Exterior condition: good		31. Open to public? no	
32. Other Surveys in which included: Heritage/St. Louis survey, 1971			
33. Further description of important features: A porch extends across almost the full width of the front facade, consisting of a gable supported by tapered brick pillars. Short, solid brick side walls are topped with a header course. Triple front windows have 3-over-1 double-hung sash. Front door features vertically divided panes. Segmentally arched side windows. Rear frame porch/addition.

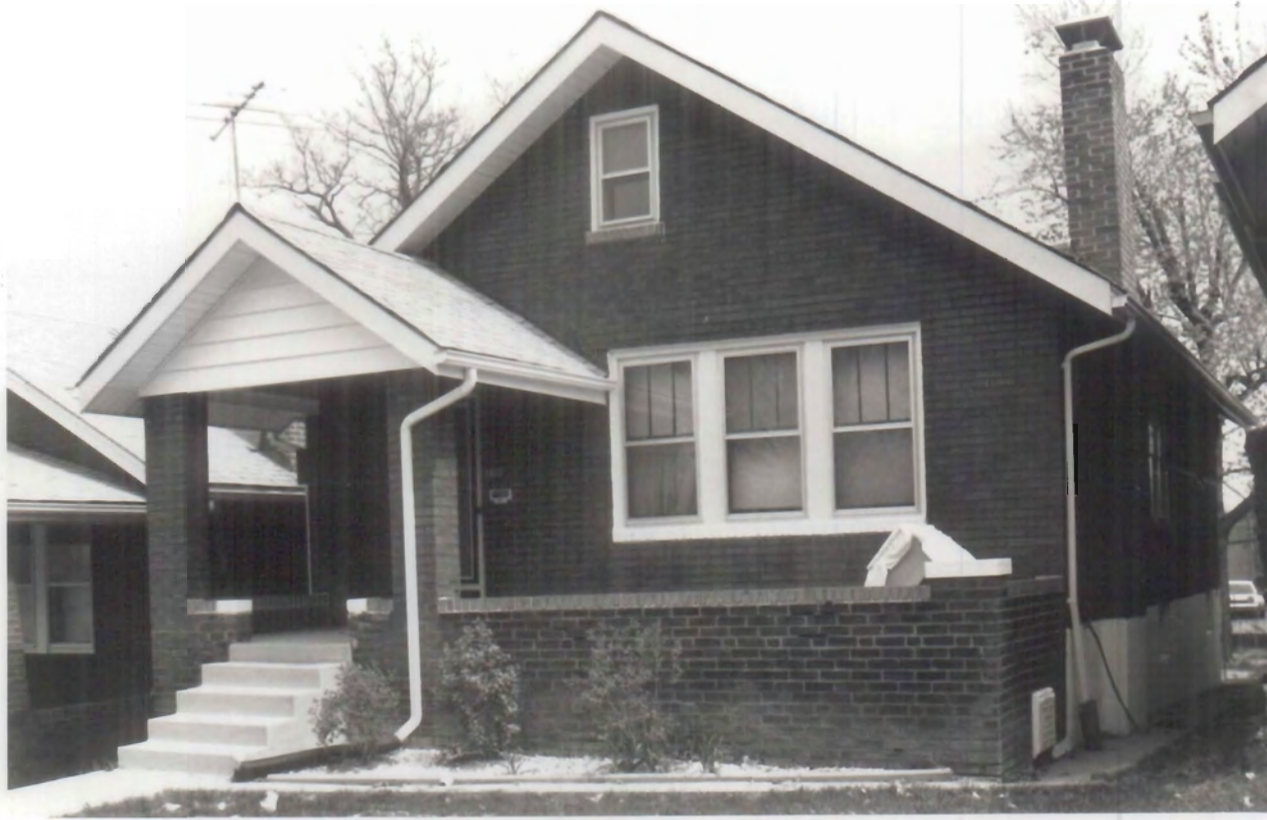
1. No. 055	3. Location of Negatives: Missouri Office of Historic Preservation, P. O. Box 176, Jefferson City, MO 65102		
2. City/County: City of St. Louis, MO	4. Prepared by: Cynthia Hill Longwisch, Landmarks Assn. of St. Louis, 917 Locust, 7th Floor, St. Louis, MO 63101

24. Foundation material: stuccoed		25. Roof type/material: front gable	
26. No. Bays: Front 2 Side 3		27. Wall treatment: red brick	
28. Plan shape: see site map		29. Changes: Addition? Altered?

30. Exterior condition: good		31. Open to public? no	
32. Other Surveys in which included: Heritage/St. Louis survey, 1971			
33. Further description of important features: The front porch of this house extends the full width of the facade; however, only the area immediately in front of the doorway is covered by the gabled porch roof. Straight brick pil-lars support this roof. The short, solid brick walls of the rest of the porch serve to enclose a patiolike, uncovered area. Triple windows of 3-over-1 double hung sash are located on the front elevation. Segmentally arched side windows.

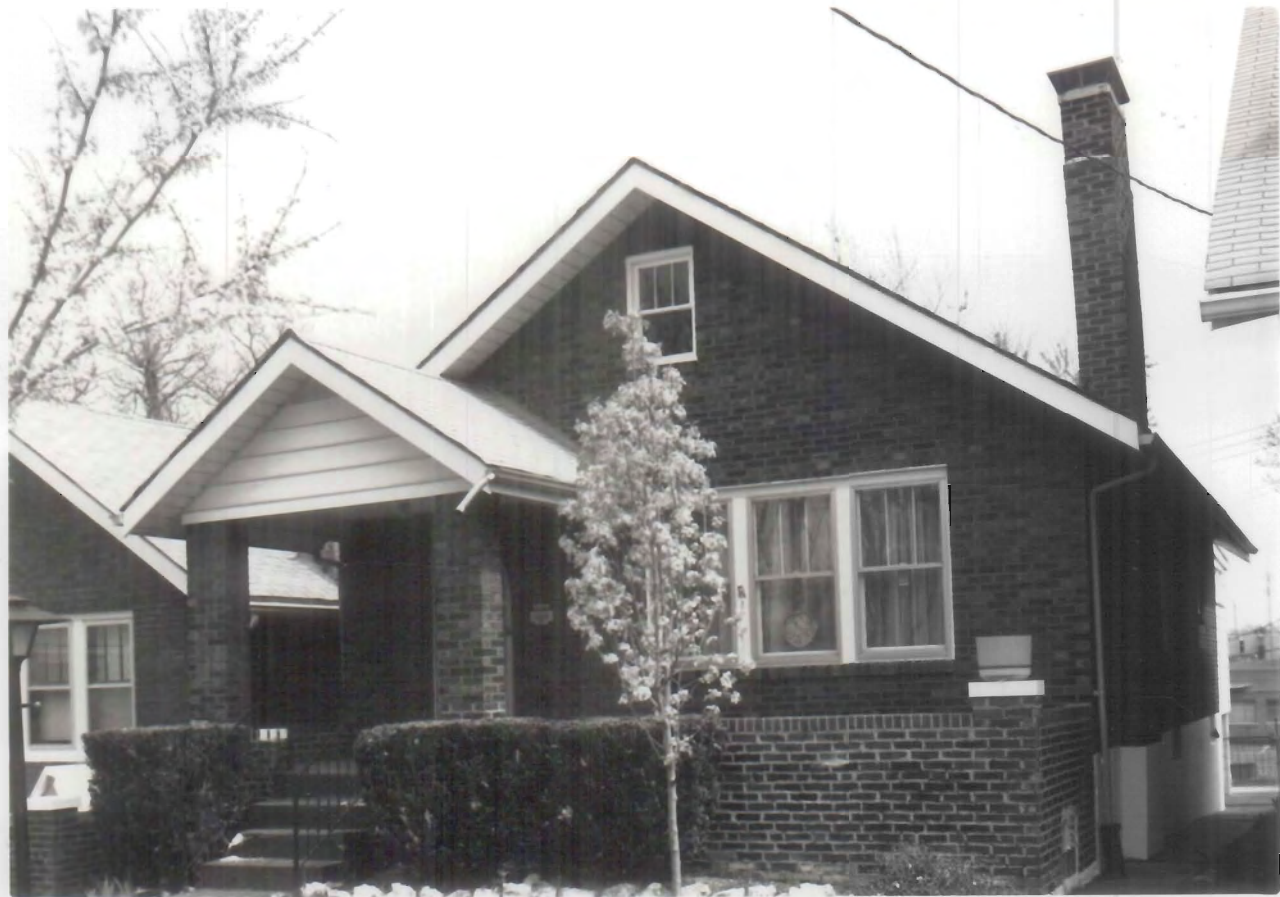
1. No. 056	3. Location of Negatives: Missouri Office of Historic Preservation, P. O. Box 176, Jefferson City, MO 65102		
2. City/County: City of St. Louis, MO	4. Prepared by: Cynthia Hill Longwisch, Landmarks Assn. of St. Louis, 917 Locust, 7th Floor, St. Louis, MO 63101

24. Foundation material: stuccoed		25. Roof type/material: front gable	
26. No. Bays: Front 2 Side 3		27. Wall treatment: textured brick	
28. Plan shape: see site map		29. Changes: Addition? Altered?

30. Exterior condition: good		31. Open to public? no	
32. Other Surveys in which included: Heritage/St. Louis survey, 1971			
33. Further description of important features: This house is very similar to survey #55 next door. A porch with short, solid brick walls extends across the width of the house; the gabled roof, however, only covers the area immediately before the front door. It is supported by straight brick pillars. Triple windows have 3-over-1 double-hung sash echoed by a single gable window. Segmentally arched side windows.

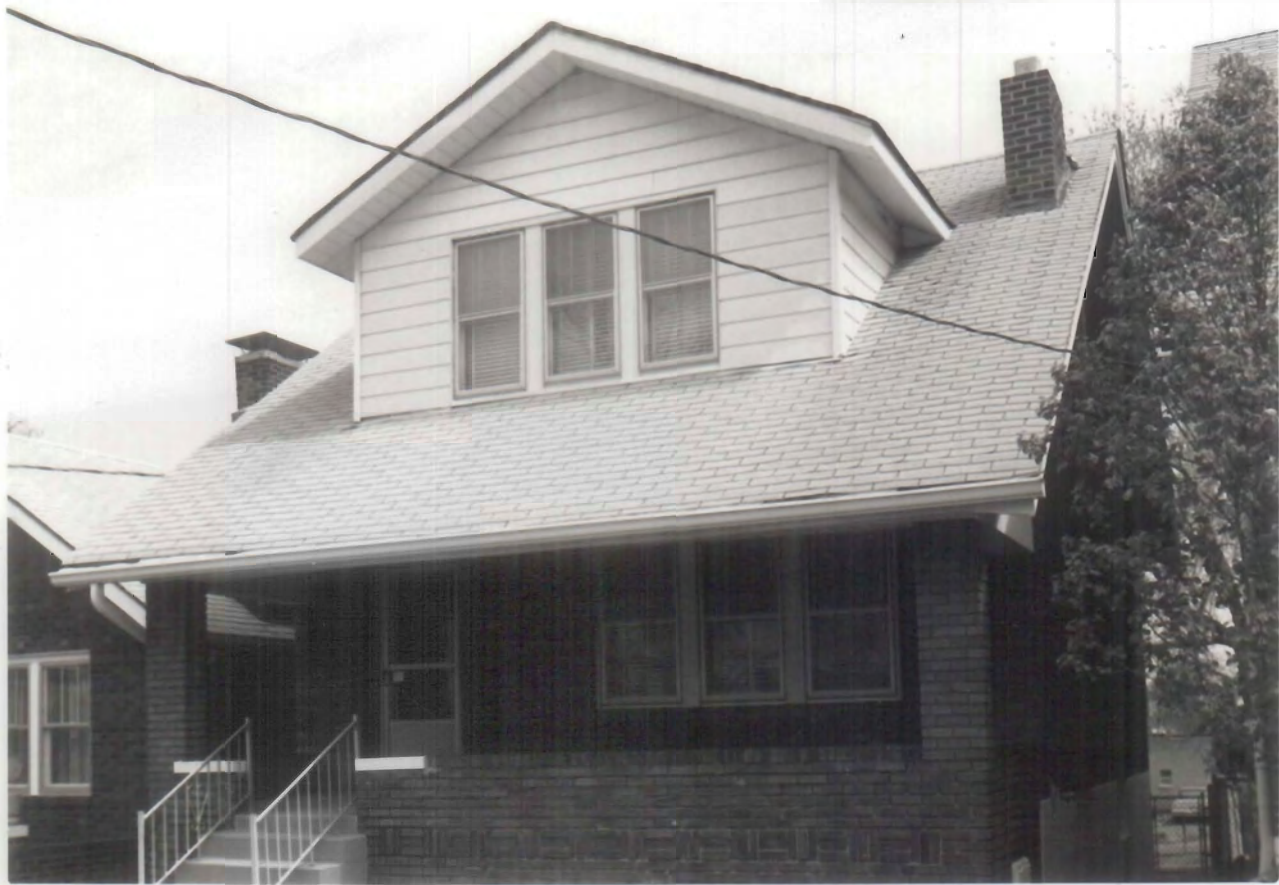
1. No. 057	3. Location of Negatives: Missouri Office of Historic Preservation, P. O. Box 176, Jefferson City, MO 65102		
2. City/County: City of St. Louis, MO	4. Prepared by: Cynthia Hill Longwisch, Landmarks Assn. of St. Louis, 917 Locust, 7th Floor, St. Louis, MO 63101

24. Foundation material: stuccoed		25. Roof type/material: side gable	
26. No. Bays: Front 2 Side		27. Wall treatment: red brick	
28. Plan shape: see site map		29. Changes: Addition? Altered?

30. Exterior condition: good		31. Open to public? no	
32. Other Surveys in which included: Heritage/St. Louis survey, 1971			
33. Further description of important features: The roof of this house features wide overhangs; it extends in the front to become the full-width porch roof, supported by straight brick pillars. A large frame, gabled dormer with triple 3-over-1 windows is centered; the windows are repeated below in the front elevation. A row of basketweave patterning highlights the short, brick porch walls, which is capped by a header course and stone at the steps.

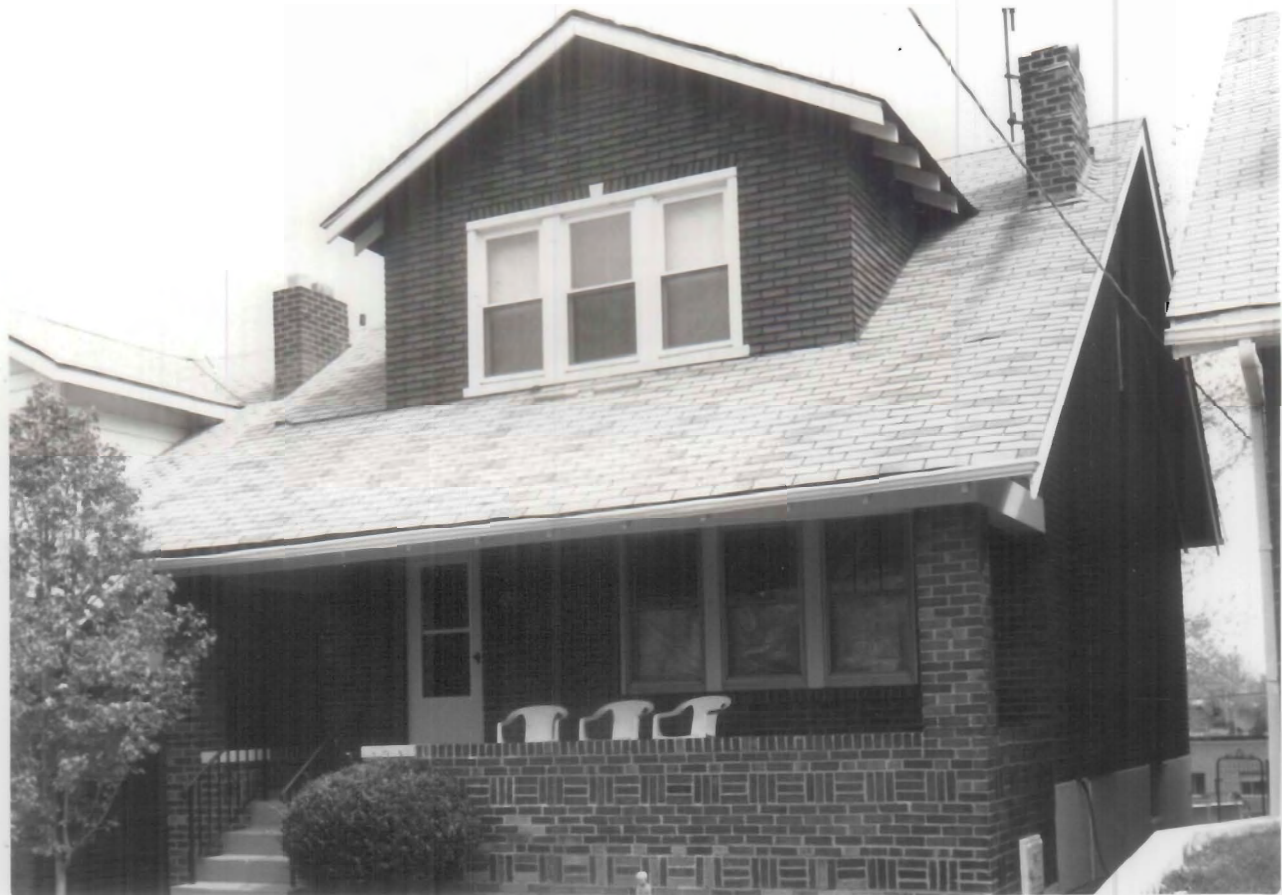
33. Further description of important features: A large frame dormer dominates the roofline; it is covered with brick-look asphalt siding and has exposed rafter ends and triple 3-over-1 double-hung sash windows. The roof of the house extends to cover the full-width porch and also has exposed rafter ends. Straight brick pillars support the porch roof at the outside corners. The porch has brick sidewalls that feature basketweave patterning. (cont'd. below)

34. History and Significance: Triple 3-over-1 windows in the front elevation. The building permit for this house included survey #57 next door. Local builder H. C. Vollmar filled out the permit in 1927, stating that the 24 x 27' dwellings would cost \$3,000 each. Vollmar did quite a lot of work in the vicinity of Clifton Heights during the late 1920s. He lived at 6105 Simpson.

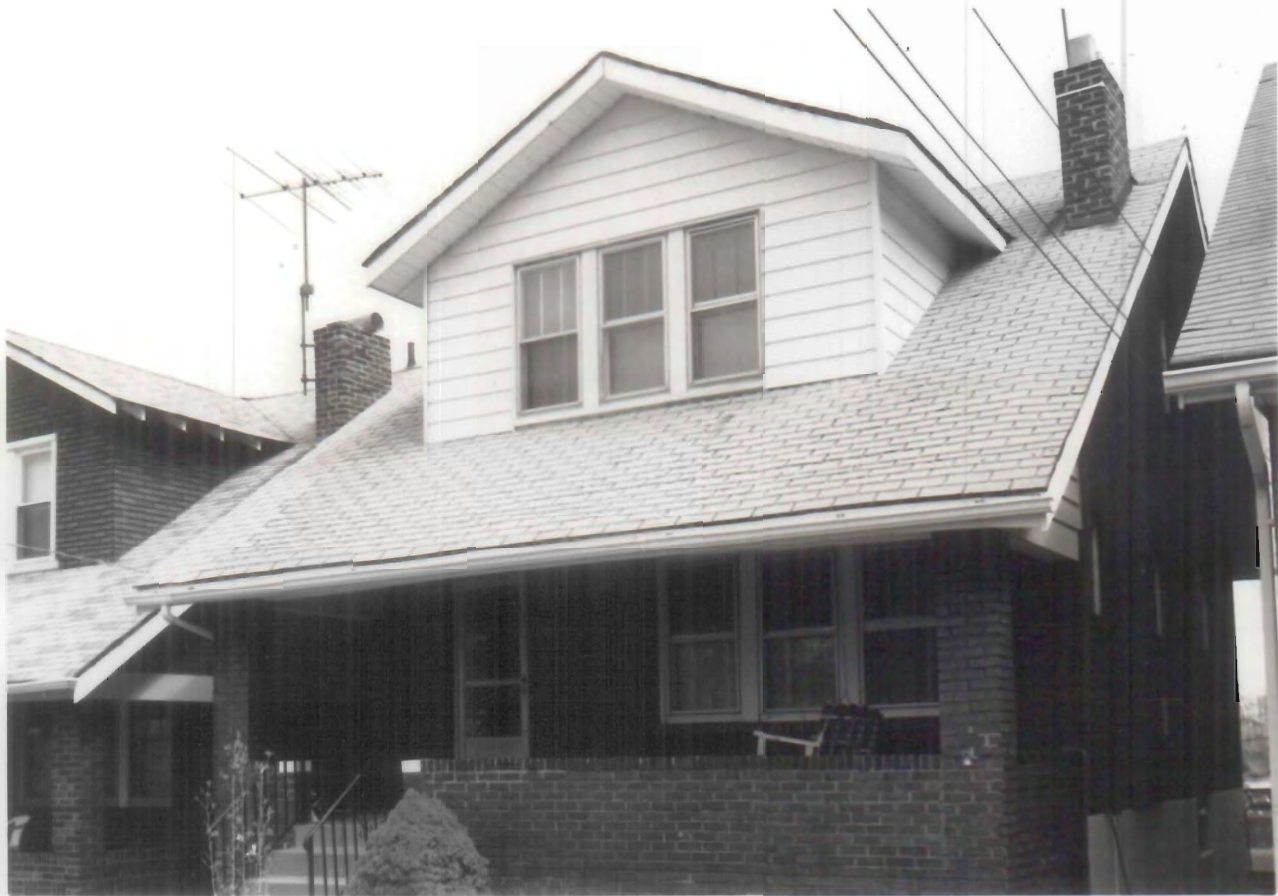
1. No. 059	3. Location of Negatives: Missouri Office of Historic Preservation, P. O. Box 176, Jefferson City, MO 65102		
2. City/County: City of St. Louis, MO	4. Prepared by: Cynthia Hill Longwisch, Landmarks Assn. of St. Louis, 917 Locust, 7th Floor, St. Louis, MO 63101

21. No. of stories: 1 1/2	22. Basement? yes	23. Wall construction: masonry	
24. Foundation material: stuccoed		25. Roof type/material: side gable	
26. No. Bays: Front 2 Side 3		27. Wall treatment: red brick mix

28. Plan shape: see site map		29. Changes: Addition? Altered?	
30. Exterior condition: good		31. Open to public? no	
32. Other Surveys in which included: Heritage/St. Louis survey, 1971

33. Further description of important features: The roofline of this house extends to cover the porch, supported at the corners by straight brick pillars. Wide overhanging eaves. A frame dormer with triple 3-over-1 double-hung sash dominates the roof. Solid brick short porch walls are topped with a brick header course and stones inset at the opening. Triple windows on front elevation are same as those above. Segmentally arched side windows.

34. History and Significance: Builder Harry C. Vollmar took out a single building permit listing six houses in 1926. These were survey #59 - 64, 2500 - 2516 Sulphur. The cost was noted as \$24,000 total, or \$4,000 apiece for the 24 x 27' dwellings - \$1,000 - 2,000 more per unit than most of the rest of his local houses. It is not known why these were more expensive; perhaps the answer lies in interior detailing. Vollmar was quite active in the immediate area in the mid-late 1920s. He lived at 6105 Simpson.

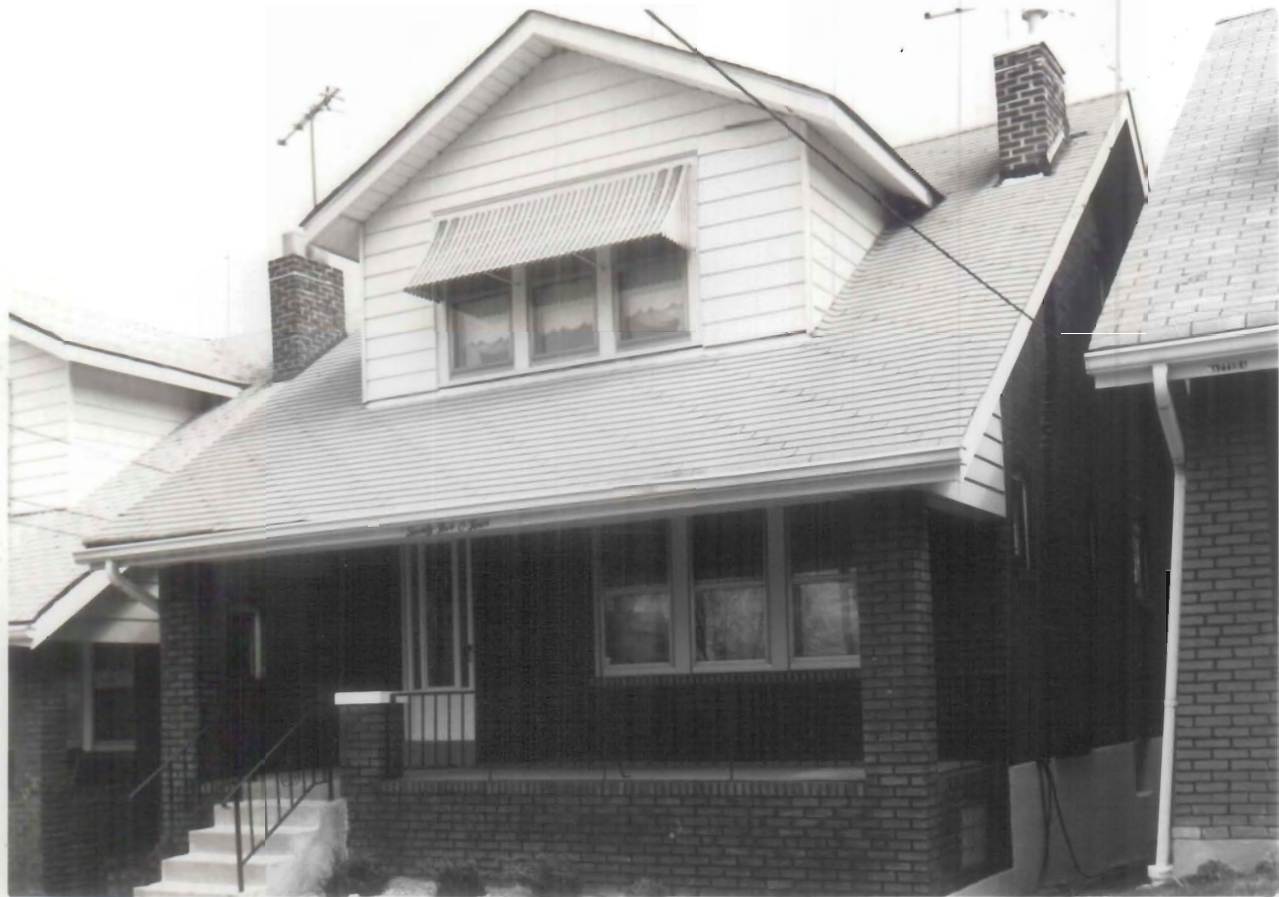
1. No. 060	3. Location of Negatives: Missouri Office of Historic Preservation, P. O. Box 176, Jefferson City, MO 65102		
2. City/County: City of St. Louis, MO	4. Prepared by: Cynthia Hill Longwisch, Landmarks Assn. of St. Louis, 917 Locust, 7th Floor, St. Louis, MO 63101

24. Foundation material: stuccoed		25. Roof type/material: side gable	
26. No. Bays: Front 2 Side 3		27. Wall treatment: red brick mix	
28. Plan shape: see site map		29. Changes: Addition? Altered?

30. Exterior condition: good		31. Open to public? no	
32. Other Surveys in which included: Heritage/St. Louis survey, 1971			
33. Further description of important features: Gabled frame dormer centered in roofline has 3-over-1 double-hung sash windows. Roof of house has wide eaves; it extends to form porch roof, supported by straight brick pillars. Porch has brick foundation but no side walls. Triple windows in front elevation also 3-over-1. Segmentally arched side windows.

34. History and Significance: This house is the second of six listed on a single 1926 building permit taken out by H. C. Vollmar. See Item 34 of survey #59 for more details.

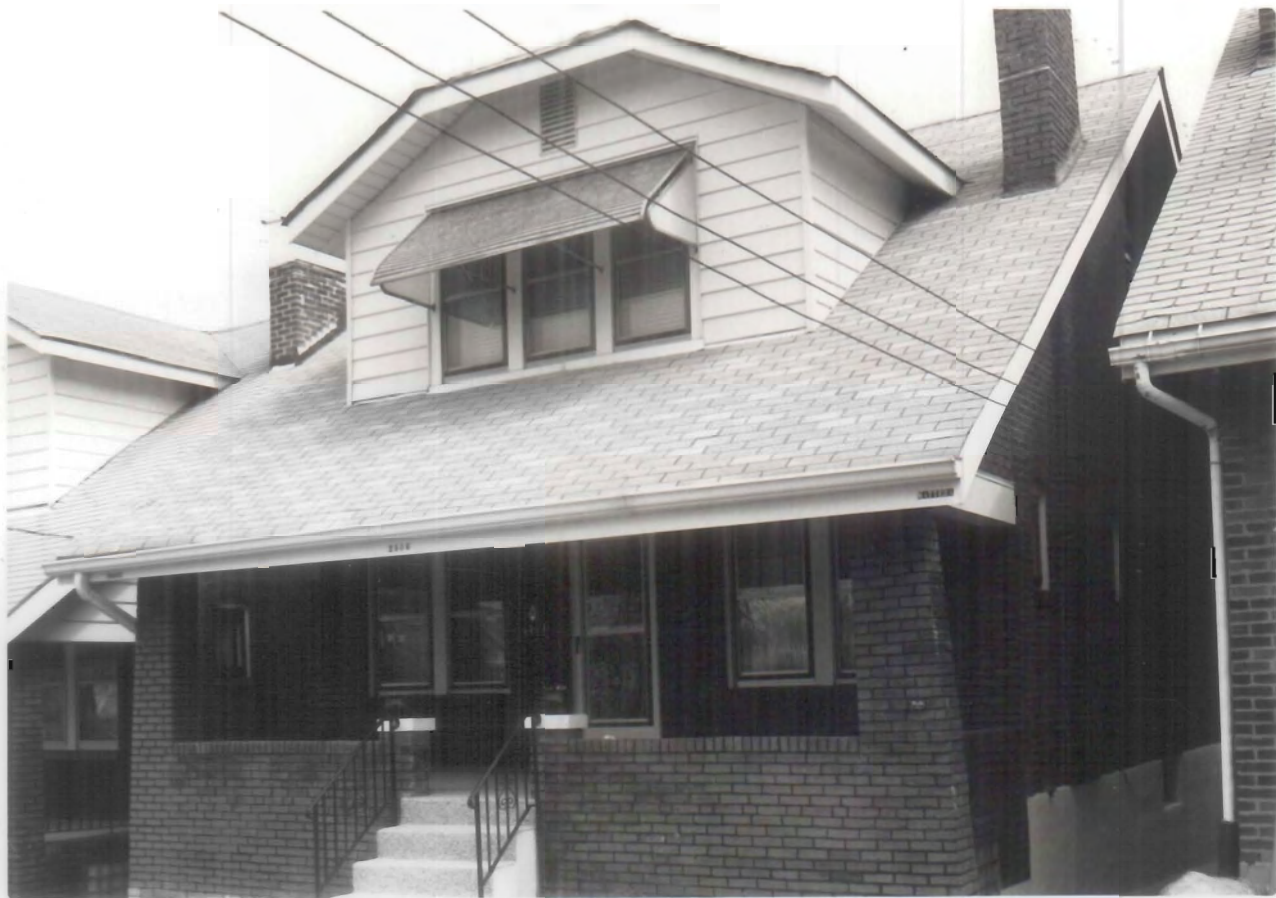
1. No. 061	3. Location of Negatives: Missouri Office of Historic Preservation, P. O. Box 176, Jefferson City, MO 65102		
2. City/County: City of St. Louis, MO	4. Prepared by: Cynthia Hill Longwisch, Landmarks Assn. of St. Louis, 917 Locust, 7th Floor, St. Louis, MO 63101

24. Foundation material: stuccoed		25. Roof type/material: side gable	
26. No. Bays: Front 3 Side		27. Wall treatment: red brick	
28. Plan shape: see site map	29. Changes: Addition?		Altered?

30. Exterior condition: good		31. Open to public? no	
32. Other Surveys in which included: Heritage/St. Louis survey, 1971			
33. Further description of important features: The frame dormer on this house features a hipped roof and triple 3-over-1 double-hung sash. Paired, 3-over-1 windows flank the centered front door. Roofline extends to form porch roof. It is supported by tapering brick pillars. Brick short walls terminate in stone caps. Segmentally arched side windows.

34. History and Significance: This house is one of six listed on a single permit by H. C. Vollmar in 1926. See Item 34 of survey 59 for more information.

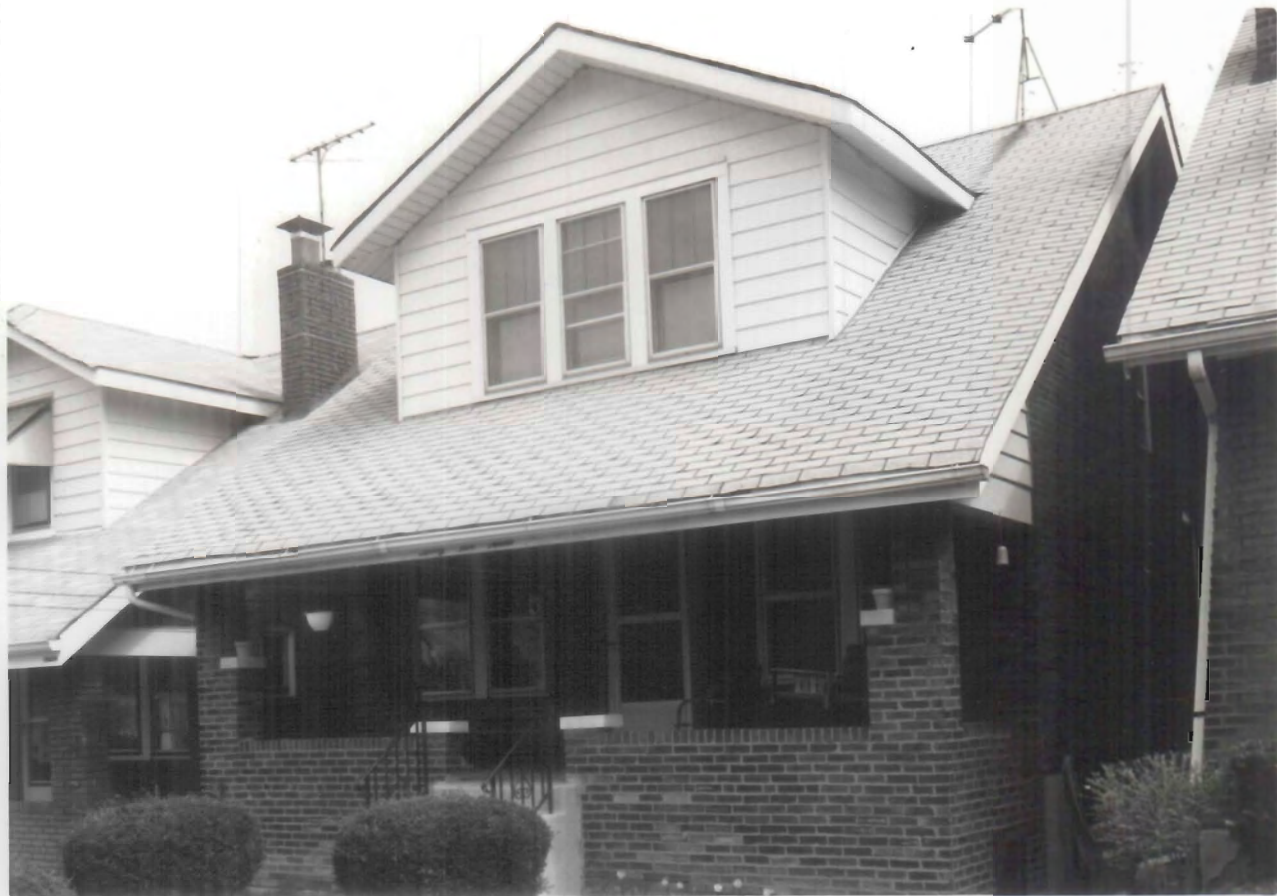
1. No. 062		3. Location of Negatives: Missouri Office of Historic Preservation, P. O. Box 176, Jefferson City, MO 65102	
2. City/County: City of St. Louis, MO		4. Prepared by: Cynthia Hill Longwisch, Landmarks Assn. of St. Louis, 917 Locust, 7th Floor, St. Louis, MO 63101

24. Foundation material: stuccoed		25. Roof type/material: side gable	
26. No. Bays: Front 3 Side		27. Wall treatment: red brick mix	
28. Plan shape: see site map		29. Changes: Addition? Altered?

30. Exterior condition: good		31. Open to public? no	
32. Other Surveys in which included: Heritage/St. Louis survey, 1971			
33. Further description of important features: Triple, 3-over-1 double-hung sash windows are centered in the gabled frame dormer that dominates the roof-line of this house. The roof, which features wide overhanging eaves, extends to form the porch roof, supported by "stepped" brick pillars. The porch has short brick side walls terminating in stone caps at the openings; stone is also used to highlight the steps of the pillars. Doubled 3-over-1 (cont'd. below)

34. History and Significance: windows flank the centered doorway. Segmentally arched side windows. H. C. Vollmar took out the permit that listed this and five other houses in 1926. For more information, see Item 34 of survey #59.
