# ARCHITECTURAL SURVEY OF CLIFTON HEIGHTS

JUNE 1991

ST. LOUIS, MISSOURI

LANDMARKS ASSOCIATION OF ST. LOUIS, INC.

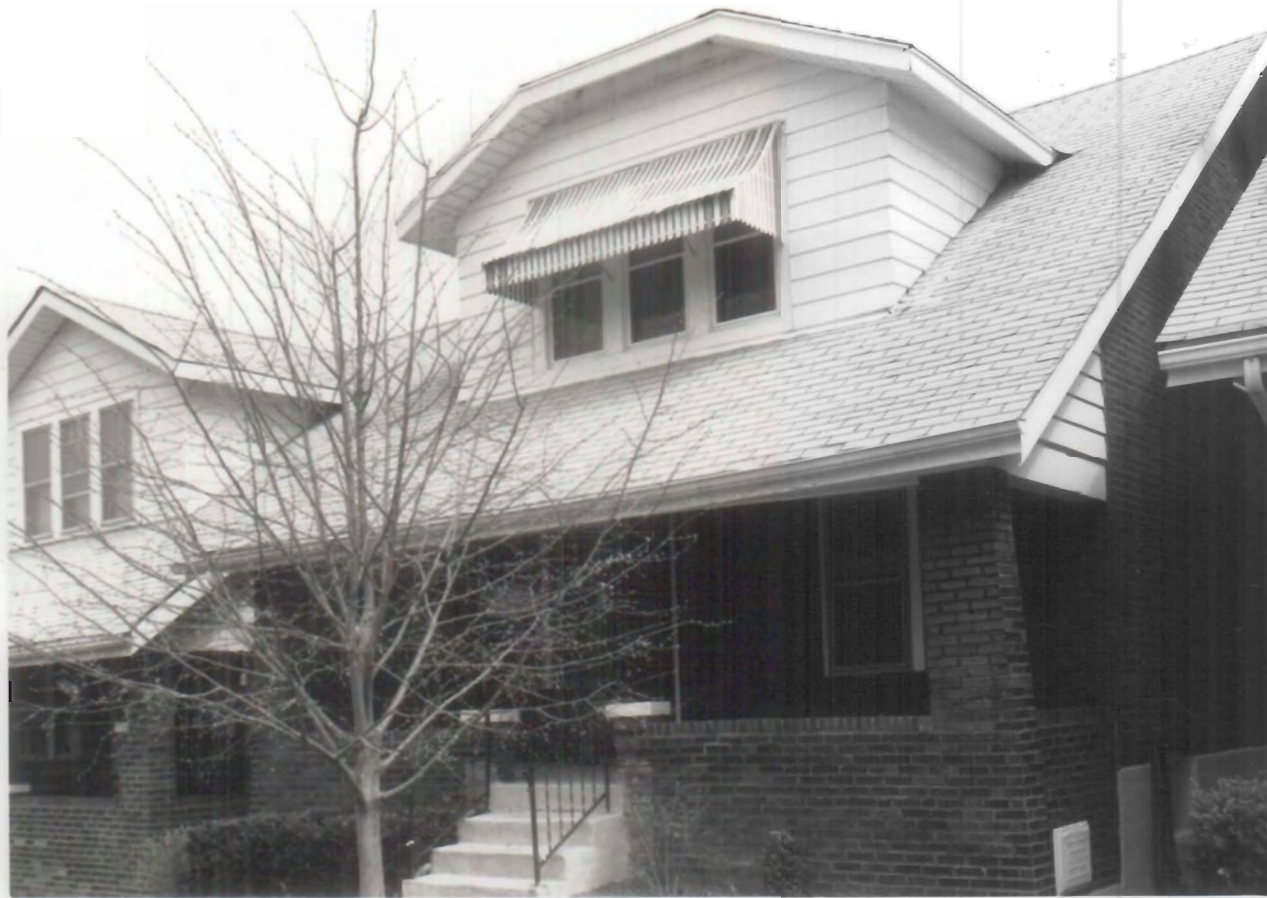
1. No. 063	3. Location of Negatives: Missouri Office of Historic Preservation, P. O. Box 176, Jefferson City, MO 65102		
2. City/County: City of St. Louis, MO

19. Original Use: residence		20. Present Use: residence	
21. No. of stories: 1 1/2	22. Basement? yes	23. Wall construction: masonry	
24. Foundation material: stuccoed		25. Roof type/material: side gable

26. No. Bays: Front 3 Side		27. Wall treatment: red brick mix	
28. Plan shape: see site map		29. Changes: Addition? Altered?	
30. Exterior condition: good		31. Open to public? no

32. Other Surveys in which included: Heritage/St. Louis survey, 1971			
33. Further description of important features: The frame dormer of this house is hipped; it has triple windows. Paired windows flank the centered front door. The roofline of the house extends to become the porch roof, supported by tapering brick pillars. Short, solid brick side walls have a header course and are capped with stone at the steps.

34. History and Significance: This house is the fifth of six houses listed on a single 1926 building permit by H. C. Vollmar. For more details, see Item 34 of survey #59.

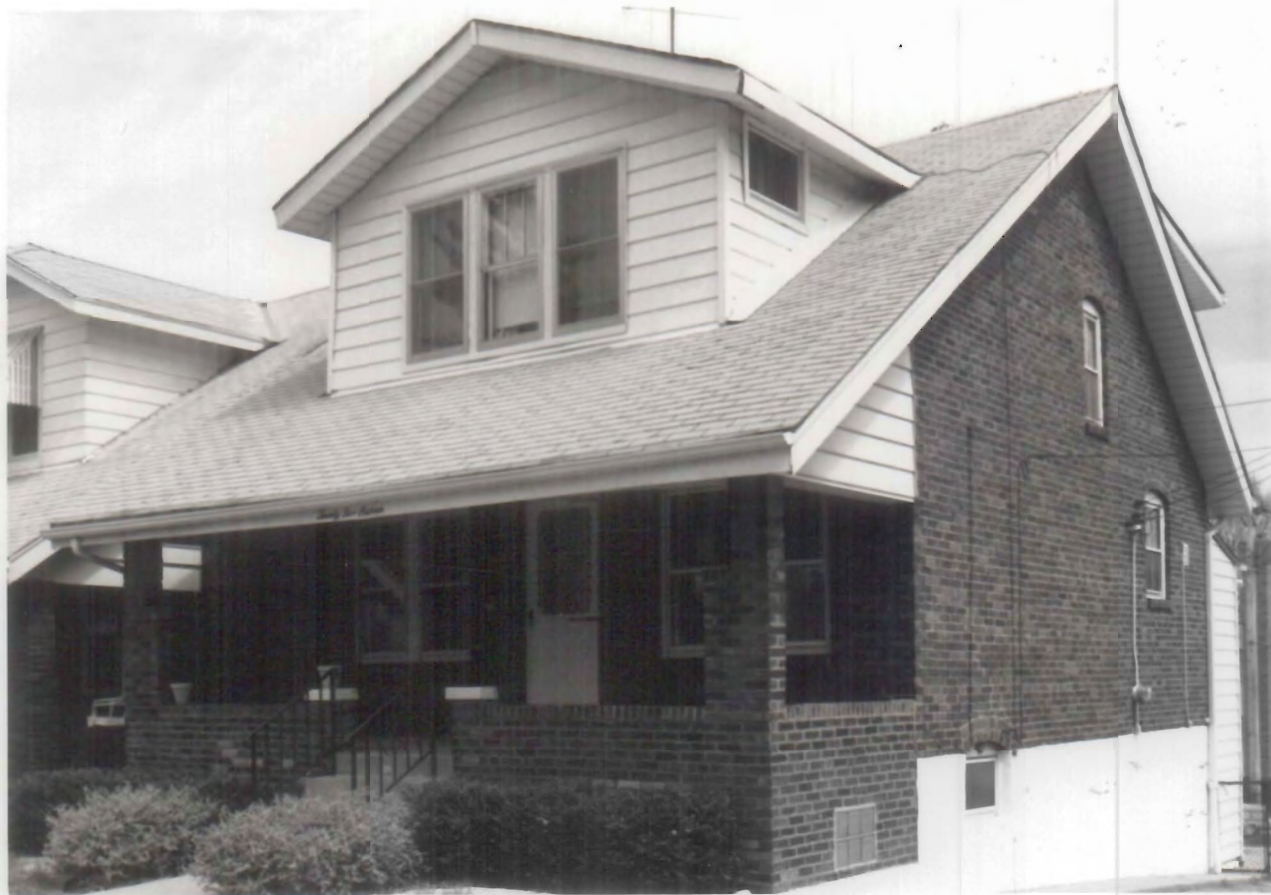
1. No. 064	3. Location of Negatives: Missouri Office of Historic Preservation, P. O. Box 176, Jefferson City, MO 65102		
2. City/County: City of St. Louis, MO	4. Prepared by: Cynthia Hill Longwisch, Landmarks Assn. of St. Louis, 917 Locust, 7th Floor, St. Louis, MO 63101

24. Foundation material: stuccoed		25. Roof type/material: side gable	
26. No. Bays: Front 3 Side 2		27. Wall treatment: red brick mix	
28. Plan shape: see site map		29. Changes: Addition? rear Altered?

30. Exterior condition: good		31. Open to public? no	
32. Other Surveys in which included: Heritage/St. Louis survey, 1971			
33. Further description of important features: The dormer of this house has triple 3-over-1 double-hung sash; it also has a small window cut into the south side. The roofline has wide overhangs and extends to cover the front porch. It is supported by "stepped" brick pillars. The short brick walls are topped with a header course and stone at the openings. Paired, 3-over-1 windows flank the centered front door. Side openings are segmentally arched. (cont'd. below)

34. History and Significance: Rear frame porch/addition.

H. C. Vollmar took out a single building permit listing this and five other houses in 1926. More information can be found in Item 34 of survey #59.
