CUBA
Crawford County
Missouri
1994

Inventory Form No. CRAS002-001

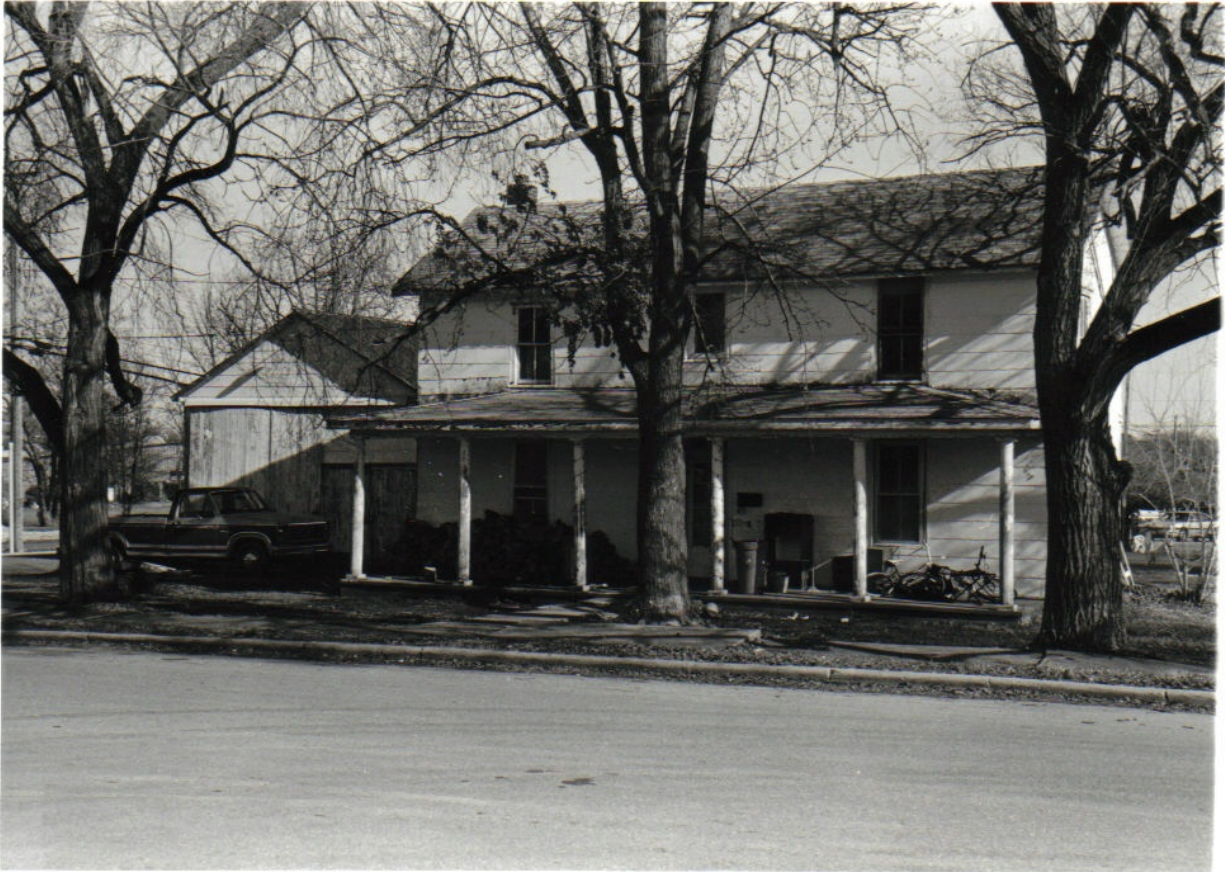
1. No. CRAS002-003	4. Present Name(s) Stewart House
2. County Crawford	
3. Location of Negatives Missouri SHPO	5. Other Name(s) Kespohl, Elmer and Norma, House

43. In July 1937, the Cuba Businessmen's Club, founded three years earlier, successfully lured the Echo Supplies Company of St. Louis, a major producer of shoe dies, to Cuba, in part through the offer of a building to house their firm (see form #51). Six employees and their families were relocated from St. Louis to Cuba and housing was provided for three employees (also see forms #42 and #61). This was built as the home of Echo employee Elmer Kespohl and his wife, Norma.

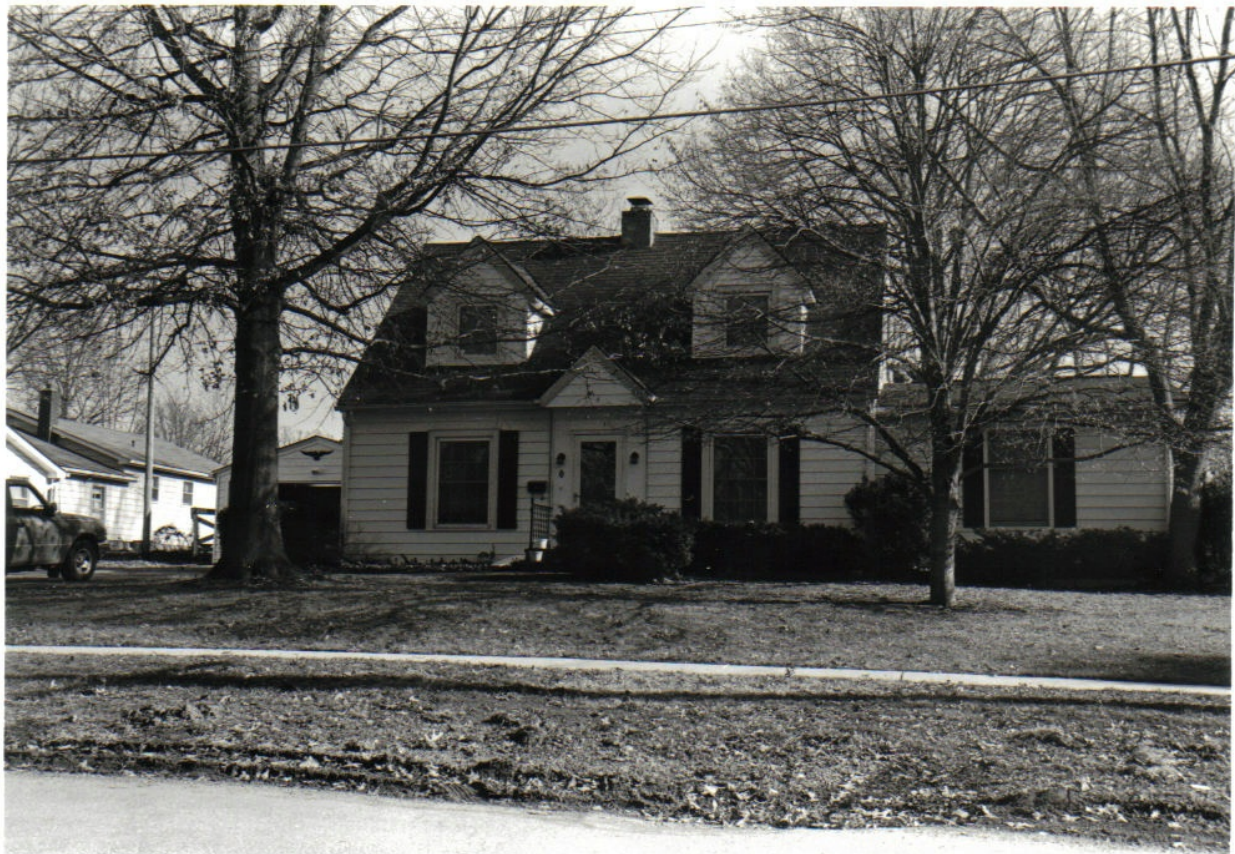
1. No. CRAS002-004 2. County Crawford 3. Location of Negatives Missouri SHPO		4. Present Name(s) Rock Fair Tavern 5. Other Name(s) Rock Fair Gas Station

28. Number of Stories 2 29. Basement Yes <input checked="" type="checkbox"/> No <input type="checkbox"/> 30. Foundation Material stone 31. Wall Construction stone 32. Roof Type and Material gable and hip, asphalt shingles. 33. Number of Bays Front 6 Side 2 34. Wall Treatment native stone 35. Plan Shape cross 36. Changes (explain in #42) Addition <input checked="" type="checkbox"/> Altered <input type="checkbox"/> Moved <input type="checkbox"/> 37. Condition Interior Exterior good q 38. Preservation underway? Yes <input type="checkbox"/> No <input checked="" type="checkbox"/> Window replacements? Yes <input type="checkbox"/> No <input checked="" type="checkbox"/> 39. Endangered? Yes <input type="checkbox"/> No <input checked="" type="checkbox"/> By What? 40. Visible from Public Road? Yes <input checked="" type="checkbox"/> No <input type="checkbox"/> 41. Distance from and frontage on road 20 feet

44. The residence located to the south and west of the main building had identical stone veneer. The main core of the building has a square footprint and is one story in height, with a pyramidal roof. A hipped roof extension (or addition) extends north from the main block of the building. A single door and double-hung, 1/1 window mark the facade.

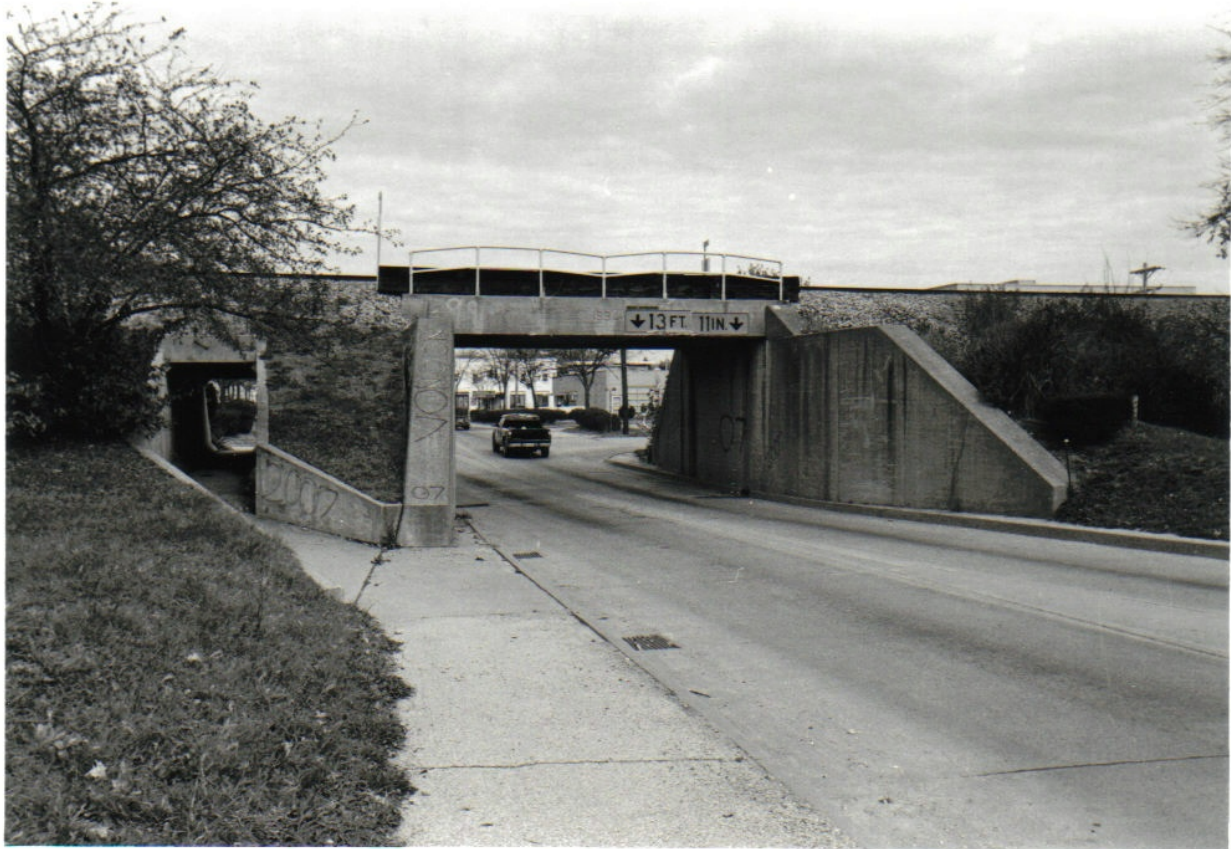
1. No. CRAS002-006					
2. County Crawford					
3. Location of Negatives Missouri SHPO					
4. Present Name(s) B W Freeman Inc.					
5. Other Name(s) Convey Heel Building

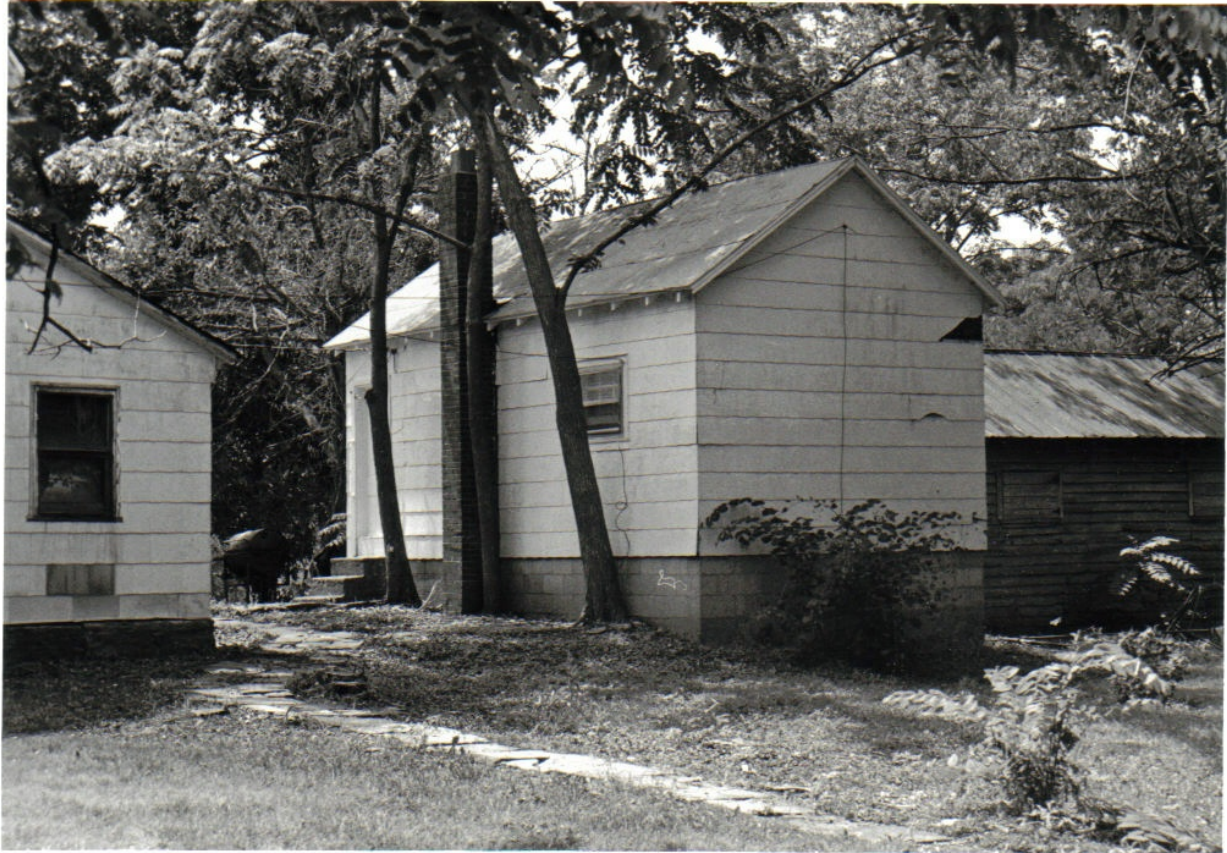
1. No. CRAS002-009 2. County Crawford 3. Location of Negatives Missouri SHPO		4. Present Name(s) 5. Other Name(s) William Sweetin House; Lutheran Parsonage

28. Number of Stories 2 1/2 29. Basement Yes <input checked="" type="checkbox"/> No <input type="checkbox"/> 30. Foundation Material stone 31. Wall Construction wood frame 32. Roof Type and Material gable, asphalt shingles 33. Number of Bays Front 3 Side 2 34. Wall Treatment siding 35. Plan Shape rectangulr 36. Changes (explain in #42) Addition <input type="checkbox"/> Altered <input checked="" type="checkbox"/> Moved <input type="checkbox"/> 37. Condition Interior Exterior god 38. Preservation underway? Yes <input type="checkbox"/> No <input checked="" type="checkbox"/> Window replacements? Yes <input checked="" type="checkbox"/> No <input type="checkbox"/> 39. Endangered? Yes <input type="checkbox"/> No <input checked="" type="checkbox"/> By What? 40. Visible from Public Road? Yes <input checked="" type="checkbox"/> No <input type="checkbox"/> 41. Distance from and frontage on road 10 feet

42. Further Description of Important Features The facade has a single centered entry with a 4/4 double hung windows on each side. The second floor has three of identical windows evenly spaced. A wall dormer with a 1/1 double hung window is centered above. All the windows appear to be replacements. The property presents a variety of siding types.

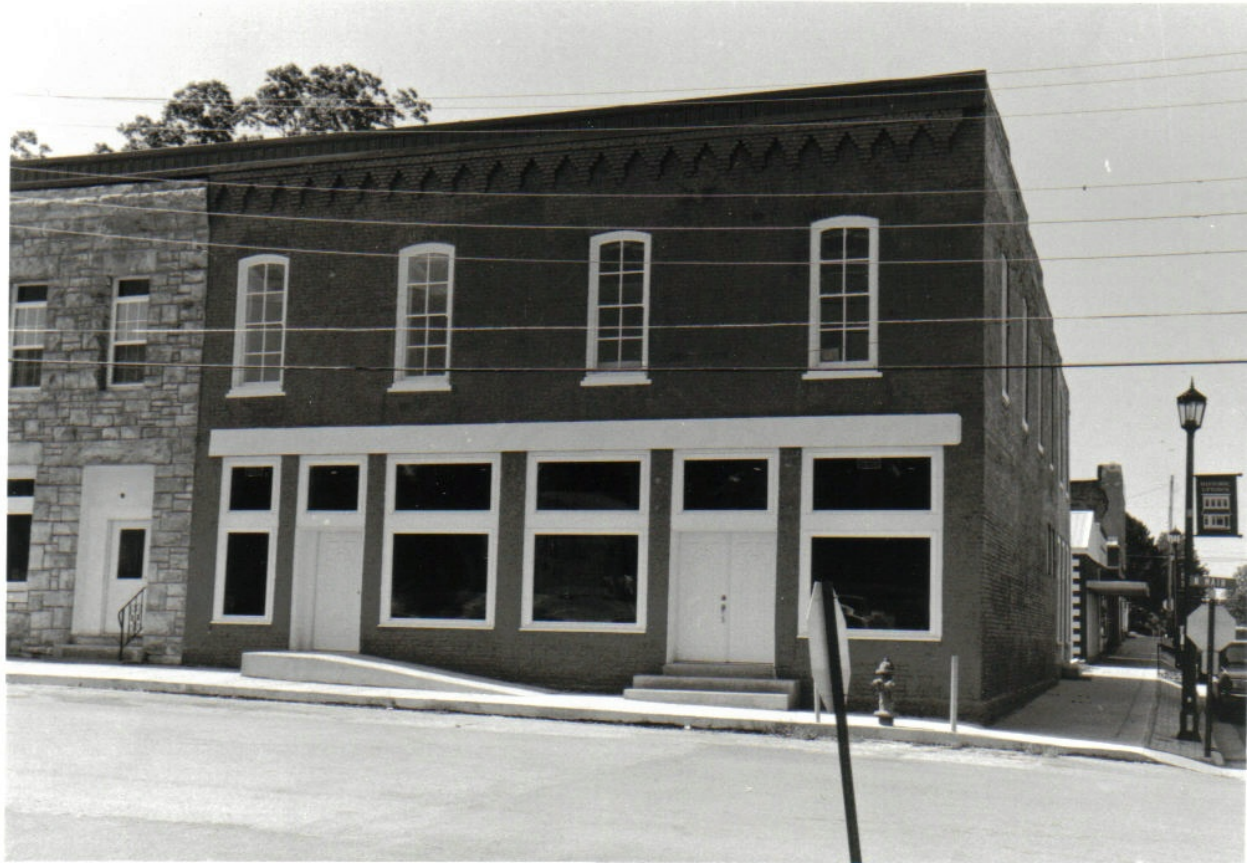
28. Number of Stories 2 29. Basement Yes <input checked="" type="checkbox"/> No <input type="checkbox"/> 30. Foundation Material stone 31. Wall Construction stone 32. Roof Type and Material flat, asphalt 33. Number of Bays Front 5 Side 34. Wall Treatment stone 35. Plan Shape rectangular 36. Changes (explain in #42) Addition <input type="checkbox"/> Altered <input checked="" type="checkbox"/> Moved <input type="checkbox"/> 37. Condition Interior Exterior good 38. Preservation underway? Yes <input type="checkbox"/> No <input type="checkbox"/> Window replacements? Yes <input checked="" type="checkbox"/> No <input type="checkbox"/> 39. Endangered? Yes <input type="checkbox"/> No <input type="checkbox"/> By What? 40. Visible from Public Road? Yes <input checked="" type="checkbox"/> No <input type="checkbox"/> 41. Distance from and frontage on road

42. Further Description of Important Features This stone building has three doors on the facade alternated with two windows. The doors have been replaced. The second story has five evenly spaced 1/1 double hung windows. The roofline features a brick cornice. <div style="text-align: right;">See Continuation Sheet <input checked="" type="checkbox"/></div> 43. History and Significance Constructed in 1897 by E.W. Hawkins at a cost of \$10,000. It has been the Hotel Grand, silent movie theatre and HUD appartments. <div style="text-align: right;">See Continuation Sheet <input checked="" type="checkbox"/></div>

42. In 1973, a fire severely damaged the interiors of this building and the building adjacent and to the east (see form #1). A metal cap unifies the roof lines of this building and the adjacent building.

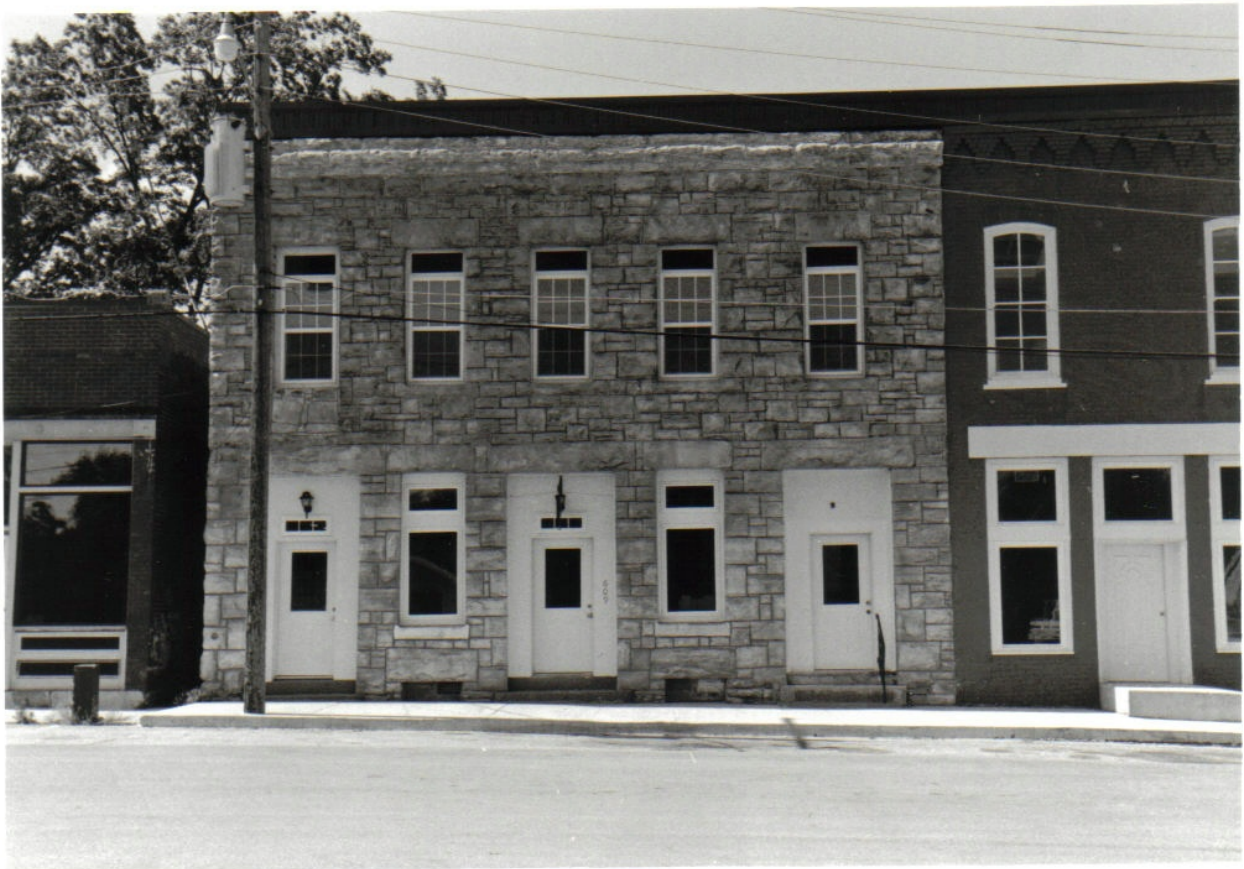
28. Number of Stories 1 29. Basement Yes <input type="checkbox"/> No <input checked="" type="checkbox"/> 30. Foundation Material concrete 31. Wall Construction brick 32. Roof Type and Material flat, asphalt 33. Number of Bays Front 5 Side 2 34. Wall Treatment brick and glass 35. Plan Shape rectangular 36. Changes (explain in #42) Addition <input type="checkbox"/> Altered <input checked="" type="checkbox"/> Moved <input type="checkbox"/> 37. Condition Interior Exterior good 38. Preservation underway? Yes <input checked="" type="checkbox"/> No <input type="checkbox"/> Window replacements? Yes <input checked="" type="checkbox"/> No <input type="checkbox"/> 39. Endangered? Yes <input type="checkbox"/> No <input checked="" type="checkbox"/> By What? 40. Visible from Public Road? Yes <input checked="" type="checkbox"/> No <input type="checkbox"/> 41. Distance from and frontage on road na		42. Further Description of Important Features The front of this building has replacement stationary glass windows with single glass transoms above them, separating the three glass door entrances. The canted corner entrance has a decorative column support. This building is currently undergoing renovation. See Continuation Sheet <input checked="" type="checkbox"/> 43. History and Significance This building has housed multiple businesses for most of its life, including the post office (in the corner portion), a drug store, a shoe store, a paint store, an antique store, and used appliance store. First owner W.S. Cox. See Continuation Sheet <input checked="" type="checkbox"/>

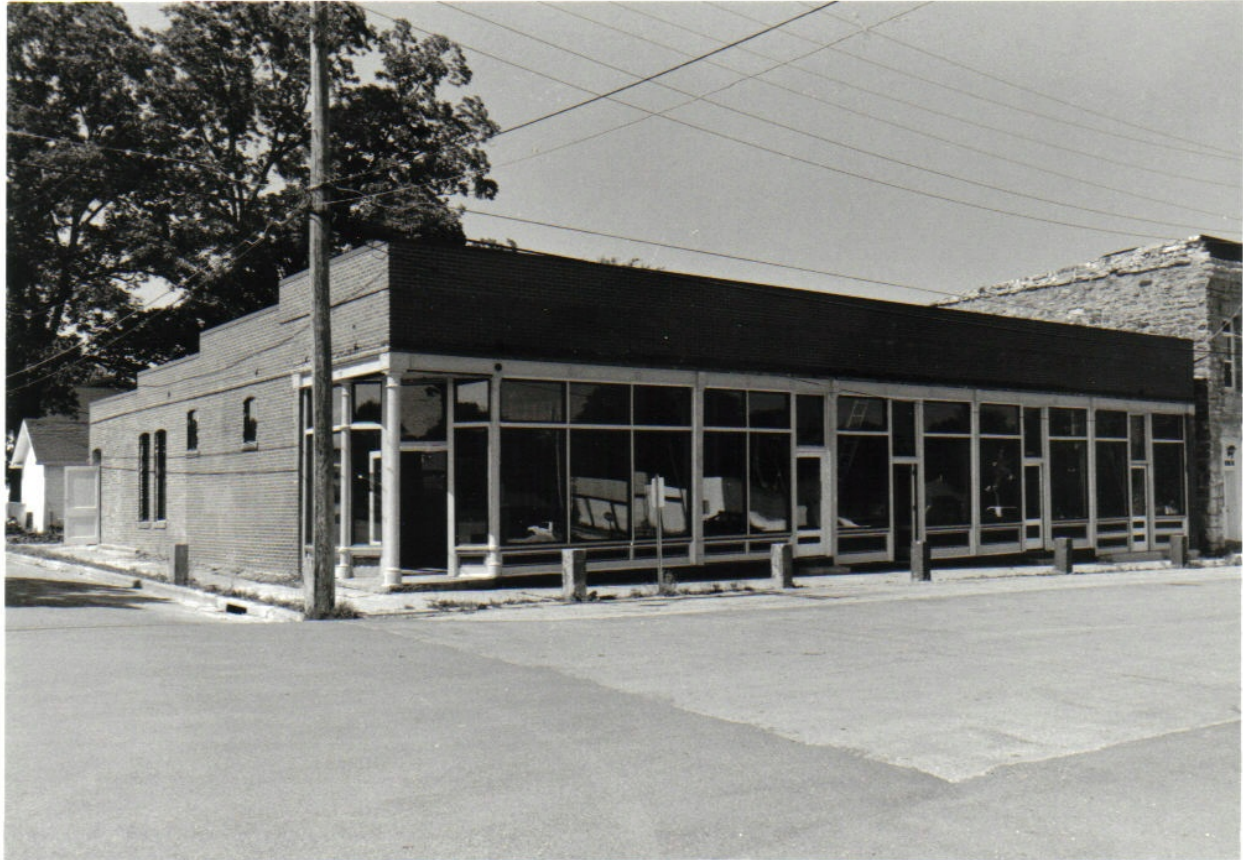
1. No. CRAS002-014		
2. County Crawford		
3. Location of Negatives Missouri SHPO		
4. Present Name(s) First Presbyterian Church		
5. Other Name(s)		
6. Specific Location <div>Township Range</div> <div>Section</div> If City or Town, Street Address 701 NW Main Cuba 7. City or Town <div>If Rural, Township and Vicinity</div> 8. Site Plan with North Arrow See Continuation Sheet <input type="checkbox"/> 9. UTM Coordinate(s) 10. Site <input type="checkbox"/> Structure <input type="checkbox"/> Building <input checked="" type="checkbox"/> Object <input type="checkbox"/> 11. On National Register? Yes <input type="checkbox"/> No <input checked="" type="checkbox"/> 12. Is It Eligible? Yes <input type="checkbox"/> No <input type="checkbox"/> 13. Part of Established Historic District Yes <input type="checkbox"/> No <input checked="" type="checkbox"/> 14. District Potential Yes <input checked="" type="checkbox"/> No <input type="checkbox"/> 15. Name of Established District, if applicable	16. Thematic Category 17. Date(s) or Period of Significance 1870 18. Style or Design 19. Architect or Engineer 20. Contractor or Builder 21. Original Use, if apparent Church 22. Present Use Church 23. Owership Public <input type="checkbox"/> Private <input checked="" type="checkbox"/> 24. Owner's Name and Address, if known 25. Open to Public Yes <input checked="" type="checkbox"/> No <input type="checkbox"/> 26. Local Contact Person or Organization Marilyn A. Stewart 503 Forest St. Cuba, MO 65453 27. Other Surveys in which included	28. Number of Stories 1 29. Basement Yes <input type="checkbox"/> No <input checked="" type="checkbox"/> 30. Foundation Material concrete 31. Wall Construction wood 32. Roof Type and Material gable, asphat shingles 33. Number of Bays Front 1 Side 3 34. Wall Treatment replacement siding 35. Plan Shape irregular; L-shaped 36. Changes (explain in #42) Addition <input type="checkbox"/> Altered <input checked="" type="checkbox"/> Moved <input checked="" type="checkbox"/> 37. Condition Interior Exterior good 38. Preservation underway? Yes <input type="checkbox"/> No <input type="checkbox"/> Window replacements? Yes <input type="checkbox"/> No <input checked="" type="checkbox"/> 39. Endangered? Yes <input type="checkbox"/> No <input checked="" type="checkbox"/> By What? 40. Visible from Public Road? Yes <input checked="" type="checkbox"/> No <input type="checkbox"/> 41. Distance from and frontage on road na

42. Further Description of Important Features The facade of the roughly L-shaped building features is characterized by the distinctive 1983 porch. Entry is through double doors. The gables have Gothic arched windows as does the side and the corner tower, set in the bend of the L. The tower has a small cupola with a hip roof.

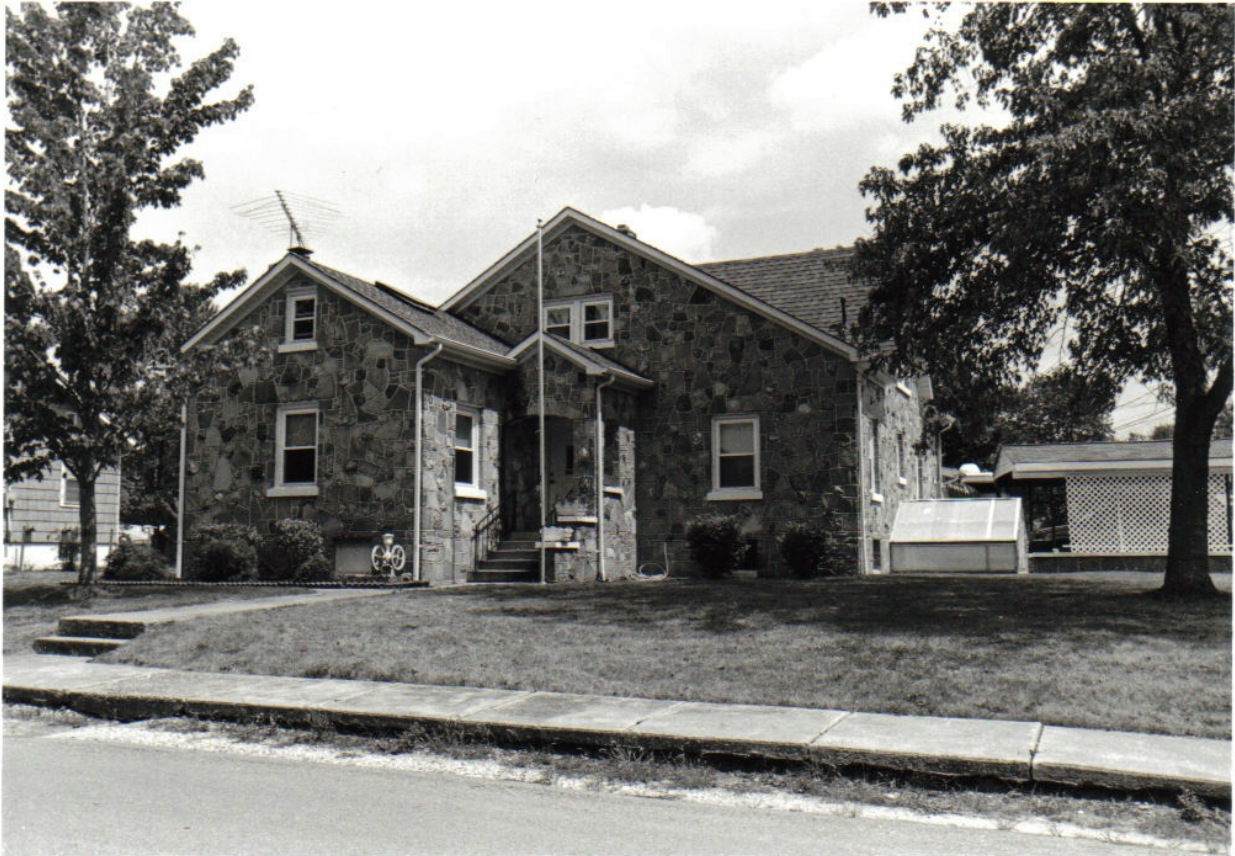
1. No. CRAS002-016	4. Present Name(s) 308 Myrtle Street
2. County Crawford	
3. Location of Negatives Missouri SHPO	5. Other Name(s) Charles Hart House

42. The west elevation features a projecting bay with three evenly spaced windows and a pair of windows in the gable above.

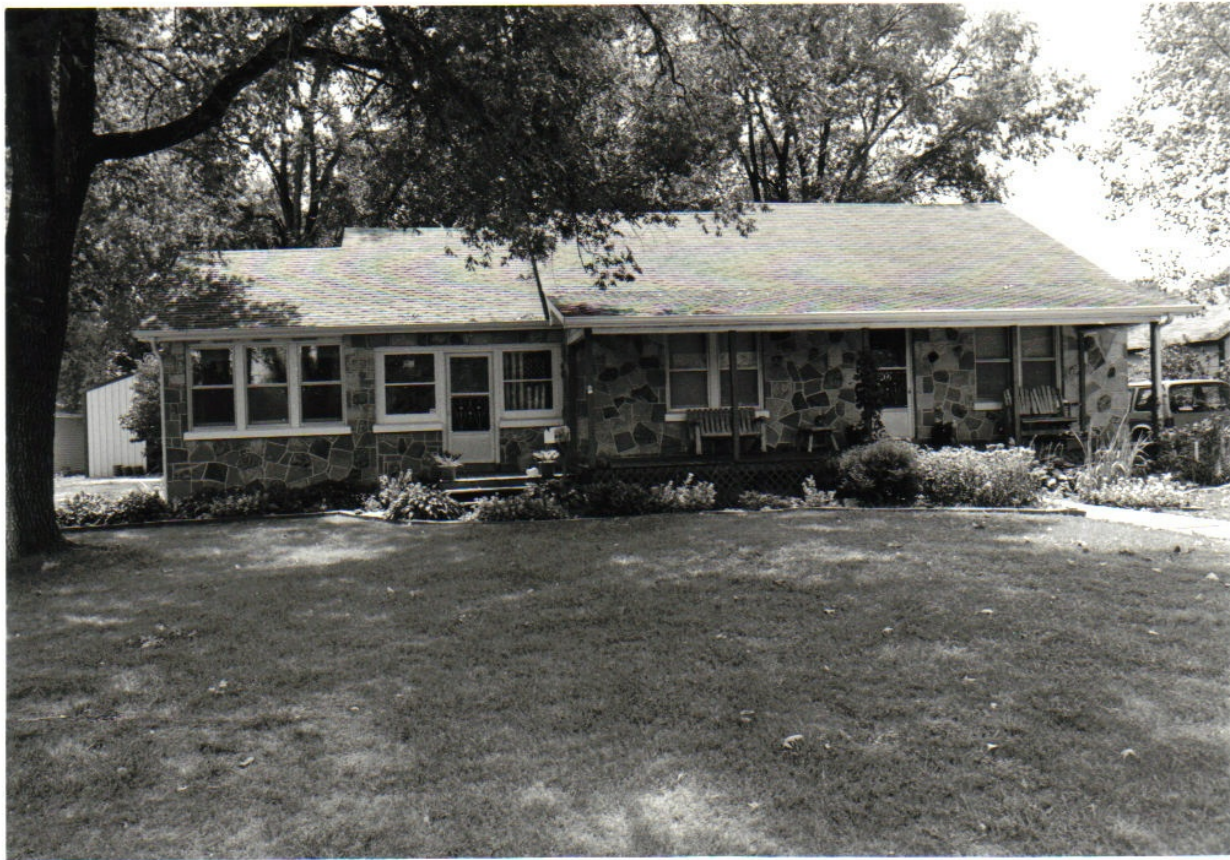
28. Number of Stories 1 29. Basement Yes <input checked="" type="checkbox"/> No <input type="checkbox"/> 30. Foundation Material concrete 31. Wall Construction wood frame 32. Roof Type and Material gabled, asphalt shingles 33. Number of Bays Front 1 Side 5 34. Wall Treatment cut native stone 35. Plan Shape rectangular 36. Changes (explain in #42) Addition <input checked="" type="checkbox"/> Altered <input type="checkbox"/> Moved <input type="checkbox"/> 37. Condition Interior Exterior excellent 38. Preservation underway? Yes <input type="checkbox"/> No <input checked="" type="checkbox"/> Window replacements? Yes <input type="checkbox"/> No <input checked="" type="checkbox"/> 39. Endangered? Yes <input type="checkbox"/> No <input checked="" type="checkbox"/> By What? 40. Visible from Public Road? Yes <input checked="" type="checkbox"/> No <input type="checkbox"/> 41. Distance from and frontage on road 15 feet

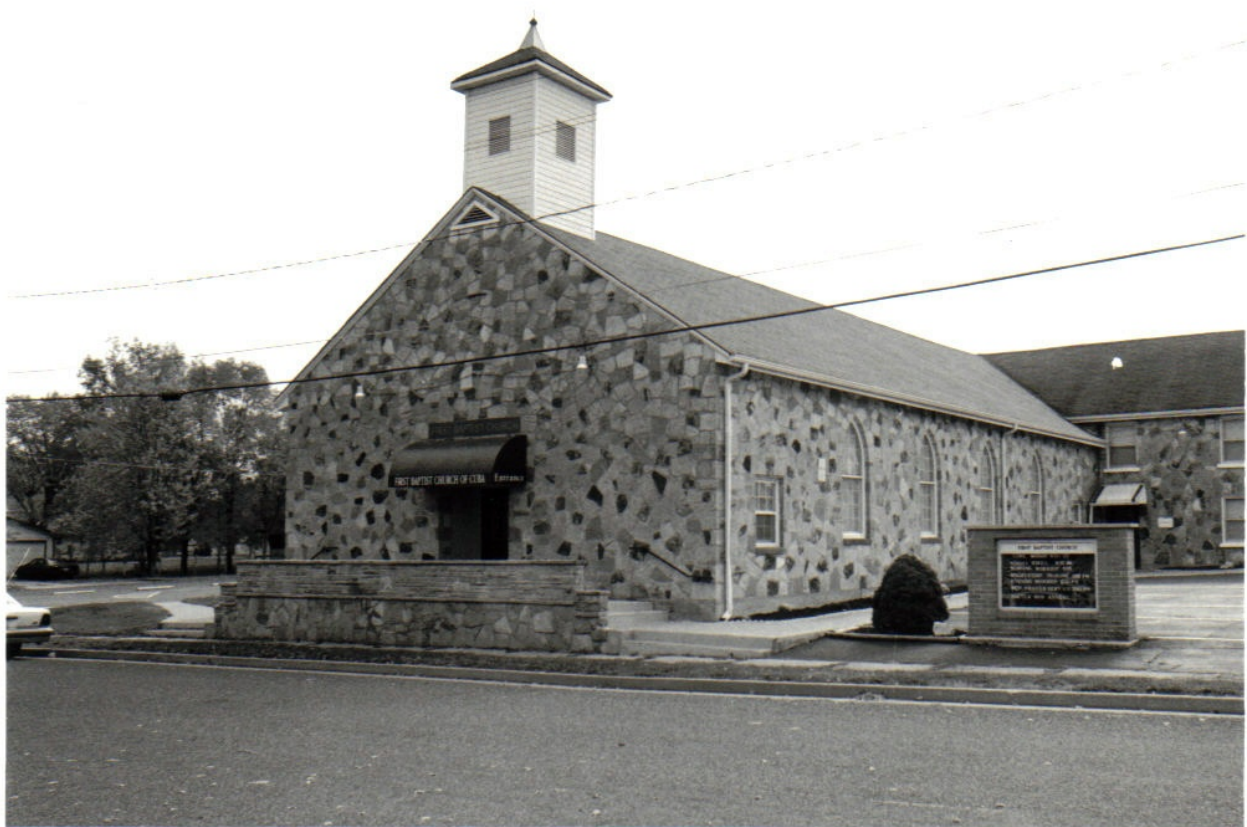
28. Number of Stories 1 29. Basement Yes <input type="checkbox"/> No <input checked="" type="checkbox"/> 30. Foundation Material concrete 31. Wall Construction concrete 32. Roof Type and Material flat, asphalt 33. Number of Bays Front 5 Side 2 34. Wall Treatment brick 35. Plan Shape rectangularr 36. Changes (explain in #42) Addition <input checked="" type="checkbox"/> Altered <input checked="" type="checkbox"/> Moved <input type="checkbox"/> 37. Condition Interior Exterior good 38. Preservation underway? Yes <input type="checkbox"/> No <input checked="" type="checkbox"/> Window replacements? Yes <input checked="" type="checkbox"/> No <input type="checkbox"/> 39. Endangered? Yes <input type="checkbox"/> No <input checked="" type="checkbox"/> By What? 40. Visible from Public Road? Yes <input checked="" type="checkbox"/> No <input type="checkbox"/> 41. Distance from and frontage on road 40 feet

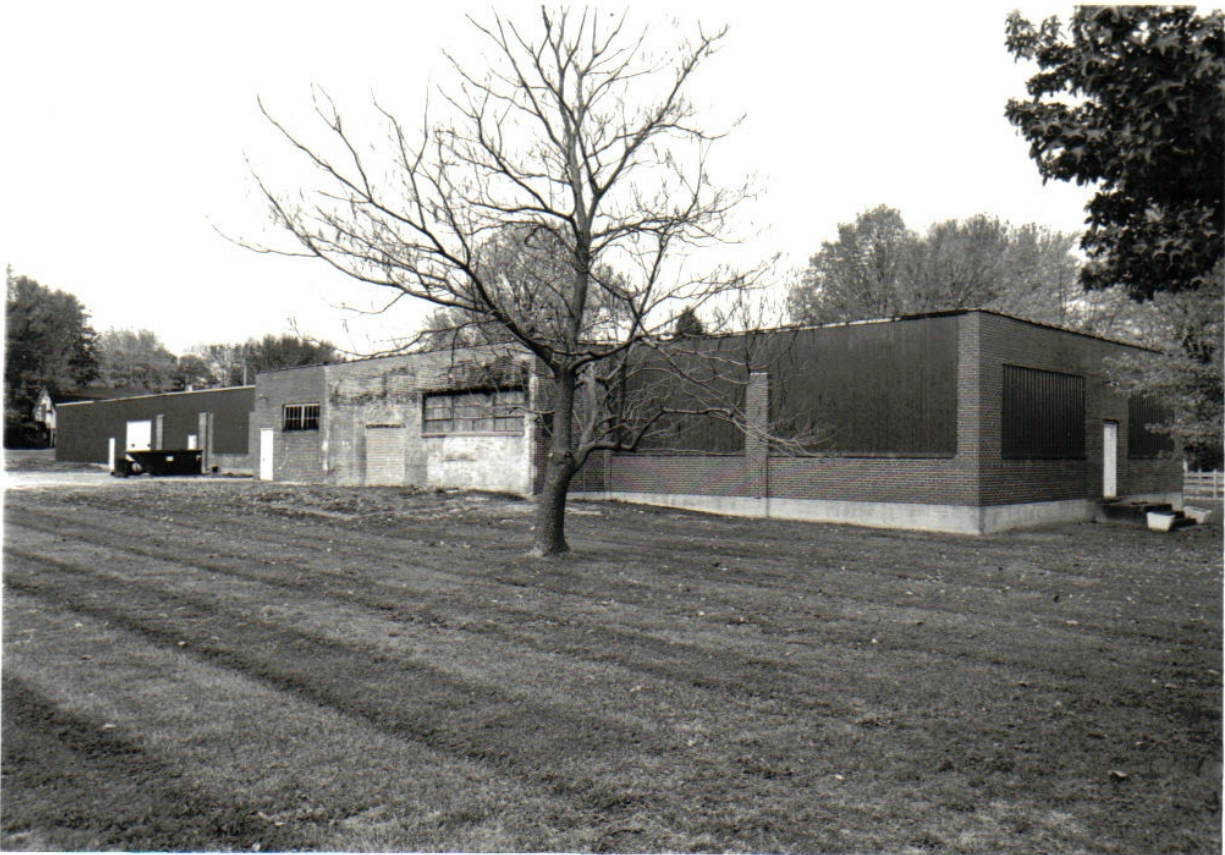
1. No. CRAS002-020	4. Present Name(s) L.J. Kapeller House	
2. County Crawford		
3. Location of Negatives Missouri SHPO	5. Other Name(s)	
6. Specific Location Township Range Section If City or Town, Street Address 201 Orchard Street Cuba 7. City or Town If Rural, Township and Vicinity 8. Site Plan with North Arrow See Continuation Sheet <input type="checkbox"/> 9. UTM Coordinate(s) 10. Site <input type="checkbox"/> Structure <input type="checkbox"/> Building <input checked="" type="checkbox"/> Object <input type="checkbox"/> 11. On National Register? Yes <input type="checkbox"/> No <input checked="" type="checkbox"/> 12. Is It Eligible? Yes <input checked="" type="checkbox"/> No <input type="checkbox"/> 13. Part of Established Historic District Yes <input type="checkbox"/> No <input checked="" type="checkbox"/> 14. District Potential Yes <input type="checkbox"/> No <input checked="" type="checkbox"/> 15. Name of Established District, if applicable	16. Thematic Category 17. Date(s) or Period of Significance circa 1937 18. Style or Design Modern 19. Architect or Engineer 20. Contractor or Builder 21. Original Use, if apparent residential 22. Present Use residential 23. Owership Public <input type="checkbox"/> Private <input checked="" type="checkbox"/> 24. Owner's Name and Address, if known 25. Open to Public Yes <input type="checkbox"/> No <input checked="" type="checkbox"/> 26. Local Contact Person or Organization Marilyn A. Stewart 503 Forest St. Cuba, MO 65453 27. Other Surveys in which included	28. Number of Stories 1.5 29. Basement Yes <input type="checkbox"/> No <input checked="" type="checkbox"/> 30. Foundation Material concrete 31. Wall Construction wood frame 32. Roof Type and Material gabled, asphalt shingles 33. Number of Bays Front 3 Side 2 34. Wall Treatment asbestos siding 35. Plan Shape rectangular 36. Changes (explain in #42) Addition <input type="checkbox"/> Altered <input checked="" type="checkbox"/> Moved <input type="checkbox"/> 37. Condition Interior Exterior good 38. Preservation underway? Yes <input type="checkbox"/> No <input checked="" type="checkbox"/> Window replacements? Yes <input type="checkbox"/> No <input type="checkbox"/> 39. Endangered? Yes <input type="checkbox"/> No <input checked="" type="checkbox"/> By What? 40. Visible from Public Road? Yes <input checked="" type="checkbox"/> No <input type="checkbox"/> 41. Distance from and frontage on road 20 feet

42. Further Description of Important Features The basic design and form of this corporate-produced Cape Cod adaptation are intact, marred by artificial siding, that is probably not original, and a garage addition on the rear, or north, elevation.

43. In July 1937, the Cuba Businessmen's Club, founded three years earlier, successfully lured the Echo Supplies Company of St. Louis, a major producer of shoe dies, to Cuba, in part through the offer of a building to house their firm (see form #51). Six employees and their families were relocated from St. Louis to Cuba and housing was provided for three families (also see forms #42 and #59). This was built as the home of Echo plant manager L.J. Kapeller.

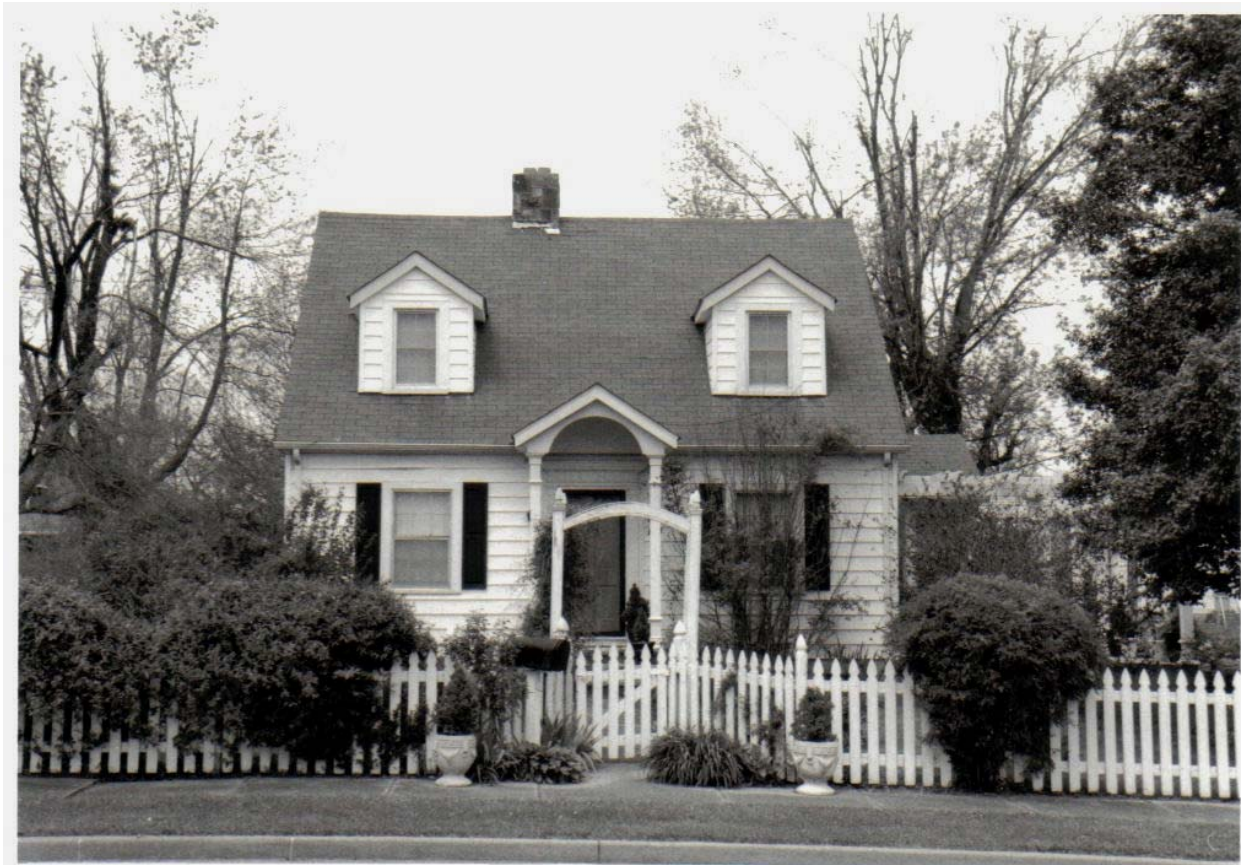
1. No. CRAS002-021 2. County Crawford 3. Location of Negatives Missouri SHPO	<div> 4. Present Name(s) 415 N. Park </div> <div> 5. Other Name(s) George and Irene Schroer House </div>

43. In July 1937, the Cuba Businessmen's Club, founded three years earlier, successfully lured the Echo Supplies Company of St. Louis, a major producer of shoe dies, to Cuba, in part through the offer of a building to house their firm (see form #51). Six employees and their families were relocated from St. Louis to Cuba and housing was provided for three employees (also see forms #59 and #61). This was built as the home of George Schroer and his wife Irene.

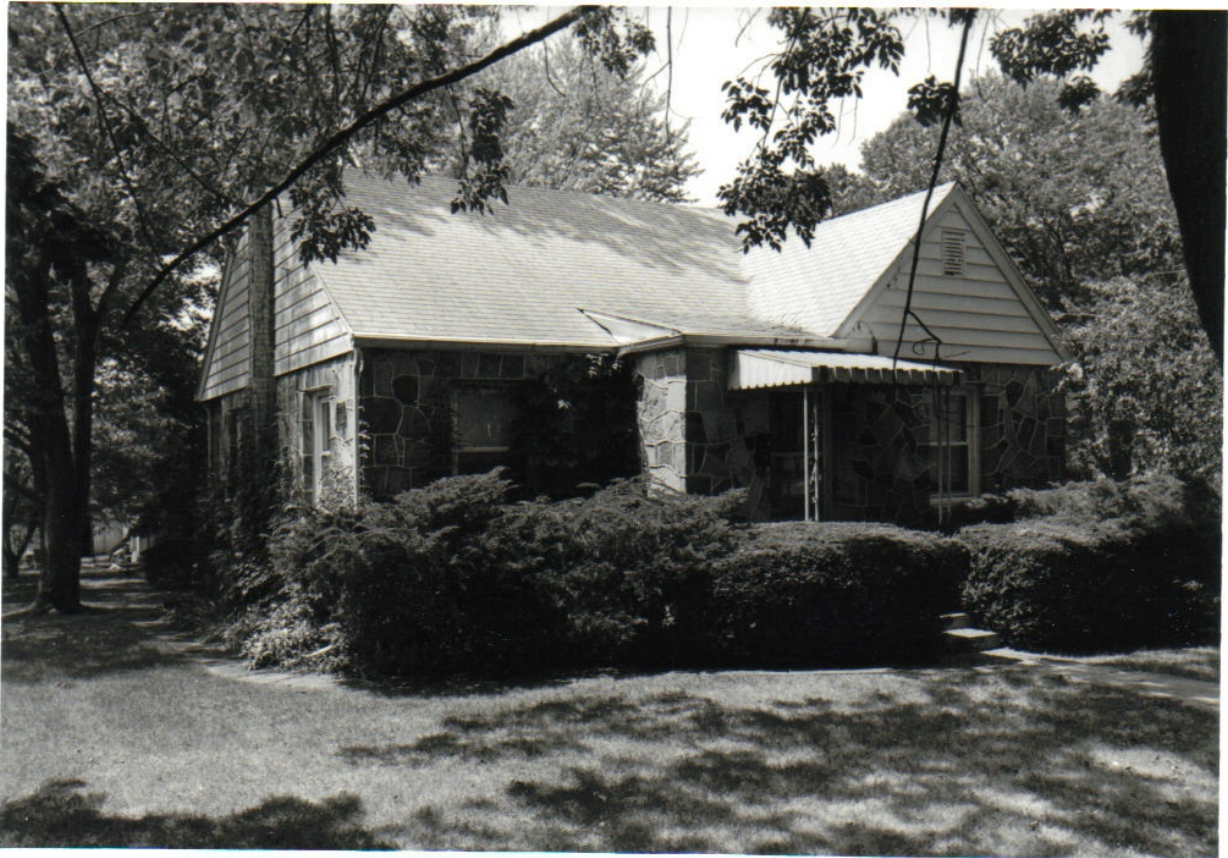
1. No. CRAS002-023 2. County Crawford 3. Location of Negatives Missouri SHPO						4. Present Name(s) 412 N. Park 5. Other Name(s)														
6. Specific Location Township Range Section If City or Town, Street Address 412 N. Park Cuba 7. City or Town If Rural, Township and Vicinity 8. Site Plan with North Arrow See Continuation Sheet <input type="checkbox"/> 9. UTM Coordinate(s) 10. Site <input type="checkbox"/> Structure <input type="checkbox"/> Building <input checked="" type="checkbox"/> Object <input type="checkbox"/> 11. On National Register? Yes <input type="checkbox"/> No <input checked="" type="checkbox"/> 12. Is It Eligible? Yes <input type="checkbox"/> No <input type="checkbox"/> 13. Part of Established Historic District Yes <input type="checkbox"/> No <input checked="" type="checkbox"/> 14. District Potential Yes <input checked="" type="checkbox"/> No <input type="checkbox"/> 15. Name of Established District, if applicable							16. Thematic Category 17. Date(s) or Period of Significance circa 1940 18. Style or Design no style 19. Architect or Engineer 20. Contractor or Builder 21. Original Use, if apparent residential 22. Present Use residential 23. Owership Public <input type="checkbox"/> Private <input checked="" type="checkbox"/> 24. Owner's Name and Address, if known 25. Open to Public Yes <input type="checkbox"/> No <input checked="" type="checkbox"/> 26. Local Contact Person or Organization Marilyn A. Stewart 503 Forest St. Cuba, MO 65453 27. Other Surveys in which included							28. Number of Stories 1 29. Basement Yes <input checked="" type="checkbox"/> No <input type="checkbox"/> 30. Foundation Material concrete 31. Wall Construction wood frame 32. Roof Type and Material gabled, asphalt shingles 33. Number of Bays Front 4 Side 2 34. Wall Treatment native stone with vining 35. Plan Shape rectangular 36. Changes (explain in #42) Addition <input type="checkbox"/> Altered <input type="checkbox"/> Moved <input type="checkbox"/> 37. Condition Interior Exterior good 38. Preservation underway? Yes <input type="checkbox"/> No <input checked="" type="checkbox"/> Window replacements? Yes <input type="checkbox"/> No <input checked="" type="checkbox"/> 39. Endangered? Yes <input type="checkbox"/> No <input checked="" type="checkbox"/> By What? 40. Visible from Public Road? Yes <input checked="" type="checkbox"/> No <input type="checkbox"/> 41. Distance from and frontage on road 25 feet

42. Further Description of Important Features The front has an offset entry covered by a small, shed roofed porch, supported by stone posts or columes. To one side of the entry is a single 1/1 double-hung window and to the other side two identical windows, with a shallow, gabled wall dormer. The ends of the house have evenly spaced windows. All the windows are shielded by metal awnings.

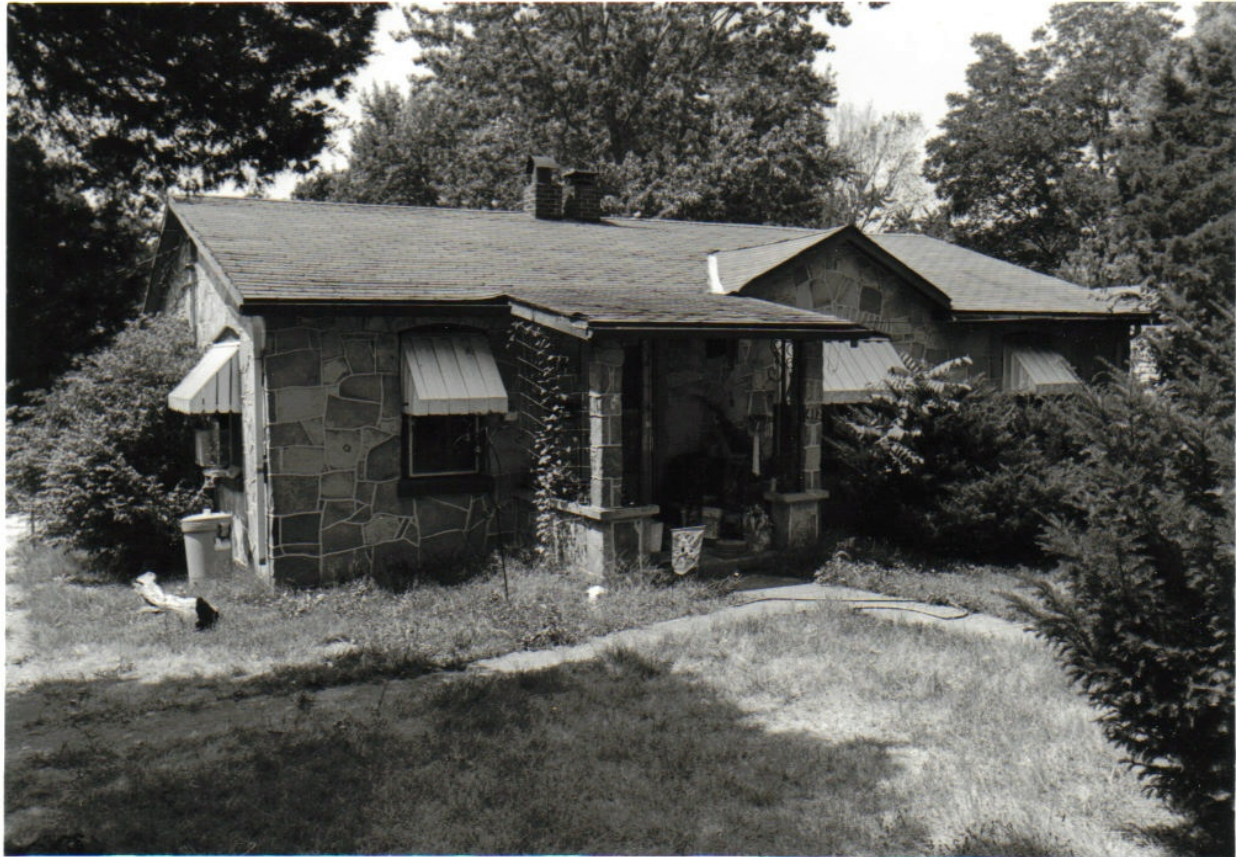
1. No. CRAS002-024	4. Present Name(s) 1908 Cuba Jail
2. County Crawford	
3. Location of Negatives Missouri SHPO	5. Other Name(s) Cuba Jail

43. Constructed in 1908, this was the second Cuba city jail. The first jail was constructed of wood and was destroyed by its inmates. The city purchased the lot for the second jail for \$40.00. The second jail was used until 1954, when it was replaced by a jail to the rear of the Cuba City Hall and Fire Station. From 2004 to 2006, Verlin Boda, a Boy Scout, renovated the second jail for his Eagle Scout project. Doors on the 1908 jail were re-used from the third city jail. In addition to replacing the doors, Boda also installed a wood stove, beds, and a desk inside the jail, and a picnic table outside.

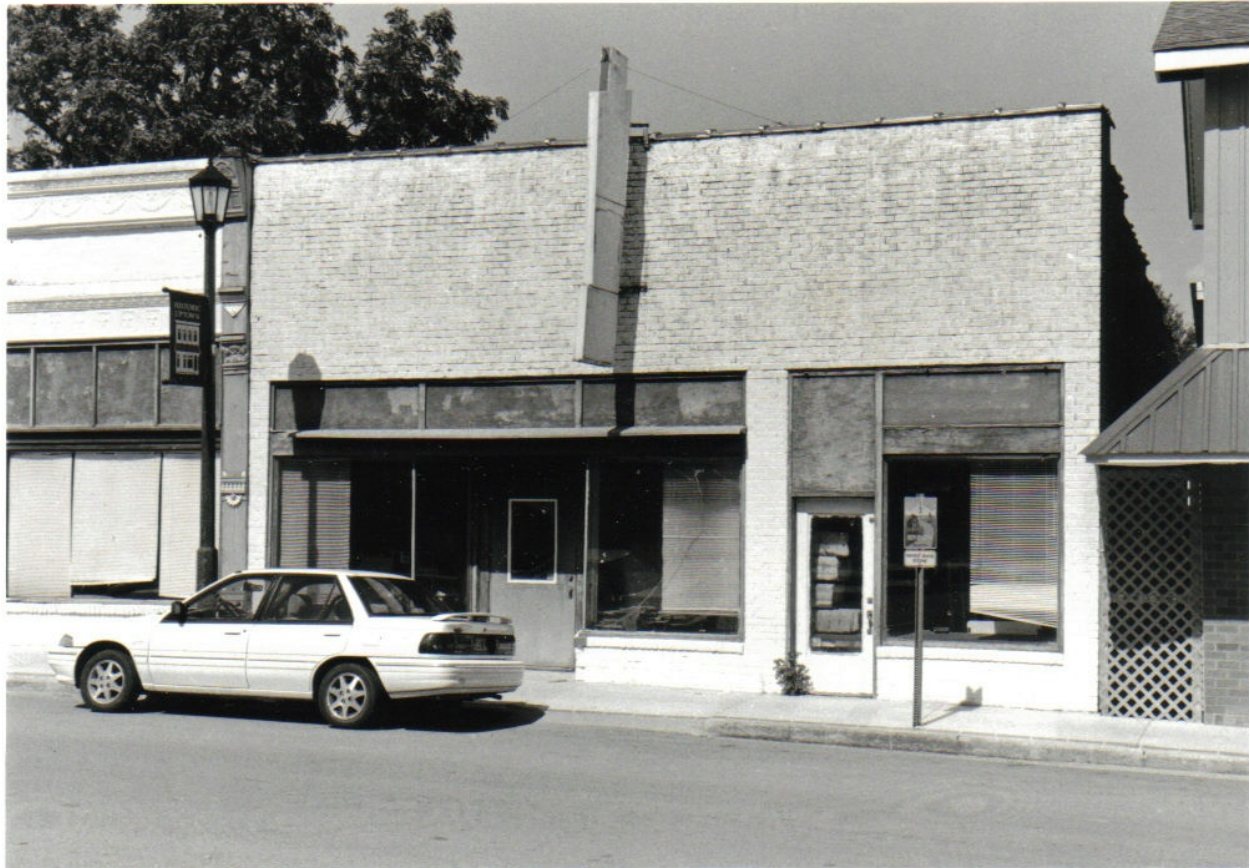
1. No. CRAS002-029	4. Present Name(s)
2. County Crawford	
3. Location of Negatives Missouri SHPO	5. Other Name(s) Bank of Cuba

43. On September 23, 1891, the Bank of Cuba was organized with capital stock of \$10,000 and a surplus of \$5,000, James E. Hollow president and Newton Jones vice-president, H.M. Ramsey cashier.

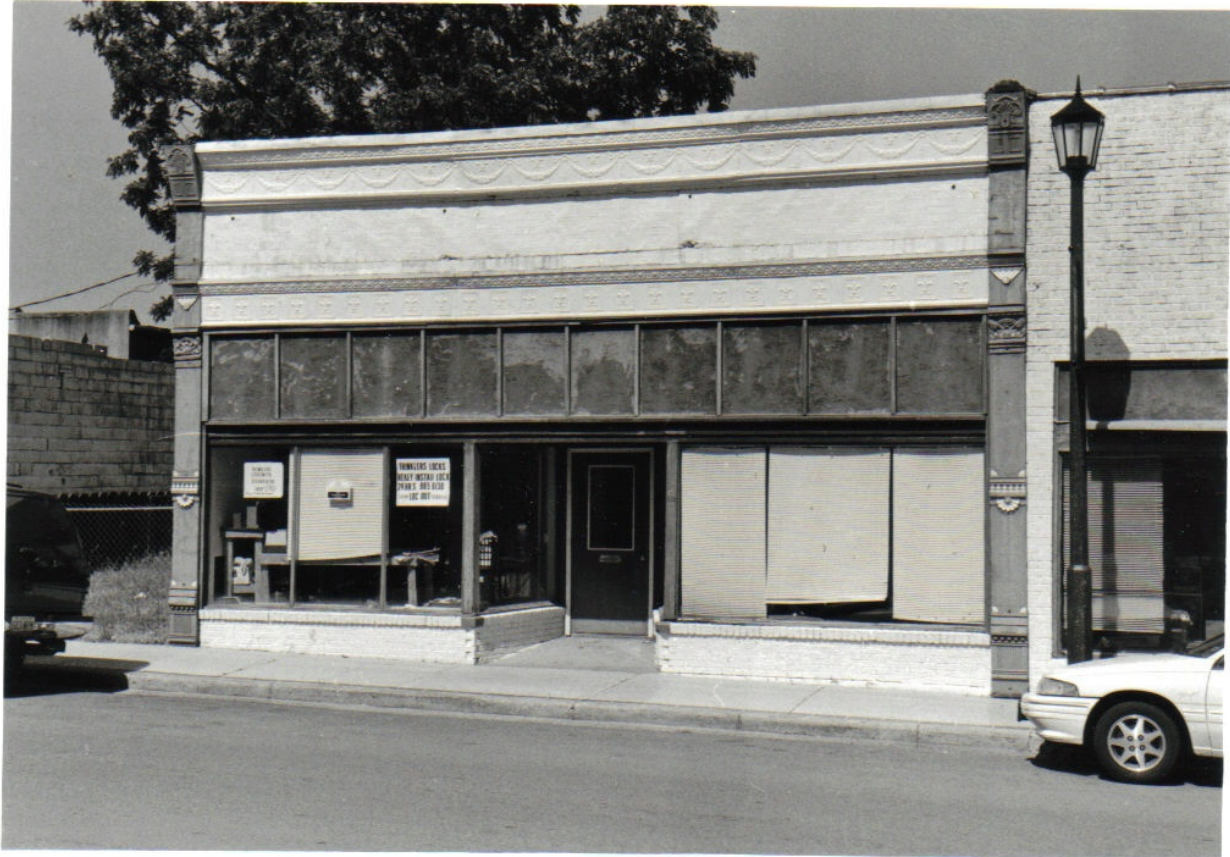
28. Number of Stories 1 29. Basement Yes <input type="checkbox"/> No <input checked="" type="checkbox"/> 30. Foundation Material concrete 31. Wall Construction brick 32. Roof Type and Material flat, asphalt 33. Number of Bays Front 1 Side 34. Wall Treatment brick 35. Plan Shape 36. Changes (explain in #42) Addition <input type="checkbox"/> Altered <input checked="" type="checkbox"/> Moved <input type="checkbox"/> 37. Condition Interior Exterior good 38. Preservation underway? Yes <input type="checkbox"/> No <input checked="" type="checkbox"/> Window replacements? Yes <input type="checkbox"/> No <input type="checkbox"/> 39. Endangered? Yes <input type="checkbox"/> No <input checked="" type="checkbox"/> By What? 40. Visible from Public Road? Yes <input checked="" type="checkbox"/> No <input type="checkbox"/> 41. Distance from and frontage on road na
