CUBA
Crawford County
Missouri
1994

Inventory Form No. CRAS002-001

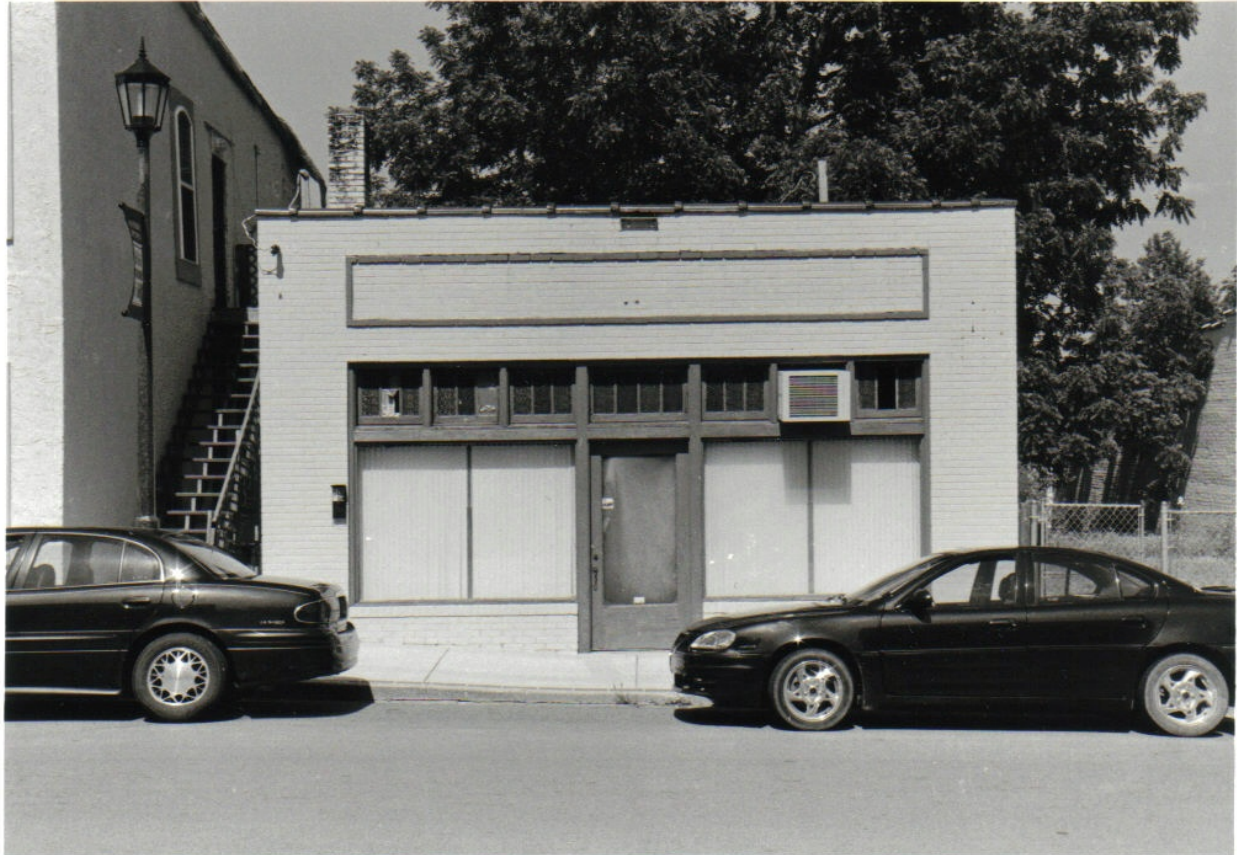
28. Number of Stories 1 29. Basement Yes <input type="checkbox"/> No <input checked="" type="checkbox"/> 30. Foundation Material concrete 31. Wall Construction stone 32. Roof Type and Material flat, metal 33. Number of Bays Front 3 Side 34. Wall Treatment stucco 35. Plan Shape rectangular 36. Changes (explain in #42) Addition <input type="checkbox"/> Altered <input checked="" type="checkbox"/> Moved <input type="checkbox"/> 37. Condition Interior Exterior good 38. Preservation underway? Yes <input type="checkbox"/> No <input checked="" type="checkbox"/> Window replacements? Yes <input checked="" type="checkbox"/> No <input type="checkbox"/> 39. Endangered? Yes <input type="checkbox"/> No <input checked="" type="checkbox"/> By What? 40. Visible from Public Road? Yes <input checked="" type="checkbox"/> No <input type="checkbox"/> 41. Distance from and frontage on road na		42. Further Description of Important Features Front has two recessed central doors on the first floor. On each side of the doors is a 1/1 double hung arched replacement window. The second floor has 1/1 double hung arched replacement windows directly above the windows on the first floor. See Continuation Sheet <input type="checkbox"/> 43. History and Significance Reputedly among the oldest buildings in Cuba, this building has been a restaurant, used furniture store, barber shop, and jewelry store. In 1924, it was a shoe repair business. See Continuation Sheet <input type="checkbox"/>

42. On the 1934 Sanborn map, the building is described as stone nogged. Stucco obscures the original construction material.

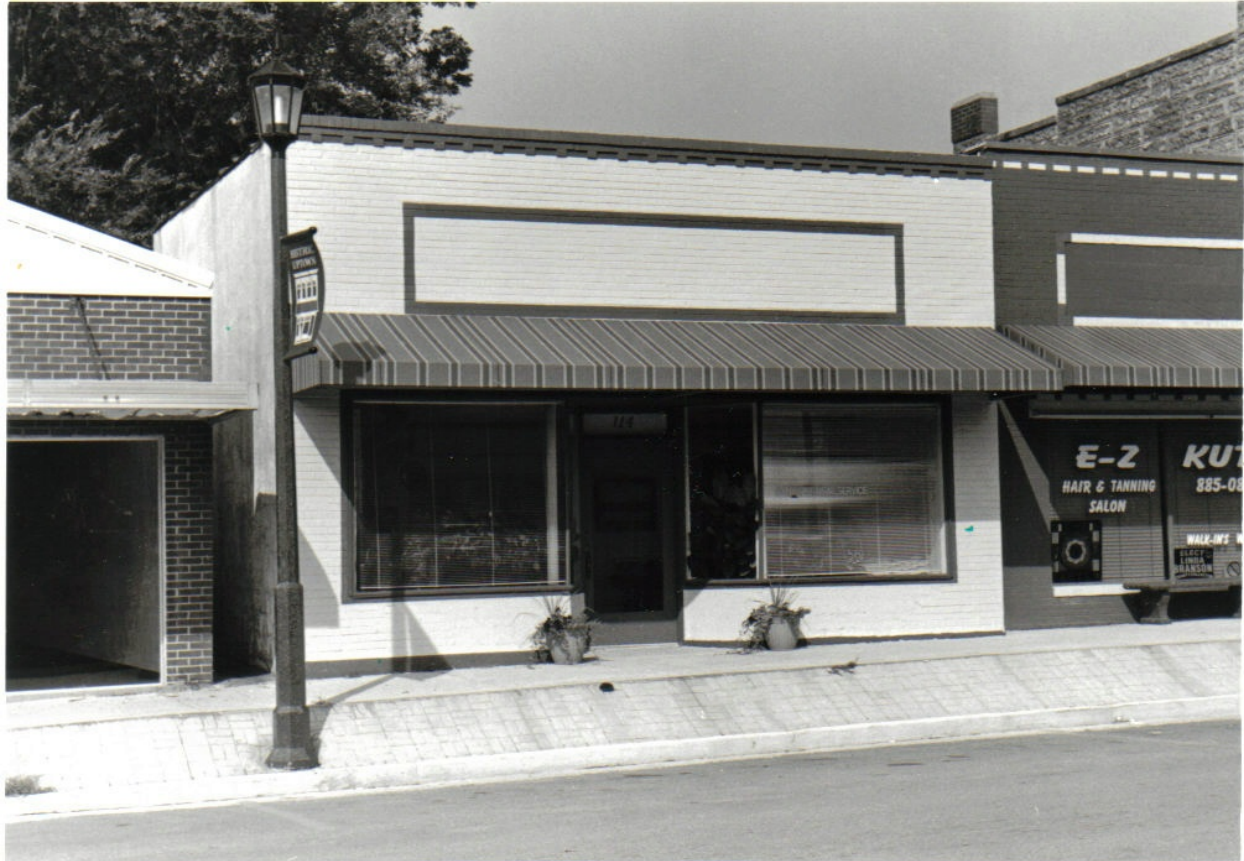
1. No. CRAS002-034	4. Present Name(s) E-Z Kuts
2. County Crawford	
3. Location of Negatives Missouri SHPO	5. Other Name(s)

The facade has a glass replacement door on the north end and two plate glass windows to the south of the door. An awning runs the length of the front and above it is a decorate brick panel and a brick cornice at the roofline.

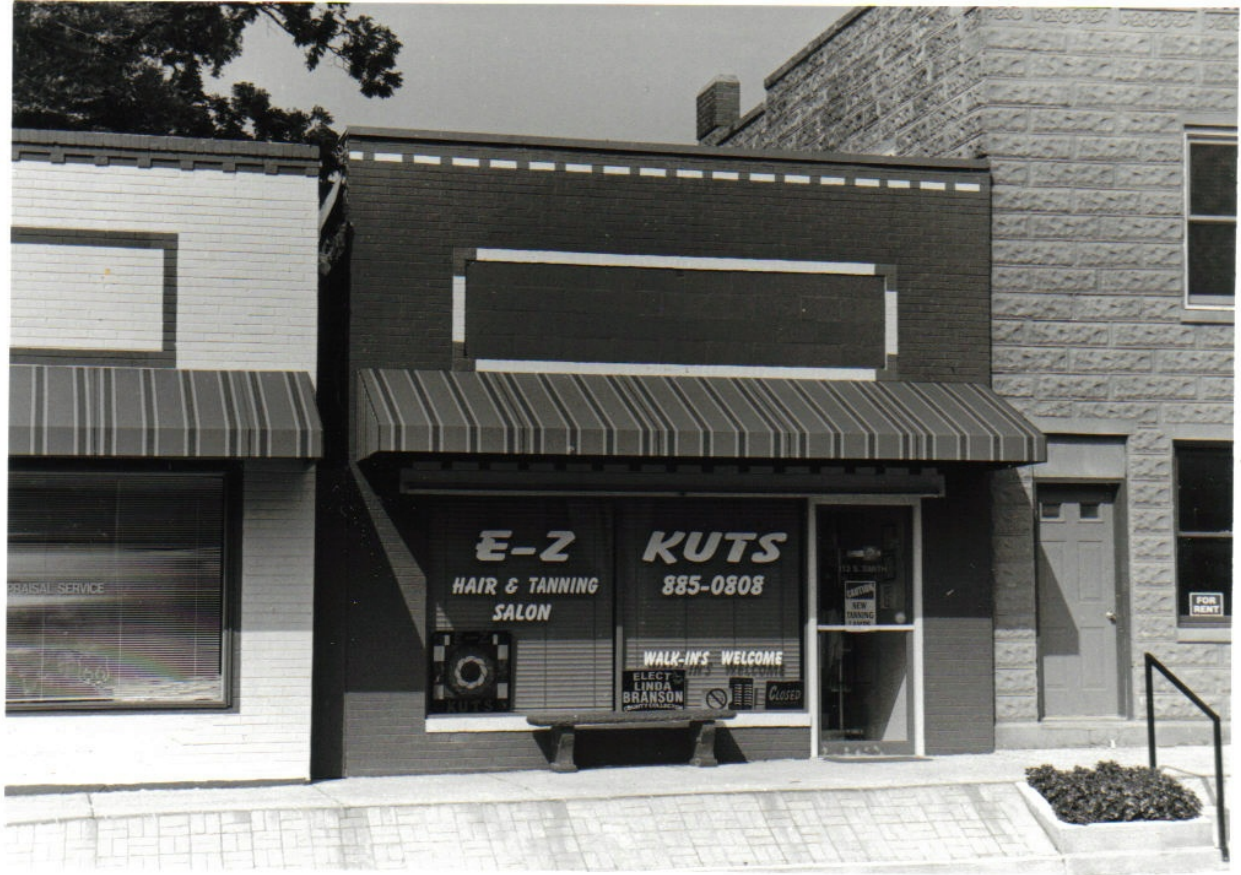
28. Number of Stories 2 29. Basement Yes <input checked="" type="checkbox"/> No <input type="checkbox"/> 30. Foundation Material concrete 31. Wall Construction stone 32. Roof Type and Material flat, asphalt 33. Number of Bays Front 4 Side 34. Wall Treatment stone, sut and shaped 35. Plan Shape rectangular 36. Changes (explain in #42) Addition <input type="checkbox"/> Altered <input checked="" type="checkbox"/> Moved <input type="checkbox"/> 37. Condition Interior Exterior good 38. Preservation underway? Yes <input type="checkbox"/> No <input checked="" type="checkbox"/> Window replacements? Yes <input checked="" type="checkbox"/> No <input type="checkbox"/> 39. Endangered? Yes <input type="checkbox"/> No <input checked="" type="checkbox"/> By What? 40. Visible from Public Road? Yes <input checked="" type="checkbox"/> No <input type="checkbox"/> 41. Distance from and frontage on road na		42. Further Description of Important Features First floor displays a single door on the south end of the storefront, flanked by a double-hung, 1/1 window, and recessed double doors flanked by another double-hung, 1/1 window. The double doors are flanked by side windows within their recess. The second floor has four, asymmetrically placed, double-hung, 1/1 windows. See Continuation Sheet <input checked="" type="checkbox"/> 43. History and Significance Served as telephone company, bakery, and appliance store. See Continuation Sheet <input type="checkbox"/>

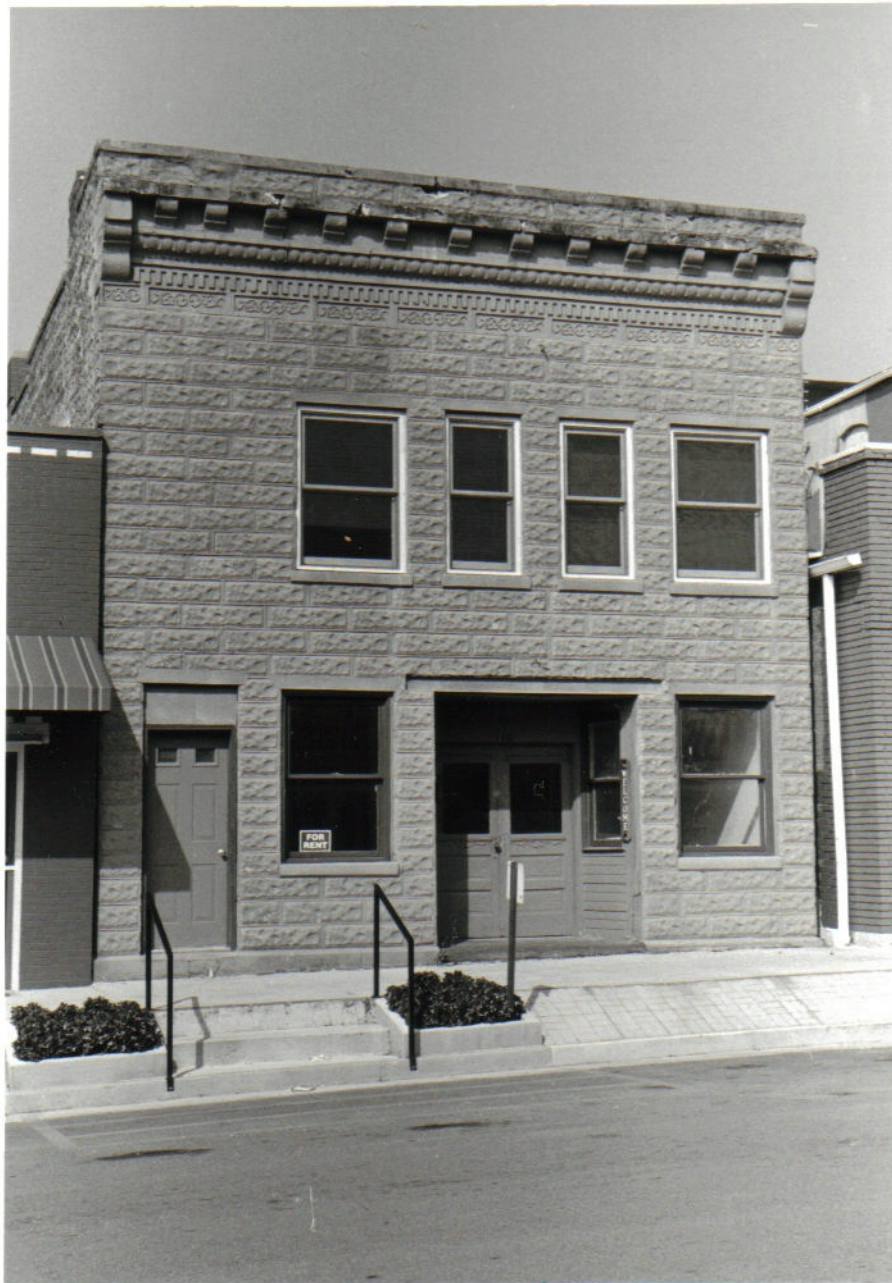
1. No. CRAS002-036	4. Present Name(s)
2. County Crawford	
3. Location of Negatives Missouri SHPO	5. Other Name(s)

<p>42. Further Description of Important Features</p> <p>The facade features a door on each end with two large plate glass windows separating them and six transom windows above them. The windows appear to be replacements. Plain coping edges the parapet.</p>	<p>See Continuation Sheet <input type="checkbox"/></p>
<p>43. History and Significance</p> <p>Constructed as the Relfe Stephen Insurance Agency, the building is currently used for conference rooms.</p>	<p>See Continuation Sheet <input type="checkbox"/></p>

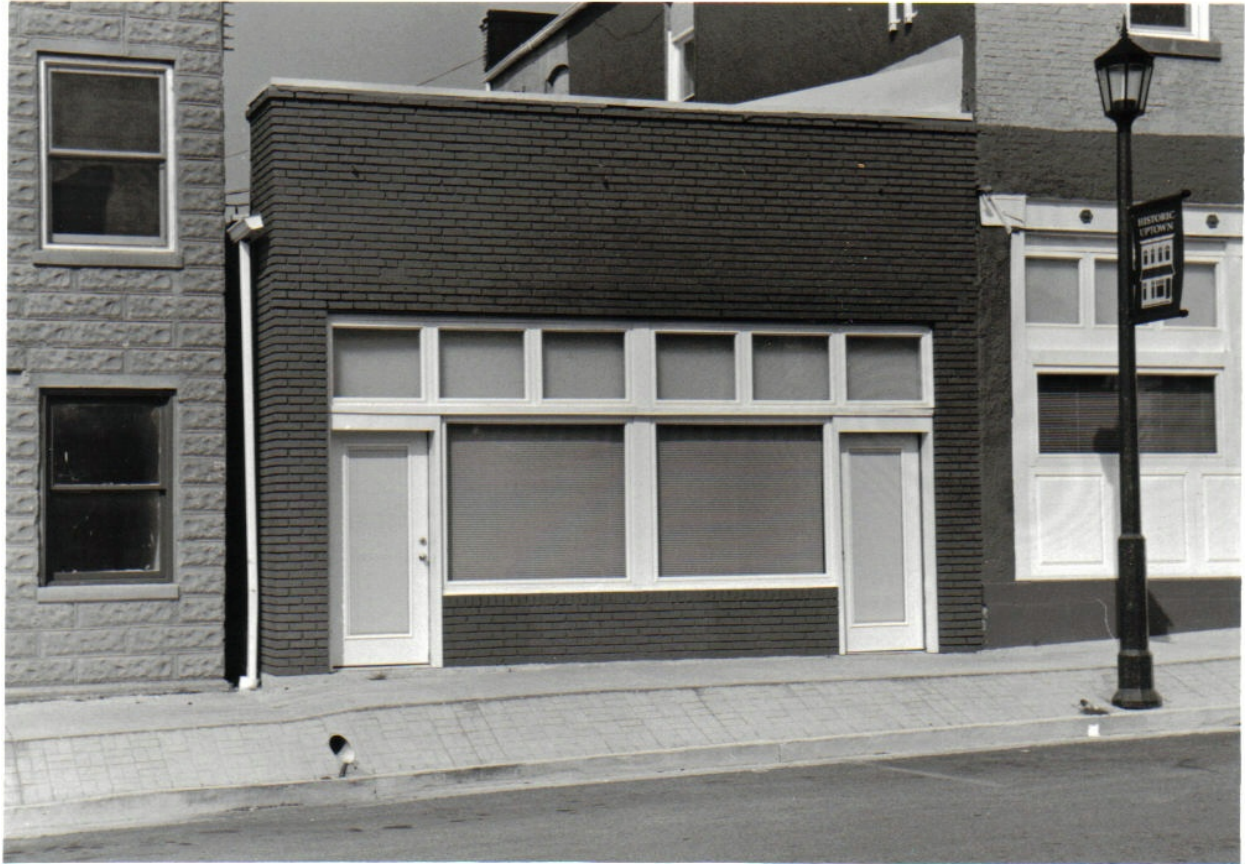
28. Number of Stories 1 29. Basement Yes <input checked="" type="checkbox"/> No <input type="checkbox"/> 30. Foundation Material concrete 31. Wall Construction brick 32. Roof Type and Material gable, asphalt shingles 33. Number of Bays Front 1 Side 34. Wall Treatment brick 35. Plan Shape rectangular 36. Changes (explain in #42) Addition <input type="checkbox"/> Altered <input checked="" type="checkbox"/> Moved <input type="checkbox"/> 37. Condition Interior Exterior good 38. Preservation underway? Yes <input type="checkbox"/> No <input checked="" type="checkbox"/> Window replacements? Yes <input type="checkbox"/> No <input checked="" type="checkbox"/> 39. Endangered? Yes <input type="checkbox"/> No <input checked="" type="checkbox"/> By What? 40. Visible from Public Road? Yes <input checked="" type="checkbox"/> No <input type="checkbox"/> 41. Distance from and frontage on road 50 feet

42. As the top of three wide, curved steps, with added metal handrails, and centered in the gable end are double replacement doors, flanked by narrow, 4/1 double hung windows on each side, with a small 4 light stationary window below each window. The gable roofed porch and main building block have returns. A circular plaque with the Mason's symbol is centered in the porch gable.

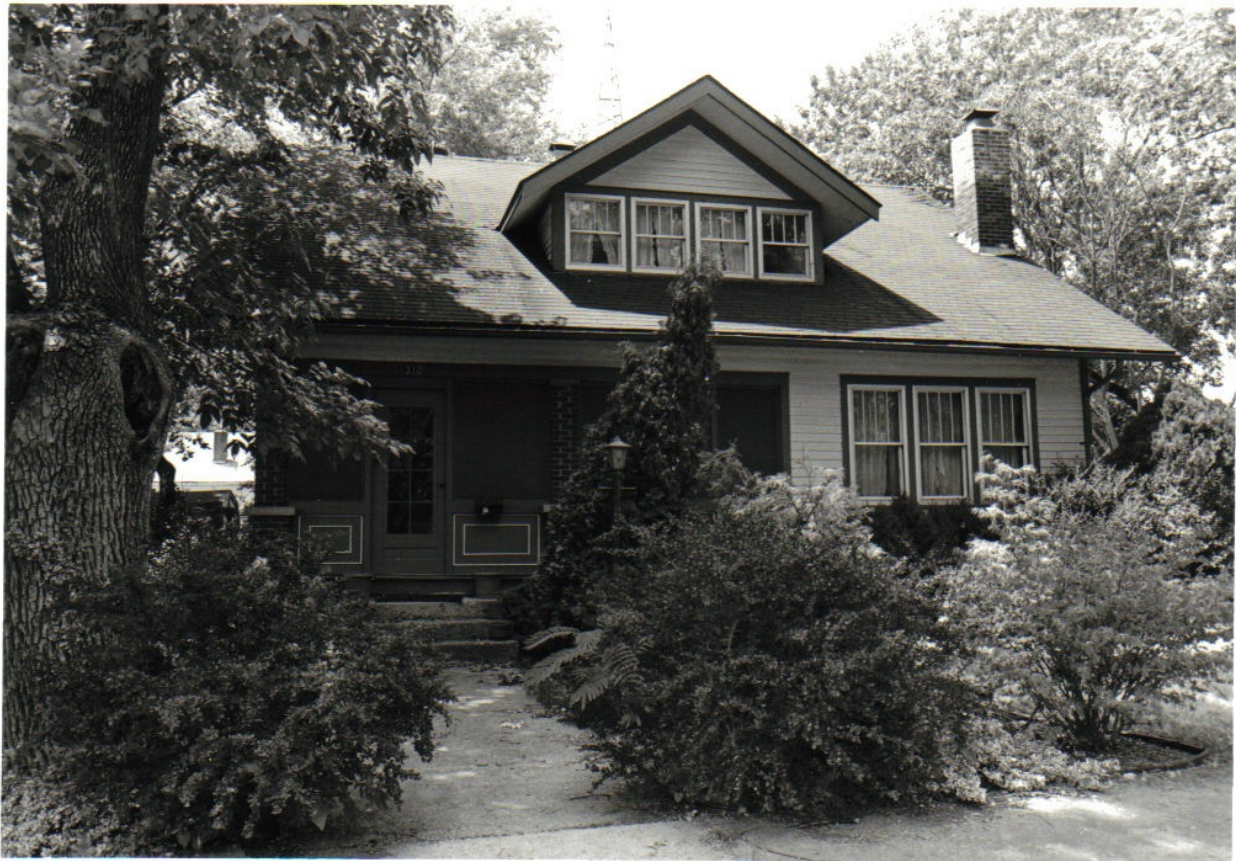
1. No. CRAS002-042	4. Present Name(s) 408 S. Smith
2. County Crawford	
3. Location of Negatives Missouri SHPO	5. Other Name(s) Charles C. and Josephine Slowensky House

44. West of the house are two historic outbuildings. A two story garage has been significantly altered, including the addition of siding compatible with the house. North of the garage is an unaltered crib or cow barn, siding with vertical boards and with a metal roof.

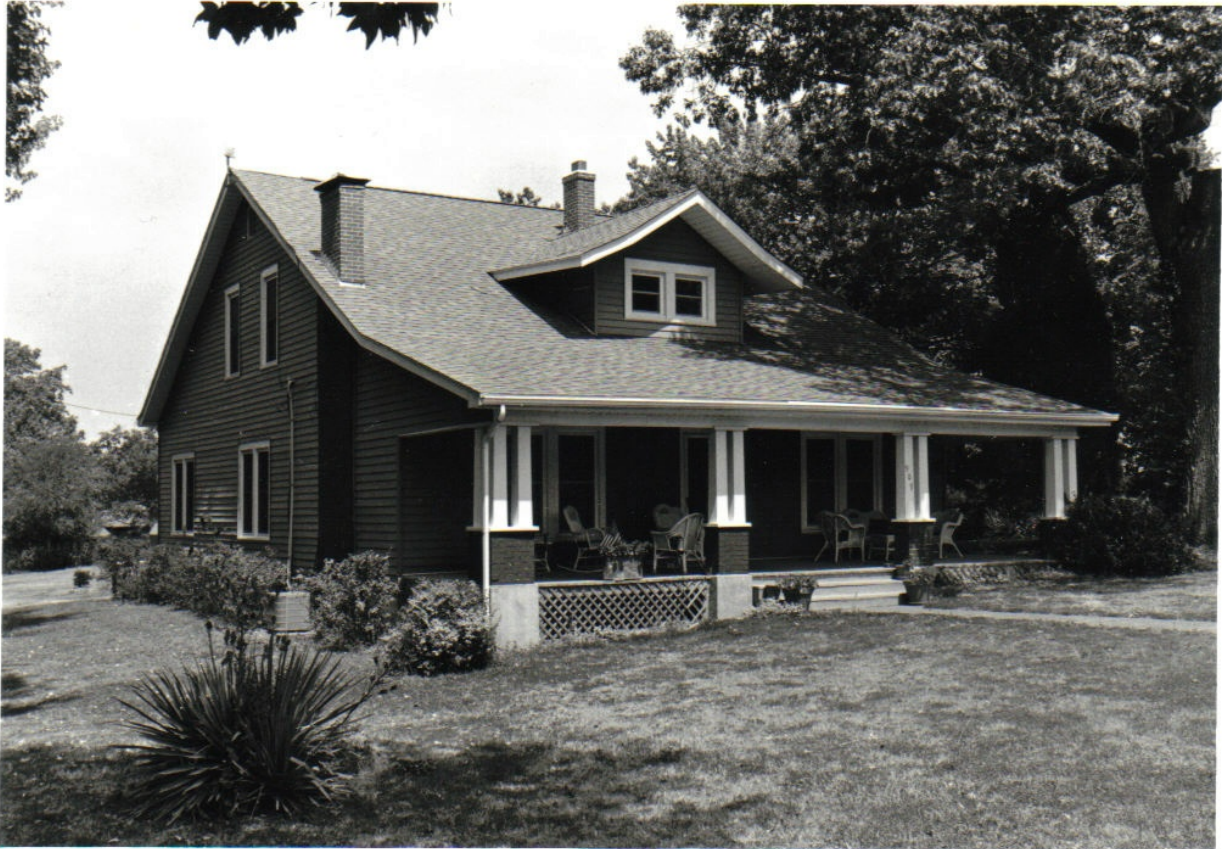
1. No. CRAS002-046	4. Present Name(s) Leroy and Carrie Leezy House
2. County Crawford	
3. Location of Negatives Missouri SHPO	5. Other Name(s)

<p>42. Further Description of Important Features</p> <p>The front features a full length porch supported by wood columns on brick piers. Projecting from the roof above the porch is a gabled dormer with three double-hung, 1/1 windows. Upstairs windows are replacements.</p> <p style="text-align: right;">See Continuation Sheet <input type="checkbox"/></p>
<p>43. History and Significance</p> <p>Original owners were Leroy Leezy and wife Carrie. He was a WW I Veteran and a teller and later cashier in a bank.</p> <p style="text-align: right;">See Continuation Sheet <input type="checkbox"/></p>

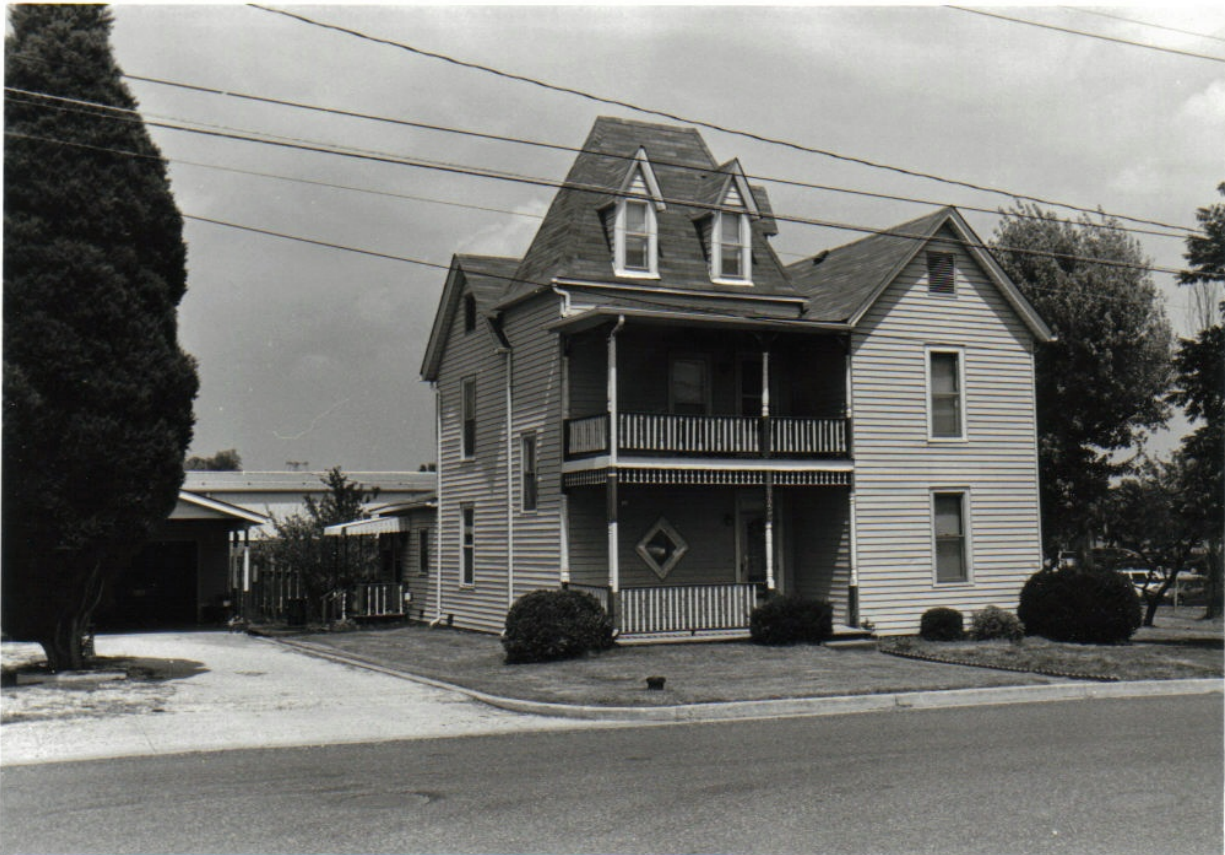
28. Number of Stories 1 29. Basement Yes <input type="checkbox"/> No <input checked="" type="checkbox"/> 30. Foundation Material concrete 31. Wall Construction brick 32. Roof Type and Material flat, asphalt 33. Number of Bays Front 2 Side 34. Wall Treatment multicolored ceramic tilen a 35. Plan Shape rectangular 36. Changes (explain in #42) Addition <input type="checkbox"/> Altered <input type="checkbox"/> Moved <input type="checkbox"/> 37. Condition Interior Exterior good 38. Preservation underway? Yes <input type="checkbox"/> No <input type="checkbox"/> Window replacements? Yes <input type="checkbox"/> No <input checked="" type="checkbox"/> 39. Endangered? Yes <input type="checkbox"/> No <input checked="" type="checkbox"/> By What? 40. Visible from Public Road? Yes <input checked="" type="checkbox"/> No <input type="checkbox"/> 41. Distance from and frontage on road na

42. Further Description of Important Features The facade of this building has two storefronts. Each features a centered single door with plate glass show windows on either side. Each door has a room air conditioner installed in the transom above the door. The westernmost storefront has banded brickwork at the window sill. See Continuation Sheet <input type="checkbox"/> 43. History and Significance One store front has been a cafe (Ruby's, Janies', and Russ's) while the other one was at one point a dress shop and is now rented by a church group. Constructed after 1934. See Continuation Sheet <input type="checkbox"/>

42. A decorative, dark horizontal line of bricks bisects the area between the windows and the roof.

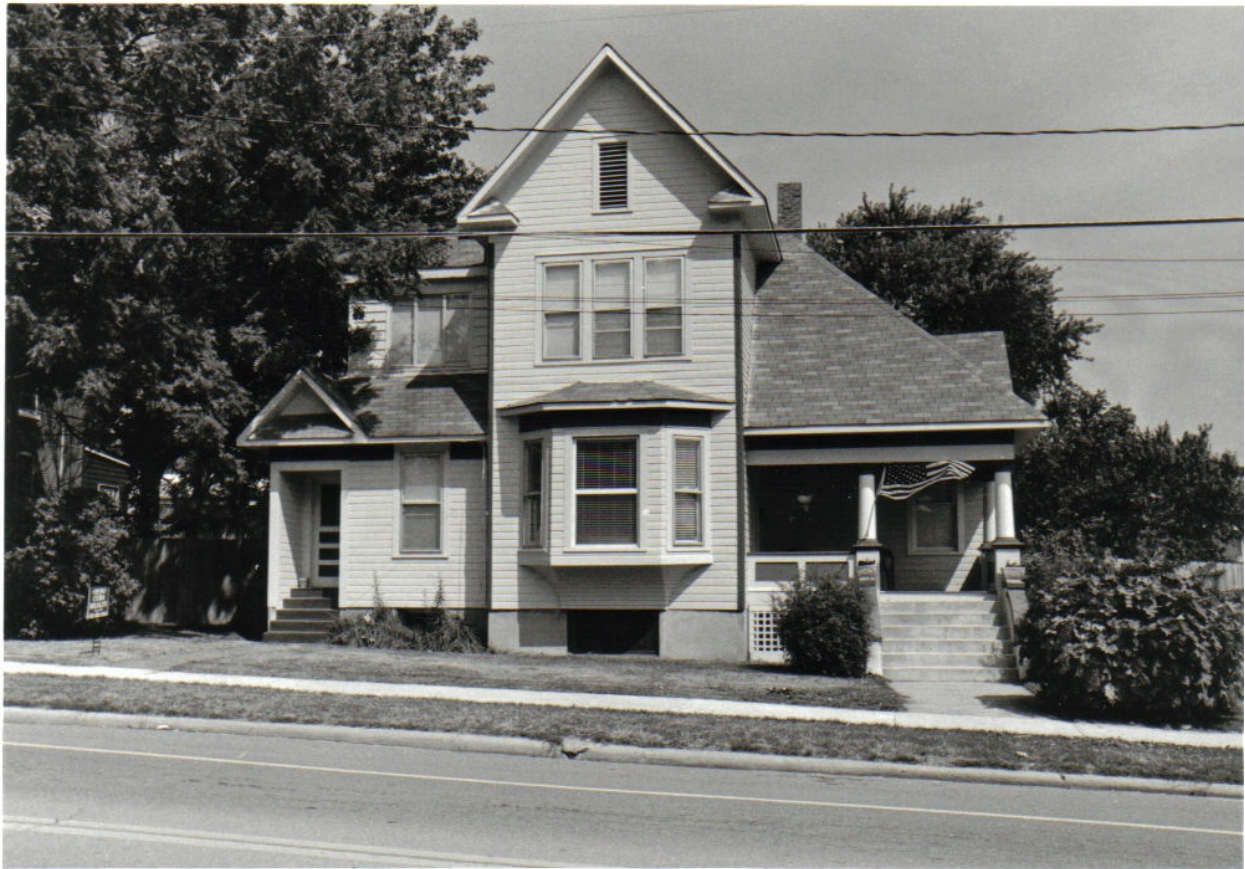
Inventory Form No. CRAS002-051

42. The dominant feature of the facade is a centered, projecting gable with first floor, three-sided bay. The second story of the projecting gable has a bank of three double-hung, 1/1 windows, and the gable itself is emphasized by returns. To the east of the projecting gable, the residence's main entrance is sheltered by a recessed corner porch supported by wooden columns on piers.

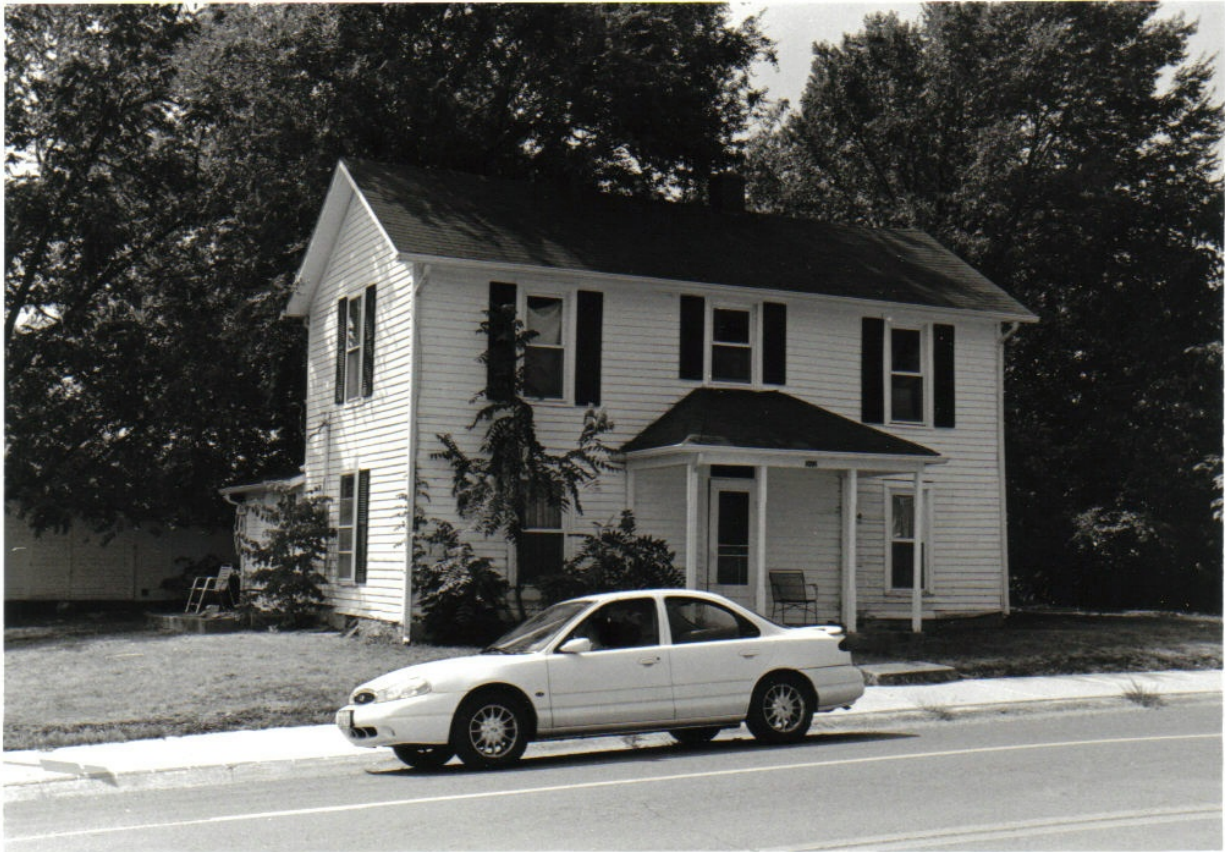
Inventory Form No. CRAS002-052

28. Number of Stories 2 29. Basement Yes <input checked="" type="checkbox"/> No <input type="checkbox"/> 30. Foundation Material concrete block 31. Wall Construction wood frame 32. Roof Type and Material gable, asphalt shingles 33. Number of Bays Front 3 Side 1

34. Wall Treatment siding 35. Plan Shape T-shape 36. Changes (explain in #42) Addition <input checked="" type="checkbox"/> Altered <input checked="" type="checkbox"/> Moved <input type="checkbox"/> 37. Condition Interior Exterior good

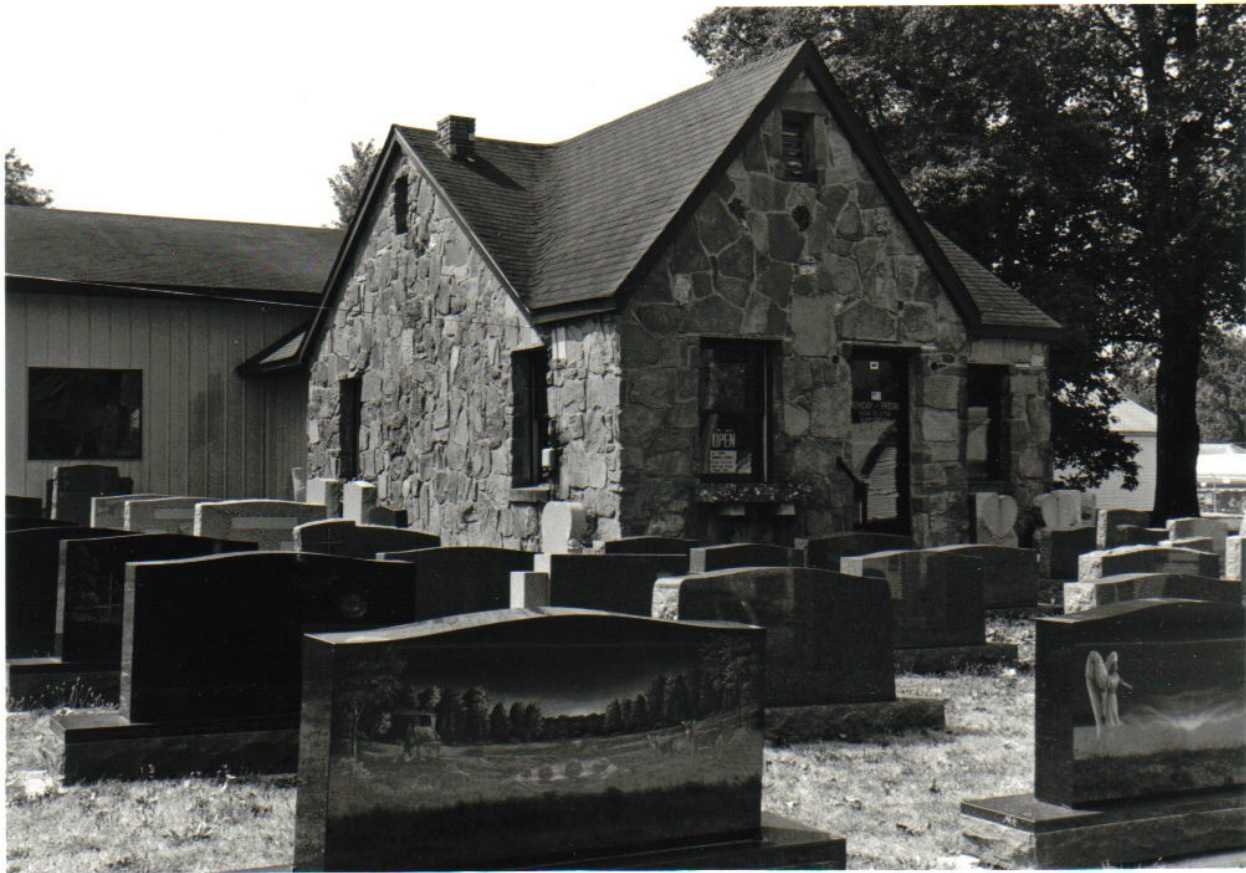
Inventory Form No. CRAS002-054

28. Number of Stories 1 29. Basement Yes <input type="checkbox"/> No <input checked="" type="checkbox"/> 30. Foundation Material concrete 31. Wall Construction stone 32. Roof Type and Material gabled, asphalt shingles 33. Number of Bays Front 3 Side 2 34. Wall Treatment native stone 35. Plan Shape irregular 36. Changes (explain in #42) Addition <input type="checkbox"/> Altered <input type="checkbox"/> Moved <input type="checkbox"/> 37. Condition Interior Exterior good 38. Preservation underway? Yes <input type="checkbox"/> No <input checked="" type="checkbox"/> Window replacements? Yes <input type="checkbox"/> No <input checked="" type="checkbox"/> 39. Endangered? Yes <input type="checkbox"/> No <input checked="" type="checkbox"/> By What? 40. Visible from Public Road? Yes <input checked="" type="checkbox"/> No <input type="checkbox"/> 41. Distance from and frontage on road 25 feet

42. Further Description of Important Features The east side of the facade projects and has a modern door on the west side and a replacement 1/1 double hung window on the east side. The portion that does not project out also contains a 1/1 double hung window. The side features a 1/1 double hung window near each corner. See Continuation Sheet <input type="checkbox"/> 43. History and Significance Despite the residential form, the building was constructed as the office for a moarble and granite works. Owned by Harve Taft, James Dodd, and then Don Bushman who bought it in the late 1950's. See Continuation Sheet <input type="checkbox"/>

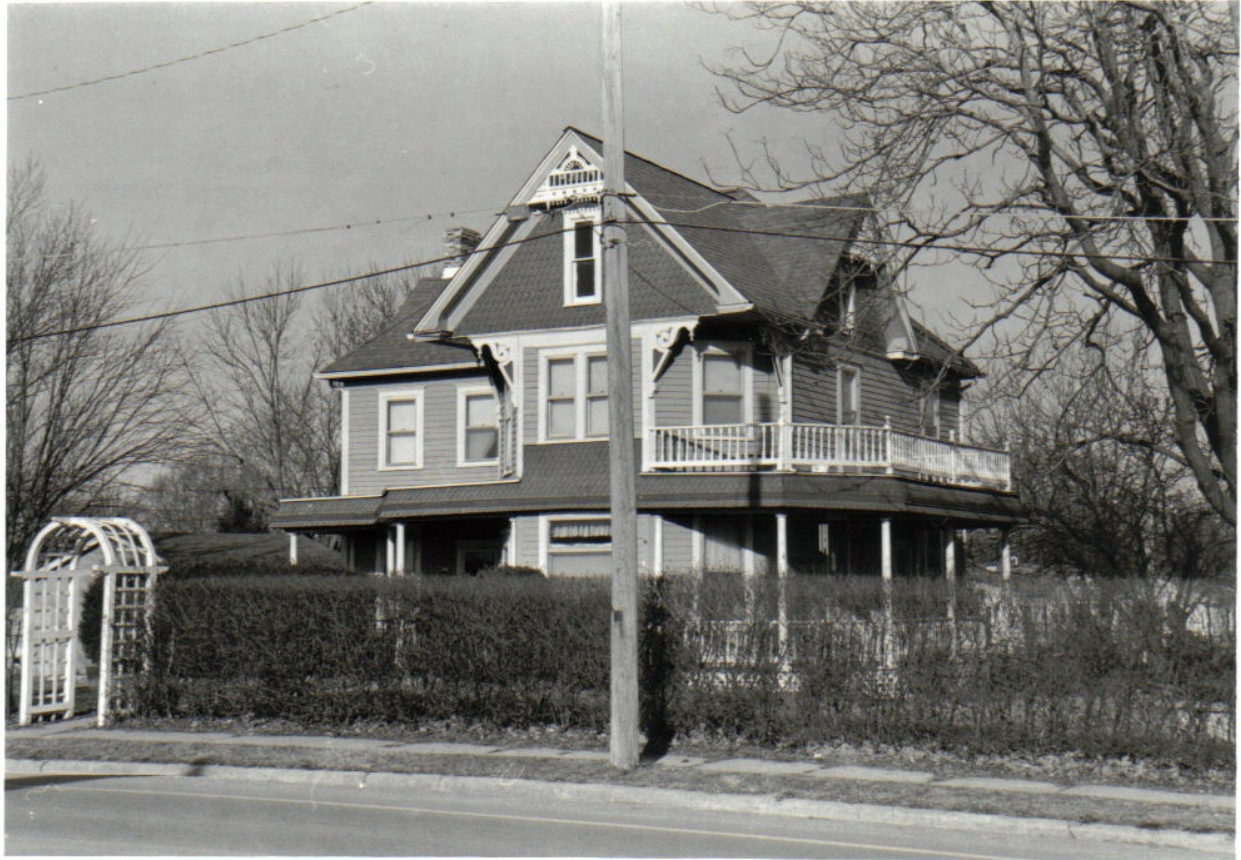
Inventory Form No. CRAS002-055

28. Number of Stories 2.5 29. Basement Yes <input checked="" type="checkbox"/> No <input type="checkbox"/> 30. Foundation Material stone 31. Wall Construction wood frame 32. Roof Type and Material hipped with crossgables, asphalt shingles 33. Number of Bays Front 3 Side 3 34. Wall Treatment wood 35. Plan Shape irregular 36. Changes (explain in #42) Addition <input type="checkbox"/> Altered <input checked="" type="checkbox"/> Moved <input type="checkbox"/> 37. Condition Interior Exterior good 38. Preservation underway? Yes <input type="checkbox"/> No <input checked="" type="checkbox"/> Window replacements? Yes <input type="checkbox"/> No <input checked="" type="checkbox"/> 39. Endangered? Yes <input type="checkbox"/> No <input checked="" type="checkbox"/> By What? 40. Visible from Public Road? Yes <input checked="" type="checkbox"/> No <input type="checkbox"/> 41. Distance from and frontage on road 25 feet		42. Further Description of Important Features The facade is dominated by a projecting gabled bay with Eastlake brackets at the pedimented gable. Porches on either side of the projecting gable are altered or replacement. Eastlake, spindlework freizes decorate each gable end. The easternmost porch has a balustrade along its roof edge. See Continuation Sheet <input type="checkbox"/> 43. History and Significance Hamilton, originally a farmer from Oak Hill township and, in 1930, a bank president, was not the original owner of the property. See Continuation Sheet <input type="checkbox"/>

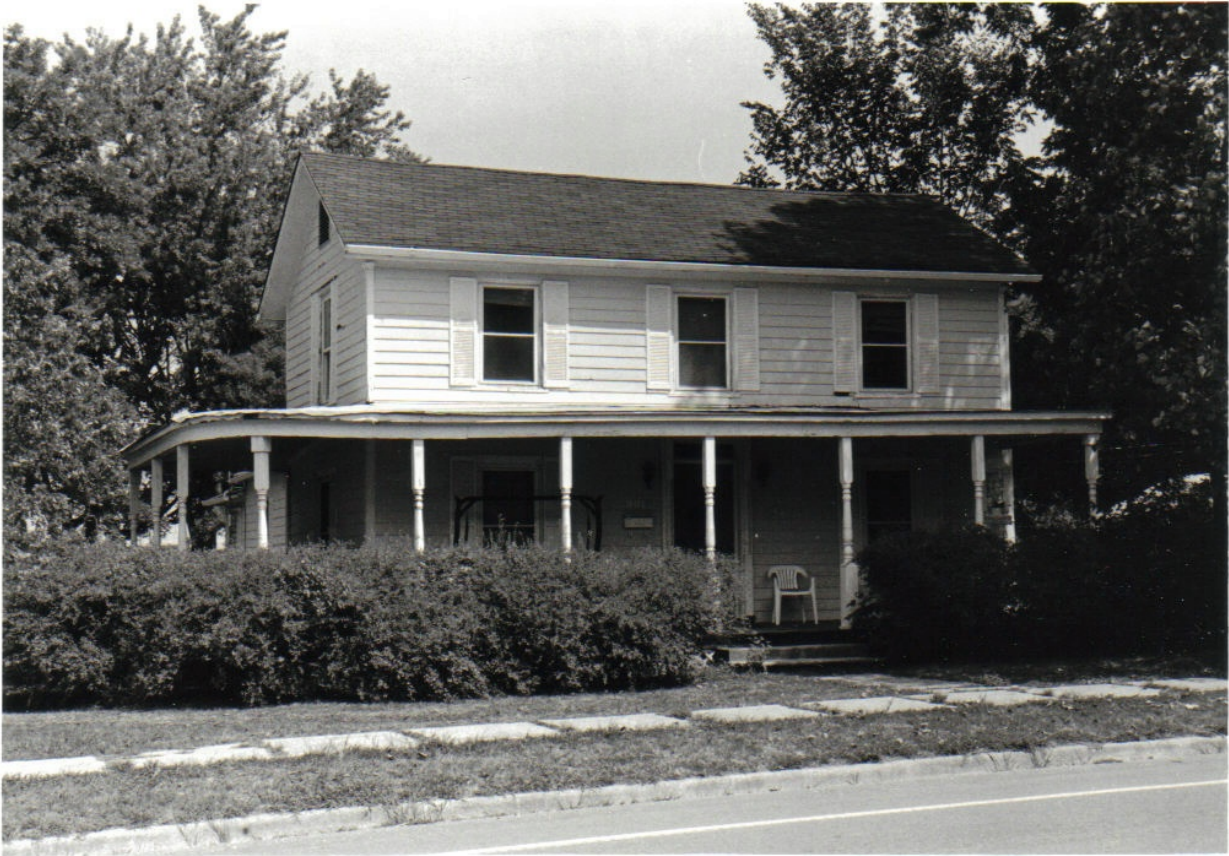
Inventory Form No. CRAS002-056

28. Number of Stories 2 29. Basement Yes <input checked="" type="checkbox"/> No <input type="checkbox"/> 30. Foundation Material stone 31. Wall Construction wood frame 32. Roof Type and Material gabled, asphalt shingles 33. Number of Bays Front 3 Side 2 34. Wall Treatment wood 35. Plan Shape rectangular 36. Changes (explain in #42) Addition <input type="checkbox"/> Altered <input checked="" type="checkbox"/> Moved <input checked="" type="checkbox"/> 37. Condition Interior Exterior good 38. Preservation underway? Yes <input type="checkbox"/> No <input checked="" type="checkbox"/> Window replacements? Yes <input type="checkbox"/> No <input checked="" type="checkbox"/> 39. Endangered? Yes <input type="checkbox"/> No <input checked="" type="checkbox"/> By What? 40. Visible from Public Road? Yes <input checked="" type="checkbox"/> No <input type="checkbox"/> 41. Distance from and frontage on road 20 feet

42. Further Description of Important Features The front features a large wrap around one story porch with turned posts, probably added to this vernacular, I-house variant. Entry is through a centered door flanked by 1/1double-hung windows. The second follor has three evenly spaced 1/1 double-hung windows (probably replacement) with non-operable shutters. The rear has a large one story addition.

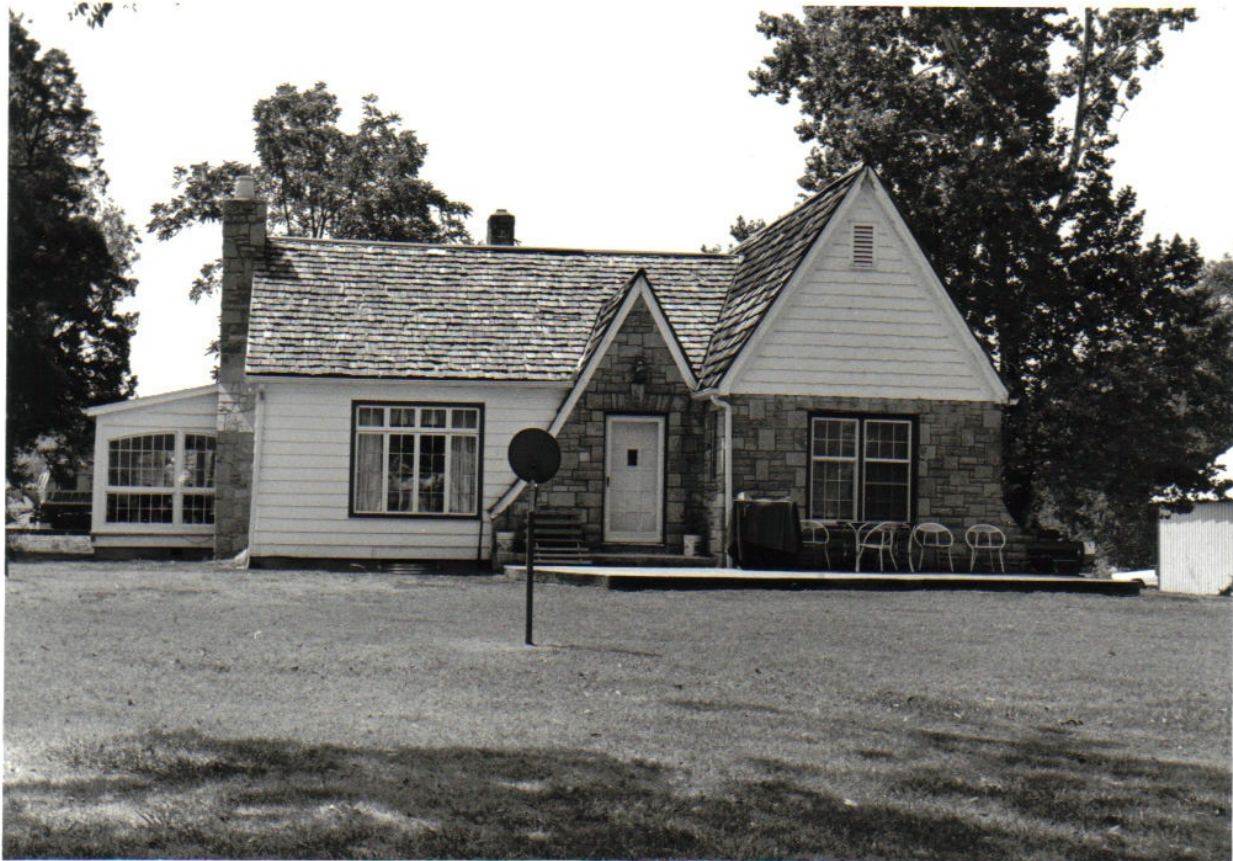
28. Number of Stories 1 29. Basement Yes <input checked="" type="checkbox"/> No <input type="checkbox"/> 30. Foundation Material concrete 31. Wall Construction wood frame 32. Roof Type and Material gabled, wood shingles 33. Number of Bays Front 3 Side 2 34. Wall Treatment weather board and stone 35. Plan Shape L-shaped 36. Changes (explain in #42) Addition <input type="checkbox"/> Altered <input type="checkbox"/> Moved <input type="checkbox"/> 37. Condition Interior Exterior good 38. Preservation underway? Yes <input type="checkbox"/> No <input checked="" type="checkbox"/> Window replacements? Yes <input type="checkbox"/> No <input checked="" type="checkbox"/> 39. Endangered? Yes <input type="checkbox"/> No <input checked="" type="checkbox"/> By What? 40. Visible from Public Road? Yes <input checked="" type="checkbox"/> No <input type="checkbox"/> 41. Distance from and frontage on road 50 feet

42. Both the entry gable and the projecting gable are clad in a stone or permastone veneer. In the projecting gable are a pair of 6/9 double-hung windows. On the east gable end are a stone chimney and sun room. The artificial siding that covers most of the building may be original.

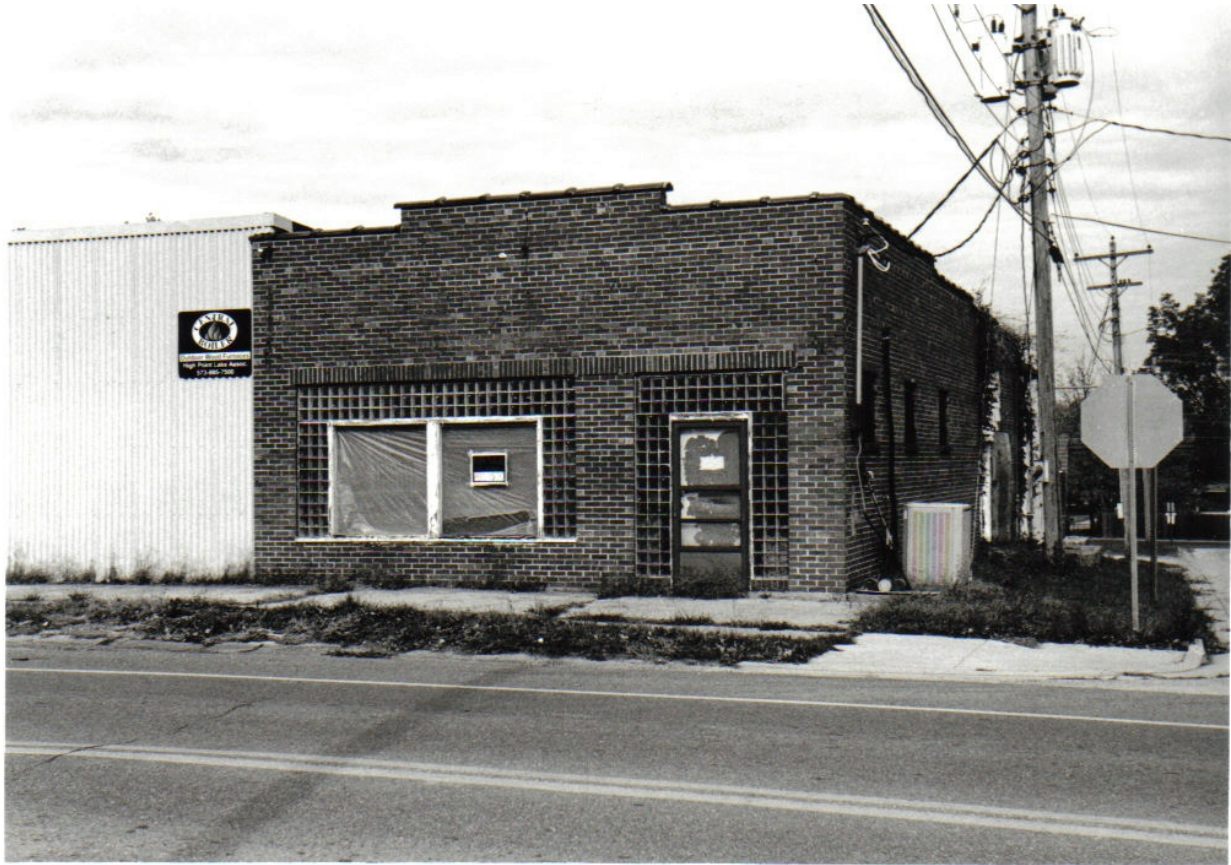
Inventory Form No. CRAS002-059

28. Number of Stories 1 29. Basement Yes <input type="checkbox"/> No <input checked="" type="checkbox"/> 30. Foundation Material concrete 31. Wall Construction brick 32. Roof Type and Material flat, asphalt 33. Number of Bays Front 2 Side 3 34. Wall Treatment brick 35. Plan Shape rectangular 36. Changes (explain in #42) Addition <input checked="" type="checkbox"/> Altered <input checked="" type="checkbox"/> Moved <input type="checkbox"/> 37. Condition Interior Exterior good 38. Preservation underway? Yes <input type="checkbox"/> No <input checked="" type="checkbox"/> Window replacements? Yes <input checked="" type="checkbox"/> No <input type="checkbox"/> 39. Endangered? Yes <input type="checkbox"/> No <input checked="" type="checkbox"/> By What? 40. Visible from Public Road? Yes <input checked="" type="checkbox"/> No <input type="checkbox"/> 41. Distance from and frontage on road 10 feet

42. Further Description of Important Features The front has a pair of replacement windows, framed by glass blocks, to the west of a single entry door, also framed by glass blocks. Decorative brickwork and a raised, central parapet adorn the roofline. There is a large metal addition on one side of the building. <div style="text-align: right;">See Continuation Sheet <input type="checkbox"/></div> 43. History and Significance <div style="text-align: right;">See Continuation Sheet <input type="checkbox"/></div>

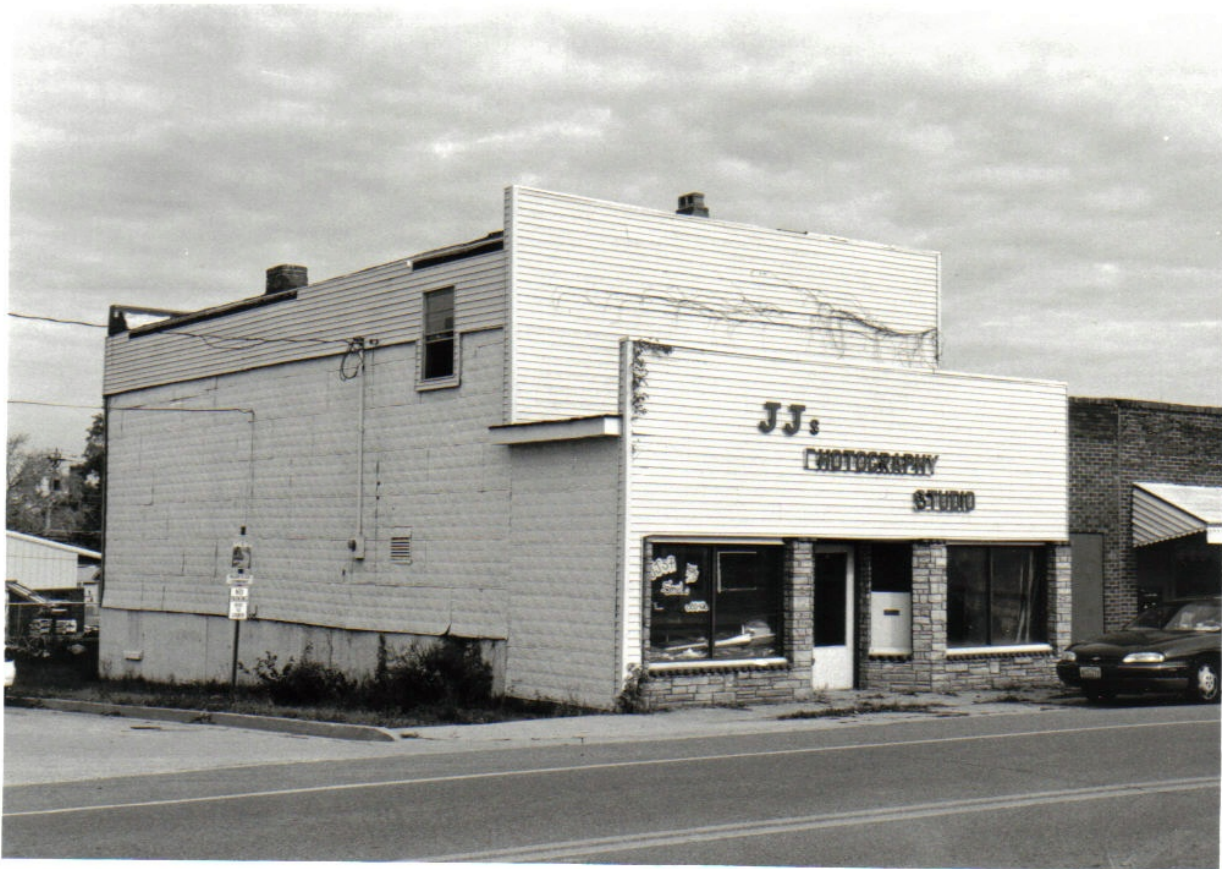
28. Number of Stories 2 29. Basement Yes <input checked="" type="checkbox"/> No <input type="checkbox"/> 30. Foundation Material concrete 31. Wall Construction wood frame 32. Roof Type and Material gabled, asphalt shingles 33. Number of Bays Front 3 Side 34. Wall Treatment permastone, artificial siding, and metal 35. Plan Shape rectangular 36. Changes (explain in #42) Addition <input type="checkbox"/> Altered <input checked="" type="checkbox"/> Moved <input type="checkbox"/> 37. Condition Interior Exterior good 38. Preservation underway? Yes <input type="checkbox"/> No <input checked="" type="checkbox"/> Window replacements? Yes <input checked="" type="checkbox"/> No <input type="checkbox"/> 39. Endangered? Yes <input type="checkbox"/> No <input checked="" type="checkbox"/> By What? 40. Visible from Public Road? Yes <input checked="" type="checkbox"/> No <input type="checkbox"/> 41. Distance from and frontage on road 10 feet
