Survey Map Troy Downtown District Area 2010

1. Survey No. LN-AS-001-008	Survey name: Troy Downtown District	:	
3. County:	4. Address (Street No.)	Street (name)	
Lincoln	210	Boone Street	
5.City: Vicinity: Troy	6. UTM: 15/674874/4316292		7. Township/Range/Section: T: 49N R: 1W S: 26

ARCHITECTURAL	HISTORIC II	NVENTORY	FORM

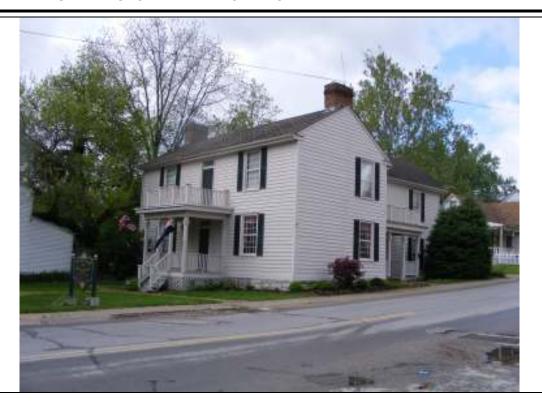
Photographer:	Date:	Description:
Ruth Keenoy	April 29, 2010

The Cottle House is a two-story Federal style dwelling with weatherboard siding and a limestone foundation. The house has an end-gable plan with interior end brick chimneys, gable returns, and a primary (east) elevation one-story central porch. Within the porch bay is an entry with a wood panel door. Above the door is an original transom. The porch is supported by four square columns. It has a flat roof with a second-floor balustrade that is centers on the second-story entry, which is similar in appearance to the lower level door/transom. Frame steps at the façade lead to the porch (which is raised). Extending around the porch is a frame first-story level balustrade. Single windows of 12-over-12 design flank the façade's upper and lower level doors. The dwelling has a rear two-story ell. The ell has a secondary one-story porch on the north elevation. This porch is situated off-center and similar in design to the façade porch. The rear porch also has a frame balustrade, second-story level entrance, and roofline balcony. Within the porch's first-story space are two entries – one facing north (toward Boone Street) and one facing west. Both entrances have wood paneled doors. Side (north/south) and rear ell windows are all 12-over-12 design. At the southwest corner of the dwelling is a one-story shed wing.

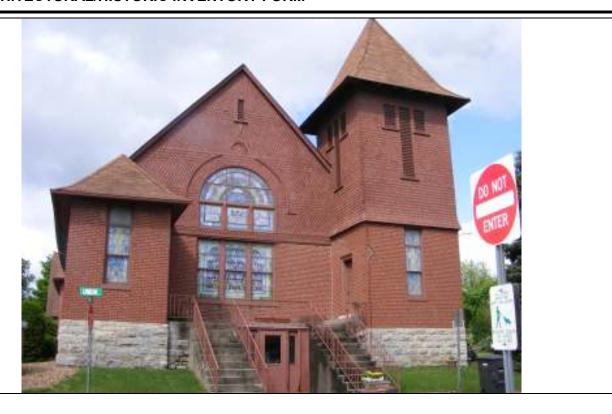
Photographer:	Date:	Description:
Ruth Keenoy	April 29, 2010	Primary elevation; view is northwest

The former church is a Shingle style building with a raised limestone foundation, exterior brick walls, and an asphalt-shingled steeply pitched gable roof. The façade faces east toward Union Street. The building has a front-gable plan with corner tower bays. Centrally at the façade (recessed between the tower bays) is an open platform/stoop with a set of concrete stairs (at either end of the stoop). The stairs frame a lower level entrance (below the stoop) that holds a single-light wood panel door flanked by sidelights. Entrances are also located at the stoop level, providing entry via the tower wings at either end of the facade. The south tower wing is one and a half-story in height. The north wing is 2.0-story in height. Both tower wings have flared pyramidal roofs. The north tower appears to be a belfry. It has louvered openings on all elevations. Tower walls are clad in decorative wood shingles and hold stained glass lights on the east, north, and south walls. Above the center of the façade, within the gable field (also covered with decorative wood shingles), is a large stained glass light. This large window is separated horizontally by a decorative sawtooth wood band. The lower half of the window has three two-over-two (horizontal sash) stained glass lights further divided vertically by engaged frame pilasters. The upper half of the window bay is arched and similar in design to the lower window. The front gable field has diamond-shaped and fish scale shingles. Decorative arched wood patterns surround the upper façade window. A louvered vent above the large arched window has a triangular wood pendant below the sill. The building's side elevations (north and south) have stained glass lights. The north elevation windows are paired triple-sash design. The south elevation windows are also triple-sash and placed as groups of three. A 1950s educational wing is situated at the building's southwest corner. This wing has exterior six-course brick walls and a steeply pitched cross-gabled roof. Several slender stained glass lights extend the full height of the rear wing. Another wing projects at the northwest corner of the church. This projection has a flat roof with metal coping, and ten-light, steel sash windows. At the building's north elevation (just east of the rear flat roof corner wing) is a projection with a steeply pitched hipped roof.

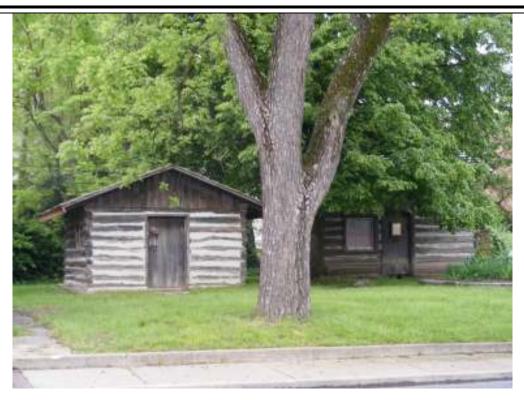
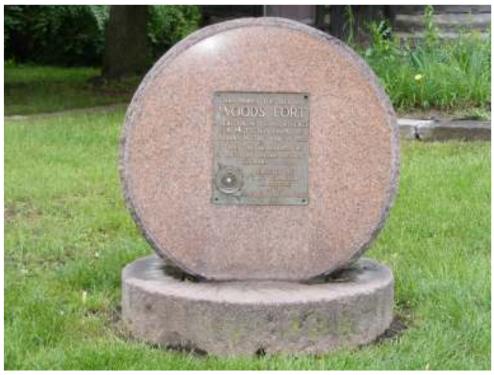
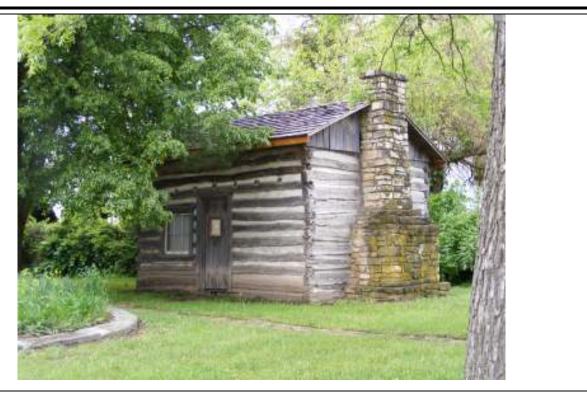
Ruth Keenoy	April 29, 2010	Viene (increased at a late late leader) in the order and illustrates at the level of the contract of the
	1 / \pi 1 20, 20 10	View (immediately below) is north and illustrates two buildings on the site.
		Second view is west and illustrates commemorative marker. Third view is southwest and illustrates one of the property's two log reconstruction properties.

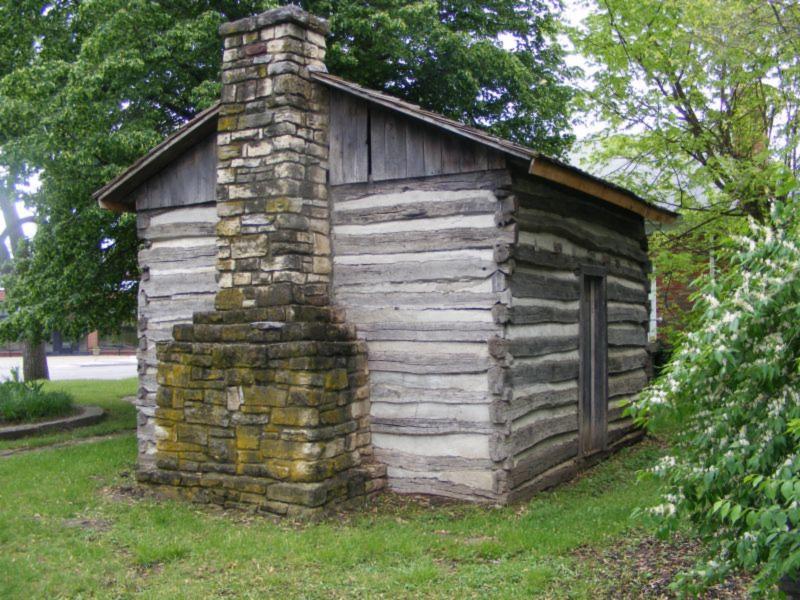
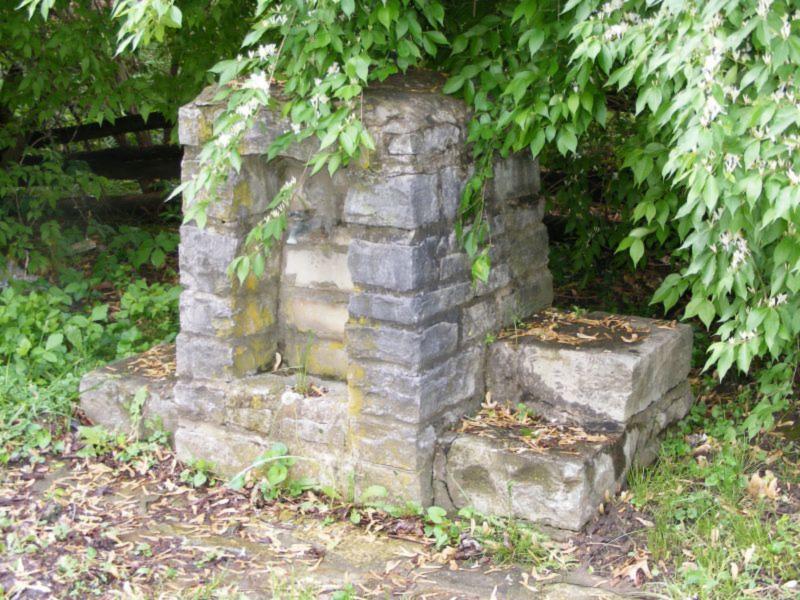
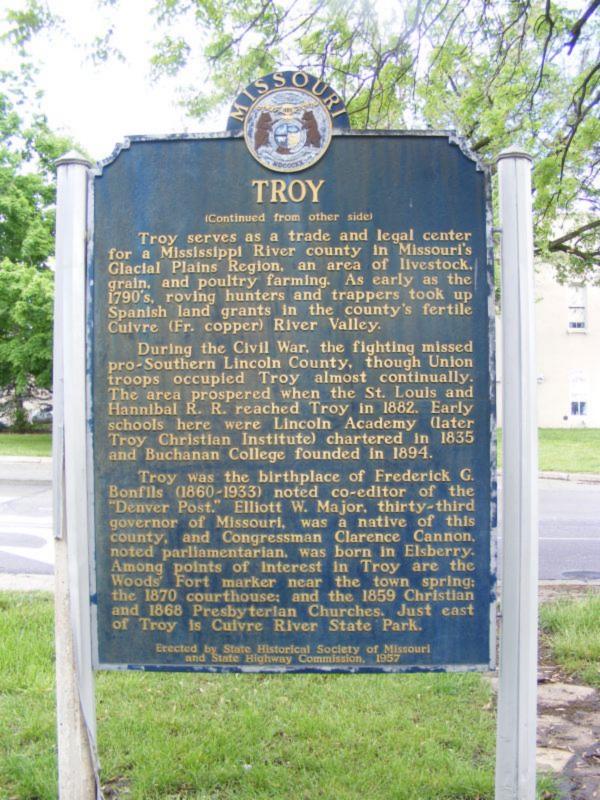
The log buildings on the site have wooden shingled gabled roofs and exterior dovetail notched log walls. Both buildings face east toward Main Street. The south building is an outbuilding with a gable-front plan. The façade holds a single door of vertical board construction. Side (north and south) elevations have single sash small windows. The dwelling is situated north of the outbuilding and has an end-gable plan. The single pen cabin façade holds a vertical board door (centrally placed) with a small single-light window. Offsetting the entrance to the south is a six-light single-sash window. The north elevation has an exterior end limestone chimney. There is a single door (vertical wood design) at the rear (west) elevation and a single window at the south elevation.

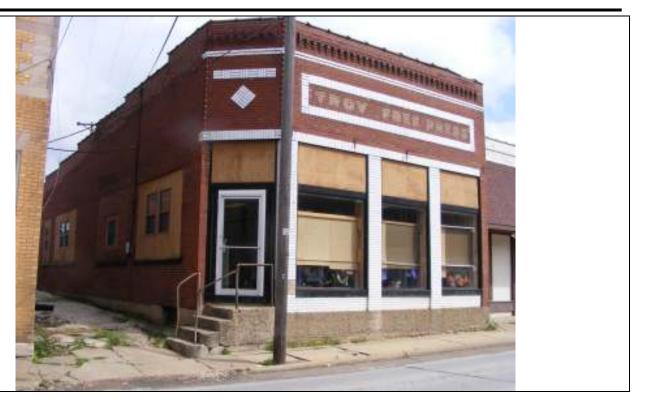
Photographer:	Date:	Description:
Ruth Keenoy	April 29, 2010	Primary (south) elevation; view is northeast.

The Troy Free Press Building is a modern 1920s-era commercial building with a truncated southwest corner entrance. The main entrance has been altered (c. 1990) with the addition of a glass and metal commercial style door. The transom above the door (as well as window transoms visible on the façade) is covered with plywood. The entry is offset (to the east) by three fixed sash commercial style windows that appear original. The door and windows are surrounded by baker's brick. Baker's brick also adorns the upper façade and the corner area above the entrance. The façade retains a painted sign, "Troy Free Press," which is set within a decorative space created by the baker's brick. Stepped brick corbelling extends horizontally above the façade's glazed brick band. Windows on the north elevation have been altered and currently hold one-over-one aluminum sash lights. It appears that these openings originally held large commercial style windows. The roofline is stepped with metal coping.

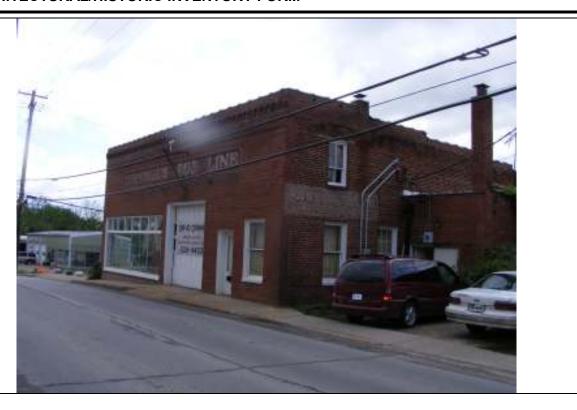
Photographer:	Date:	Description:
Ruth Keenoy	April 29, 2010	Primary (north) and west elevations; view is southeast.

This former auto dealership is a brick two-story building that has been minimally altered since construction in c. 1925. The primary (north) elevation is built up at the façade and features an original band of stepped decorative brick pendants along upper façade wall. Below the patterned brick, the building bears the painted sign for "Turnbull's Bus Line." Fainter painted signs appear on the west wall (which appears to be for a grocery) and the east wall (for a Plymouth dealership). There is an original commercial style window on the primary elevation (east end) with an upper multi-light band. This window is offset by a garage bay with an overhead track door, and by a commercial (single-light original) door and one-over-one window. The south elevation has a commercial style window bay that imitates the one noted on the north elevation. There are one-story wing additions at the east and west elevations. The east wing addition has two garage bays (north elevation) with modern overhead track doors. This wing is constructed of hollow core tile and the façade is covered with brick. The west wing appears older. The wing is constructed of brick and has a garage bay (north elevation) and brick flue. Both the main building block and wings have metal roofline coping.

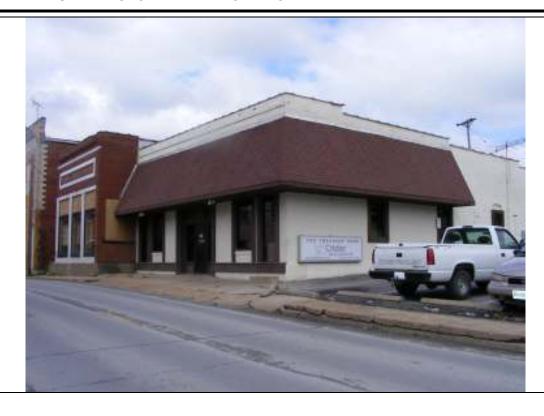
Photographer:	Date:	Description:
Ruth Keenoy	April 29, 2010	Primary (south) and east elevations; view is northwest.

The building at 185 E. Cherry Street is a one-story brick building with a primary (south elevation) central recessed entrance. The entry is flanked by fixed-sash commercial style windows (paired lights). All of the building's doors and windows are modern, dating to c. 1990. There is evidence of an original window configuration on the east elevation, indicating that the building probably originally held some arched, one-over-one windows. A modern wood awning extends along the façade above the entry/windows. The roofline is stepped with metal coping.

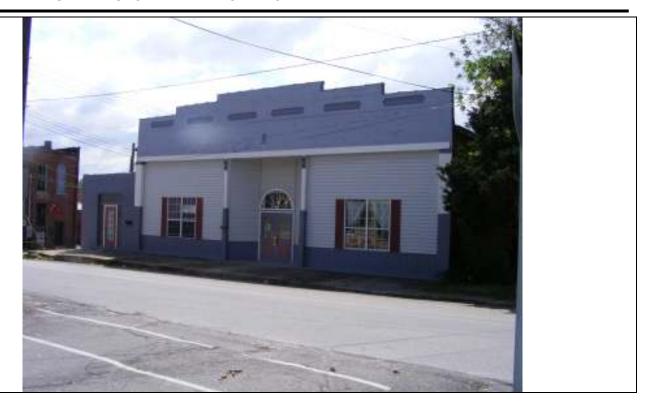
Photographer:	Date:	Description:
Ruth Keenoy	April 29, 2010	Primary elevation; view is southeast.

This brick commercial building retains much of its original appearance with the exception of the façade, which has been clad with synthetic siding and holds replacement style windows with nine-light muntins (double-hung). The façade has paired modern doors situated centrally. Above the doors is a non-original fanlight transom. The side and rear elevations retain original exterior brick walls. At the east end of the building is a one-story brick c. 1940 wing that has a flat roof and original eight-light awning windows with steel sashes. This wing has a concrete foundation and an original glass block surround on the façade (north elevation). The primary door (on the wing/façade) is replacement design. The building retains an original stepped façade wall with metal coping.

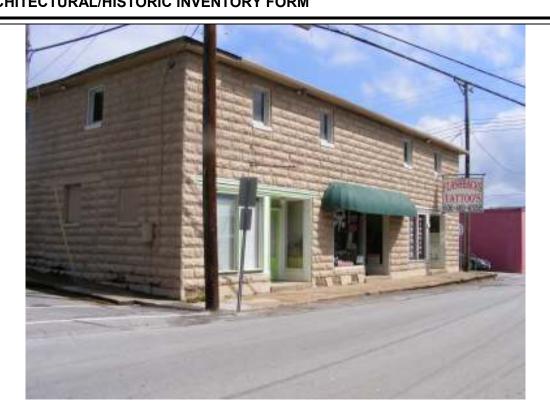
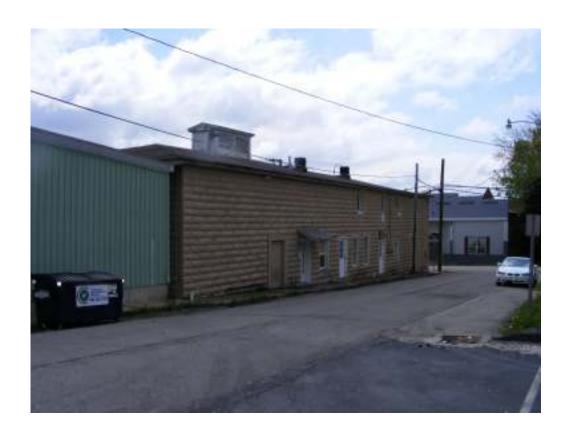
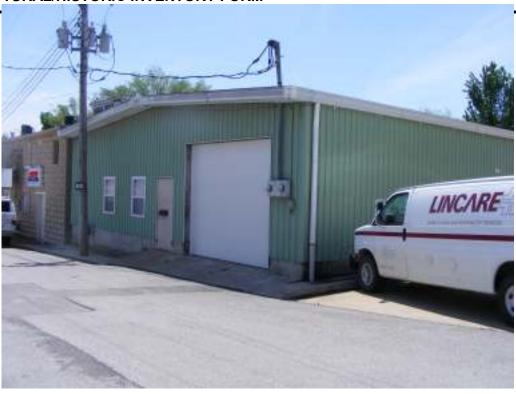
Photographer:	Date:	Description:
Ruth Keenoy	April 29, 2010	Primary elevation - view is northeast; side elevation - view is southeast;
	,	outbuilding - view is southwest.

The building is located in downtown Troy, approximately one-half block west of Main Street. Concrete sidewalks border the building's primary (south), west and east elevations. The walkway on the east side of the building is stepped and appears to have served as a loading dock (the concrete walk is raised, like a platform, above the street level). The rear (north elevation) abuts a warehouse clad with prefabricated metal siding. The outbuilding has a concrete foundation, indicating that it may be an older property. The building has been sided with synthetic materials in recent years. Sanborn maps illustrate that this area was originally used for cold storage (1910s-1920s). The Kuhne Family also operated a mercantile establishment in downtown Troy that burned in 1991.

The building at 171 W. Cherry Street is a large rectangular plan building with a low hipped roof and exterior textured block walls. At the crest of the roof is a frame (original) louvered gable monitor/vent. The primary (south) elevation holds three recessed entry storefronts. These appear original with single-light doors offset by commercial style windows. The central storefront has an added canvas awning. Although the building has had most secondary elevation doors and windows replaced, original openings are intact. Some original two-over-two windows remain on the west elevation.

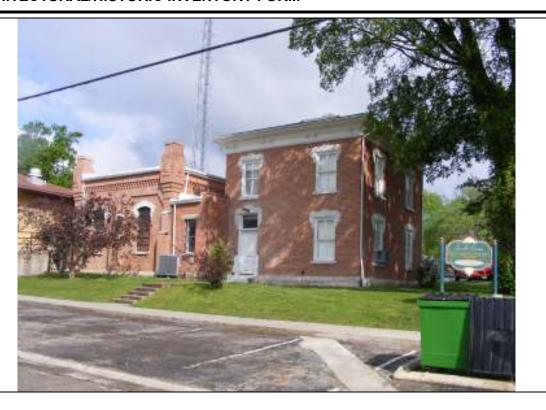
Photographer:	Date:	Description:
Ruth Keenoy	April 29, 2010	South elevation; view is northwest

The property consists of two adjoined buildings, both of which are of brick construction. At the west end of the complex is a one-story jail with a flat roof. It appears that access to the jail was via the jailer's residence – a two-story brick Italianate building at the east end of the property. The jail is Gothic Revival in style with corner brick buttresses and stepped corbel table near the roofline. One gothic arched window is noted at the north elevation. Remaining windows have original limestone bell arches. All of the jail's windows are covered with exterior iron bars. The two-story residential wing and holds off-center entrances on the south and north elevations. The south elevation retains an original wood paneled door and single-light transom that is offset (at the east) by a single window. The residence has a low hipped roof with asphalt shingles, exterior five-course common bond brick walls, and a limestone foundation. Paired Italianate brackets are visible below the cornices. All of the residential windows are two-over-two, double-hung design with stone swag arches and stone sills.

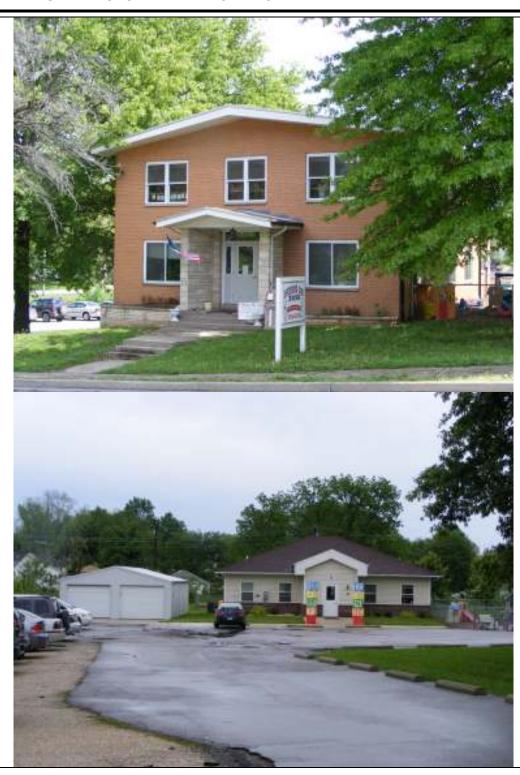
Photographer:	Date:	Description:
Ruth Keenoy	April 29, 2010	Primary and south elevations, view is northeast – outbuildings, view is east.

The building was constructed in 1960 as a rectory. The façade holds a centered one-story porch with limestone walls (partially enclosing the open style porch, which is an original feature) and a low gabled roof. The central entry holds a c. 2000 door with sidelights/transom. Windows on the lower level are two-by-two sliding design. Upper story windows are one-over-one replacement. The foundation is poured concrete that is scored at the side and rear elevations. The primary elevation foundation has a limestone veneer that matches the porch detailing.

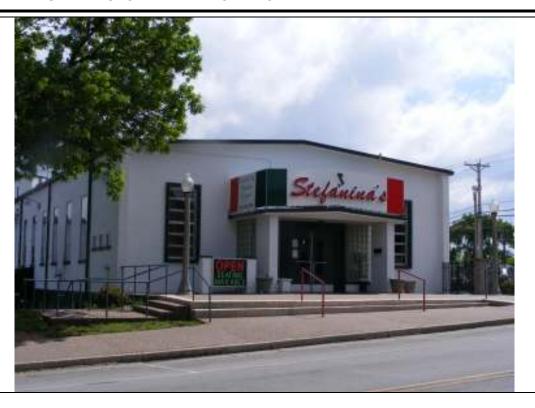
Photographer:	Date:	Description:
Ruth Keenoy	April 29, 2010	Primary and north elevations; view is southeast.

The irregular plan church/school combination building (presently used as a restaurant) appears much as it did in the 1950s (when first constructed). The building retains original stained glass windows and a partially enclosed entrance/vestibule area with glass block walls. The porch has a low gabled roof and paired doors. Interior space has been retained as originally planned and holds former confessional booths, school restrooms/finishes (rear), and a baptismal area. Floors, windows, and ceilings are intact. Original awning style (stained glass) and glass block windows are also intact.

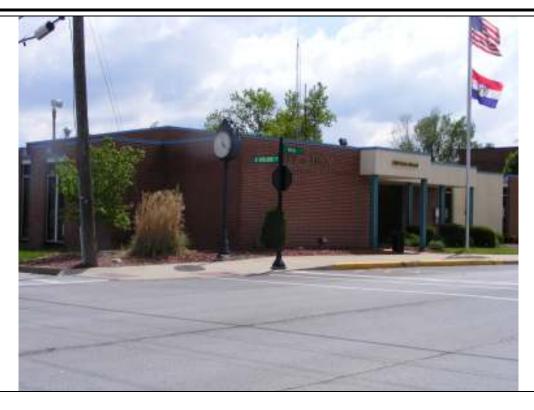
Photographer:	Date:	Description:
Ruth Keenoy	April 29, 2010	Primary and north elevations; view is southeast.

The property is a contemporary bank style structure with single-light commercial style entrances at the east (primary) and rear (west) elevations. Windows are single-sash fixed lights and are recessed, as is the primary entry bay. A canopy type awning extends above the entrances and above the primary elevation windows. The building was recently remodeled for current governmental-related use.

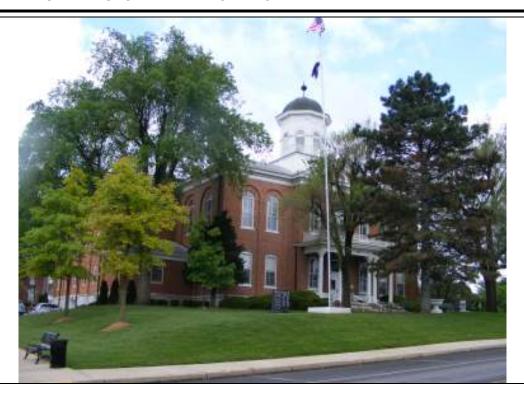
Photographer:	Date:	Description:
Ruth Keenoy	April 29, 2010	Primary & south elevations; view is northwest.

The Lincoln County Courthouse was constructed in 1869-1870. It was designed by Gustave Bachmann, a German immigrant who also designed the Montgomery County courthouse. Plans were somewhat altered during construction when four additional windows were provided on the south and east (primary elevations); walls were reduced from 18 to 14 inches in thickness; oak (rather than pine) was used to construct the roof/cupola; and window sills were installed as stone (rather than cast iron). Construction costs were \$27,447.50.

The Lincoln County Courthouse is a two-story brick Georgian style building with a cupola, asphalt-shingled hipped roof, exterior common bond brick walls, and a limestone foundation. The cupola has an asphalt-shingled octagonal dome with a finial. The cupola also features dentilled trim (near the cap) and exterior weatherboard siding. Arched eight light windows surround the cupola which rests on a frame platform surrounded by a decorative iron balconet. The building's primary elevation also supports a balconet, similar in design, which rests on the roof of the façade porch. The façade entry/porch is centrally located. The porch has a flat roof supported by Corinthian columns. The primary entrance is situated centrally within the porch bay and holds original paired doors of single-light, four-panel design. A large sunburst transom is situated above the doors. This entrance is mirrored at the second-floor level (leading to the balconet). Single windows of two-over-two double-hung design flank the doors at the façade. A fanlight opening is noted in the façade pediment above the projecting entrance/porch bay. Remaining windows are two-over-two design. All have brick arches and sills. The building has a rear two-story addition (west end). The north elevation of the rear wing has arched recessed areas but no windows. A much smaller addition that is one-story in height is situated at the southeast corner of the building near the south original elevation and primary porch projection (south end).

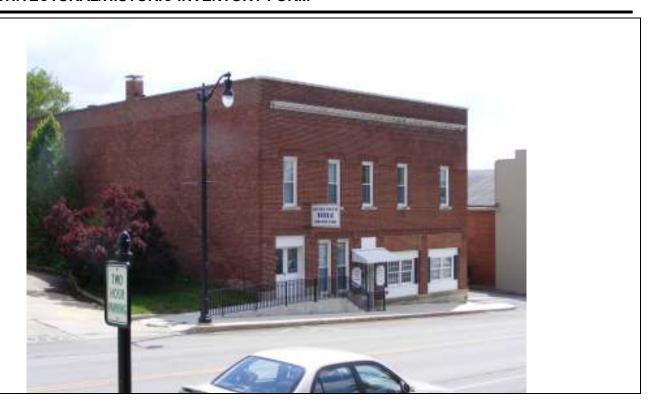
Photographer:	Date:	Description:
Ruth Keenoy	April 29, 2010	Primary and north elevations; view is southeast.

The building is a commercial property type located in downtown Troy at the northeast intersection of Main and Collier Streets. A concrete sidewalk surrounds the lot at the west and south. An asphalt paved drive extends along the north side of the lot to the rear alley/parking lot. Landscaping with trees and shrubs is noted at the north end of the building. A contemporary street lamp is situated on the sidewalk at the northwest lot corner.

This two-story brick commercial building has a poured concrete foundation and stepped built-up side elevations that obscure views of the roof. The façade has two entrances facing Main Street at the lower level. At the north end of the elevation are paired single-light, wood paneled doors. A transom above the doors is enclosed. The entry is offset by two single windows of one-over-one replacement design. The adjacent sidewalk is stepped at the building's center façade and provides service to a central door (situated lower than the north entrance). This entry holds a single-light commercial style door with an enclosed transom. A metal awning extends above the entrance. The south end of the façade holds commercial style windows that have been partially infilled and altered with the addition of contemporary six-over-six paired windows. Entrances and windows (at all elevations) retain original jack arches and limestone sills. The upper façade holds five windows of replacement one-over-one design. Above the windows is a decorative brick pattern (rectangular). Above the brick decorative band is a terra cotta tile cornice with dentils. A secondary commercial style (recessed cant) entrance is noted at the south elevation facing Collier Street. Windows on the south and rear (east) elevations are one-over-one design. The rear elevation has an upper (second-story) level entrance accessed via metal stairs. Rear elevation windows have single-light transoms. There is no fenestration at the north elevation.

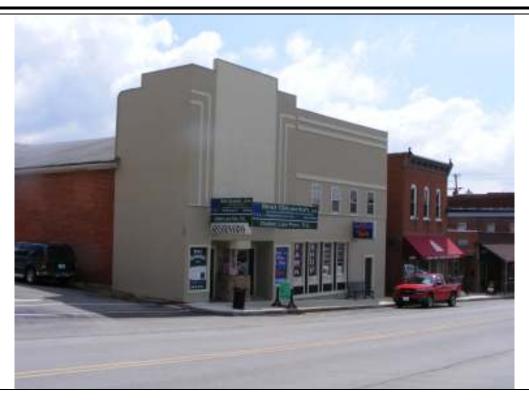
Photographer:	Date:	Description:
Ruth Keenoy	April 29, 2010	Primary elevation; view is southeast.

The two-story building has a low gabled roof and a built-up Art Deco style façade clad with stucco that is consistent with the property's former use as a theater. Contrasting lighter bands of stucco are noted in the upper false façade that provide a streamlined decorative motif. The lower level of the elevation has an off-center (north end) recessed theater entrance with a projecting beveled bay which held a ticket booth. The booth projection has an Ozark stone type base and upper fixed-sash windows on the projecting elevations. Single-light commercial style doors flank the ticket booth. Recessed poster/advertising bays flank either side of the theater entrance. South of the former theater entrance/ticketing area, the façade holds four linear fixed sash windows (c. 1990). A single-door offsets the altered commercial bay at the south elevation. This opening holds a contemporary multi-panel door. The second story of the façade holds four single windows with replacement one-over-one lights. There is no fenestration at the north elevation (facing Collier Street).

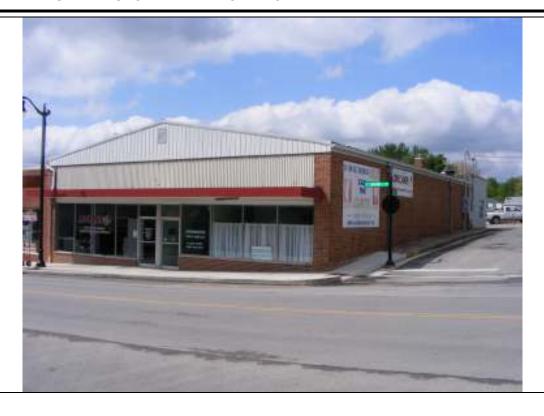
Photographer:	Date:	Description:
Ruth Keenoy	April 29, 2010	Primary and north elevations; view is southwest.
,

The building is a one-story brick commercial property with a low gabled roof and exterior brick walls. The building's primary (east) elevation features a continuous band of single-pane commercial style windows. Within the center of the façade are paired glass and aluminum commercial style doors. A flat awning that appears to be constructed of concrete extends above the window/entry openings along the full width of the façade. A thin band of concrete serves as a sill below the windows at the façade. Above the façade awning, the elevation has prefabricated metal siding. The gable field holds prefabricated siding that appears more modern than the band above façade windows/doors. There is no fenestration on the north elevation; but a rear concrete block addition (west end of the building, probably constructed in 1971) has a single-window on the north elevation. The rear addition has a west elevation entry and a flat roof with metal roofline coping.

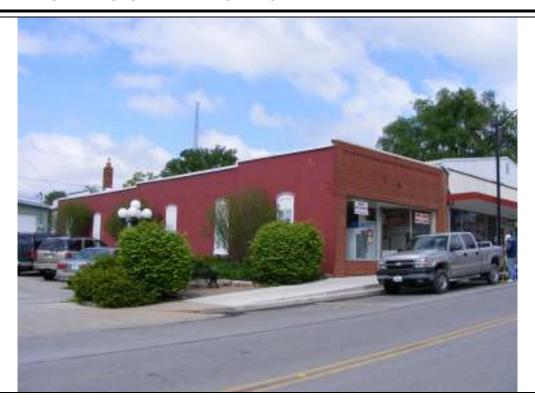
Photographer:	Date:	Description:
Ruth Keenoy	April 29, 2010	Primary and south elevations; view is northwest.

This one-story commercial building has a brick exterior and a flat roof. The façade has a central recessed cant entrance with a solid wood door (centrally placed). The entry is flanked by commercial style glass windows. Above the entry is an original transom light. A wide band of decorative brick patterning extends the full width of the upper façade. The south elevation has trompe l'oeil painted windows. The roofline is stepped and has terra cotta coping.

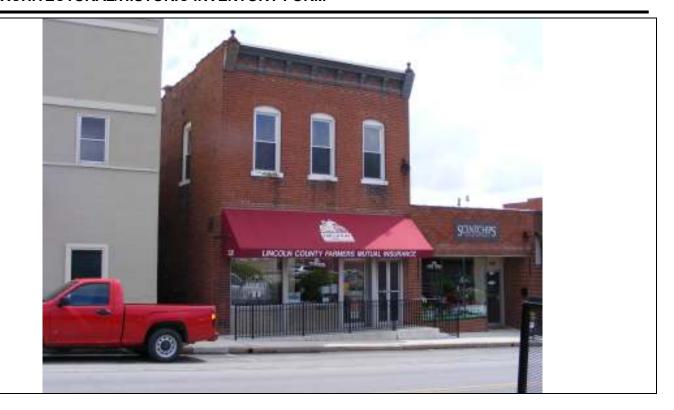
Photographer:	Date:	Description:
Ruth Keenoy	April 29, 2010	Primary elevation, view is southeast.

The building is a two-story brick commercial property with a flat roof. The lower façade storefront has been updated (c. 1980) with glass and aluminum commercial style windows and doors. There are two entries at the façade, both of which are set within the southern half of the elevation. Below the windows (lower level) is scored concrete that mimics a laid brick pattern. Above the windows/doors is a canvas awning that bears the name of the present tenant/owner. Upper story windows retain original brick arches and concrete sills, though the lights themselves have been replaced in recent decades. A decorative cast iron band is noted at the façade near the roofline. Metal coping caps the elevation walls (near the roof).

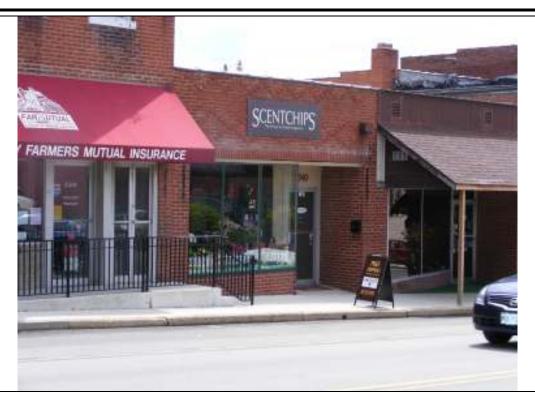
Photographer:	Date:	Description:
Ruth Keenoy	April 29, 2010	Primary elevation, view is southeast.

The property is a one-story commercial building with a three-fixed-light commercial window bay that is offset by a recessed square entry. The entrance holds a single-light commercial style door (not original) with a modified surround (enclosed). A decorative brick band extends along the façade above the window/door. Above this band, the upper façade holds diamond-shaped brick work. There is metal coping at the roofline.

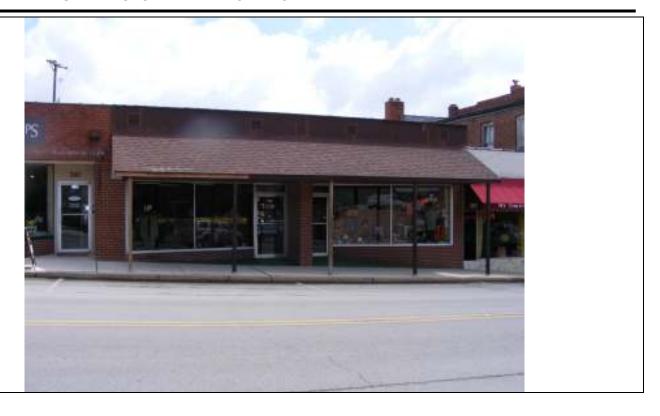
Photographer:	Date:	Description:
Ruth Keenoy	April 29, 2010	Primary elevation; view is southeast.

This one-story commercial building is an unadorned rectangular building with a flat roof, brick façade exterior, and two individual storefronts. The façade features two single-light commercial style doors at the center of the elevation – each of which provides entry to a separate store/commercial space. A projecting brick party wall divides the doors. Each of the entrances is offset by two-fixed-light commercial style windows. An asphalt-clad awning supported by wood columns extends above the entrances/windows along the sidewalk. Louvered vents are noted in the upper façade wall above the awning.

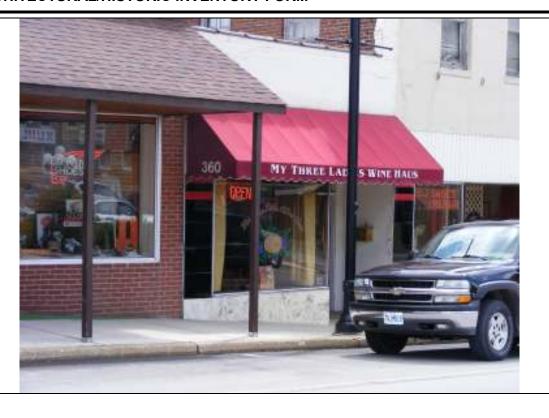
Photographer:	Date:	Description:
Ruth Keenoy	April 29, 2010	Primary elevation; view is southeast.

The building is a one-story small commercial property with a flat roof, stucco exterior, and Carrara glass below the commercial storefront window. An off-center entry with a recessed cant is situated at the south end of the elevation. The entry holds a single-light commercial style door with an overhead transom (replacement) light. A commercial window bay is situated at the east end of the elevation and holds three (replacement) single-sash lights. A canvas awning extends above the entrance and window. Terra cotta tile coping extends horizontally across the roofline/upper exterior wall.

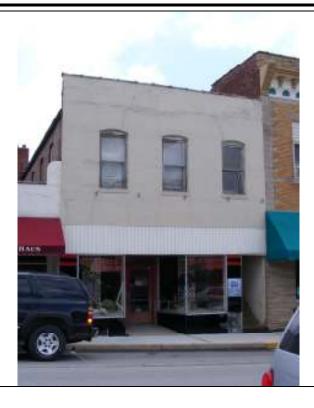
Photographer:	Date:	Description:
Ruth Keenoy	April 29, 2010	Primary and north elevations; view is southeast.

This two-story brick commercial building was remodeled in c. 1940 at which time the façade was clad with stucco and the primary storefront was remodeled. The building retains an original recessed cant entrance with a single-light wood door. Above the door is a single-light transom. The entry is centrally placed and offset by replacement light commercial style windows with Carrara glass surrounds. At the south end of the façade is a recessed area that holds an original wood staircase leading to the upper level entrance. A horizontal band of modern siding is noted on the façade that separates the lower storefront from upper façade windows. The windows (of which there are three) are double-hung single-light design. Window openings are arched and retain original sills covered with stucco. The façade wall rises above the roofline and is capped with terra cotta tiles. The north elevation extends above the adjacent one-story building and features original arched double-hung windows.

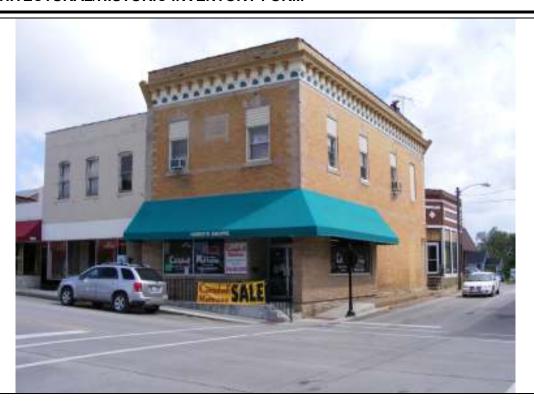
Photographer:	Date:	Description:
Ruth Keenoy	April 29, 2010	Primary and north elevations; view is northeast.

This building is a two-story buff brick commercial property with a flat roof and a concrete foundation. The primary and side (south) elevation have been altered with exterior (c. 1970) stone veneer (lower level storefront). The building has an off-center recessed entry with paired single-light replacement doors. There is a replacement transom light above the doors. Offsetting the entry at the main elevation is a c. 1970 commercial style window bay with paired fixed glass and aluminum lights. The side (south) elevation has a similar commercial style window (east end) and a single door entry (west end). Two openings in the mid elevation (lower level) have been enclosed. A canvas awning extends above the entrance and commercial style windows at the primary (east) and south (partial) elevations. Upper story windows are partially infilled with synthetic siding and hold replacement one-over-one windows. The window openings retain original limestone sills and decorative fan jack arches. A course of pink granite extends horizontally along all elevations at the sill level. The building retains original pink granite quoins. A pink granite date stone that bears the name of the lodge, Masonic symbol, and date of establishment is centered at the upper façade between the elevation's two windows. The building retains an original heavy terra cotta cornice along the roofline decorated with dentils and scalloped shells.

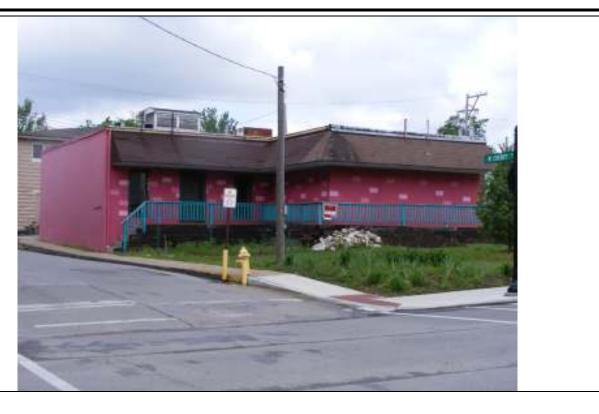
Photographer:	Date:	Description:
Ruth Keenoy	April 29, 2010	Primary elevation; view is northwest.

This one-story commercial building is constructed of concrete block. The primary entry is situated on the wing that extends linear to Main Street. The entry is centered and holds a modern multi-panel door. The entrance is flanked by fixed sash commercial style windows. A projecting block wing (with no fenestration) extends toward Main Street at the north end of the building. A concrete block stoop/platform extends along the façade on both wings. Above the platform porch is a hipped heavy awning with asphalt shingles. The roof is flat and features metal coping along the roofline.

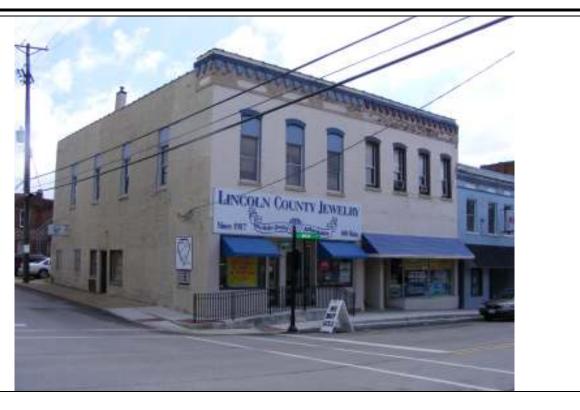
Photographer:	Date:	Description:
Ruth Keenoy	April 29, 2010	Primary and north elevations; view is southeast.

The building is a two-story brick commercial property with a flat roof and metal roofline coping. The primary (east) elevation holds two storefronts. The north end of the façade has two centered doors that lead to a jewelry store (current tenant). The entries are slightly recessed and hold single-light commercial style doors. Each of the doors is offset by a large commercial window. Awnings extend horizontally above each of the windows. Separating the north commercial storefront from the south business is a recessed entry that leads to the upper floor. This entrance is offset by another storefront with an off-center entry and adjacent large commercial style window. A single awning extends above the recessed (access to the second floor) entrance and the south façade storefront. The upper façade holds seven arched windows. The windows above the north storefront are larger (of which there are three) than those above the south storefront (of which there are four). The larger windows are partially infilled. Windows are replacement one-over-one with original jack arches and stone sills. A decorative brick teardrop cornice extends above the upper façade windows near the roofline. The north (side) elevation has upper story arched windows (partially infilled) with one-over-one replacement lights. The lower story of the north elevation has a commercial style window, a secondary entry, two windows infilled with glass block, and a one-over-one sash window (offsetting the entrance).

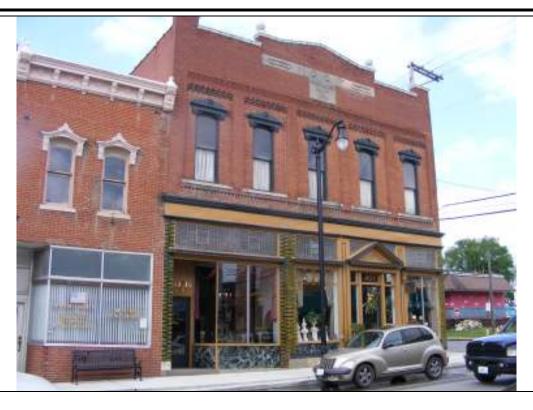
Photographer:	Date:	Description:
Ruth Keenoy	April 29, 2010	Primary elevation; view is northwest.

Troy Lodge is a two-story commercial brick building. The property's nineteenth-century characteristics include original arched double-hung windows (upper floor), sawtooth brick pattern above windows, and ornate cast iron window hoods. In 1925, the building was altered by the renovation of a rear one-story wing to two-stories in height. Also at that time, the first-floor storefront was remodeled with the addition of exterior glazed brick pilasters, Carrara glass (below commercial windows), and a continuous band of glass blocks above the facade's first-story windows/doors. The building has two storefronts. The north storefront (401) has a flush entrance with a pediment above the door, sidelights, and a transom. The south storefront holds a recessed half-cant entry. Both entries hold single-light commercial style doors. The entrances are offset/flanked by large fixed windows. The façade bears an upper level date/name stone ("Troy Lodge No. 68, I.O.O.F."). The false front that extends above the roofline is capped with terra cotta coping.

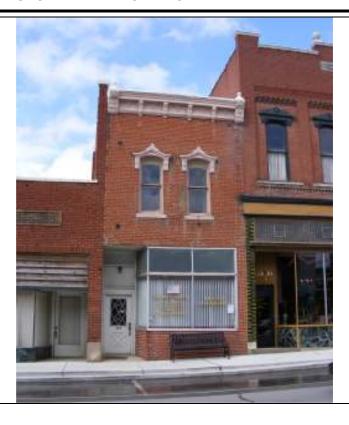
Photographer:	Date:	Description:
Ruth Keenoy	April 29, 2010	Primary elevation, view is northwest.

The building is a two-story brick commercial property with arched double-hung (second story) windows. The building retains original decorative window hoods, limestone sills, and a decorative cornice with terra cotta acanthus leaves and flowers. The façade retains original star-shaped tie rod supports. The lower level storefront has been modernized with replacement commercial style windows and a c. 1975 modern door. The recessed side entry has enclosed transoms above the door.

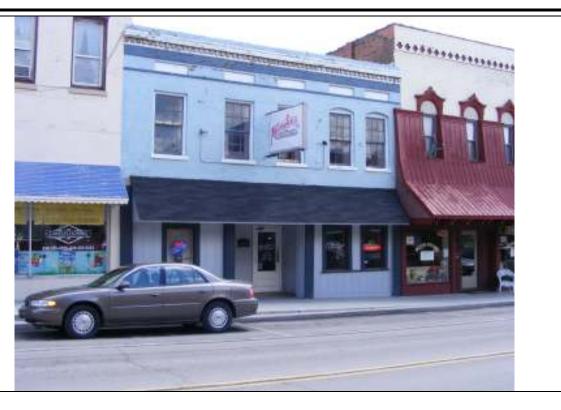
Photographer:	Date:	Description:
Ruth Keenoy	April 29, 2010	Primary elevation; view is southeast.

The building is a two-story brick commercial building with a dentilled cornice and altered lower story storefront (c. 1990). The primary lower elevation has a recessed central entry that holds a single-light commercial style door (c. 1920). Commercial style windows flank the recess, and the lower story façade has exterior synthetic siding surrounding the windows/entry. A frame awning with asphalt shingle siding extends above the storefront. The upper façade holds five windows with six-over-six lights. Two windows (south end of elevation are arched. All of the windows retain stone sills. A brick patterned band extends horizontally above the windows.

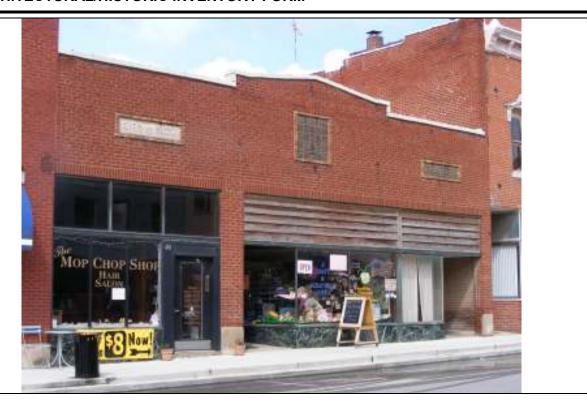
Photographer:	Date:	Description:
Ruth Keenoy	April 29, 2010	Primary elevation; view is northwest.

The City Building is a one-story brick commercial property with a stepped false façade that features terra cotta coping. The property has two storefronts – the one at the north end is larger and has single doors flanking the central window bay. The north storefront's doors are recessed; whereas the south storefront has one flush side entrance. The building has a marble base (just below commercial windows/doors). Some commercial windows appear to be replacement. The south storefront has replacement transom lights (fixed design). The north storefront has horizontal wood in place above the windows/doors. Doors are single-light original commercial design. The façade (above the storefront) on the south end bears a stone (or possibly concrete) sign with the building's name and date inscribed as "City 1930 Bldg." Decorative brick patterns are noted centrally and at the north end of the upper façade.

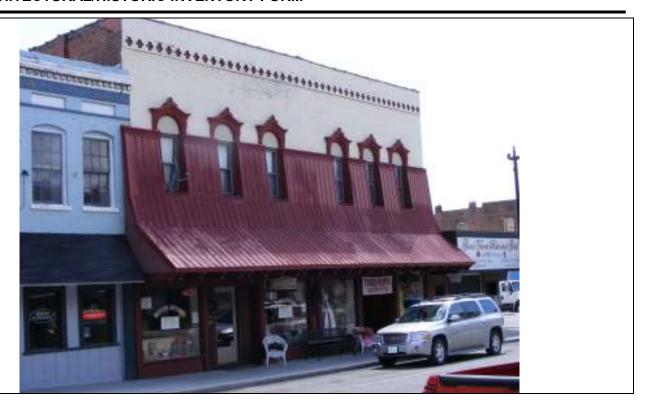
Photographer:	Date:	Description:
Ruth Keenoy	April 29, 2010	Primary elevation; view is southeast.

The property is a two-story brick commercial building that was modified c. 1980 with the addition of a heavy frame awning that frames the building's upper façade windows and extends above the lower storefronts. The façade has two storefronts – the north storefront has a single-light commercial style door that is flanked by single-light commercial windows. The south storefront has a recessed entrance that is also flanked by single-light commercial style windows. This entry also holds access to the upper story. The building retains original Italianate window hoods above the façade's six windows. The window openings hold replacement one-over-one lights. A patterned brick cornice is intact above the windows. Metal coping extends along the upper façade and side walls that extend above the roofline.

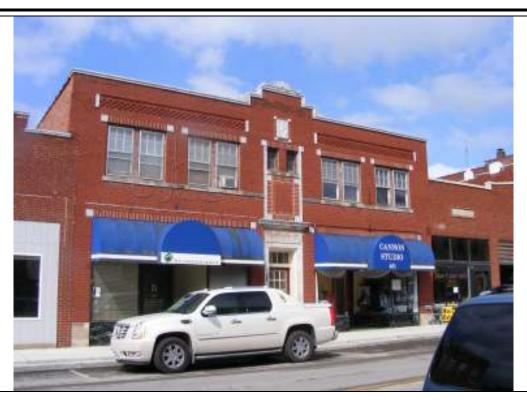
Photographer:	Date:	Description:
Ruth Keenoy	April 29, 2010	Primary elevation; view is northwest.

The Troy Building is a two-story Renaissance Revival style commercial (double-front) building. The building has a central entrance (leading to second story offices) with an original 15-light door. Above the door is an original four-light transom. A decorative terra cotta band with egg-and-dart detailing surrounds the entrance. Above the door, a stone lintel bears the building's name (Troy Building) and date of construction (1928). A terra cotta band extends from the building (with a lower egg-and-dart motif) above the lintel/entrance. On the second-story level, the façade holds a section of patterned bricks with center paired diamond-tracery windows. At the center of the façade, near the roofline, are a terra cotta crest and a stepped parapet with terra cotta scrollwork. Additional terra cotta details include coping and tablet flower molding. Upper floor windows are original double-hung six-over-one design. The lower level storefronts (two – north and south ends) have marble surrounds, single-sash commercial style windows, and recessed single-door entrances. The north storefront appears relatively unaltered with an original wood/single-light glass door. The south storefront holds a modern commercial style door. Above the storefronts are canvas awnings.

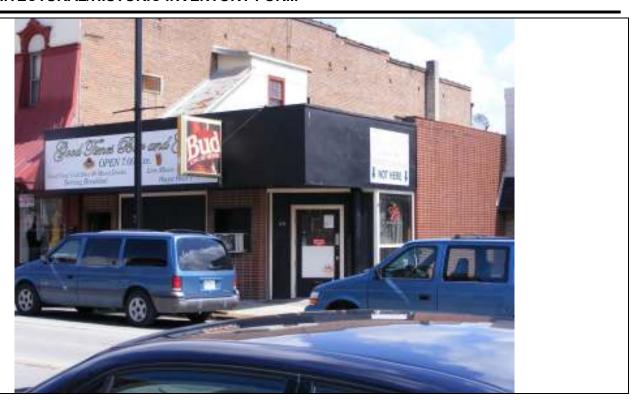
Photographer:	Date:	Description:
Ruth Keenoy	April 29, 2010	Primary elevation; view is northeast.

The property is a one-story flat roofed commercial building with a flat corner entrance that holds a single-light commercial style door. The entry bay door is surrounded by synthetic materials and a one-over-window window offsets the entrance at the south. The roof projects above the entrance, supported by a single round column. The west elevation holds a centered enclosed commercial window that is flanked by smaller enclosed windows.

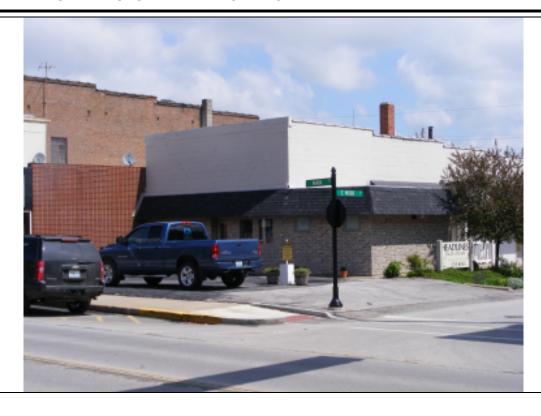
Photographer:	Date:	Description:
Ruth Keenoy	April 29, 2010	Primary elevation; view is northeast.

The building is a one-story mid-century property with a contemporary storefront that surrounds the west and south elevations. The storefront has exterior brick veneer (west elevation) and vertical board siding (south elevation). The west elevation has a mansard awning; the south elevation has a hipped awning with a centered one-story central gabled porch/stoop. Entries are situated on the west and south elevations. The alterations appear to date to c. 2000. The original stepped walls rise above the altered elevations and retain terra cotta tile coping.

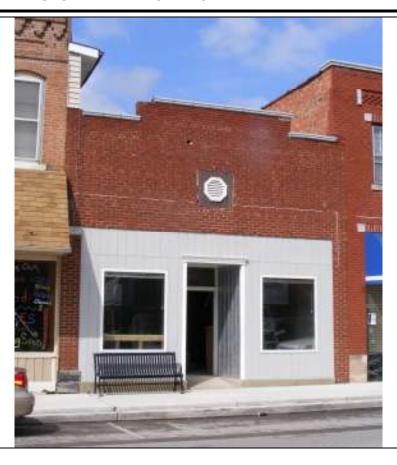
Photographer:	Date:	Description:
Ruth Keenoy	April 29, 2010	Primary elevation; view is northwest.

The building is a one-story commercial brick property with a flat roof, exterior brick walls, and a concrete foundation. The façade (east elevation) has a modified storefront with a central recessed square entrance (single-door) flanked by single-light commercial windows. The storefront is clad with synthetic siding. The entrance retains a single-light transom opening. Above the entrance is a modern louvered vent that may cover (or replace) a central decorative motif. The false façade wall is stepped.

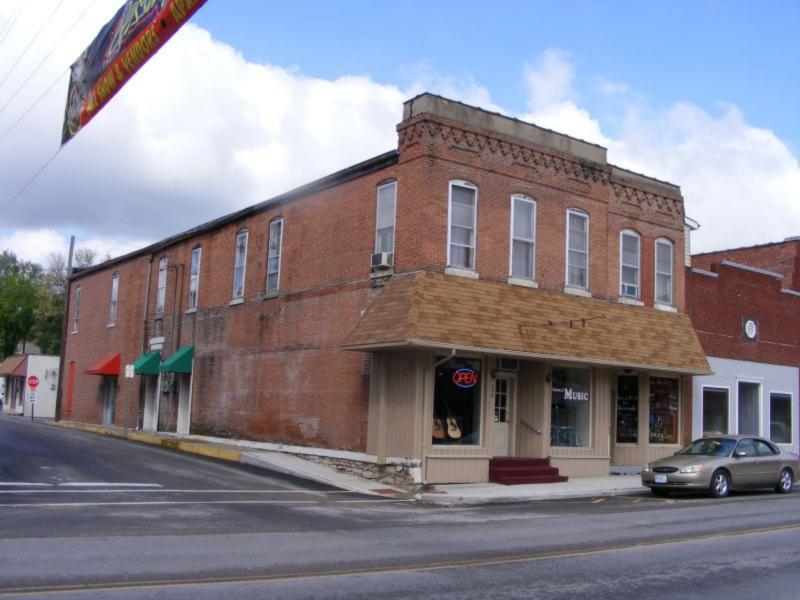
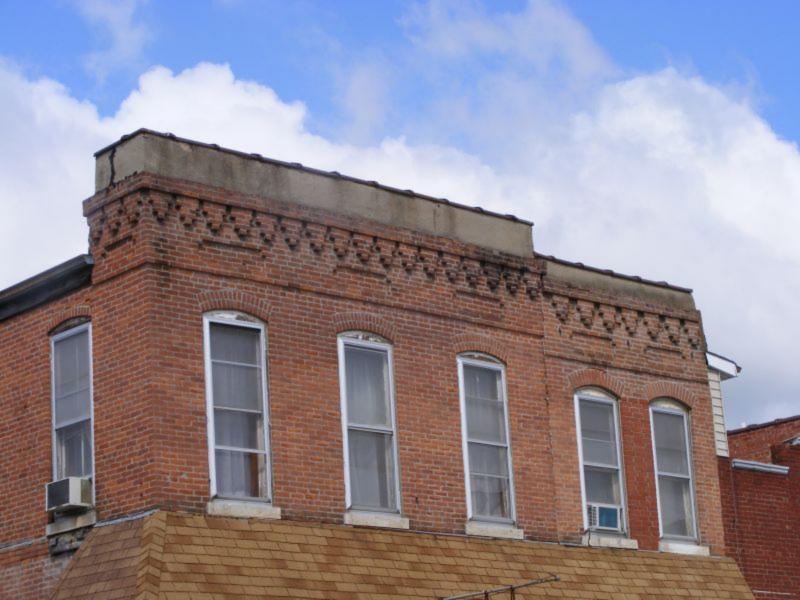
The property is a 2-story brick commercial building with a flat roof, exterior brick walls, and a continuous limestone foundation. The first-story level façade has a modern storefront (c. 1985) with three projecting commercial style window bays and two recessed modern entrances. Surrounding the single-light windows and doors is modern synthetic exterior siding (first-story only). A mansard style frame canopy with asphalt shingles extends above the first-story entrances/windows. The second-story façade retains original one-over-one windows with stone sills and brick segmental arches. The façade extends falsely above the roofline and has decorative brick pendant corbelling. A low concrete sheathed (brick) wall capped with metal coping borders the top of the façade. The south elevation (which faces Wood Street) has three single door entrances with modern canvas awnings. Original windows are intact at the elevation. The windows are similar in design to those noted on the façade (east elevation). An original door and exterior wall staircase on the south elevation (east end) have been removed (date unknown). As noted above, a portion of the building was reconstructed following a fire in the late 1920s.
