Survey Map Troy Downtown District Area 2010

1. Survey No. LN-AS-001-008	Survey name: Troy Downtown District	:	
3. County:	4. Address (Street No.)	Street (name)	
Lincoln	210	Boone Street	
5.City: Vicinity: Troy	6. UTM: 15/674874/4316292		7. Township/Range/Section: T: 49N R: 1W S: 26

ARCHITECTURAL	HISTORIC II	NVENTORY	FORM

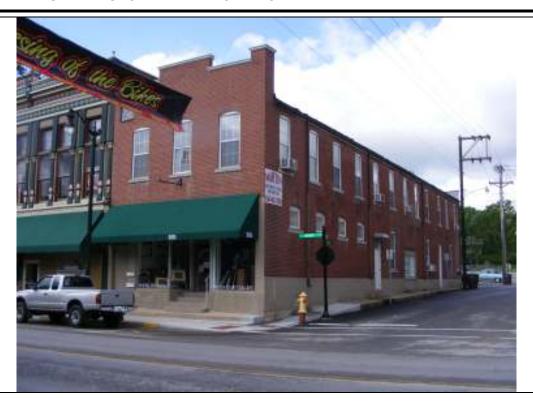
Photographer:	Date:	Description:
Ruth Keenoy	April 29, 2010	Primary and north elevations; view is southwest

The property is a two-story brick commercial building that faces east toward Main Street. The primary elevation has a first-story commercial storefront with glass single-light windows and a slightly off-center glass and metal commercial door. Situated at the south end of the first-story façade is a paneled door that leads to the second-story space. Second story façade windows are replacement design with original arches and concrete sills. Above these windows is an off-center louvered vent. The façade wall rises above the roofline and is stepped. The north elevation has two first-floor level entrances near the central and rear portions of the building. The entries have solid wood paneled doors with arched transoms. Windows at the first story (north elevation) are arched. Most are single-panel six-light design; three are double-hung six-over-six design. Second story windows are also six-over-six design.

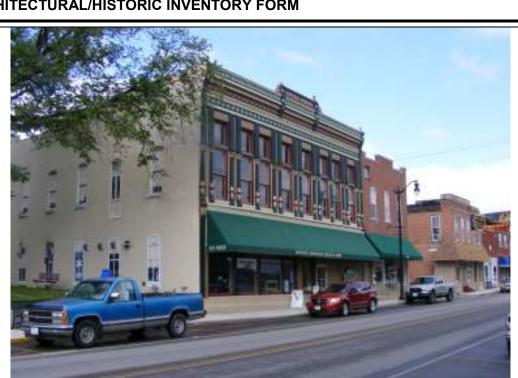
Photographer:	Date:	Description:
Ruth Keenoy	April 29, 2010	Primary and south elevations; view is northwest

The building (formerly Troy's opera house) is a two-part commercial two-story building with a cast iron façade. The first-story level holds a commercial storefront with five single pane glass windows and an off-center single-light commercial style door. The entry is flanked by wood paneled siding and a single-light window. Within the wood paneled section is a sign bearing the business name, "Hechler's Mainstreet Home and Hearth." A modern canvas awning extends the full width of the first-story level. Engaged cast iron pilasters with decorative capitals are situated at the north and south ends of the elevation. An imprint by the company that manufactured the cast-iron façade, Christopher & Simpson, St. Louis, MO, is located at the base of the building's north end façade pilaster. The second-story façade level holds eight double-hung windows divided by smaller cast-iron pilasters with Corinthian capitals. The windows have a starburst type pattern (cast iron) above them. Above the decorative starburst bands are single-light transoms. The building's cornice is decorated with four bands that include flowers and beading. Centered near the roofline is a projection that bears the name "Opera House." The south (side) elevation is exposed and has been covered with concrete sheathing. This elevation has original arched two-over-two windows the upper (second story) level. The second story level also holds an original arched door with a Queen Anne arched transom. The first-floor level has trompe l'oeil paintings of windows that imitate the second floor windows.

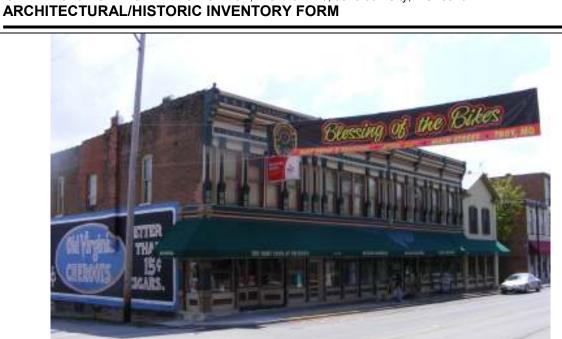
Photographer:	Date:	Description:
Ruth Keenoy	April 29, 2010	Primary and north elevations; view is southeast.

Hechler Hardware is a two-story commercial (double-front) building with a flat roof, brick exterior, and limestone foundation that has been sheathed in concrete. The primary (east) elevation has an original decorative cast-iron storefront that features Corinthian capped pilasters at the upper/lower floors, an acanthus leaf and flower motif along and above the cornice, and Queen Anne sashed (upper level) windows. Both Kempf and Hechler names are inscribed in the frieze. The façade has three street-level entrances; two of which (north/south ends) hold paired doors. The central entry has a single door. Windows and doors on the façade first-story level are original. The doors retain single-light/wood patterns; and the commercial style windows are set within their original framing. A canvas awning extends above the first-story façade openings. The building's north elevation (facing Wood Street) has a large painted advertisement for cigars. The elevation holds original arched two-over-two windows and a rear loading bay opening enclosed with vertical wood panels. The rear (east) elevation has a frame loading dock. Window openings are arched and hold original lights. The rear elevation doors are modern but retain their original transoms and brick arches.

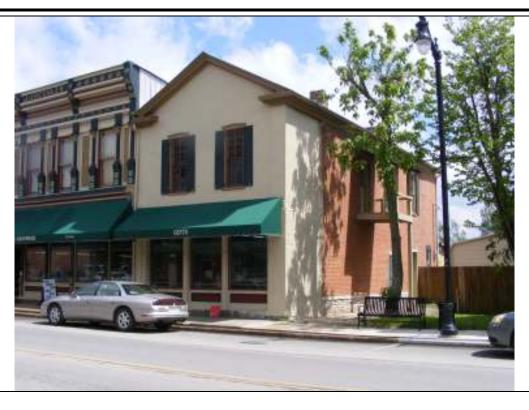
Photographer:	Date:	Description:
Ruth Keenoy	April 29, 2010	Primary elevation, view is northeast.

The property is a two-story, gable-front plan building with a metal clad roof, brick exterior, and limestone foundation. The lower façade was altered c. 1980 with removal of the lower façade entry, transom and windows. Currently the lower façade has three bays of fixed-sash commercial style windows. A canvas awning extends above the first floor windows. The upper façade holds two original windows of four-over-four design. The windows retain Greek Revival style hoods and the front gable returns also reflect Greek Revival detailing. Entries are noted at the south elevation at both the first- and second-story levels. The upper story entrance is original although the associated staircase has been removed.

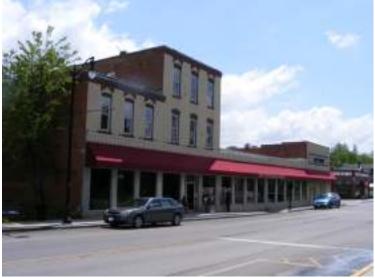
Photographer: Date: Description: Ruth Keenoy April 29, 2010 Primary elevation (north end), view is southeast.

The property consists of two nineteenth-century buildings at the north and south ends of the building block, connected by a low one-story modern wing (c. 1975). The north end of the complex consists of a two- and three-story commercial property that was associated with the Kemper Family and used as a furniture store/cabinet shop. This end of the property retains original brick decorative window hoods and sills, though lights are replaced by contemporary one-over-one windows. Window openings are arched (second and third-story levels). The lower storefront holds a modern glass and aluminum door flanked by multiple single-light commercial windows. This pattern continues along the entire façade, including the c. 1975 wing and south (nineteenth-century) wing. The south wing is a brick two-story building (c. 1890) with a stepped parapet and roofline coping. The façade of the wing has c. 1975 linear narrow windows and a contemporary glass and metal door with fixed sidelights. The wing has a prefabricated attached one-story rear wing addition that faces Second Street (which borders the east end of the lot).

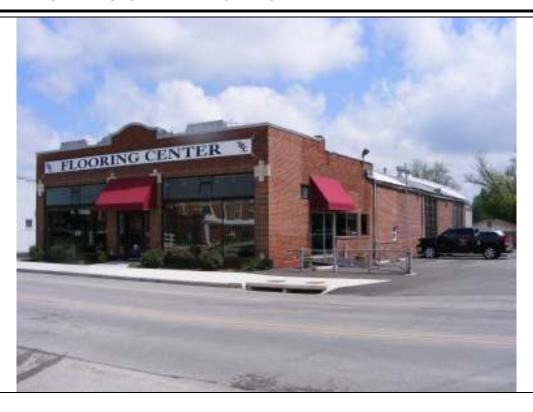
Photographer:	Date:	Description:
Ruth Keenoy	April 29, 2010	Primary and south elevations, view is northeast.

The property is a brick commercial property probably constructed as an automobile showroom and garage. The primary elevation features an arched parapet capped with terra cotta tile. Decorative terra cotta scrollwork flanks the parapet. The primary elevation is centered at the façade and holds a contemporary glass entry and surround. The bay is flanked by fixed commercial style windows that retain upper glass block transoms. Terra cotta cross patterns flank either end of the upper window bays and the central entry. A canvas awning (contemporary) stretches above the entry. The south elevation holds a contemporary entry (with a canvas awning) offset by modern single-pane windows. The east end of the building supports an original rear brick wing/garage. The wing has a barrel vaulted roof clad with metal. Original multi-light hopper windows are noted at the wing's north and south elevations. The north elevation retains three garage bay openings with overhead track doors. A more modern wing is noted at the northeast corner which has prefabricated siding, a gabled metal roof, and a concrete foundation.

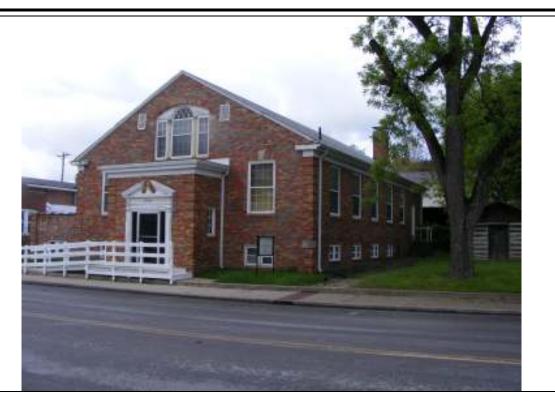
Photographer:	Date:	Description:
Ruth Keenoy	April 29, 2010	Primary and north elevations; view is southwest

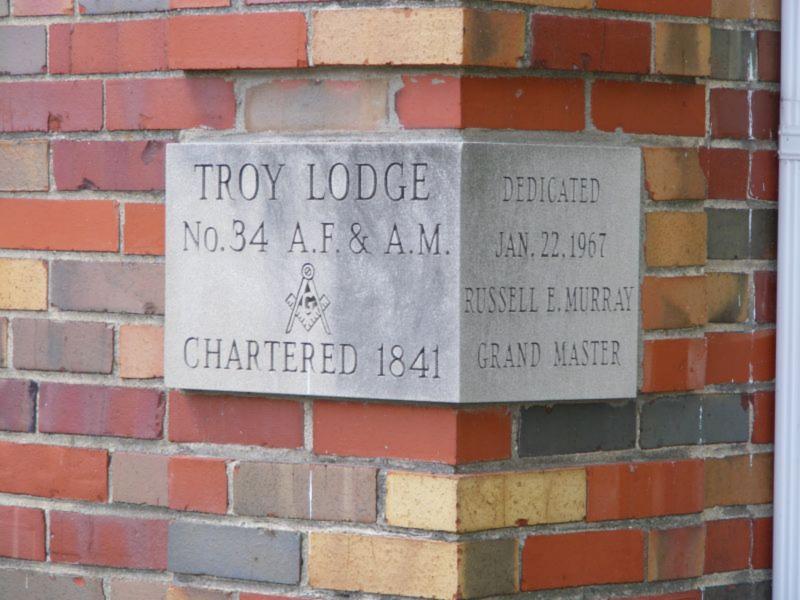
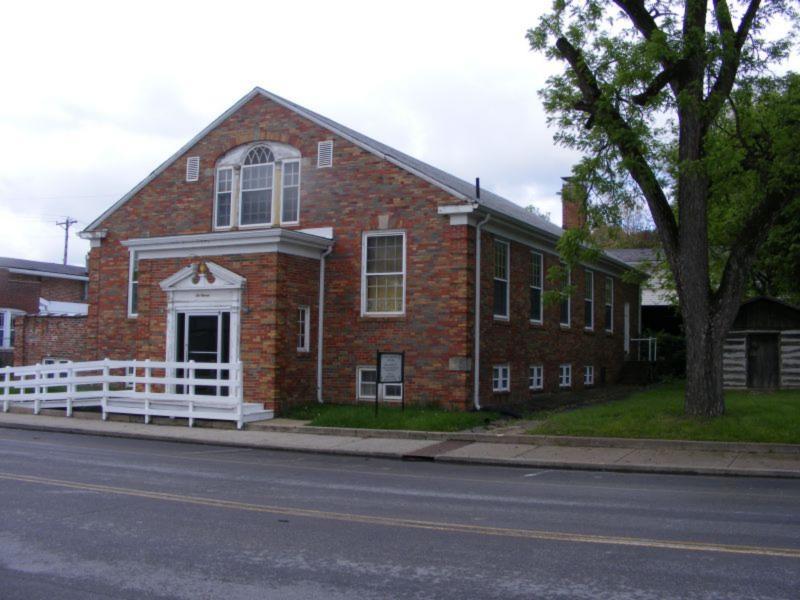
The property is a 1.0-story gable-front plan church with an asphalt-shingled gabled roof and exterior brick walls. The primary (east) elevation holds a central enclosed vestibule with a flat hipped roof. The entry (vestibule) projecting bay holds a commercial style glass door set within an original Colonial Revival style surround that has a broken pediment and engaged fluted pilasters. Above the entrance is a Masonic Lodge sign. The vestibule walls (north/south) hold original six-light single-sash windows. Flanking the vestibule are single windows of 12/12 double-hung design. Within the gable field (above the entrance) is an original arched tri-partite window bay with decorative engaged pilasters (dividing the three windows) and a Gothic light arch. Vents flank the upper gable bay window. Also visible at the façade are gable returns. An added date stone (at the northeast building corner) indicates that the property has been in use as a lodge since 1967. Visible near the foundation are windows, indicating that the building has a full basement. The south elevation has a one-half story wing with a shed roof. North and south elevations retain original windows (12/12 design), one of which has been covered at the south elevation. Fronting the building façade is an attached frame ramp with a frame handrail.

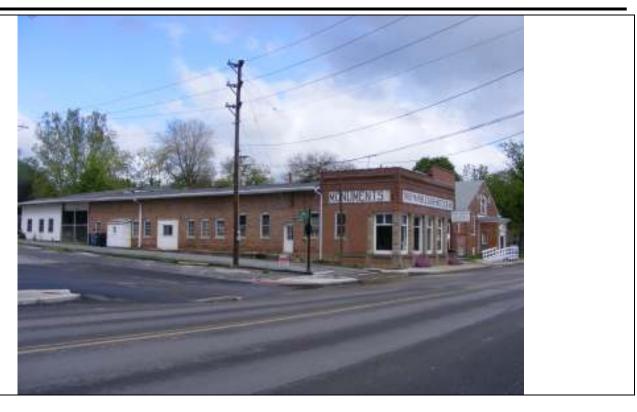
Photographer:	Date:	Description:
Ruth Keenoy	April 29, 2010	South and primary (east) elevations; view is northwest

The Troy Marble & Granite building is a one-story brick building with a flat and gabled roof. The building is constructed of brick and rests on a concrete foundation. There are two entrances at the façade – one is centrally located and recessed with paired single-light doors. The other entrance is situated at the building's northeast corner. This entry is recessed and holds a single-light door. A single marble column with a Corinthian capital supports the umbrage style corner porch, which is flanked by engaged limestone pilasters at either side of the porch. The column rests on a date stone that bears the imprint of "1905" – the date of the business's establishment (not the building's construction). The east end of the property (façade) has commercial style (storefront) windows of two over one design. Although the window glass does not appear original, the windows are in their original fenestrations. Some windows at the side (north and south) elevations are replacement one-over-one design. These lights were originally two-over-two design. Side elevation windows retain brick arches and sills. The rear linear wing at the west end of the building, which holds the work area, has original windows of six-over-six design, a small shed projection, and an enclosed garage bay that holds a two-light modern window. The west end of the rear wing appears to have been open in plan originally but has recently been enclosed with synthetic materials. The south elevation of the enclosed wing holds four modern double-hung windows.

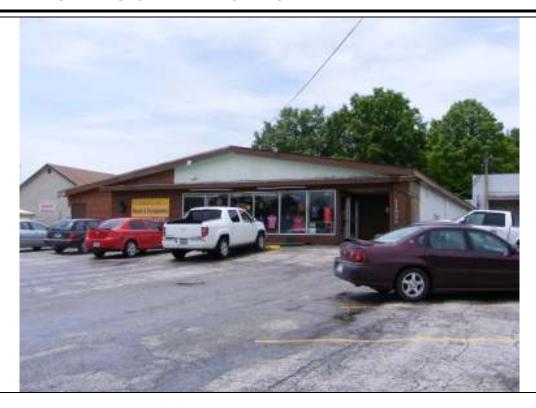
projecting shed wing that is clad with brick veneer and synthetic metal siding. The façade projection holds a five single-light commercial style band of windows that is offset at the north by a recessed modern glass/aluminum commercial style entry. The east (primary) elevation has a secondary solid metal door near the south end of the façade. The side (north/south) elevations have concrete block buttresses. A secondary solid door is noted near the west end of the north elevation. At the northwest corner of the building is a c. 1940 one and a half-story wing. The wing has a shed roof, exterior synthetic siding, and an overhead garage style door on the primary (east)

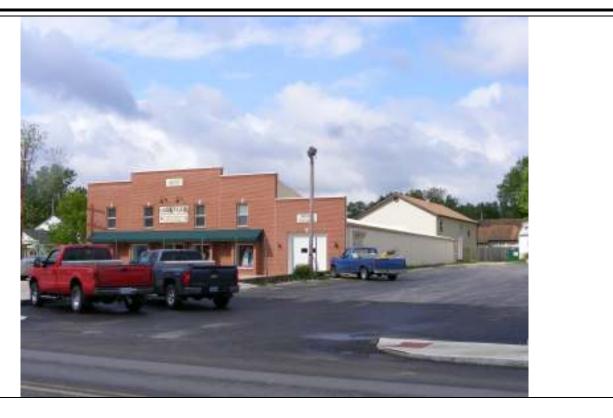
Photographer:	Date: April 29, 2010	Description:
Ruth Keenoy	April 29, 2010	Primary (east) and north elevations; view is southwest

The building has a flat roof, exterior brick walls, and a concrete foundation. Windows and doors are modern design. The primary entry is centrally located on the façade (east wall) and holds paired single-light commercial style doors. Lower story windows are all fixed sash with large single lights. A modern awning extends above windows and the primary entrance at the first-story level. Second floor windows are one-over-one design. The upper floor windows retain keystones and brick jack arches. At the north elevation is a one-story wing with a garage bay (east elevation) that holds an overhead track door.

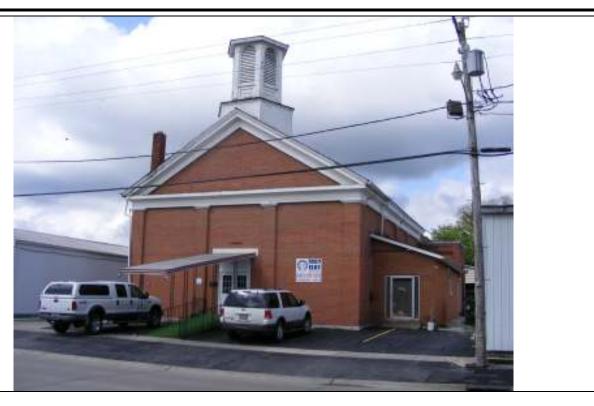
Photographer:	Date:	Description:
Ruth Keenoy	April 29, 2010	Primary and north elevations; view is southwest.

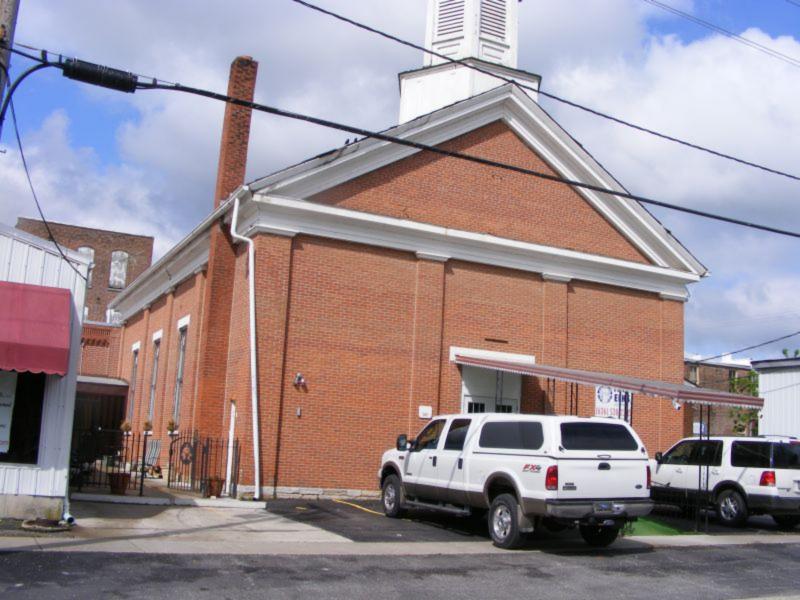
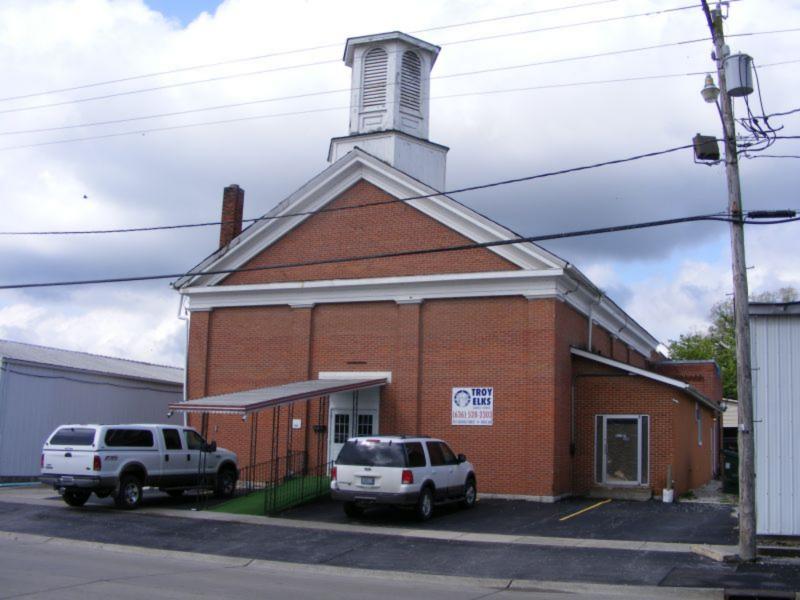
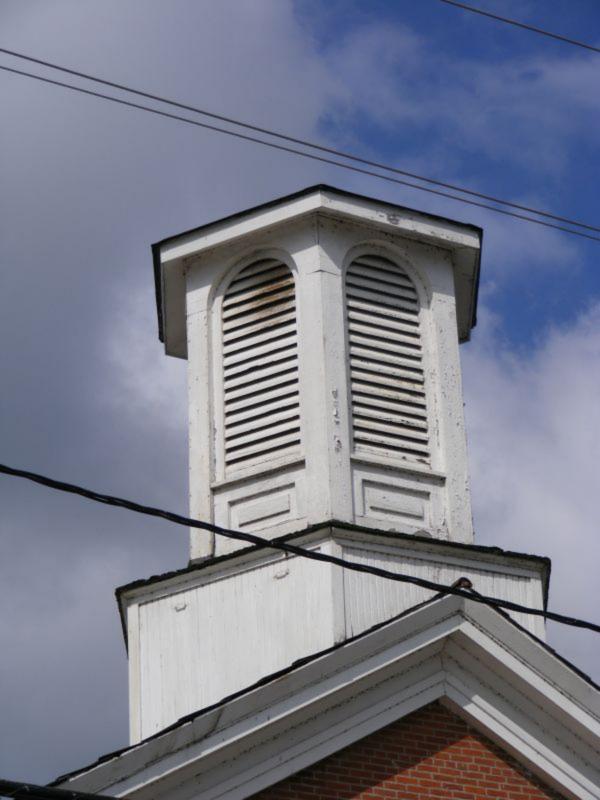
The former Church of Christ in Troy is a brick gable-front plan early nineteenth-century building that has been modified since construction. The primary (east) elevation entrance, which is centrally located on the elevation, has modern paired six-light doors. The original lintel remains (above the doors), as do the solid brick flanking bays. These bays did not hold any openings originally. A prefabricated metal awning extends above the walk that leads to the entrance toward Second Street. The building retains an original pediment above the entrance, as well as brick buttresses on the primary and side elevations. The steeple has been removed; though the louvered frame base remains at the roofline ridge. Original window openings are intact on the south elevation; but all (four) original windows on the north elevation are covered by a 1950s-era shed brick wing. The building has a rear "T" wing with decorative brick corbelling that appears to date to the building's 1911 renovation.

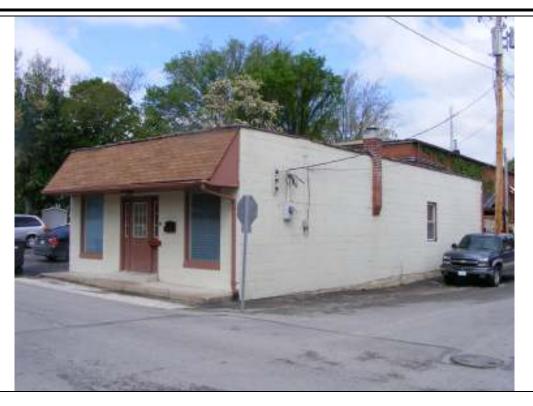
Photographer:	Date:	Description:
Ruth Keenoy	April 29, 2010	South and east elevations; view is northwest.

This one-story concrete block building appears to have been re-oriented since original construction. Currently, the building is addressed to indicate that it faces Wood Street. The elevation that is currently designated as the rear, however (facing north toward Cherry Street) is clad with exterior (original) brick veneer. This elevation also has an original jack arch that may have stretched above a commercial storefront or garage style opening. Both the north and south elevations hold single central doors (modern). Each entry is flanked by single windows (not original) of fixed sash (south) and one-over-one (north) design. The south elevation has a modern shed awning with asphalt shingles that extends above the door/windows. The building has metal roofline coping.
