National Register of Historic Places Registration Form

1. Name of Property	
historic name <u>Farmers Bank Building</u>	ara an an Arthrean Arthrean Arthrean an Arthrean A Arthrean Arthrean Art
other names/site number <u>Citizens Bank of Norbor</u>	ne

2. Location	
	n and for a set
street & number 114 South Pine Street	
city or town <u>Norborne</u>	
state <u>Missouri</u> code <u>MO</u> county <u>Carrol</u>	1 code 033 zip code 64668

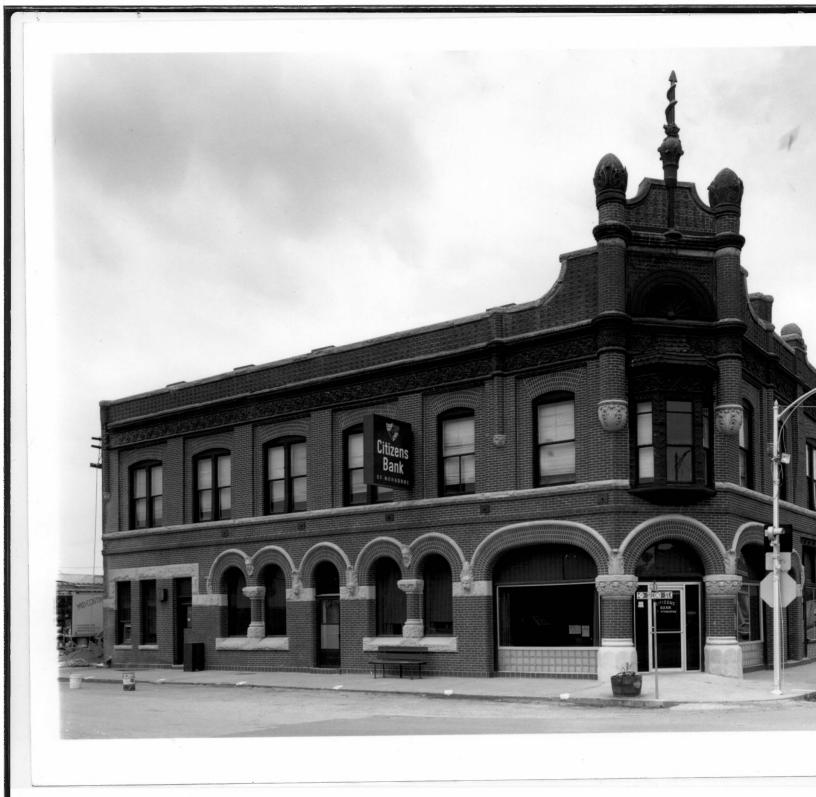
#1

SOUTH AND EAST FACADES; VIEW LODKING NORTH WEST

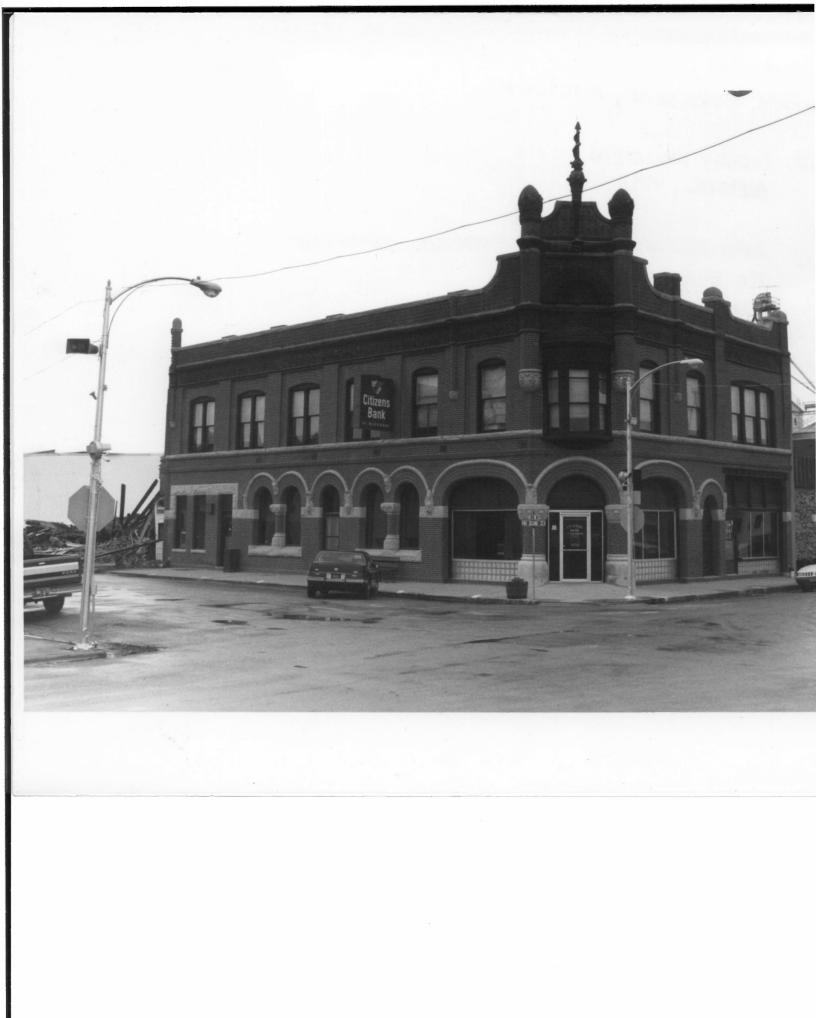
Farmers Bank Bruilding 114 S. Pine Atreet Orroll County, Missonia John W. Gutowski, photographer May 3, 1994 negative lostion: Architectural and Art Historicse Research View of Sorutheast Façade; facing northwest # 2

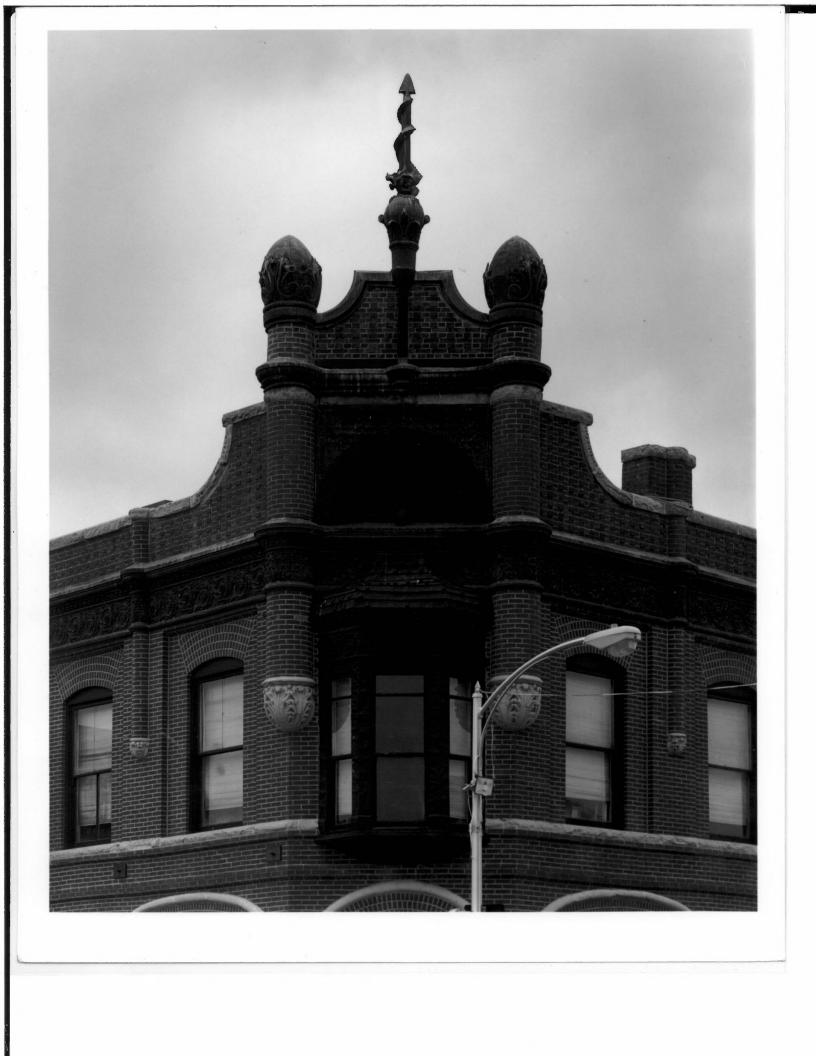
PARTIAL DOWTH AND EAST FACADES; VIEW LOOKING NORTHWEST #2

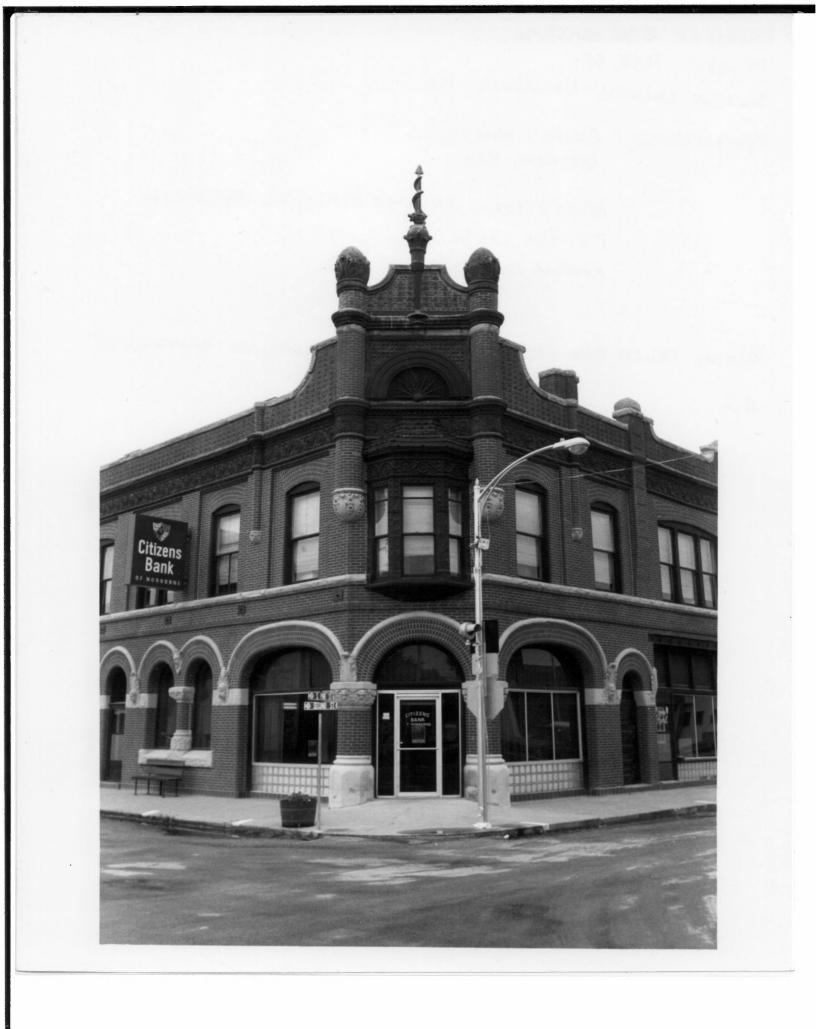
#3

EAST AND PARTIAL NORTH FACADE; VIEW LOOKING SOUTHWEST

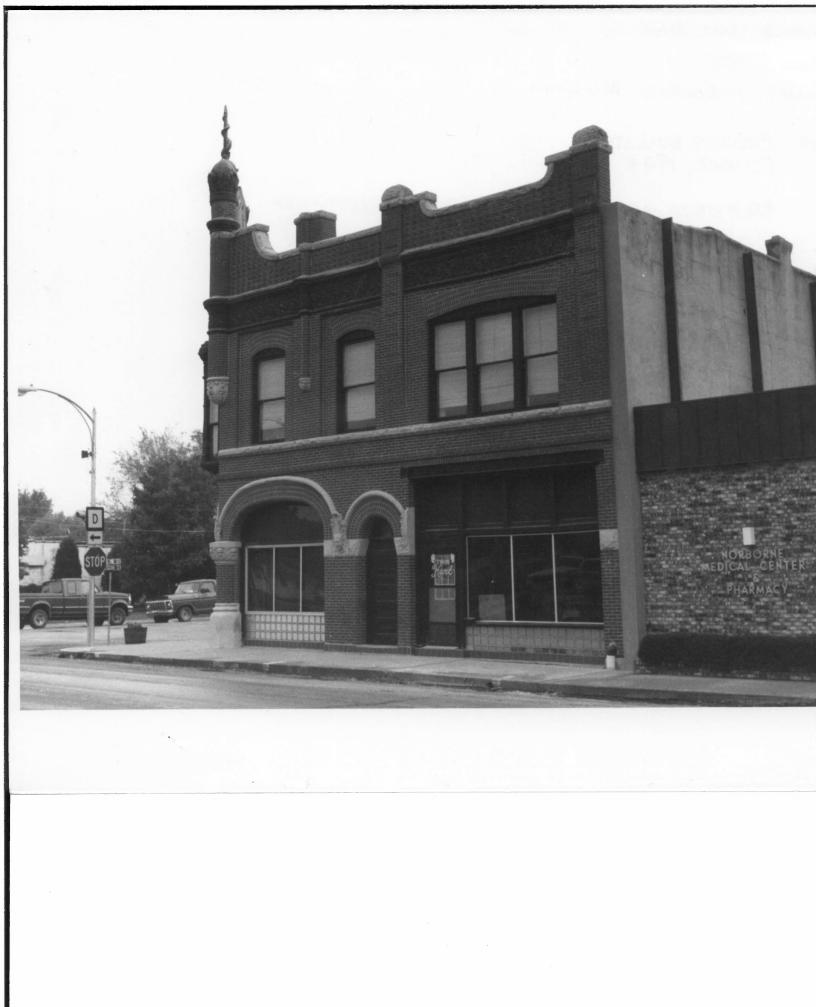
Farmers Bank Building 14 S. fine Atkeet Overeoll County, Missonia John W. Gutowski, photographer May 3, 1994 Negative location: Architectural & Art Historical Research View of south Façade; Facing portheast #3

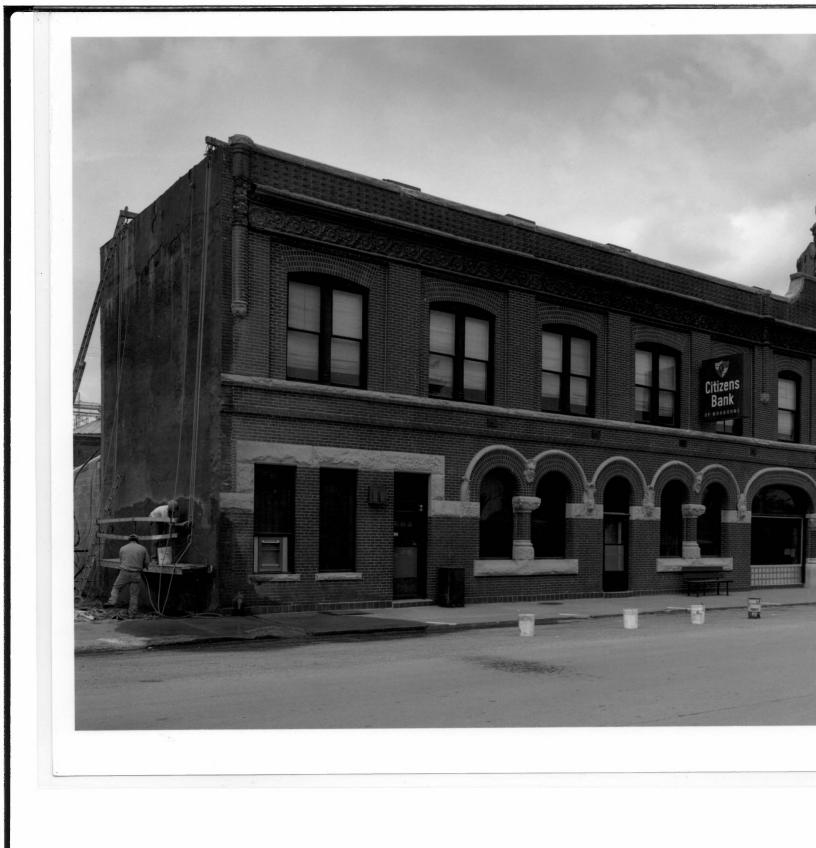
#4

SOUTH AND PARTAL WEST FALADES, VIEW LOOKING NORTHEAST

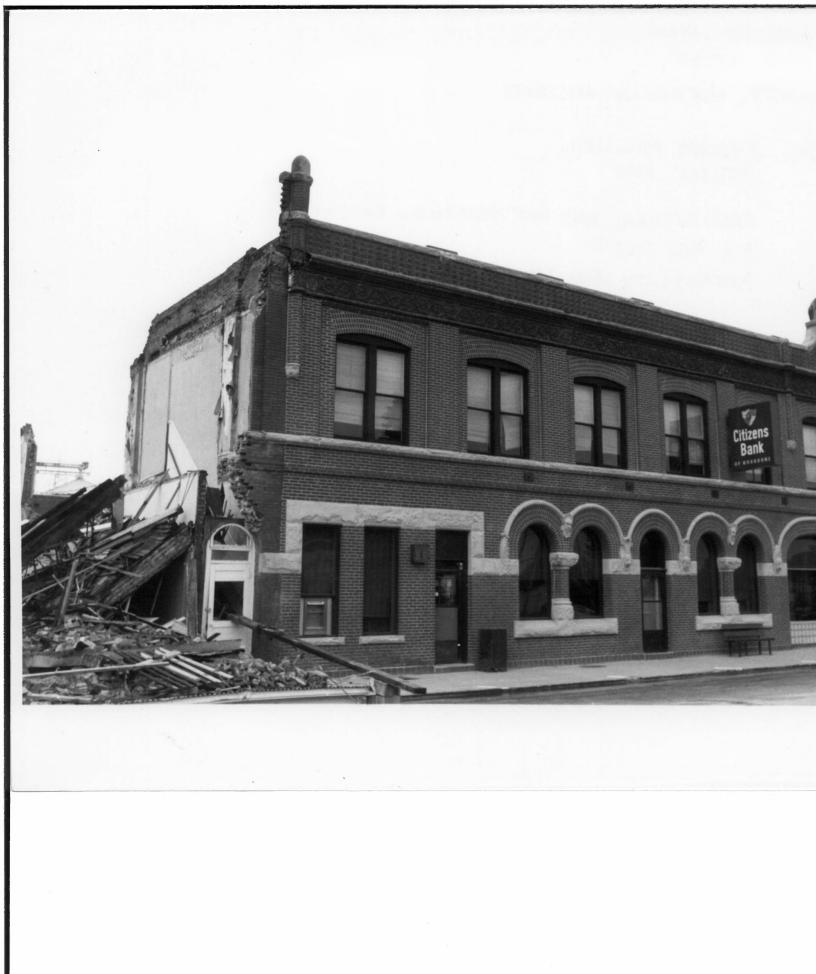
Farmers Bank Building 1145. Pine Street Corroll County, Missonia John W. Gutowski, photographen May 3, 1994 Negative location: Architectural : Art Historical Research detail of South Facade; facing north # 4

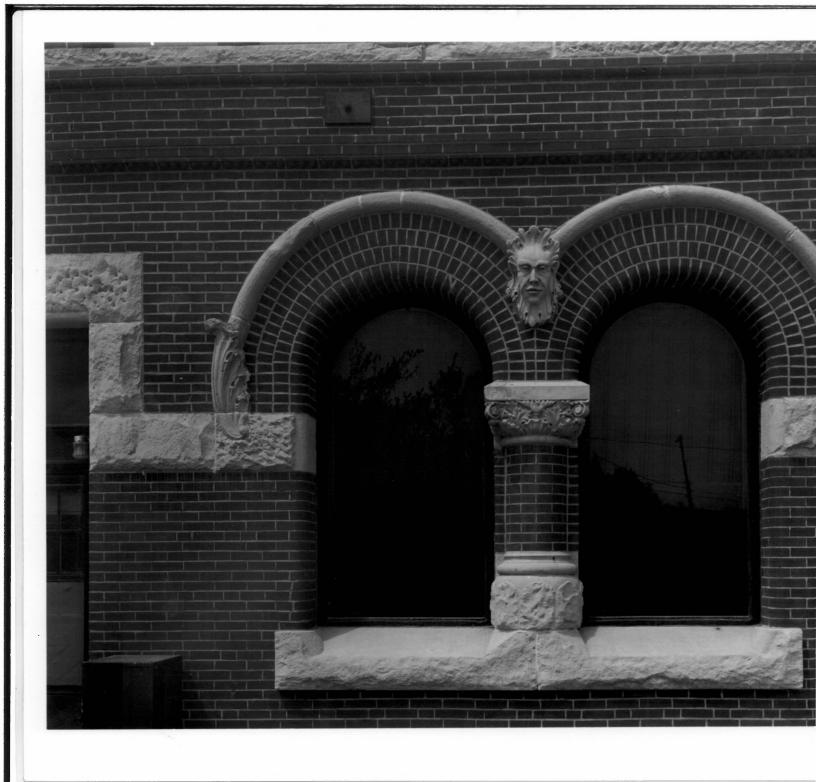
#5

DETAIL - SOUTH FACADE; VIEW LOOKING NORTH

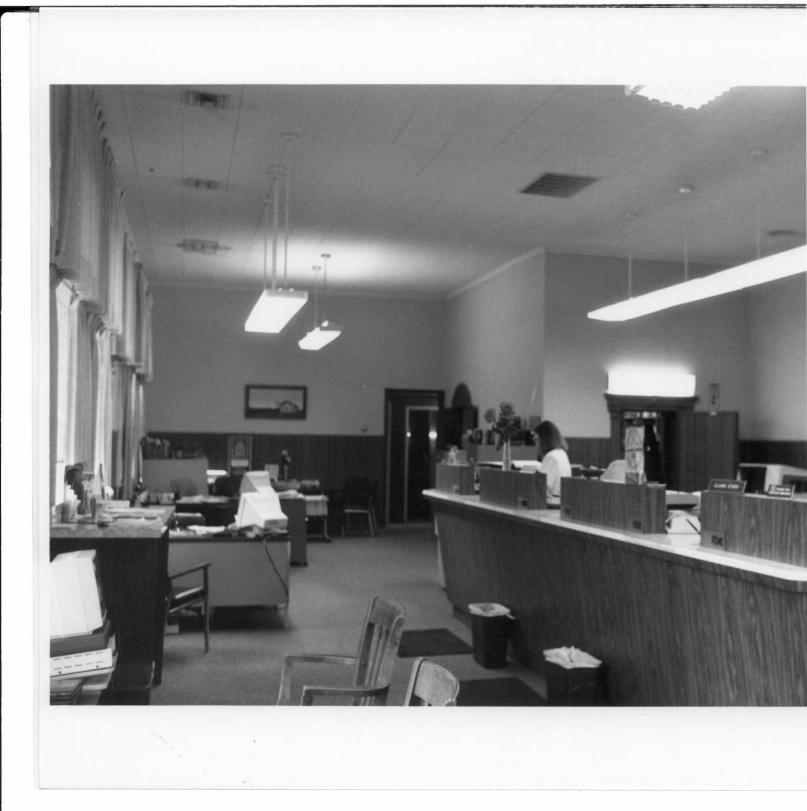
Farmers Bank Bruilding 114 S. Pine Atreet County, Missonia John W. Gutowski, photographer May 3, 1994 Negative location: Architectural = Art Historical Tasearch brew of worth and west facades : facing southeast # 6

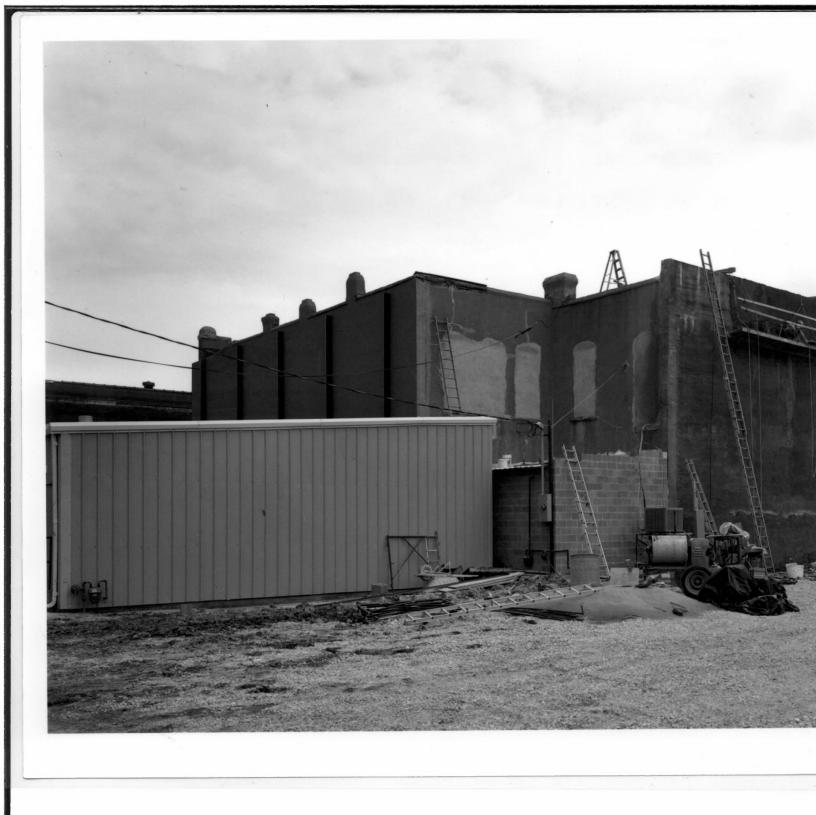
Shroll County: Missonia John W. Gutowski, photographen May 3, 1994 Negative location: Architectural i Art Historical Research West Façade; facing east #7

Due to high water during the flood of the Summer of 1993, the foundation of the historic building adjacent to the west of the Farmers Bank Building failed and the building collapsed. This occurred on September 26, 1993.⁴ Subsequently, the portion of the west facade of the Farmers Bank Building that was originally a fire wall, has been recently covered with plaster to protect the exposed surface. The remaining portion of this facade, an "L"-shaped area approximately 15 x 17 feet at the northwest corner of the building, was also covered with plaster due to damage from the failure. All original window openings at this area have been infilled.
