# **SURVEY REPORT FIFTH STREET SURVEY**

**CITY OF WASHINGTON  
FRANKLIN COUNTY, MISSOURI**  
[CDFA # 15-904]

**AUGUST 2014**

Submitted by:  
Landmarks Association of St. Louis, Inc.  
911 Washington Avenue, Suite 170  
St. Louis, Missouri 63101  
314-421-6474

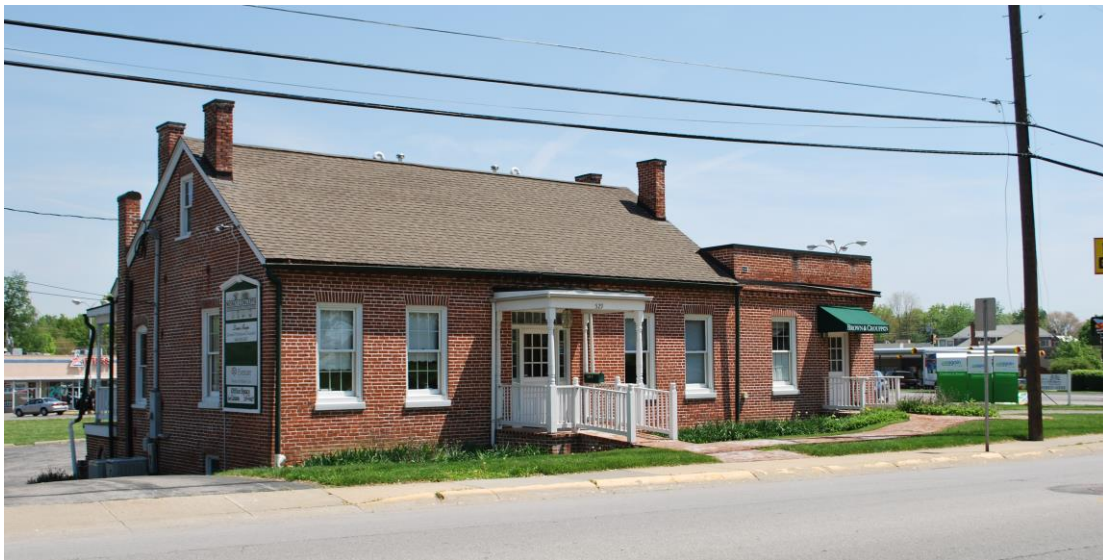
Surviving buildings from the earliest period of development in the survey area (c. 1850-1870) are constructed of brick and can be classified as subtypes of either Property Type A: Neo-Classical, or Property Type B: Vernacular Missouri-German as defined by the MPDF.<sup>21</sup> As noted in the MPDF, these categories overlap to a certain extent and both may be appropriate descriptors for some buildings. Buildings falling into these categories are one- or one-and-one-half stories with side gabled roofs and modest ornamentation that includes a virtually ubiquitous dentilled cornice. For example, a building that could be classified either as Neo-Classical: Federal subtype or as an early Vernacular Missouri-German: Center Hall survives at 529 E. Fifth (Figure 8). The building has a central entry surrounded by multi-paned sidelights and transom flanked by pairs of jack arched windows. A simple dentilled cornice delineates the roofline and paired chimneys extend from its side gabled roof.

**Figure 8. 529 E. Fifth Street, example of a neoclassical federal subtype dwelling, view is northeast.**

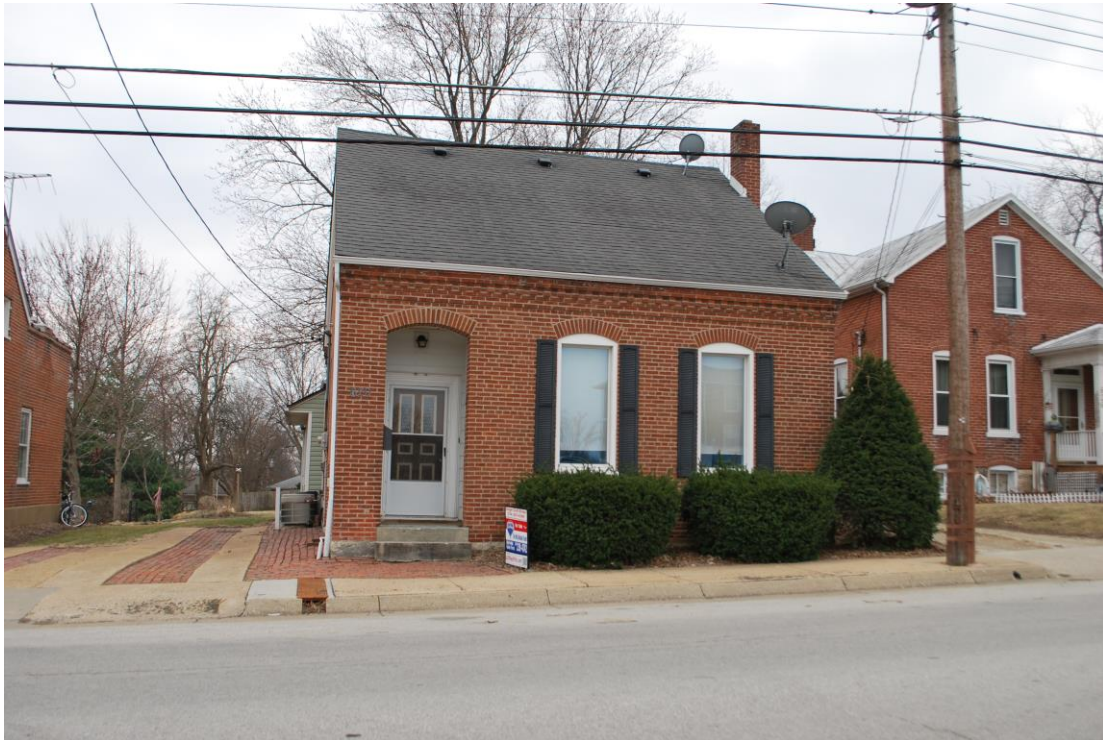
On the other side of the survey area at 618 W. Fifth Street is an example of what may be best characterized as an early Vernacular Missouri-German house of the Center Hall subtype (Figure 42). Five bays wide with a side gable roof, the building exhibits jack arches that typify older examples of the style. The upper half story has a pair of jack arch window bays and the wide central entry has sidelights and a transom. Again a very modest dentilled cornice delineates the roofline. Next door at 620 W. Fifth Street is another example of a Vernacular Missouri-German house defined as a Side Entry subtype (Figure 9). This one story house has a side gable roof and

its fenestration consists of a door and two windows. All bays have segmental arches and the door is deeply recessed. The ubiquitous dentilled cornice is present.

**Figure 9. 620 W. Fifth Street, example of a side entrance plan Missouri-German vernacular dwelling, view is southwest.**

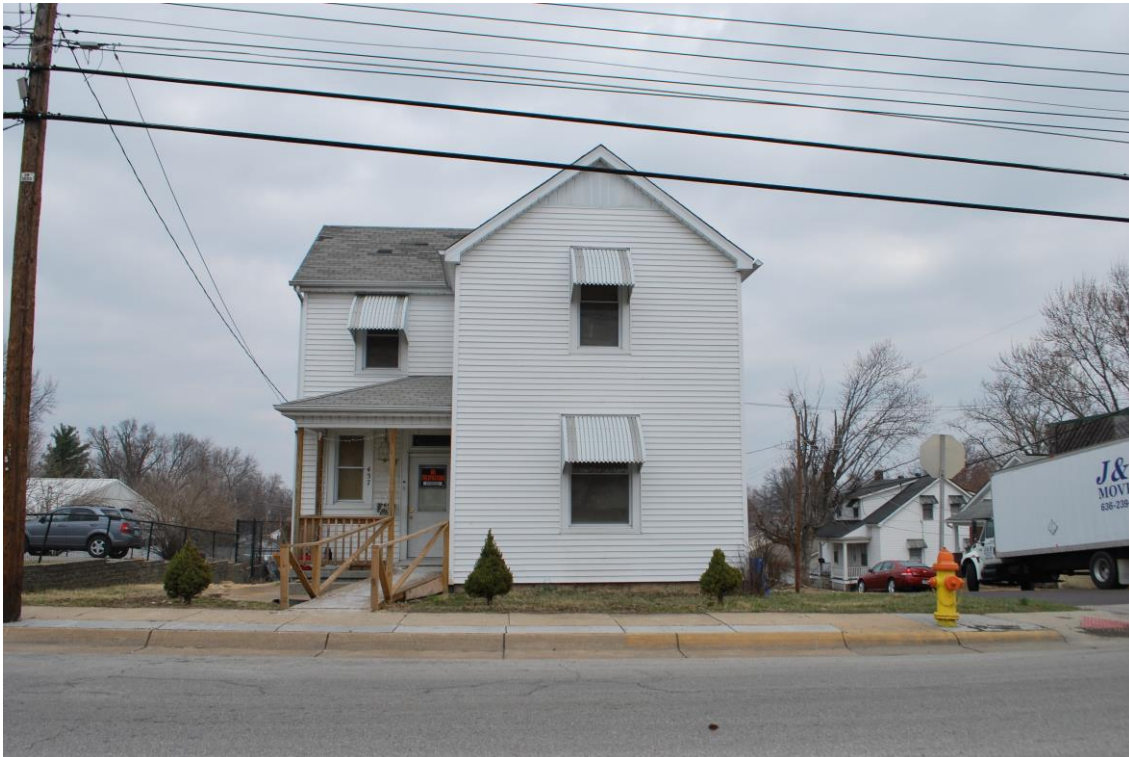
Figure 11. 437 E. Fifth Street, a modest plan Gabled Ell, view is north.

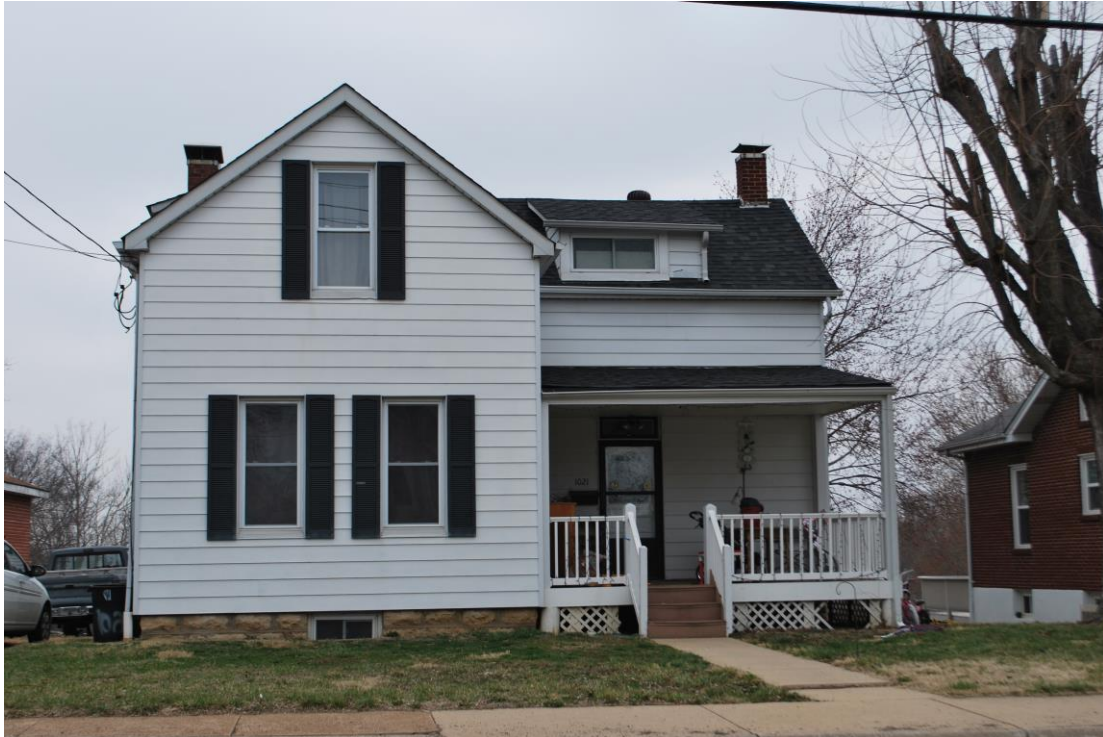
**Figure 12. 1021 W. Fifth Street, another example of the Gabled Ell plan dwelling, view is north.**

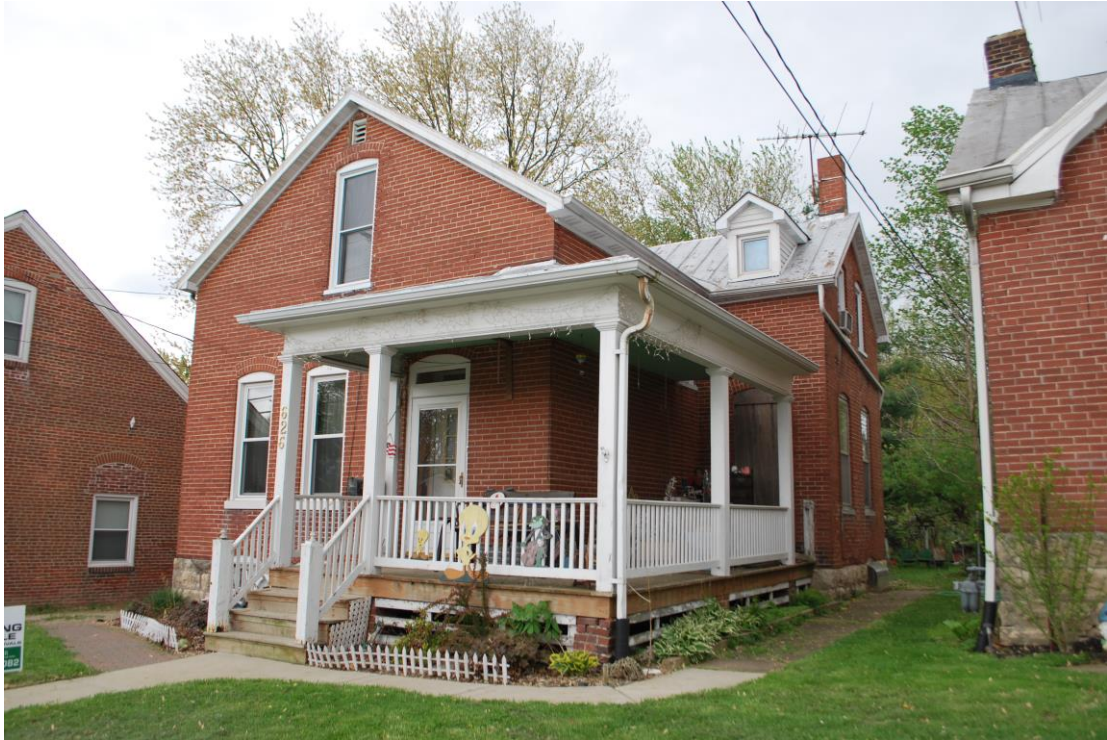
**Figure 13. 626 W. Fifth Street, example of a brick Gabled Ell plan dwelling, view is southwest.**

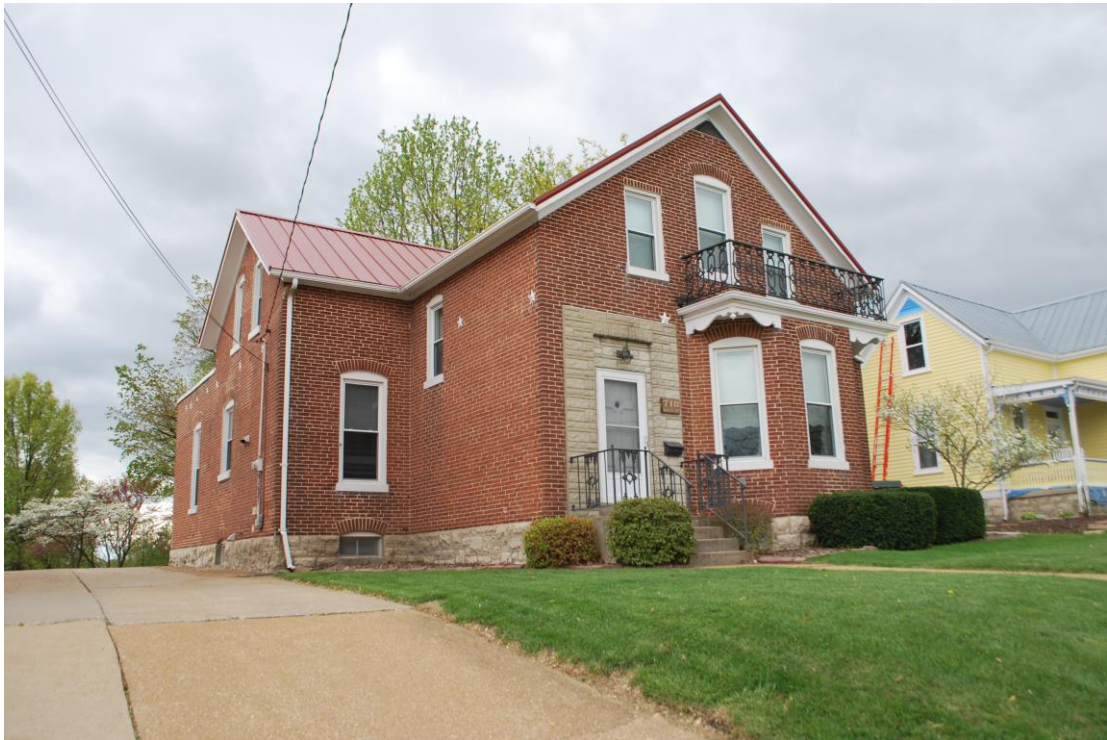
**Figure 14. 718 W. Fifth Street, narrow Gabled Ell plan brick dwelling, view is southwest.**

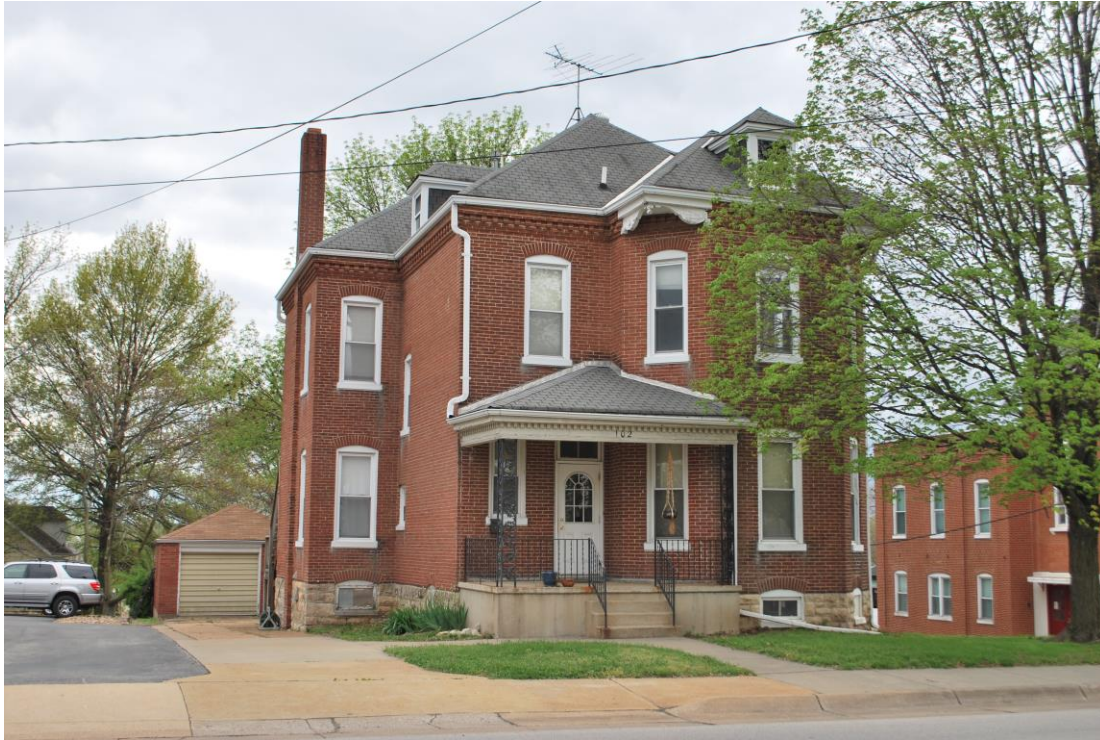
**Figure 15. 102 E. Fifth Street, example of a Victorian-influenced dwelling, view is southwest.**

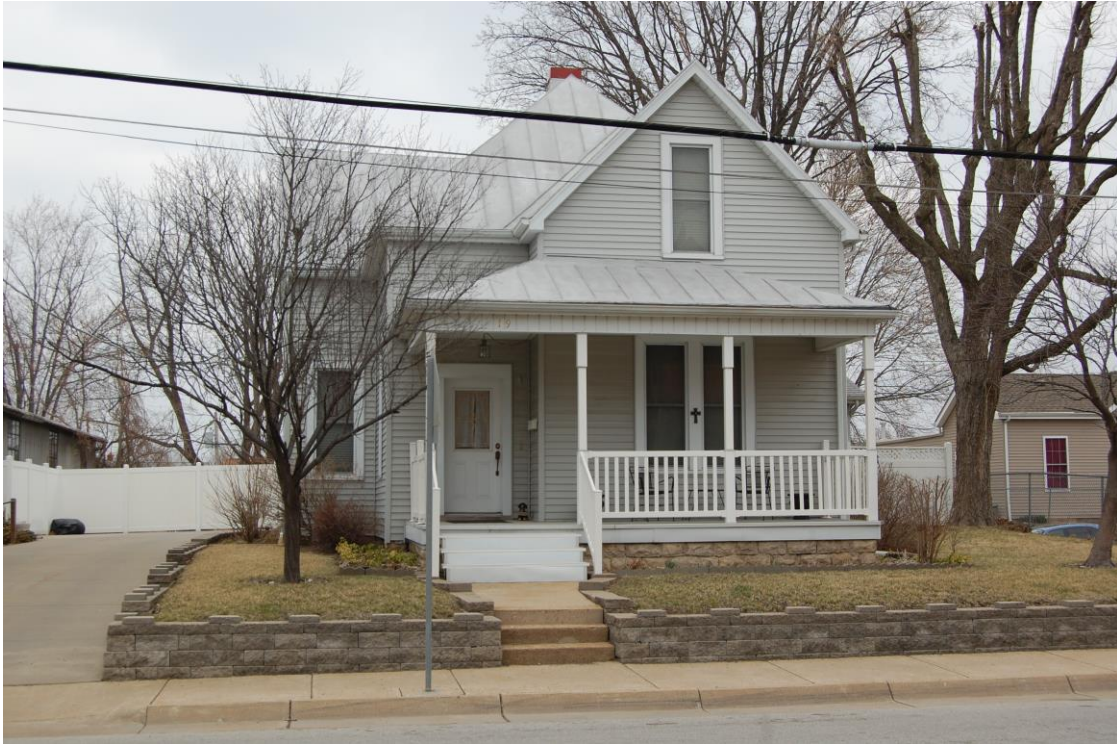
A frame building demonstrating the Victorian influence is located at 19 E. Fifth Street (Figure 16). This home has an irregular floor plan with a steeply pitched, complex, roofline, and a one-story porch that wraps the corner between the front gable and the central portion of the building.

Figure 16. 19 E. Fifth Street, view is northeast.

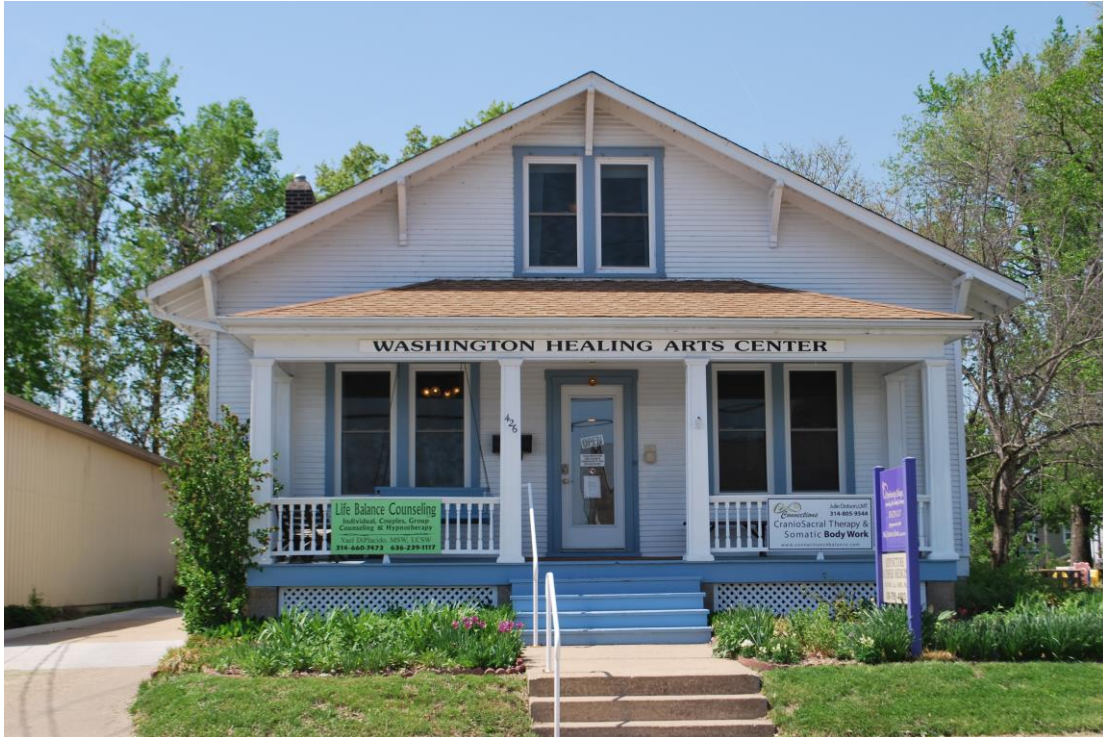
A less common building type present in the survey area is Property Type F: Gable Front. There are three residential examples and three commercial adaptations. The residential gable front houses are located at 124 E. Fifth Street (Figure 17), 426 E. Fifth Street (Figure 18) and 1013 W. Fifth Street (Figure 19). All are one-and-one-half stories tall with a nearly full width front porch. Stylistic details are minimal. Colonial Revival influence is seen in a pedimented door frame at 1013 W. Fifth Street, while Craftsman influence is detected with bracketed eaves at 426 E. Fifth Street and three-over-one windows at 124 E. Fifth Street.

Figure 18. 426 E. Fifth Street, view is south.

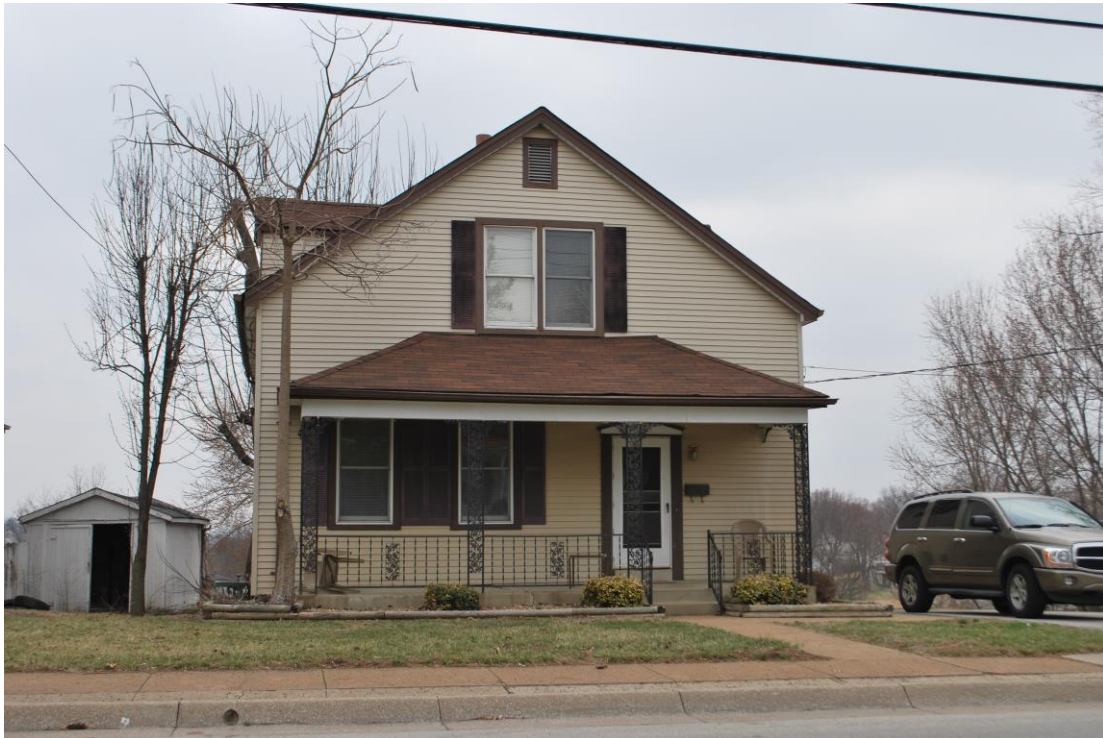
Figure 19. 1013 W. Fifth Street, view is north.

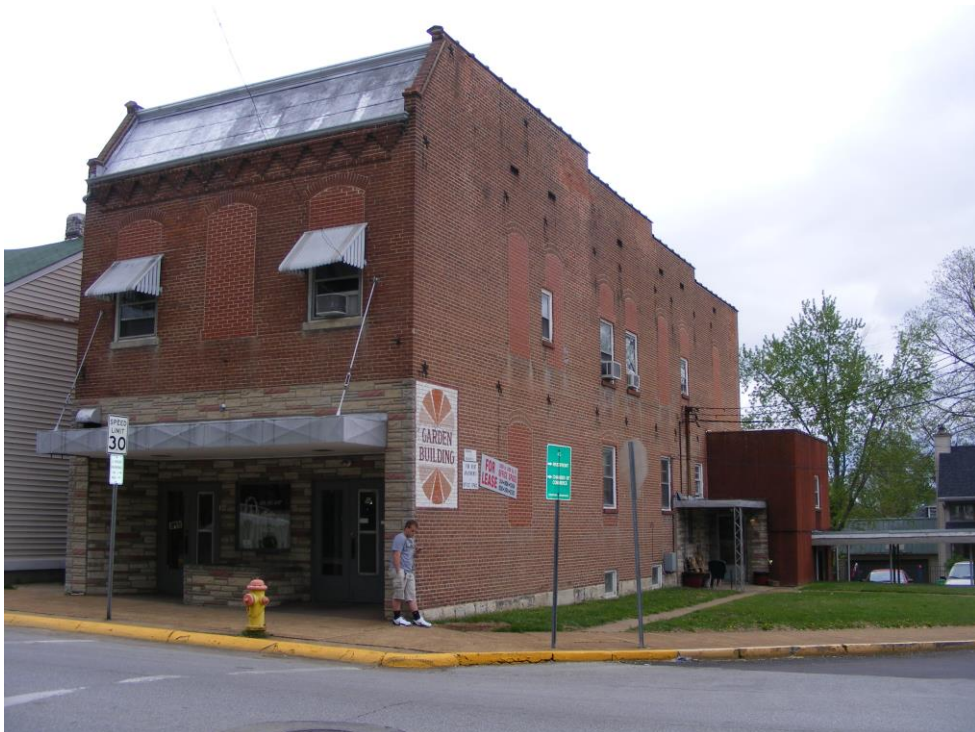
The most common form of commercial property in the survey area is the recognized Two-Part Commercial Block subtype. Examples in the survey area were constructed in both the nineteenth and twentieth century and range from the red brick building at 421 W. Fifth Street (Figure 44), which has an elaborate storefront and segmental arch windows on the second floor, to the variegated brick building at 401 E. Fifth Street (Figure 20) which has soldier arched window bays, an elaborate tile entry and a shaped parapet. While modest when compared to many of the commercial buildings in the central business district, some of the commercial buildings in the survey area display eye-catching ornamental embellishments such as the elaborate corbelling on the building at 401-403 W. Fifth Street (Figure 21).

Figure 21. 401-403 W. Fifth Street, view is northwest.

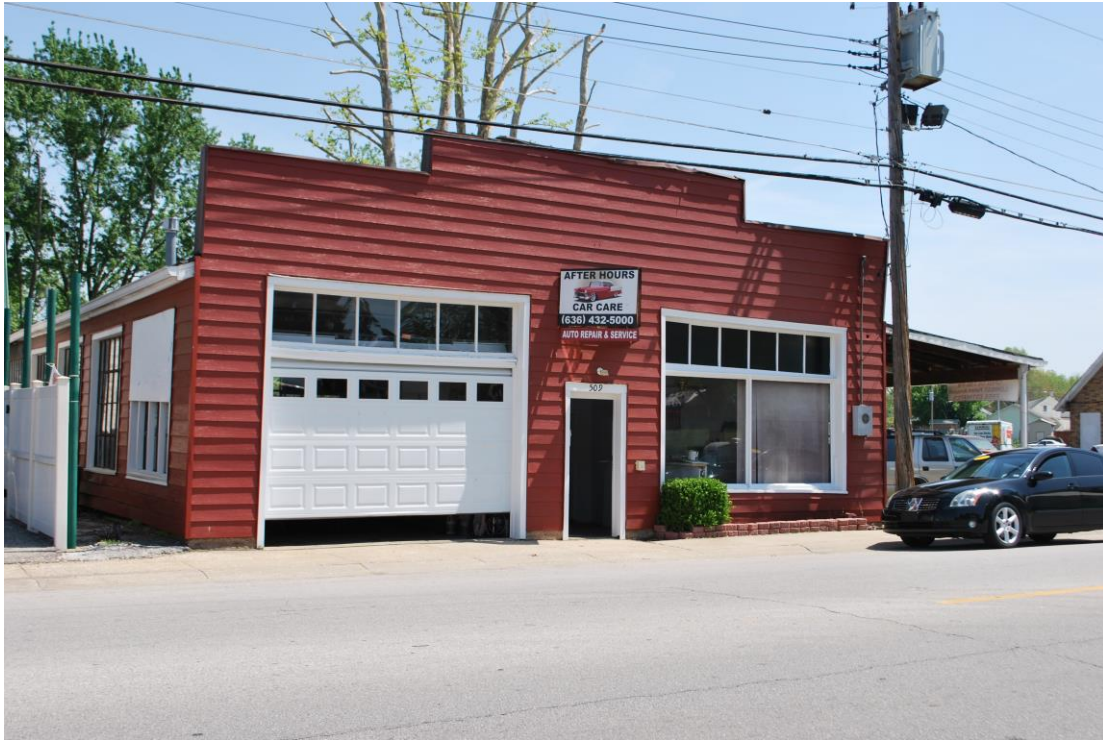
Other commercial buildings of note include an early twentieth century garage at 509 E. Fifth Street (Figure 22), a one-part commercial block with two doors and elaborate brick corbelling at its cornice at 415-417 W. Fifth Street (Figure 23), and a Tudor Revival style cottage service station at 515 E. Fifth Street (Figure 50).

Figure 22. 509 E. Fifth Street, view is northeast.

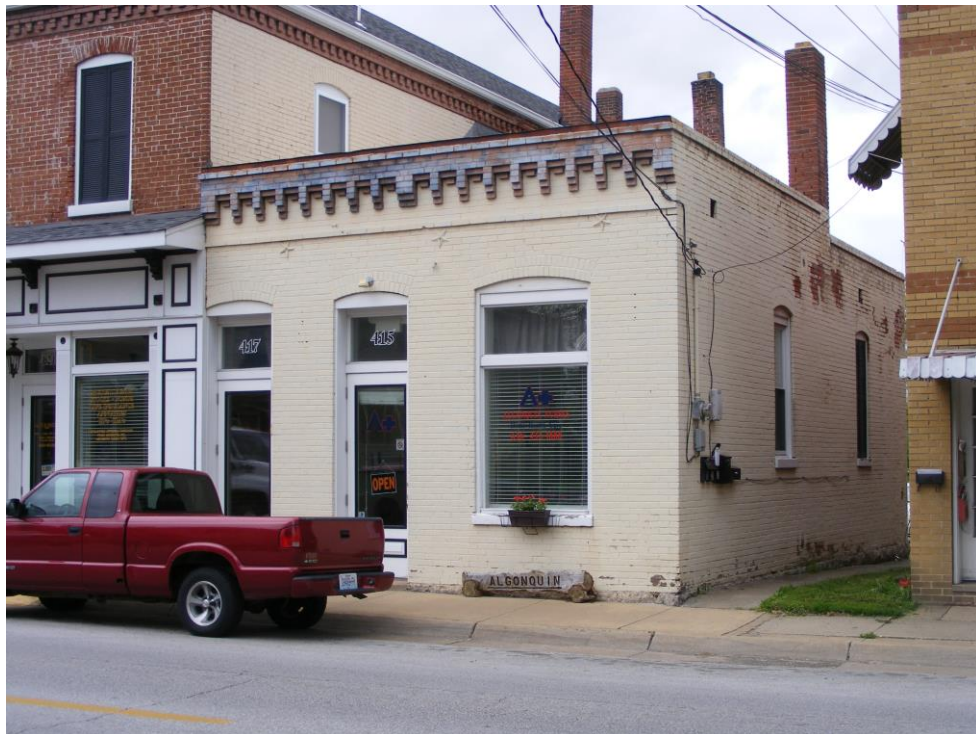
Figure 23. 415-417 W. Fifth Street, view is northwest.

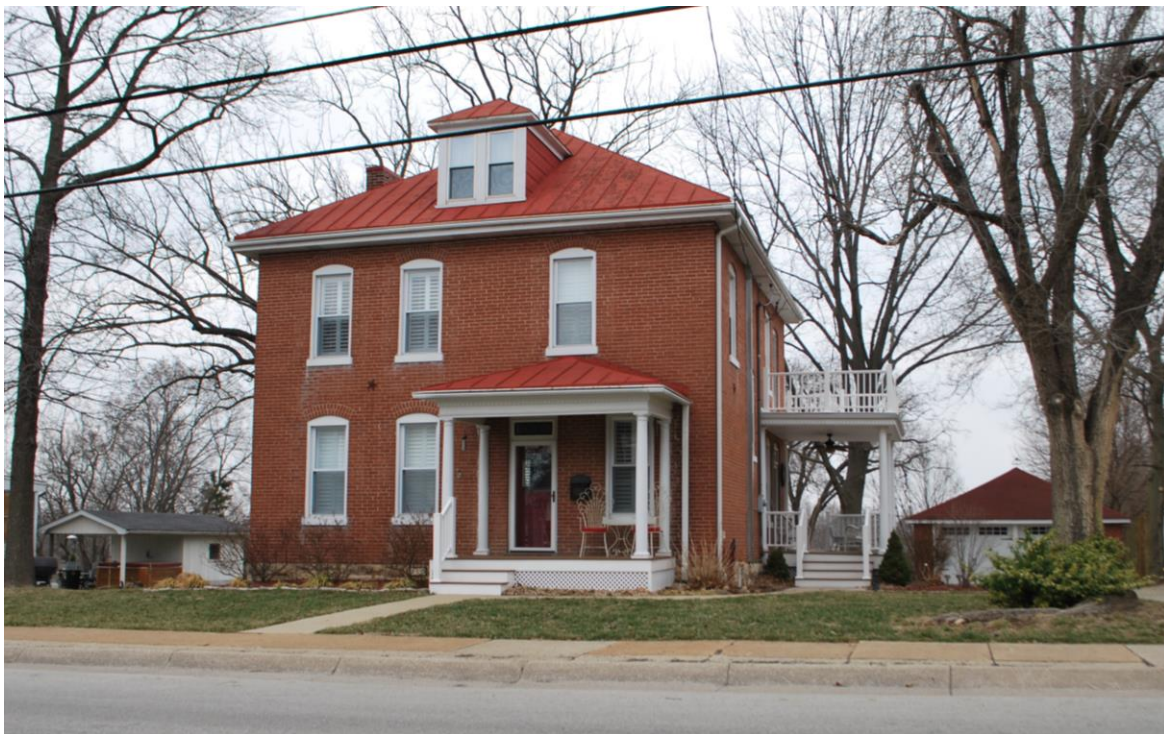
Another category of residential buildings that is identified by the MPDF and present in substantial numbers in the survey area is Property Type G: Foursquare. Constructed from the turn of the twentieth century through the 1930s, these two-story homes are constructed out of brick or frame and usually have modest ornament. In keeping with their early twentieth century vintage, stylistic details are usually Craftsman or Colonial Revival. Excellent examples of brick foursquare homes can be found at 915 (Figure 24), 806 (Figure 25), and 510 W. Fifth Street (Figure 26). While slightly less common, frame examples can be found at 502 (Figure 40) and 904 W. Fifth Street (Figure 27).

**Figure 24. 915 W. Fifth Street, an example of a Foursquare dwelling, view is northwest.**

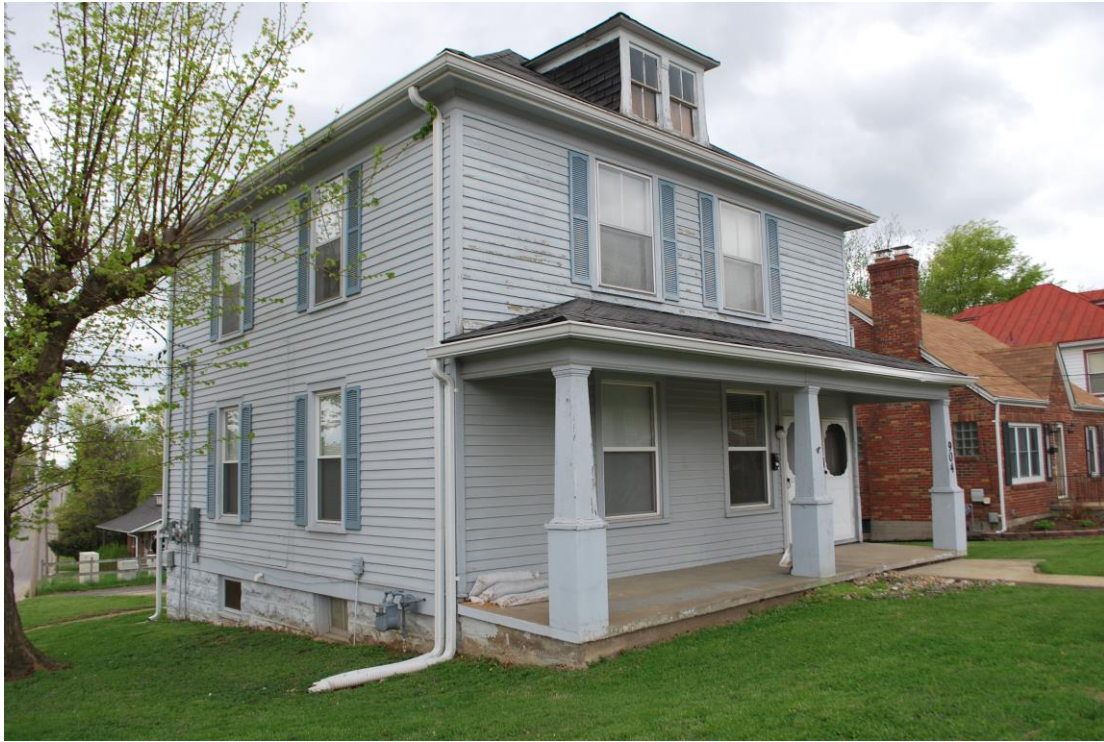
**Figure 27. 904 W. Fifth Street, view is southwest.**

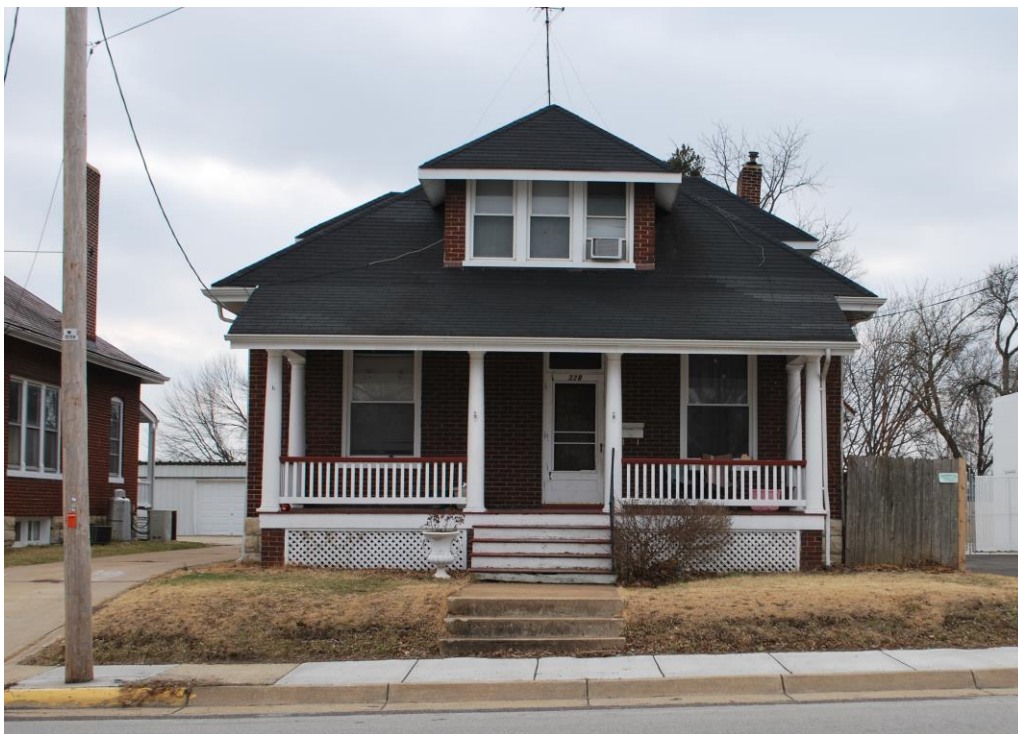
**Figure 28. 320 E. Fifth Street, a one and a half-story Bungalow, view is south.**

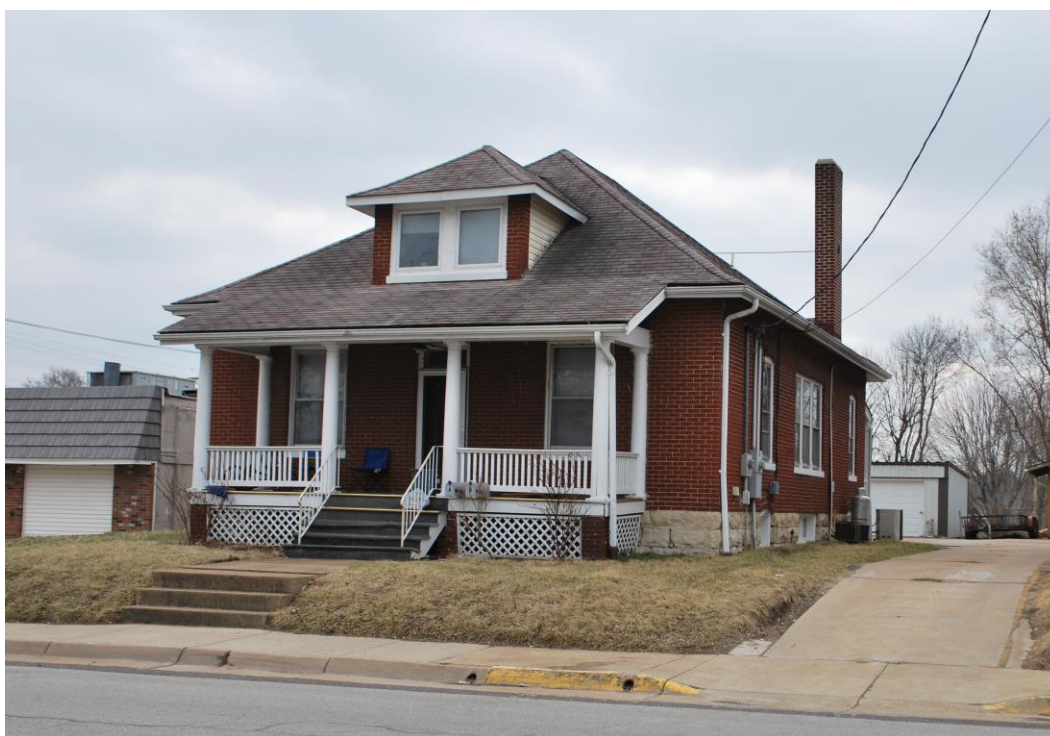
**Figure 29. 322 E. Fifth Street, a brick Bungalow, view is southeast.**

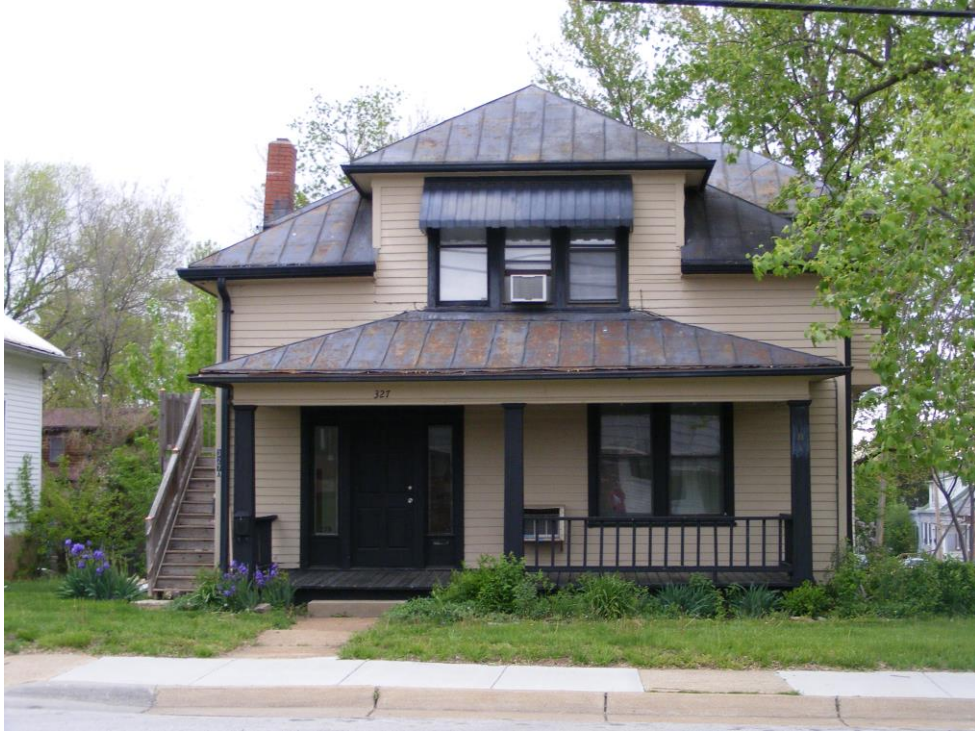
Figure 30. 327 E. Fifth Street, example of a frame hipped Bungalow, view is north.

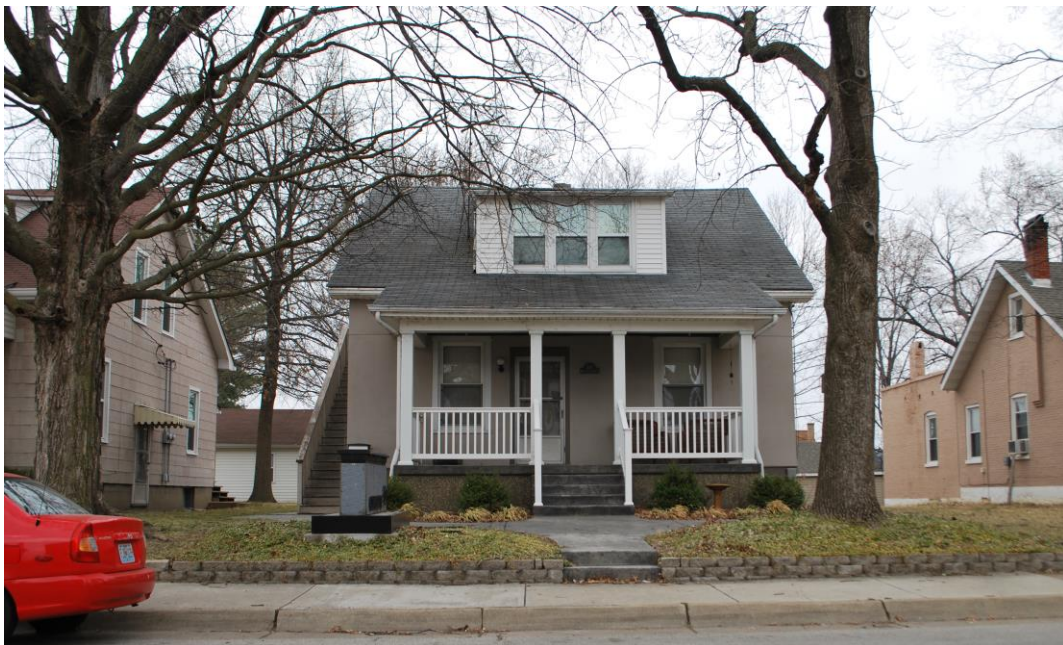
Figure 31. 507 W. Fifth Street, example of an end-gable plan Bungalow, view is north.

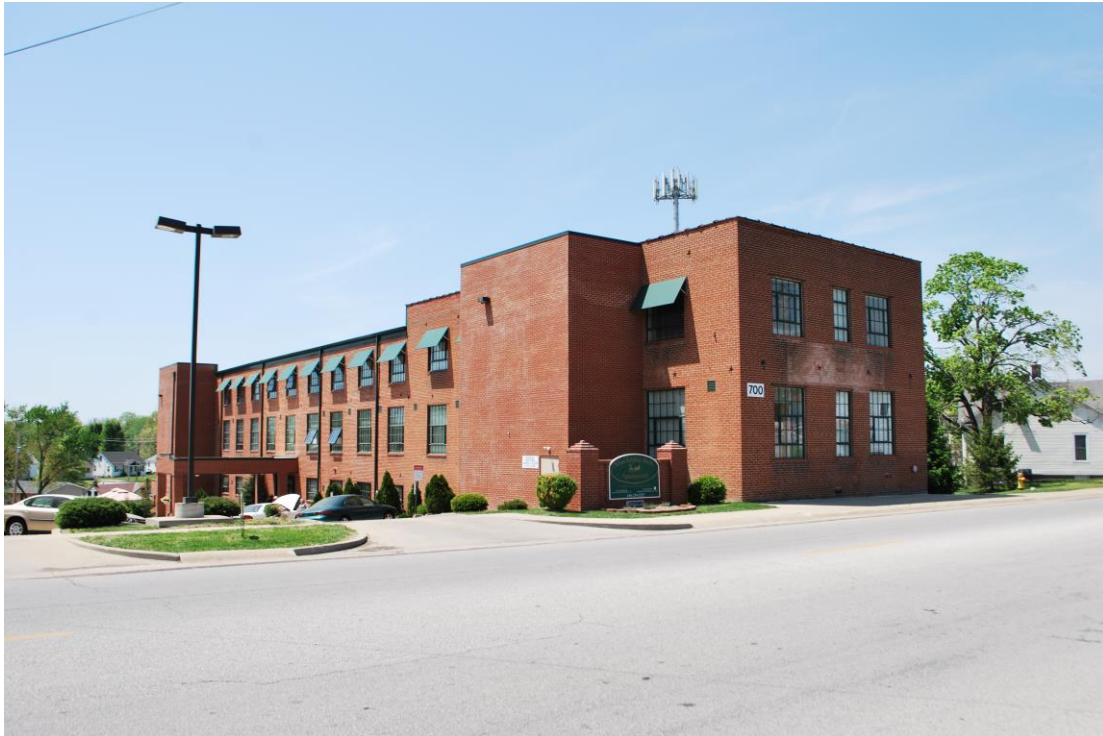
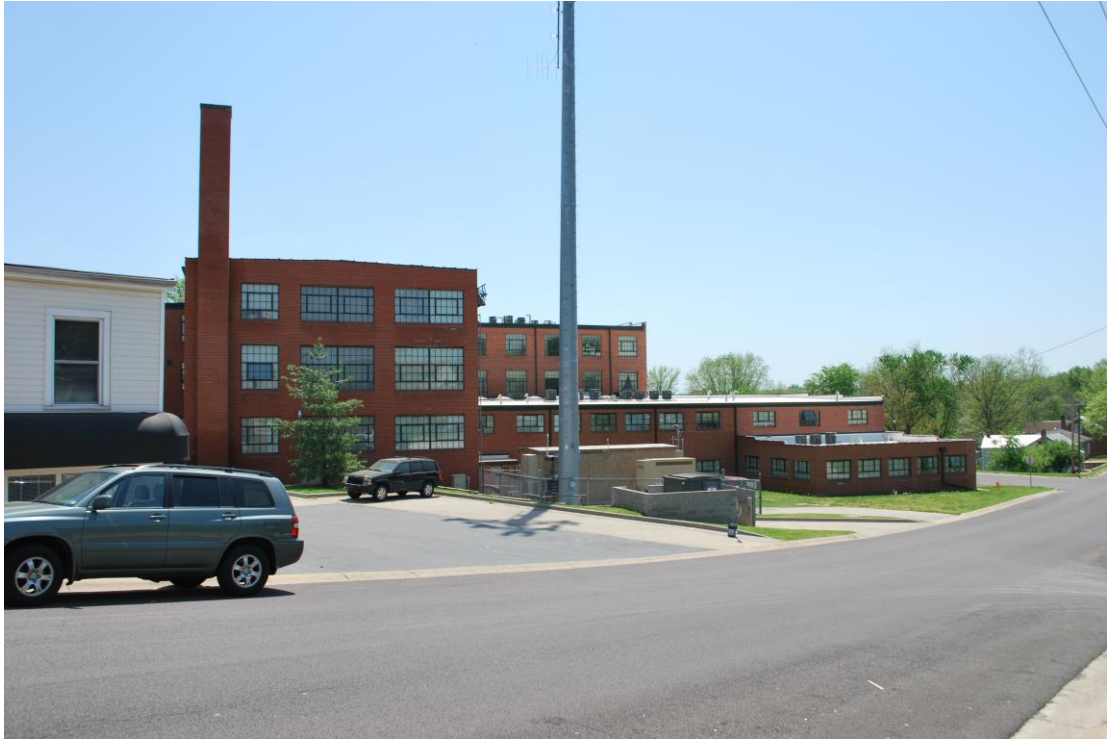
construct the factory in 1924 and the current building was completed in 1925.<sup>25</sup> The property operated as Fore Shoe Company for less than a year. Within eight months of its construction, it was purchased by another company that utilized the nomenclature “Washington Shoe Company.” The building was enlarged in 1927 and in 1929, at which time the factory was renamed as “Kane, Dunham and Kraus.”<sup>26</sup> The factory continued to change ownership and names, most recently owned by Wolff Shoe Company of St. Louis. Production continued until Wolff closed its operation in Washington in 1971.<sup>27</sup> The building is addressed as 700-708 E. Fifth Street in the study area and retains its architectural integrity.

Figure 32. Fore Shoe Company (NRL, 2005), view of 700-708 E. Fifth Street / 601 E. Fifth Street is southeast.

**Figure 33. Fore Shoe Company (NRL, 2005), view is northeast.**

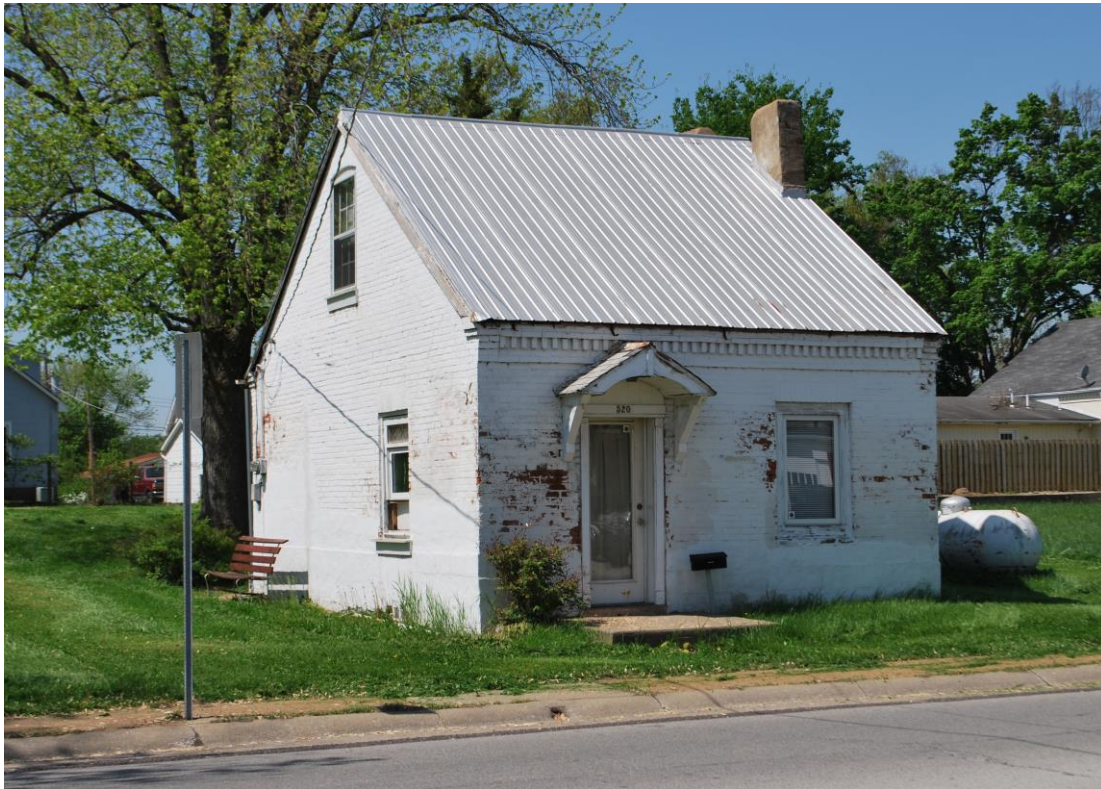
The Charles Helm House at 520 E. Fifth Street was listed to the NRHP in 2000 under the MPDF contexts of “Early Development and German Immigration: 1839-1870” and “Architectural Development: 1839-1950.” The dwelling is an excellent example of the Missouri-German Kleinhaus subtype, nominated under Criterion A: Ethnic Heritage and Criterion C: Architecture. When nominated, the property included the extant c. 1873 brick house and a c. 1900 detached frame kitchen that has been demolished. The kitchen was “a significant part of the property” but its demolition does not render the house ineligible for the NRHP.<sup>28</sup> The brick house with dentilled trim is a unique example of its type, despite alterations and loss of its primary outbuilding. As indicated in the nomination, “the Charles Helm House presents a significant example of the smallest of the Missouri-German subtypes, the Kleinhaus. Intact examples of this very modest house form are particularly rare . . . [and it is] one of the least altered examples of the Kleinhaus type in Washington.”<sup>29</sup>

Figure 34. Charles Helm House, 520 E. Fifth Street, view is southwest.

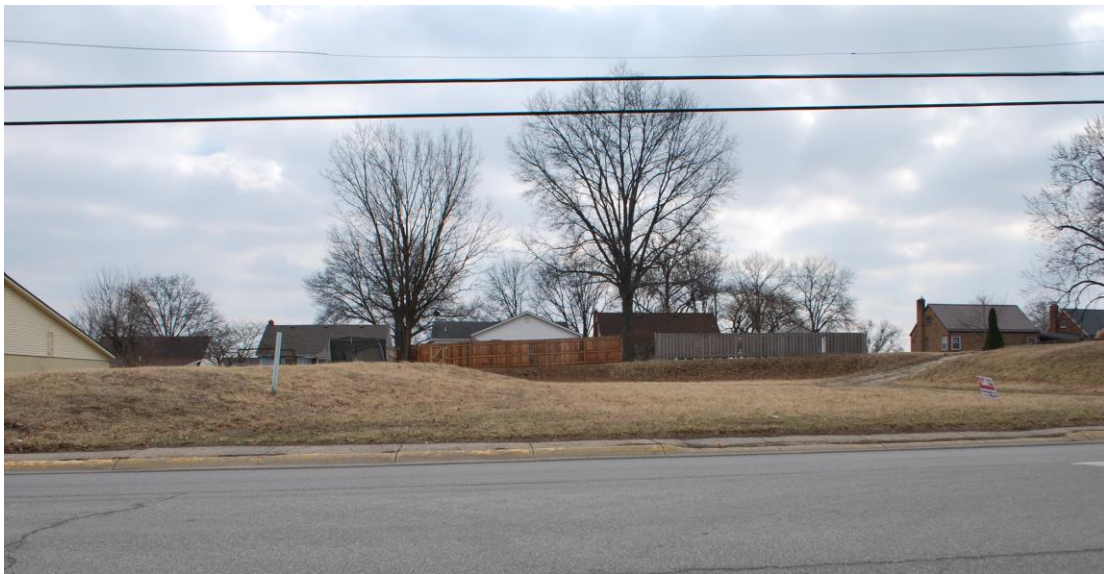
The John and Wilhelmina Helm House at 536 E. Fifth Street was listed to the NRHP in 2000 under the MPDF contexts of “Early Development and German Immigration: 1839-1870” and “Architectural Development: 1839-1950.” The dwelling was an example of the Missouri-German Double Entrance subtype, nominated under Criterion A: Ethnic Heritage and Criterion C: Architecture. Like the Charles Helm house, the dwelling had a detached kitchen but the building was brick and attached to the primary house by a breezeway. Today neither the house (c. 1868) nor the kitchen (c. 1873) remains standing. The current owner purchased the property in 2010 and filed a demolition permit in 2011. Due to the fact that the parcel no longer retains any of the buildings for which it was nominated to the NRHP, the property should be removed from the NRHP.

**Figure 35. Site of the former John & Wilhelmina House, 536 E. Fifth Street, view is south.**

schools in Washington. Finally, it is recommended that the John and Wilhelmina Helm House (536 E. Fifth Street) be removed from the National Register as the dwelling and its originally detached kitchen have been demolished.

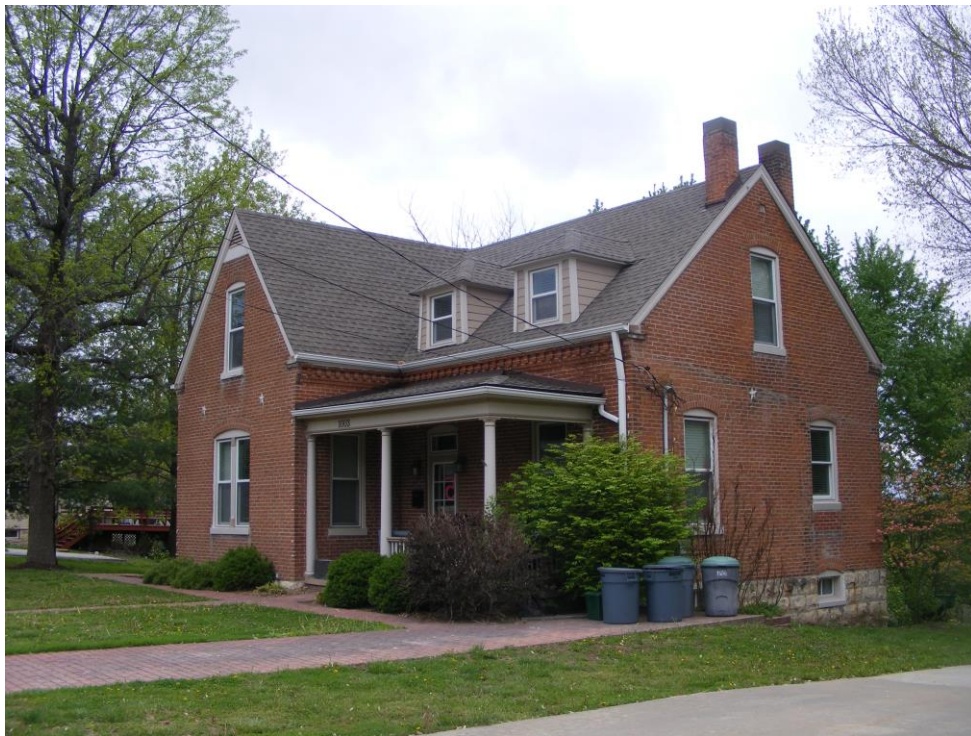
The Paul Monje House at 1003 W. Fifth Street was listed to the NRHP in 2000 under the MPDF context of “Architectural Development: 1839-1950.” The dwelling is good example of the Gabled Ell subtype, nominated under Criterion C: Architecture. The dwelling was constructed c. 1908, illustrating a nationally popular form of folk housing (Gabled Ell), as well as traditional Missouri-German vernacular influences demonstrated throughout the study area (i.e. brick vs. frame construction, dentilled cornices, arched windows and paired chimneys). The property is a good example Washington’s collection of “turn of the century building form[s]” embellished with “Victorian or Colonial Revival detailing . . . [demonstrating] the longevity of Missouri-German building traditions in Washington.”<sup>30</sup>

**Figure 36. Paul Monje House, 1003 W. Fifth Street, view is northwest.**

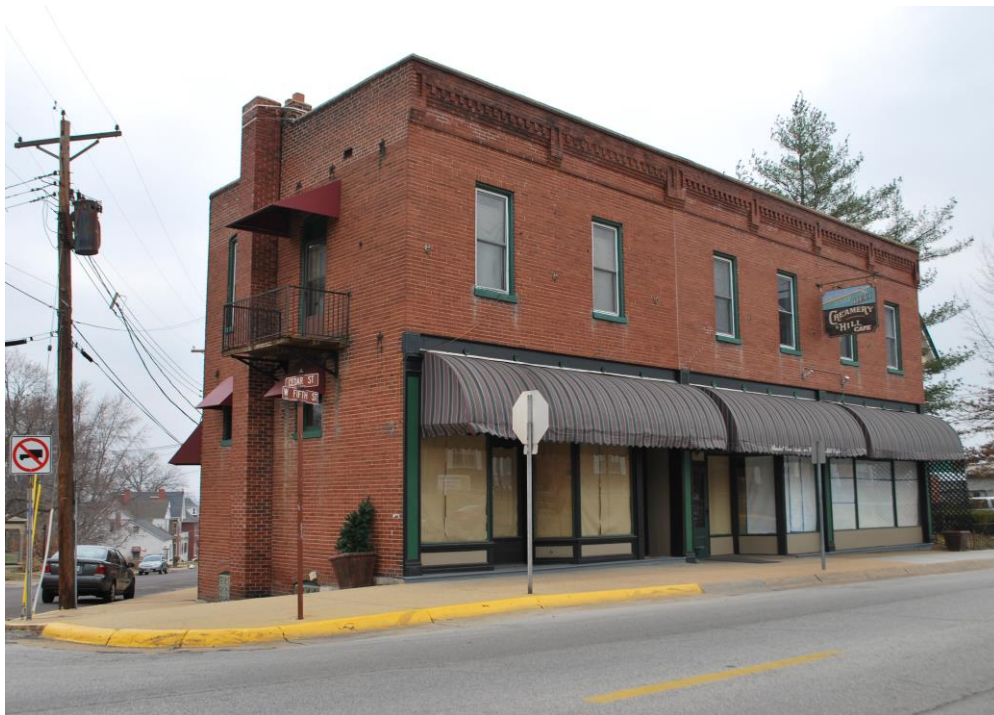
Two of the survey area's inventoried buildings are contributing resources in the Tibbe Historic District, 311 and 319-323 W. Fifth Street. The district is composed primarily of residential properties constructed near the turn of the twentieth-century. Architectural styles within the broader district include Federal, Greek Revival, Italianate, Second Empire, Queen Anne, Colonial Revival, Tudor Revival and Neoclassical. Tibbe Historic District was nominated for its architectural significance (Criterion C) and listed to the NRHP in 1996. The period of significance is 1857-1941. Although most contributing properties are residential, there are also commercial properties, including 319-323 W. Fifth Street. This two-story brick commercial building was constructed c. 1910 and has a cast-iron storefront. The building, constructed by Frederick Mauntel, held a general store and upper floor residential units. Mr. Mauntel lived in the Queen Anne influenced dwelling at 311 W. Fifth Street.<sup>31</sup>

**Figure 37. 319-323 W. Fifth is a contributing building in the Tibbe Historic District. View is northeast.**
