# **SURVEY REPORT FIFTH STREET SURVEY**

**CITY OF WASHINGTON  
FRANKLIN COUNTY, MISSOURI**  
[CDFA # 15-904]

**AUGUST 2014**

Submitted by:  
Landmarks Association of St. Louis, Inc.  
911 Washington Avenue, Suite 170  
St. Louis, Missouri 63101  
314-421-6474

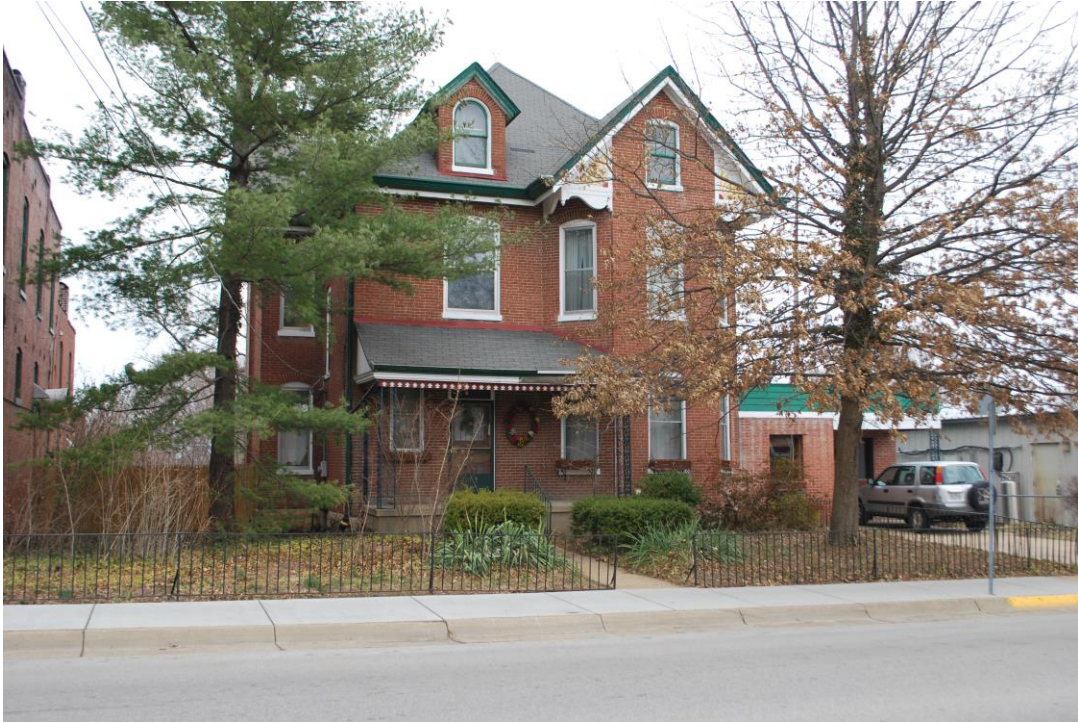
Two of the survey area's inventoried buildings are contributing resources in the Tibbe Historic District, 311 and 319-323 W. Fifth Street. The district is composed primarily of residential properties constructed near the turn of the twentieth-century. Architectural styles within the broader district include Federal, Greek Revival, Italianate, Second Empire, Queen Anne, Colonial Revival, Tudor Revival and Neoclassical. Tibbe Historic District was nominated for its architectural significance (Criterion C) and listed to the NRHP in 1996. The period of significance is 1857-1941. Although most contributing properties are residential, there are also commercial properties, including 319-323 W. Fifth Street. This two-story brick commercial building was constructed c. 1910 and has a cast-iron storefront. The building, constructed by Frederick Mauntel, held a general store and upper floor residential units. Mr. Mauntel lived in the Queen Anne influenced dwelling at 311 W. Fifth Street.<sup>31</sup>

**Figure 38. The dwelling at 311 W. Fifth Street is a contributing feature of the Tibbe Historic District. View is northeast.**

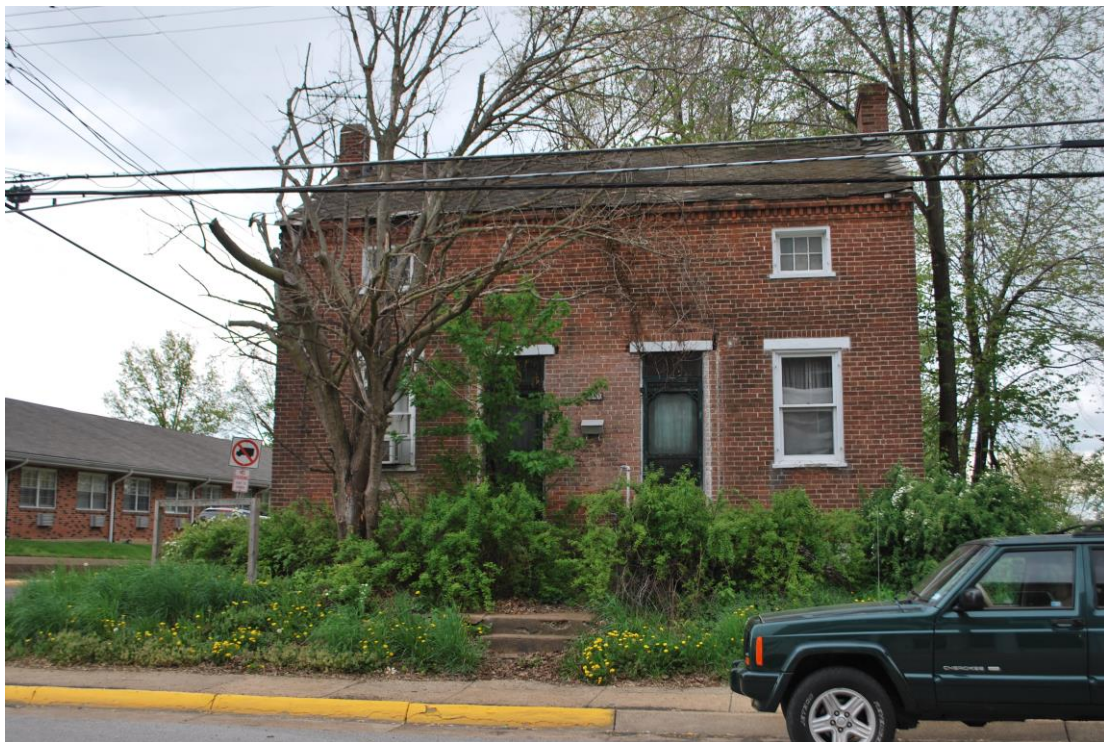
**Figure 39. The dwelling at 500 W. Fifth Street is a contributing resource in the Stafford-Olive Historic District. View is south. The property is an example of the Missouri-German double house, constructed c. 1858.**

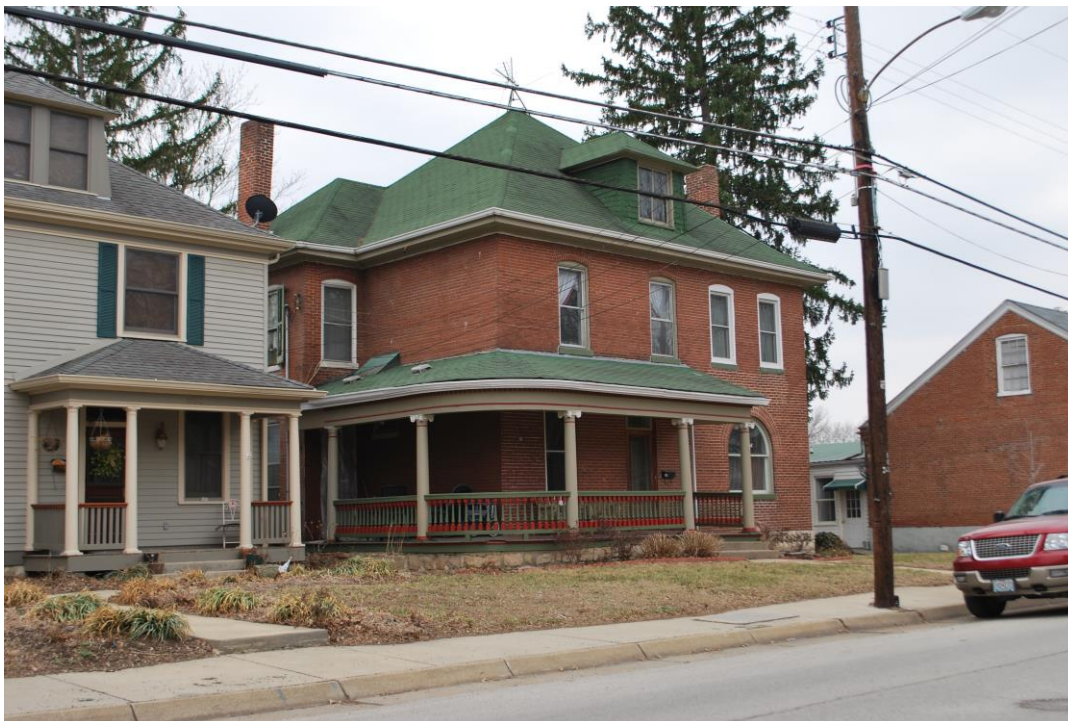
**Figure 40. 502 (left) and 504 (right) W. Fifth Street contribute to the Stafford-Olive Historic District. View is southwest. Both dwellings were constructed c. 1910 and reflect the district's foursquare property type.**

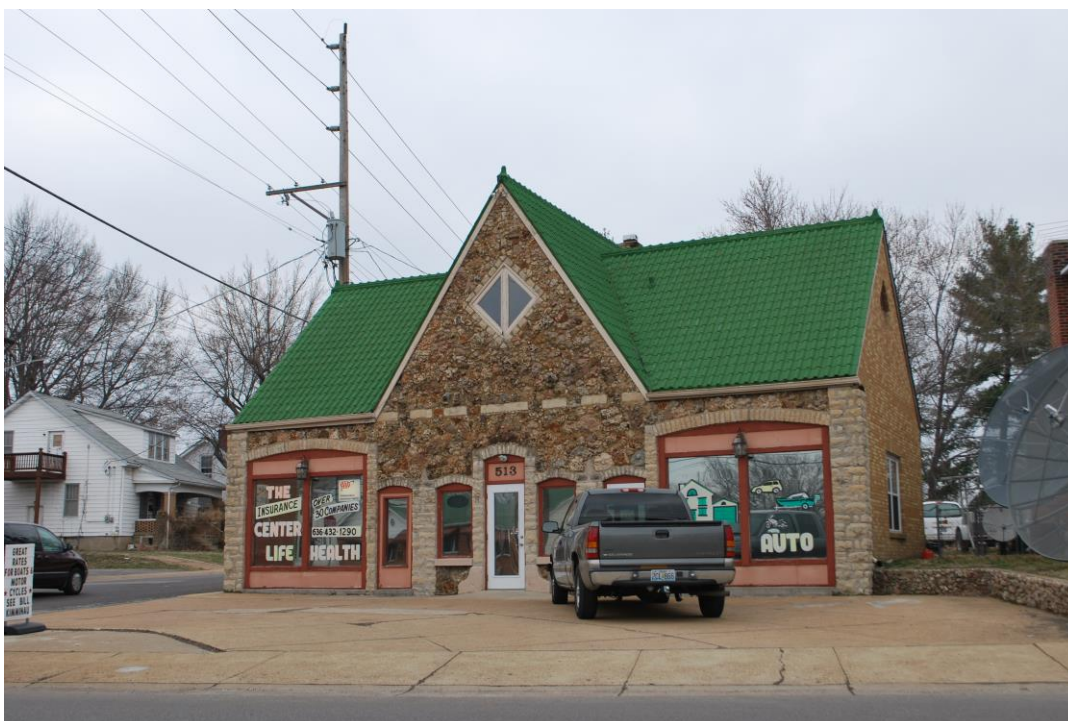
**Figure 41. The former gasoline station at 513 W. Fifth Street is the single commercial property within the study area's Stafford-Olive Historic District. View is northwest.**

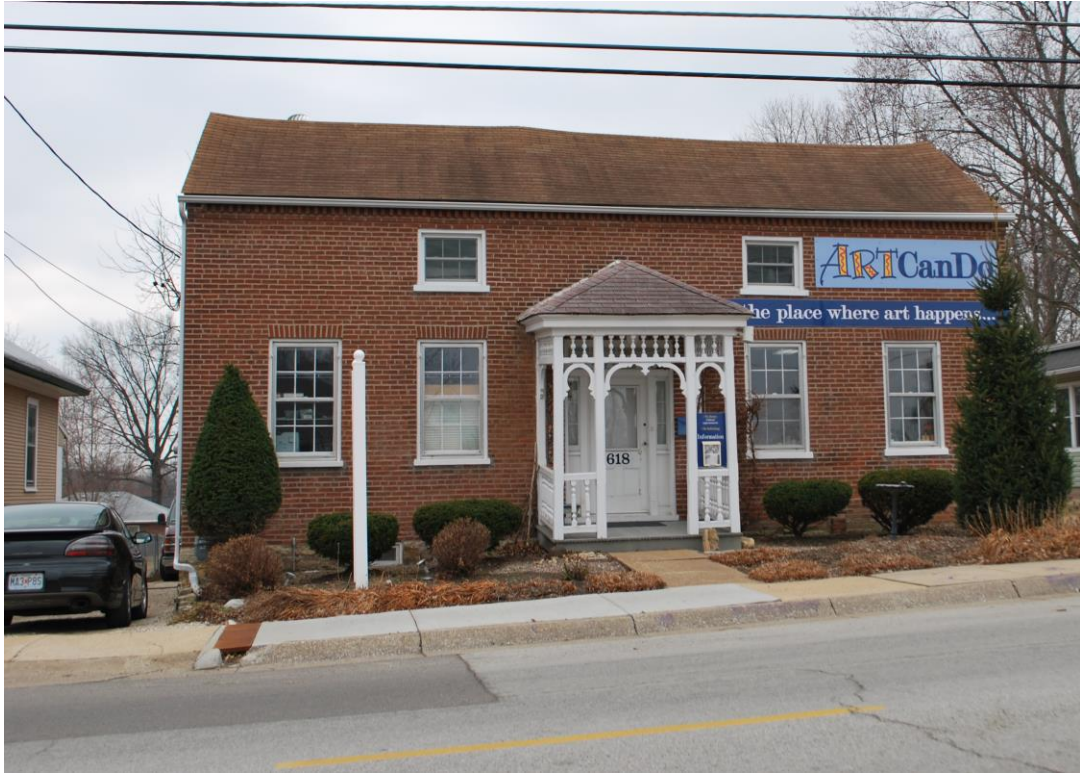
On the other side of the survey area at 618 W. Fifth Street is an example of what may be best characterized as an early Vernacular Missouri-German house of the Center Hall subtype (Figure 42). Five bays wide with a side gable roof, the building exhibits jack arches that typify older examples of the style. The upper half story has a pair of jack arch window bays and the wide central entry has sidelights and a transom. Again a very modest dentilled cornice delineates the roofline. Next door at 620 W. Fifth Street is another example of a Vernacular Missouri-German house defined as a Side Entry subtype (Figure 9). This one story house has a side gable roof and

Figure 42. The Menzenworth House, 618 W. Fifth Street, view is southwest.

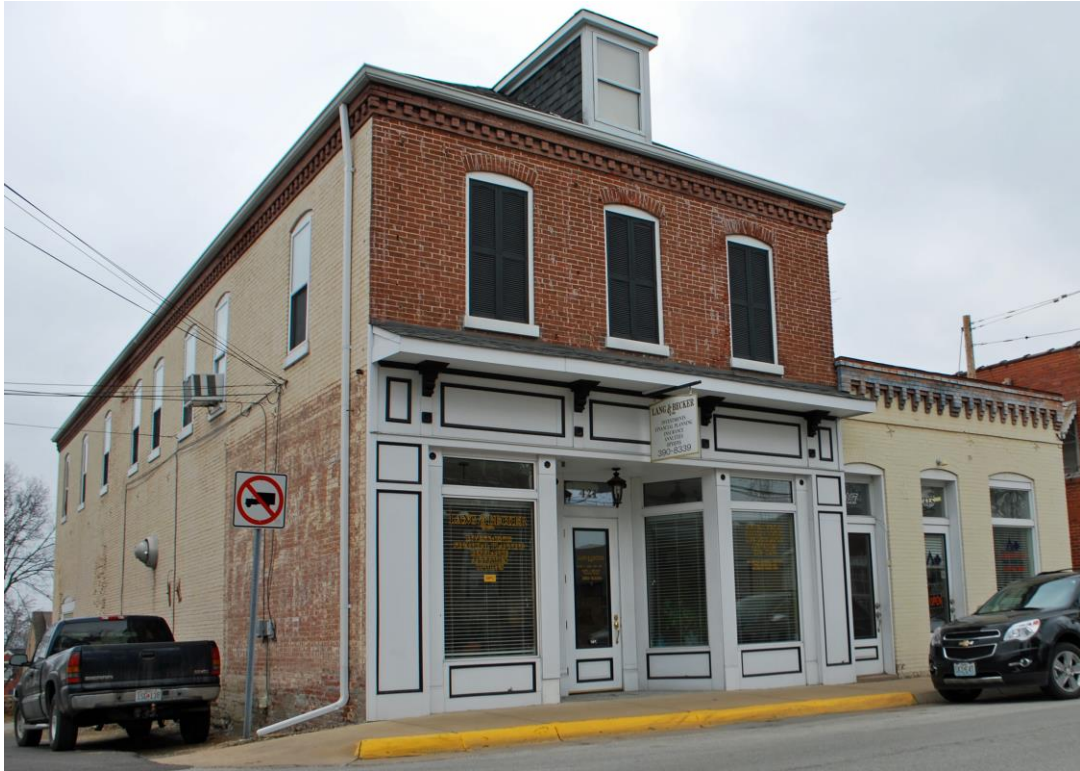
The most common form of commercial property in the survey area is the recognized Two-Part Commercial Block subtype. Examples in the survey area were constructed in both the nineteenth and twentieth century and range from the red brick building at 421 W. Fifth Street (Figure 44), which has an elaborate storefront and segmental arch windows on the second floor, to the variegated brick building at 401 E. Fifth Street (Figure 20) which has soldier arched window bays, an elaborate tile entry and a shaped parapet. While modest when compared to many of the commercial buildings in the central business district, some of the commercial buildings in the survey area display eye-catching ornamental embellishments such as the elaborate corbelling on the building at 401-403 W. Fifth Street (Figure 21).

Figure 44. 421 W. Fifth Street, view is northeast.

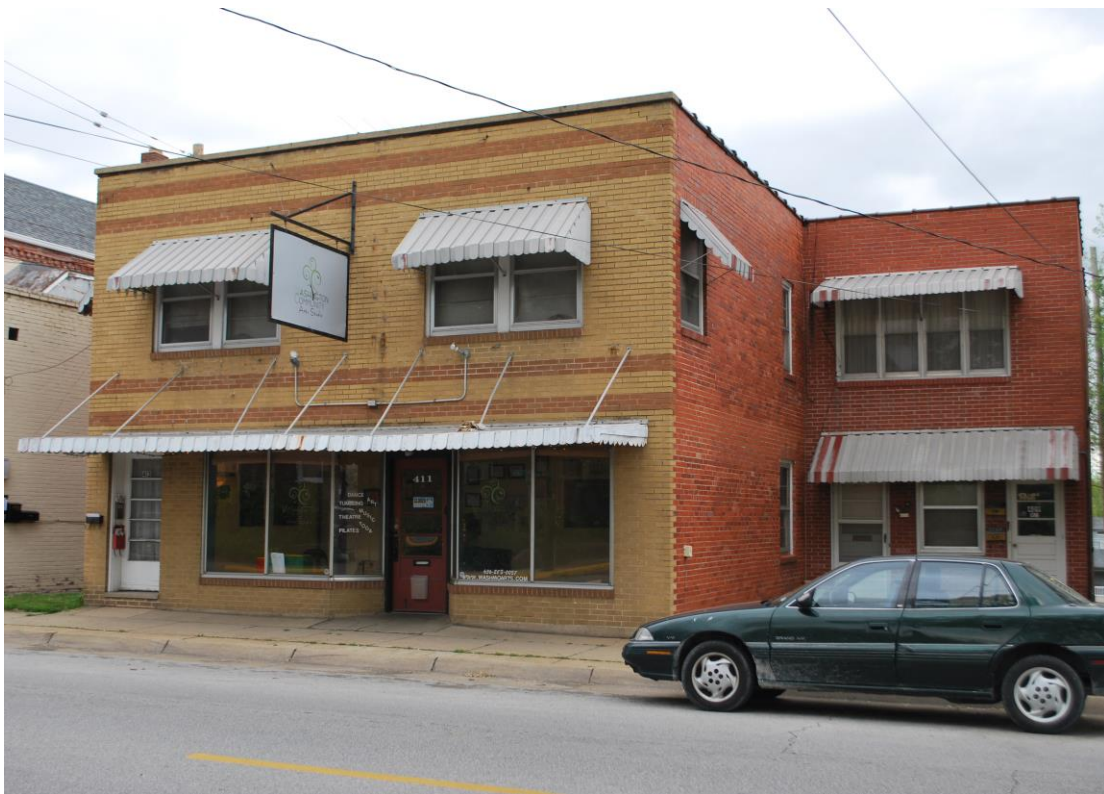
The building at 409-413 W. Fifth Street is a later example of Washington's commercial properties along Fifth Street, constructed c. 1946. The building was (and remains) utilized commercially and residentially. The property meets the MPDF contexts of "Assimilation and Twentieth Century Development: 1905-1950" and "Architectural Development: 1839-1950." The building falls into the MPDF property subtype of a two-part commercial building, meeting NRHP Criterion A: Commerce and Criterion C: Architecture. The building has architectural integrity (based on its exterior examination) and does not appear to have been significantly altered since its construction. The property is good example of modern architectural movements, illustrated by its banded brick facade cornice, boxy shape. The building continues to serve the dual purposes (commercial/residential) for which it was designed.

**Figure 45. 409-13 W. Fifth Street is a multi-purpose commercial building. View is northwest.**

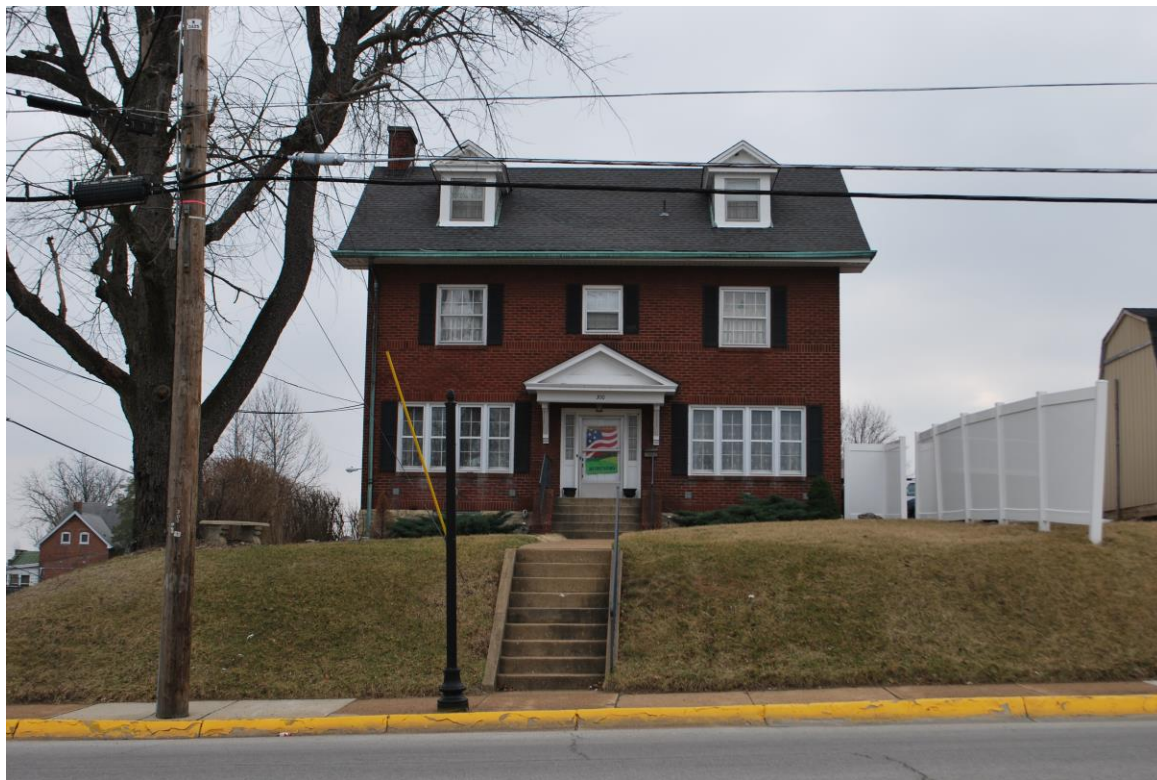
The dwelling at 300 W. Fifth Street is a good example of the Colonial Revival style. Constructed c. 1925, the dwelling reflects the MPDF contexts of “Assimilation and Twentieth Century Development: 1905-1950” and “Architectural Development: 1839-1950.” The building falls into the MPDF property subtype of Colonial Revival (Period Revival Property Types). The Colonial Revival style dominated American housing styles in the early twentieth century, particularly during the 1920s-1930s.<sup>38</sup> The example at 300 W. Fifth Street bears classic details of the style in its pedimented entrance and dormers, multi-sash windows, symmetrical facade placement of windows, and classical entrance. Other than replacement of the original roof materials, the dwelling bears no exterior evidence of alterations since construction. Based on exterior evaluation, the dwelling appears eligible for the NRHP under Criterion C: Architecture.

Figure 46. The dwelling at 300 W. Fifth Street is a good example of a Colonial Revival style dwelling. View is north.

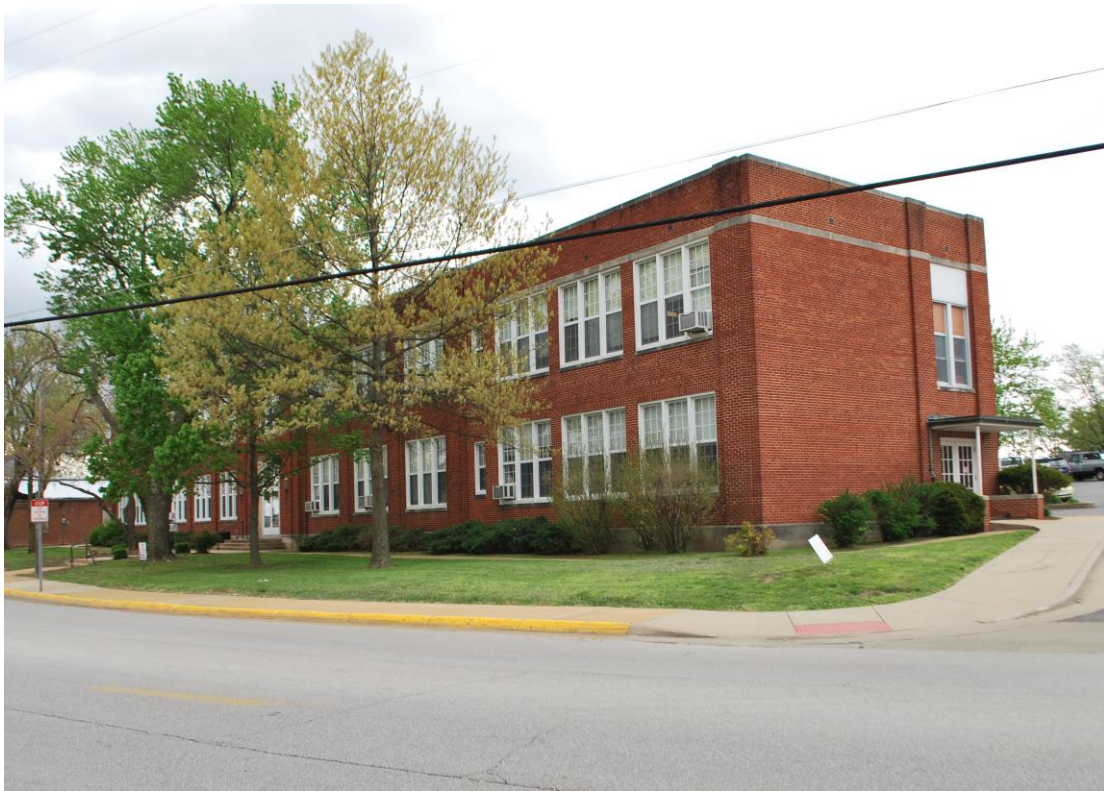
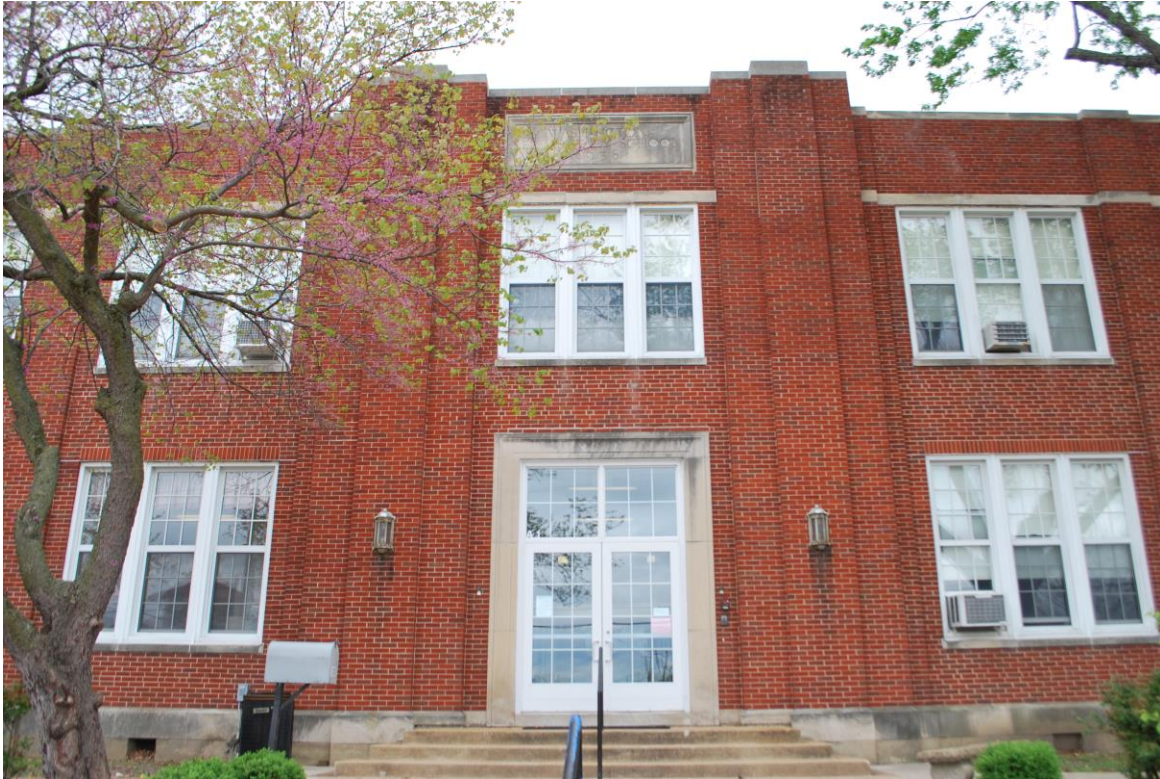
The Fifth Street Elementary School (originally known as Washington Elementary School) at 100 W. Fifth Street was constructed in 1938. The building appears individually eligible for the NRHP under Criterion A: Education and Criterion C: Architecture. Unaltered examples of schools constructed in the 1930s are infrequent. Also remarkable is the fact that the building remains in use for its original purpose. The school reflects restrained detailing with engaged brick pilasters flanking the central two-story bay and a decorative band of concrete spanning the upper elevations above windows. It is a good example of the transition from classical public school design to more modern ideas about educational buildings. Additional research is recommended to determine whether the building was constructed utilizing New Deal era funds. The building's period of construction and design indicate this may be the case. Such an association would add to the building's significance under Criterion A.

**Figure 47. Fifth Street Elementary School at 100 W. Fifth Street. View is southeast.**

**Figure 48. Facade detail of Fifth Street Elementary School, 100 W. Fifth Street.**

The MPDF provides both a context for understanding the significance of most of the individual historic resources within the survey area and promotes the possibility for nominating the seven properties identified above. Further recommendations include conducting research for the residential buildings identified as potentially eligible to determine whether interior integrity remains that would qualify the properties for listing in the NRHP. Additionally, further research concerning the impact(s) of the Fore Shoe Company on the surrounding neighborhood is recommended to determine the possibility of a Craftsman/Bungalow district in this area. The Fifth Street Elementary School requires additional research to determine whether it was a New Deal era project and to evaluate its architectural significance in comparison to other older public

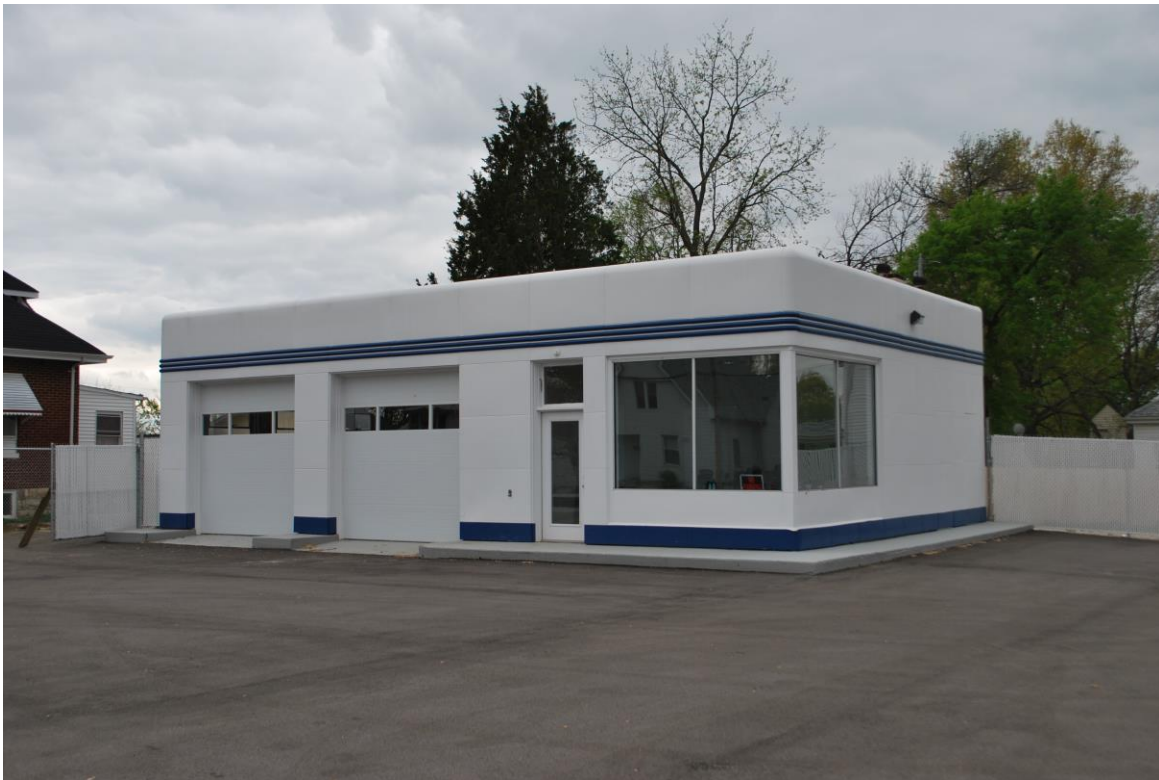
The former gasoline station at 300 E. Fifth Street was constructed c. 1950 and appears eligible under NRHP Criterion A: Commerce and Criterion C: Architecture. The porcelain tile clad service station reflects post-World War II ideas that dominated gasoline station design. Based on earlier (1930s) examples in which oil/gasoline companies constructed “metal boxlike” buildings covered with porcelain tiles, later examples (after 1946) are consistently more streamlined, presenting a “cleaner, more efficient design” with “aluminum accents and [in some instances] all-glass fronts.”<sup>39</sup> The example at 300 E. Fifth Street is an excellent representation of the postwar transition. The building’s estimated date of construction, 1950, is based on the fact it is not illustrated on the City’s 1945 Sanborn map. Recently restored (c. 2013), the historic features that could not be fully restored were replaced with elements that imitate the building’s historic materials.

Figure 49. The former Arro Gasoline Station at 300 E. Fifth Street, view is northwest.

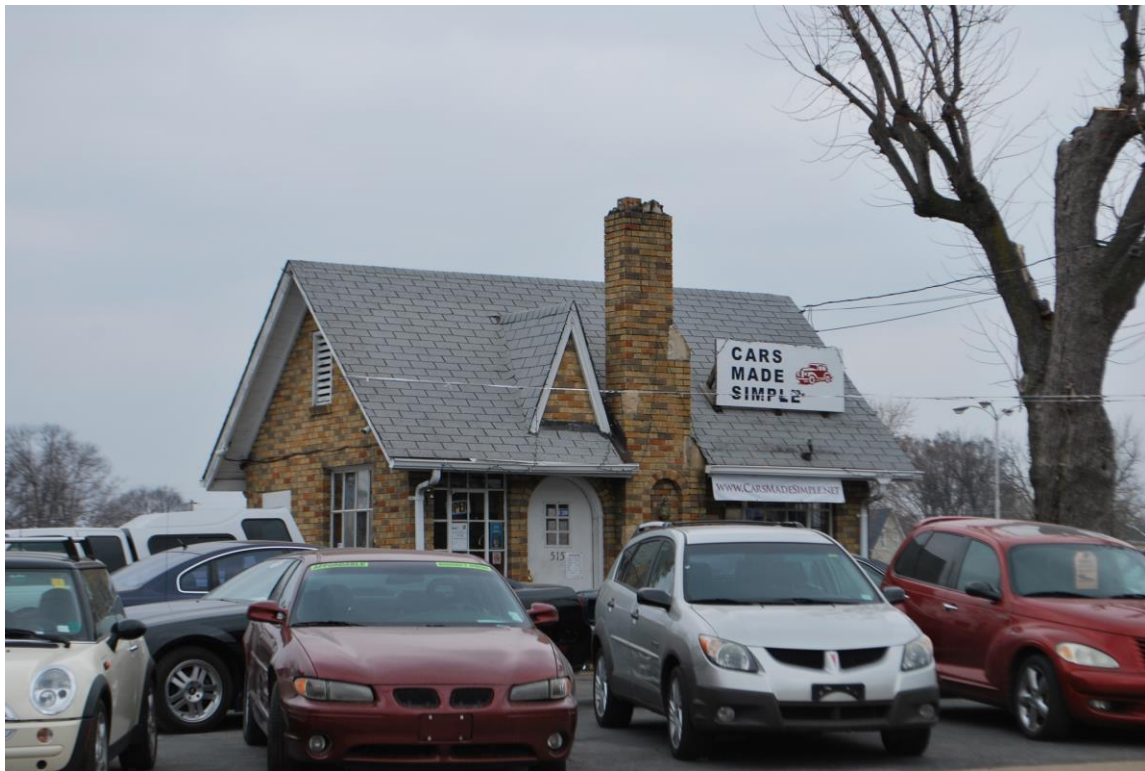
The Tudor Revival cottage style gasoline service station at 515 E. Fifth Street is another automobile use commercial building that appears eligible for the NRHP. The property is an earlier example than 300 E. Fifth Street, probably constructed c. 1930 for Pure Oil Company. During the 1920s-1940s, American gasoline companies frequently constructed service stations that imitated small houses. Pure and Phillips both designed “quaint English country cottage-style stations” beginning in the late 1920s. Pure often used Tudor-influenced designs, incorporating arched entries and exterior facade chimneys (similar to 515 E. Fifth Street).<sup>40</sup> The cottage style station in Washington is an exceptionally intact example that illustrates no alterations (other than replacement of the original roof covering) since its construction. The building retains its original windows, doors, decorative features, and its original shape and form. The building meets NRHP Criterion A: Commerce and Criterion C: Architecture.

Figure 50. 515 E. Fifth Street was originally used as a gasoline station. View is northeast.

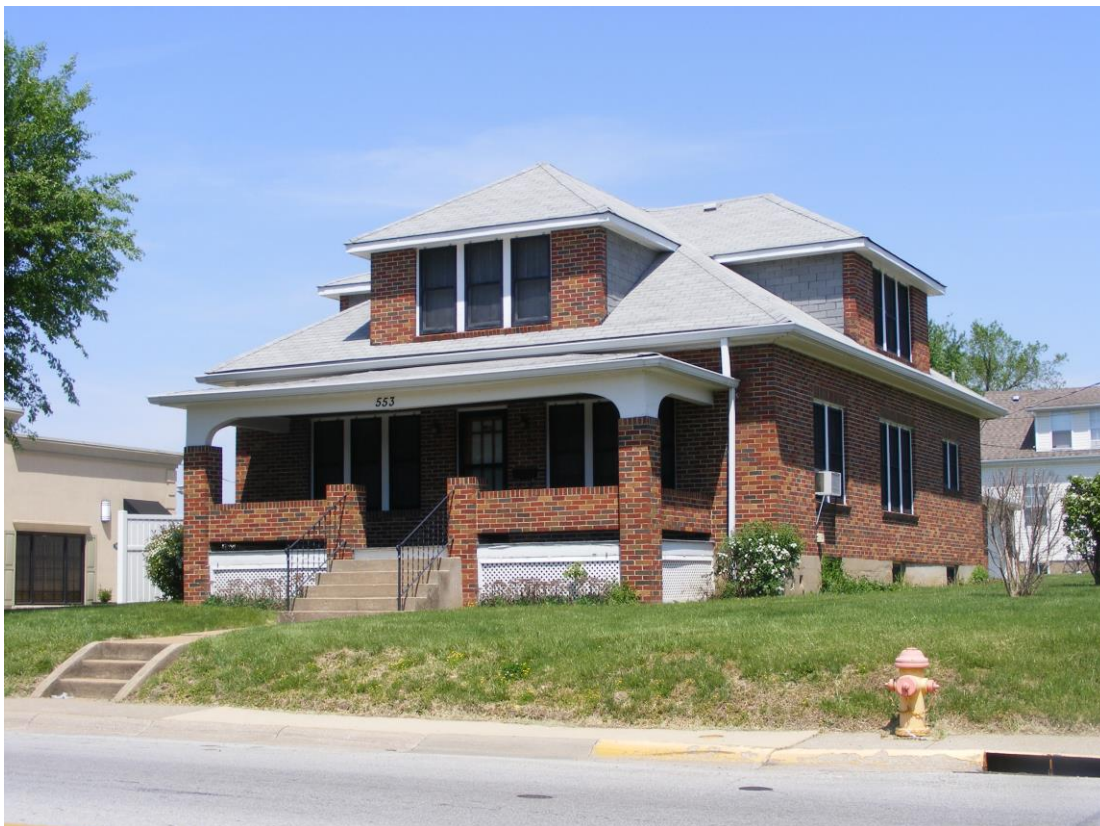
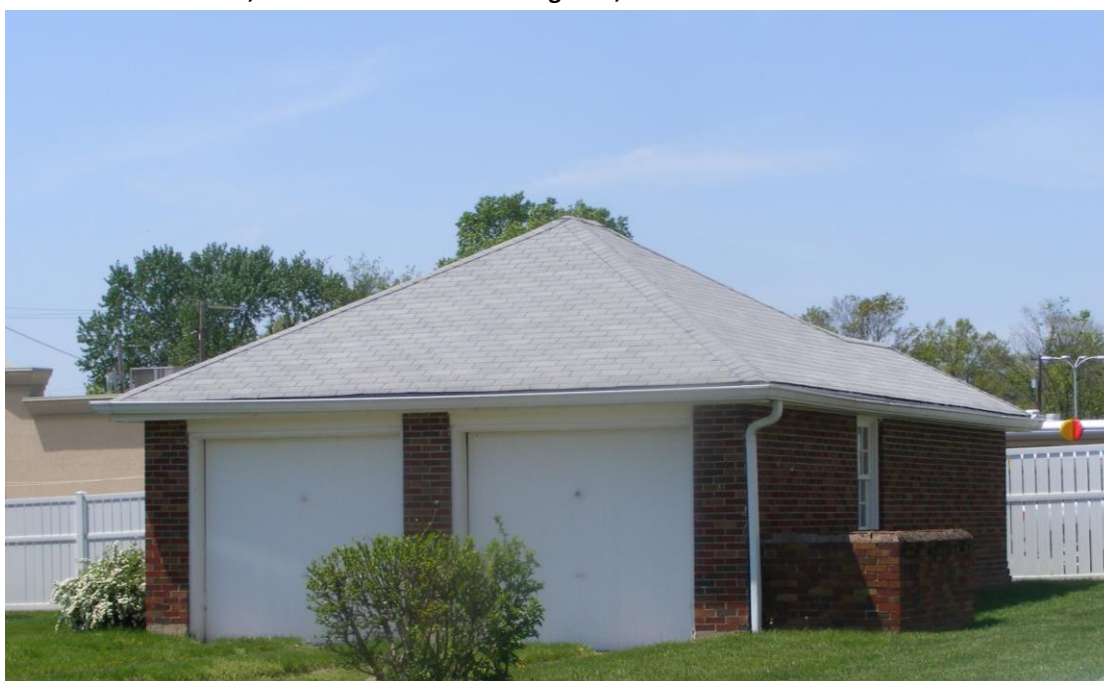
The Bungalow at 553 E. Fifth Street retains original exterior finishes, including shingles on dormer walls, three-over-one windows, hinged window screens, and a multi-light Craftsman door. The dwelling and its associated brick garage have very few alterations. These alterations include replacement roof shingles (house and garage), the replacement of original garage doors with contemporary overhead track doors, and synthetic siding on the dwelling’s rear two-story frame shed wing, which encloses original sunrooms. The dwelling and associated garage retain architectural integrity, as well as integrity of their site and setting. The property is the most unaltered example of a Craftsman-influenced Bungalow within the survey area and appears eligible for the NRHP under Criterion C: Architecture.

**Figure 51. 553 E. Fifth Street, Craftsman influenced Bungalow, view is northeast.**

**Figure 52. Garage associated with 553 E. Fifth Street. View is southwest.**

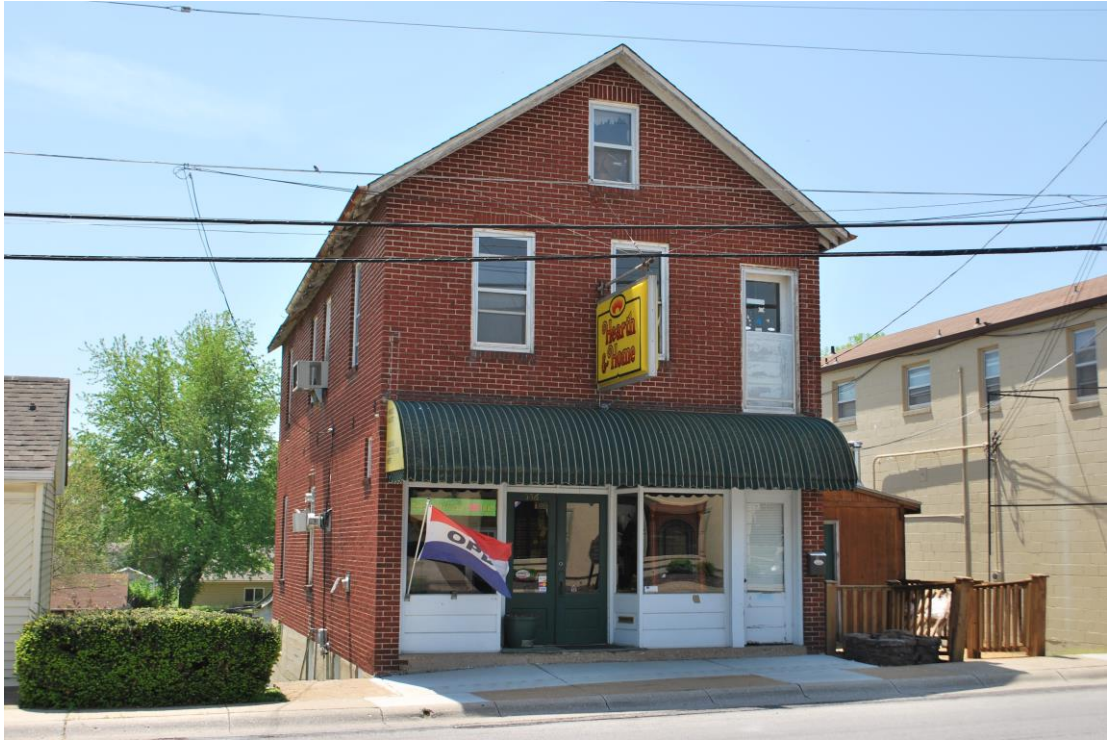
A commercial building within the survey area that employs a gable-front form is located at 556 E. Fifth Street (Figure 53). It is a brick building of two-and-one-half stories that functions as a two-part commercial block with a storefront on the first floor and residential or office space on the second. Gable-front plan commercial buildings are categorized in the MPDF as Type C: Commercial Buildings. The two-story gable-front plan commercial building, also known as a “house-store” property type, was common in Missouri by the mid-1800s. In many areas, particularly rural communities, the building form was perpetuated well into the twentieth-century, as seen in the examples of 554 and 556 E. Fifth Street (Figure 53).<sup>24</sup>

Figure 53. Hearth and Home, 556 E. Fifth Street, view is southwest.
