MISSOURI	HISTORIC	PRO	JPER	LA IN	VENT	ORY	FO	PRM						JA-AS-053-001
REFERENCE NU	IMBER	A	. HISTO	RIC NAM	IE						Tan Tan S			
93JA	7 0244		HIC	KORY	HILLS	FAI	RM C	COMP	LEX,	FA	RM HO	JSE

MISSOURI DEPARTMENT OF NATURAL RESOURCES HISTORIC PRESERVATION PROGRAM

MISSOURI HISTORIC BUILDING INVENTORY FORM - CONTINUATION SHEET

REFERENCE NUMBER A. HISTORIC N			C. ADDRESS		
COSPANIES SERVICES SALVES SALV	Hills Farm Complex	Jackson	47th Street	Kansas City	
Farm Ho	use

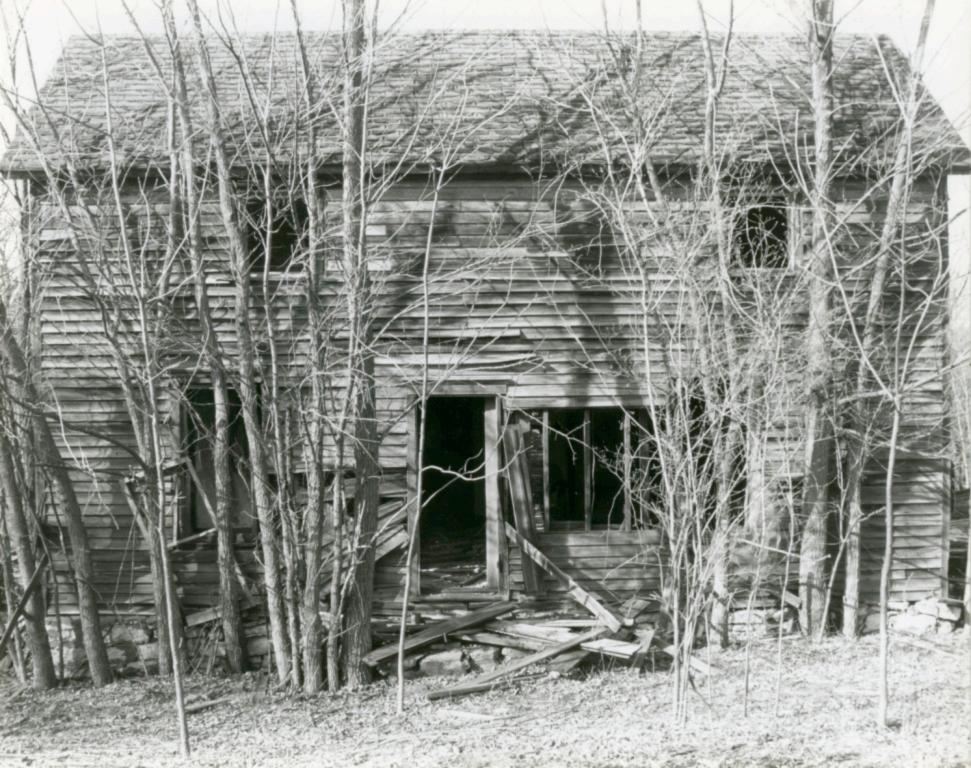
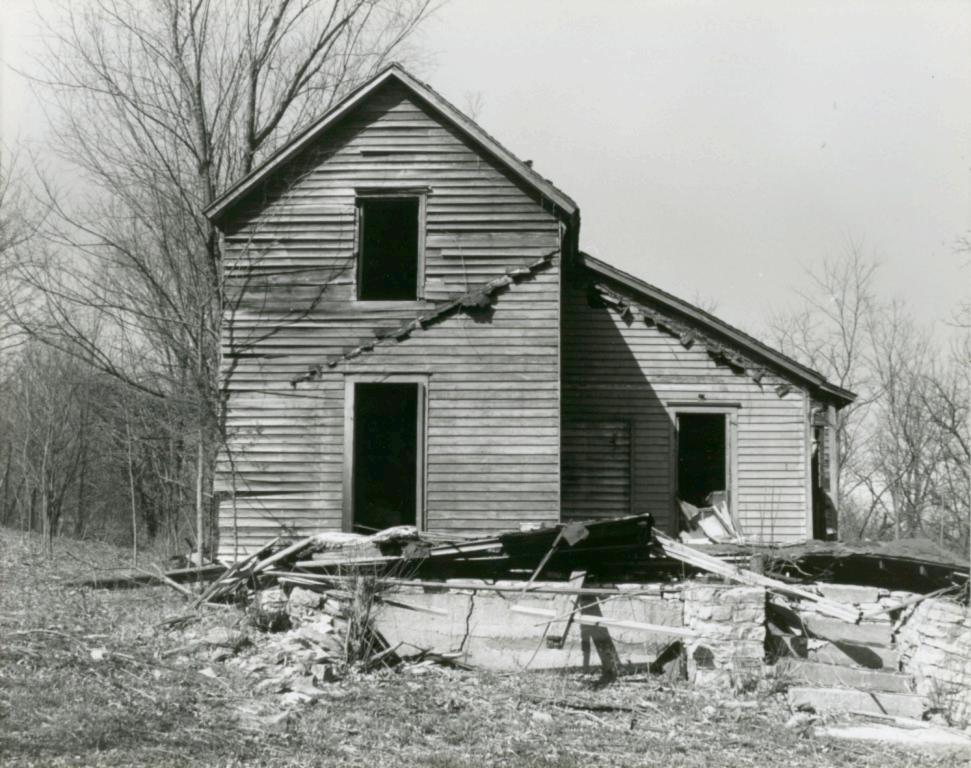
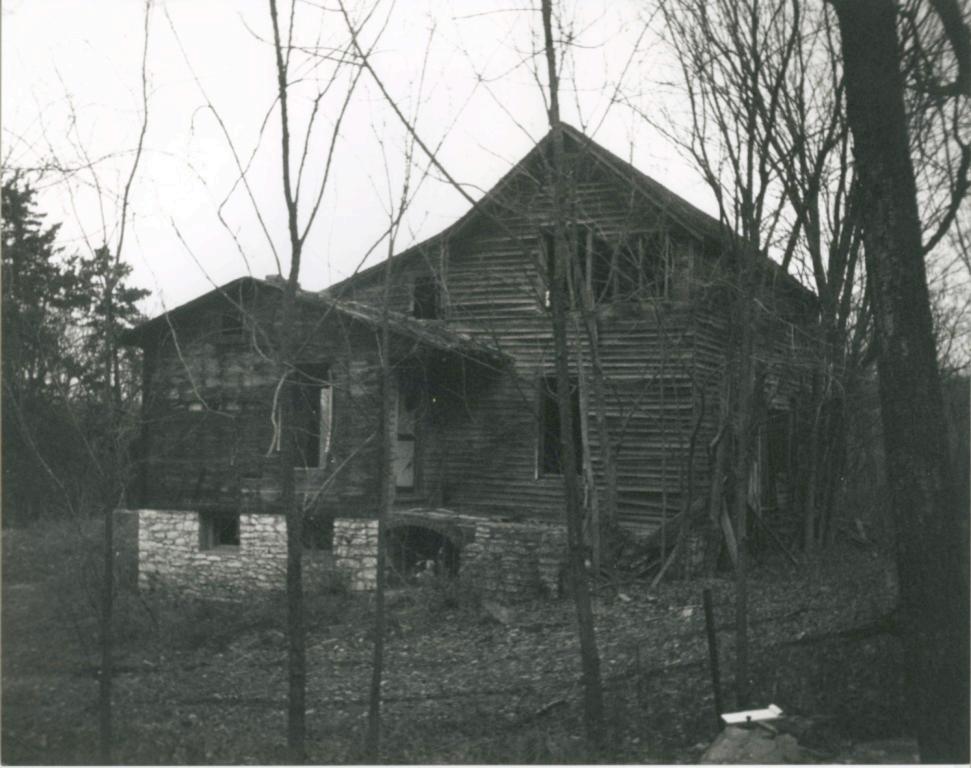
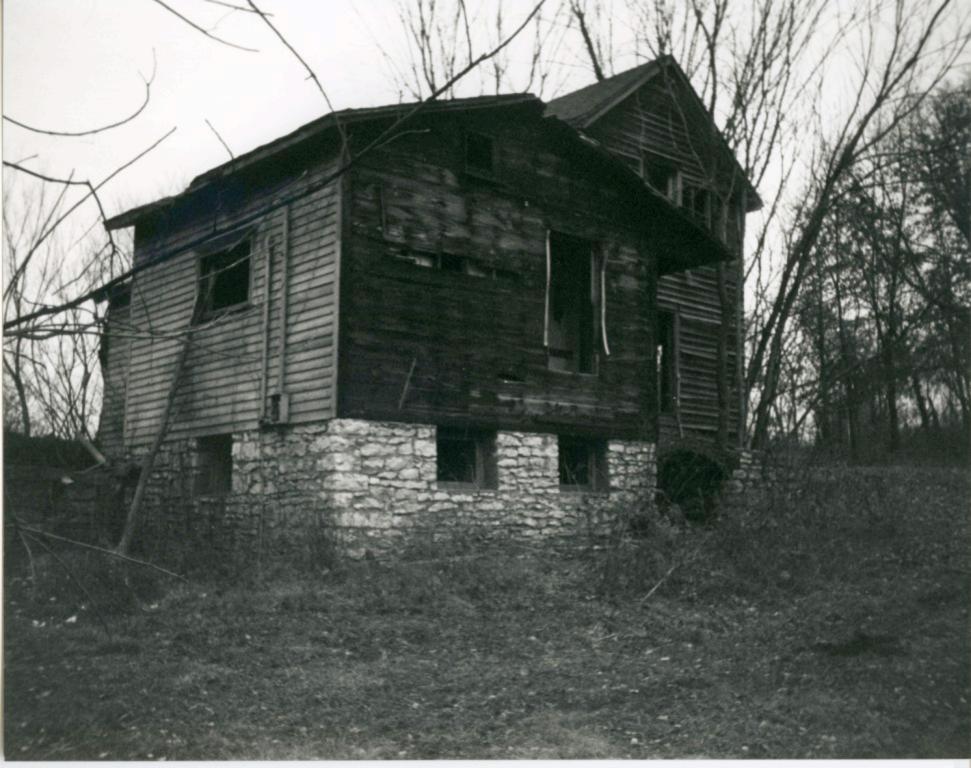
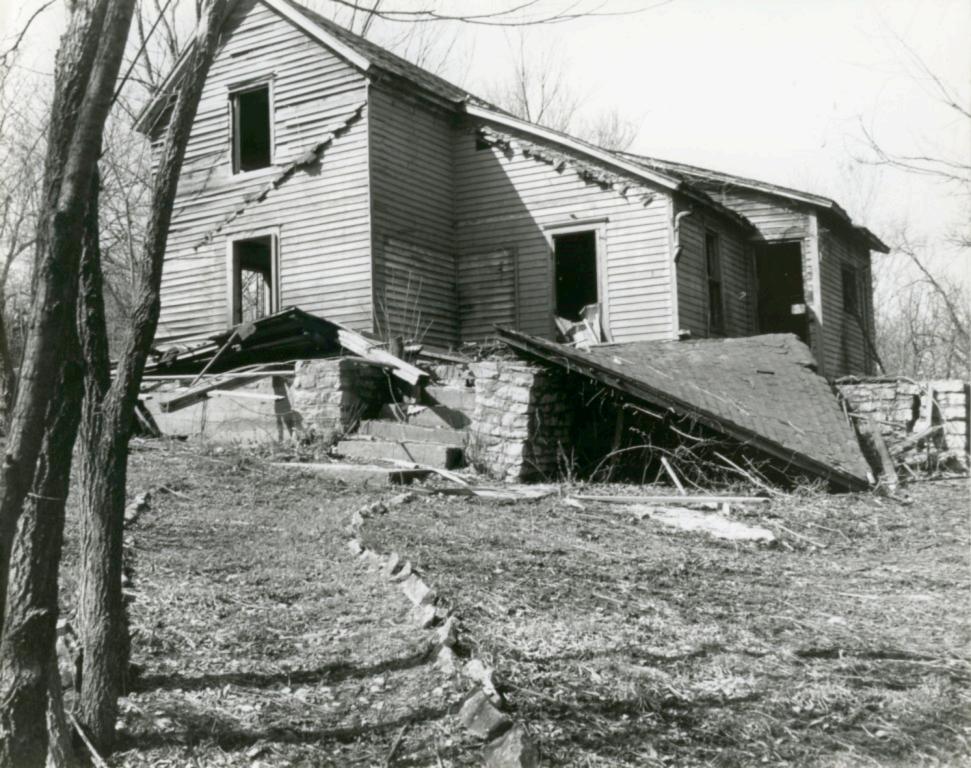
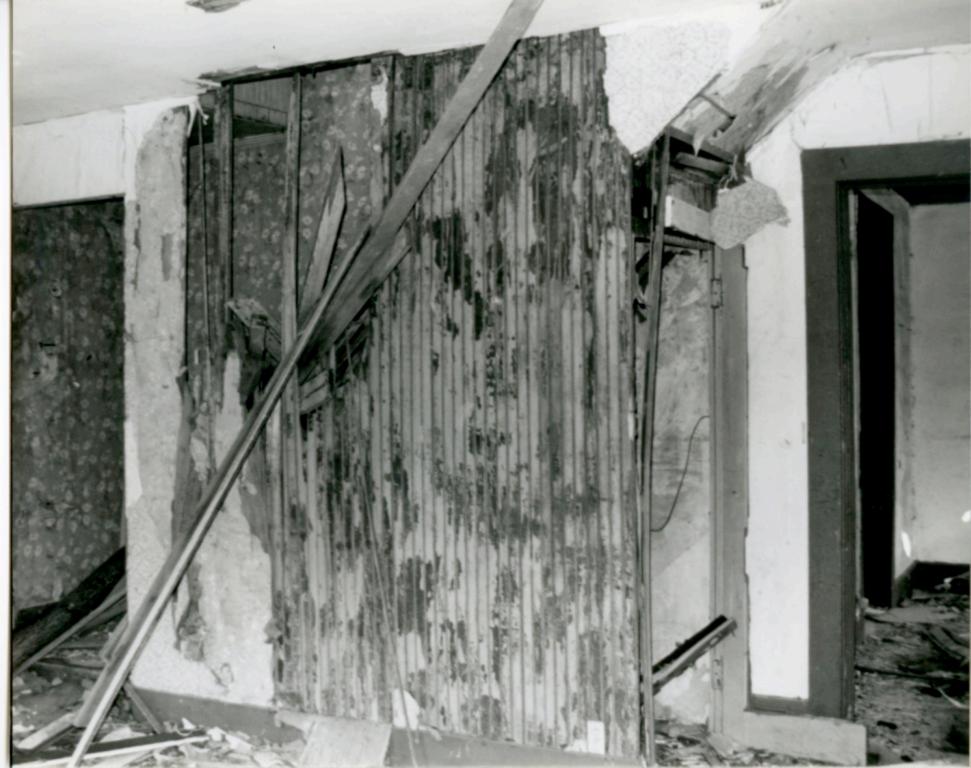
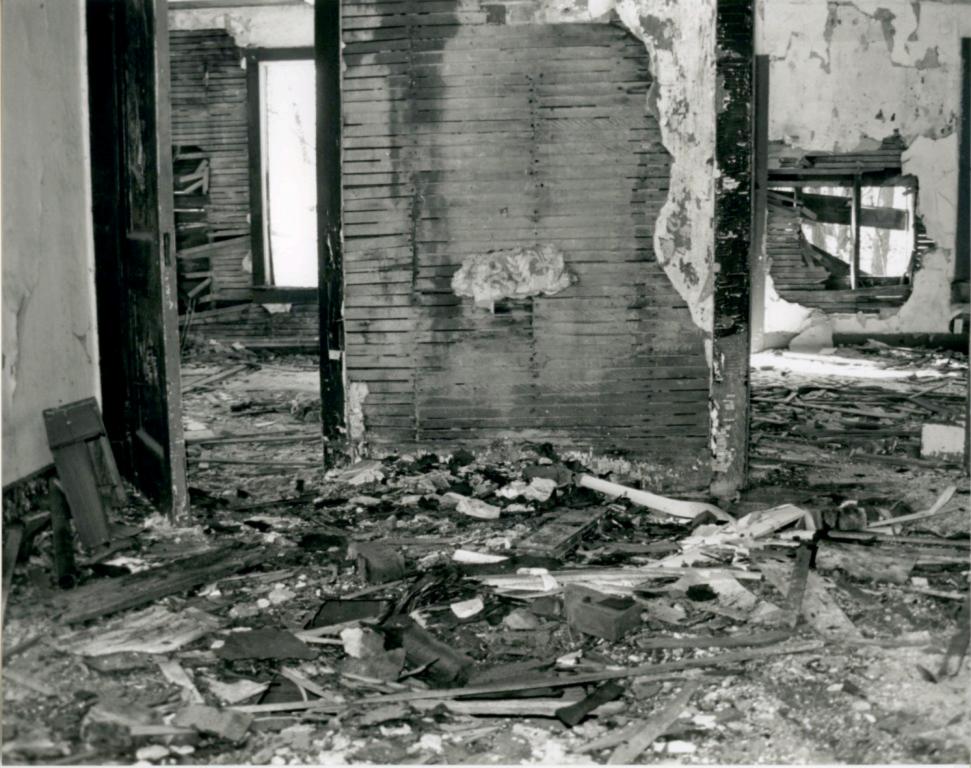
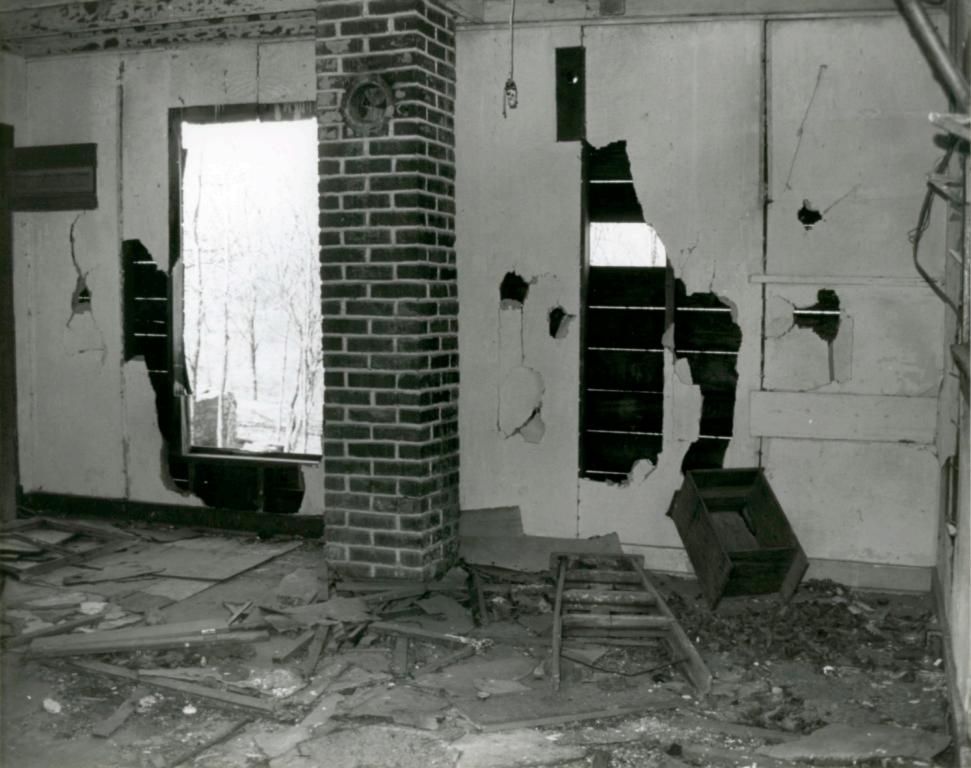
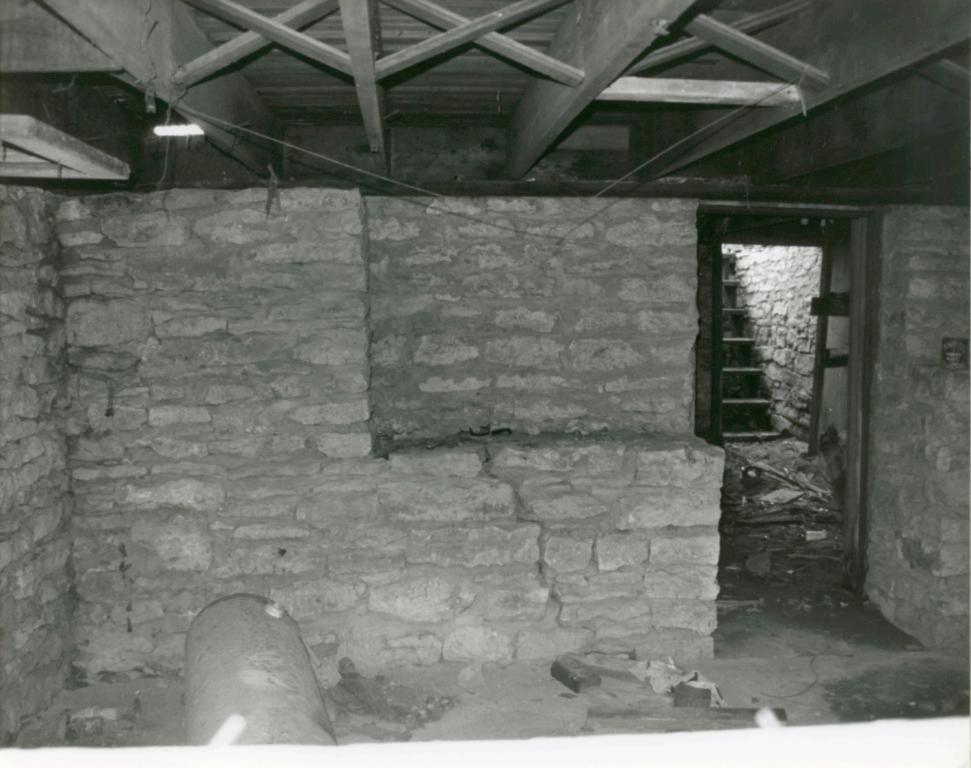
The frame farm house was constructued at the top of the hill south of the log house and was used as the caretakers residence during the years the farm was owned by Mr. Gossett. The original section of the house (which is one and one half stories with a one story section to the north) contain the sleeping and living areas. The apparent additions to the house include the kitchen and bathroom to the north, and the porch to the east. Both the original house and the additions were built on rubble limestone foundations with a basement under the kitchen and one story section of the original house only. A cistern was also added in the ground under the porch floor. Stone steps lead down from the porch to stone lined paths that connect to the front gate and drive and down the hill to the log house. This house sustained fire damage on the northwest corner of the kitchen probably from a wood burning stove that once stood there.

The squared and coursed rubble limestone foundation walls support the balloon framed structure of the house. The exterior of the walls is covered with beveled siding with 4" of the board exposed. This siding was trimmed around the doors and windows and at all corners with 4" trim pieces. The exterior was painted. The types of windows and doors on this structure are difficult to determine because of the deteriorated state of the structure. The roof is currently composed of asphalt shingles with one gutter on the north side which deposites water into the cistern.

Plumbing in the house was limited to the kitchen/bathroom addition and a hot water heater was added at some time. The house was wired for electricity but no evidence of a heating system other than stoves was found. Interior finishes include lath and plaster in the original part of the house with gypsum board walls in the addition. Wallpaper was used as a wall covering and the floors are hardwood.

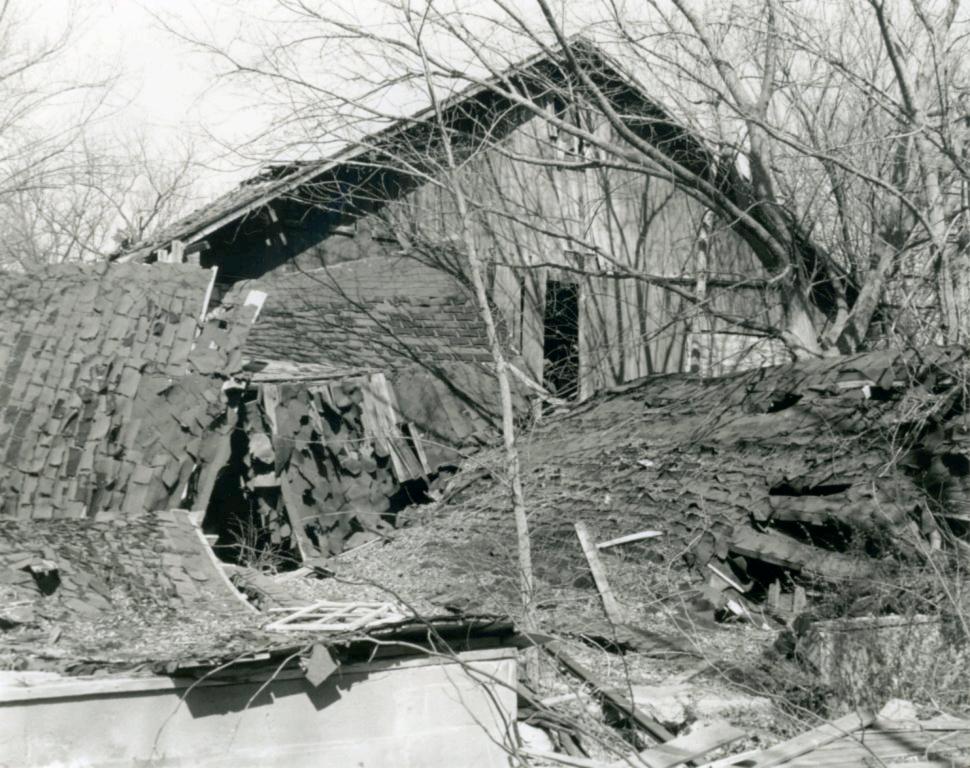
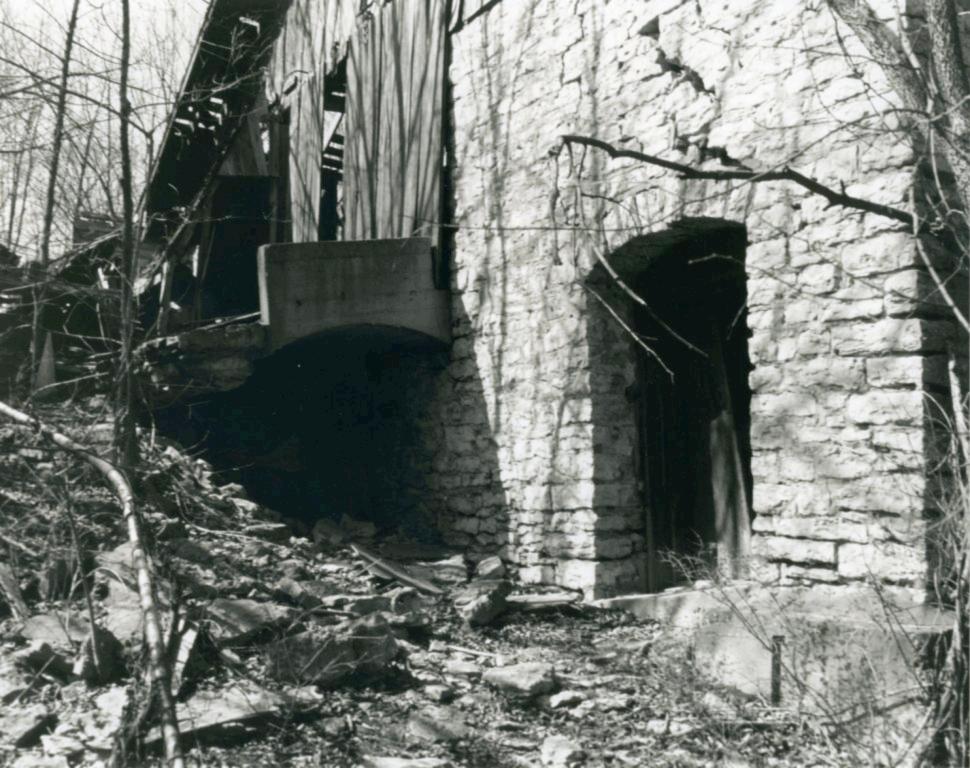
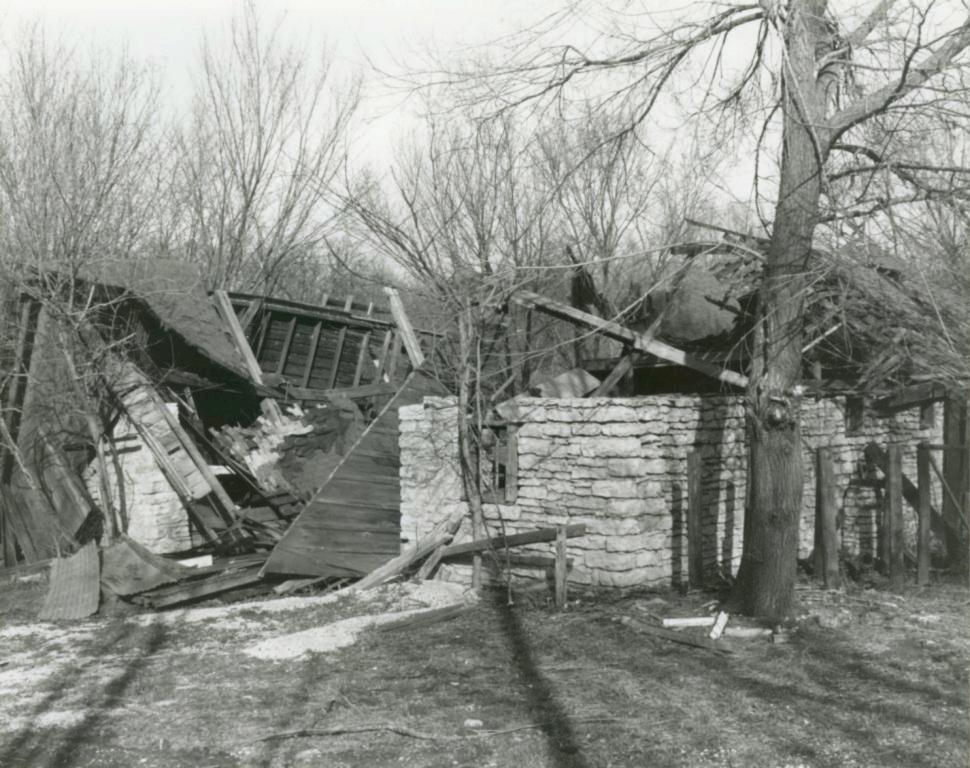
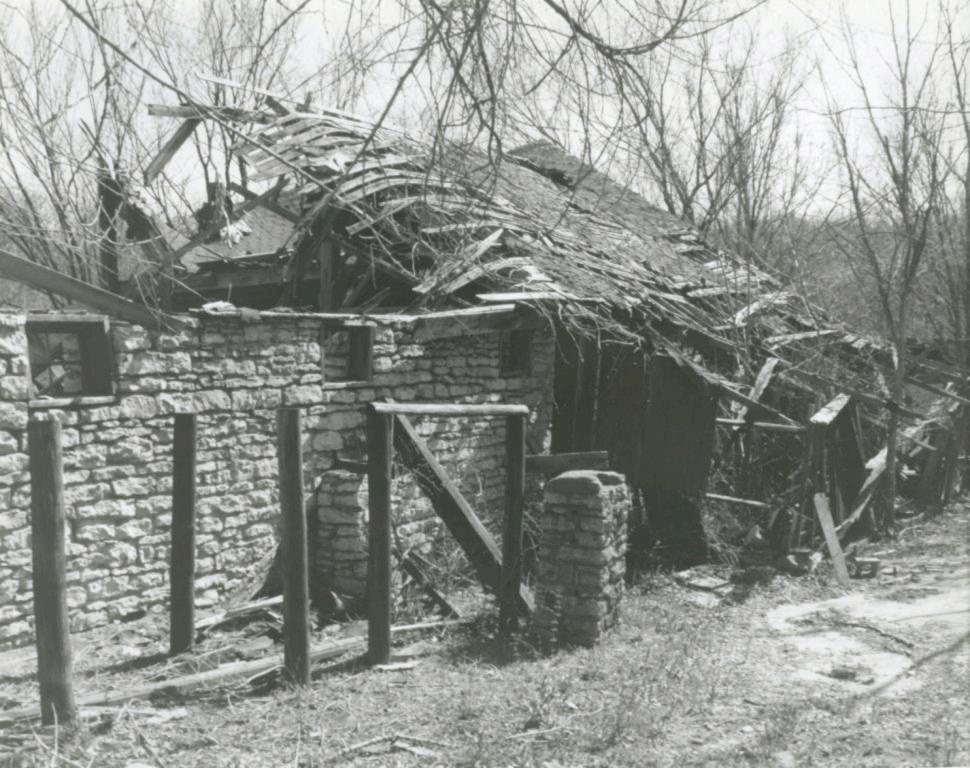
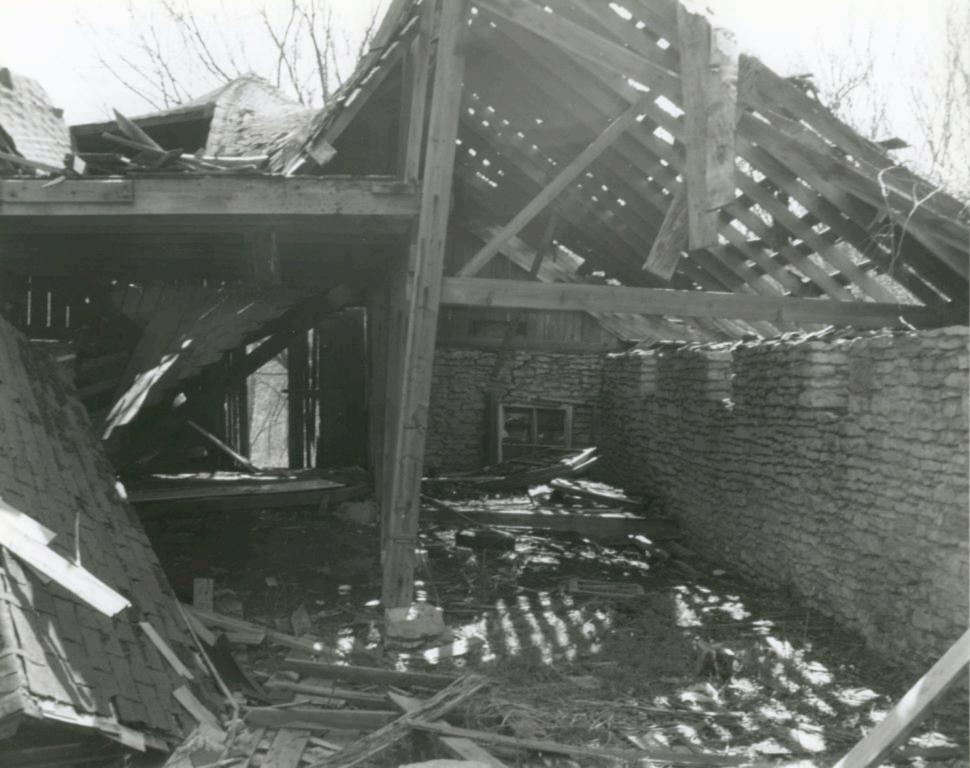
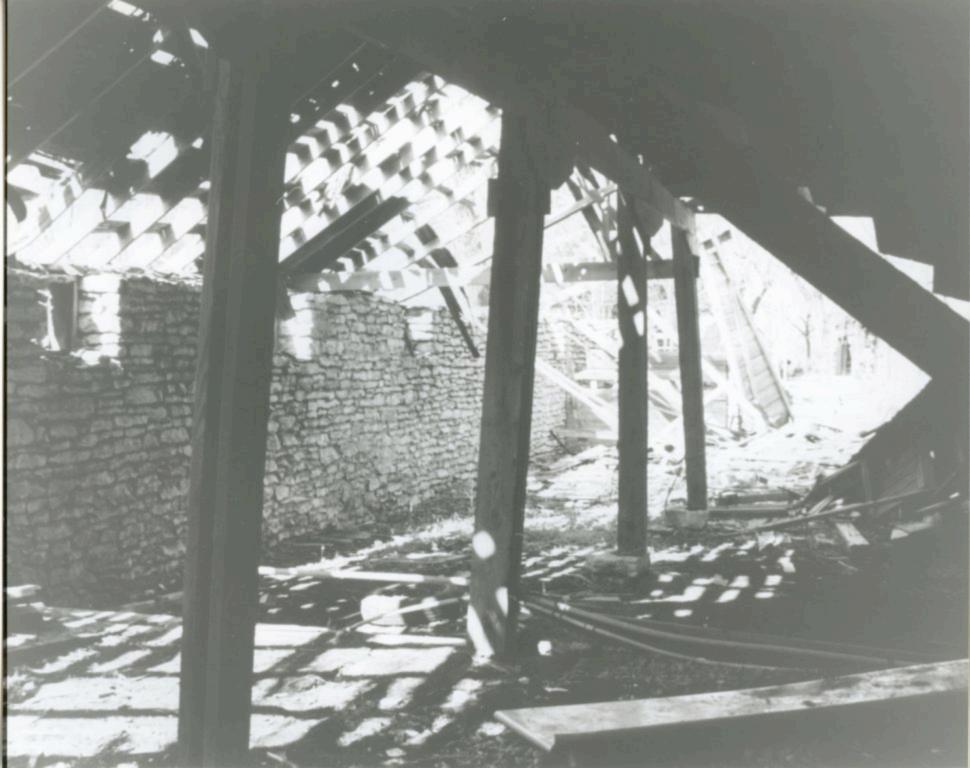
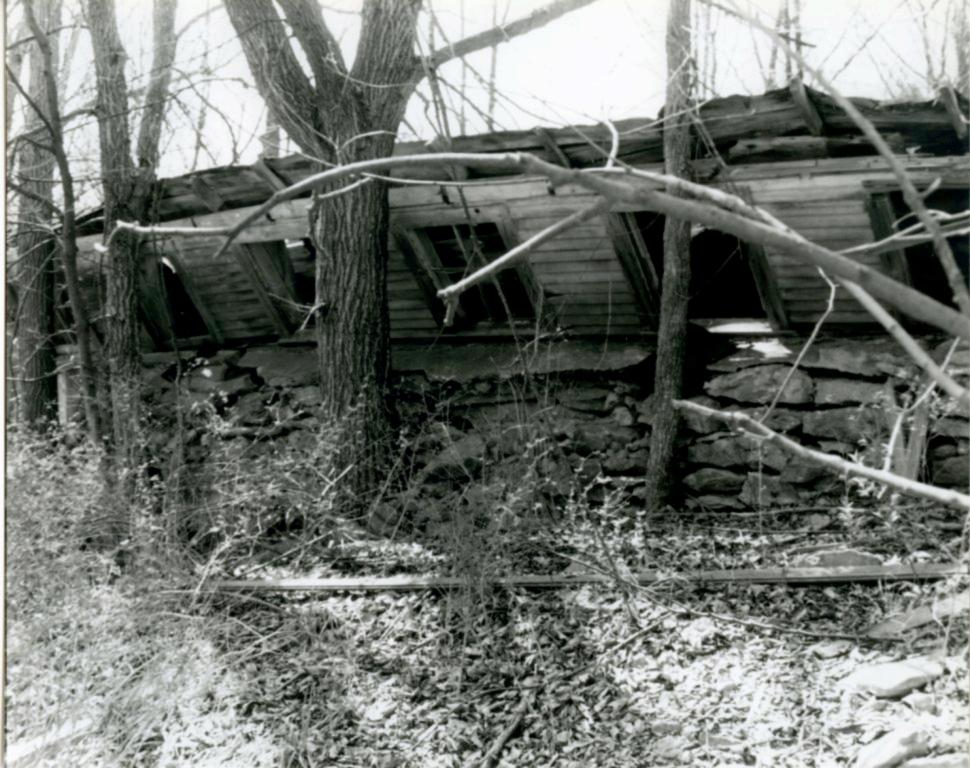
This barn was used for hay storage and winter livestock protection. A frame addition to the southeast is a Grade A milk barn. This barn has rubble limestone walls with wood center support posts and a wood end gable and trusses. The main floor and loft spaces were used for hay storage. A drive through runs the length of the barn from the northwest to the south east. Access is through sliding double doors at each end. Due to a rapid drop in grade the barn has a partial lower story which runs the full length of the northeast elevation. Another lower room, approximately 16' x 20' is under the southeast corner. The lower level can be accessed by large Roman-arched openings in the northwest and southeast elevations. There is no evidence of windows on the northeast elevation. The southwest elevation has square windows evenly spaced. Square windows flank each side of the double doors on the facade (northwest) elevation; there is no evidence of windows on the southeast elevation. An earthen ramp with a concrete walkway beneath, leads up to the double doors on the southeast elevation. The configuration of the milk barn addition and the livestock pens on the southwest elevation are unclear due to their state of deterioration. This barn was deemed a hazard by the school district and the roof was pulled down.

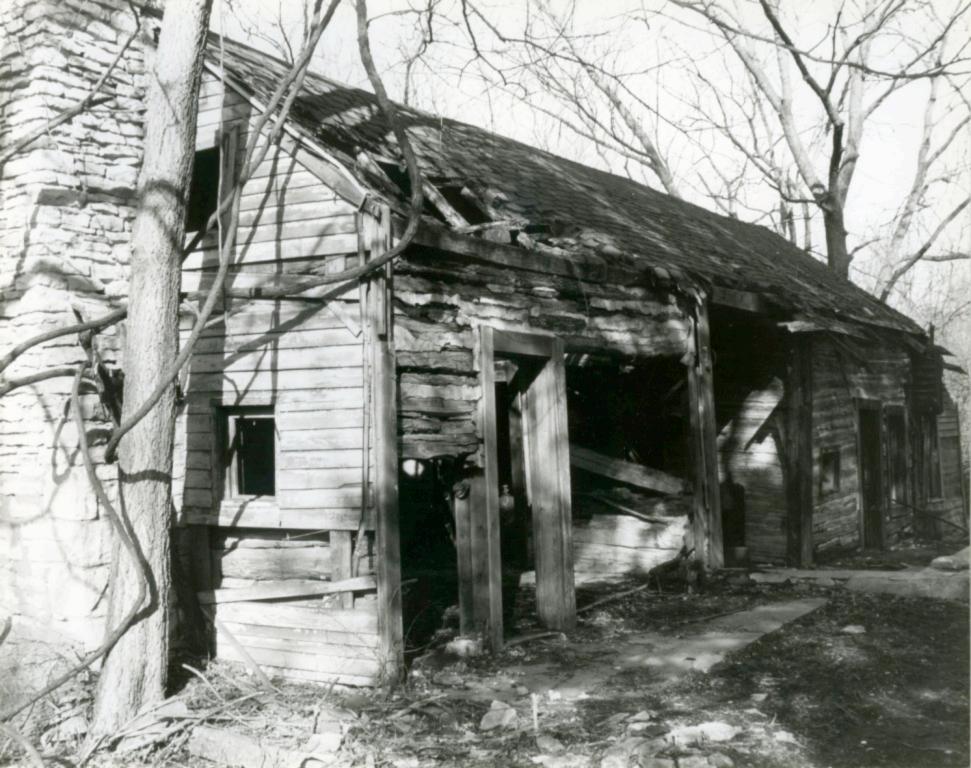
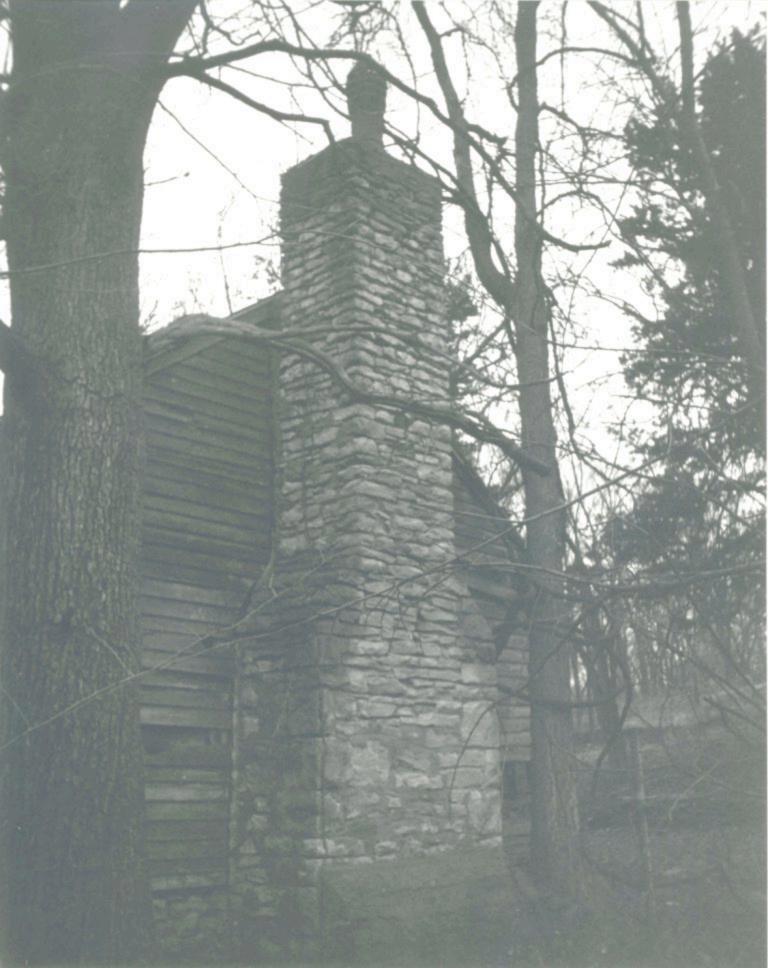
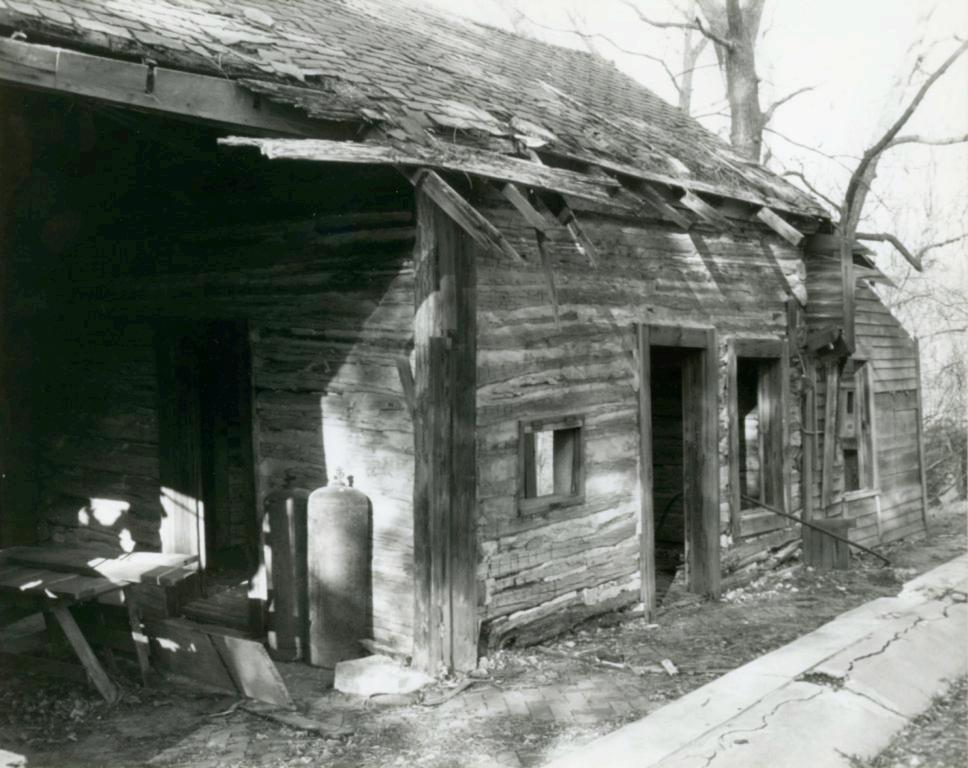
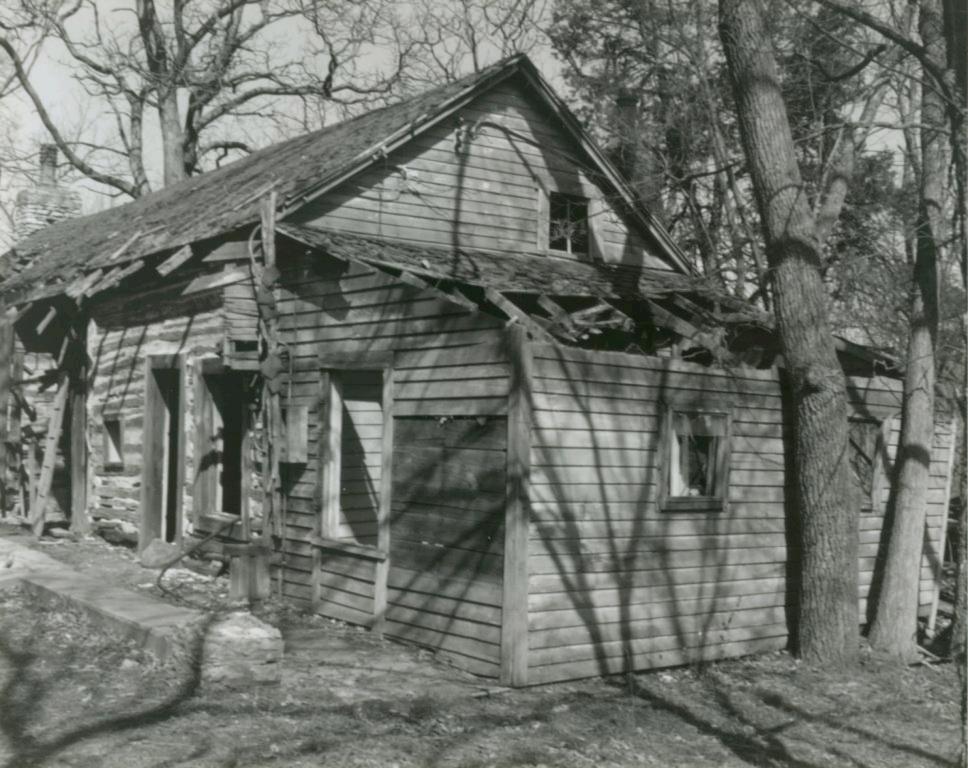
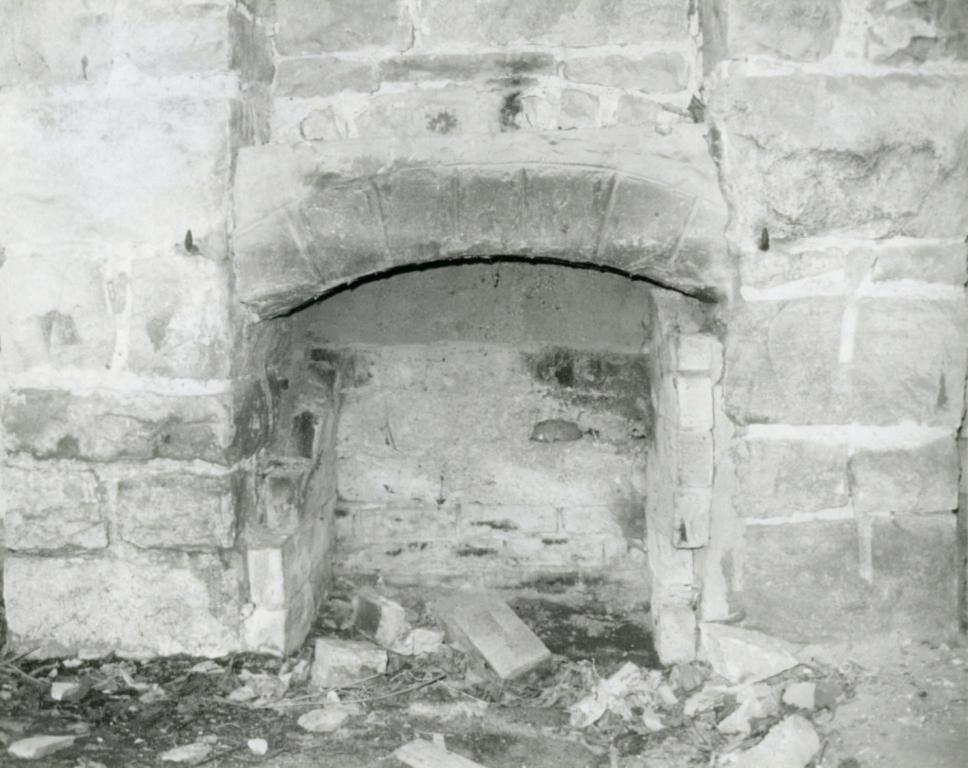
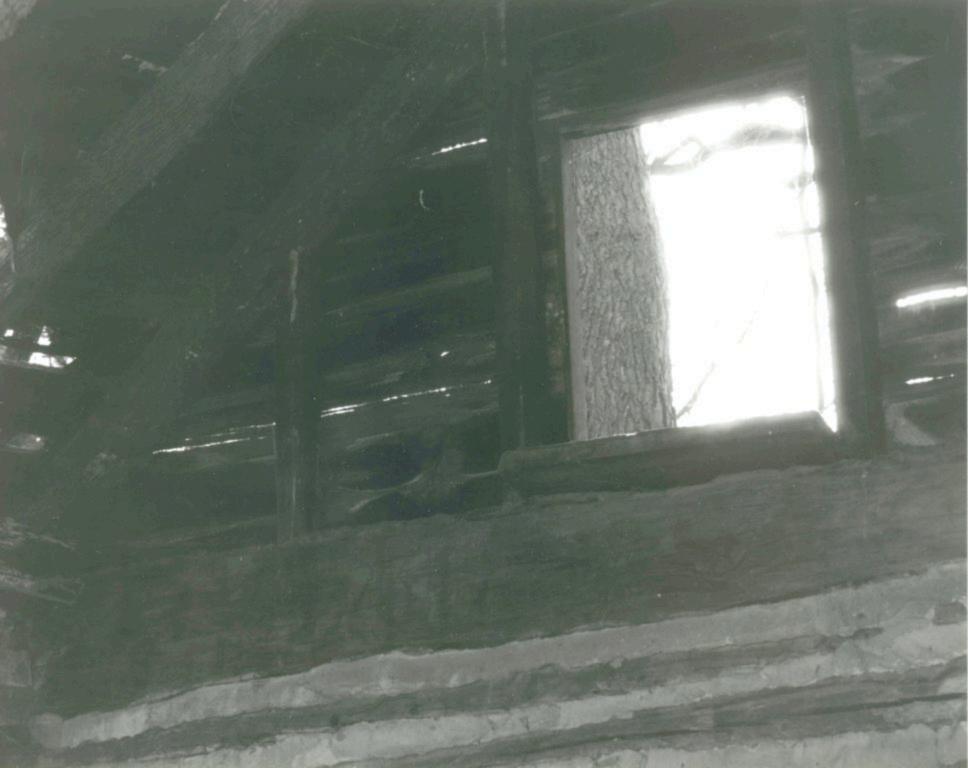
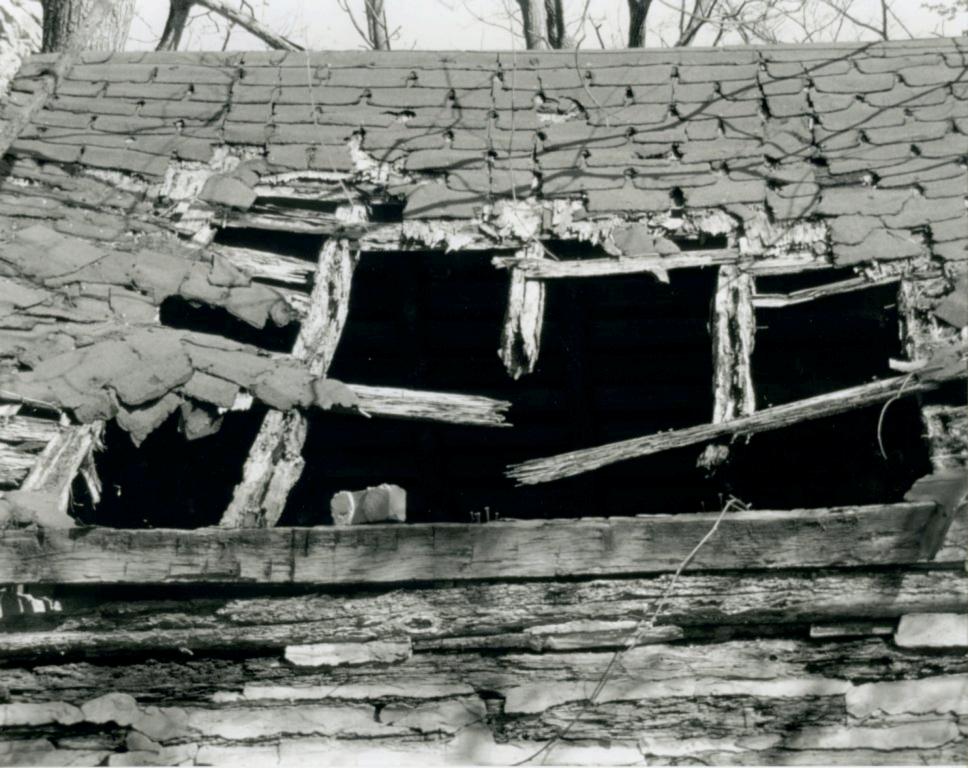
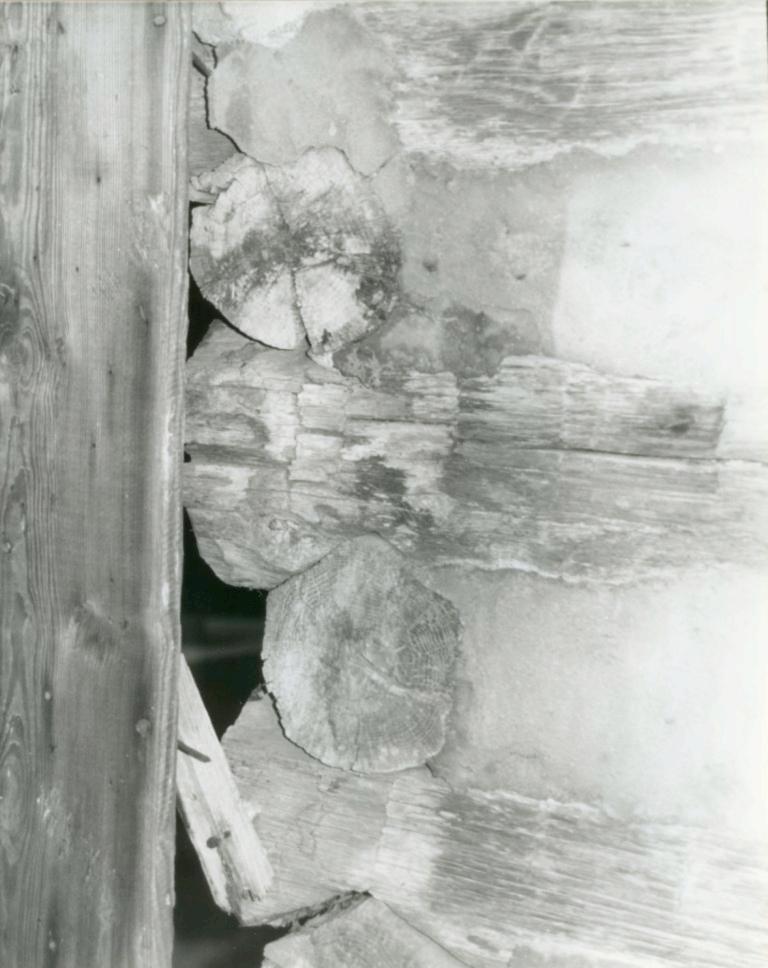
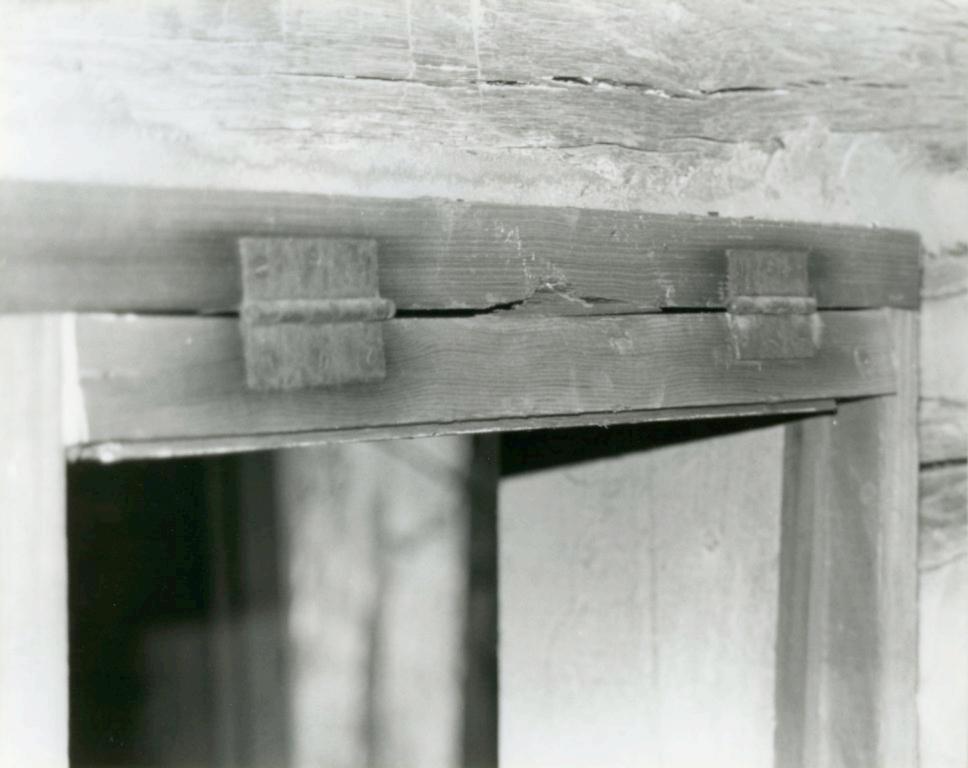
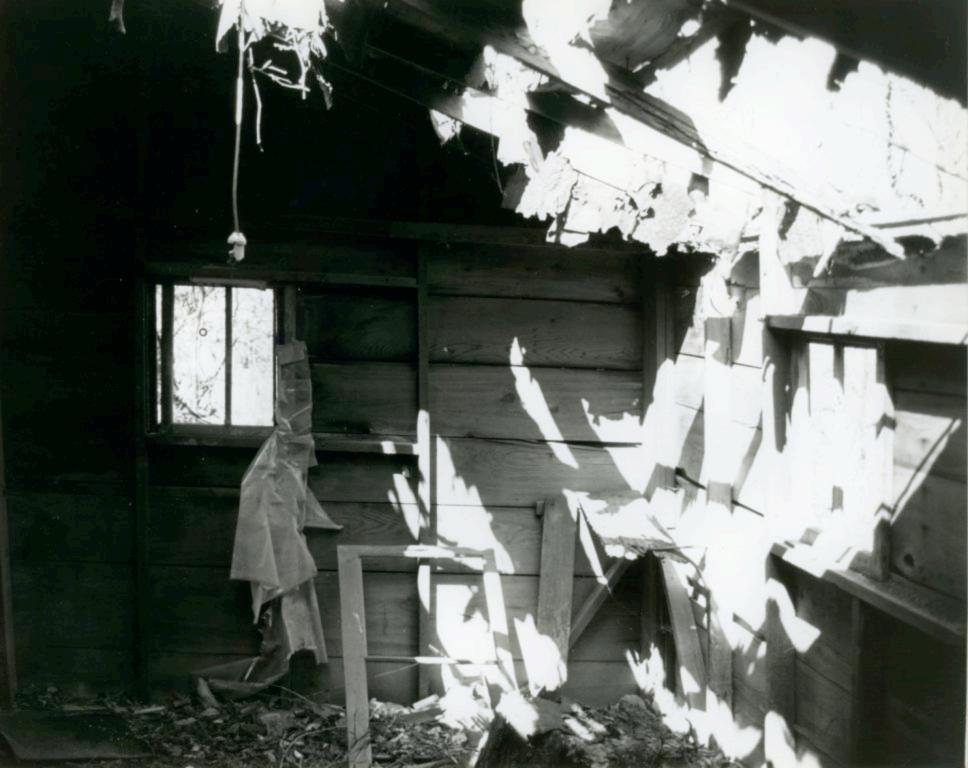
The log structure on the Hickory Hills Farm property has apparently seen many changes over time. As it stands today, it is a dog trot plan with frame additions on the north and east sides. The logs on the exterior were at some point covered with wood clapboards. The fireplace in the house is on the west side of the original log structure. Another stove chimney was added with the kitchen addition. The northeast addition has collapsed except for the lime stone basement and the south wall of the original log structure. The west half has rough- hewn log rafters, while the east side has milled lumber. Old records indicate the east and west halves of the structure may have been brought here from other sections of the property and joined together. A full length porch once existed on the south side of the house and brick pavers (in a herringbone pattern) form the floor surface between the two log rooms.

Plumbing in the house was apparently limited to the bathroom in an addition. The house was wired for electricity, but no evidence of a heating system other than a stove and fireplace was found.
