MISSOURI	HISTORIC	PRO	JPER	LA IN	VENT	ORY	FO	PRM						JA-AS-053-001
REFERENCE NU	IMBER	A	. HISTO	RIC NAM	IE						Tan Tan S			
93JA	7 0244		HIC	KORY	HILLS	FAI	RM C	COMP	LEX,	FA	RM HO	JSE

MISSOURI DEPARTMENT OF NATURAL RESOURCES HISTORIC PRESERVATION PROGRAM

MISSOURI HISTORIC BUILDING INVENTORY FORM - CONTINUATION SHEET

REFERENCE NUMBER A. HISTORIC N			C. ADDRESS		
COSPANIES SERVICES SALVES SALV	Hills Farm Complex	Jackson	47th Street	Kansas City	
Farm Ho	use

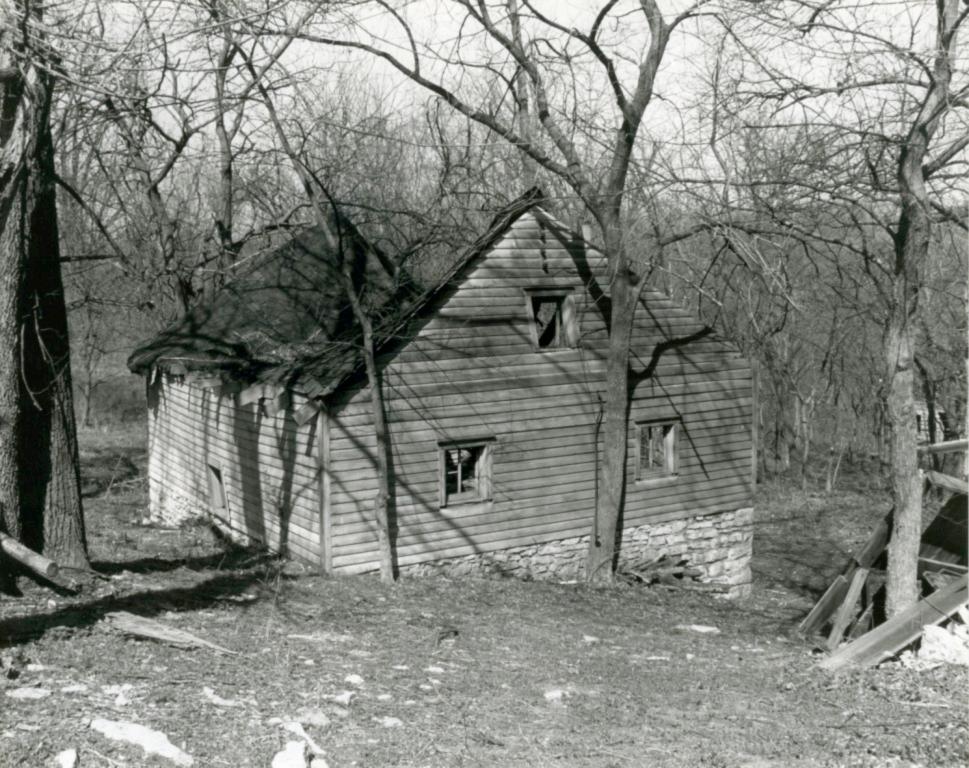
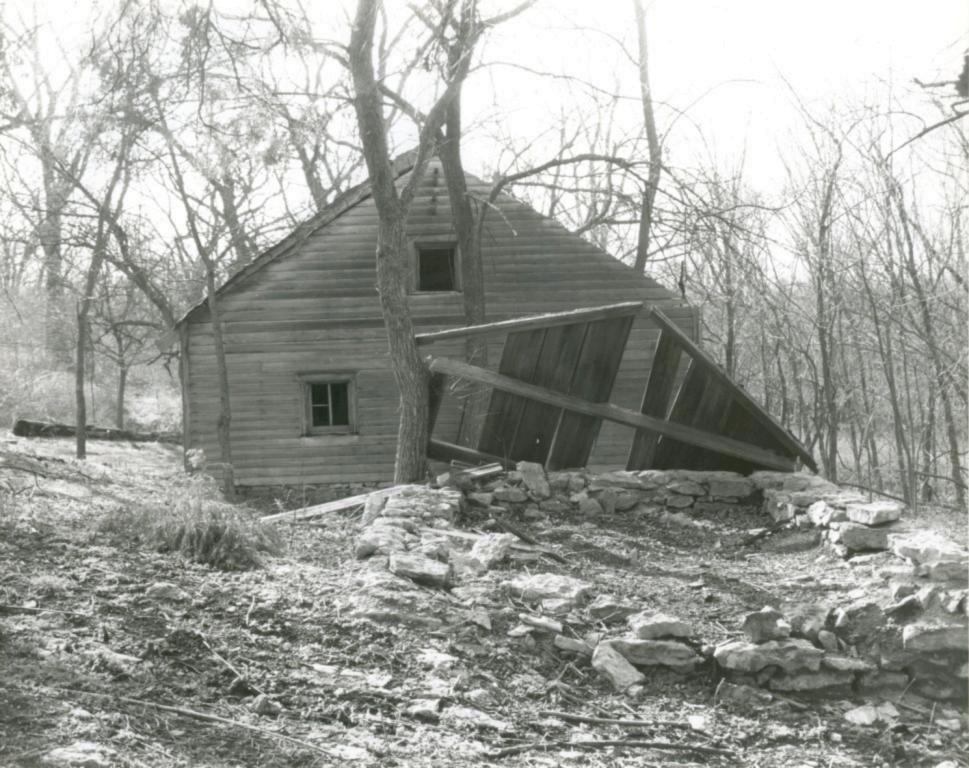
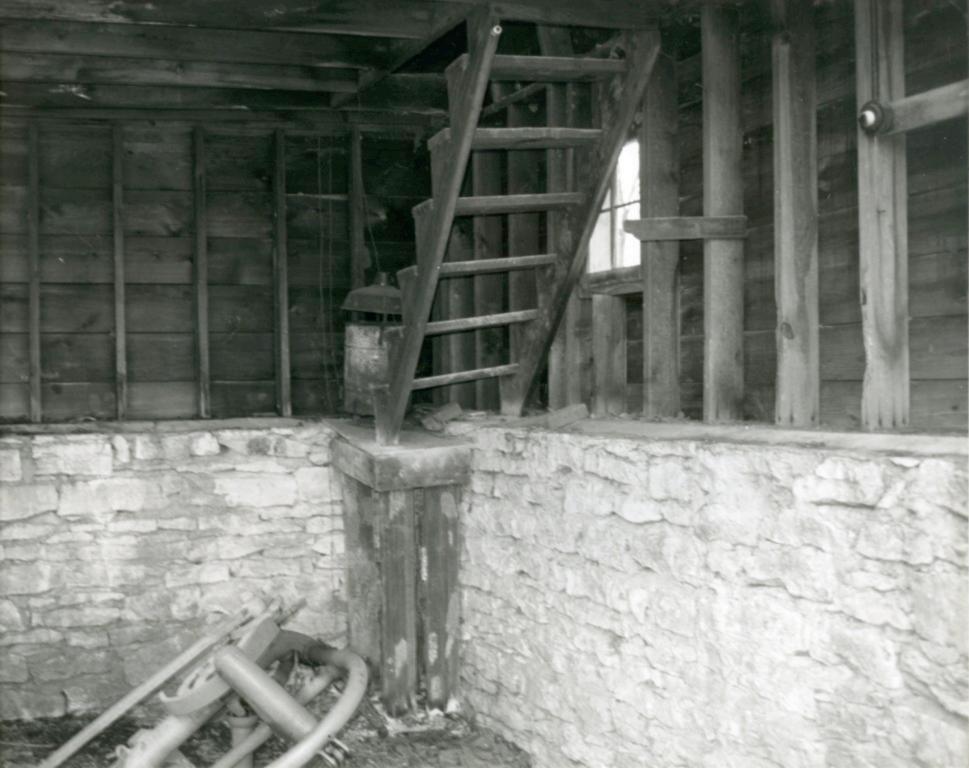
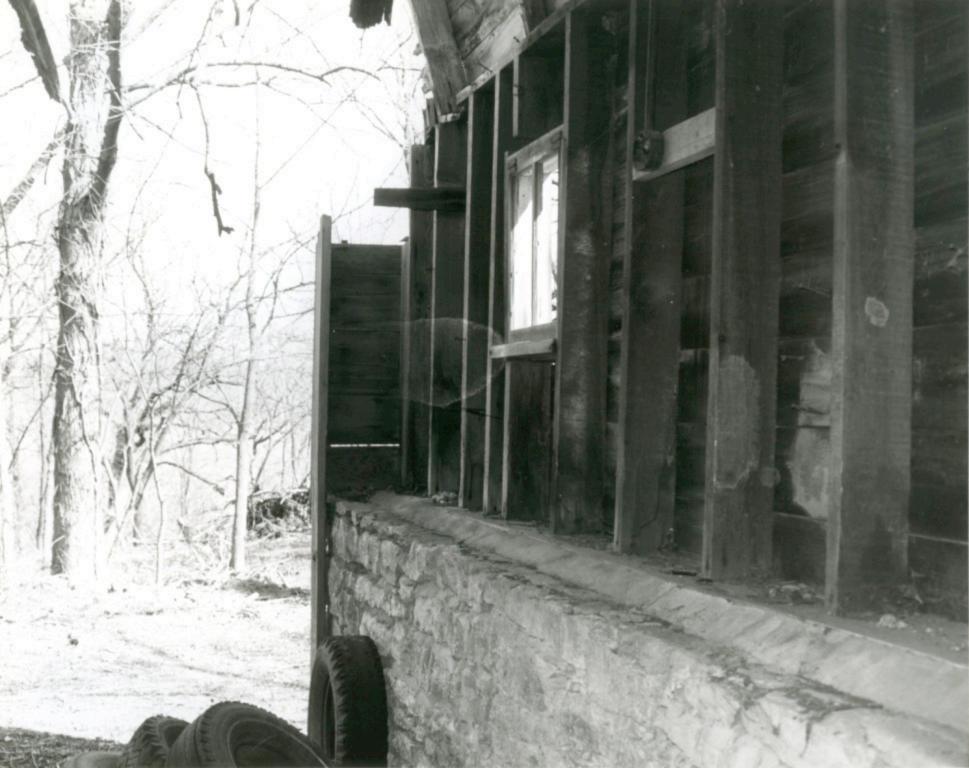
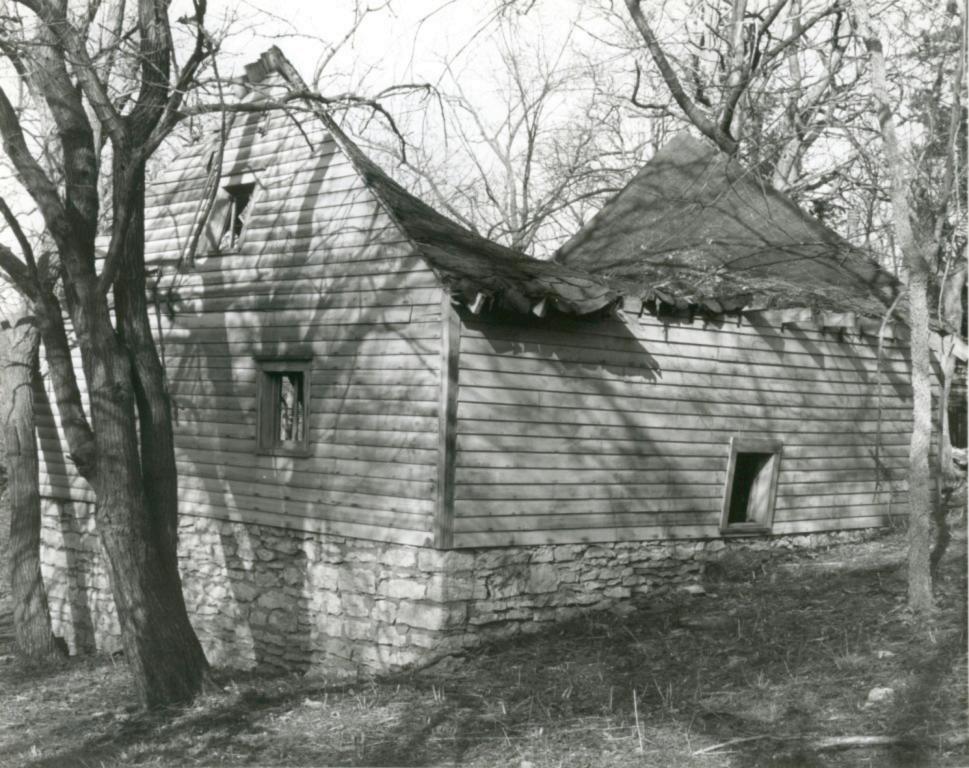
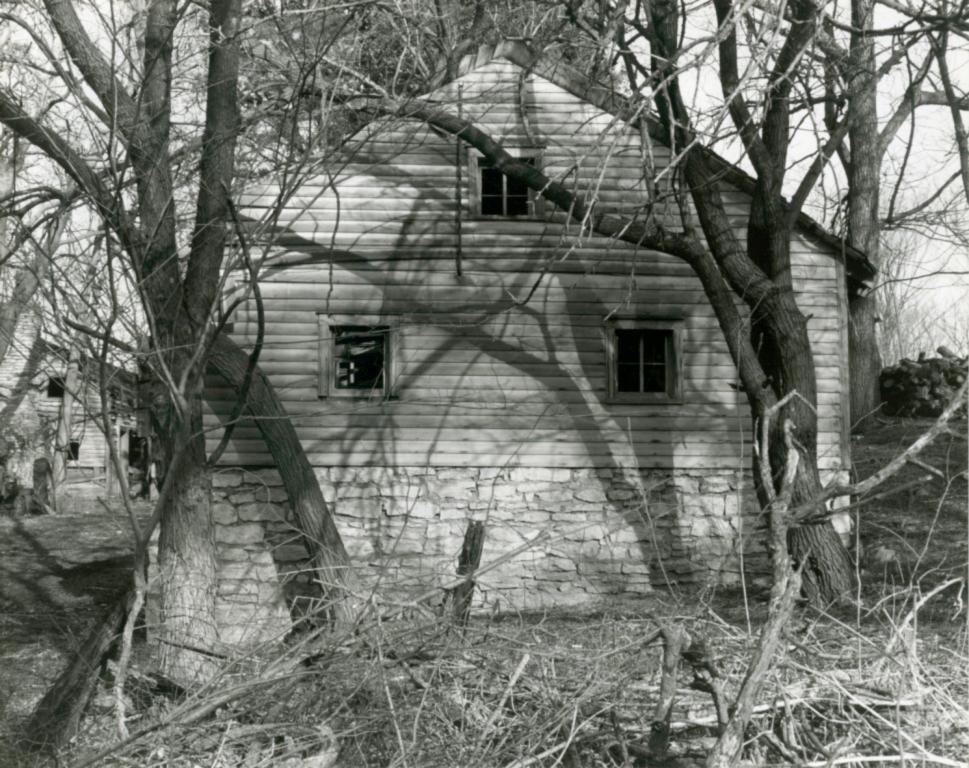
The shed has five foot high rubble lime stone walls that are embedded into the hillside. A wood frame structure was constructed on top of these walls with a gable roof. The two gable end walls each contain three four light awning windows and the whole structure is sheathed in beveled siding. A small loft area is found under the roof with a steep wooden stair leading to it. The entrance is on the north side spanning the width of the structure.

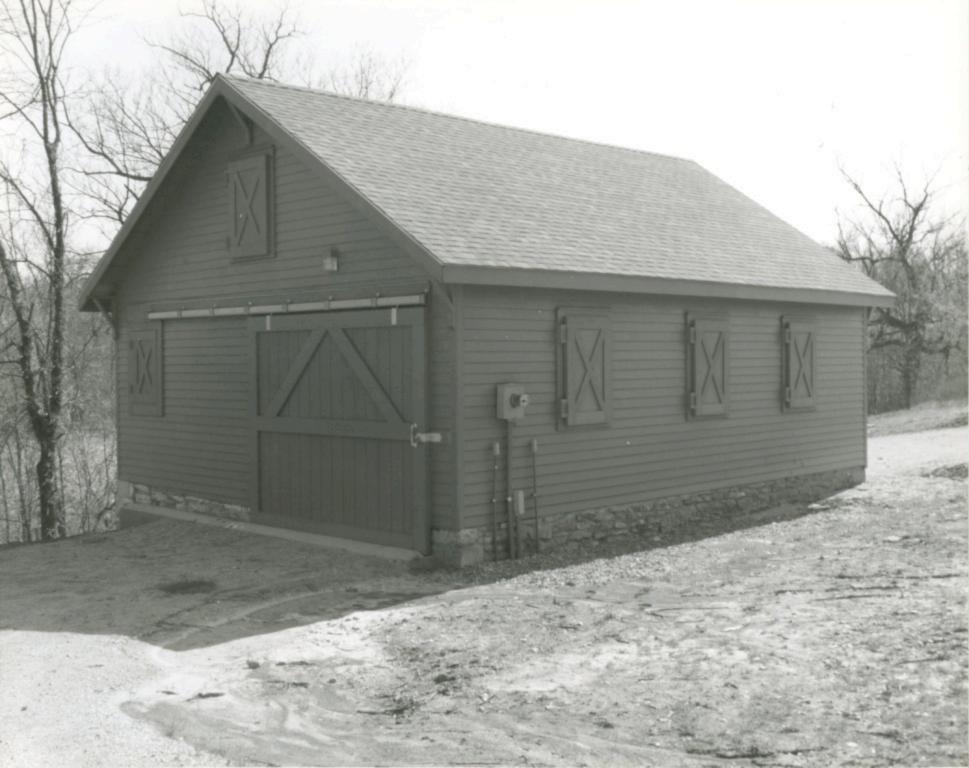
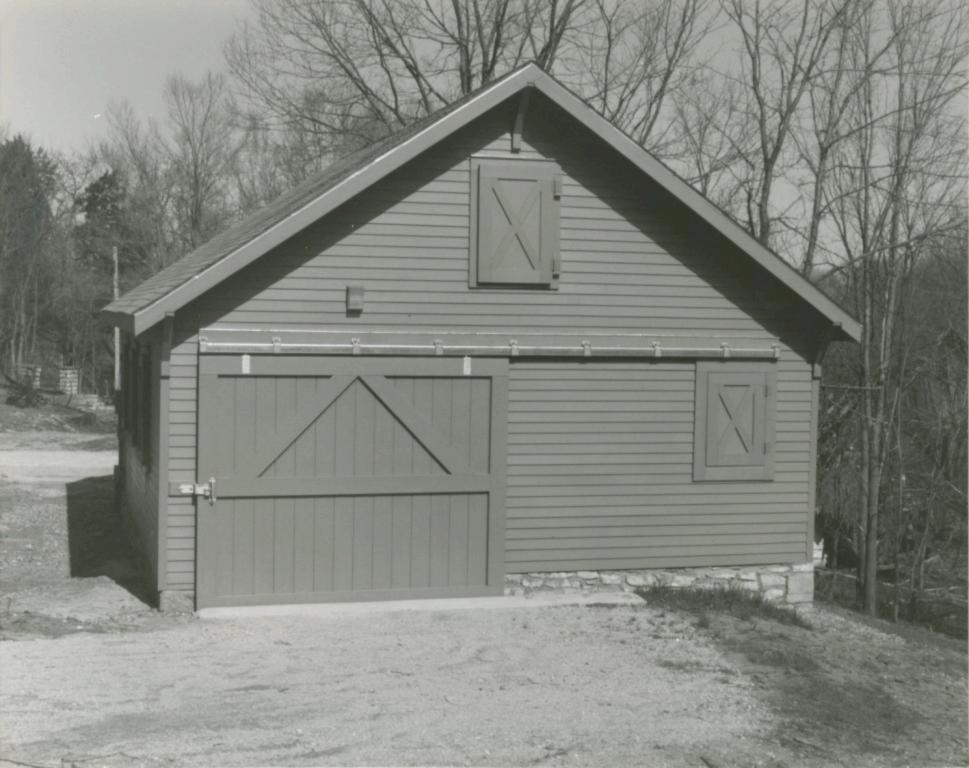
This structure which is just east of the farm house was recently rebuilt by the school district. The building was not restored according to HABS standards. Structural steel, masonite, and plywood siding were used in the reconstruction, and glass windows with shutters were installed. A concrete floor slab was also added, though it appears the original studs and rafters still remain. It appears the original use for this barn was as a garage though now it is used as a temporary classroom and storage.

This building is rectangular with a gabled roof. The small barn is entered through either one of two large sliding doors, one on the south facade and one on the north facade. There is also a small square window on each of these facades as well as three square windows each on the east and west facades.

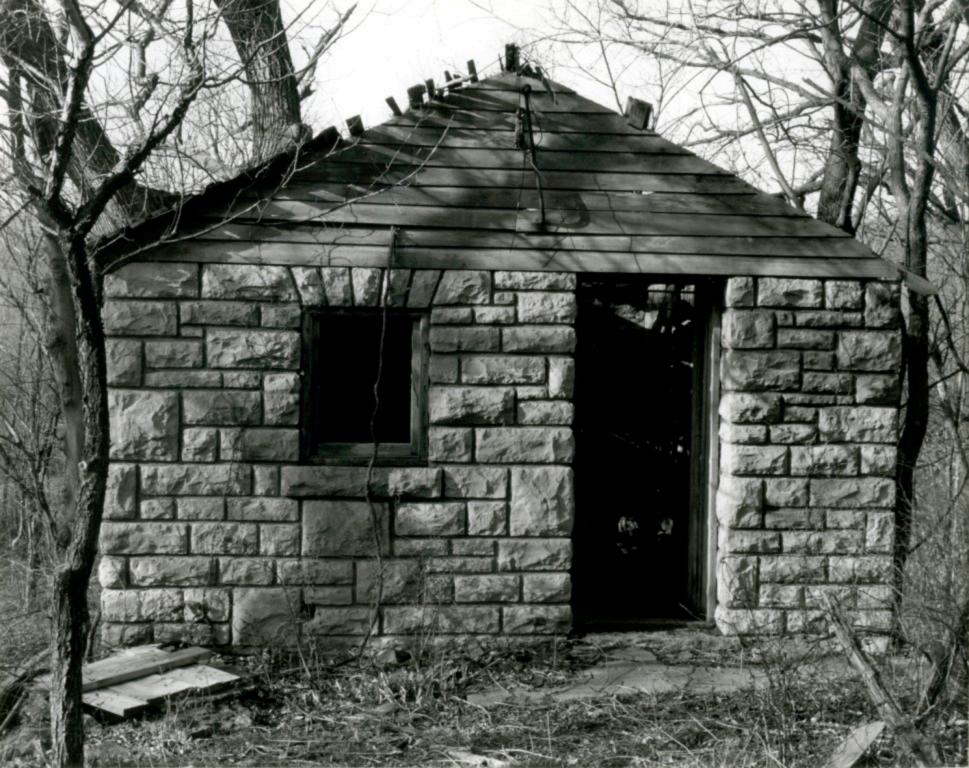
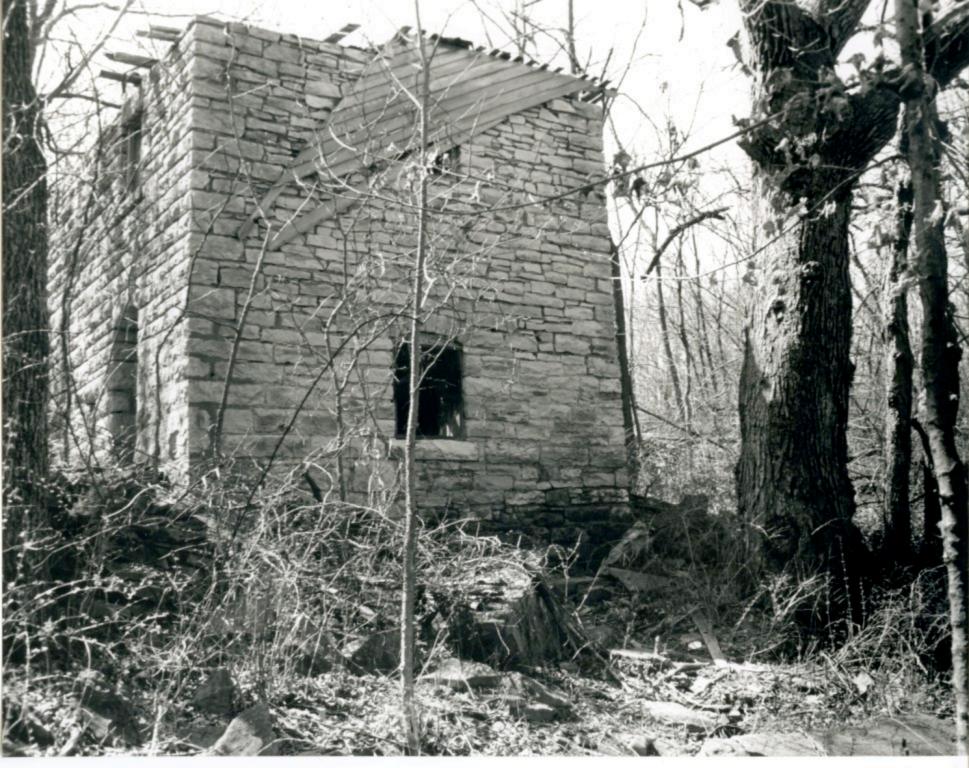
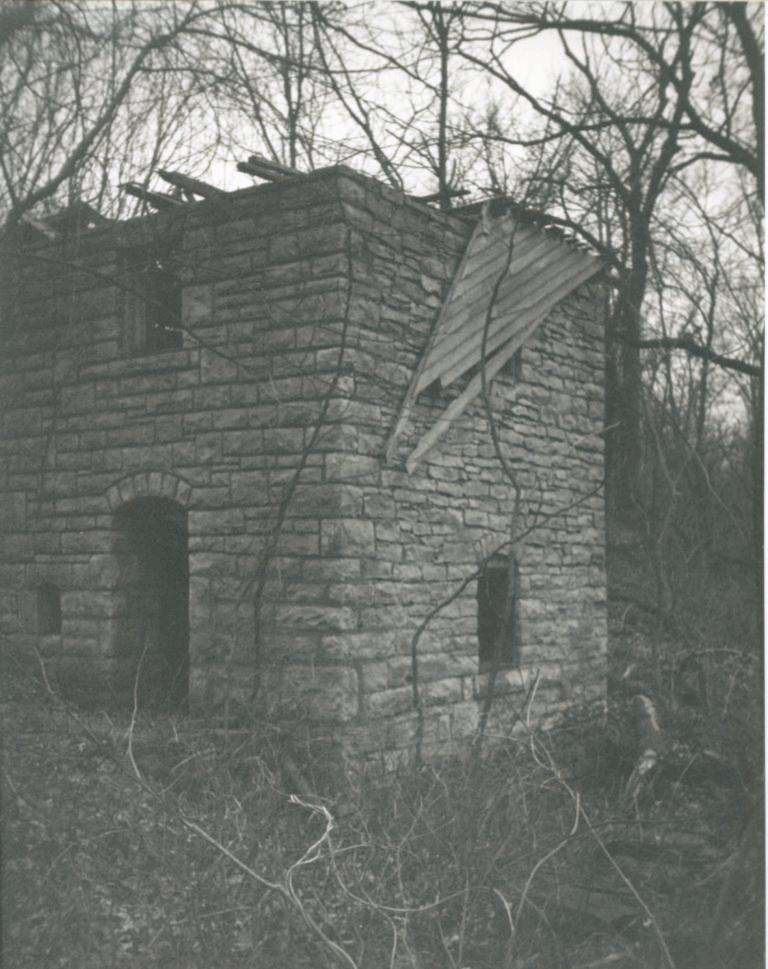
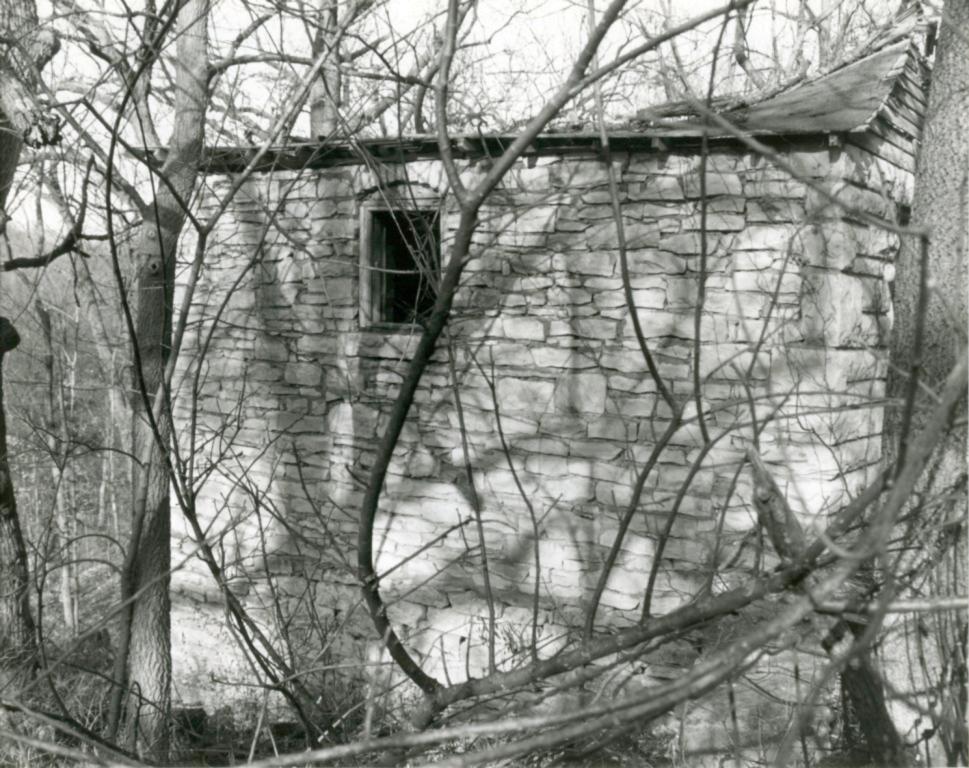
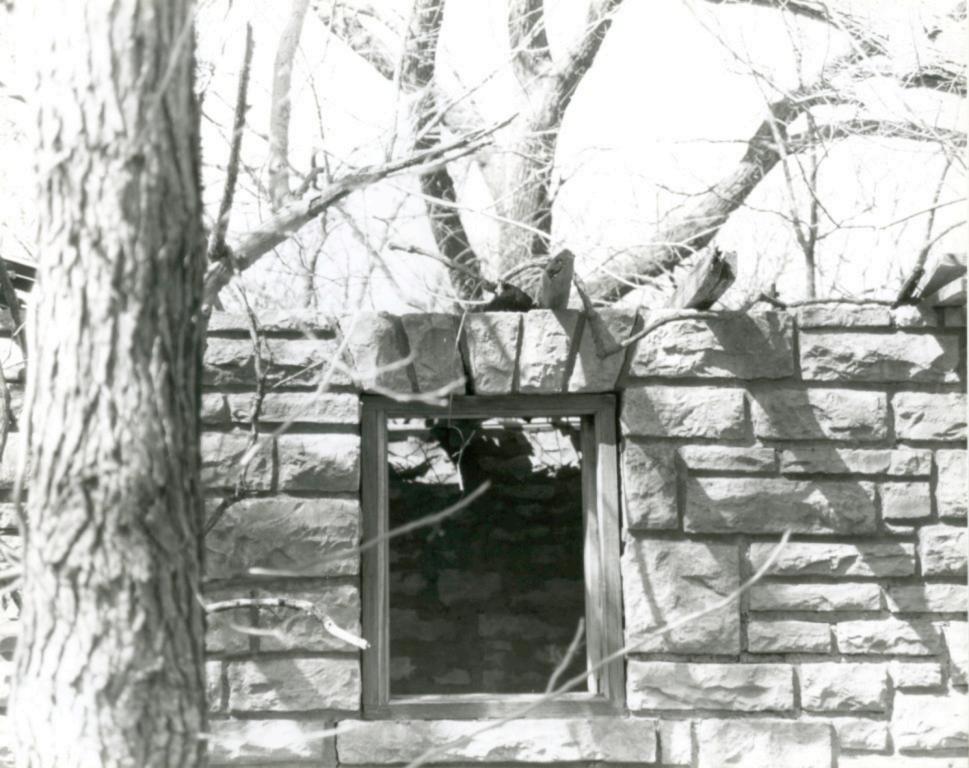
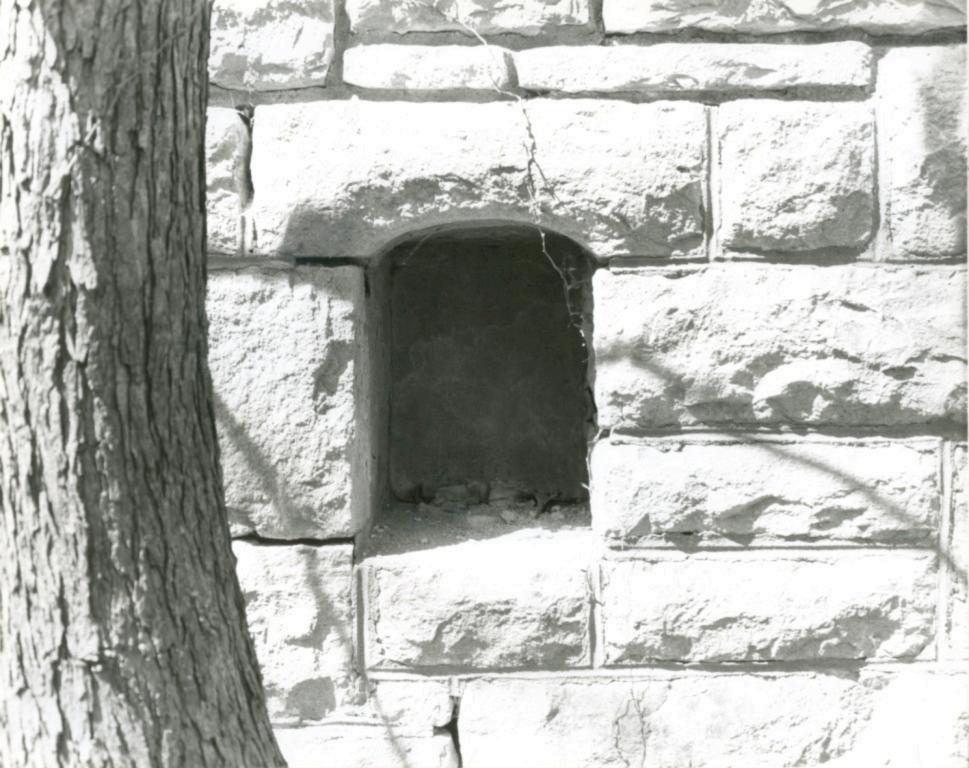
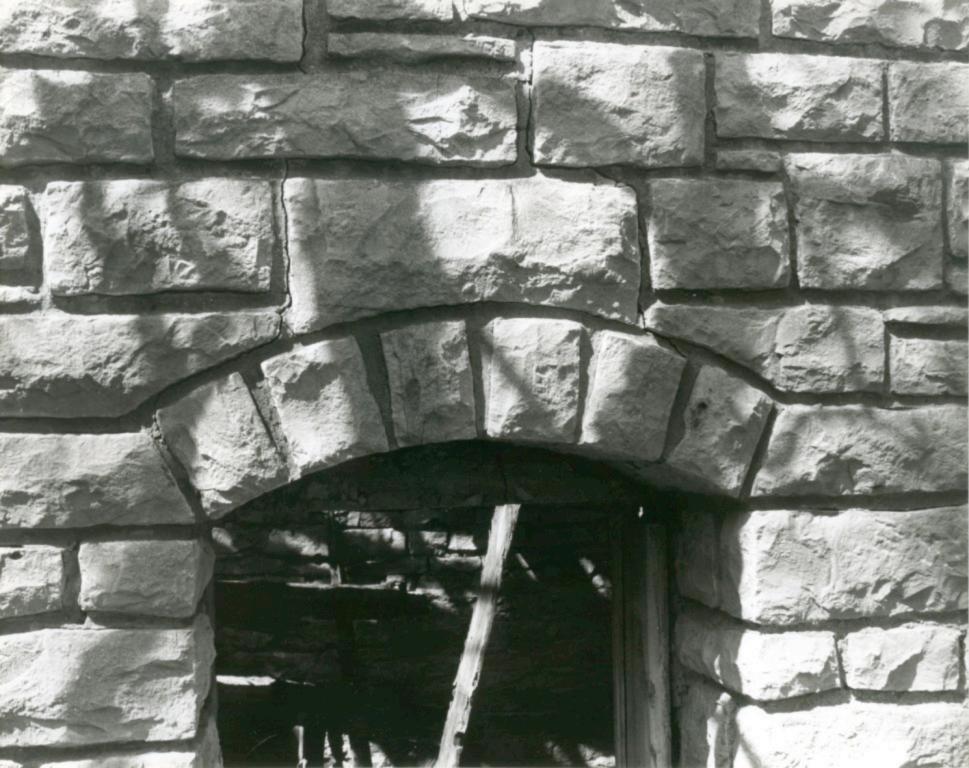
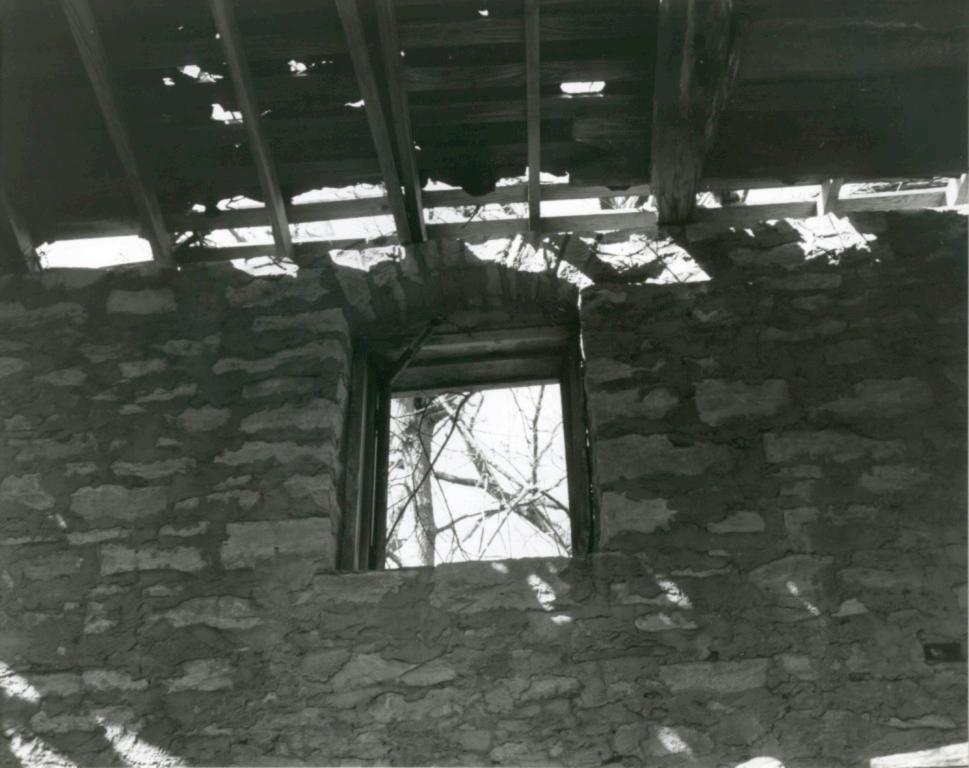
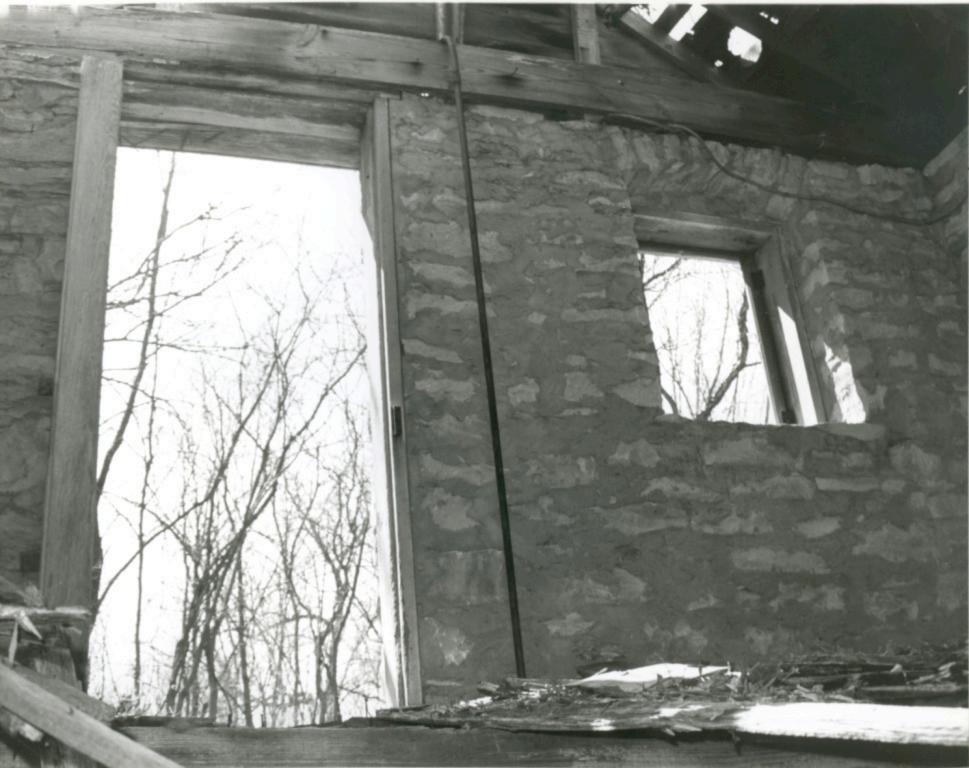
The spring house is constructed of rusticated random ashlar limestone on the south and east sides while the north and west sides are of squared and coursed rubble limestone. The difference in the stone type may be attributed to the possible reuse of stone from the grist mill that may have once stood here. Different types of arches were utilized for each of the windows and doors. These include a solid lintel, a jack arch, and a standard arch. Although different type of arches were used, it is interesting to note that not all of the arches have keystones.

The simple gable roof of the spring house was constructed of wood with asphalt shingles and a red clay tile ridge cap. The spring house is a two level structure with a ground level entrance on each level. An exterior stone stair leads from the upper level door on the east side of the south facade to the lower level door on the corner of the east facade. The spring itself ran through this lower level into a floor-level pool which was used to cool the spring house and flowed out through a pipe in the wall to the collecting pool below.

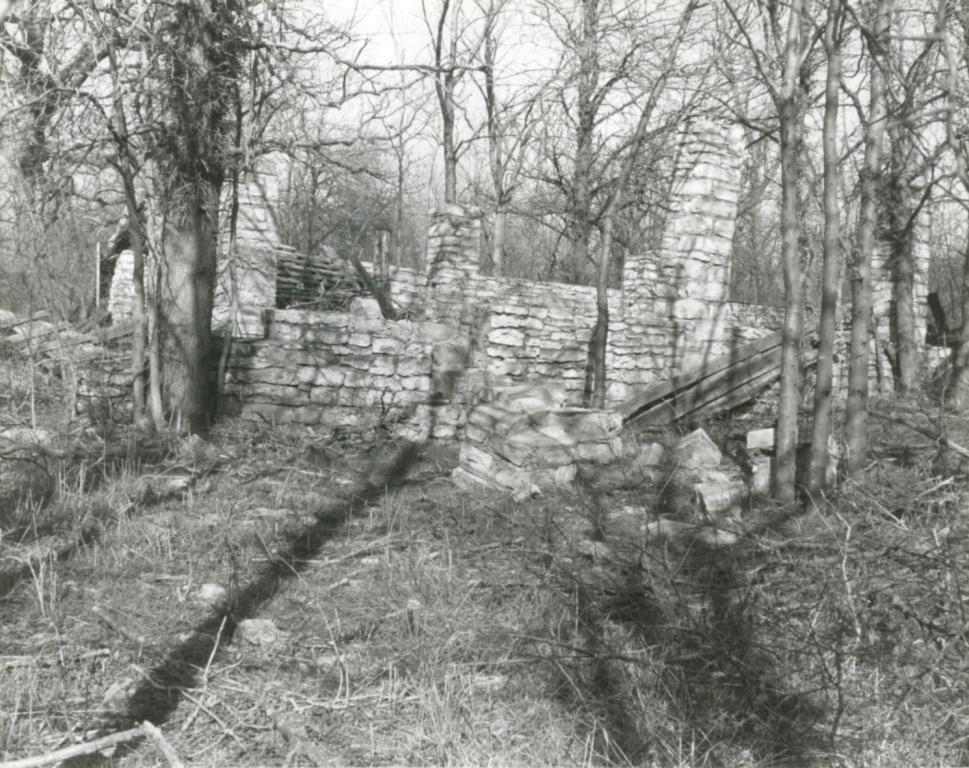
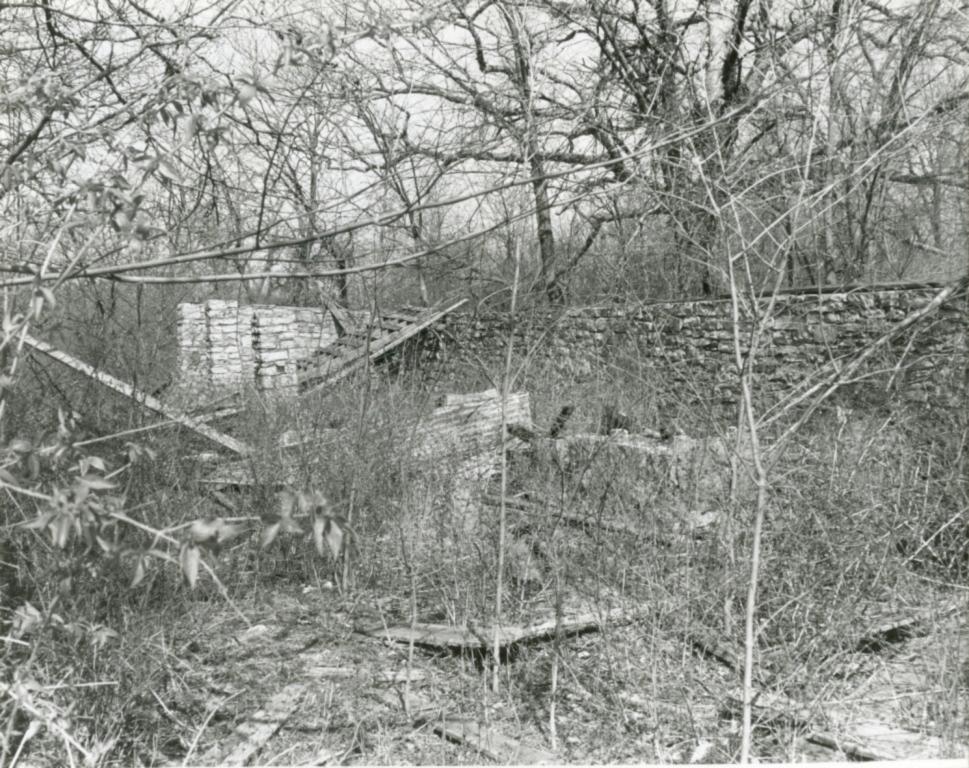
The stone shelter built across the meadow to the northeast of the farmhouse was constructed of rubble limestone. Only two of the interior stone columns remain standing. It appears that animals were kept in the north side of the building because metal gate pins are still visible in the two remaining columns. Also, the surrounding terrain and the openings in the east and west walls make it look as if either carraiges or farm equipment were pulled in under the roof for protection. The portions that remain of the south wall show that the building was made up of seven bays, the end two of which are smaller than the other five.
