# National Register of Historic Places Registration Form

historic name International Shoe Company Building

street & number 160 North Main Street [n/a] not for publication

**International Shoe Company Building  
Franklin County, MO**

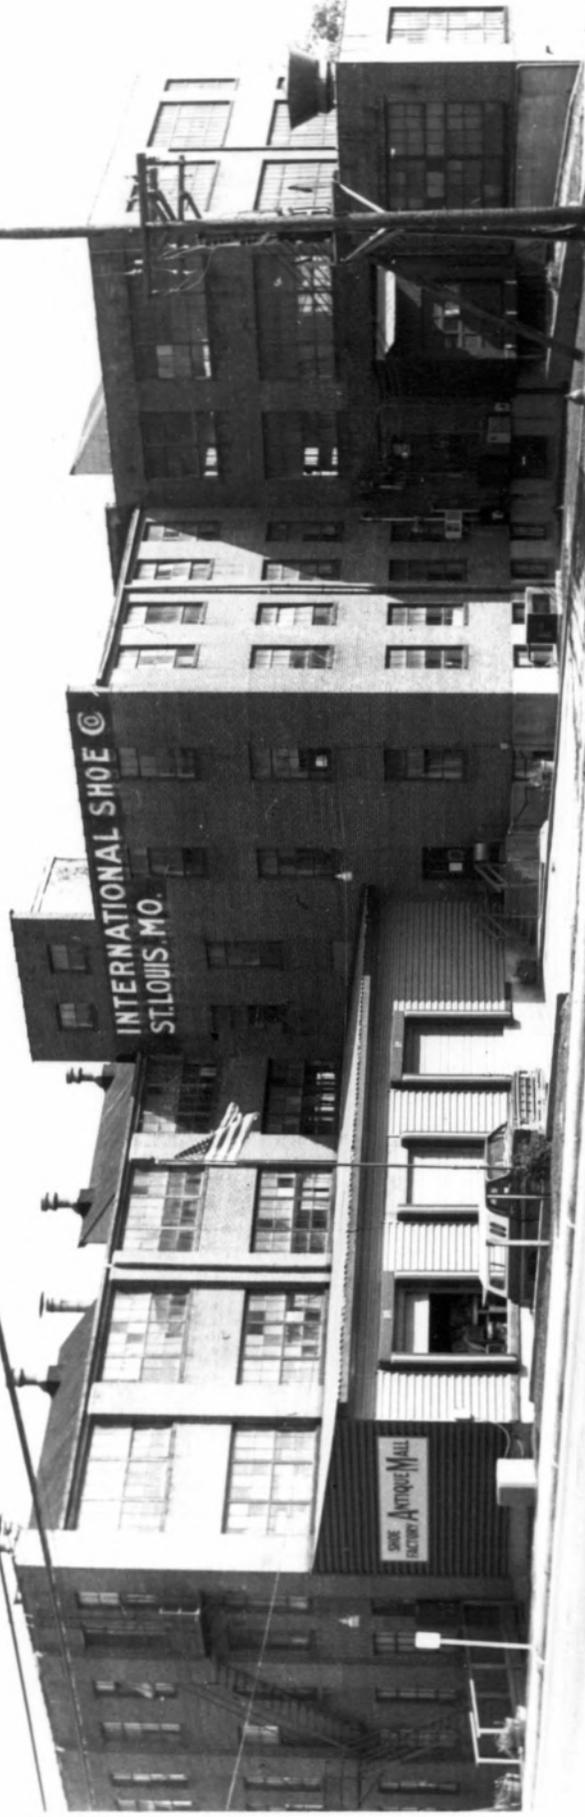
#1

FRONT OR WEST ELEVATION  
CAMERA FACING EAST

**Narrative:** The facade, or west elevation, consists of a central section, which houses the main entrance, stairwell, offices, restrooms and hallways which connect to the other sections of the building. The northernmost portion of the building is a long rectangular section which measures 46 feet by 150 feet and extends 58 feet past the facade to the street. This north section houses the elevator shaft, the present loading dock area which is constructed of uninsulated galvanized metal, and fourteen first-floor, symmetrically arranged bays. There were originally seventeen bays, but three were eliminated with the construction of the uninsulated, galvanized metal loading dock in 1982 (photo #1).

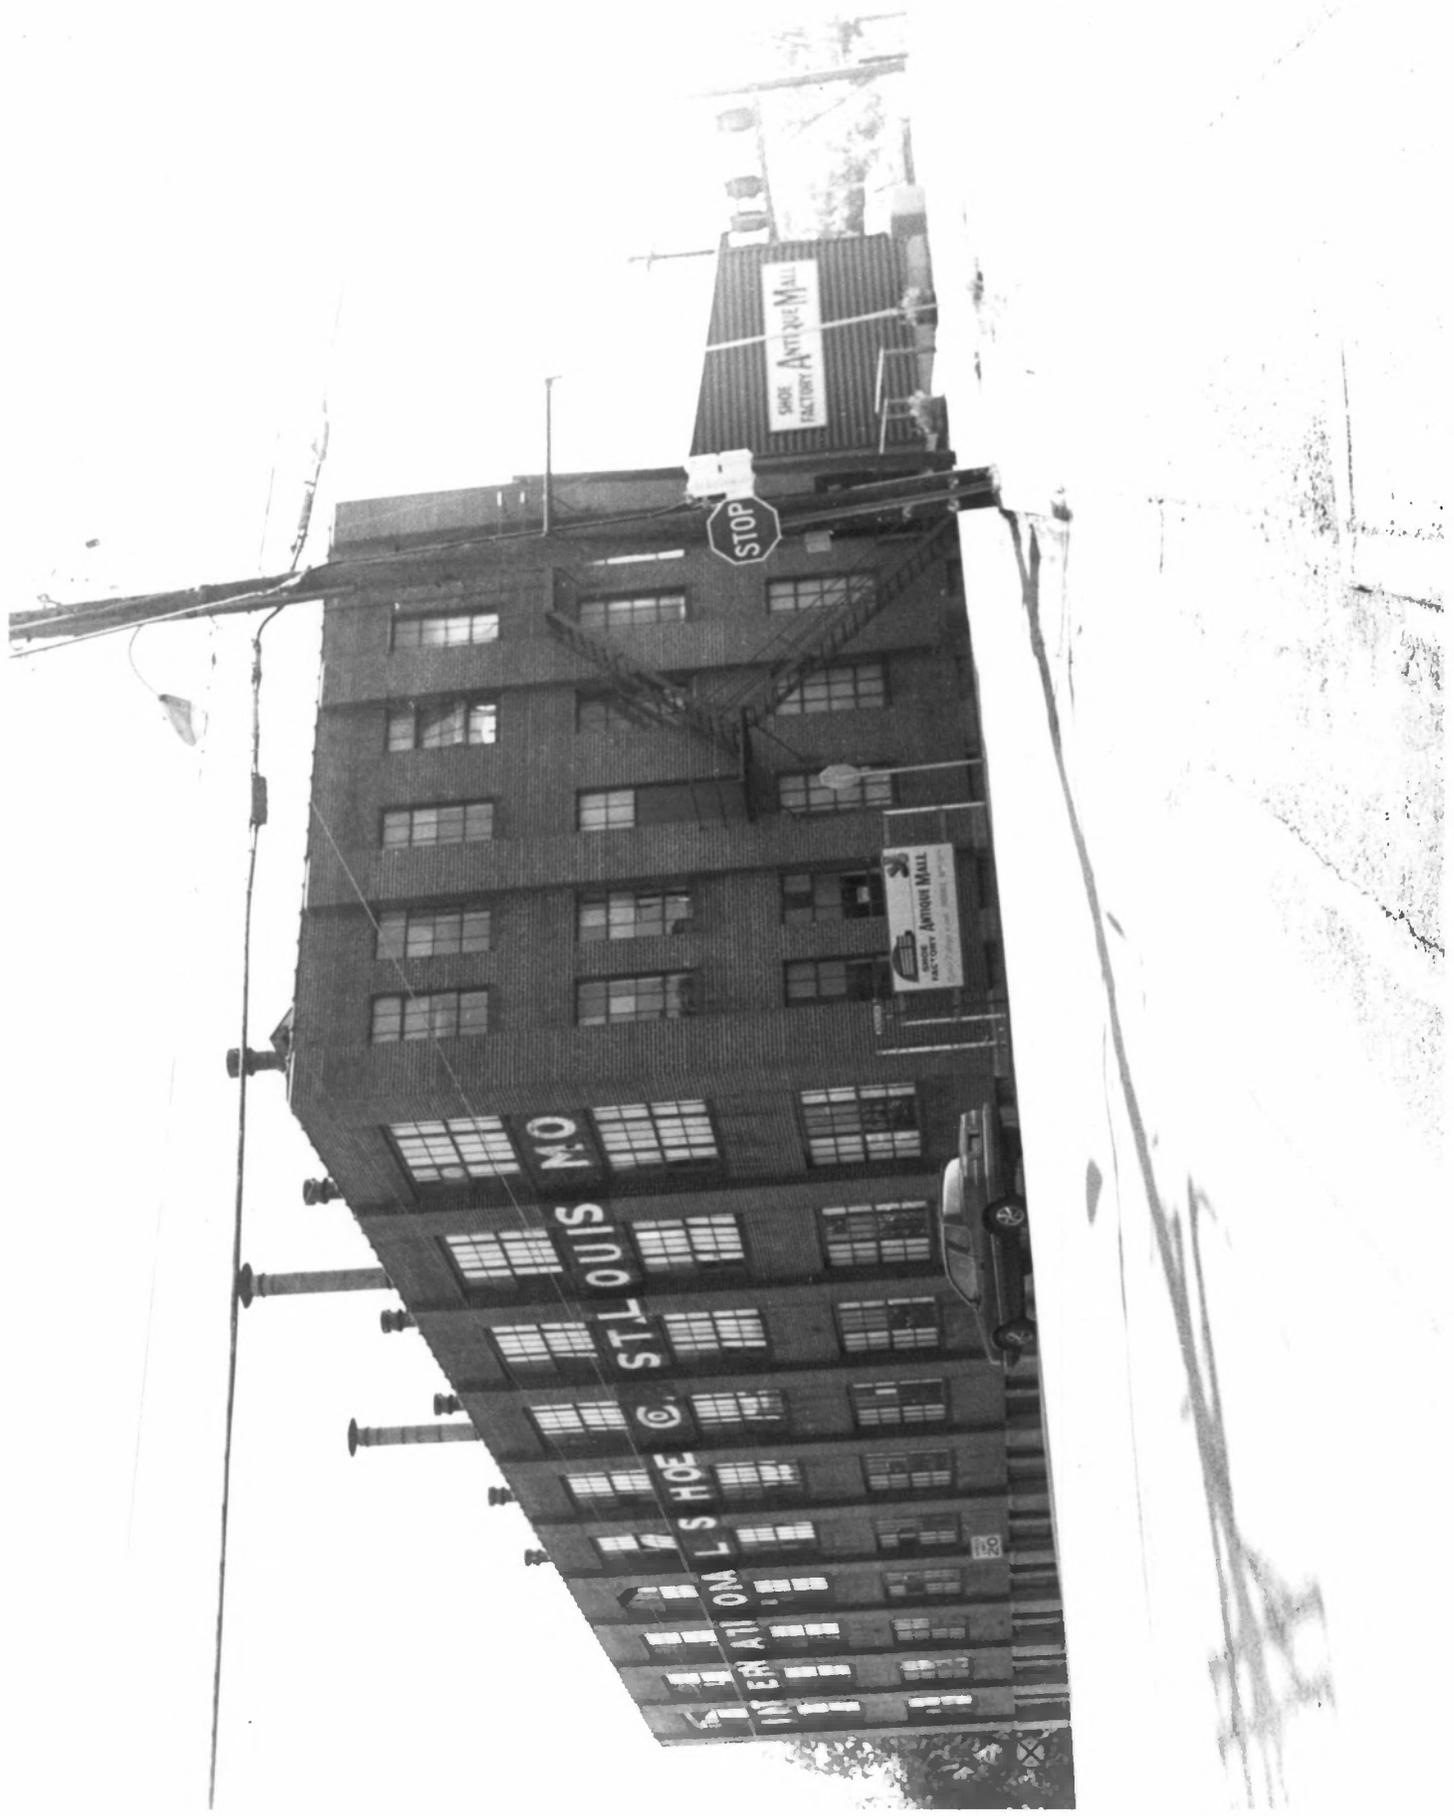
Photograph #2

NORTH AND PART OF WEST ELEVATION  
CAMERA FACING SOUTH EAST

On the second and third floors, the original seventeen bays are still intact and the fenestration is identical to that of the first floor. On all three floors, each bay is filled by three six-over-six, double-hung sash, except on the east and west walls where fenestration consists of single openings of six-over-six double-hung sash (photo #5). Additional illumination is provided on the third floor through three skylights, each measuring 14 feet by 28 feet, of single-hung sash (photo #6 and floor plan 2). Brick pilasters on the exterior rise from the cast concrete foundation to the roof, marking the location of the internal bays on both sections of the north and south elevations (photos #2 and #3).

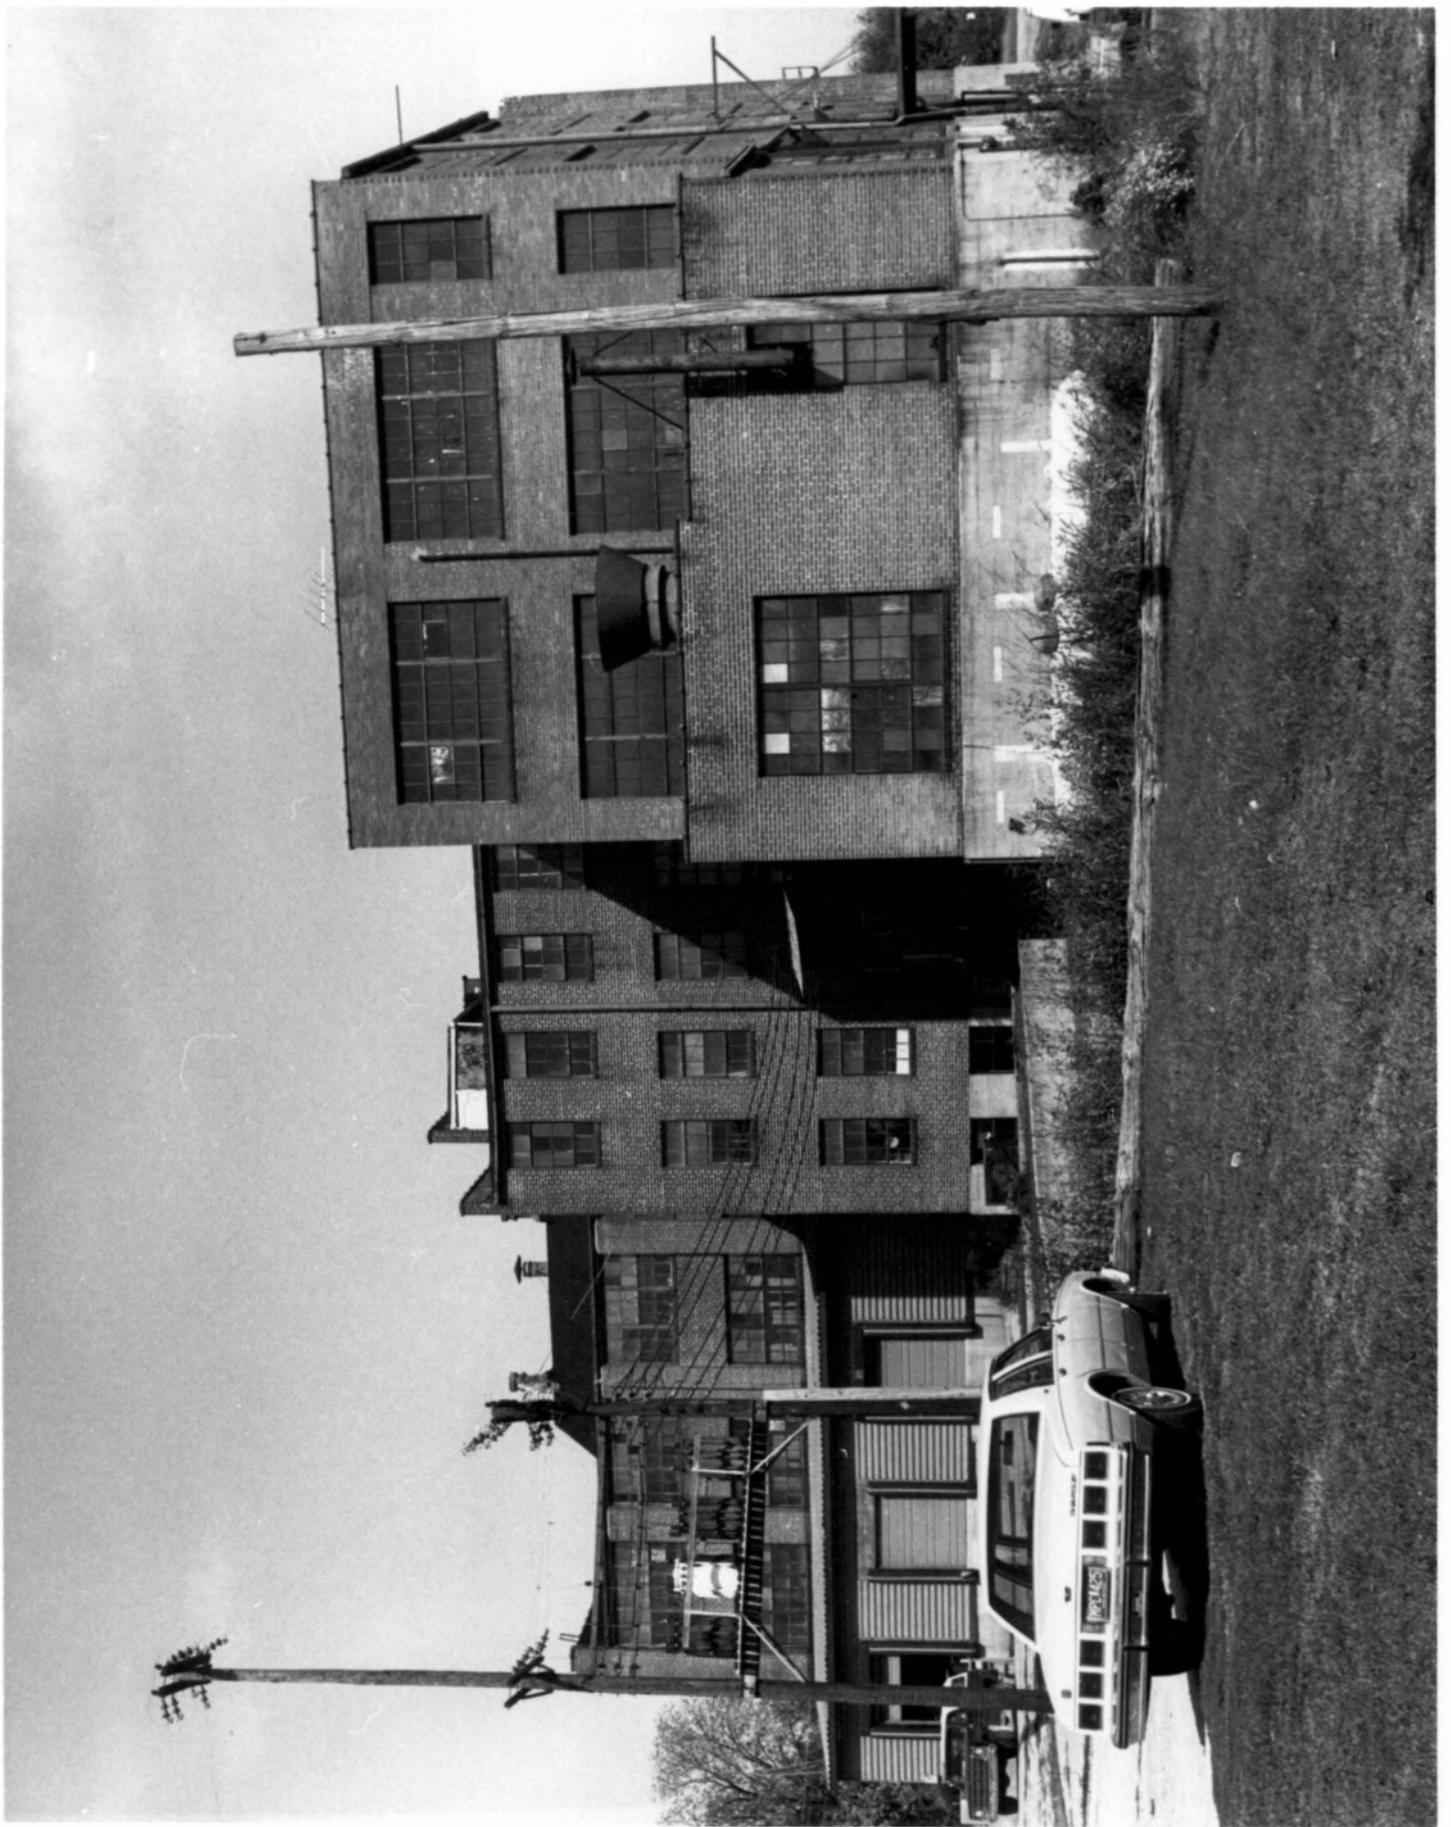
Photograph #4

SOUTH ELEVATION  
CAMERA FACING NORTH

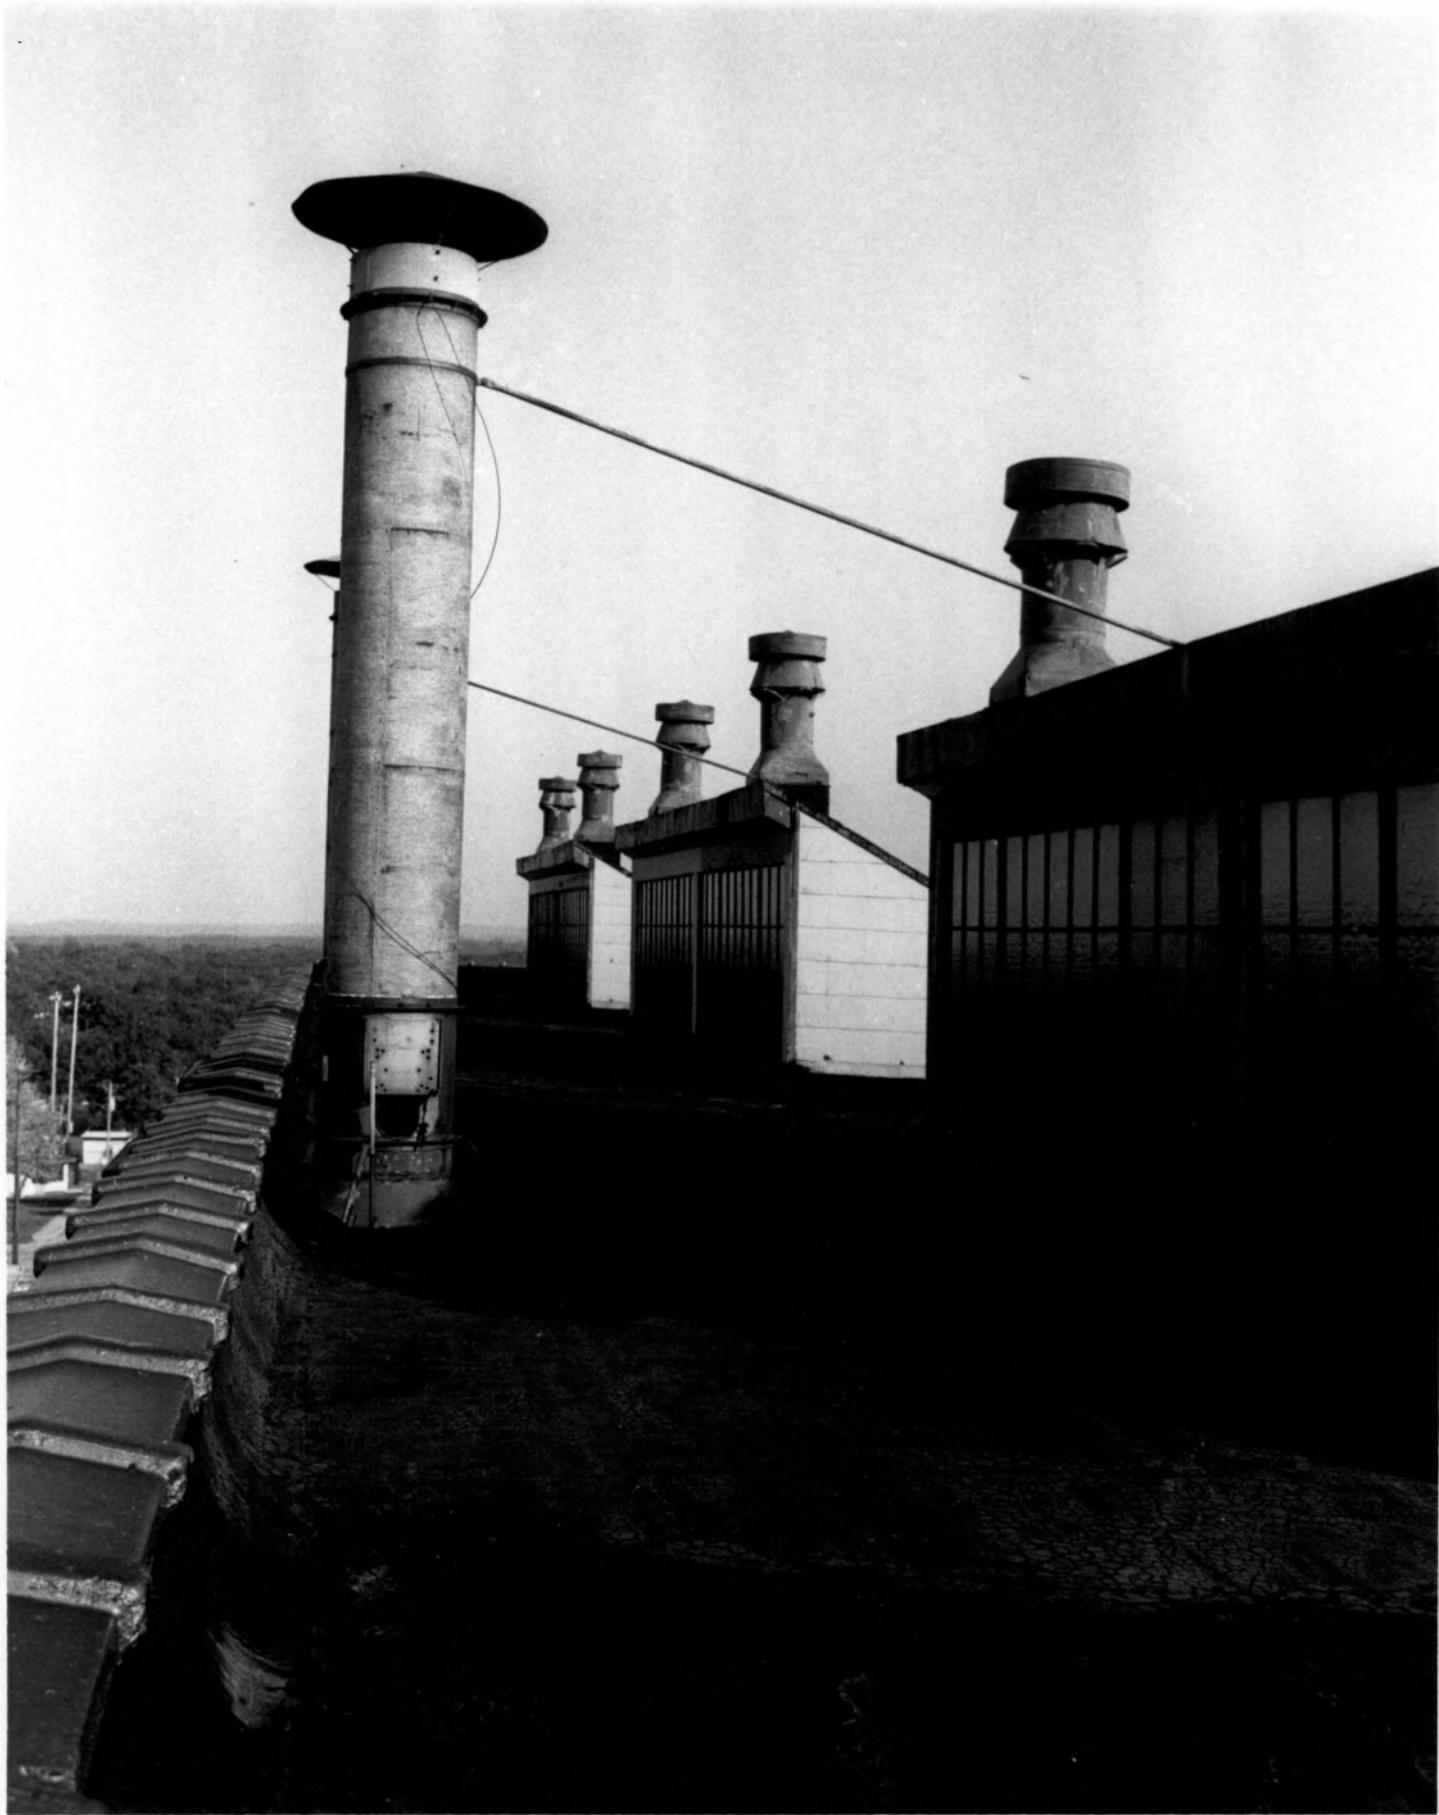
Photo No 8

EXTERIOR VIEW - NORTH SECTION ROOF SHOWING SKYLIGHT FENESTRATION  
CAMERA FACING EAST

All machinery has been removed from the building; however, the pulley belts for machinery remain in the ceiling of the first floor of the north elevation (photo #8). Three Modine heaters used originally for oil heating remain in place throughout the entire building. Presently the first floor is heated by forced air natural gas furnaces and preparation has been made to extend this type system to other floors as they are occupied. Exhaust fans for the spraying booths remain on the third floor of the northern section.

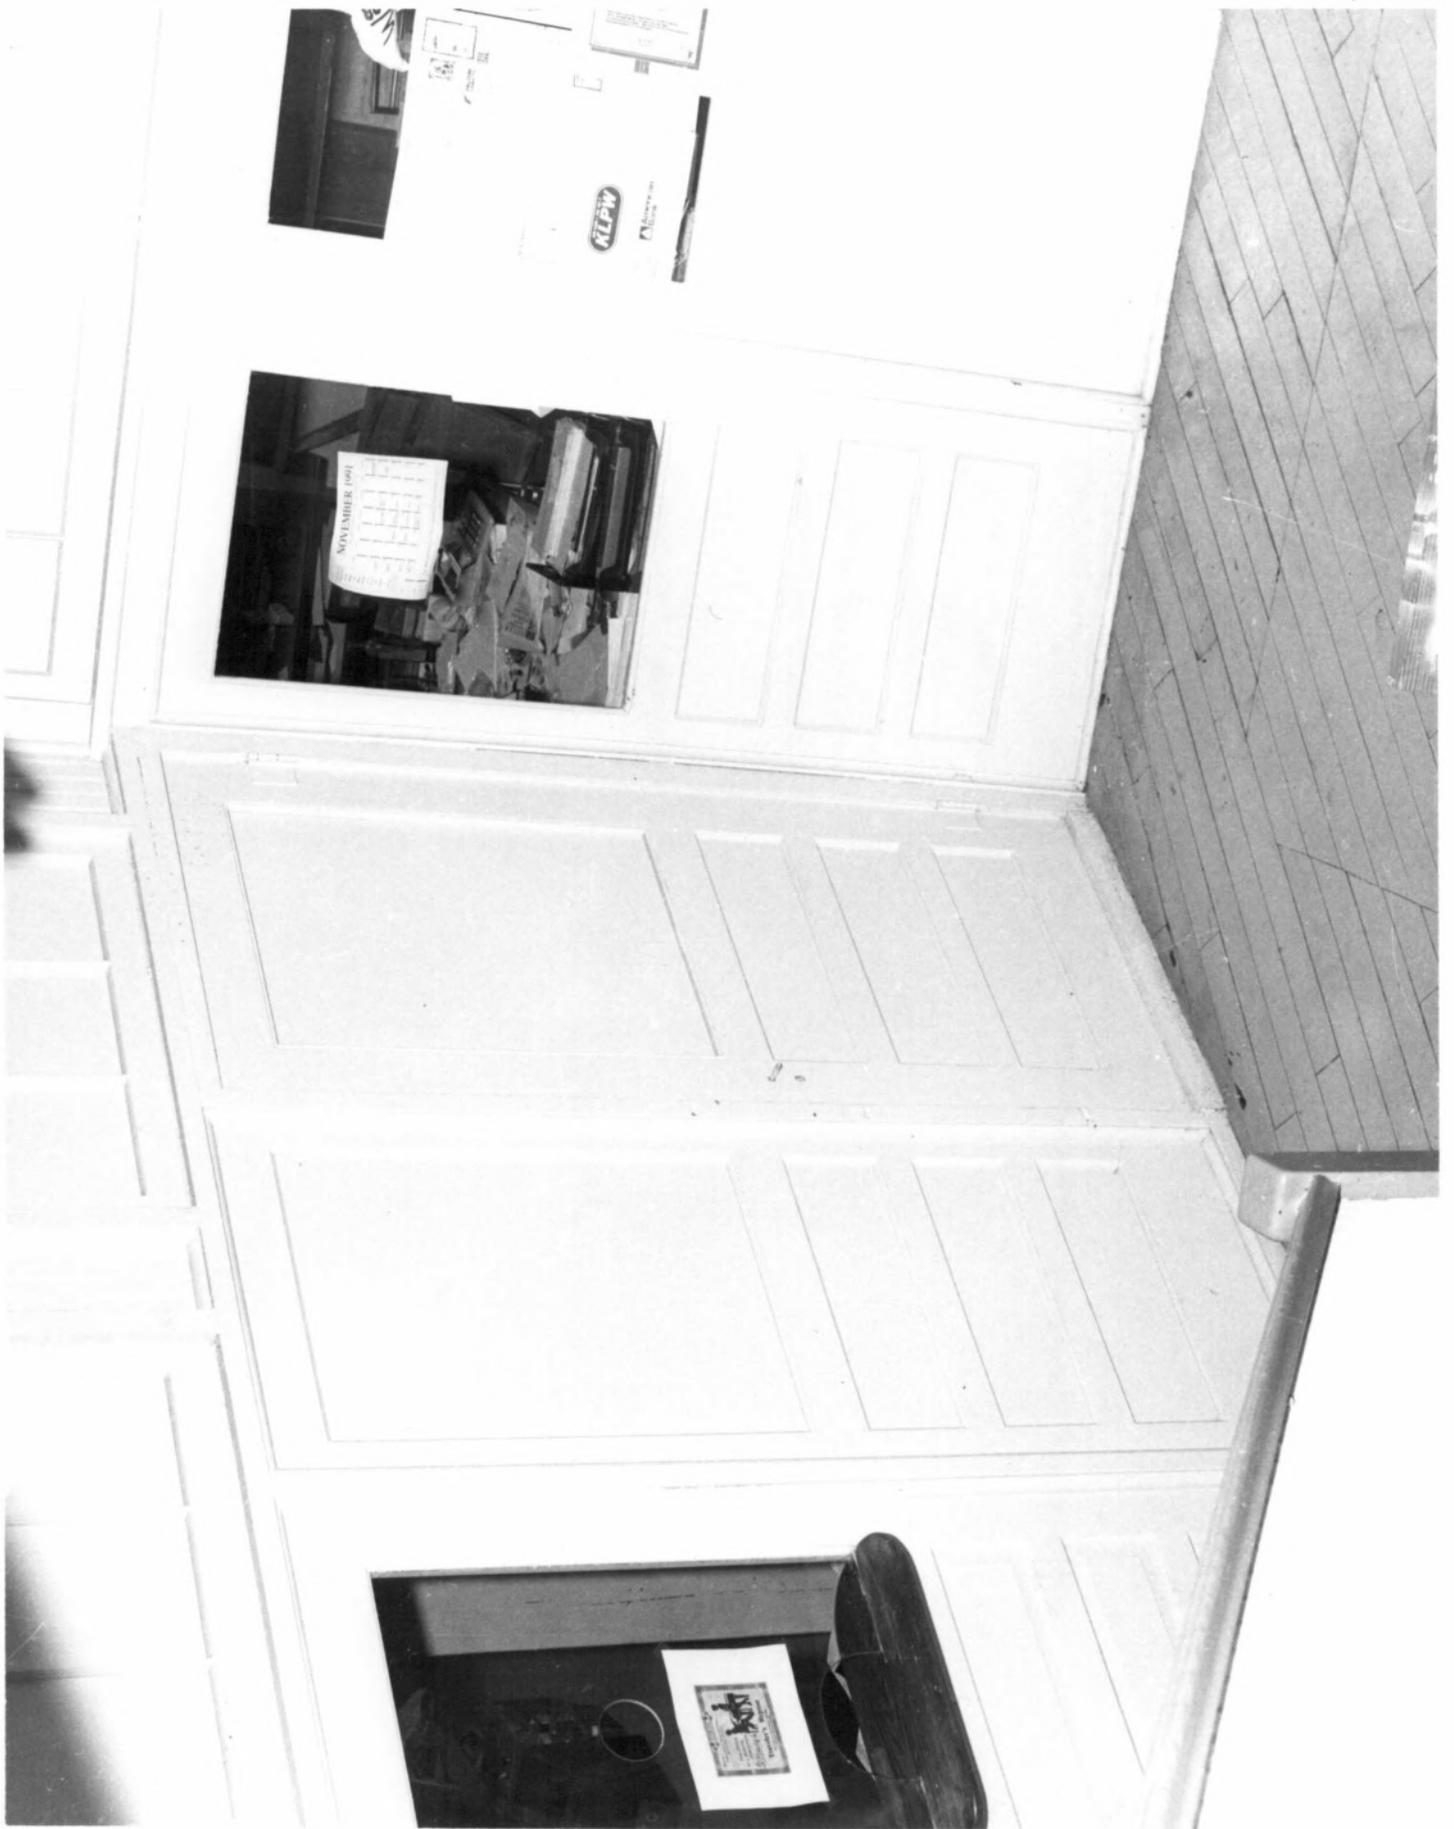
Photograph No 11

FIRST FLOOR INTERIOR - WEST HALLWAY FROM STAIRS SHOWING EXTERIOR  
WALLS 6F OFFICE

CAMERA FACING SOUTHEAST

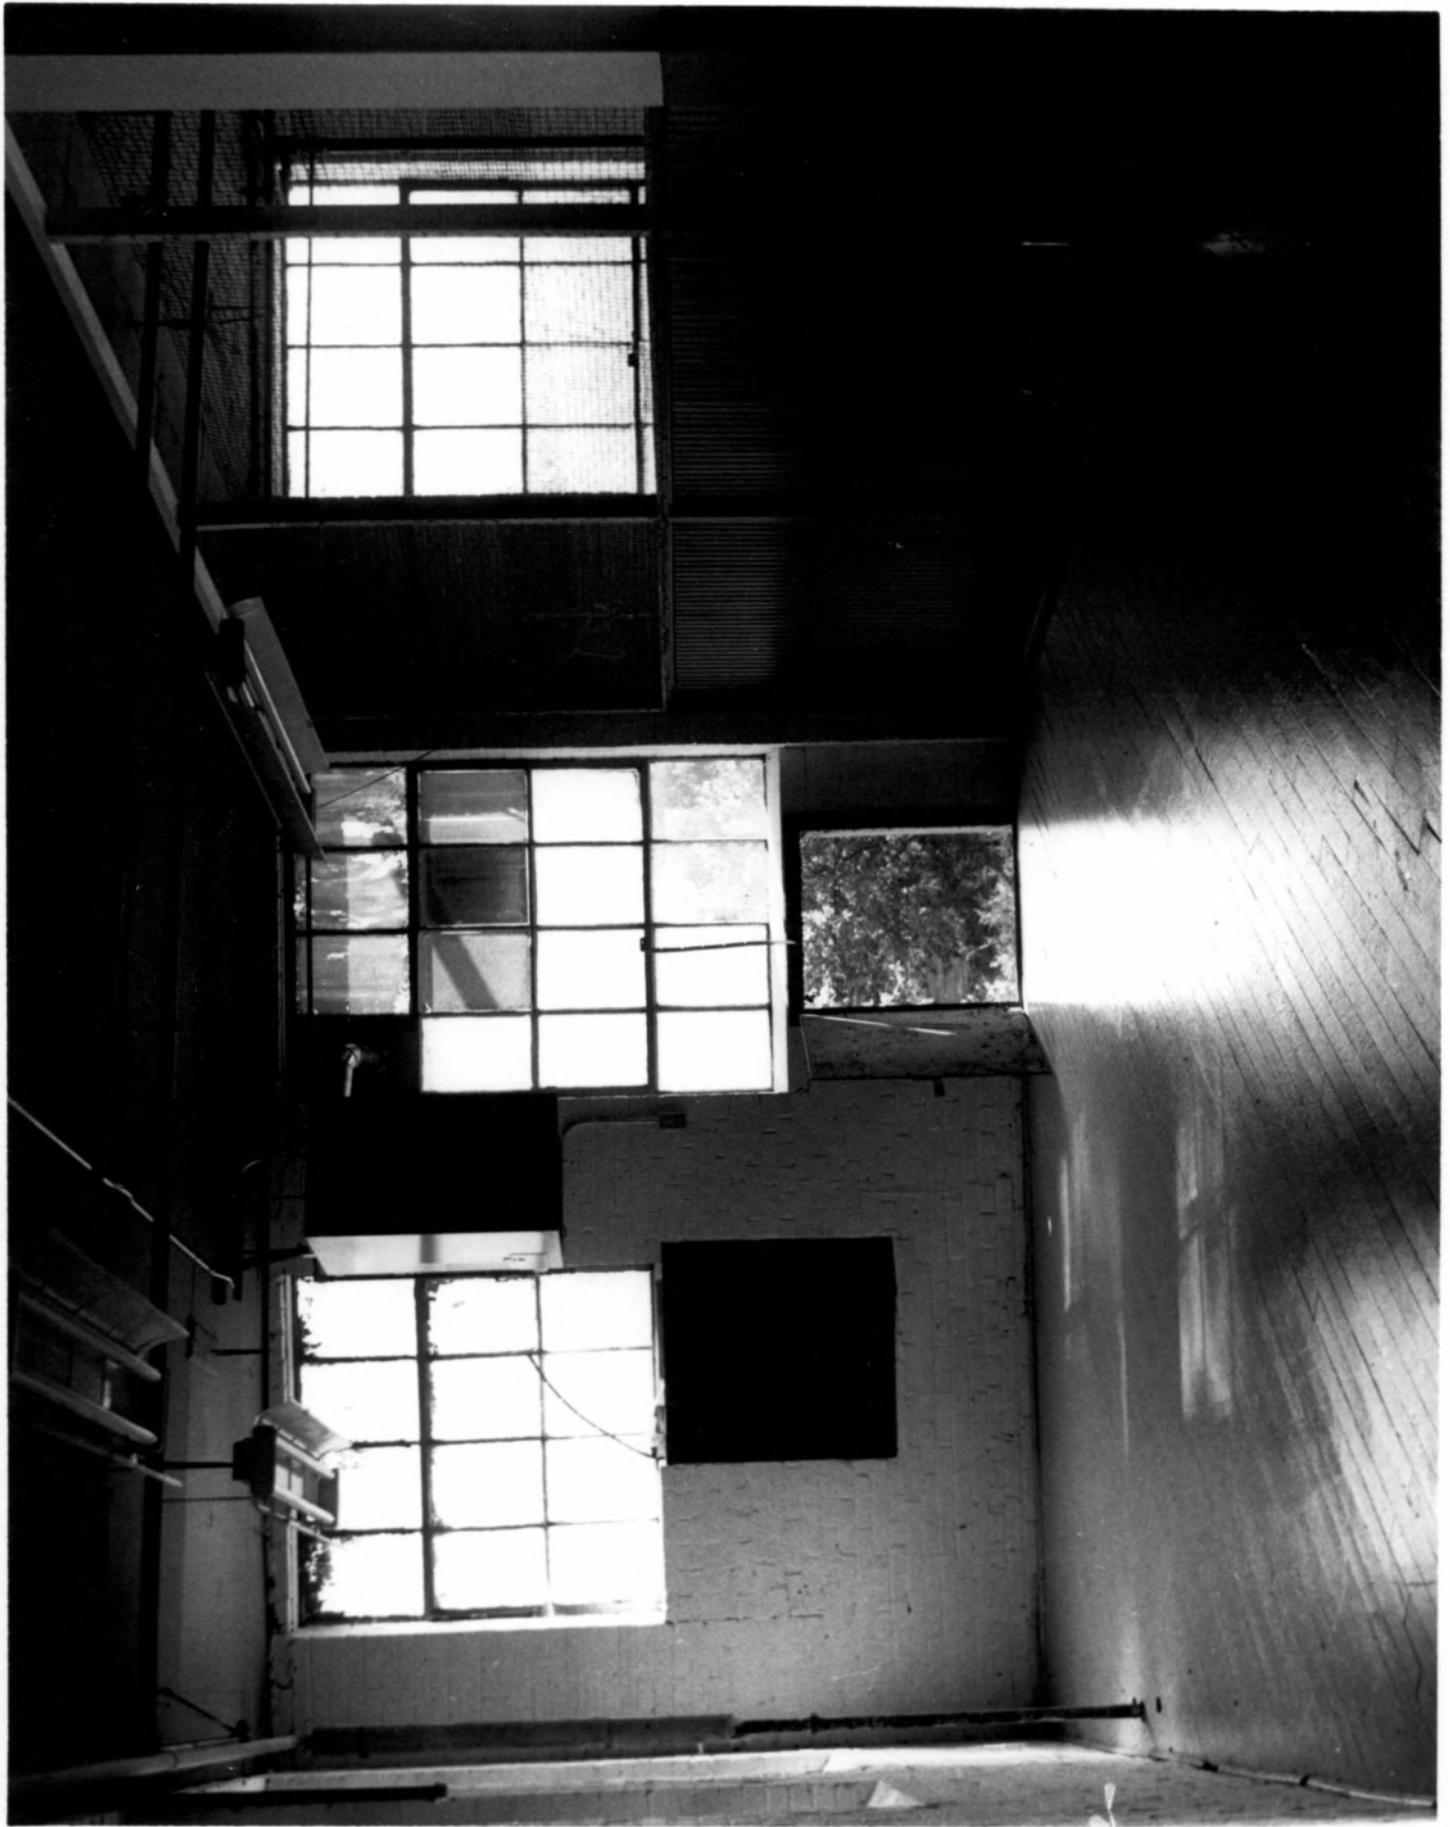
Photograph 12

FIRST FLOOR INTERIOR OF SOUTHEAST SECTION SHOWING TRAPDOOR USED  
PREVIOUSLY FOR LOADING RAILROAD FREIGHT CARS

CAMERA FACING EAST

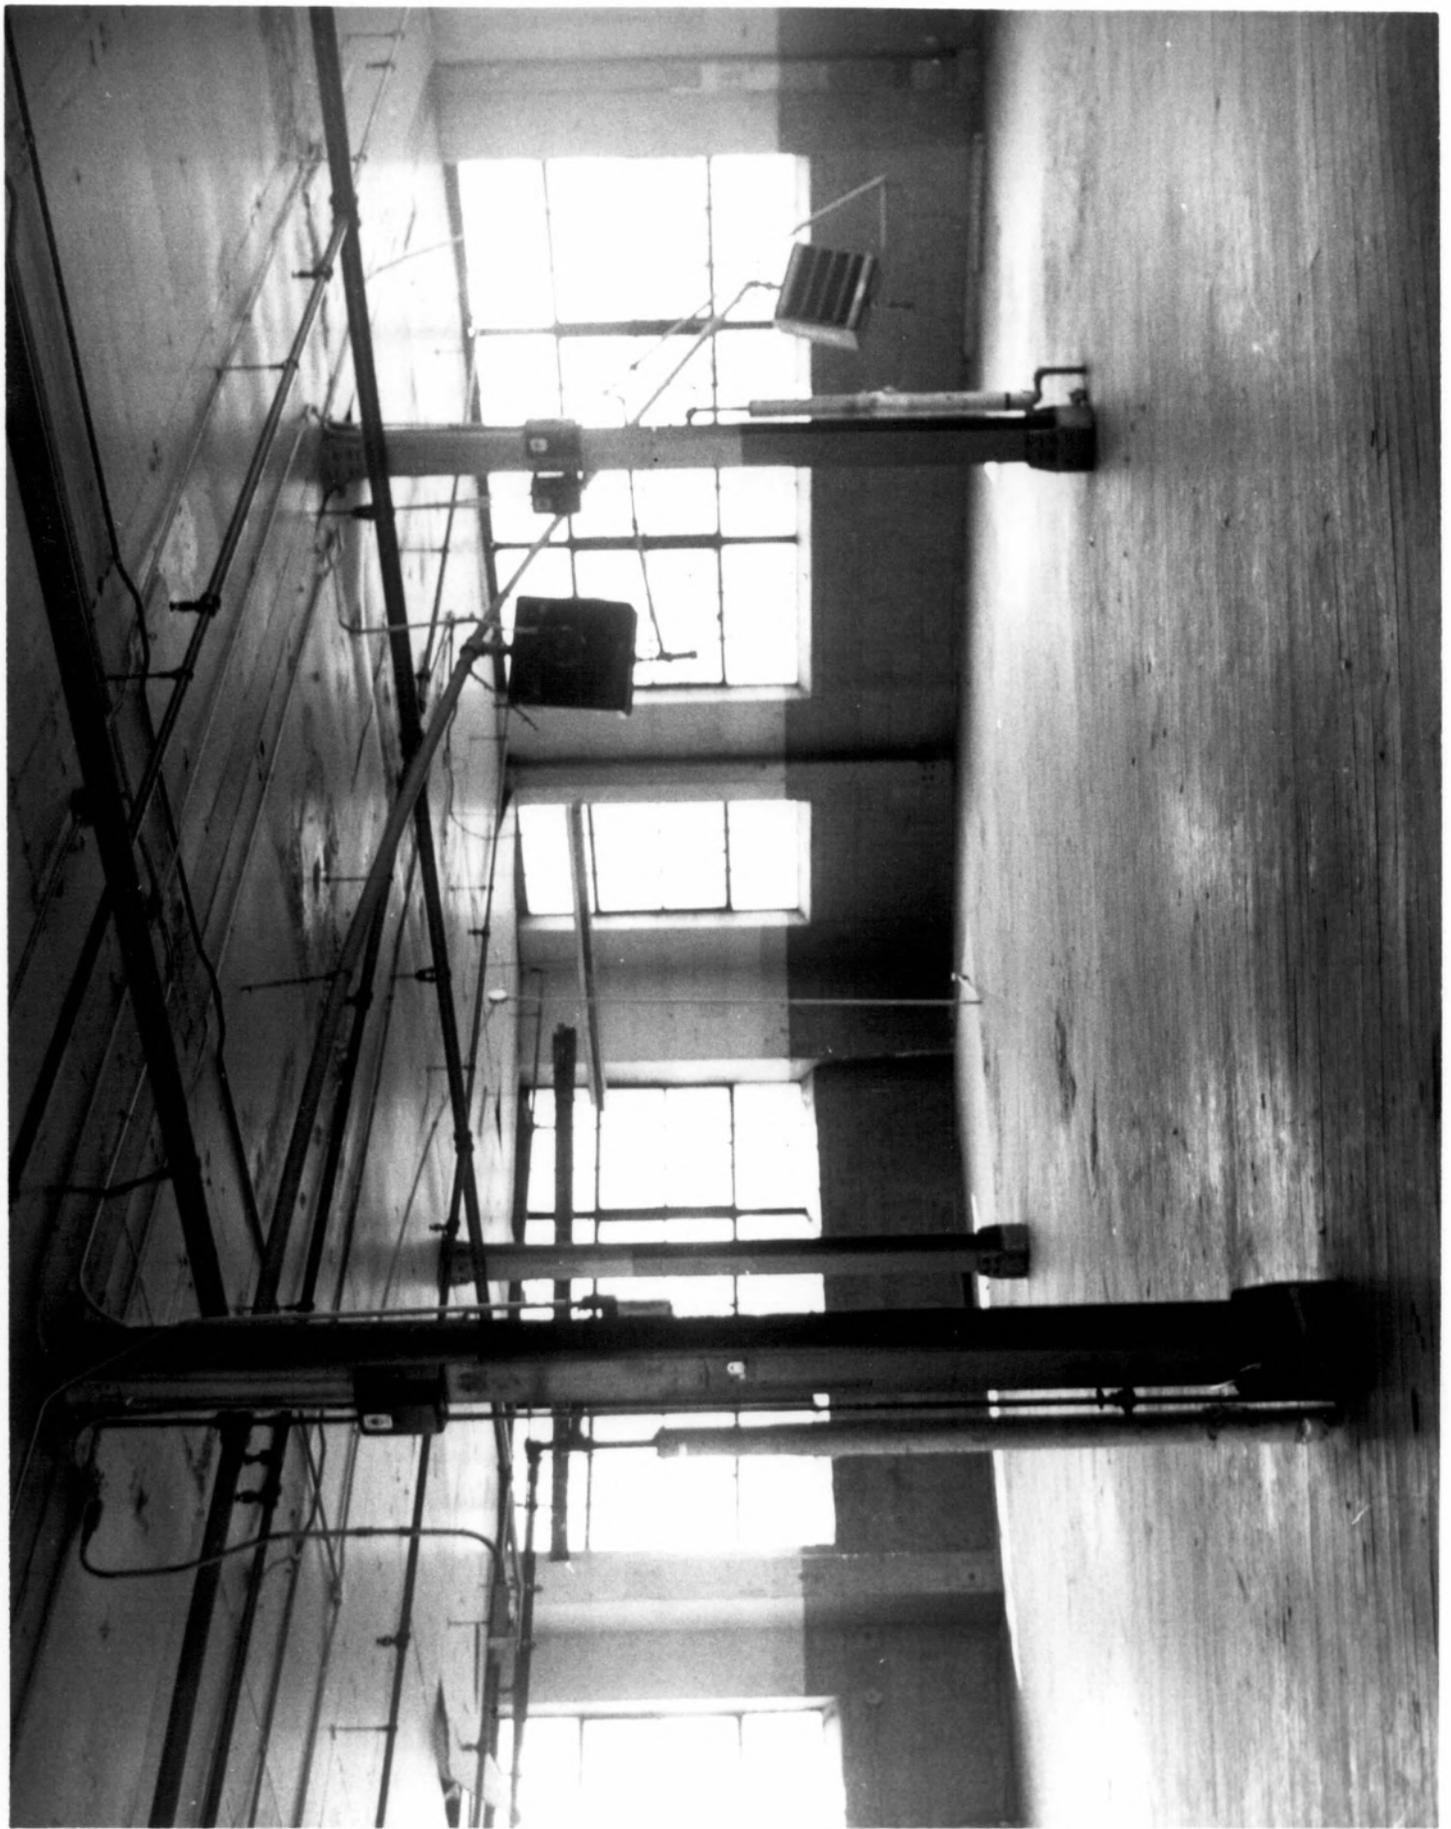
Photograph No 13

2ND FLOOR INTERIOR OF SOUTHEAST SECTION SHOWING FENESTRATION AND  
STEEL I BEAM SUPPORTS

CAMERA FACING SOUTH

The basement floor of the shoe factory is cast concrete while all upper floors are maple. Wooden beams support the upper floors in all areas except the east-south section, which has steel I-beams. Fenestration in the basement is mostly single opening six-over-six, double-hung sash. The floor layout of the basement duplicates that of the upper floor with one exception - on the extreme southern exposure there is a 15 feet by 39 feet room attached which houses the heating plant - originally a wood furnace, later replaced by an oil, hot water boiler system. The ceiling in this room is approximately 25 feet high to accommodate heating and exhaust systems. Fenestration in the room is twelve-over-twelve, double-hung sash, sixteen feet above floor level.

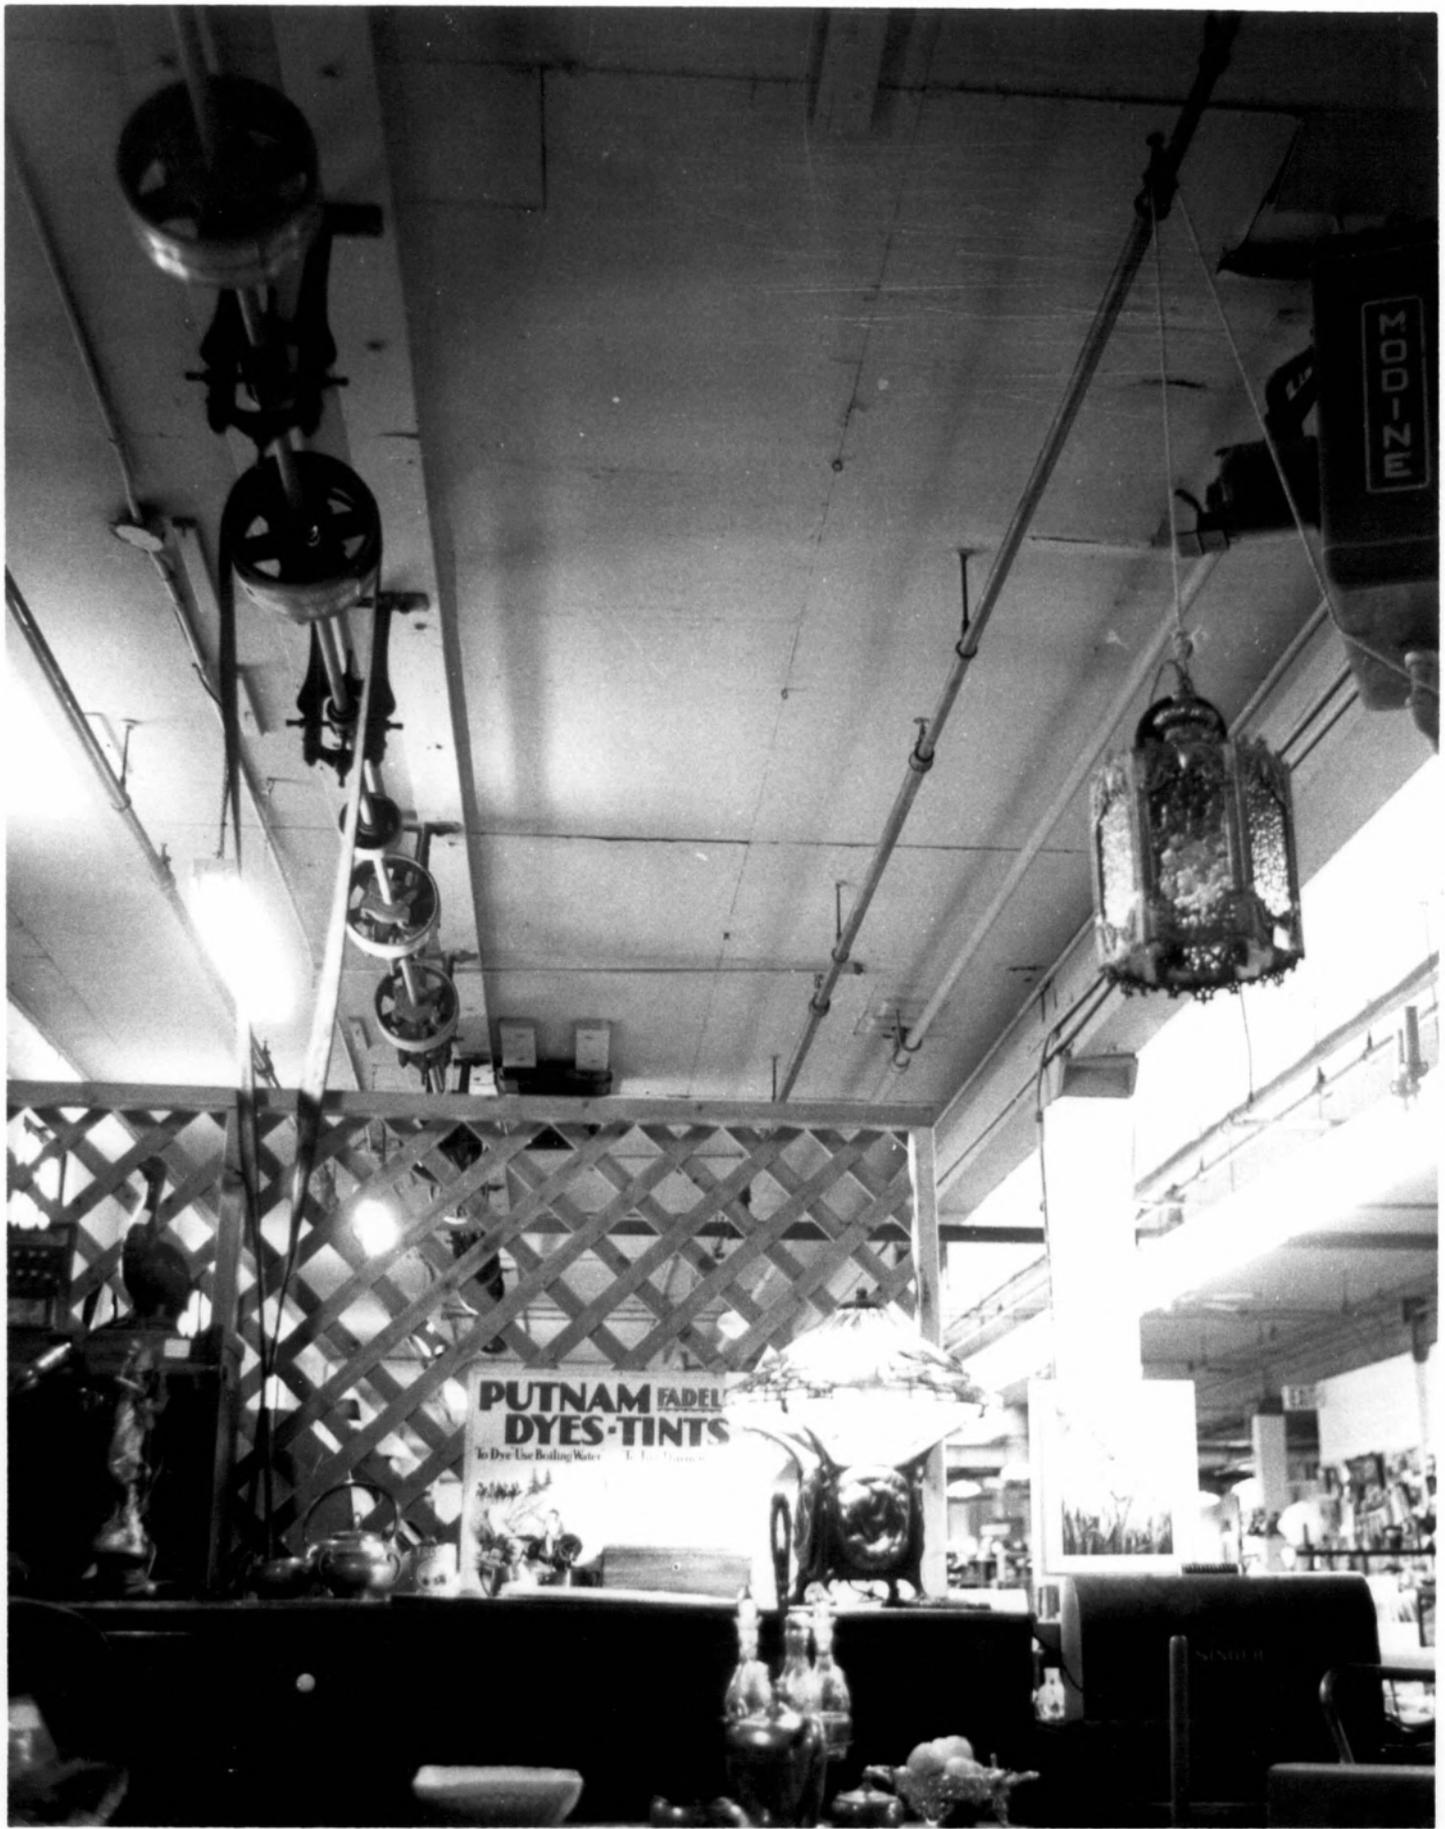
Photograph No. 16

FIRST FLOOR INTERIOR NORTH SECTION SHOWING DULLEY BELT MACHINERY  
AND MODINE HEATER

CAMERA FACING EAST

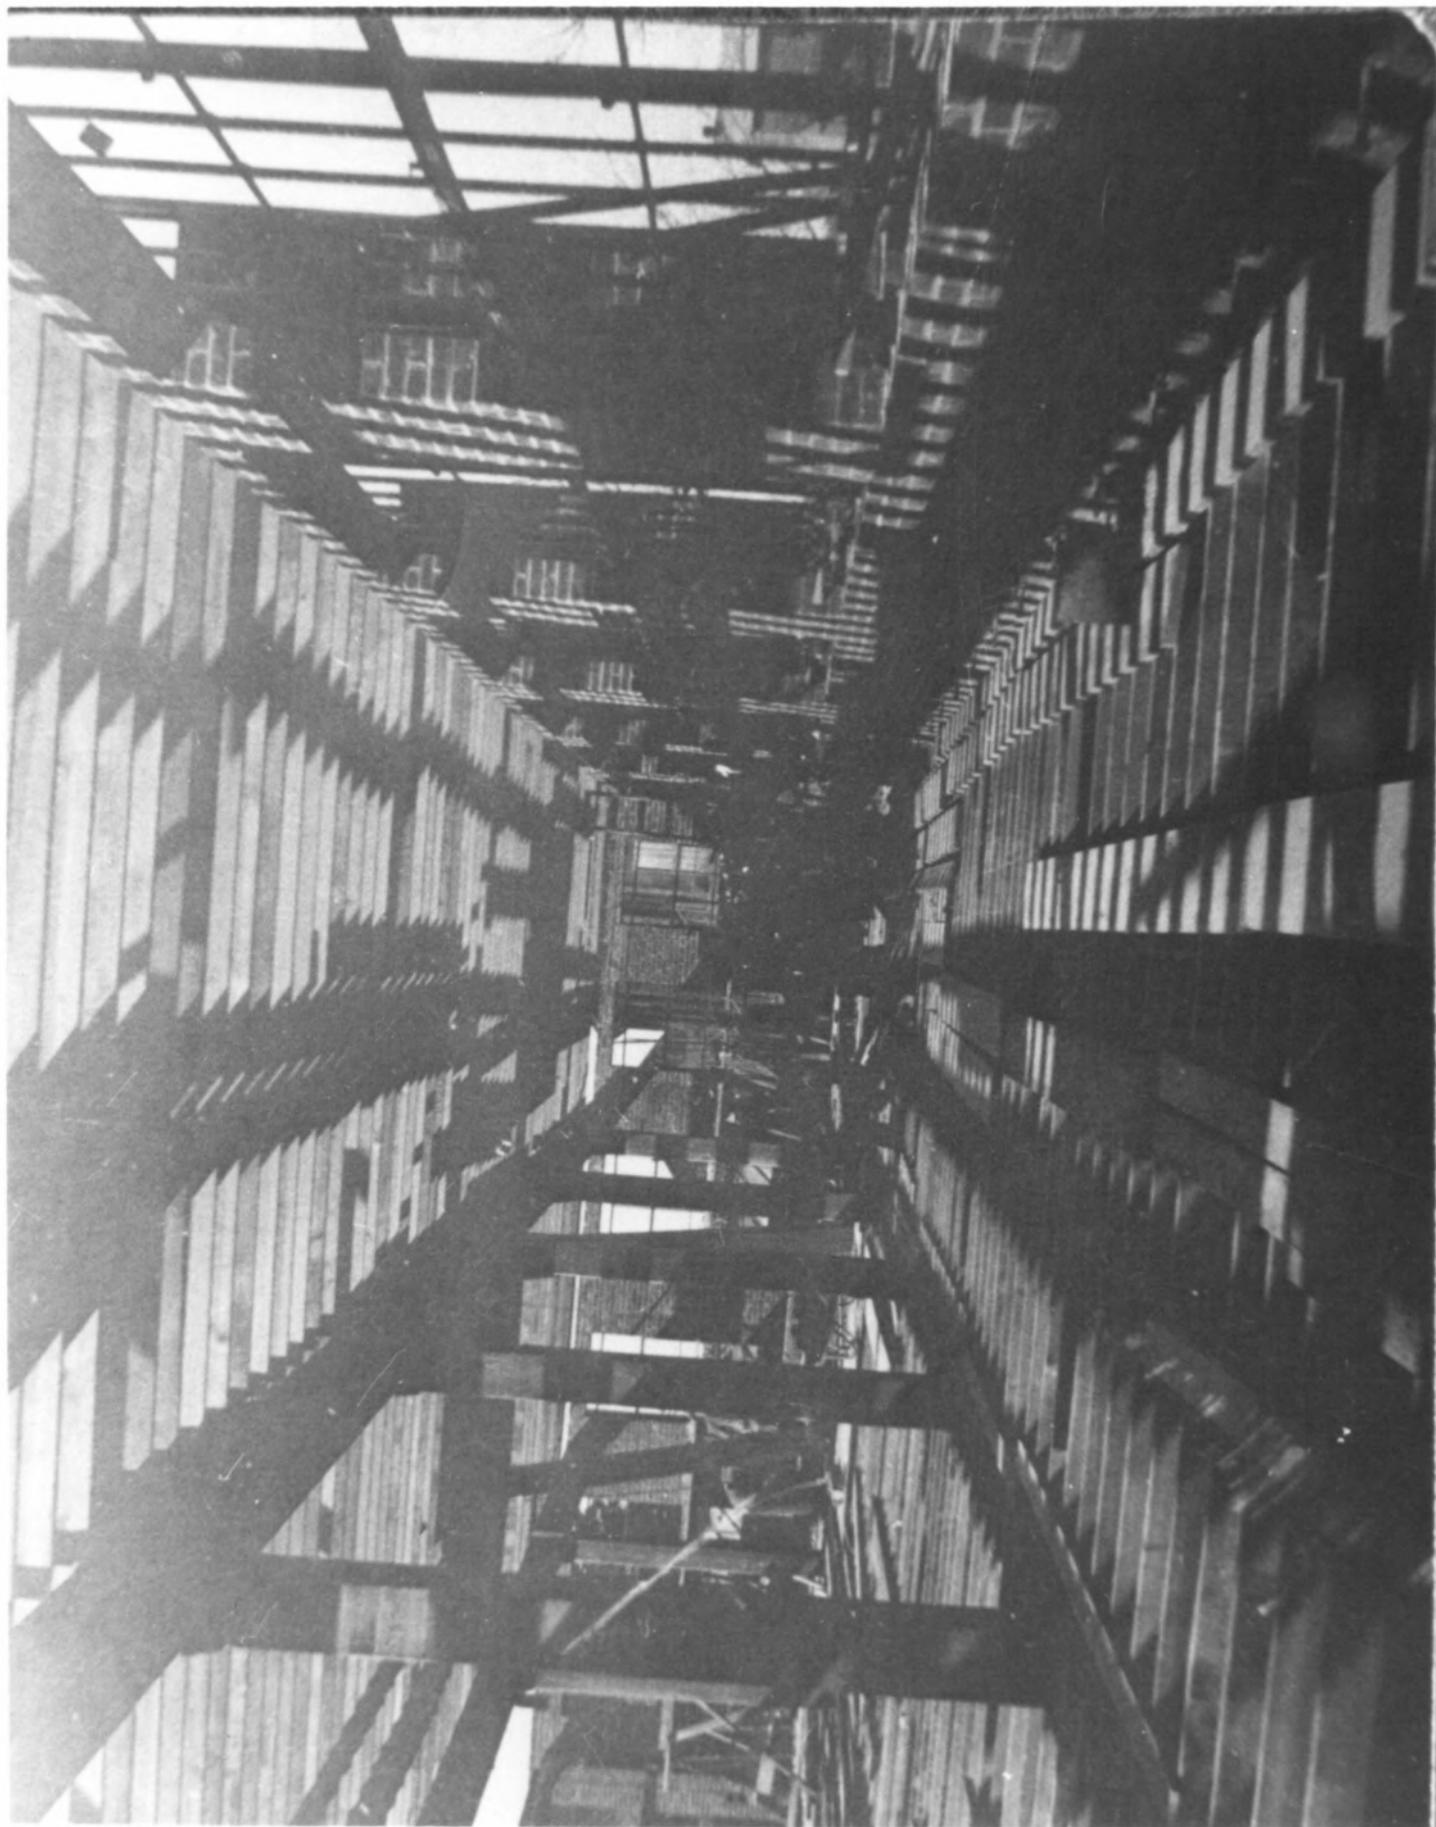
Photograph No. 21

INTERIOR VIEW NORTH SECTION UNDER CONSTRUCTION  
CAMERA FACING WEST
