National Register of Historic Places
Registration Form

historic name The Kessler Apartments

The Kessler Apartments
Jackson County, Missouri
Apartment Buildings on the North End of The Paseo Boulevard in Kansas City, Missouri

7. Narrative Description

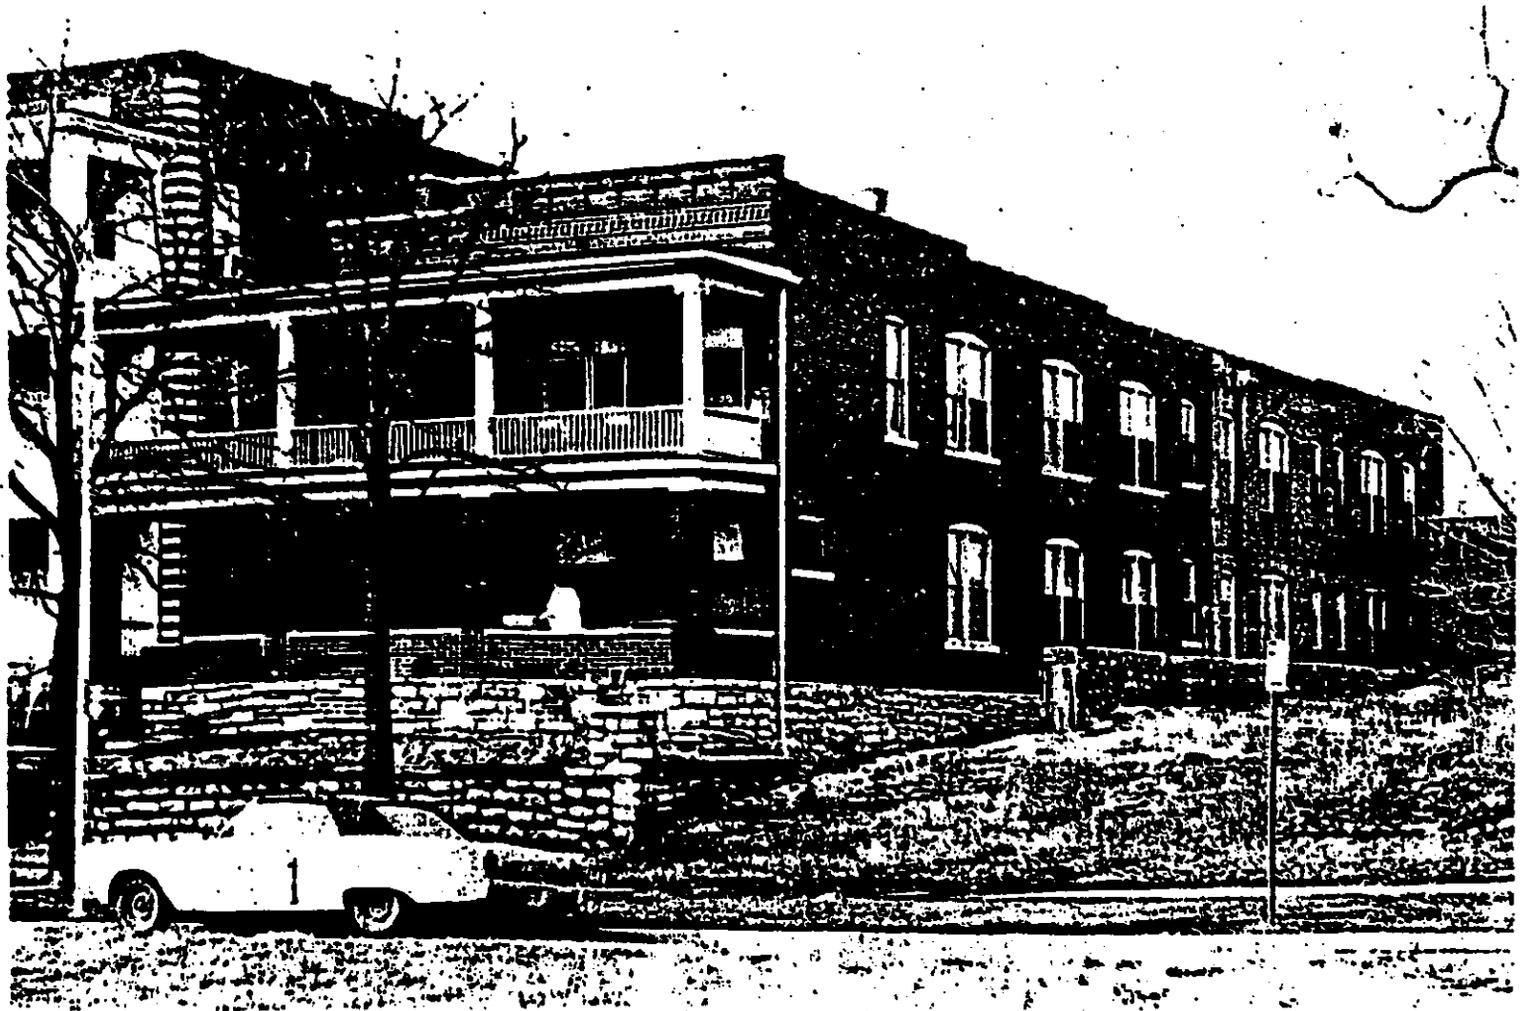
Figure 2. 924 Paseo, Photograph from 1975 Drawings for HUD Remodeling, William Johnson, Architect

FIG. 924 PASEO
#2 1975 Drawings for HUD
Remodeling
William Johnson, Architect

The HUD rehabilitation in 1975 involved the replacement of porch railings, windows and doors, as well as extensive interior remodeling to meet contemporary living needs and building codes. There is no existing historic fabric visible on the building's interior. The changes in this building are common modifications as defined in the property type registration requirements. These modifications do not sufficiently affect the integrity of the property to cause it to be ineligible for listing.
