National Register of Historic Places
Registration Form

historic name Kirkwood Building

street & number 1737-41 McGee Street [n/a] not for publication

**National Register of Historic Places
Continuation Sheet**Section 7 Page 1**Kirkwood Building,
Jackson County, Missouri****SUMMARY**

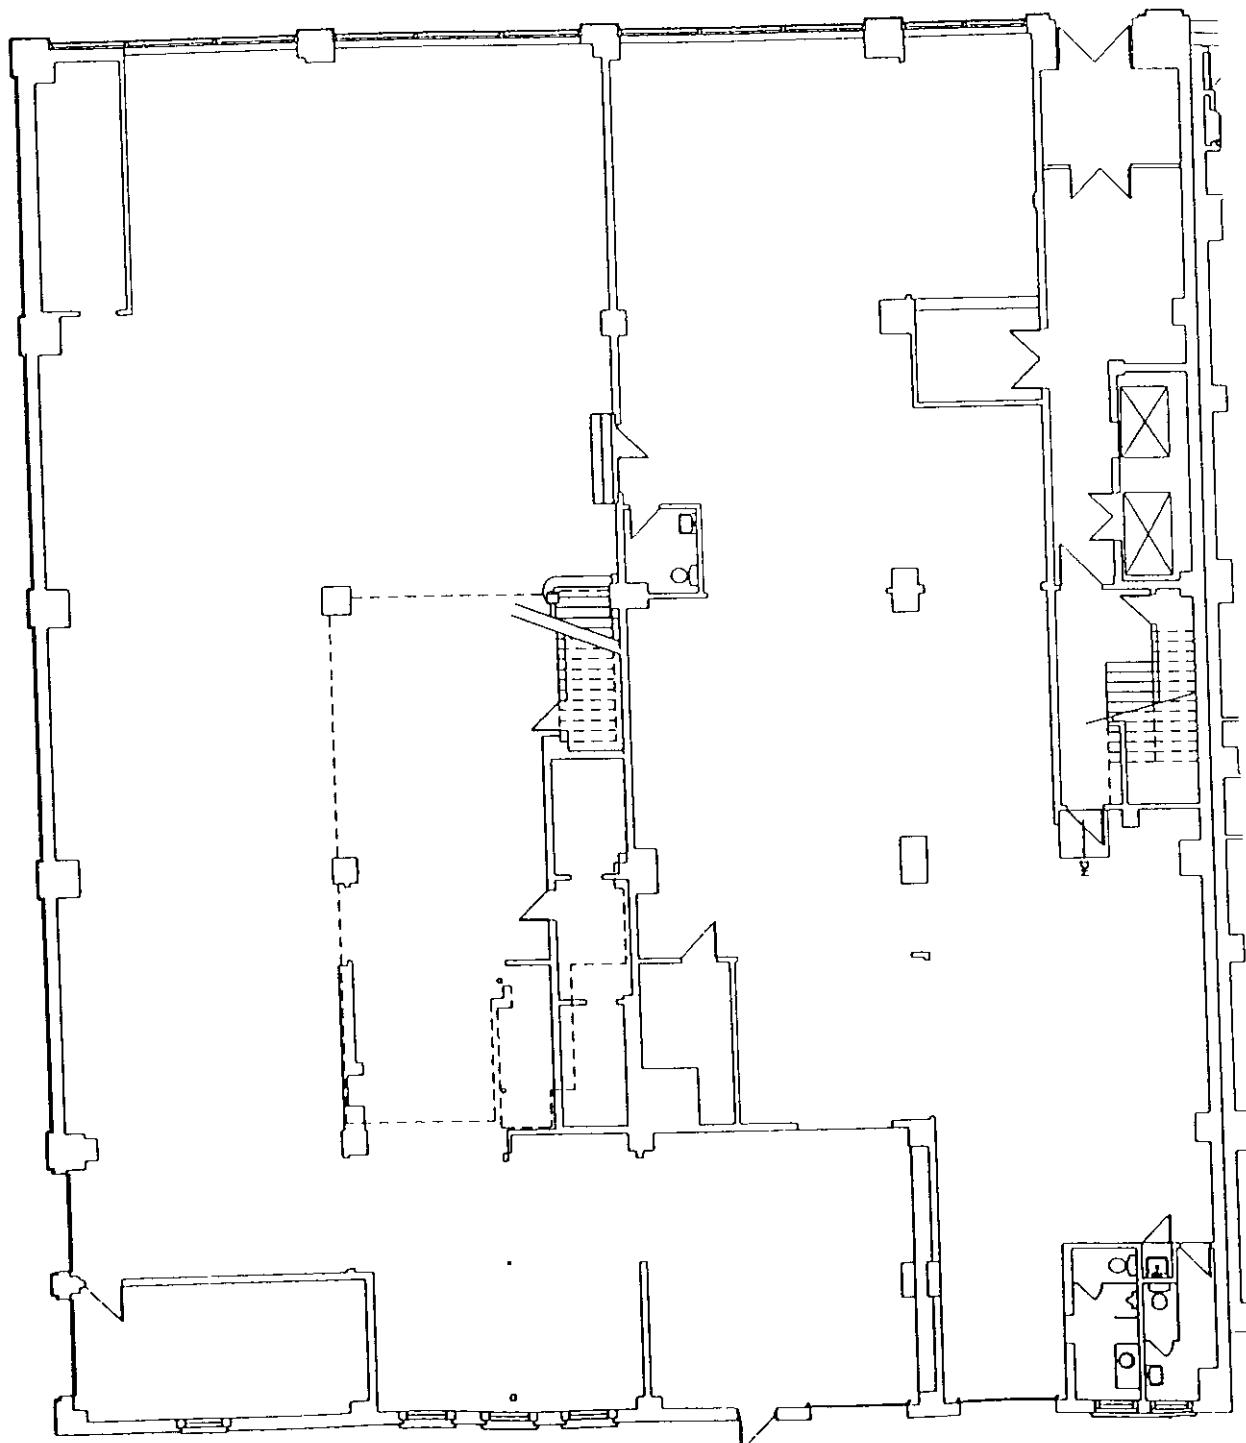
First Floor Plan

Existing Floor Plan
Scale: 1/16"=1'-0"

The interior of the building remains largely intact. Few alterations have been made to its historic fabric. The first floor areas have had little alteration. The floor in the original display room is a grid of black terrazzo with inlaid sections of Carthage marble and is in very good condition. The original used car department and the additional rental space have their original terrazzo flooring, although a small area of floor has been altered for the installation of a printing press and other equipment. The floor in the original repair shop is concrete and remains intact.
